Annele Matintupa, Seppo Tuisku

SUMMARY OF DRAINAGE ANALYSIS IN SISIMIUT, GREENLAND

Demonstration Project Report

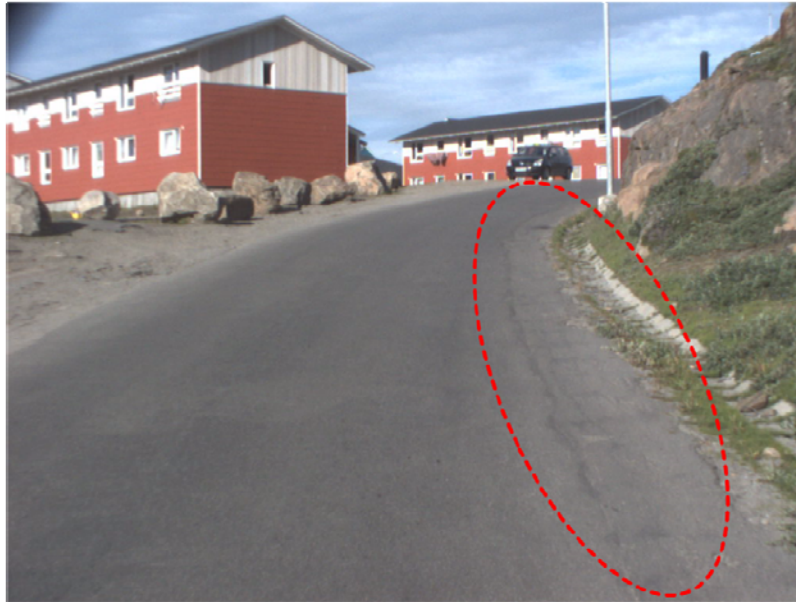
Figure 6. Adammip; Shallow concrete ditch on the upper side of the slope, with damages in the edge of the pavement (marked with red circle).

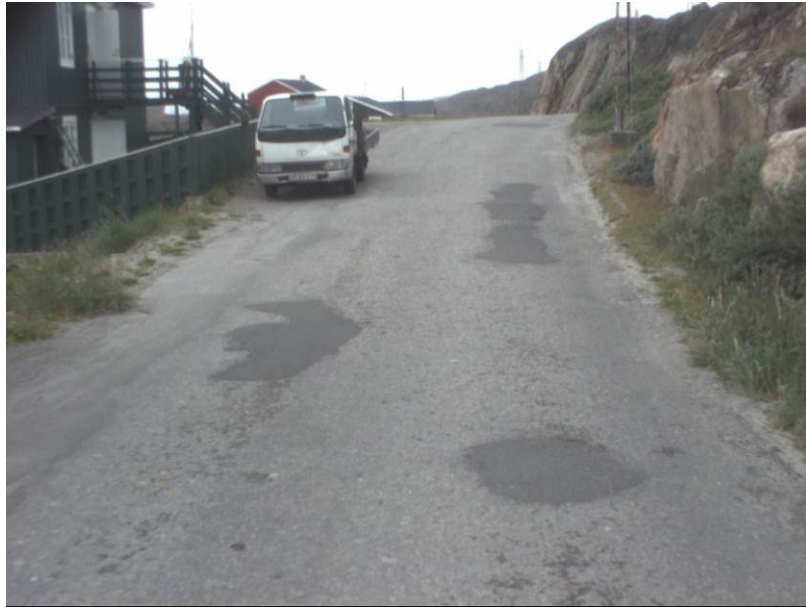
Figure 7. Jooruaqqap; No drainage system on the upper (right) side of the side slope, problems also on the lower (left) side

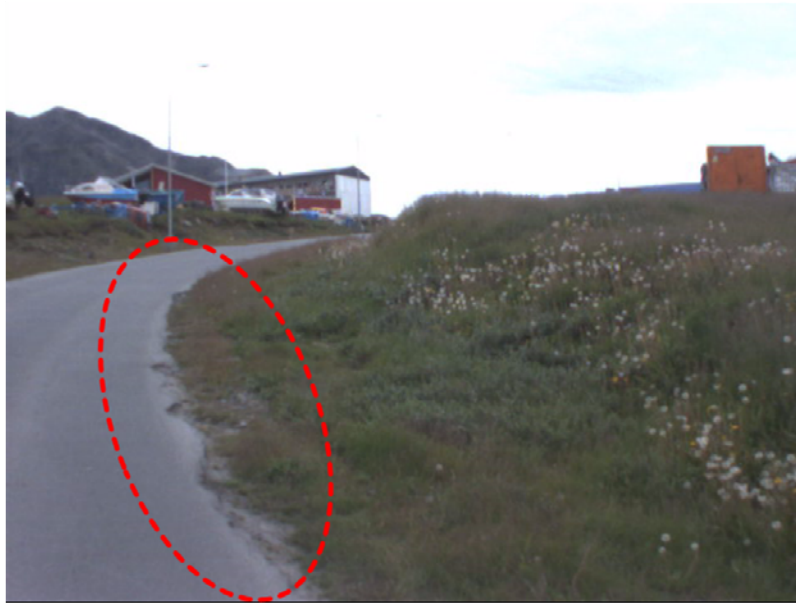
Figure 8. Muunup; No drainage system on the upper side (right) of the steep side slope, damages in the edge of the pavement (marked with red circle).

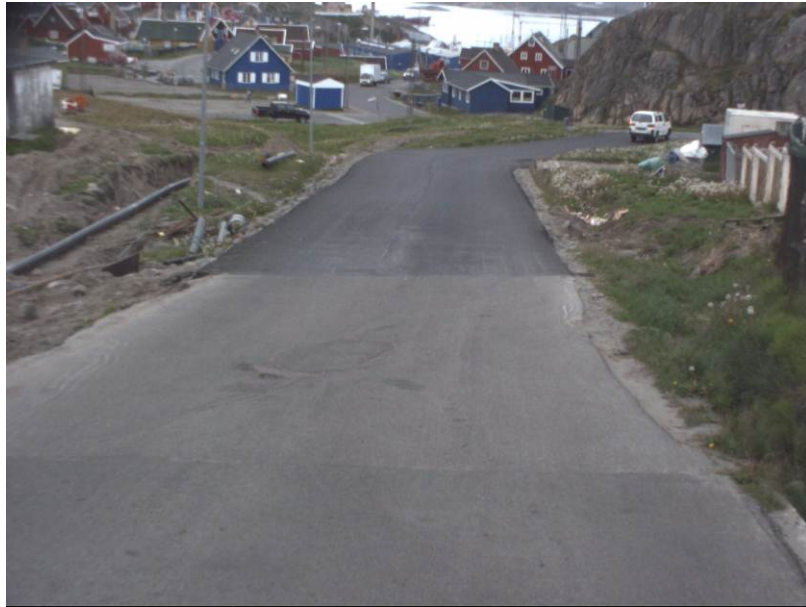
Figure 9. Saamualip; No working drainage on the upper (right) side of the side slope

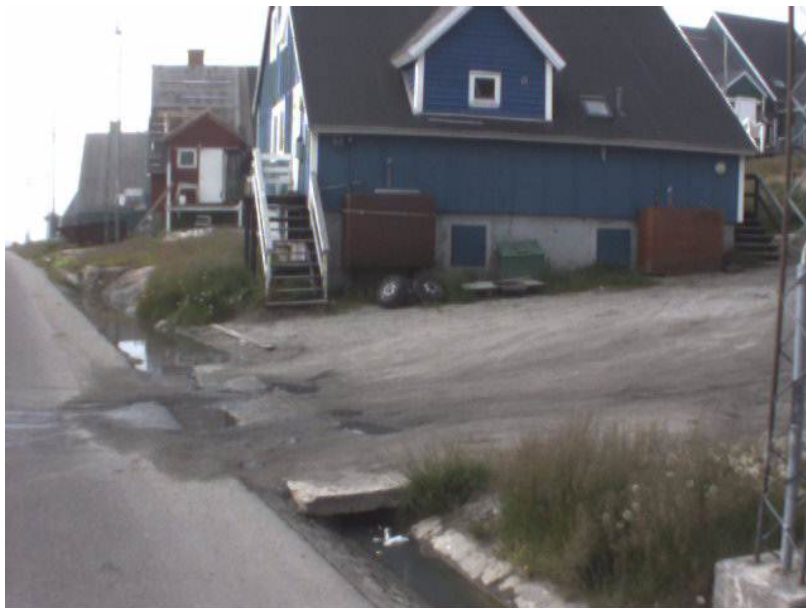
Figure 10. Clogged access road culvert on Jooruaqqaap. Note the water trapped on the upper side of the culvert.

The drainage surveys also revealed that some of the accessing road culverts were clogged with soil and rubbish. In most cases these culverts just need cleaning out, but it is recommended that the condition of the culvert should be checked at the same time, and the culvert replaced if necessary. Typical examples of clogged access road culverts are shown in Figures 10-11.

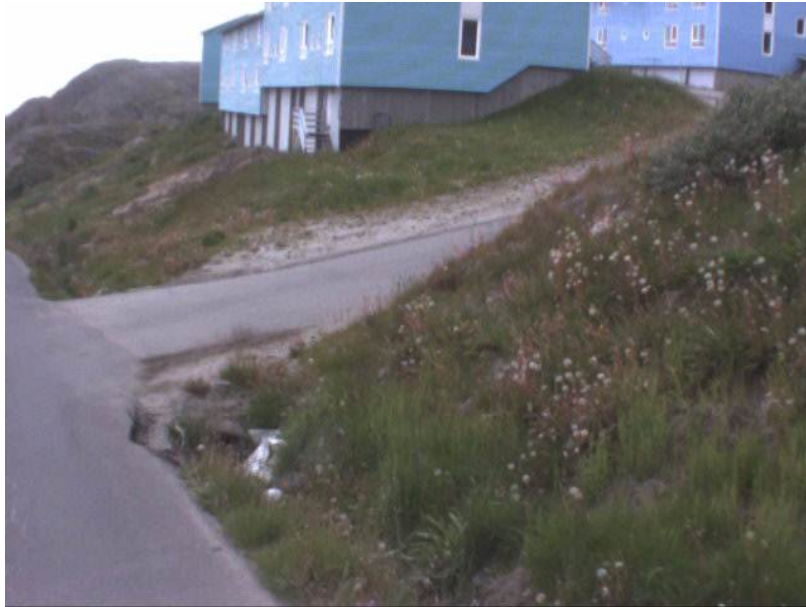
Figure 11: Eggaavimmut; Soil and rubbish in an access road road culvert.

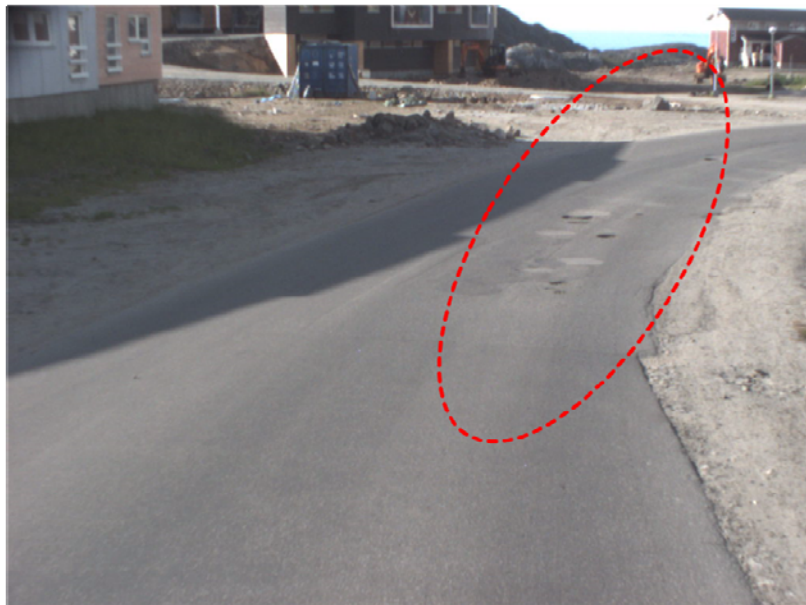
Figure 12. Adammip; no existing drainage system, potholes in the middle of the lane.

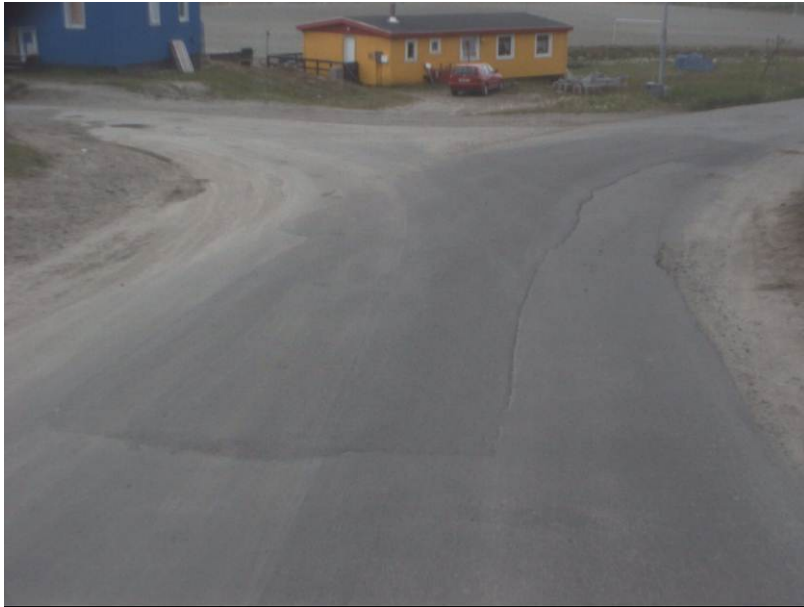
Figure 13. No ditches on both sides of the street in Eggaavimmut

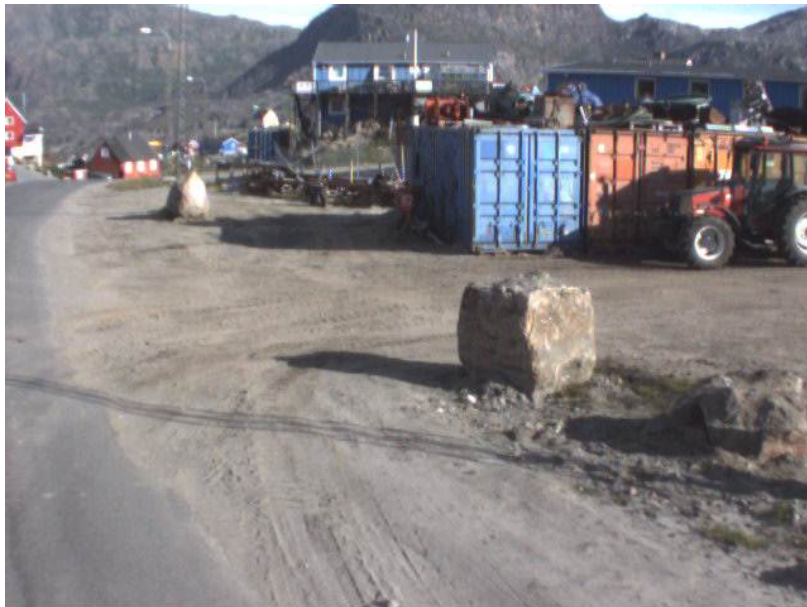
Figure 14. No room for a ditch in Glahnip.

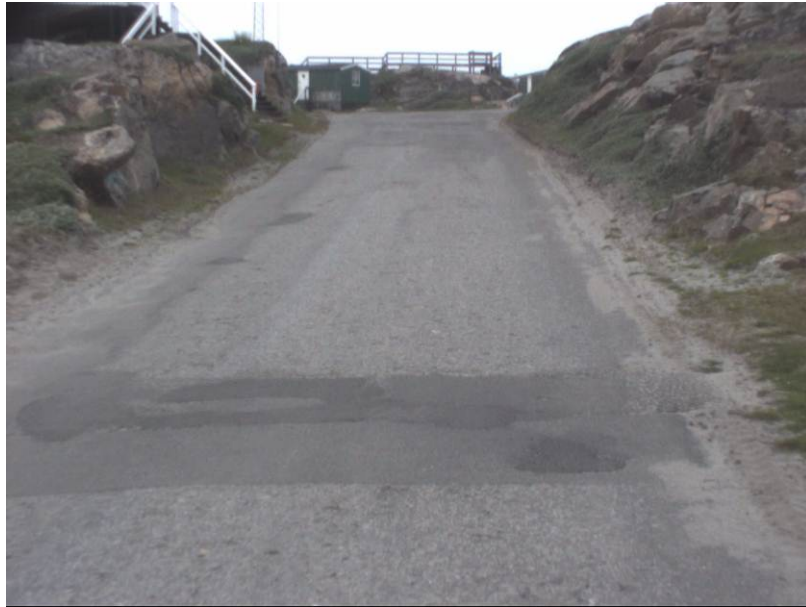
Figure 15. Jooruaqqap; No drainage system in a road cut.

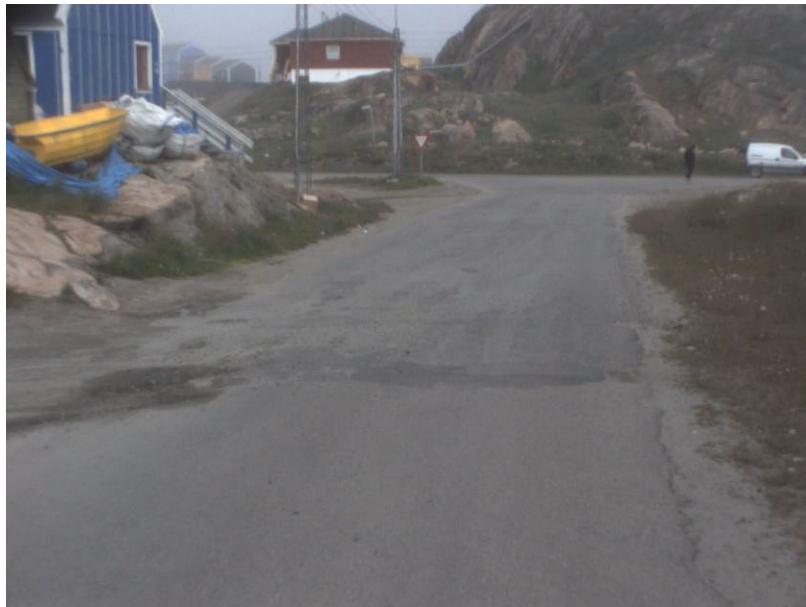
Figure 16. No drainage system in Qiviarfik in a road cut.

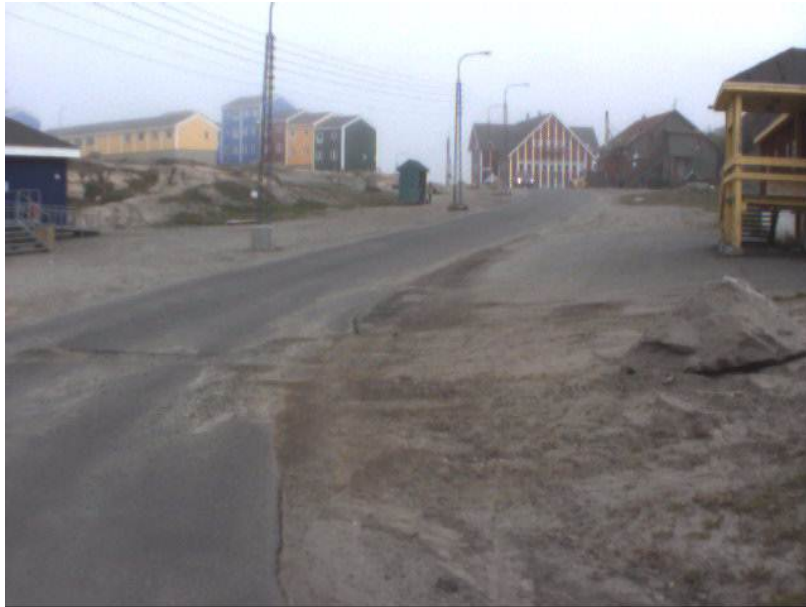
Figure 17. Nikkorsuit; No drainage system

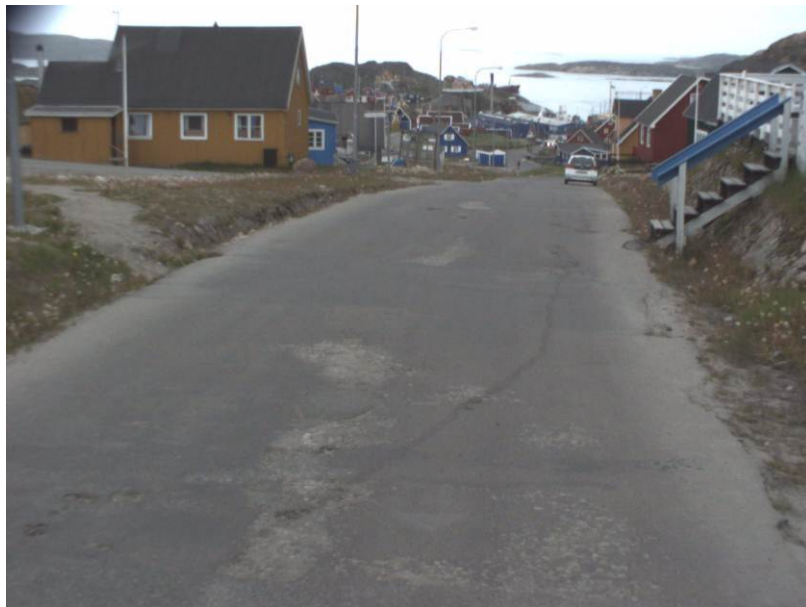
Figure 18. Saamualip; No ditch on the right, the ditch on the left needs cleaning.

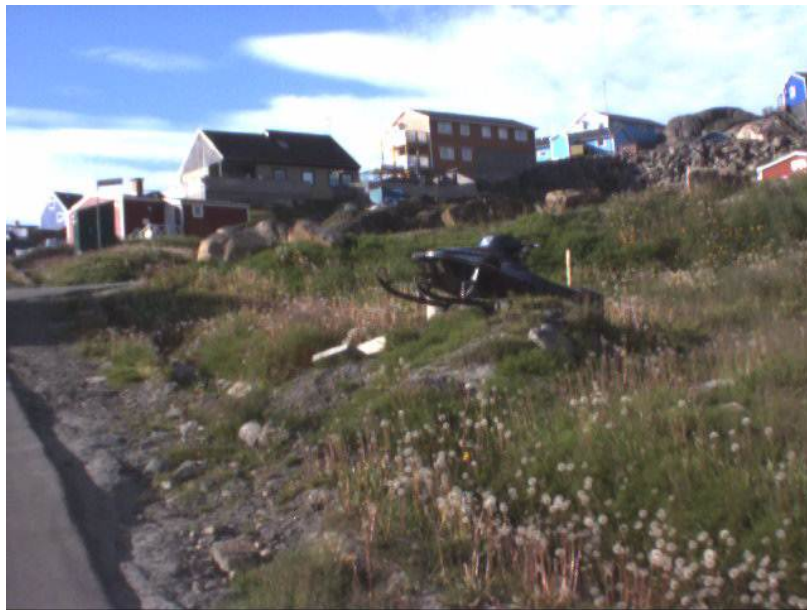
Figure 19. Partly destroyed concrete ditch in Glahnip street.

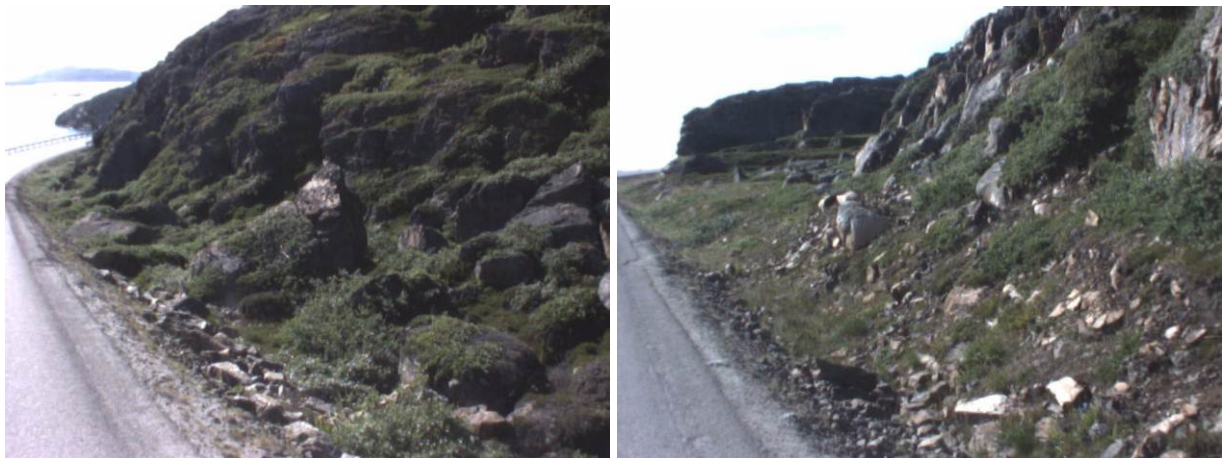
The road to the airport, Asummiunut, was the only road section surveyed outside the urban area. Asummiunut lies on a hillside which makes the road profile mostly side sloping (57%). The general circumstances of the road were the closest to Nordic countries roads and the drainage was found to be in good condition. A total of 81% of the section was classified as being drainage Class 1 and the only drainage deficiencies that were found were partly blocked ditches in the upper side of the slope. Examples of typical drainage deficiencies on the road are shown in Figure 20.

Figures 20. Stones are slowing down the water flow in Asummiunut.

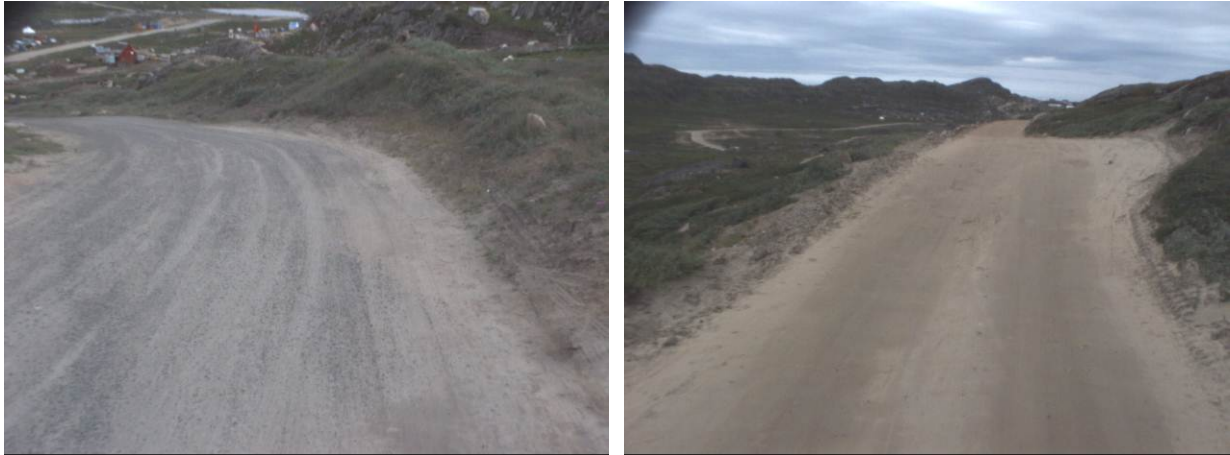
The selected section was mostly in side sloping road profile (81%) and the drainage deficiencies found were fairly typical for the road conditions. This road had long sections without existing drainage system on the upper side of the slope which could cause erosion risks in some circumstances.

Figures 21. Aqqusenersuaq gravel road; No ditch on the upper side of the side slope.

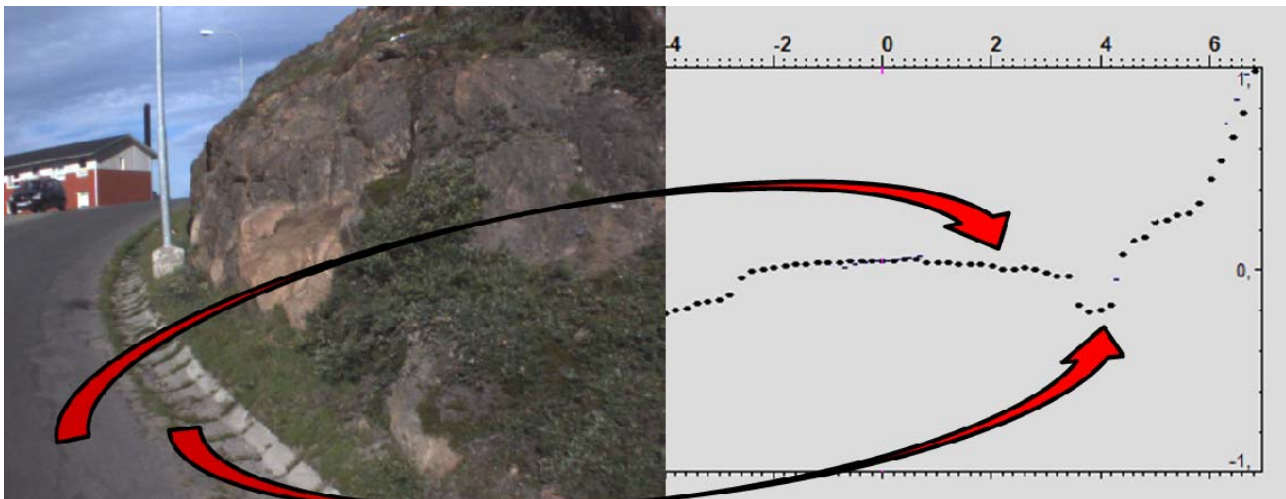
An example from Adammip street, where the rutting on the right is clearly visible in the laser scanner data. The ditch can be seen to be shallow on the road cut side of the cross section (Figure 32).

Figure 32. Cross-section showing laser scanner data from Adammip. The upper red arrows indicates ruts on the right edge of the street and the lower arrow indicates the shallow ditch. Both features can be clearly seen in the output from the laser scanner.

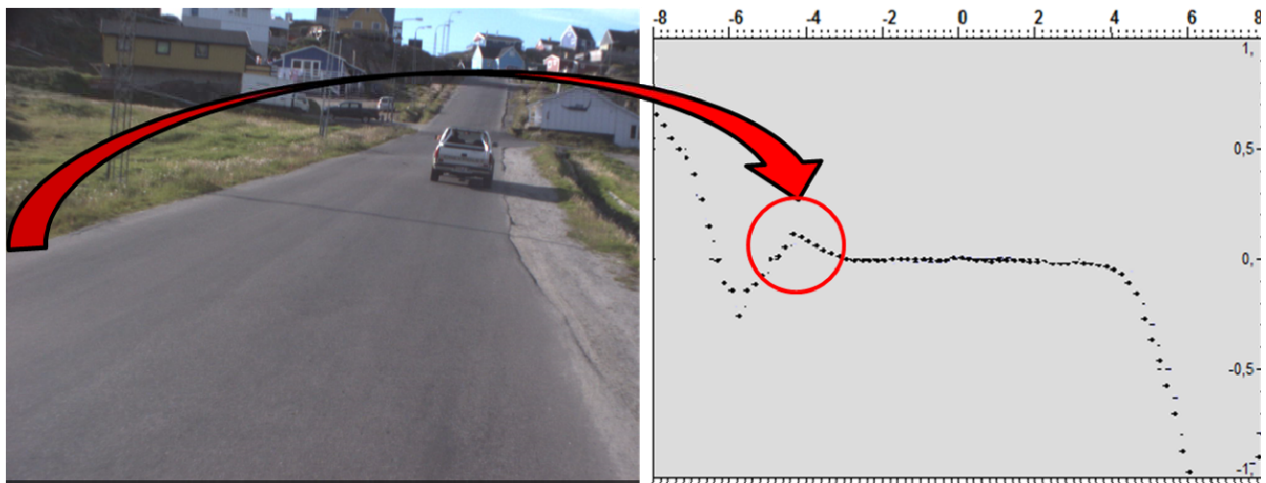
Verges were not a significant problem on the surveyed street sections. Some street sections with verges were detected and they could also be seen in the laser scanner data. Figure 3 shows an example of a high verge from Glahnip Street.

Figure 34. Cross-section showing laser scanner data from Glahnip; The high verge on the left edge can also be clearly seen in the output from the laser scanner.

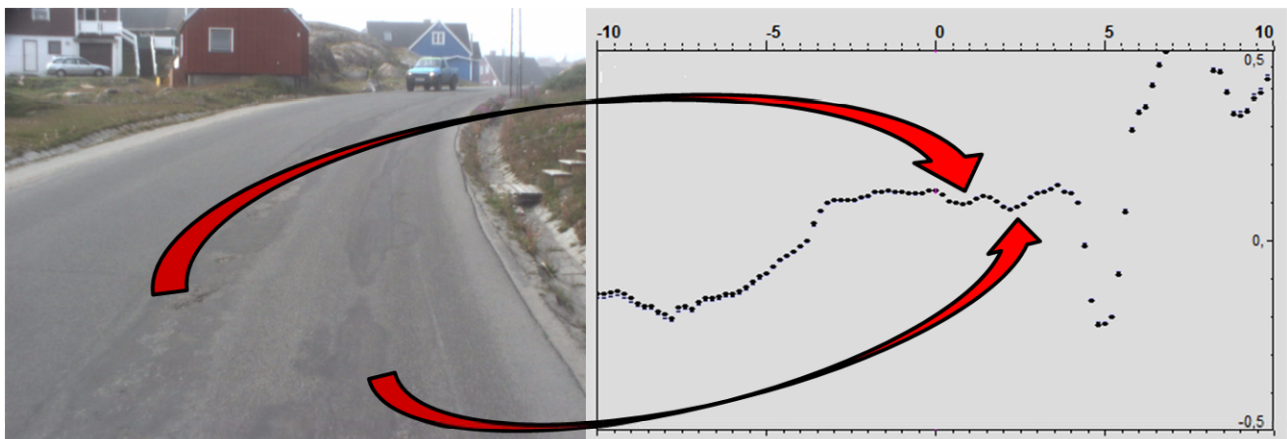
On Kaaliikassaap the road profile comprised a road cut and on the right bend there was deep rutting. The ditch on the right hand side was in acceptable condition.

Figure 35. Cross-section showing laser scanner data from Kaaliikassaap. Major rutting is present and can be clearly seen both in the output from the laser scanner and the digital video.

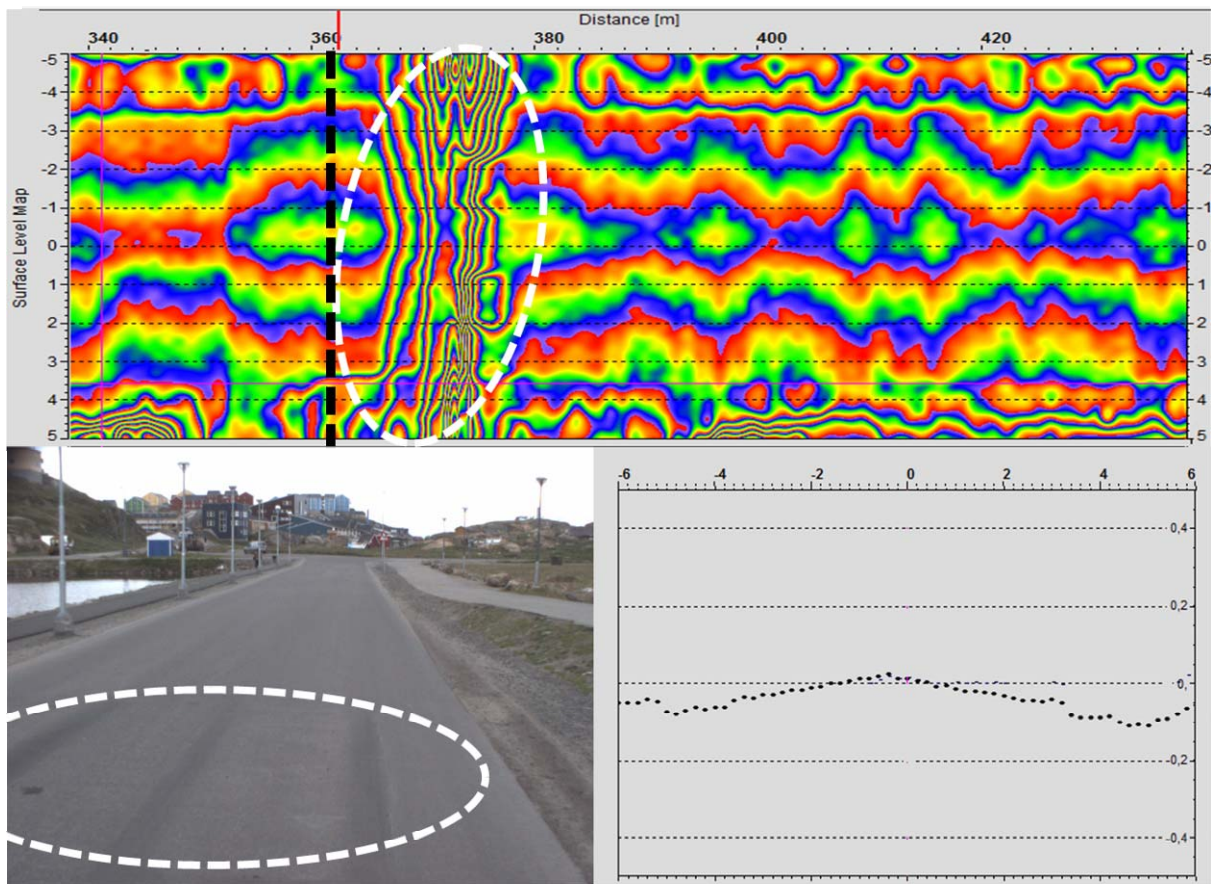
Figure 37 shows a section from Fahlip street as a rainbow map. Overall the Fahlip Street pavement is relatively new and in good condition. In the foreground of the photograph there is an unevenness in the street surface (dotted white circle) which is clearly visible in the surface topography rainbow map (upper white dotted circle). The cross section at the point is shown on the right side, and it is also marked on the surface map with a black dotted line.

The continuity of the surface topography map breaks at the point where the unevenness occurs. Once the unevenness ends the continuity in the topography map returns (from 380m chainage).

Figure 37. Pavement surface topography map from Fahlip street shown as a rainbow map together with a still photograph and cross section
