ROAD 582 SELET-BODEN

Demonstration of three different rehabilitation structures on a Swedish Low Volume Road

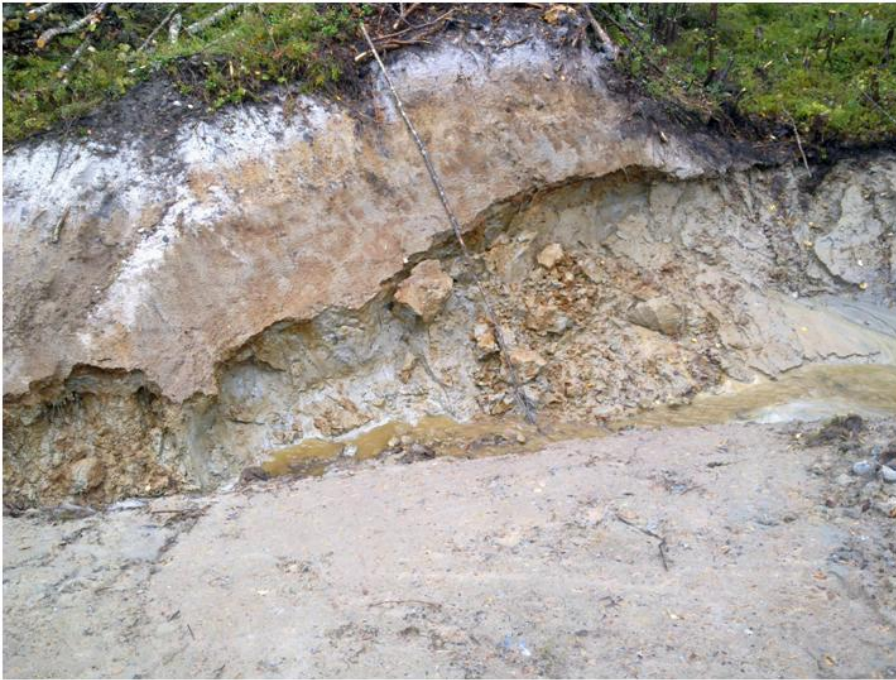
Moraine and fine-grained silty sediments cause frost heaving because of their frost-susceptible nature indicated by high capillarity (Figure 2.5). They allow ice-lenses inside the road structure to grow by adding water from the ground. This reduces the spring time bearing capacity and leads to frost heave damages where the road is poorly drained. Wide, longitudinal cracks are common in these conditions. They occur when the top of the road is bent by the swelling ice underneath.

Figure 2.5 Frost-susceptible, erosion sensitive silty subgrade material of the area.

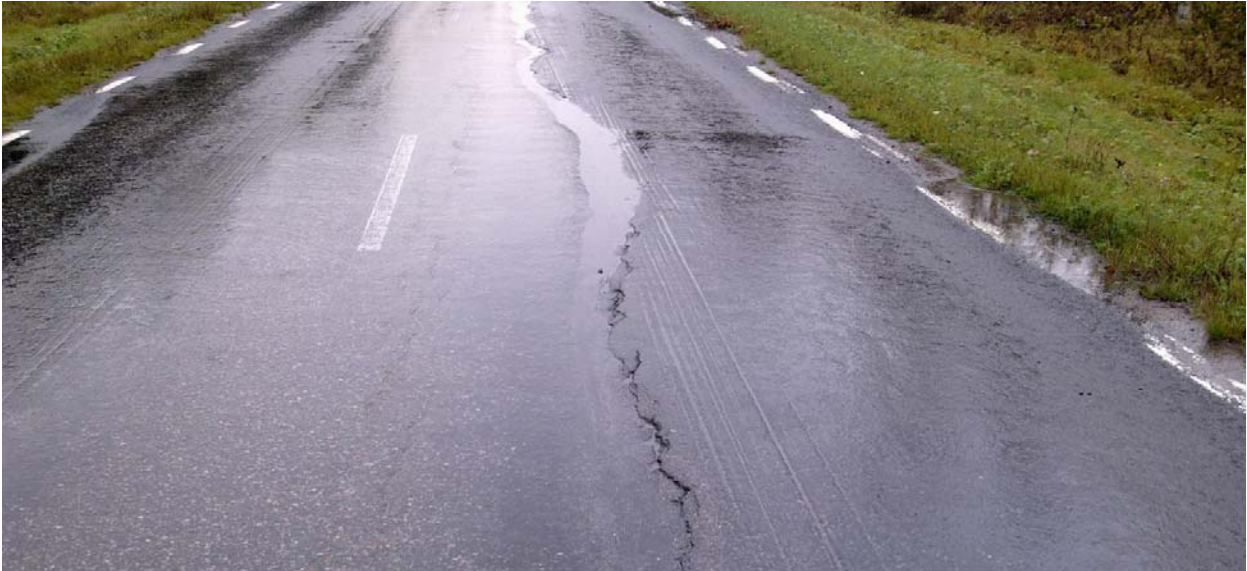
Figure 2.6 Longitudinal cracks in the pavement at demonstration Section 3, km 25/020 to km25/100.

The third demonstration section selected for closer follow up was km 25/020 to km 25/100. This section was mainly suffering from longitudinal cracking of the road surface (figure 4.3). An obvious reason for this type of pavement damage is known to be uneven frost heave along the road cross section if the materials of road structure and/or the underlying subgrade are frost-susceptible, and at the same time drainage system of the road is not functioning properly. These factors had clearly been the main reasons for cracking of the asphalt concrete wearing course on this section as well.

The same road structure was used for demonstration section 3, km 25/020 to km 25/100, but in this case one layer of 10 mm diameter steel net was installed under the base course.

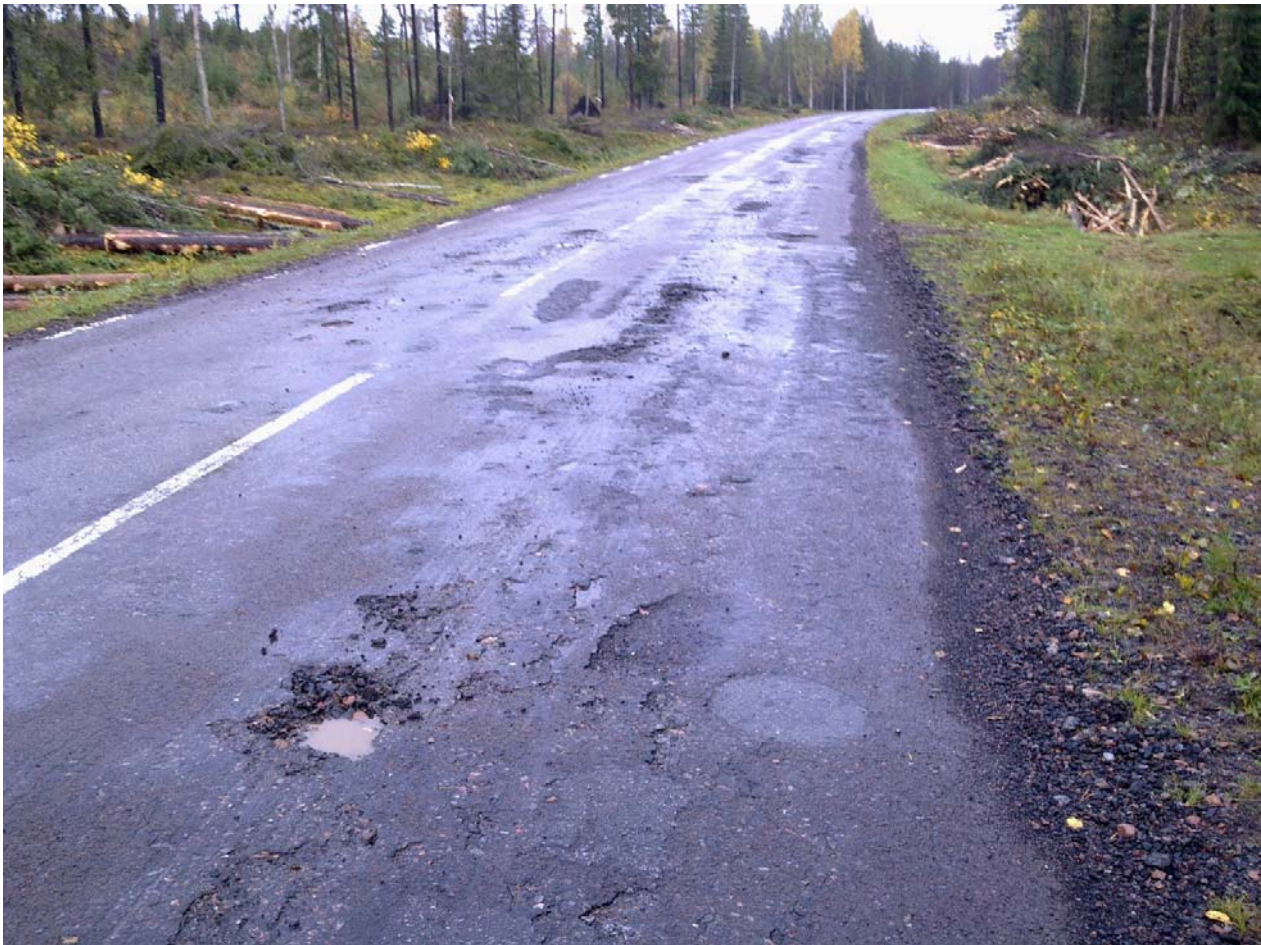
The first demonstration section selected for closer follow up was km 15/750 to km 15/830. On the section there were a number of deep holes and other types of pavement damages (figure 4.1).

The main reason for the problems on this demonstration section was assumed to be the degradation of the air-cooled blast furnace slag (ACBFS). This was covered with only a thin base course layer of about 100 mm, or less, and 10 to 50 mm of asphalt pavement. The damages had been accelerated by poor drainage of the section.

Figure 4.1 Demonstration section 1 at km 15/750 to 15/830 in September 2011. Logging work has started along the roadside. The photograph is taken northward from point 15/750.

- 50 mm wearing course (1)
- 100 mm base course (2)
- 200 mm sub-base course (3)
- 300 mm road edging (4)
- 50 mm boarding strip/support strip (8)
- New ditches, minimum 1.3 m below road surface.

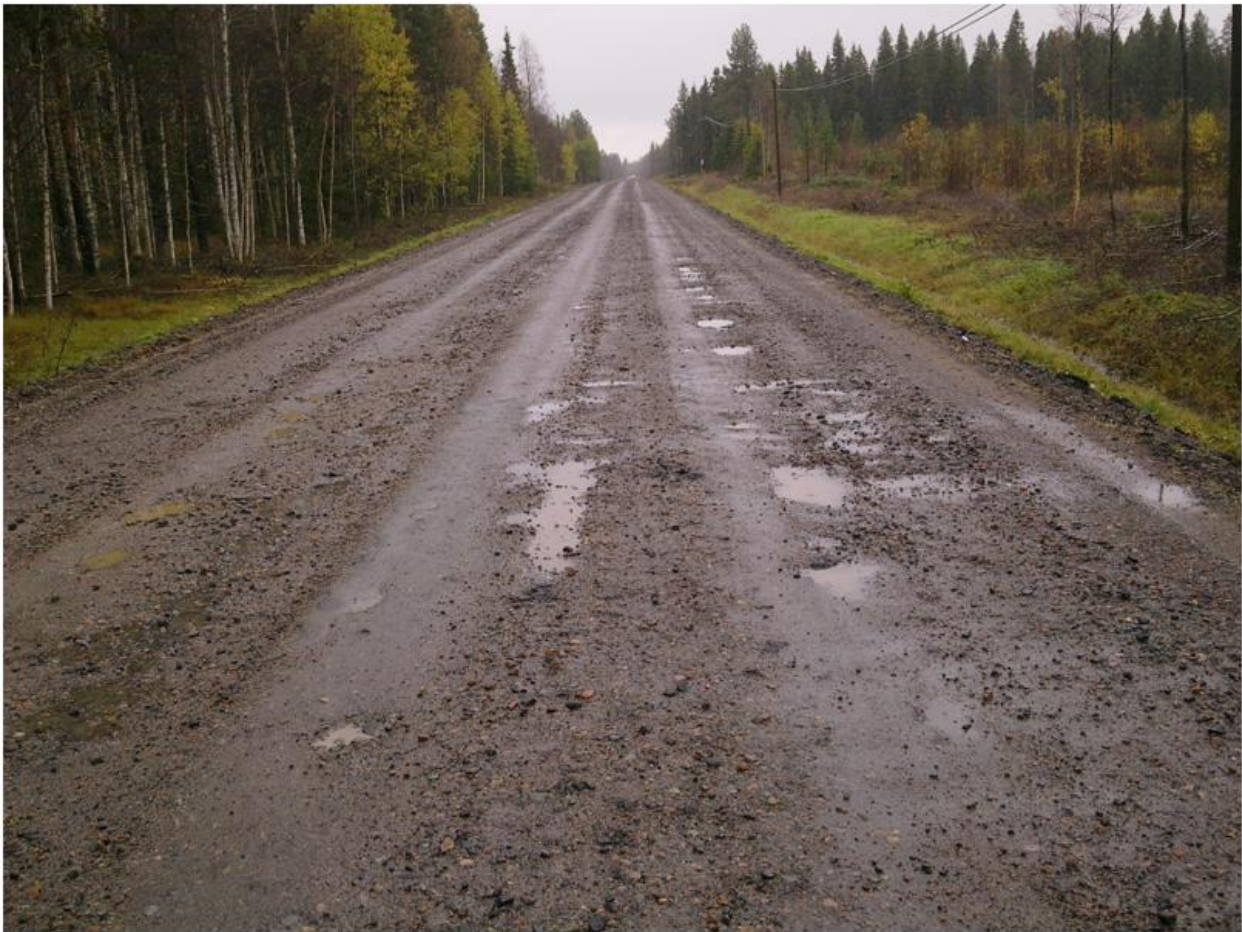
The second demonstration section selected for closer follow up was km 20/100 to km 20/180. The main problem on this demonstration section had been overall low bearing capacity of the road that had resulted in such severe rutting and other types of pavement damages that the AC wearing course had already been removed by the time of the start of the construction works (figure 4.2).

The obvious reasons for the distresses on this section were poor drainage combined with inadequate material quality. In addition, the problems of low bearing capacity had evidently been enhanced by the layer of peat at the depth of 1 to 2 metres below the road surface.

Figure 4.2 Demonstration section 2 from km 20/100 to km 20/180 in September 2011, south of point 20/180. The wearing course was in very bad condition and has already been removed.

- 50 mm wearing course (1)
- 100 mm base course (2)
- 400 mm sub-base course (3)
- 50 mm boarding strip/support strip (8)
- Excavating for new road structure (9)
- New ditches, minimum 1.3 m below road surface

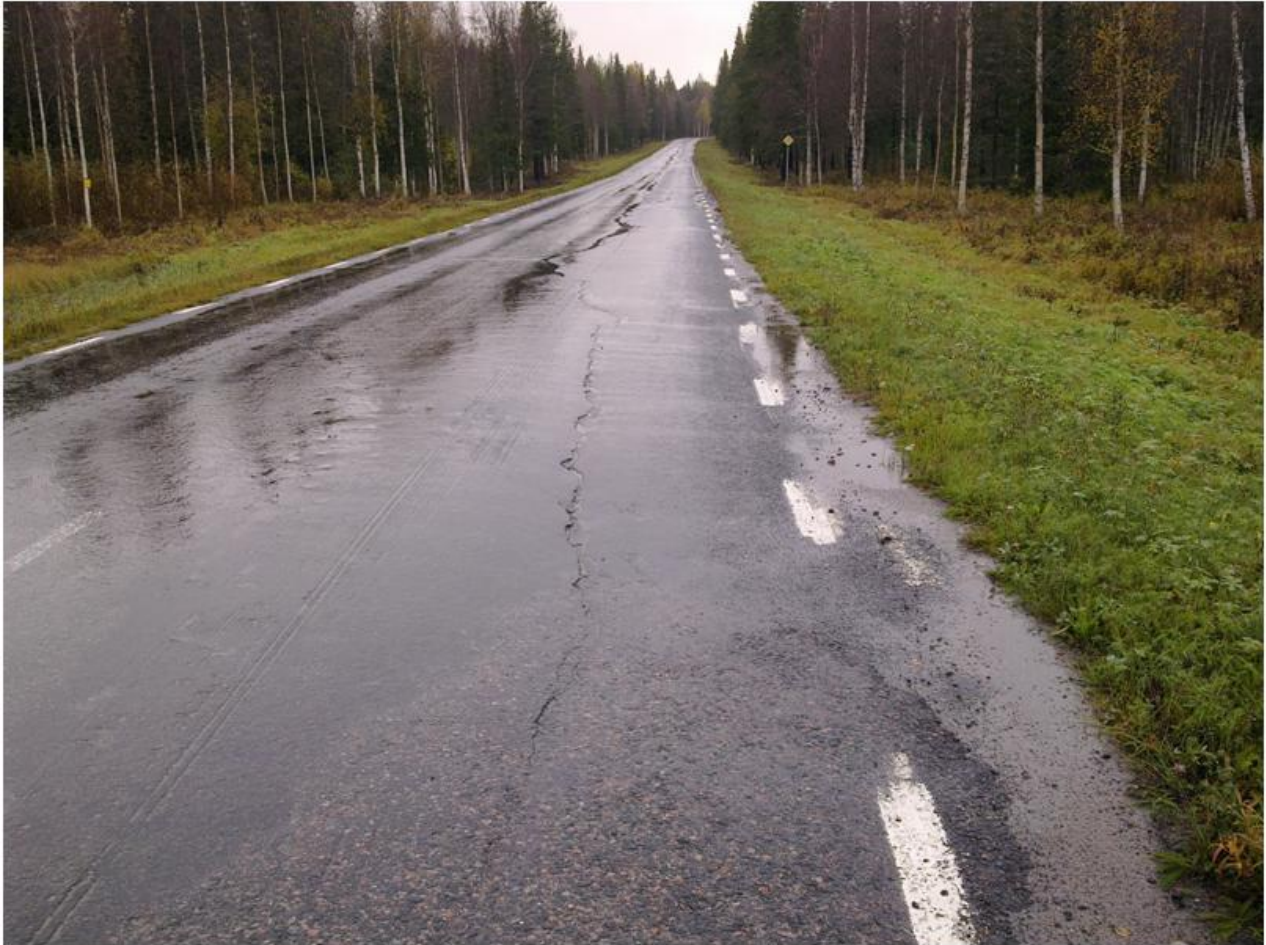
Figure 4.3 Demonstration section 3 from km 25/020 to km 25/100 in September 2011, northward from 25/020.

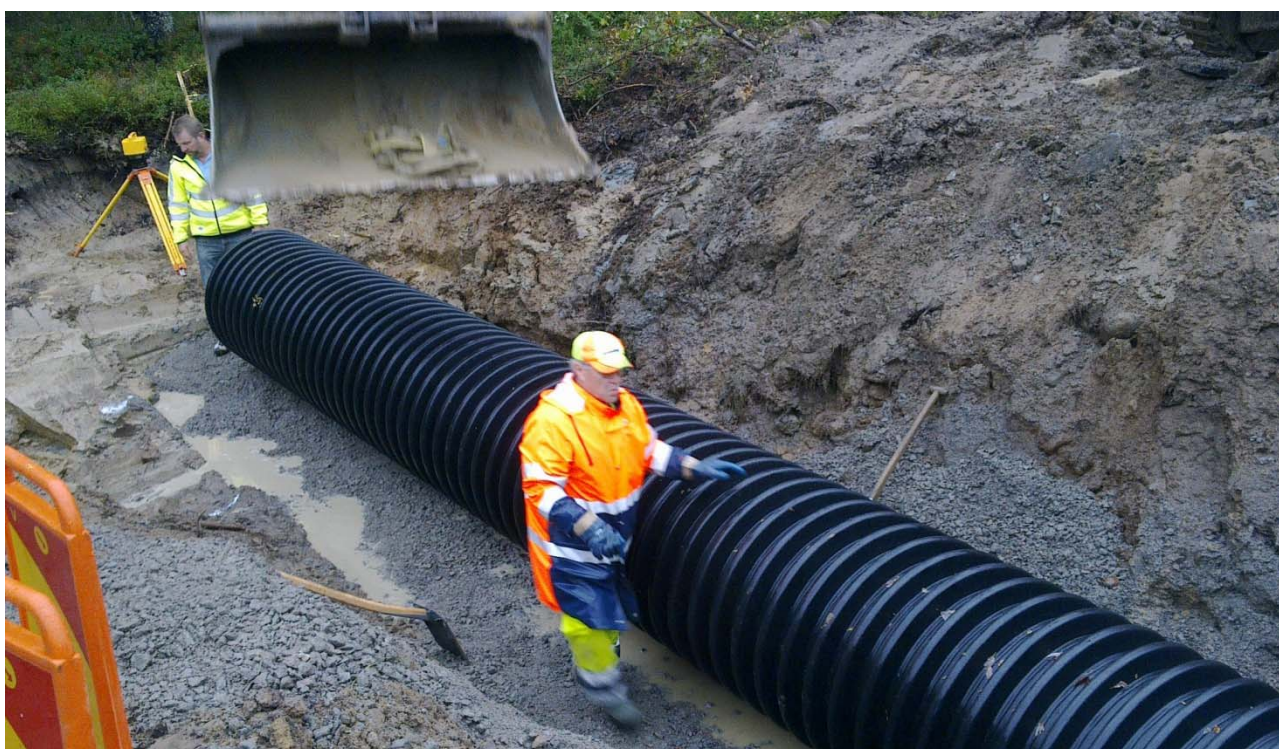
Figure 6.1 The drainage system is improved with new 800 mm plastic culverts

The construction work started in early September 2011. It was considered that many of the problems on Road 582 were due to poor drainage and as a first step the contractor began to replace all existing concrete culverts with plastic culverts, diameter 800 mm, see Figure 6.1.

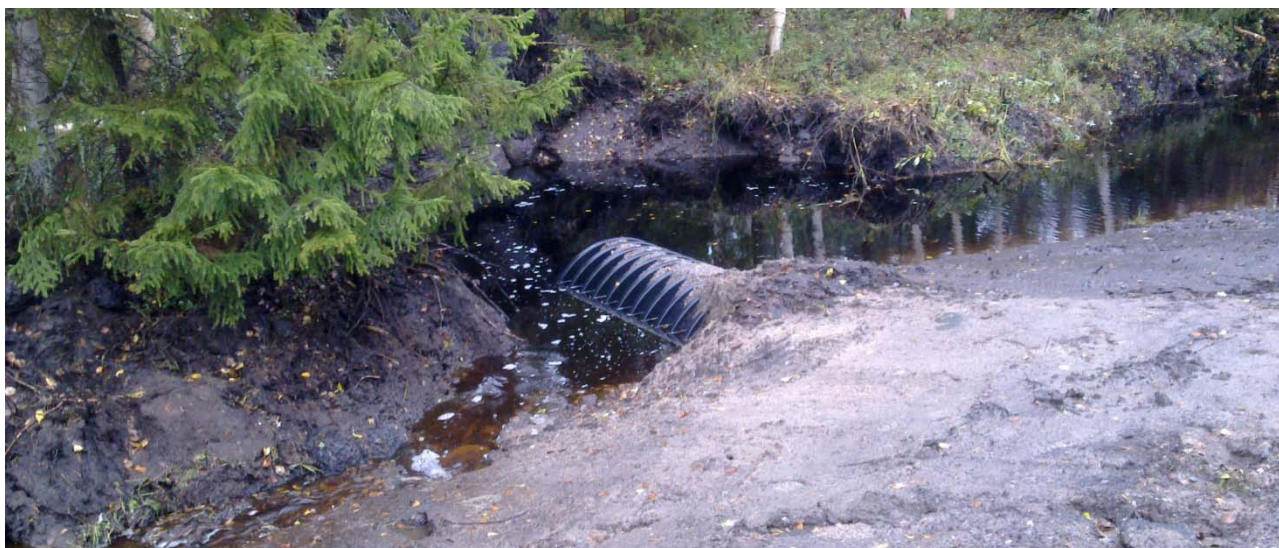
The work in improving drainage systems continued for the next four weeks. During that time, the area had three times more rain than usual, see Figure 6.2. This caused large water flows and forced the workers to dam the water and employ pumps to drain the worksite. An old ordnance mine was uncovered in one of the culvert trenches and had to be dealt with by military staff.

Figure 6.2 Even some of the new larger drainage culverts were overfilled during the heavy rains in September.

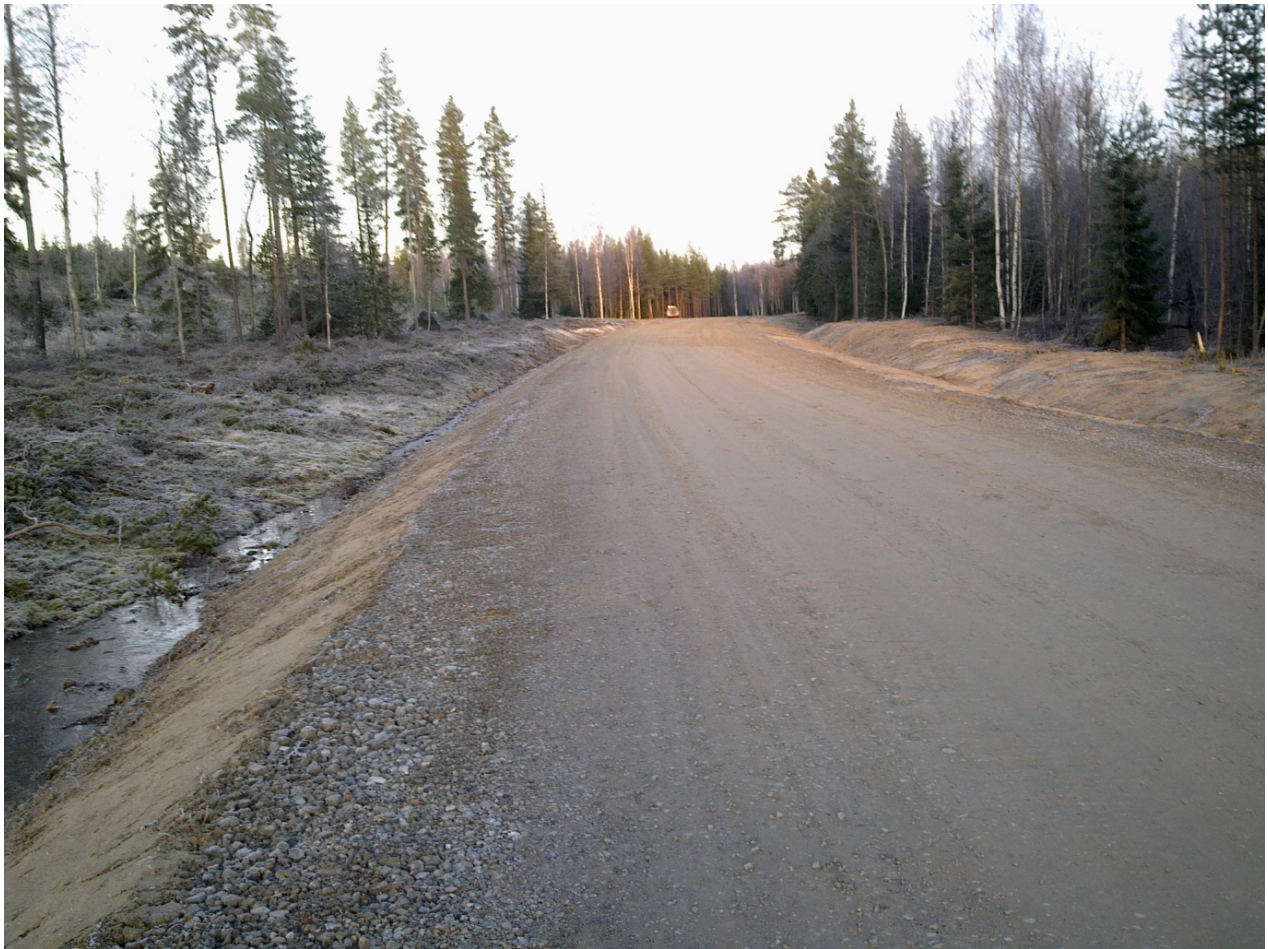
Figure 6.4 The new widened road formation at demonstration section 1 in November 2011. The old wearing course has been removed and new ditches excavated.

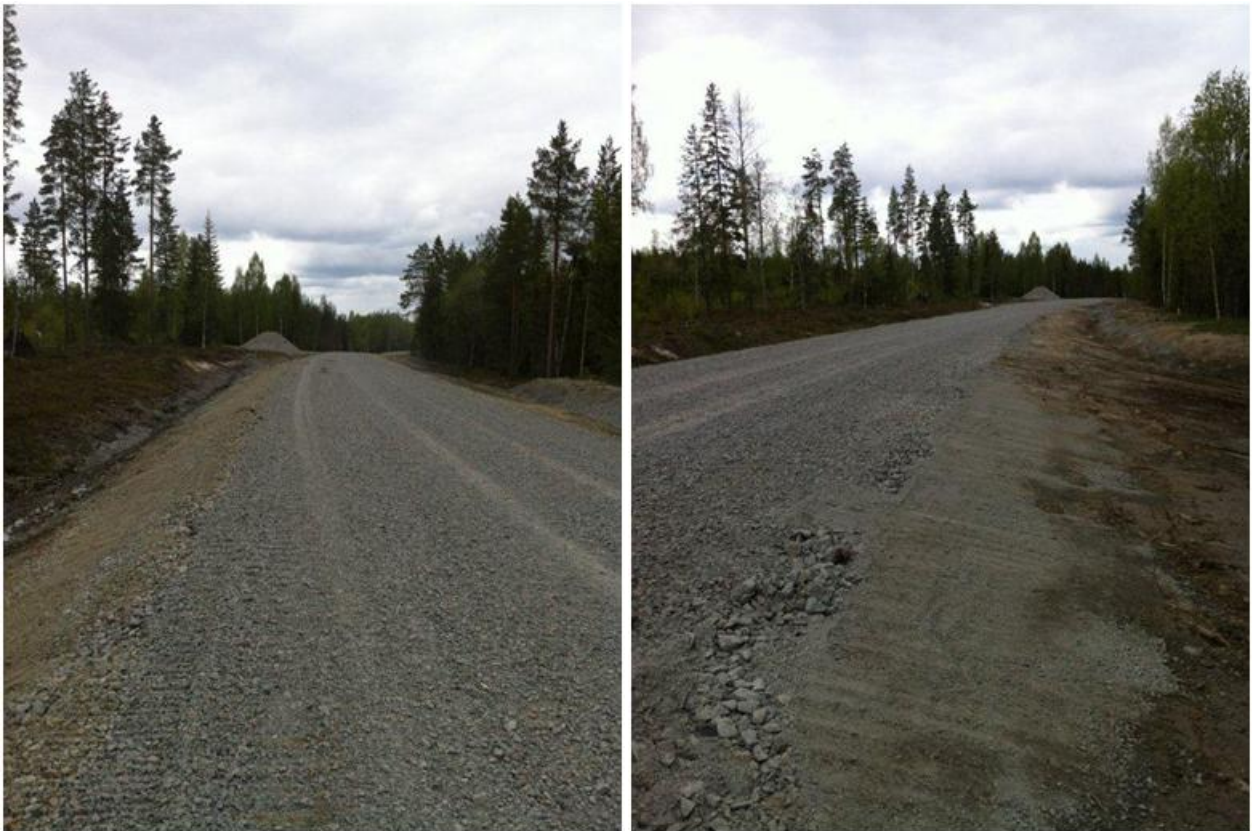
Figure 7.1 Views on demonstration section 1 in early June 2012.

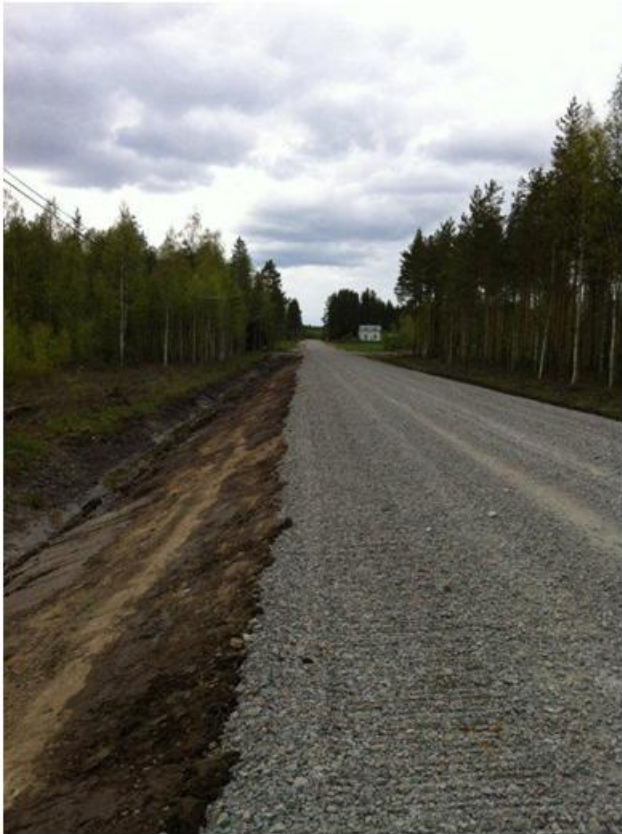
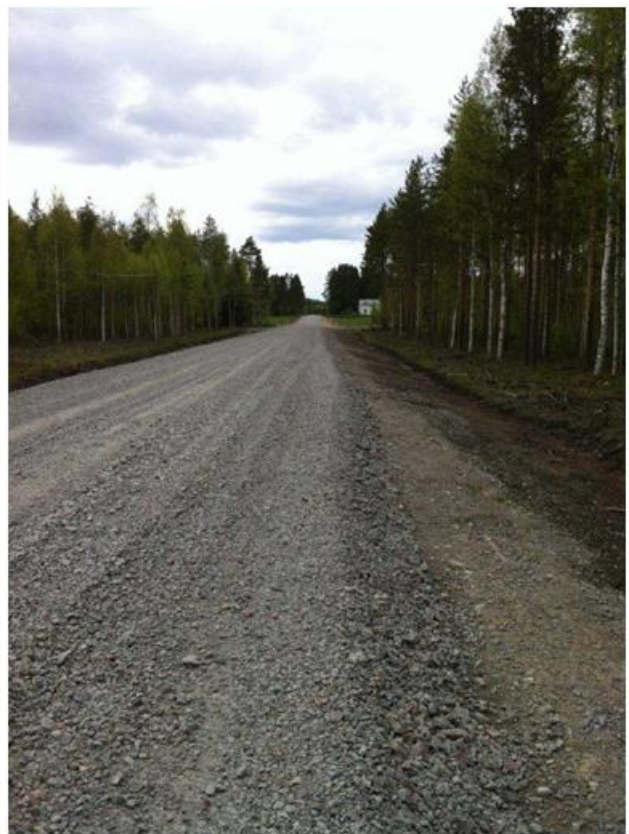
Figure 7.2 Views on demonstration section 2 in early June 2012.

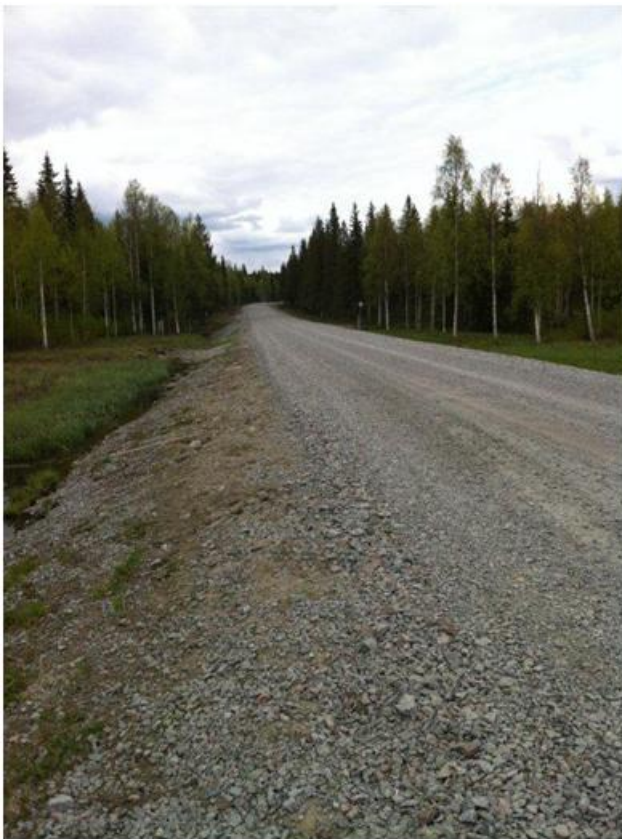
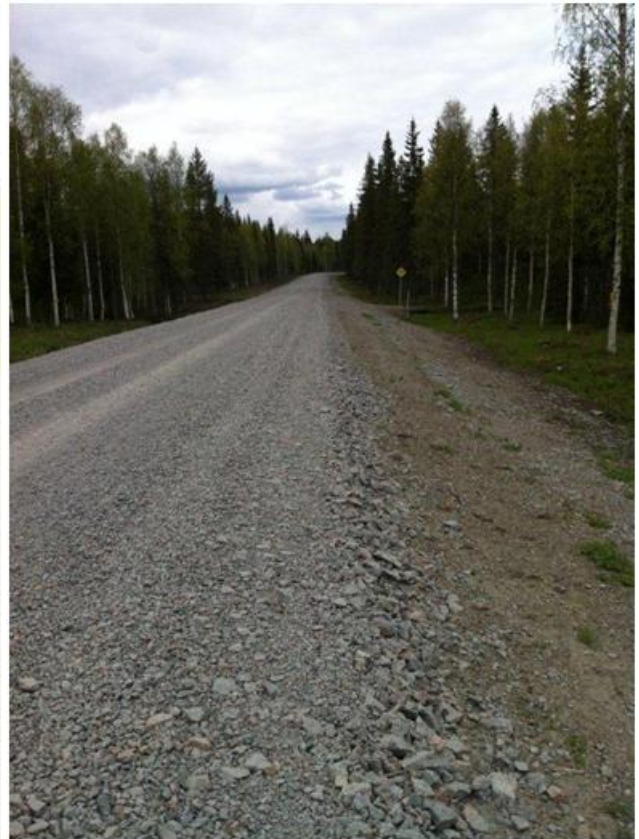
Figure 7.3 Views on demonstration section 3 in early June 2012.
