Annele Matintupa, Seppo Tuisku

# **SUMMARY OF DRAINAGE ANALYSIS IN IRELAND, ROADS N56 AND N59**

**Demonstration Project Report**

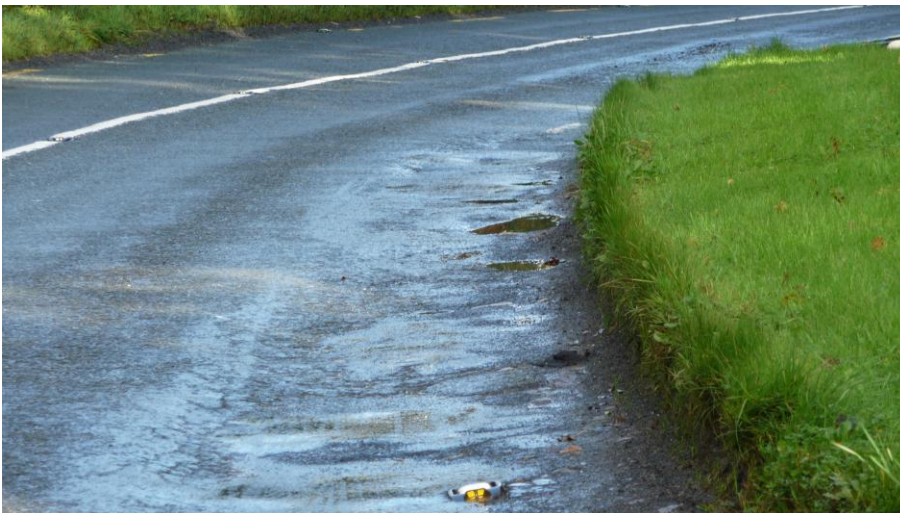
Verges are very common on the N56 and N59, and there use is widespread on the Irish road network. An example of an extremely high verge is shown in Figure 6. Verges prevent the water flowing away from the roadway, forcing any surface water to drain through the pavement structure instead of flowing away from the road. Water also runs along the road surface causing a risk for aquaplaning and splash problems.

*Figure 6: A high verge on the Irish road network, photo taken on road N59.*

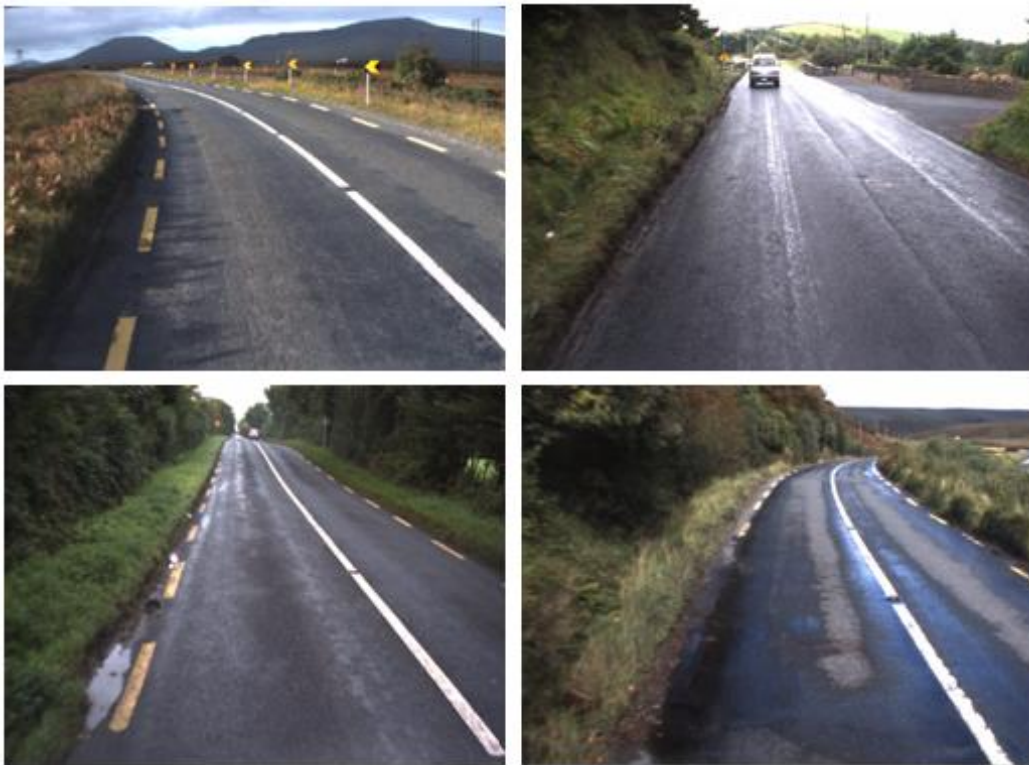
Verges can cause a number of problems to roads. The greatest is that of reduced bearing capacity, as seen as large deformations in the pavement. Where drainage has been improved, the drainage through the verges has usually been handled by adding or opening offlets. In cases, where the road has been upgraded or repaved some verges have been removed. However in those sections where the drainage through the verges was not improved problems have reappeared soon afterwards. A few examples of the types of problems caused by high verges are presented in Figure 7.

Figure 7: Examples of road sections suffering from problems due to verges.

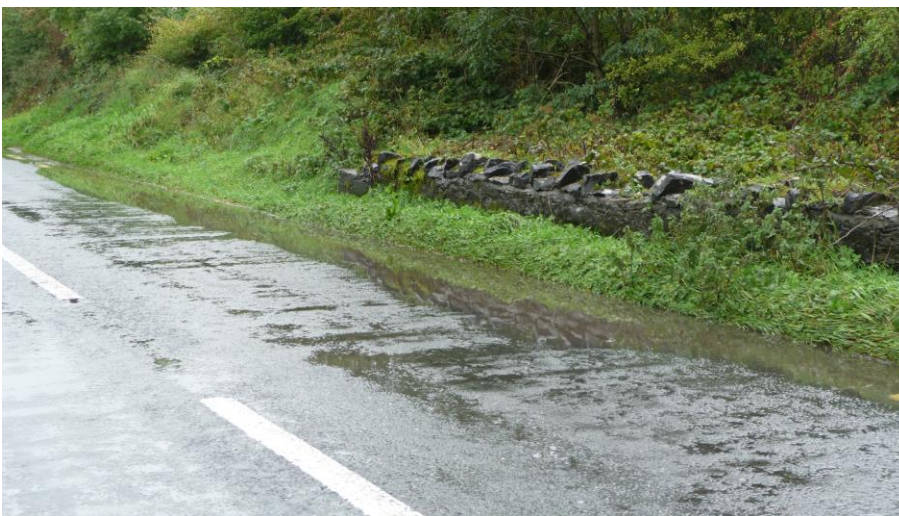
Another typical feature on the Irish roads surveyed was the presence of stone boundary walls. An example of a stone wall is shown in Figure 8. These were very common along both roads N56 and N59. Usually these walls were located along old sections of roads that had not been upgraded. Where road improvements had been carried out these walls appear to have been removed. Usually the walls are very old and in many cases not visible due to vegetation growth.

Figure 8: A typical stone walls on road N59.

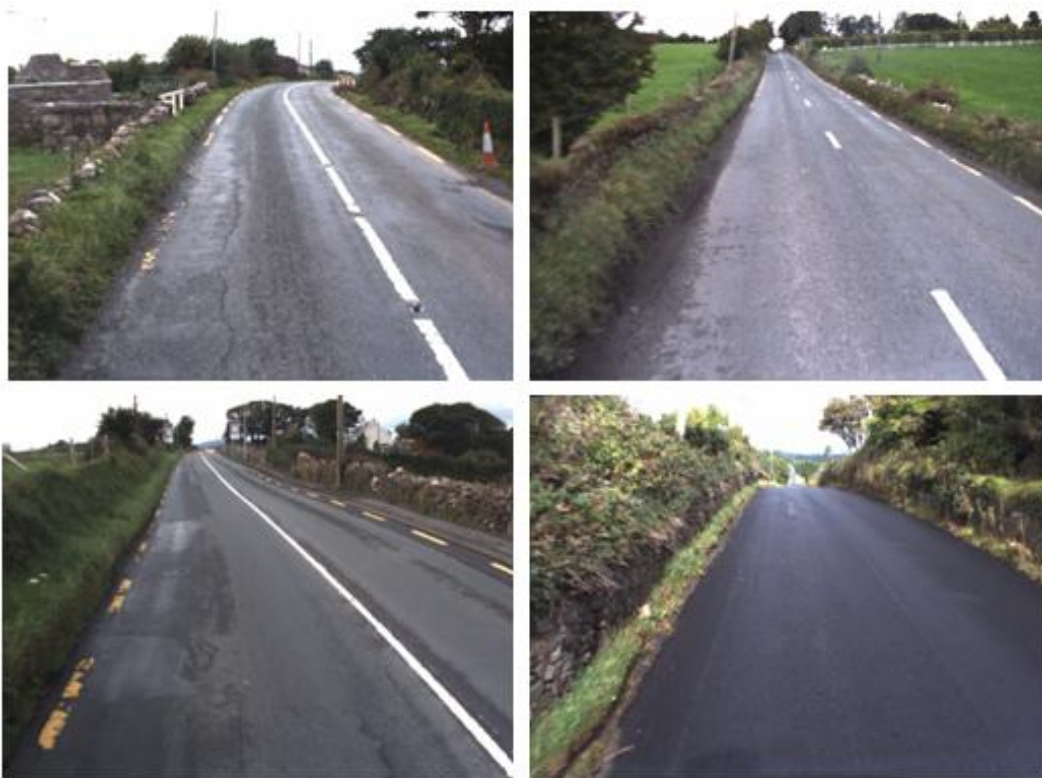
Typically these walls blocked the flow of surface water away from the road unless water outlets had been provided. This caused problems to the road similar to those caused by high verges, i.e.

reduced bearing capacity and deformations. Examples of typical problems caused by stone walls without water outlets are shown in Figures 9.

*Figure 9: Examples of road sections suffering problems due to stone walls.*

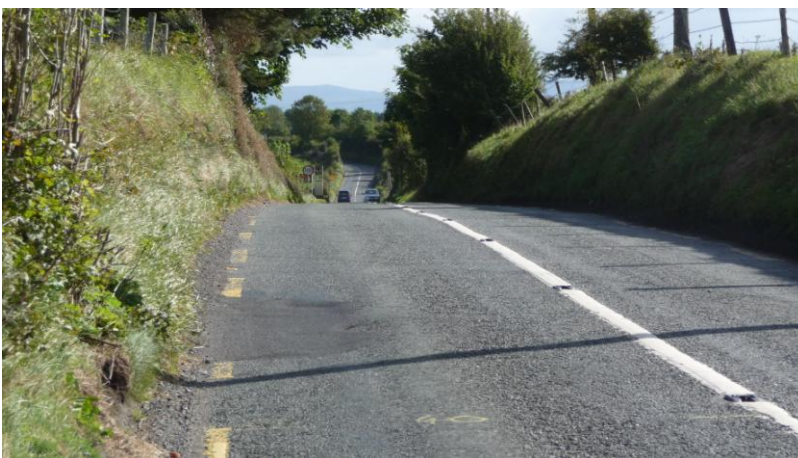
A very special feature on the roads surveyed was the narrow road cutting. A typical example of an Irish “road cut” as seen in Figure 10 shows sharply inclined side slopes that start immediately at the pavement edge leaving very little room for drainage structures. A high proportion of these steep slopes appear to consist of stone walls obscured by vegetation and soil.

*Figure 10: An example of a road cut on road N59.*

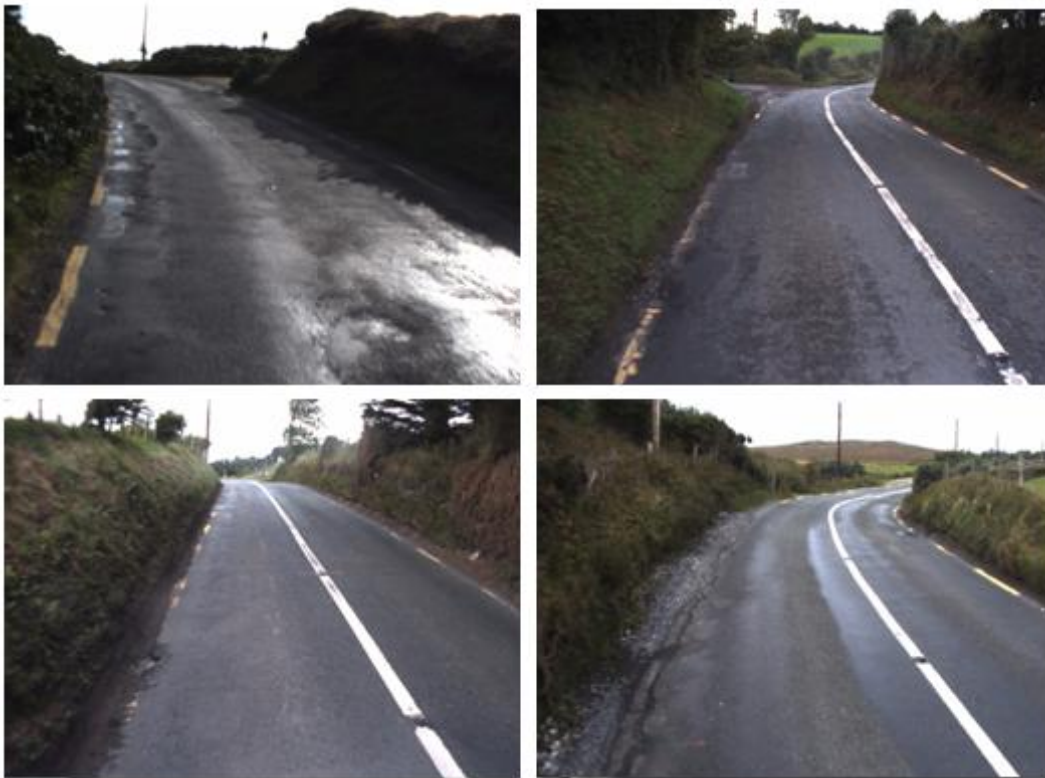
In many cases there is a complete absence of ditches or any other drainage structure within these types of road cuts. This means that water generally flows along the road as there is no possibility for it to get off the road, and this in turn causes erosion, bearing capacity and deformation

problems to the road. Examples of typical problems that can occur in such road cuts are shown in Figures 11.

*Figure 11: Examples of road sections located in road cuts.*

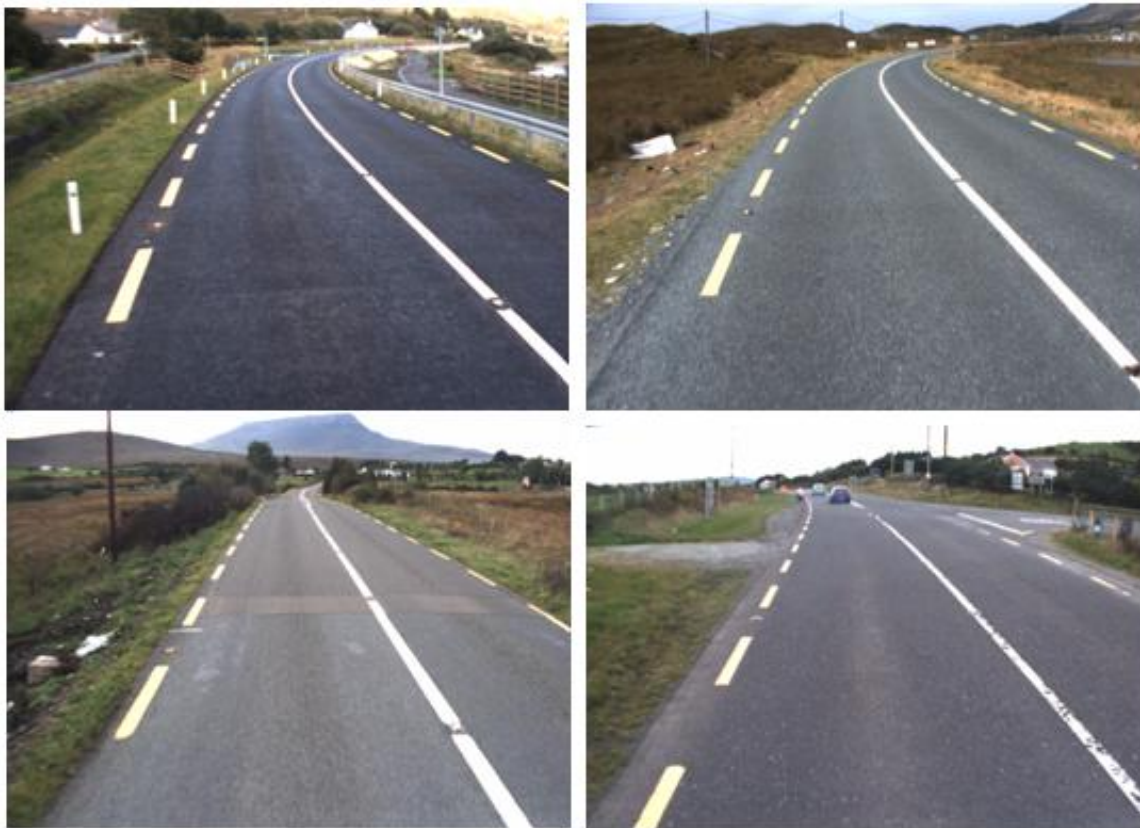
Drainage Class 1 means that the drainage condition is faultless. The cross-section of the road has preserved its form well and water flows unrestricted from the pavement to the ditch. Water has also a clear passage in the ditches. Where a verge is present it has enough offlets to let the water flow to the ditch.

*Figure 12: Examples of road sections with drainage Class 1 in Ireland.*

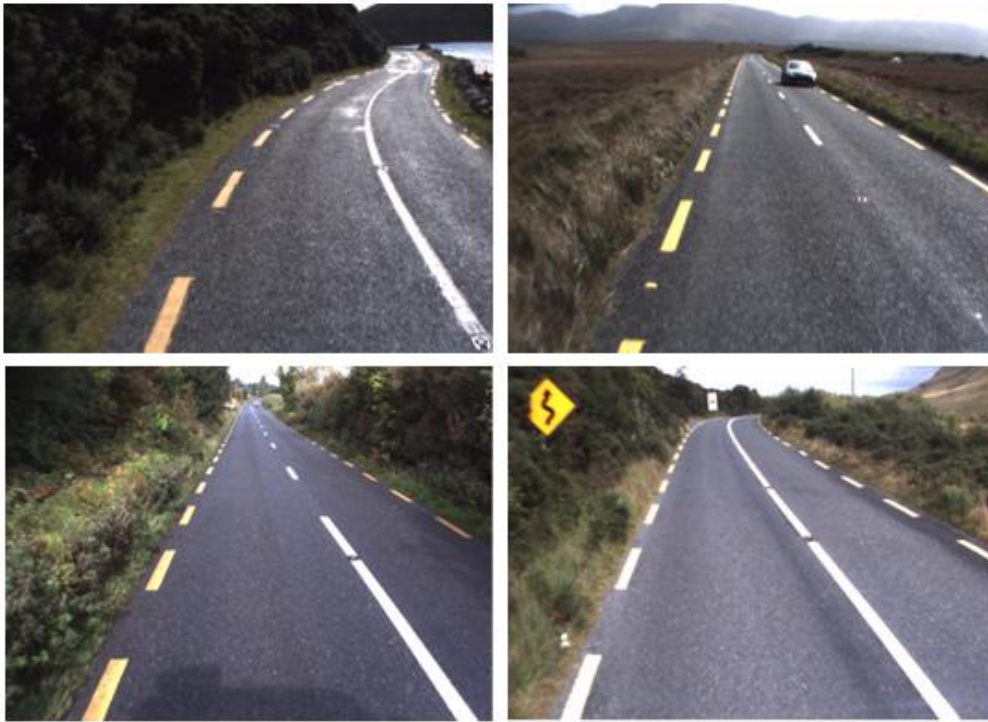
In drainage Class 2 there can be some visible changes to the road cross-section. The road shoulder has narrow verges or vegetation growth that is preventing the free flow of surface water from the road surface into the ditch. There is some vegetation in the ditch that restricts water flow and creates damages. Some soil is sliding from the road sideslope into the ditches and raising the bottom of the ditch. This hinders water flow and raises the ground water level.

Figure 13: Examples of road sections with drainage Class 2 in Ireland.

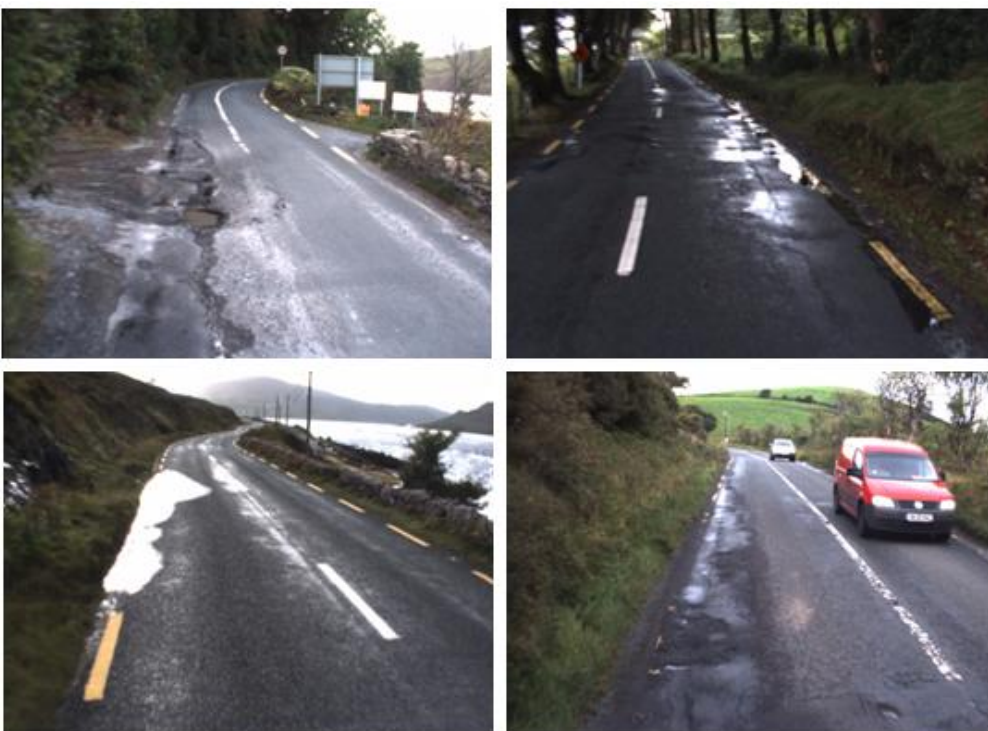
Drainage Class 3 covers those road sections with severe drainage problems. The road shoulder has a high verge and/or dense vegetation that is causing ponding on the traffic lane or on the shoulder. Vegetation is growing in the ditches and restraining the flow of water creating dams in the ditches. Unstable soil is flowing from ditch slopes into the bottoms of ditches and blocking the flow of water. Clogged culverts or outlet ditches is preventing the flow of water in the ditch. All of these situations lead to the development of deformation and damage in the road cross-section.

Figure 14: Examples of road sections with drainage Class 3 in Ireland.

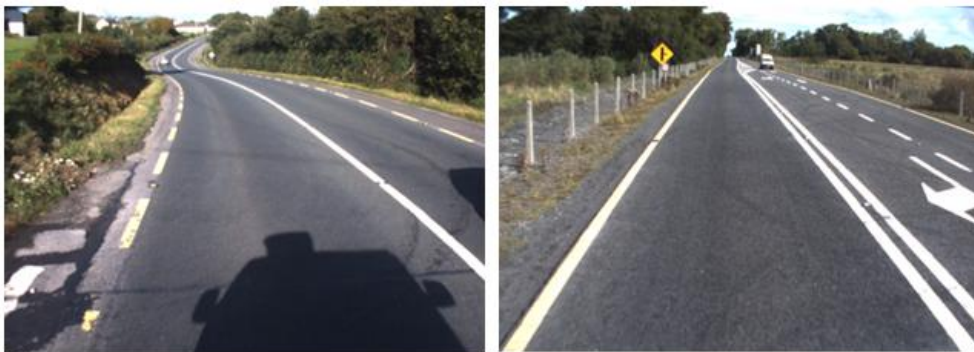
Class 1 verges cover those road sections where there is no verge and water can flow freely from road surface. Figure 15 presents a few examples of verge Class 1 road sections.

*Figure 15: Two examples of verge Class 1, i.e. road sections without verges. The photo on the left is from road N56 at point 15,222m, the photo on the right is from road N59 at point 40,996m.*

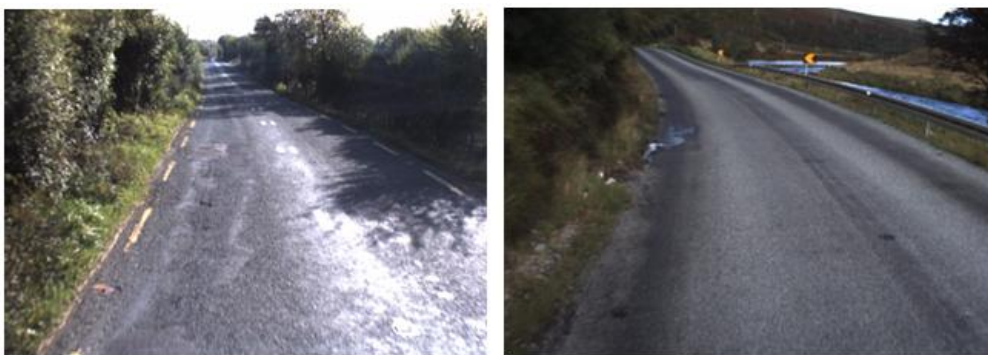
Class 2 verges cover all road sections with minor verges and adequate offlets. The number of offlets is enough to ensure proper drainage and they are in good condition. The water can flow freely from the road surface. Verges do not restrict the water flow or the workings of the road drainage system. Figure 16 shows a few examples of road sections with verge Class 2.

*Figure 16: Two examples of verge Class 2, roads with a verge which has minor effect on the workings of the road drainage system. The photo on the left is from road N56 at point 27,591m, the photo on the right is from road N59 at point 91,163m.*

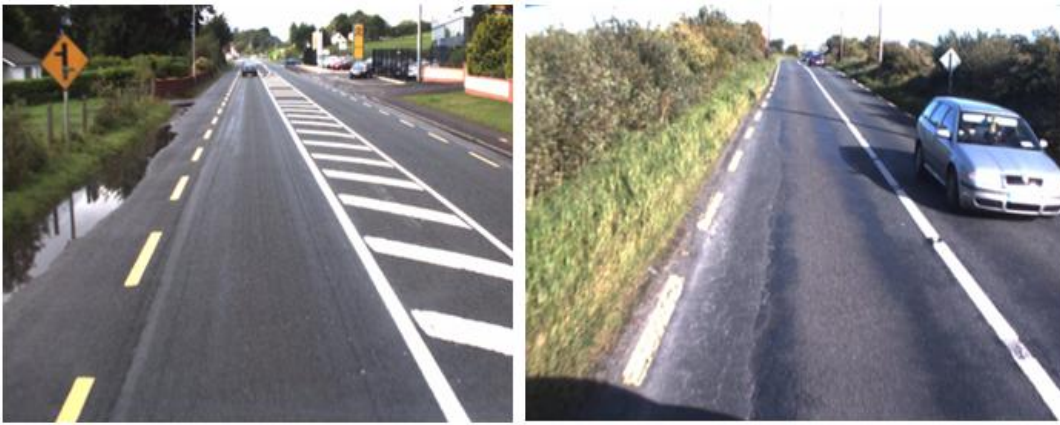
Class 3 verges cover those road sections with significant verges restricting the water flow away from the pavement causing ponding and other problems. There are no offlets or they are in poor condition. Figure 17 shows a few examples of road sections belonging to verge Class 3.

*Figure 17: Two examples of verge Class 3, roads with a verge that has a significant negative impact on the workings of the road drainage system. Both photographs are from road N56. The photo on the left is at point 2,777m, the photo on the right is at point 20,685m.*

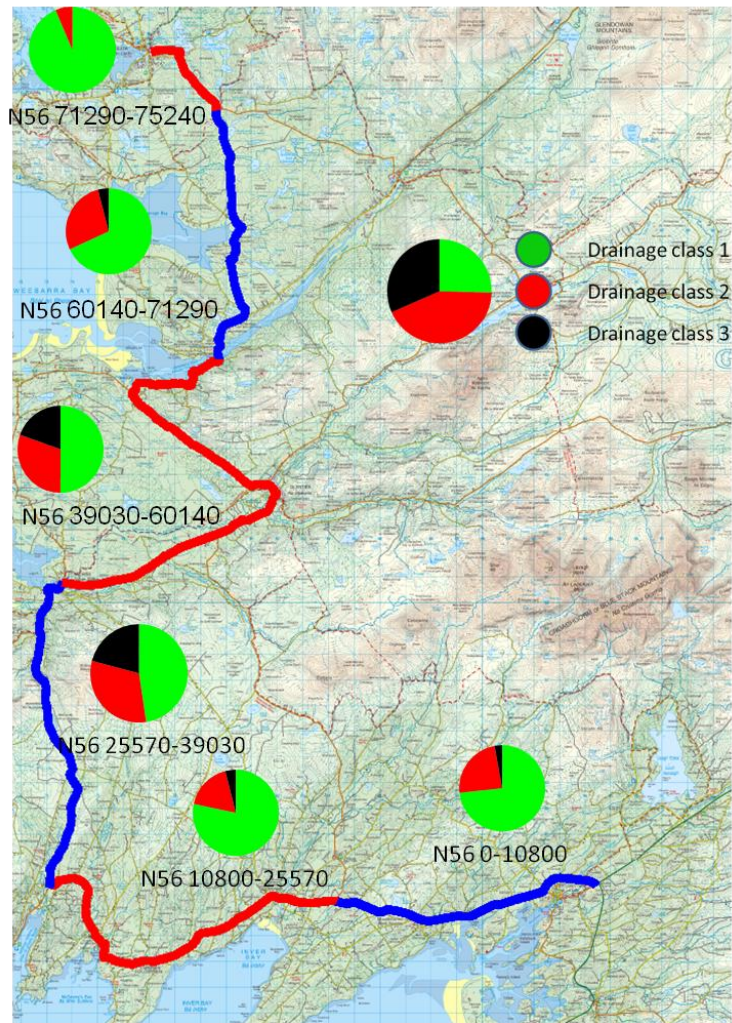
The first surveyed section of the N56 was from Donegal to Dungloe. The drainage in this section is mainly in good condition. The best section is located at the end of the road from the R252 crossroads to Dungloe (71,290 – 75,240m). The section with the worst drainage is from the R263 crossroads to the R261 crossroads (25,570 – 39,030m). A map of the drainage statistics for this section is presented in Figure 18.

Figure 18: Drainage condition in the first part of road N56 from Donegal to Dungloe.

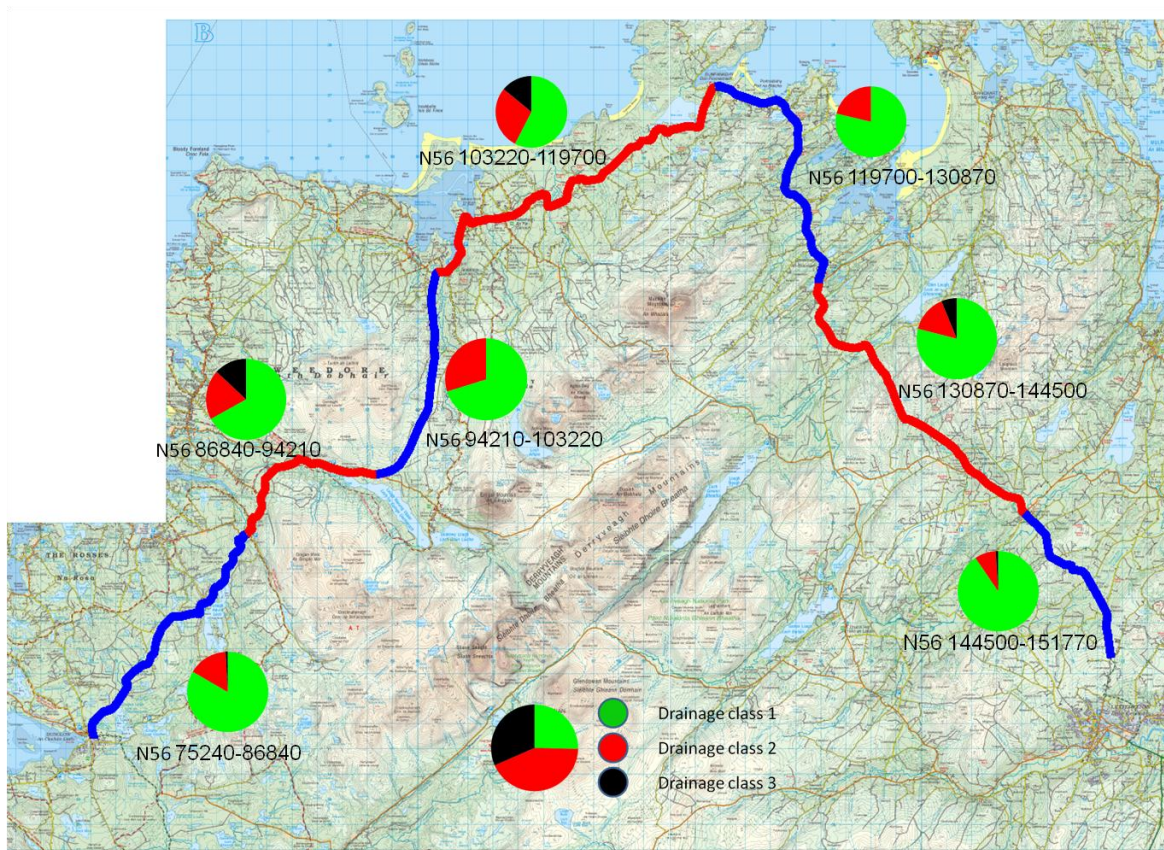
The second surveyed section of the N56 was from Dungloe to the Mountaintop Roundabout in Letterkenny. This part is in generally good condition. The best section is from the R249 crossroads to the Mountaintop Roundabout in Letterkenny (144,500 – 151,770m). The worst part is from the R257 crossroads to Dunfanaghy (103,220 – 119,700m). A map of the drainage statistics for this section is presented in Figure 19.

Figure 19: Drainage condition in the second part of road N56 from Dungloe to Mountaintop Roundabout in Letterkenny.

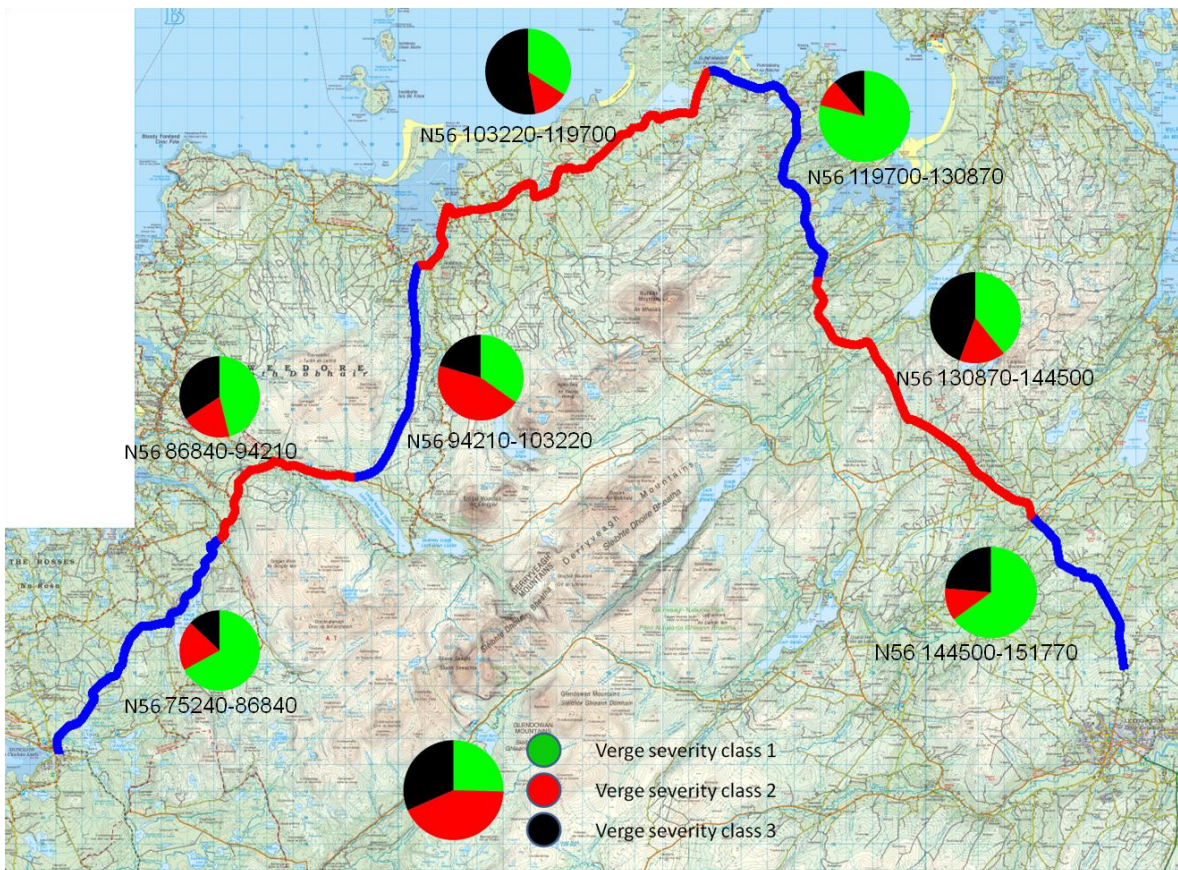
The second section of N56, from Dungloe to the Mountaintop Roundabout in Letterkenny, has a greater quantity of verges. The section from Dunfanaghy to the R245 intersection (119,700 – 130,870) has the least verges, while the most verges could be found on the section from the R257 intersection to Dunfanaghy (103,220 – 119,700). The map of verge class along this part of road is presented in Figure 21.

Figure 21: Verge class in second part of the road N56 from Dungloe to Mountaintop Roundabout in Letterkenny.

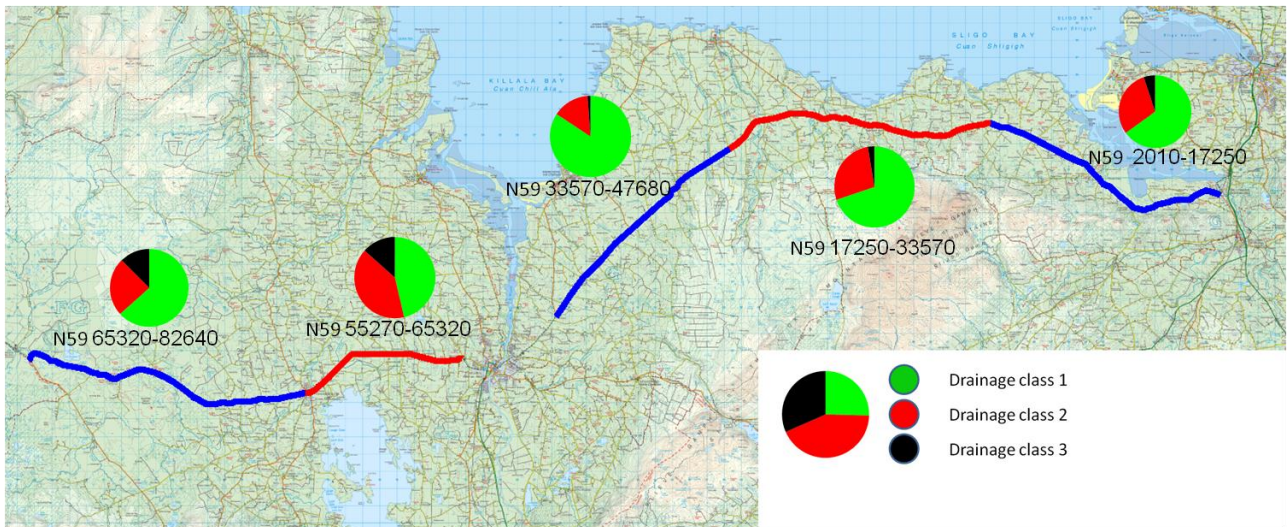
The first section of road N59 was from Ballisodare to the R312 intersection. The drainage in this section is mainly in good condition. The section with the best condition is the section from Owenberg to the R297 crossroads (33,570 – 47,680m), just before the village of Ballina. The section with the worst condition is the section from the R297 crossroads to Crossmolina (55,270 – 65,320m) after the village of Ballina. A map showing the drainage statistics of this section is presented in Figure 22.

Figure 22: Drainage condition in the first part of road N59 from Ballisodare to the R312 intersection.

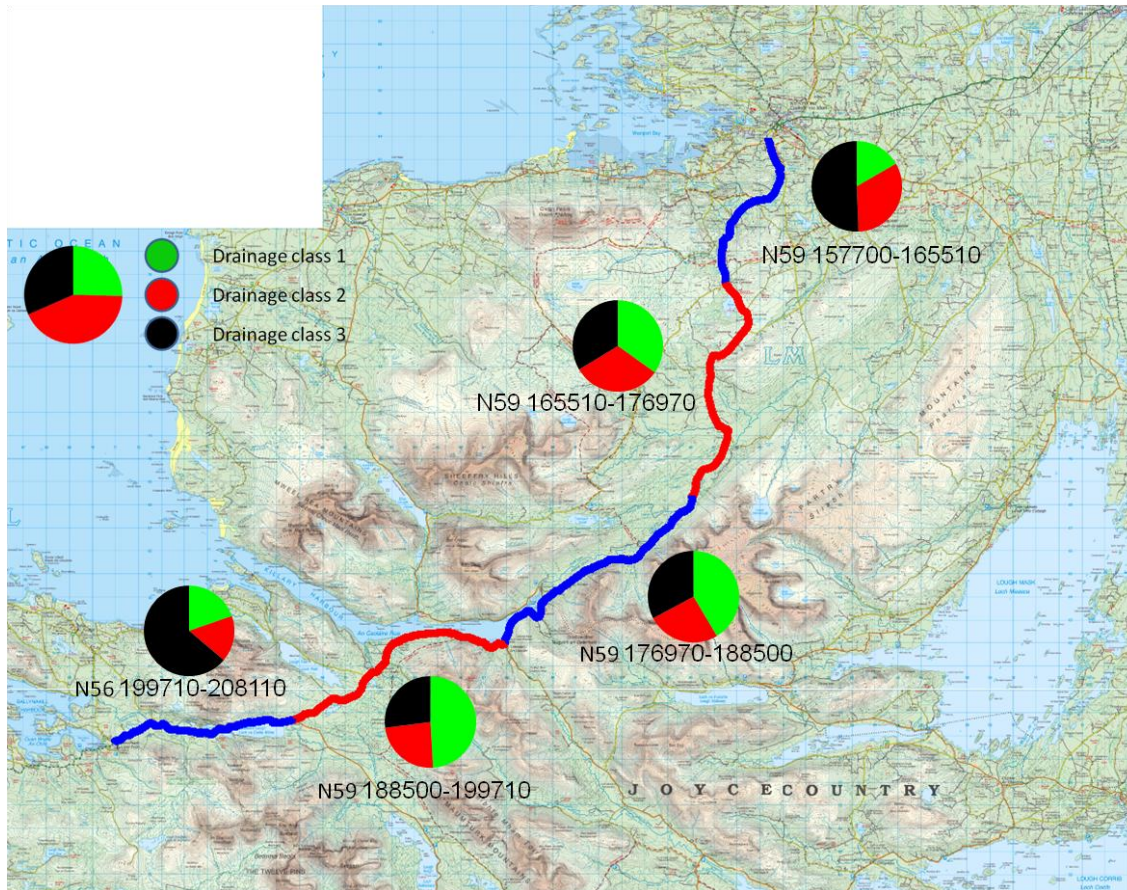
The third section was from Westport to Letterfrack. The best drainage condition was found to be from the R344 crossroads to the R336 crossroads (188,500 – 199,710m). The worst section is at the end, from the R344 crossroads to Letterfrack (199,710 – 208,110m), where more than 50 % of the road was classified as drainage Class 3. A map showing the drainage statistics of this section is presented in Figure 24.

Figure 24: Drainage condition in the third part of road N59 from Westport to Letterfrack.

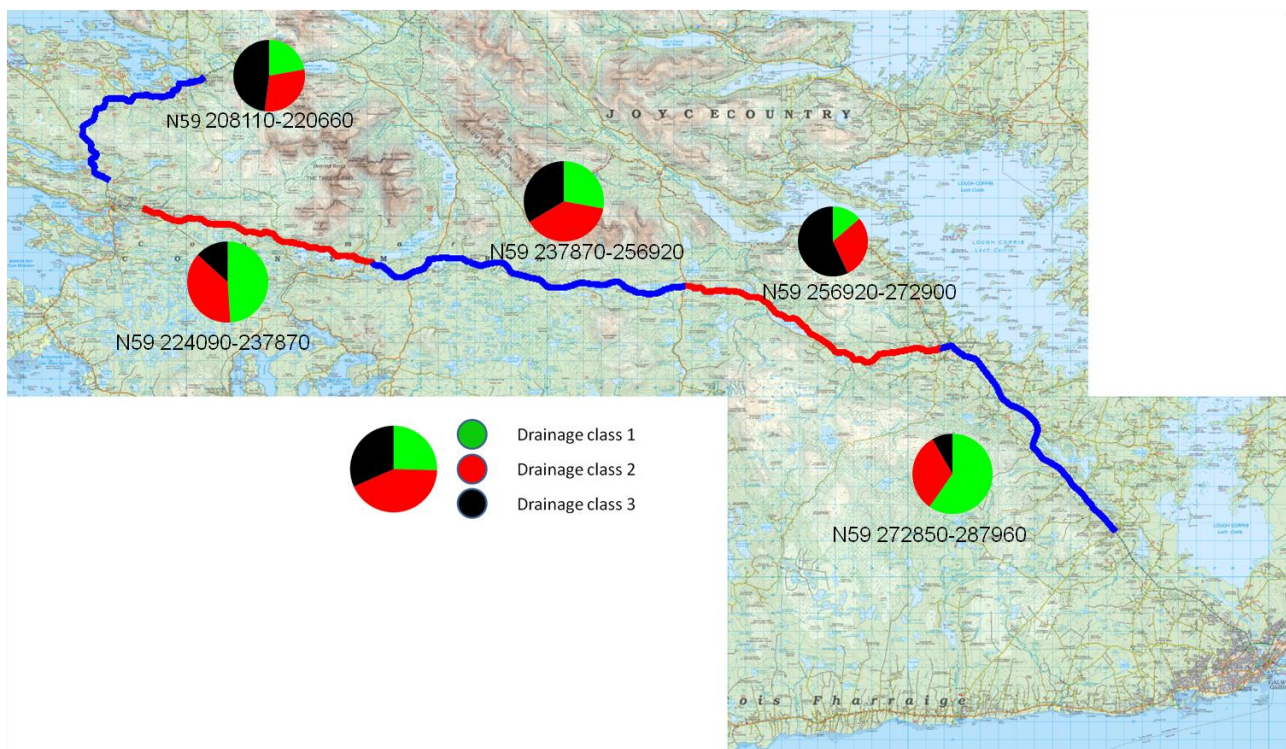
The fourth section was from Letterfrack to Galway (Forest Hills intersection). The end part of this section, from Oughterard to Forest Hills (272,900 – 287,960m) has the best drainage condition with more than half of the road section classified as drainage Class 1. A map showing the drainage statistics of this section is presented in Figure 25.

Figure 25: Drainage condition last part of road N59 from Letterfrack to Galway (Forest Hills intersection).
