# Impact Analysis Pajala - Svappavaara Road Iron Ore Transportation Options

# Impact Analysis and Cost Benefit Analysis of Pajala – Svappavaara Road Iron Ore Transportation Options

## GOAL:

- a) detailed structural diagnosis and risk analysis for the current road in order to know the immediate strengthening need before the haulage starts*
- b) perform a cost-benefit analysis for different heavy haulage option in order to propose an optimal socio-economic transportation solution for all the interest parties*

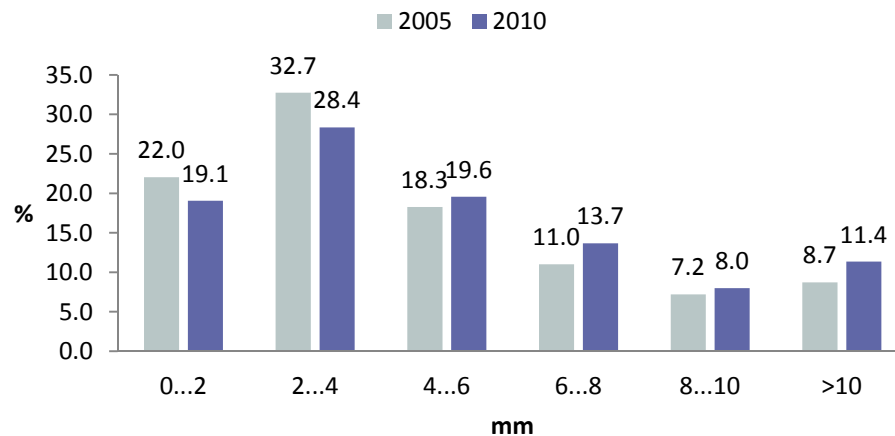
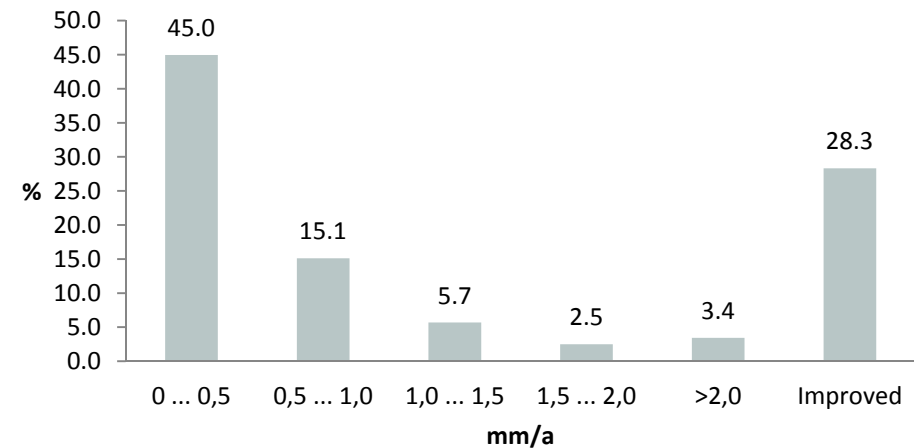
## Comparison of the rut depth values of whole Pajala – Svappavaara road in 2005 and 2010

rutting getting worse

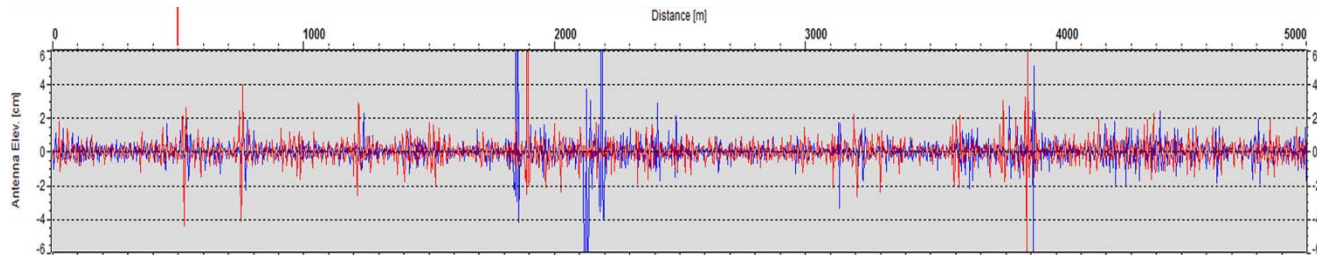
# Villages with major roughness problems

- Antinrova village (42550-44200m),
- Lovikka village (54400-55500m, 55950-56600m, 57100-58000m),
- Huhtanen village (59100-60450m),
- Junosuando village (67900-68100m, 68600-71600m),
- Masugnsbyn village (89300-92250m),
- Vittangi village (120150-124450m).

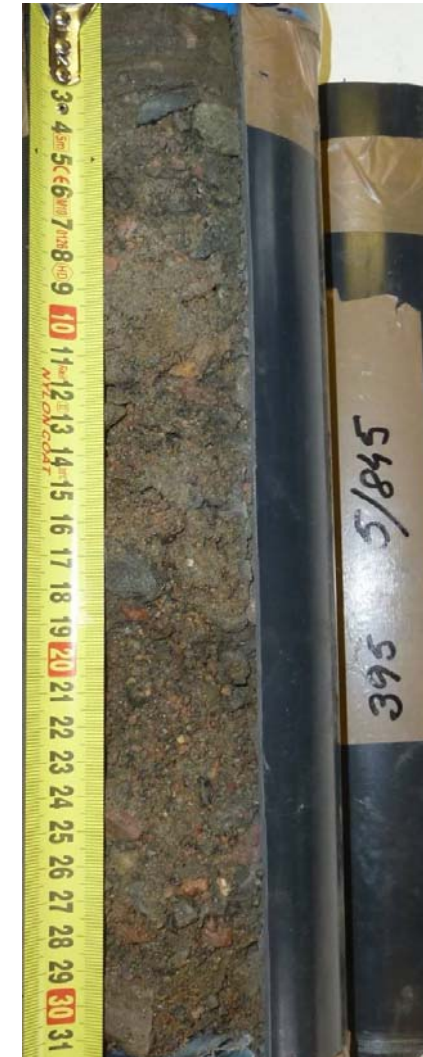
# Material Surveys: Tube Suction Test Results of Base Course Samples

All TS-test dielectric values indicate that base course is frost susceptible

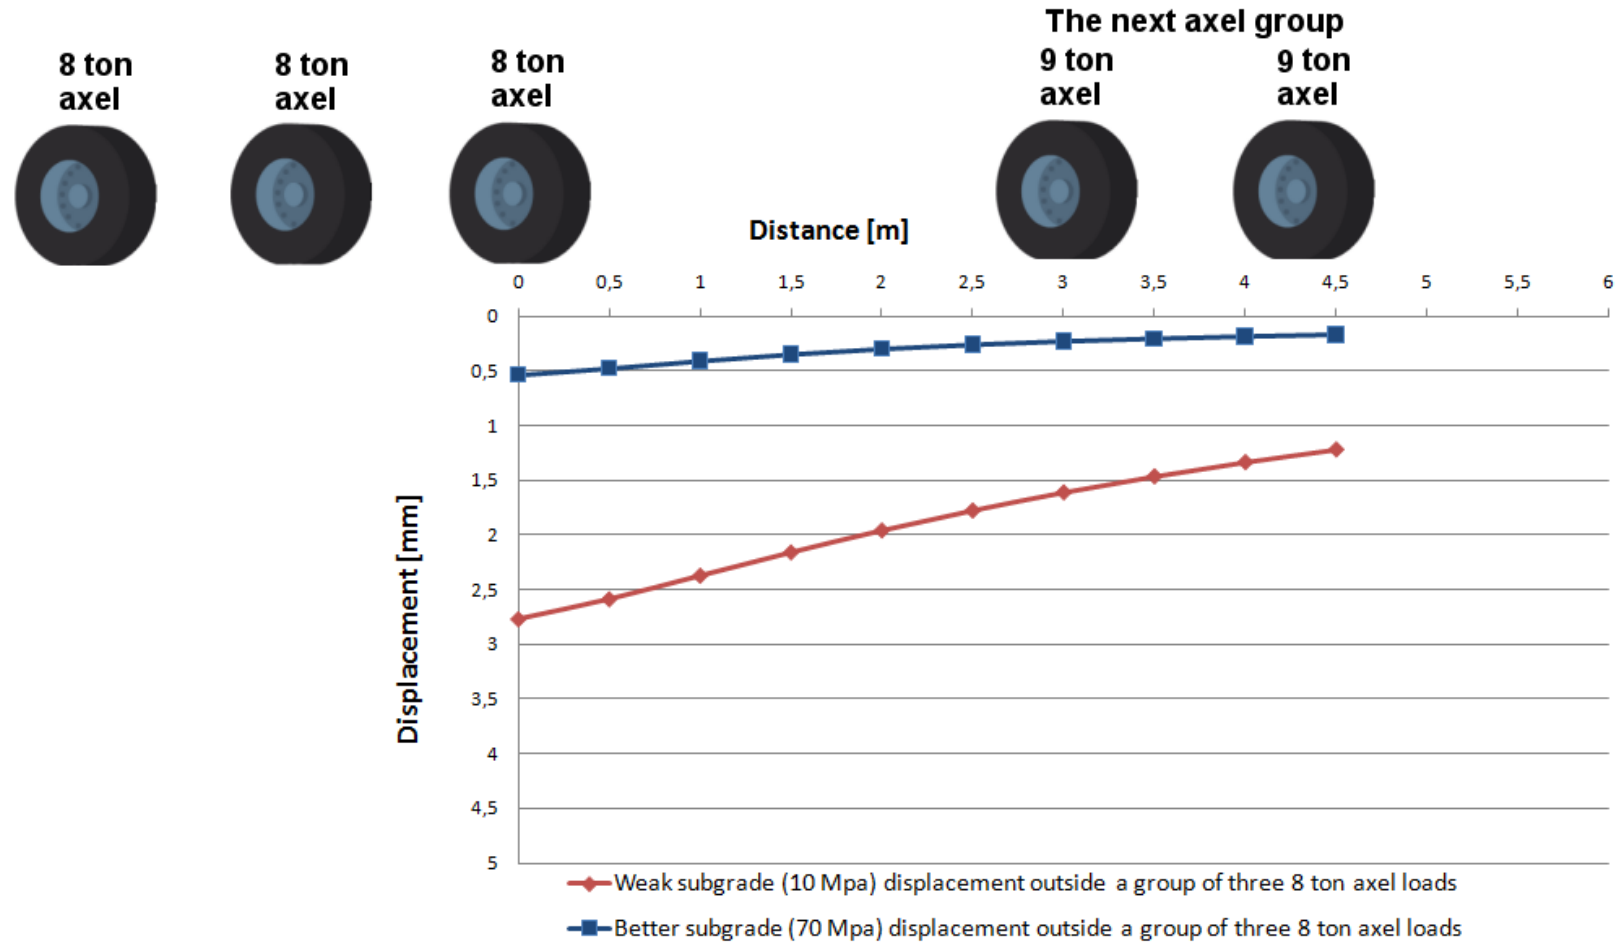
With 200 mm bound structures risks are focus on weak subgrade sections – 8 tn axle

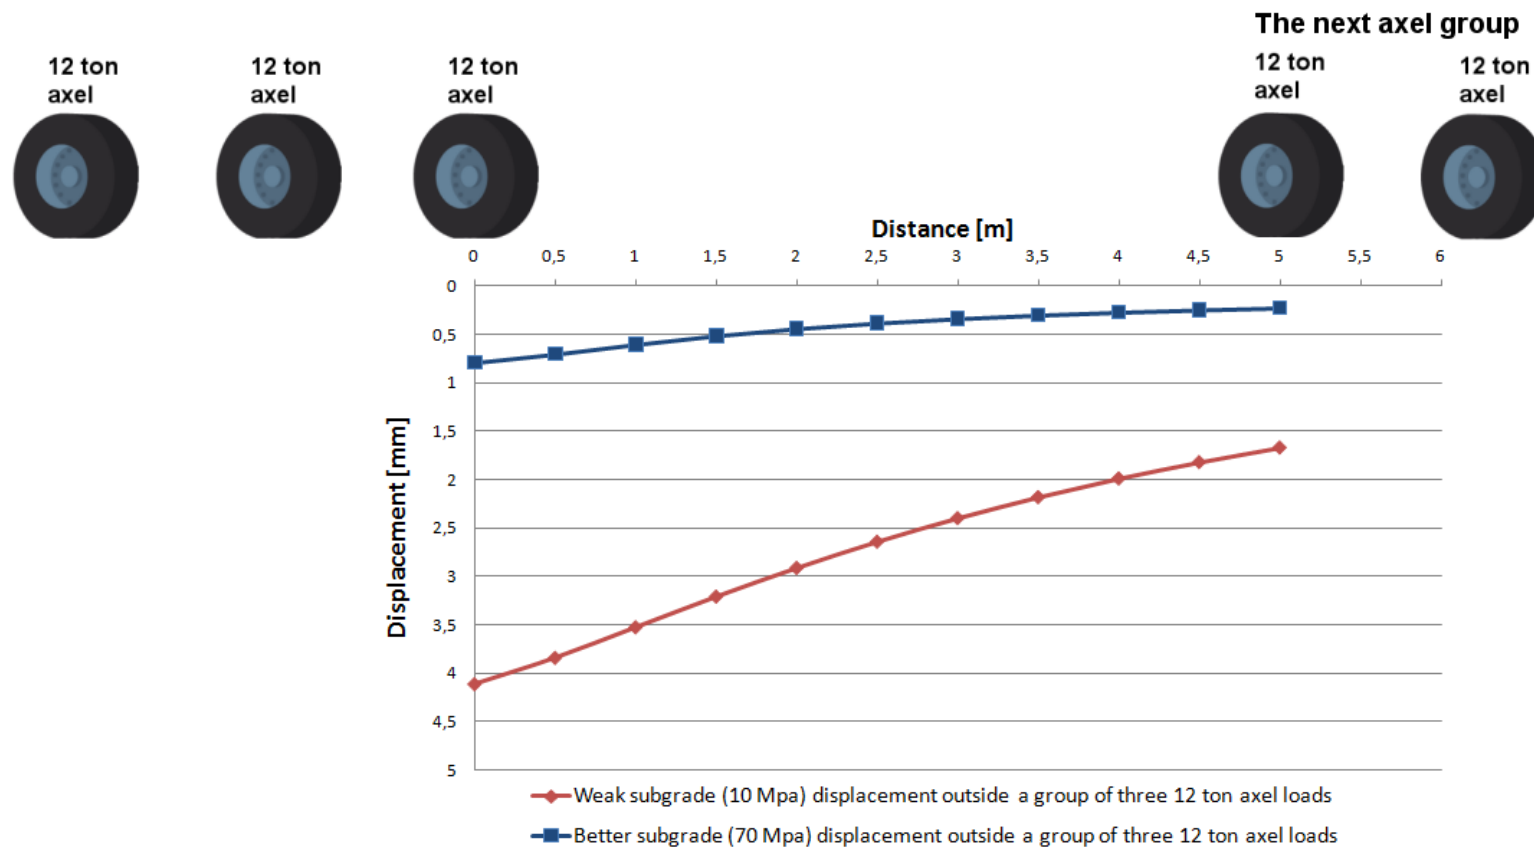
With 200 mm bound structures risks are focus on weak subgrade sections – 12 tn axle

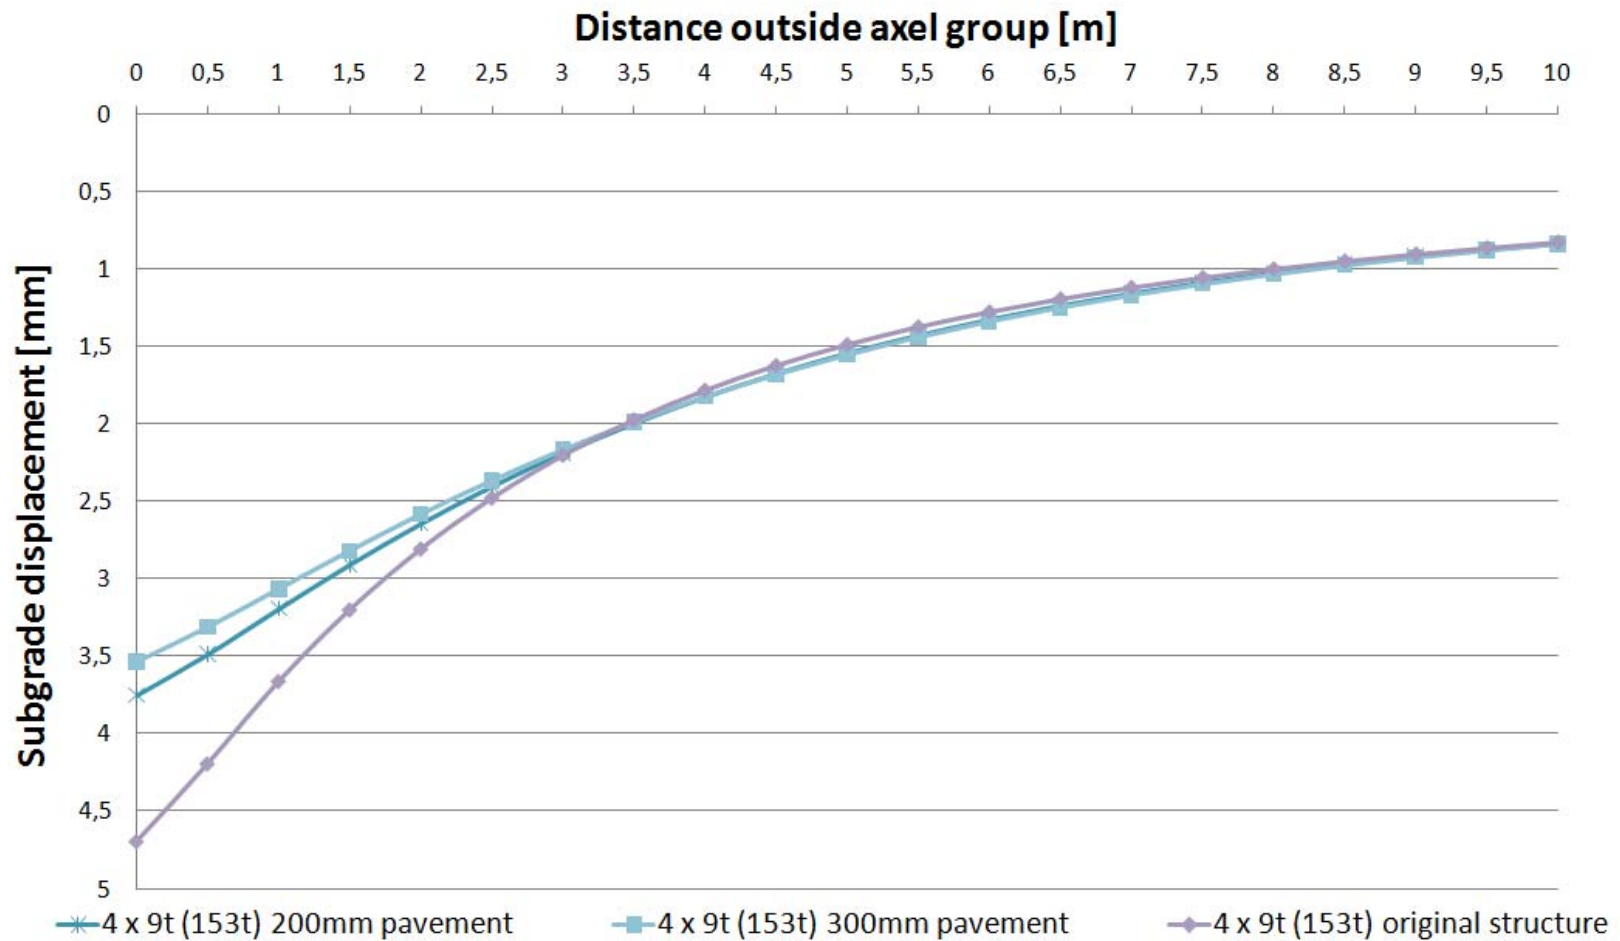
# Bisar Calculations – Pavement thickness after 200 mm does not help!
