Ride vibration & road condition

Johan Granlund, Chief Technology Officer
Vectura Consulting AB, Sweden

ROADEX IV Final Seminar
Rovaniemi, Finland, 26 April 2012

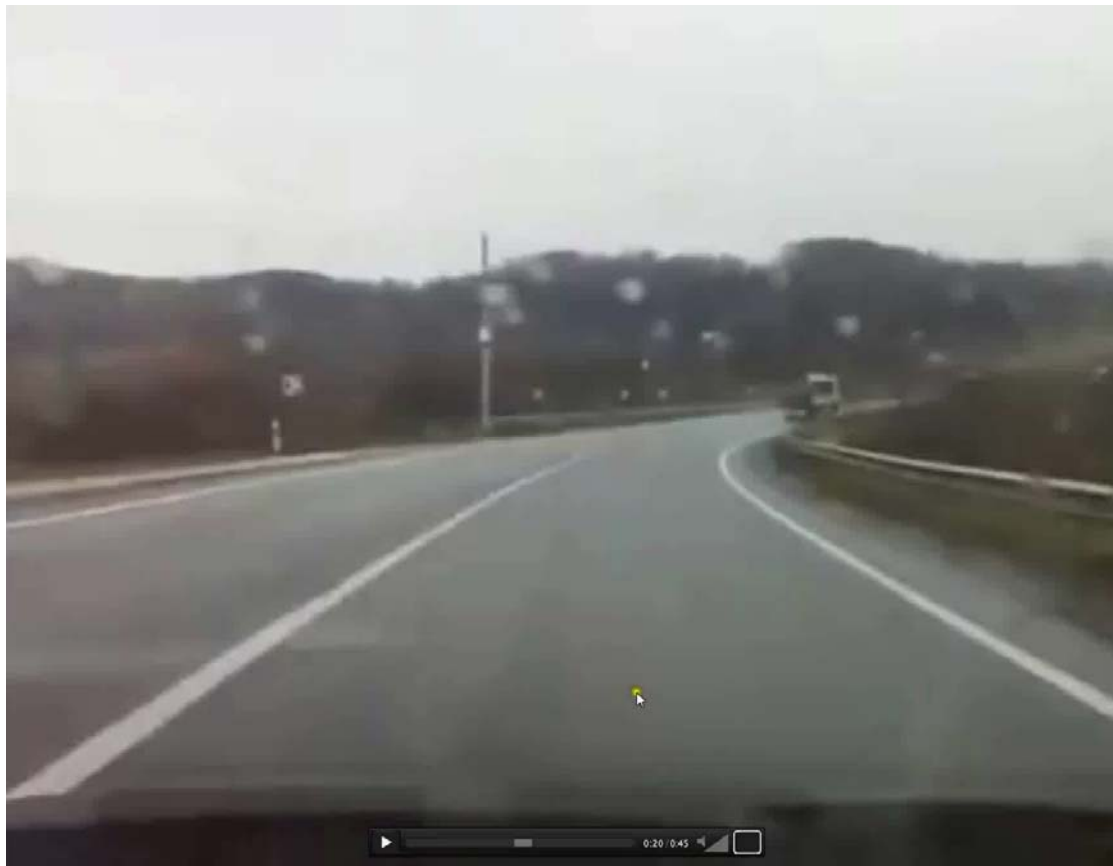
Hydroplaning at banked outer-curve

Oncoming Heavy Goods Vehicle brakes at curve entrance. The waterfilm is very thick just there, due to improperly designed Drainage Gradient (DG).

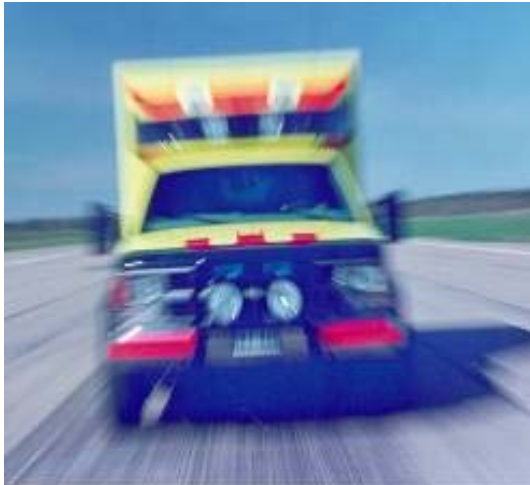
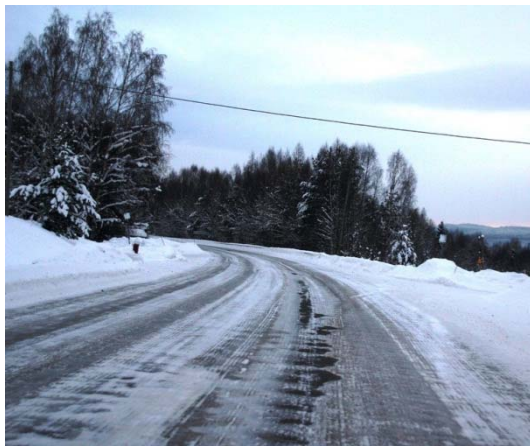
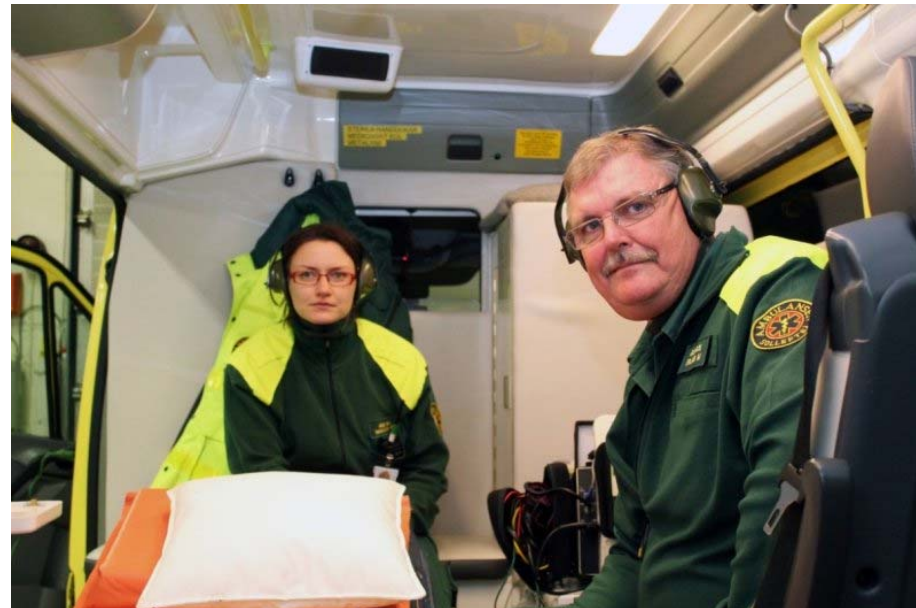
Dec 2011, corrugated icecap on Hw 90: Ambulance passengers needed earmuffs

Noise in Ambulance:

- Average 100 dB(A).
- Peak 120 dB(A).

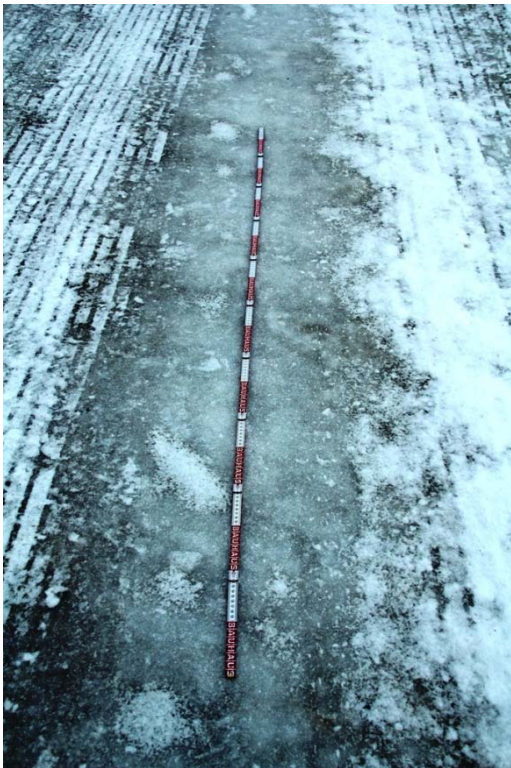
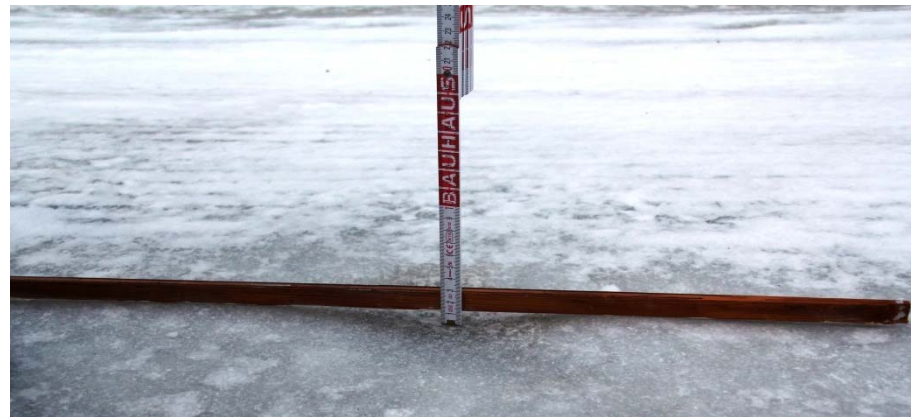
Corrugation in the icecap

Photos taken in March 2011, after worst corrugation was graded away.

Noise in Ford Galaxy @ 90 km/h

Normal icecap: 65 dB(A)

Corrugation (graded): >75 dB(A)

3-4 dm wavelengths

Less than 1.5 cm amplitude

Additional spec. is needed for corrugation!

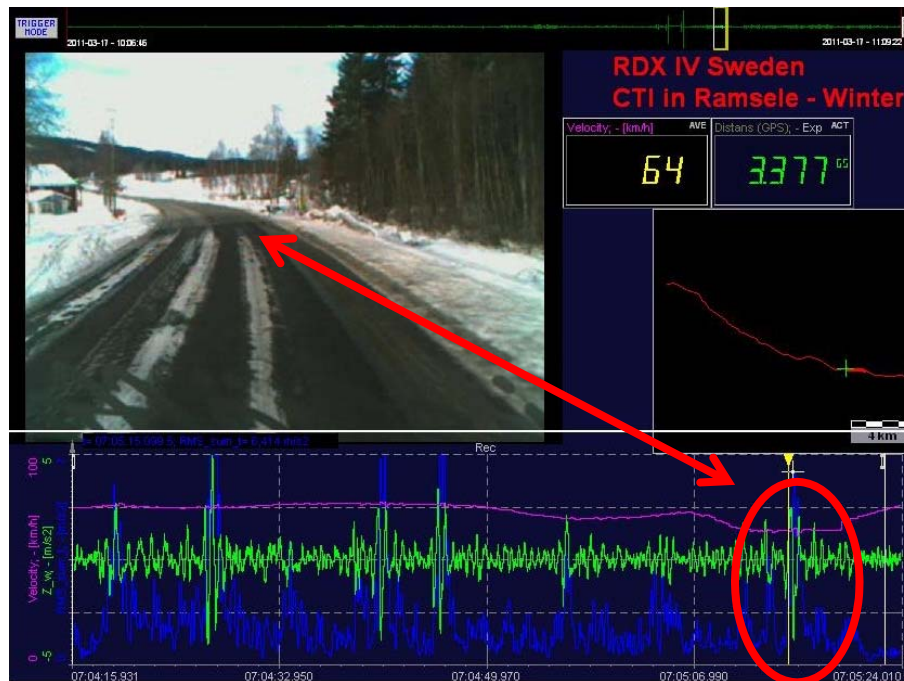
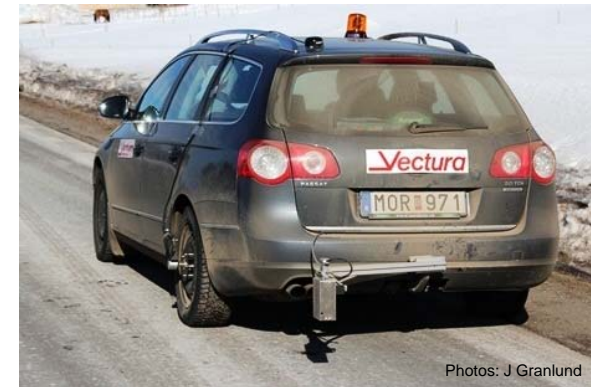
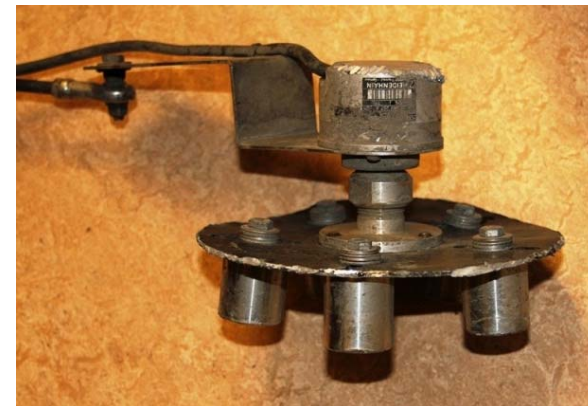
Poor Quality in Road Repair - Sweden

Road 1035 was locally reconstructed in autumn 2010.

- March 2011: Bumpier than urban speed bumps!

At a 3 dm bump, our laser system odometer bounced off!!!

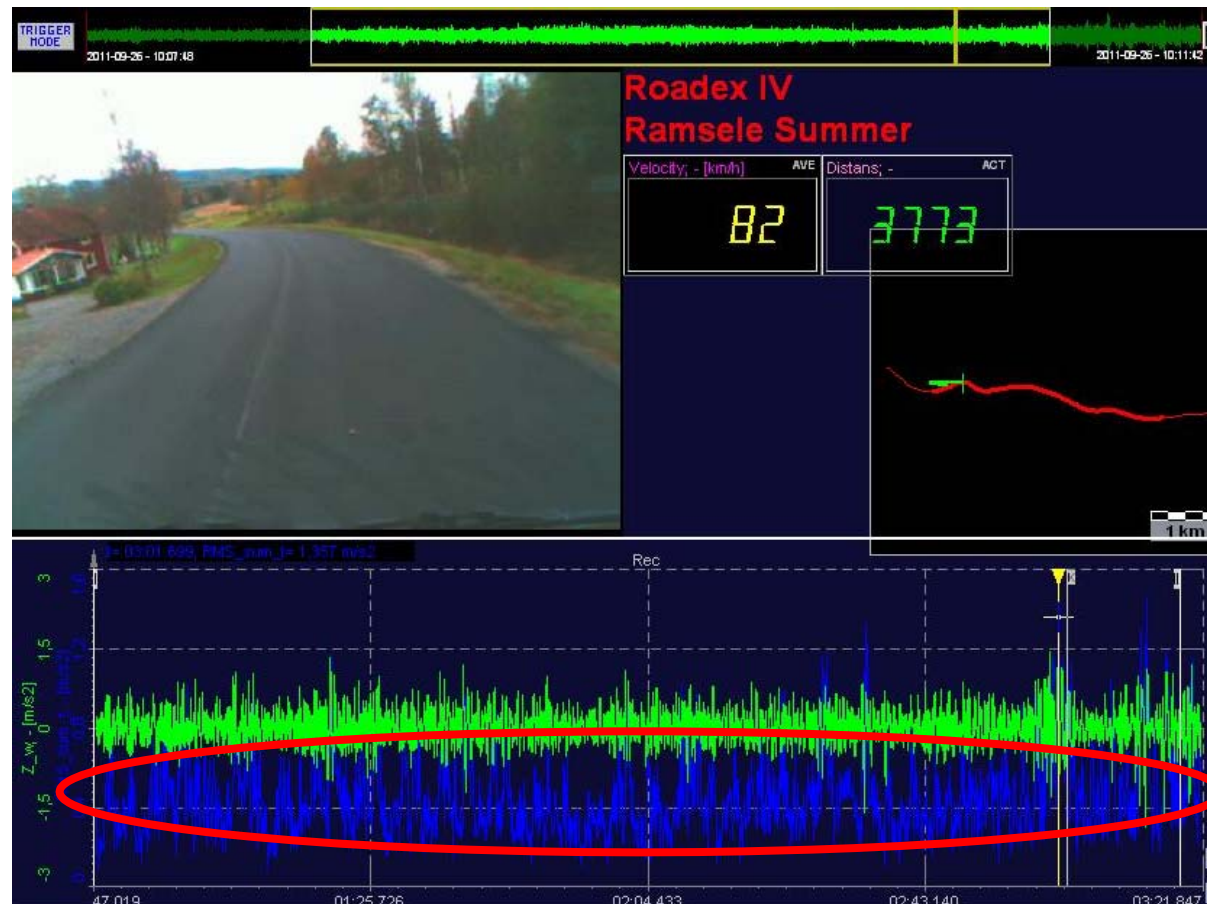
Poor Quality in Road Repair - Sweden (2)

Road 1035, 6 km resurfaced in summer 2011.

Sept 2011: Average ride 0.6 m/s² > EU Action Value!

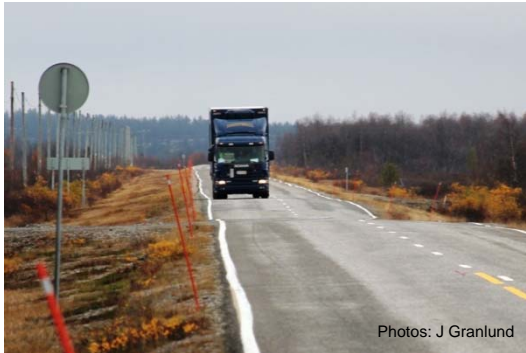
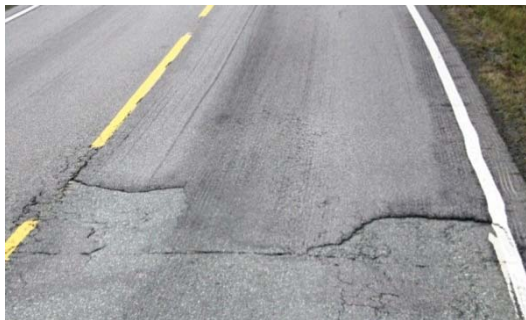
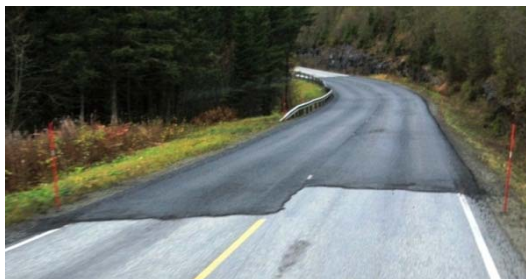
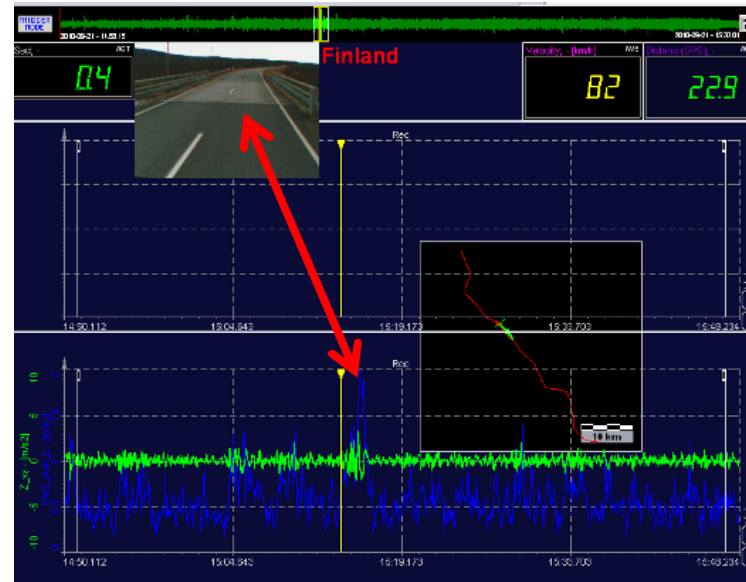
Some root causes to vibration

Severe bumps typically at:

- Settlements in thawing permafrost, Hw 21.
- Poorly installed culverts.
- Transversal joints at improper patches.
- Wrong pavement height at bridge joints.
- Settlement in backfill at bridges.

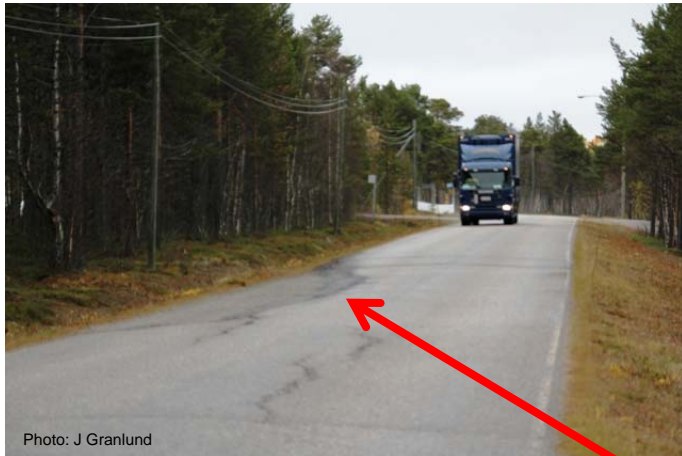
Lateral buffeting at Raattama Rd

All Roadex demo-routes occasionally gave high lateral buffeting.

Route Palojoensuu - Enontekis - Raattama - Muonio. Including parts of Hw 93, Rd 956 & 957 and Hw 79. Rd 957 very rough => severe Rock 'n Roll, lateral buffeting.

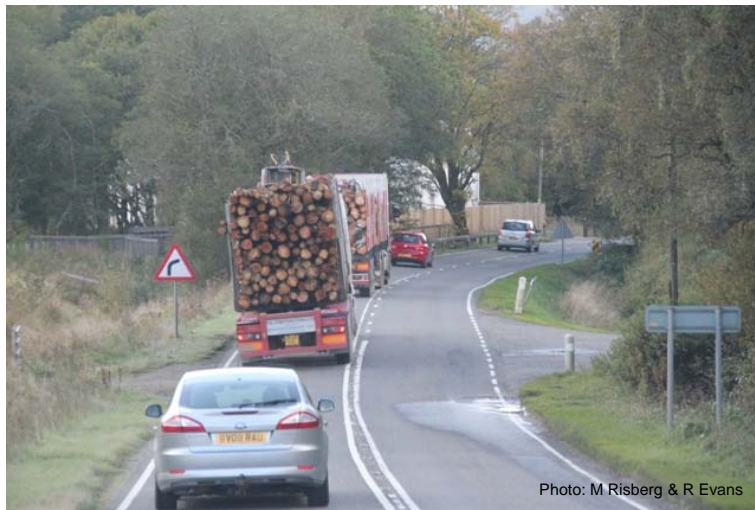
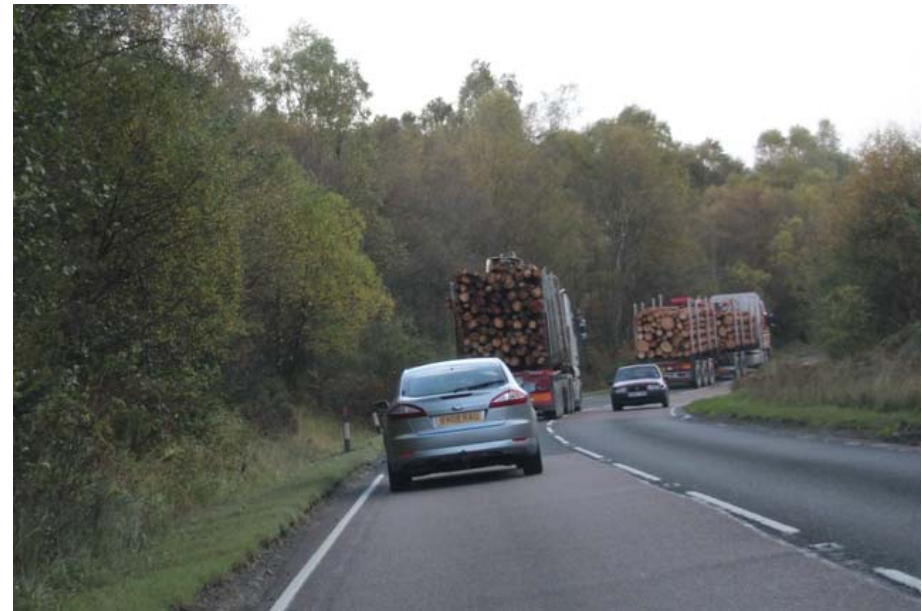
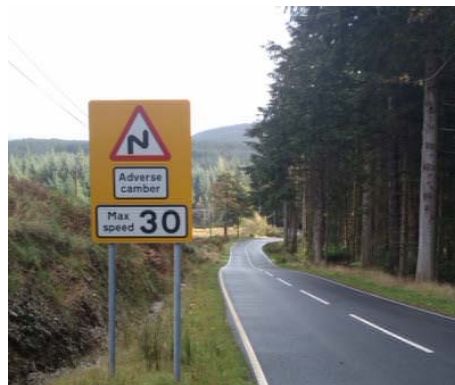
Many improperly banked outer-curves at all demo routes

Outer-curves have 5 times
more fatal single-crashes
than inner-curves.
At low volume roads: 6 times.

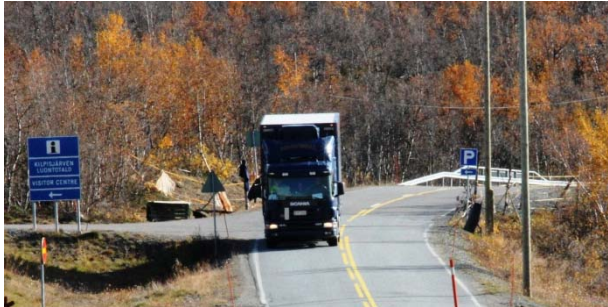
Improperly banked outer-curves

Sharp outer-curve with adverse camber
=> High need for side friction,
high risk for loss-of-control crashes.
