ROAD 16881 HUMALAMÄKI

Coarsening the base/sub-base course layers using only local stones

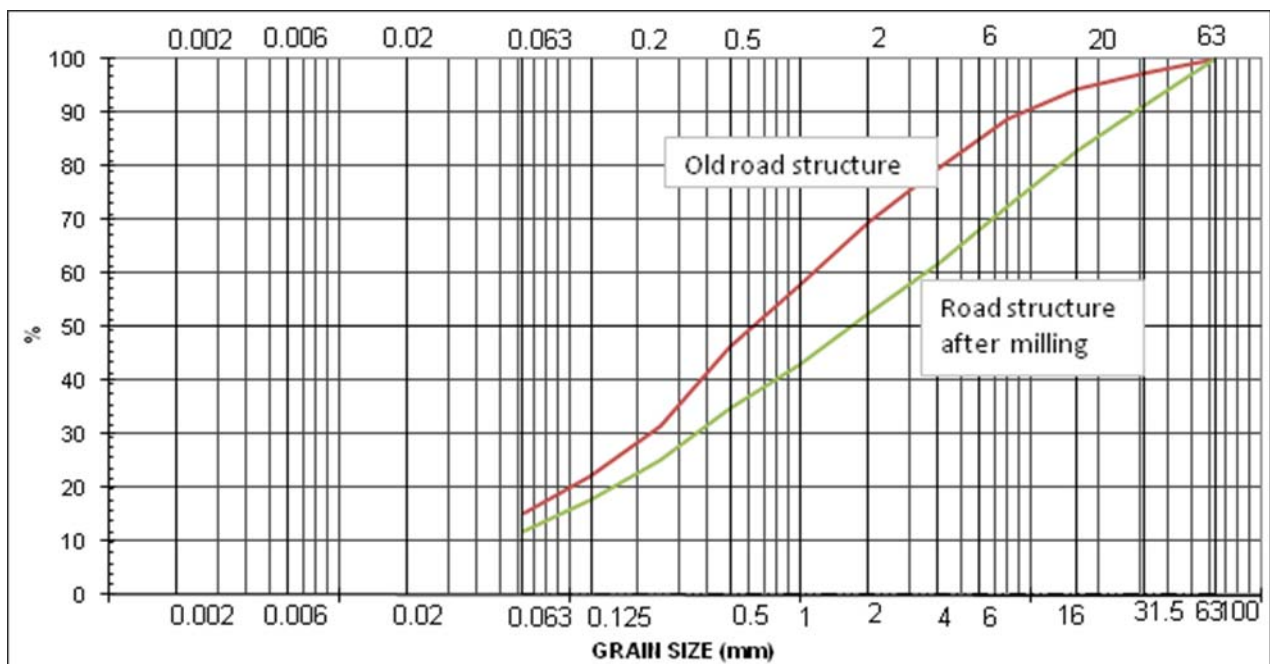
Figure 3.1 Changes in the grain size distribution from the chainage 6850.

selected points were at chainage 1700, 4825 5675 and 6850. The grain size distribution changes from the chainage 6850 are shown in figure 3.1. The all of the results are attached in appendix 2.

The grain size distributions before and after the rehabilitation work are shown in appendix 2. Following the rehabilitation work the fines content of the aggregate was 3 - 8 % smaller than before. Also the shape of the grain size distribution curves was improved.

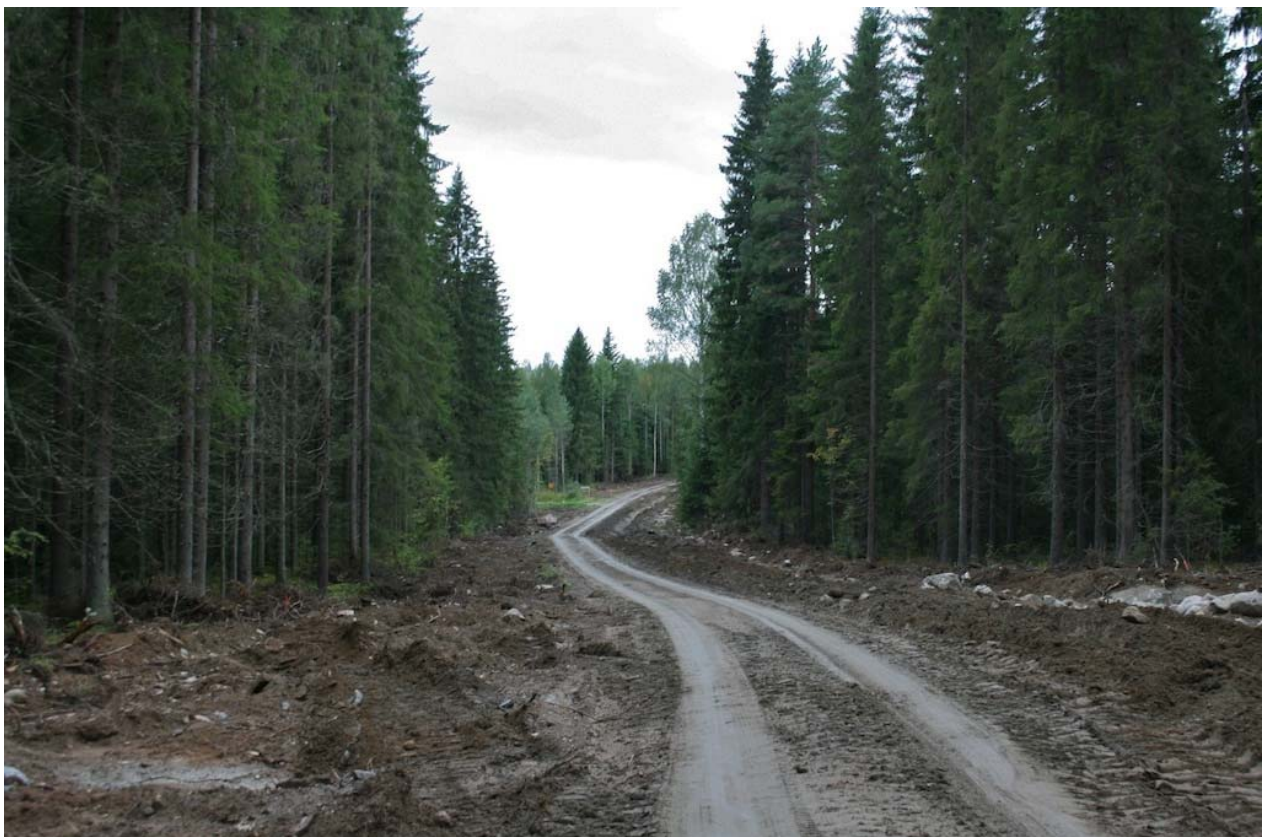
Figure 6.1 Cleared road area and temporary road

Stage one: All humus soil (organic material) was removed from the old road surface and road area. Trees on the road area were also cut down. Where the existing road was narrow a further area was cleared for the new road width. Temporary road lanes were occasionally provided off the new road line to keep traffic running through the site, as shown in Figure 6.1

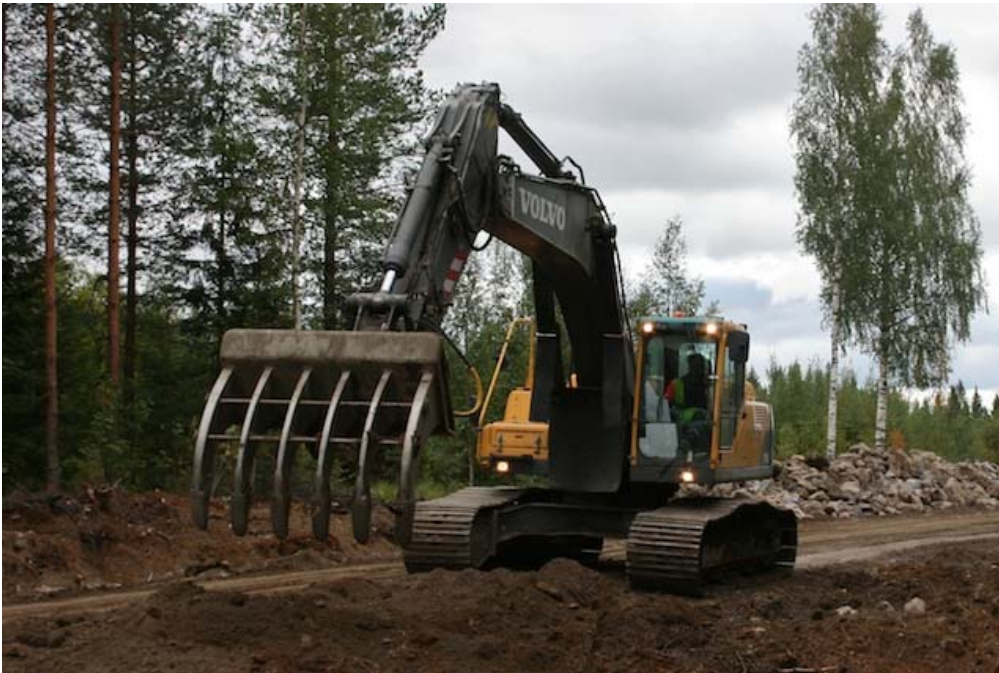
Figure 6.2 Digging up rock material from the old road structure

Stage two: Rocks larger than 300 - 350 mm were removed from the old road structure by a backhoe excavator as shown in Figure 6.2. In this way the old road structure was homogenized typically down to 500 mm deep. Rocky material was also excavated from the ditches and any widening areas. Rocky material was put to the side of the road. Depending of the amount and size of the rocks, the rocks were mechanically crushed by other means, e.g. rammer and jaw crusher.

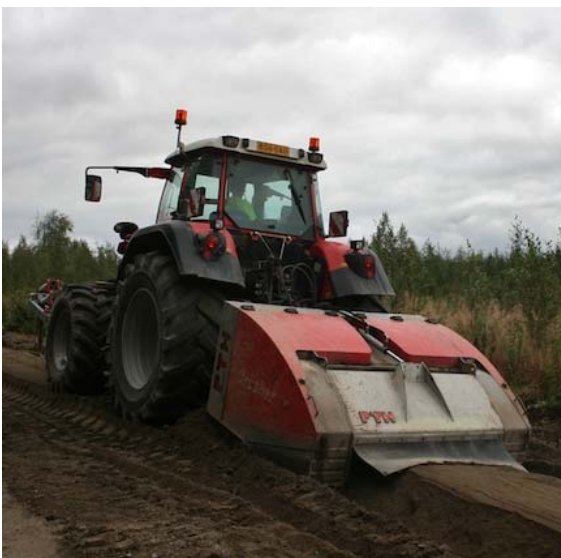
Figure 6.3 Crushing the rock material with PTH Crusher

Stage three: The rock material produced in Stage two was spread on the road by road grader. Then the rock material was crushed and milled with a crusher mounted on the back of a tractor as shown in Figures 6.3 and 6.4. Rocks up to 300-350 mm rocks can be crushed quite easily [3]. Larger rocks can also be crushed but the operation takes more time and wears out the machine quicker [4]. The crusher used in this case was manufactured by Profiteam Holzer GES.m.b.H (PTH). The crusher was later modified by Tirkkonen. [3] This crusher mills and mixes stones down to a depth of 300 mm. The first mixing and crushing produces a material with maximum grain size of 55 - 65 mm [4]. The mixed material can be milled several times until the specified maximum grain size is achieved. Usually the specified maximum grain size is 32 - 55 mm. The crusher is stated to be able to work with any kind of material, regardless of the hardness of the stone.

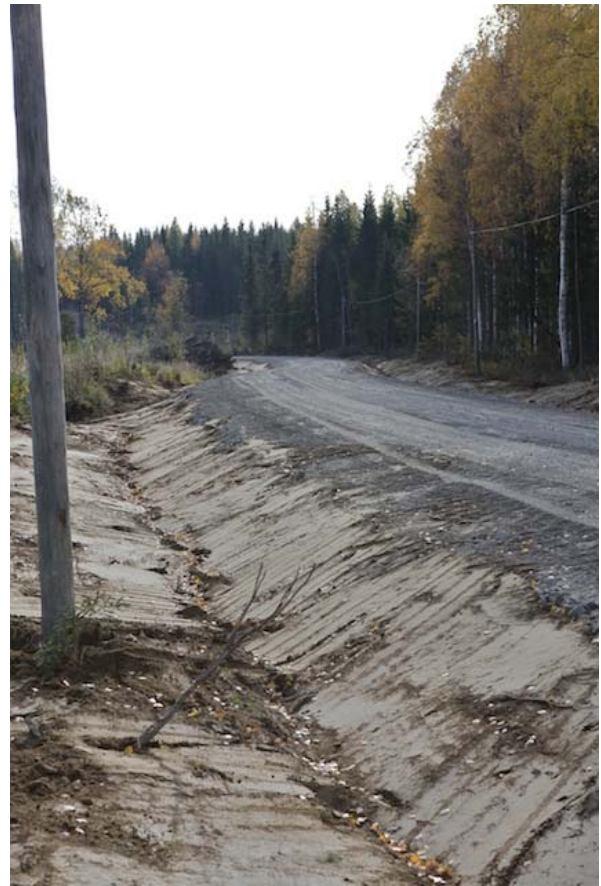
Figure 6.6 Finished shaping of the road

Stage four: The road was shaped and finished to the required crossfalls with a grader and compactor as shown in Figures 6.6 and 6.7. The ditches were also finished with the excavator to ensure that the drainage worked and the road was kept dry.

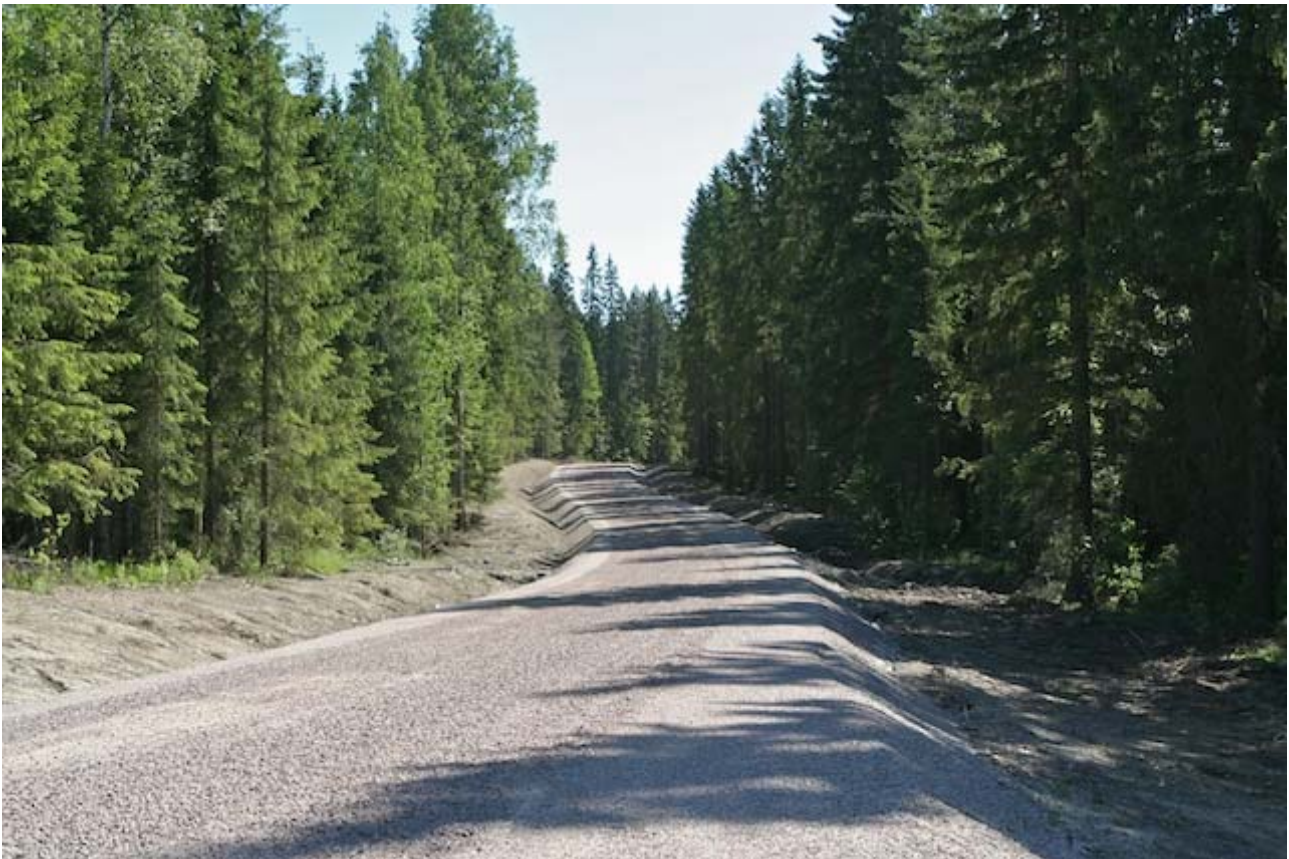
Figure 6.8 Ready and easy-care road (8.6.2011)

The compactor gave the finishing touch to the road following which the road achieved the specified bearing capacity and was opened to full traffic. The final result was a ready and easy-care road as shown in figure 6.8. This photograph was taken on 8 June 2011.
