Ilkka Hyvönen, Nuutti Vuorimies, Pauli Kolisoja

ROAD 16583 EHIKKI-JUOKSLAHTI

Demonstration of a Possible Drainage Solution for an Eroding Sideslope and Ditch

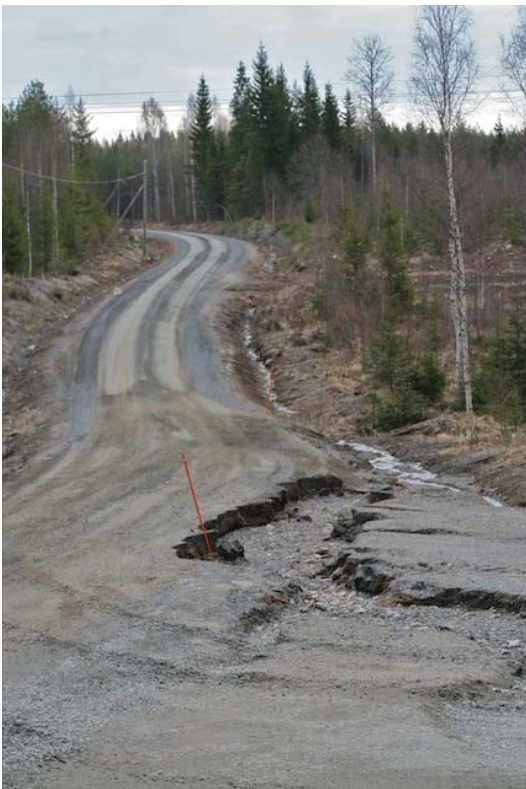
Figure 2.3 Water erosion on the road

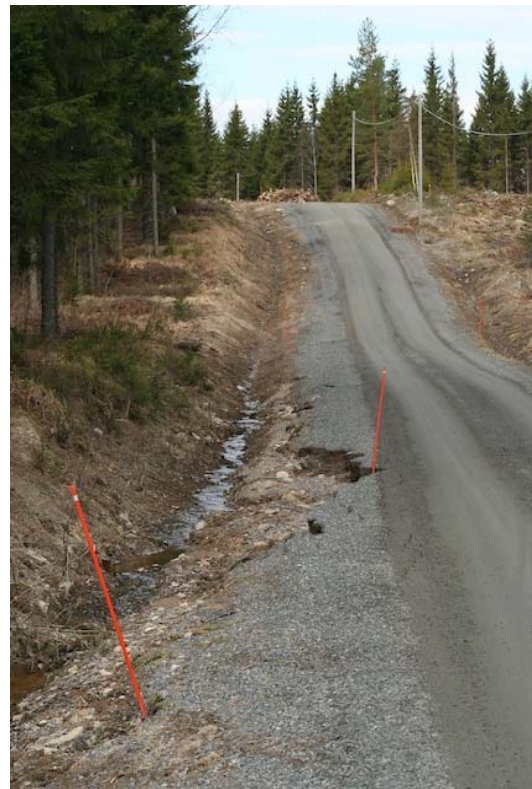
Figure 2.4 Water erosion

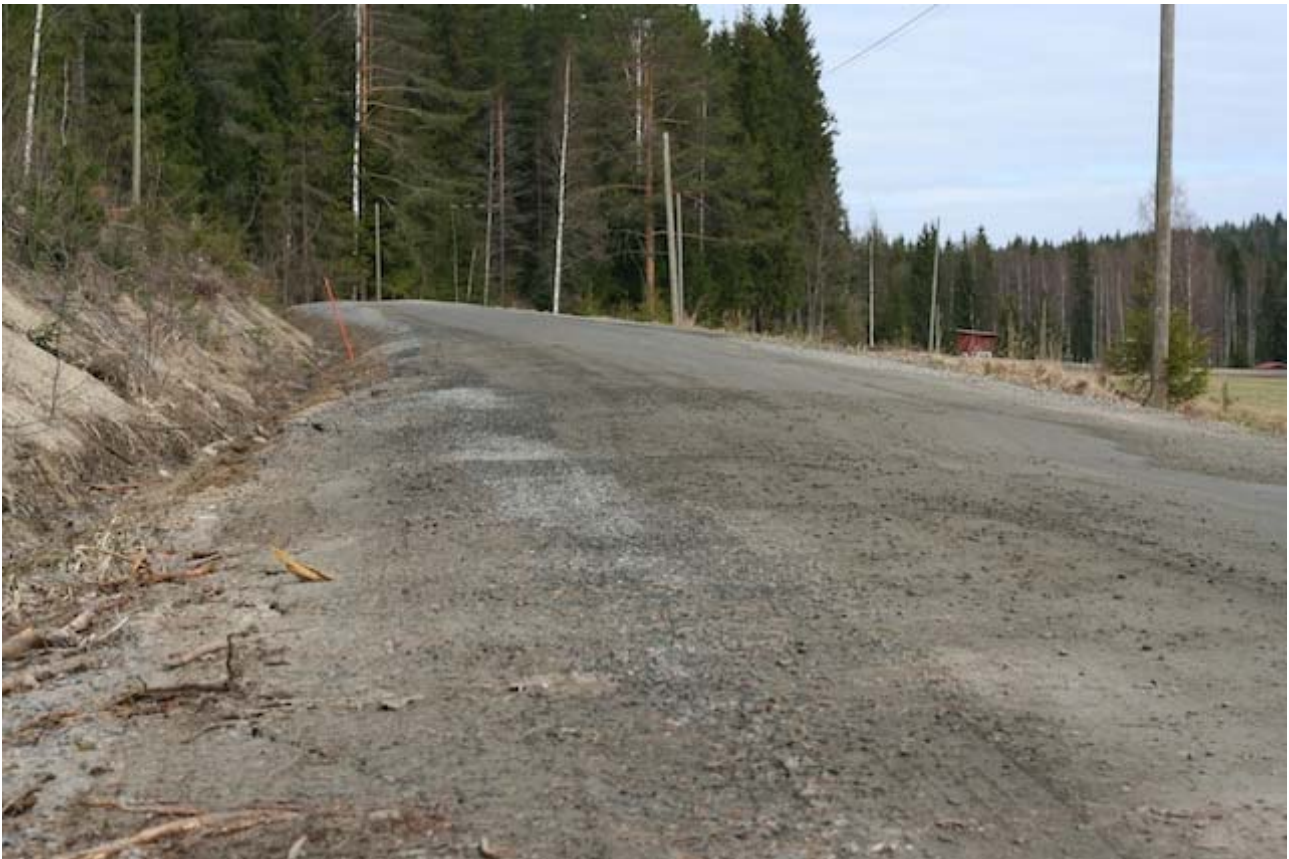
Phase 2: As the air temperatures keep rising the frost thaws deeper into the road and the structural thaw weakening phase starts. The thawing frost produces excess water in the lower structure and subgrade. If the subgrade has low water permeability it may become plastic causing permanent deformations with Mode 2 rutting, the subject of this report. In addition the passage of heavy vehicles can create increased hydrostatic pressures which can force excess water to flow up and to the side. As a consequence of this damaged roads sections which have suffered structural thaw weakening can also experience embankment widening to the ditches. [2]

Figure 2.5 Damages of the road in the Spring

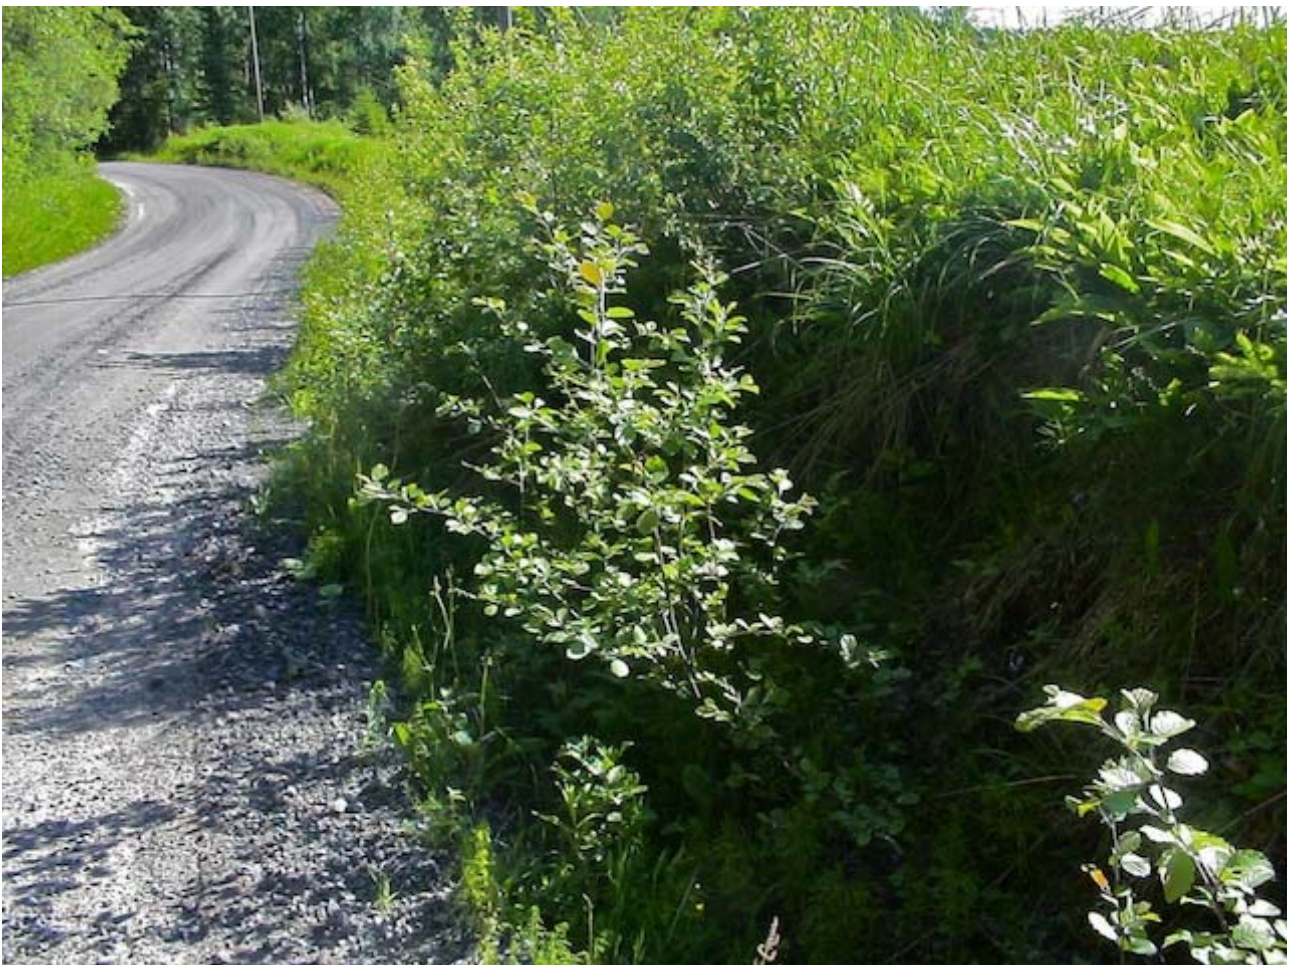
Figure 3.1 Filled up ditch in the beginning of the summer

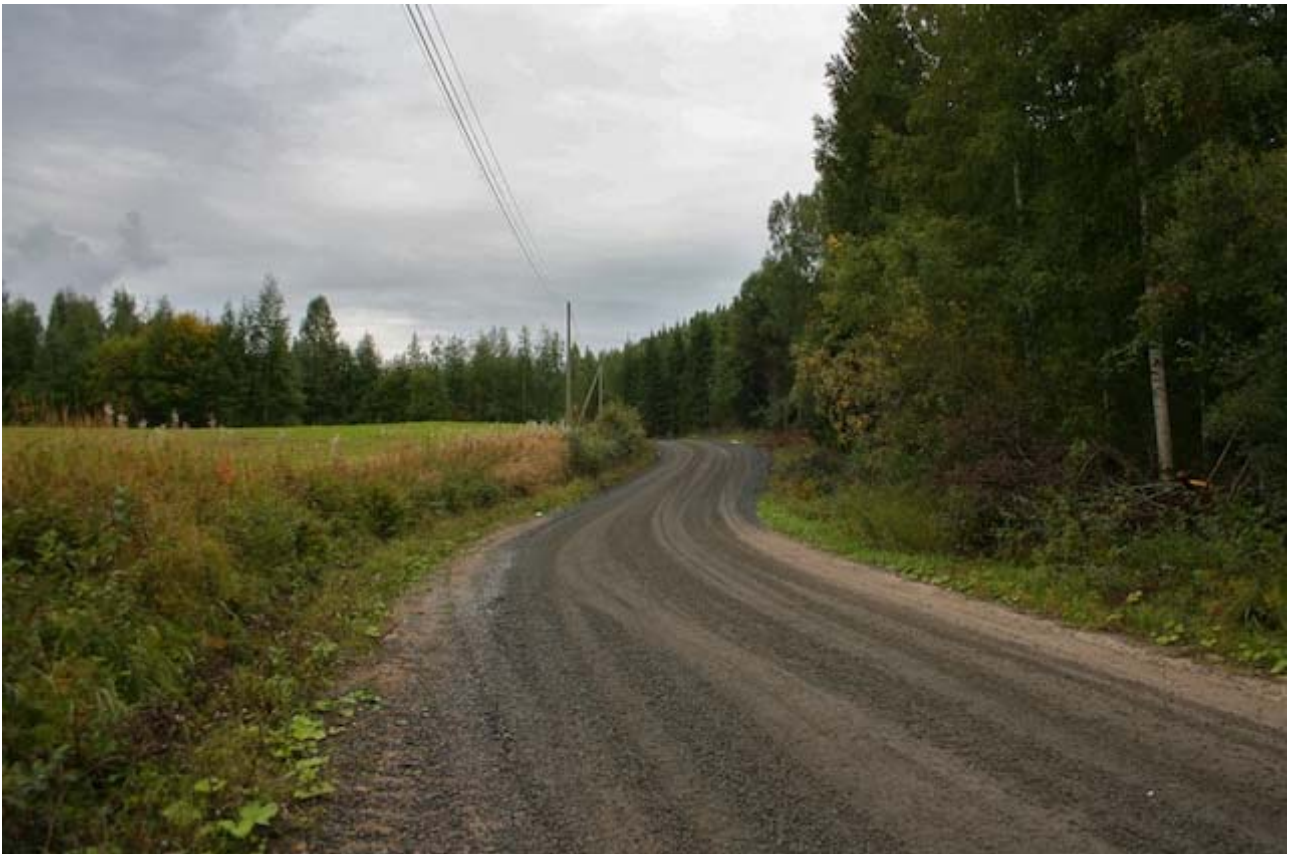
The main defect in the test section was that the road had widened towards the ditch as discussed in Section 2.5 and that the outer slope had become too steep. This had resulted the outer slope becoming unstable and collapsing in to the ditch especially during the spring thaw. Without cleaning, the ditch had filled with mud and vegetation, as shown in Figure 4.1. As a consequence of this the drainage capacity of the ditch had reduced, causing the ground water table to rise in the road structure and reduce the bearing capacity of the road. (A secondary effect of the rise in the ground water table is an increase in the risk of frost heave damage.)

Figure 4.1 Steep slope and filled up ditch

- Removal of the old banking material + clearing of the ditch + shaping
- Installation of a separation geotextile
- Stabilisation with 250 mm coarse graded aggregate

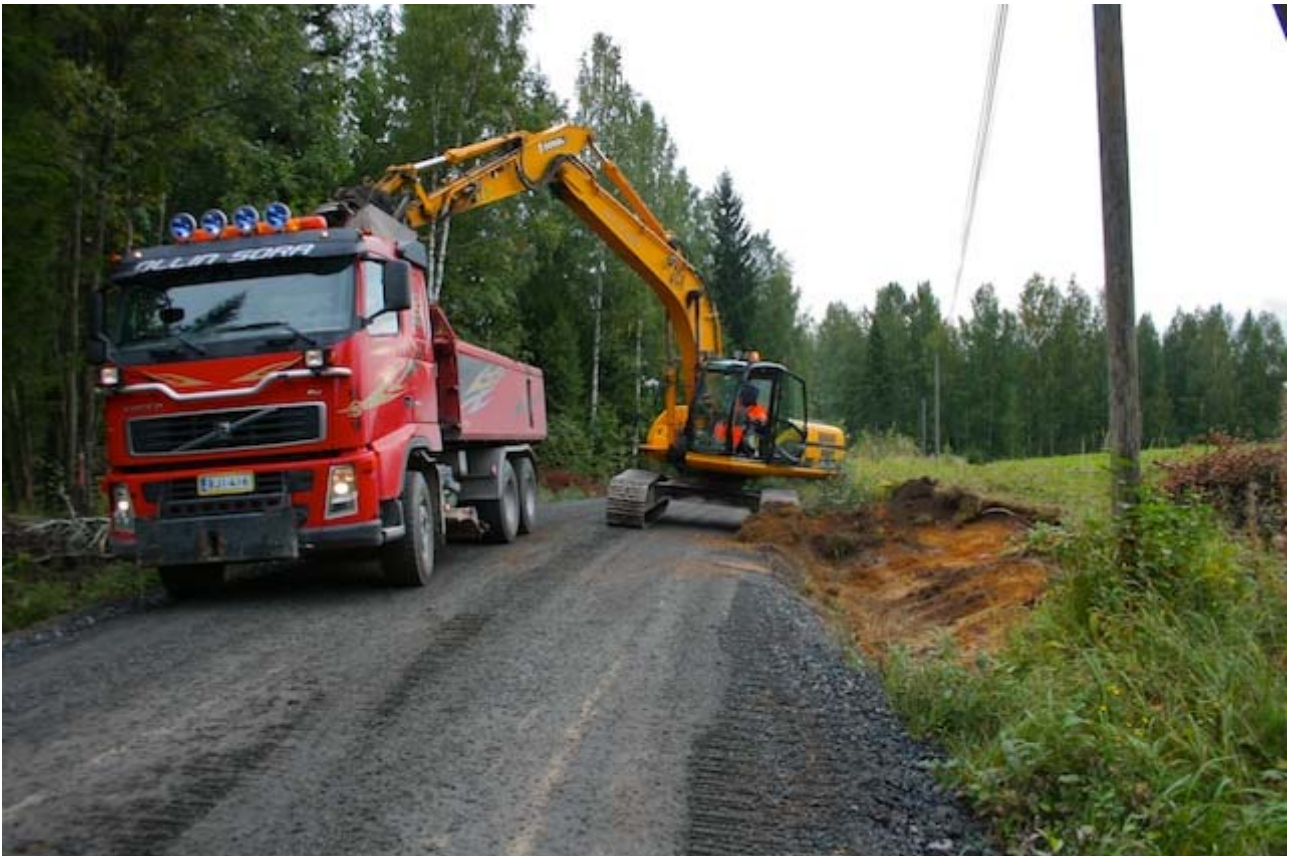
Figure 6.1 *Clearing the ditch and removing the vegetation*

The work on site started with clearing the debris from the ditch and removing the vegetation, as shown in Figure 6.1. At the same time the excavator shaped the slope and the ditch. Two men, an excavator and earth-hauling truck were used on this part of the work.

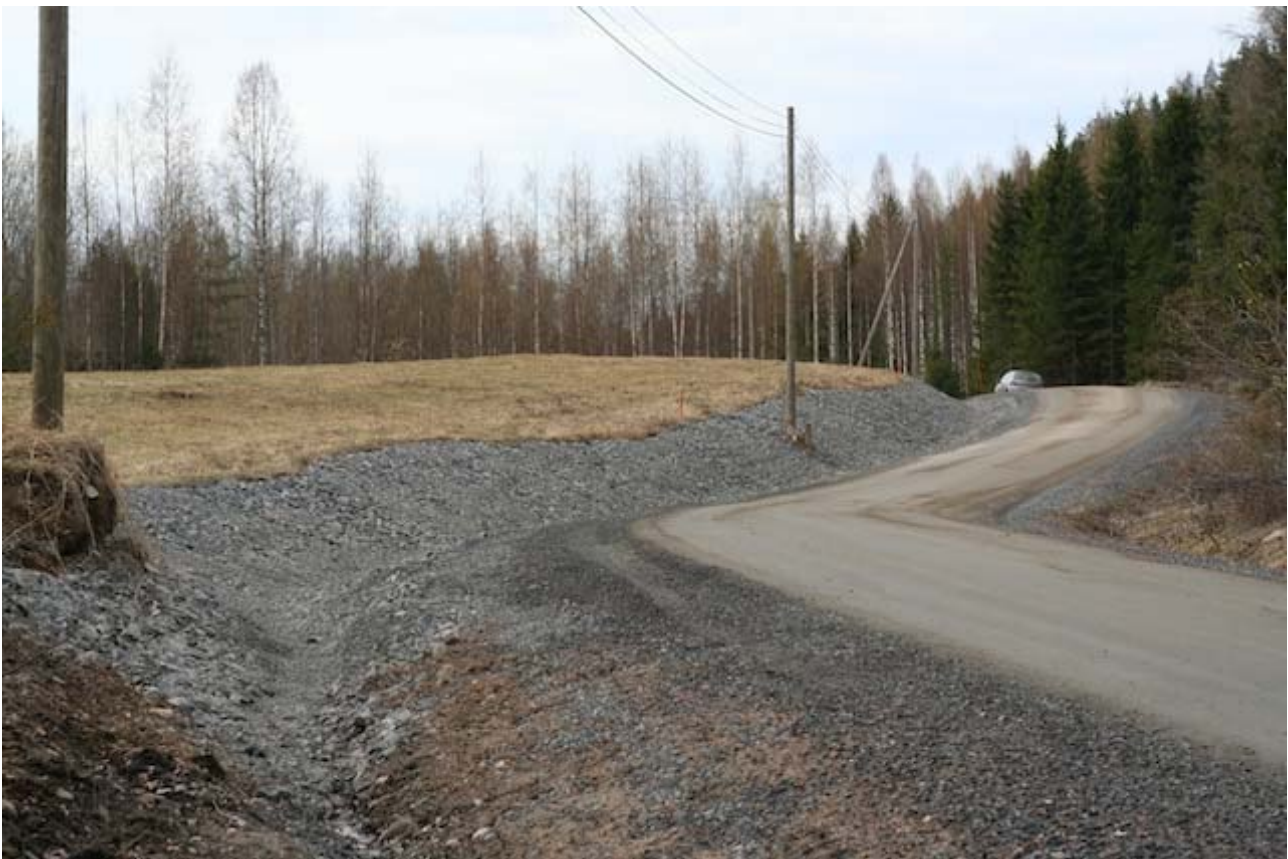
An initial site investigation was carried out on 5th of May 2011 after the spring thaw. The road was found to be in good condition and the drainage was also found to be working without any problem. The condition of the road on the day of the inspection is shown in figure 7.1. No areas of marked bearing capacity loss could be observed, unlike the case before the drainage improvement. A site investigation was also carried out in a rainy day on 24th of November 2011. The road was found to be in good condition as shown in figure 7.2.

Figure 7.1 The test section after the first spring thaw (05.05.2011)

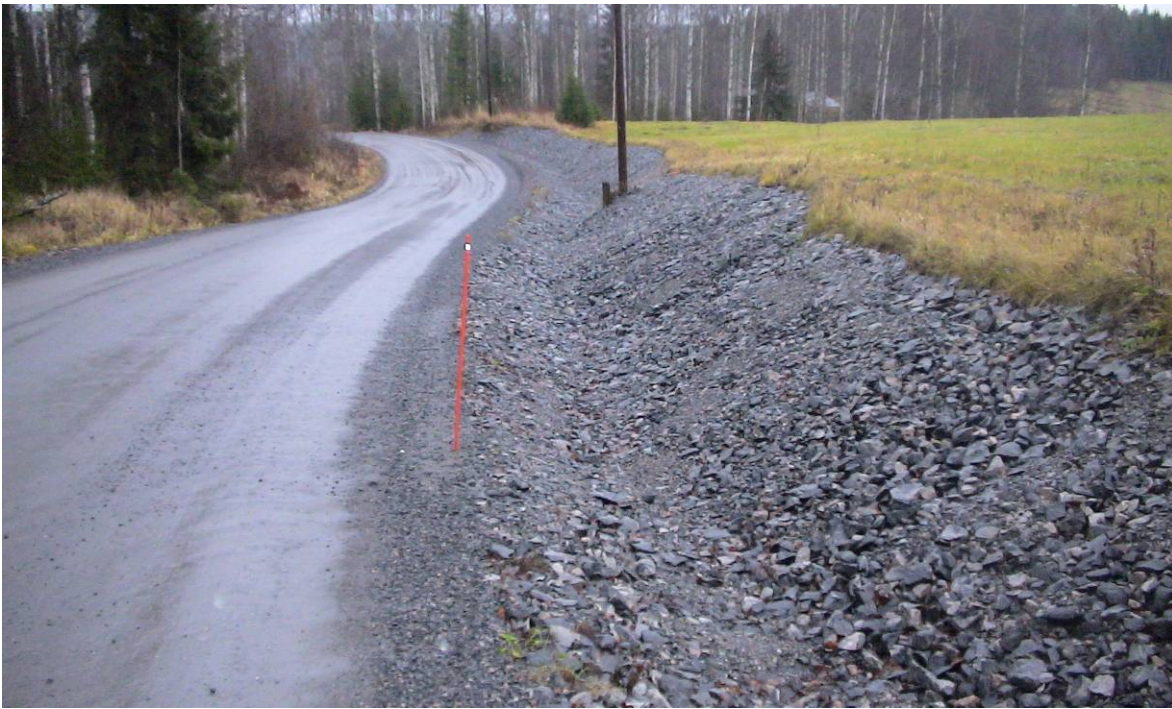
Figure 7.2 The test section on late autumn (24.11.2011)

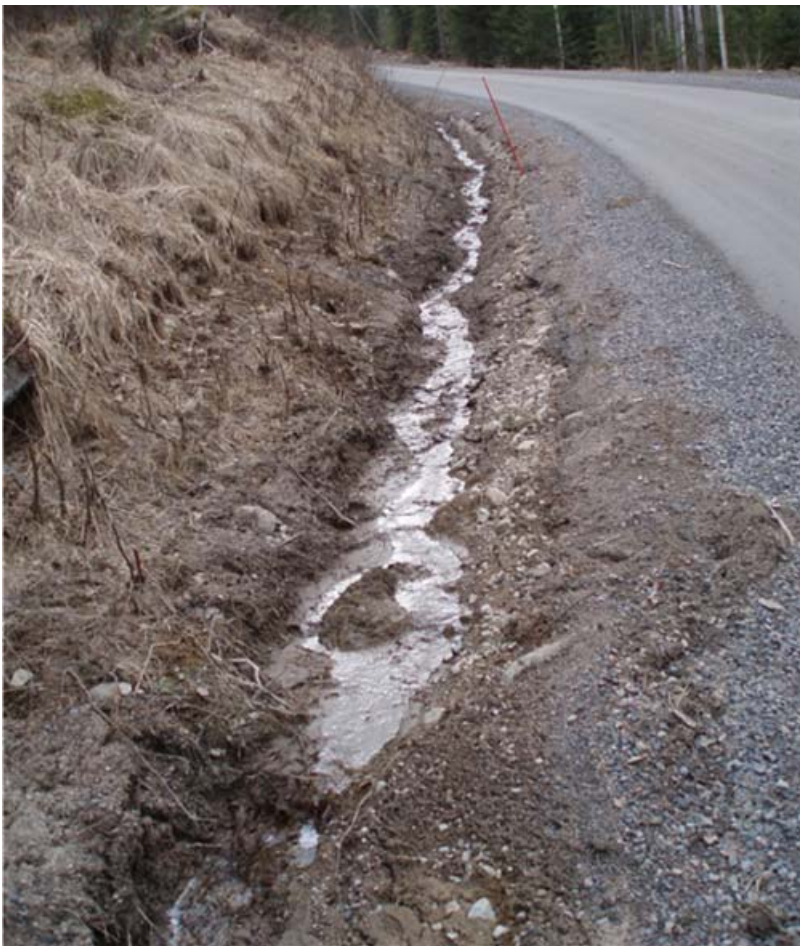
Evidence of the success of the drainage improvement structure could be seen on a nearby site originally considered as an alternative location for the drainage demonstration. On this site the ditch had been cleaned out in the normal way, i.e. without using the ROADDEX solution of geotextile and coarse grained aggregate, and there were already clear signs visible of the side ditch starting to be fill up after the first spring thaw (figure 7.3).

Figure 7.3 Initiating reclogging of the side ditch on a nearby site after the first spring thaw cycle.
