Ilkka Hyvönen, Nuutti Vuorimies, Pauli Kolisoja

# ROAD 16583 EHIKKI-JUOKSLAHTI

Demonstration of a Possible Drainage Solution for a Sloping and Rocky Terrain

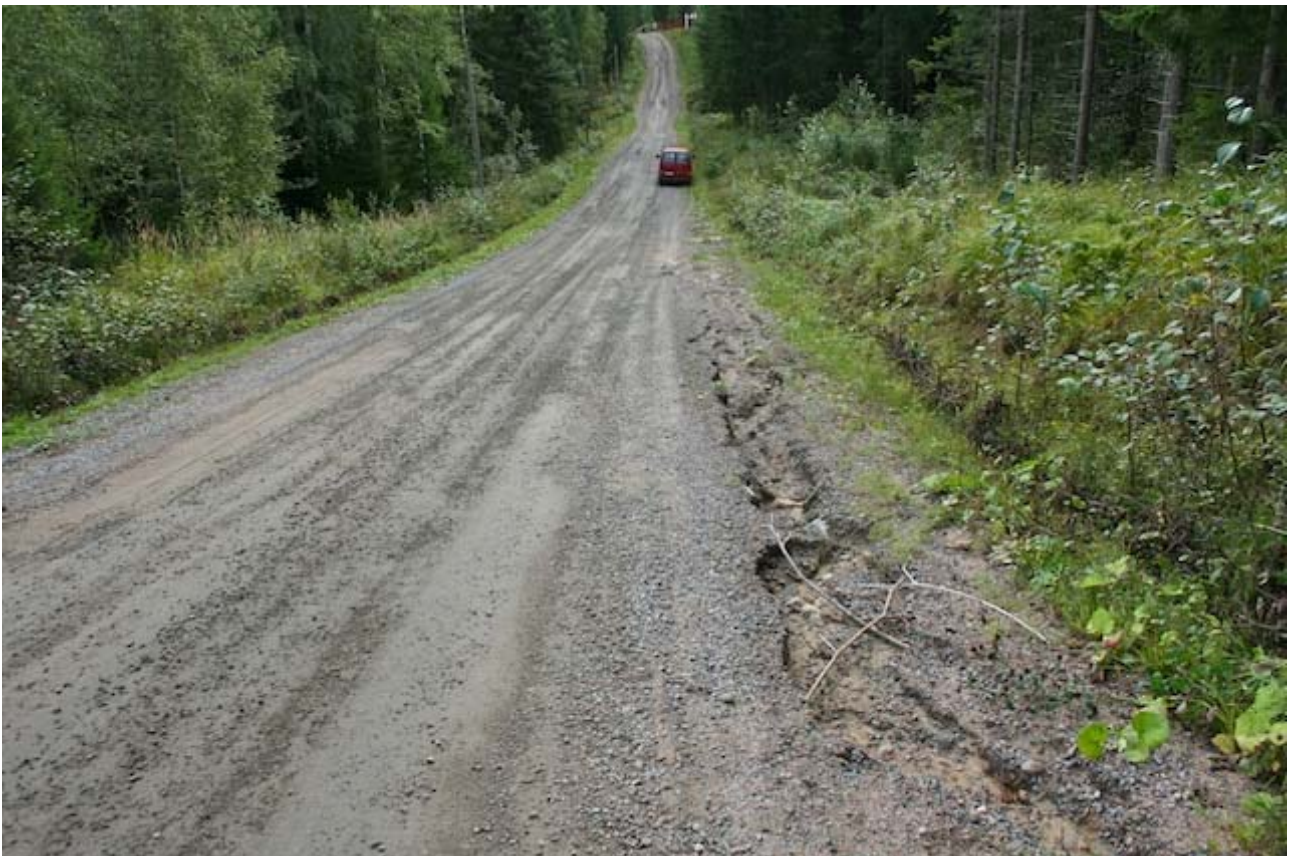
**Figure 2.3** Water erosion on the side of the road

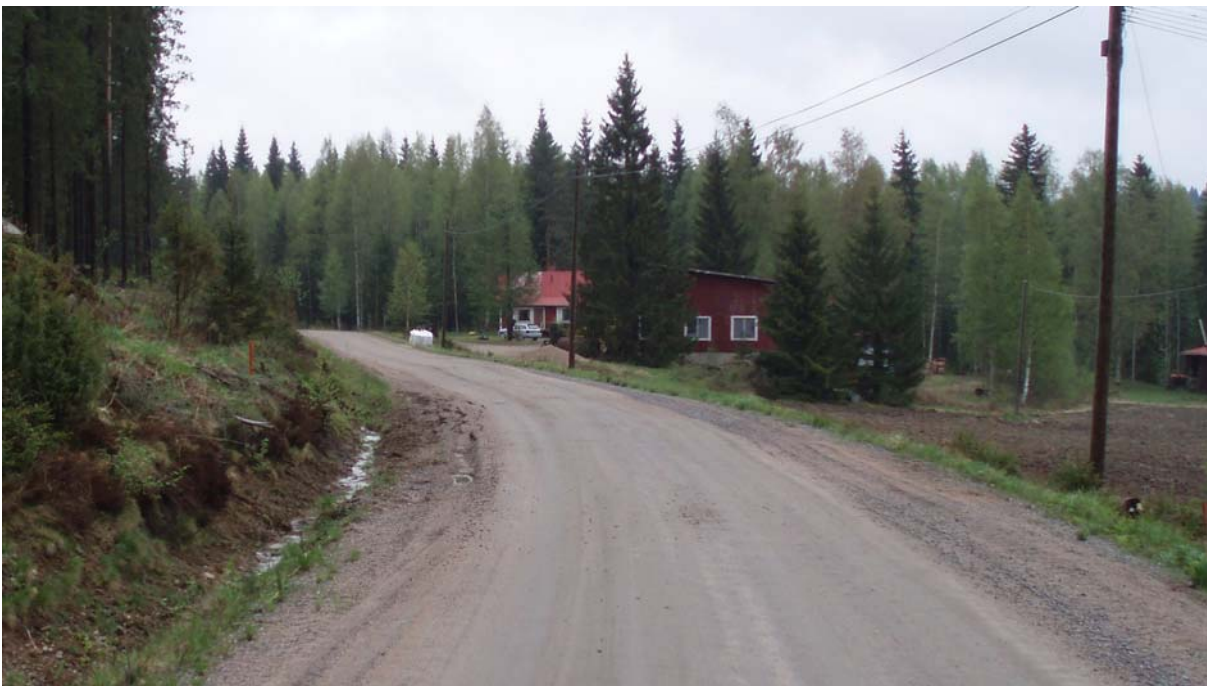
Phase 2: As the air temperatures keep rising the frost thaws deeper into the road and the structural thaw weakening phase starts. The thawing frost produces excess water in the lower structure and subgrade. If the subgrade has low water permeability it may become plastic causing permanent deformations with Mode 2 rutting, the subject this report. In addition the passage of heavy vehicles can create increased hydrostatic pressures which can force excess water to flow up and to the side. As a consequence of this damaged roads sections which have suffered structural thaw weakening can also experience embankment widening to the ditches. [2]

**Figure 2.4** Damages of the road in the Spring

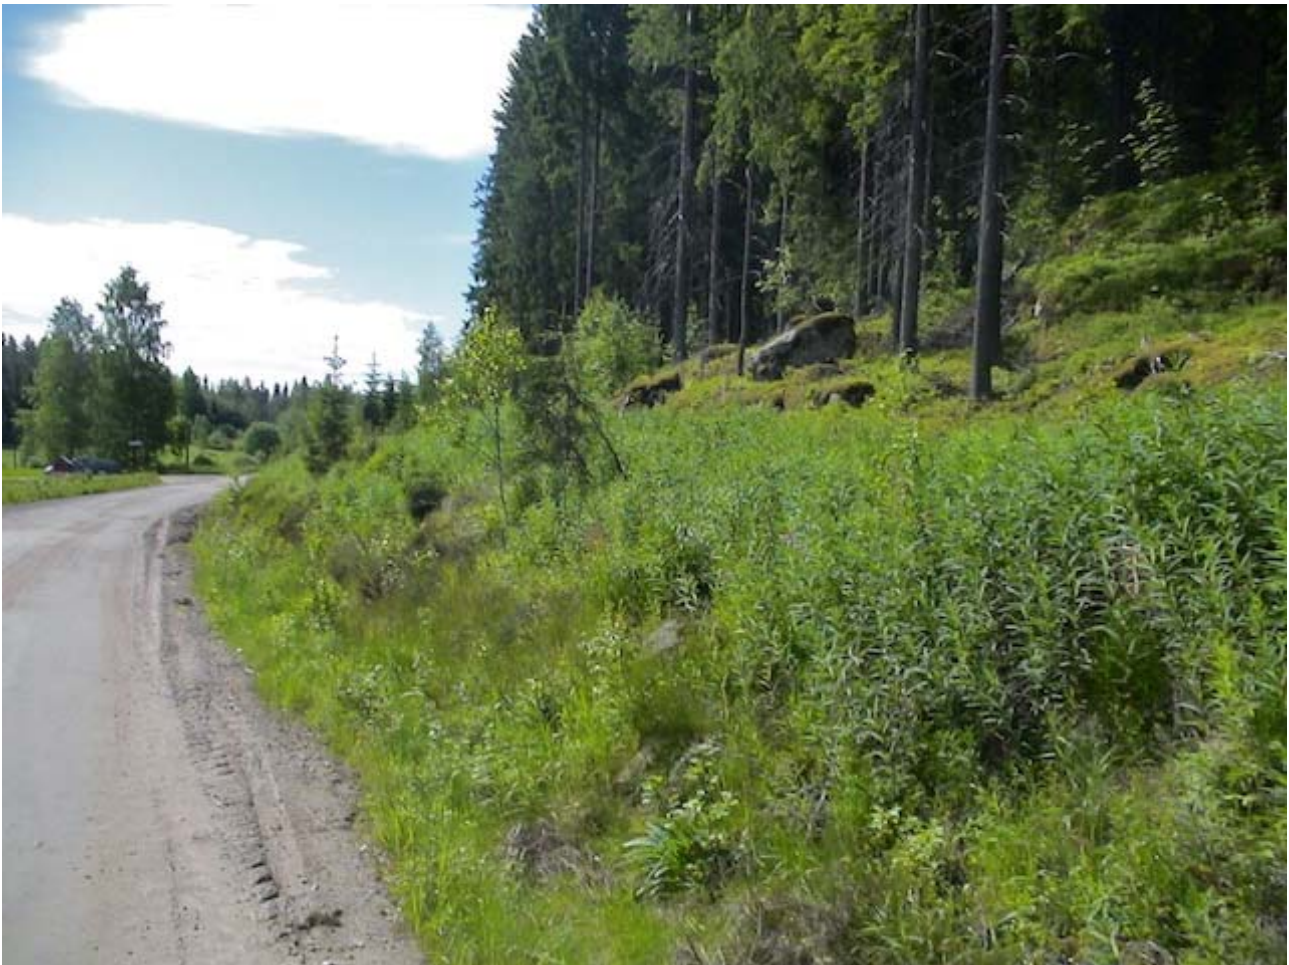
Normally site investigations are carried out only once for a road rehabilitation but in this site they were carried out twice. The first site investigation was carried out during the spring thaw process in April 2010 when road damages could be seen. The second visit, the 'official' site investigation, took place in the beginning of June when the road was in better shape and only severe damages remained. Inventory photos were taken during this investigation and the damaged sections of drainage systems were checked for location and condition.

**Figure 3.1** Filled up ditch in the beginning of the summer 2010

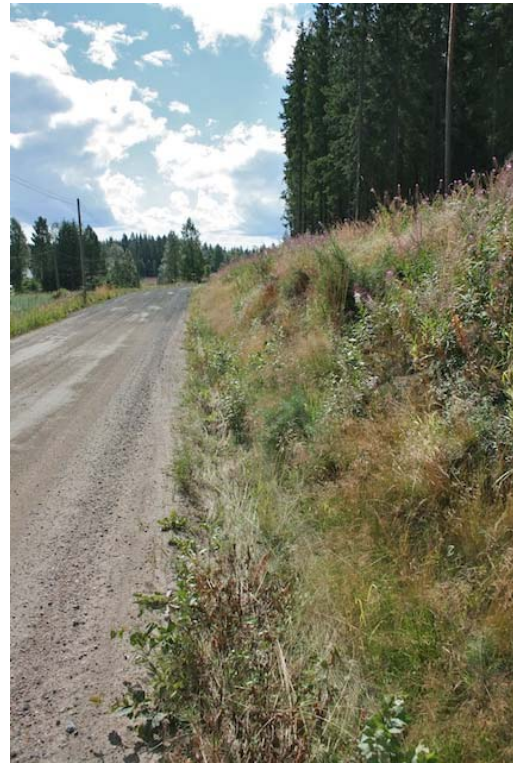
The main problem in the demonstration section was that the outer slope of the road embankment was too steep. The presence of bedrock was additionally causing problems by forcing groundwater and water from rainfall, up through the ground surface to collect locally in places. The presence of bedrock was also preventing water draining in the ditches. As a consequence of these circumstances part of the outer slope had collapsed into the ditch and the road had widened towards the ditch. A further contributing factor was that the ditch had not been cleared for some time and had filled up with vegetation, as shown in Figure 4.1 and 4.2. The consequence of this was that the drainage capacity of the ditch had been reduced. This had caused the ground water table to rise in the road structure and reduce its bearing capacity with the result that

uneven frost heave damages had regularly occurred along the road on the hill side.

**Figure 4.1** Filled up ditch

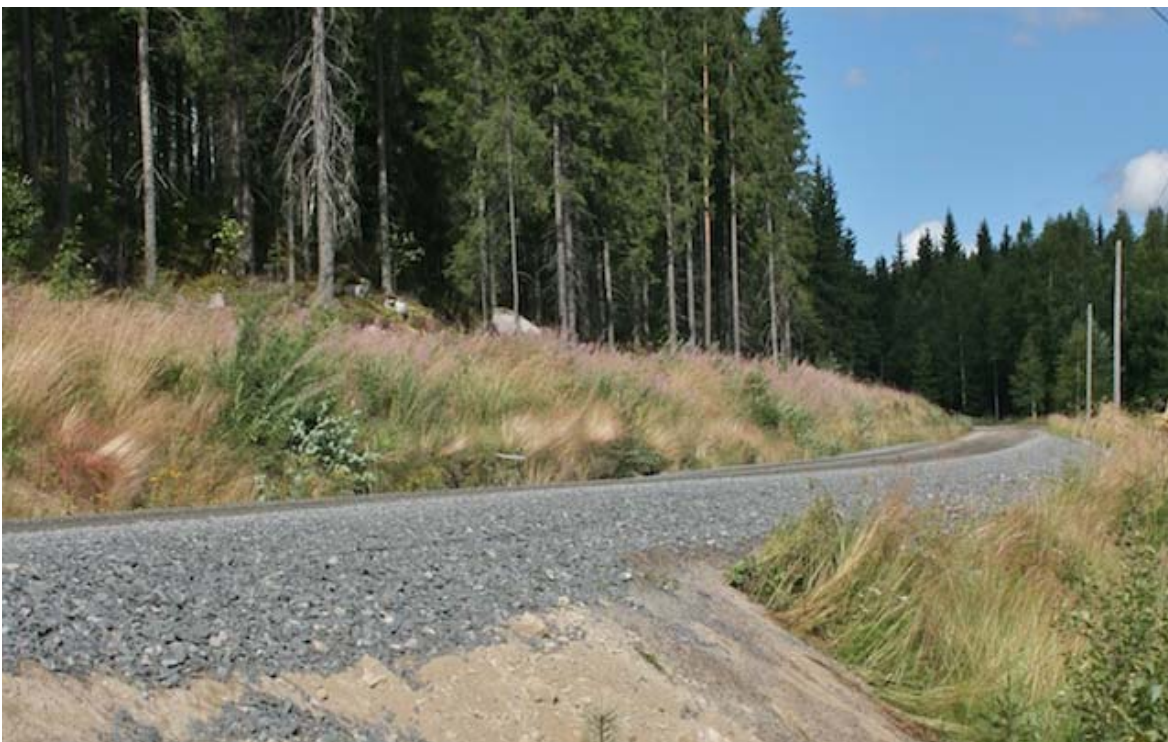
**Figure 4.2** Side sloping profile

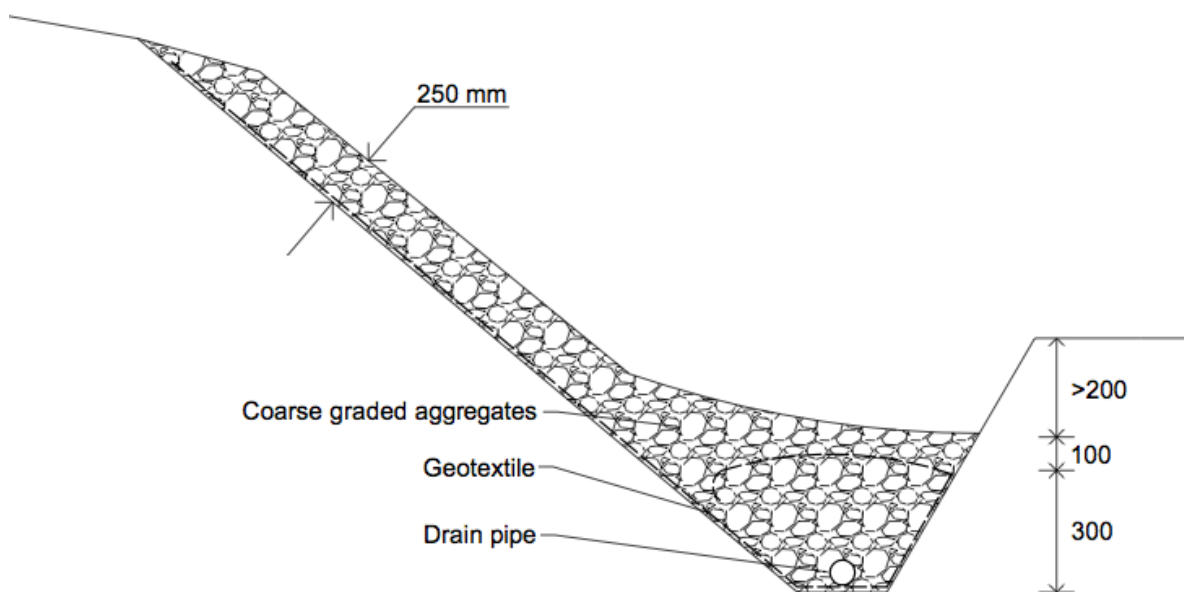
**Figure 5.1** Principal of the rehabilitation Structure (Note: The construction was accomplished in a slightly different way, see chapter 6)

- Removal of the old banking material
- Installation of a separation grade geotextile
- A carrier drain in the bottom of the ditch
- Backfill with 250 mm coarse graded aggregate

The subsoil in the demonstration section was variable. The uphill side of the road was very steep and rocky, and the downhill side was a fine graded soil. Improving the slope stability in the upper slope with a geotextile and coarse aggregate was intended to reduce the potential for the slope to erode, and reduce the need for frequent ditch clearing. Fine graded soils have a low bearing capacity at high moisture content and require a well working drainage system to perform at their best. In the ditch, the coarse graded aggregate was wrapped inside a geotextile to keep the aggregate clean and prevent fine particles from clogging the ditch. A carrier drain pipe was additionally placed in the base of the drain to enhance the flow capacity of the drain.

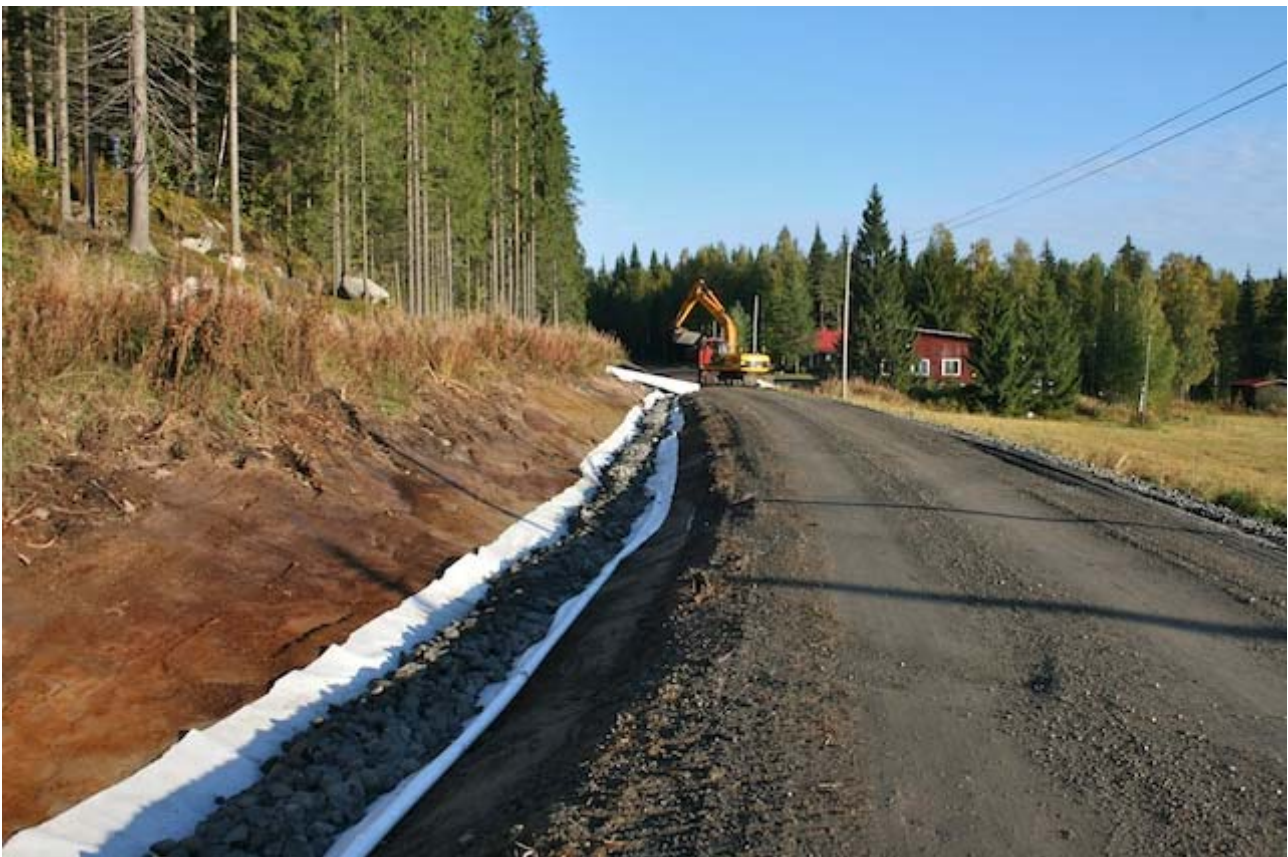
**Figure 6.1** *Constructing the drain structure*

After the whole ditch was cleared and reshaped, the geotextile and drain pipe were installed in the bottom of the ditch. The geotextile was cut into manageable pieces for ease of installation. A 300 mm thick layer of coarse graded aggregate was laid over the drain pipe. This stage of the drain installation is shown in Figure 6.1.

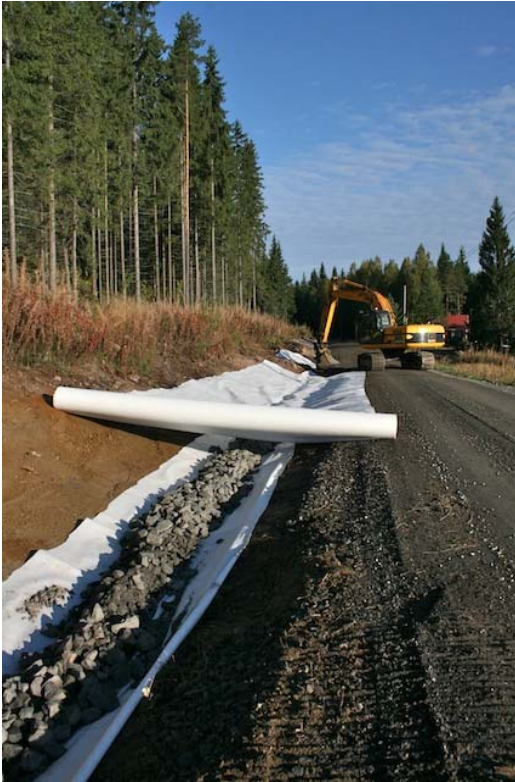
**Figure 6.2** *Rolling the second geotextile layer*

The actual constructed drain structure was slightly different than the original plan. Because of the width of the side slope, it was found to be easier to first install a short ditch liner under the drain pipe and then roll the new layer of geotextile on top over the completed ditch and side slope, as shown in Figure 6.2. This structure results in a similar arrangement to the planned structure and should work just as well. The completed ditch then drains to a culvert at the end of the test section and which takes the water forward. The end of the drainpipe and the culvert is shown in Figure 6.3.

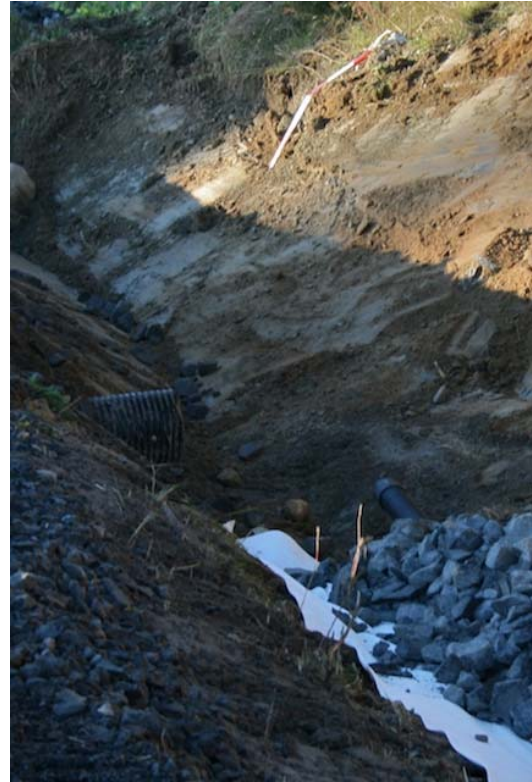
**Figure 6.3** *End of the drainpipe and culvert*

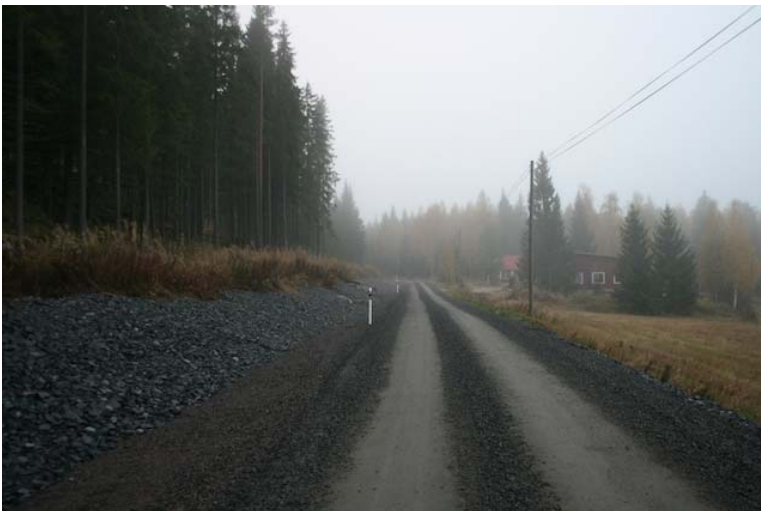
**Figure 6.4** *Finished drainage improvement*

On completion of the work it became apparent that the aggregate used in the inner slope looked very similar to the aggregate on the wearing course of the road and as a safety measure the edge of the road was marked with road marking poles. The finished drainage improvement is presented on Figure 6.4.

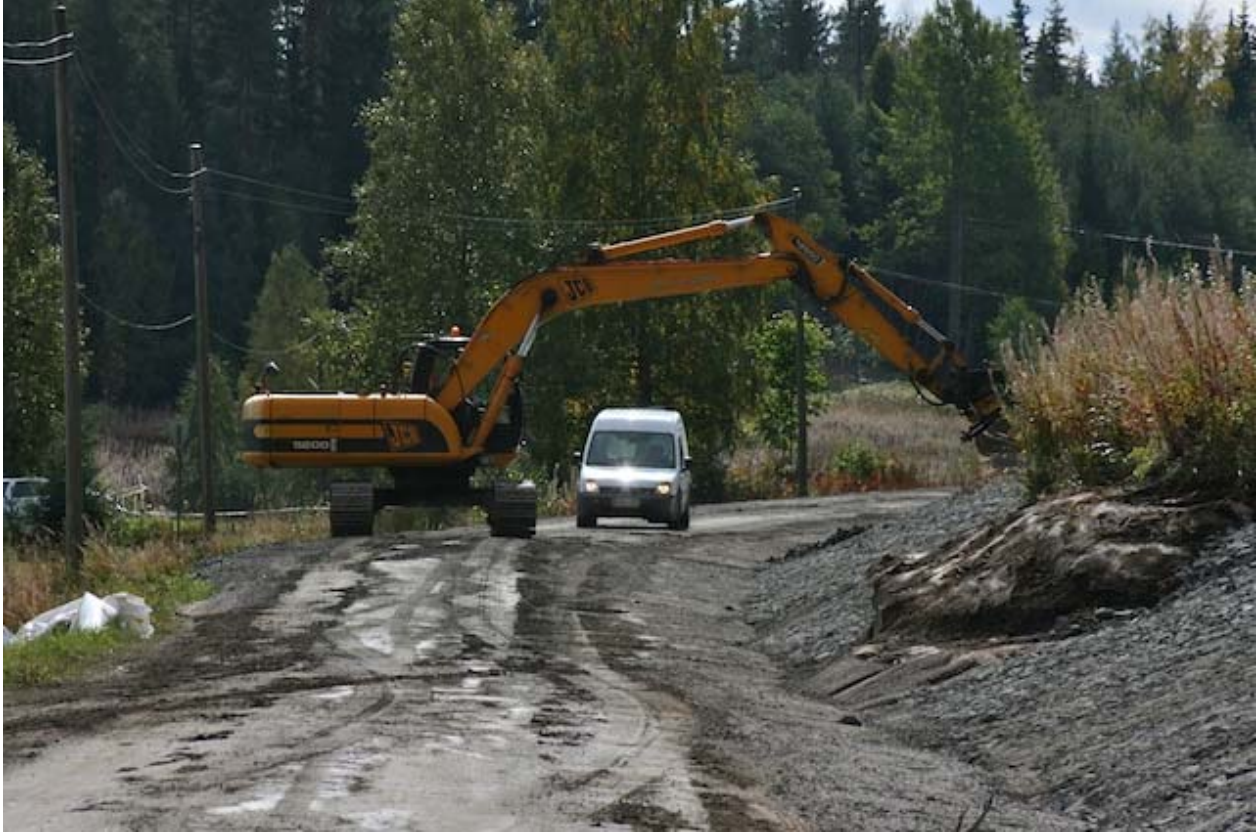
Another minor problem was the presence of bedrock on site as shown in the right corner of Figure 6.5. At the beginning of the rehabilitation works only a small piece of bedrock was visible and it was not known if the inclination of the slope could be reduced. In the event exposures of bedrock were found to be very localized and only visible in two places after the rehabilitation was complete.

**Figure 6.5.** *Passing vehicle and bedrock on the right*

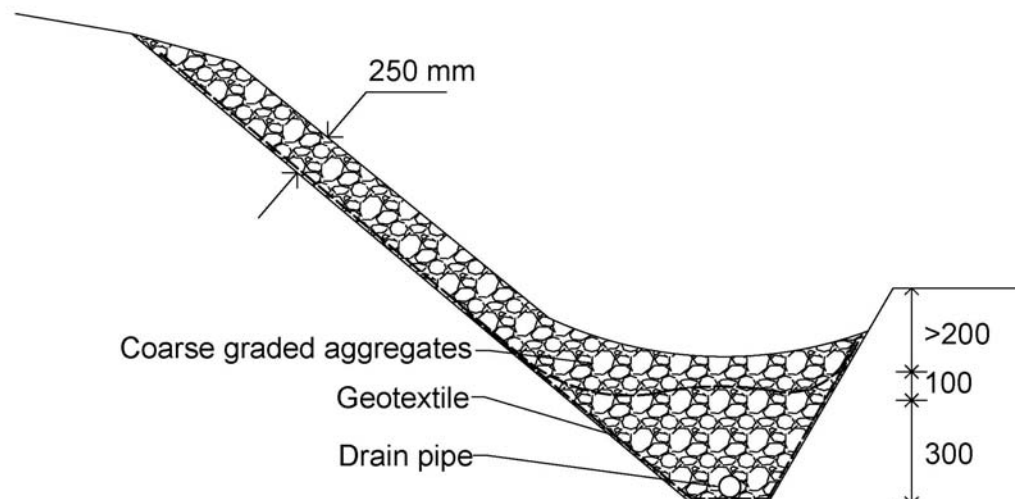
The actual structure constructed in the test section is shown in Figure 6.6. The difference from the original plan is that the geotextile is installed in two pieces instead of one.

**Figure 6.6.** *The final rehabilitation structure*

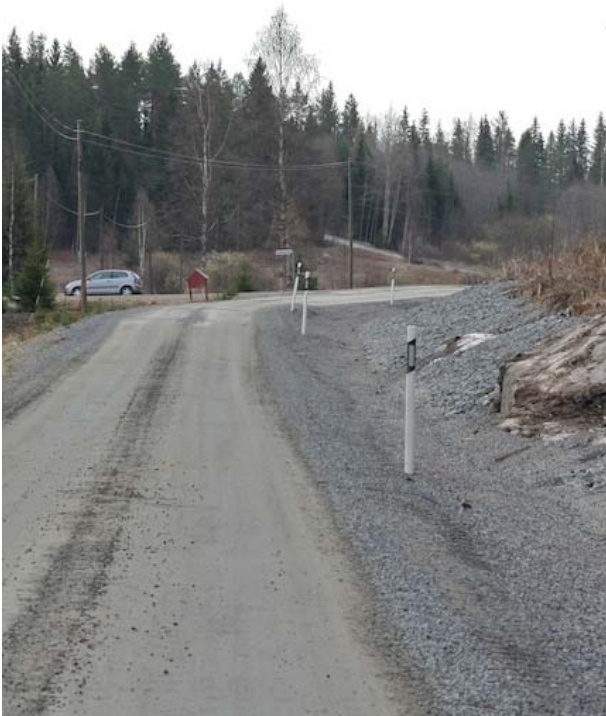
An initial site investigation was carried out on 5th of May 2011, after the spring thaw. The road was found to be in good condition and the drainage was found to be working well, as shown in figures 7.1 and 7.2. No areas of poor bearing capacity were observed on the section of the road next to the drainage improvement structure, and only one cross-section with differential frost heave was noted (figure 7.3). However, immediately after the end of the drainage structure, in the direction of the village of Juokslahti, a number of severe frost heaves and areas of poor bearing capacity could be seen on the road (figure 7.4).

**Figure 7.1** The test section after the first spring thaw (05.05.2011)

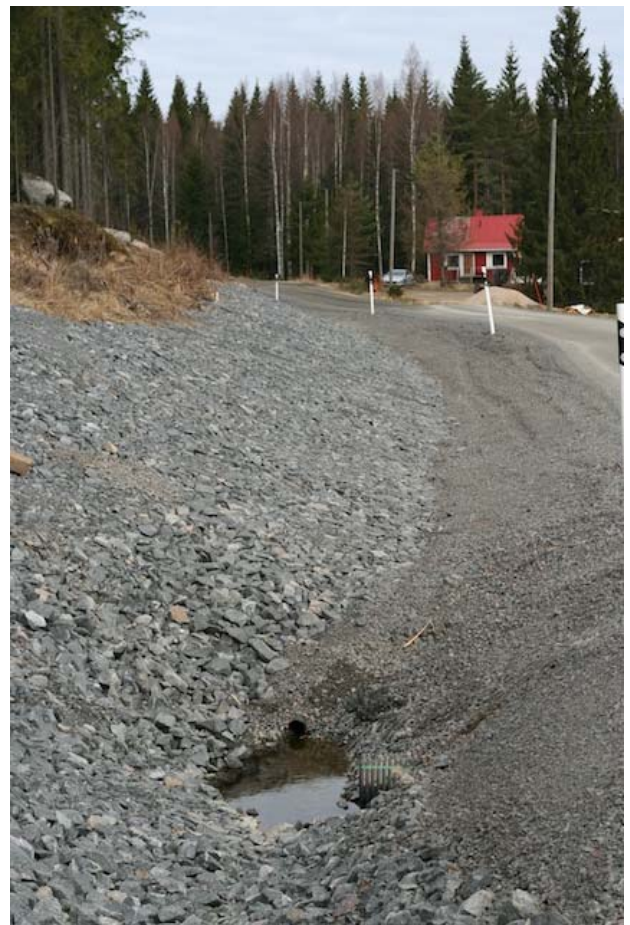
**Figure 7.2** Well working drainage

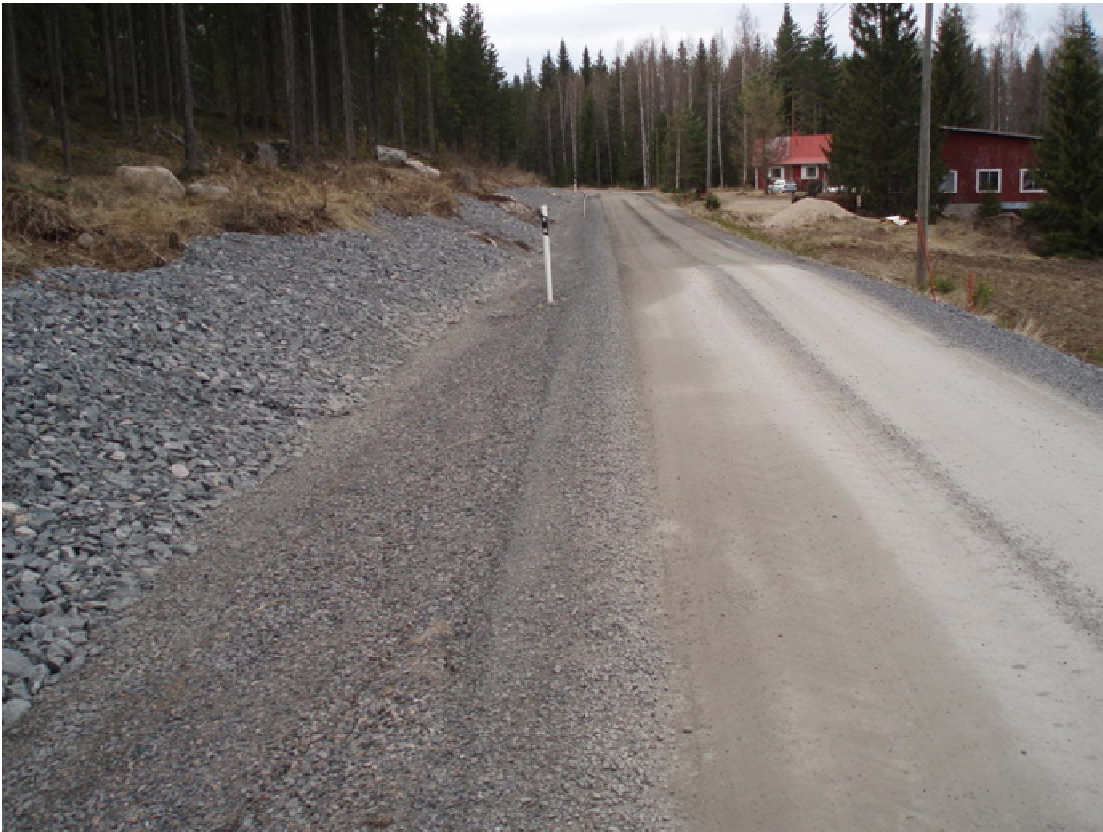
**Figure 7.3.** The only cross section with differential frost heave along the drainage structure in the spring 2011.

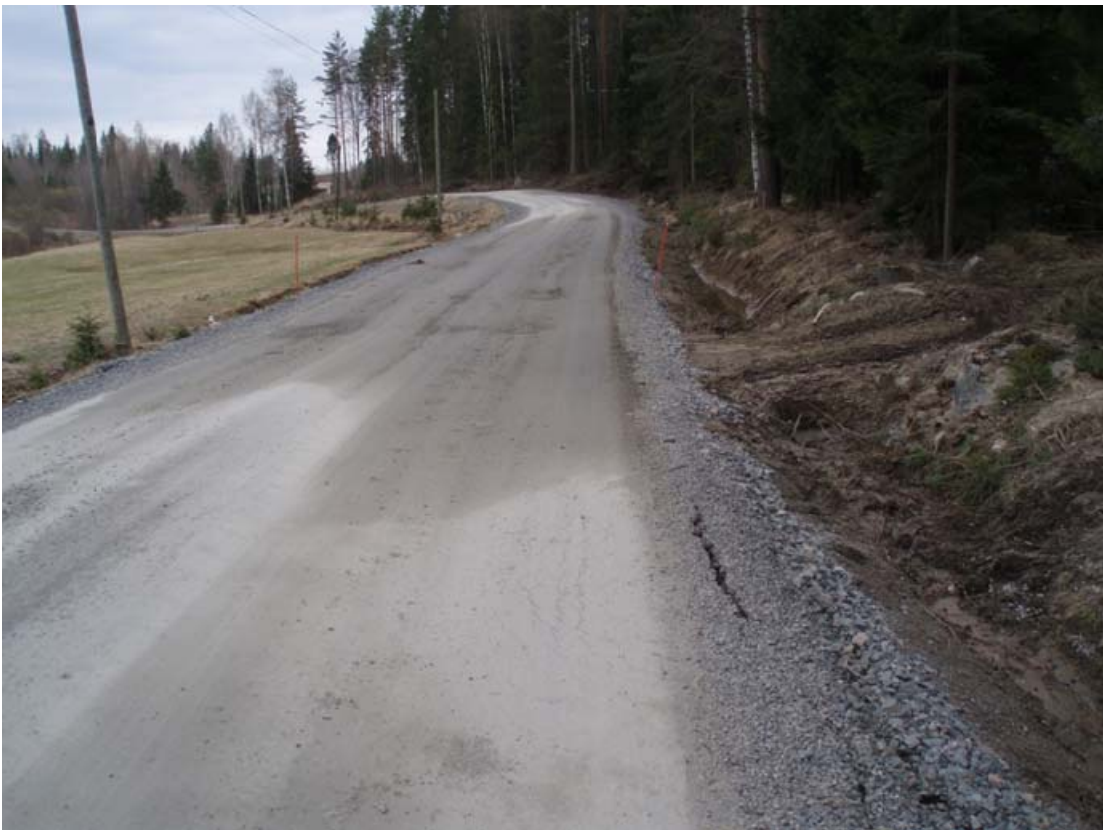
**Figure 7.4.** Severe frost heave and bearing capacity damage after the end of the drainage structure. The damage is not as visible in the picture as it was on the site.

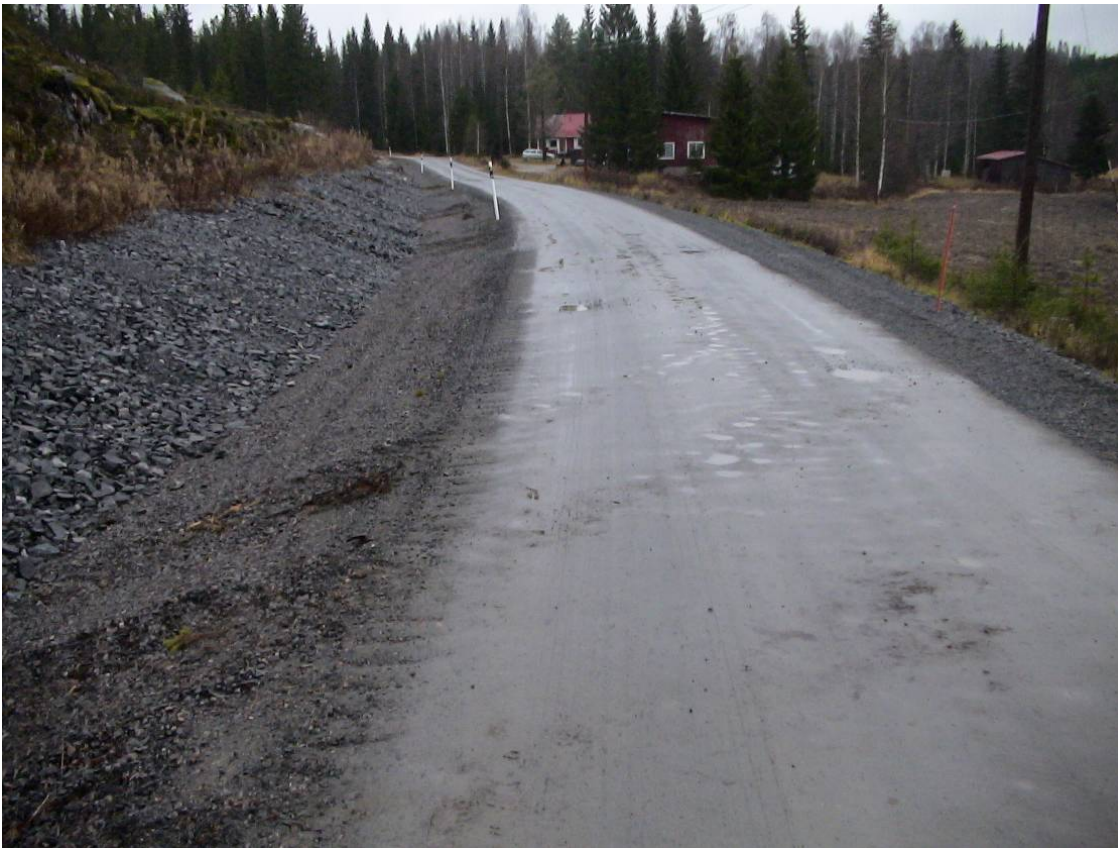
**Figure 7.5.** The marks of a harvester on the ditch and road (24.11.2011)

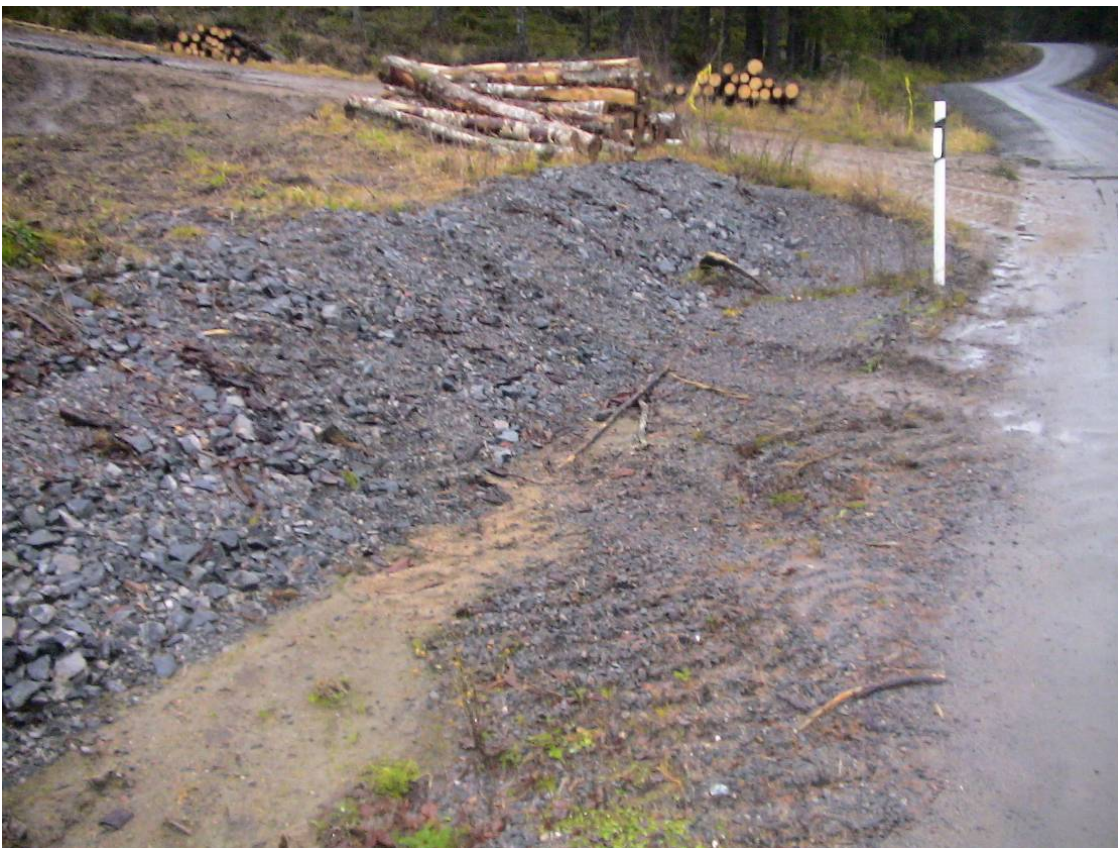
A site investigation was also carried out on rainy 24th of November 2011. The road was found to be in generally good condition with some low potholes and a slightly softened wearing course in some parts. The drainage was found to be working well, although a harvester had used the ditch as an access to cut trees as shown in figure 7.5. It was noticed that some fine sand and coarse silt from the outer slope and the forest road had accumulated into the ditch as shown in figure 7.6. It appeared that the presence of the geotextile in top of the drain had prevented the material infiltrating into the drain.

**Figure 7.6.** Photograph of the fine sand and coarse silt from the slope and forest road being held by the geotextile on top the drain
