# ROAD 16583 EHIKKI-JUOKSLAHTI

Mode 2 Rutting Site on Peat

This report describes a ROADDEX demonstration exercise carried out on a low volume road section of Road 16583 from Ehikki to Juokslahti in Jämsä, Central Finland. The section was located on a peat subgrade and was reinforced with a geogrid. The road had been deforming and widening significantly over the section mainly due to clogged side ditches, a low outlet ditch, and settlement of the road structure into the peat subgrade. As it was very difficult in practice to improve the operation of the outlet ditch, it was decided to reduce the further development of permanent deformations on the road by the addition of a new base course layer reinforced with a geogrid. As a reference structure, half of the test section was built with the addition of a new base course layer underlain by a geotextile, which could be considered as a standard solution in this type of problem site.

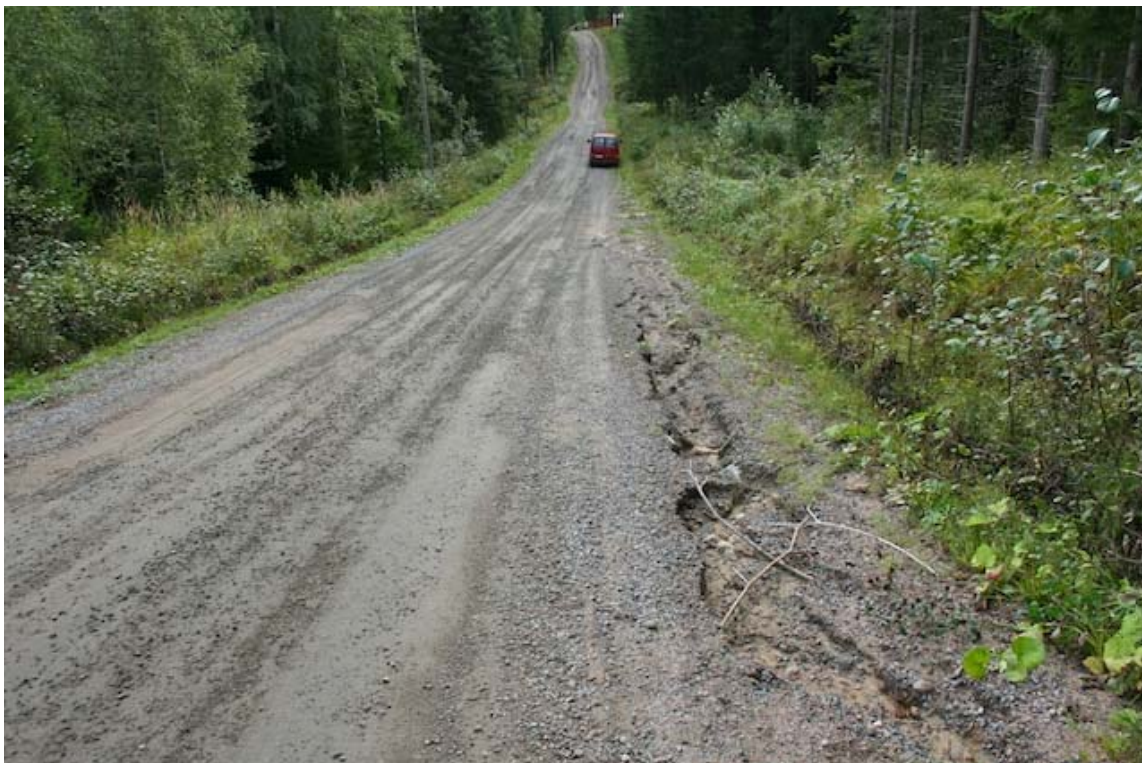
**Figure 2.3** Water erosion on the side of the road

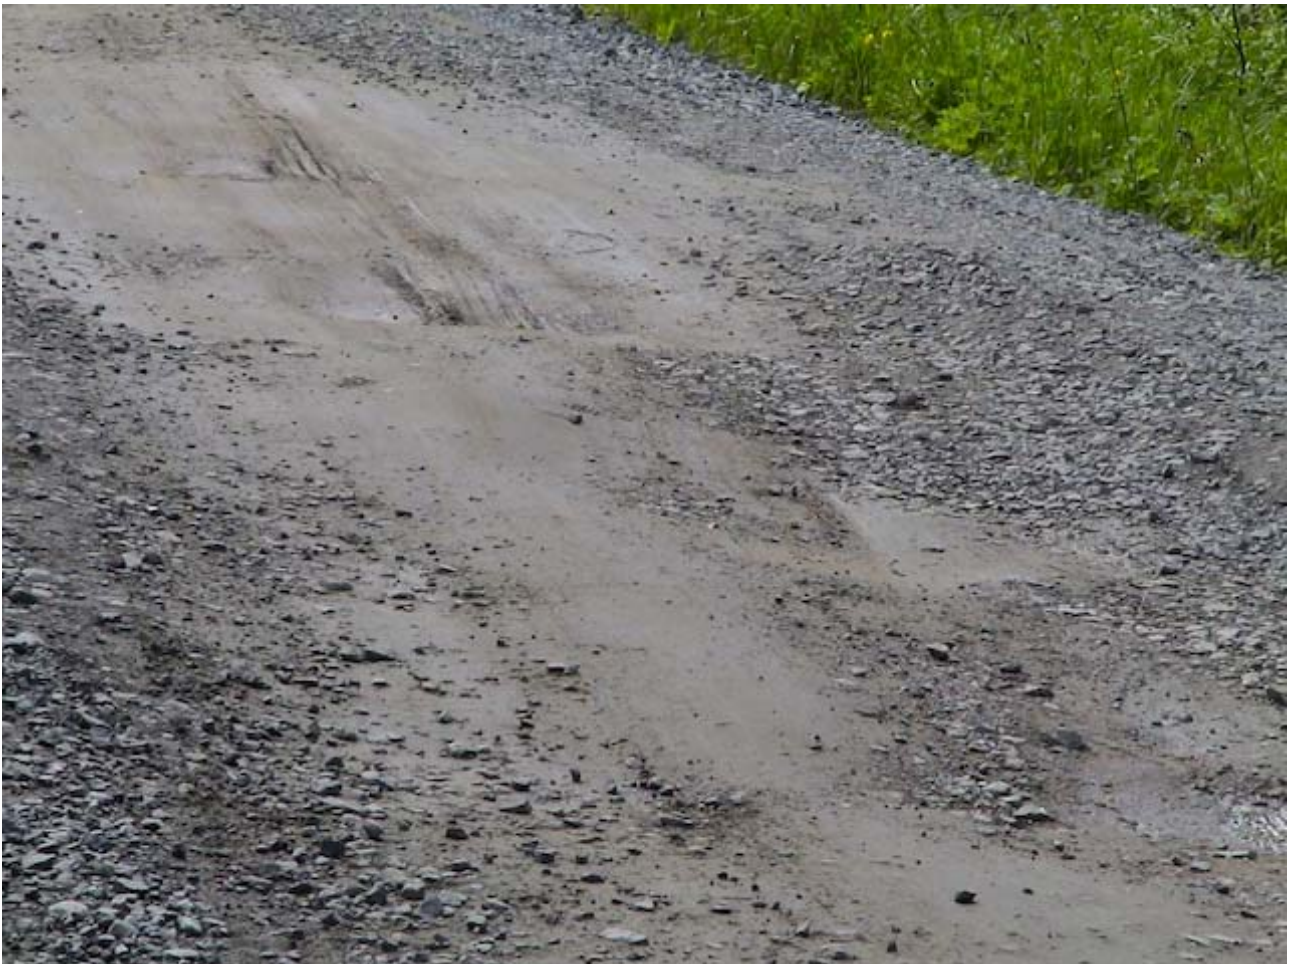
Phase 2: As the air temperatures keep rising the frost thaws deeper into the road and the structural thaw weakening phase starts. The thawing frost produces excess water in the lower structure and subgrade. If the subgrade has a low water permeability it may become plastic causing permanent deformations with Mode 2 rutting, the subject of this report. In addition the passage of heavy vehicles can create increased hydrostatic pressures which can force excess water to flow up and to the side. As a consequence of this damaged road sections which have suffered structural thaw weakening can also experience embankment widening to the ditches. [2]

**Figure 2.4** A late thaw weakening damage of the road in the spring (17.6.2010)

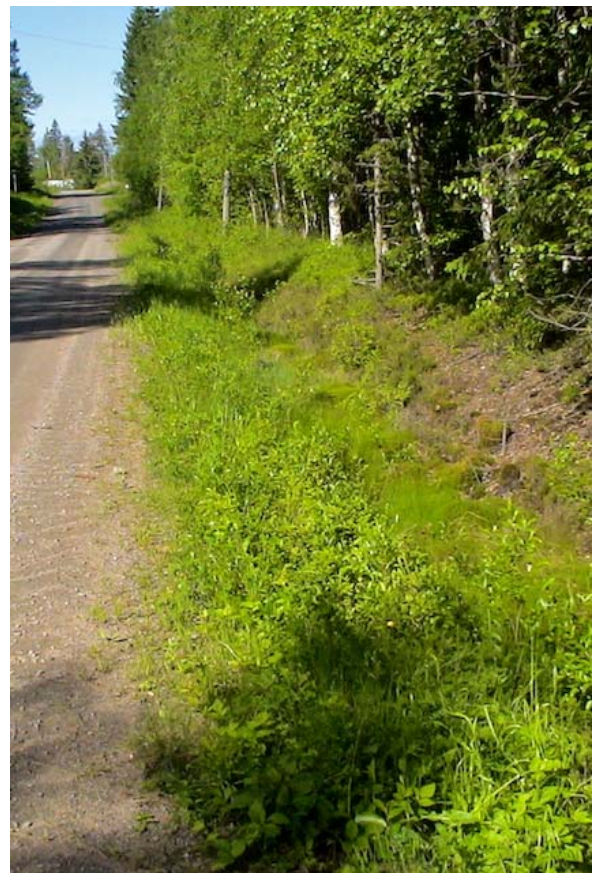
**Figure 3.2** Filled up ditch

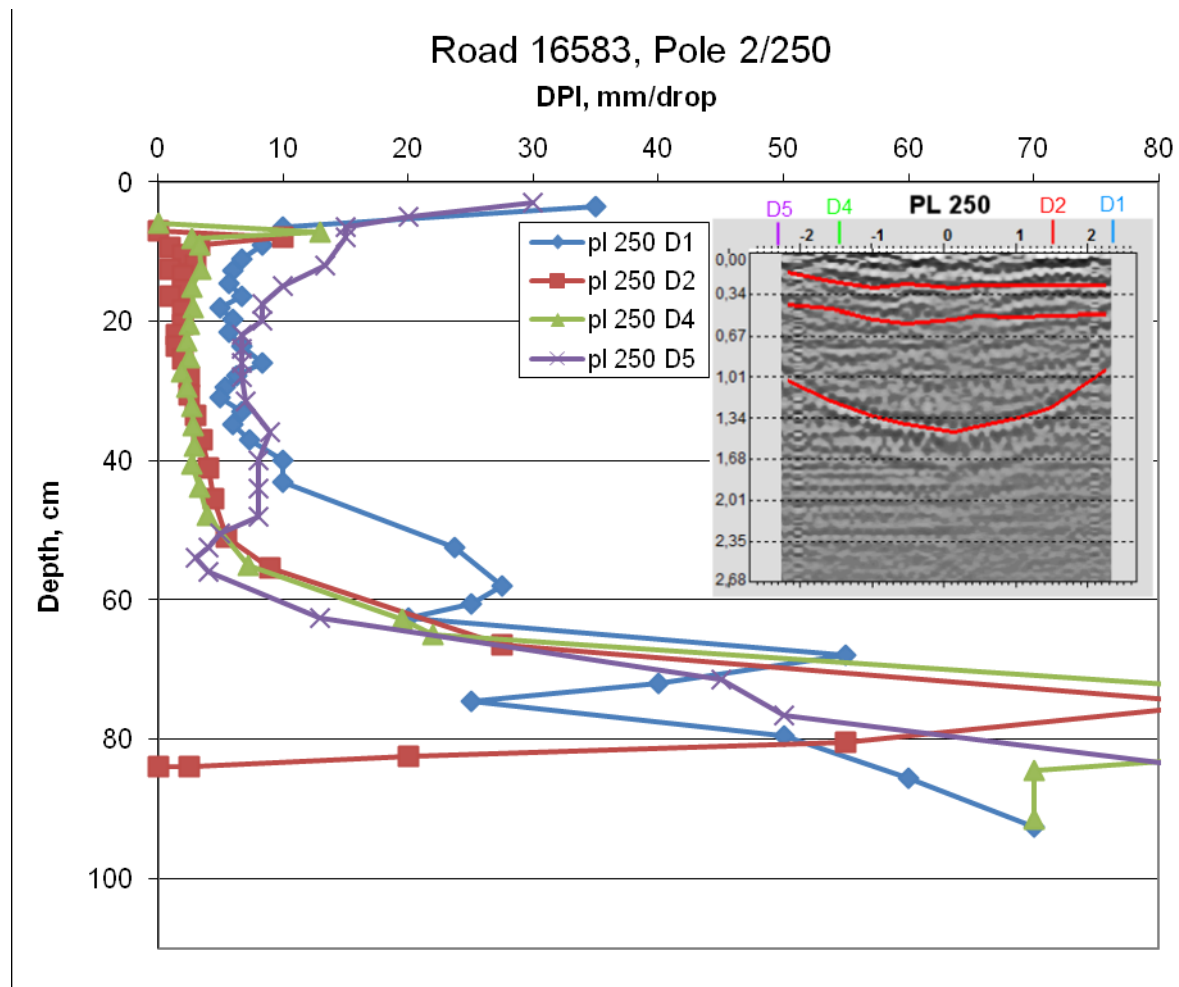
Figure 3.5 shows an example of the DCP measurements from road 16583. On the x-axis is the DCP Penetration Index and on the y-axis is depth. Measurement point D1 (blue) is 50 cm from the right side of the road, D2 (red) is 130 cm from the right side, D4 (green) is 145 cm from the left side and D5 (purple) is 60 cm from the left side. The figure shows that the road structure is softer on the edges (blue and purple) between the depths of 0-50 cm and the DPI is lower under the wheel paths (red and green). The base of the road structure is at a depth of circa 50 cm on a soft subgrade that causes the DPI to rise rapidly. The same road structure's layer thicknesses can be seen in the GPR cross-section at the pole 2/250. In the cross-section the highest red line is the base course + wearing course, the middle red line is the lowest surface of the road structure and the lowest red line is the frost depth.

**Figure 3.5** The DCP measurements from pole 2/250

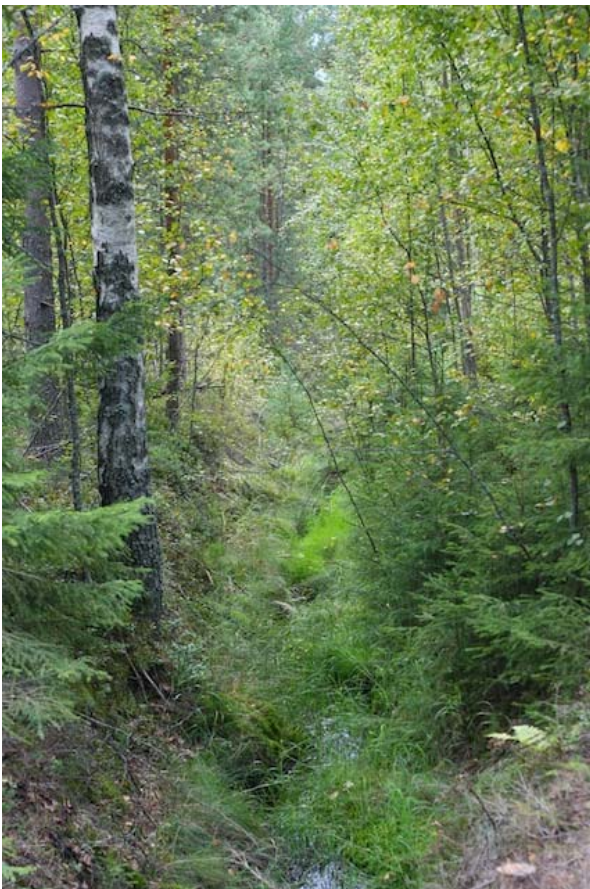
The site visits helped the understanding of the peat-land surface features (ditches, watercourses, culverts, surface topography, waterlogged areas and areas of free water) and the design of rehabilitation structure. One problem identified was a filled up outlet ditch, as shown in Figure 4.1. This ditch was not permitting water to drain from the roadside ditches and as a result the ditches were always wet and never dried out, as seen in Figure 4.2, taken after the two weeks of dry season in July. This clogged outlet ditch caused the trapped water in the roadside ditches to soak into the road structures and subgrade causing subgrade deformation and widening of the road.

**Figure 4.1** Filled up outlet ditch

It was not practical to improve the drainage condition of the site by making the outlet ditch deeper, and the decision was made to rehabilitate the site by reinforcing the road structure with a geogrid. On one half of the test section length, from chainage 02/200 to 02/266, a 150 mm layer of new base course and a 50 mm layer of wearing course were laid on top of a geogrid installed on the old base course layer. A reference structure was built on the other half of the test section length, from chainage 02/100 to 02/200, in an identical fashion to the demonstration section, except that under the new base course layer a geotextile was used instead of the geogrid.

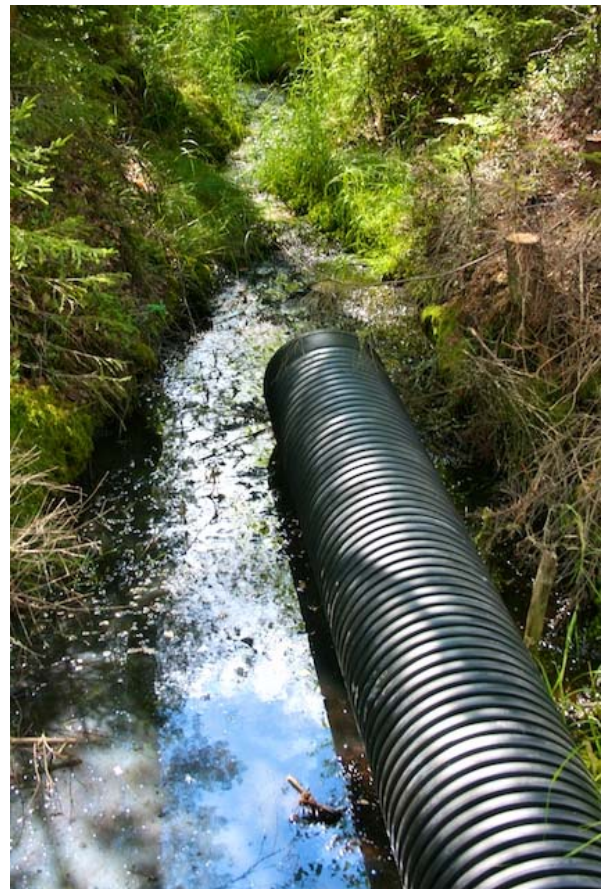
**Figure 4.2** Wet ditches

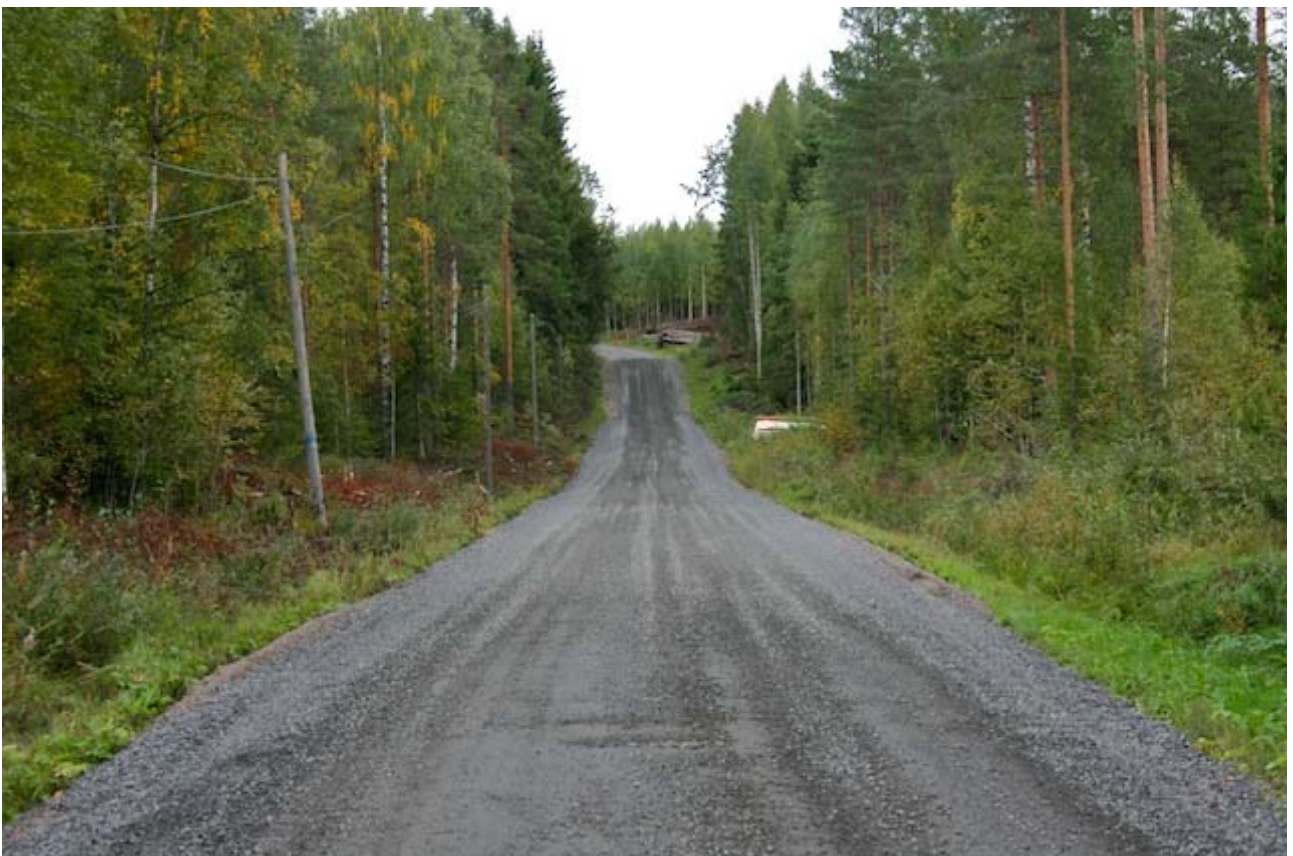
**Figure 6.11** *Improved test section after two weeks from construction (ditches are not cleared yet)*

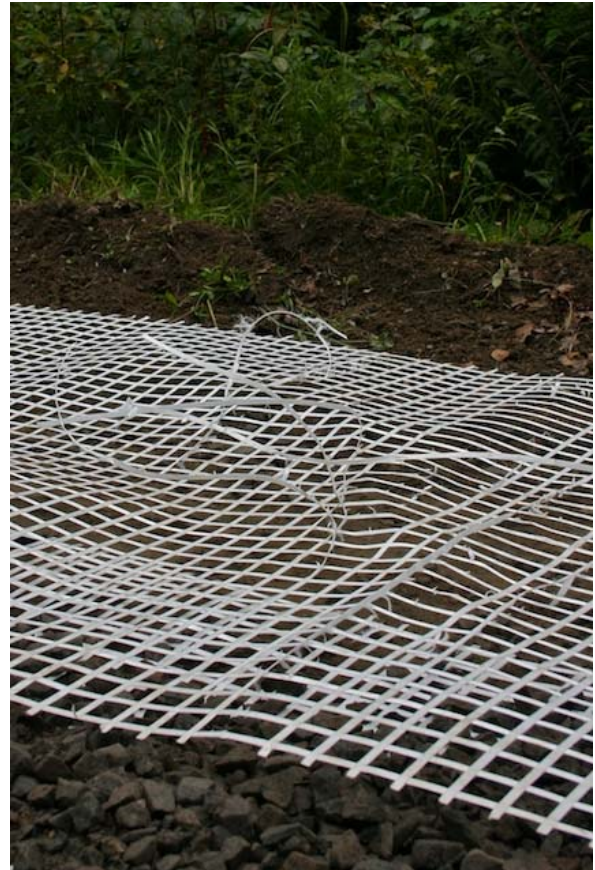
Although the rehabilitation work did not take long, it was not without problems. The biggest problem was the behaviour of the geogrid under the moving truck. When the truck had emptied the load and was driving off to get a new load, the geogrid did not hold still under the truck and became undulated, as shown in Figure 6.13. It was felt that if the widening geogrid strip had been attached to the main geogrid part most of undulating could have been avoided. The widening strip was easy to straighten where it was unloaded, but where crushed aggregate had been laid this remained deformed. The section of geogrids with undulations was at chainage 02/250-266. Another problem also occurred when the truck drove over the exposed geogrid. The geogrid net got stuck in tyres of the truck and strands of the net were ripped off, as shown in Figure 6.12.

**Figure 6.12** *Ripped off geogrid*

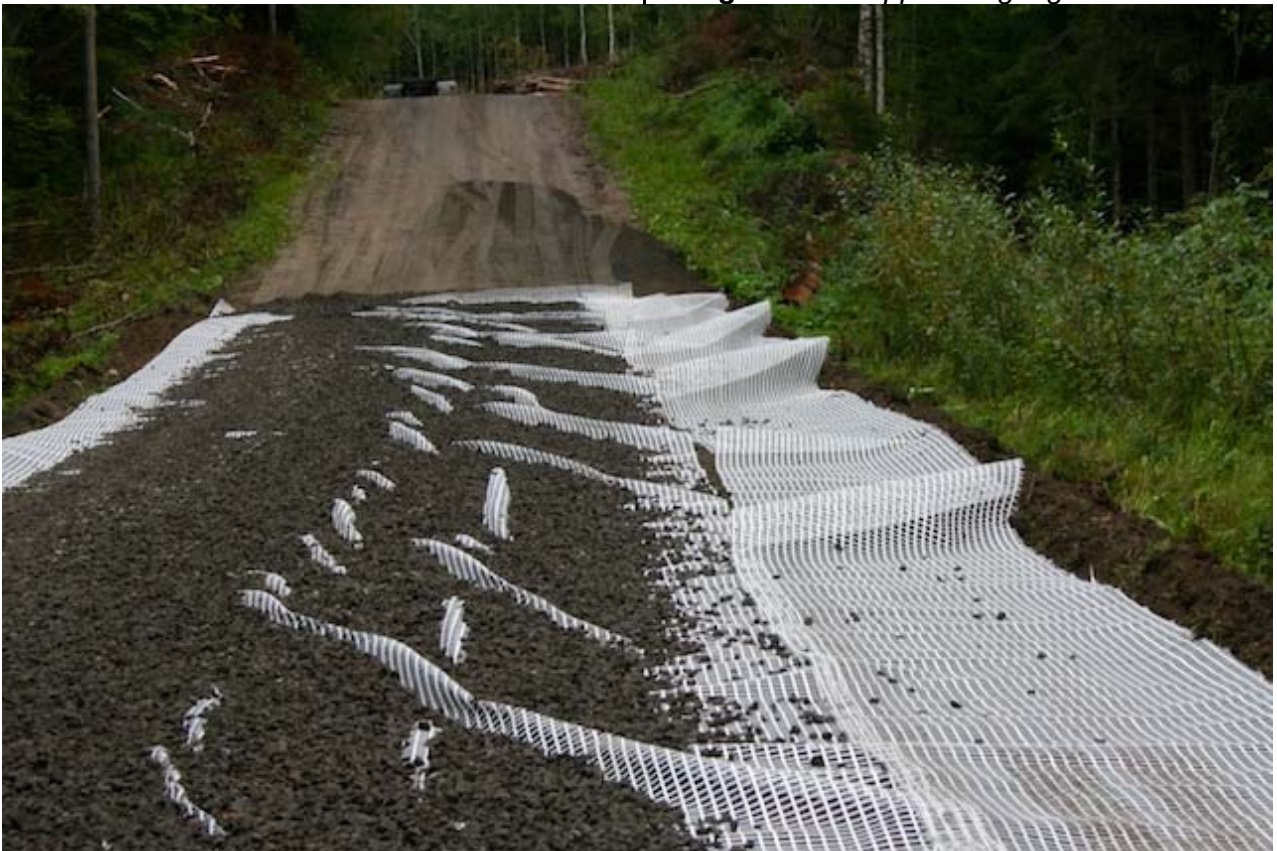
**Figure 6.13** *Undulated geogrid, widening part on the right hand side*

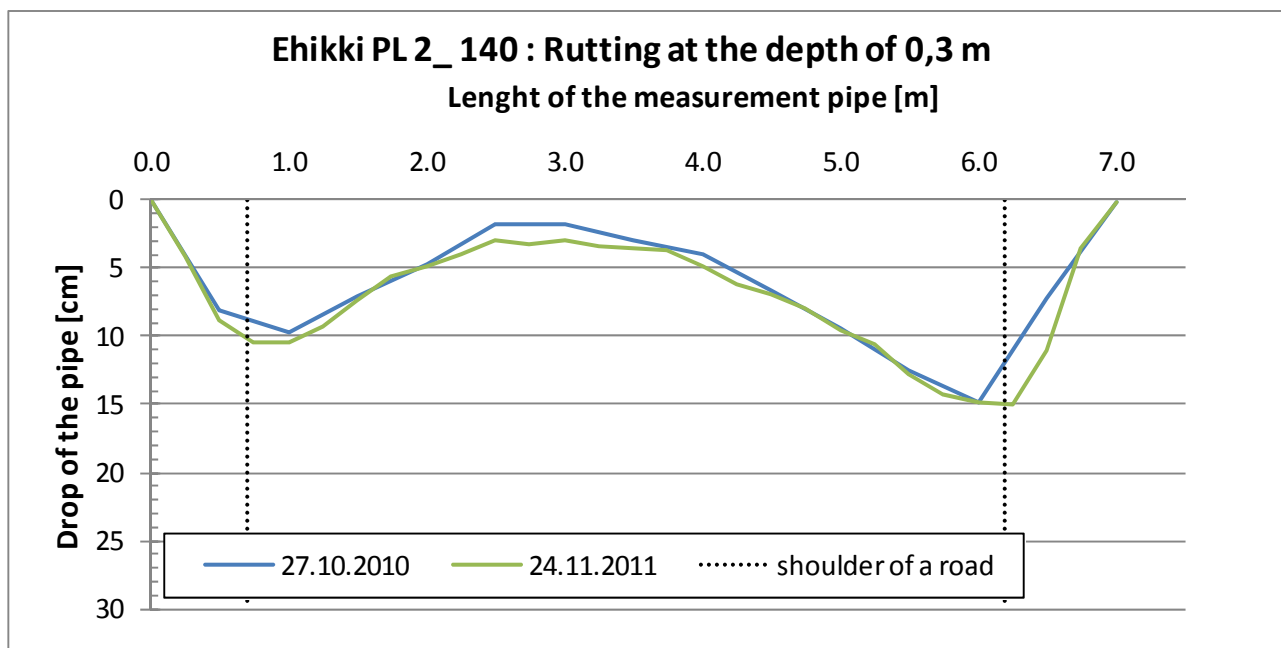
The first measurements were recorded at half a meter intervals on 27<sup>th</sup> October 2010. These will be the baseline against which all the further measurements will be made. Measurements should be taken at 0.25 m intervals as was done on 24<sup>th</sup> November 2011. Figure 7.1 shows initial baseline measurements (blue) and the measurements taken after one year (green) for chainage 1/1610. The figure shows that there might have been minor deformation between the measurements.

**Figure 7.1** Settlement measurements from chainage 2/140

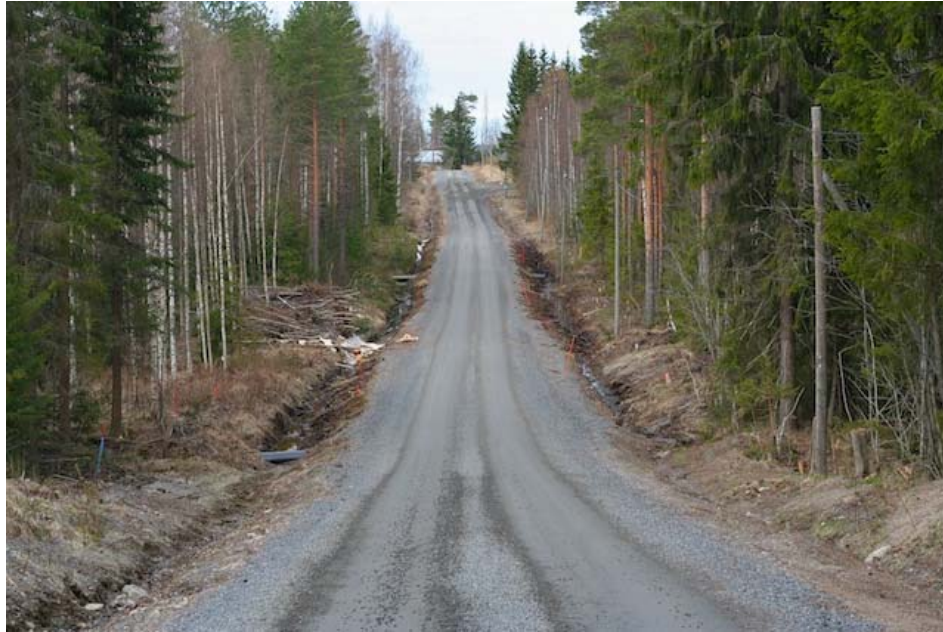
Figure 7.2 shows the test section after the first spring thaw. The test section was found to be in good condition. Winter 2010-2011 came fast and there were no additional freeze-thaw cycles in the road surface during the winter. Later the dry weather in the spring did not affect the good condition of the road.

**Figure 7.2** *The test section after the first spring thaw (5.5.2011)*
