ROAD 16589 SAALAHTI

Mode 2 Rutting Site on a Soft Subgrade

This report describes a ROADDEX demonstration exercise carried out on a low volume road section of Road 16589 Saalahti in Jämsä, Central Finland. A geogrid reinforcement was used in the demonstration to retard the development of permanent deformations of a gravel road section located on a silty subgrade. The demonstration section had been suffering from deformations primarily taking place in the subgrade material that had become very soft during the spring thaw of the seasonal frost. This had also resulted in severe widening of the road cross-section and almost total clogging of the side ditches. According to the GPR profiles the total thickness of the structural layers was much higher in the middle of the road than towards the edges of the road which was a clear indication of Mode 2 rutting.

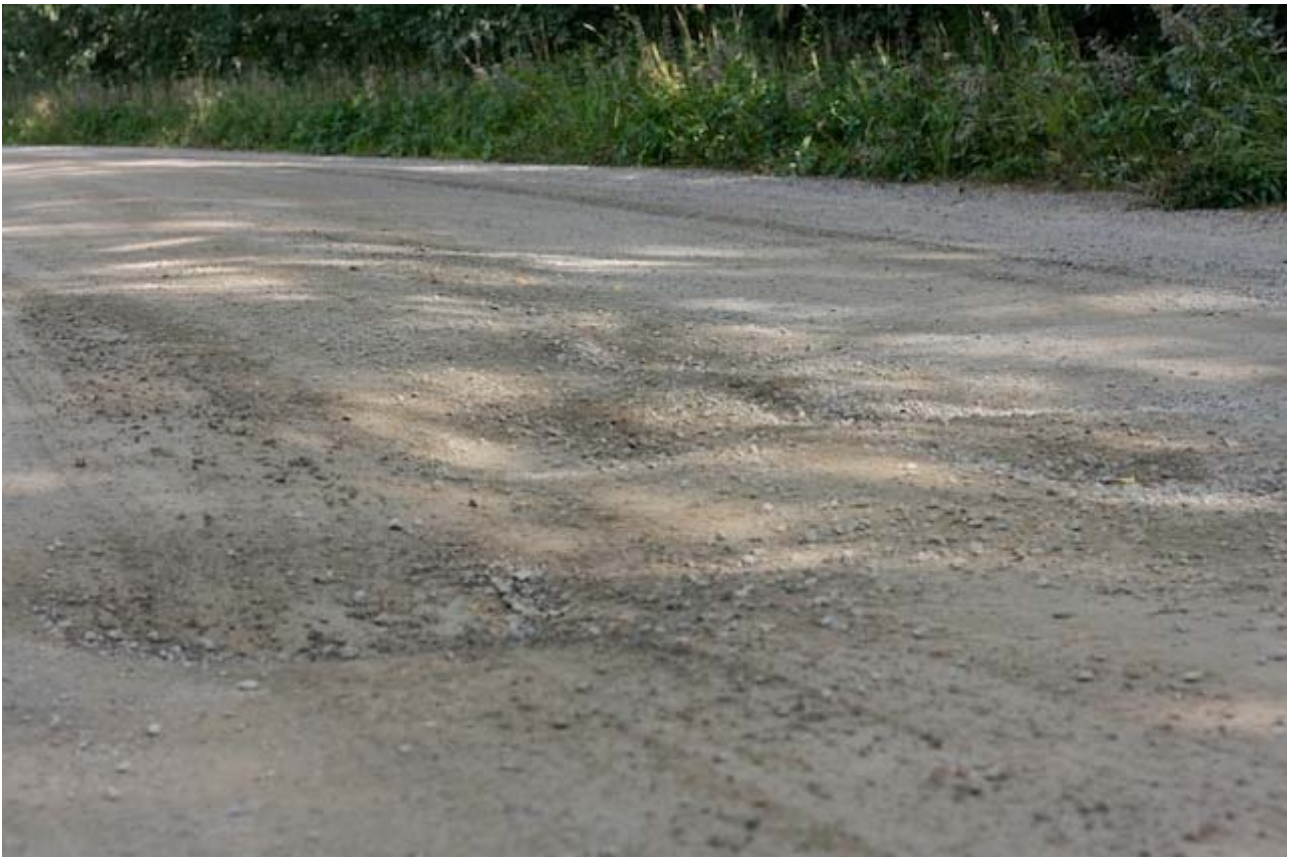
The condition of road 16583 is generally good for most of the year, but problems can appear during springtime. These are generally caused by spring thaw weakening which can be divided into two phases.

Phase 2: As the air temperatures keep rising the frost thaws deeper into the road and the structural thaw weakening phase starts. The thawing frost produces excess water in the lower structure and subgrade. If the subgrade has low water permeability it may become plastic causing permanent deformations with Mode 2 rutting, the subject this report. In addition the passage of heavy vehicles can create increased hydrostatic pressures which can force excess water to flow up and to the side. As a consequence of this damaged roads sections which have suffered structural thaw weakening can also experience embankment widening to the ditches.[2]

Figure 2.4 Typical damages of the road in the summer

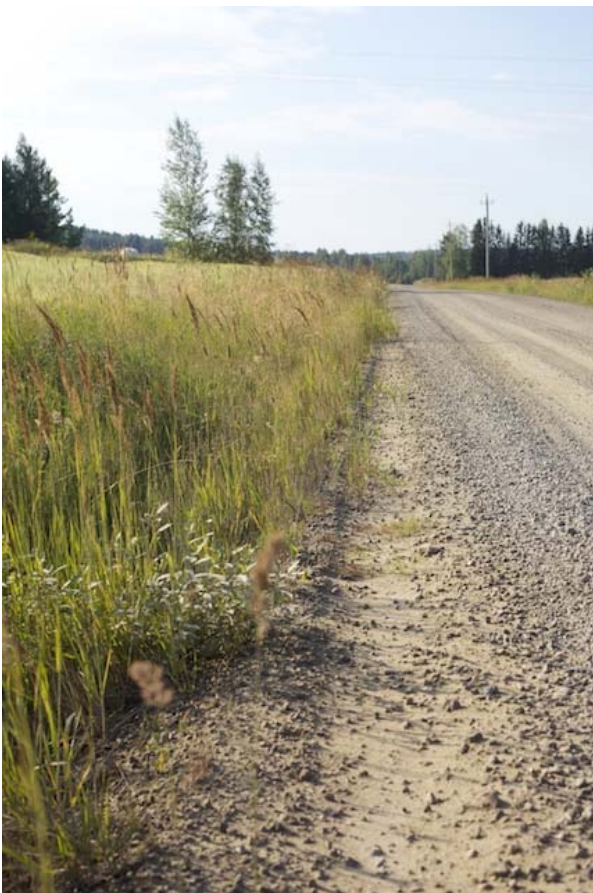
Figure 3.1 Widened road and filled up ditch

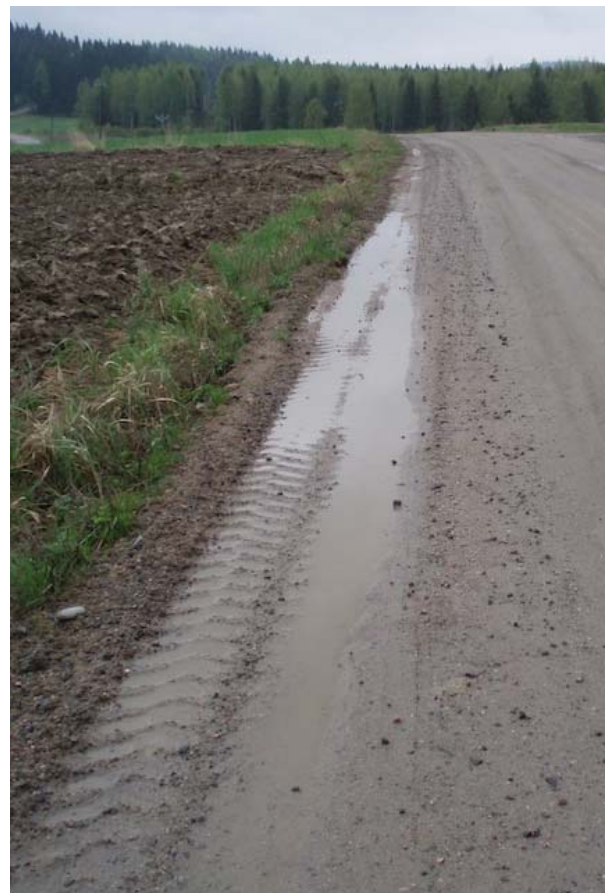
Figure 3.2 Water stays on the road

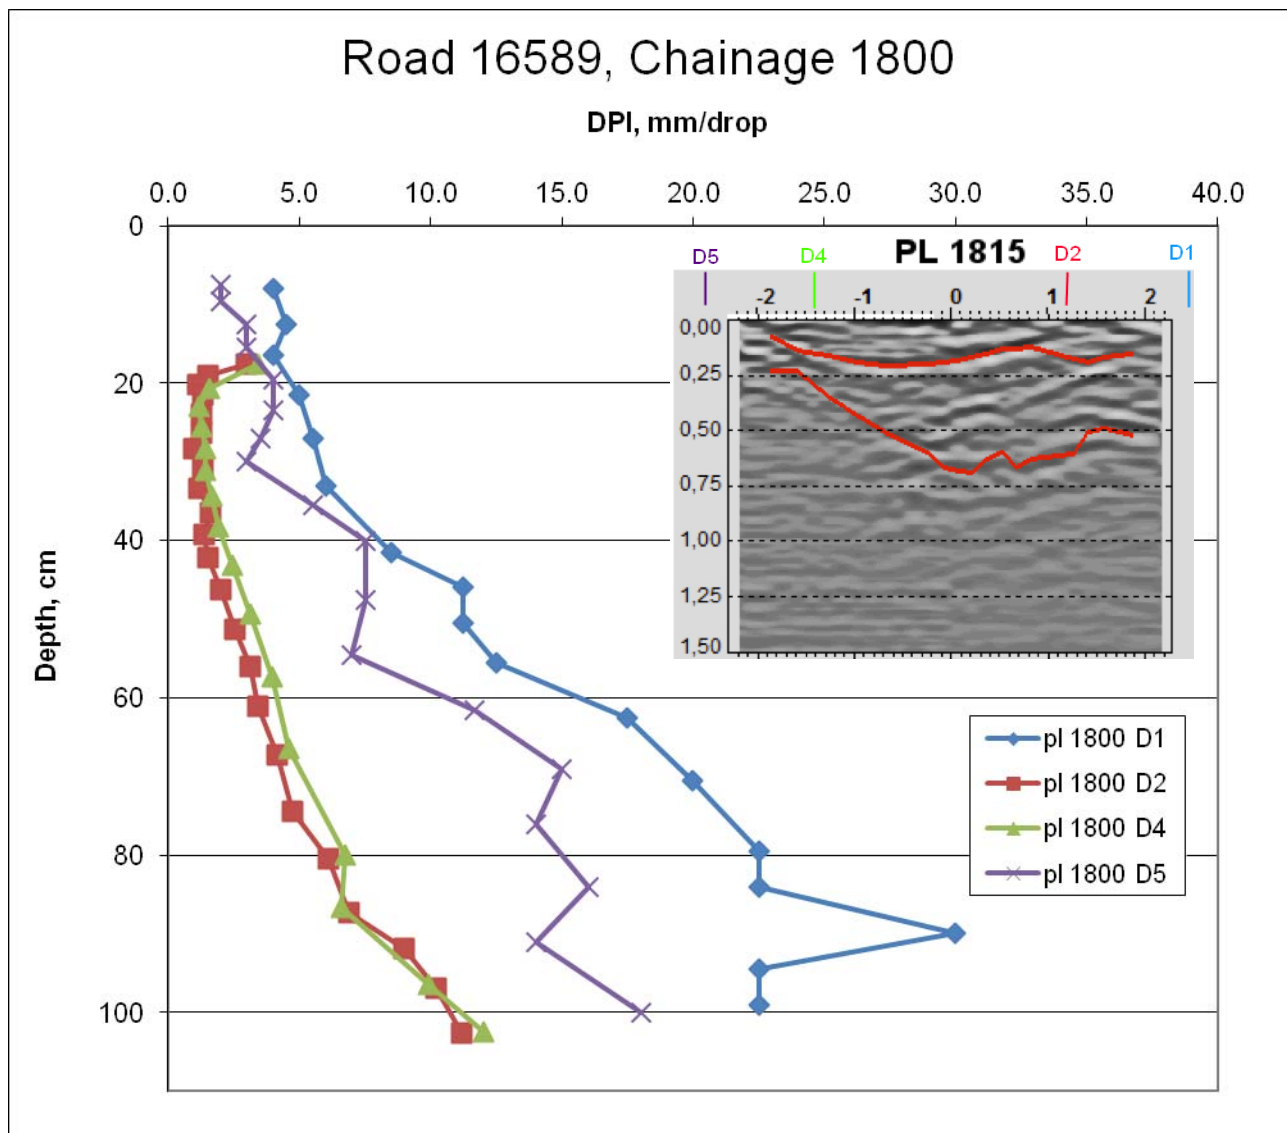
Figure 3.5 shows an example of the DCP measurements from road 16589. On the x-axis is the DCP Penetration Index and on the y-axis is depth. Measurement point D1 (blue) is 1.0 m from the right side of the road, D2 (red) is 2.4 m from the right side, D4 (green) is 2.1 m from the left side and D5 (purple) is 1.0 m from the left side. The figure shows that the road structure is softer on the right edge (blue) than in the middle and left edge. The DPI is lower under the wheel path (red) and on the left edge (purple). Measurement point D3 probably stops at the depth of 0.25 m because of a large boulder or rock. The same road structure's layer thicknesses can be seen in the GPR cross-section at the chainage 1/1815. In the cross-section the highest red line is the base course + wearing course and the lowest red line is the lowest surface of the road structure. The full DCP measurement results are given in Appendix 5, 6 and 7.

Figure 3.5 The DCP measurements from chainage 1/1800 with GPR data

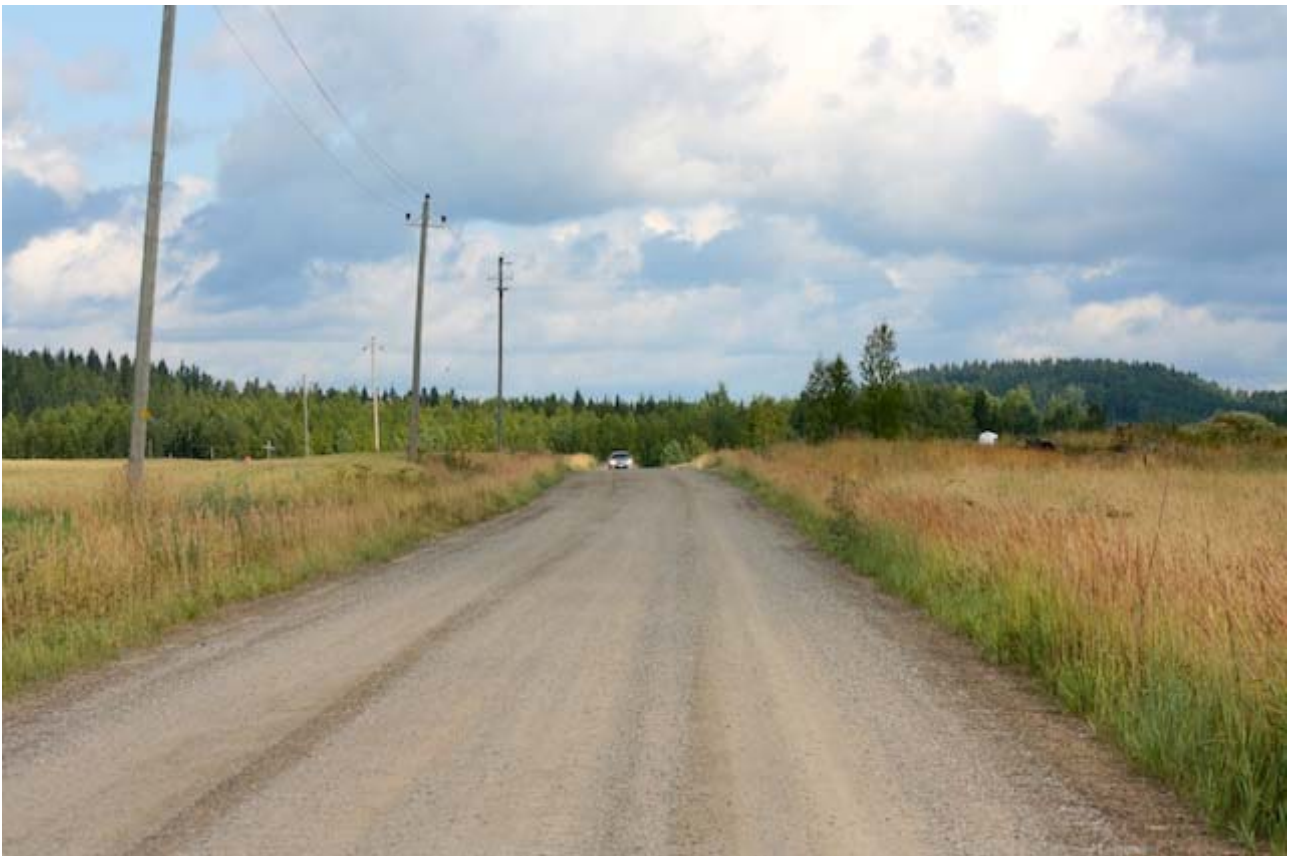
The site investigations identified that the main problem on the test section was poor drainage and possibly also the result of poor material in the road structure. When the moisture content of a road and subgrade increases, the road softens and widens to the ditches. In a few places widening had already gone so far that there was no ditch at all, as is shown in Figure 3.2. The normal width of a gravel road in central Finland is about 6 metres, but road 16589 had places where the road was up to 9 metres wide. Because of the poorly functioning drainage system, water stays on the road and soaks through the road structure and subgrade. The excess water in the road structure and subgrade creates problems such as subgrade deformation and widening of the road. In addition the excess water makes the road surface plastic and uncomfortable to drive.

Figure 4.1 Widened Road 16589

The section was known to have a weak subgrade which was causing problems during the frost thaw period. The road had widened so badly that the ditches between the field and road had almost been closed. It was decided that the existing wearing course should be removed and the new structures built onto the exposed surfaces. Ditches would be cleared after the improvement. The reference structure and the two rehabilitation solutions selected are shown in the following sections.

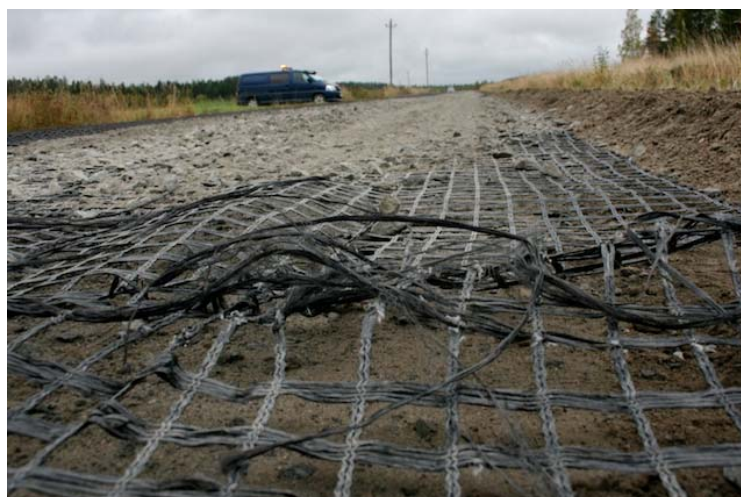
Other than these minor issues the installation of geogrid did not cause any major problems. Passing vehicles travelled safely on the grid without adverse effect, except for one occasion when the net got stuck in tyre of an earth-hauling truck and parts of the net ripped off, as shown in Figure 6.10.

Figure 6.10 *Ripped off geogrid*

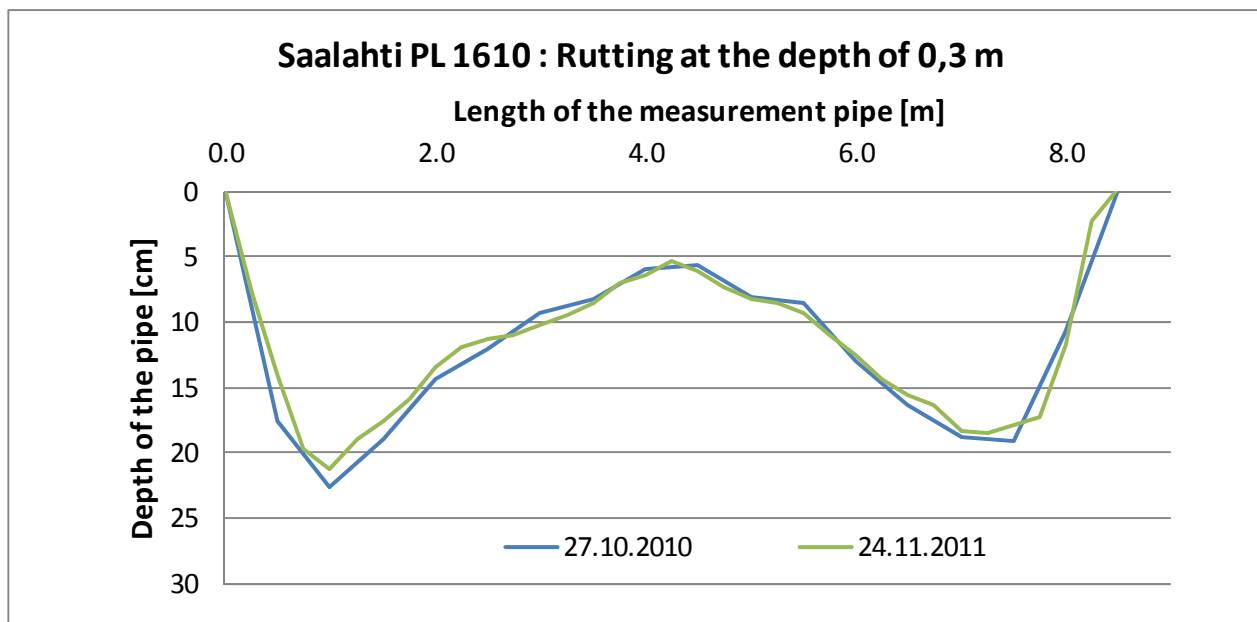
The first measurements were recorded at half metre intervals on 27th October 2010. These will be the baseline against which all the further measurements will be made. Measurements should be taken at 0.25 m intervals as was done on 24th November 2011. Figure 7.1 shows the initial baseline measurements (blue) and the measurements taken after one year (green) for chainage 1/1610. The figure shows that there has been hardly any deformation between the measurements. Winter 2010-2011 came fast and there were no additional freeze-thaw cycles in the road surface during the winter. Later the dry weather in the spring did not affect the good visible condition of the road.

Figure 7.1 Settlement measurements from chainage 1/1610

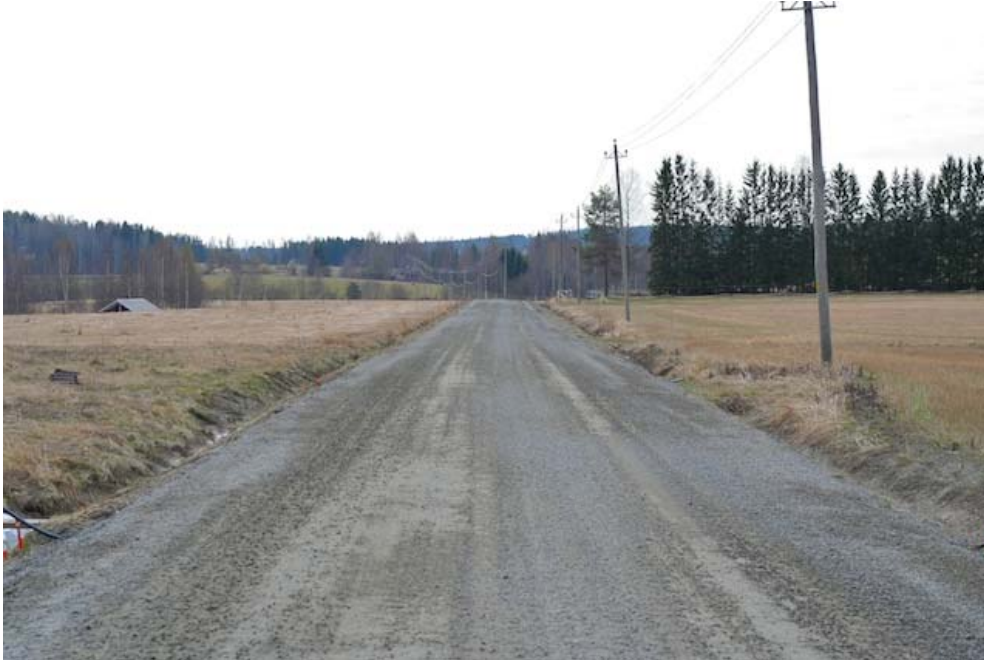
Figure 7.2 shows the test section after the first spring thaw. The test section was found to be in good condition at this time. However, there were some visible cracks caused by differential frost heave near to the edges of the road as shown in the Figure 7.3. These indicated that the subgrade had been heaving more than the surrounding area as it had been covered with temperature isolating snow. The reinforcement had however kept the structure in one piece.

Figure 7.2 The test section after the first spring thaw (5.5.2011)

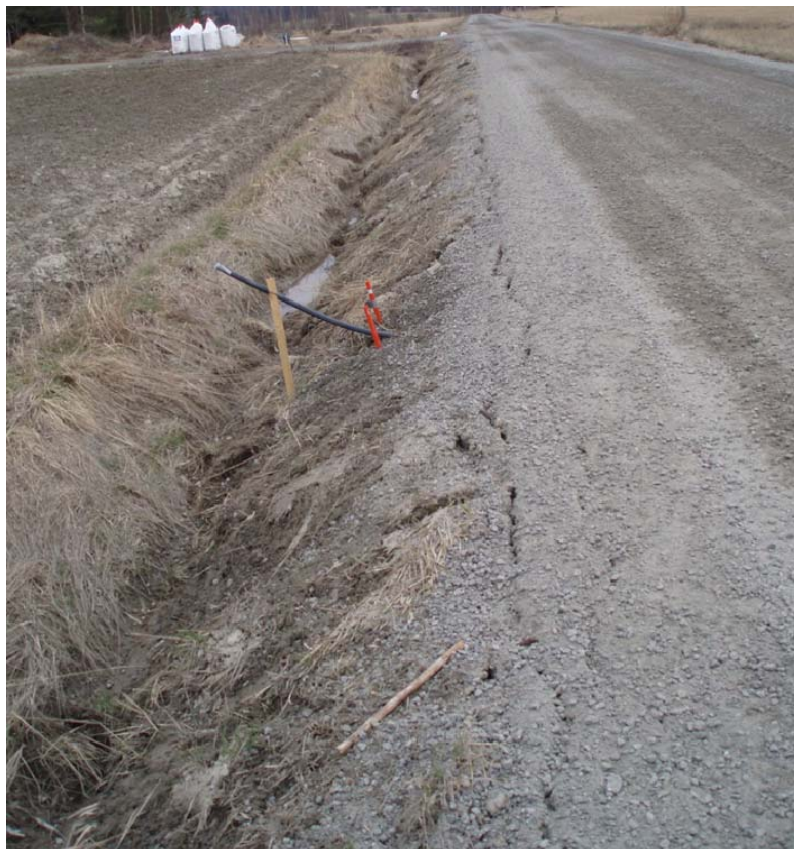
Figure 7.3 Crack caused by differential frost heave near to the edge of the road (5.5.2011)
