ROADEX DRAINAGE DEMONSTRATIONS IN NUUK, GREENLAND

A report on drainage demonstrations in Greenland, carried out by the Center for Arktisk Teknologi,
DTU Byg, August 2011

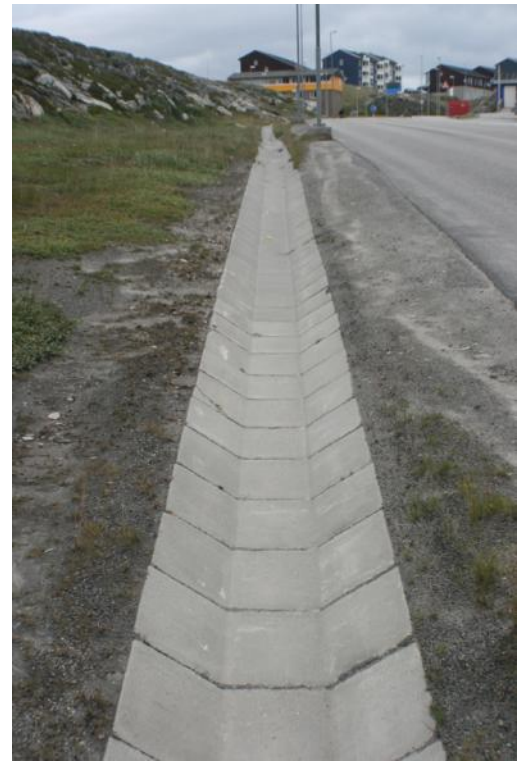
Figure 5 shows a typical example of the type of concrete ditch that is often used in Nuuk. These ditches generally work as intended and are effective in carrying water away from the road. This type of ditch is marked in green on the maps.

Figure 7 – Concrete ditch

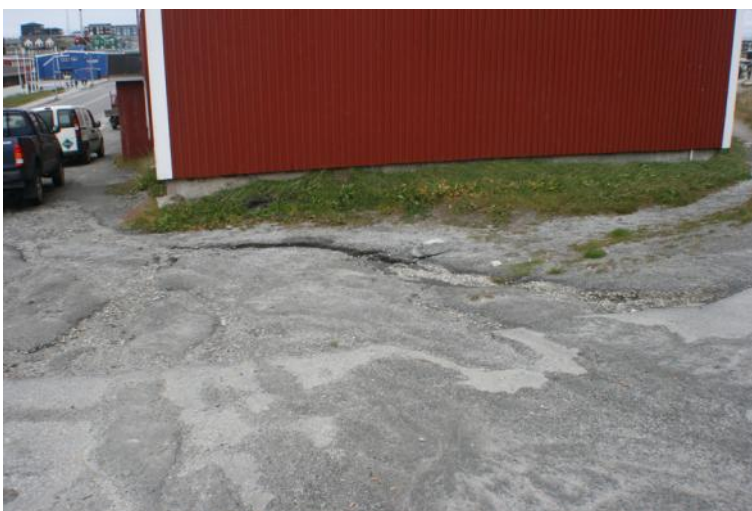
Figure 7 shows clearly how gravel and stone can be washed away from unpaved gravel roads where water is permitted to run uncontrolled, and what kind of cracks can be caused. This photograph also shows the patching that becomes necessary to repair the water damage caused.

Figure 5 – Wear on gravel road

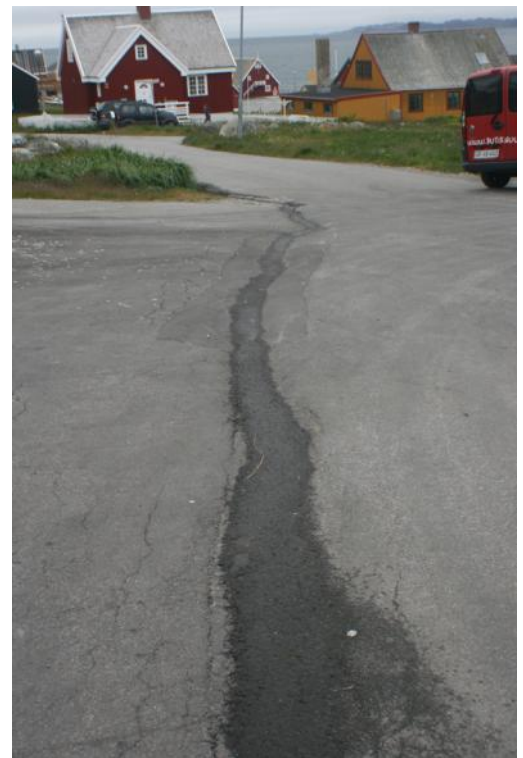
Figure 6 shows that even paved roads can be damaged when ditches are not provided.

Figure 6 – wear on paved road

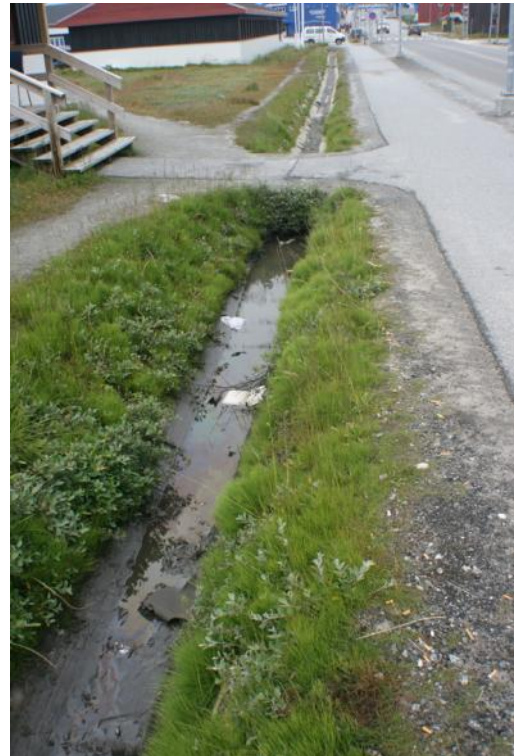
In some places, where ditches are blocked by gravel, stone or waste pools of stagnant water can be created. These ditches can be well constructed with concrete, but fail to work due to clogged outlet pipes.

An example of stagnant water in a well constructed ditch can be seen in Figure 8.

Figure 8 – Stagnant water in a ditch

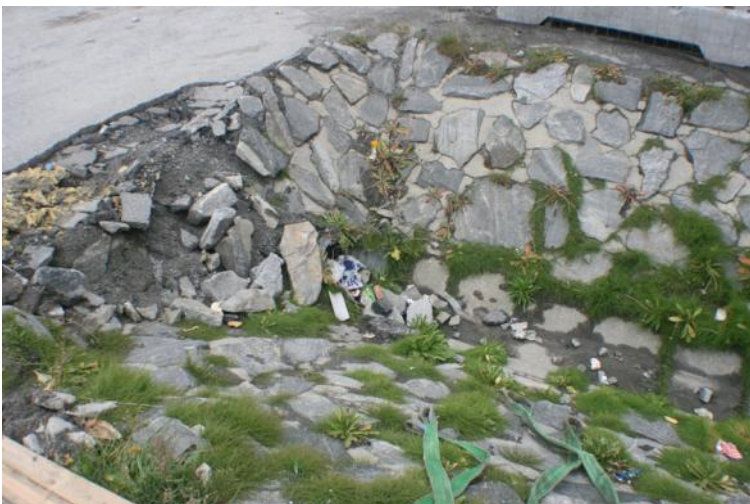
Figure 9 and Figure 10 give examples of typical materials that can block drainage systems. In some cases, it can be sand and gravel (Figure 10) in other cases, large rocks and waste (Figure 9).

Figure 9 – Ditch blocked by stone and garbage

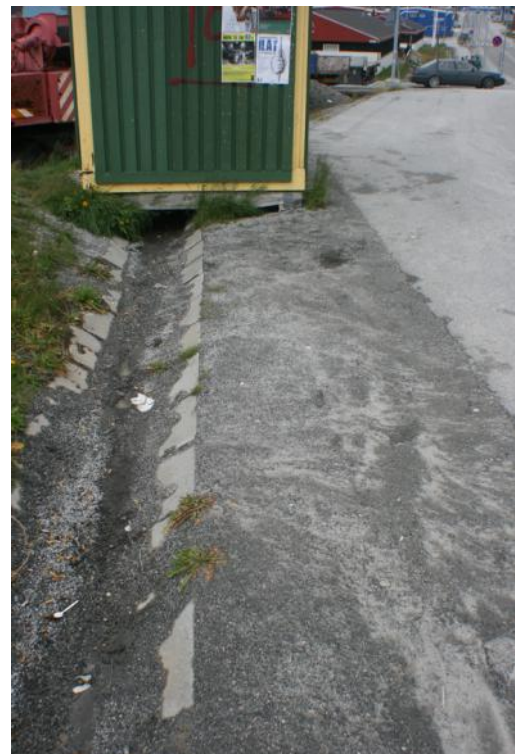
Figure 10 – Ditch filled with sand and gravel

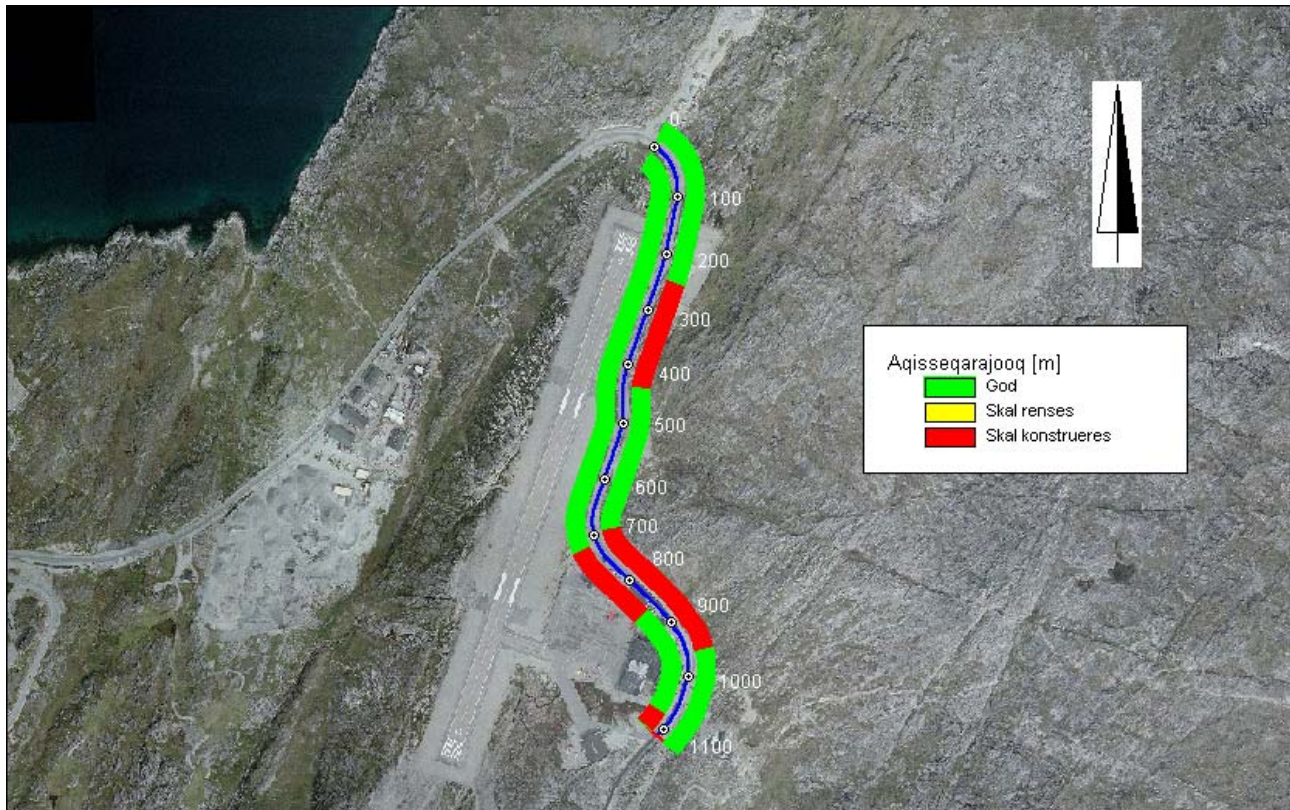
Figure 12 - Aqisseqarajooq

Aqisseqarajooq has a combination of ditches, with or without concrete, and road sections without ditches. Drainage seems to be acceptable in most places, but it could possibly be improved with new ditches in a few places where the water runs toward the road. There is a steep slope in the local landscape that slopes from left to right, that can lead the water towards the road. See Figure 12.

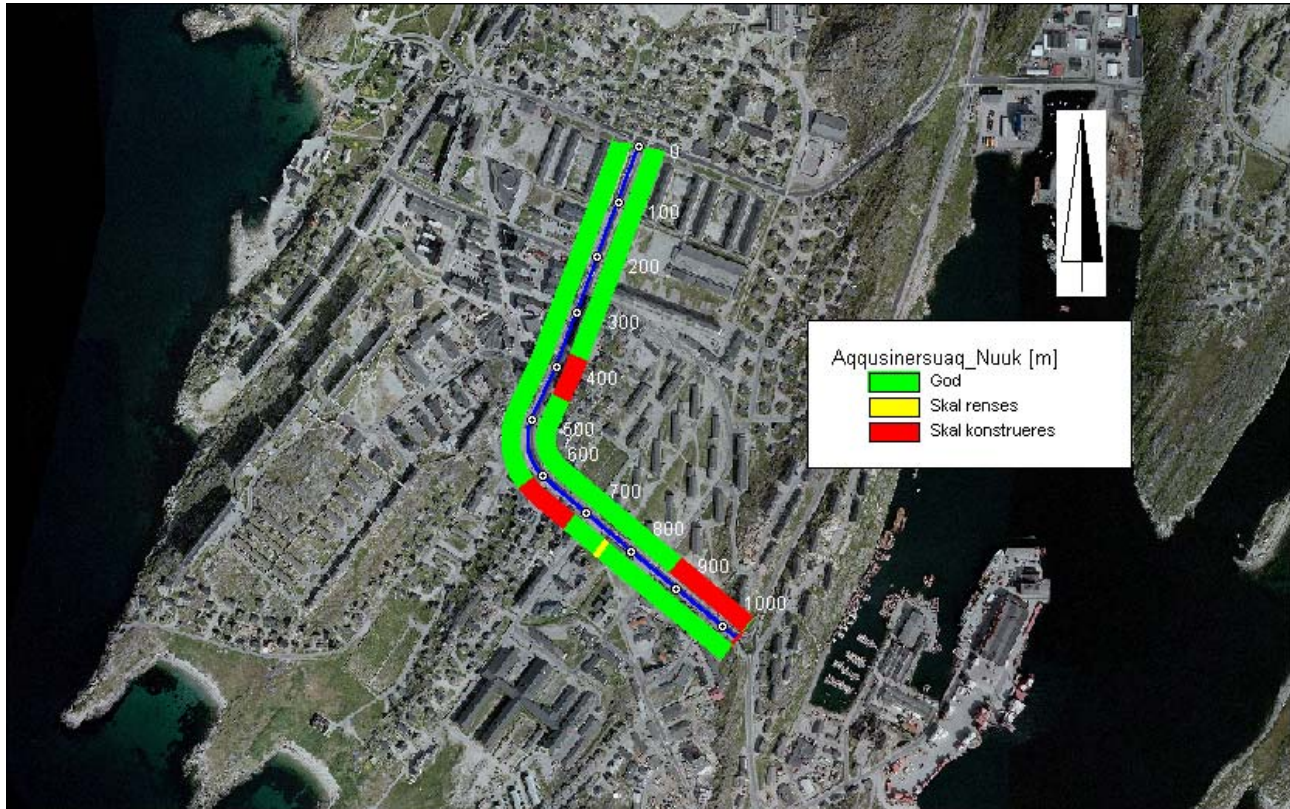
Figure 13 - Aqqusinersuaq_Nuuk

This road has good ditches with concrete inverts. Most sections have a paved sidewalk/cycle path between the road and ditch. The slope on the road could be changed in some places where the water runs on to the road. There could be need for ditches at the end of the left side. See Figure 13.

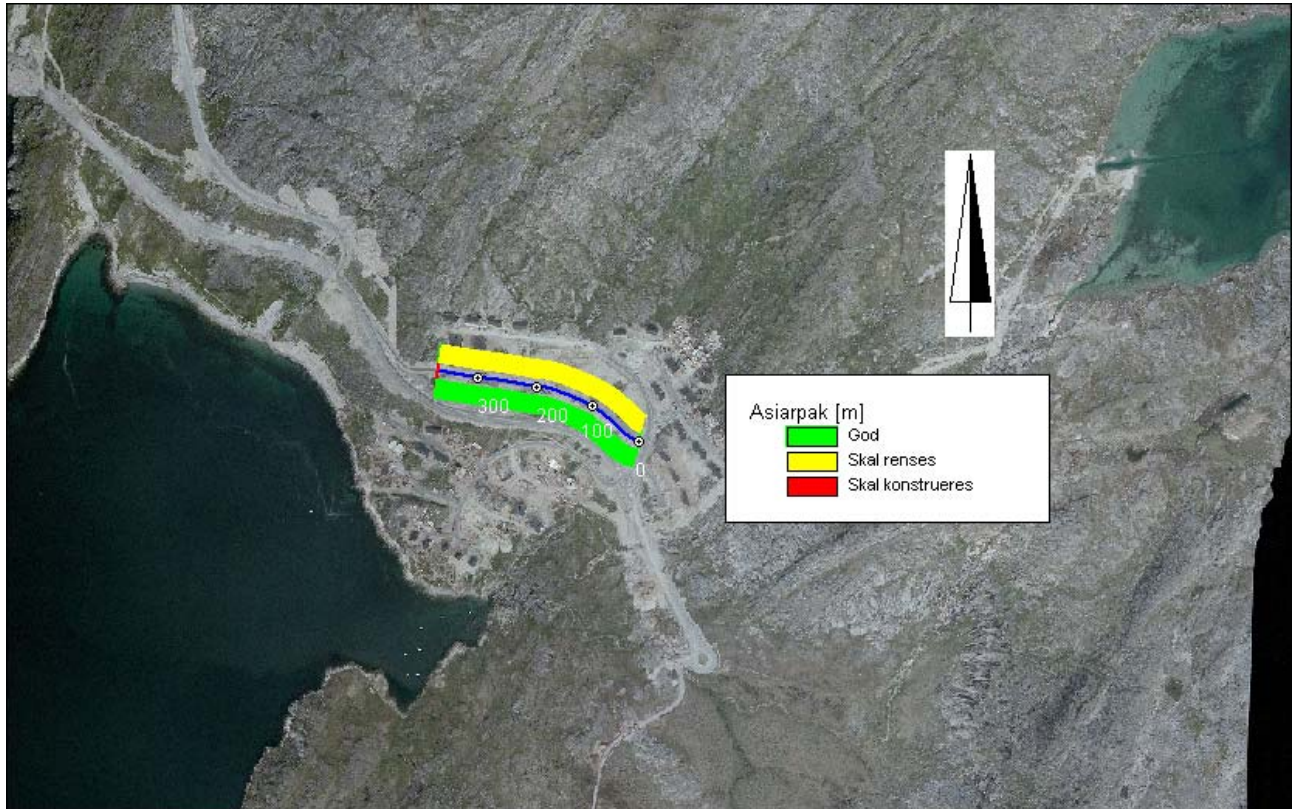
Figure 14 - Asiarpak

There is a ditch on the right side of this road, but it should be cleaned thoroughly. Because of the slope in the surroundings, water will run towards the road. Something could be done to ensure that the ditch is not filled with stones again. The left side of the road does not have a ditch, but it is not strictly necessary, as the slope is fairly steep away from the road. See Figure 14.

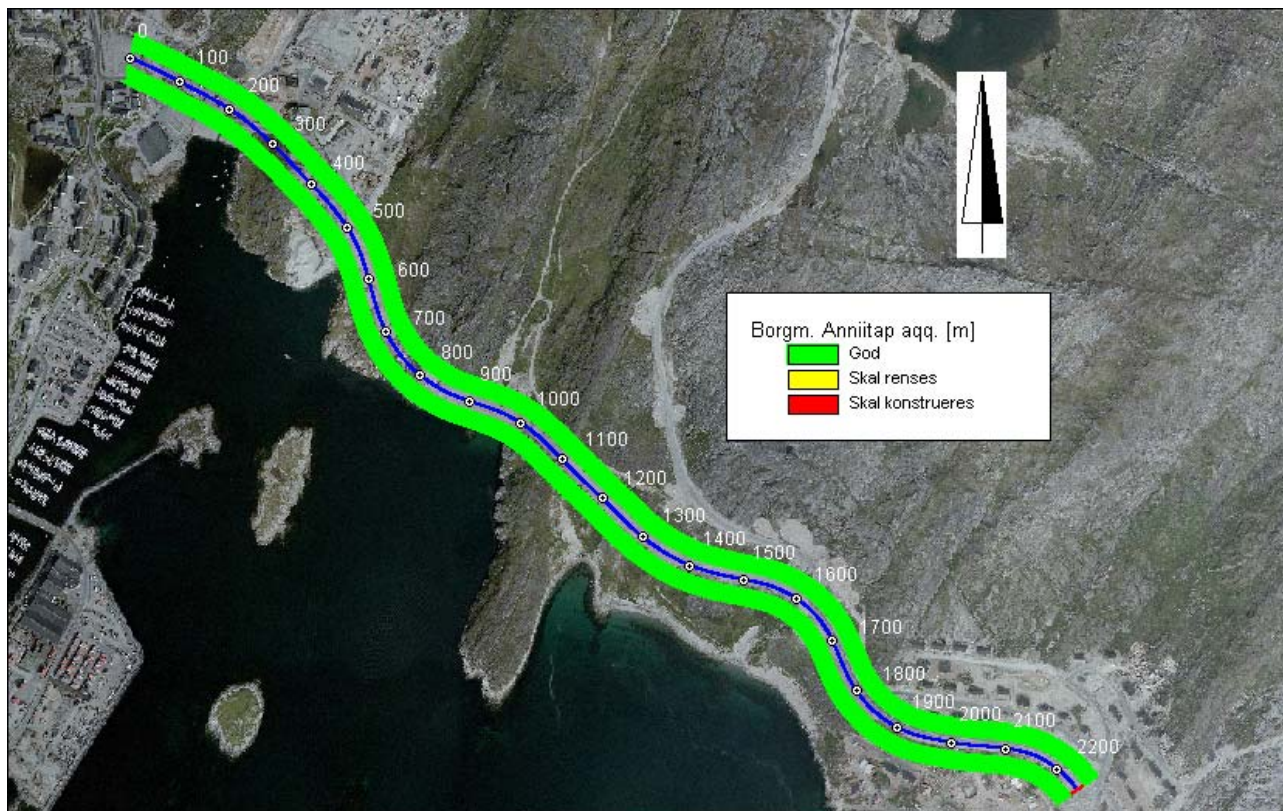
Figure 15 - Borgmester Anniitap aqq.

New asphalt surfacing was laid on part of this road section during the survey. The beginning of the section has changed since the map shown was made, which explains the change of the road at the beginning of the road. Drainage seems to work very well on both sides. See Figure 15.

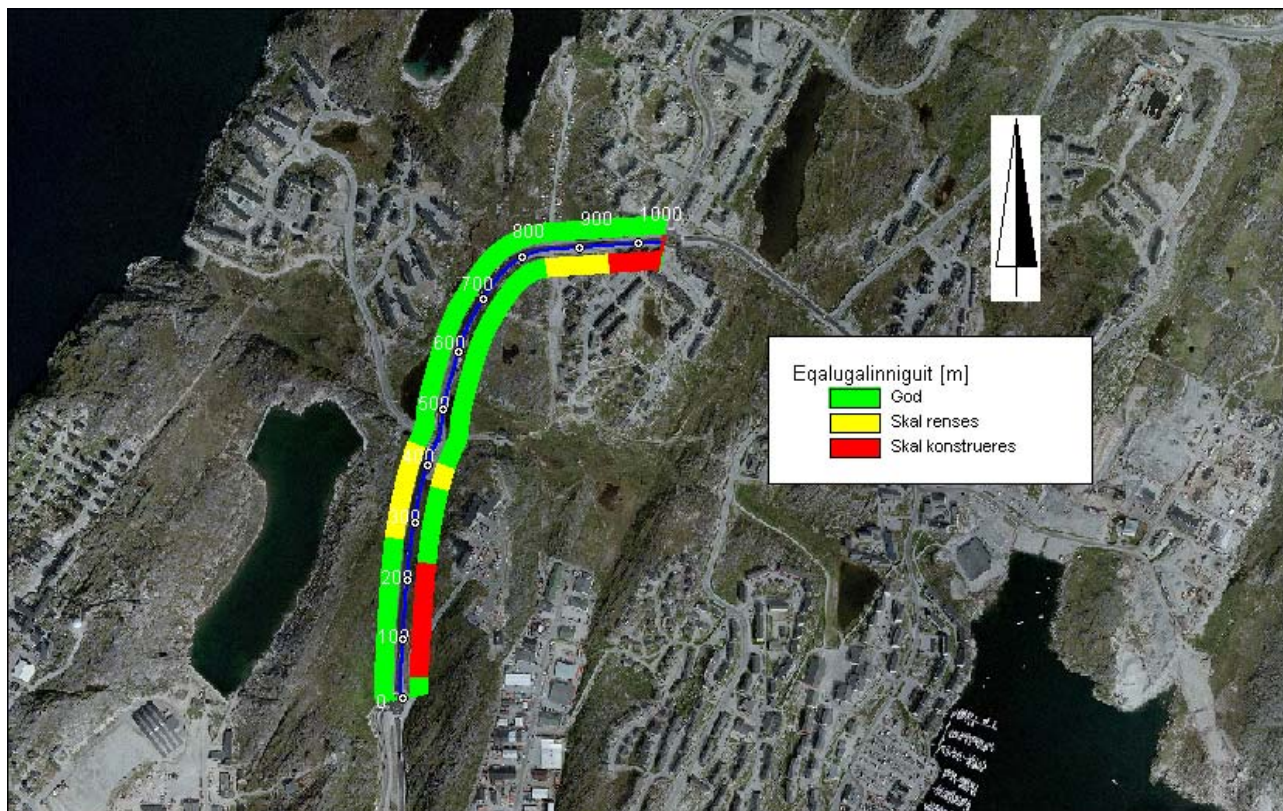
Figure 16 - Eqlugalinniguit

This road section is partly ditched, and parts sloping away from the road. The road is constructed with a wide paved cycle path between the road and ditch. At the beginning of the road there is a very swampy area, where something could be done to direct water away from the area. The road is elevated slightly above the surrounding area, so it should therefore be possible to get the existing drainage pipe to function. The slope on the road on the right shoulder from 840m to 950m should be improved so that water does not run on the shoulder, but away from the road. See Figure 16.

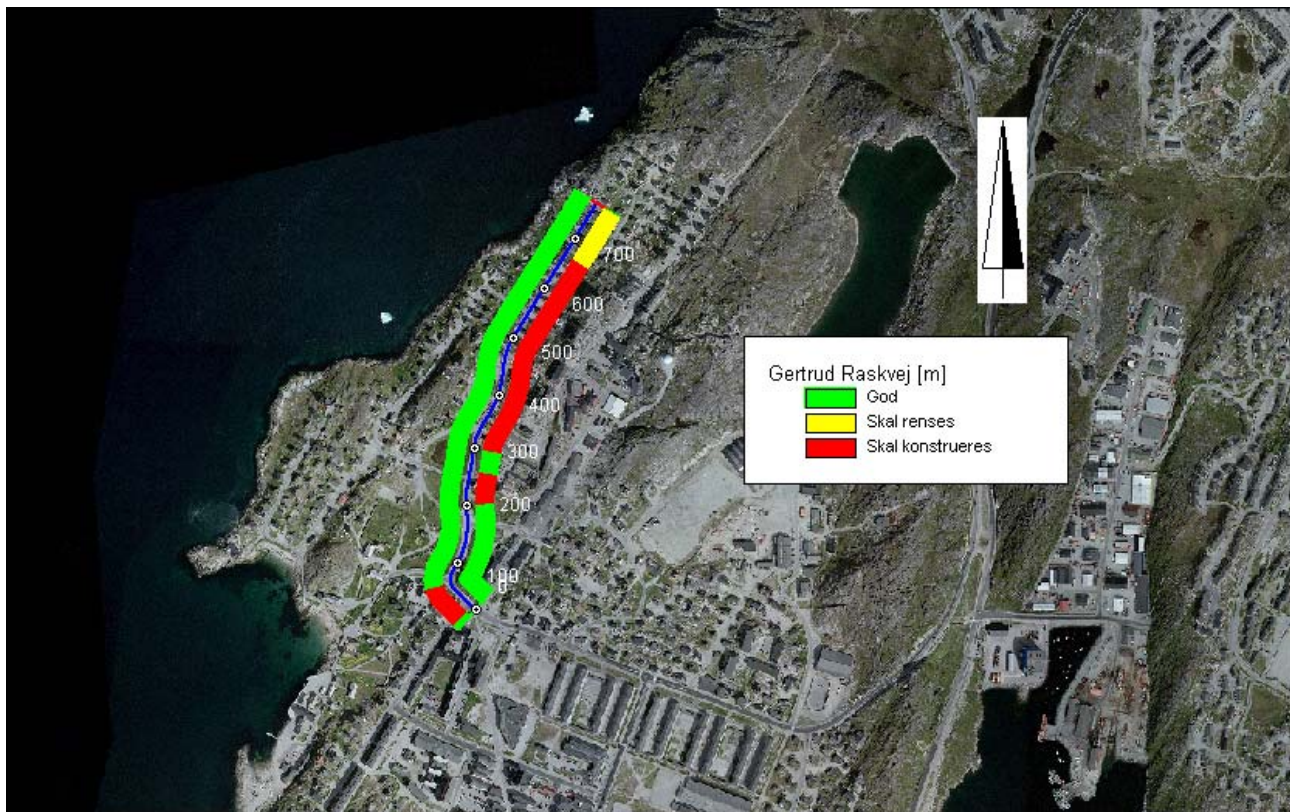
Figure 17 - Gertrud rask

This is a narrow single track road. There is a good ditch on the right side at the beginning of the road, but later on it lacks a ditch in some places on the right side, where the surrounding slope towards the road. The surroundings on the left side slope away from the road, and therefore drainage here is generally fine. It is only at the beginning of the road, where the road goes downhill and turns where there could be need of a ditch on the left side. See Figure 17.

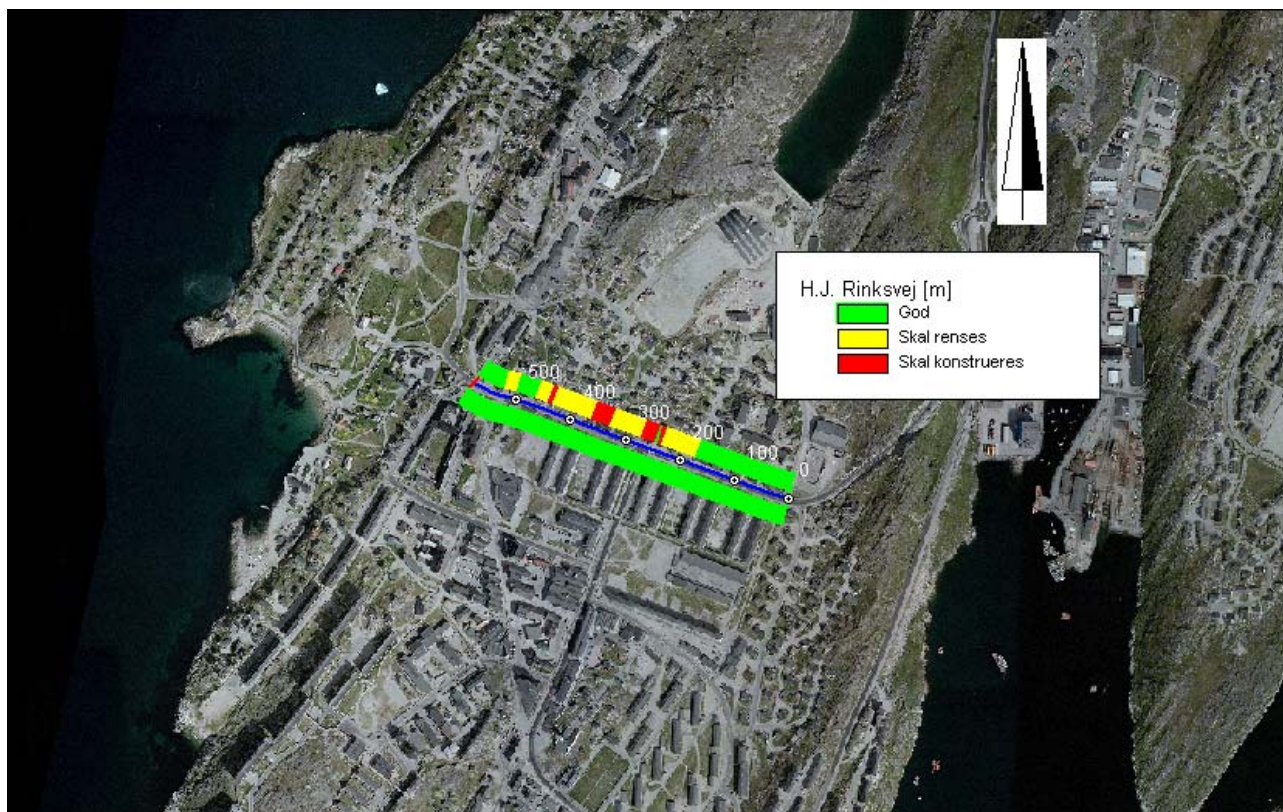
Figure 18 - H.J. Rinksvej

A ditch has been constructed for most of this road section. The ditches are deep, but should be cleaned. Water accumulates in some places due to waste or stones, and soil materials. This should be checked if it is causing stagnant water, and if it is a failure of design of the slope. The left side appears to be acceptable although it could be cleaned of grass. See Figure 18.

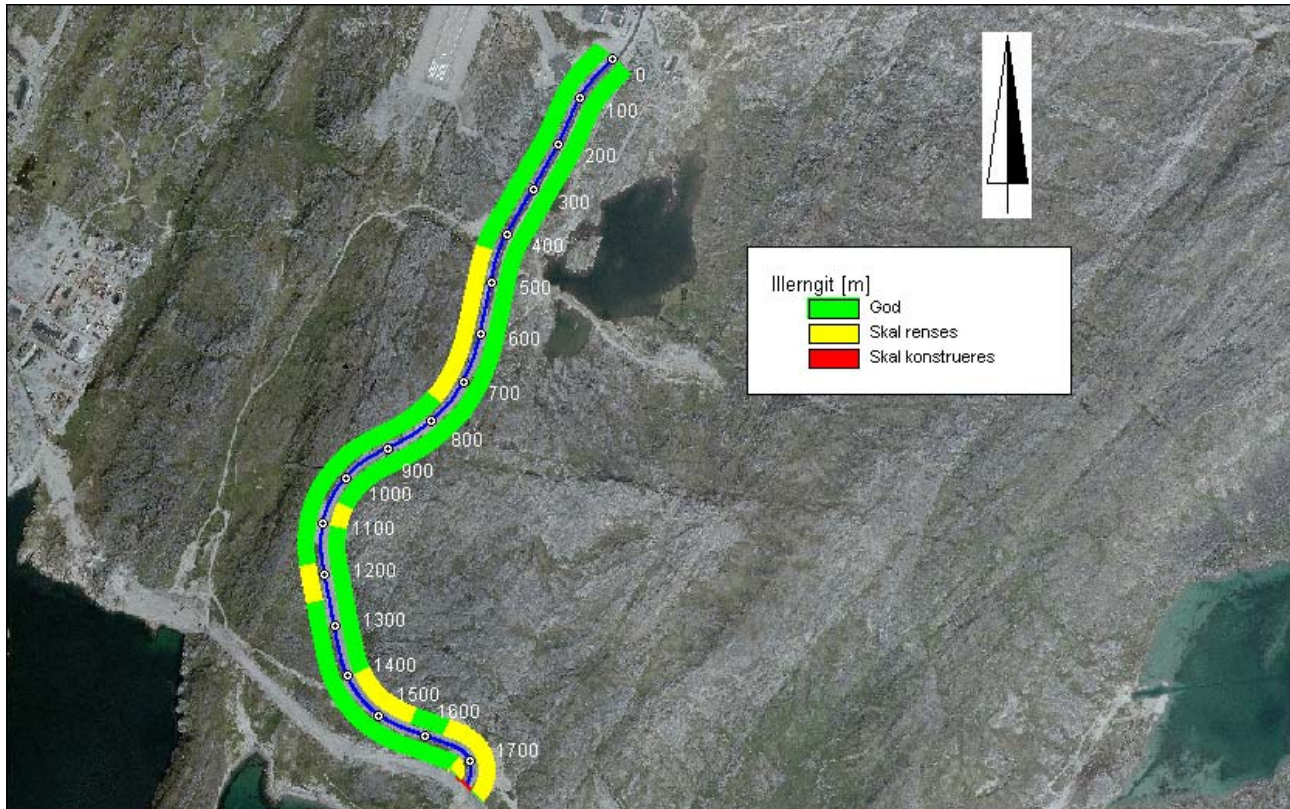
Figure 19 - Illerngit

Concrete ditches have been constructed on some of this road section. Initially these are fine, but later there are places that are filled with sand and stones that should be cleaned. At the end of the road, the surroundings slope steeply away from the road towards the sea, so it works fine. The left side should be cleaned in some places, but otherwise it works fine. See Figure 19.

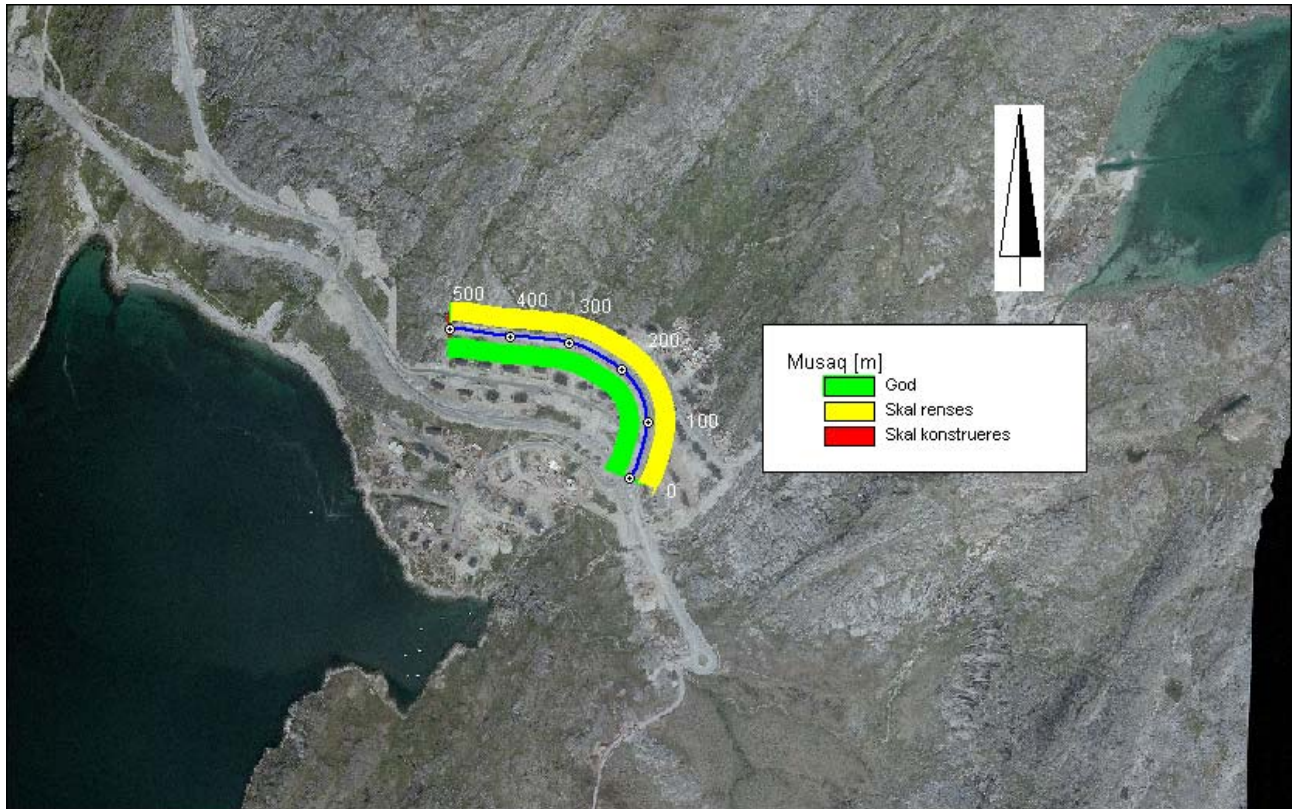
Figure 20 - Musaq

There are many rocks and soils in the right roadside ditch. The ditch is made with concrete bottom, but must be cleaned. Something could be constructed to keep the rocks and soil from entering the ditch. The left side has a ditch in the beginning, and otherwise a steep slope away from the road, so it works well. See Figure 20.

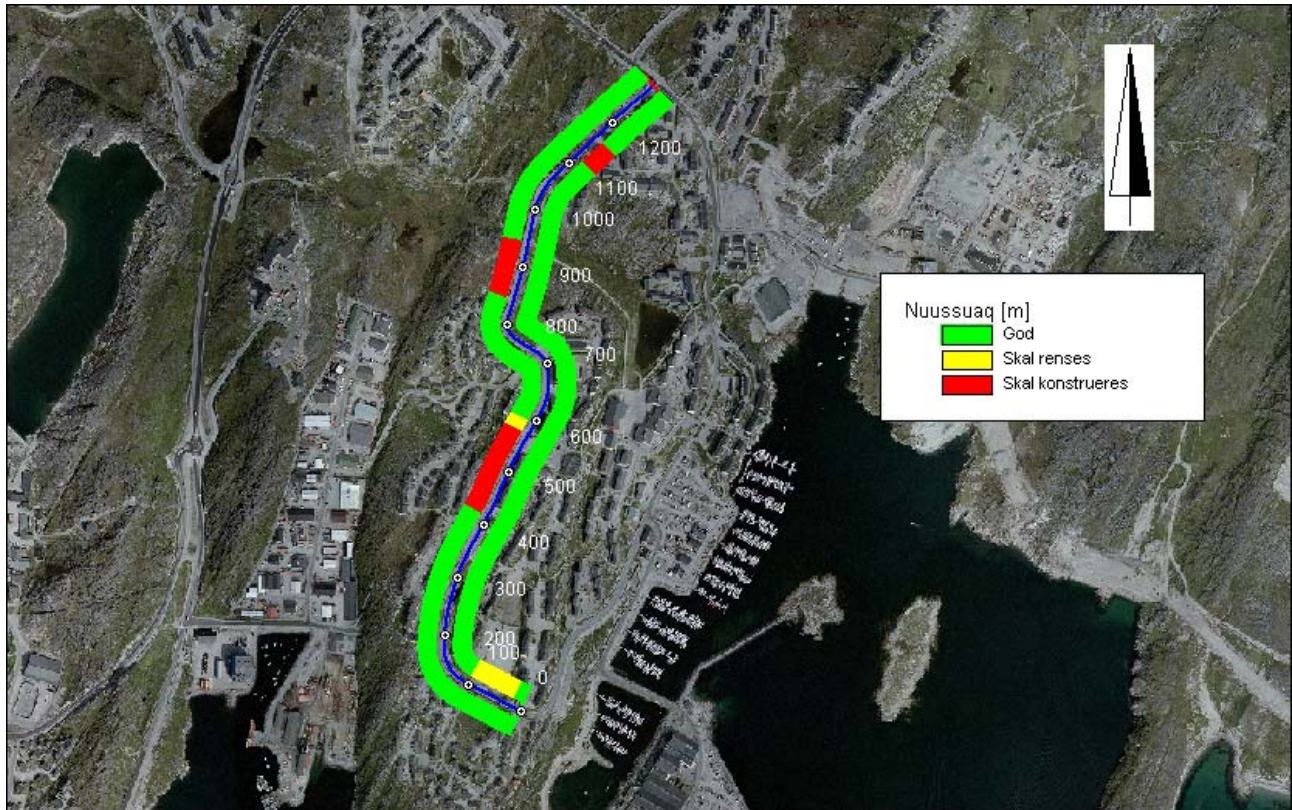
Figure 21 - Nuussuaq

On the right side there is either a concrete ditch, or a steep slope away from the road. This works fine. But in the beginning the ditch should be cleaned, as there is stagnant water. The left side has short sections where a ditch could be constructed, but otherwise it is fine. See Figure 21.

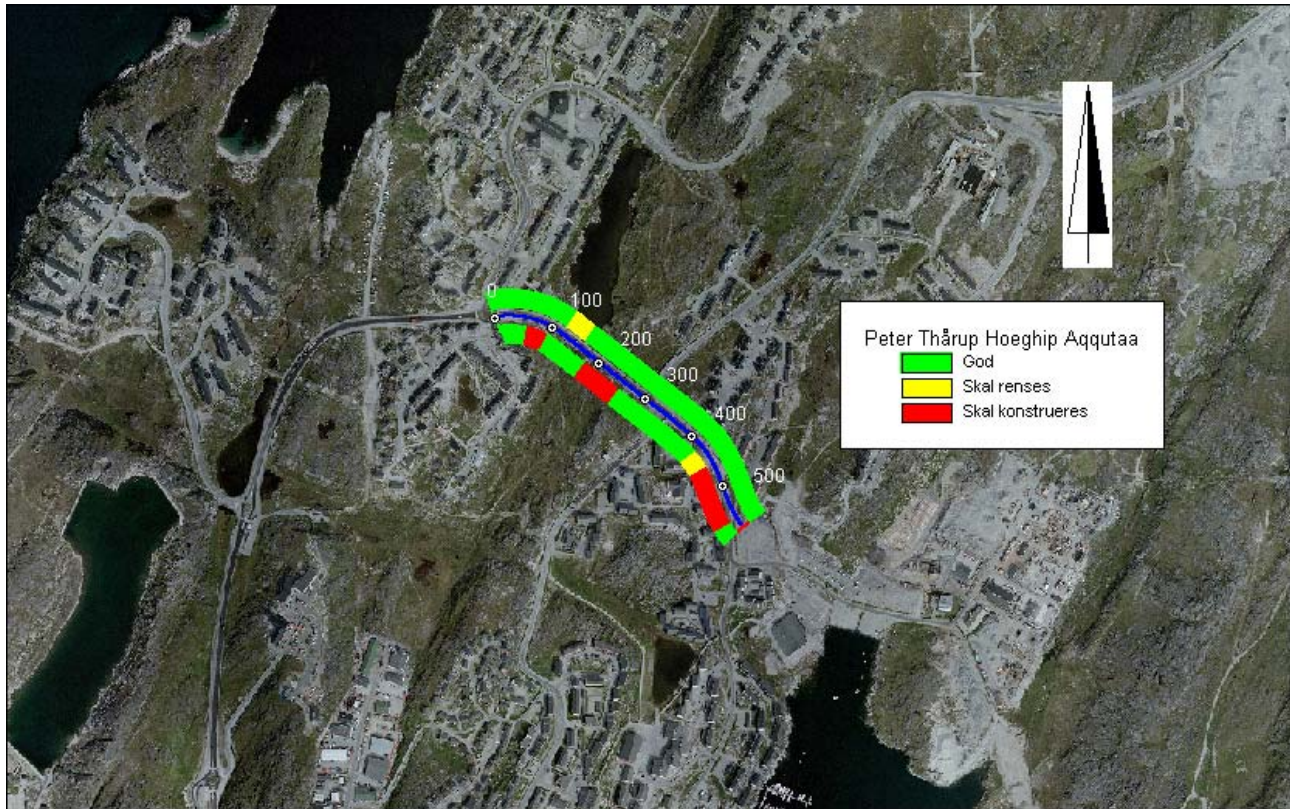
Figure 22 - Peter Thårup Hoeghip Aqqutaa

This section has ditches or a steep slope most of the way. However, there are shorter sections where there is no ditch. Some culvert on the right hand side should be examined. On the left side, there are some places where the water runs between the cycle path and road. Here a ditch could either be constructed or a better slope provided to the road. See Figure 22.

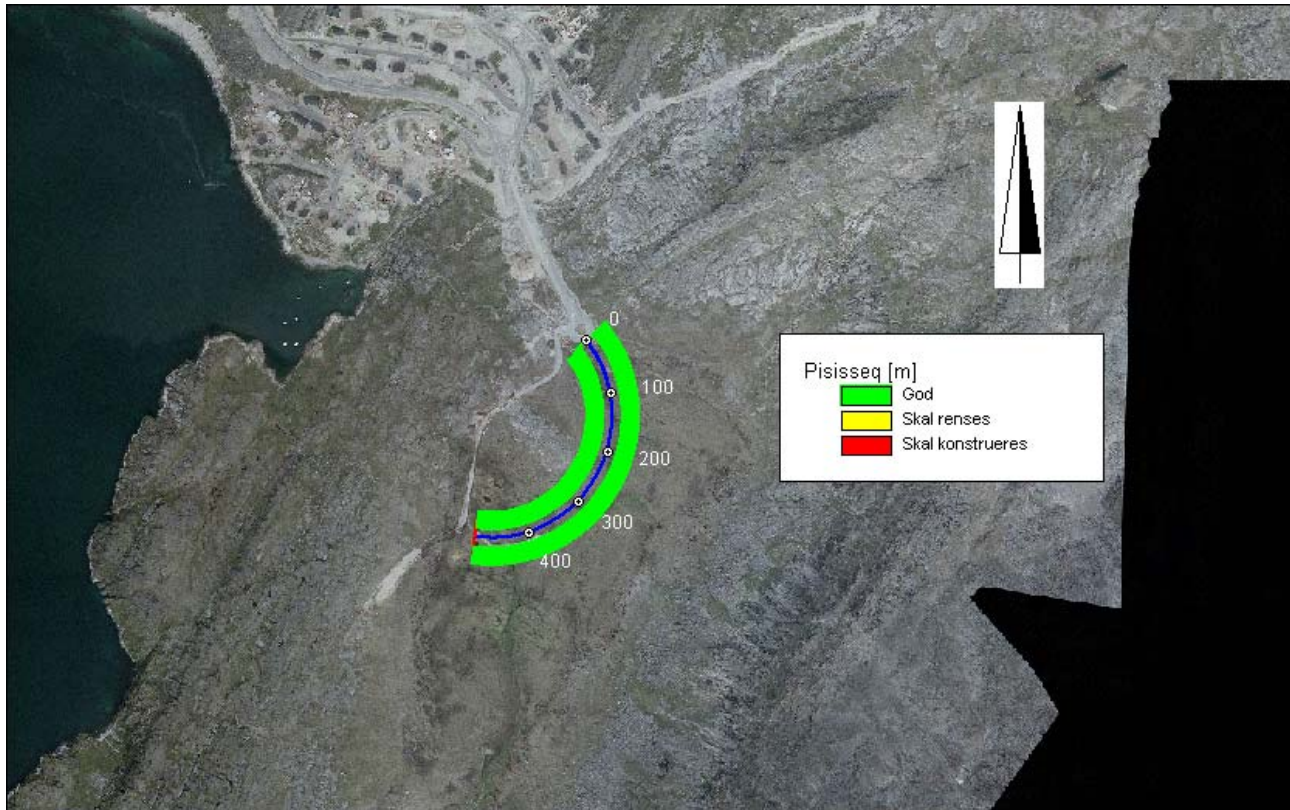
Figure 23 - Pisisseq

Pisisseq is a newly constructed road, with good ditches. The left side accumulates a little water in the gap between road and cycle path. There could be a better slope on the shoulder between the road and cycle path, but otherwise the drainage works fine. See Figure 23.

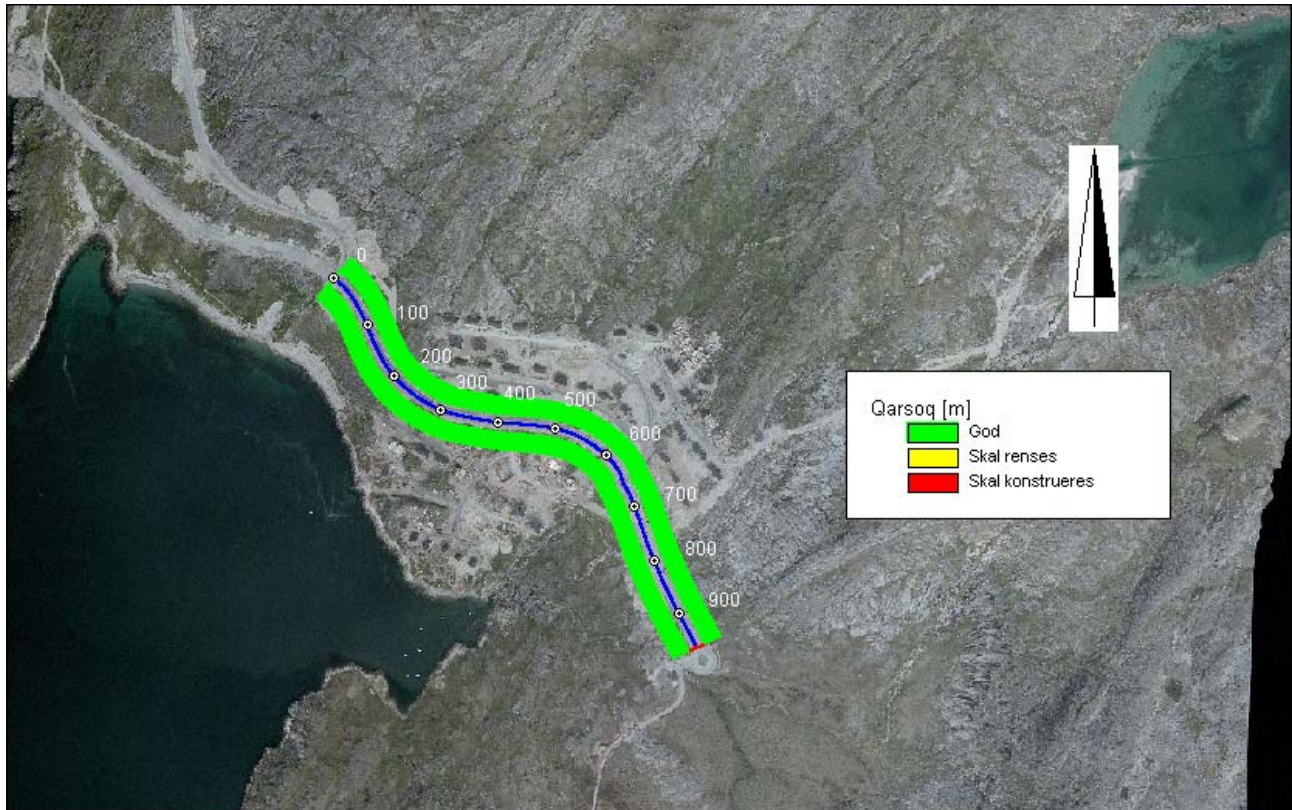
Figure 24 - Qarsoq

The right hand side of this road section has no ditch but a steep slope towards the sea, so there is no need for a ditch. The left hand side has ditches, but as the surroundings have a very steep slope toward the road, their capacity should be examined. See Figure 24.

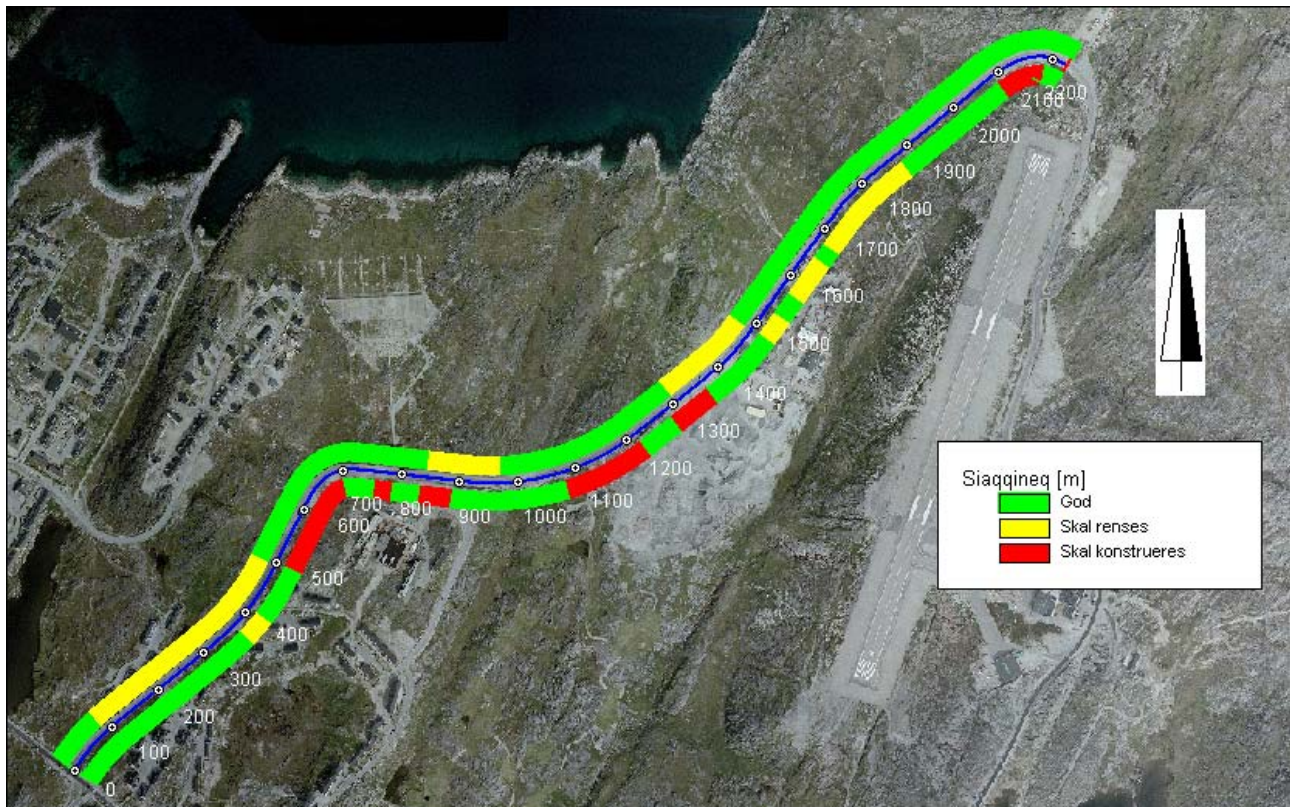
Figure 25 - Siaqqineq

This road section only has ditches some of the way. In the beginning a ditch is not necessary, but on the right side ditches are missing in some places. The ditches that are present should be cleaned in several places. On the left hand side there are several places where the ditch needs to be cleaned, otherwise the drainage works well. At the end of the road there is either a ditch or a steep slope away from the road towards the sea, which works fine. The slope between the road and cycle path could possibly be better, so that the water is led away from the road. See Figure 25.

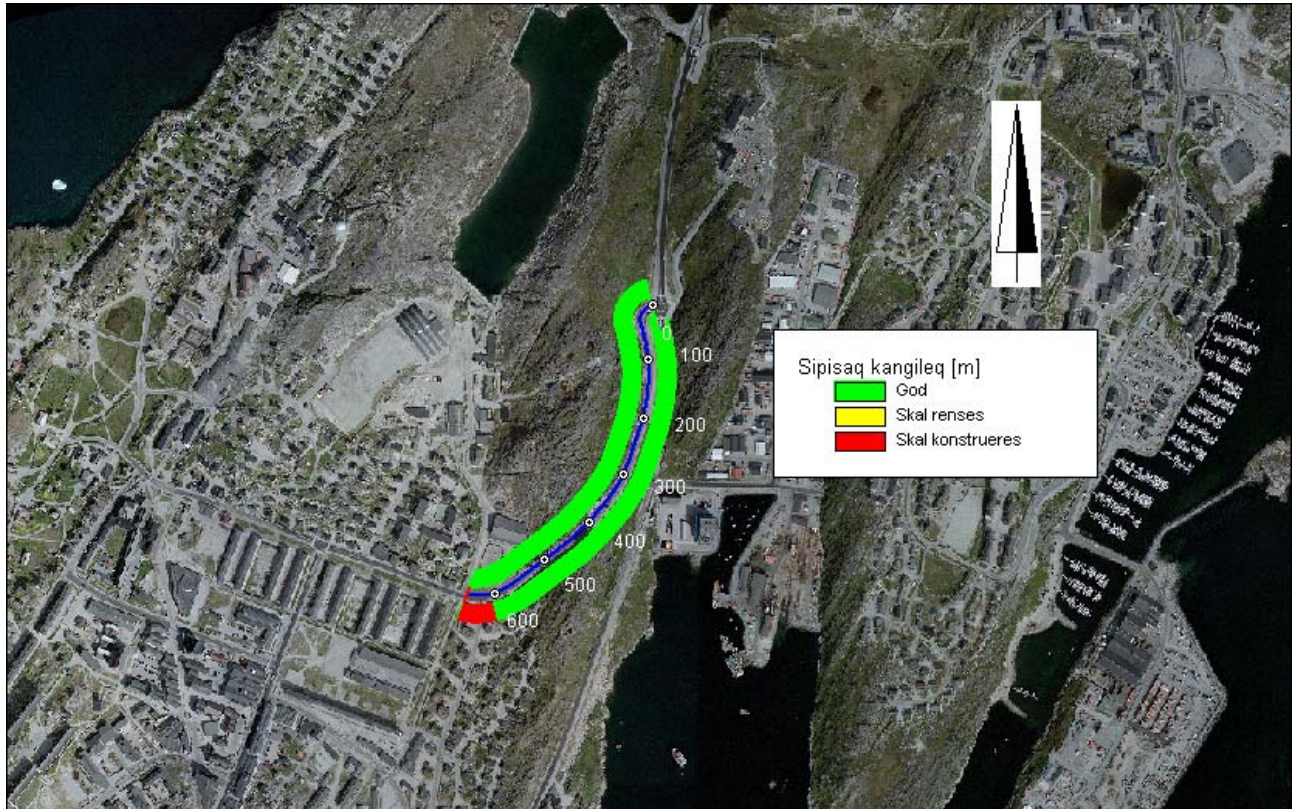
Figure 26 - Sipisag kangileq

There is a good concrete ditch all the way on the right hand side on this road section. The left side has a steep slope away from the road in the beginning of the section. Thereafter the road is paved to the rock, so there is no ditch. A ditch and culvert should be constructed on the left hand side at the end of the road section. See Figure 26.

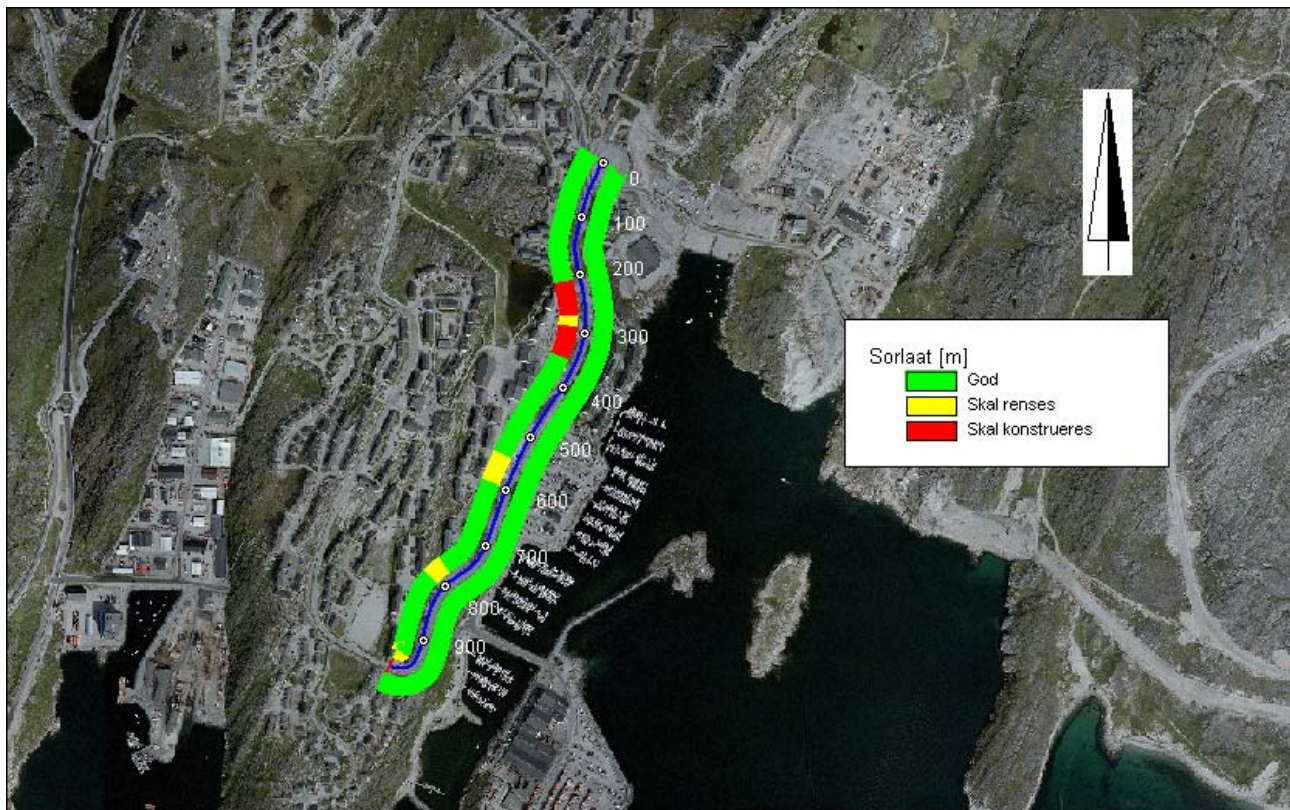
Figure 27 – Sorlaat

The Sorlaat road section has concrete ditches or a steep slope at the beginning which appear to work. However, there is some stagnant water present in places, suggesting lack of ditch from about 200 m. From there, there is stagnant water in the ditch, at approximately about 570 metres. The drainage on the left side works satisfactorily and consists of either a good ditch or a slope towards the water. See Figure 27.
