ROADEX Drainage Demonstration Projects: N56 and N59, Ireland

Timo Saarenketo, PhD
Roadscanners, Finland

N56 & N59 IRELAND

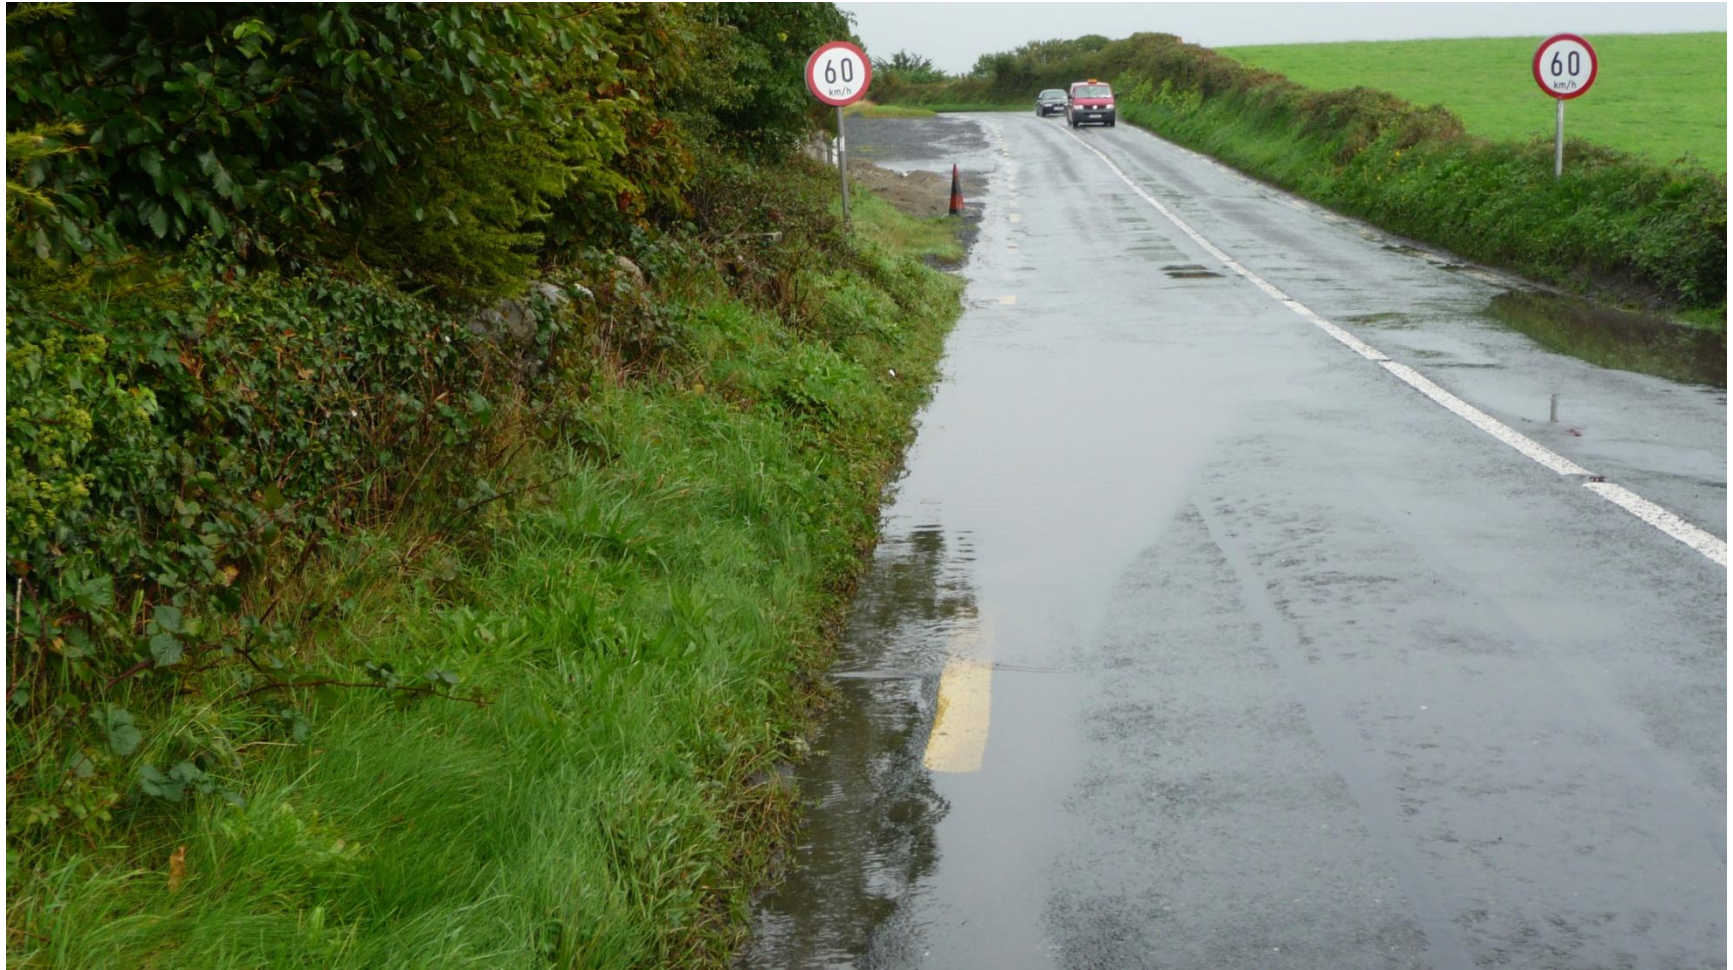
- The majority of the severe drainage problems in Ireland appear to occur in the same kind of circumstances as in Nordic countries.
- A good example of this are the road sections located on side sloping ground
 - If the ditch is not in good condition in the upper side of the road problems will most likely occur

Problems in the upper side of the side slope

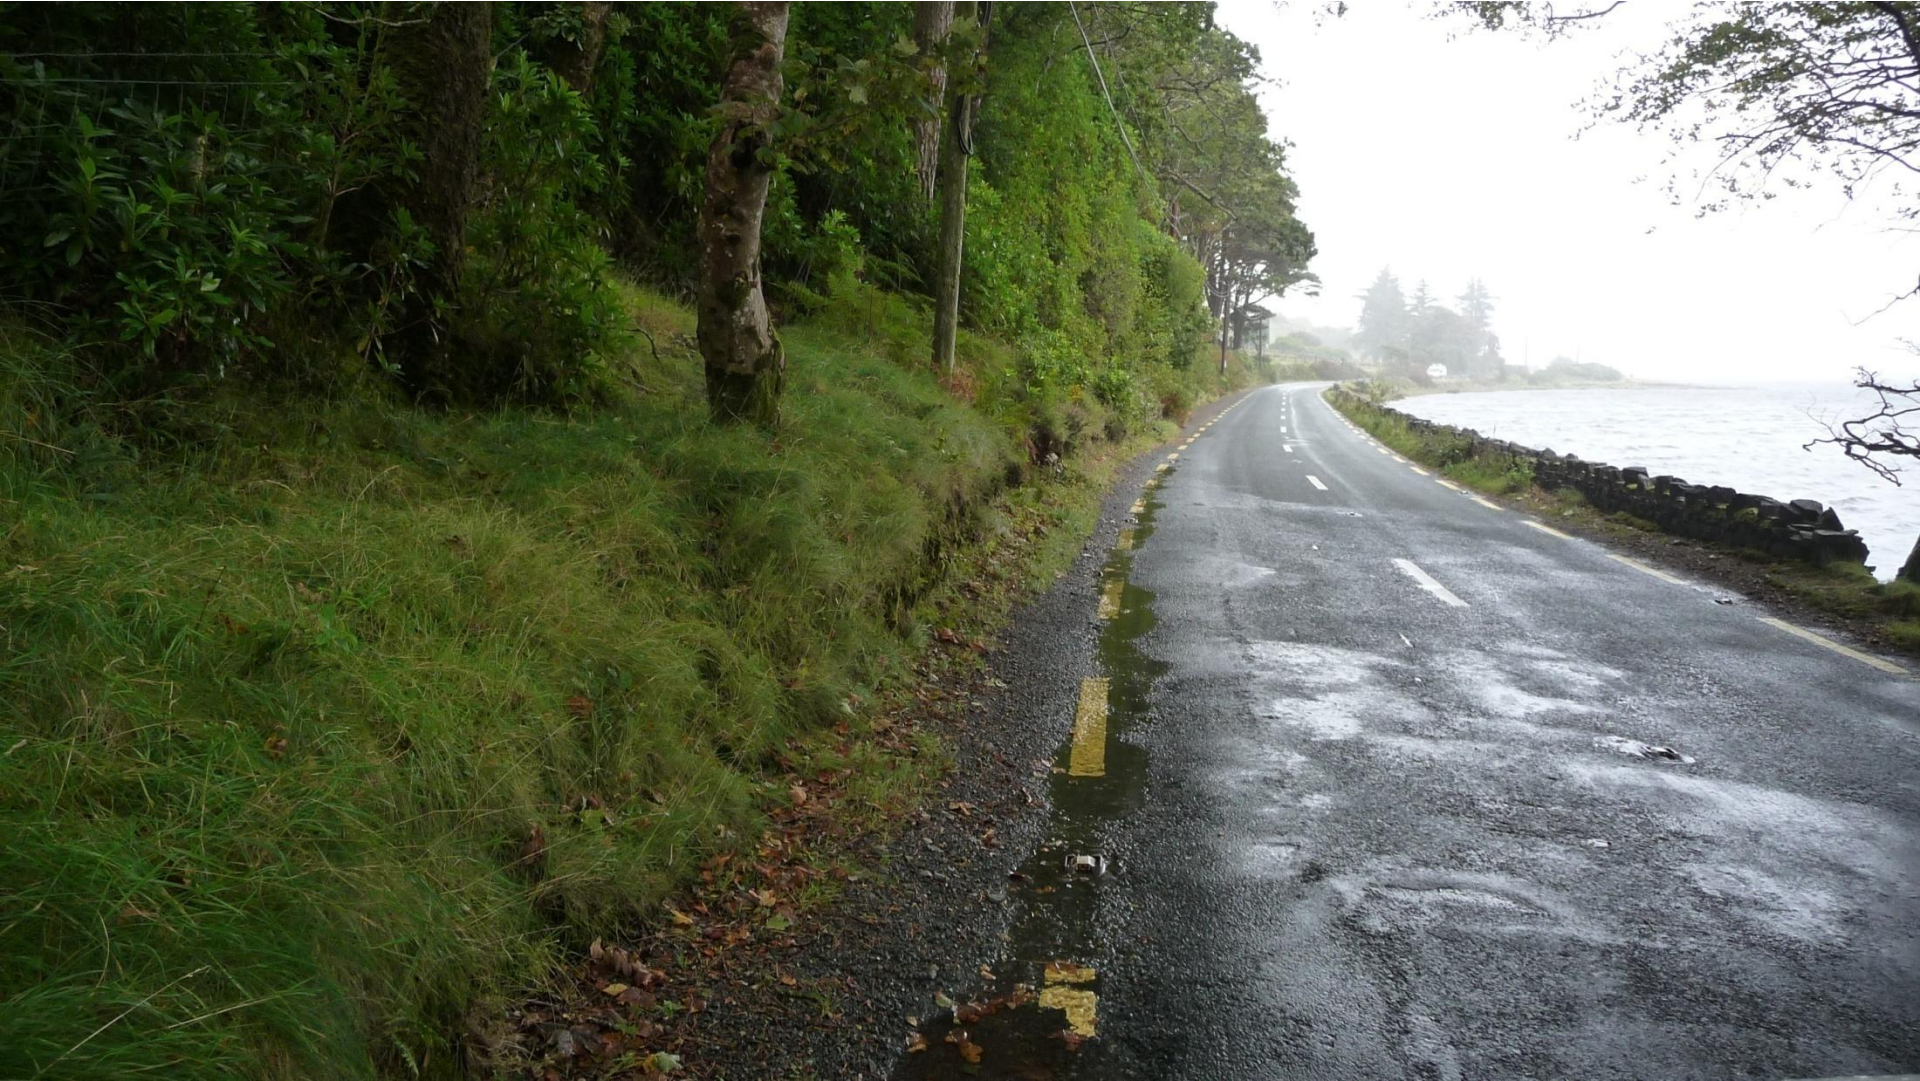
- Verges are very common on the N56 and N59,
- Verges prevent the water flowing away from the roadway, forcing any surface water to drain through the pavement structure instead of flowing away from the road

Example of extremely high verge

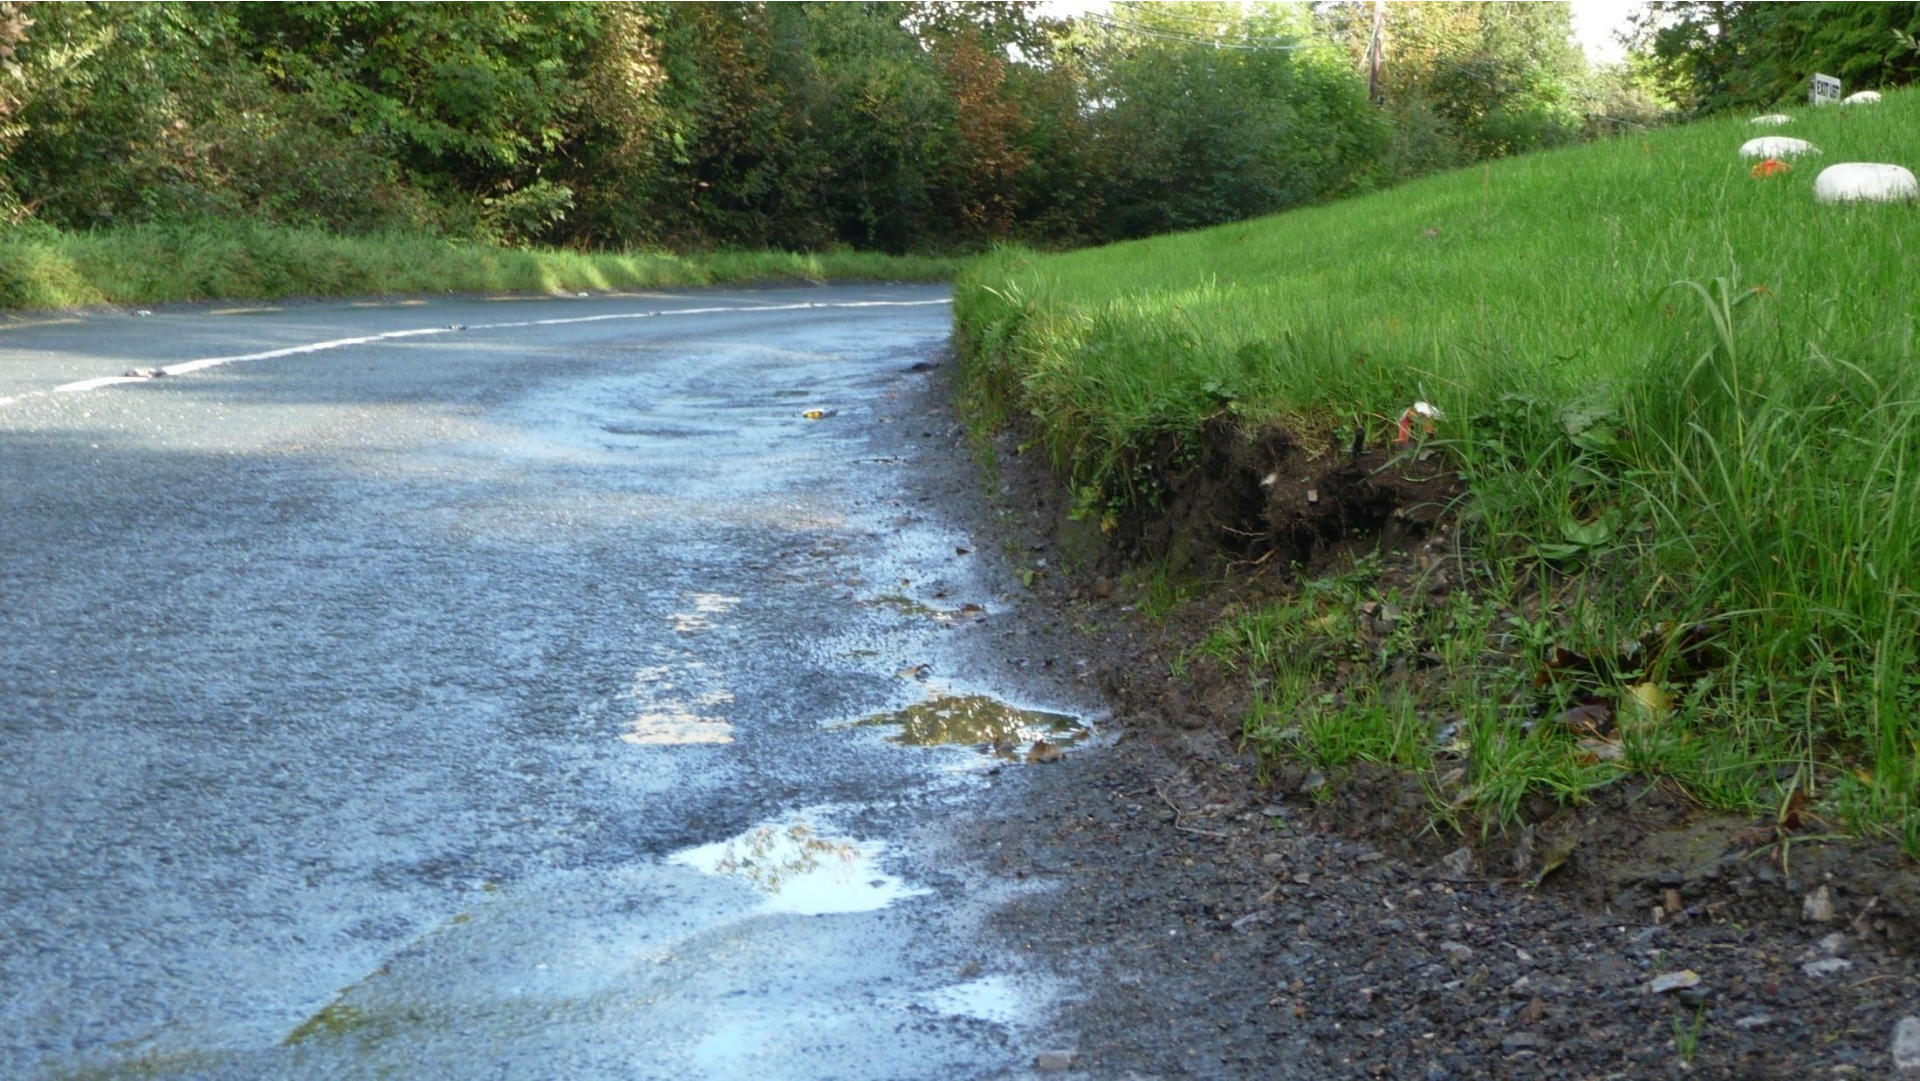
- Another typical feature on the Irish roads surveyed was the presence of rock walls.
- Where road improvements had been carried out these walls appear to have been removed.
- Usually the walls are very old and in many cases not visible due to vegetation growth.
- Typically these walls blocked the flow of surface water away from the road unless water outlets had been provided

Rock wall blocking the water

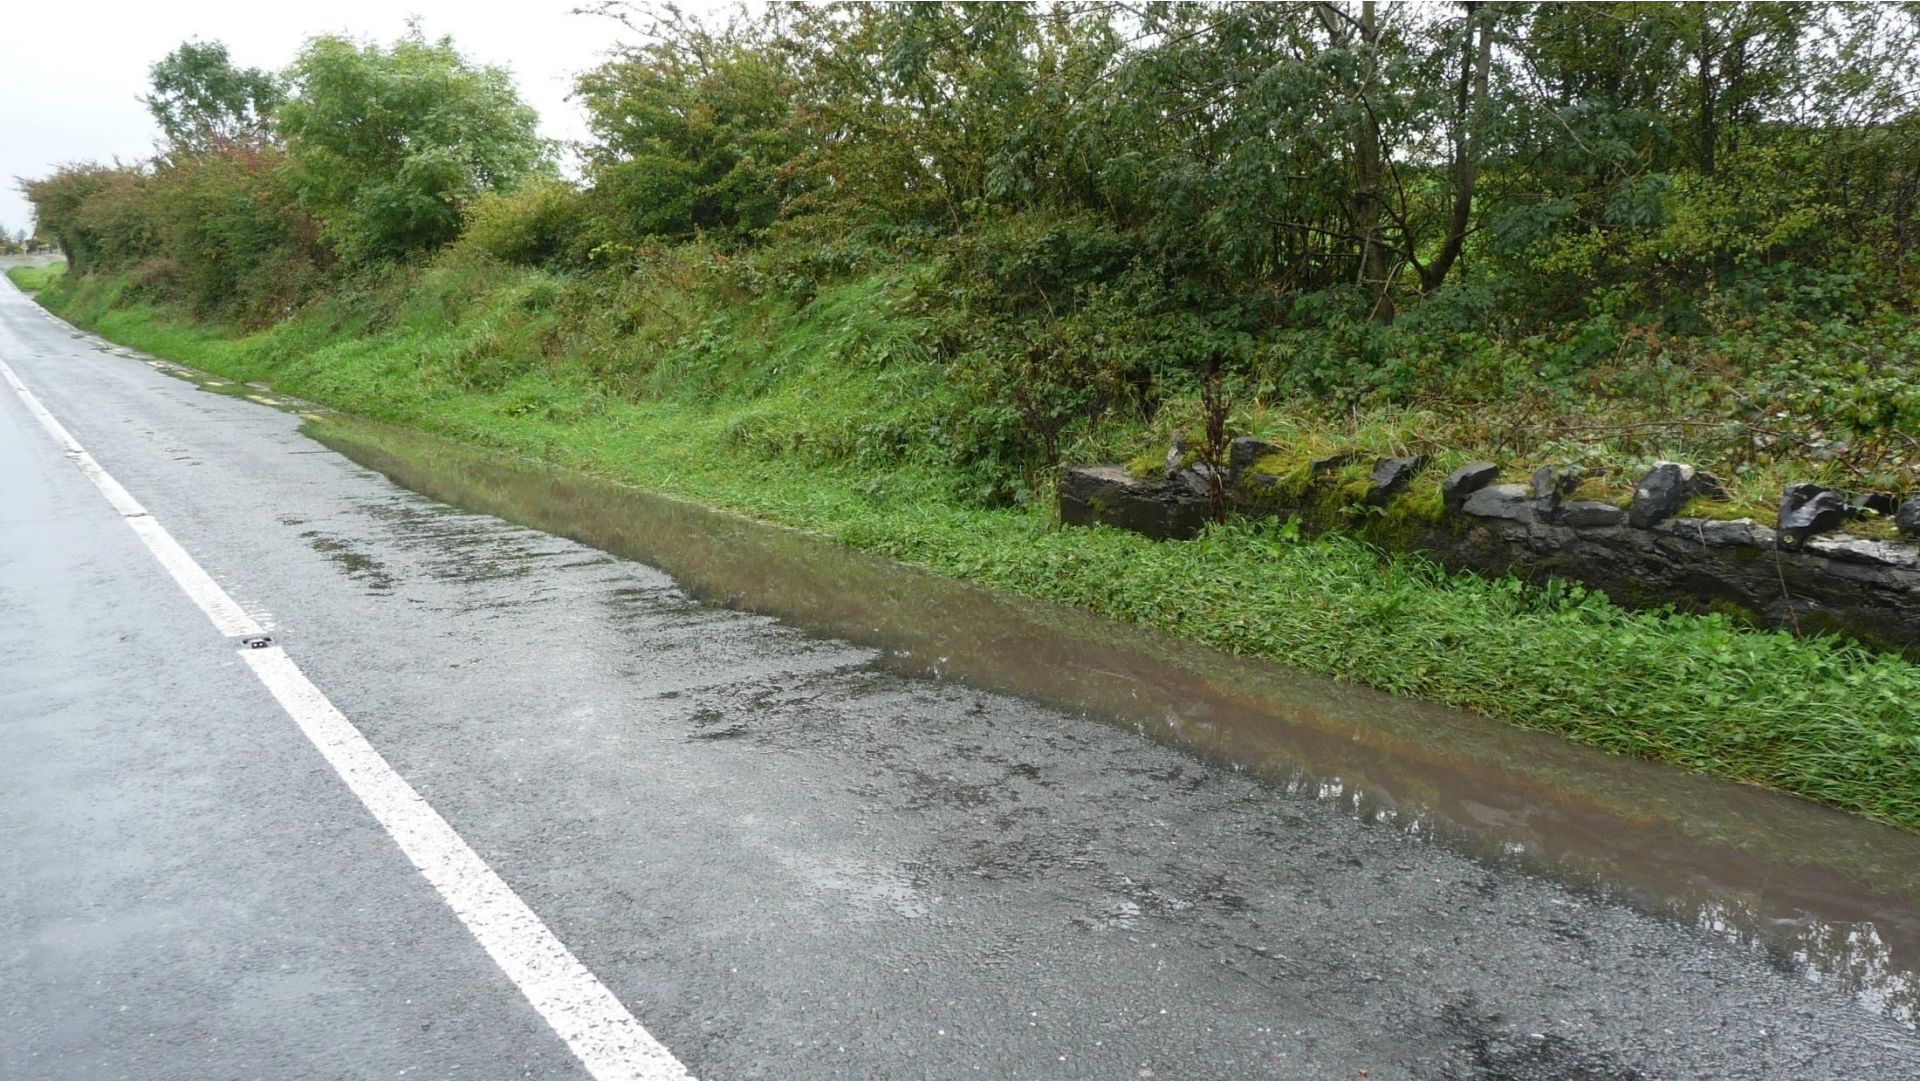
- A very special feature on the roads surveyed was the narrow road cutting
- In many cases there is a complete absence of ditches or any other drainage structure within these types of road cuts.
- This means that water generally flows along the road as there is no possibility for it to get off the road, and this causes erosion and deformation problems to the road

Problems in a road cutting

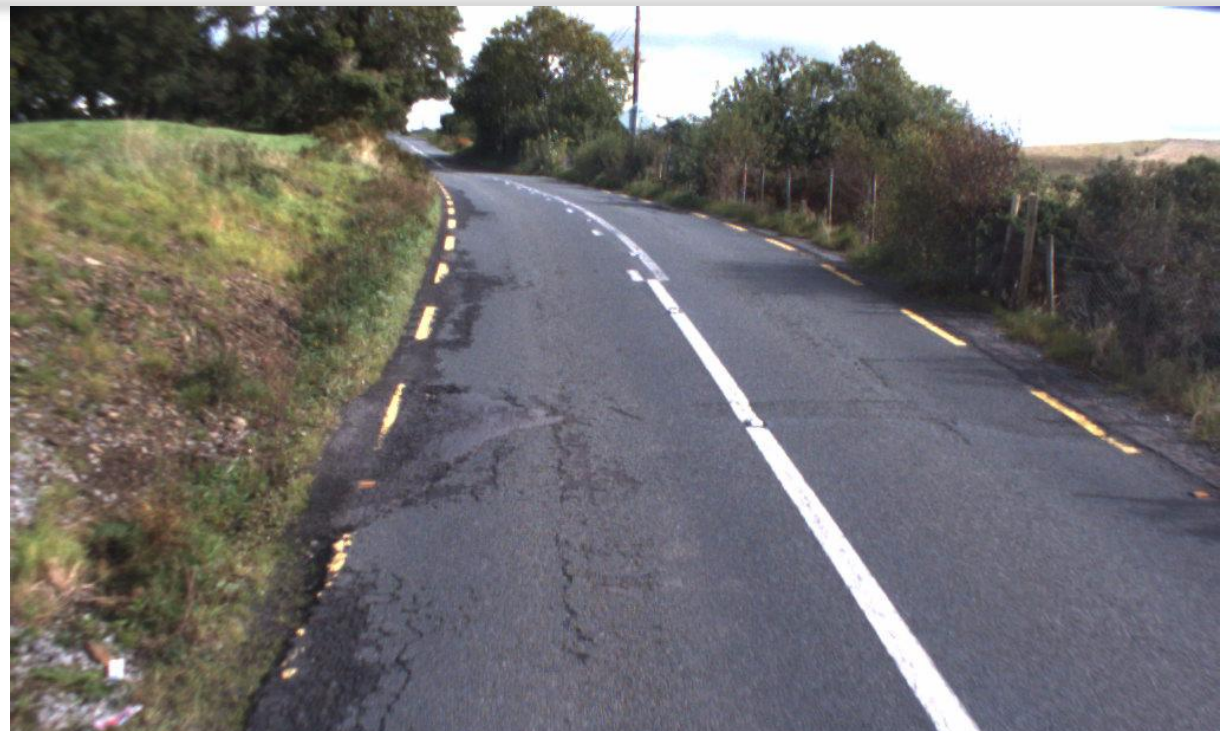
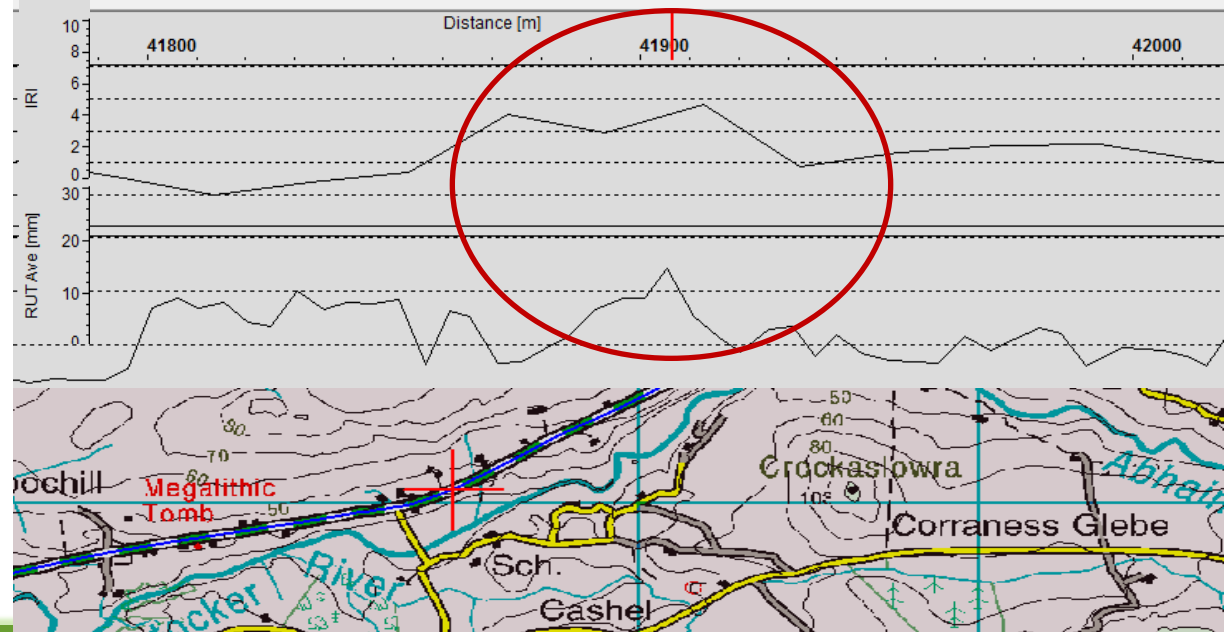
41900m the road profile is side sloping from left to right. Possibly there is a french drain but it's not working well enough. Higher IRI and Rutting values!

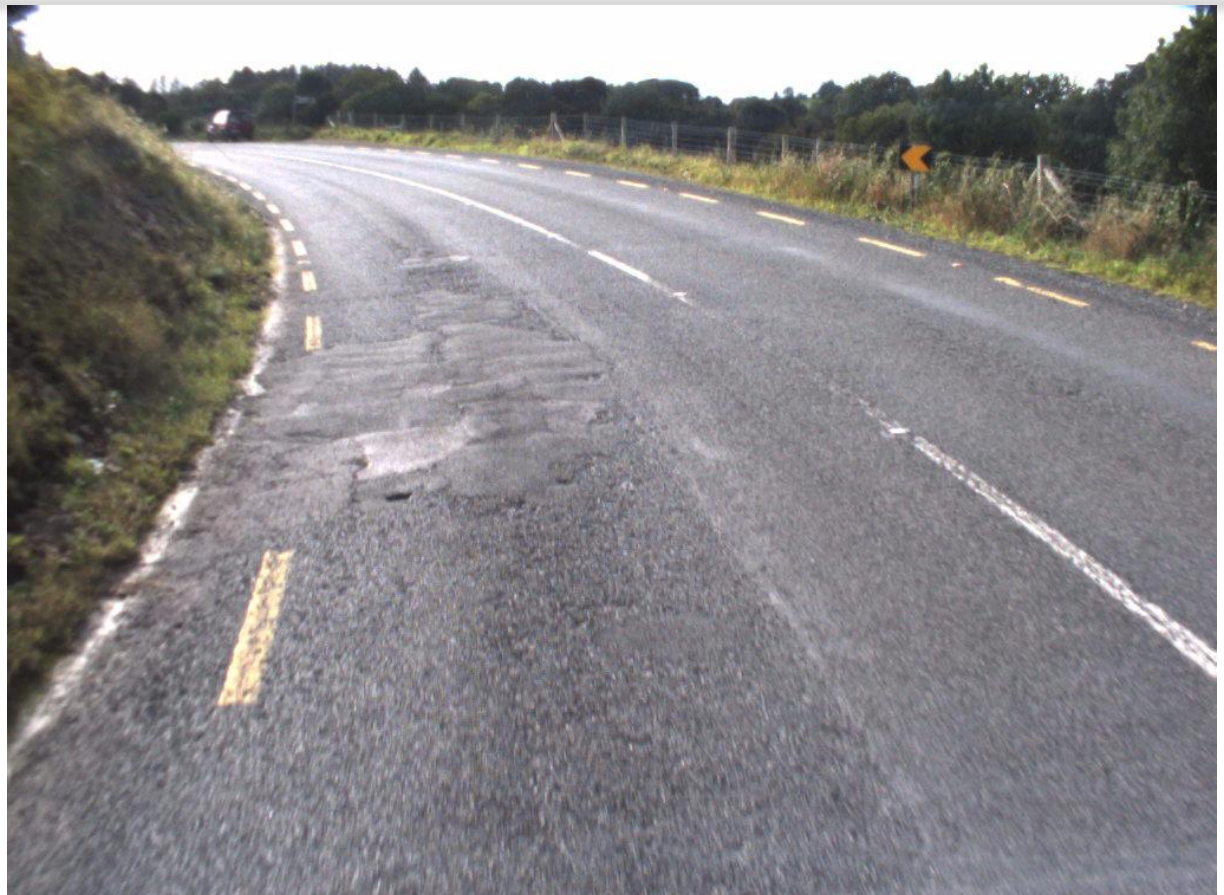
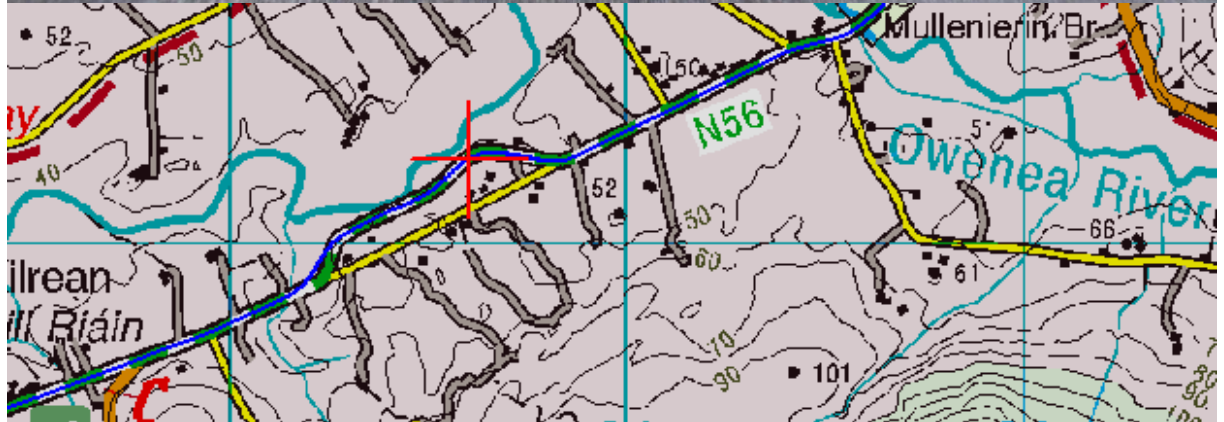
46600m there is a tight bend to the left in side sloping road profile. There is no room for a ditch in the upper side of the slope. Severe damages on the road!

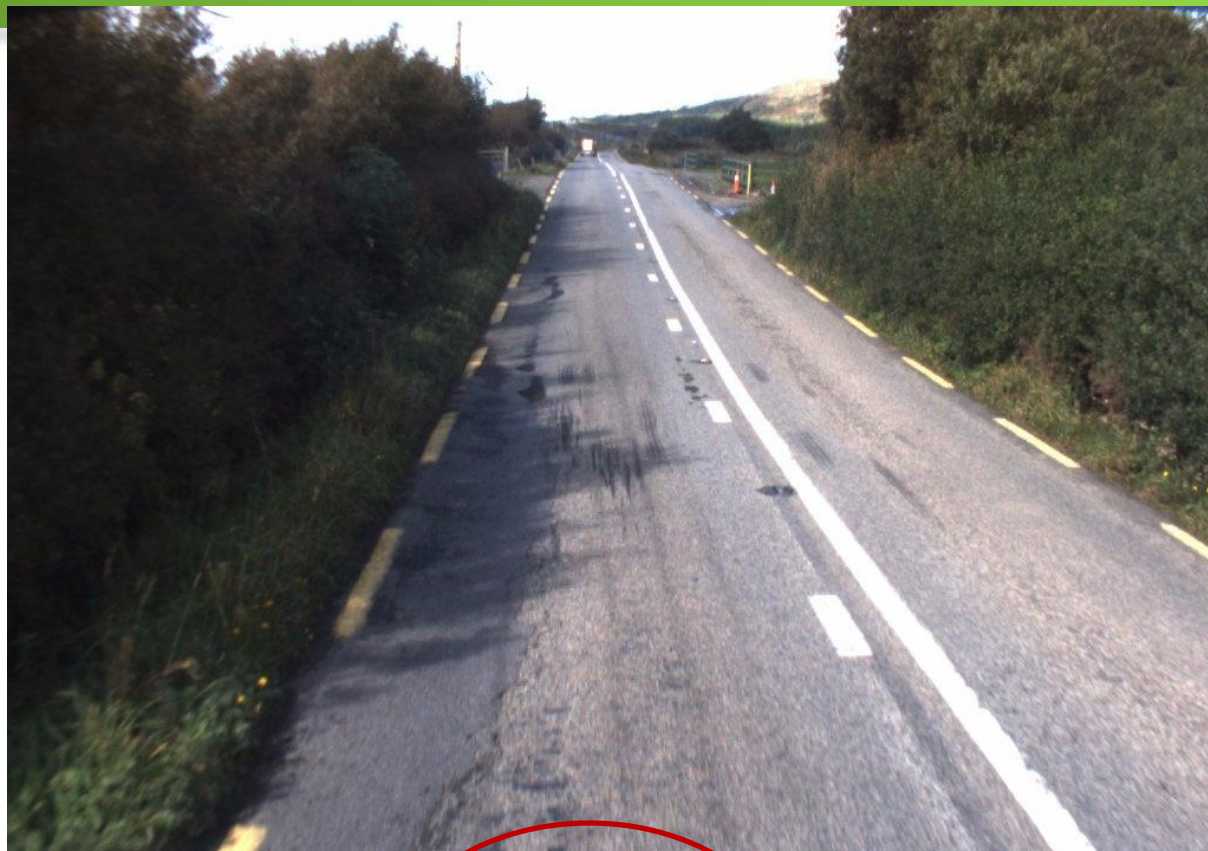
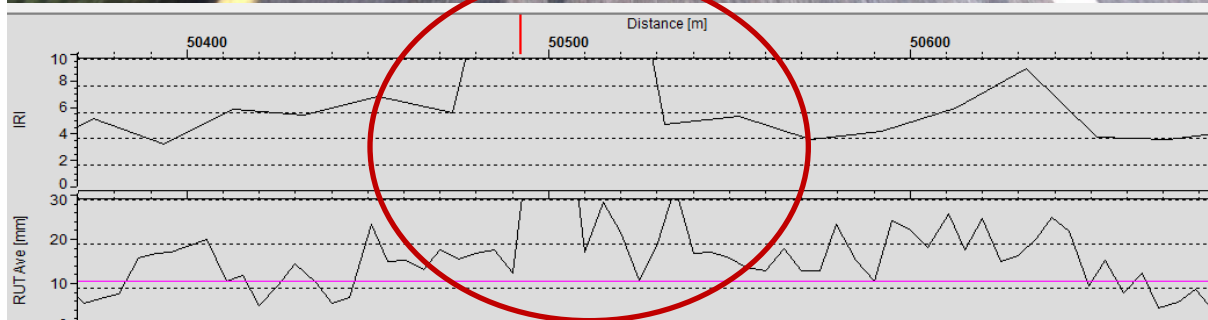
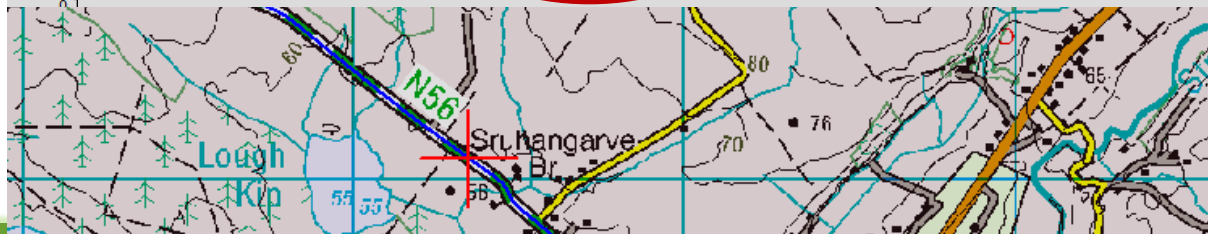
50500m the road profile is side sloping from right to left. On the left (lower) side there is a problematic verge stopping the water. High IRI and Rutting values!

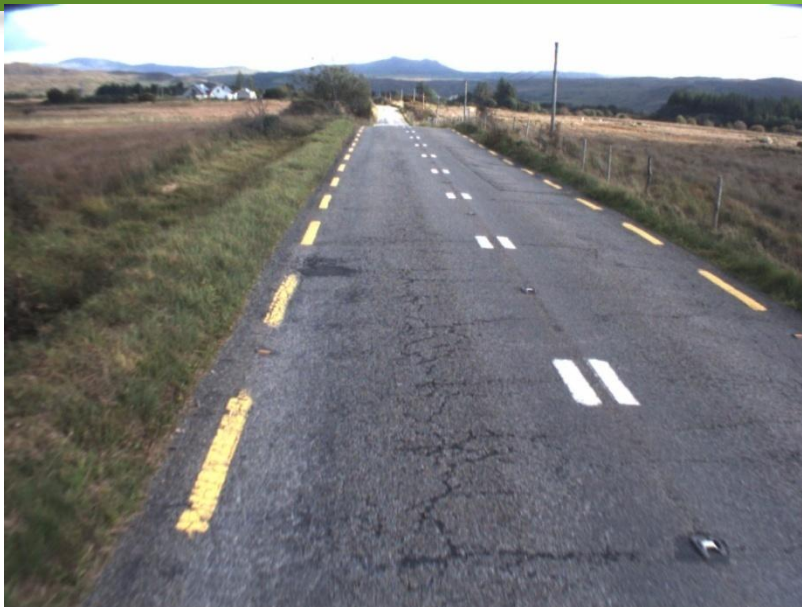
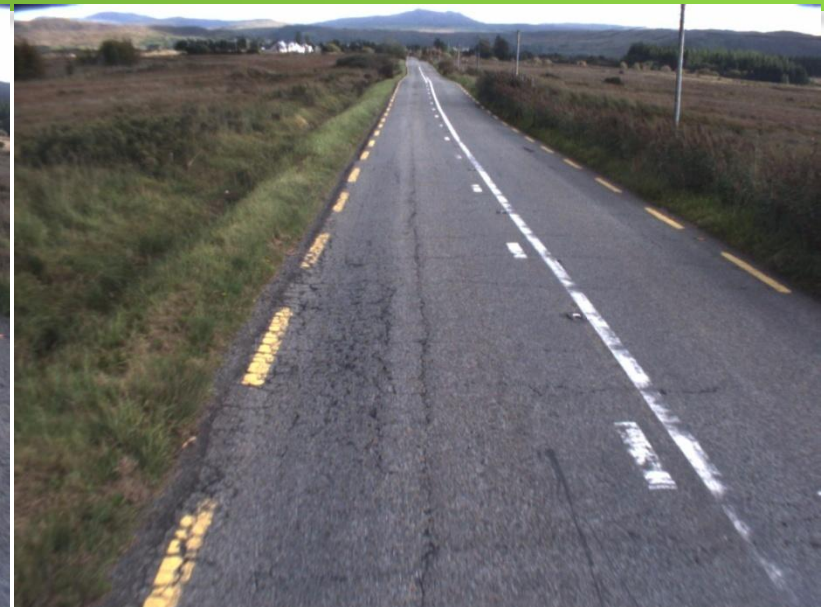
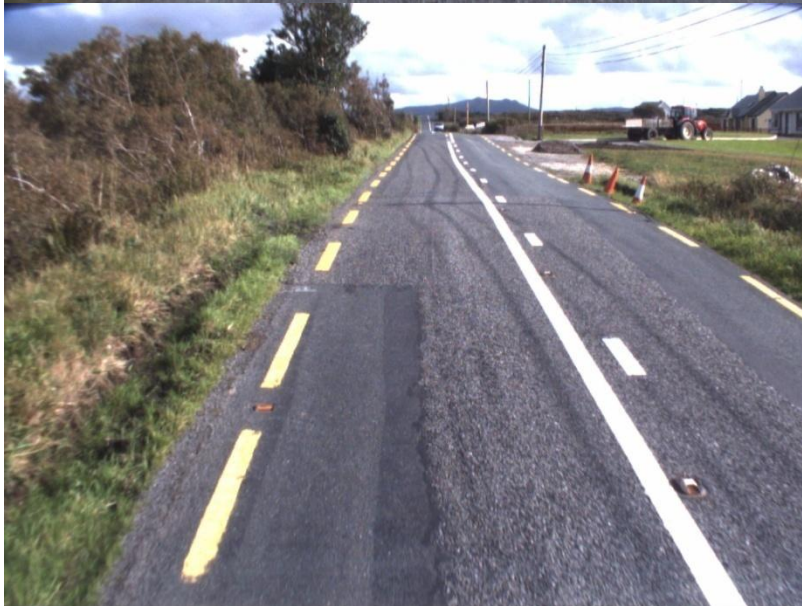
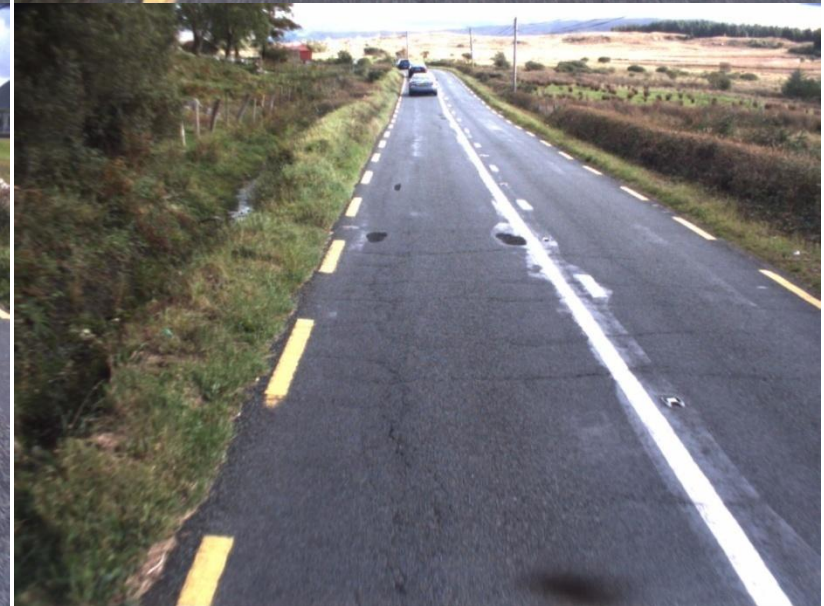
50600-52900 open ditch full of vegetation on the right which needs cleaning to improve the drainage

53200 steep downhill and on the left the ditch is missing. Clearly a peak in the IRI and Rutting values and damages on the road!

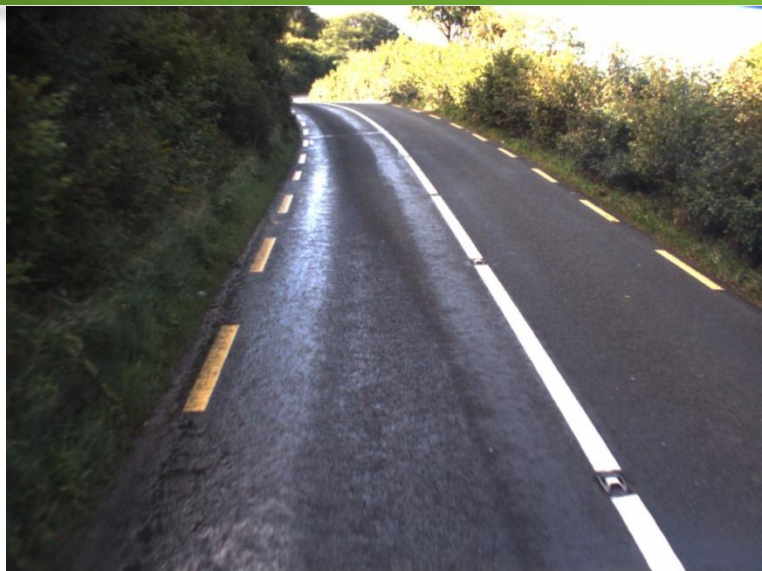
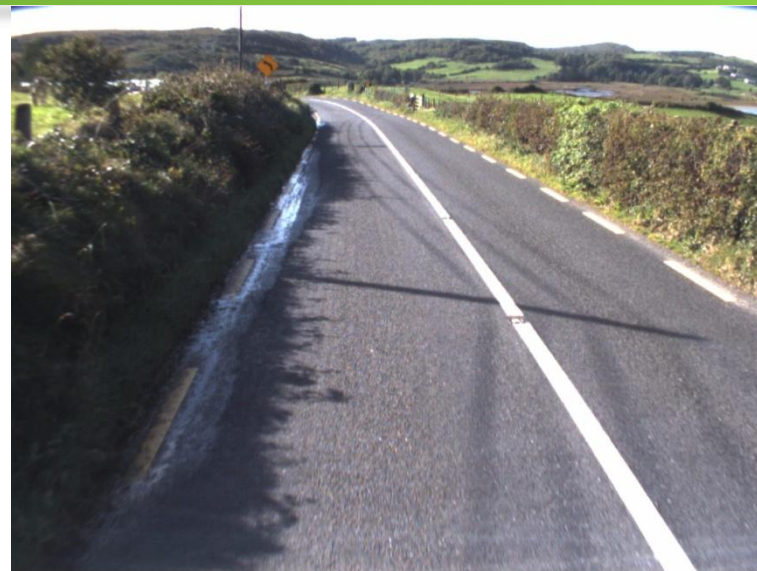
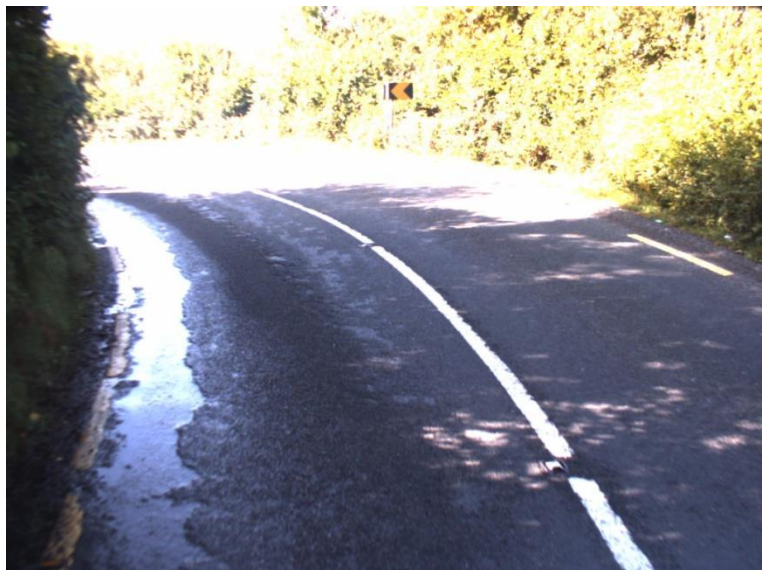
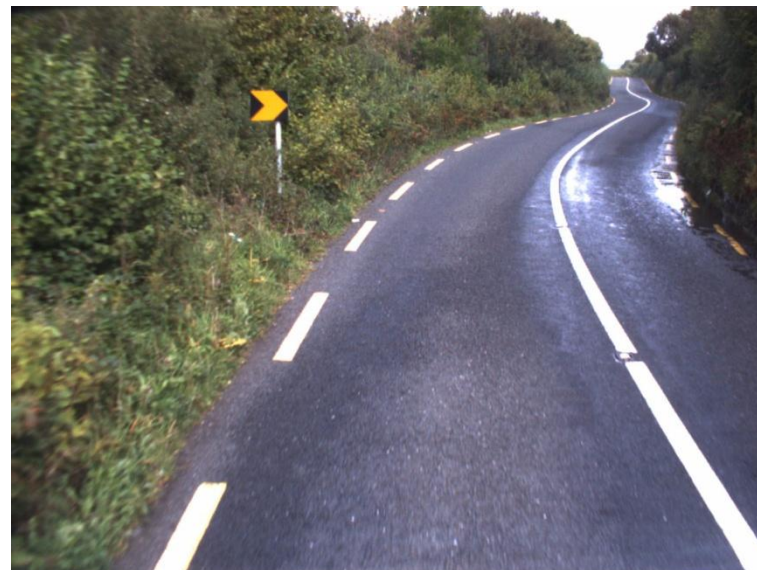
From 56000 to the end of the section the road is in quite steep side sloping ground. On the upper side there are drainage deficiencies in times. There is little room for a ditch which makes it hard to improve drainage.
