Petri Varin, Timo Saarenketo

ROAD WIDENING

Field survey report

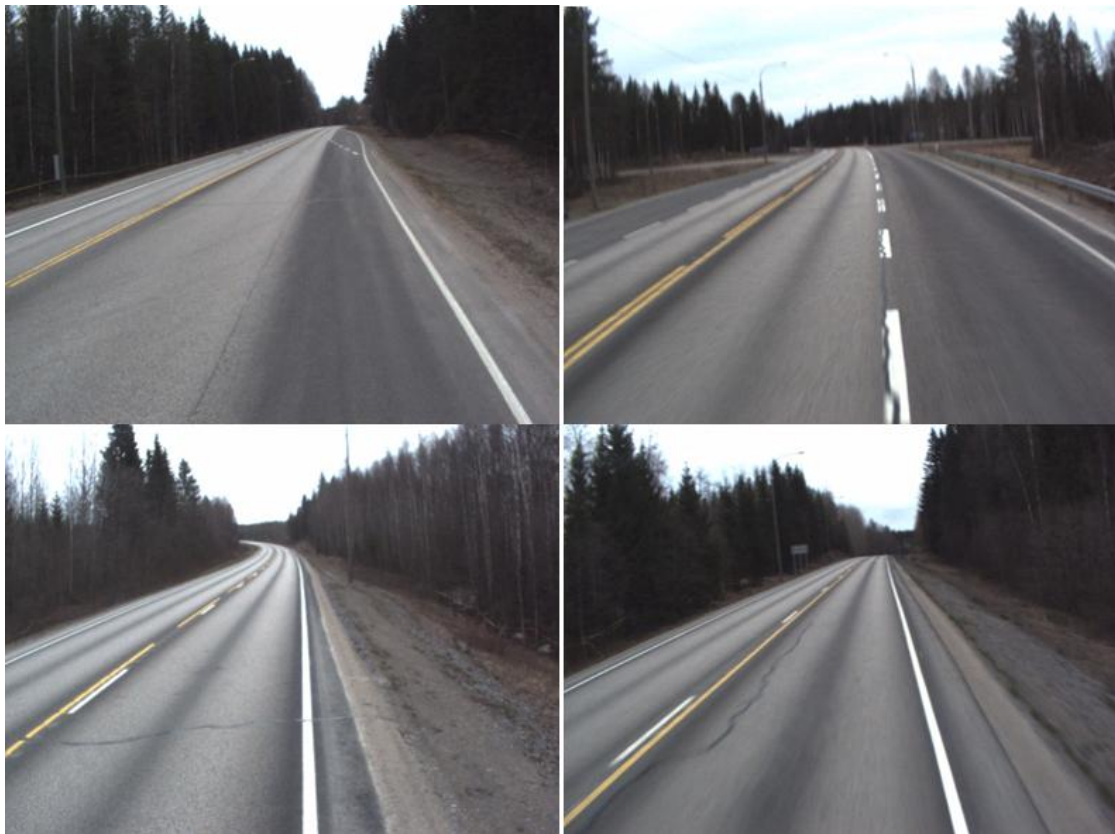
The monitoring results after the first frost season following widening showed no distress, such as cracks between the old road and the widening, or differential frost heave problems. The widening and the whole road were generally in a very good condition. Examples of the general condition in spring 2011 are presented in Figure 4.1_4. There were only some transverse cracks, longitudinal frost cracks in the middle of the road and opened pavement joints between driving lanes, but none of these were related to the widening. Examples of the damages in spring 2011 are presented in Figure 4.1_5.

Figure 4.1_5. Examples of the Hw 9 damages in spring 2011

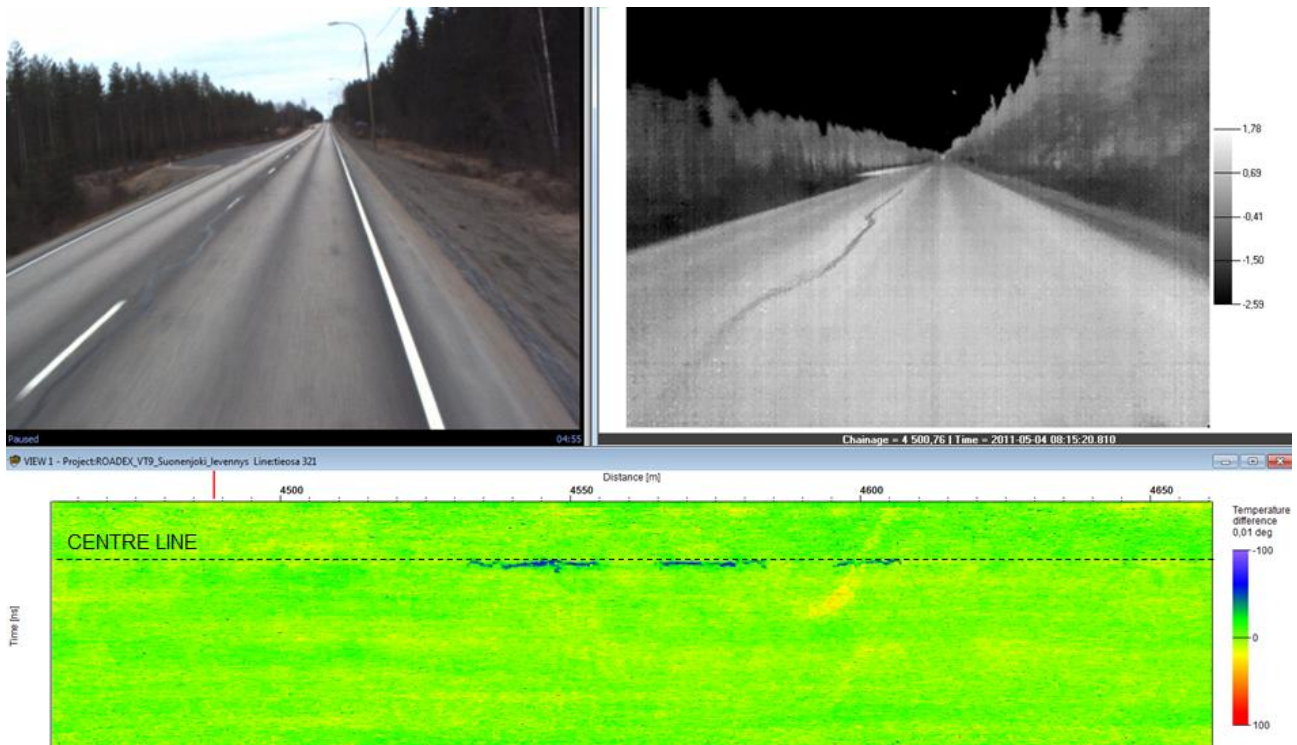
Figure 4.1_9. An example of the results of thermal analysis on Hw 9. The longitudinal crack in the middle could be associated with the end of the rest area, indicating possible drainage problems.

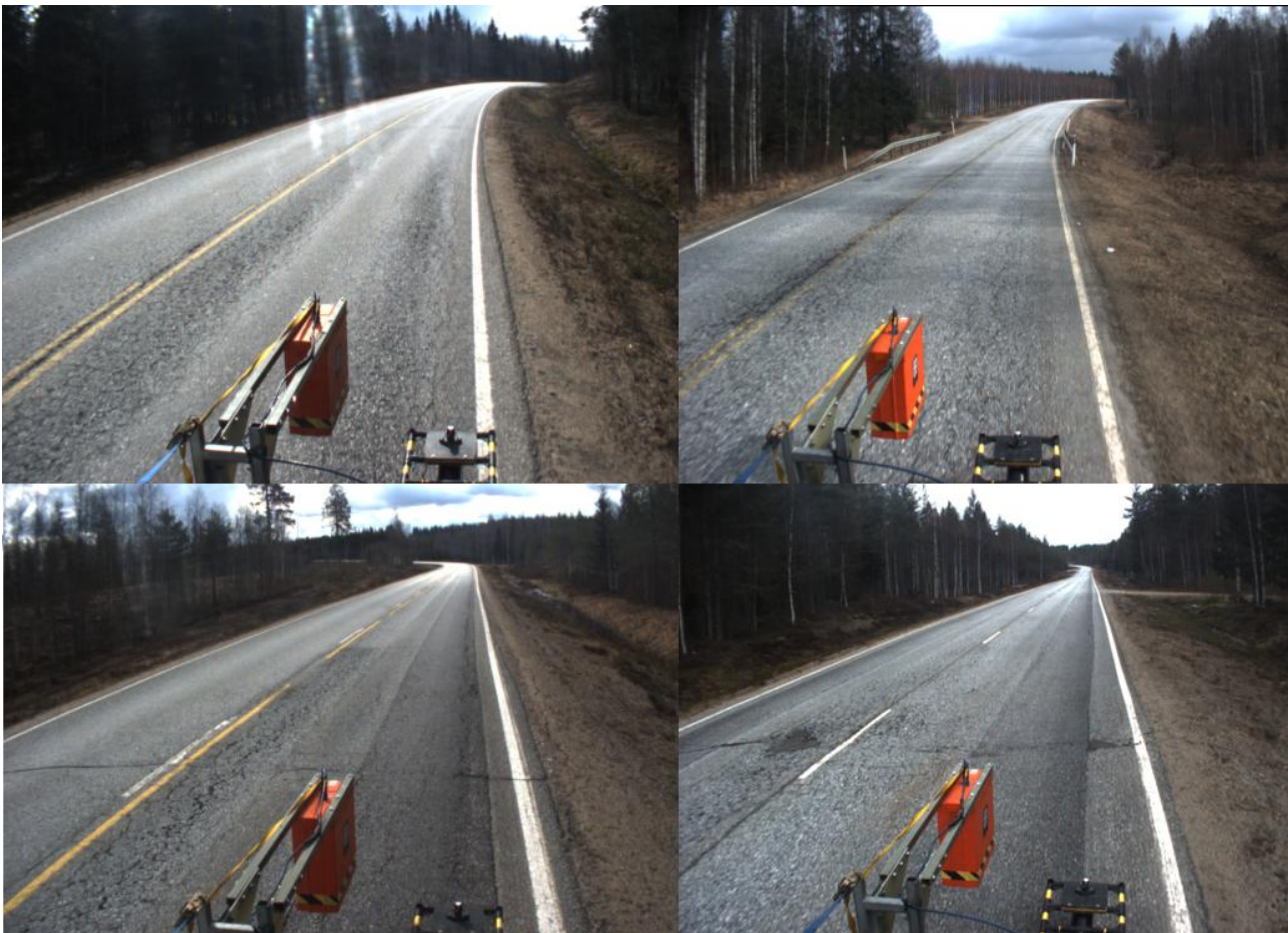
Figure 4.1_10. The majority of the damage type on Road 75 was alligator cracking on the wheel paths due to pavement fatigue. There were also many patched sections.

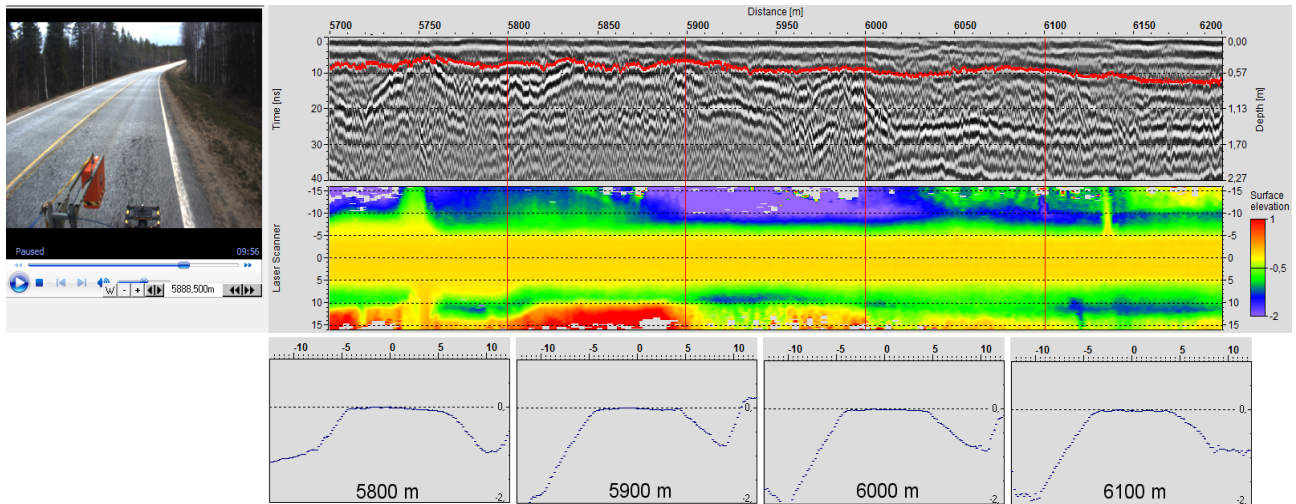
Figure 4.1_11 shows an example section from Road 75 with an analysis of the reasons for the typical alligator cracking damages. The total thickness of the road structure was in many places very thin 0.4 – 0.6 m), which can be seen in the GPR data profile in the top window. The road drainage is also not working properly. In this example the road is located on side sloping ground and the upper ditch is too shallow. The red lines show the locations of the laser scanner cross section profiles.

Figure 4.1_11. An example indicating the reasons for the typical alligator cracking damage on Road 75. The total thickness of the road structure is very thin. Drainage is not working properly due to the upper ditch on side sloping ground being too shallow. The top field gives the 400 MHz GPR data, the middle field is the laser scanner height map, and the lowest field presents laser scanner cross sections. The red lines show the locations of the cross section profiles. The video still photograph on the top left is from chainage 5890 m.

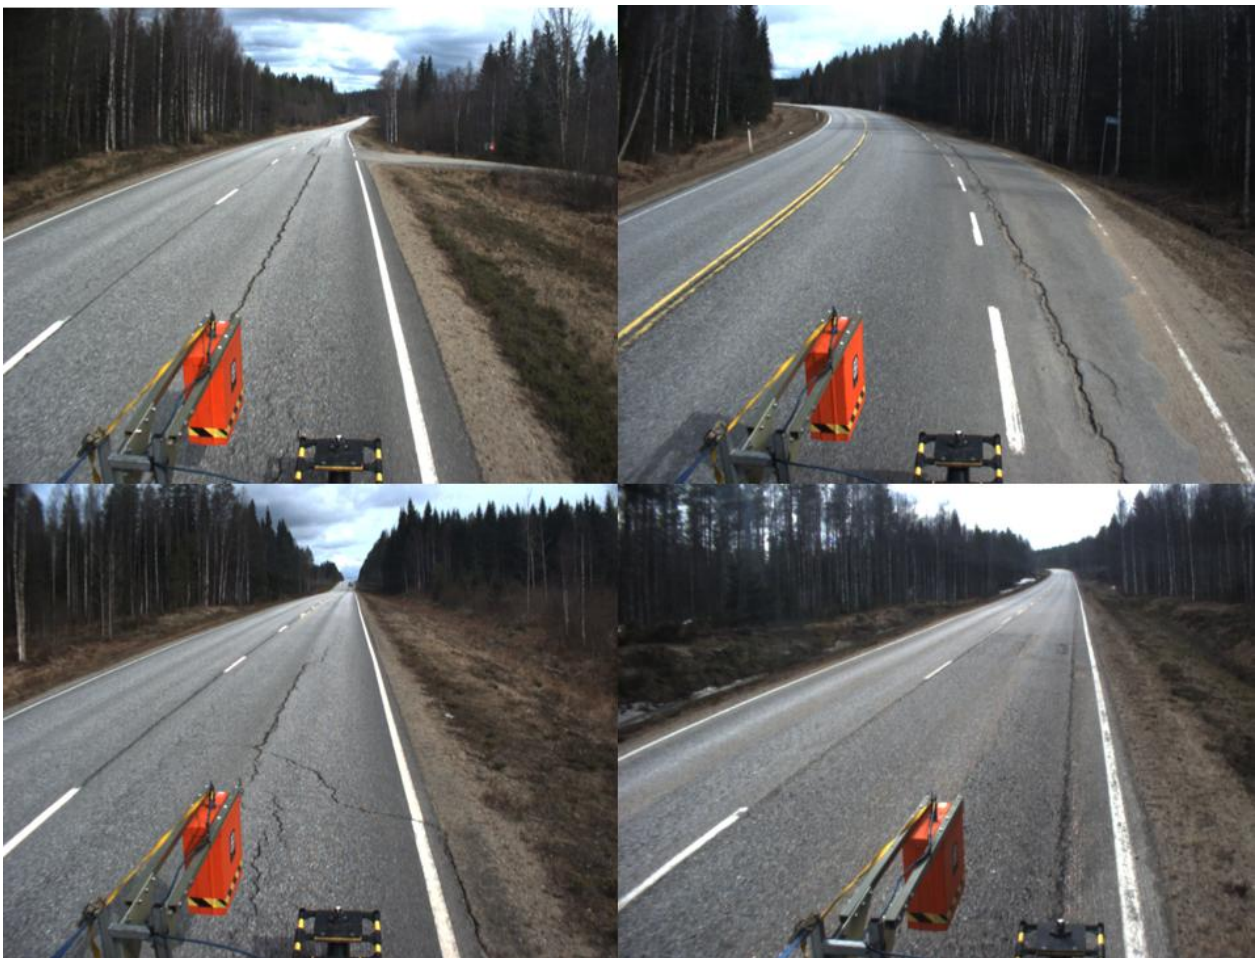
Damages due to road widening were seen along all the road sections. Examples are shown in Figure 4.1_12.

Figure 4.1_12. Examples of widening related damages on Road 75

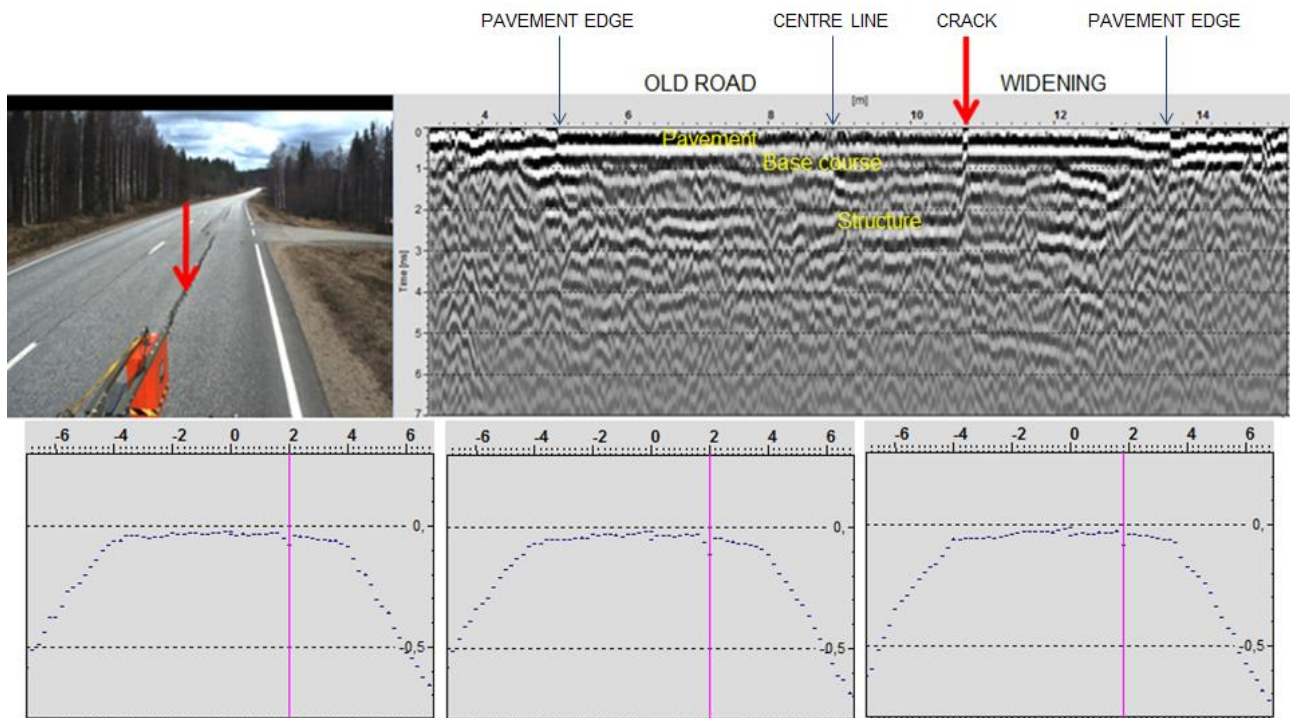
Figure 4.1_13. An example case from Road 75 showing a discontinuity and thickness difference between the old and new parts of the widened structure. The top field shows the 400 MHz GPR cross section and lower field the laser scanner cross section profiles from the same location at 10 m intervals (the one in the middle is from the red arrow location). The crack is clearly visible on the cross section profiles also. Drainage problems from an adjacent private access road might have partly triggered the distress process.

The photograph in Figure 4.1_13 shows that the distress problem could also be associated with the presence of a private access road junction. ROADDEX research has shown that drainage problems with access road culverts can cause consequential problems to the adjacent main road. An example section showing the correlation between damages and the presence of access road exits is given in Figure 4.1_14. This Figure shows that the pavement damages in Direction 1 are located close to private access roads junctions and bus stops, which supports the findings made during the ROADDEX drainage research. More information on this topic can be found from the extensive E-Learning package "Drainage of Low Volume Roads" available on ROADDEX website (<http://www.roadex.org/index.php/e-learning>). From this it can be concluded that the failures in the widened road structures, in otherwise well performing road drainage sections, have been due to water being trapped in the roadside ditches by clogged private access road culverts and infiltrating into the road structures.

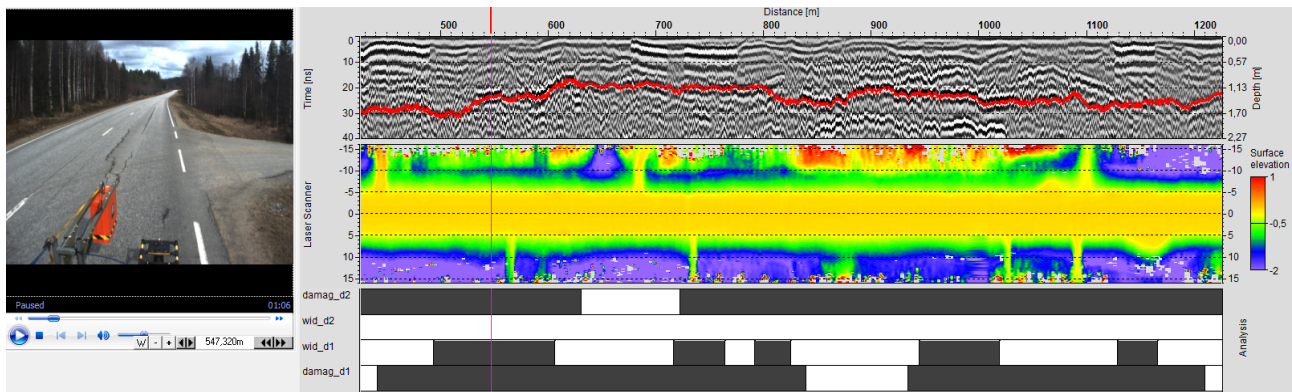
Figure 4.1_14. Example section showing the correlation between damages and the locations of access road exits. The top field shows the 400 MHz GPR longitudinal section, the middle field gives the relative height map and the lowest field presents the pavement distress analysis results. Damage code “damag_d1” and d2 mean the location of pavement damages in Direction 1 and Direction 2 respectively, and codes “wid_d1” and d2 indicate damages that can be related to road widening. In this case these damages related to road widening only exist in Direction 1.

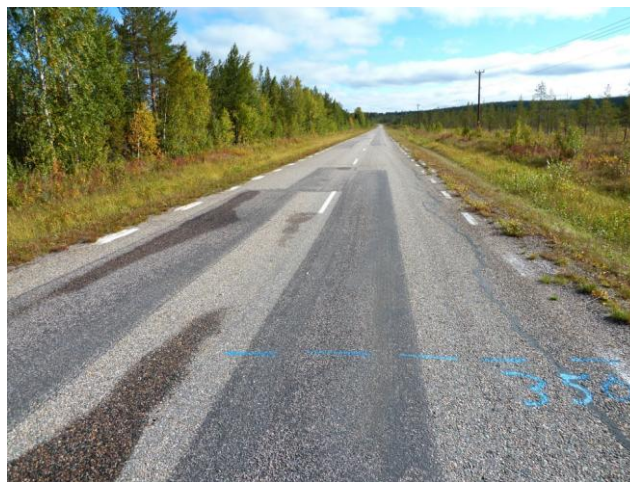
Figure 4.2_1. General condition of the Ohtanajärvi road at 350 m. See water on the pavement in the left lane.

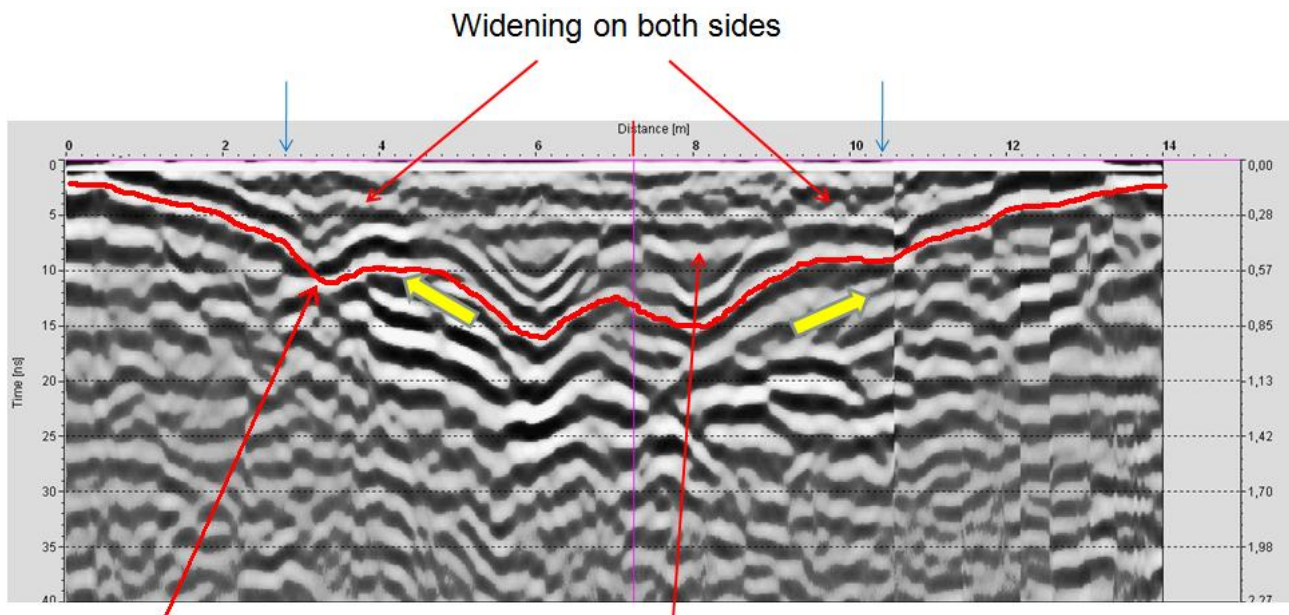
All these findings are clear indicators of Mode 2 rutting, which can be confirmed from the GPR cross section shown in Figure 4.2_4. The old gravel road with Mode 2 rutting can be seen clearly below the new structures. Spring thaw weakening and Mode 2 rutting causes the soft subgrade soil to flow from beneath the road to both sides. This leads to deformations and unwanted widening of the road. The road has been widened on both sides but it has also widened by itself, and the widening is still going on.

Bottom of road structures Old gravel road with mode 2 problems

It can be concluded that, unlike the Hw 9 in Finland, the “light widening” structure on the Ohtanjärvi road section has not been working. This has been due to the old road being too weak already in the beginning. It should have been strengthened also during the widening. Frost action also has a major role in the damage process in the Ohtanjärvi test section.

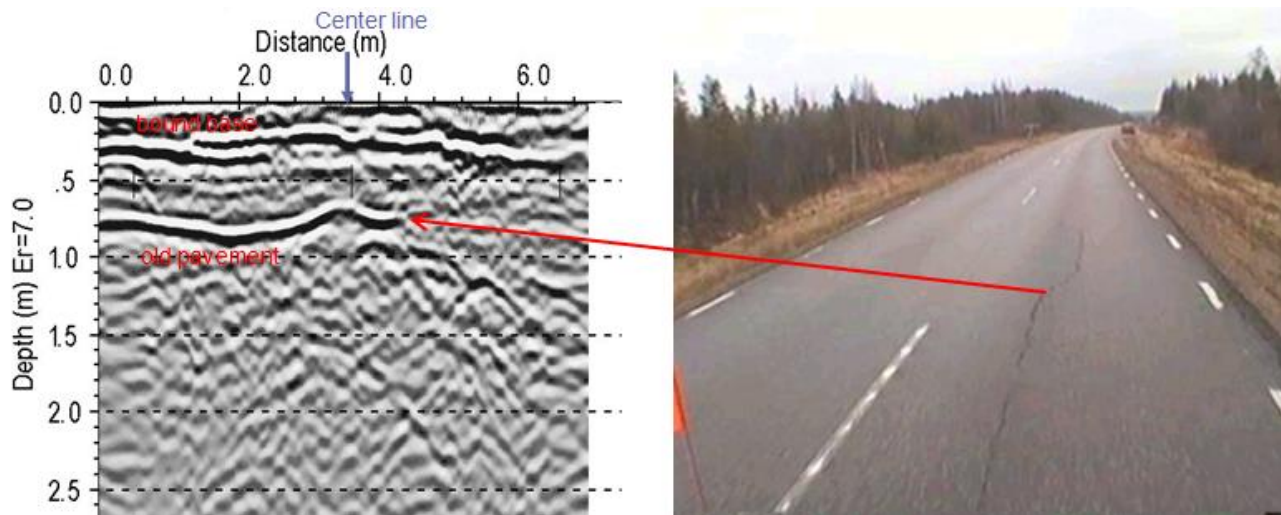
Figure 4.2_8. Old bituminous pavement layer inside the road structure on Salmi road in 2000.

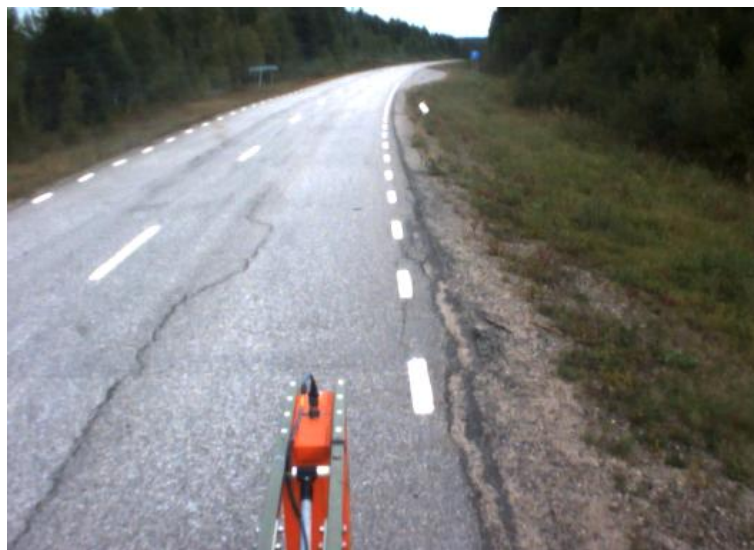
Figure 4.2_9. The same reflection crack as in previous figure is still visible on the road in 2010.
See also edge cracking that was not so bad in 2000.

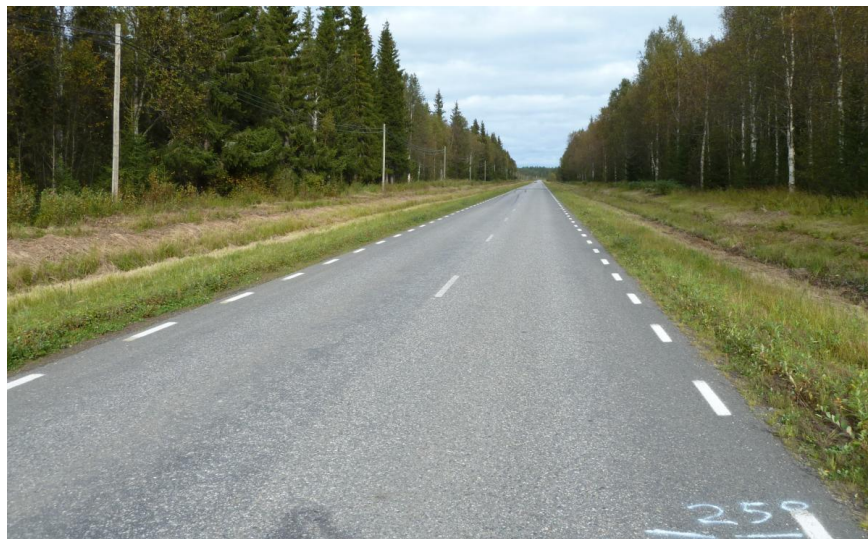
Figure 4.2_11. General condition of the Karrbäck road at chainage 250 m. Observe the shallow ditch depth.

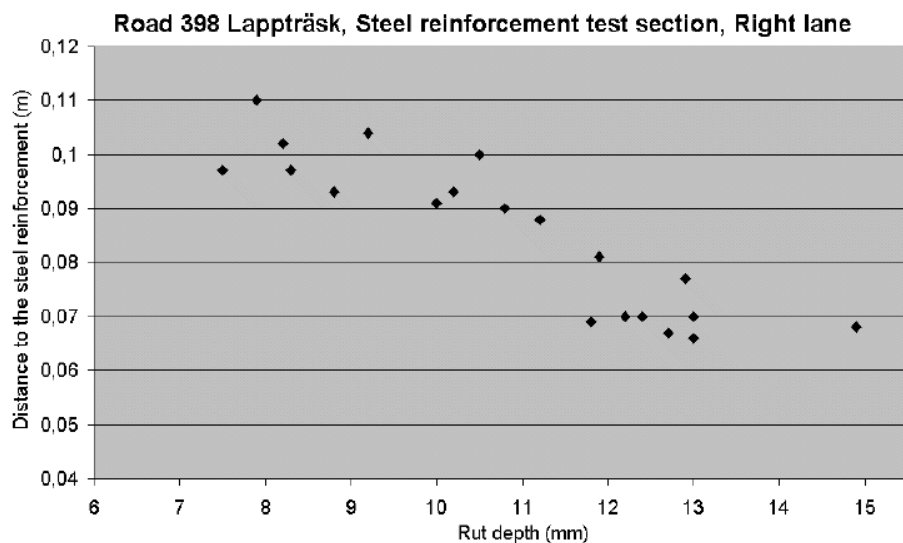
Figure 4.2_17. Correlation between the depth of the steel reinforcement and the rut depth on the Lapträsk road in 2000

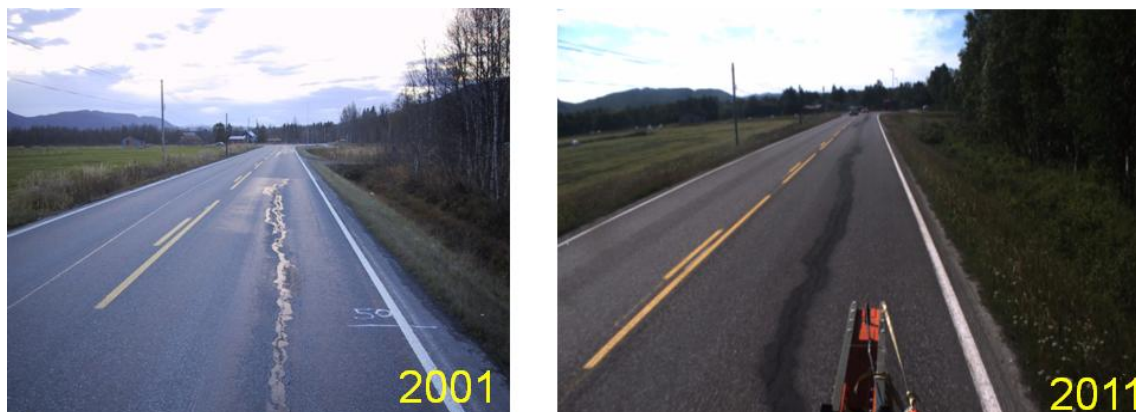
Figure 4.3_1. Engerud test road condition in 2001 and 2011

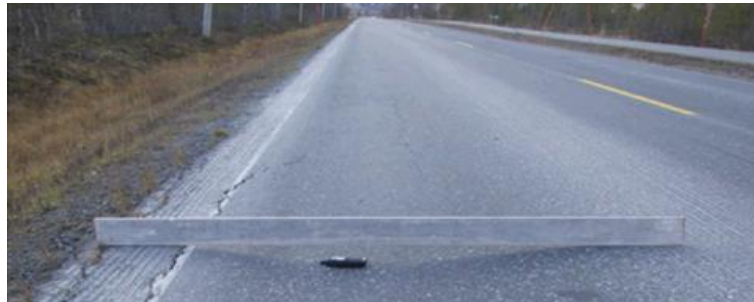
Figure 4.3_4. Peat settlement on Kjosemyra road in 2001

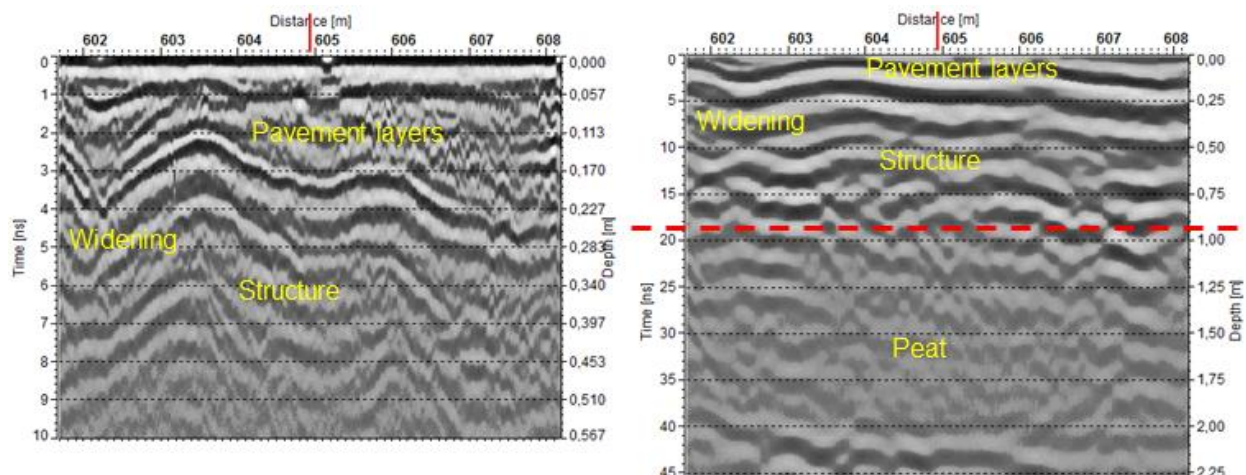
Figure 4.3_6. GPR cross sections (left: 1.5 GHz, right: 400 MHz) showing peat settlement on the Kjosemyra road

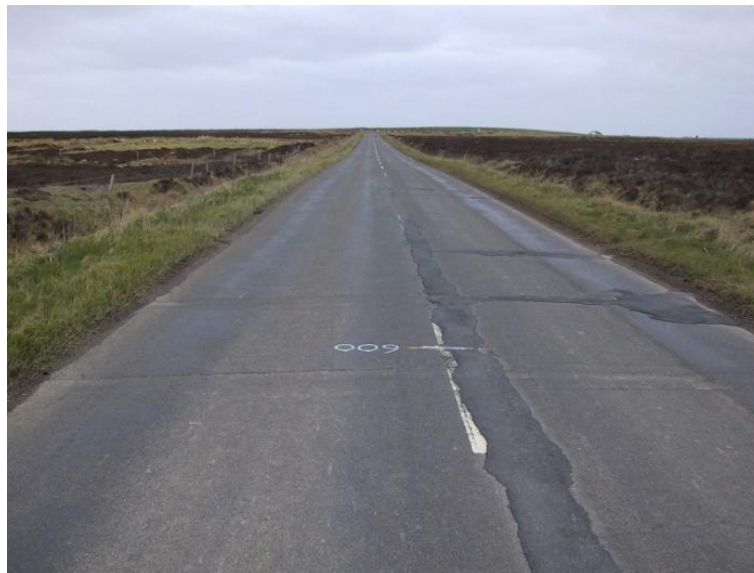
Figure 4.4.1_1 Example of problems with Killimster road in 1999.

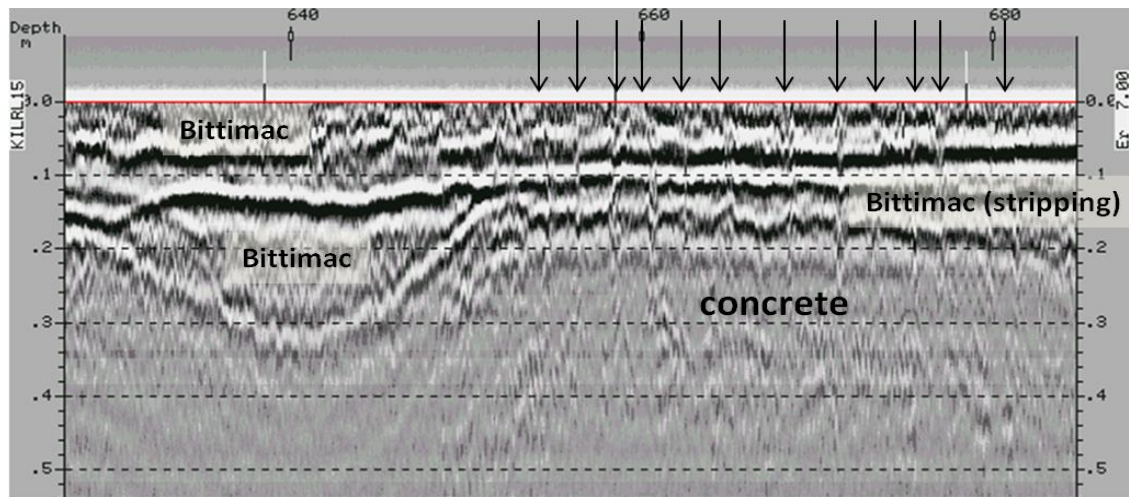
Figure 4.4.1_2 A 1.5 GHz GPR longitudinal profile over Killimster Moss. Transverse cracks going through the concrete slab and bitmac are shown with arrows. Stripping in the bitmac layers starts roughly at level of 0.1 m.

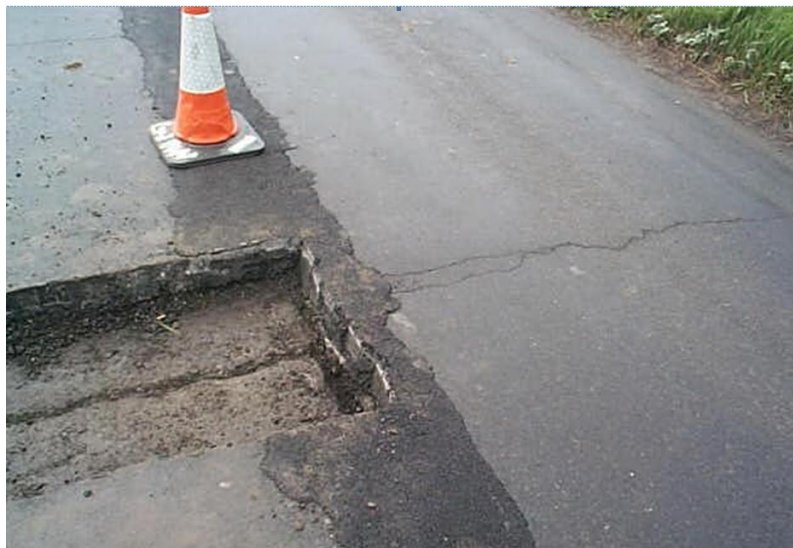
Figure 4.4.1_3 Photograph taken from a test section showing stripping on the bottom part of bituminous layers, and longitudinal cracks and transverse cracks in the concrete slab causing reflection cracking on the pavement surface.

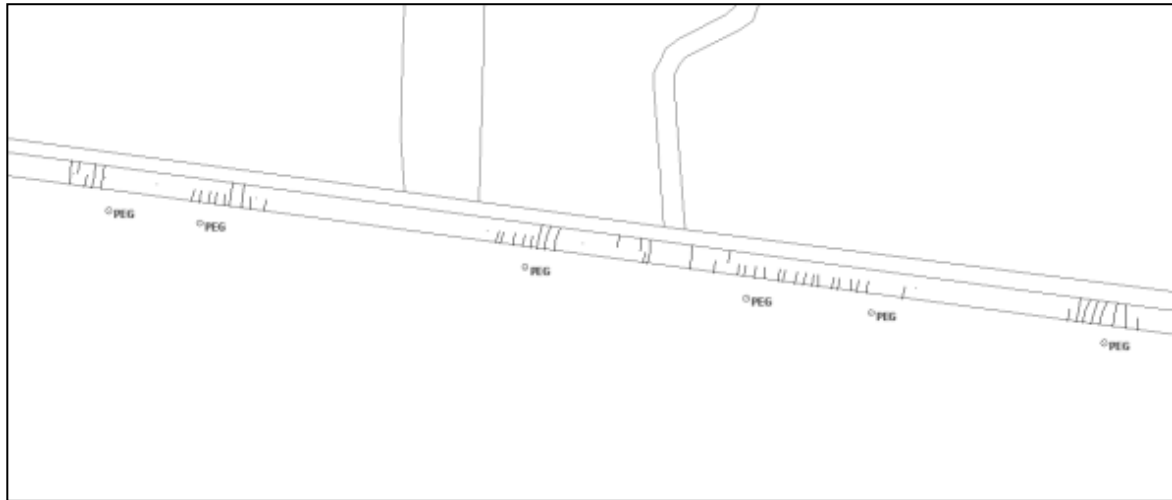
Figure 4.4.1_9. Example from the map of surface cracks from Killimster road in 2011, Heavy traffic is using the westbound left lane from right towards left.

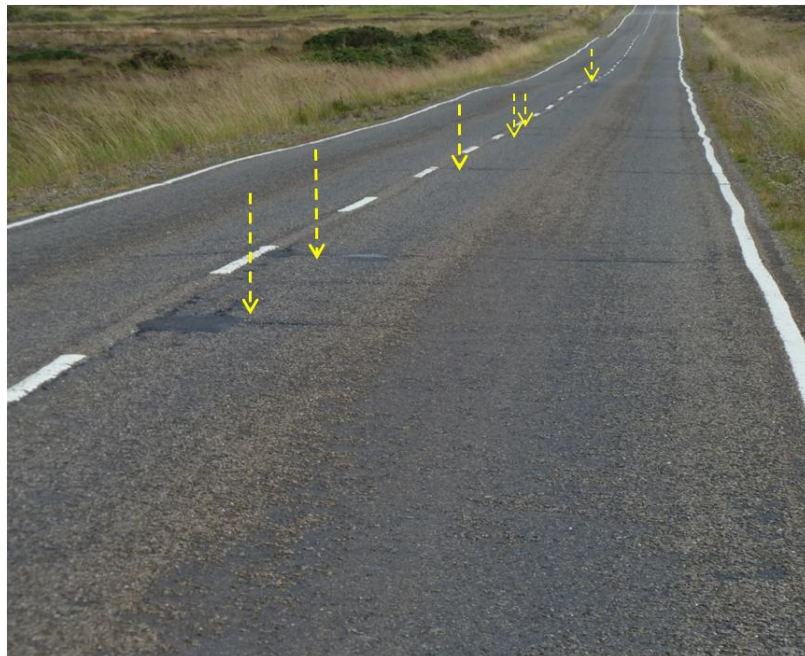
Figure 4.4.1_10. The cracks in the B876 in 2011 were mainly located on sections where there were differential settlements in the peat. The wavy white line at the edge of the pavement shows that there are also lateral movements in the road structures in these sections.

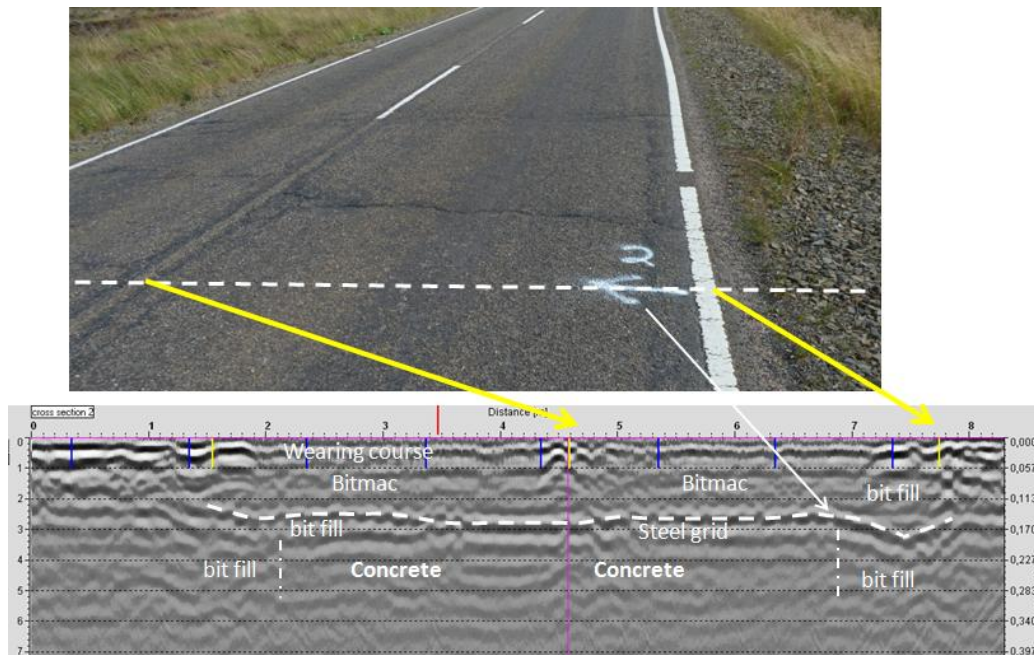
Figure 4.4.1_11. 1.5 GHz GPR cross section from Killimster Moss road with closely spaced transverse cracks (see photograph) and longitudinal cracks in road centre (left yellow arrow) and road shoulder (white arrow). In this case the steel grid was installed directly on top of the concrete slab and only a thin bituminous leveling mix could be found under the left side. The longitudinal shoulder crack reflects the location of the end of the concrete slab.

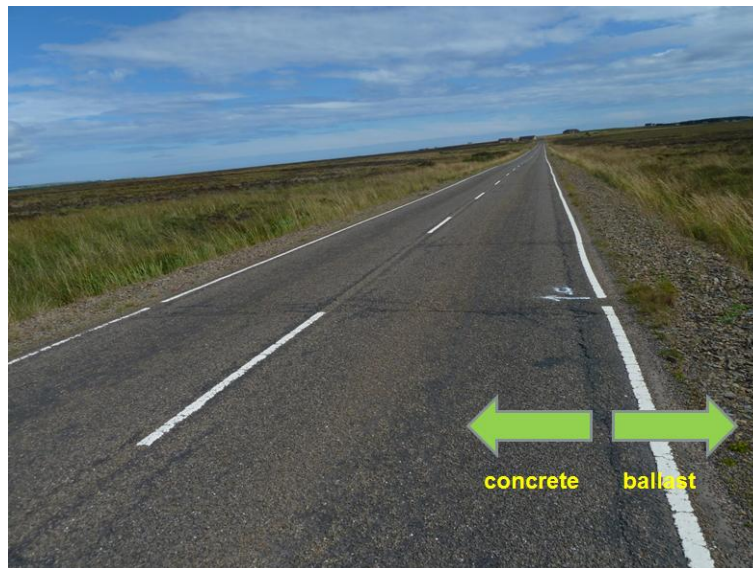
Figure 4.4.1_15 Reflection crack at Killimster Moss indicating the edge of the concrete slab.

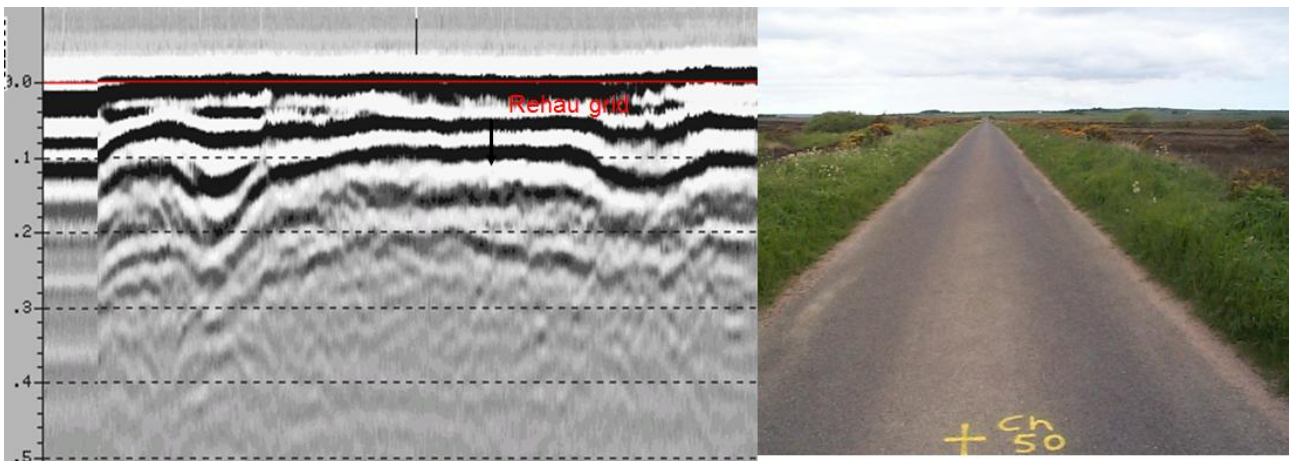
Figure 4.4.2_2 GPR cross section measured in 2000 at the Sibster ROADDEX test section chainage 50 m. GPR data (left) shows about 60-80 mm settlements in the road shoulders and the photograph shows additional settlements since last paving.

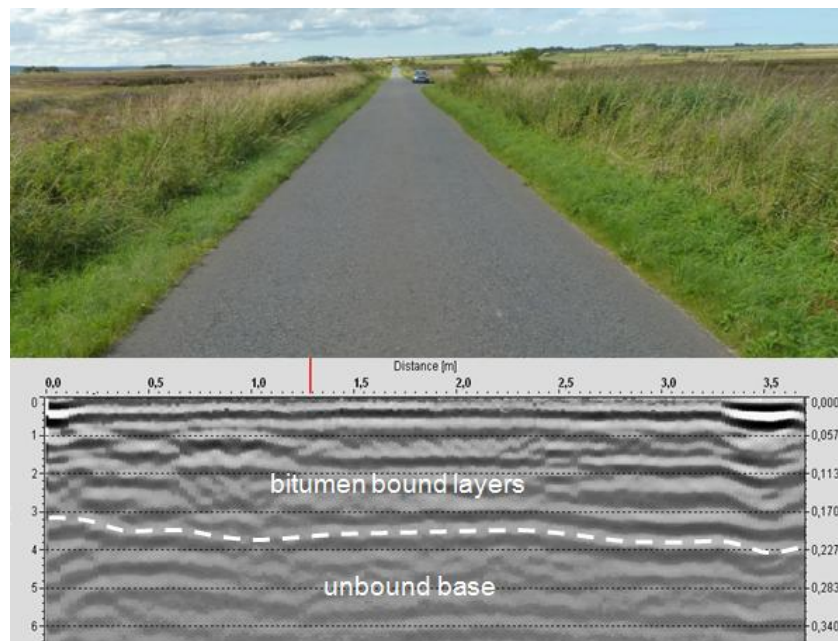
Figure 4.4.2_3. Photograph from the B874 road together with a GPR cross section measured in 2011. The data shows that the road structures have quite uniform thickness in road cross section. The strong reflections in the upper part of the pavement on both sides of the road show that water is infiltrating into the pavement structure due to the presence of verges.

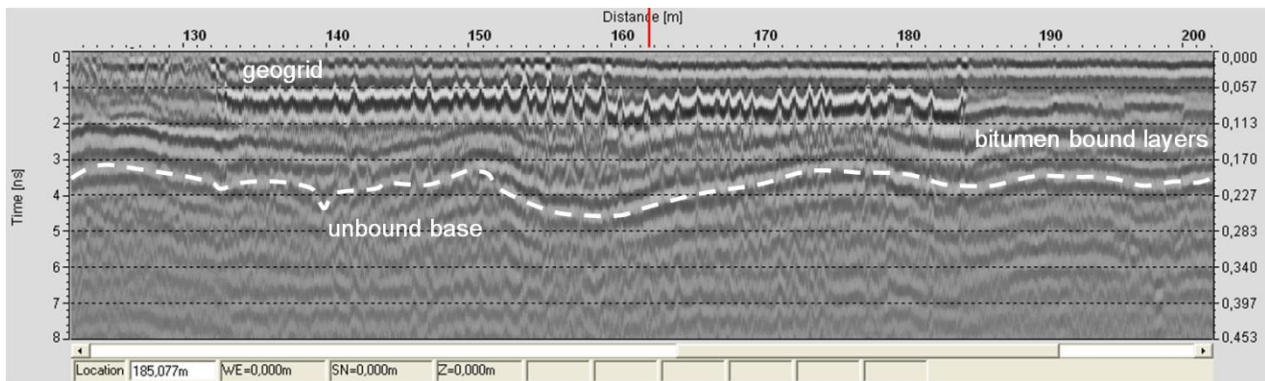
Figure 4.4.2_4. 1.5 GHz GPR longitudinal section of Sibster test site (133 – 184 m) showing the Rehau geogrid in the pavement at the level of 60-90 mm. Cracks in the geogrid can be seen as hyperbolas in the GPR data.

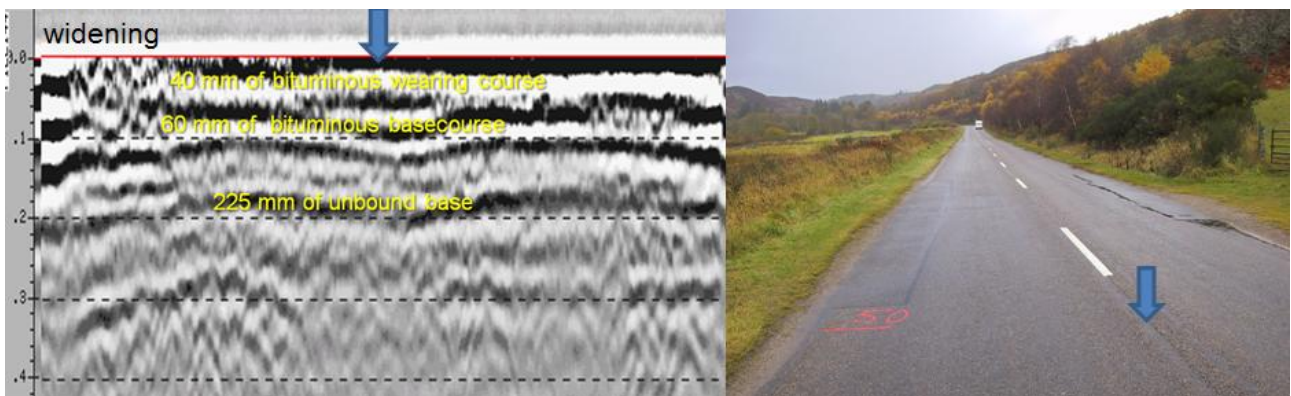
Figure 4.4.3_1. A 1.5 GHz GPR cross section and digital photograph of the Rogart test section measured in 2000. Strong reflections in the bound layers and the top part of the unbound base in the widened area in left indicate high amount of moisture in the structure.
