Anne Peltoniemi-Taivalkoski, Timo Saarenketo

# **DRAINAGE MAINTENANCE FOLLOW UP – EXPERIENCES FROM THE ROVANIEMI AND KITILÄ PROJECTS, FINLAND**

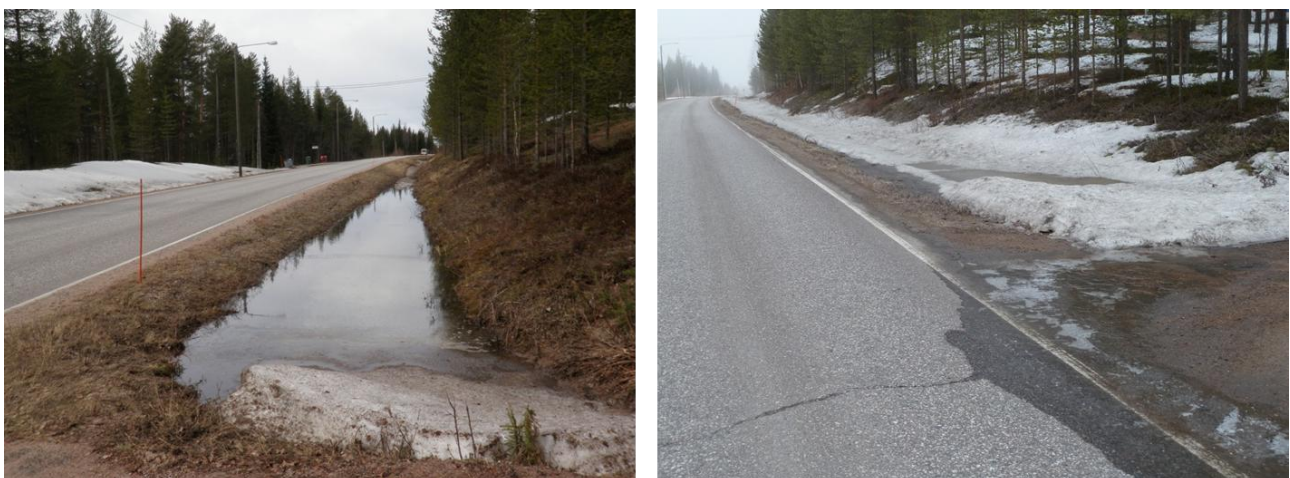
*Figure 42\_1. An example of a clogged private access road culvert from road 934, section 3, right ditch. Photographs are taken in spring 2010 (left) and in spring 2011 (right). The private road access culvert (chainage 1700 m) was frozen in both years and water was flooding into the ditch and flowing to the road.*

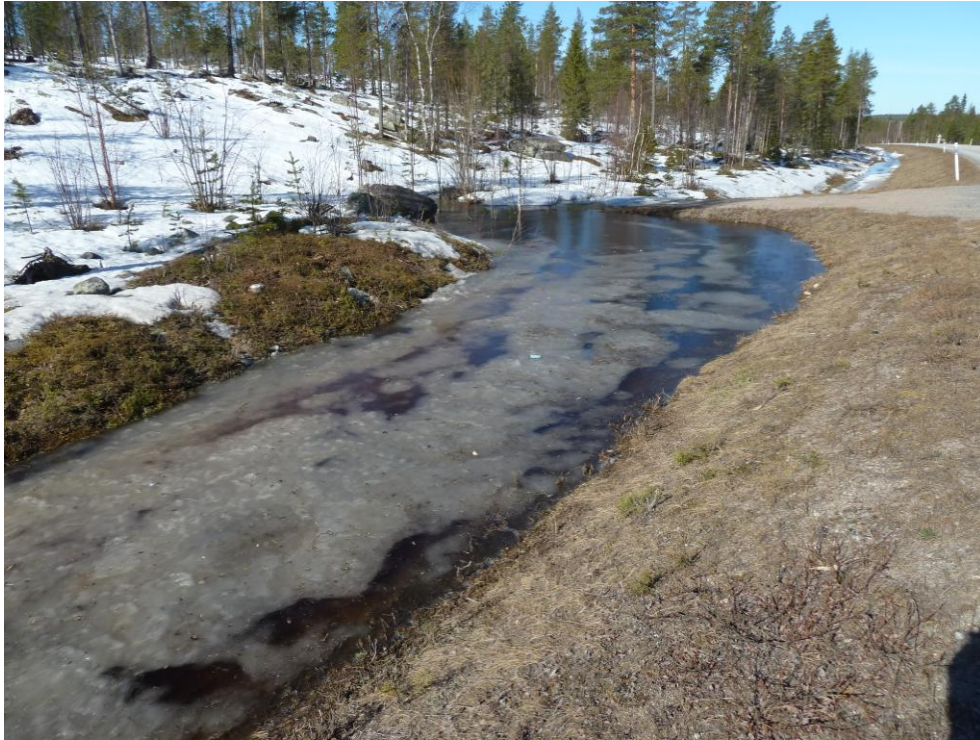
*Figure 42\_2. An example from road 78, section 219, left ditch, from spring 2011. At chainage 8030m the private road access blocks the water flow and creates a pond in the ditch causing water to infiltrate into the road structure.*

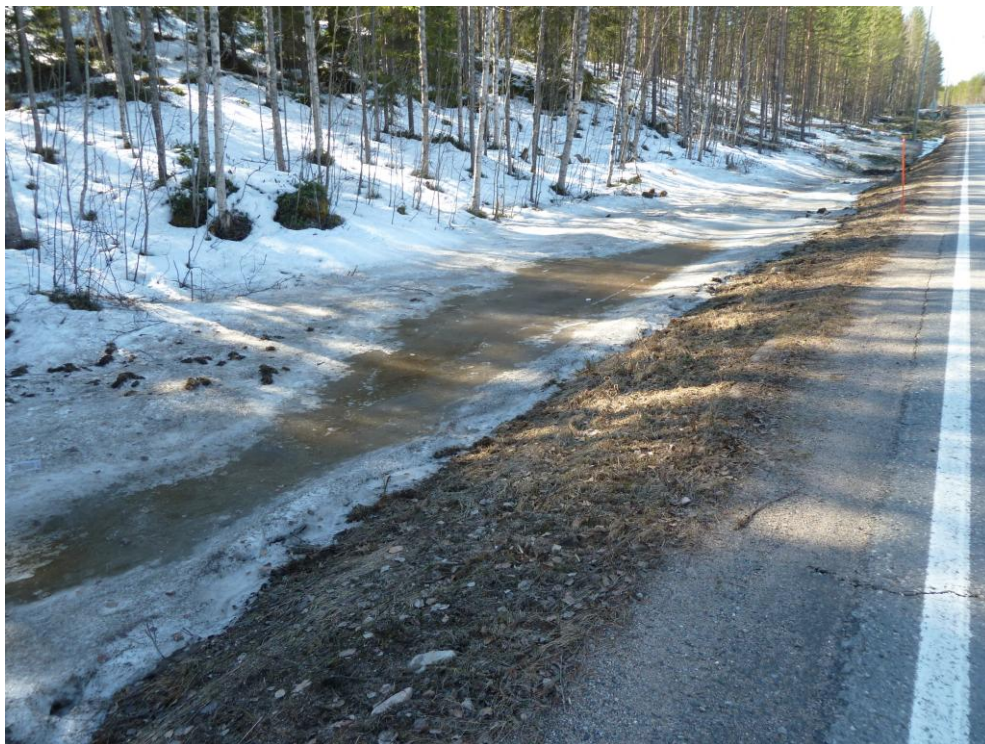
Another drainage issue that was found to cause problems to the condition of the main road was sheet ice (Figure 42\_3) from shallow ground water slowly flowing to a ditch and freezing. If this sheet ice was not removed from the ditch it caused a higher water table in the ditch that infiltrated into the road structures during spring, with further consequential road failures.

*Figure 42\_3. Sheet ice on road 926, at the beginning of section 19. The road is on side sloping ground and water is flowing from the slope creating sheet ice. Shoulder deformation, alligator cracking and transfer cracking were observed on this road.*

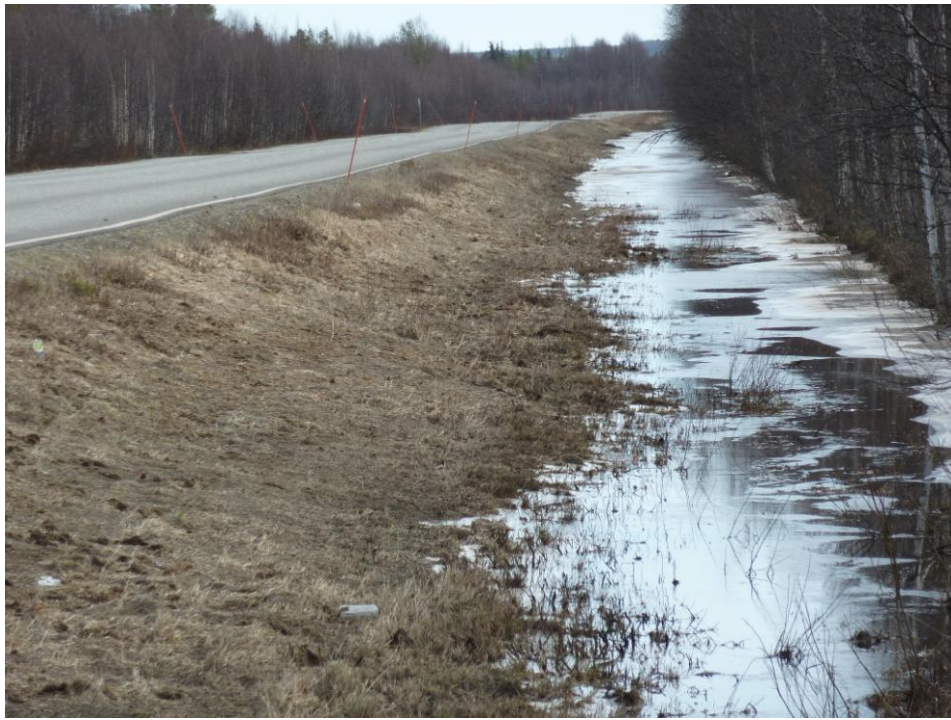
A third drainage problem found during early spring was side ditches that flooded due to frozen main road culverts or clogged outlet ditches. These flooding ditches caused shoulder deformation and differential frost heave (Figures 42\_4, 42\_5)

*Figure 42\_4. An example from road 80, section 11, from chainage 3980 m forward. The side ditch is full of water and there are frost heaves on the road.*

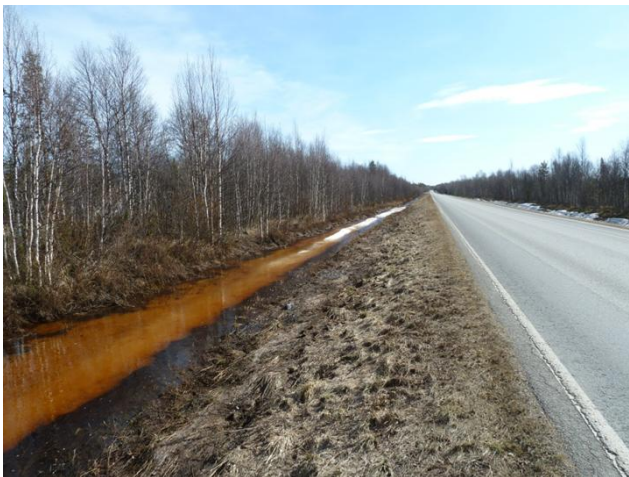
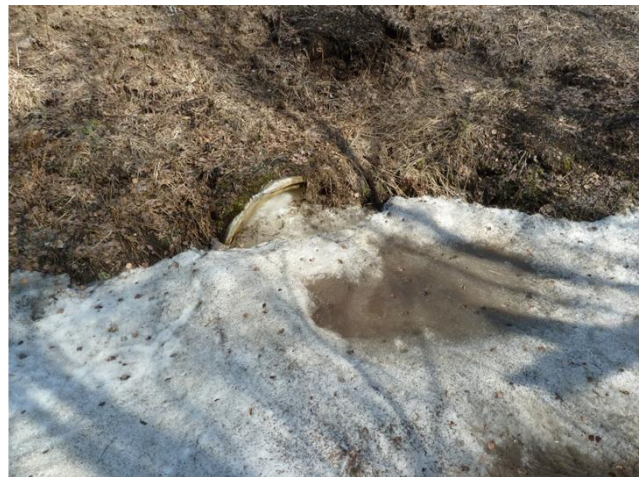
*Figure 42\_5. An example from road 80, section 12, from spring 2011. The left ditch is flooding (chainage 4590 m forward), because the main road culvert (chainage 4960 m) is frozen and stopping the flow of water from the left ditch to the outlet ditch.*

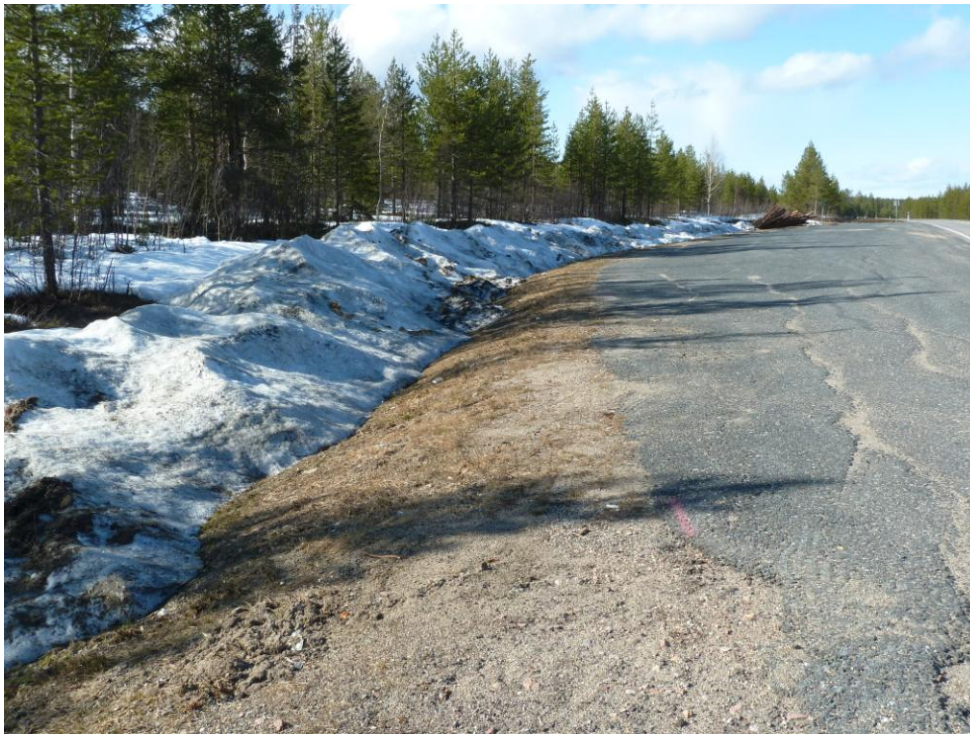
A final problem category that was found in many places was bus stop and rest areas where snow was stored on the ditch. This stored and compacted snow blocked the water flow in the ditch causing it to infiltrate to the adjacent main road structures (Figure 42\_6).

*Figure 42\_6. An example from highway 21, section 151, chainage 2000m. Melting snow behind the rest area keeps the ditch wet and prevents the flow of water. This has caused damages to the rest area and to the main road.*

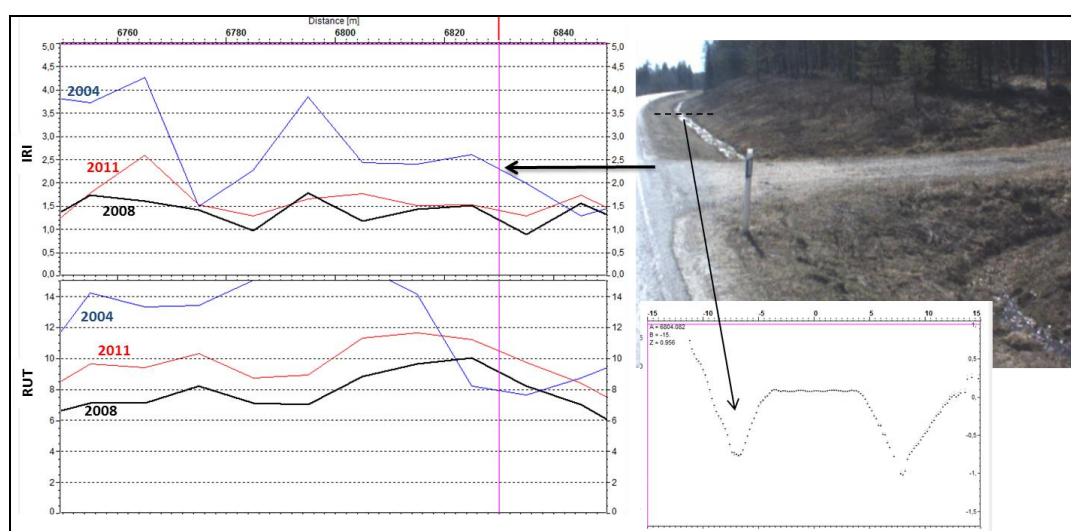
Figure 432\_3. Example from road 78, section 219. The culvert is missing under the private road access (chainage 6830 m) and water is ponding in the left ditch. Moss in the left ditch is also

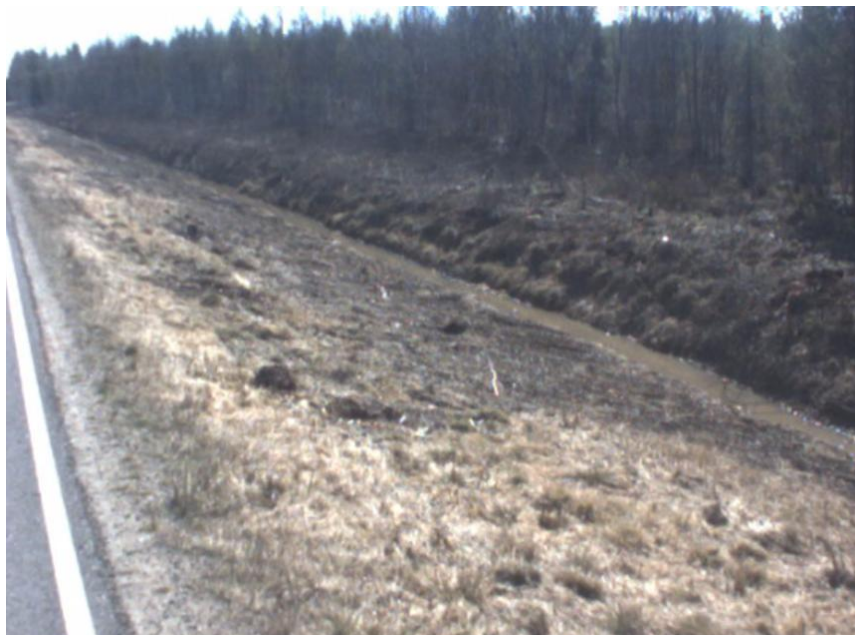
*Figure 432\_4. Ditch in adequate condition. The ditch has water as the longitudinal gradient is not sufficient in the left ditch. An example from road 926, section 17, chainage 5300 m.*

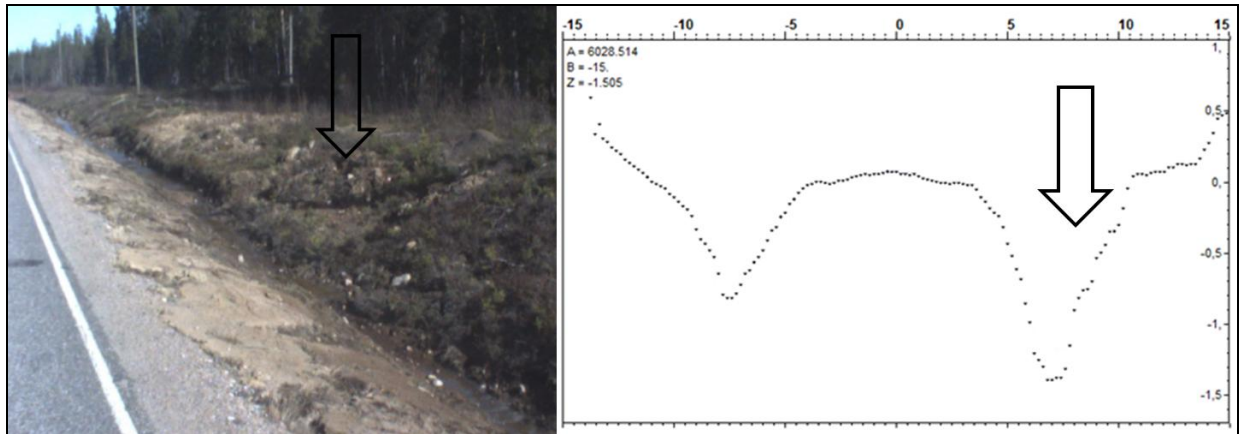
problems on this road was caused by soil flowing from the ditch slopes (Figures 432\_5 and 432\_6), and clogged private road access culverts. The ditch slopes had slipped down after the contractor had repaired the ditches.

Figure 432\_5. Road 934, section 3, 6020 m. Soil flows on the outer slope of the right ditch and is blocking the flow of water downhill. The cross section on the right shows how narrow the bottom of the ditch is.

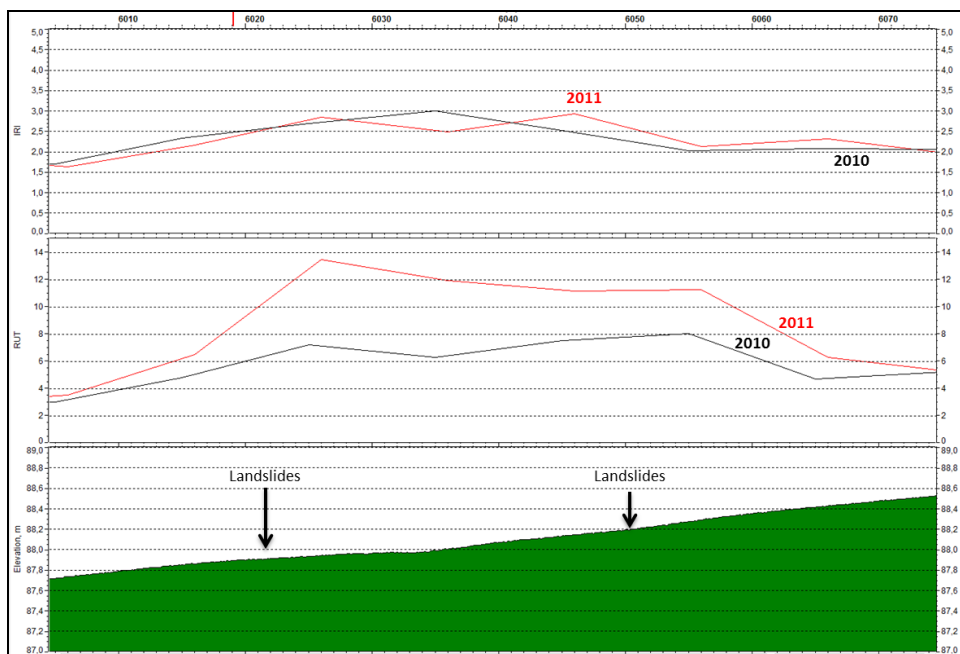
Figure 432\_6. Rutting values (in the middle) in 2011 have increased even more than 4 mm/year just above the section where soil flow has filled the ditch, and are 14 mm at the highest. Roughness values (first frame) are rising at this point too. The elevation graph (lowest frame) shows the direction of the water flow in the ditch.

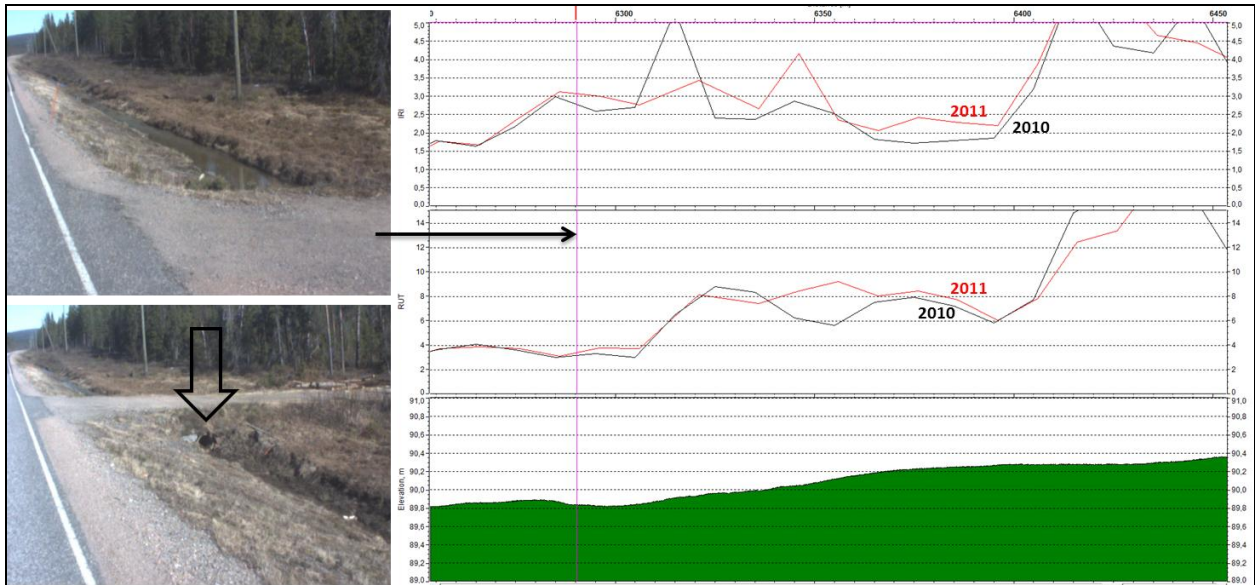
Private road access road culverts were causing problems in many places. An example is shown in Figure 432\_7.

Figure 432\_7. Example from road 934, section 3. The private road access culvert (chainage 6290 m) has been poorly installed (and clogged) and is blocking the water flow. The rutting values (second frame on the right) are high at the private road access, and rise even higher further on. Water above the clogged culvert is saturating the soil in the ditch slopes and the high water table is causing the growth of rutting and roughness values. The IRI values are shown in the upper right.

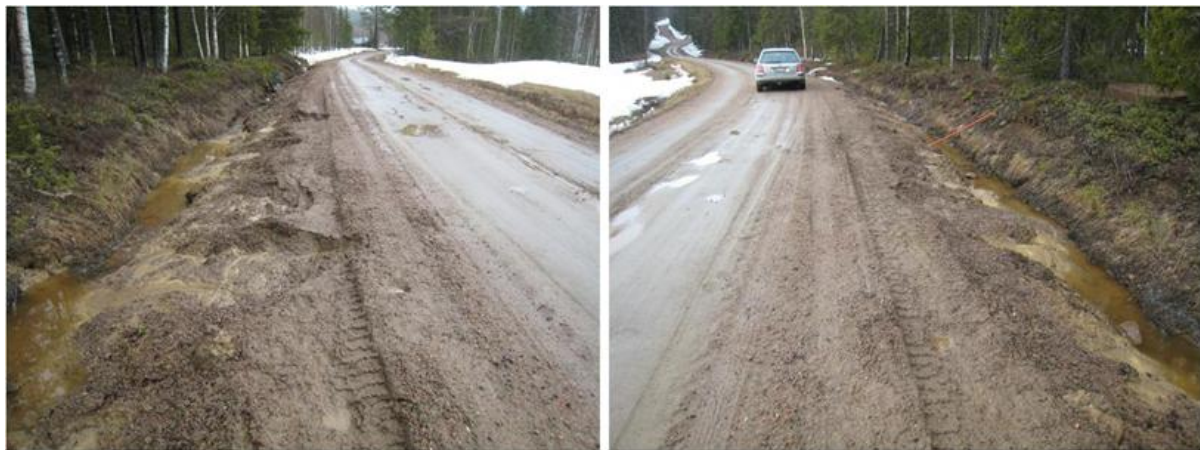
Figure 432\_8. Clogged side ditch causing road problems and frost heaves on the local road 19686.

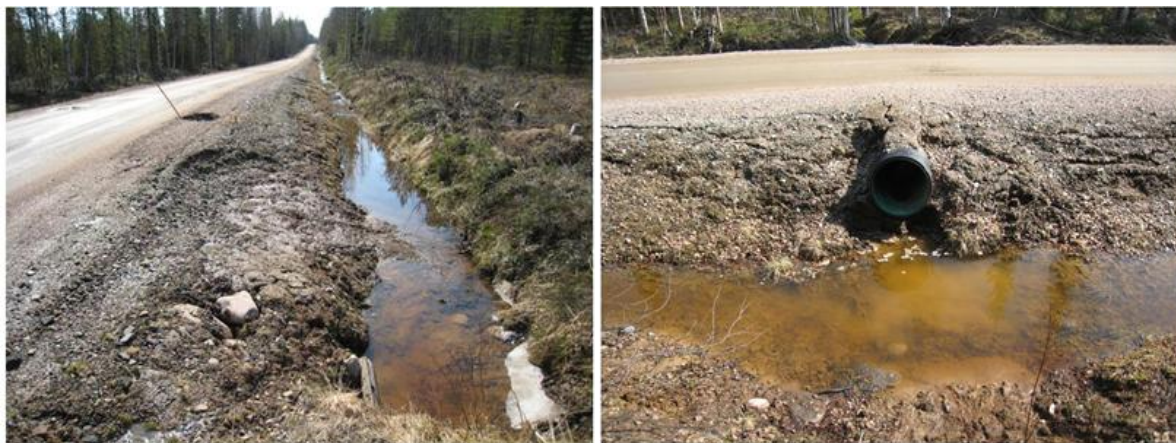
Poorly installed or clogged culverts were the biggest reason for the problems in the gravel roads monitored. Figure 432\_9 shows examples where flooding water from a clogged access road culvert is saturating the material on the inside ditch slope which then flows and fills the ditch bottom. Melting ice lenses also create a big hole in the road. The Figure also shows an example of poorly installed main road culvert.

*Figure 432\_9. A clogged private road access culvert has caused the water level in the ditch to rise and soil flow from the inner ditch slope (left). The stick in the road shows the location of a big hole in the road due to melting ice lens (left photograph). The right photograph shows an example of a poorly installed main road culvert. Both examples are from road 19688.*

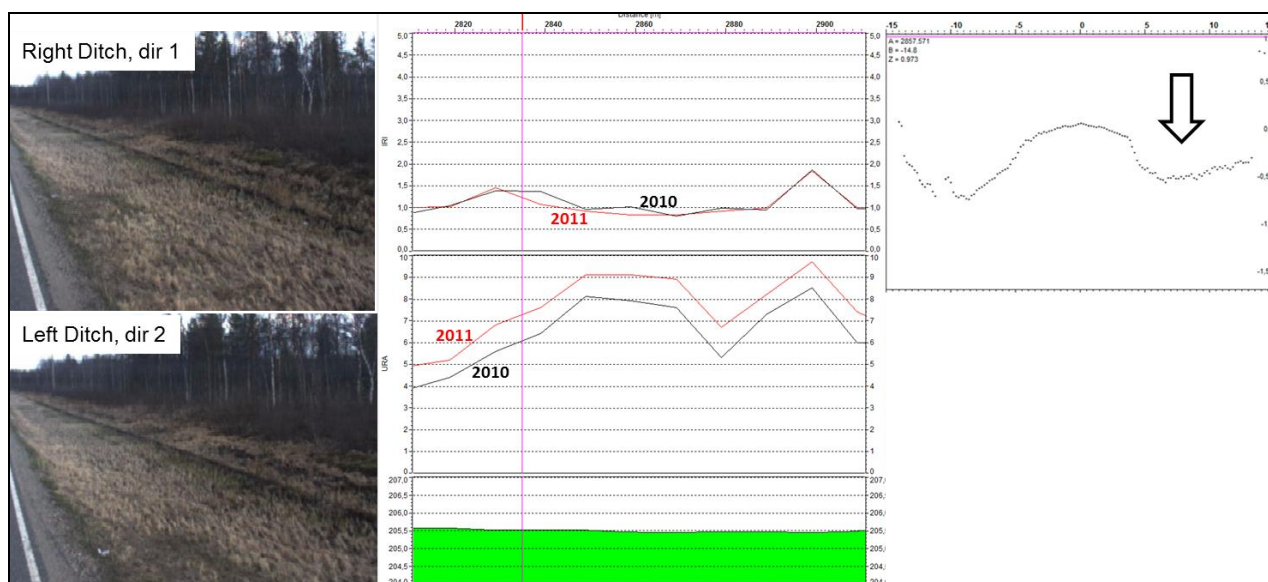
The biggest problem on road 80 was that it is not possible to repair the ditches on the follow up sections on road sections 11 and 12 because they were located on wet bog and clearing the ditches would be too expensive (Figure 433\_3). On section 10, most of the ditches on the follow up sections had been repaired, but still the proportion of adequate or drainage Class 2 was almost 80 %. Vegetation and soil flows from ditch slopes were blocking water flow in the ditches and poorly working private road accesses were the reasons for poor results in section 10.

Figure 433\_3. Example from road 80, section 11, chainage 2020 m. The cross section (top right) from the right ditch shows that the bottom level of the ditch is only about 50 cm from the road profile and clogged with vegetation, which is preventing water flow. The elevation frame (bottom middle) shows how flat the topography is in the area. The rutting values from 2011 (second graph in the middle) have grown evenly by about 1 mm from the results of 2010. The maximum rutting values are about 10 mm at this point. The IRI values (top middle) are about 2.0 mm at the highest.

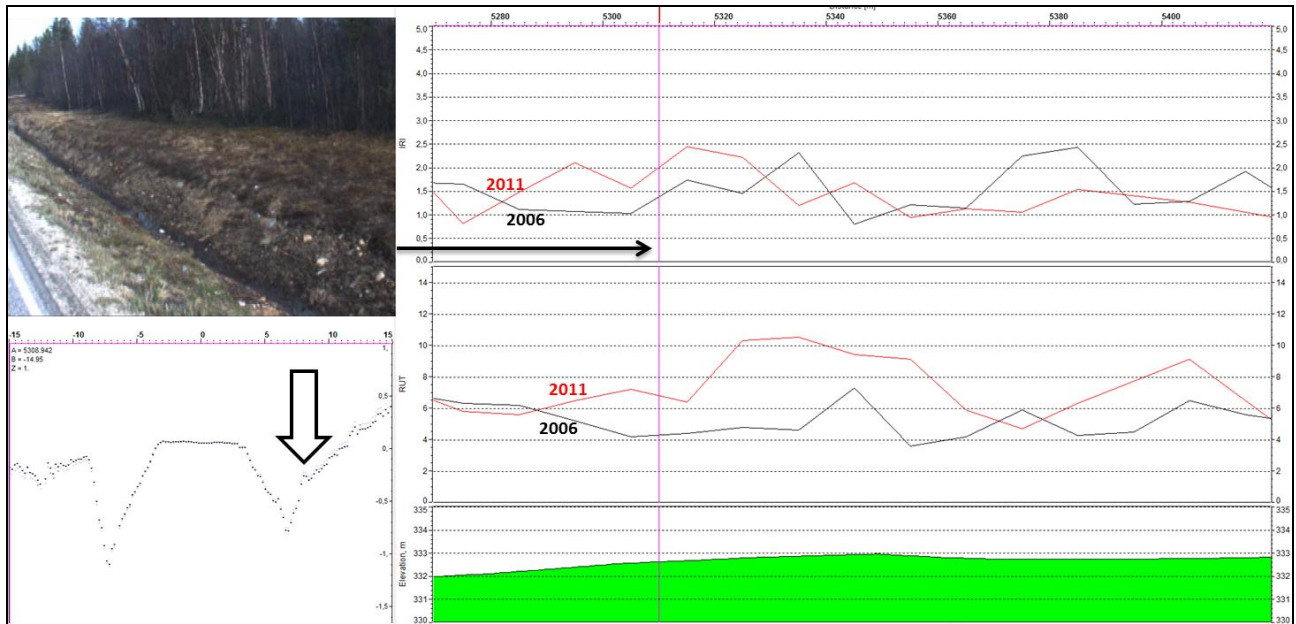
The main problem on road 93 section 3 was that the road was also partly located on an area of peat bog. The location of a lake close by the road also prevented the repair of the ditches at the first two follow up sections. Deepening the ditches at this point could make the lake water flood into the ditches. Some ditches at the follow up sections were repaired, but vegetation and soil slippages continued to hinder the flow of water and cause problems to the road (Figure 433\_4).

Figure 433\_4. Example from road 93, section 3, chainage 5300 m where soil flow from the outer slope has blocked the ditch and the water flow. This is causing further water flow into the road structures. Rutting values (second frame on the right) above the blockage have grown by about 6 mm from 2006 to 2011 and are now 11 mm at highest. Roughness values (first graph on the right) show just small changes at this point. Soil flows can also be seen in the cross section of the ditch (lower left). The road surface elevation profile (lower right) shows that water should be able to flow freely from right to left at this point.

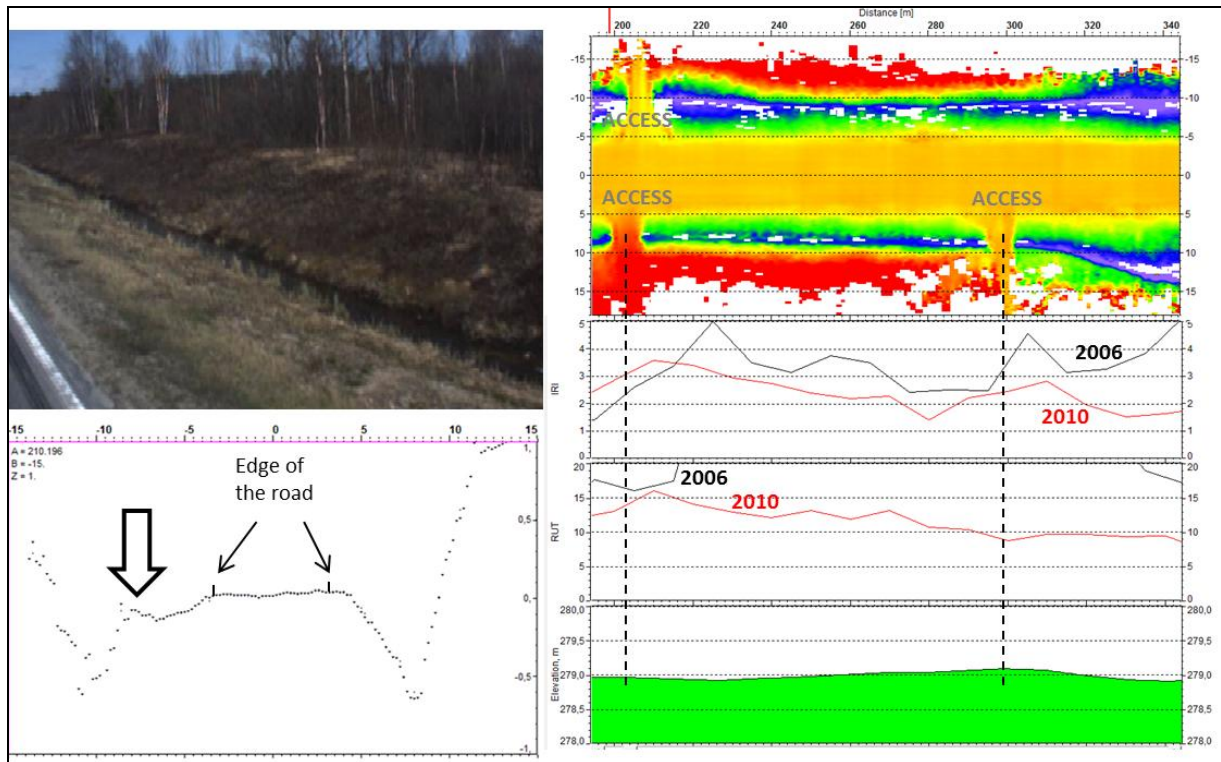
Figure 433\_5. Example from drainage problems on highway 21, section 205. The water in the ditch on the right has backed up between the private road accesses, as can be seen from the video picture taken from chainage 210 m. Most likely the private road access culverts are clogged. The elevation frame (fourth on the right) also shows that the road elevation shelves gently down to the private road access at chainage 200m. Rutting values (third frame on the right) were higher than 20 mm in 2006 but had decreased by 2010. This is due to the road being repaved between surveys, but the highest value still reaches 16 mm. The cross section (lower left, chainage 210 m) shows that the depth of the right ditch is only about 60 cm. Excavated materials from cleaning out the left ditch bottom have been deposited on the inner slope of the ditch (arrow) and this slope is now slipping and filling the ditch.

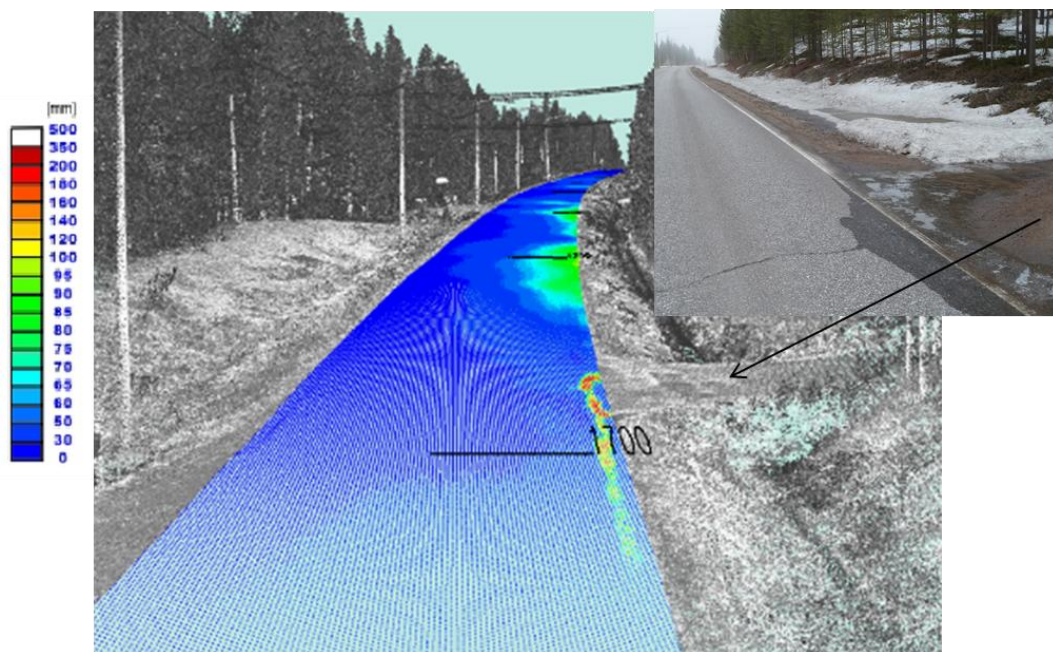
Figure 442.2. Example from road 934, section 3. Frost heaves above beside a private road access (chainage 1700 m), where the culvert was clogged in early spring (see also Figure 42\_1 in chapter 4.2).

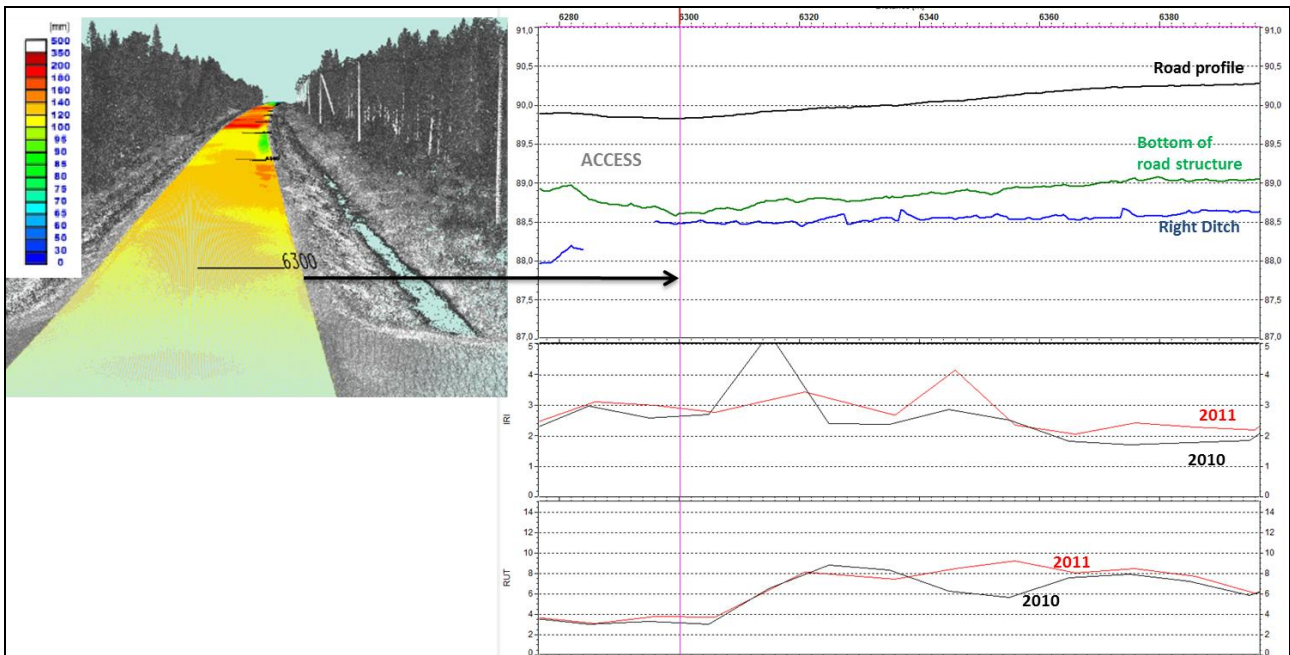
Figure 442\_3. Example of drainage problems at chainage 6300 m, road 934, section 3. The private road access is preventing the flow of water downhill and has caused material sedimentation above the culvert which can be seen from the horizontal bottom level of the right ditch (the blue line on the top frame). The longitudinal gradient in the 78 m long section before the private road access is only 2.2 mm/m, when minimum specified value is 4 mm/m. The roughness and rutting values (second and the third graphs on the right) have started to grow at this point. The values from 2010 and 2011 are given in both frames. Figure 432\_7 shows still photographs from the same point.

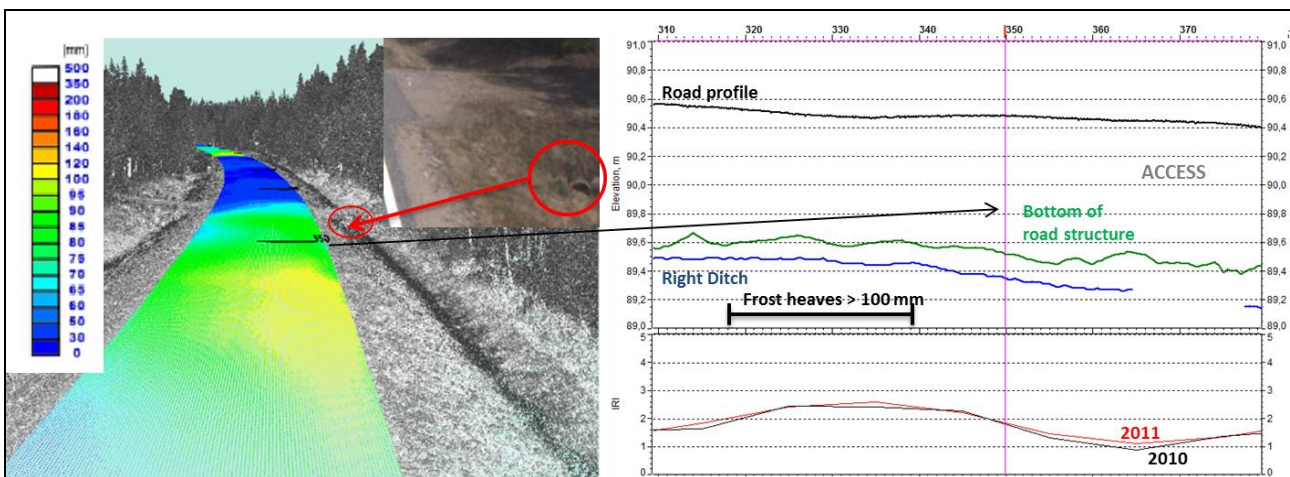
Figure 442\_4. Example from road 934, section 4. The frost heaves above the private road access (chainage 370 m) can be related to the private road access. The inset photo shows, how the private road access culvert is clogged by vegetation and soil. The elevation data (upper right) shows the elevation of the road profile, elevation of the right ditch and the bottom of the road structure. The roughness values (second graph on the right) have risen higher than the average values. Frost heaves occur at the highest point, over 100 mm (yellow).

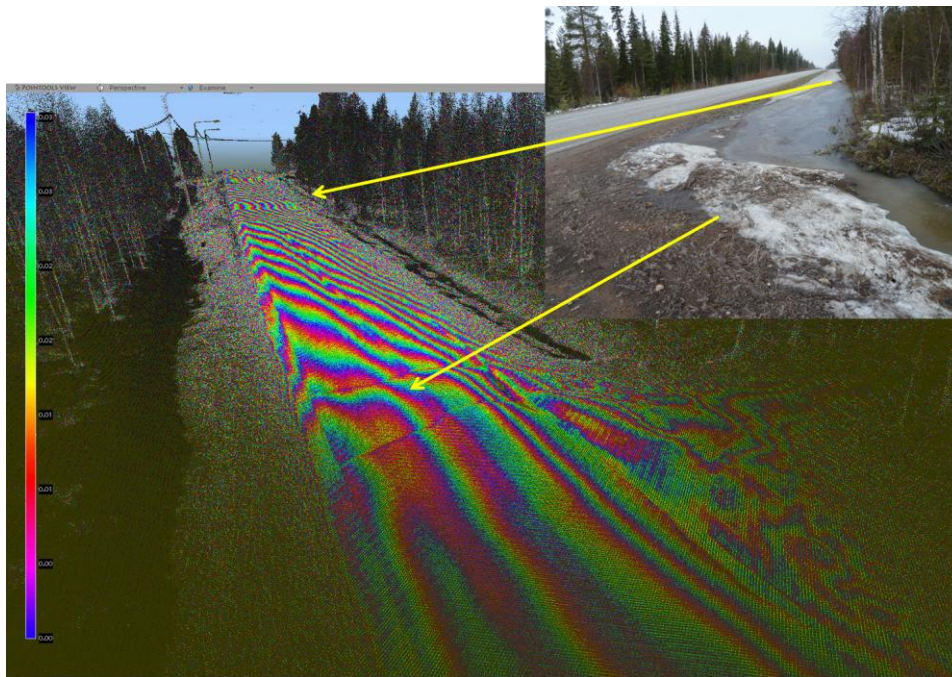
Figure 444\_1. Example from road 934, section 2. The private road access is frozen and the culvert clogged with the result that water has flooded above it in the right ditch. The rainbow image shows the places where the problems appear on the road: 1) around the private road access and 2) at the end of the flooded "lake".

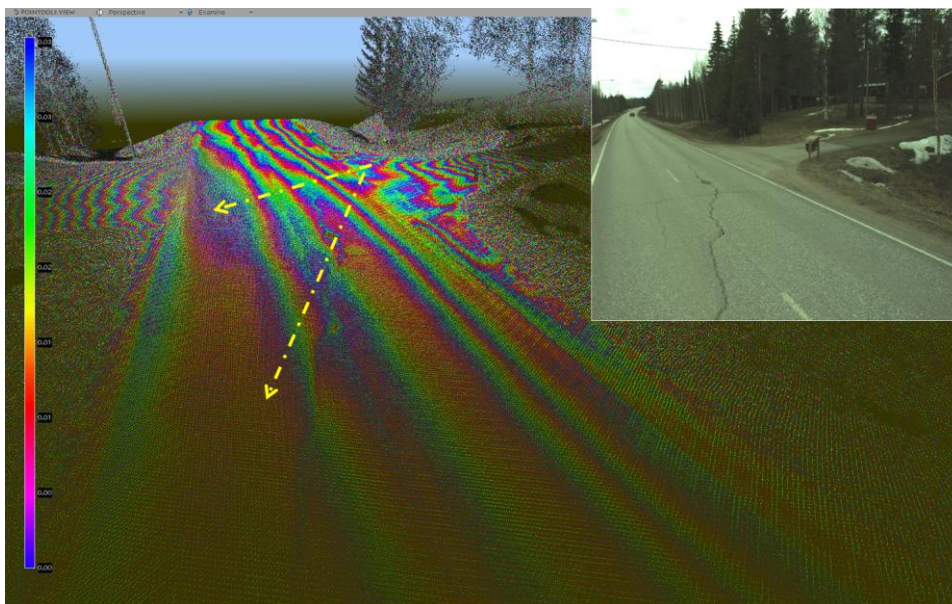
Figure 444\_2. Another example from road 934, section 2. The private road access culvert has clogged up during winter and water is flooding above it. Water is flowing into the road structure and differential frost heave is causing cracking in the pavement.
