ROADEX ROAD REHABILITATION REVIEW

**Road AC 1093 Morkan – Dikanäs
Västerbotten, Sweden**

ROADEX Road Rehabilitation Review
ROAD AC1093 MORKAN – DIKÄNAS
VÄSTERBOTTEN, SWEDEN
October 2010

David O'Brien
Trafikverket

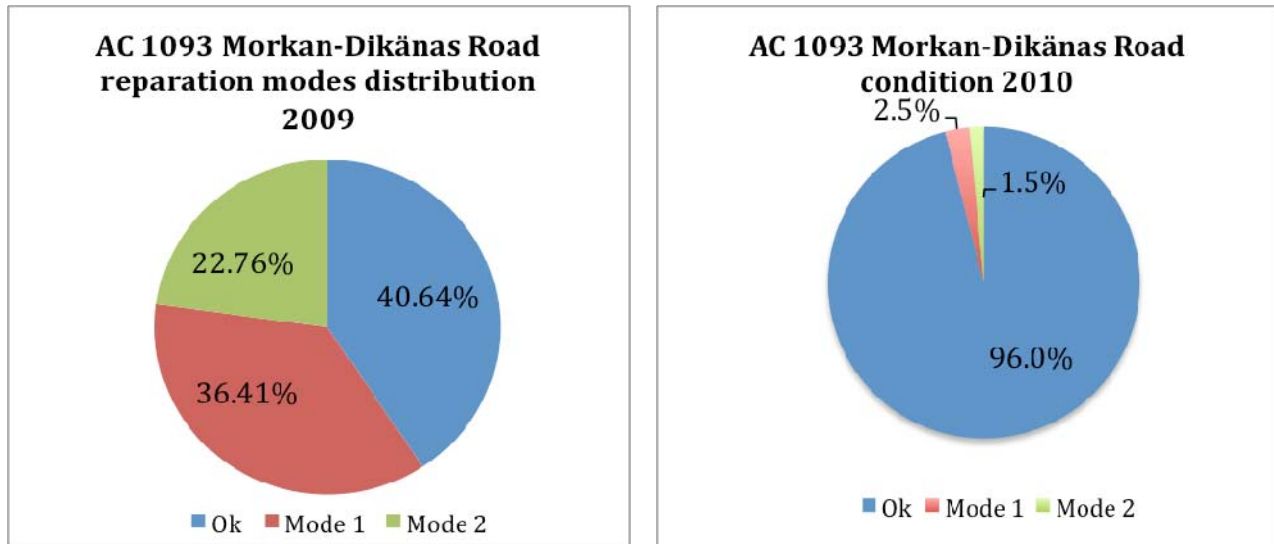
Figure 3.1 Road repair modes 2009

Looking at the road one year after rehabilitation works will show if the methods used were an appropriate remedy for the permanent deformations that the road had suffered from. Looking at figures 3.1 and 3.2 it can be seen that the percentage of rutting has been dramatically reduced looking at the statistics prior to the rehabilitation works (Matintupa, 2009).

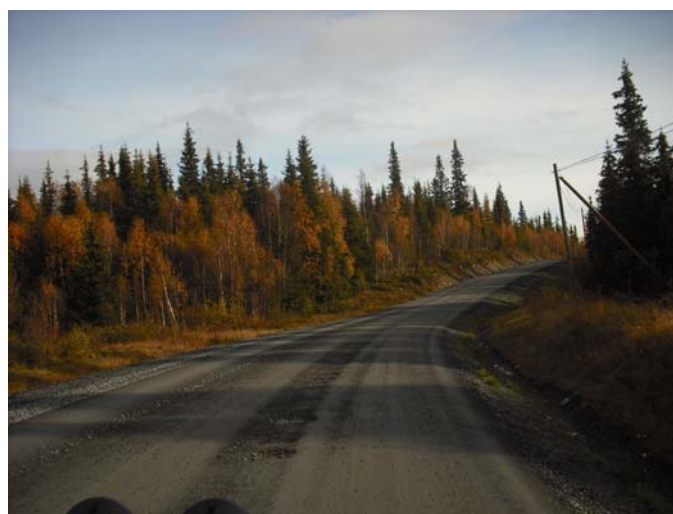
Throughout the entire road, Mode 1 rutting was apparent in approximately 500 meters of the road surface. However, the rutting was seen to occur due to a build of potholes resulting in the failure of the aggregates close to the road surface, which can be seen in figure 3.3. A probable cause of this is the high level of fines in the top layers, which can then hold an excess amount of water that can weaken the layers and the load is not distributed throughout the road evenly.

Figure 3.3 Section 2\170 with visible Mode 1 Rutting

A misleading factor from this pie chart is that there is approximately 4km of road with section type 3 compared to only 424m of road type 2, 3843m of 80mm base course and 1085m of road type 1. As a result, over 9% of section type 1 shows deformation compared to only 4% of section type 3 showing that type 3 was a more effective section. This may be a result of removing more of the old layers or adding a new 100mm base course rather than adding 80mm new 8-32 macadam and milling it by 200mm. A remedy for such rutting is to improve the aggregate or by reducing the tire imposed stresses (Andrew Dawson, 2006).

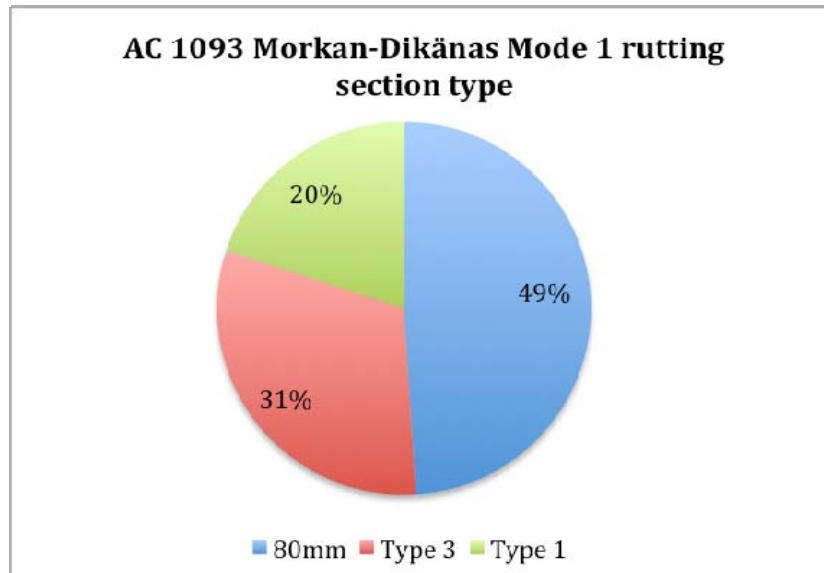
Figure 3.4 Mode 1 Rutting section type

From figure 3.4 it can be seen that, the road type that this mode of rutting was most evident in was where there were problems with the milling and mixing. Instead of milling and mixing the road was given a new base course of thickness 80mm which was estimated on the original price of the rehabilitation works of these sections. Consequently, the road that had suffered from Mode 1 rutting, probably had a high level of fines below the 80mm new base course which may have had a high moisture content that migrated in to the top layer thus resulting in further deformations.

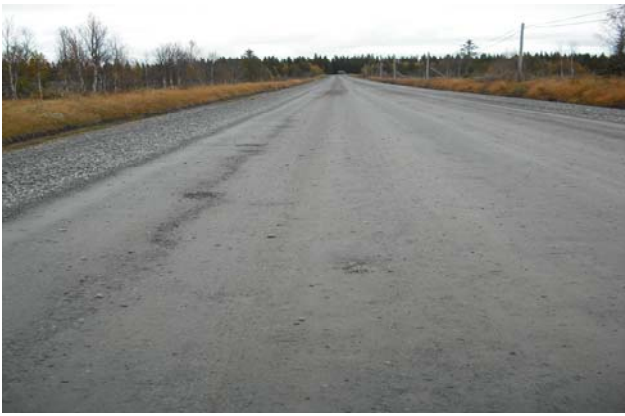
Mode 2 rutting occurred in only one area and section type. Close to where the road stops there is a large peat land area where the subgrade of the road was found to be very poor (Hjelm, 2009). As a result, section type 6 was chosen as the appropriate rehabilitation works. Out of the 1050m of section type 6, 28% of it was found to suffer from Mode 2 rutting after the rehabilitation works. From a visual inspection of the topography of the area it is assumed that the rutting and transversal cracks in the road surface become most prominent in the middle of a sloping peat area. Here, the peat area may be at its deepest therefore the subgrade is at its weakest here. Figure 3.5 shows the road section where Mode 2 rutting is apparent.

Figure 3.5 Section 20\250 with visible Mode 2 Rutting

A remedy for this type of rutting would be to improve or thicken the aggregate so that the wheel loads are spread better. This will result in less stress on the subgrade. Another solution would be to put a load restriction on the road during the thawing seasons (Andrew Dawson, 2006).

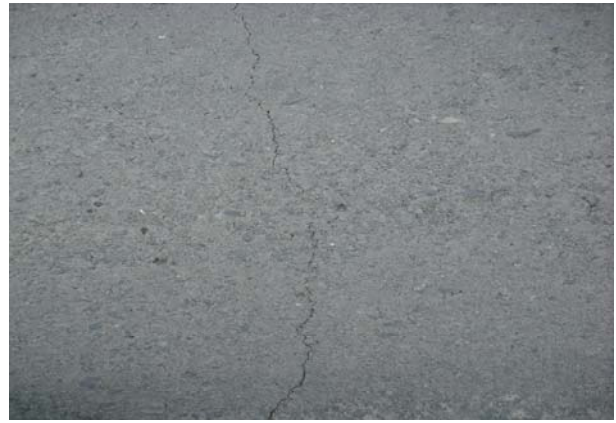
Figure 3.6 Section 20\175 Transversal cracks visible

As mentioned previously, transversal cracks are visible along the edges of the steel nets, which can be seen in figure 3.6. These cracks came shortly after the construction of the road and there are many possible scenarios for their occurrence such as:

- Increased thickness of the superstructure that causes settlements (Hjelm, 2009)
- Joint between the nets is insufficient due to skidding (Hjelm, 2009)
- Increased volume due to excess water during construction
- Frost heave occurring at steel net connections thus pushing up at the weakest point in the reinforcement.

Possible solutions to reduce the forming of these cracks would be similar to the mMode 2 rutting remedial actions. Also, if the steel nets were overlapped by a greater amount and the connections made stronger it may reduce the risk of the crack formations.

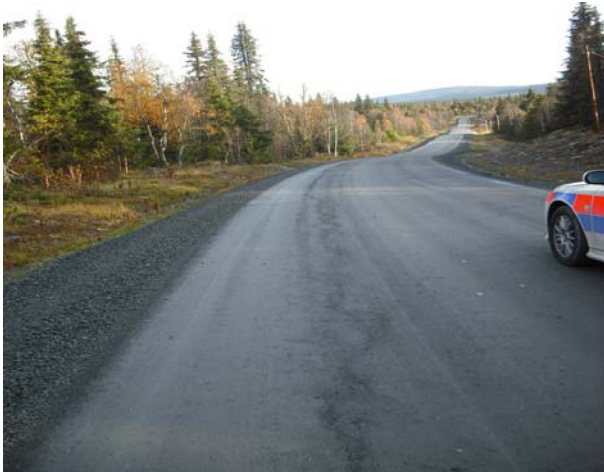
Longitudinal indentations in the road appeared quite frequently throughout the entire road which can be seen in the inventory in Appendix A. However, not all can be directly correlated to frost heave. In figures 3.7 and 3.8 the difference between the frost heave and longitudinal indentations can be seen. Here it can be seen that the frost heave does not act in a straight line compared to the longitudinal indentations. These longitudinal indentations are thought to occur on sloping surfaces where the water runs down the road in the wheel tracks and takes the fines in the road surface away with it. Therefore they are of no concern in relation to the structural integrity of the road and are more of a maintenance issue and should be dealt with accordingly.

Figure 3.7 Section 1\626 with visible frost heave

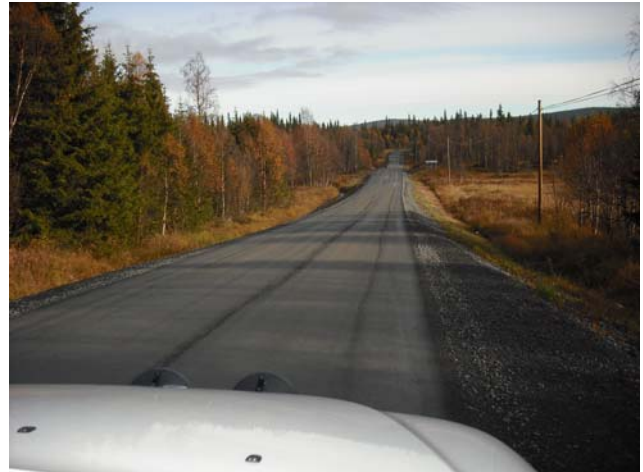
Figure 3.8 Section 1\854 with longitudinal indentations

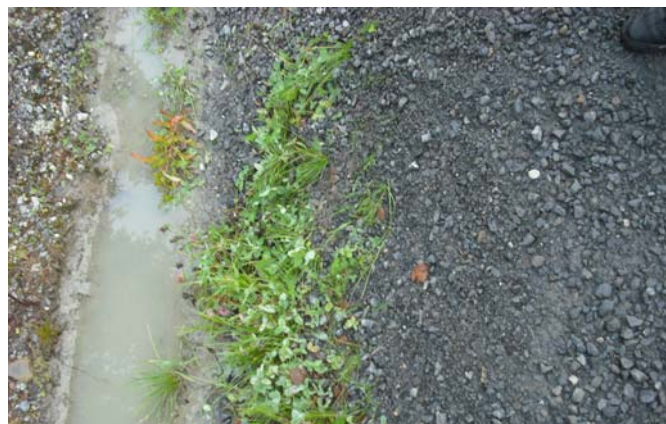
Looking at figure 3.9 it is thought that there is a high level of silt in the road surface that is been washed off with the flow of water. This high level of fines may also be in the road structure which in turn can give rise to frost heave as mentioned previously. Therefore a possible remedy for this defect would be to reduce the level of fines, especially silt in the road structure.

Figure 3.9 Section 0\640 with silt visible in the drainage

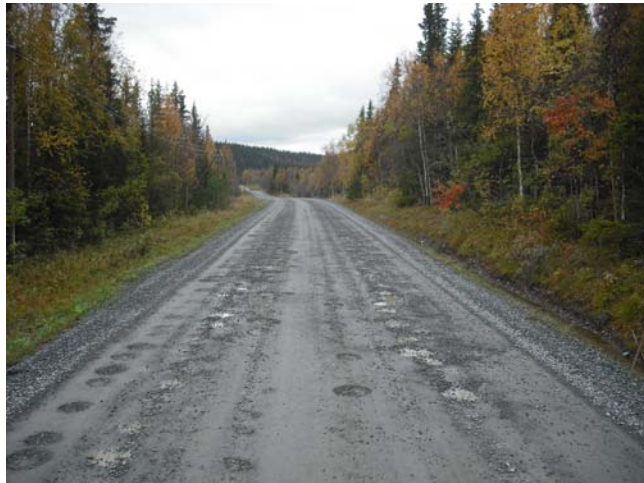
Throughout the entire road there was a significant amount of potholes considering that this road had rehabilitation works done the previous year. Figure 3.10 shows how bad the condition of the road gets in a localised area. This potholing is seen frequently at the bottom of sloping roads and it is due to the buildup of the water on the road, which may also be related to high fines content in the road structure. However, this is also only a maintenance issue, which does not alter the structural integrity of the road.

Figure 3.10 Section 19\190 with severe pothole conditions

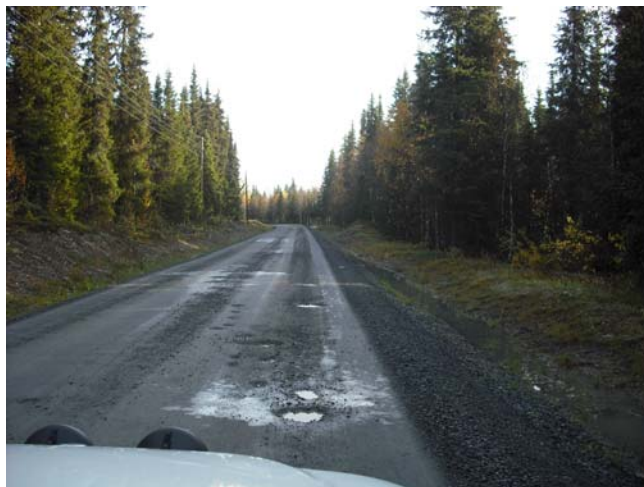
It is also important that trees and other flora are kept at an appropriate distance from the road. Without this the road is provided with shade which in turn reduces the speed of evaporation and thawing of water from the road. A good example of this can be seen in figure 3.11.

Figure 3.11 Section 0\520 with visible shading of road surface by flora
