SUMMARY OF DRAINAGE ANALYSIS IN REGION NORD, NORWAY

Demonstration Project Report

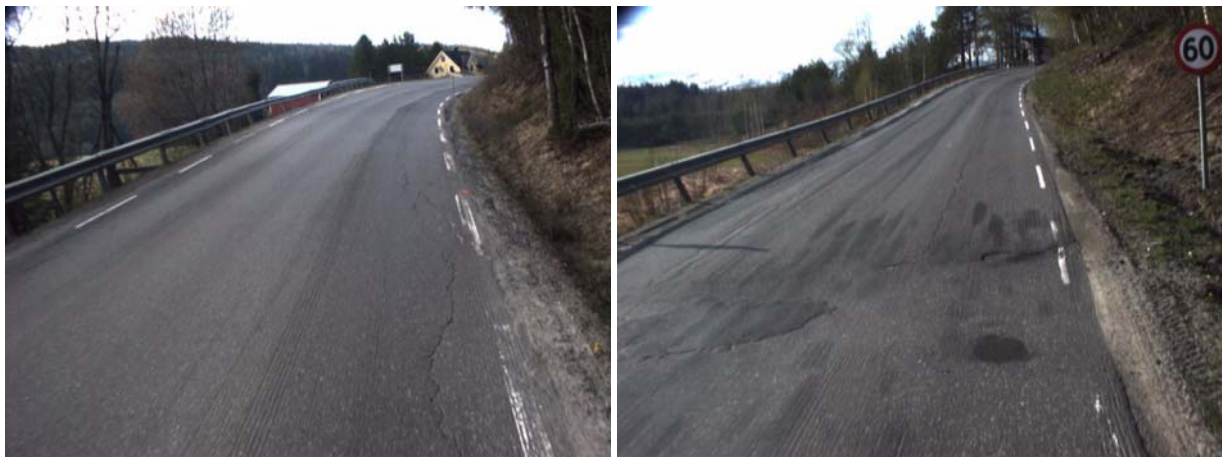
Figure 13: Little room for ditches on the upper side of the slope, chainage left: 995m, right: 5720m

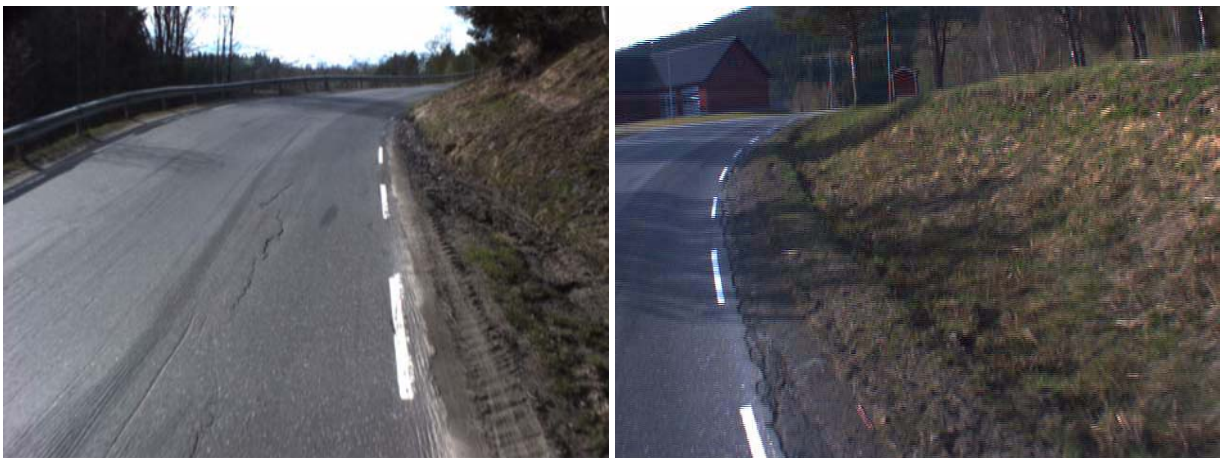
Figure 15: Drainage problems in a steep side sloping road profile, chainage left: 5650m, right: 7070m

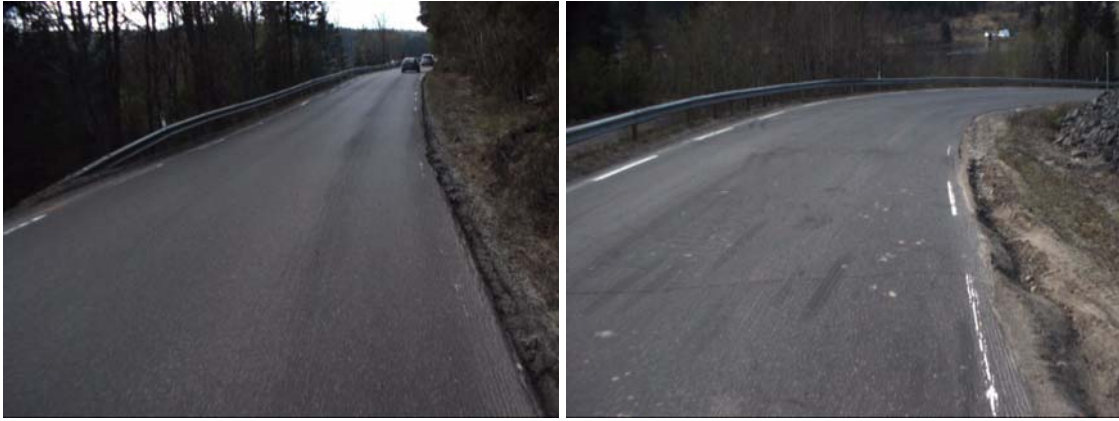
Figure 17: Erosion damages, chainage left: 870m, right: 1465m

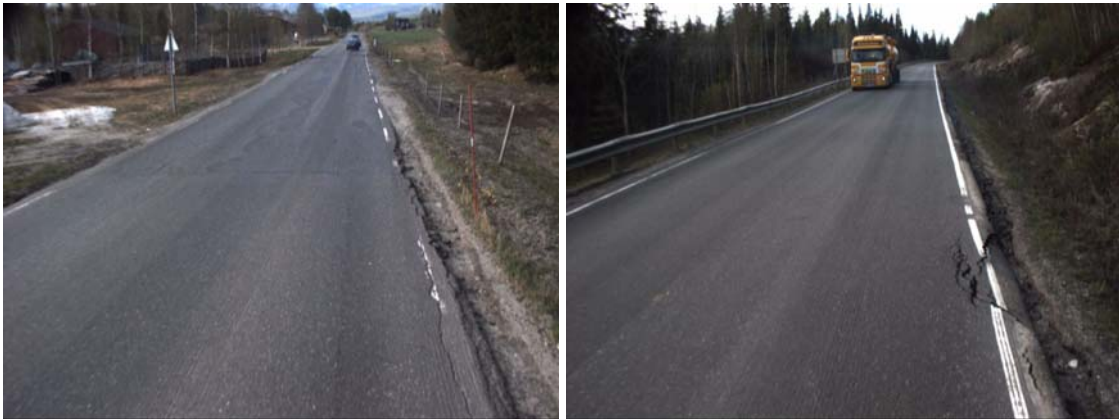
Figure 18: Erosion damages, chainage left: 1710m, right: 13635m

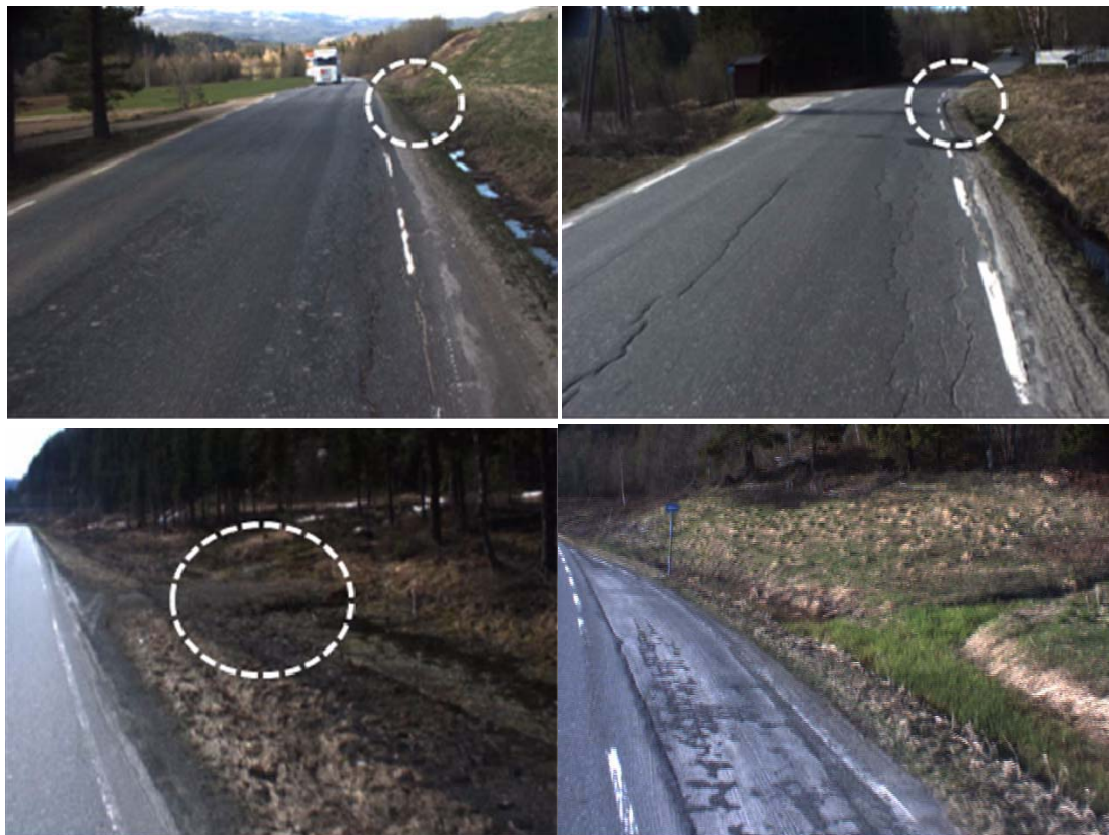
Figure 19: Examples of problems resulting mainly from private road access junctions and their culverts, chainages top left: 2250m, top right: 4300m, bottom left: 13495m. At chainage 32635m water is standing behind bus stop (bottom right).

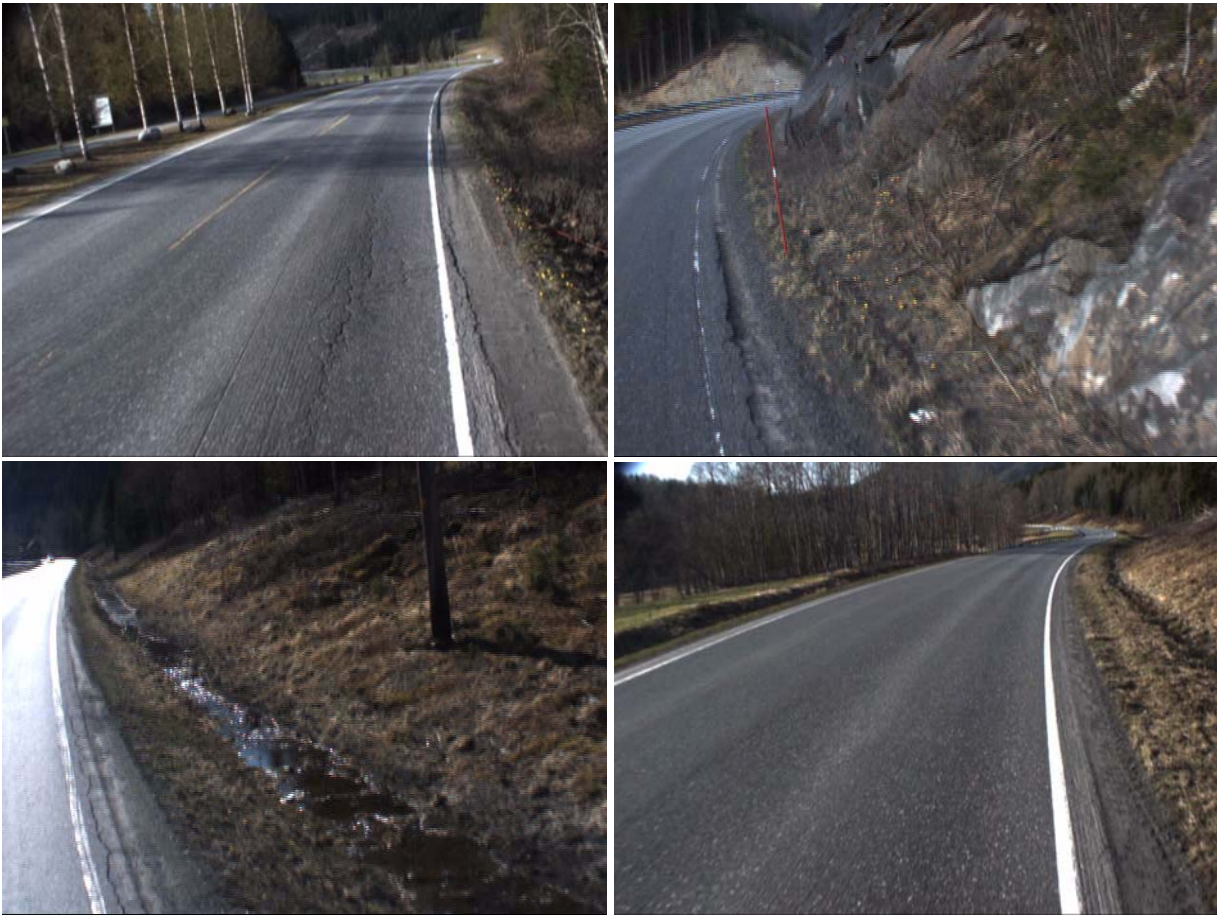
Figure 20: Ineffective drainage on the upper side of the side sloping road profile, chainages top left: 12350m, top right: 29330m, bottom left: 35270m, bottom right: 37220m

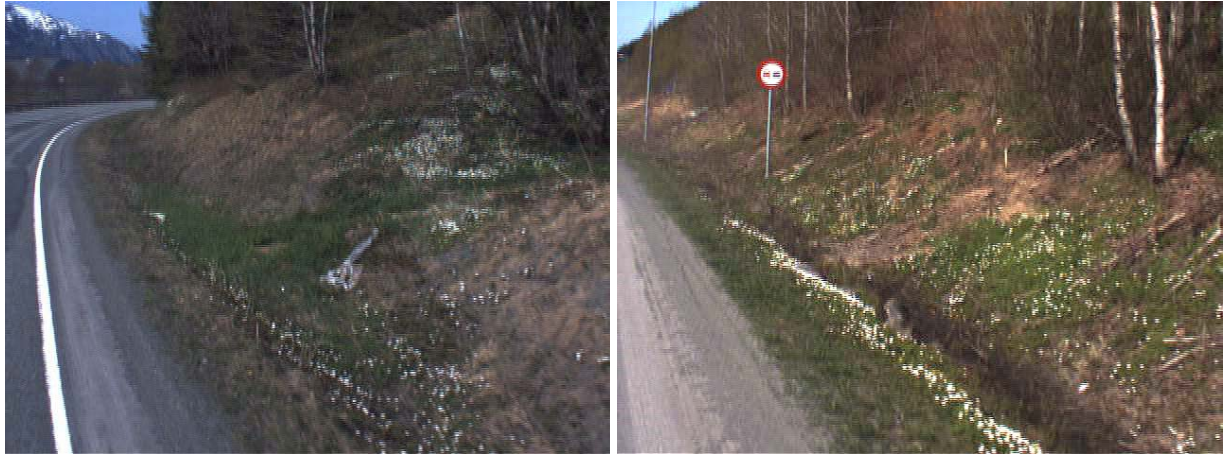
*Figure 22: Inadequate drainage on the upper side of the side sloping ground
(chainage 1600m, 1840m)*

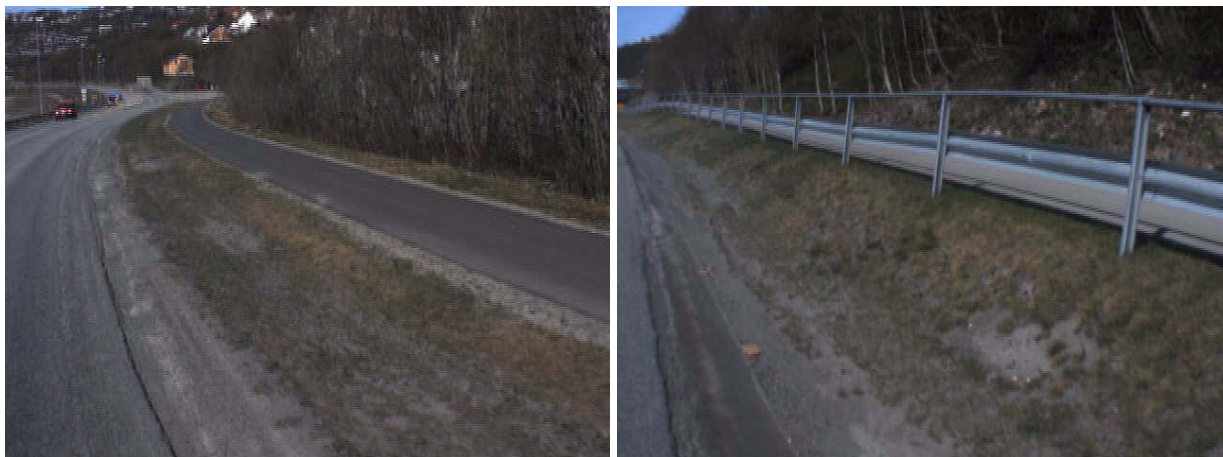
*Figure 23: No drainage system between the cycle path and the E6 road
(chainage 5445m, 5910m)*

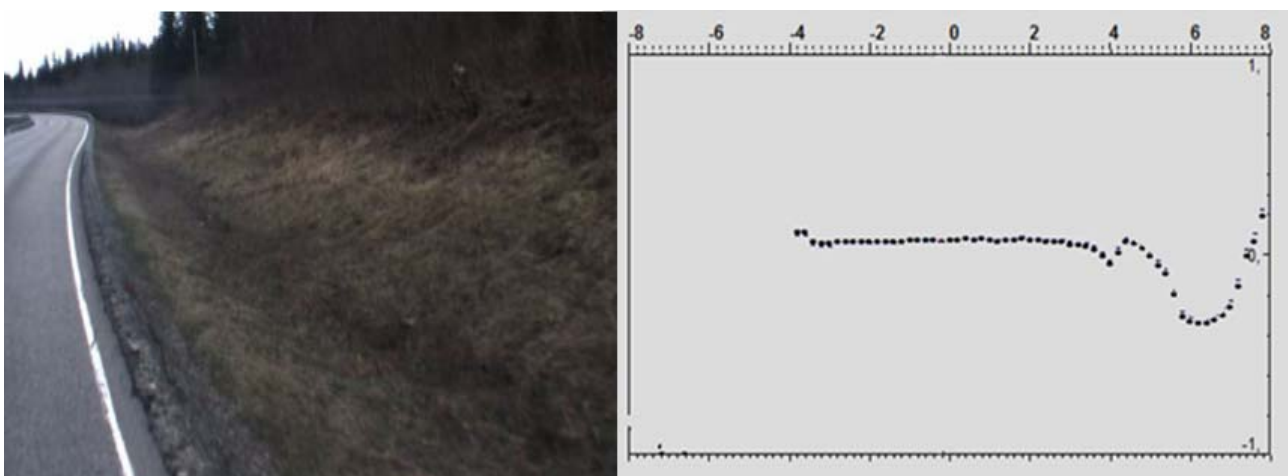
Figures 27: Inner slopes of road have lost their shape and verges have been formed. The ditch depth is only 50cm, example at 5160m. Erosion can also be seen at the pavement edge.

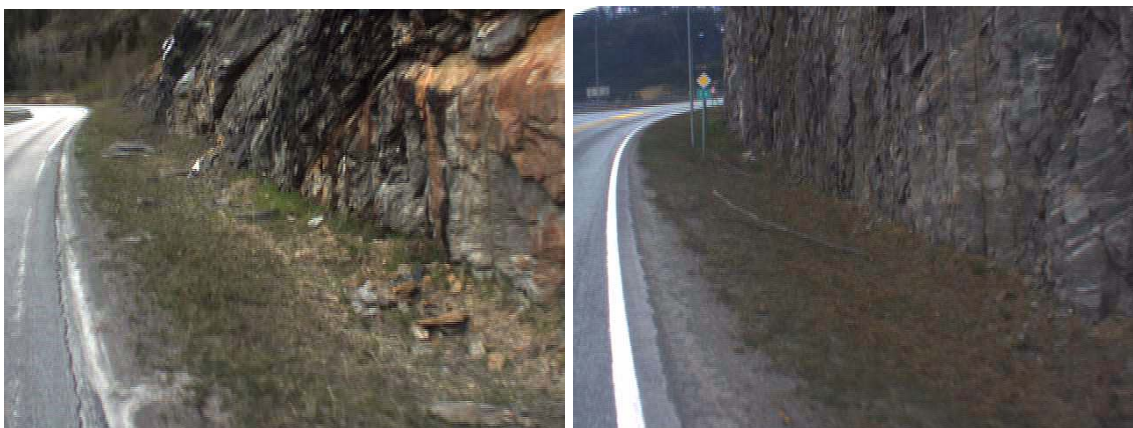
Figures 28: Left: Stones in the bottom of the ditch at chainage 2180m. Right: Rock cutting with good ditch depth at 3500m.

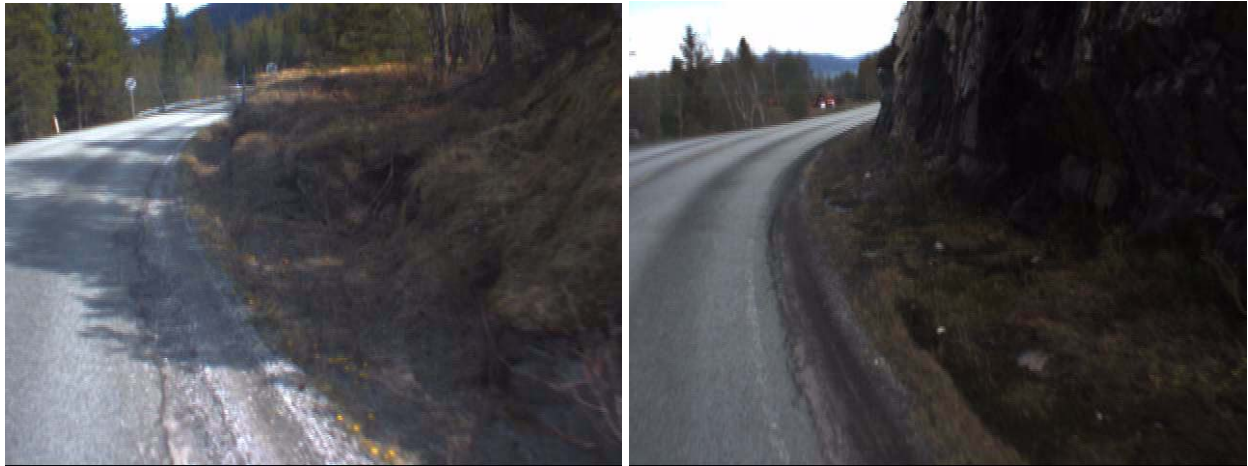
Figure 29: Examples of erosion, Left: Shallow ditch filled with unstable material at chainage 5530. Unstable material has filled the ditch at 8560m.

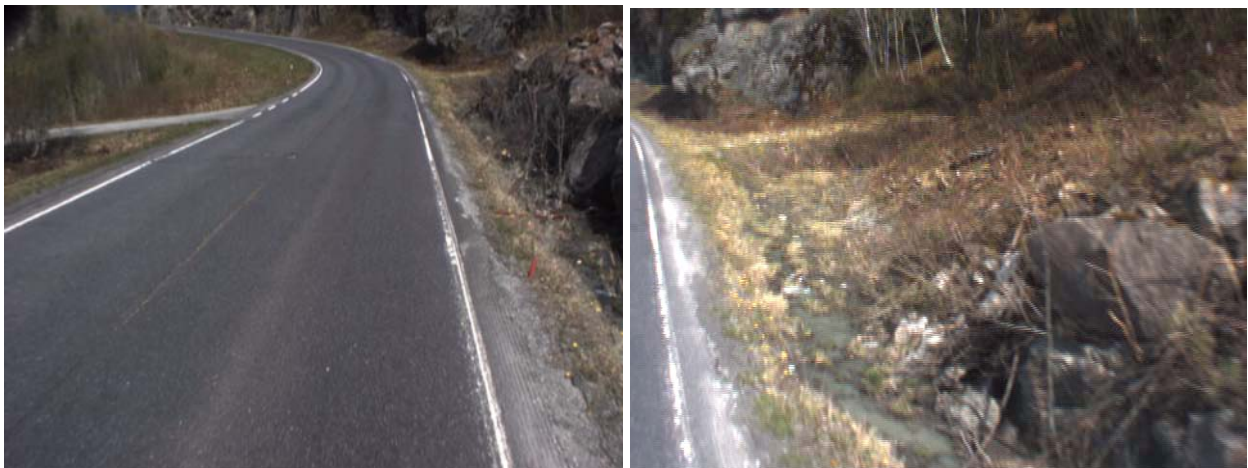
Figure 30: Example of rock cutting near the road. Left: general perspective at chainage 10400m and Right: detailed photo of clogged ditch at chainage 10440m.

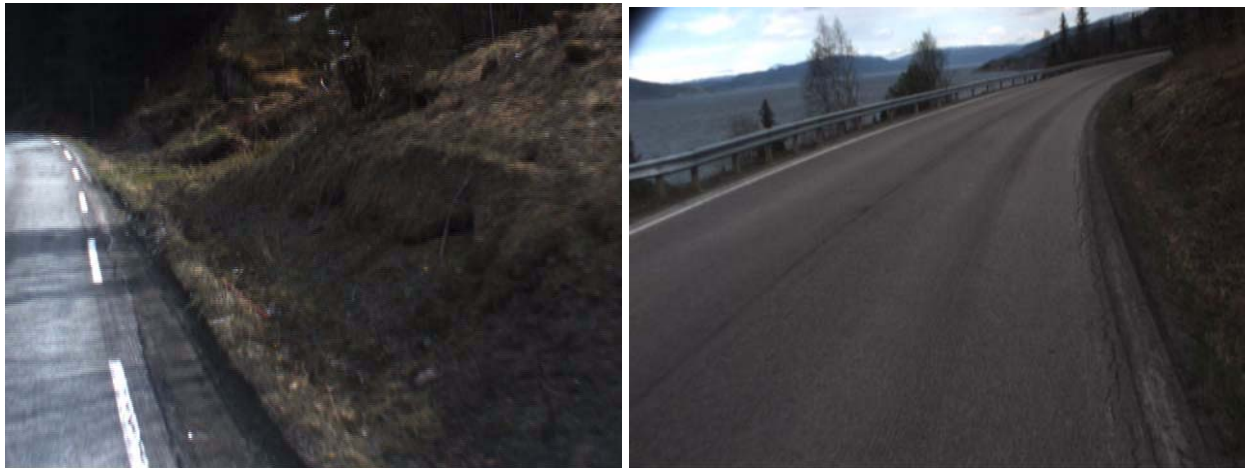
Figure 31: Examples of verge problems, Left: High verge at chainage 2970m, Right: Verge problem at 8130m chainage

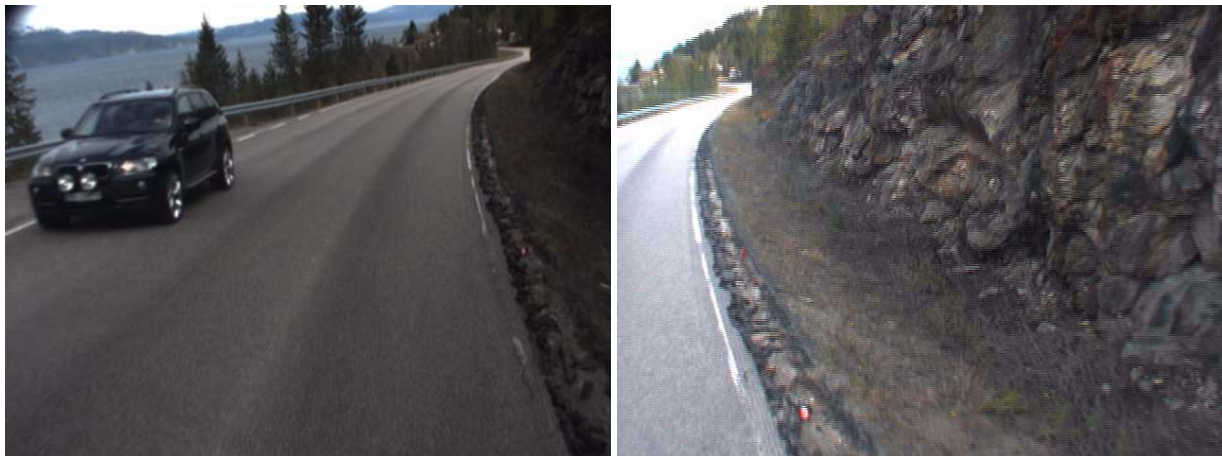
A typical problem arising from slide sloping profiles is erosion. Water runs along the pavement or near the edge causing damages (Figure 32).

Figure 32: Examples of erosion damage; Right: Washout damage at chainage 2320m and Left: more detailed photo at chainage 2330m.

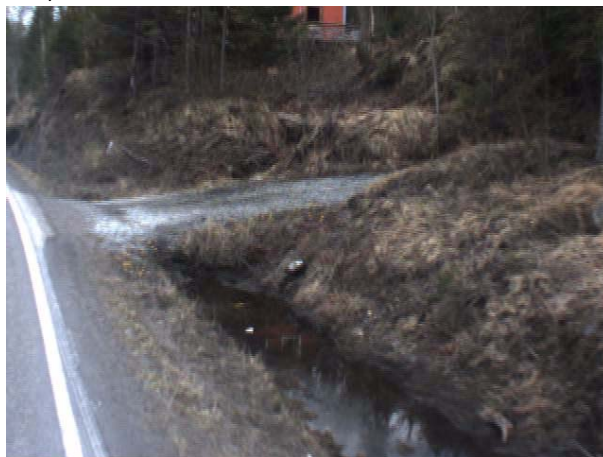
Figure 33: Private access road junction is blocking the water at chainage 4160m,

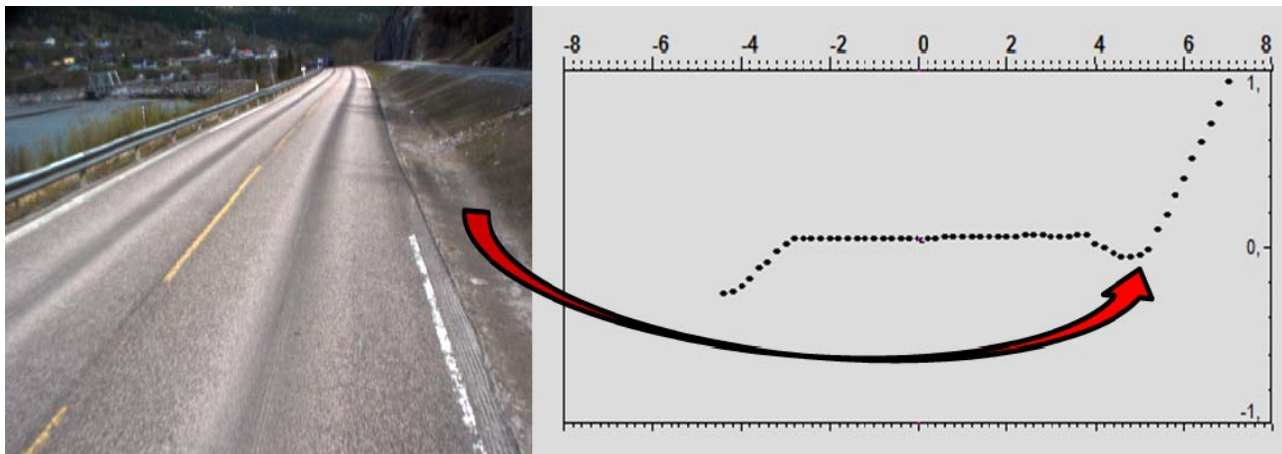
Near the end of the section a new bicycle path had been provided on the upper side of the side sloping road profile. This was located on a higher elevation than the road itself and the ditch between them was shallow. This was considered to be a potential problem over time if the ditch fails to keep the surface water off the road (Figure 34).

Figure 34: Shallow ditch between the road and the bicycle path. Laser scanner shows small deformations on the right side of the road.

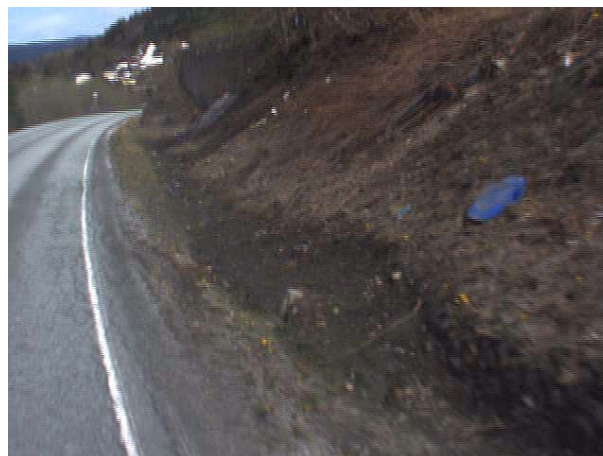
Figure 35: Partly blocked ditch on the upper side of the slope at chainage 5320m.

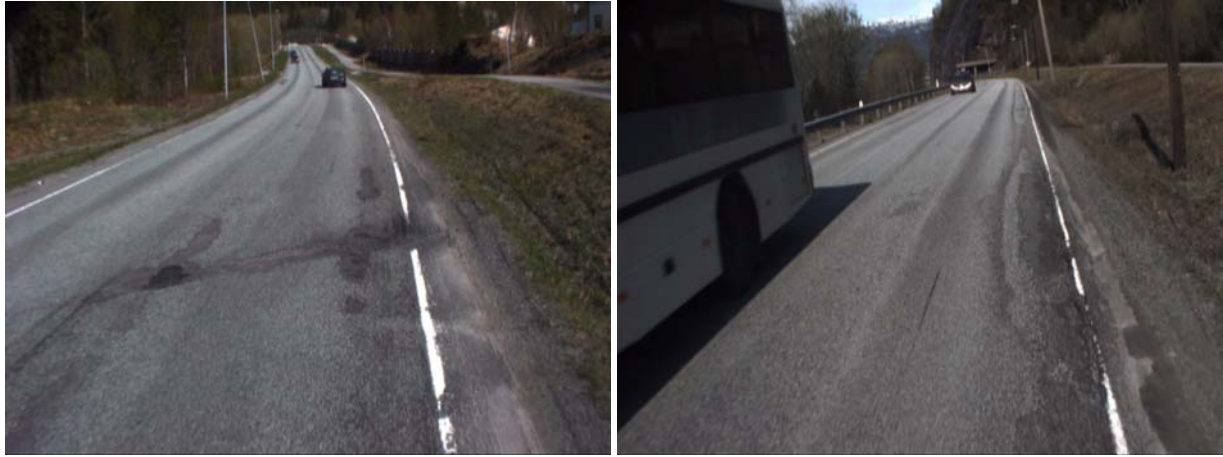
Figure 36: Road damages because there is little room for ditches, chainage left: 1160m, right: 2110m

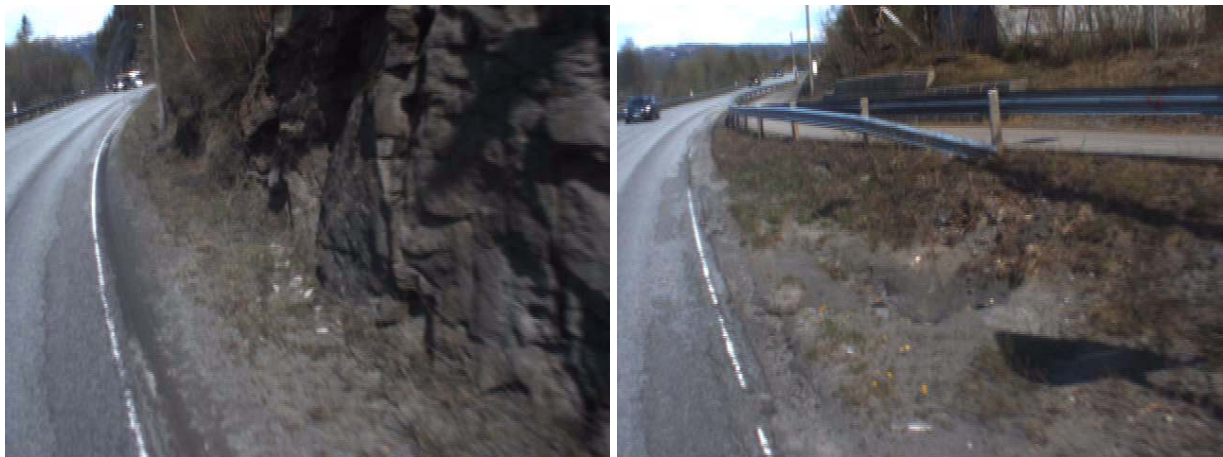
Figure 37: No ditches, chainage left: 2050m, right: 2530m

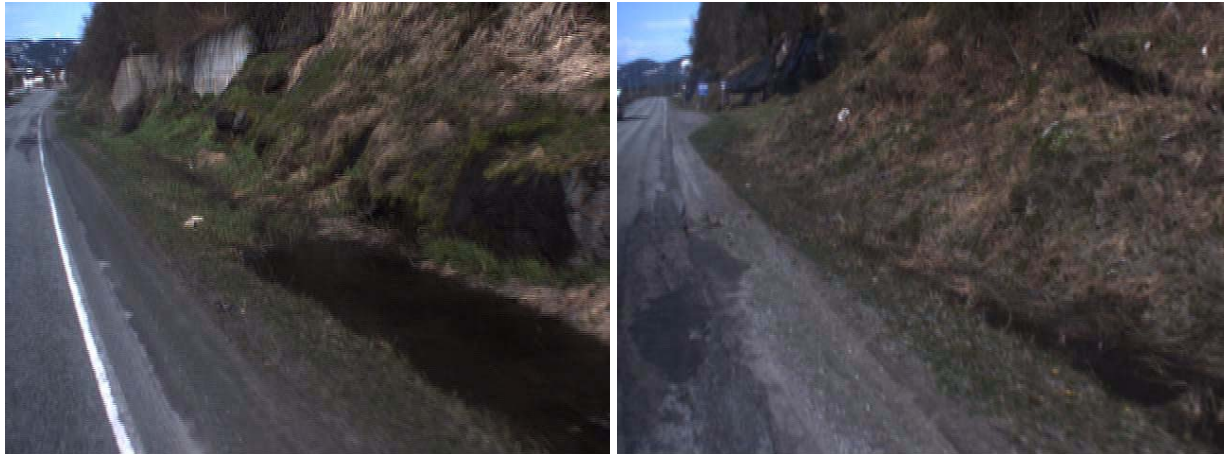
Figure 38: Partly filled ditch blocks the water flow at chainage 240m. Right: No ditch at 550m chainage.

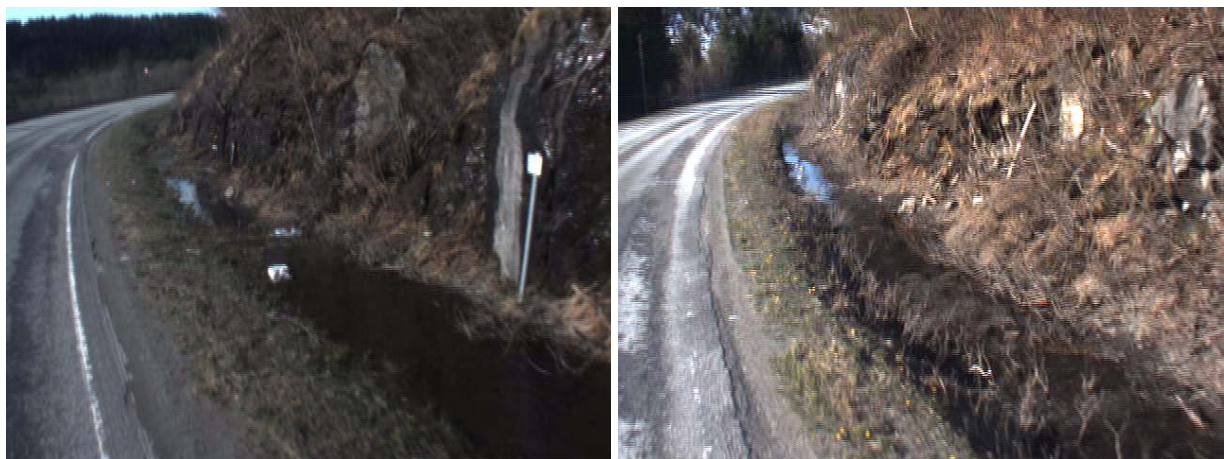
Figure 39: Severe drainage deficiencies, chainage left: 2500m, right: 5470m.

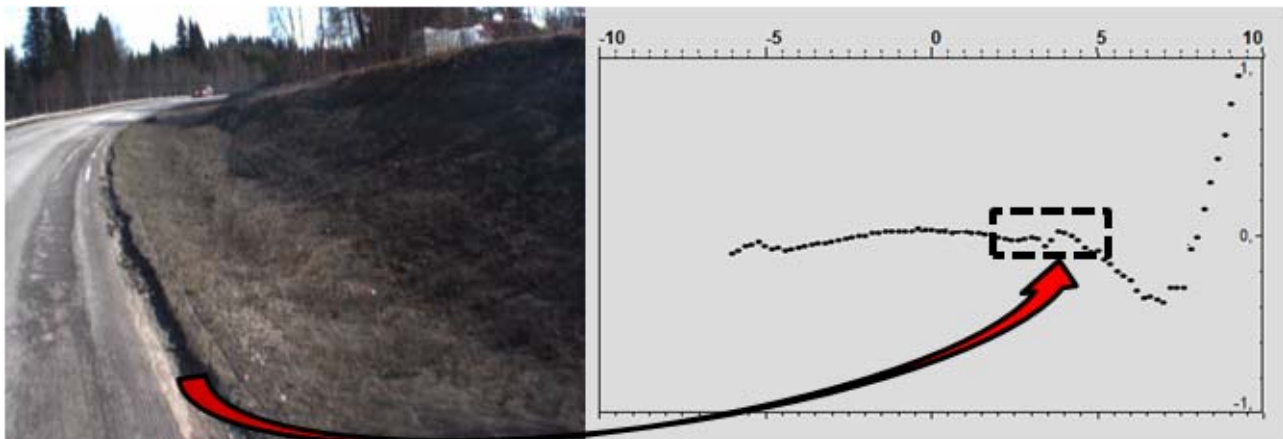
At the end of the section the inner slope had lost its shape. This had caused verge and erosion problems (Figure 40).

Figure 40: Erosion damage on the edge of the pavement at chainage 5840m

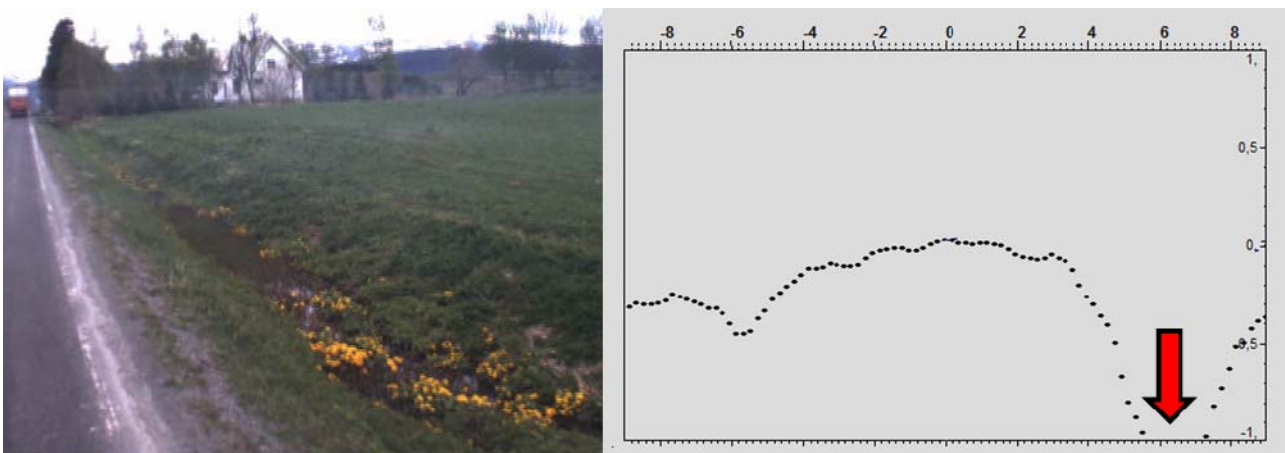
Figure 43: Vegetation was slowing down the water flow at chainage 25220m, good depth on the right ditch though. Laser scanner shows that the ditch on the left side is too shallow. Severe deformation problems can also be seen on the road.

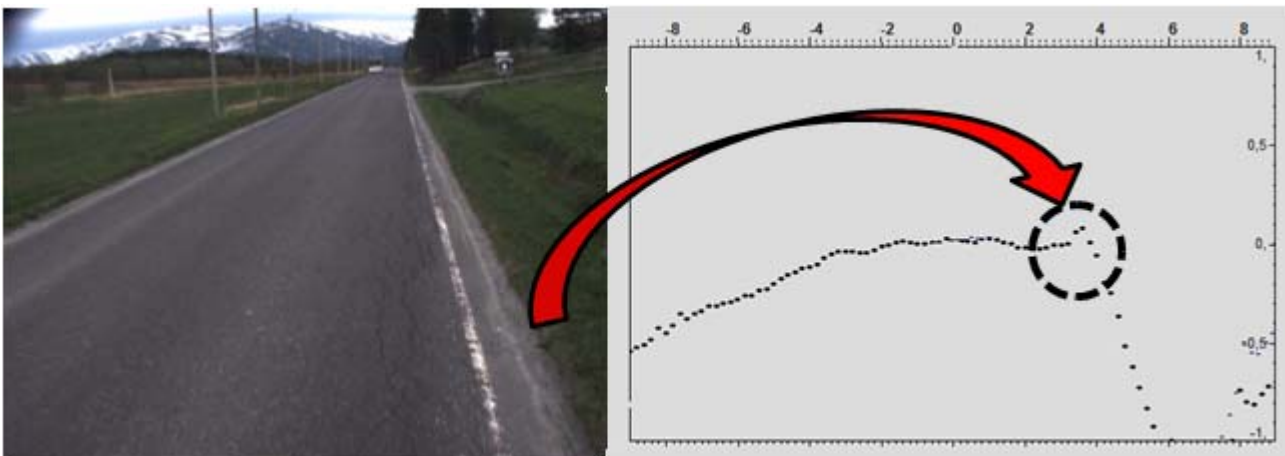
Figure 44: Laser cross section data shows the verge, chainage 24930m. Road cross section shows deformations and the road is dipping to the left.

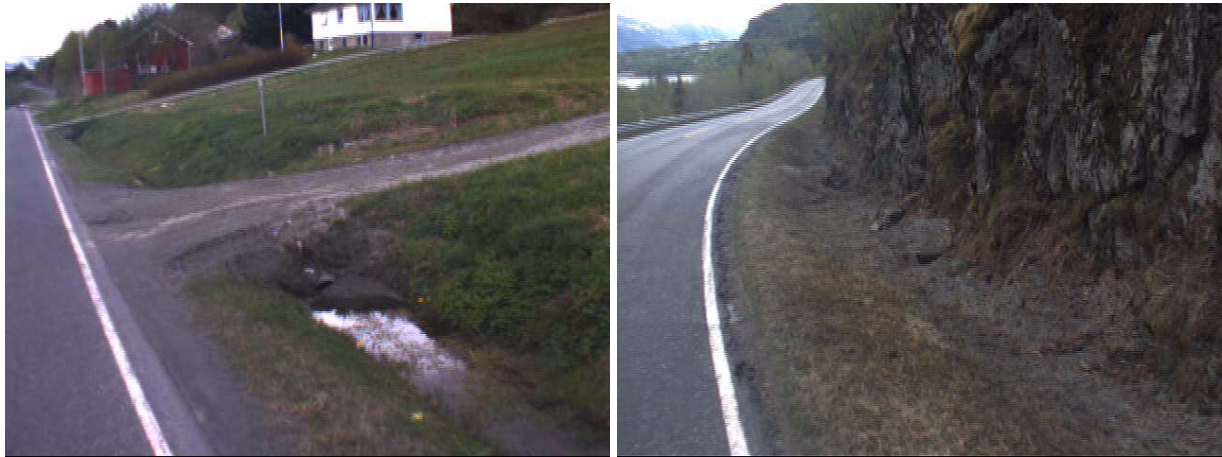
Figure 45: Left: Clogged culvert at chainage 4040m, Right: High verge at 11700m.

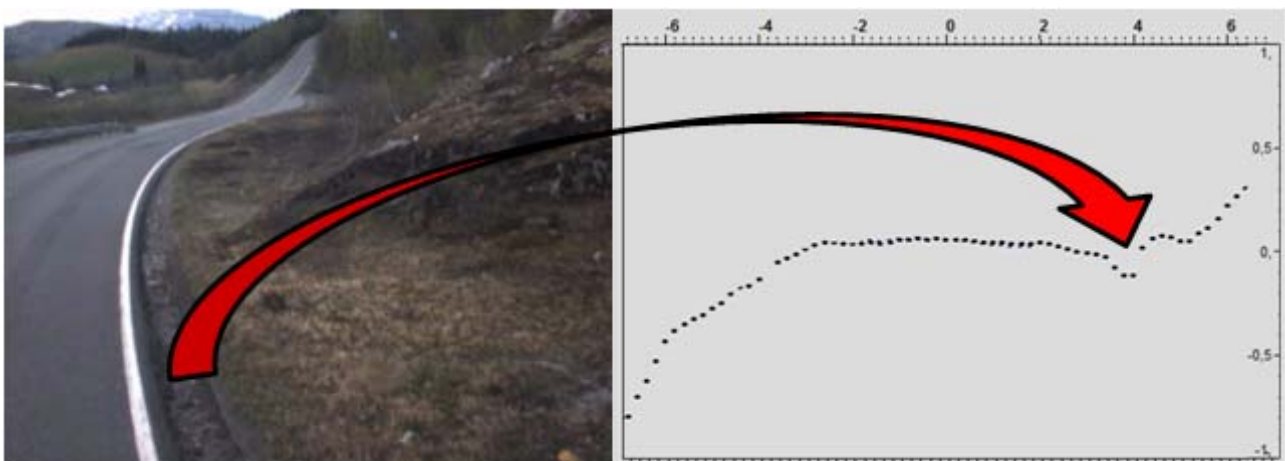
Erosion can cause significant damages. Figure 46 shows a section where water has washed out a remarkable amount of loose material from the edge of the road. This washout phenomenon can also be seen in the cross section from the laser scanner data (Right).

Figure 46: Unstable soil has filled the ditch and erosion can be seen on the still image at the edge of the pavement, and on the laser scanner cross section image (8900m).

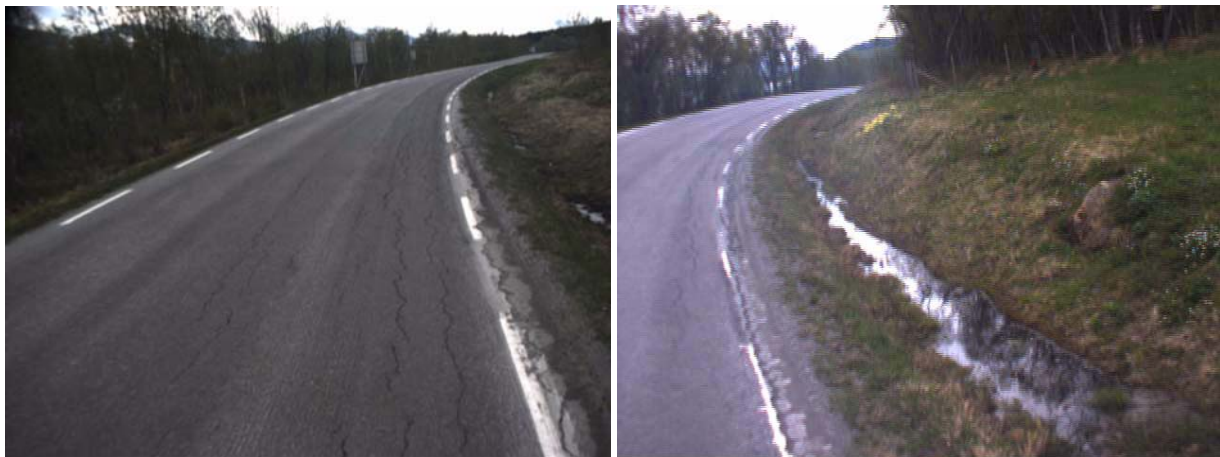
*Figure 47: Typical drainage shortages for side sloping road profile,
(chainage left: 1640m, right: 2900m)*

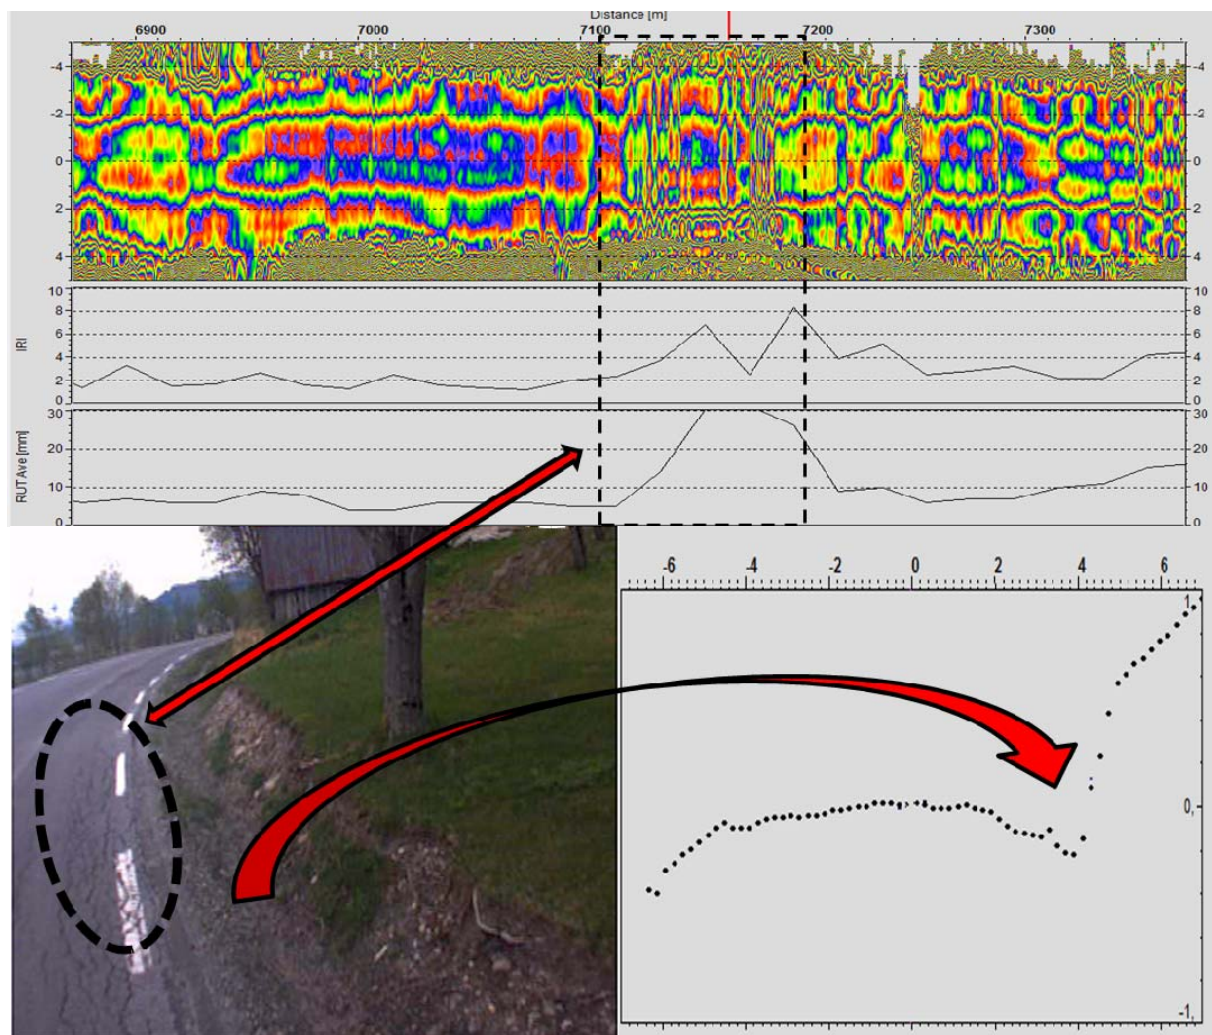
From chainage 7100m to 7250m there was a short section in side sloping road profile where the ditch on the upper side was shallow. Here there were visible damages in the pavement and the road profilometer data indicated higher rutting and roughness values. This section stands out from the surrounding data on the laser scanner pavement rainbow colour map (Figure 48).

Figure 48: Shallow ditch at chainage 7150m with high IRI and Rutting values, also the surface rainbow colour map (on top) shows deformations in the shape of the pavement surface. The laser scanner cross section image also shows that the gradient slopes towards the left whereas it should be sloped to the right side.

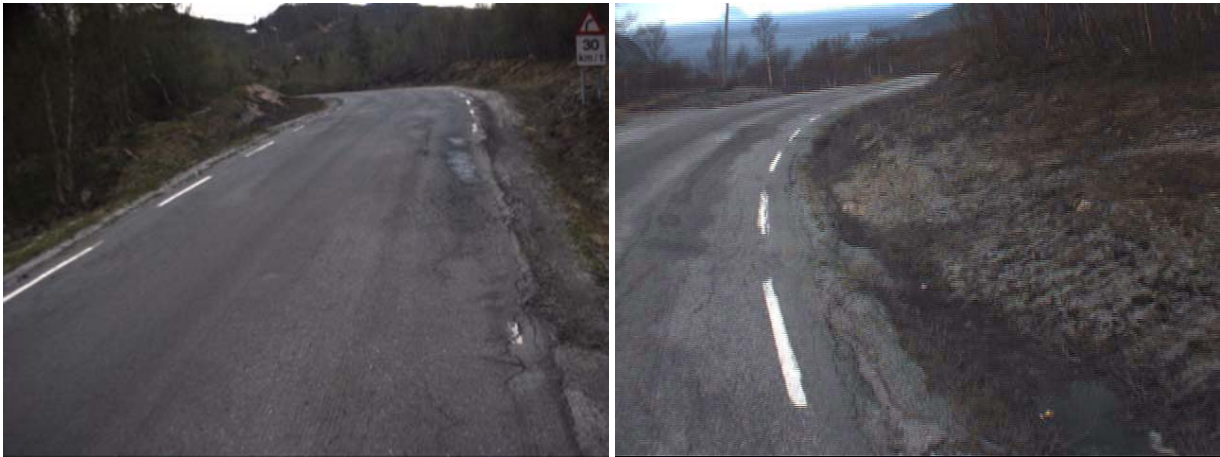
From around chainage 12000m to 27000m the road at first rose to about 300 metres on the mountainside and later came down again. Within this length there were some drainage deficiencies mostly in side sloping road profile. Because of the large elevation changes the risk of erosion needs to be taken into account if drainage improvement actions are to be carried out (Figure 49).

Figure 49: Drainage deficiencies (left: 13950m, right: 16740m).

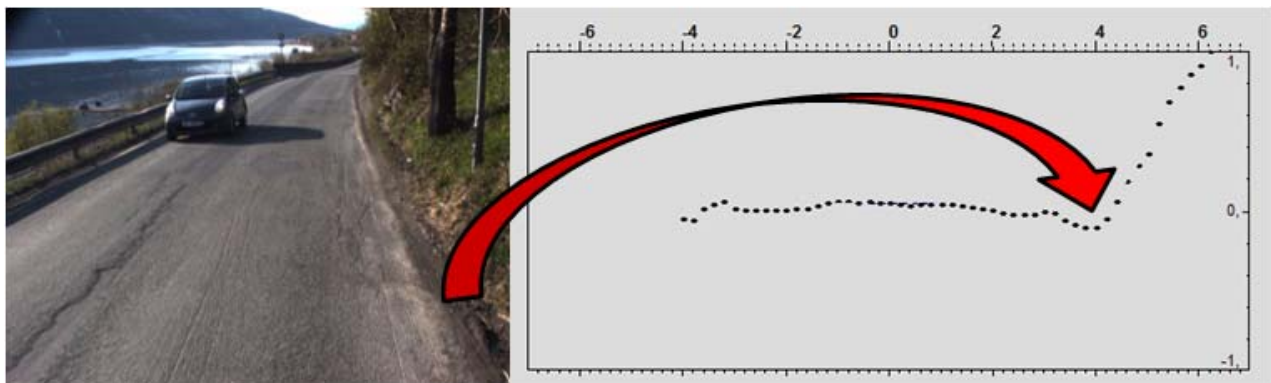
Figure 52: No room for a ditch, also trees and bushes close to the road (chainage 720m).

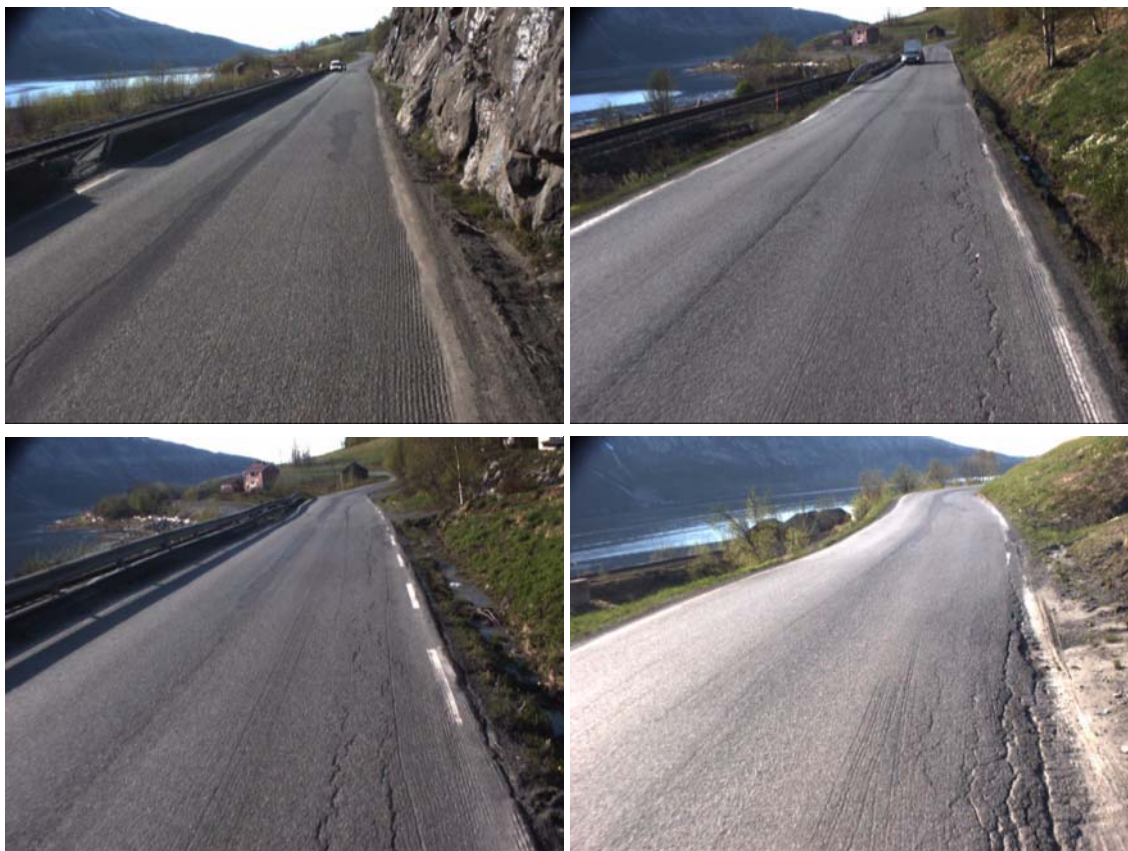
Figure 53: Drainage problems in steep side sloping road profile before the first tunnel, chainages shown from top left to bottom right: 850m, 1250m, 1330m and 1890m.

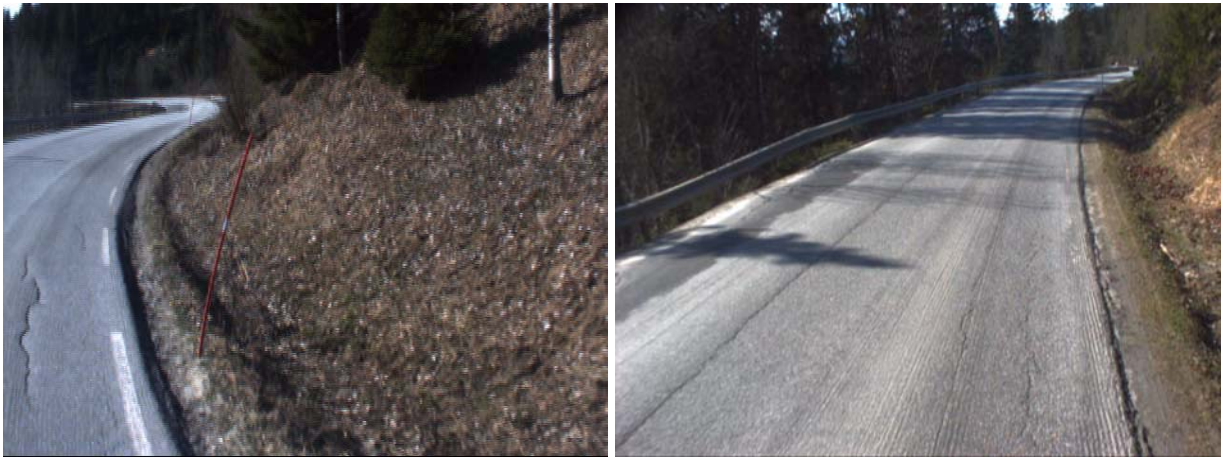
Figure 56: Inadequate ditch on the upper side of the slope, chainage left: 2380m, right: 3180m.

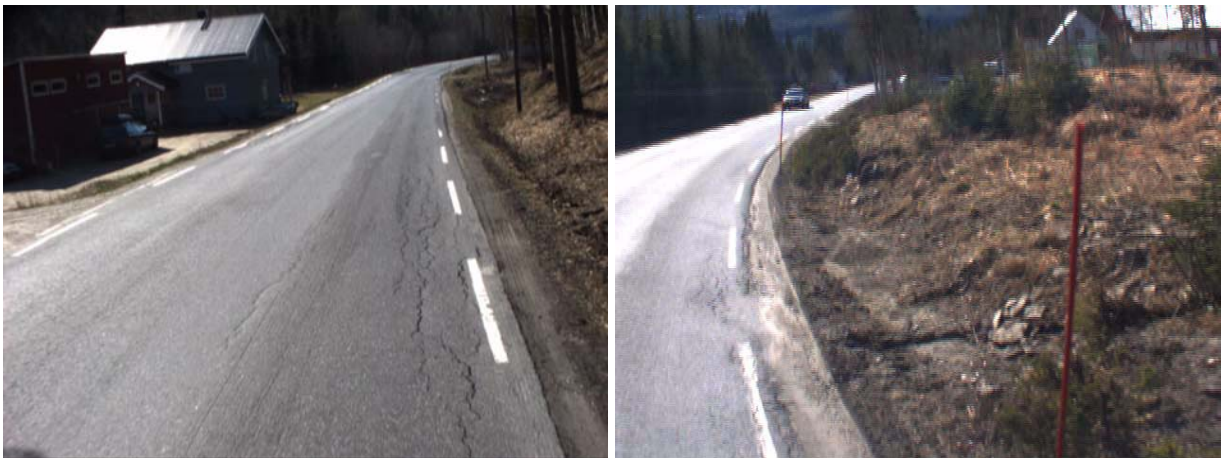
Figure 57: Unstable soil has filled the ditch and is blocking the water, chainage left: 3760m right: 5410m.

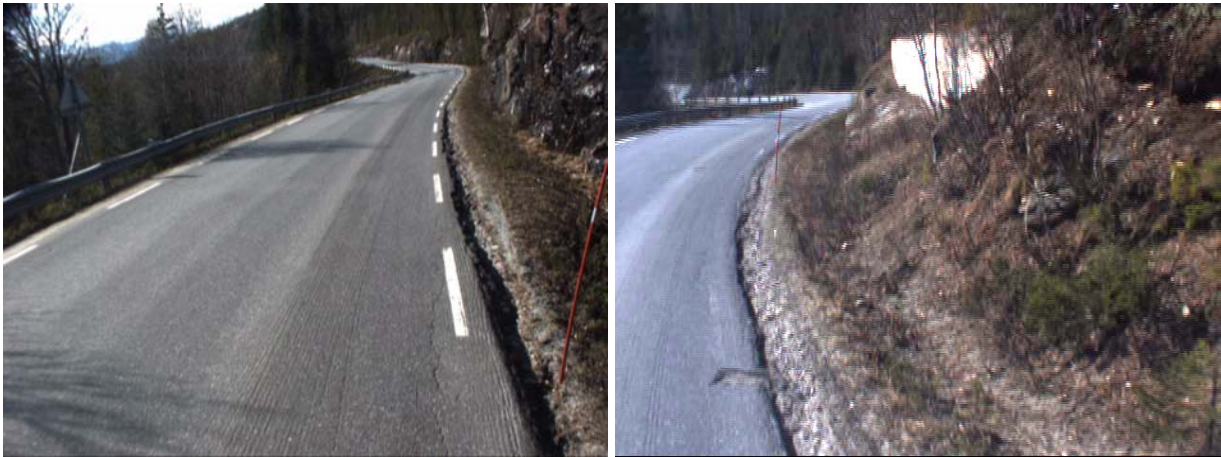
Figure 59: Erosion damages on the edge of the pavement, chainage left: 7650m, right: 8700m.

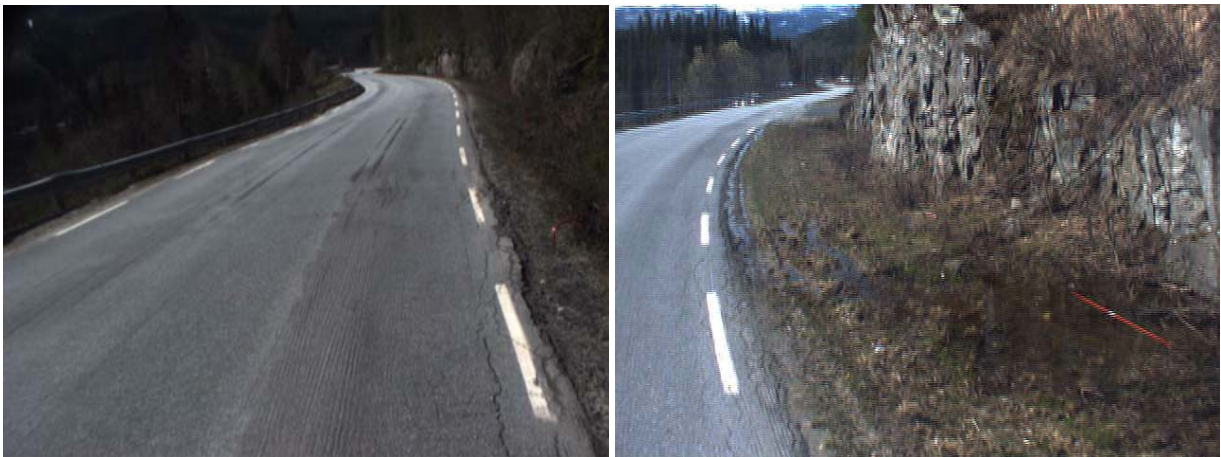
Figure 60: Problems in the upper side of the side sloping road profile, chainage left: 810m, right: 3480m.

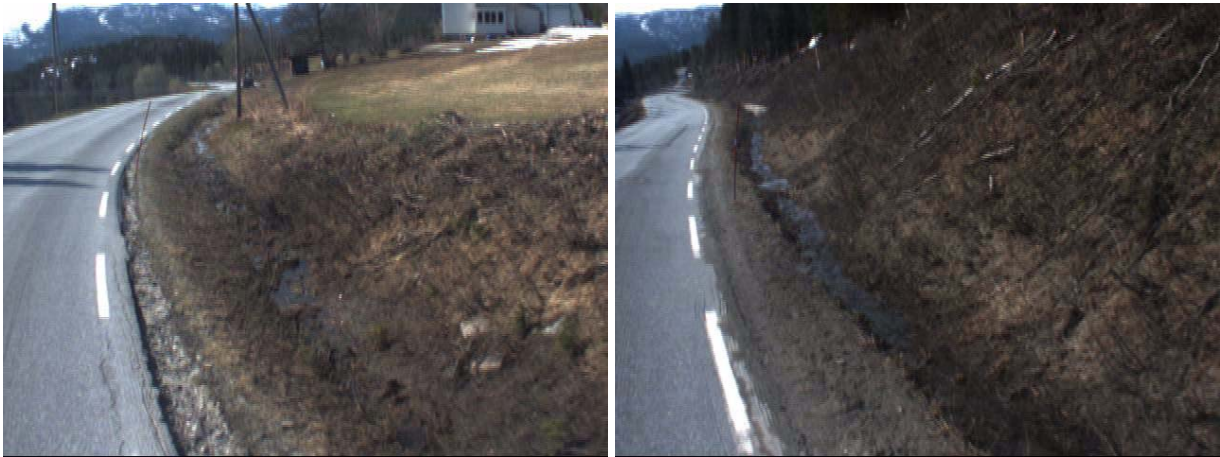
Figure 61: Shallow ditches and verge (also erosion damage on the left photo) were hindering the water flow, chainage left: 3700m, right: 4170m.
