SUMMARY OF DRAINAGE ANALYSIS IN REGION NORD, NORWAY

Demonstration Project Report

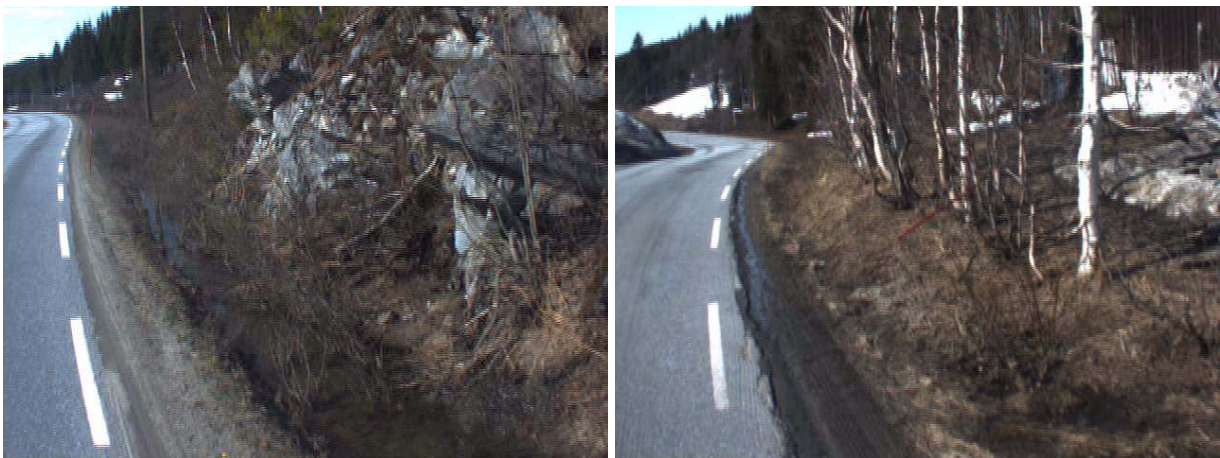
Figure 62: Inadequate drainage, chainage 4870m and 5060m.

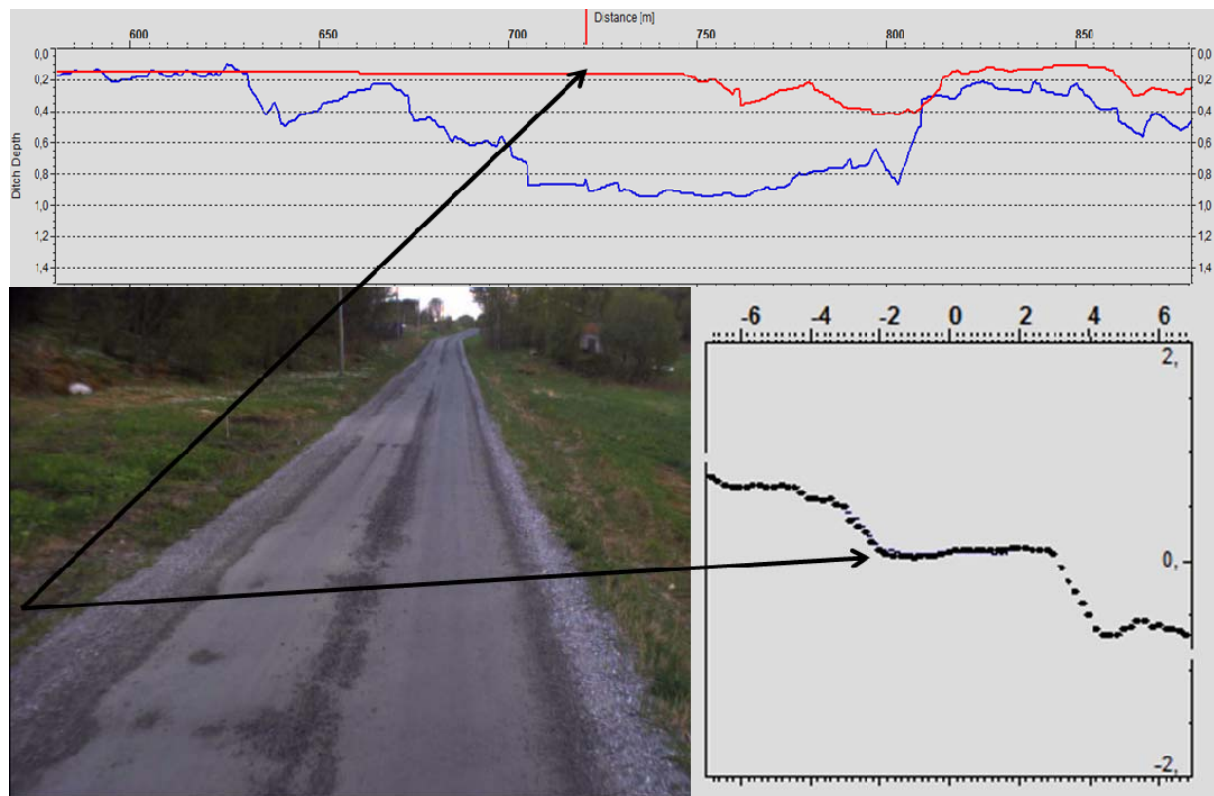
Figure 63: On the upper side of the slope the ditch was inadequate which is seen both on ditch depth data (top field) and on cross section data (lower arrow). Chainage 722m.

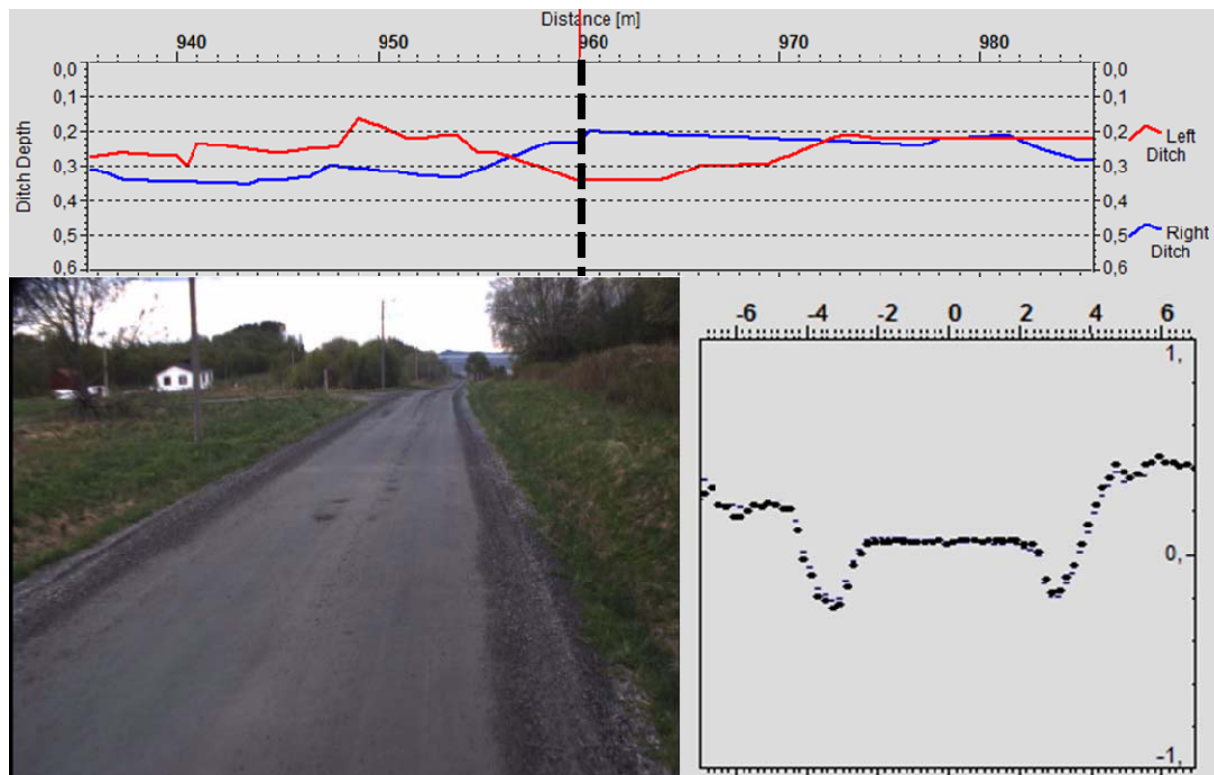
Figure 64: Shallow ditches on both side of the road, chainage 960m.

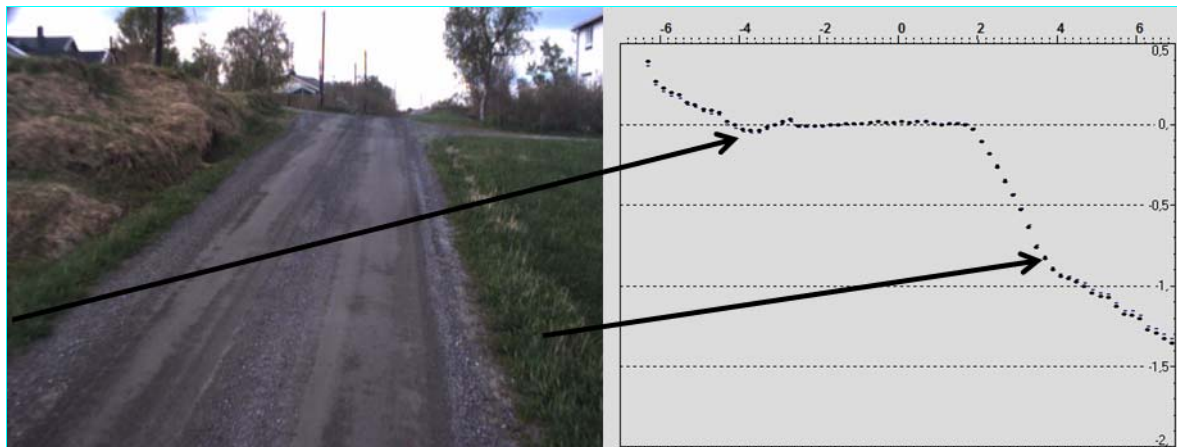
The ditch on the upper (left) side at chainage 3060m was inadequate as can be seen in photograph and cross-section in Figure 65 (upper arrow). On the right side, which was the lower side of the slope, a ditch was not needed and the drainage was Class 1 (lower arrow).

Figure 65: Inadequate ditch on the upper side of the slope, chainage 3060m.

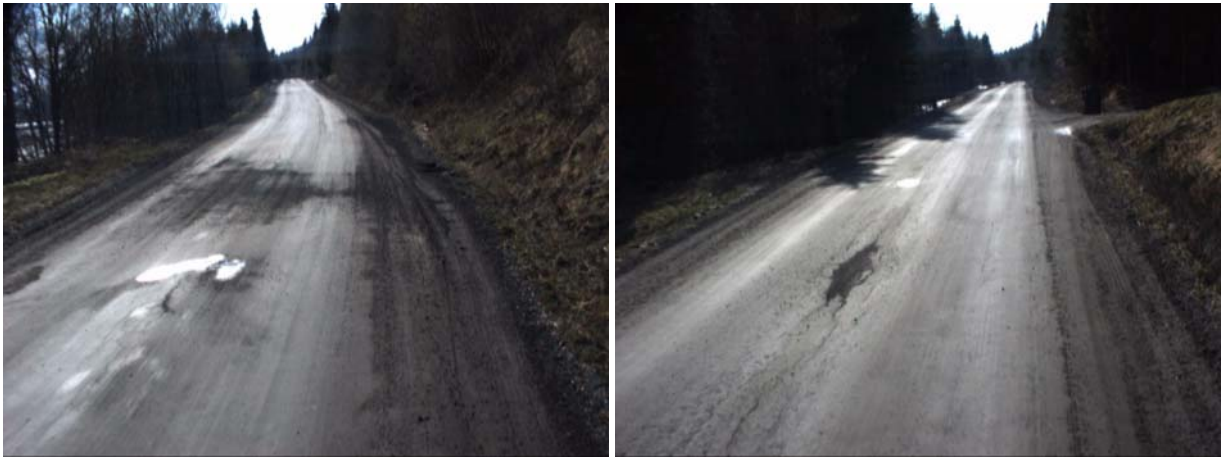
Figure 67: Drainage deficiencies on the upper side of the slope (Chainage 1330m and 1440m). Poor drainage is also causing Mode 2 deformations on the road, which can be seen as cracks in the road centre.

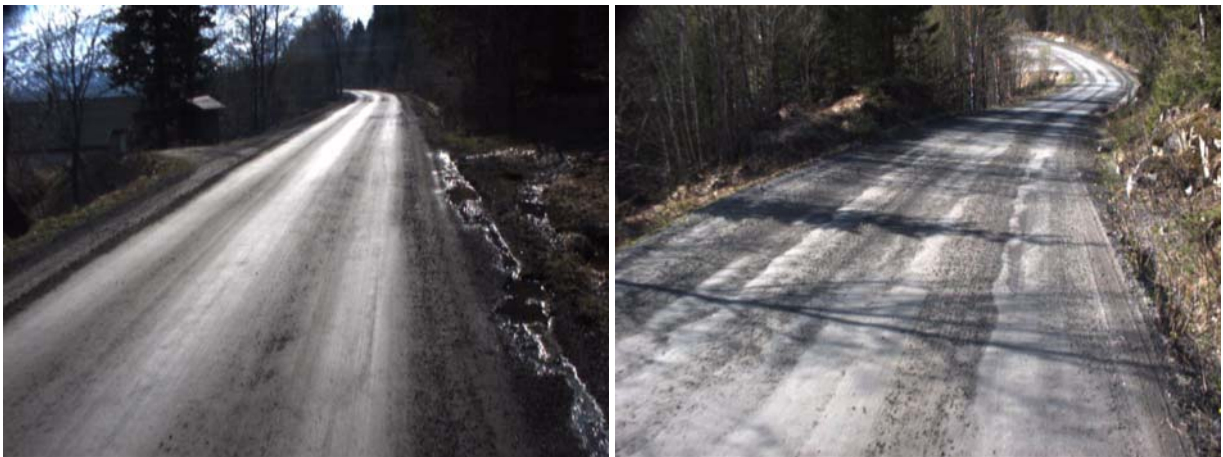
Figure 68: Drainage deficiencies on the upper side of the slope (Chainage 2130m and 4840m)

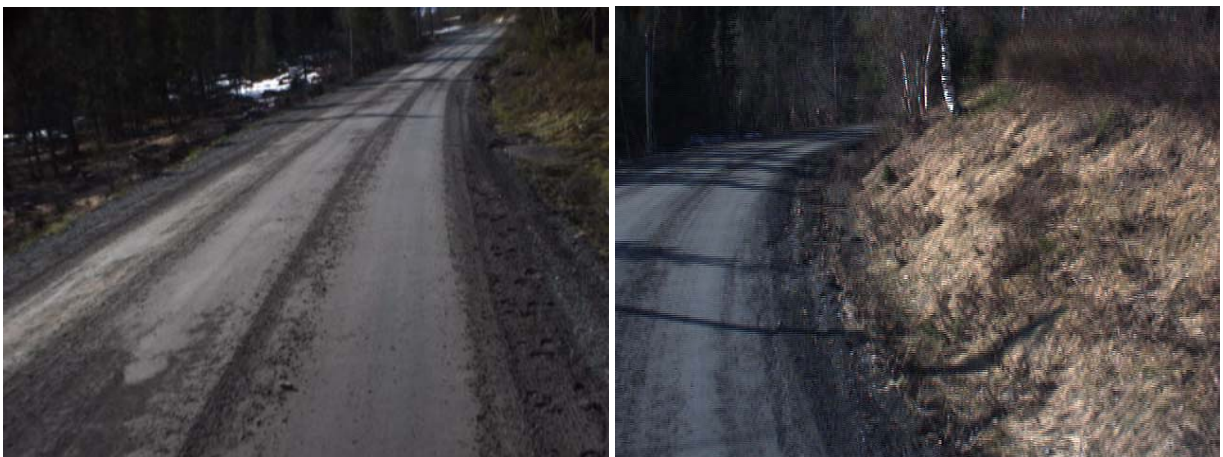
Figure 69: Drainage deficiencies on the upper side of the slope (Chainage 5430mm and 7600m)

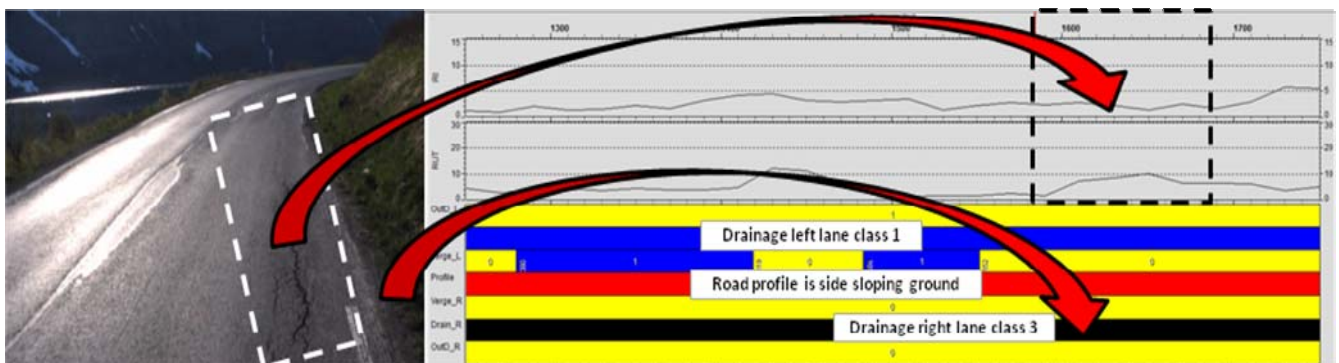
Figure 76: Drainage problems and severe damages on the pavement on the right lane. Profilometer data (upper arrow) shows low values which do not reflect the actual condition of the road. (chainage 1580-1680m).
