VEHICLE AND HUMAN VIBRATION DUE TO ROAD CONDITION

A Report from Studies on Low Volume Roads in the EU Northern Periphery of:

- Demonstrations of Truck Ride Measurements in ROADEX Partner Areas
- Effectiveness on Isolation of Ride Vibration by a Tyre Pressure Control System
- Impact from Road Maintenance Standard on Truck Drivers Working Environment

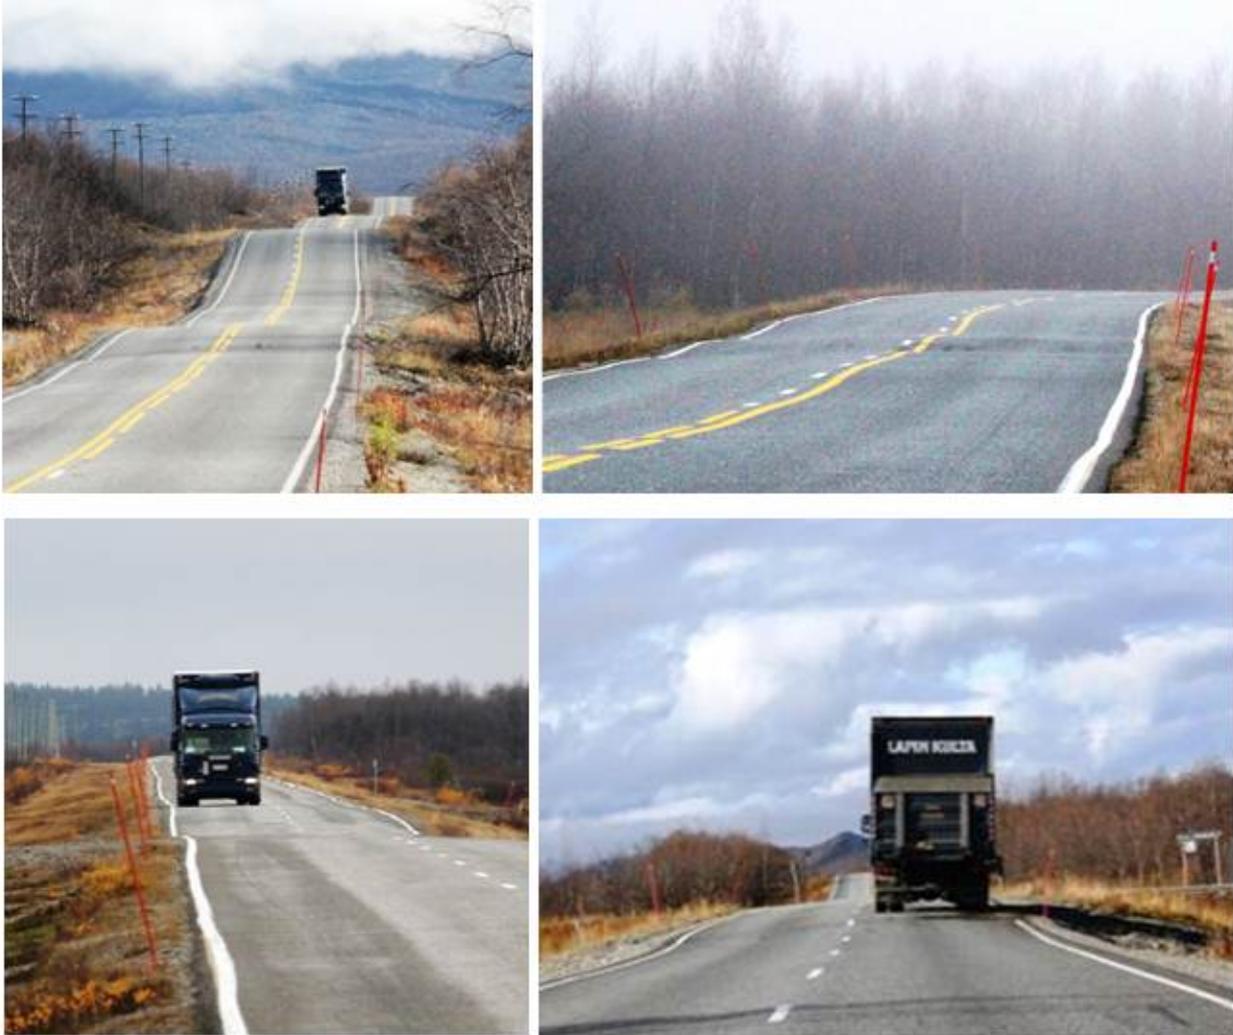
Many sections of Highway 21 are very undulating, with frequent dips and crests. The subarctic climate is very cold and some parts of the road are built on permanently frozen (“permafrost”) soils. In frozen condition, soft soils such as peat and clay can have high bearing capacity almost comparable to cured Portland cement concrete. After paving the road with black asphalt, increased absorption of solar energy makes the ground warmer. This causes the soil beneath the road structure, otherwise permanently frozen, to begin to thaw during the warmest summer days. As the peat slowly thaws, it dramatically loses bearing capacity. As a result thawing permafrost can bring extreme settlements, as seen on the photographs in Figure 10, and thus very poor ride quality.

Figure 10 Thawing permafrost under Highway 21 gives severe settlements and a rough ride

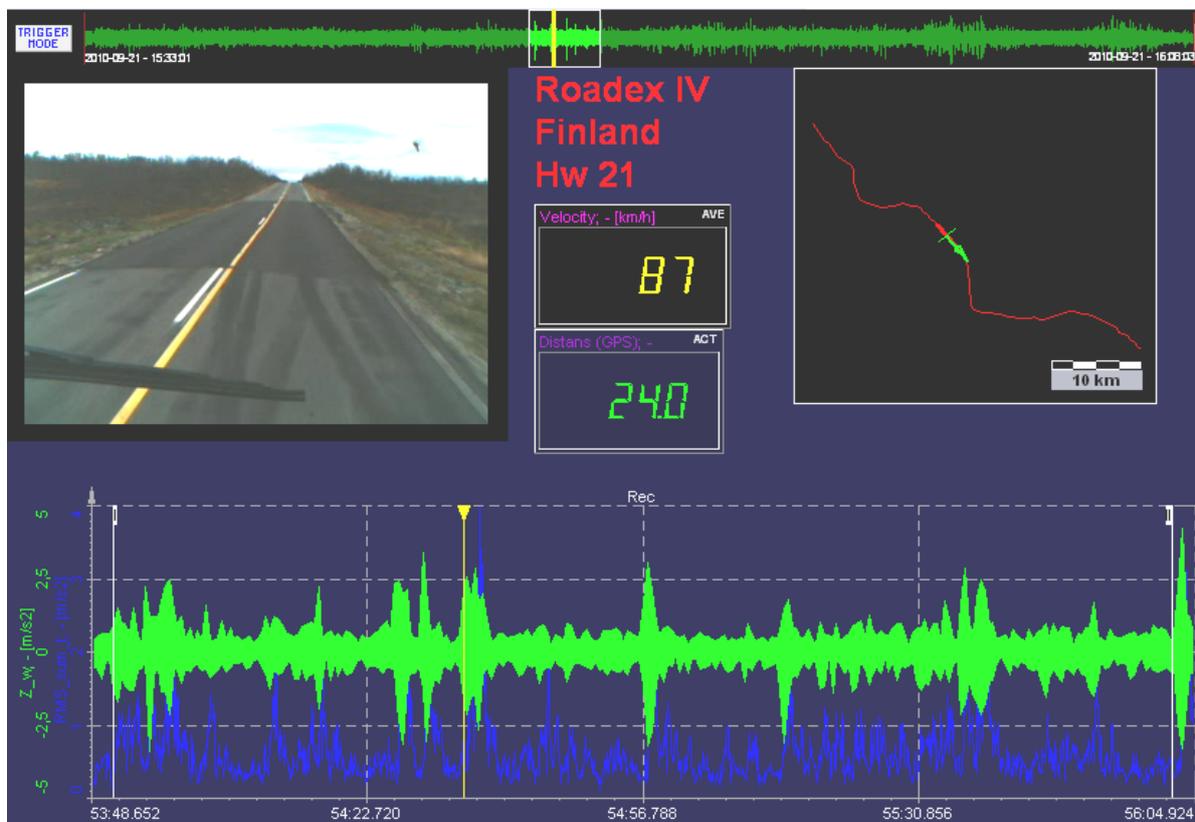
Good practice in the ROADEX Partner areas recommends that the transversal edge of the new asphalt should not be placed “layer-on-layer” with the old asphalt, but cut down into the same elevation as the surface of the old asphalt. For this, good asphalt patch works require the use of a small milling machine. Such machines are available on the market, but are currently not used in all highway pavement maintenance projects.

Figure 11 Patch repair zone at Highway 21: Intense mechanical shocks on the driver seat

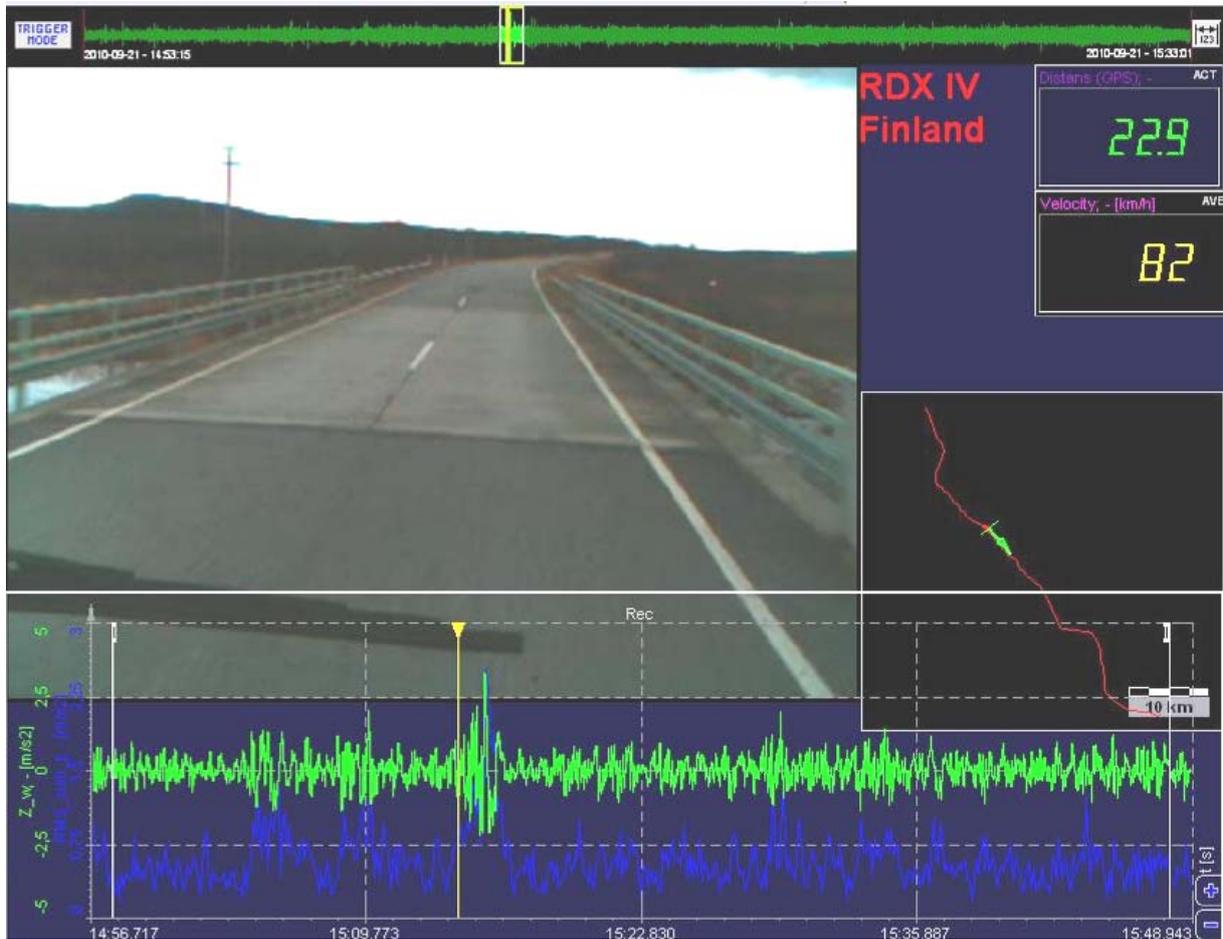
At many bridges, the backfill behind the bridge front wall is inadequately compacted during construction. This can result in severe settlement at the bridge joint, and thus also to intense ride vibration in vehicles. Measurements taken in the study show numerous cases of high compression stresses in the truck driver's spine at improper bridge joints, such as seen in the 1 minute graph at the bottom of Figure 12.

Figure 12 Intense ride vibration at an improper bridge backfill

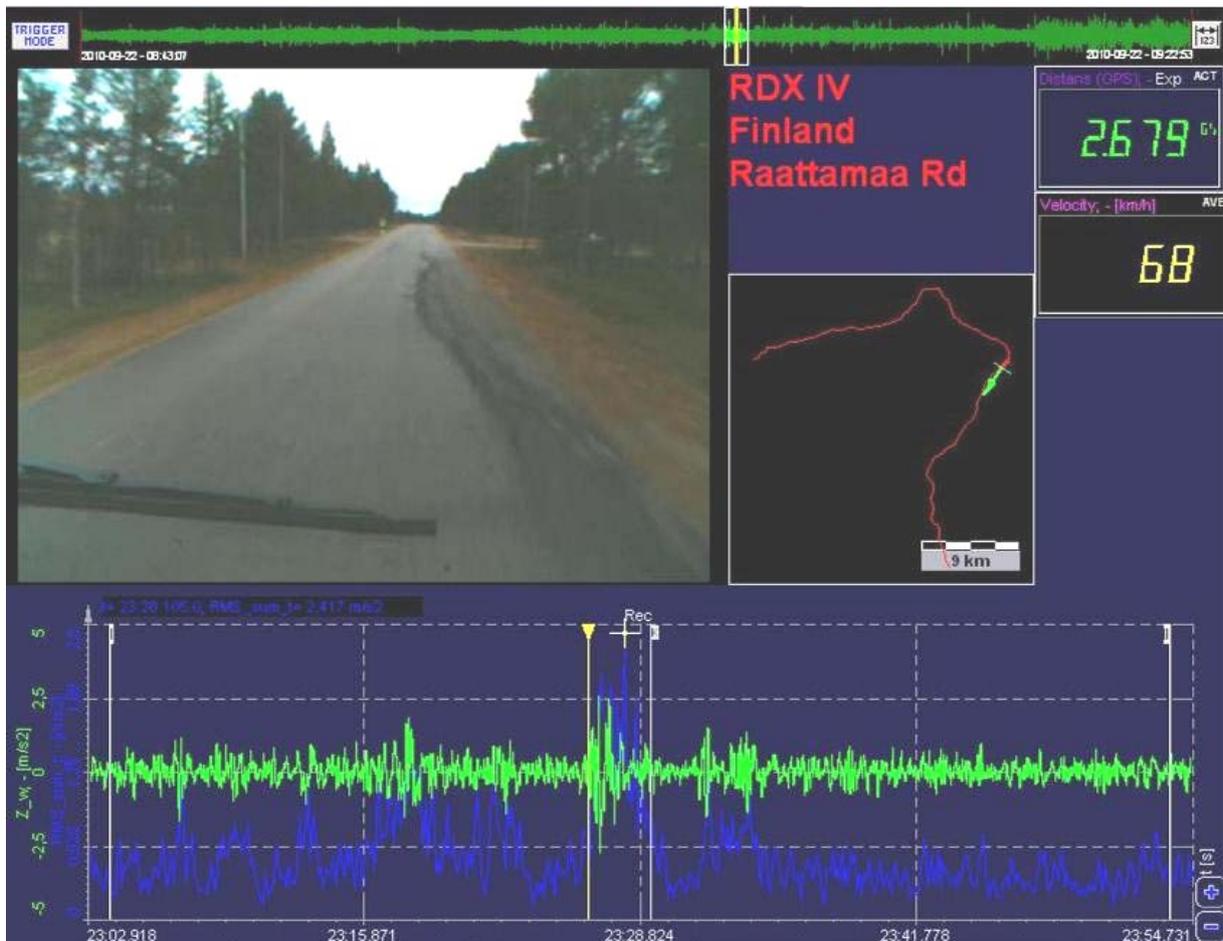
Figure 14 Intense truck ride vibration at deformed pavement edge on Road 956/957

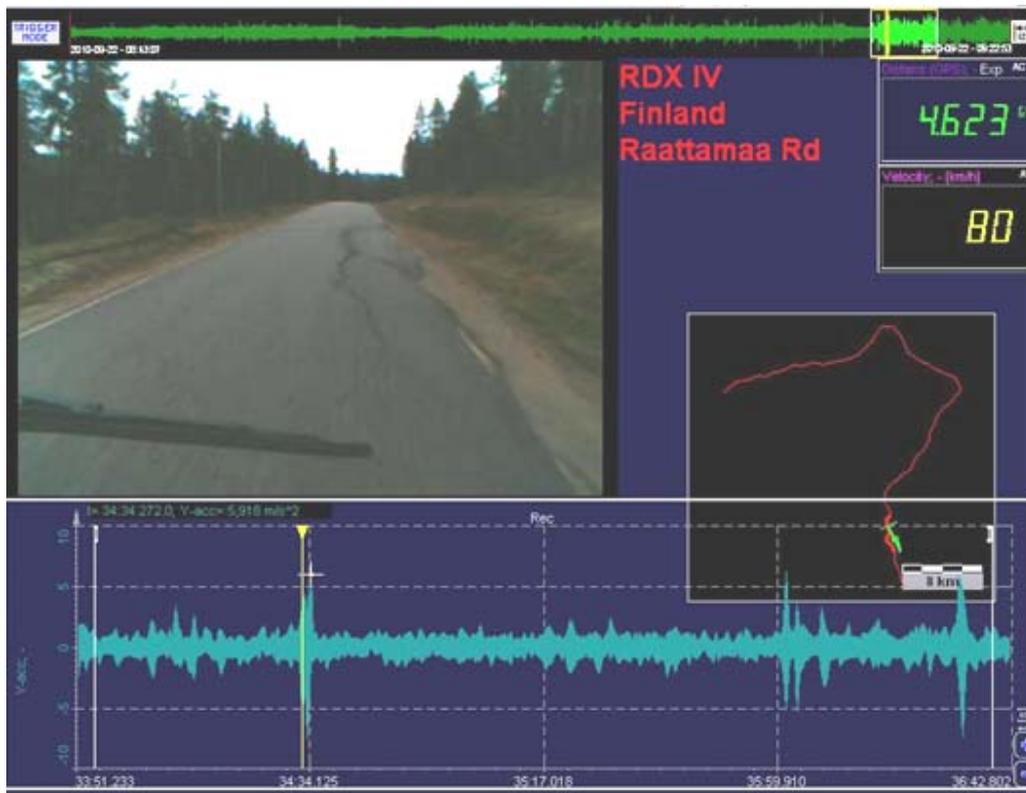
Figure 15 Hazardous truck cab lateral vibration at deformed pavement edge on Roads 956/957

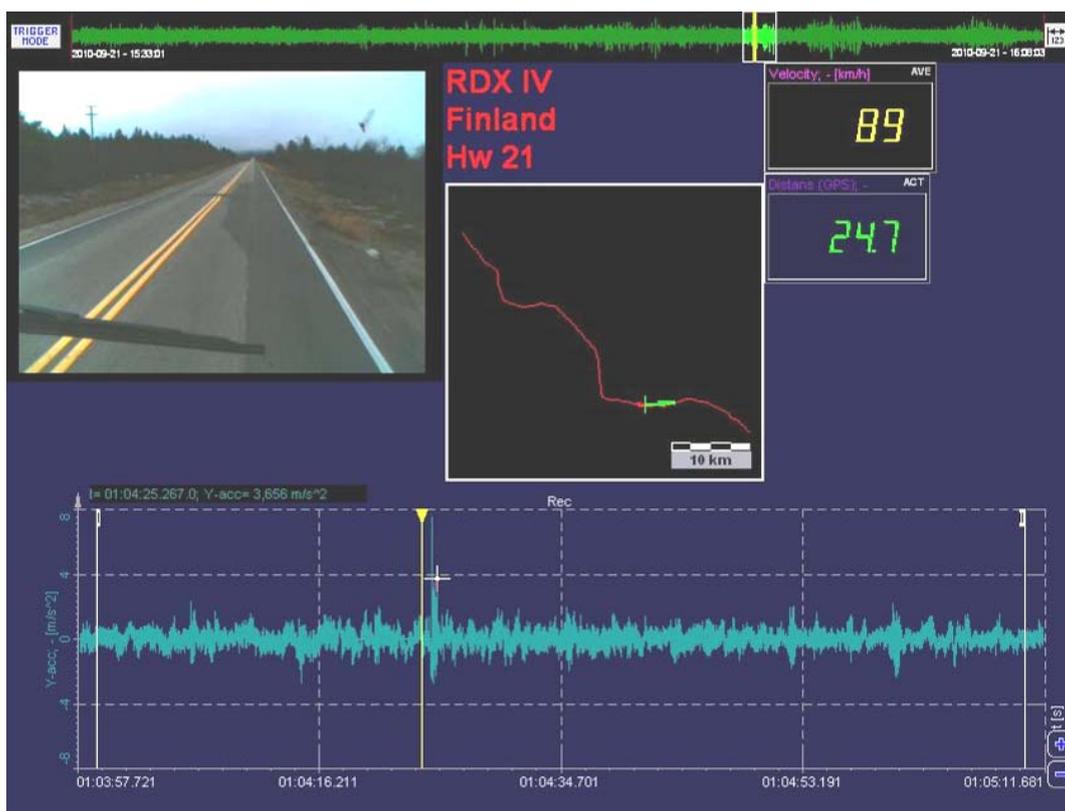
Road sections with severe edge damage can yield a RBCSV value above the limit value 0.30 %, which was established in the ROADEX III project on "*Health Issues Raised by Poorly Maintained Road Networks*". Pavement edge damages worse than RBCSV 0.30 % should therefore be repaired as soon as practically possible, with a warning sign being raised until the road repair is completed. Truck operators should also educate their drivers to drive slowly at this kind of pavement damage.

Figure 16 Hazardous lateral truck vibration at deformed pavement edge on Highway 21

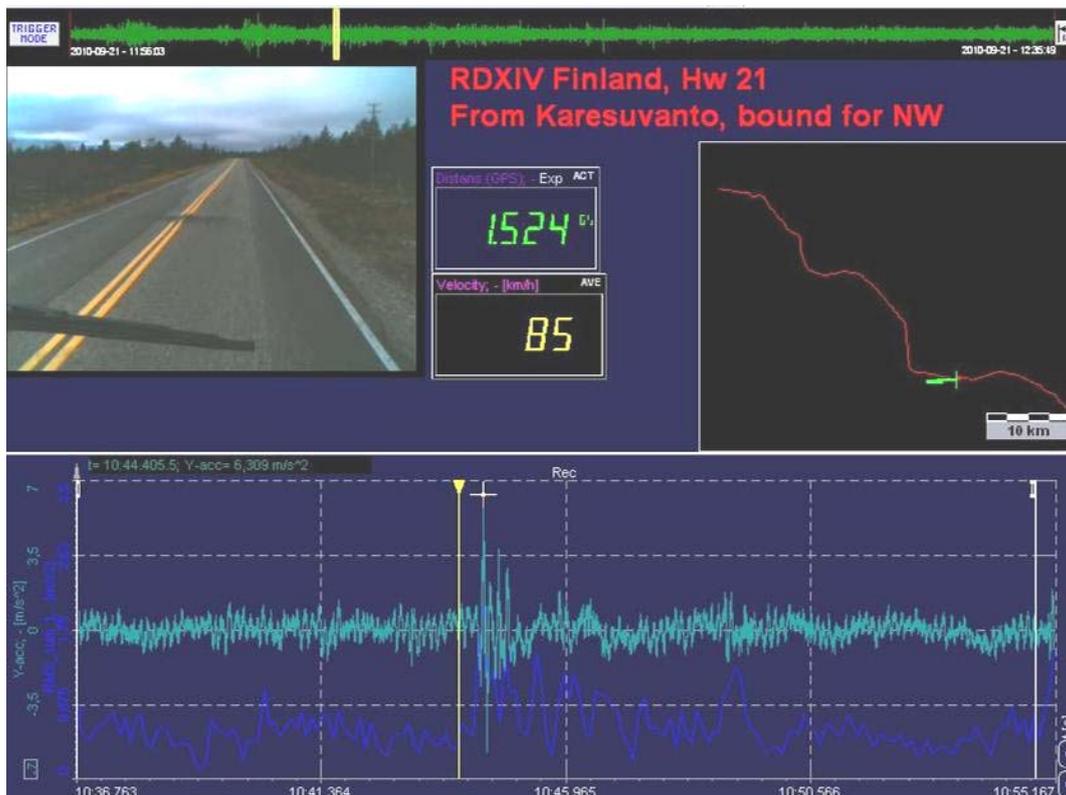
When driving on many roads in the cold climates of the EU Northern Periphery, other sources of both roll-related lateral buffeting and high compression stress in the driver's spine are freezing boulders rising up through the road. Every winter the road structure in cold climates heaves due to frost. In case of a large boulder in the structure, during the spring thaw period, fine material may migrate down through the soil via voids and come to rest under the boulder. This makes it impossible for the boulder to sink down as much as the rest of the road. This process is repeated annually. So as years pass by, the boulder rises more and more by the accumulation of fines beneath. Eventually the rising boulder will create such a large bump, that it will require to be dug out by an excavator. This is a very costly road repair action in paved roads but, as seen in example in Figure 17, a rising boulder can result in hazardous lateral buffeting of the truck (here 6.3 m/s^2). The high cost for the repair of rising freezing boulders can therefore be paid back by the large benefit of preventing hazardous lateral buffeting of heavy trucks and buses with a high positioned centre of gravity (CoG).

Figure 17 Lateral buffeting of test truck at a rising boulder on the road centreline on Highway 21

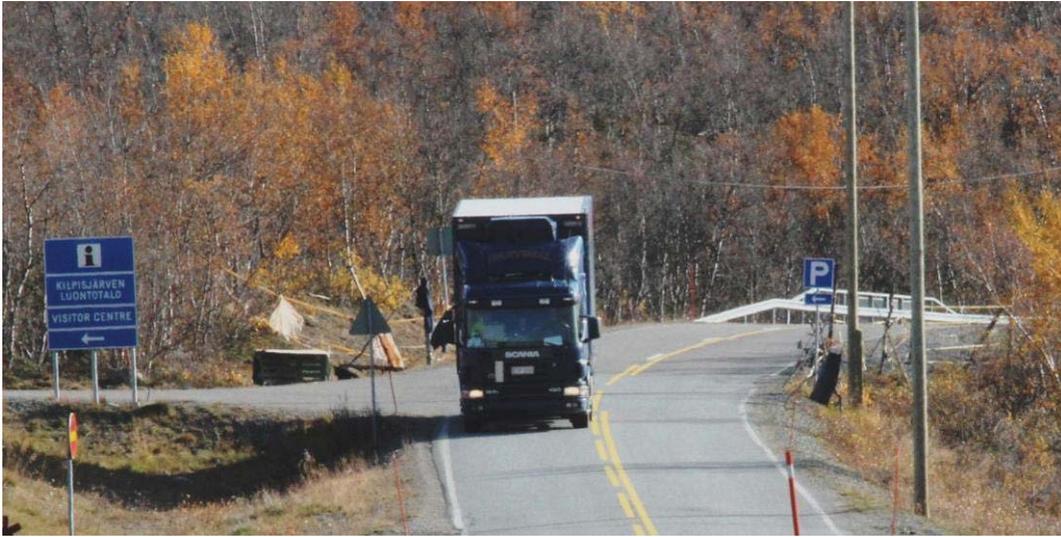
Several outcurves on the demonstration route in Finnish Lapland were perceived to be improperly banked. One example was at the sharp curve at Kilpisjärvi, as seen in Figure 18.

Figure 18 Test truck at an improperly banked outercurve on Highway 21 in Kilpisjärvi

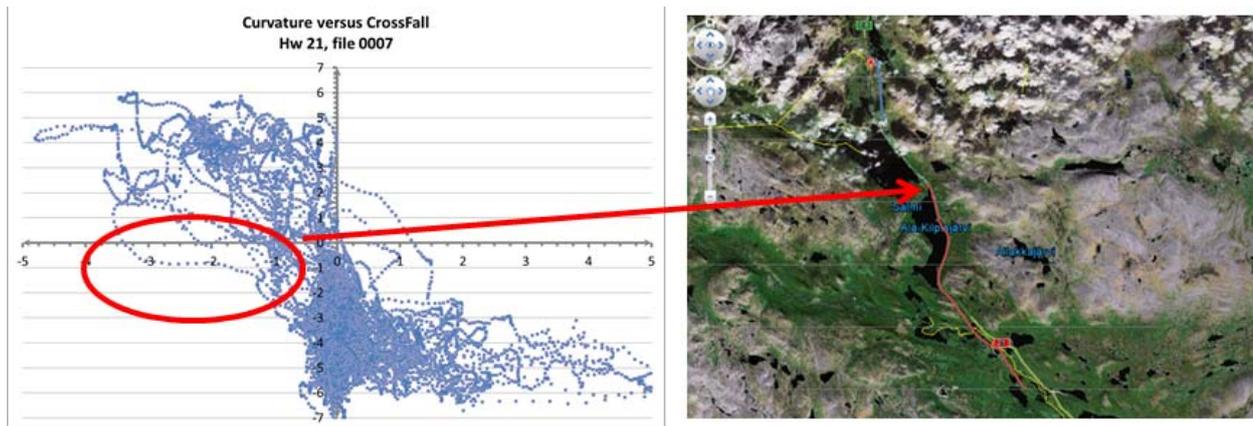
With accurate data from a laser/inertial Profilograph (see Figure 3) averaged over 1 m steps, it is relatively easy to objectively identify sharp outcurves with adverse cross slope (camber). Such curves have a high need for side friction, which can bring a high risk for loss-of-control crashes. Risky outcurves are recognized by having a combination of negative curvature and negative cross slope, as seen in the left hand graph in Figure 19. Curvature expressed as $1000/\text{radius}$ [m] is plotted on the x-axis, while crossfall [%] is plotted on the y-axis. By filtering the Profilograph database, it is easy to find the coordinates of the improperly banked road curve, such as marked in the right hand map of Figure 19.

Figure 19 Profilograph data reveals an improperly banked sharp outer-curve at Kilpisjärvi

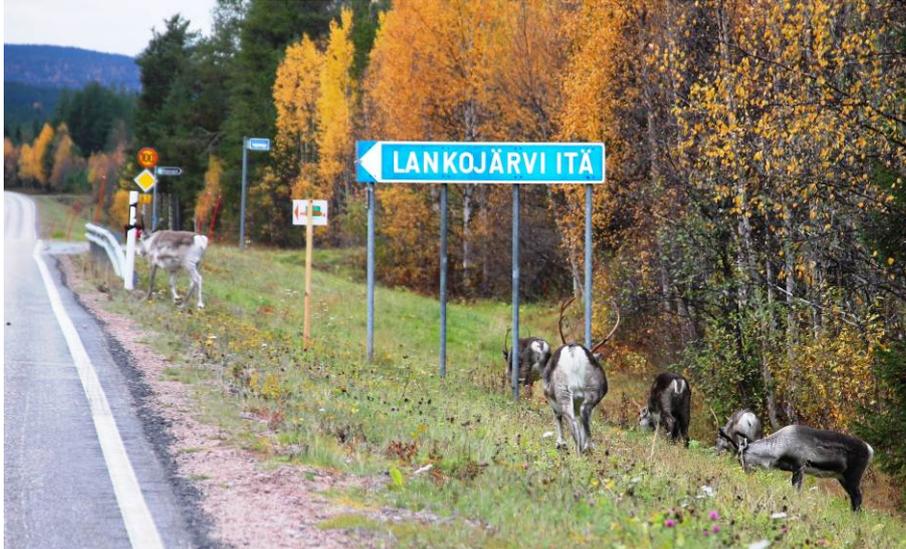
Reindeers are nice and cute in front of Santa's sledge, but they do post a serious crash risk when in front of a car at highway speed on an icy road. Wild reindeers, as seen in Figure 20, are a common crash risk in Lapland. Roadside fencing may be an effective measure against wild animals on these roads.

Figure 20 Wild reindeers are a crash risk on Lapland roads

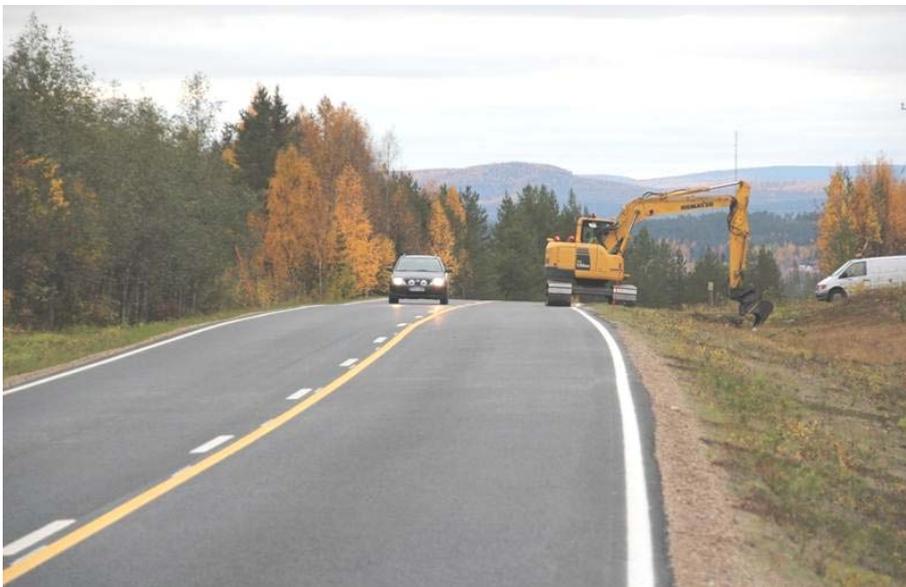
At several road work zones, collision hazards were present without relevant warnings for stationary or low speed heavy road construction machines on the road. An example is shown in Figure 21.

Figure 21 An excavator blocking part of the National Highway 21 without any warning signs

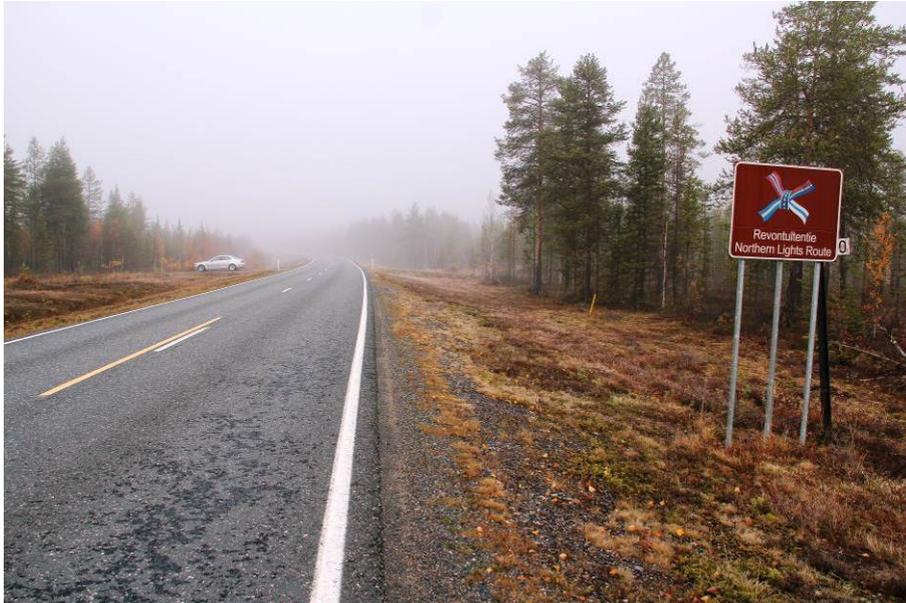
Long sections of the Finnish roads surveyed showed surface damage “ravelling”, as illustrated in Figure 22. This kind of damage brings many waves in the 50 – 500 mm Megatexture band. Megatexture is known to cause high tyre/road noise, bringing vehicle internal noise as well as external noise.

Figure 22 Pavement surface ravelling at Highway 21

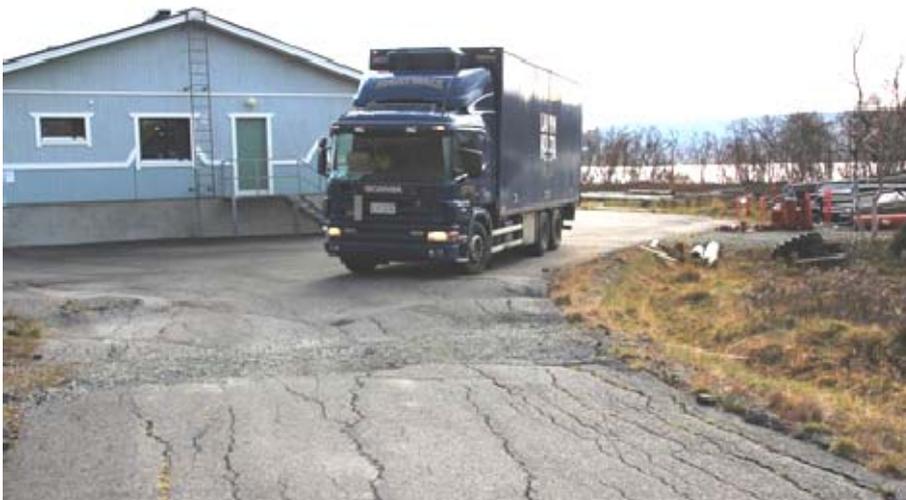
Severe frost-related permanent damages as seen in Figure 23 are also common in Lapland.

Figure 23 Road damages caused by frost action in the late winter season

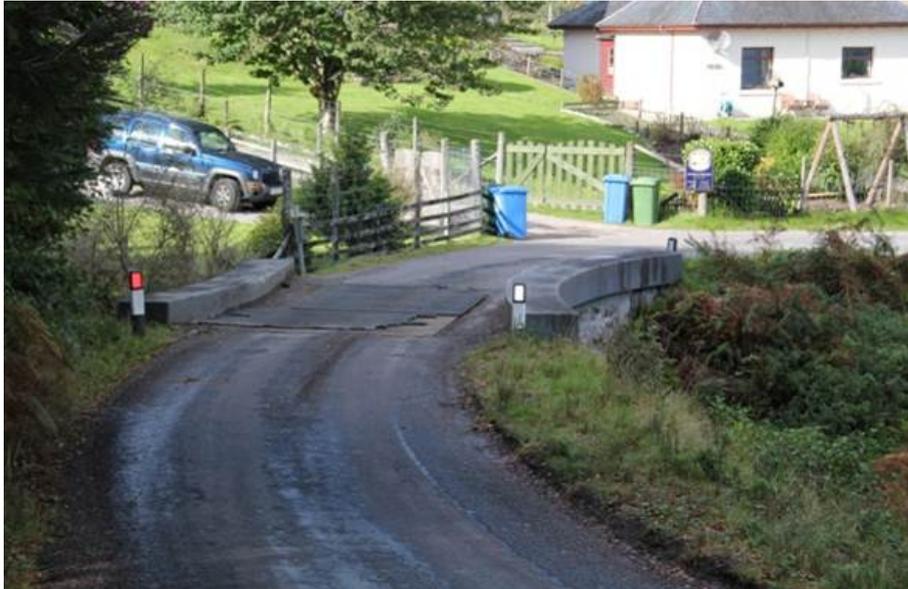
Figure 32 Damaged bridge deck at Road B8005 from Banavie to Loch Arkaig

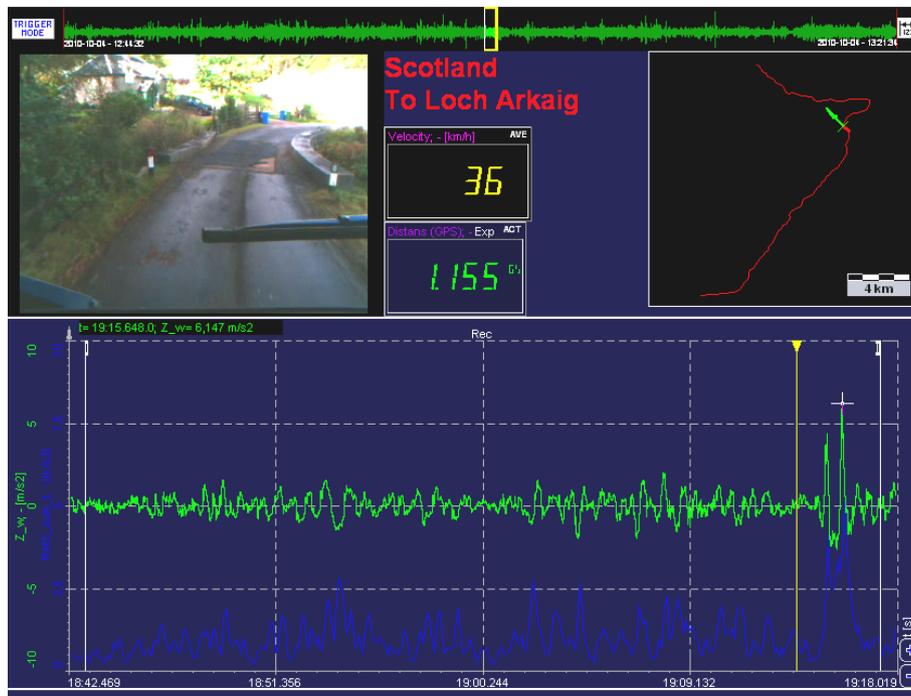
Figure 33 Powerful bumps at one of the ancient bridges on Road B8005

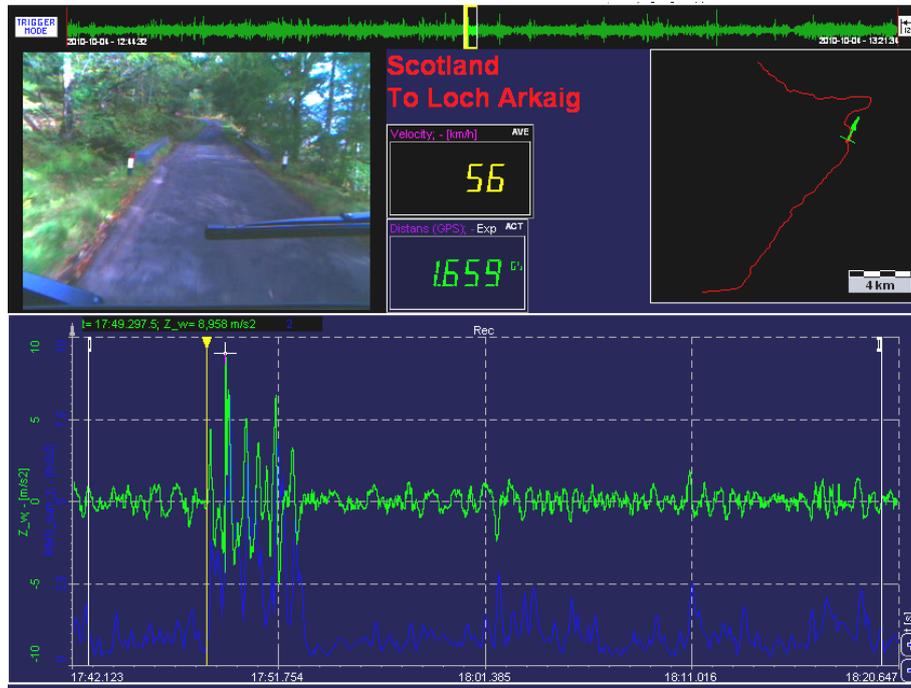
The second example of an “unhealthy” bump is an arch-shaped bridge, also on Road B8005, as shown in Figure 34 and Figure 35. Travelling northbound at 56 km/h, the truck almost went airborne, when it was accelerated vertically with 0.9 G. Take-off occurs at 1 G (10 m/s^2). When the truck went southbound at the lower speed of 43 km/h, the driver incurred a maximum vertical vibration of 5.7 m/s^2 , as seen in the 40 second long graph. Note that the intensive vibration started tens of metres before the bridge itself, when riding southbound. This indicates that the causes of the truck ride problem included settlements in the backfill behind the bridge abutment.

Figure 34 The Northbound truck almost went airborne (0.9 G) at the bridge on B8005

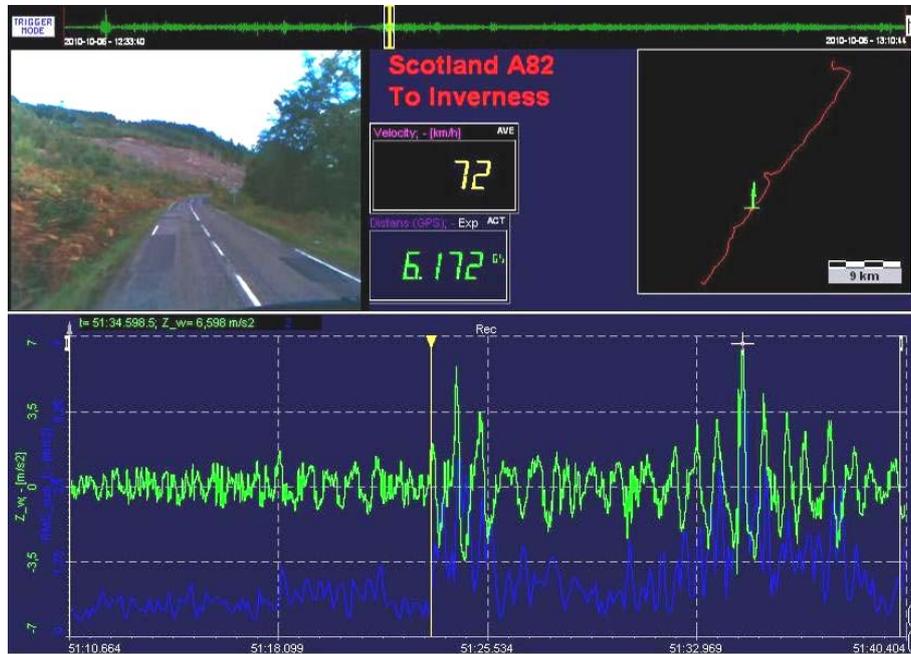
Patch repair can be necessary before an overlay is funded. However, the result of the patch work is often still a rough road, as can be seen in the results from highway A82 in Figure 37.

Figure 37 Rough truck ride over patches on A82 bound for Inverness

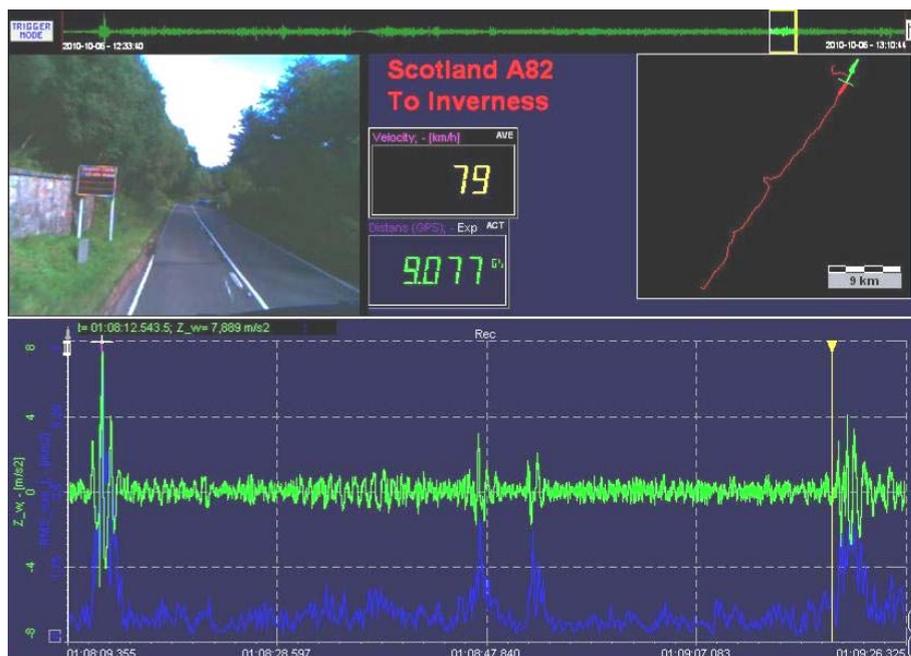
In the Highlands, as well as in the other ROADEX Partner Areas, a frequent bumpy problem is the transversal joint at the start of overlays and patch repairs. See the example in Figure 38.

Figure 38 Impulse-response in the truck at a rough transversal joint on A82

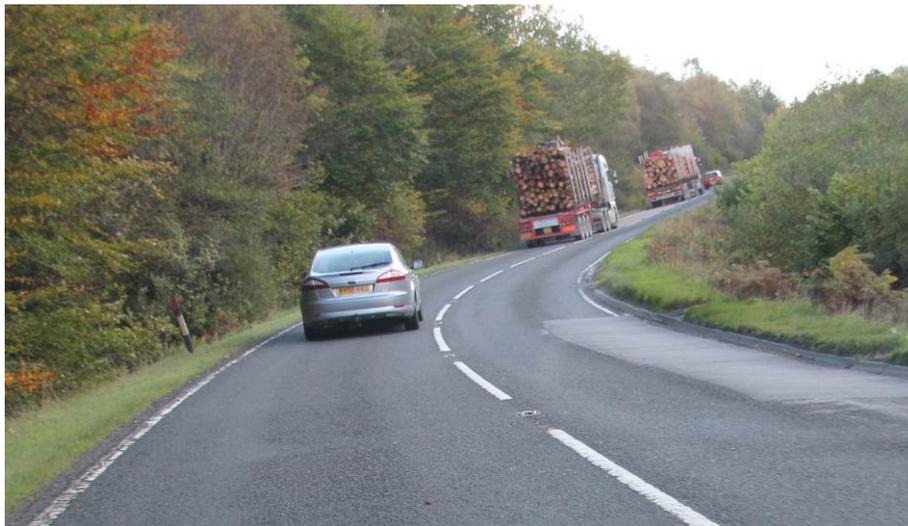
Just as with the route in Finnish Lapland, the route in the Scottish Highlands included several outercurves that were seen to be improperly banked. One example was the sharp curve shown in Figure 41. Rollover and various other types of loss-of-control crashes cluster at this kind of “flat curve”, indicating that they are extremely hazardous. With accurate data of crossfall and curvature from a road network condition survey, it is easy to identify curves with adverse camber, such as demonstrated in the data from Finland in Figure 19. A more advanced analysis of improperly banked outer-curves, relating to design codes for geometry of new roads, was presented in the ROADEX III study “Health Issues Raised by Poorly Maintained Road Networks” (2008).

Figure 41 A82 has many improperly banked and thus hazardous sharp outer-curves

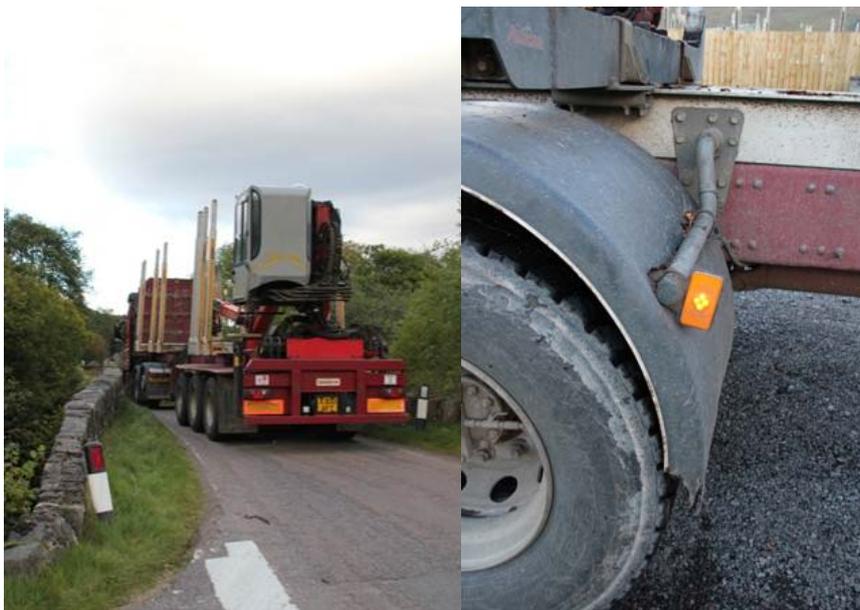
Figure 44 Narrow sections cause frequent scratching on tyre sidewalls and fenders

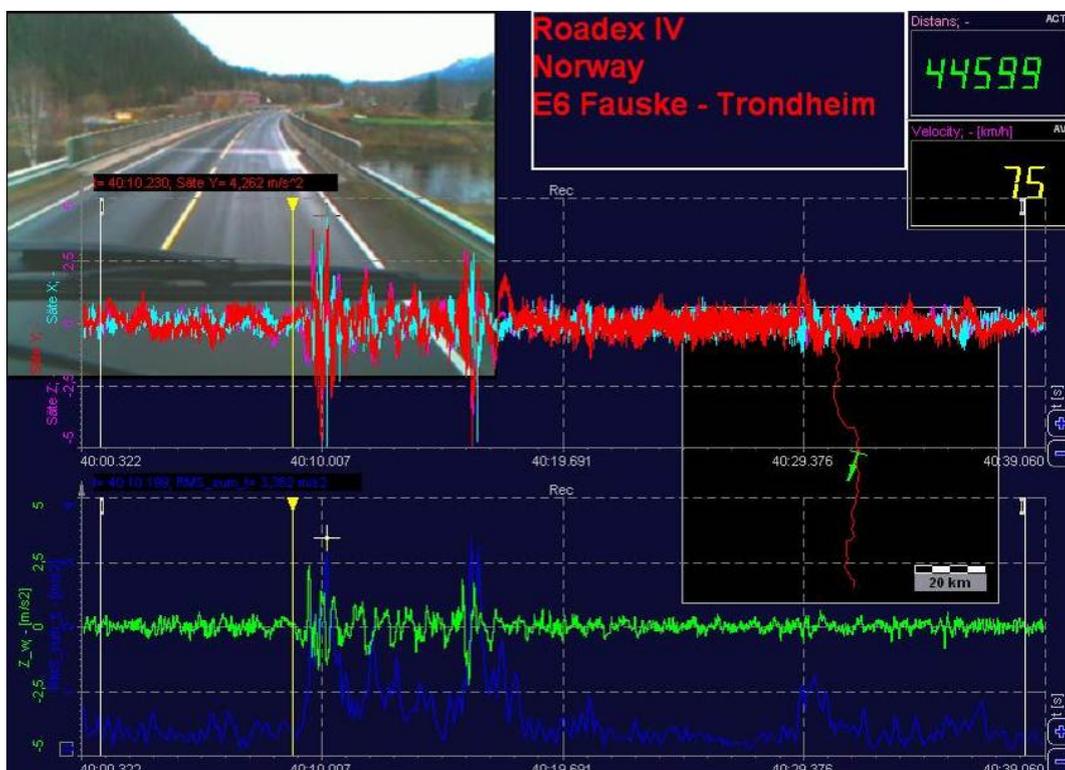
Figure 51 Unhealthy truck ride at a bridge on E6

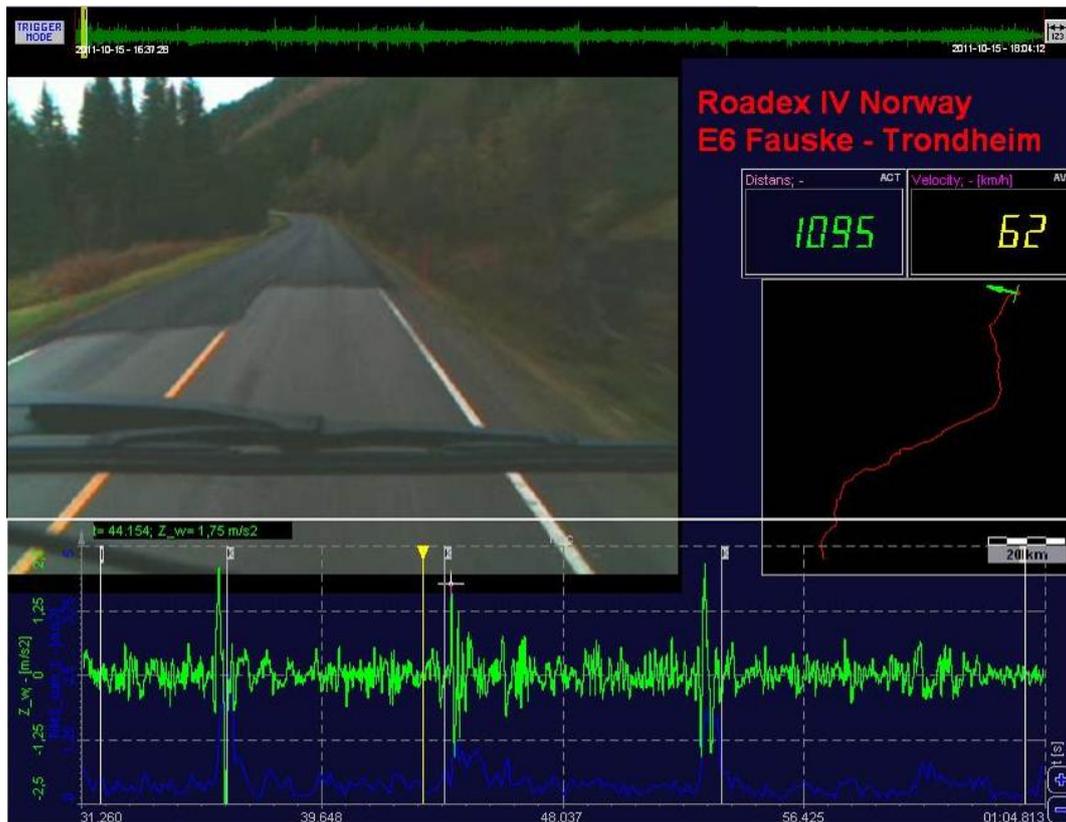
Figure 54 Mechanical shocks in the truck driver's seat at a bad asphalt-joint

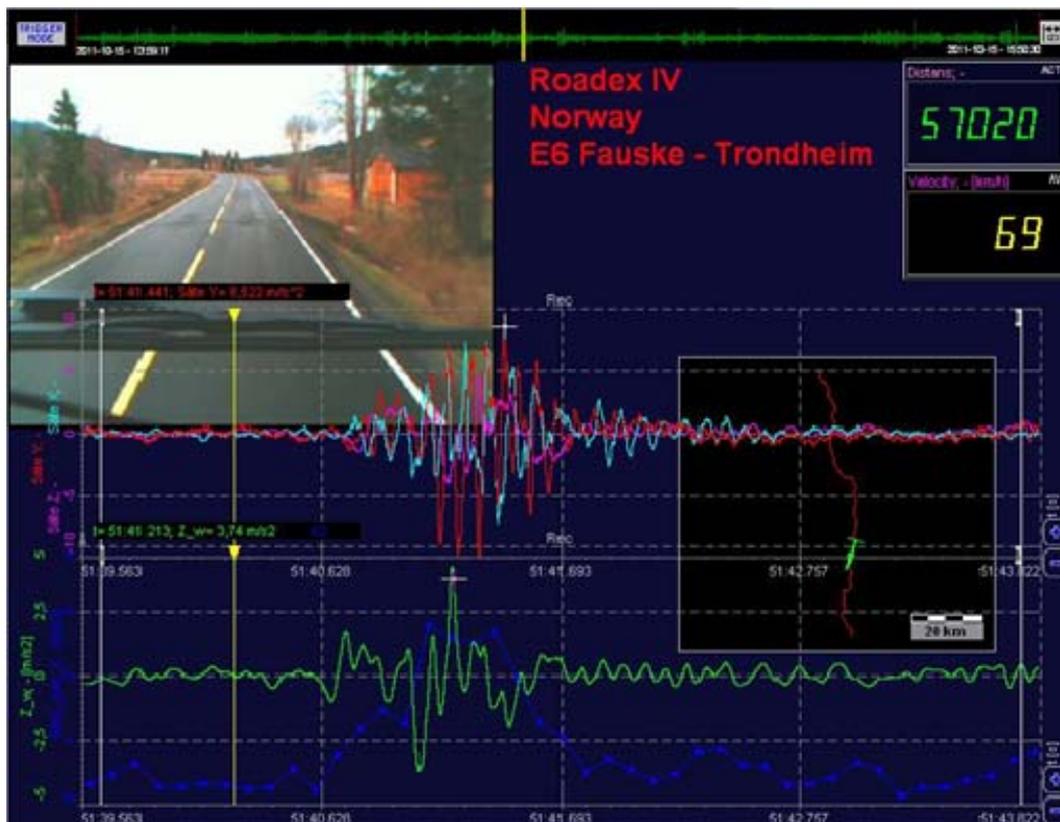
Figure 57 Bumpy truck ride due to settlements at a culvert

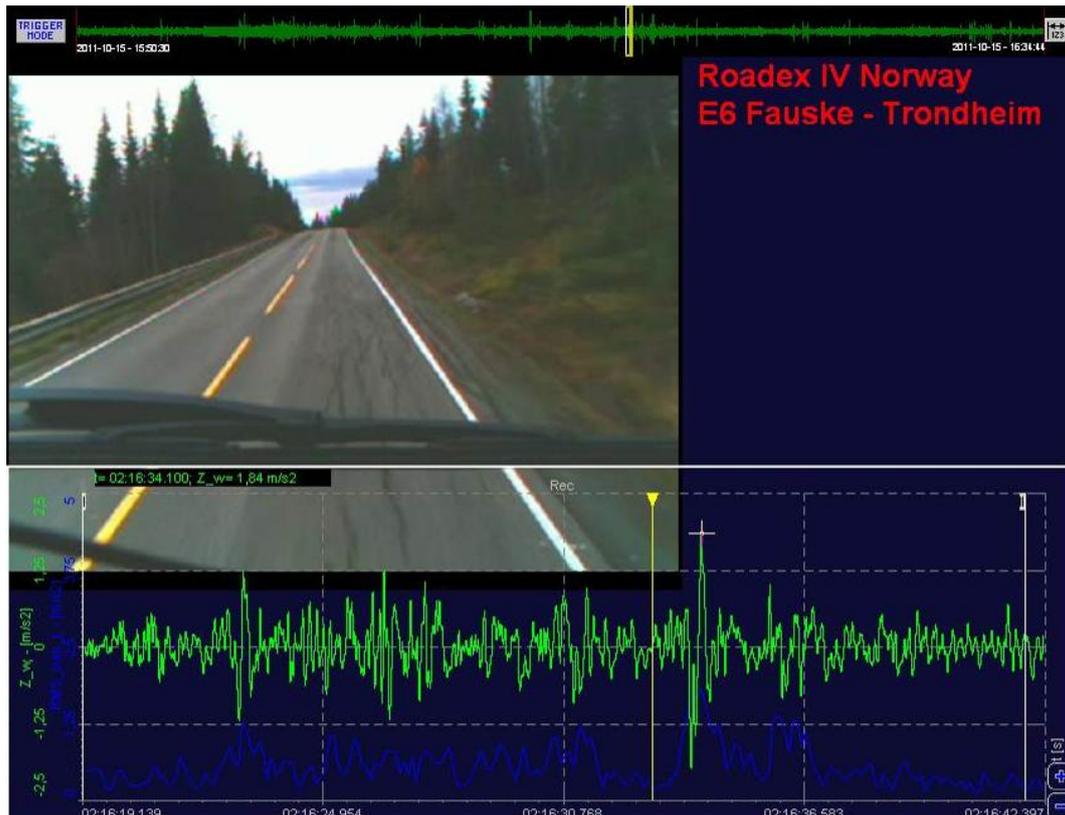
Figure 58 Bumpy truck ride at a deformed and alligator-cracked weak pavement section

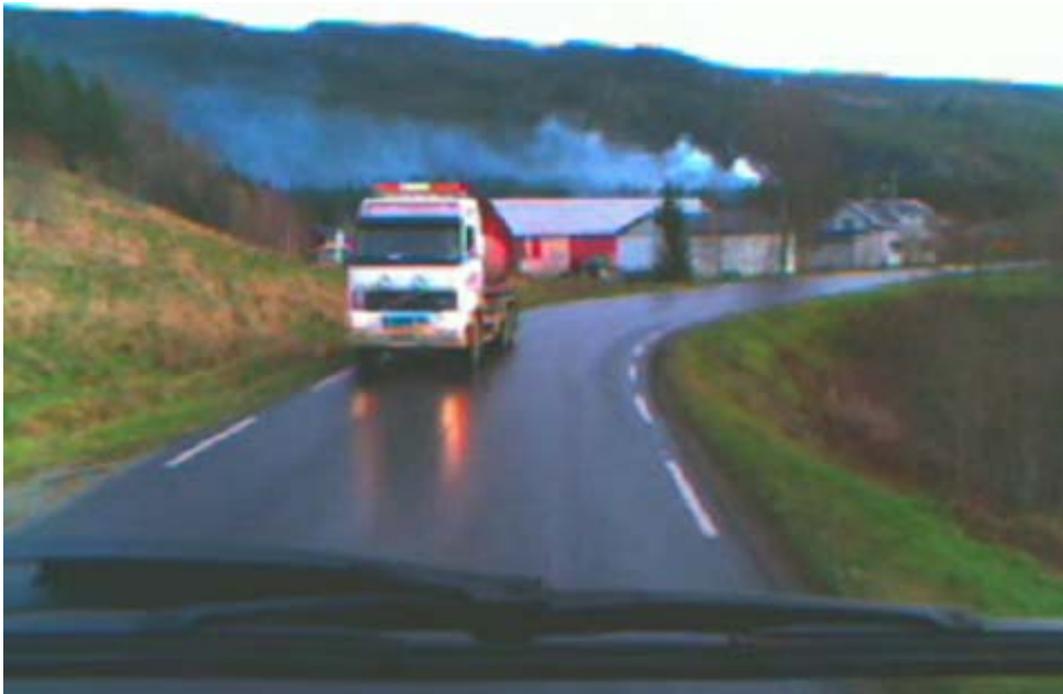
Figure 61 The E6 highway north of Trondheim is remarkably narrow for long haulage transports

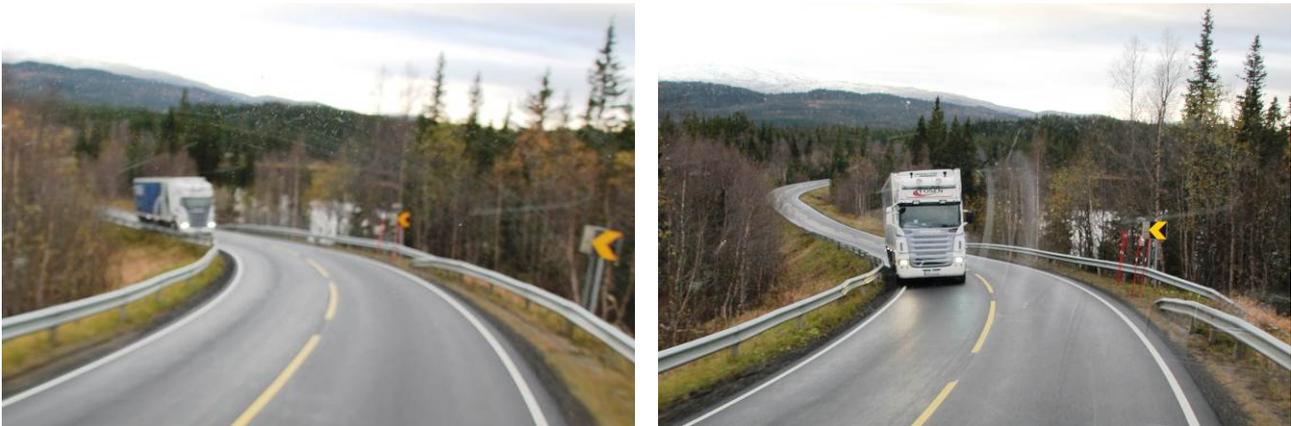
Figure 62 Narrow road for truck meeting on the sharp and improperly banked curve at Stortjønna

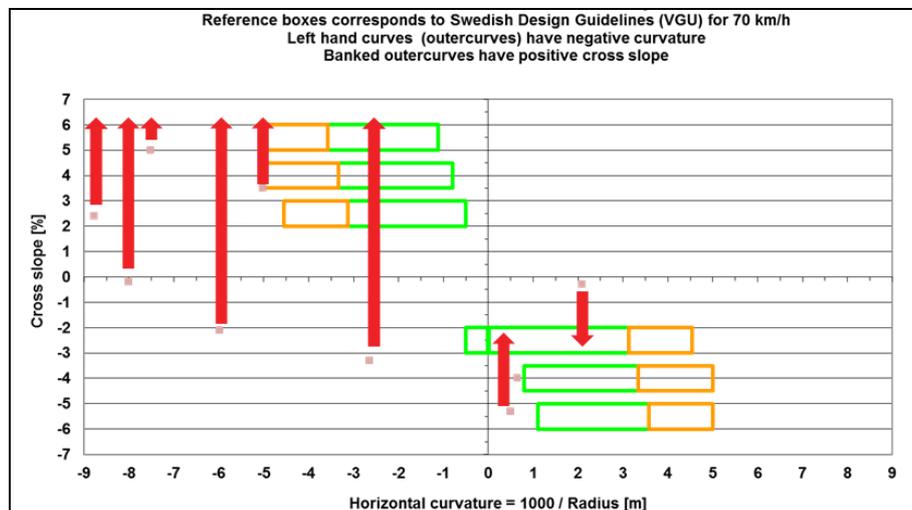
Figure 63 The Stortjønna outercurve needs to be banked up from -3.3 % into high superelevation

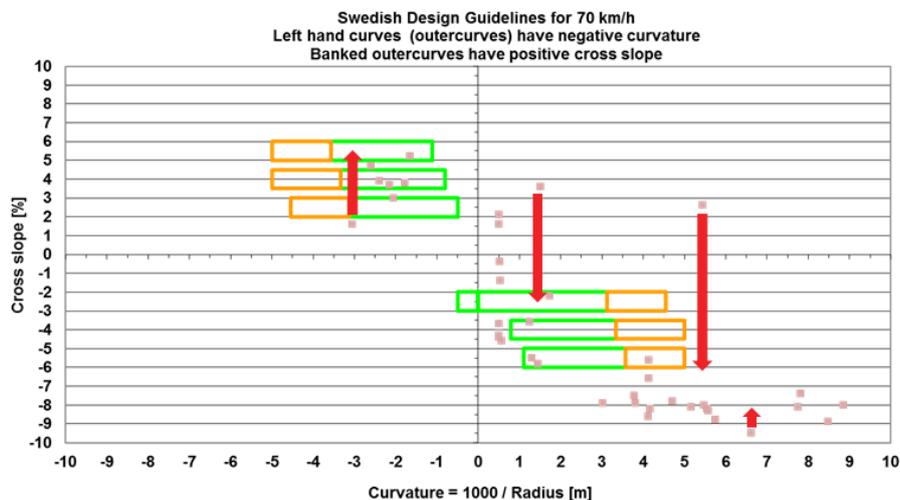
Figure 65 The Smalåsen adversely cambered inner-curve needs reconstruction including lowering

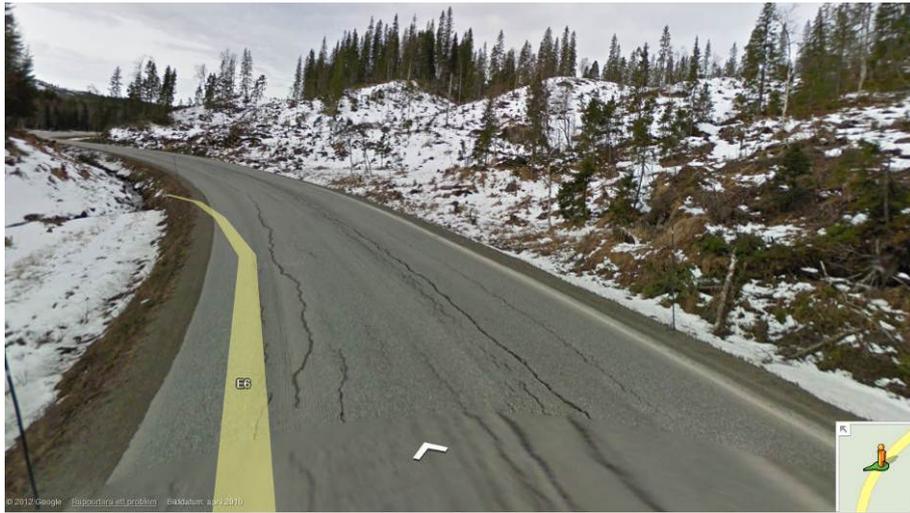
Figure 67 The hazardous S-shaped and narrow crash-curve on E6, 2 km north of Fjerdings
