VEHICLE AND HUMAN VIBRATION DUE TO ROAD CONDITION

A Report from Studies on Low Volume Roads in the EU Northern Periphery of:

- Demonstrations of Truck Ride Measurements in ROADEX Partner Areas
- Effectiveness on Isolation of Ride Vibration by a Tyre Pressure Control System
- Impact from Road Maintenance Standard on Truck Drivers Working Environment

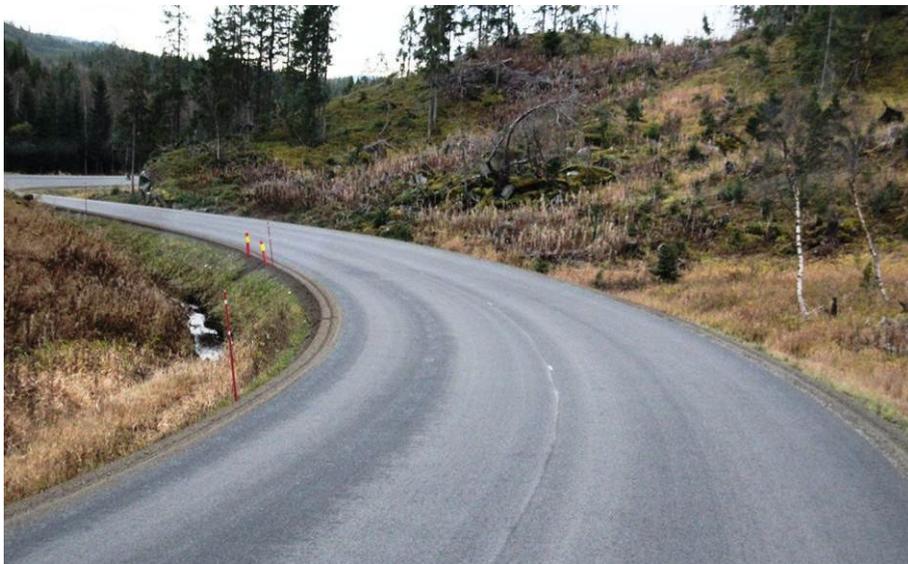
Figure 68 The Fjerdings S-curve is improperly banked after resurfacing 2011

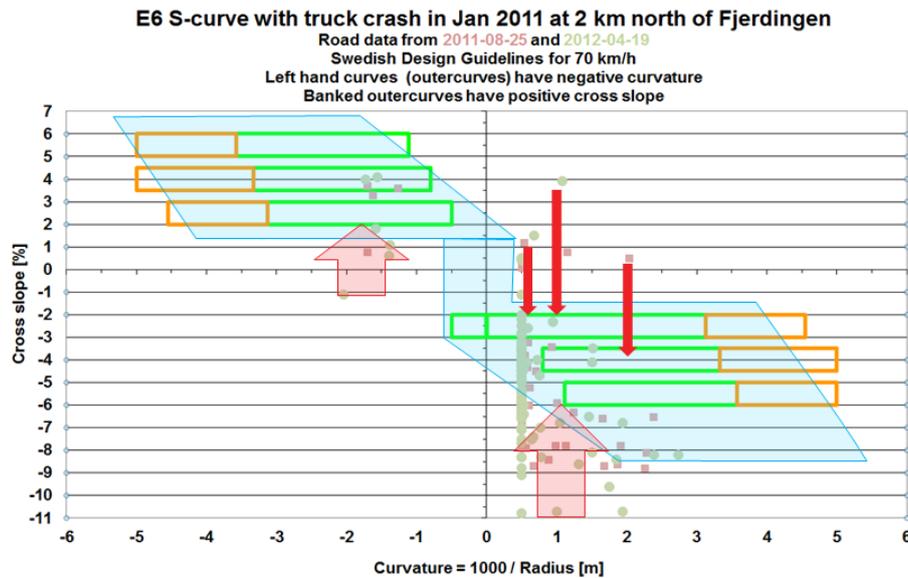
Figure 69 The hazardous S-curve is improperly banked also after resurfacing

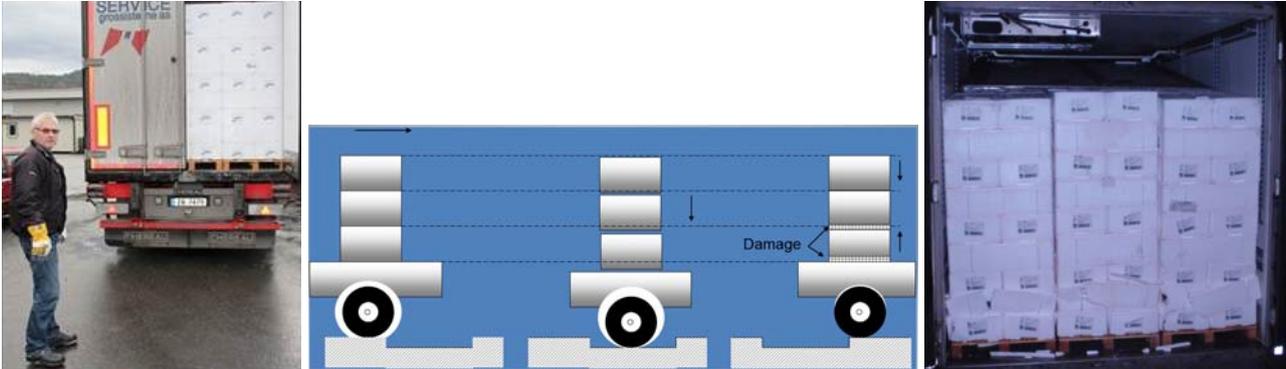
Figure 71 Payload damage on frost damaged road sections

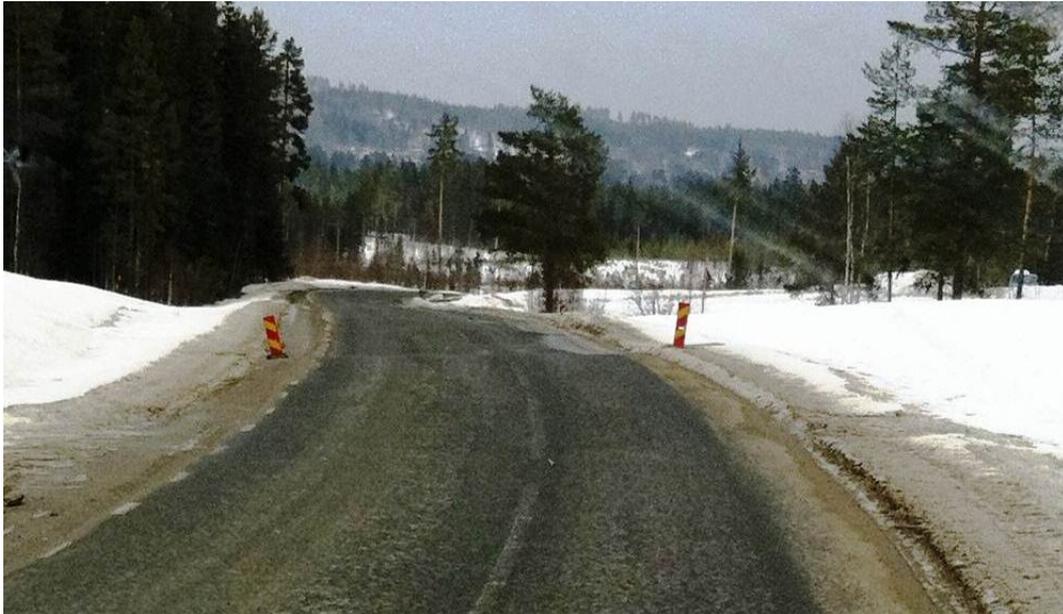
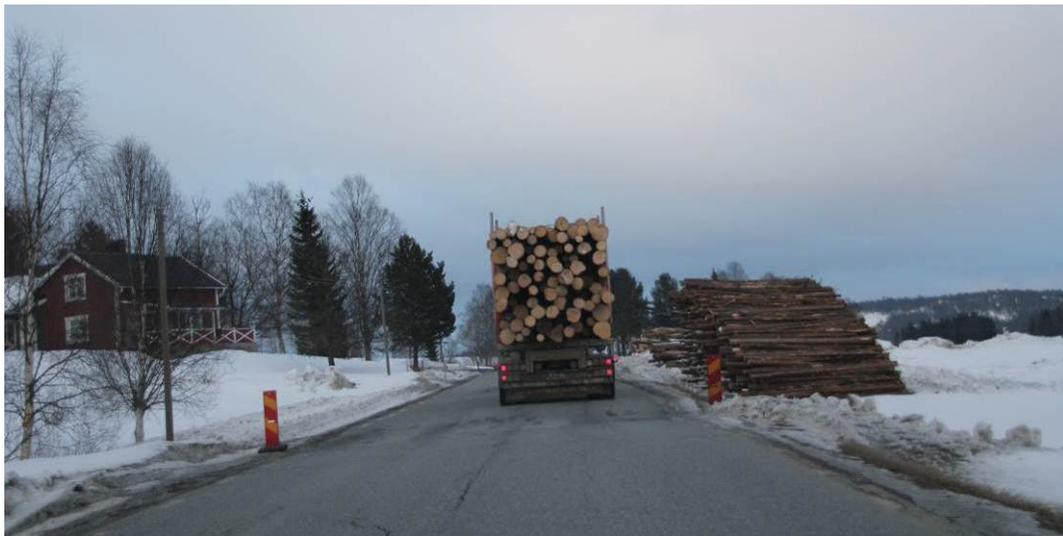
Figure 78 Roughness with several decimetre amplitudes, caused by frost action

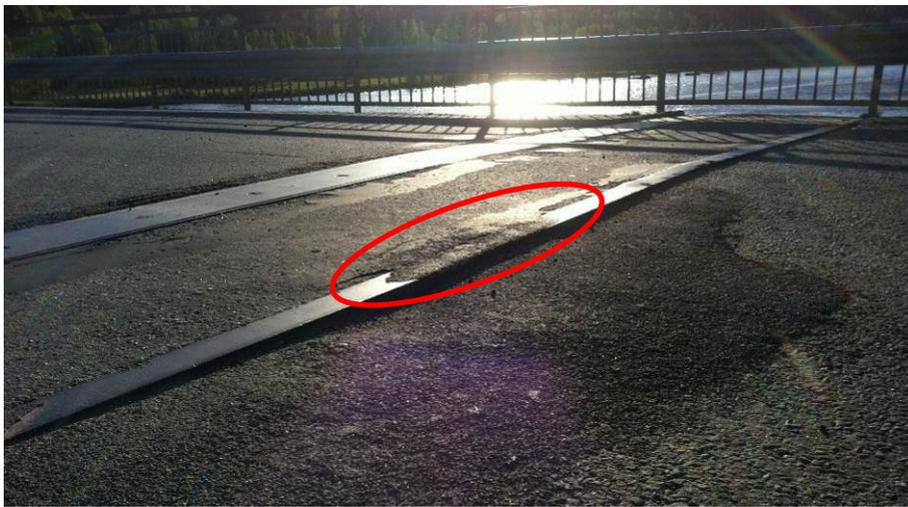
Figure 79 A very rough bridge joint at Nämforsen

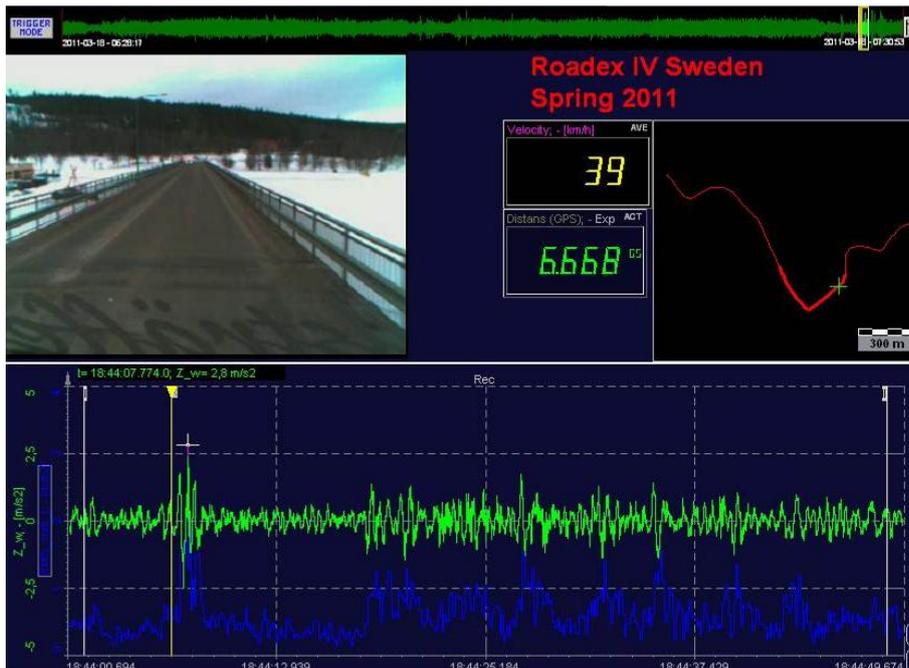
Figure 80 Shock load into the truck drivers spine when passing the bridge joint at Nämforsen

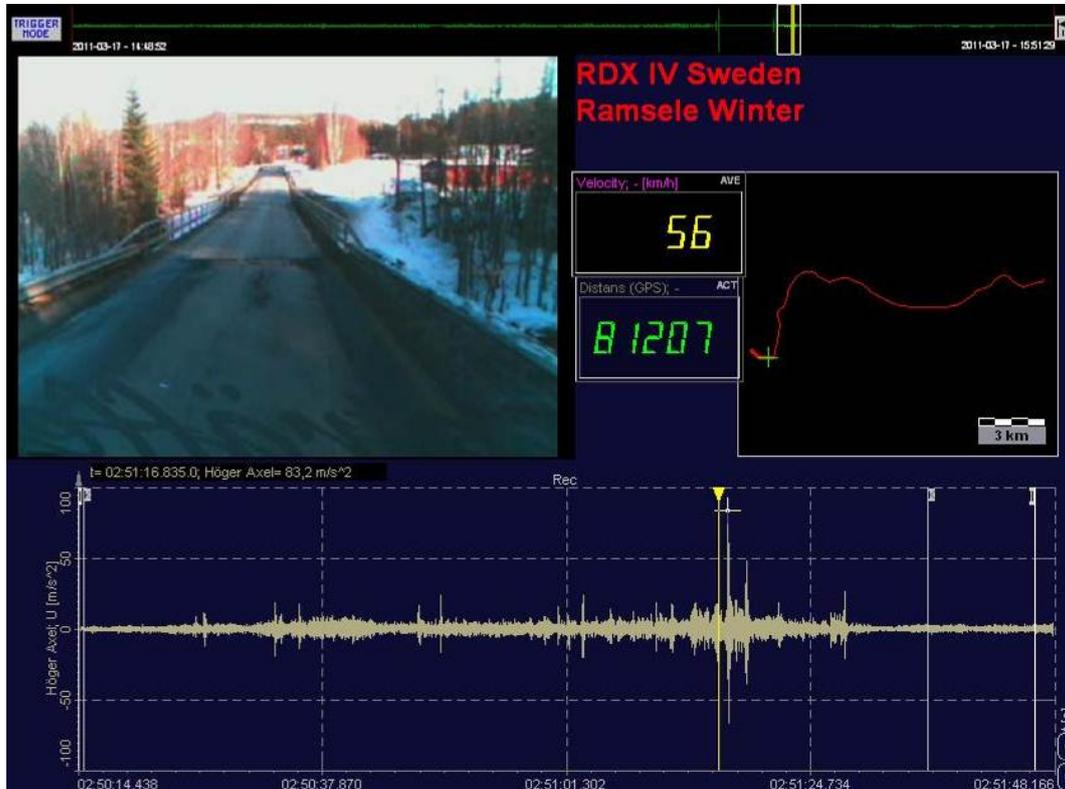
Figure 81 High acceleration of the truck wheel assembly at settlement in bridge backfill

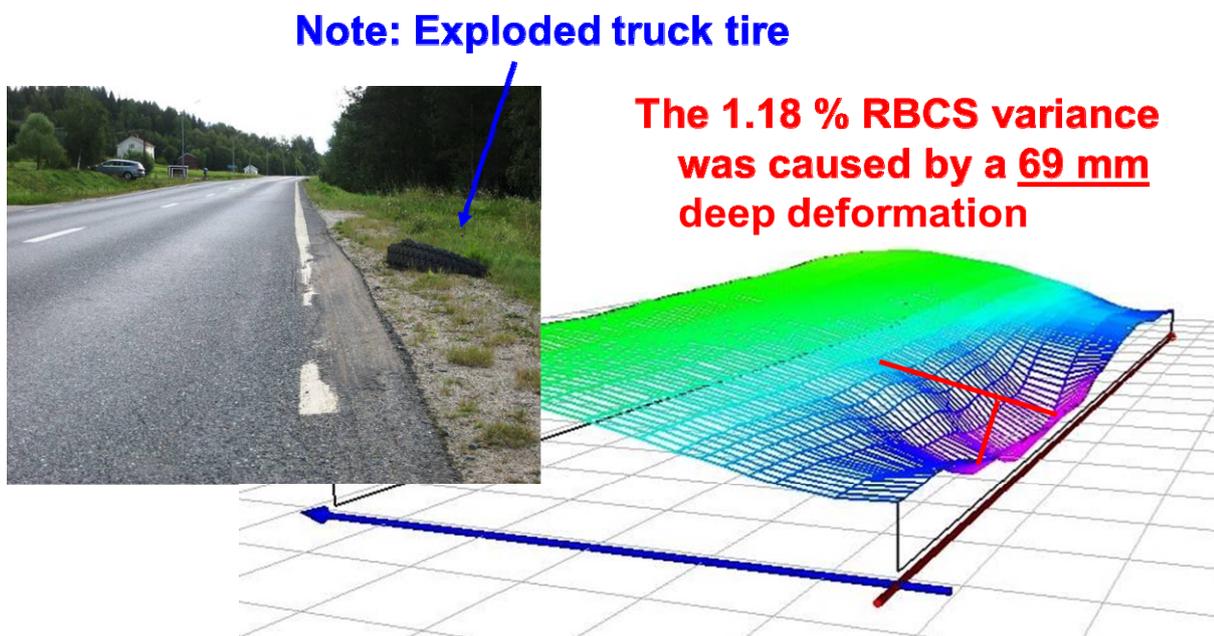
Figure 82 The Åkerö edge deformation in 2007 [Source: The ROADEX III project]

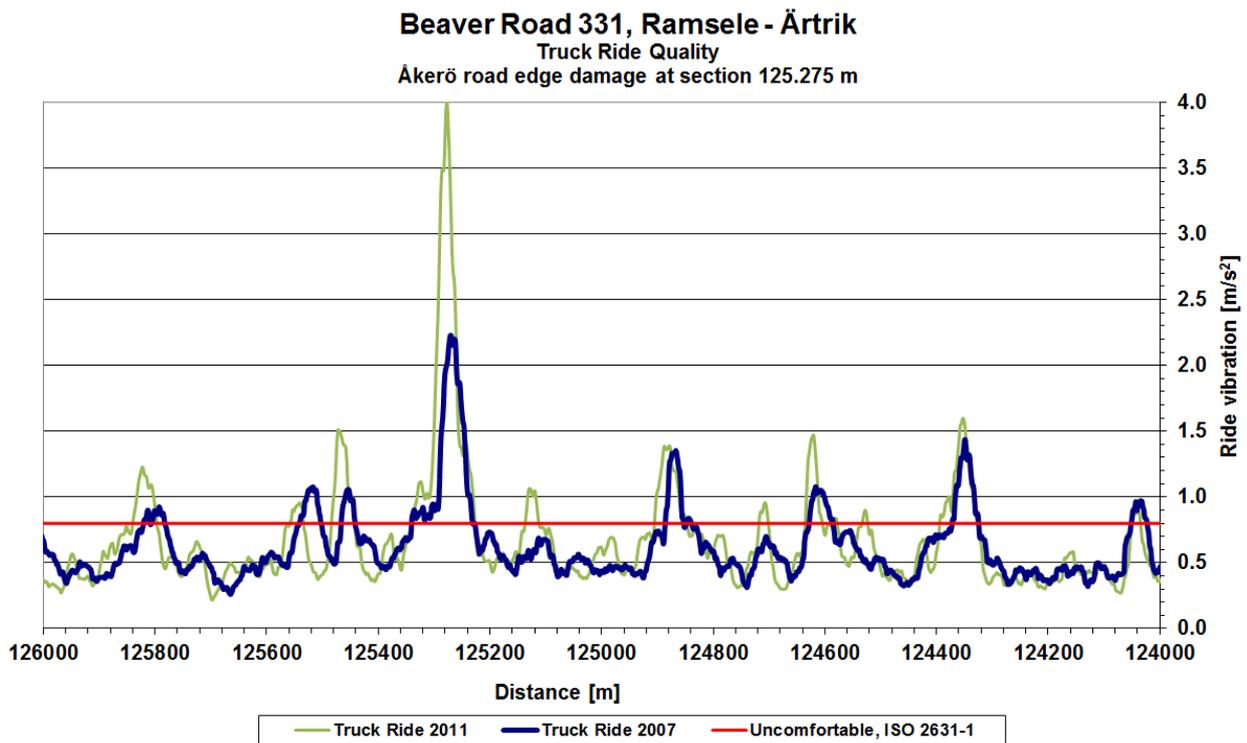
Figure 83 The seat vibration at the edge deformation in Åkerö was worse in 2011 than 2007

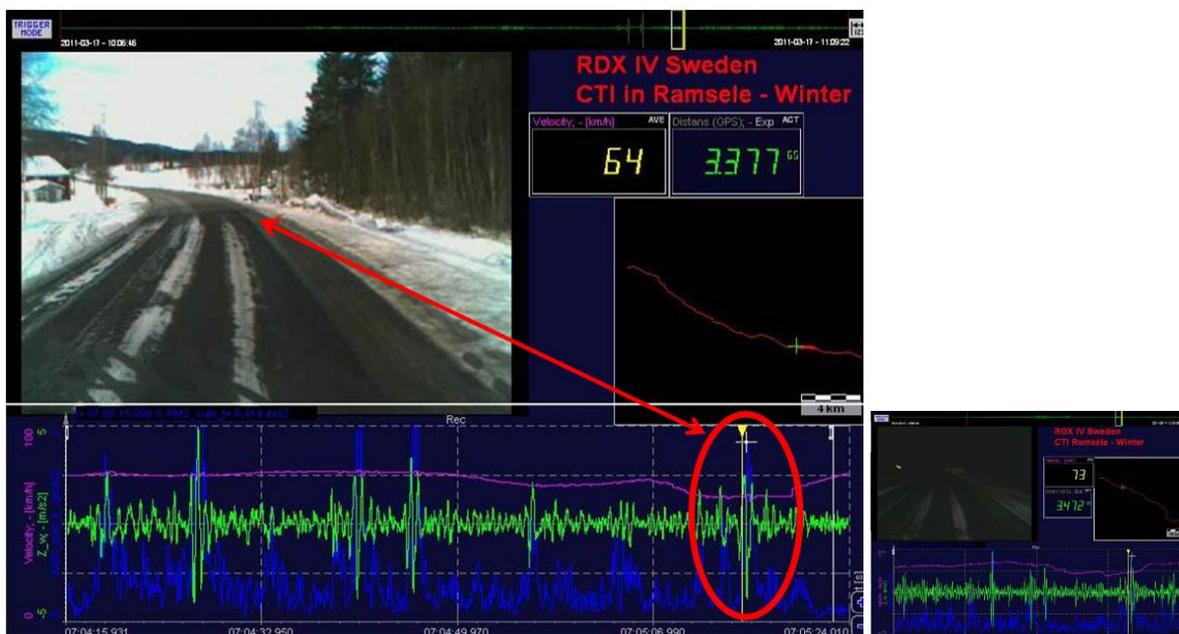
Figure 85 Several high acceleration events at newly reconstructed sections of Road 1035

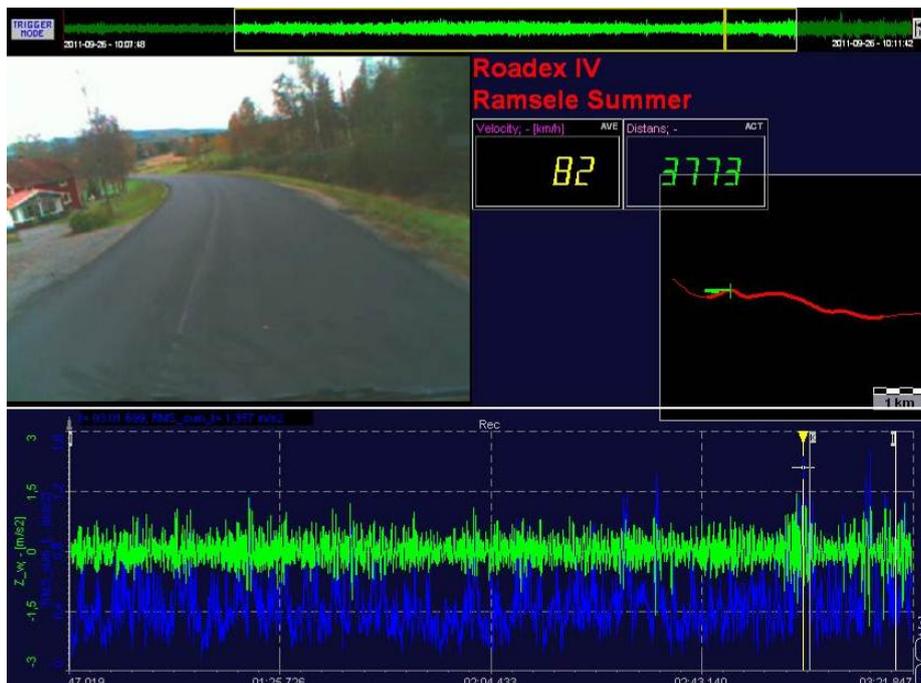
Figure 86 Road 1035 still gives a rough truck ride just after resurfacing 2011

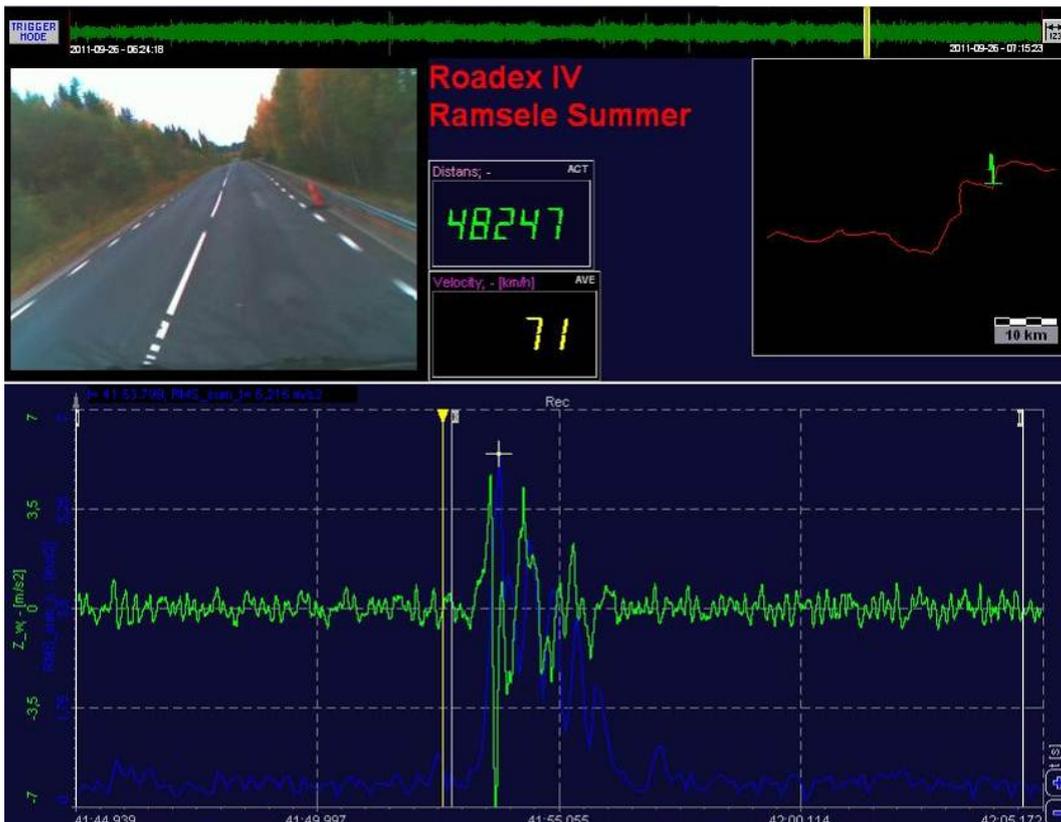
Figure 87 Transient vibration at an edge deformation on a newly repaired section of Road 335

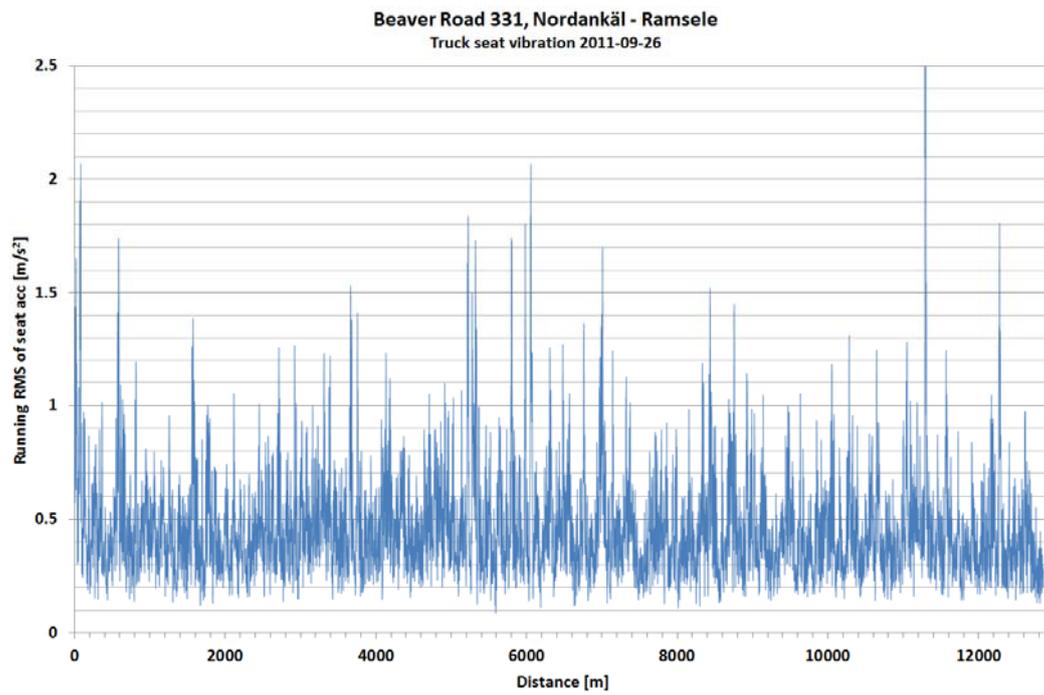
Figure 88 Average vibration 0.46 m/s^2 despite the road being reconstructed in 2008

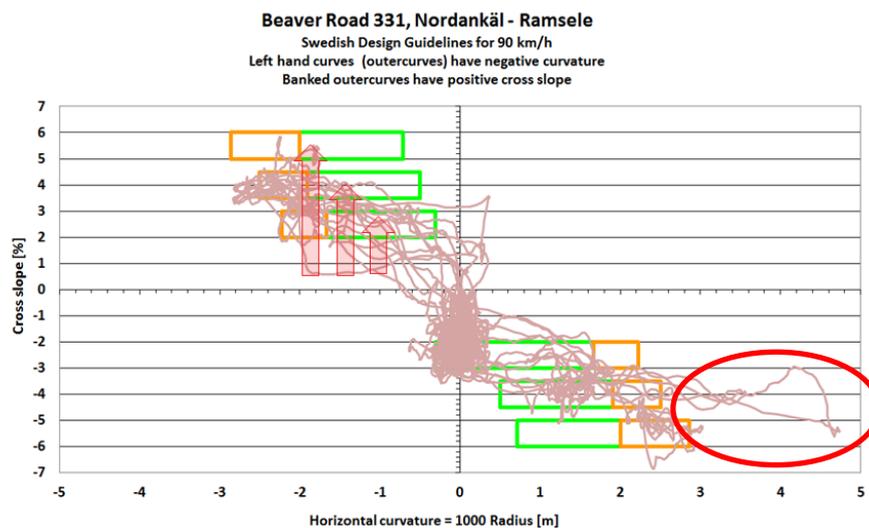
Figure 89 One outercurve became hazardous low superelevation after reconstruction 2008

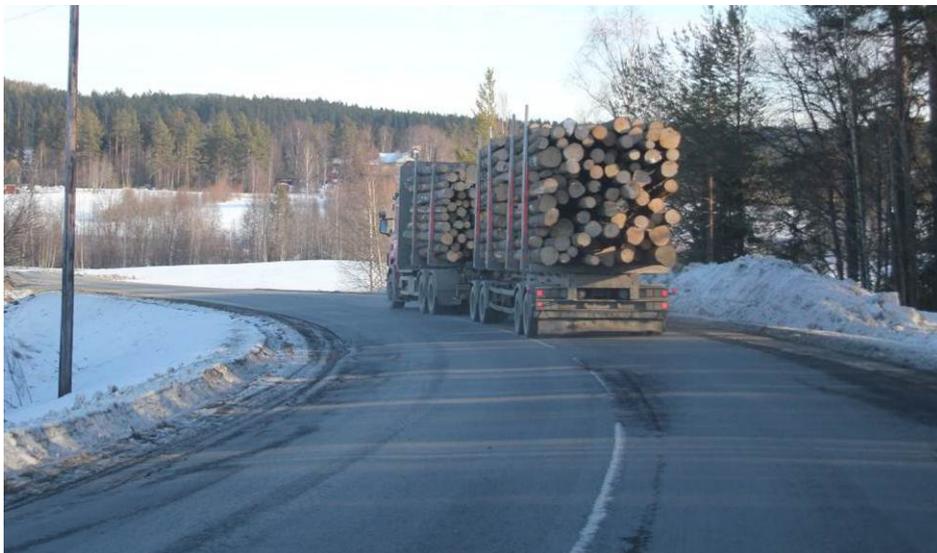
Figure 91 The “Roos curve” on Road 331 between Österforsse and Helgum

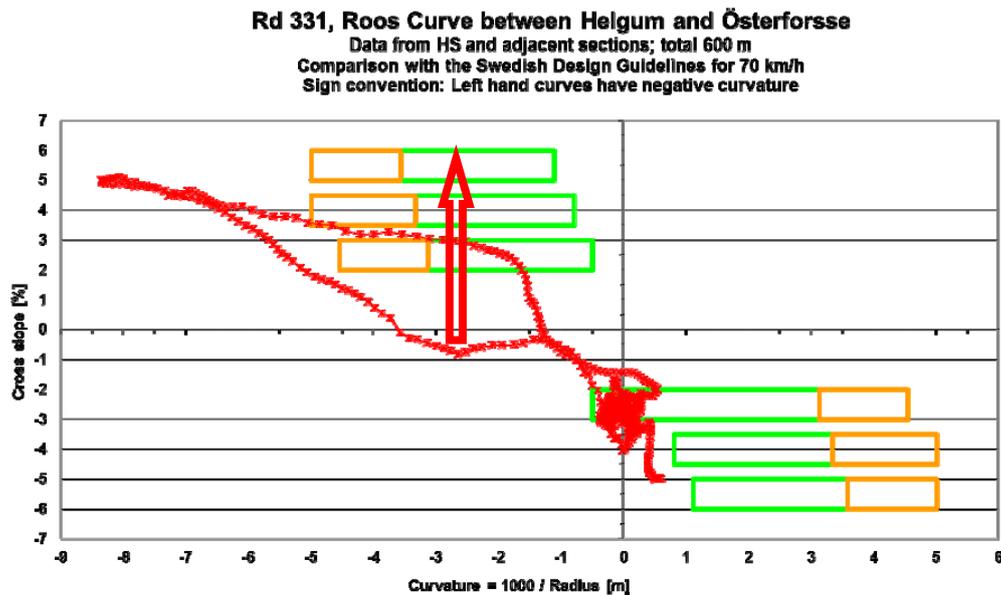
Figure 92 Profilograph data from the improperly banked, sharp Roos Curve

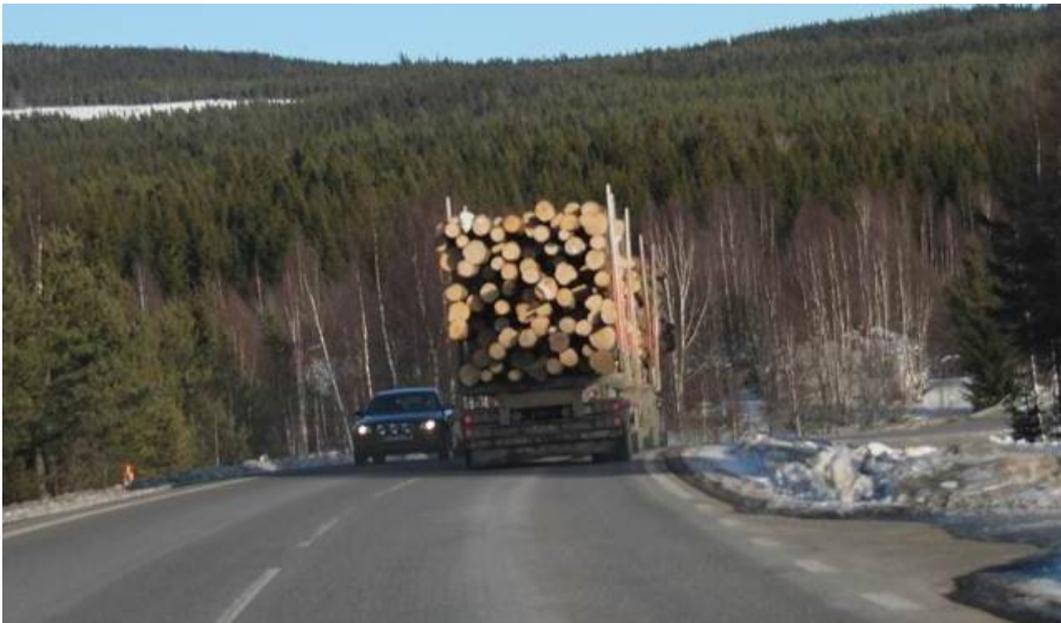
Figure 93 Unusual hazard: Insufficient crossfall of INNER-curve at Road 331 at Mo

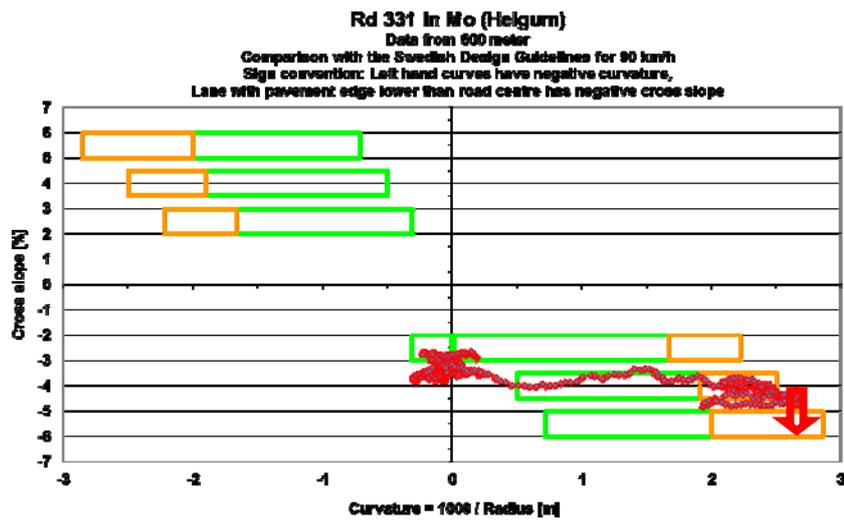
Figure 94 Profilograph data from the sharp and too flat innercurve at Mo

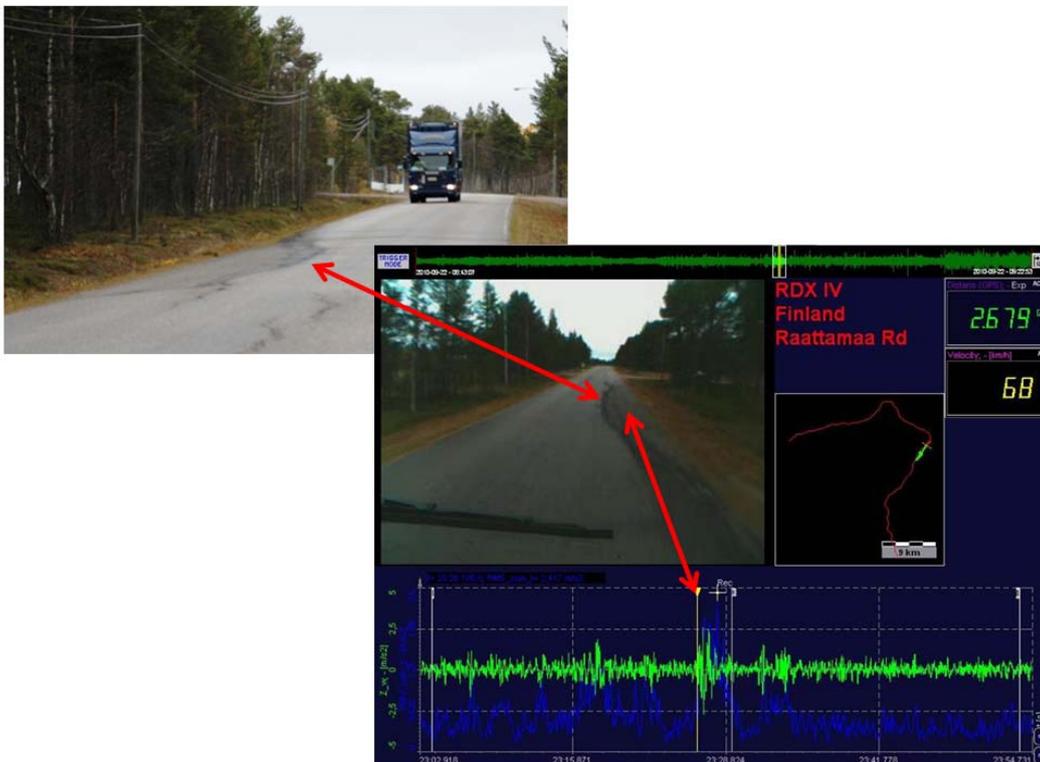
Figure 99 Pavement edge deformation is a common cause of road warpiness

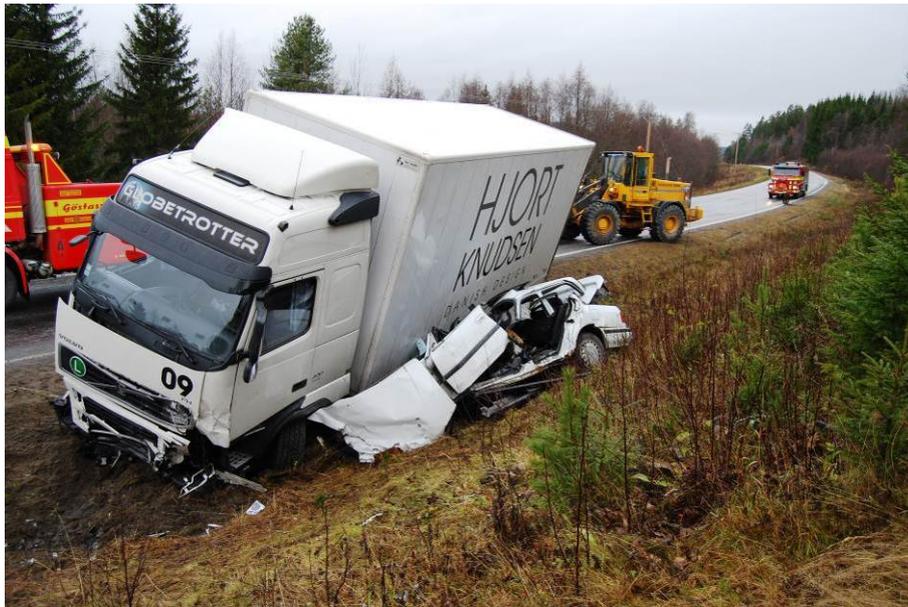
Figure 100 A fatal skid crash on “black ice” at a section of Rd 331 with RBCSV \gg 0.3 %

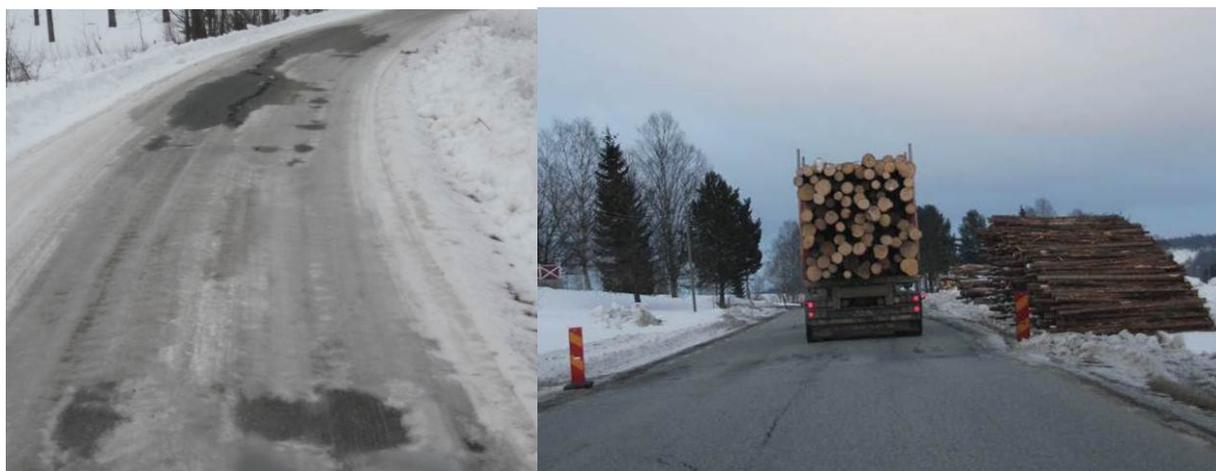
Figure 104 The winter conditions included driving on corrugated ice layers and uneven frost heaves

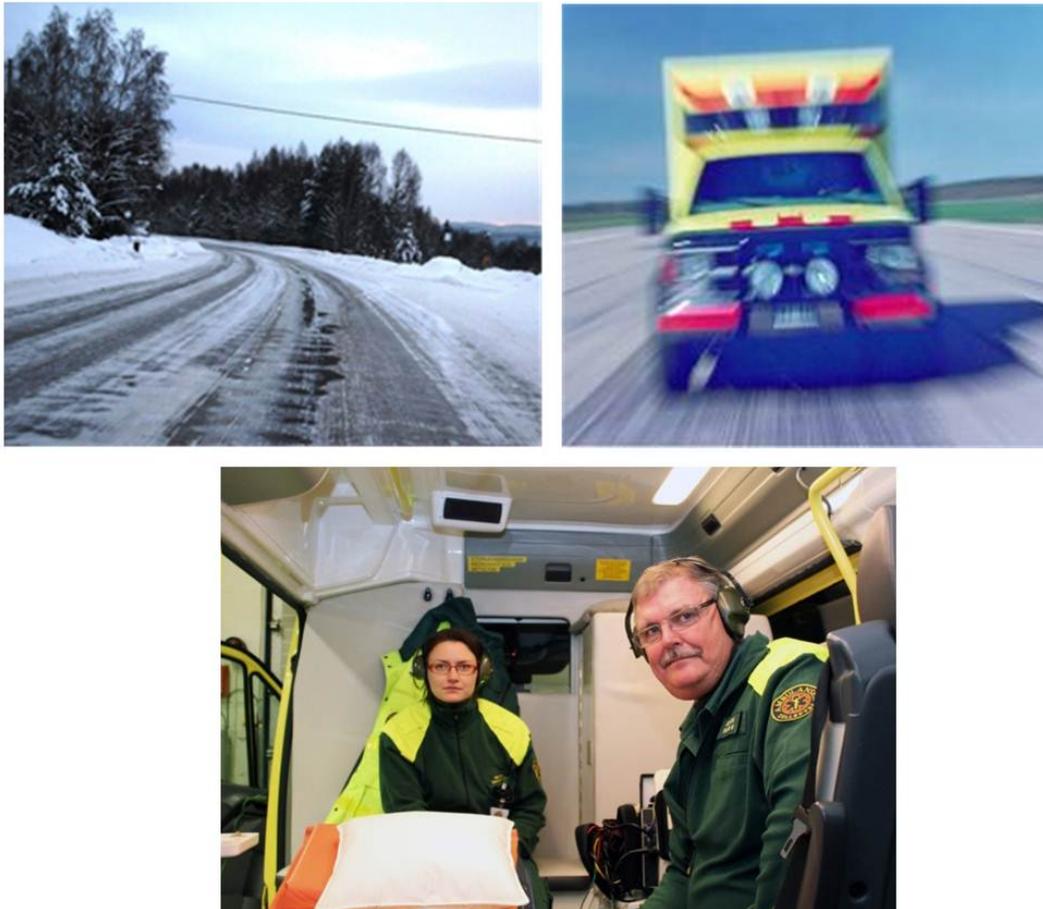
Figure 105 Corrugated ice caused noise in ambulances [Photo: S Engblom, Wiman Amb., J Granlund]
