ROADEX III
NORTHERN PERIPHERY

Health Issues Raised by Poorly Maintained Road Networks

March 2008

Johan Granlund
Swedish Road Administration Consulting Services

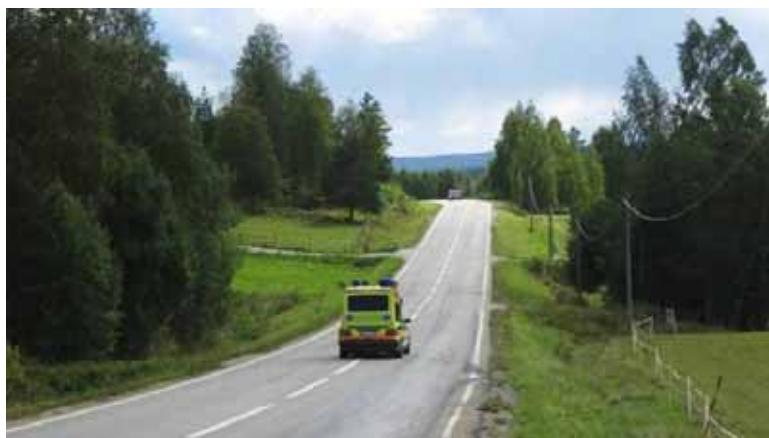
Figure 3 *Emergency Ambulance on wrong side of Road 331, avoiding edge deformations*

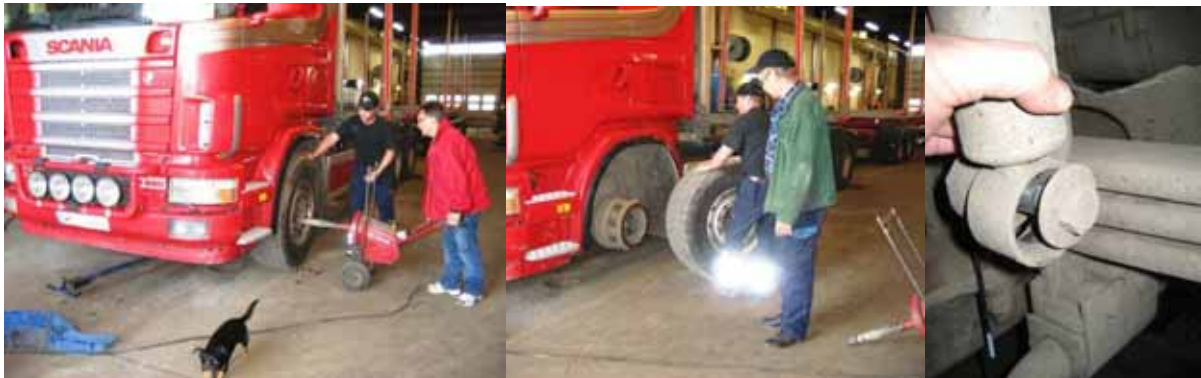
Figure 30 *A damper bush was broken, but this was not perceived under normal driving*

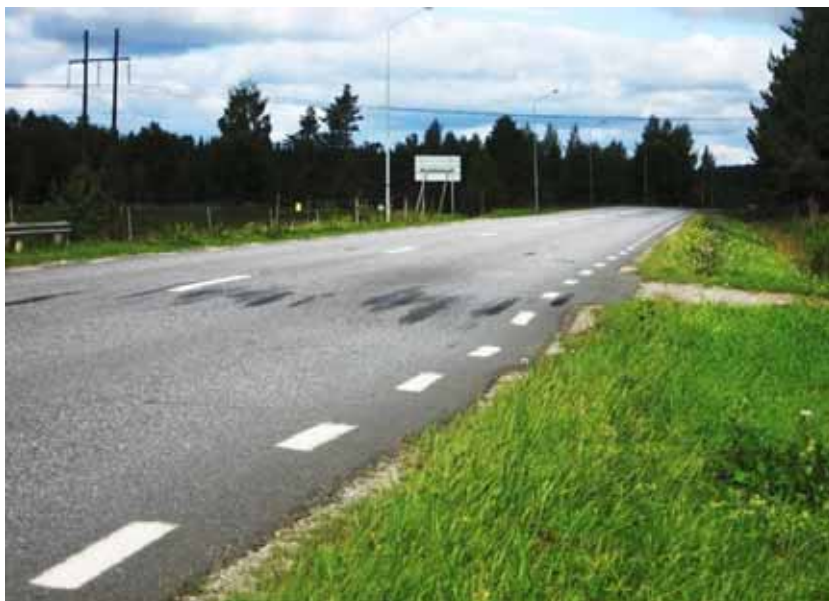
Figure 40 *Bump due to settlement at an old culvert in Ramsele, RDB section 141/336 km*

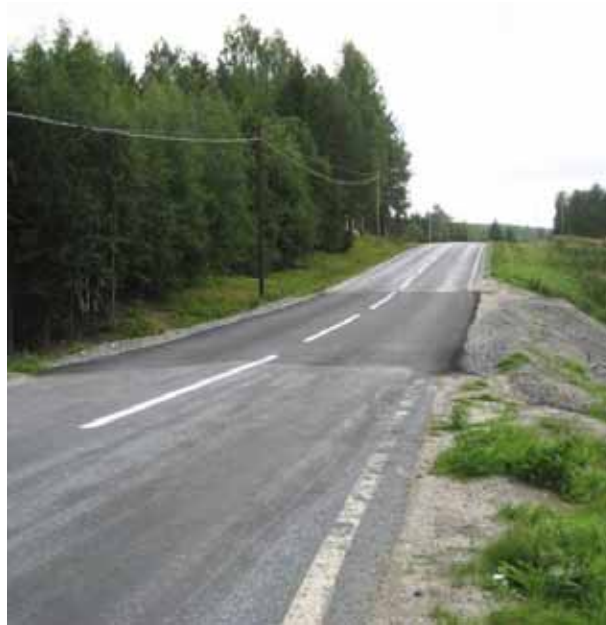
Figure 41 Bumpy newly reconstructed culvert in Gammelmo, RDB section 133/000 km

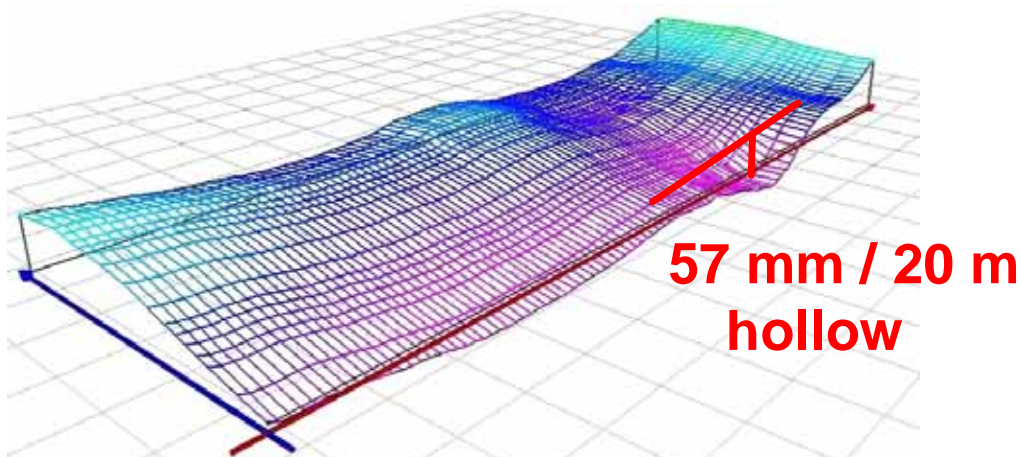
Figure 43 3D laser scan of settlement at reconstructed culvert in Gammelmo

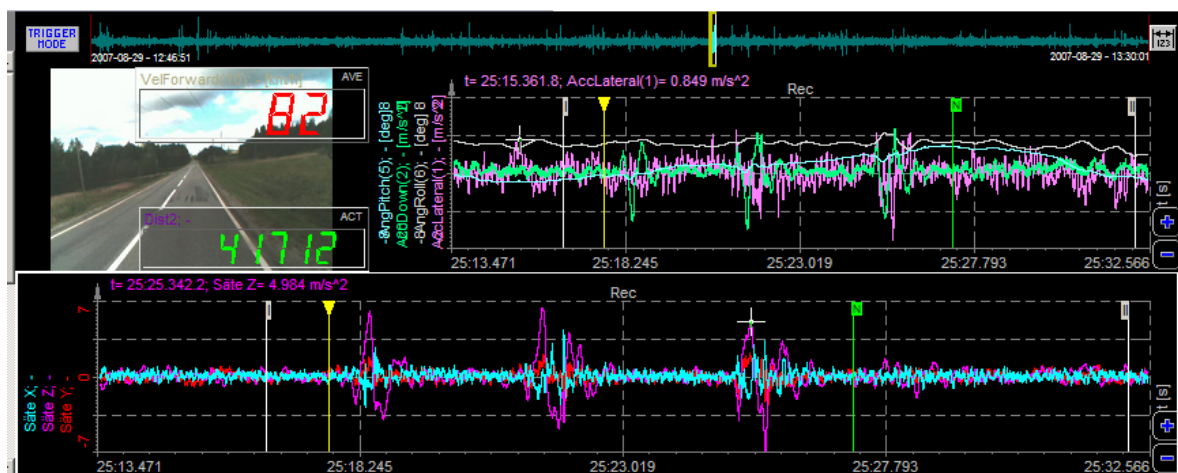
Figure 44 Three bumpy culverts within 200 m, RDB section 117/200 km

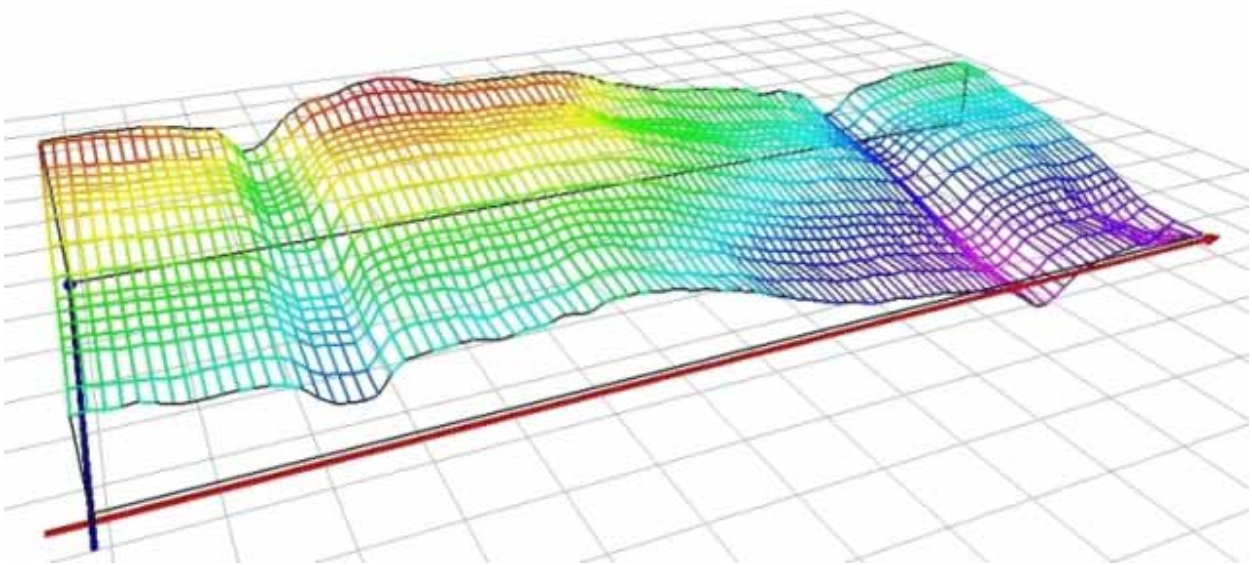
Figure 45 **3D laser scans of two bumpy adjacent culverts, RDB section 117/200 km**

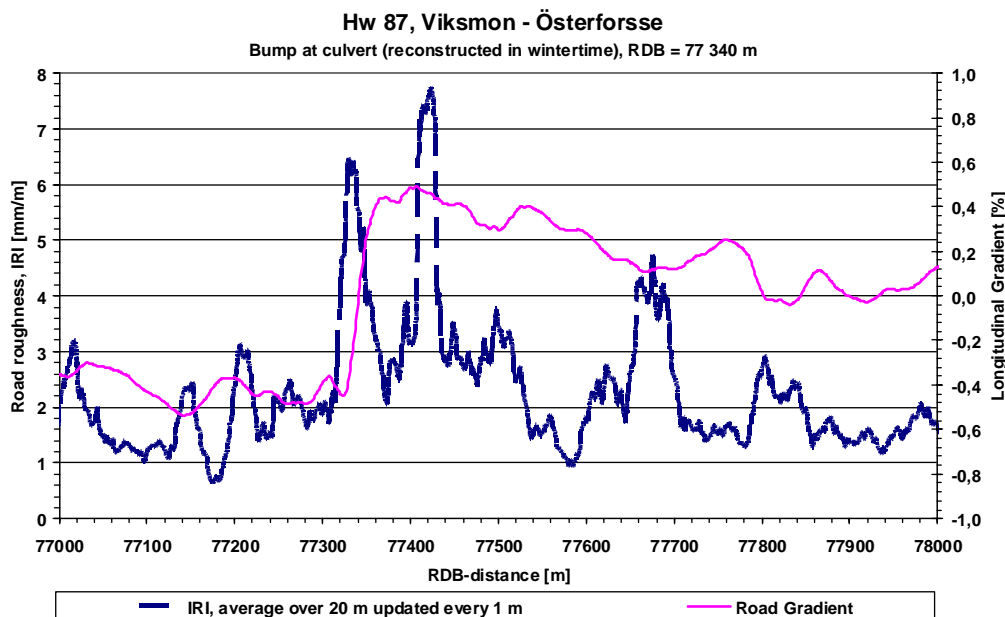
Figure 46 *Bump at culvert in the bottom of a valley, where grade change from downhill to uphill at 0 %*

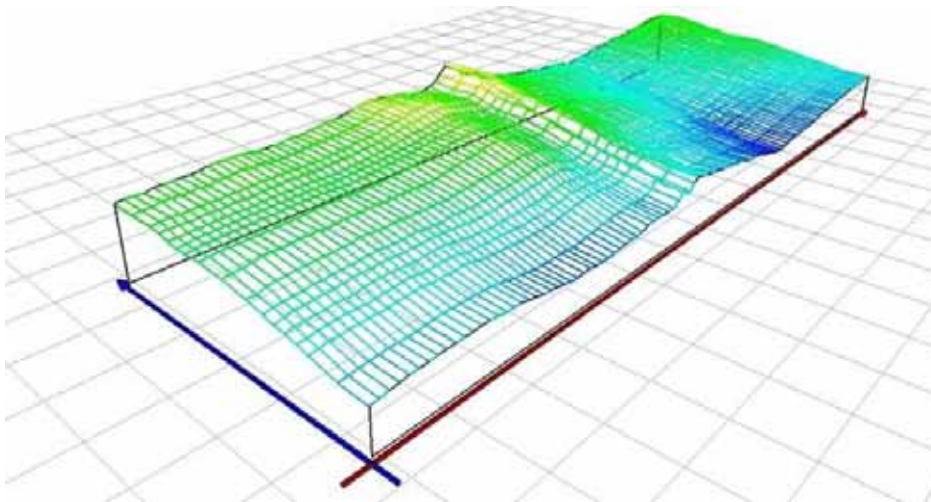
Figure 47 **3D laser scan of a bumpy joint at the bridge over the Fax River at HS Helgum**

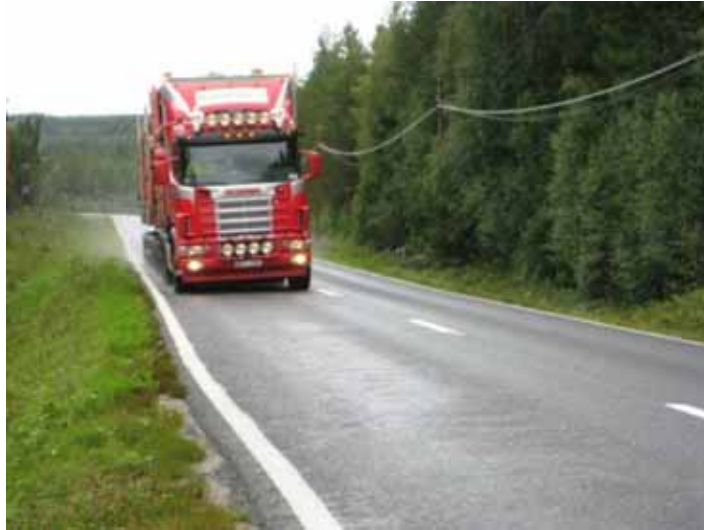
Figure 53 *HS Backe (Edsele): Warping truck and trailer at RDB distance 127/325 km*

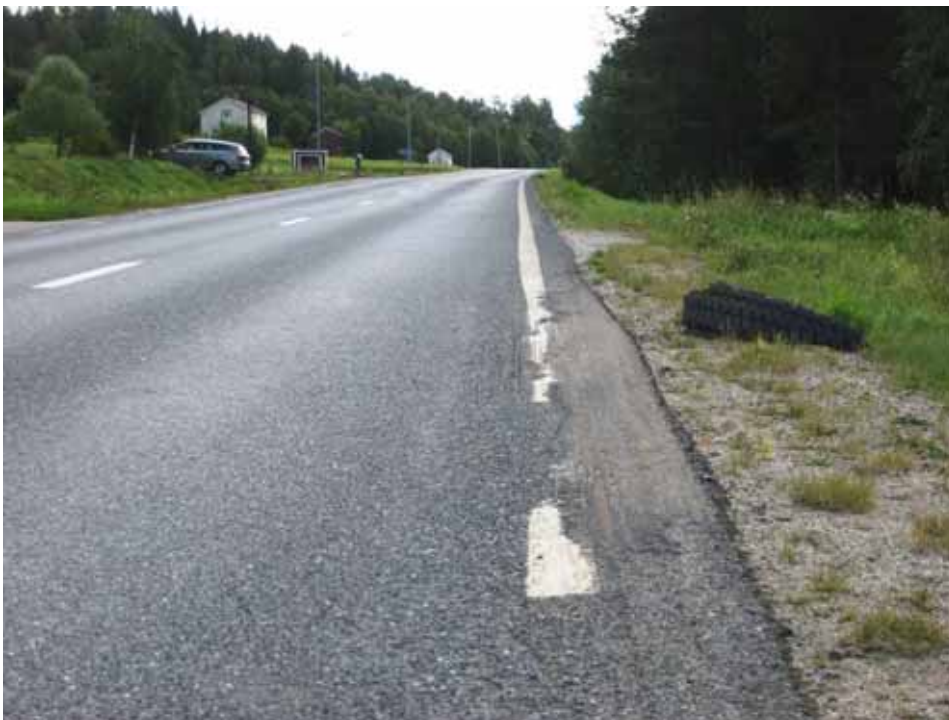
Figure 55 *Pavement edge deformation at HS Åkerö. Take note of the exploded truck tyre!*

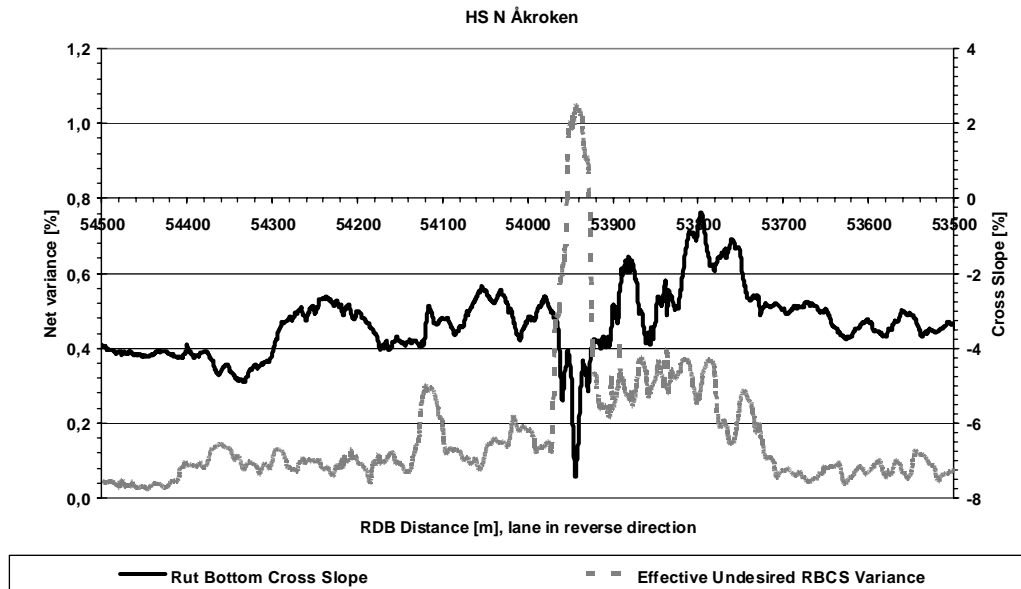
Figure 59 High RBCSV indicate severe pavement edge deformation at HS N Åkroken

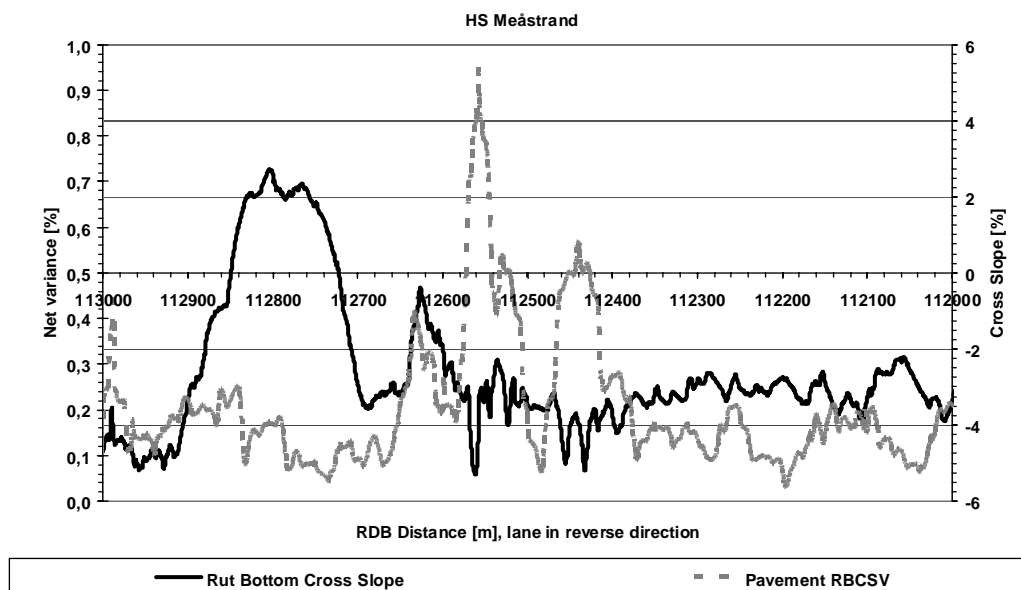
Figure 60 High RBCSV indicate severe pavement edge deformation at HS Meåstrand

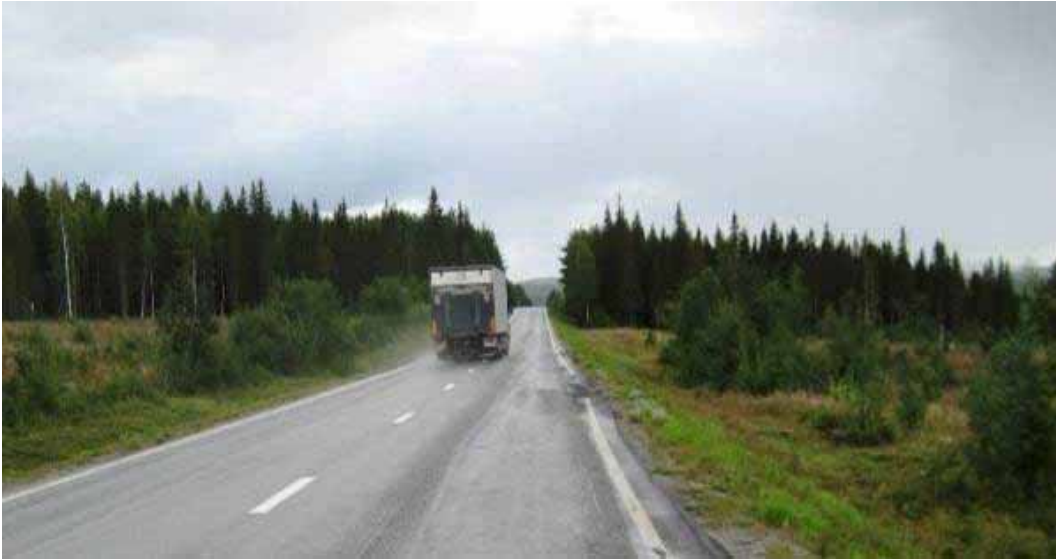
Figure 61 **Severe pavement edge deformation at HS Meåstrand**

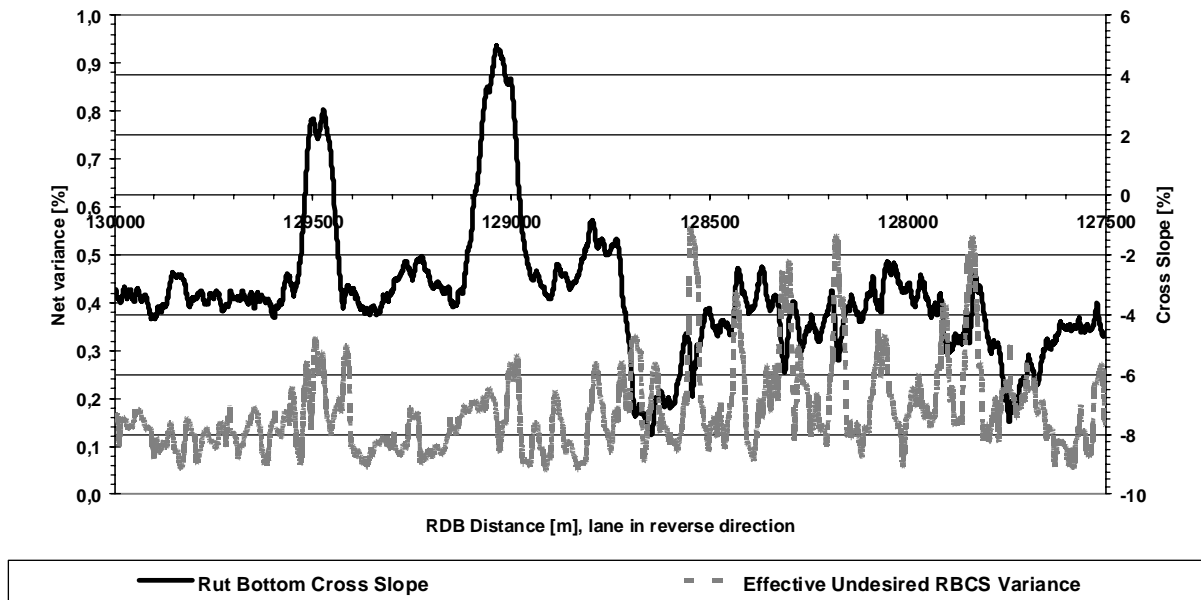
Figure 62 High RBCSV indicate warping pavement edge deformation at HS Alderån

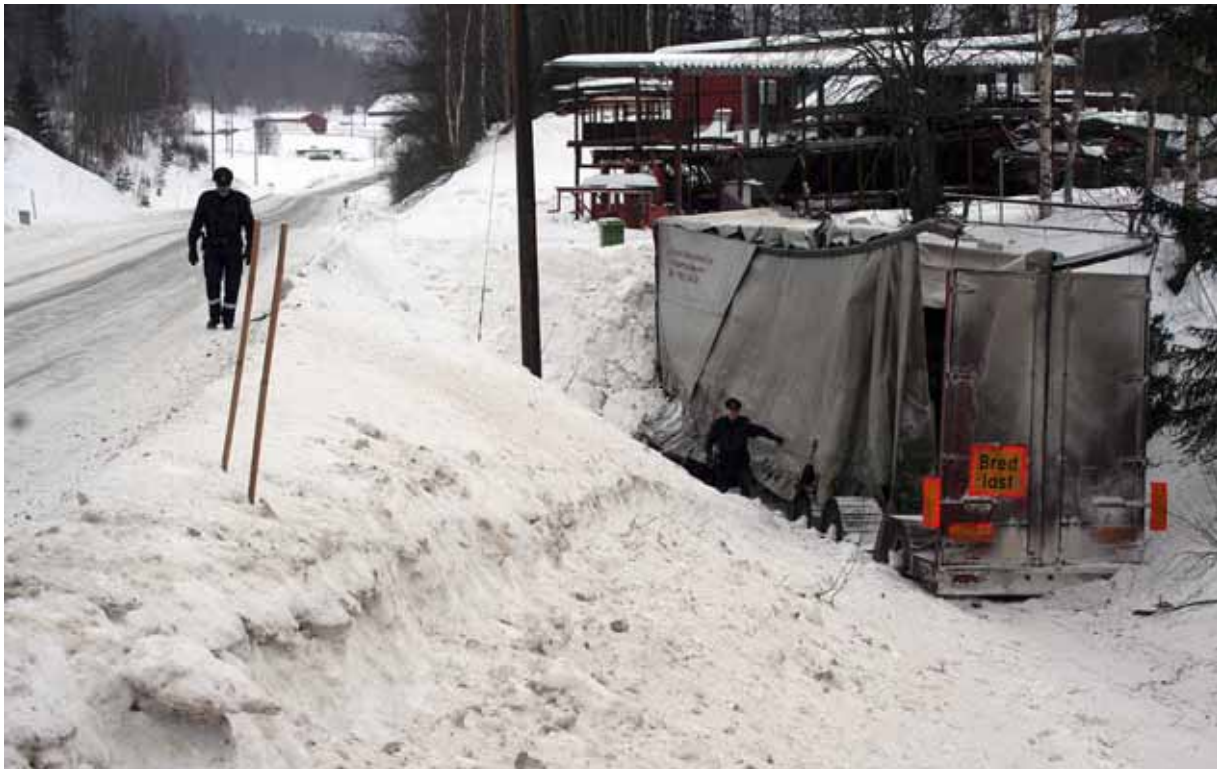
Figure 63 **Truck skid accident in Åsäng, 2007-02-22 [Photo: Torbjörn Elverheim, ST]**

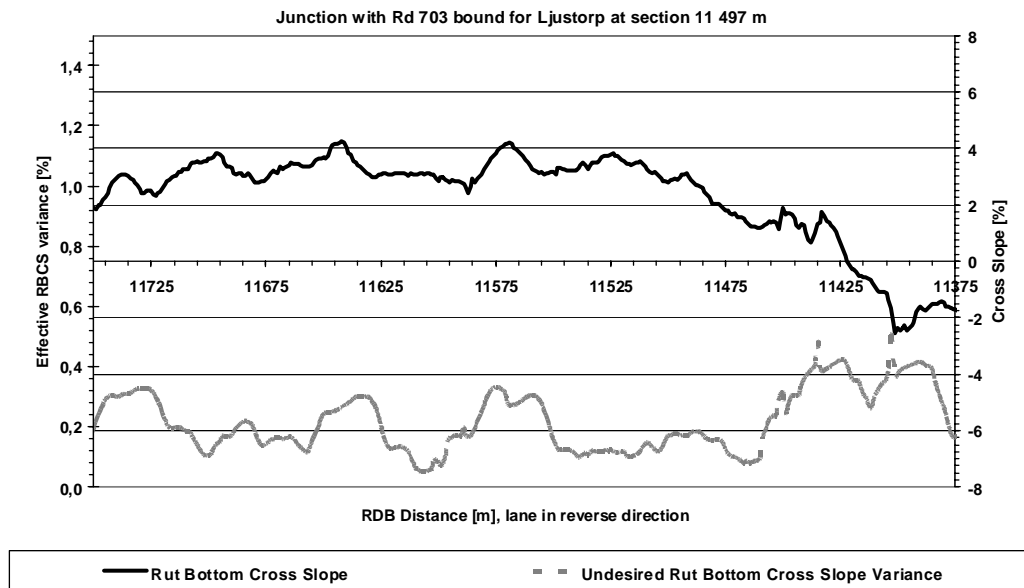
Figure 64 *High RBCSV indicate warping pavement edge deformation at HS Åsäng*

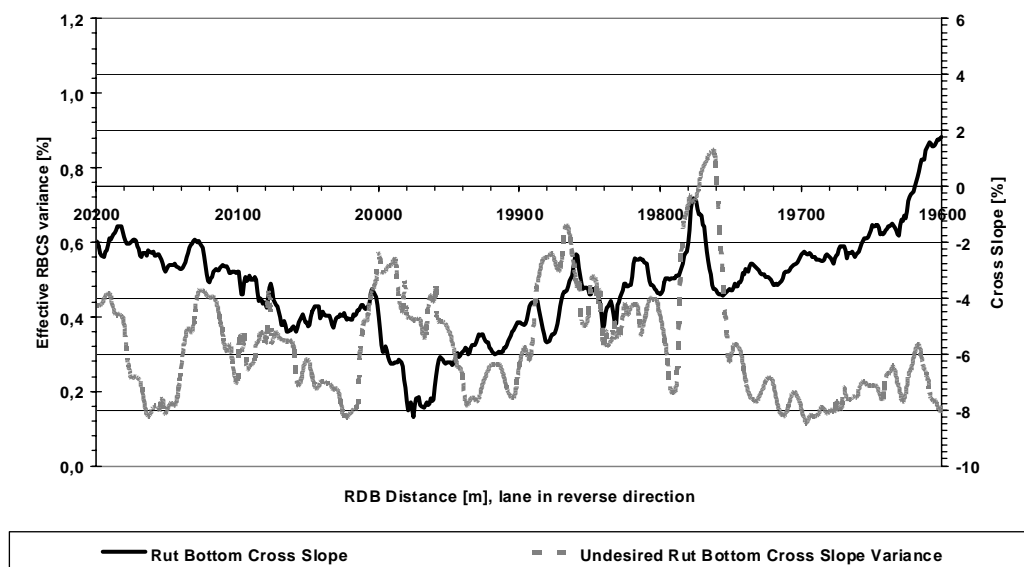
Figure 65 *High RBCSV indicate warping pavement deformation at HS Mjällåsen*

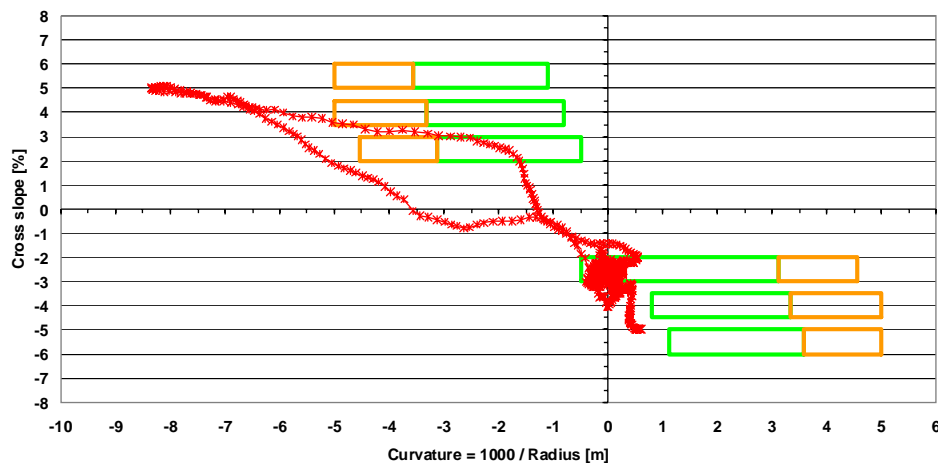
Figure 74 *Poor road alignment cause dynamic imbalance at the Hazardous Site Roos Curve*

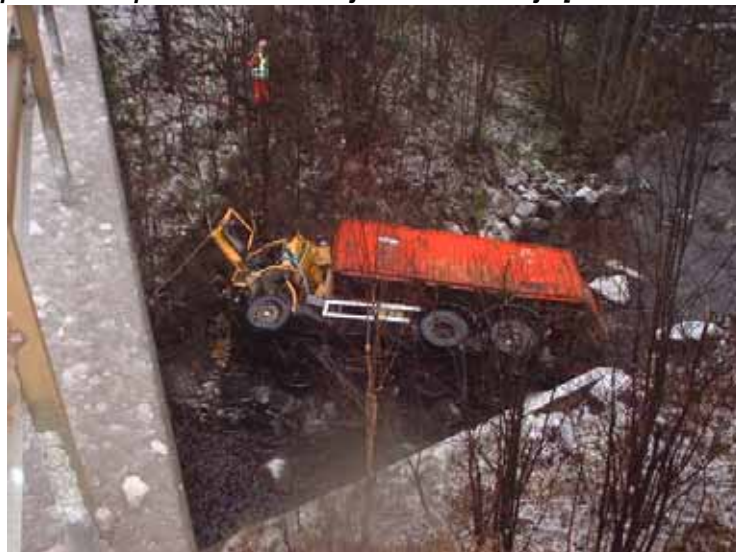
Figure 76 HS S Viksjö: Truck crash in Oct 2005 [Photo: High Coast Rescue Dept]

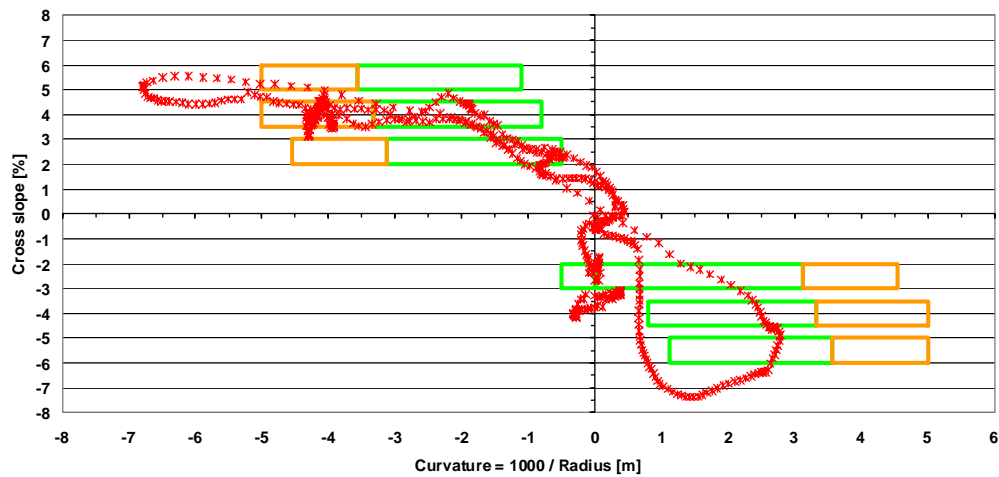
Figure 77 *Poor road alignment cause dynamic imbalance at the Hazardous Site S Viksjö*

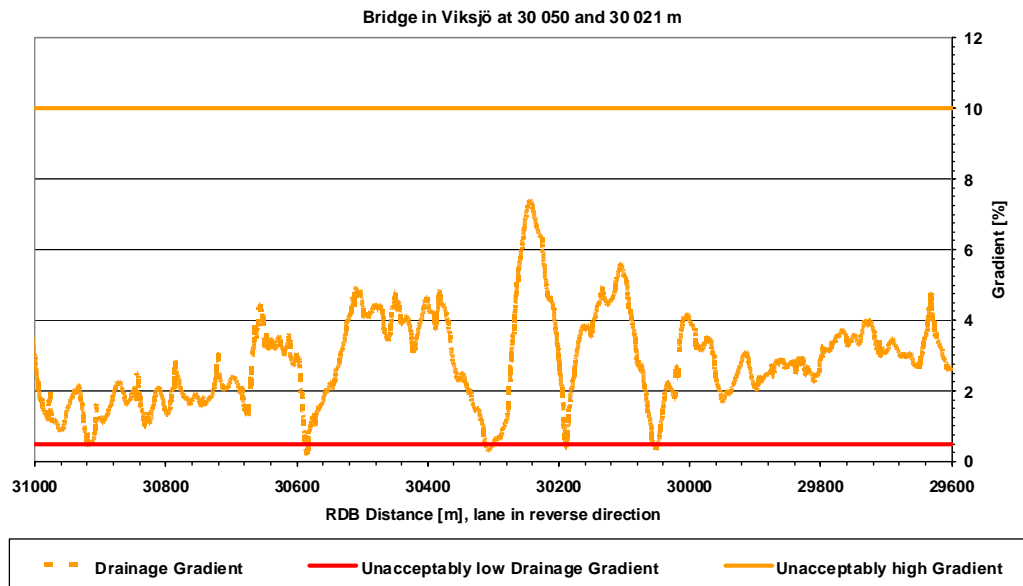
Figure 81 High skid risk due to low Drainage Gradient before the bridge at HS S Viksjö

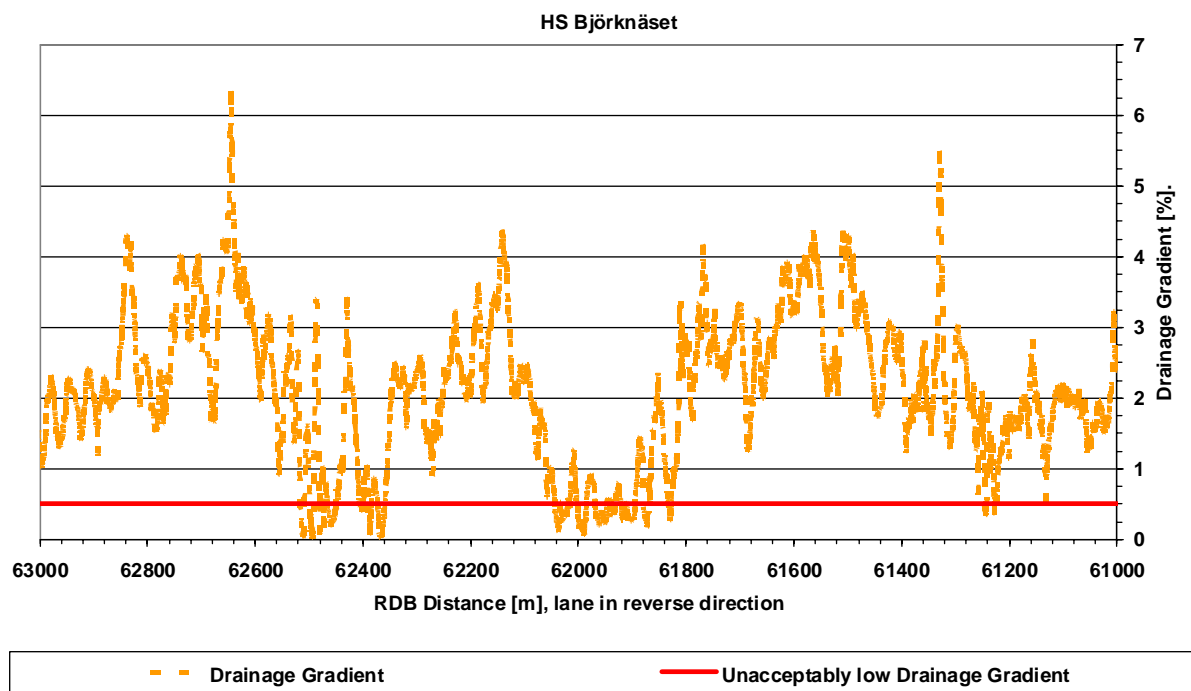
Figure 82 *Skid risk due to low Drainage Gradient over hundreds of metres at HS Björknäset*

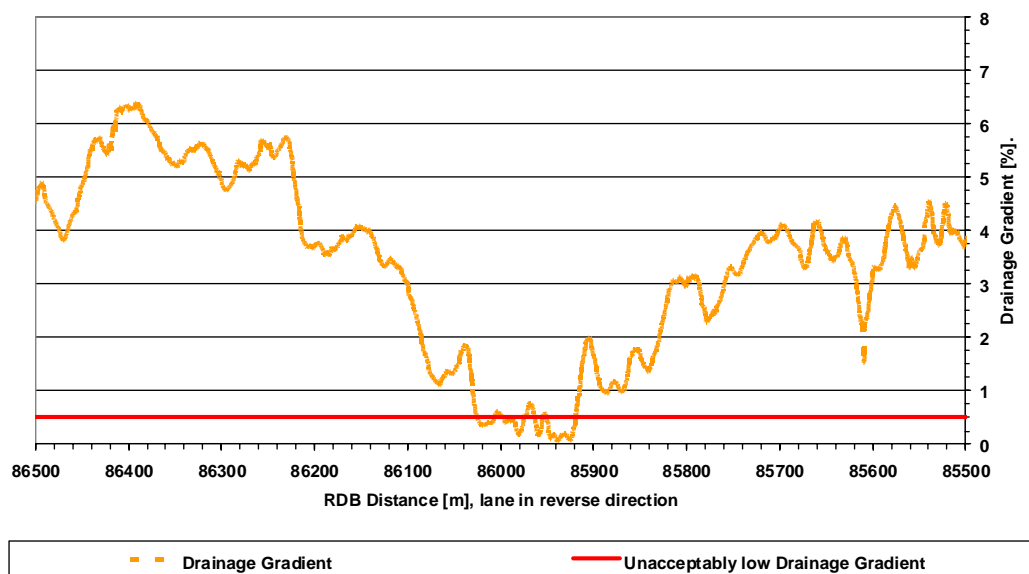
Figure 83 *Extreme skid risk due to low Drainage Gradient on one hundred meter at HS Helgum*

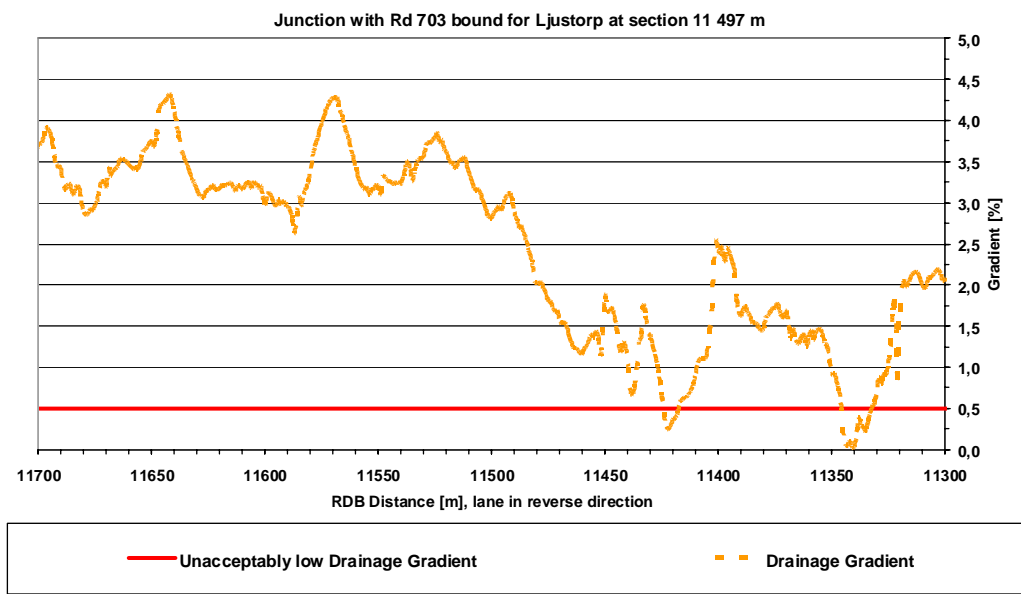
Figure 84 *Unacceptably high skid risk due to too low Drainage Gradient at HS Åsäng*

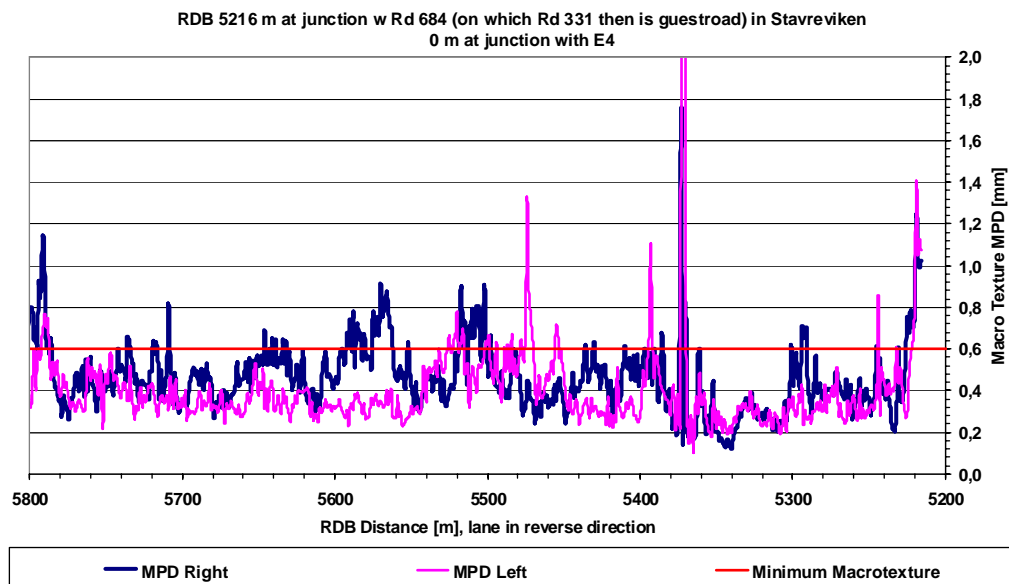
Figure 87 *Insufficient Macro Texture at HS Stavreviken*

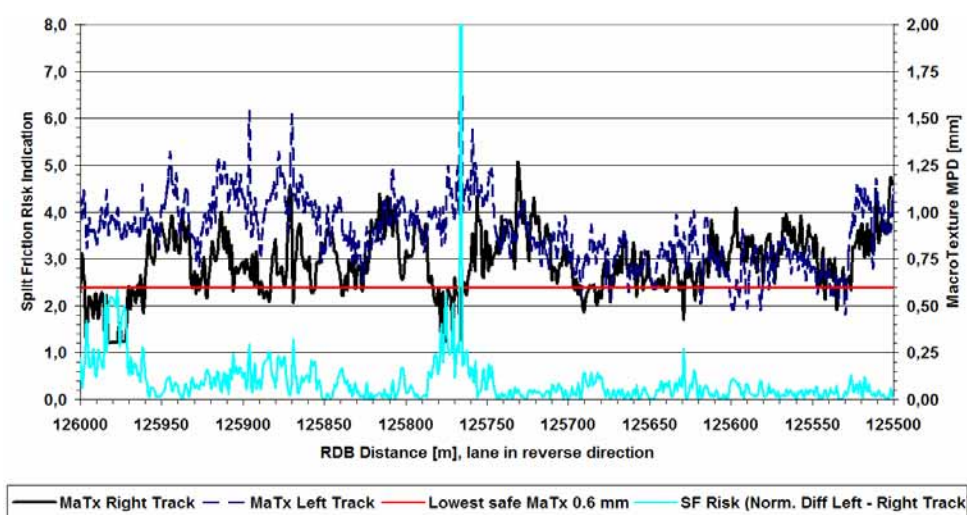
Figure 88 *Macrotexture values indicating low and split friction (due to patch repair in only one track)*
