NEW SURVEY TECHNIQUES IN DRAINAGE EVALUATION

- LASER SCANNER AND THERMAL CAMERA

A ROADEX IV report for Task D1 "Drainage maintenance guidelines"

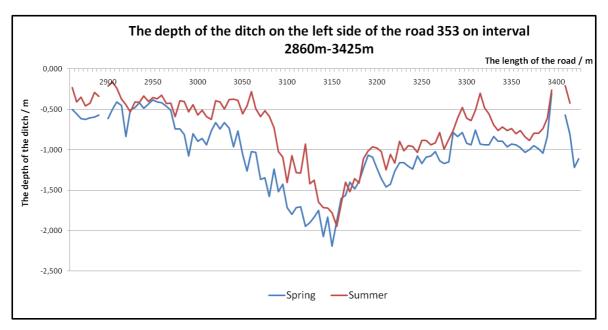
Figure 6 presents the depth of left ditch bottom of Road 353 from 2860m to 3425m. This part of the road had no vegetation in the bottom of the ditch in the spring surveys, but there was vegetation during the summer surveys. The results show some noticeable differences between the respective datasets. During the summer surveys the ditch bottom level was seen to be higher than in spring. In this section, the bottom of the left ditch is on average about 36.5cm higher in the summer scanning than in the spring scanning. In the right ditch the difference is about 29cm.

Figure 6. The depth of ditch bottom of Road 353 from 2860m to 3425m. The blue line represents the spring measurement results and the red line the summer measurement results.

The difference in the measured ditch bottom level can be mainly explained by vegetation, but part of the difference can also be due to frost heave effects, which can be present in Spring measurements. Snow filled ditches usually insulate the ditch bottom from frost heave with the result that the ditch bottom level generally remains at the same level in the Spring. The road surface on the other hand can be higher because of frost heave. On Road 353 the ditch bottom level was seen to be roughly 30-40cm higher in summer due to the presence of vegetation in the ditch. Given these results it is recommended that laser scanning measurements should be conducted in the Spring at a time when the vegetation has not yet begun to grow.

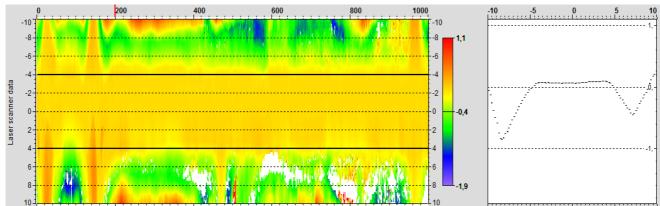
Figure 8. An example of laser scanner data with sufficient quality. There are no interruptions and the shape of cross-section is easily seen.

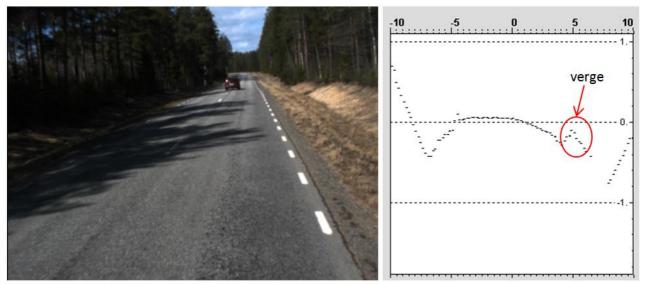
Figure 9. The cross section of Road 353 at point 2285. The verge is marked in red.

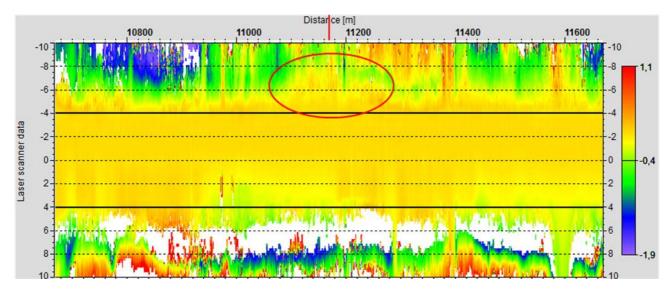
Figure 10. Laser scanner data from Road 353, from 10650m to 11650m. The colour of the road surface level is orange or yellow, the black lines represents the road edges. The red oval shows a section where the left inner slope is flowing into the ditch.

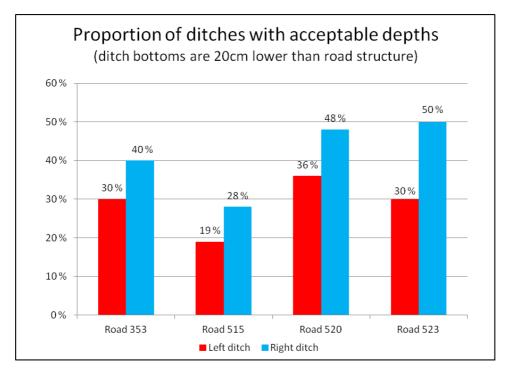
The Umeå test roads surveys showed that only 20-50% of ditches were deep enough. The percentages of each of the analysed roads are listed in Figure 12. Figure 13 presents the distribution of drainage classes of Roads 353, 515, 520 and 523. On Road 353 (both sides) and Road 523 (left side) the ditches are, for the most part, in good condition. Most of Road 523 (right side) and Road 515 (left side) were rated as Class 3, poor drainage.

Figure 12. Diagram showing the percentage of ditches surveyed that were deep enough (i.e. over 20cm deeper than the road structure).

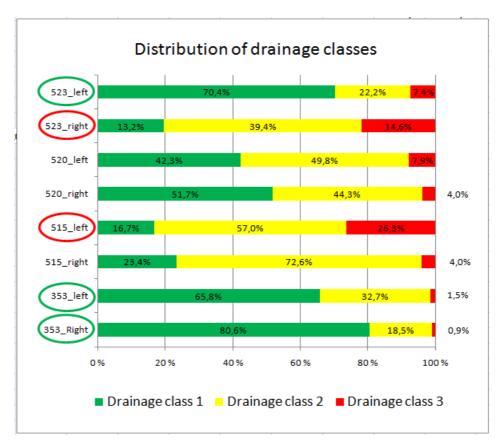
Figure 13. The distribution of drainage classes on the surveyed roads.

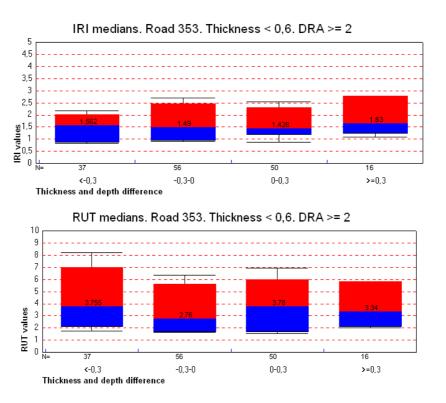
The statistical analysis of the survey data (Figures 14) showed that for thin roads (i.e. roads with a structure of less than 60cm) the depth of the bottom of the ditch had no effect on the road roughness or rutting values. This is likely to be due to the fact that thin roads only survive over good and drainable soils. If they had been constructed on poor soils or water permeable subgrades they would have collapsed a long time ago. This is why we do not see a good correlation between the ditch bottom level vs. road rutting and roughness

Figure 14. Road 353; distribution charts of rut depths and roughness values as function of the difference between the road structure depth level and ditch bottom level. The road structure thickness of the road in this chart is less than 0.6m. The horizontal axis classifies the different ditch bottom depth vs road structure bottom depth. The rightmost bar (>= 0.3) represents those cases where the ditch bottom level is clearly above the bottom level of the road structure. The value inside the columns shows the median value of the class.

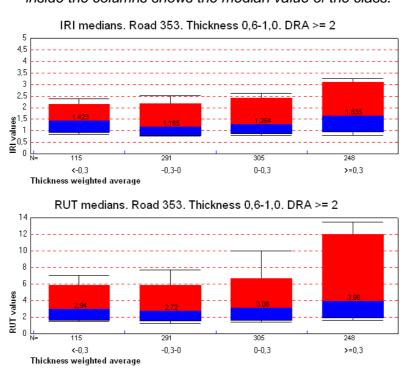
The results of the analysis clearly show that the ditch bottom depth level had the most significant effect on road performance when the thickness of the road structure is between 0.6 and 1.0m (Figures 15). This is the usual case with low volume roads in Nordic countries. The analysis also showed that both roughness and rutting values were higher if the ditch bottom level was higher than -0.3m. The median of the IRI-values, for example, is 15% higher when the bottom of the ditch is more than 0.3m higher than the bottom level of the road structure. Similarly the rut value median

for the same case is 35% larger, and the worst 10% values (the conditions that measure pavement lifetime) are roughly 3-4 times larger than the median values.

Figure 15. Road 353; distribution charts of rut depths and roughness values as function of the difference between road structure depth level and ditch bottom level. The road structure thickness

in this chart is 0.6 - 1.0 m. The horizontal axis classifies the different ditch bottom depth vs road structure bottom depth level. The rightmost bar (>= 0.3) represents those cases where the ditch bottom level is clearly above the bottom level of the road structure. The value inside the columns shows the median value of the class.

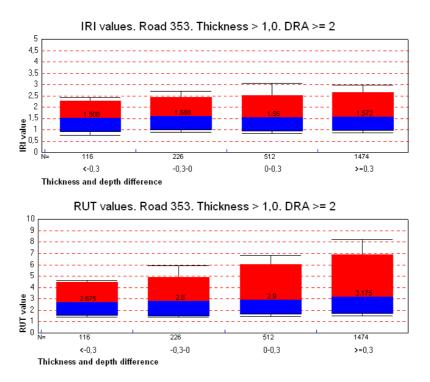
Where the road structure is thicker than 1.0m, the ditch bottom level seems only to have a meaningful effect on the highest rut depth values as Figures 16 show. Here the median values of rutting and roughness increase slightly when the elevation of bottom of the ditch rises.

Figure 16. Road 353; distribution charts of rut depths and roughness values as function of the difference between road structure depth level and ditch bottom level. The road structure thickness in this chart is thicker than 1.0 m. The horizontal axis classifies the different ditch bottom depth vs road structure bottom depth level. The rightmost bar (>= 0.3) represents those cases where the ditch bottom level is clearly above the bottom level of the road structure. The value inside the columns shows the median value of the class.

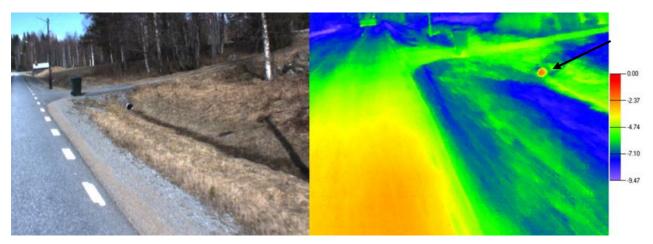
Figure 17. Road 353, chainage 22184m, right ditch; the access road culvert is in good condition (sufficient size and open, not clogged). The access road culvert can be seen in both digital video and thermal camera image. The location of the access road culvert is indicated with a black arrow.

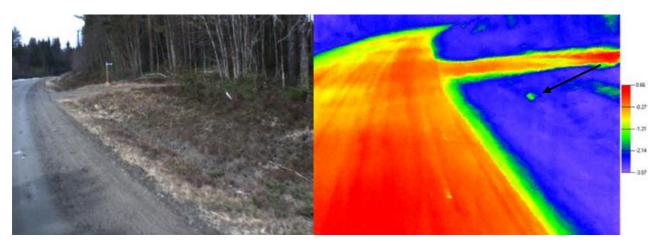
Figure 18. Road 515, chainage 5832m, right ditch; the access road culvert is almost clogged. The access road culvert can be seen in the thermal camera image, but not in the digital video. The location of the access road culvert is indicated with a black arrow.

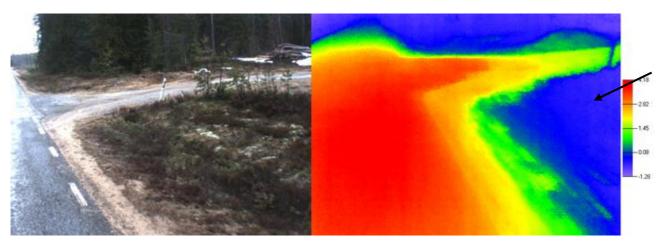
Figure 19. Road 514, chainage 2730m, right ditch; an access road without a culvert. The access road culvert cannot be seen either in the thermal camera image or in the digital video. The place where an access road culvert should be installed is indicated with a black arrow.

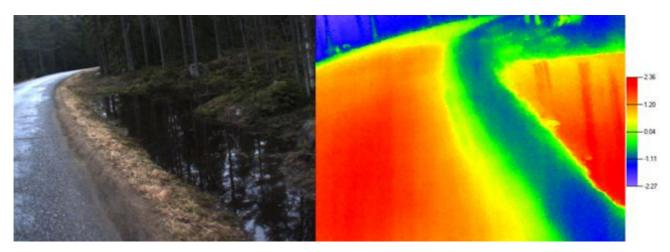
Figure 20. Road 514, chainage 6765m, right ditch; a large quantity of water is trapped in the ditch. The water surface acts partly as a mirror and reflects thermal waves from surroundings (see the tree trunks on the water surface in the thermal camera image).

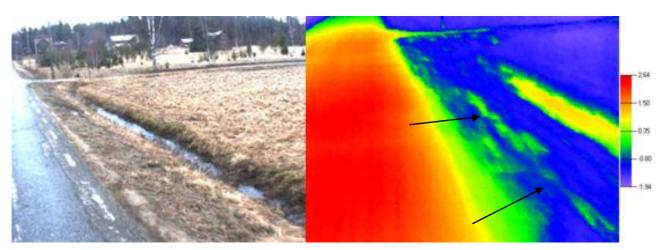
Figure 21. Road 514, chainage 7557m, right ditch; a small amount of water is standing in the ditch. The water surface is warmer in the thermal camera image. The thermal camera image also shows that the road is suffering from Mode 2 rutting and cold water is being released from the thawing frost (marked with black arrows). This is seen as cold areas (blue) in the middle of warmer areas (green).

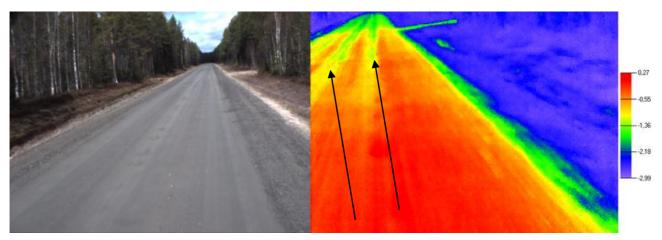
Figure 22. Road 515, chainage 4250m, gravel road section. Moisture, pumping through the road structure can be seen in the wheel paths (seen as colder lines in the thermal camera image, marked with black arrows).

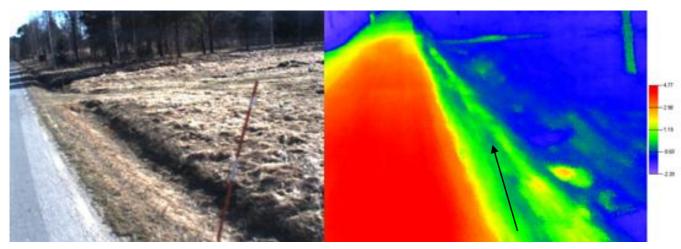
Figure 23. Road 568, chainage 9076m. Cold water, released from thawing ice, is being pushed through the inside road slope (colder section on the edge in the thermal camera image, marked with black arrow). This is a clear sign that the road is suffering from Mode 2 rutting.

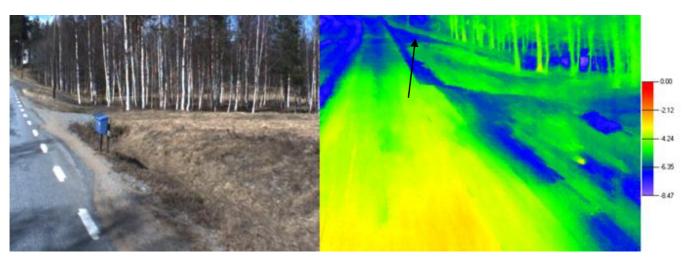
Figure 24. Road 353, chainage 22445m, right ditch. The thermal camera image shows that the road structure is wet (seen as blue in the image) and that water is pumping through the pavement. Water released from thawing ice is flowing along the inner slope towards the forest (marked with a black arrow). The data also shows a possible cable excavation close to road shoulder that is collecting water.

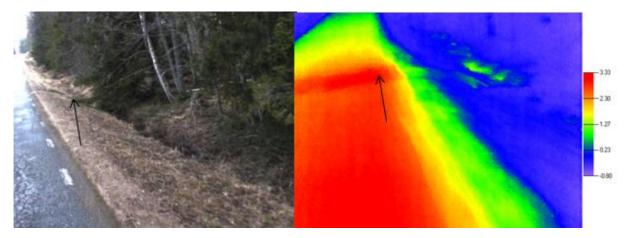
In some cases main road culverts can also be seen in thermal camera images. In Figure 25 a culvert under the road has been marked with black arrows. From the fact that the culvert is seen so clearly and is warmer than its surroundings, it can be concluded that culvert is not frozen and is working well. Figure 26 shows a plastic culvert that is installed too close to the pavement surface.

Figure 25. Road 514, chainage 7440m, left ditch; a culvert under the road is marked with black arrows.

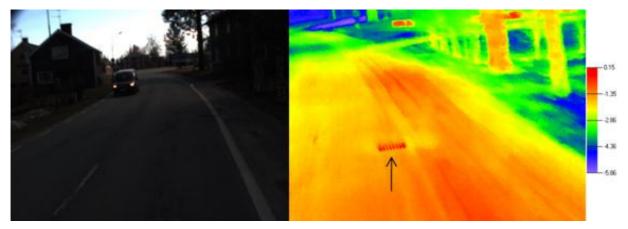
Figure 26. Road 353, point 23680m, left ditch; a plastic culvert under the road is set too high (marked with black arrow).

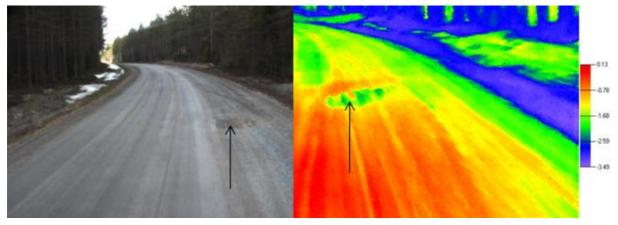
Figure 27 shows an example of a pothole being created in the road surface due to an ice lens developing in the road structure. When an ice lens thaws, it releases water causing the road structure to soften and a pothole is born.

Figure 27. Road 515, chainage 5130m, pothole developing in the road surface.

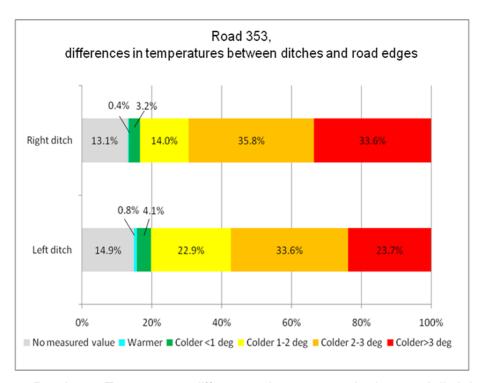
In addition to visual inspection, the thermal camera results were analysed statistically. Differences in temperatures between the bottom of the ditch and the edge of the road were compared. For example in Road 353, for the most part, both of the ditches are 2-3 degrees colder than the edge of the road (Figure 28). According to results presented earlier in chapter 4.1.3 from Road 353, 30% of the left ditch and 40% of the right ditch were 20cm lower than the road structure. This information correlates well with Figure 28. When the ditch is deep enough and the drainage is in good condition the ditch is colder because well-working ditches and drier conditions cool faster in the night. It has not been possible so far to make any further conclusions or correlations regarding the significance of differences in temperatures between the edge of the road and the bottom of the ditch.

Figure 28. Road 353. Temperature differences between road edges and ditch bottoms.
