Annele Matintupa, Seppo Tuisku

SUMMARY OF DRAINAGE ANALYSIS IN IRELAND, ROADS N56 AND N59

Demonstration Project Report

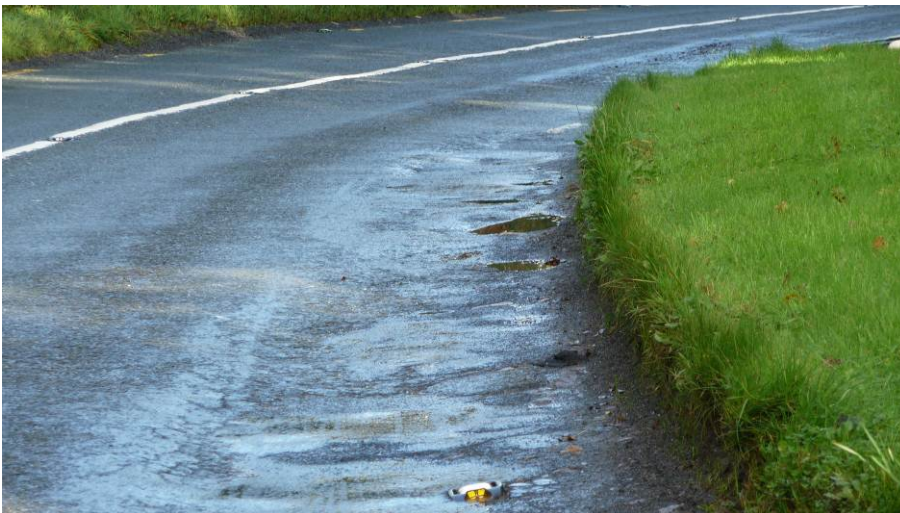
Verges are very common on the N56 and N59, and there use is widespread on the Irish road network. An example of an extremely high verge is shown in Figure 6. Verges prevent the water flowing away from the roadway, forcing any surface water to drain through the pavement structure instead of flowing away from the road. Water also runs along the road surface causing a risk for aquaplaning and splash problems.

Figure 6: A high verge on the Irish road network, photo taken on road N59.

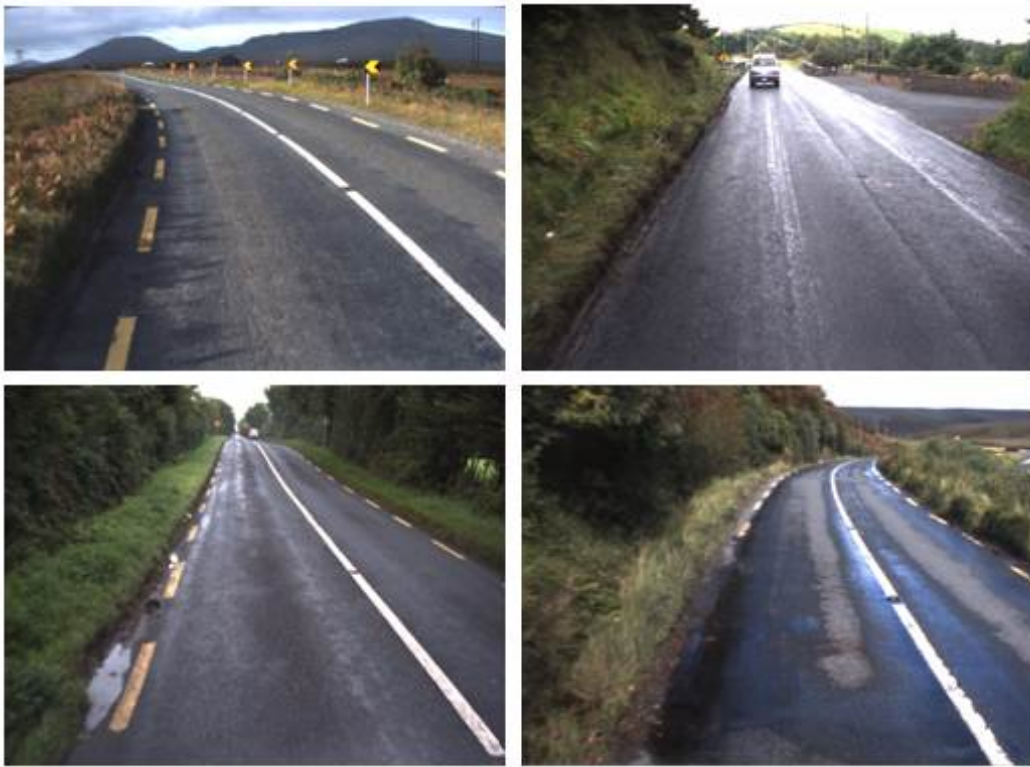
Verges can cause a number of problems to roads. The greatest is that of reduced bearing capacity, as seen as large deformations in the pavement. Where drainage has been improved, the drainage through the verges has usually been handled by adding or opening offlets. In cases, where the road has been upgraded or repaved some verges have been removed. However in those sections where the drainage through the verges was not improved problems have reappeared soon afterwards. A few examples of the types of problems caused by high verges are presented in Figure 7.

Figure 7: Examples of road sections suffering from problems due to verges.

The most noteworthy feature of the surveyed sections of the N56 and N59 in Ireland is the lack of traditional open ditches. This will cause difficulties in the improvement of the road drainage, as will the presence of verges. The solution for road sections where verges are producing problems is to remove the verge or make more offlets.

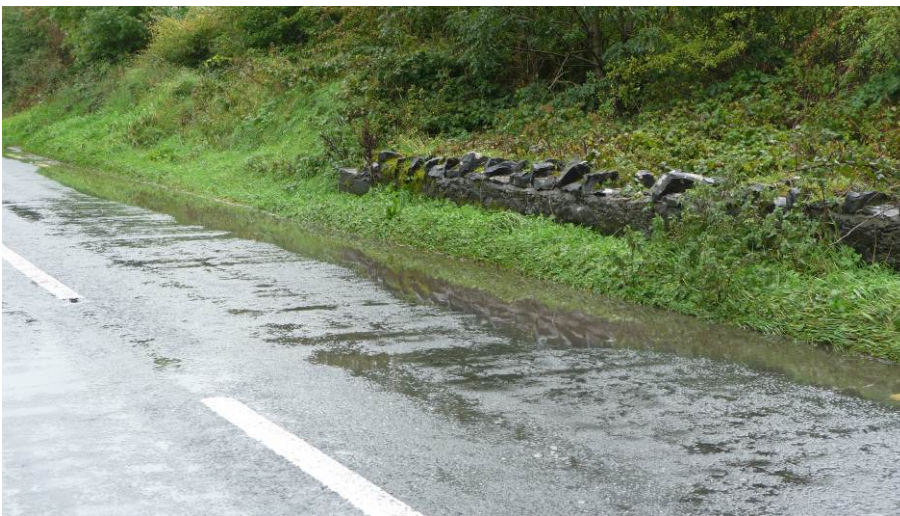
Another typical feature on the Irish roads surveyed was the presence of stone boundary walls. An example of a stone wall is shown in Figure 8. These were very common along both roads N56 and N59. Usually these walls were located along old sections of roads that had not been upgraded. Where road improvements had been carried out these walls appear to have been removed. Usually the walls are very old and in many cases not visible due to vegetation growth.

Figure 8: A typical stone walls on road N59.

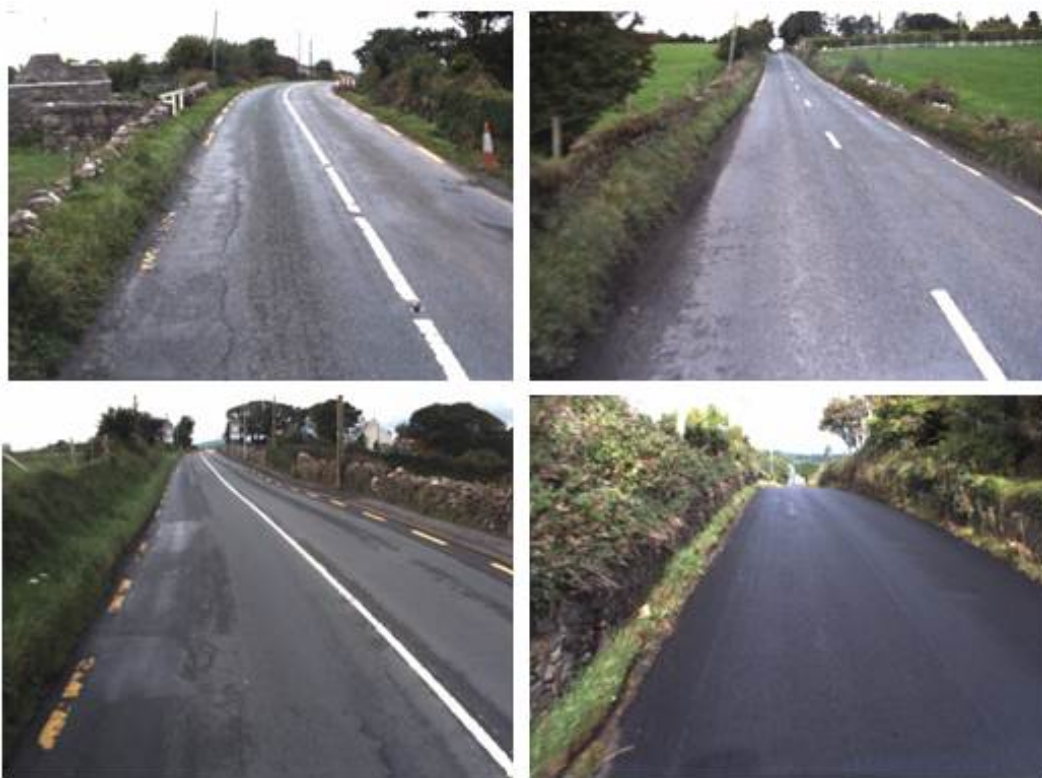
Typically these walls blocked the flow of surface water away from the road unless water outlets had been provided. This caused problems to the road similar to those caused by high verges, i.e.

reduced bearing capacity and deformations. Examples of typical problems caused by stone walls without water outlets are shown in Figures 9.

Figure 9: Examples of road sections suffering problems due to stone walls.

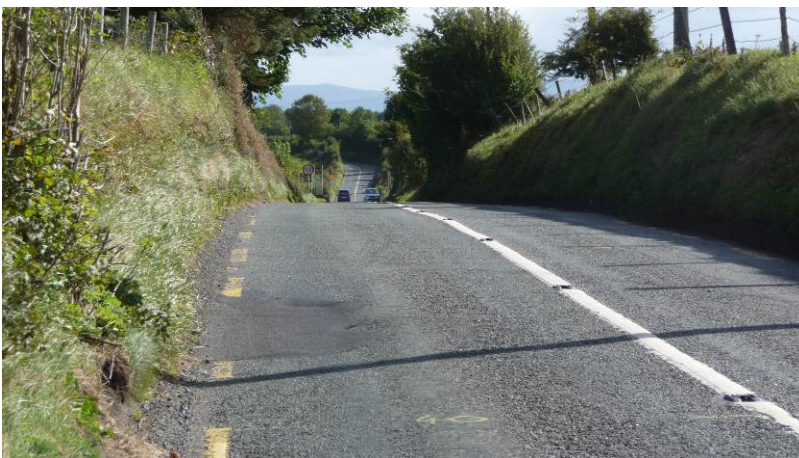
A very special feature on the roads surveyed was the narrow road cutting. A typical example of an Irish “road cut” as seen in Figure 10 shows sharply inclined side slopes that start immediately at the pavement edge leaving very little room for drainage structures. A high proportion of these steep slopes appear to consist of stone walls obscured by vegetation and soil.

Figure 10: An example of a road cut on road N59.

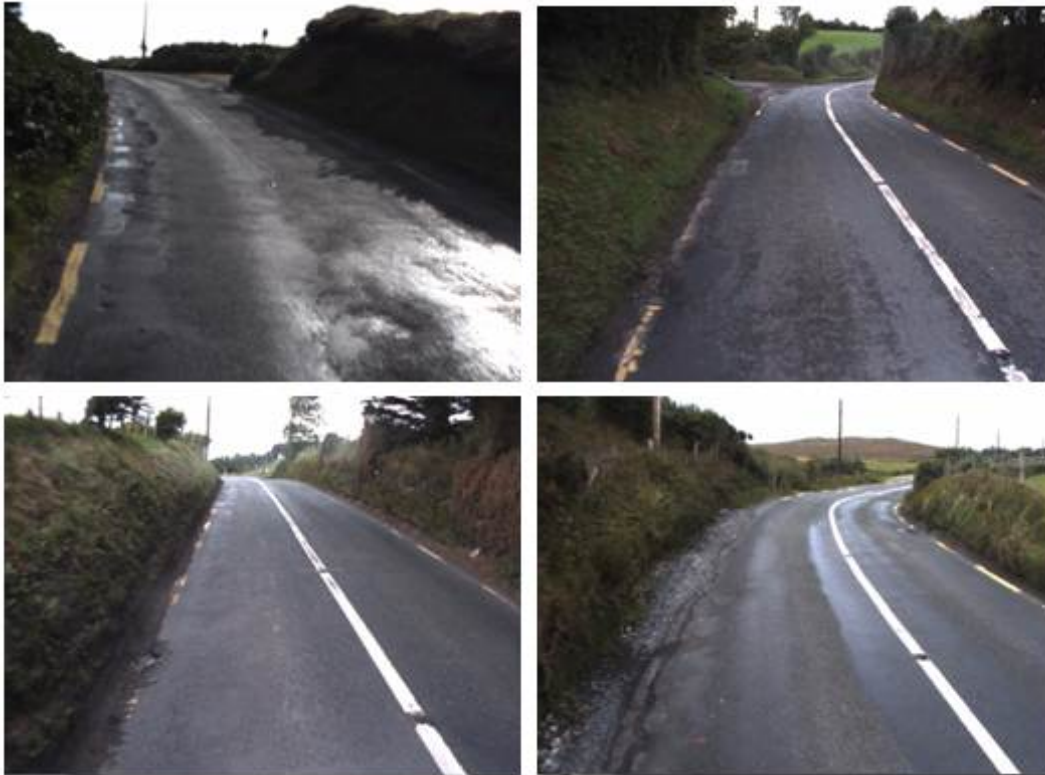
In many cases there is a complete absence of ditches or any other drainage structure within these types of road cuts. This means that water generally flows along the road as there is no possibility for it to get off the road, and this in turn causes erosion, bearing capacity and deformation

problems to the road. Examples of typical problems that can occur in such road cuts are shown in Figures 11.

Figure 11: Examples of road sections located in road cuts.

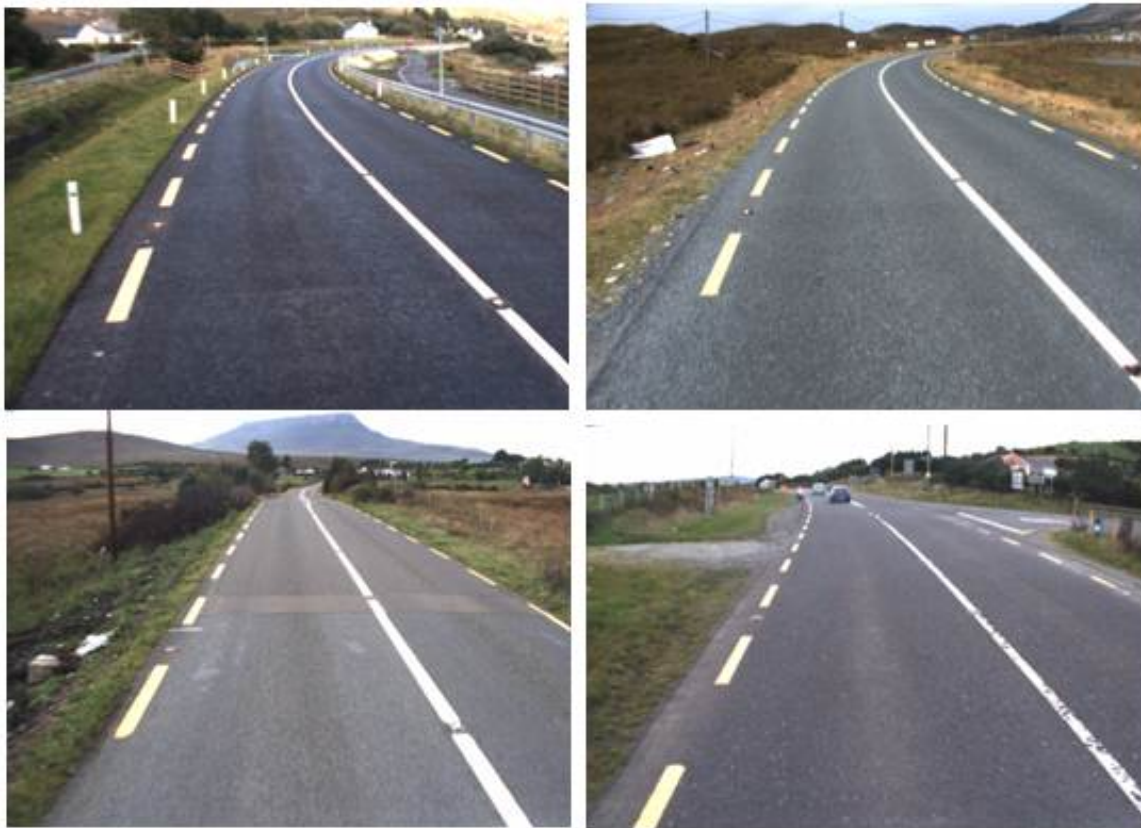
Drainage Class 1 means that the drainage condition is faultless. The cross-section of the road has preserved its form well and water flows unrestricted from the pavement to the ditch. Water has also a clear passage in the ditches. Where a verge is present it has enough offlets to let the water flow to the ditch.

Figure 12: Examples of road sections with drainage Class 1 in Ireland.

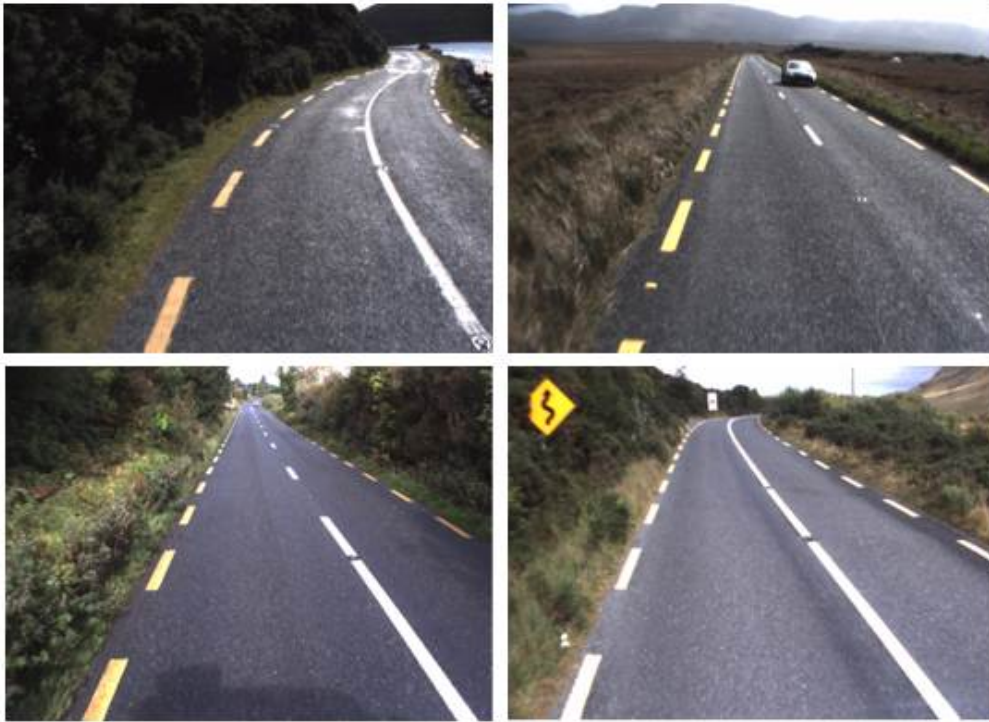
In drainage Class 2 there can be some visible changes to the road cross-section. The road shoulder has narrow verges or vegetation growth that is preventing the free flow of surface water from the road surface into the ditch. There is some vegetation in the ditch that restricts water flow and creates damages. Some soil is sliding from the road sideslope into the ditches and raising the bottom of the ditch. This hinders water flow and raises the ground water level.

Figure 13: Examples of road sections with drainage Class 2 in Ireland.

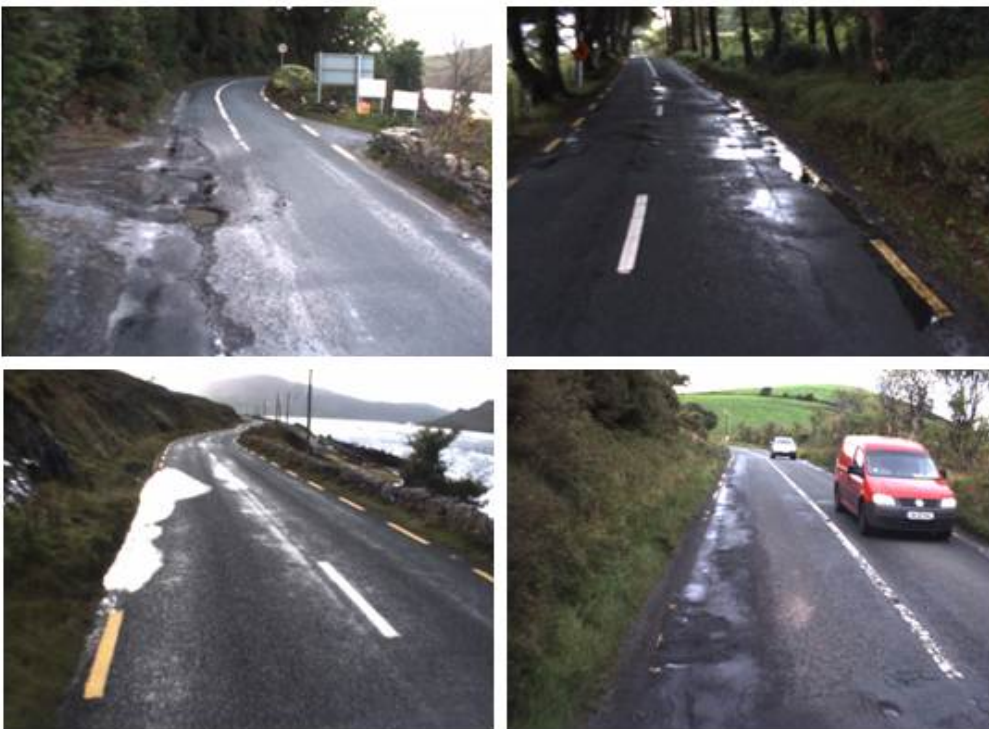
Drainage Class 3 covers those road sections with severe drainage problems. The road shoulder has a high verge and/or dense vegetation that is causing ponding on the traffic lane or on the shoulder. Vegetation is growing in the ditches and restraining the flow of water creating dams in the ditches. Unstable soil is flowing from ditch slopes into the bottoms of ditches and blocking the flow of water. Clogged culverts or outlet ditches is preventing the flow of water in the ditch. All of these situations lead to the development of deformation and damage in the road cross-section.

Figure 14: Examples of road sections with drainage Class 3 in Ireland.

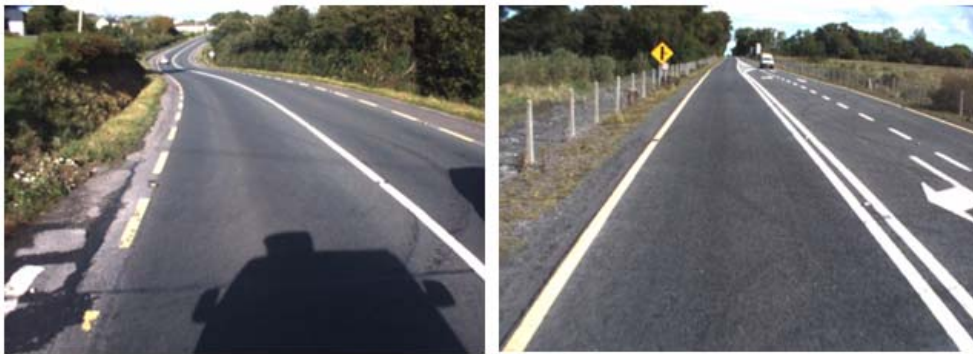
Class 1 verges cover those road sections where there is no verge and water can flow freely from road surface. Figure 15 presents a few examples of verge Class 1 road sections.

Figure 15: Two examples of verge Class 1, i.e. road sections without verges. The photo on the left is from road N56 at point 15,222m, the photo on the right is from road N59 at point 40,996m.

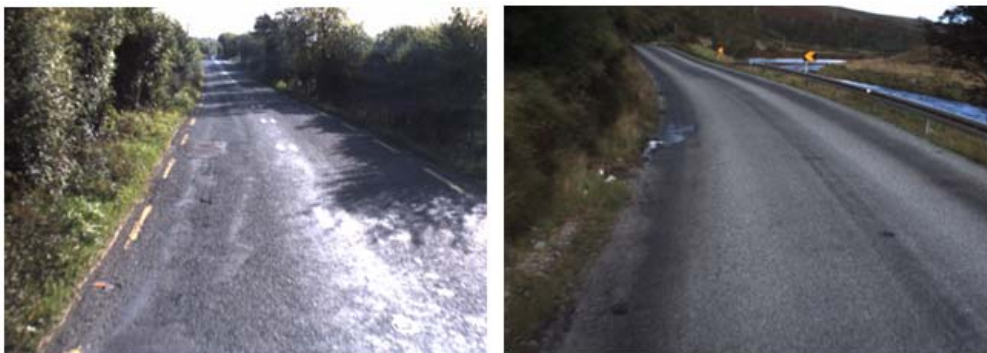
Class 2 verges cover all road sections with minor verges and adequate offlets. The number of offlets is enough to ensure proper drainage and they are in good condition. The water can flow freely from the road surface. Verges do not restrict the water flow or the workings of the road drainage system. Figure 16 shows a few examples of road sections with verge Class 2.

Figure 16: Two examples of verge Class 2, roads with a verge which has minor effect on the workings of the road drainage system. The photo on the left is from road N56 at point 27,591m, the photo on the right is from road N59 at point 91,163m.

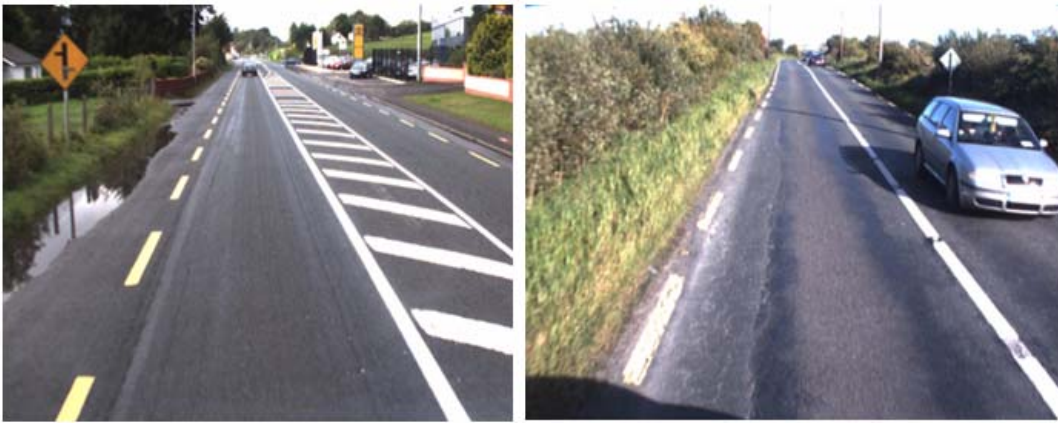
Class 3 verges cover those road sections with significant verges restricting the water flow away from the pavement causing ponding and other problems. There are no offlets or they are in poor condition. Figure 17 shows a few examples of road sections belonging to verge Class 3.

Figure 17: Two examples of verge Class 3, roads with a verge that has a significant negative impact on the workings of the road drainage system. Both photographs are from road N56. The photo on the left is at point 2,777m, the photo on the right is at point 20,685m.

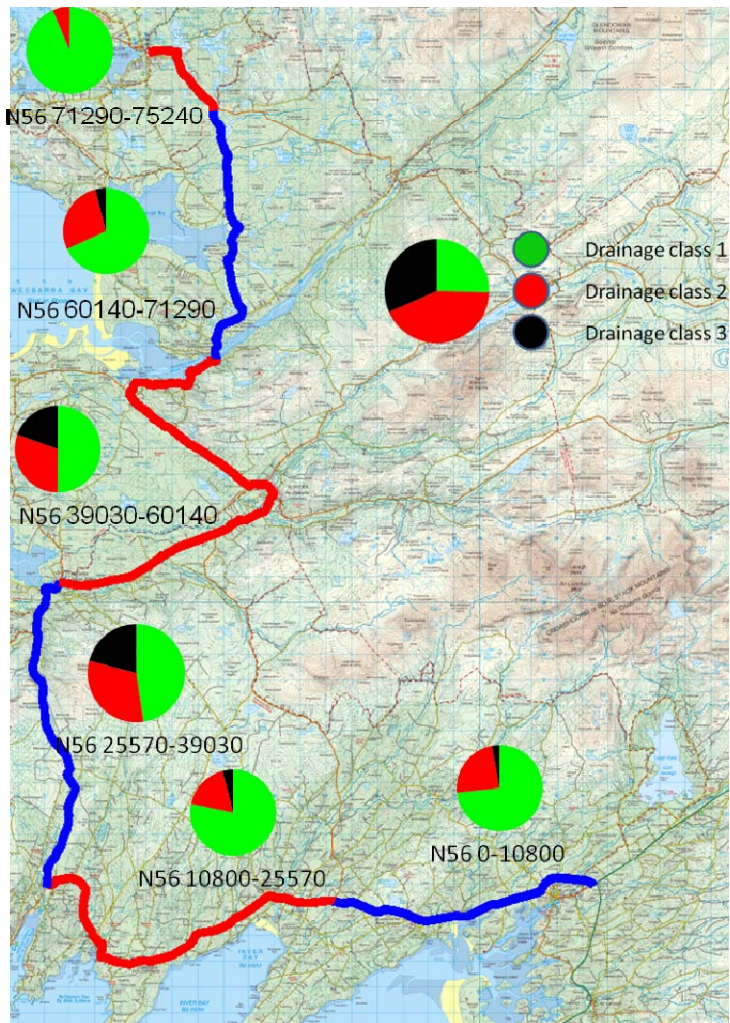
The first surveyed section of the N56 was from Donegal to Dungloe. The drainage in this section is mainly in good condition. The best section is located at the end of the road from the R252 crossroads to Dungloe (71,290 – 75,240m). The section with the worst drainage is from the R263 crossroads to the R261 crossroads (25,570 – 39,030m). A map of the drainage statistics for this section is presented in Figure 18.

Figure 18: Drainage condition in the first part of road N56 from Donegal to Dungloe.

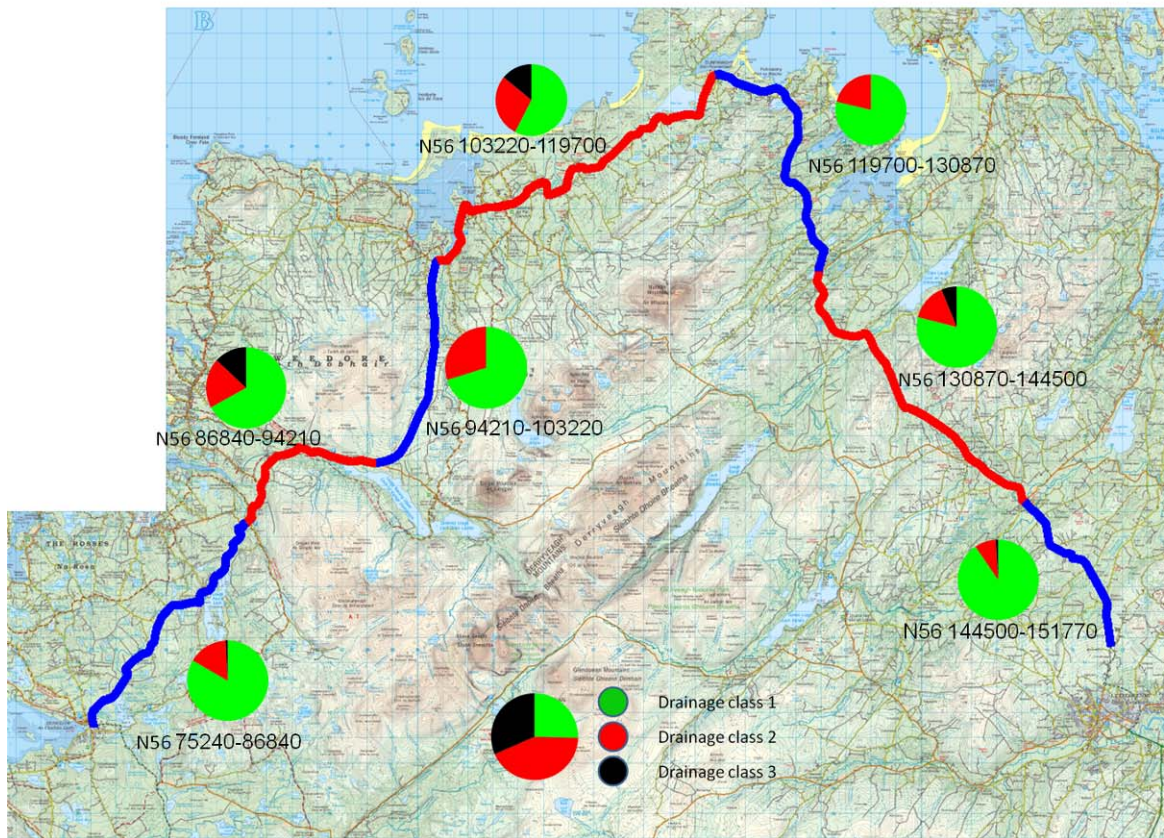
The second surveyed section of the N56 was from Dungloe to the Mountaintop Roundabout in Letterkenny. This part is in generally good condition. The best section is from the R249 crossroads to the Mountaintop Roundabout in Letterkenny (144,500 – 151,770m). The worst part is from the R257 crossroads to Dunfanaghy (103,220 – 119,700m). A map of the drainage statistics for this section is presented in Figure 19.

Figure 19: Drainage condition in the second part of road N56 from Dungloe to Mountaintop Roundabout in Letterkenny.

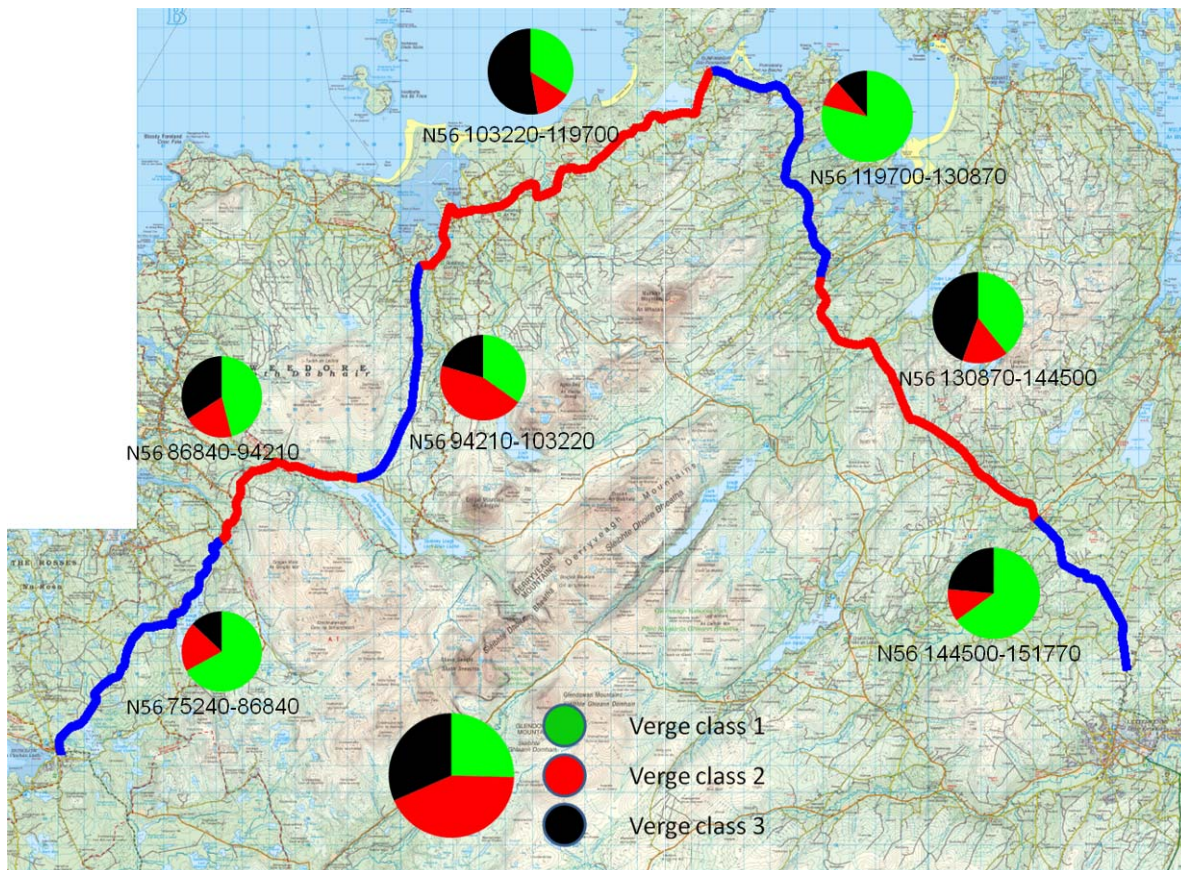
The second section of N56, from Dungloe to the Mountaintop Roundabout in Letterkenny, has a greater quantity of verges. The section from Dunfanaghy to the R245 intersection (119,700 – 130,870) has the least verges, while the most verges could be found on the section from the R257 intersection to Dunfanaghy (103,220 – 119,700). The map of verge class along this part of road is presented in Figure 21.

Figure 21: Verge class in second part of the road N56 from Dungloe to Mountintop Roundabout in Letterkenny.

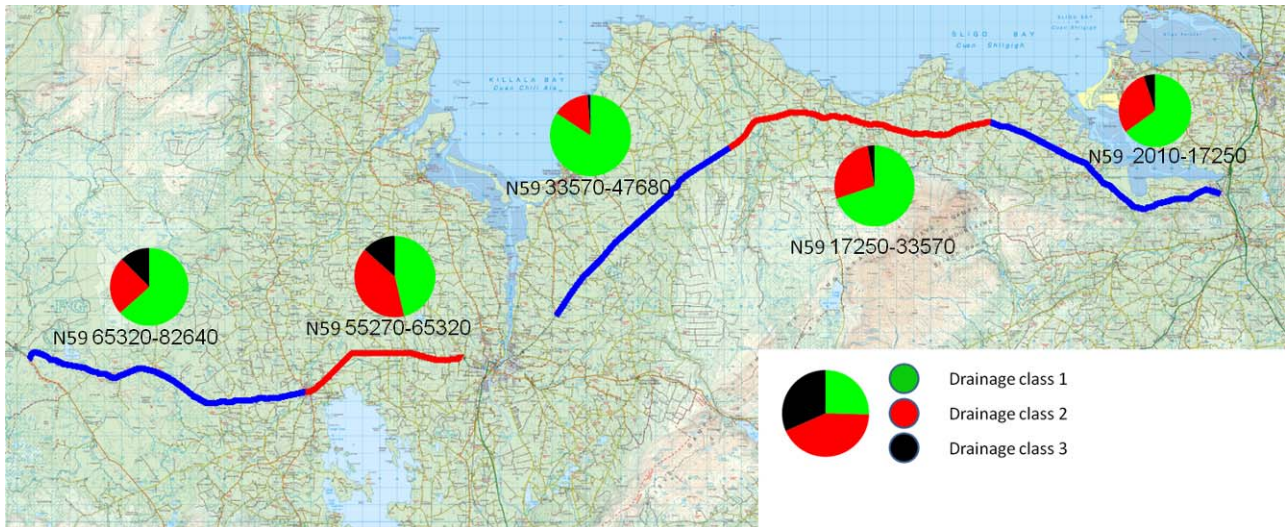
The first section of road N59 was from Ballisodare to the R312 intersection. The drainage in this section is mainly in good condition. The section with the best condition is the section from Owenberg to the R297 crossroads (33,570 – 47,680m), just before the village of Ballina. The section with the worst condition is the section from the R297 crossroads to Crossmolina (55,270 – 65,320m) after the village of Ballina. A map showing the drainage statistics of this section is presented in Figure 22.

Figure 22: Drainage condition in the first part of road N59 from Ballisodare to the R312 intersection.

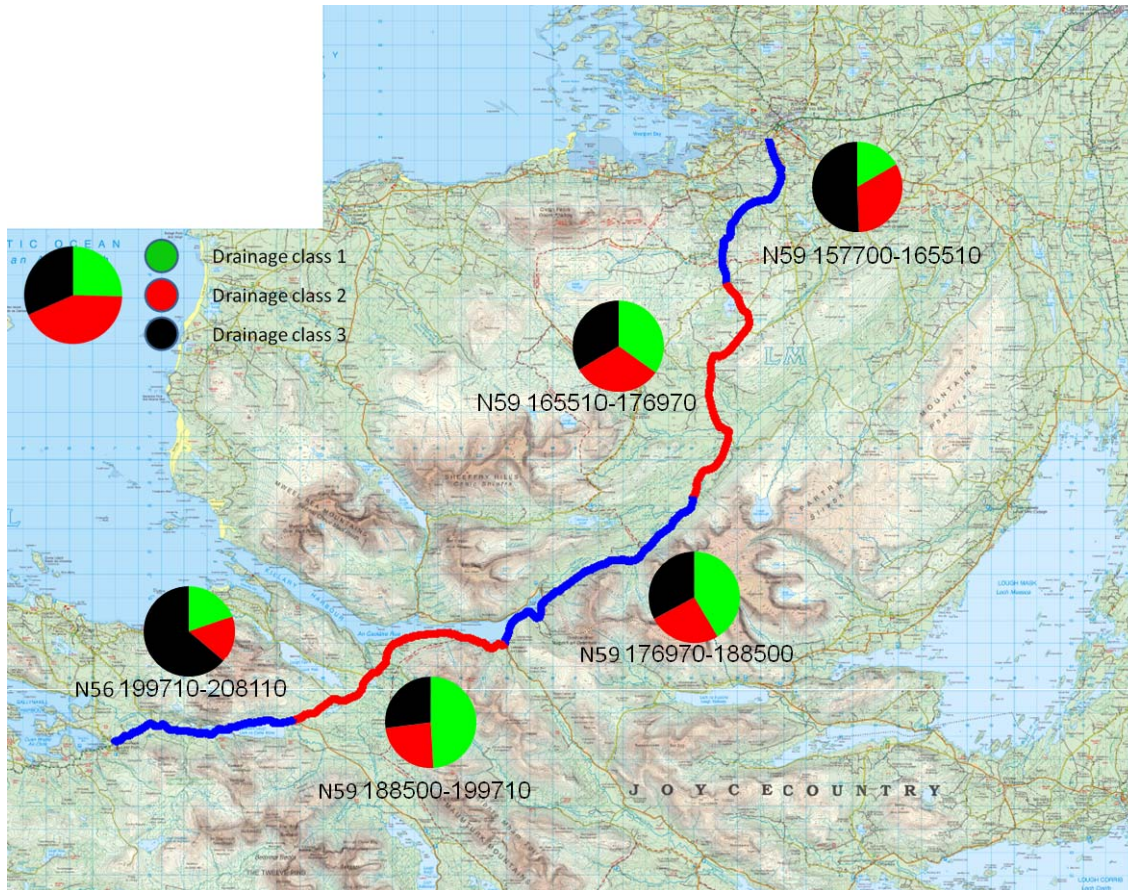
The third section was from Westport to Letterfrack. The best drainage condition was found to be from the R344 crossroads to the R336 crossroads (188,500 – 199,710m). The worst section is at the end, from the R344 crossroads to Letterfrack (199,710 – 208,110m), where more than 50 % of the road was classified as drainage Class 3. A map showing the drainage statistics of this section is presented in Figure 24.

Figure 24: Drainage condition in the third part of road N59 from Westport to Letterfrack.

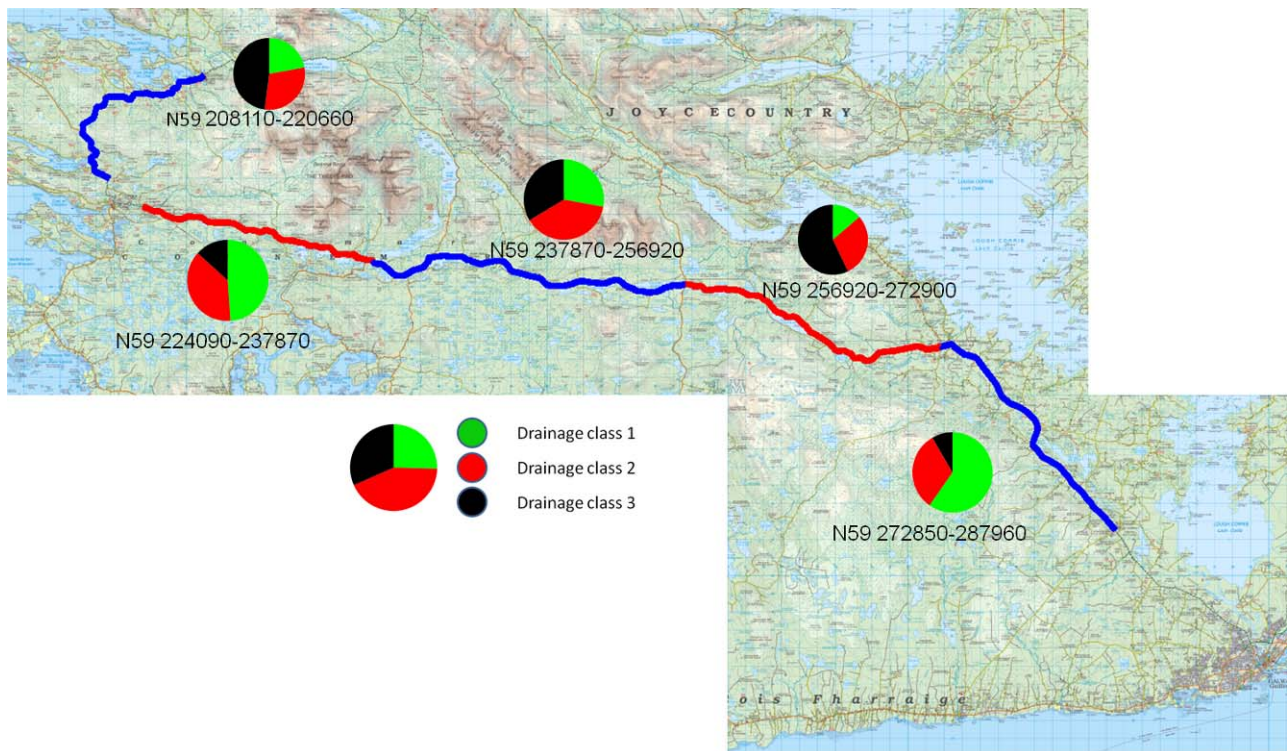
The fourth section was from Letterfrack to Galway (Forest Hills intersection). The end part of this section, from Oughterard to Forest Hills (272,900 – 287,960m) has the best drainage condition with more than half of the road section classified as drainage Class 1. A map showing the drainage statistics of this section is presented in Figure 25.

Figure 25: Drainage condition last part of road N59 from Letterfrack to Galway (Forest Hills intersection).
