Annele Matintupa, Seppo Tuisku

SUMMARY OF DRAINAGE ANALYSIS IN THE SCOTTISH HIGHLANDS

Demonstration Project Report

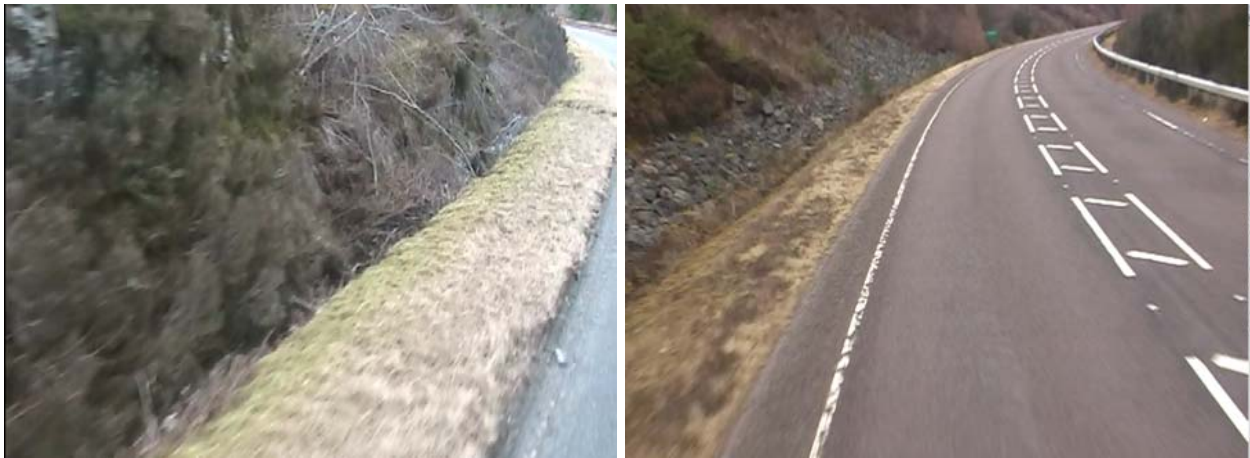
This section started at the Loch Maree Hotel and ended in Slattadale at a cattle grid. The length of the section was 5912m. The beginning of the section had high verges which blocked surface water flowing from the road. The left ditch was poor and full of bushes. In the upgraded section, starting from 1400m, the drainage was in good shape

Figures 6: Left: High verge and bushes, Right: Good drainage in upgraded section

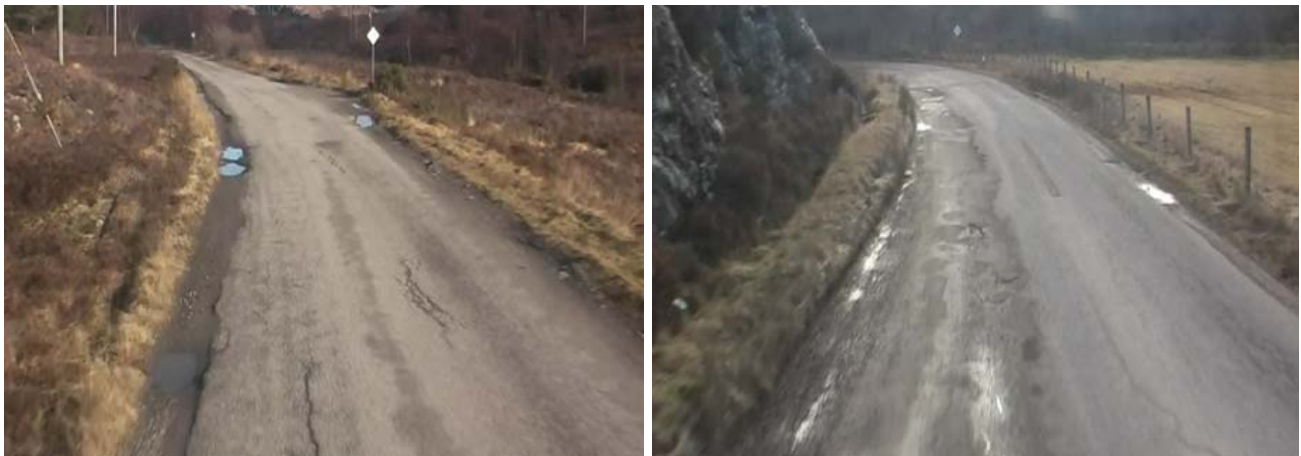
The section from Slattadale cattle grid started as a 2-lane road but after 550m it changed to single track. The single track part had several severe drainage deficiencies especially at the end of section. The length of the surveyed section was 5730m and ended at the junction with the B8056 road.

Figures 7: Severe drainage problems towards the end of the section

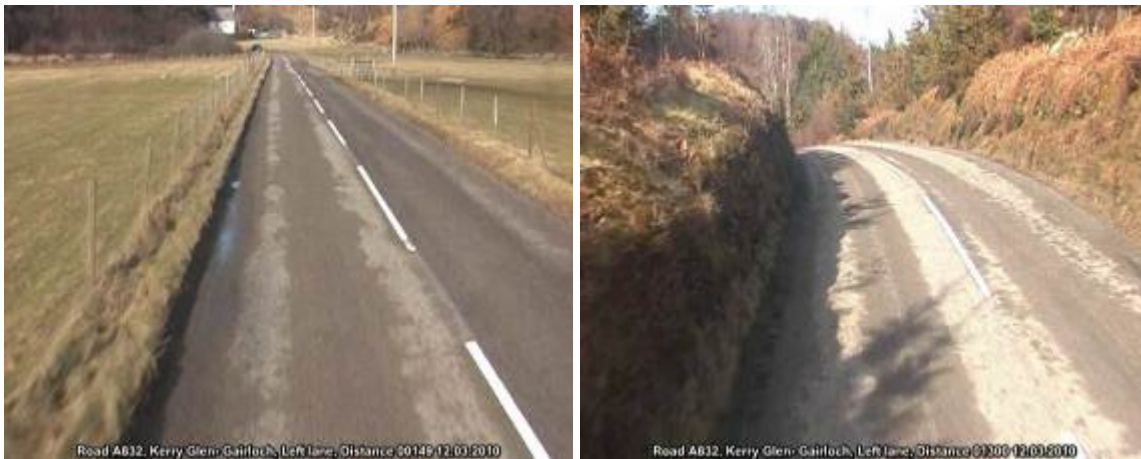
The A832 road changed back to a two-lane road in Kerry Glen. Verges were present along nearly all the section length. These clearly blocked any surface water flowing away from the road surface. At 1300m there was a narrow road cut which did not have a drainage system. Another longer road cut started at 1600m which did have open ditches. These ditches were narrow and shallow. At the end of the section there was a French drain in a road cut that seemed to be working well. The length of the surveyed section was 2731m and ended at Gairloch Pier.

Figures 8: Left: Problematic verges, Right: Narrow road cut without ditches

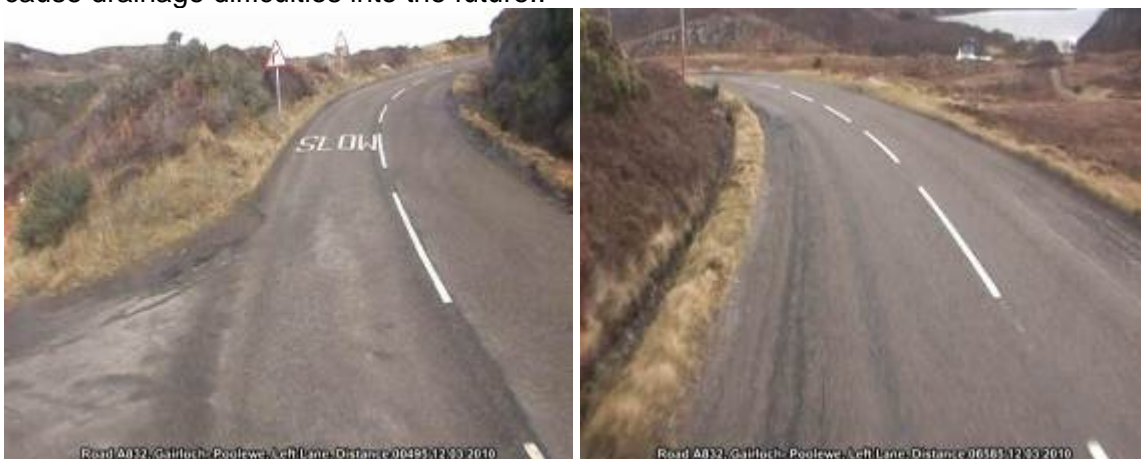
The section started from the junction with the B8021 road in Gairloch. The length of the surveyed section was 8643m and ended at the junction with the B8057 road in Poolewe. The road profile was mostly side sloping ground (76%) and the drainage deficiencies found were typical for this road profile. Verges were seen to cause drainage problems in this section. This was also the case on the length of new pavement from 7600m to 8400m where the presence of verges is expected to cause drainage difficulties into the future..

Figures 9: Drainage deficiencies on the upper side of the side sloping profile

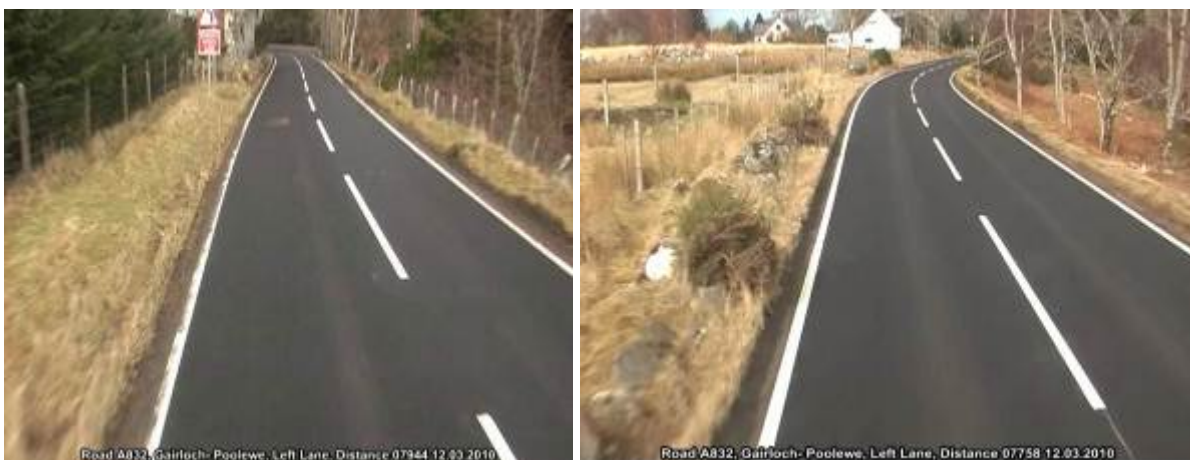
Figures 10: High verge in section where the paving is new

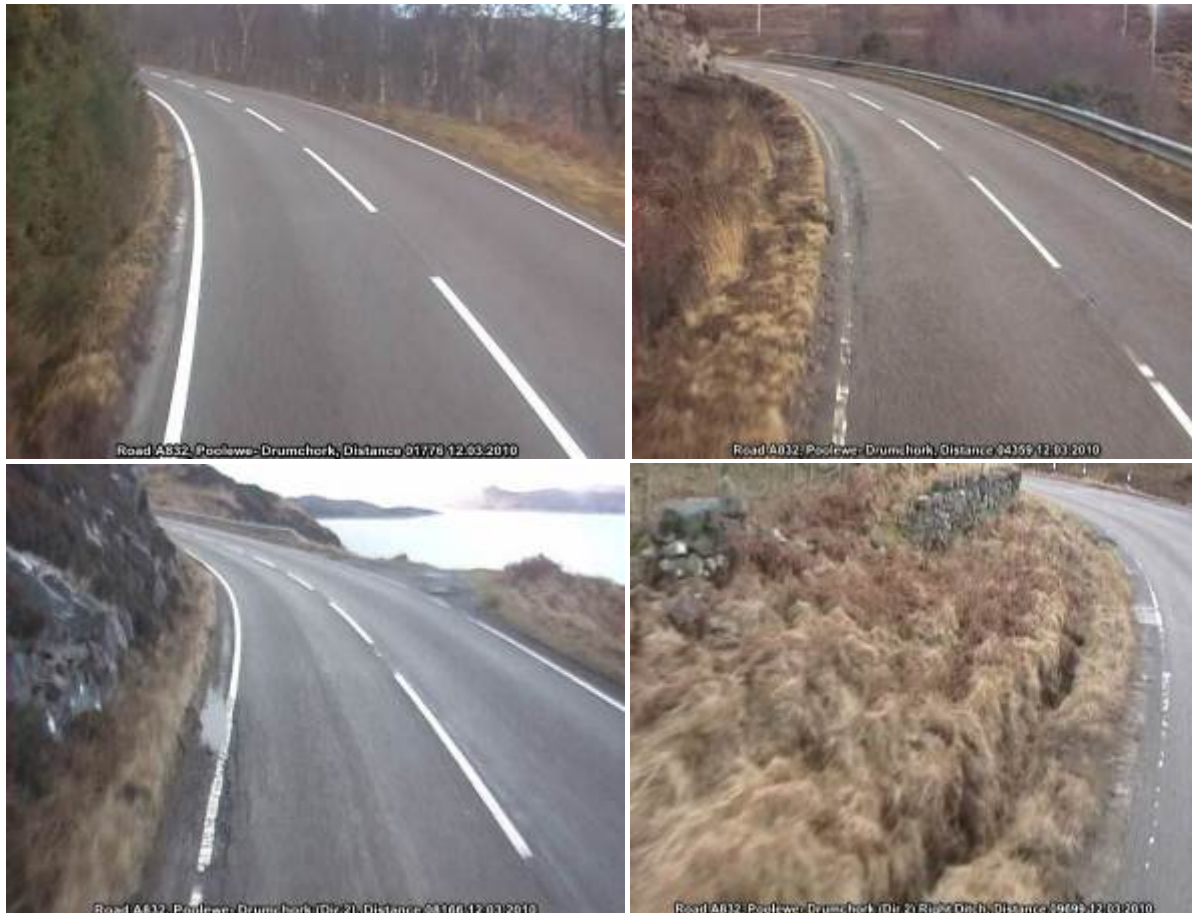
The pavement was in fairly good condition between Poolewe and Drumchork. There were a couple of short lengths with old and weak pavement. The road was generally located in side sloping ground (73%) with many drainage deficiencies in the upper side of the slope.

Figures 11: Drainage deficiencies in side sloping ground in section Poolewe – Drumchork

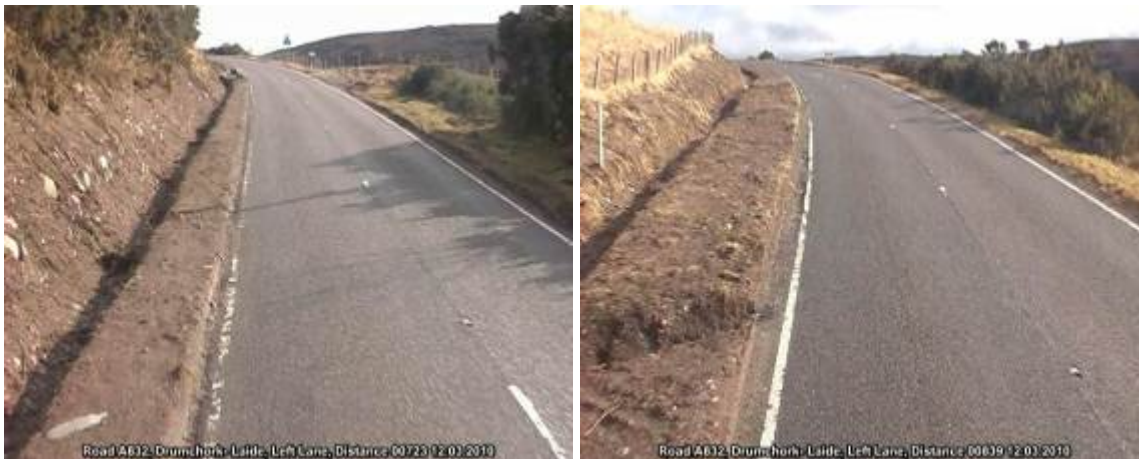
The final section surveyed on the A832 was from the junction to the village of Drumchork and ended at the junction to Laide. The length of the section was 4162m. The pavement was quite new in this section and was in relatively good shape. The road profile was mainly side sloping (78%). The drainage deficiencies noted were typical for the kind of road profile but they did not appear to have affected the pavement condition as much as in other sections. The reason for this could be that the paving was quite new and the effect of any drainage shortcomings had not yet become visible. Recent drainage maintenance work had taken place from 450m to 1050m where the ditch on the left side had been cleaned out but the verge had also been rebuilt.

Figures 12: Rebuilt verge, Right: Good offlets on rebuilt verge

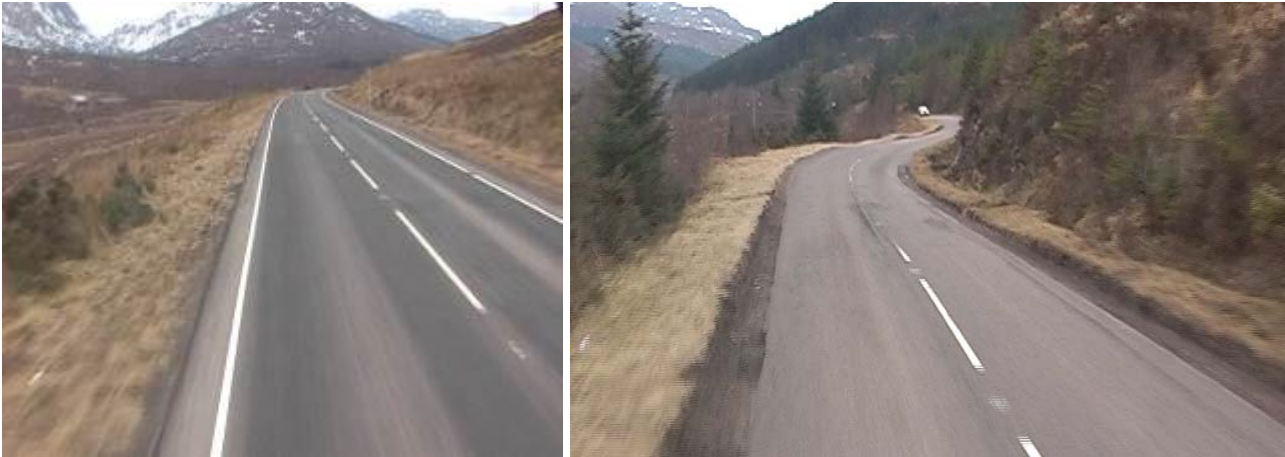
The surveyed section started at the bridge at Glen Carron and had length of 8934m. From the beginning to 1350m the road had been upgraded and the drainage was in good condition. The verges had been removed. The road mainly followed a valley for the full section and the road profile steeply slopes from right to left. The drainage deficiencies identified were typical for this kind of road profile. The presence of verges caused drainage problems at times.

Figures 14: Left: Upgraded section where the verges have been removed, Right: Older structure with high verges

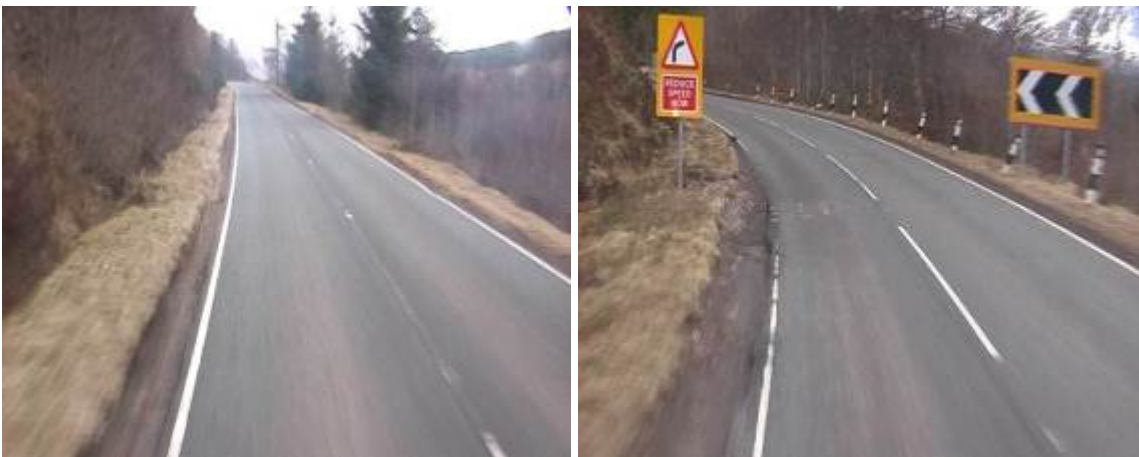
Figures 15: Inadequate drainage in steep side sloping road profile

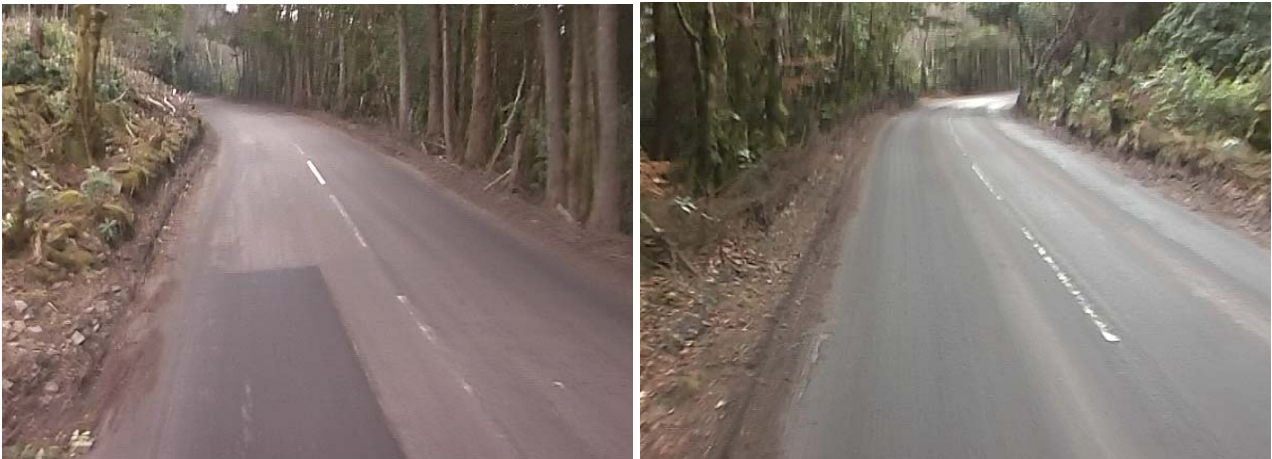
This section started at the railroad bridge and ended at the junction of the A896 road to Strathcarron. The surveyed length was 10300m. Nearly all of the section was narrow single track road with passing places. In many cases the ditches around passing places were inadequate or totally absent. This section was mostly in side sloping road profile and nearly all the drainage deficiencies were in the upper side of the road profile (in this case in the right side). Towards the end of the section there was a part where the ditch on the upper side had been cleaned, but water still remained in the cleaned ditch at times.

Figures 16: Poor drainage and also the trees grow dangerously close to the road

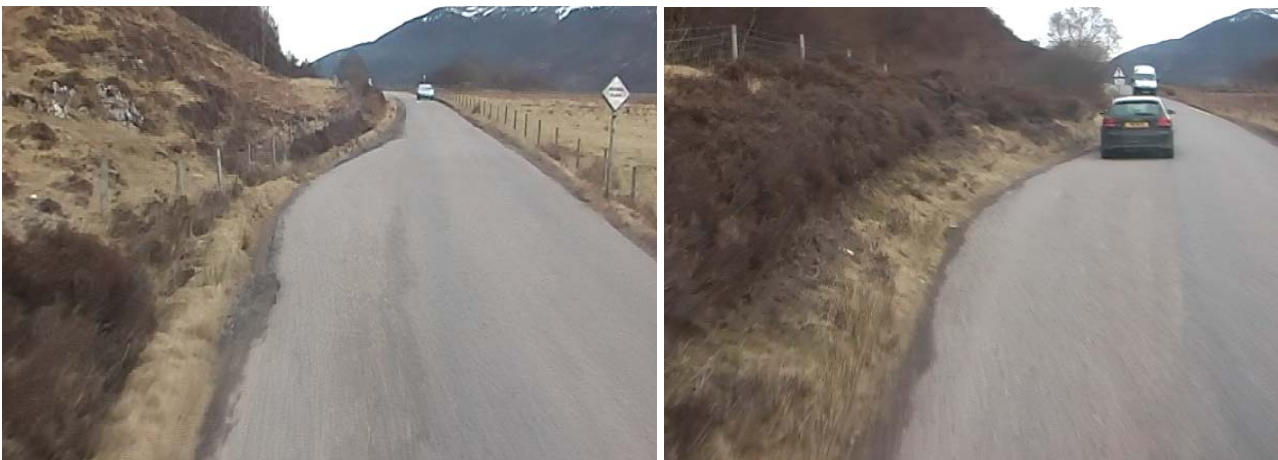
Figures 17: Drainage problems with the passing places

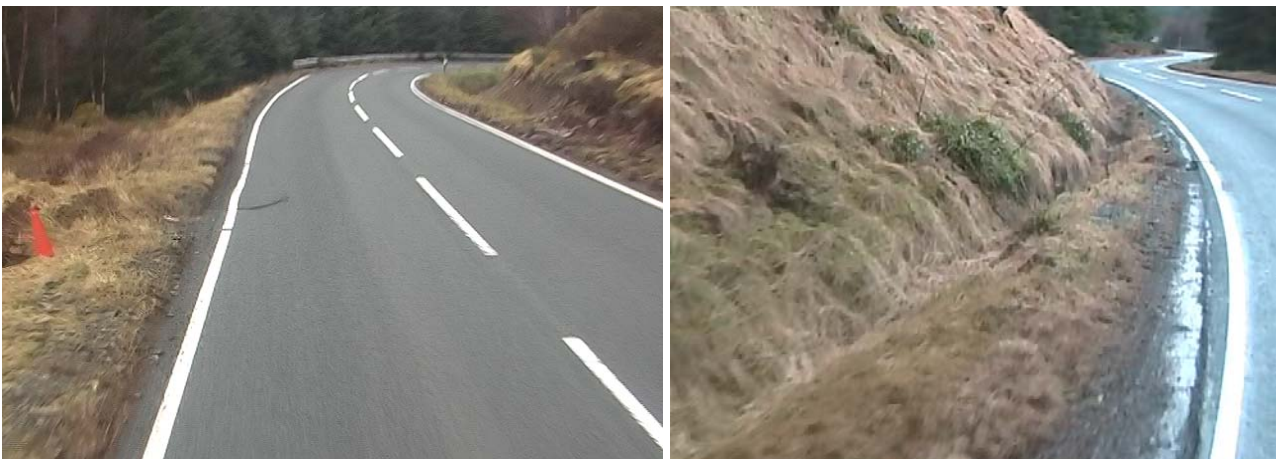
This short section of road (3465m) was located on the mountain side for its full length and the road profile was naturally side sloping. The road had a steep gradient (downhill for the survey) that dropped approximately 150m in elevation over the length. There was an upgraded portion within the section from 1220m to 2920m which included most of the steep gradient. This upgraded part was in very good condition and the drainage was working well. Some sections inside the upgraded part had high verges that might need additional offlets to ensure that surface water is taken away quickly from the road surface. At 2250m there was a road cut on the right (upper side) which had an inadequate ditch. The older parts of the section had several severe drainage shortcomings.

Figures 18: Left: High verges in the upgraded section might need some offlets added at times, Right: Shallow ditch at 2250m on the right side of the road (upper side of the side slope)

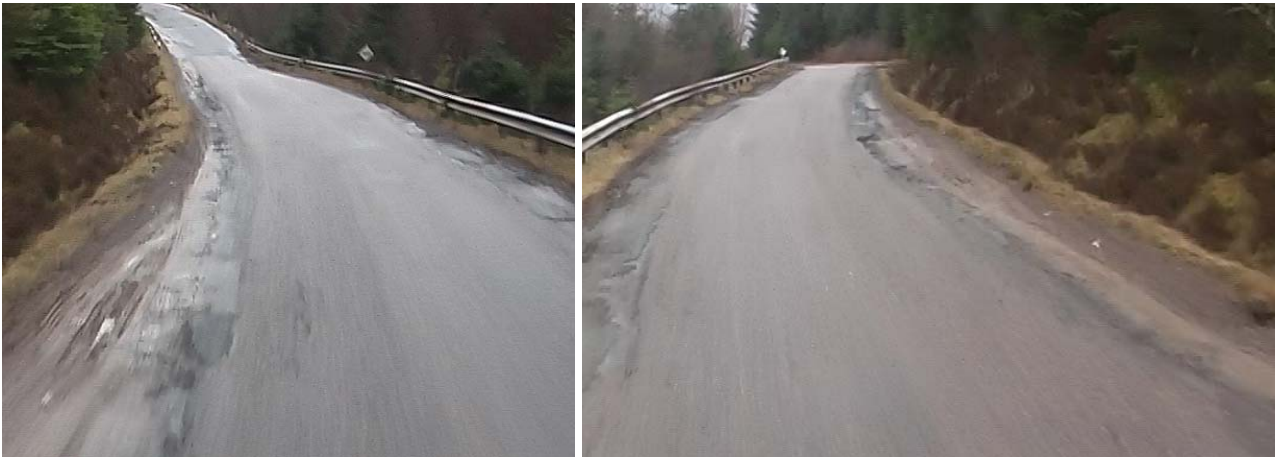
Figures 19: Inefficient ditches and high verges in the old structure

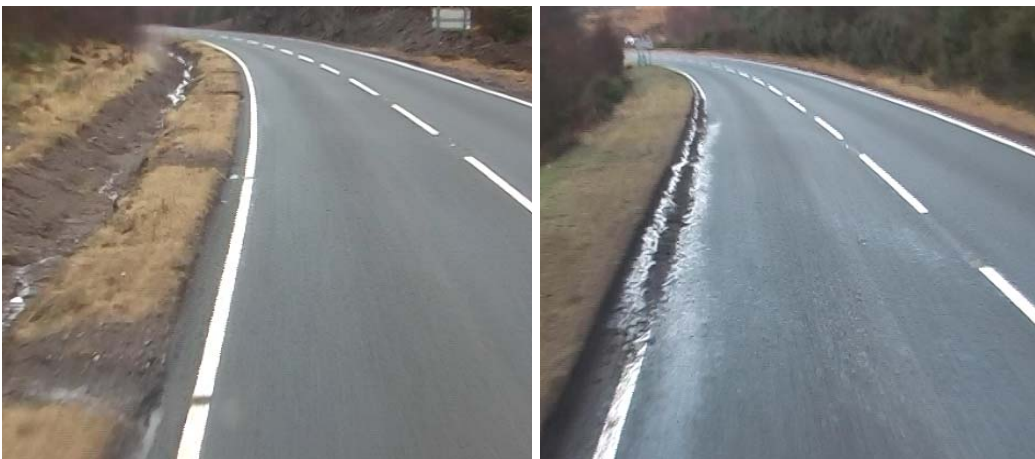
This section started from the junction to the village of Braeintrá. Length of the section was 4671m and ended at the viewpoint at Strome Ferry. At the start of the section the drainage had been improved recently. The ditch had been cleaned and the wide offlets were working. Towards the end of the section there were some parts where the verges needed some attention.

Figures 20: Left: Wide offlets which are cleaned, Right: High verge, not enough offlets

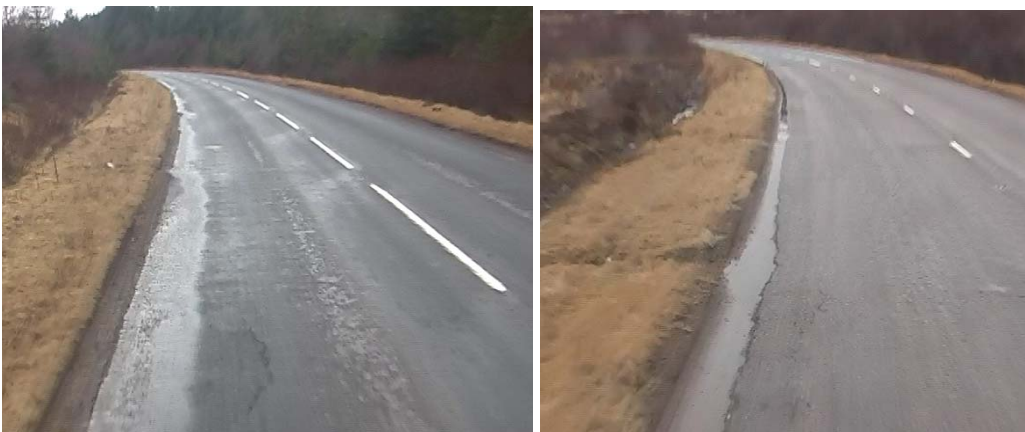
The section started at the junction with the A87 road in Auchtertyre. The length of the section surveyed was 5593m and ended at the junction to Braeintrá village. The road rises nearly 200 metres in this section and has a variable road profile. There were many drainage issues with verges. Some offlets were blocked and in some cases additional offlets should be provided.

Figures 20: Problems with the verge

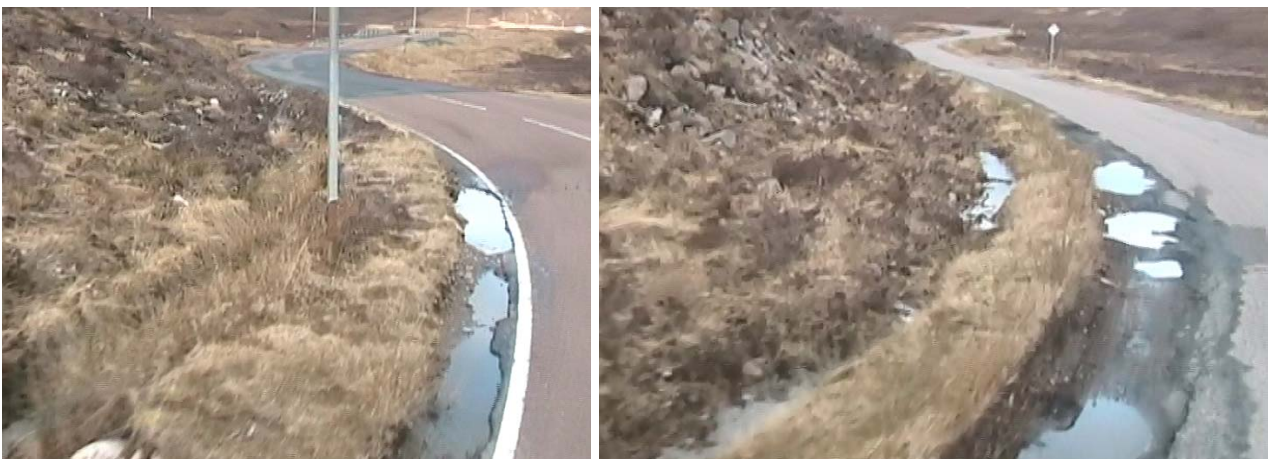
This section started at the junction to Torridon village and ended at the junction to the Cowlin Estate. The length of the section was 10947m. The road was mainly single track road but there were a few short two-lane sections to help overtaking. The condition and the age of the pavement varied widely. The drainage problems found were typical for the circumstances. Verges were common and there were several side sloping sections with drainage problems in the upper side of the slope.

Figures 22: Inadequate drainage in the upper side of the slope

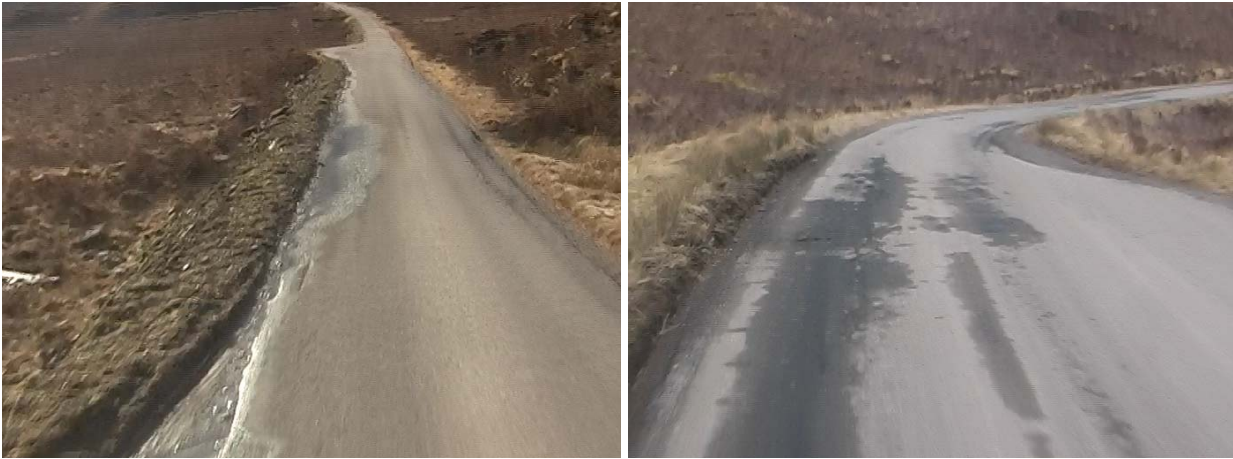
Figures 23: Left: Recently built verge which should be removed or have more offlets at 8400m, Right: Problematic verge on passing place

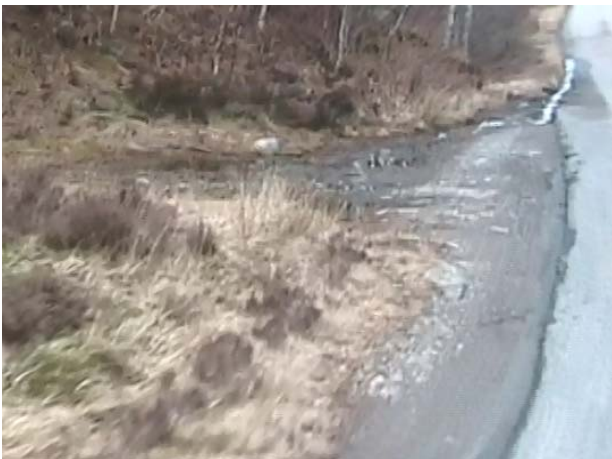
The second section surveyed on the road was from Cowlin Estate junction to the A832, a length of 4875m. The road was single track and had a side sloping road profile for the first 3 kilometres which is in. There were several sections in the upper side of the side slope (this case left side) with typical drainage problems for this kind of profile.

Figure 24: Poor ditch and verge blocking the water

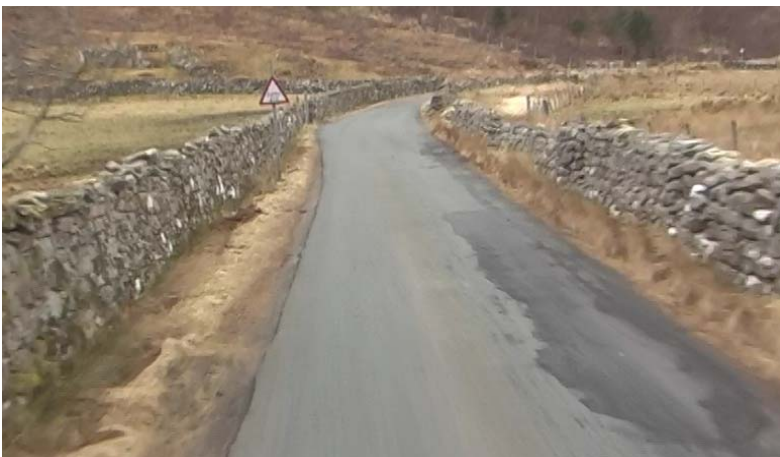
The Shiel Bridge (A87) to Moyle junction was single track road with a two lane section in the middle from 5750m to 6500m. The section length was 9388m. The road lay on a hillside and nearly all of the section had a steep side sloping road profile. The road rose by nearly 350m in elevation over the first part of the section and returned down again in the second part. At the start of the section there was a combination of stone walls and verges close to the road which left no room for open ditches. Verge problems were also common later inside the section.

Figure 26: Stone walls and verges block the water

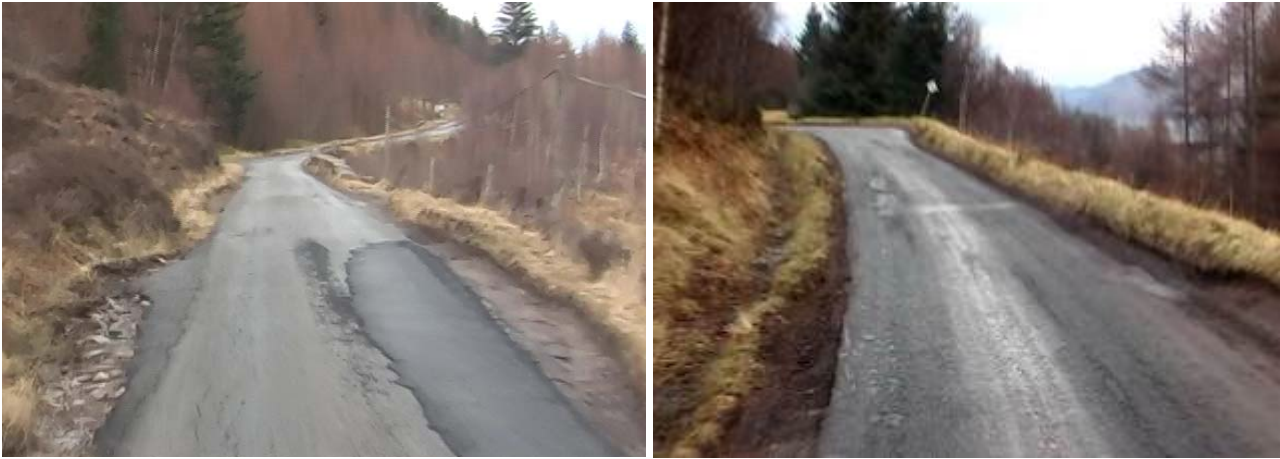
Figures 27: Drainage problems in side sloping road profile

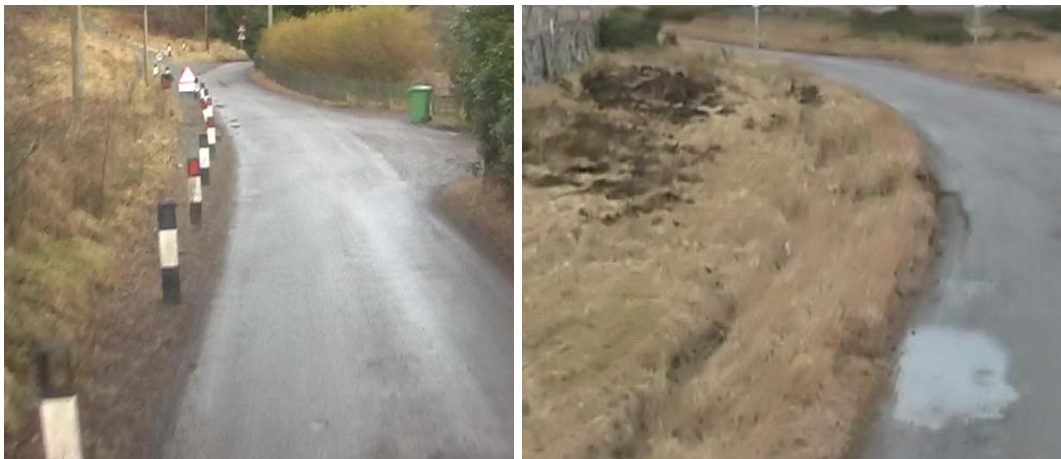
The first 1900m of this section was in the village of Glenelg and there were water outlets available to take care of surface water. The final part of the section was mostly in side sloping road profile and in the upper side had several drainage deficiencies which were typical for this kind of road profile.

Figures 28: Left: French drain in the upper side of the side sloping ground, Right: Poor drainage

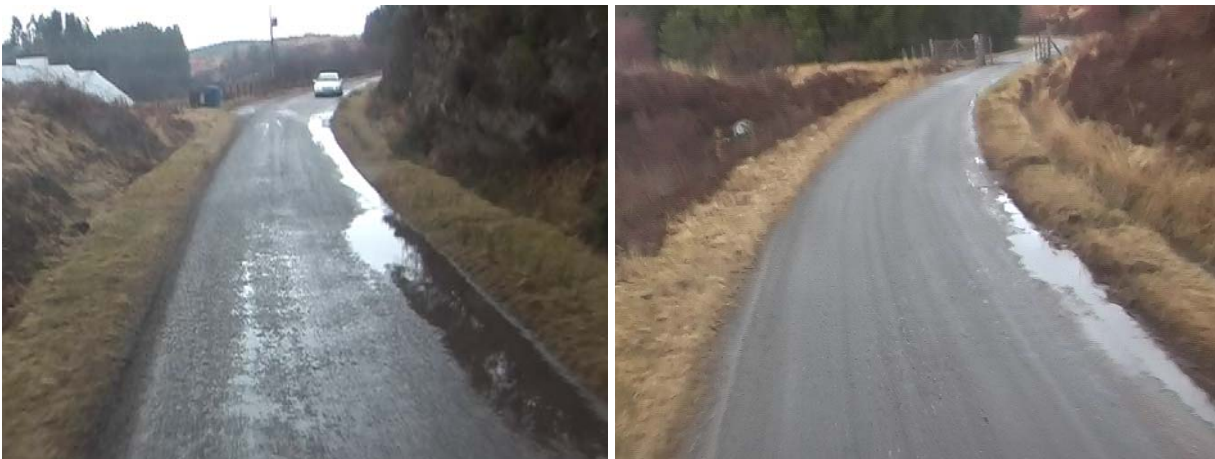
This section of road was from Eilanreach to the “4th cattle grid”. The length of the section was 9840m. The road profile in this single track section was mainly side sloping but there were many short lengths of road cuts which had inadequate drainage systems.

Figures 29: High verges and shallow ditches in a road cut

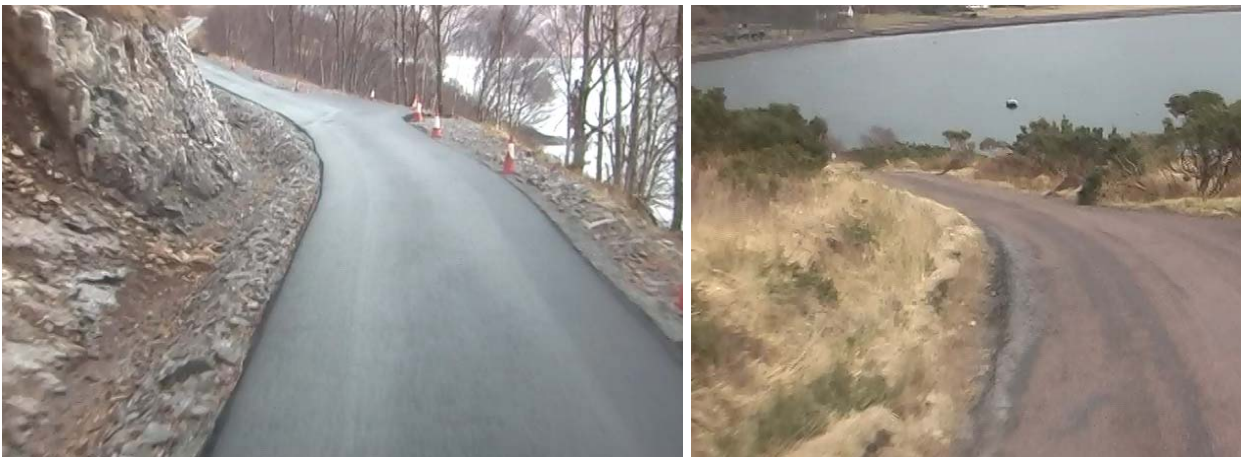
This section continued from the 4th cattle grid to the village of Corran which was also the end of the public road. The length of the section was 5581m. From the beginning to the village the road was mostly in steep sloping profile and there were several drainage shortcomings typical for this kinds of circumstances. The drainage was in good condition in the village area from 3800m to the end of the road.

Figures 30: Left: Improved section, good ditch and no verge: Right: Problems on the upper side

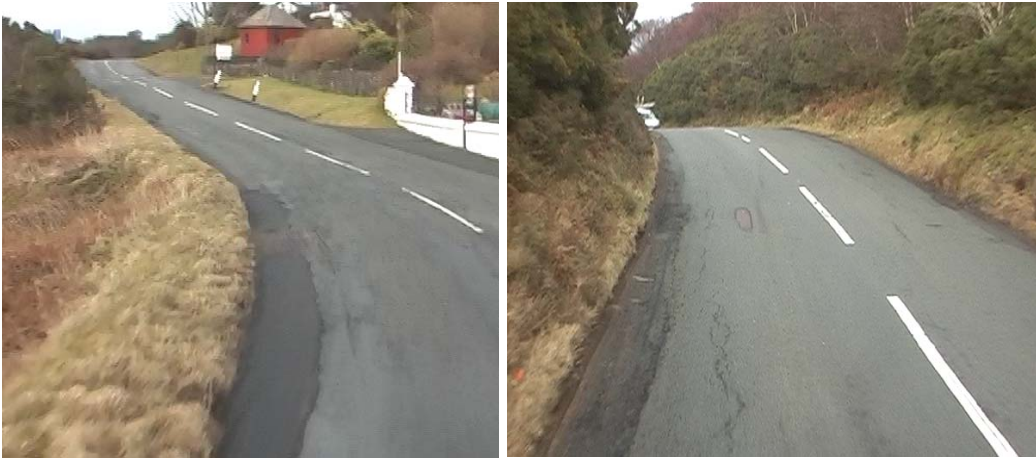
This section starts in Kyle of Lochalsh at the junction of Main Street and Plock Road. The length of the section was 8535m and ended at the railroad bridge in Plockton. For the first two kilometres of the section the road was in good condition and drainage generally worked well. The road then became partly single track and the condition of the pavement varied. There were several problematic sections where the drainage was not working efficiently enough. Most of these problems were in side sloping ground.

Figures 31: Left: Problematic verge, Right: No ditches in road cut

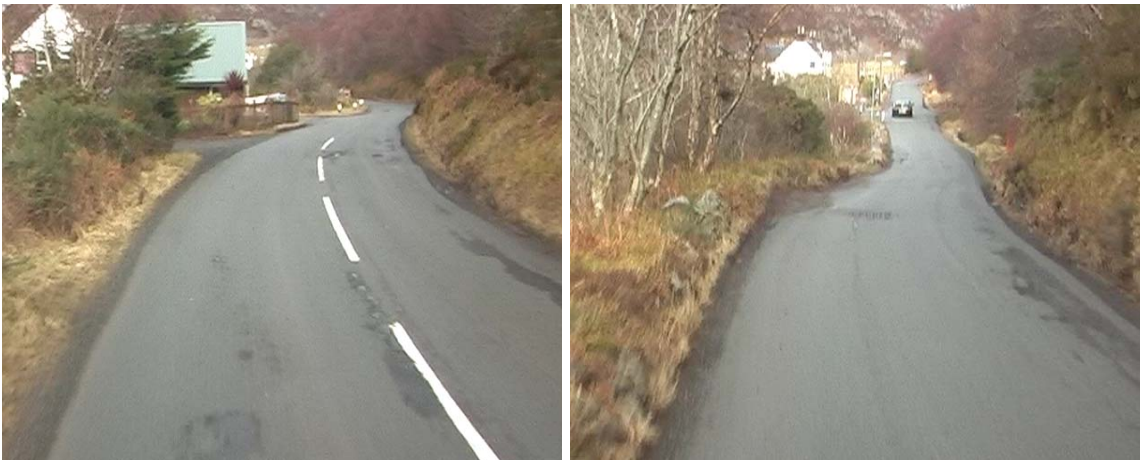
Figures 32: Problematic section in steep side sloping road profile near Kyle of Lochalsh

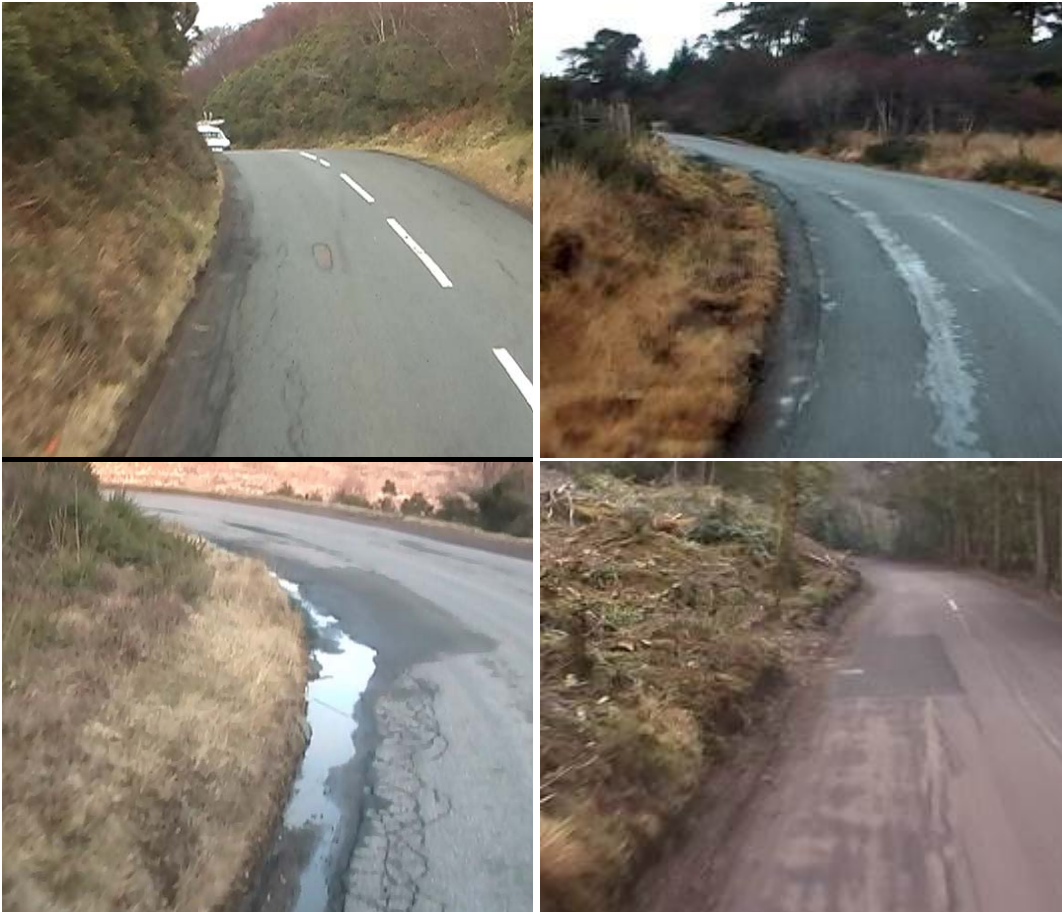
Drainage Class 3 covers those road sections with severe drainage problems. The road shoulder has a high verge and/or dense vegetation that are causing ponding on the traffic lane or on the shoulder. Vegetation is growing in the ditches and restraining the flow of water creating dams in the ditches. Unstable soil is flowing from ditch slopes into the bottoms of ditches and blocking the flow of water. Clogged culverts or outlet ditches is preventing the flow of water in the ditch. All of these situations lead to the development of deformation and damage in the road cross-section.

Figure 35: Examples of road sections with drainage Class 3 in Highland

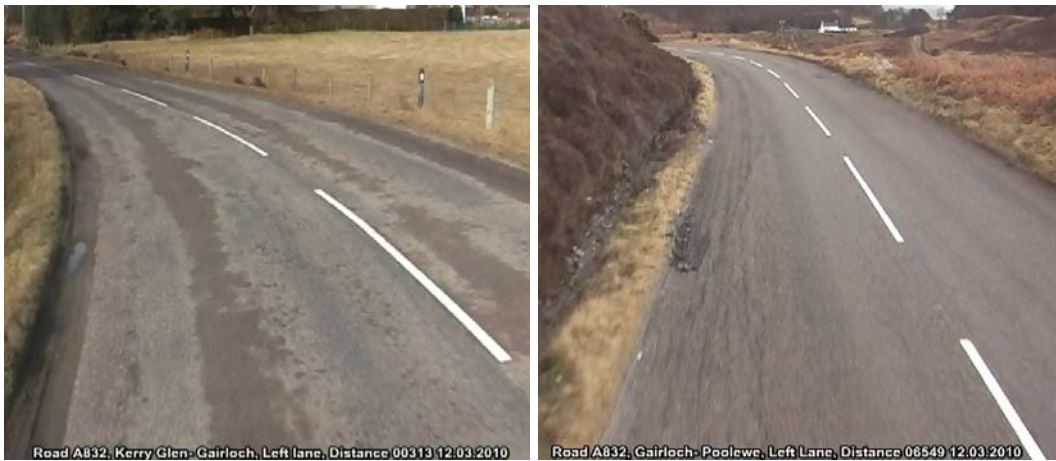
Figures 53: Left: Class 2= Moderate damages, Right: Class 3= Severe damages
