Annele Matintupa, Seppo Tuisku

SUMMARY OF DRAINAGE ANALYSIS IN THE UMEÅ AREA, SWEDEN

- SEASONAL TESTS**

- TOOLS FOR OUTLET DITCH INVENTORY**

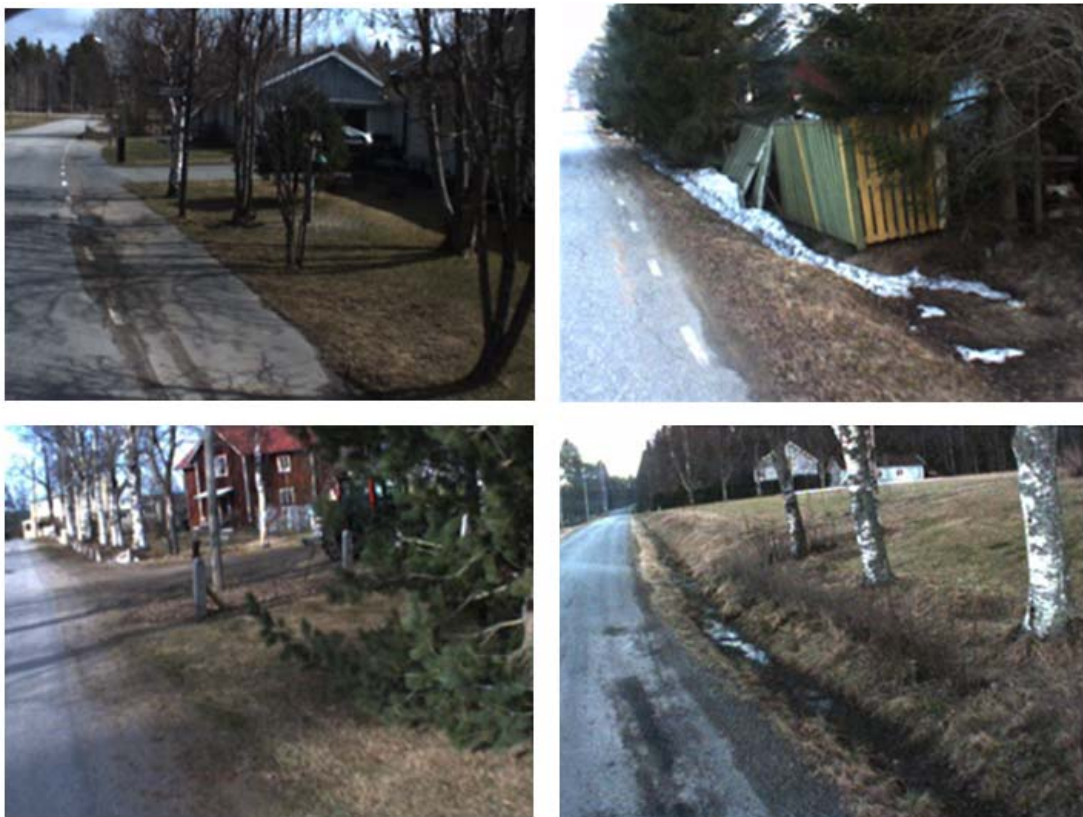
There were several villages along the roads surveyed. Typical in these villages the private land of the houses came extremely close to the road. Where this happened the ditches between the road and the house property were usually missing resulting in the local drainage being very poor. In these circumstances it will be impossible to improve the roadside drainage without destroying the vegetation within the private land. These sections were noted in the analysis, but were left out of the identification of special maintenance sections. Examples of house properties close to the road are shown in Figure 6.

Figure 6. Examples of road sections with private land or trees close to the road.

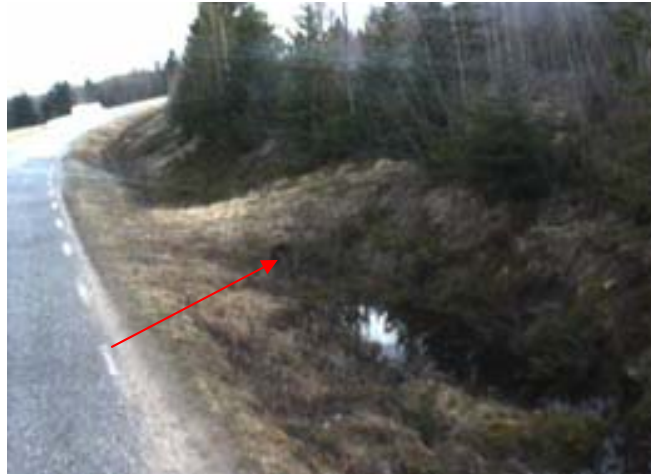
Figure 7. An example of an access road culvert which had been set too high. The culvert is marked with a red arrow.

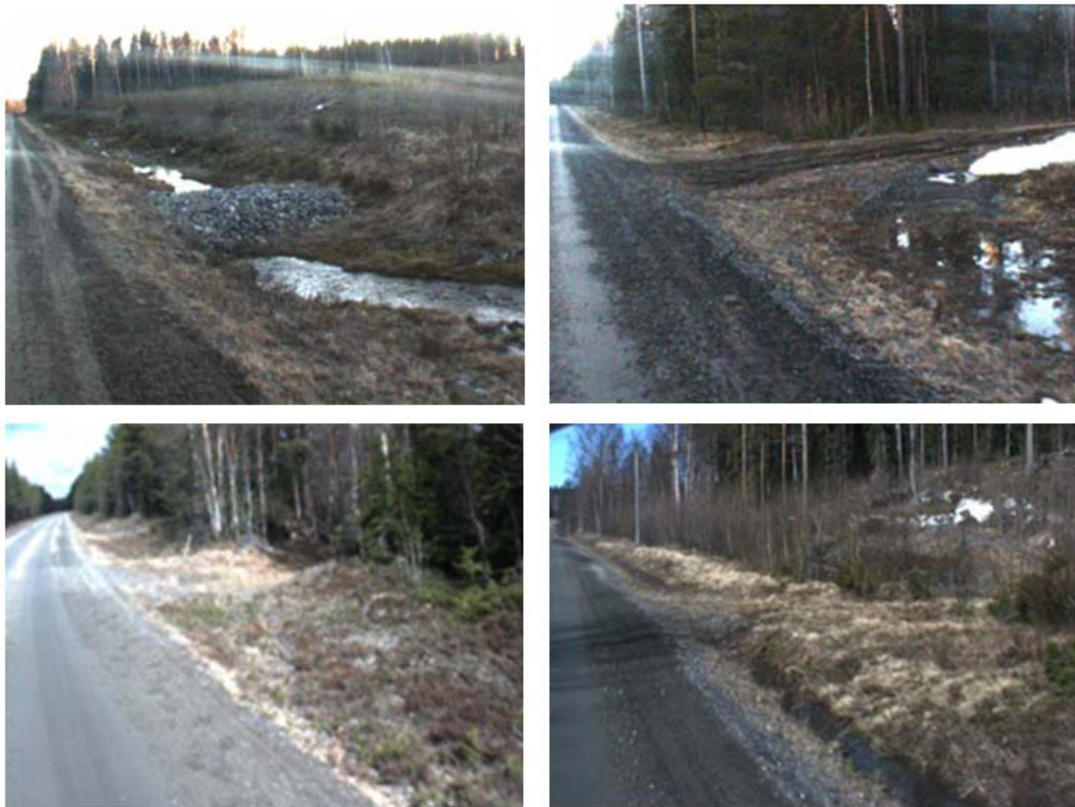
Another typical feature on the roads in the Umeå Södra area was that of the access road culverts. Typically these culverts were missing with the result that water had built up next to the junction as it had no possibility to flow freely through the junction. Another issue with these culverts was that they were clogged with soil or vegetation that blocked the water flow. Figure 7 shows an example of a culvert, set so high that water could not flow freely through it. Figure 8 shows examples of access roads where the culverts were missing.

Figure 8. Examples of missing access road culverts.

The most important feature of the surveyed roads in the Umeå Södra area was clogged access road culverts. Opening and renewal of these access road culverts should be included in the improvement design process.

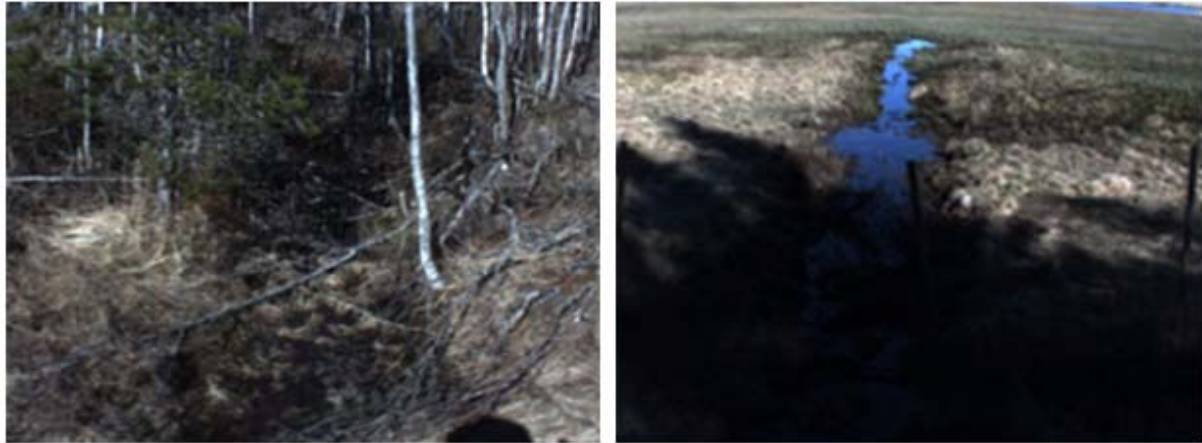
The outlet ditches surveyed were found to have problems in flat and even areas. A number of outlet ditches were clogged. In flat areas there was often not enough gradient to assure that the water flowed away from the road area. A few examples of outlet ditches in poor condition are shown in Figure 9. The survey of outlet ditches is covered in chapters 6 and 7.

Figure 9. Examples of outlet ditches, which are in poor condition.

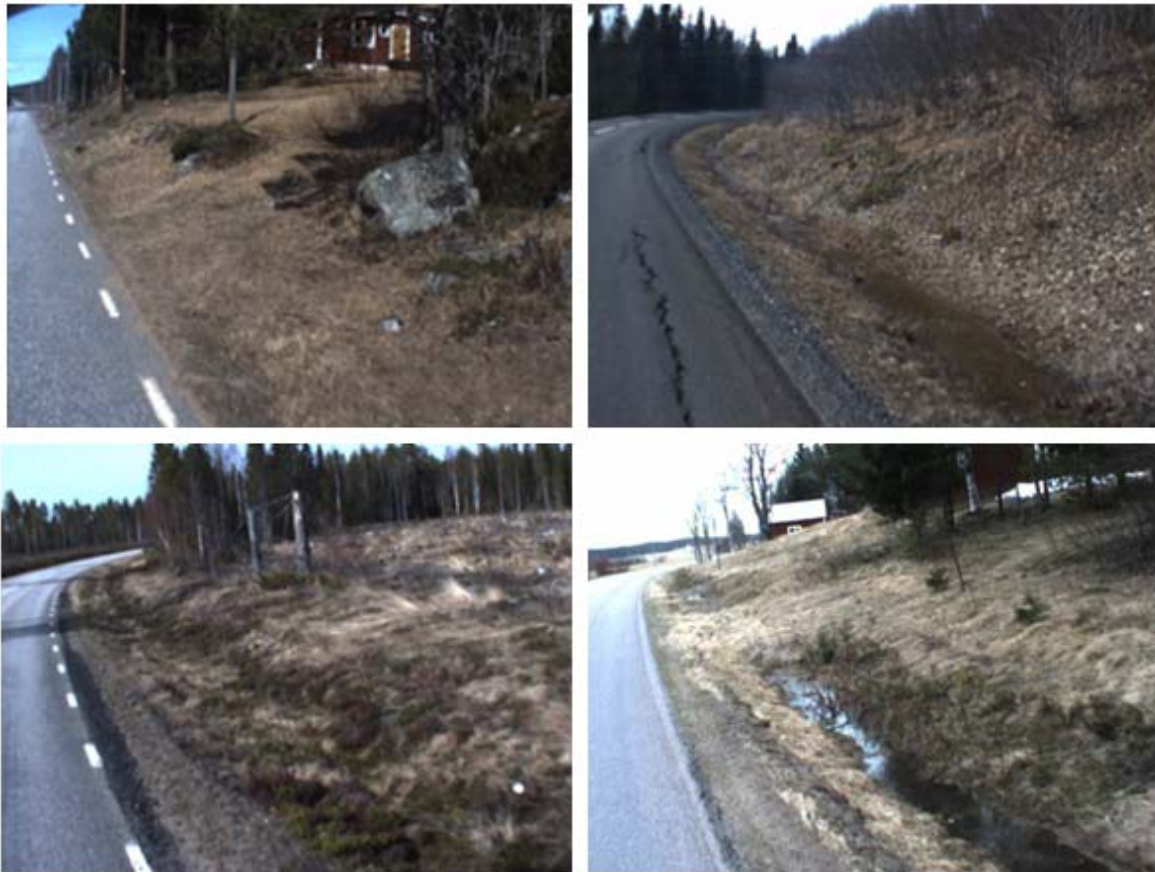
A number of drainage problems were noted on the surveyed roads which could be clearly related to the road profile. This was particularly the case on the sections located on side sloping ground where the ditch on the upper, road cut, side was regularly filled in. Figure 10 shows examples of typical problems related to side sloping ground.

Figure 10. Examples of problems related to side sloping ground.

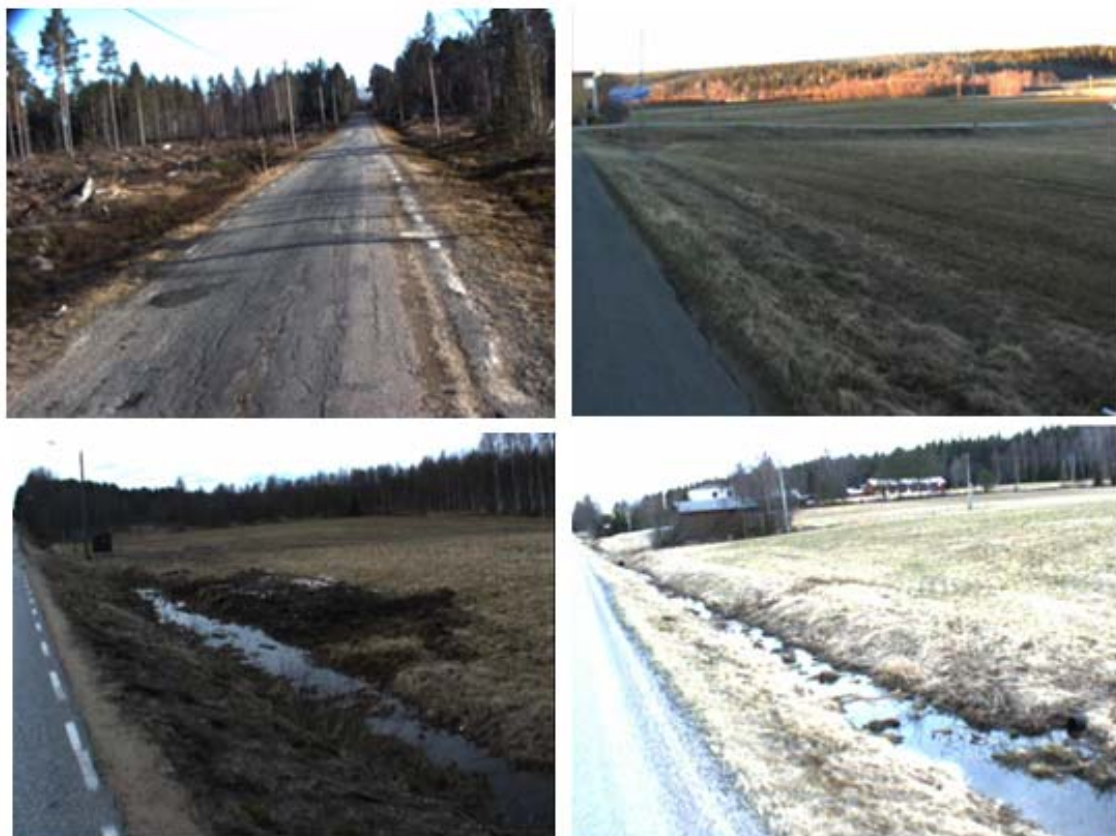
A further drainage issue concerned those roads near the coast where the topography was generally level and flat. Clogged ditches were typical in this topography. The main problem was that it was almost impossible to make a gradient in the ditch. The result was that water could not freely flow and instead lay in pools in the ditches. Figure 11 shows some photographs of typical problems related to flat and level areas.

Figure 11. Examples of problems related to flat and level areas.

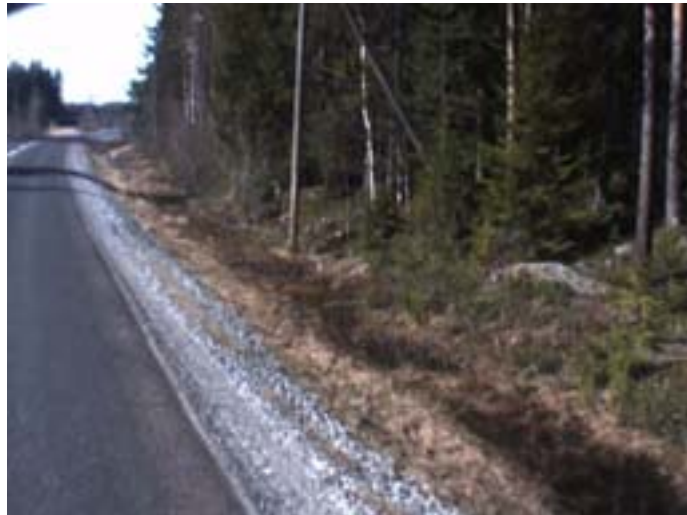
During the analysis it was observed that some road sections had been repaved but that the ditches had not been cleaned out at the same time. Examples of such sections could be found on Road 508 (Figure 12). Based on earlier research in ROADDEX, it can be expected that these sections will start to show damage quite quickly. For this reason ROADDEX recommends that when a road is repaved the drainage should be improved at the same time as this will increase the pavement lifetime.

Figure 12. Example photograph from road 508, at point 43285m. The road has been repaved, but the ditch has not been cleaned out.

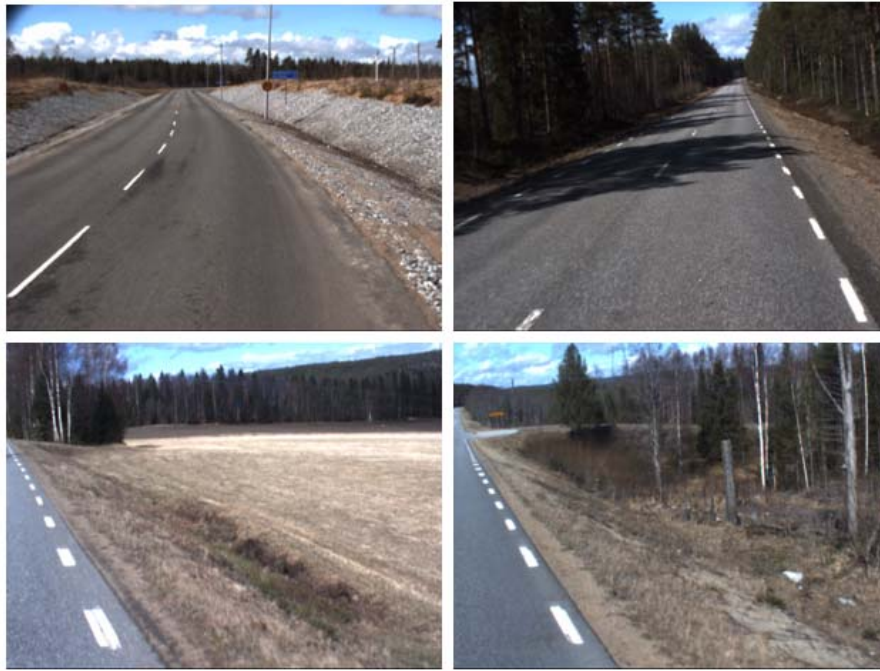
Description: The drainage condition in Class 1 is flawless. The cross-section of the road has preserved its form well and water flows from the pavement into the ditch unrestricted. Water also has a clear passage in the ditches.

Figure 13. Examples of road sections which have been classified into drainage Class 1.

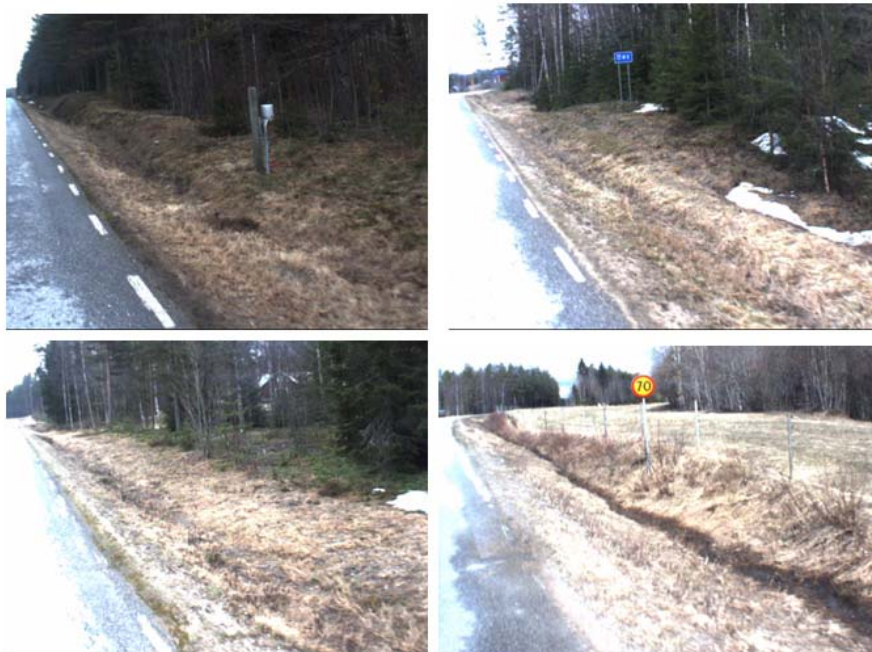
Description: There are minor deformations in the road profile. Along the edge there are minor ridges or dense vegetation can be seen, which prevents water from flowing freely into the side ditch. Vegetation in the ditch slows down the water flow and creates dams. Soil can be sliding from the slopes into the ditch, which raises the bottom level of the ditch and impedes water flow.

Figure 14. Examples of road sections which have been classified into drainage Class 2.

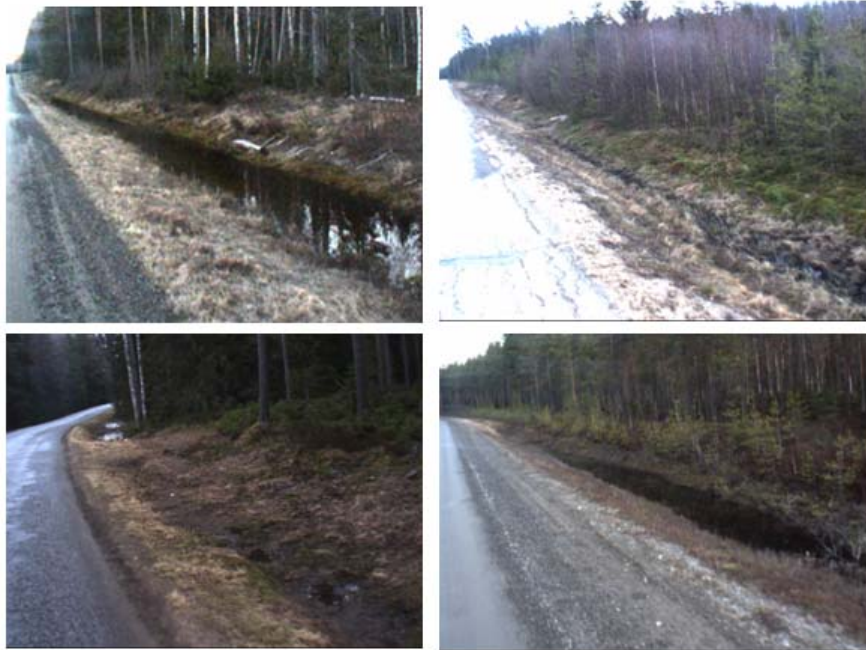
Description: There are local deformations and distresses in the road cross section. There are ridges and/or dense vegetation between the road shoulder and the inner slope, causing ponds to form in the carriageway or shoulder. Vegetation prevents water from flowing into the ditch. The outer slope or both slopes are unstable and have slid into the bottom of the ditch preventing water flow. A blocked outlet ditch or culvert prevents water flow in the ditch.

Figure 15. Examples of road sections which have been classified into drainage Class 3.

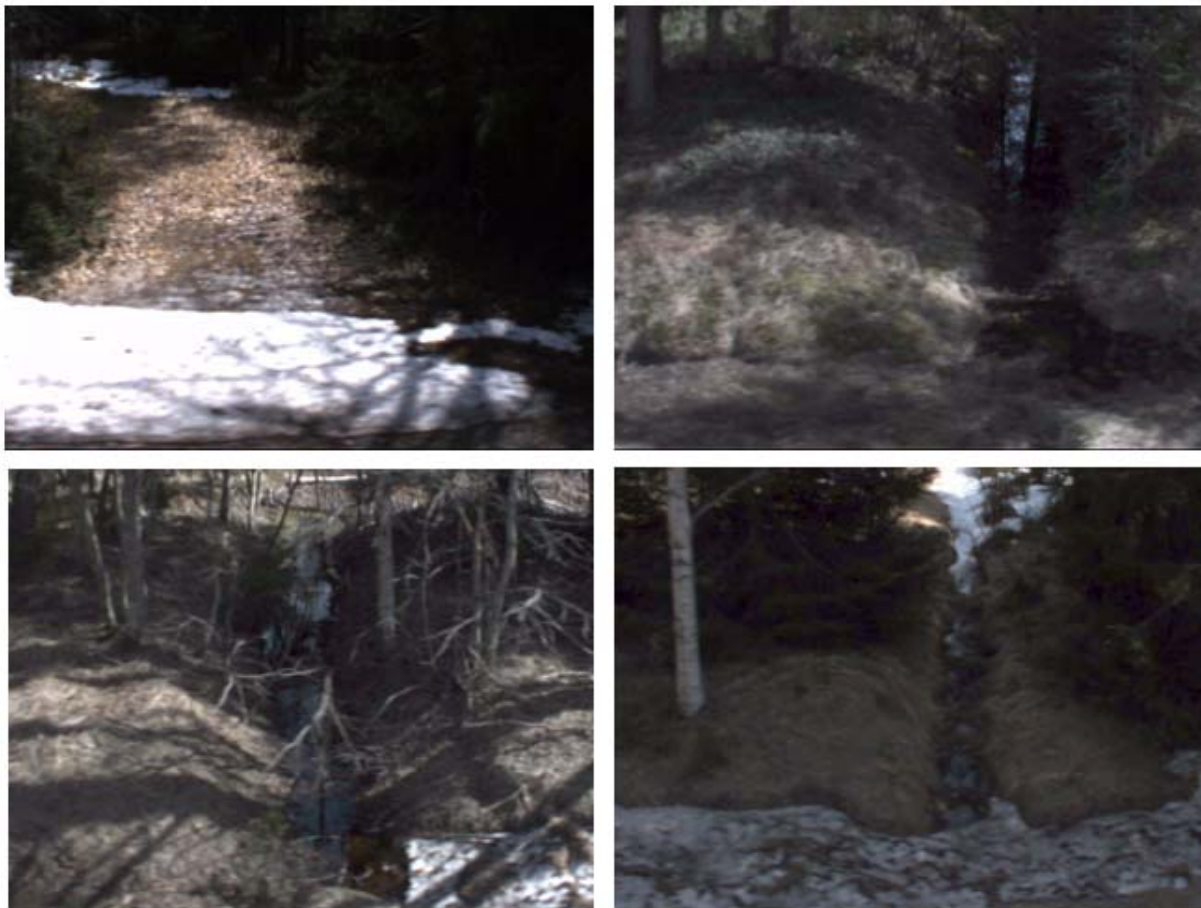
Figure 24. Outlet ditches can be observed easily from the 90 degree camera.
