Annele Matintupa, Seppo Tuisku

SUMMARY OF DRAINAGE ANALYSIS IN THE WESTERN ISLES, SCOTLAND

Demonstration Project Report

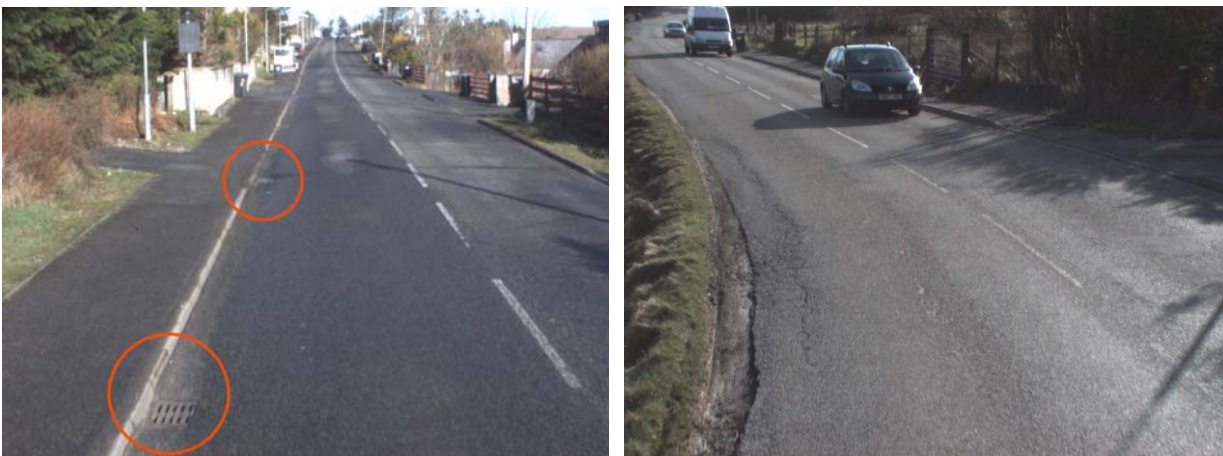
The beginning of the section, from the roundabout in Stornoway to the cattle grid at 3700m, is within the urban area. Water outlets are available to take the water away from the road surface. There are additionally a couple of short sections with problematic verges inside this section.

Figure 6: An example of water outlets in the Stornoway urban area, marked with red circles (left) and an example of problematic verge (right).

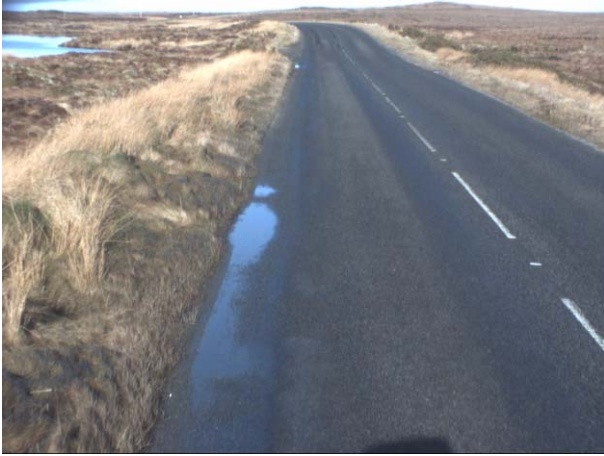
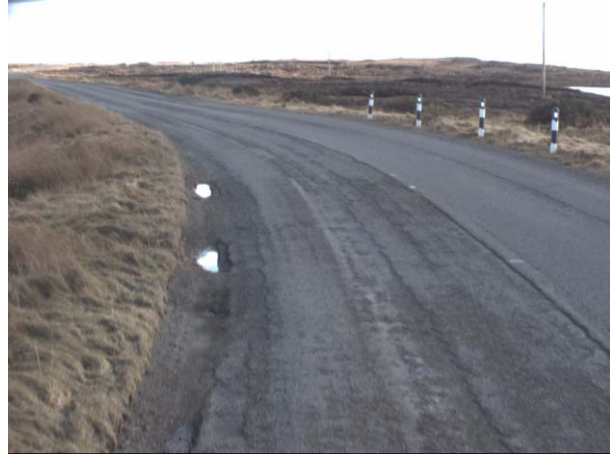
Figures 7: Examples of problematic verges

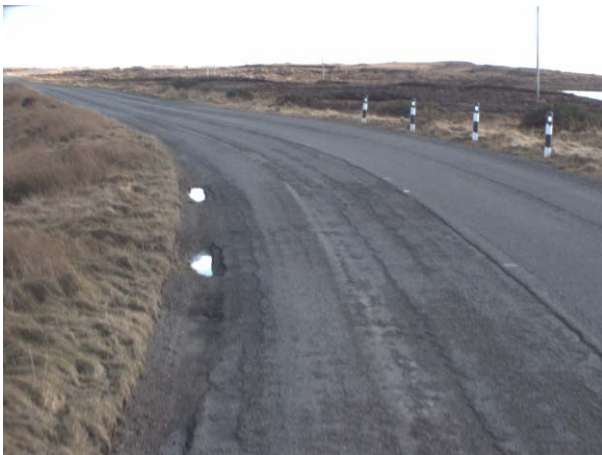
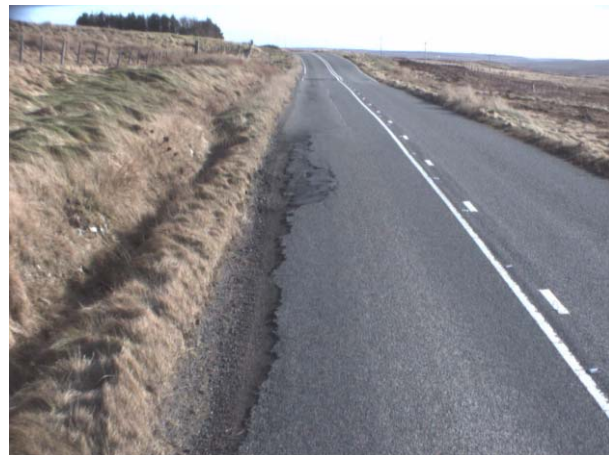
several sections where the ditch in the upper side of the side sloping ground was not good enough to take the water away. In some peat sections there were a few obvious drainage problems, where the ditches should be cleaned. It should be noted however, that making the ditches deeper in peat areas can cause other problems, such as retriggering settlement, and these should be taken into account. Verges were also causing problems at times by blocking the surface water from the road and preventing it running unrestricted to the ditch. The photographs below show some of the typical drainage problems on this road section.

Figures 8: Drainage deficiencies on the upper side of the side sloping ground.

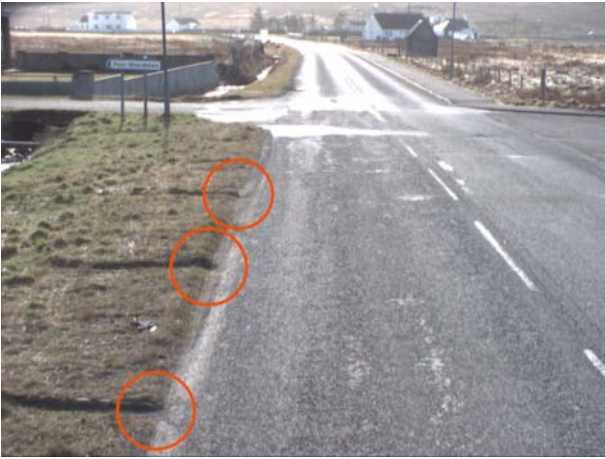
Figure 9: “Special” offlets in the village of Barvas (marked with red circles). The concrete offlets were working well.

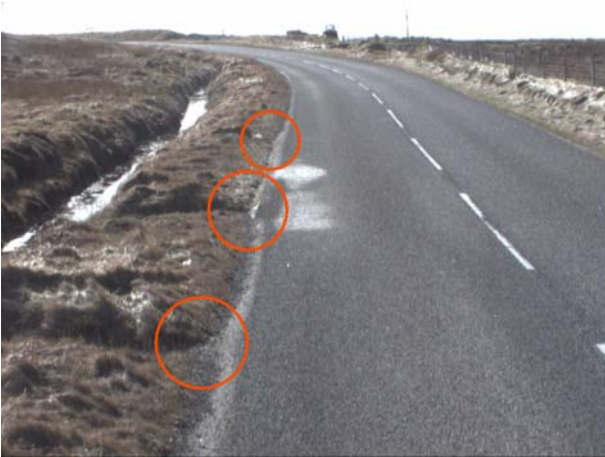
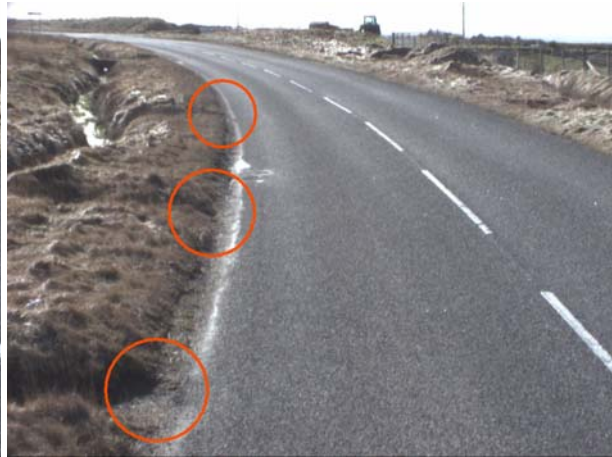
From chainage 3000m to 4000m the presence of verges was again creating drainage problems at times. Here there were numerous offlets available that appeared to be open but surface water was still lying at the edge of the pavement (Figure 10). Later along this same section a couple of weak outlet ditches were noted.

Figures 10: Photograph showing that even with sufficient offlets the surface water was still running along the edge of the pavement

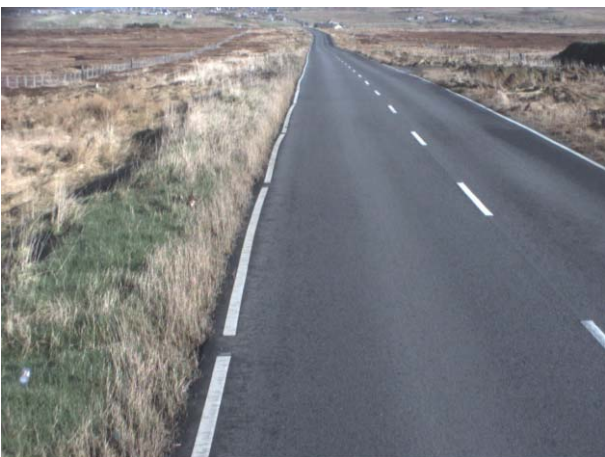
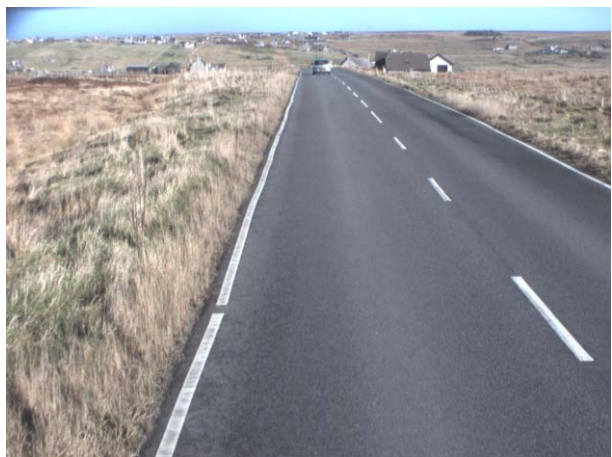
The road from chainage 4100m to the village of Baile an Truiseil had been upgraded. The structure appeared thicker and the verges had been removed in the upgrading process. This section was in good condition and the drainage was working well (Figure 11).

Figures 11: Upgraded section of road close to the village of Baile an Truiseil

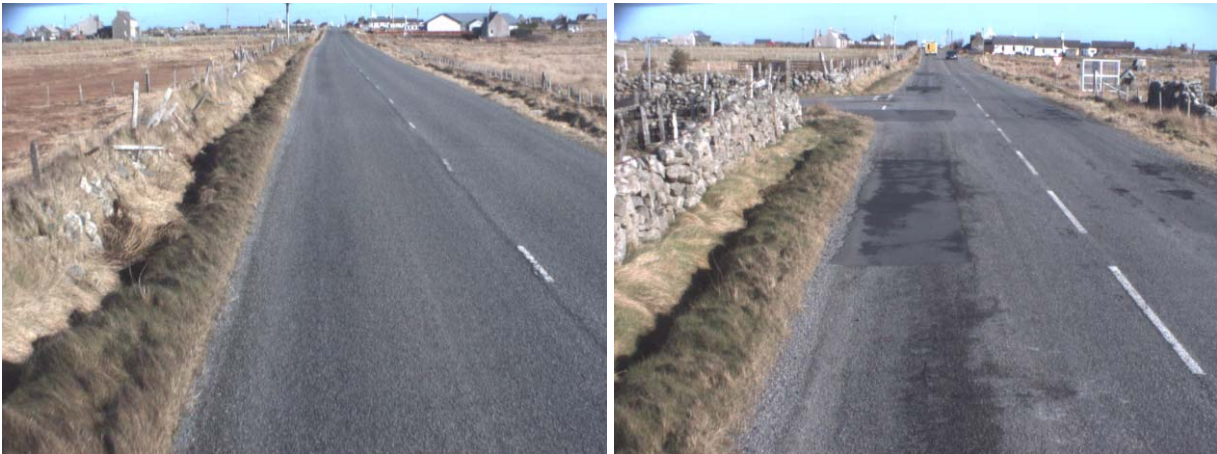
There were stone walls to the rear of the verges on the left side of the road on the approach to Borge village with the result that there was little room for a ditch. The ditch present was clogged with vegetation (Figure 12).

Figures 12: Stone wall close to the road near the Borge village.

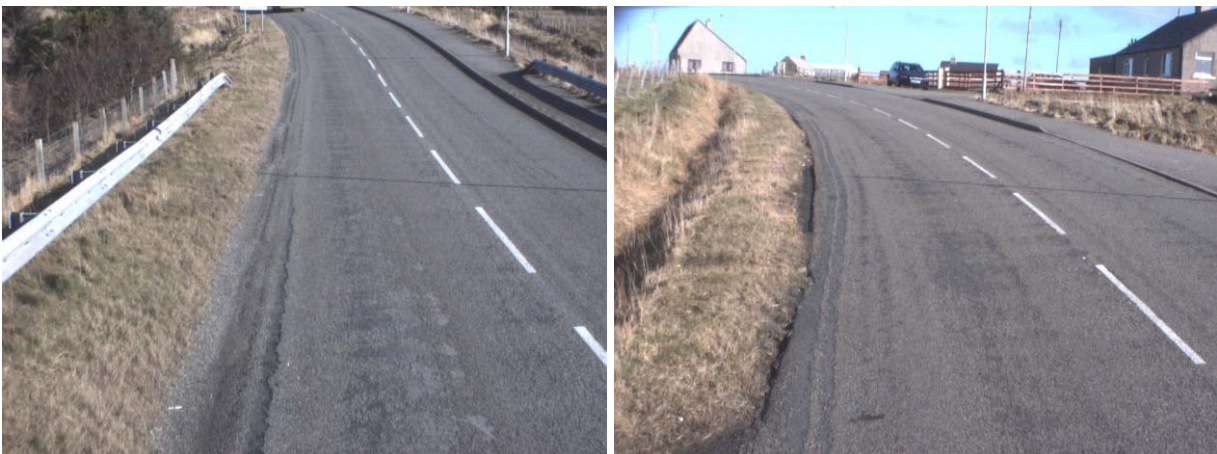
After the bridge in Borge there was a short section of road with a very high verge on the left side and a damaged road edge (Figure 13).

Figures 13: Problematic verge in the village of Borge

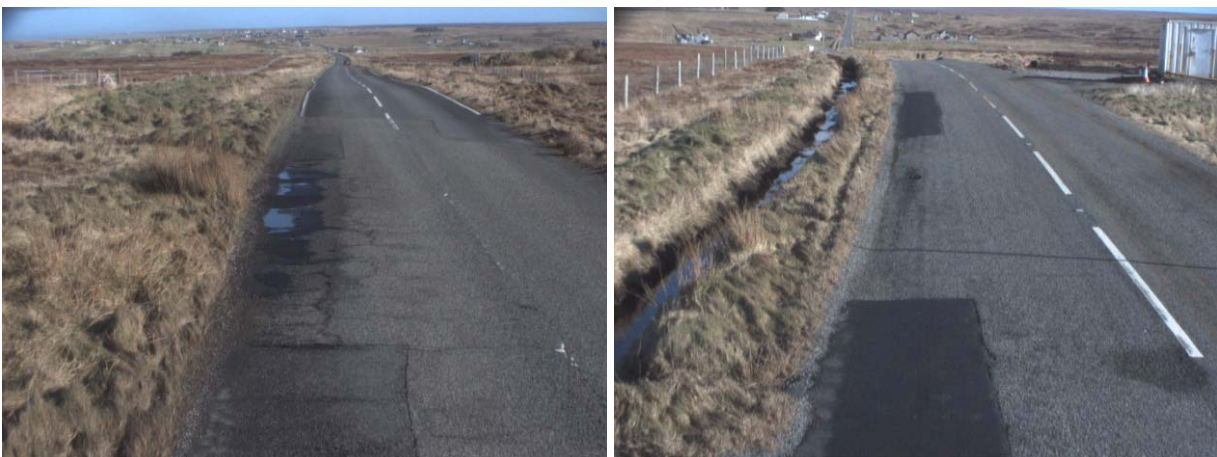
Also in this section there were many examples of drainage problems that correlated with damages in the road surface correlate, especially where the road was in side sloping ground and the upper ditch was not functioning well.

Figures 14: Inadequate drainage located in the upper side of the road

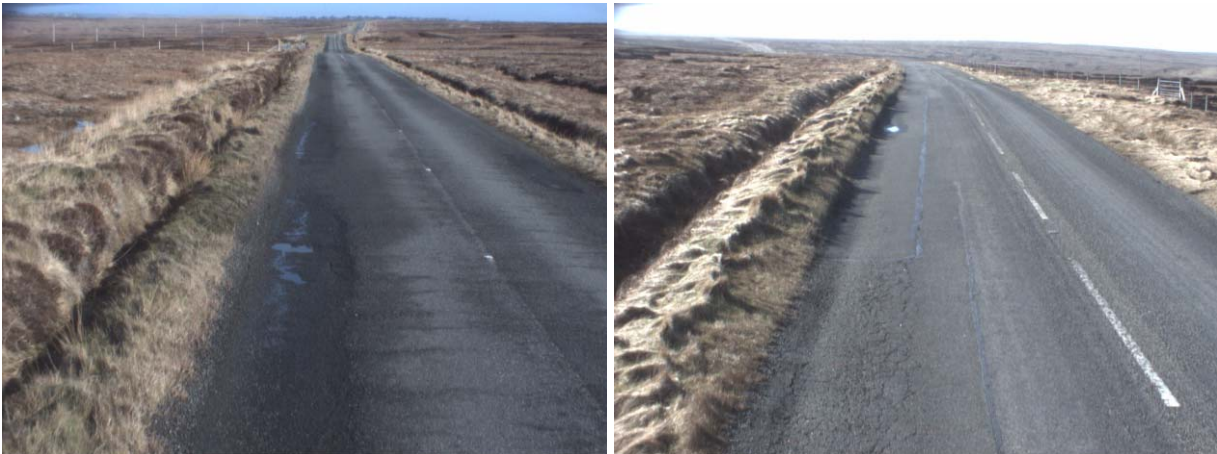
From Loch Barabhat to the end of the section at Dell cattle grid there was a long section with inadequate drainage. The section was located on peat and the road profile was mostly in side sloping ground. The most of the road damage was on the upper side of the side slope.

Figures 15: Shallow ditches and also problematic verge

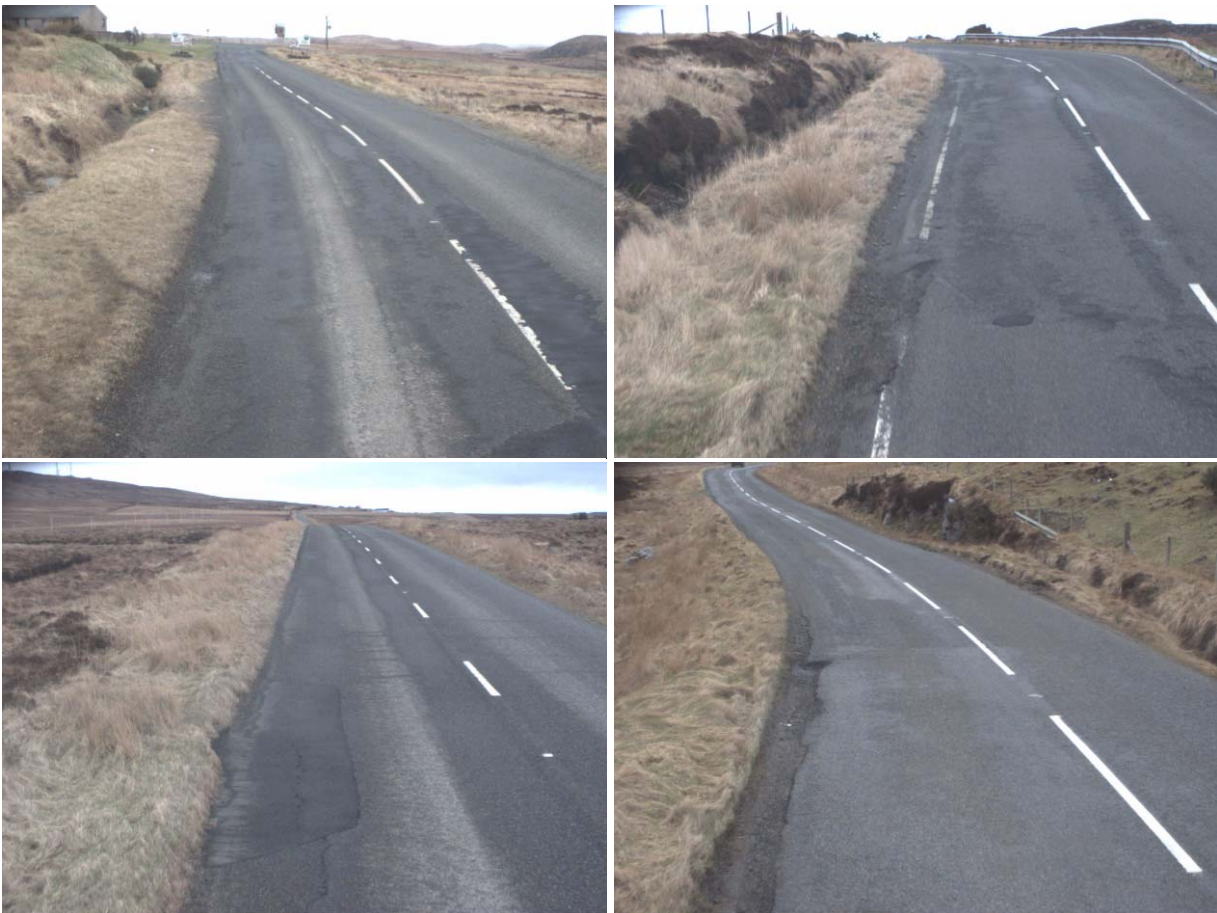
The road profile of this section of road was mostly (90%) in side sloping ground. The drainage deficiencies noted were quite typical for the road profile. Drainage problems mainly occurred mainly on the right hand side of the road, i.e. the upper side of the side slope. Drainage difficulties were compounded by the presence of verges.

Figures 16: Example photographs of typical drainage deficiencies on Road A858

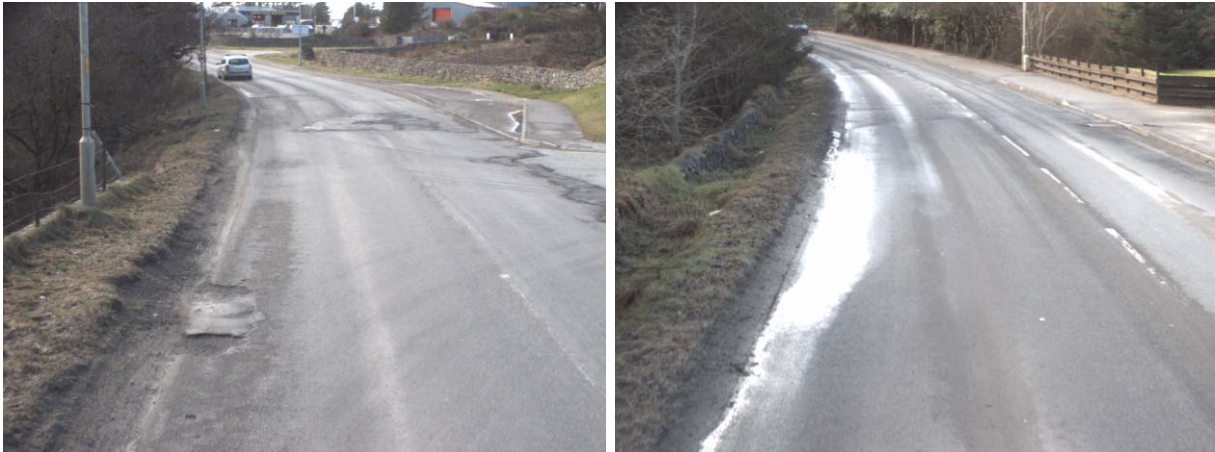
The beginning of this section was located in an urban area. Typical features for this part of the road were water outlets and drains from the beginning until chainage 1800m. Within the urban section there were several sections with damages which correlated well with drainage deficiencies. In some places the water outlets did not appear to be working efficiently enough. Also in some sections the high verges were blocking the surface water from reaching the drains.

Figures 17: Drainage deficiencies in Stornoway at the start of the surveyed section.

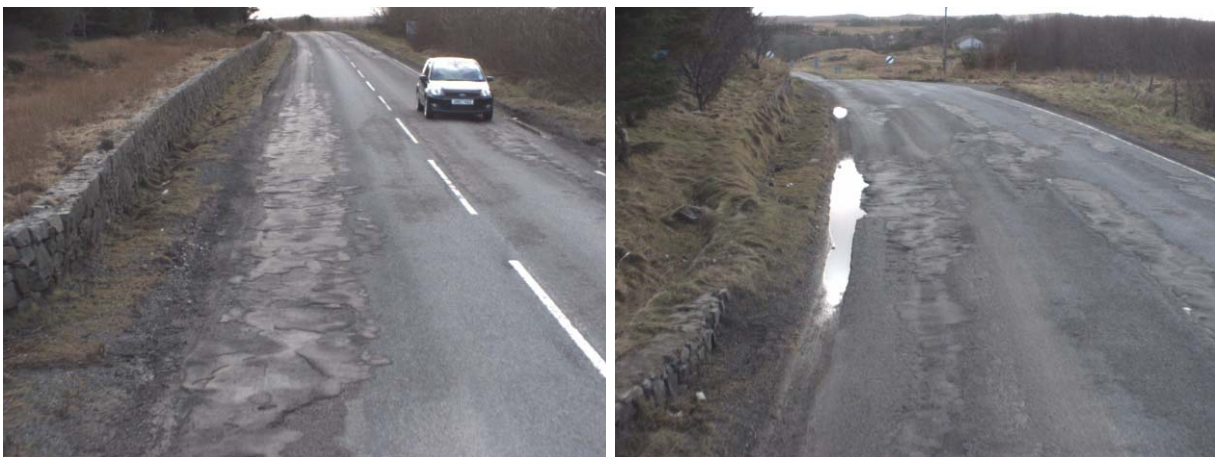
Several severe drainage deficiencies occurred immediately after leaving the urban area. The road profile had been constructed on side sloping ground and the ditch on the upper side of the road did not appear to be functioning well. Stone wall was very close to the road on the left side, and the ditch between the road and the wall was partly missing or too shallow.

Figures 18: Problems caused by the proximity of the stone wall to the road.

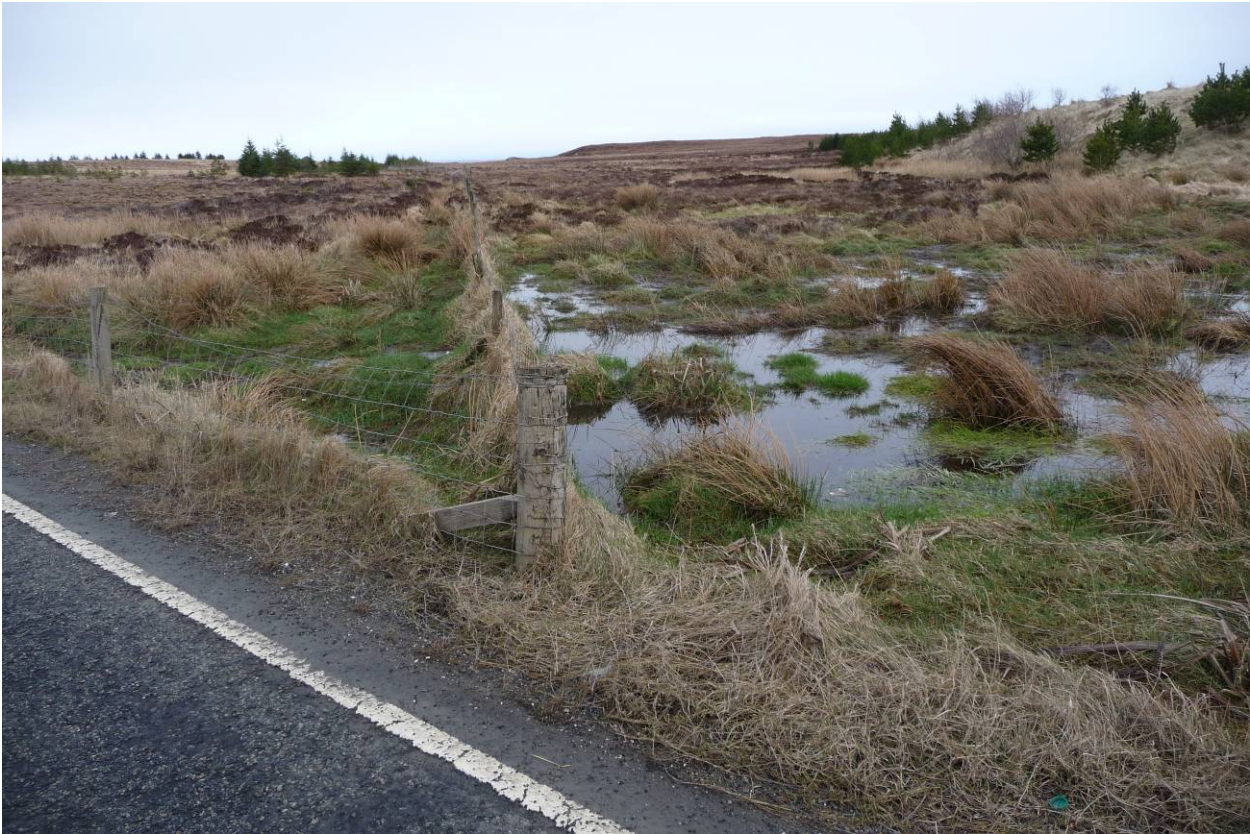
At chainage 4250m there was a clear outlet ditch problem; water was lying in the ditch on the left side of the road (figure 19). This might be difficult to improve as the landscape is flat. For this reason it may be very difficult to ensure that water can flow freely away from the area.

Figure 19: Problematic outlet ditch on the left side of the road.

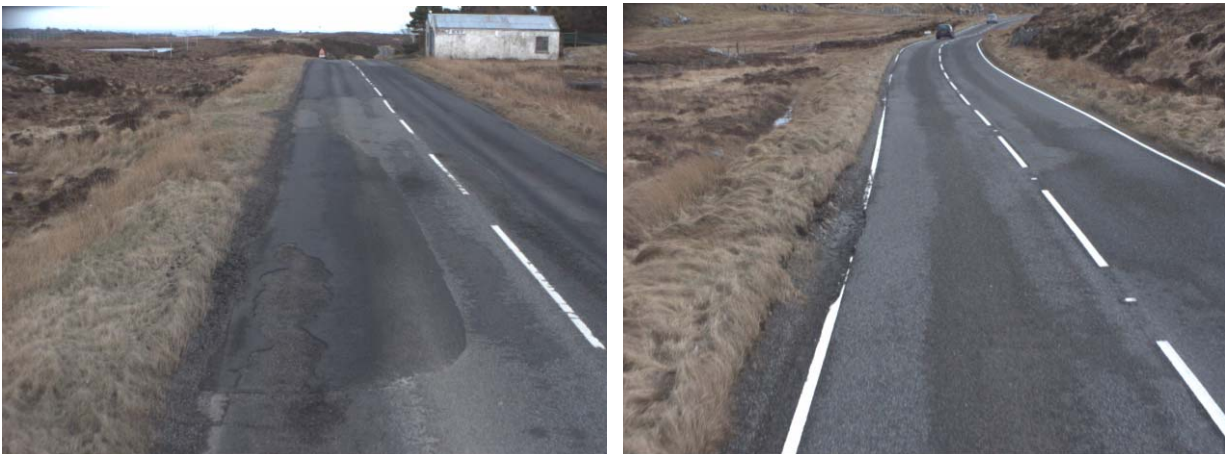
The condition of the pavement varied greatly along the remainder of the surveyed section. There were several sections with new pavement and also sections with old and weak pavement surface. The terrain also varied towards the end of the section. The end section was much drier compared to the beginning of the section. Most of the drainage deficiencies were due to problematic verge sections but there were also a few sections with clogged ditches. These ditches should be cleaned and deepened where appropriate. (Figure 20)

Figures 20: Problematic verges and damages they have caused.

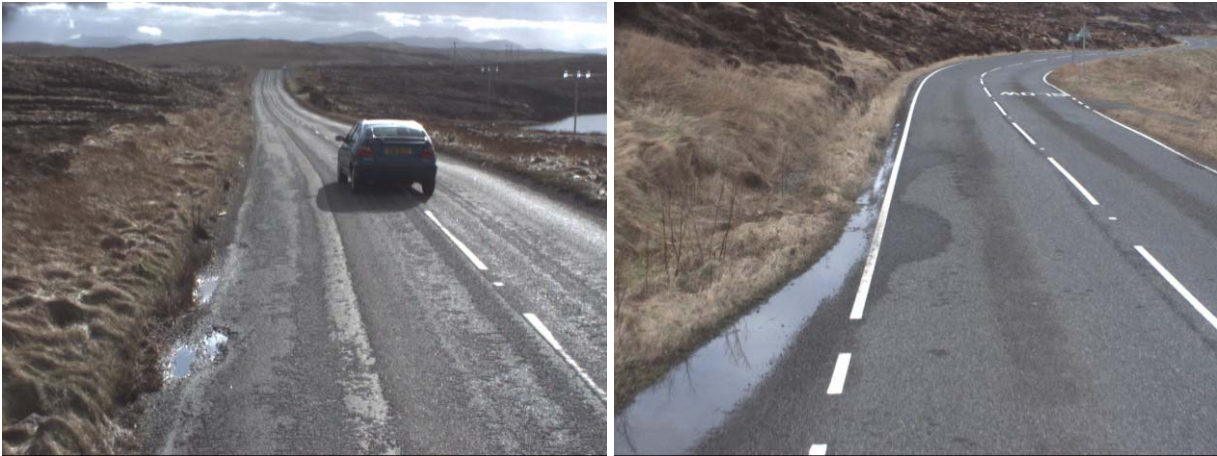
Figures 21: Drainage deficiencies in the upper side of the side sloping ground

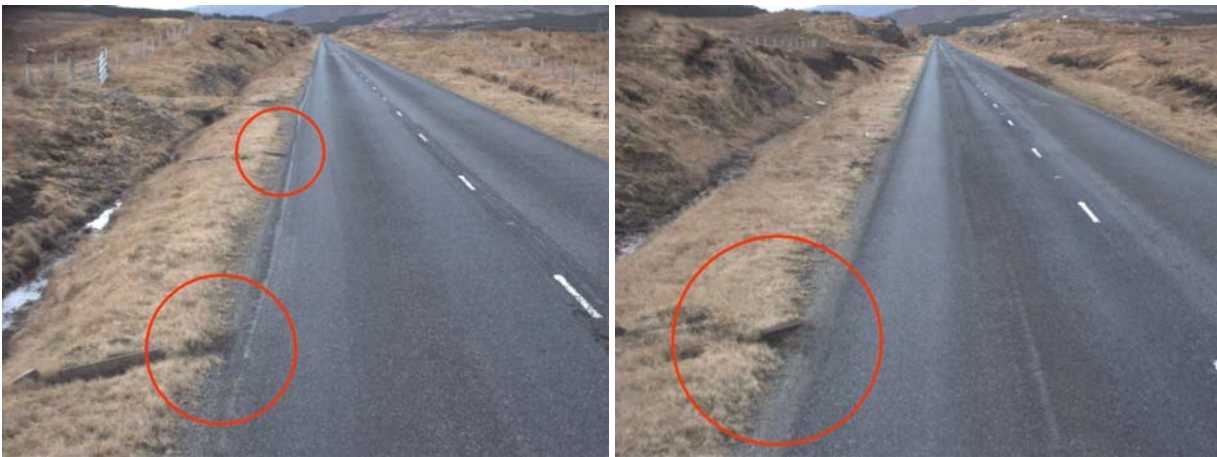
In this section the majority of the offlets were made of concrete. Most of the offlets were working well but some were broken. In some cases, especially in the middle part of the section, the concrete offlets were clearly open and looking fine, but the surface water was still lying in the edge of the pavement.

Figures 22: Offlets made of concrete, an example of broken concrete offlet on the right figure

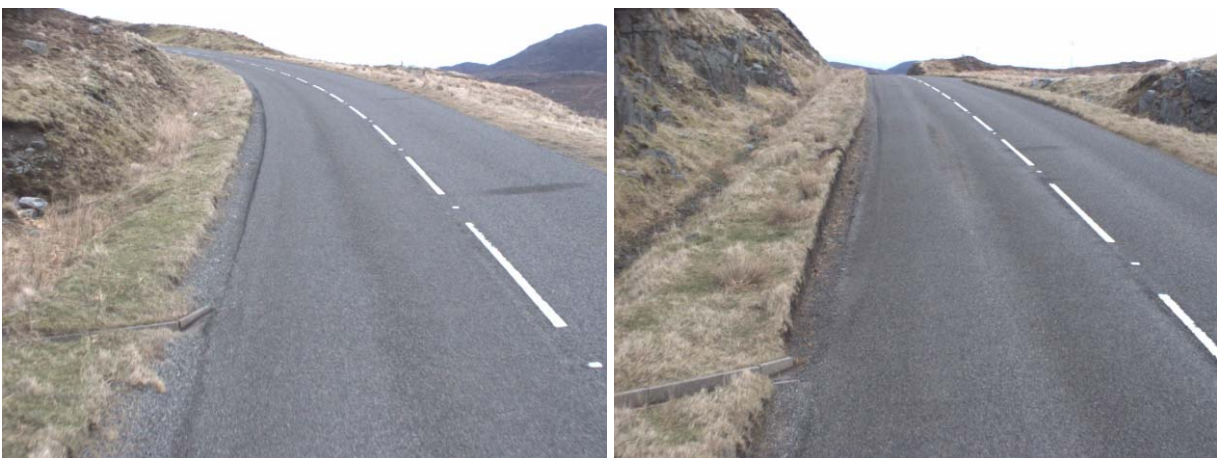
Figures 23: Good concrete offlets, but it still appears that the water has stayed in the edge of the pavement

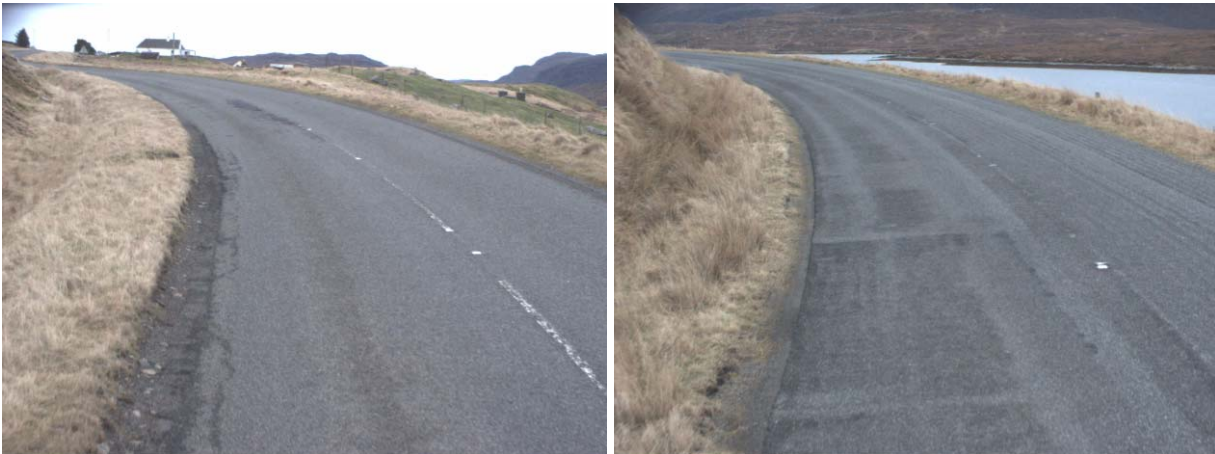
In the village of Arivruach the road profile was steeply side sloping. On the right (upper) side of the road there were drainage deficiencies and sections with problematic verges. The drainage deficiencies noted were typical for this kind of road profile.

Figures 24: Drainage deficiencies on the upper side of the side sloping ground

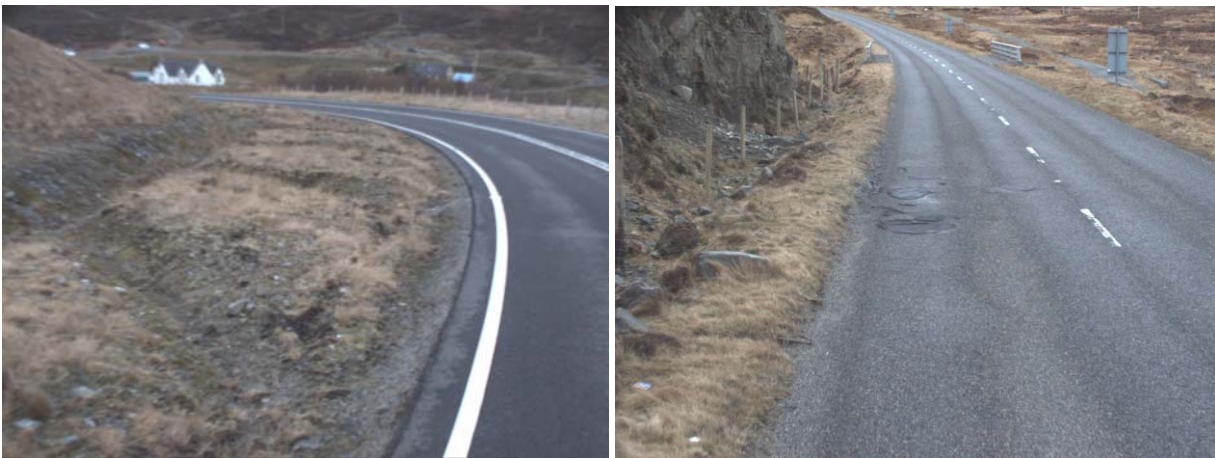
An upgraded section of road commenced at chainage 11550m and ended near the bridge at chainage 14800m. In this renewed section drainage has been well maintained: the verges have been removed and the ditches are deep enough. The section is located on side sloping ground and it will be important in the future to keep the ditches in the upper side in good condition. A special drainage structure has been used in this section. Long offlets lead the water from the road surface to the ditch which is located further from the road. This solution appeared to be working well.

Figures 25: On the left picture there are long offlets to lead the water to the ditch at Bowglass. On the right picture unstable soil is blocking the ditch.

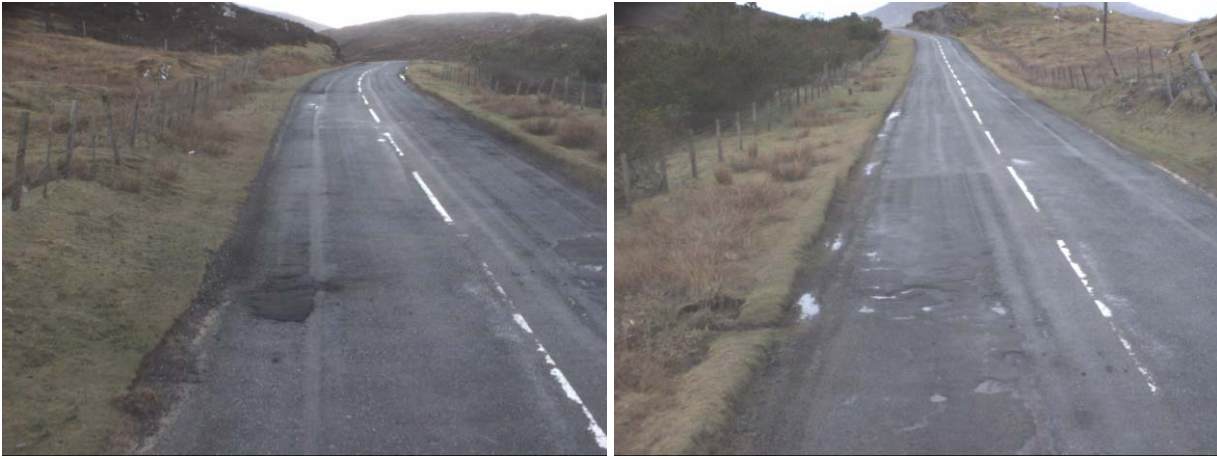
This section started as two lane road but changed to a single-lane road within the surveyed length. The quality of the pavement varied significantly; the section in the middle was in quite poor condition. The end of the section in Leverburgh was in good shape. The ditch in the upper side of the road was missing from chainage 700m to chainage 800m.

Figures 26: The ditch in the left side of the road is missing

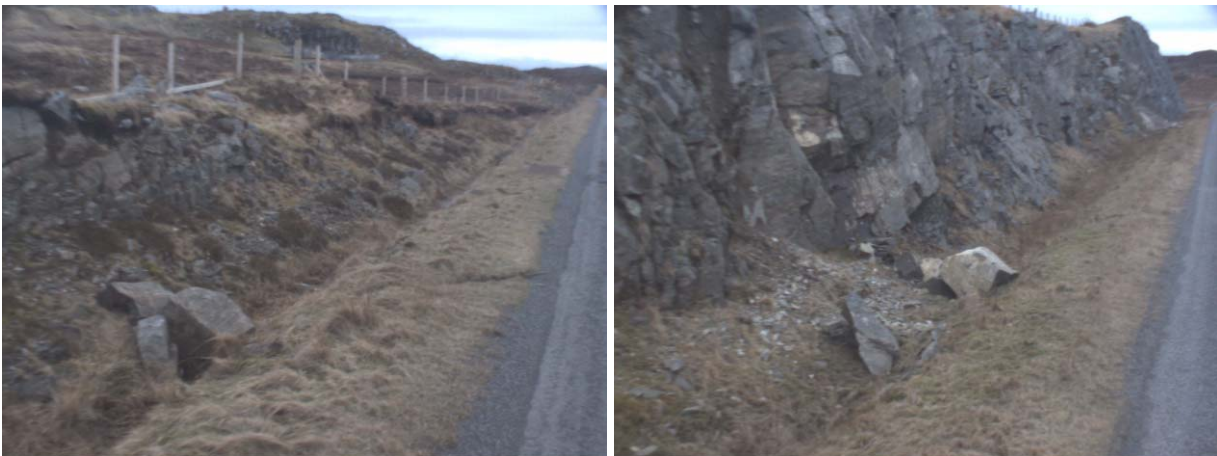
Figures 27: Stones are blocking the ditch

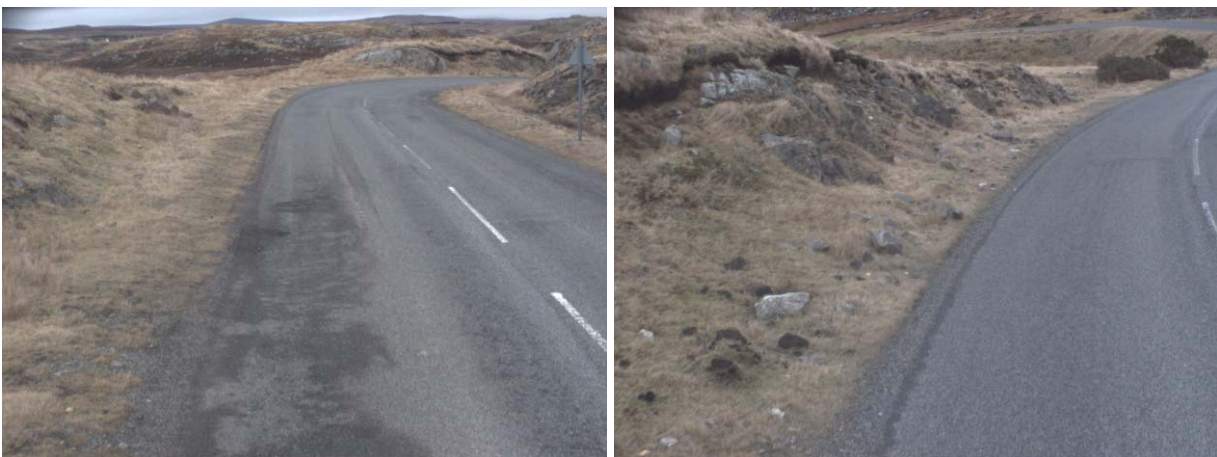
Another typical problem in some road cuts in this section was the absence of a ditch. This lack of ditch appeared to correlate with adjacent pavement damages. Where the ditch was missing, there were more damages in the pavement surface.

Figures 28: The ditch is missing in a road cut

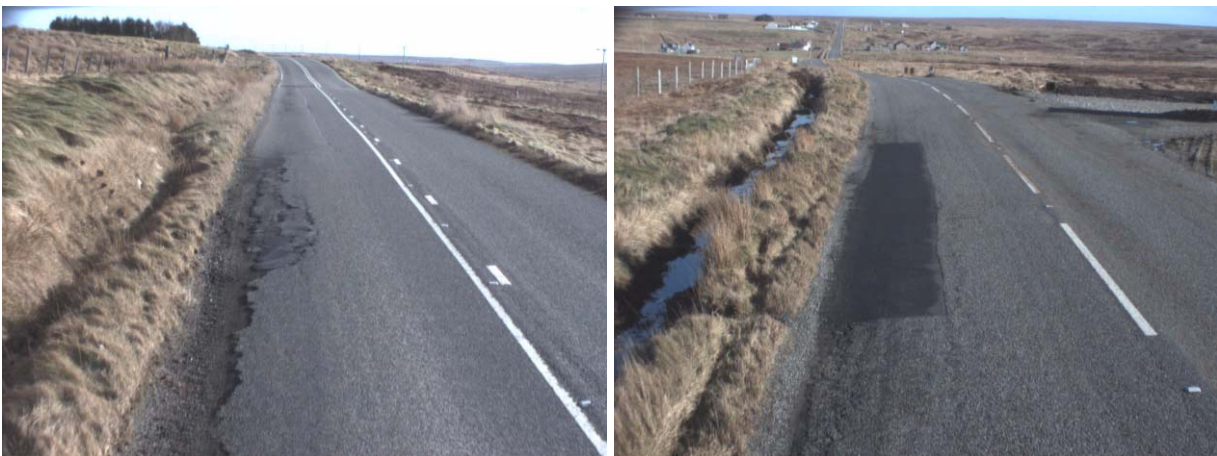
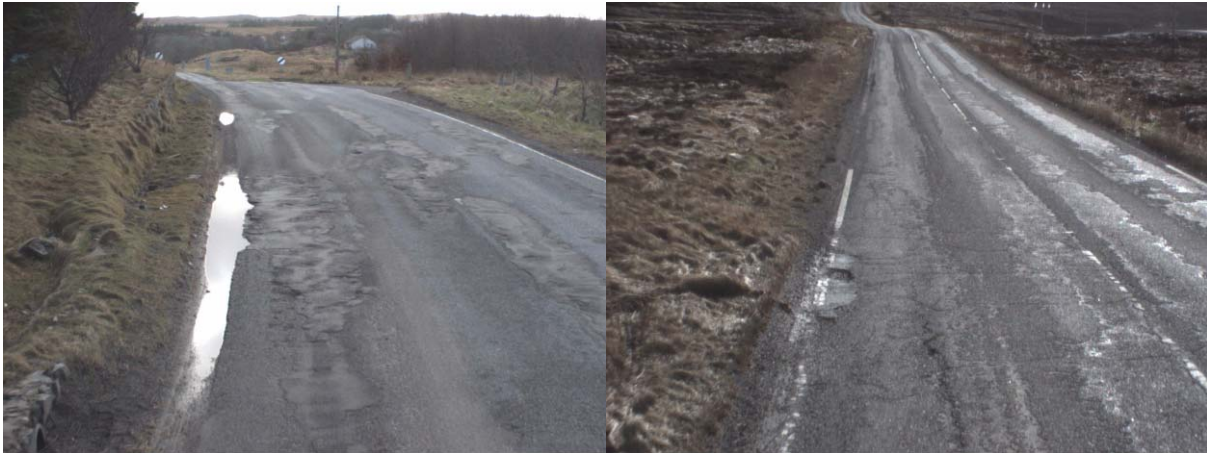
Drainage Class 3 covers those road sections with severe drainage problems. The road shoulder has a high verge and/or dense vegetation that are causing ponding on the traffic lane or on the shoulder. Vegetation is growing in the ditches and restraining the flow of water creating dams in the ditches. Unstable soil is flowing from ditch slopes into the bottoms of ditches and blocking the flow of water. Clogged culverts or outlet ditches is preventing the flow of water in the ditch. All of these situations lead to the development of deformation and damage in the road cross-section.

Figure 31: Examples of road sections with drainage Class 3 in the Western Isles.

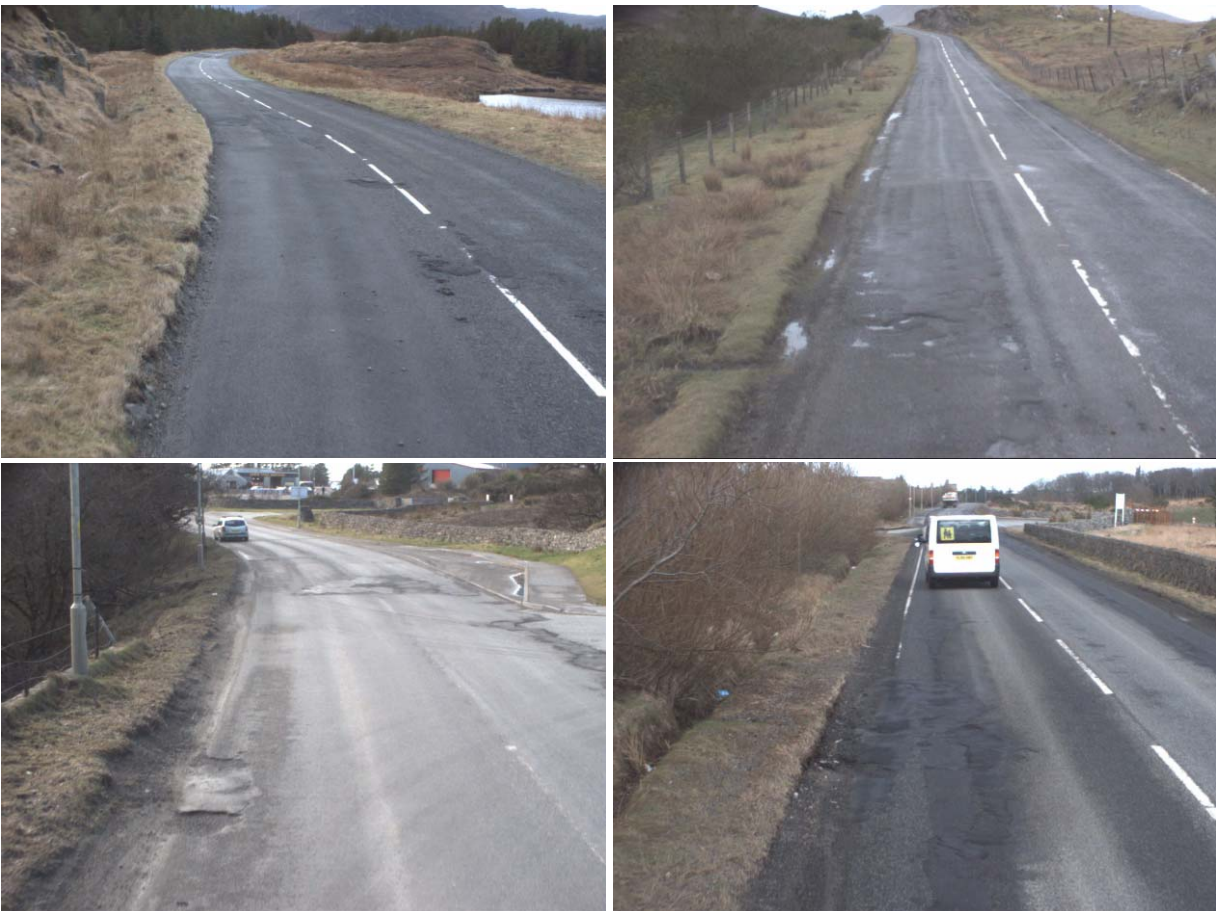
Class 3 verges cover those road sections with significant verges restricting the water flow away from the pavement causing ponding and other problems. There are no offlets or they are in poor condition. Figure 34 shows a few examples of road sections belonging to verge Class 3.

Figure 34: A few examples of verge Class 3, roads with a verge that has a significant negative impact on the workings of the road drainage system.

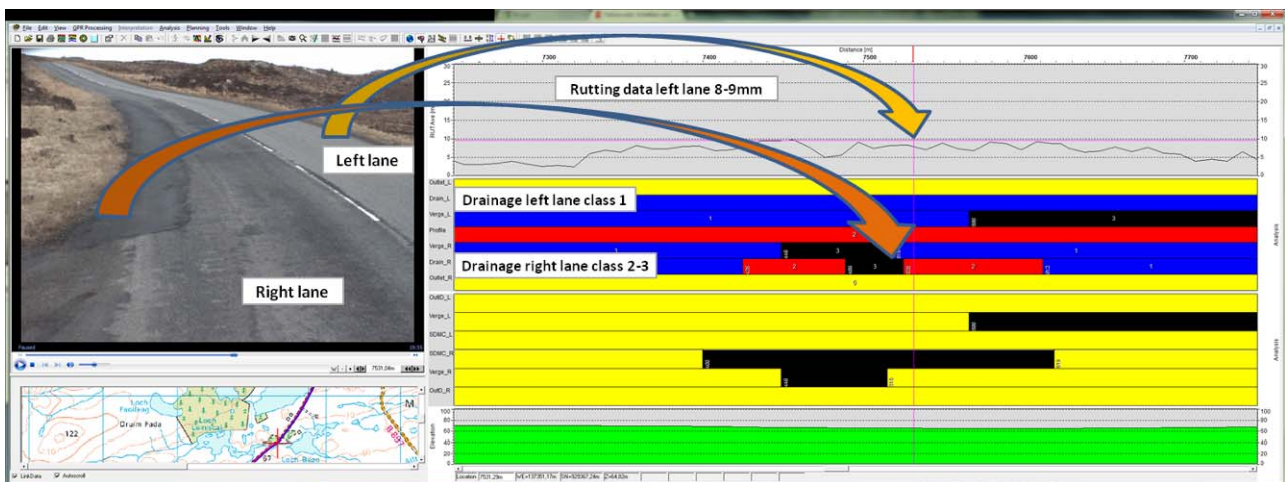
It is usually the case is that the most of the problems on roads on side sloping ground take place in the upper side of the side slope and the lower side usually has less damage (Figure 48). That is because in side sloping ground the water wants to flow “through” the road using the shortest possible path. If the drainage in the upper side of the side slope is not in good condition the water will stay in the ditch causing problems which are usually visible and measurable in that side of the road. This might have had some effect on rutting depth calculations by drainage classes.

Figure 48: Road Doctor view from direction 2. Drainage problems and severe damages on the pavement on the right lane. Rutting data is from left lane which is in much better condition. Also the drainage is Class 1 on the left lane.

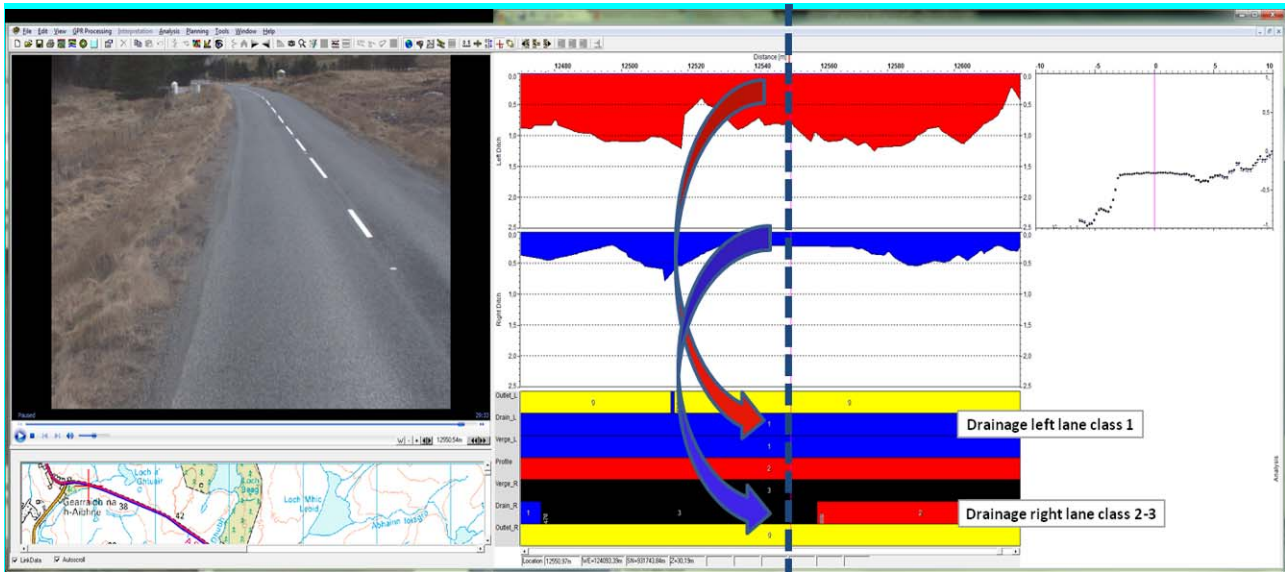
Figure 59: The drainage on the right has been classified as Class 2 and Class 3 as the ditch (blue field) is nearly non-existent. Left side the drainage is classified as Class 1 (red field). There is not a ditch on this side but the program has detected the toe of the high embankment as a deep ditch.

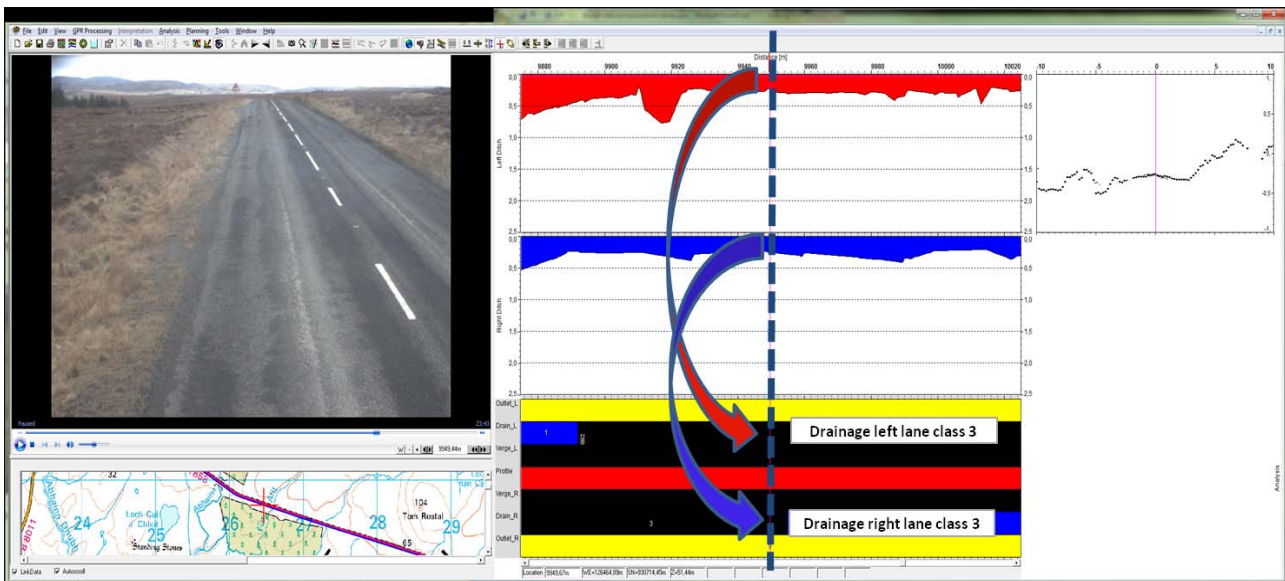
Figure 60: Drainage deficiencies on both sides of the road. The drainage has been classified as Class 3. The ditches on both sides are full of vegetation.

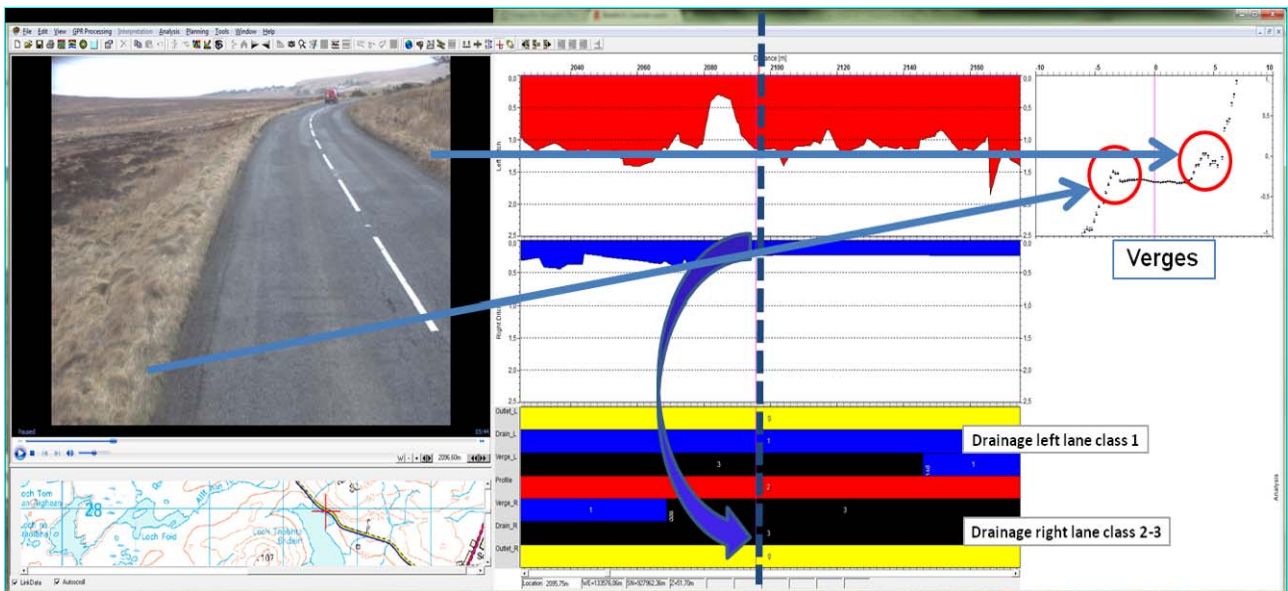
Figure 61: Drainage deficiencies on the right side where the ditch is shallow. The road profile is side sloping from right to left. In the cross section the verges are clearly visible.

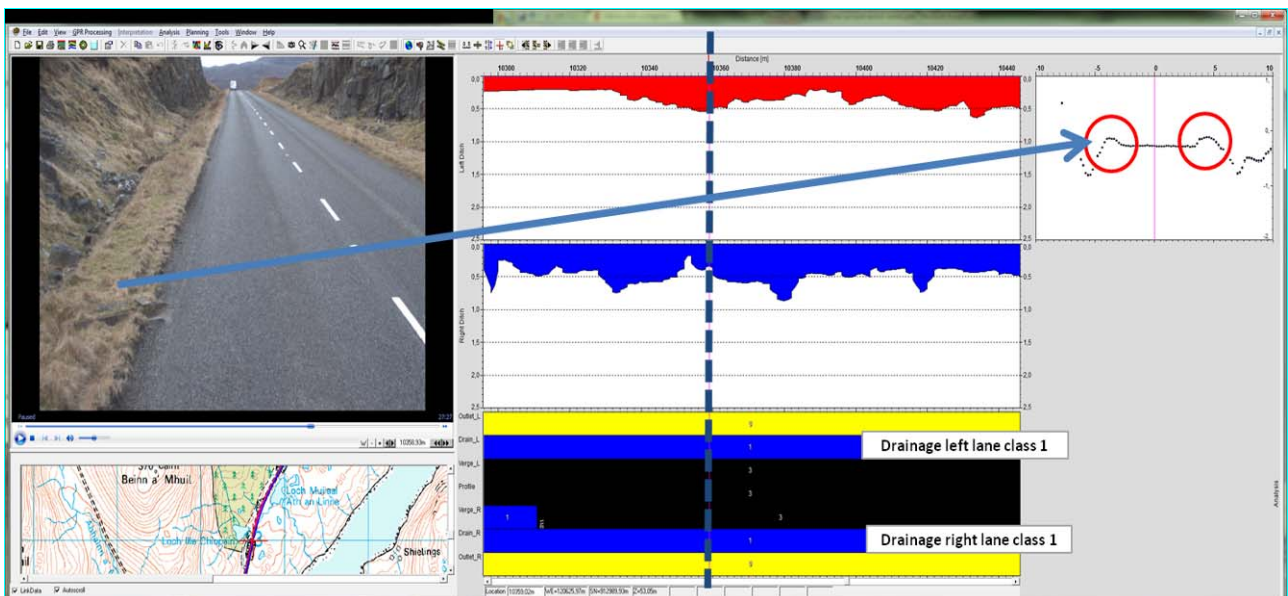
Figure 62: Shallow ditches in a road cut in dry terrain. The drainage has been classified as Class 1 on both sides but there are verges present on both sides.
