# ROADEX Drainage Research:

Timo Saarenketo, PhD  
Roadscanners, Finland

## DEVELOPING DRAINAGE GUIDELINES FOR MAINTENANCE CONTRACTS

Results of a ROADEX III pilot  
project in the Rovaniemi  
Maintenance Area in Finland

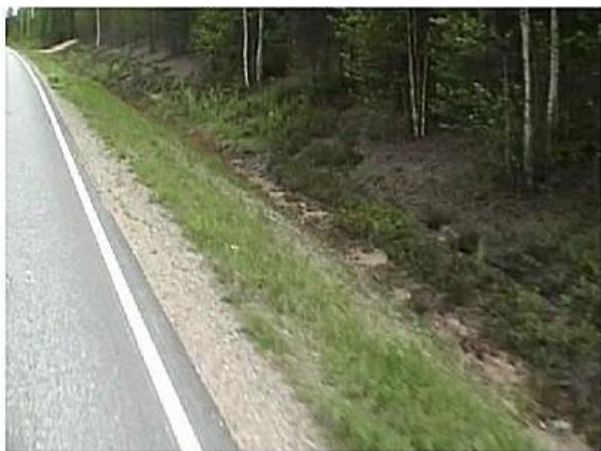
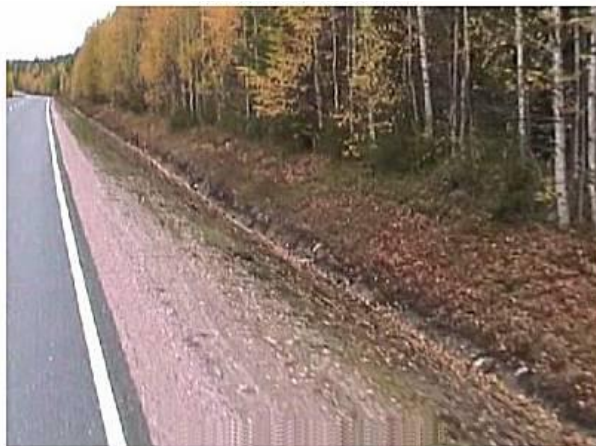
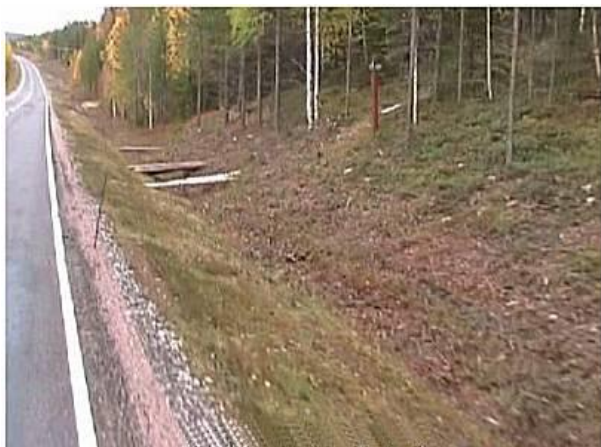
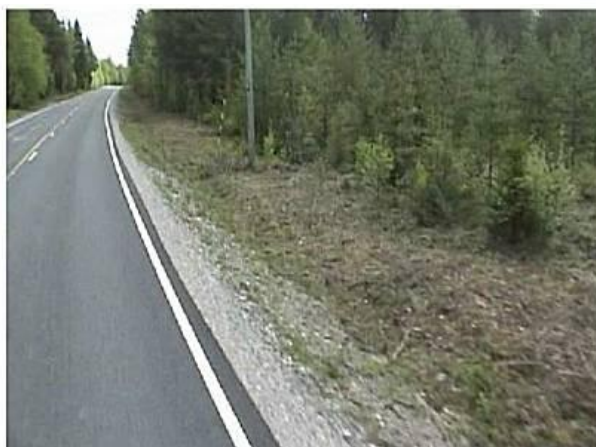
## Class 1: Good Drainage Condition

Faultless drainage. Road cross section shape has preserved its form well and water flow from the pavement to ditch has no obstacles. Unrestricted water flow in ditches.

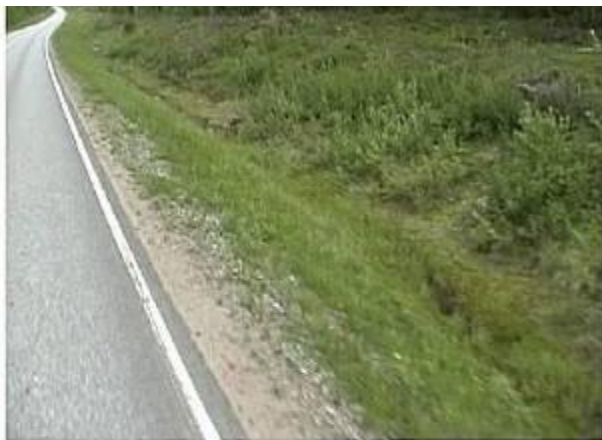
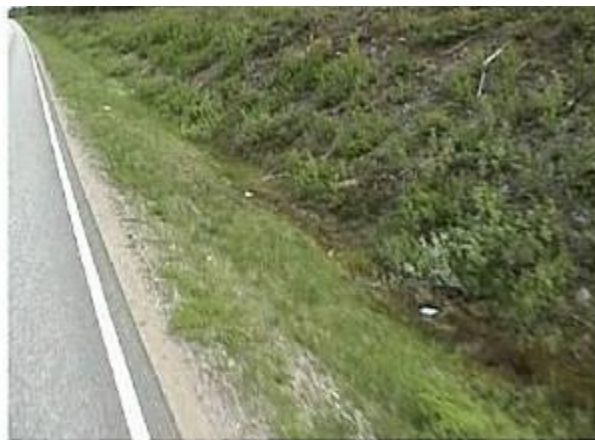
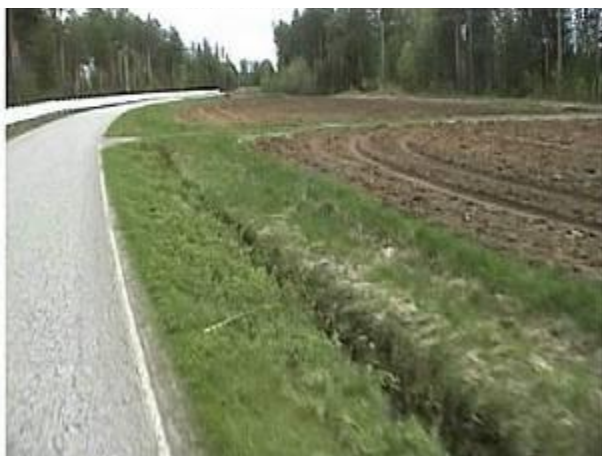
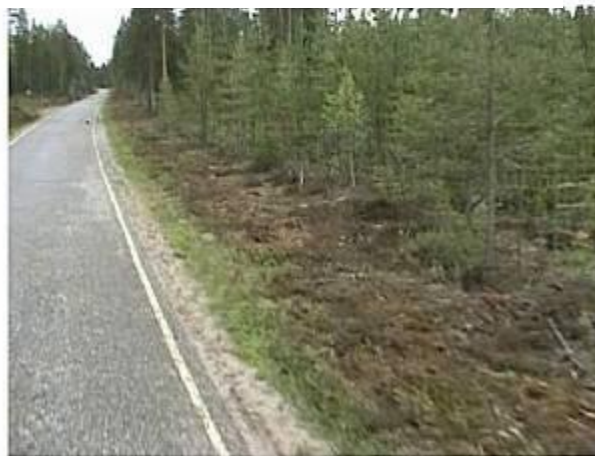
## Class 2: Adequate Drainage Condition

Small changes in the road cross section form can appear. Road shoulder has small verges or vegetation that prevents good water flow to ditch. Vegetation in ditch restrains water flow and causes dams. Small amount of soil flows from road slopes into ditches and raises the bottom of the ditch, slows the water flow and raises the ground water table.

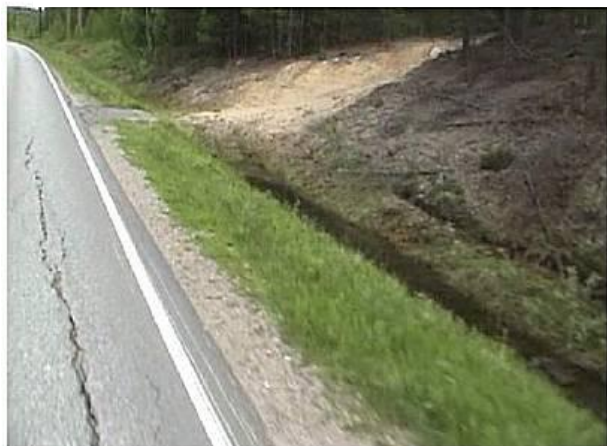
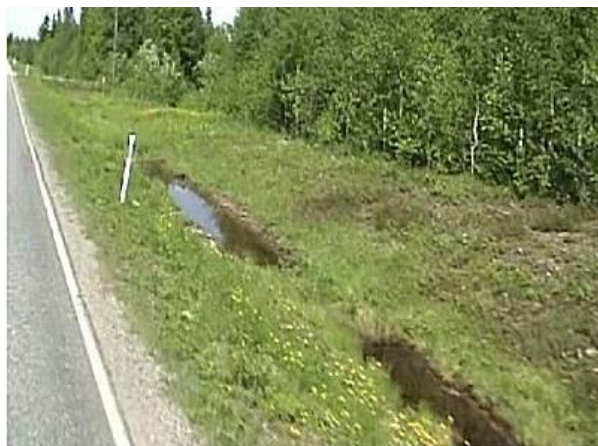
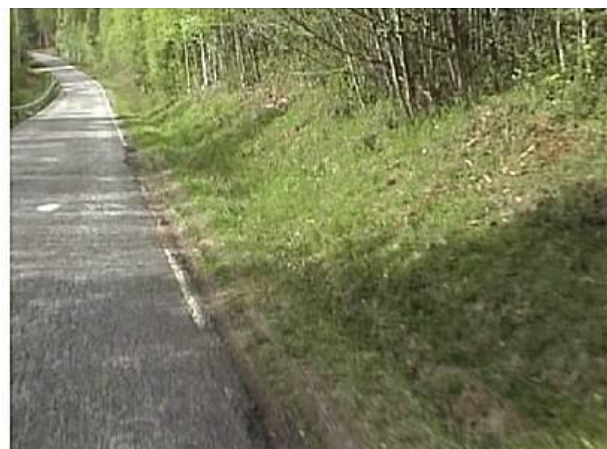
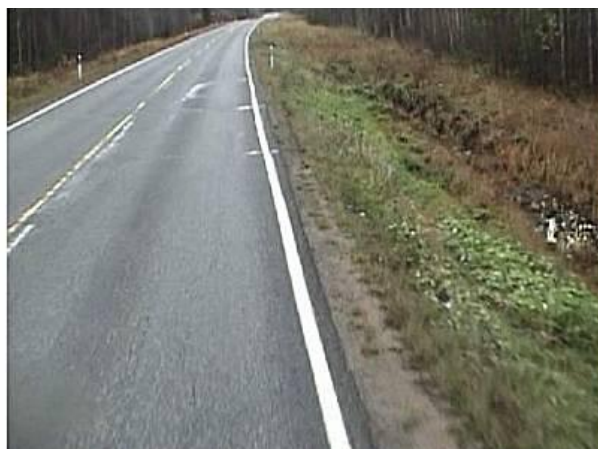
## Class 3: Poor Drainage Condition

Deformations and damages in the road cross section. Road shoulder can have a high verge and/or dense vegetation that causes ponding on the traffic lane or on the shoulder. Vegetation in ditch restrains water flow and causes dams in the ditch. Unstable soil flows from ditch slopes into ditches and blocks the water flow. Clocked culvert or outlet dict prevent the water flow in the ditch.

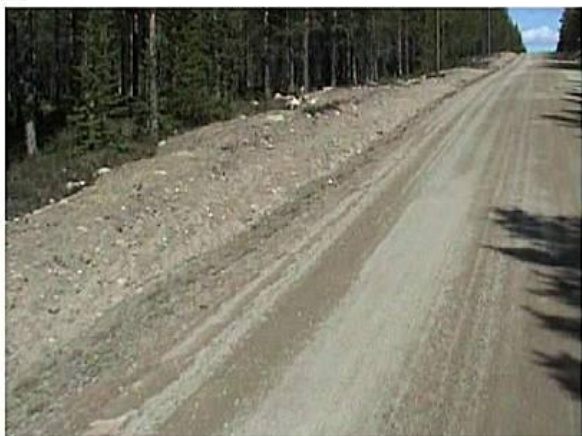
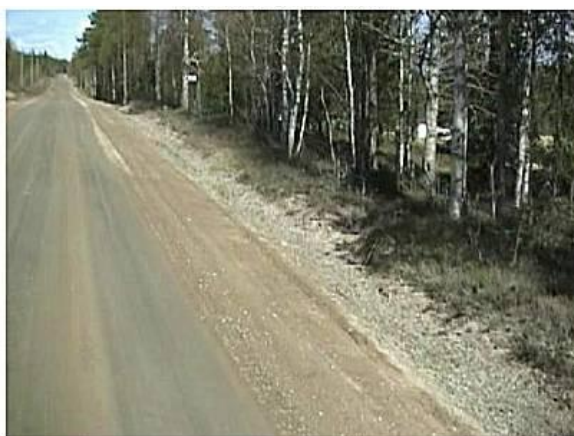
## Class 1: Good Drainage Condition

Faultless drainage. Road cross section shape has preserved its form well and water flow from the pavement to ditch has no obstacles. Unrestricted water flow in ditches.

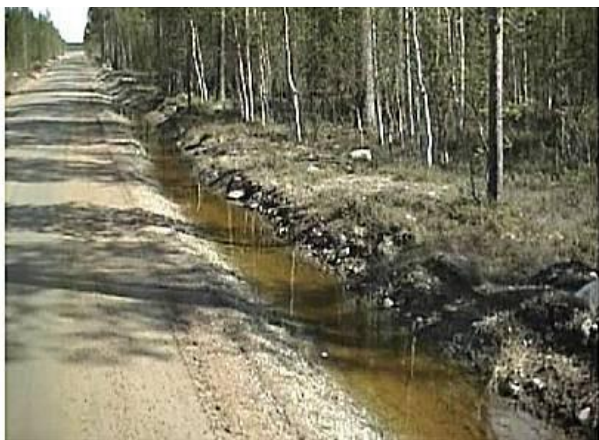
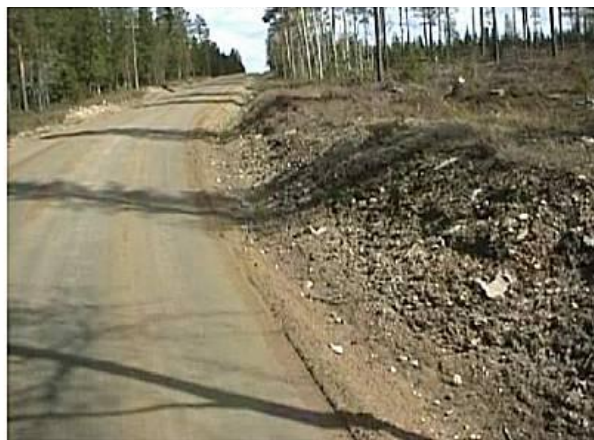
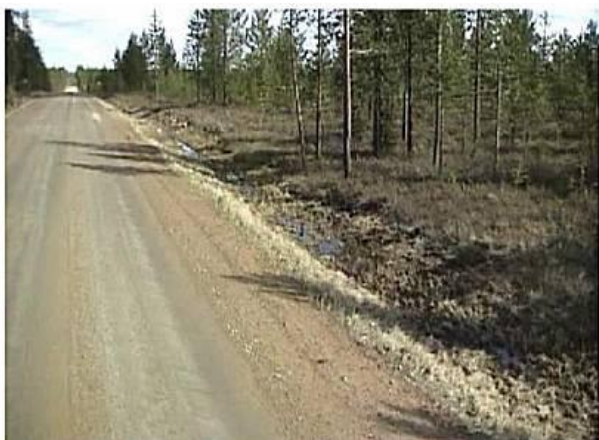
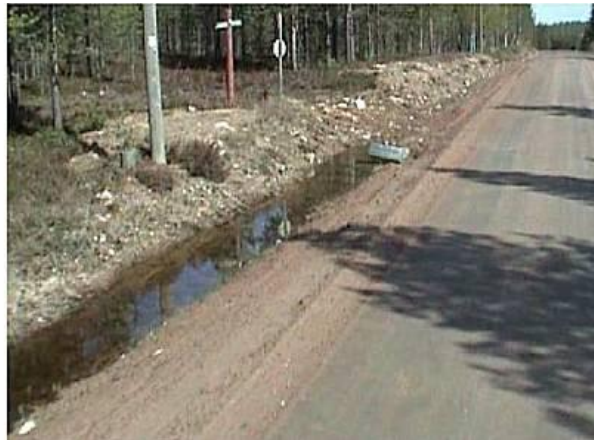
## Class 3: Poor Drainage Condition

Deformations and damages in the road cross section. Road shoulder can have a high verge and/or dense vegetation that causes ponding on the traffic lane or on the shoulder. Vegetation in ditch restrains water flow and causes dams in the ditch. Unstable soil flows from ditch slopes into ditches and blocks the water flow. Clocked culvert or outlet dict prevent the water flow in the ditch.

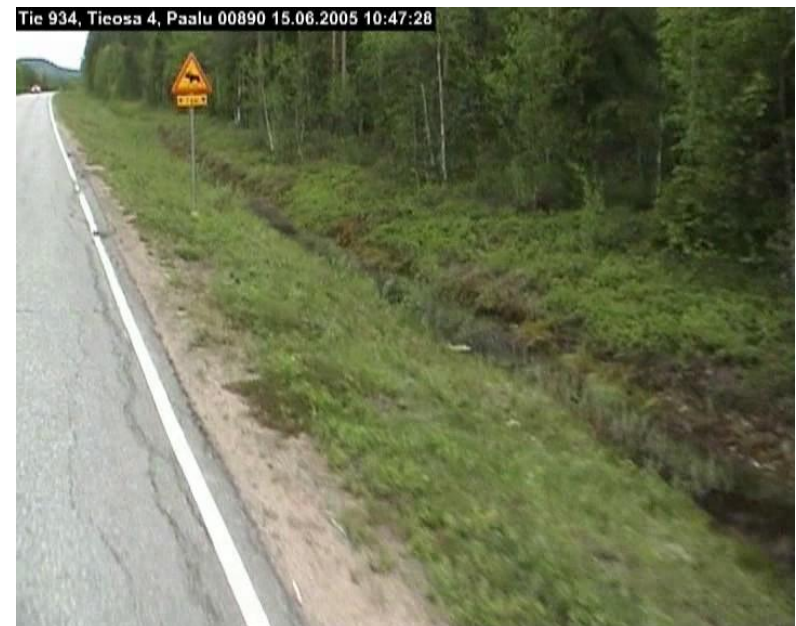
b) Good correlation between pavement distress and poor drainage

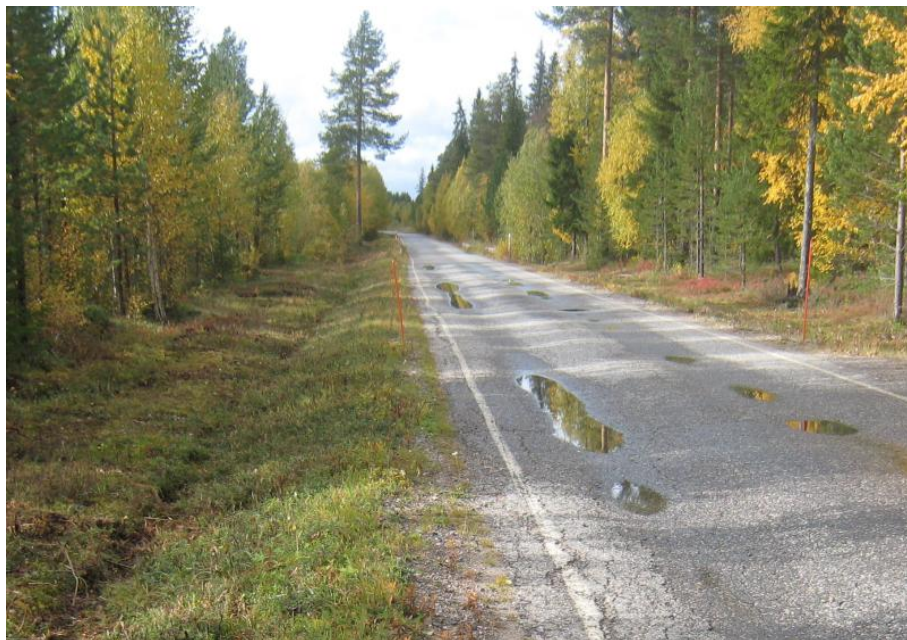
Filled ditch

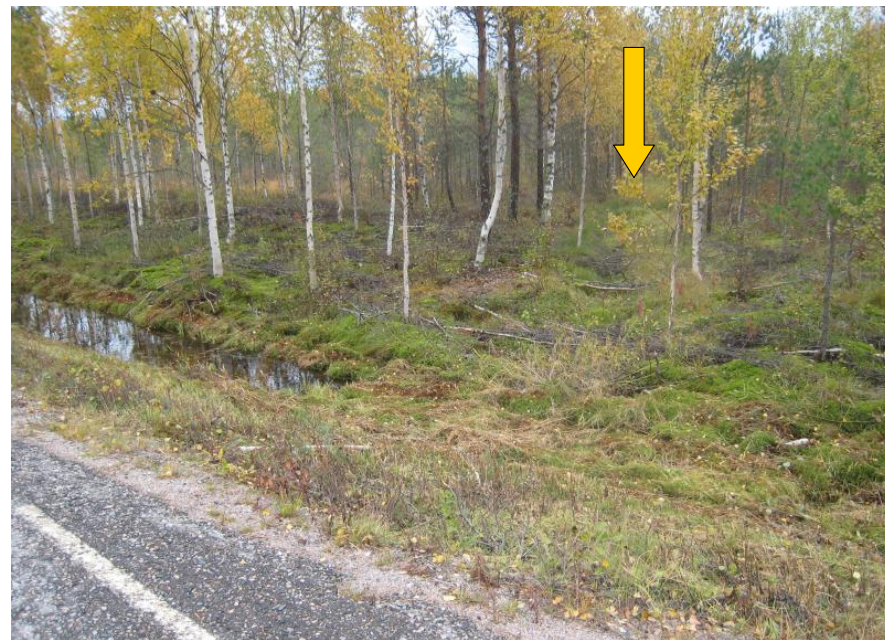
Clogged outlet ditch

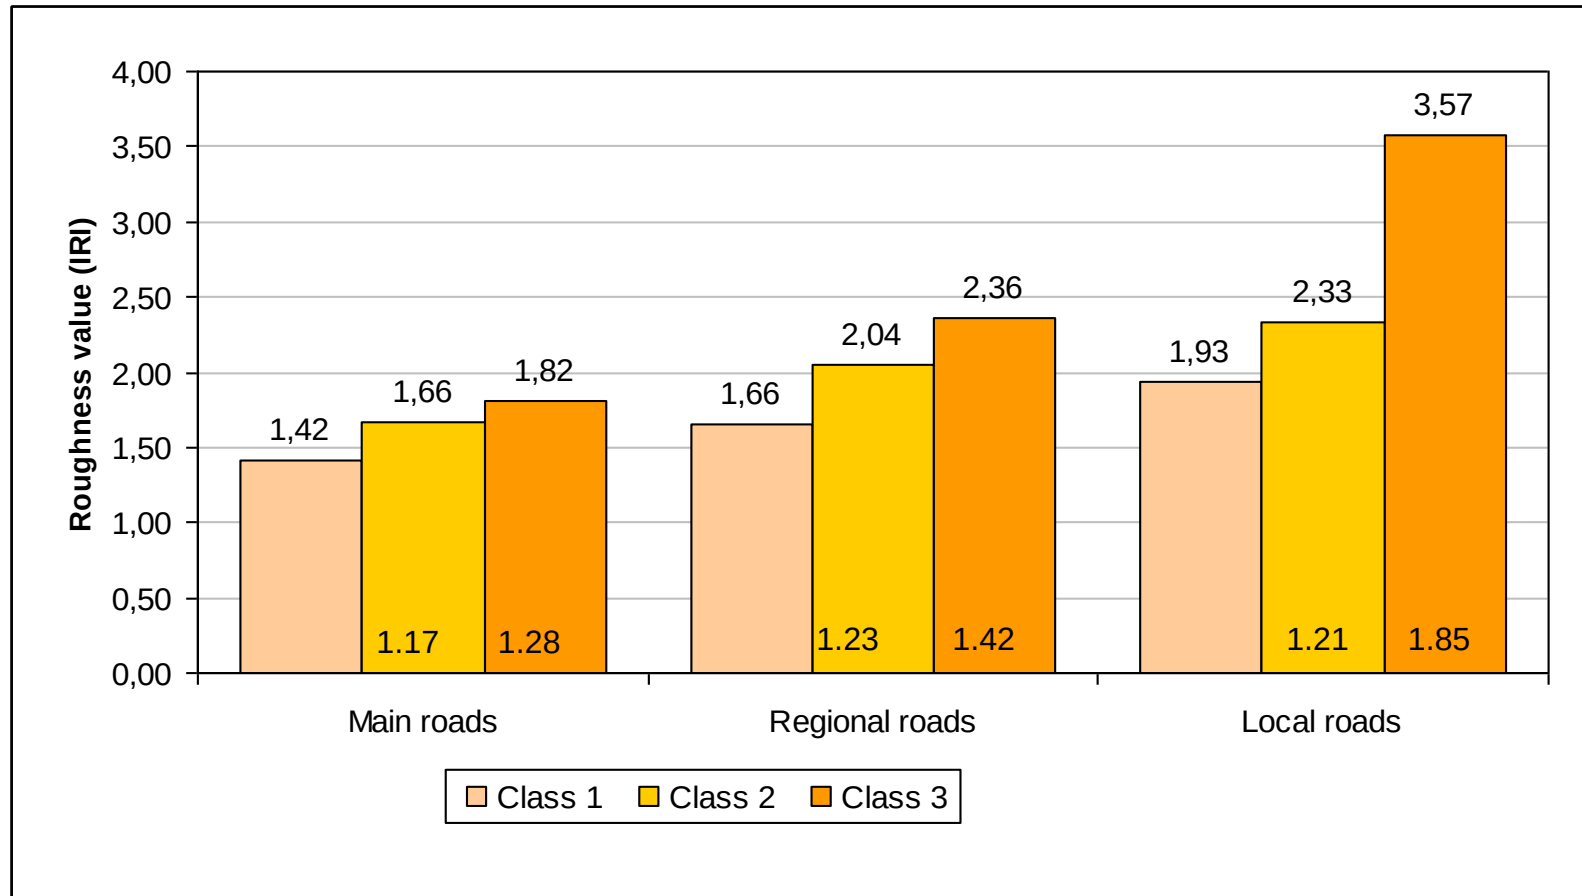
## Average IRI Values in Each Road Class and Drainage Class

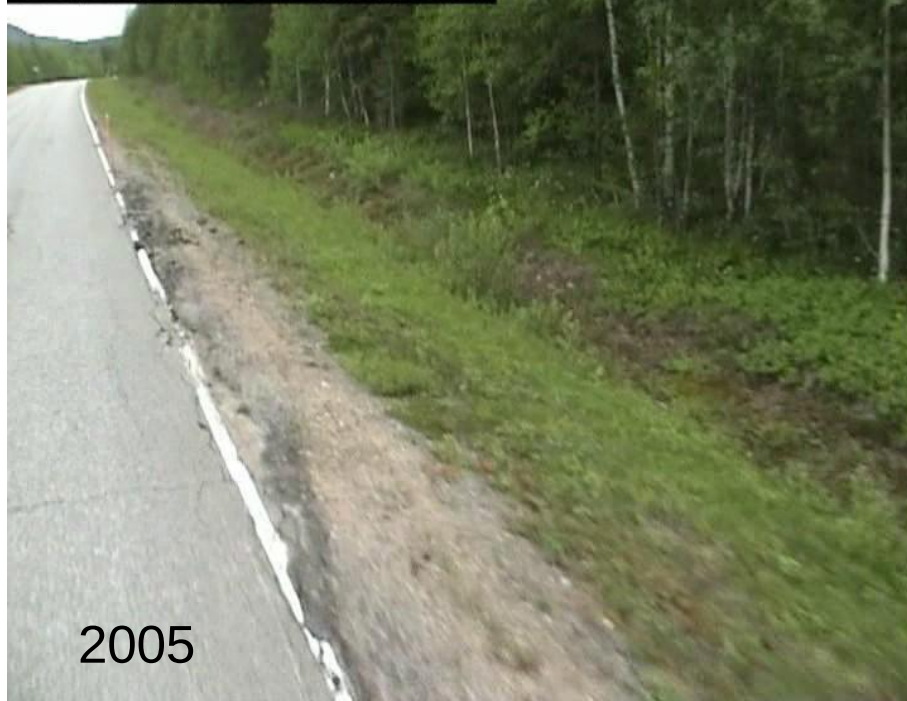
Tie 934, Tieosa 4, Paalu 01150 15.08.2005 10:47:59

## Example of Poor Drainage on Roughness and Pavement Distress Growth, Road 934, section 4

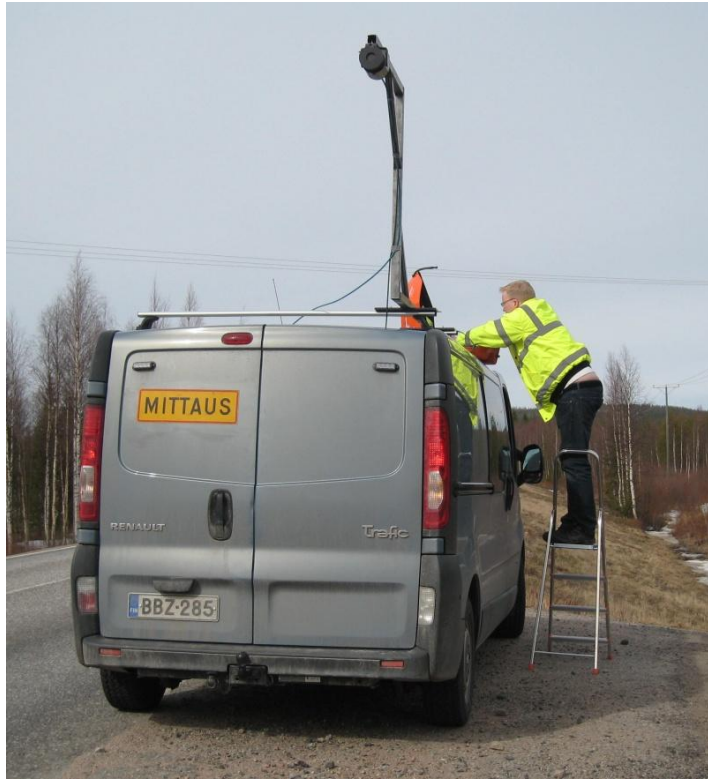
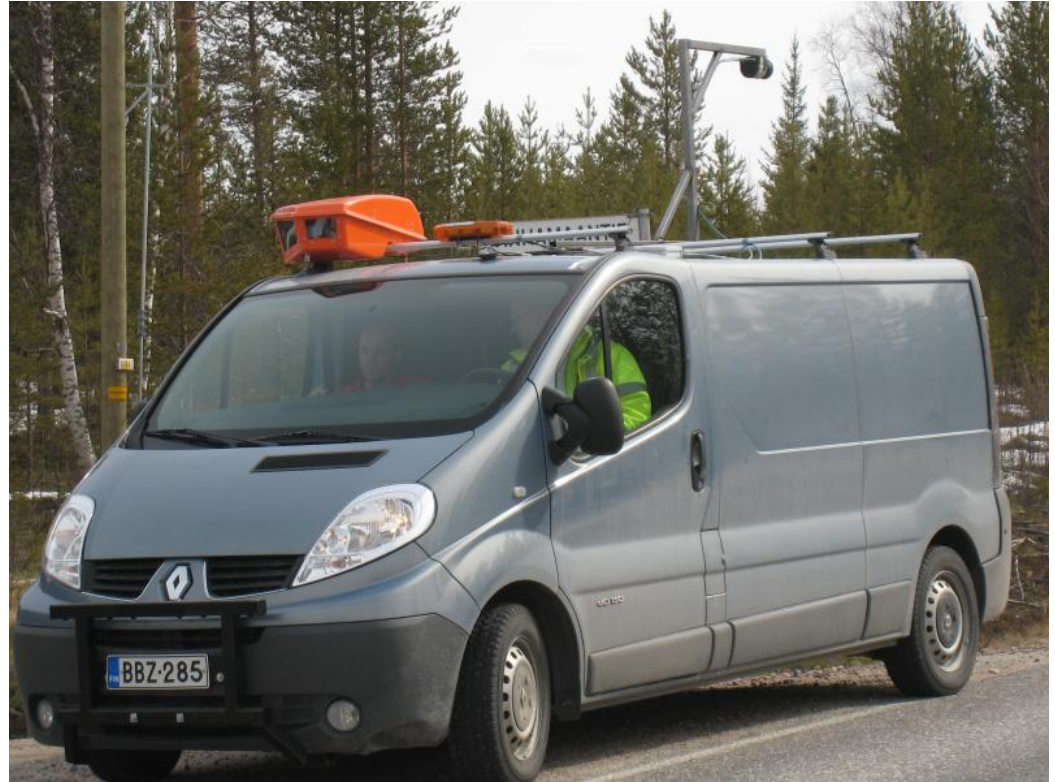
# Road Doctor Laser Scanner

RD Cam Link (video cameras + GPS + inventory)  
Laser Scanner (+ 3d Inclinometers)  
Thermal Cameras

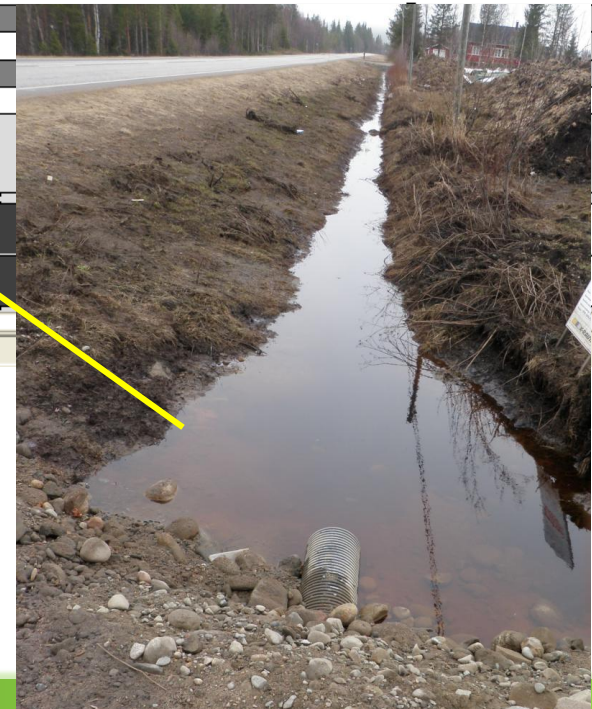
# Kittilä Follow Up: Rd 80\_10, 7000-8000 m
