ROADEX

ROADEX Research and eLearning Package: Drainage

Timo Saarenketo, PhD
Roadscanners

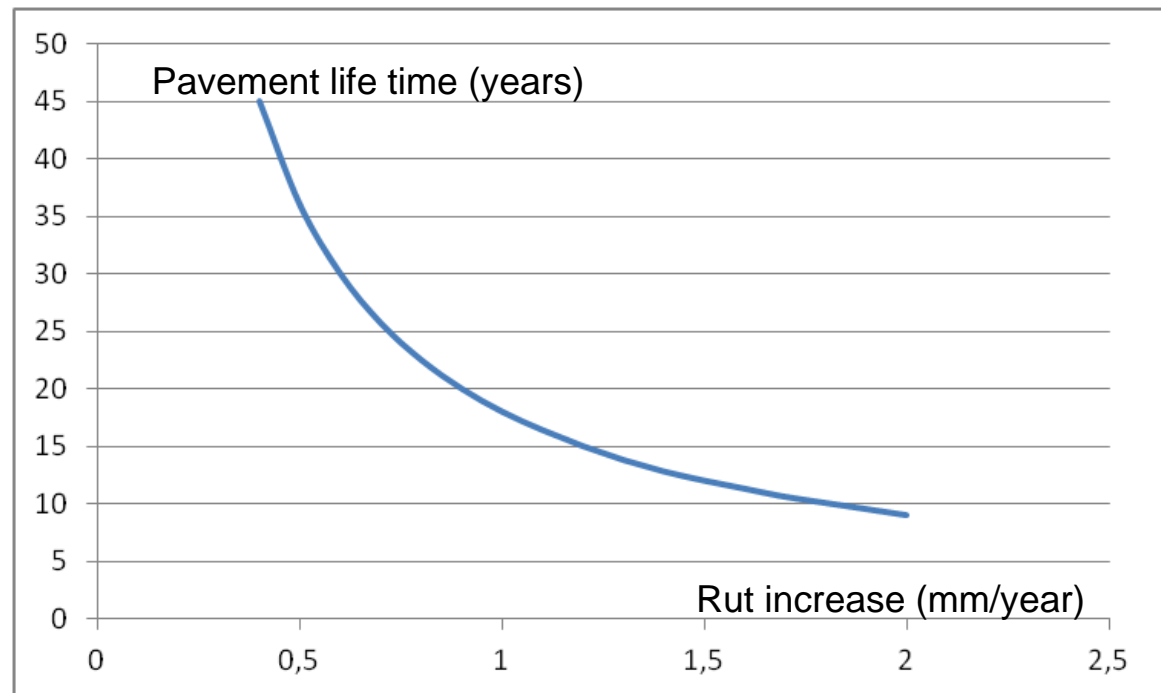
Critical Parameters in Pavement Life Time Evaluation are Rut and IRI Growth Speed

Rut increase (mm/year)	Initial rut (mm)	Life time years	rut depth max(mm)
0,4	2	45	20
0,5	2	36	20
0,6	2	30	20
0,7	2	25,7	20
0,8	2	22,5	20
0,9	2	20	20
1	2	18	20
1,1	2	16,4	20
1,2	2	15	20
1,3	2	13,8	20
1,4	2	12,8	20
1,5	2	12	20
1,6	2	11,3	20
1,7	2	10,6	20
1,85	2	9,8	20
2	2	9	20

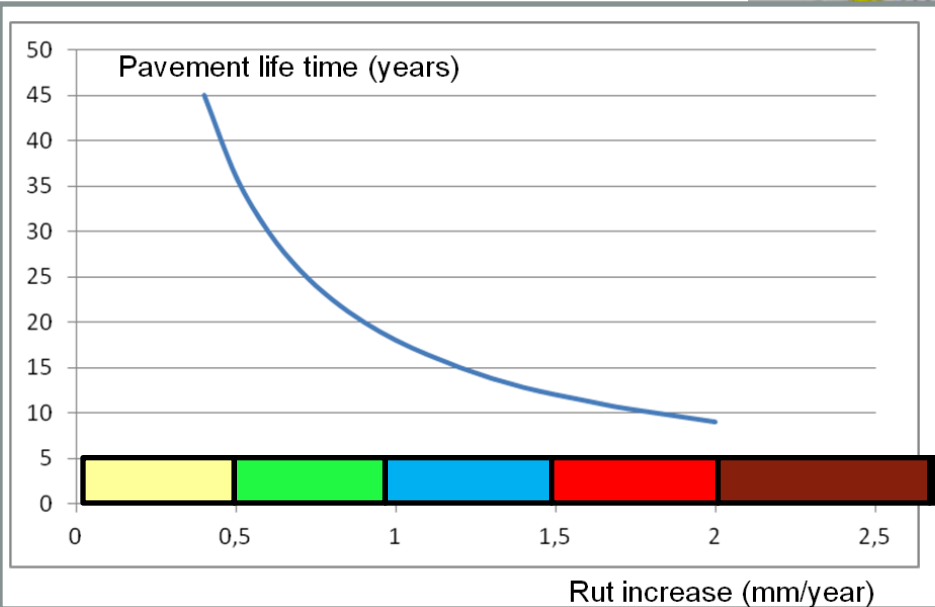
But, in additon to linear elastic fatigue, poor drainage is causing permanent deformation!

Road 78 Section 219 Pavement Life Time

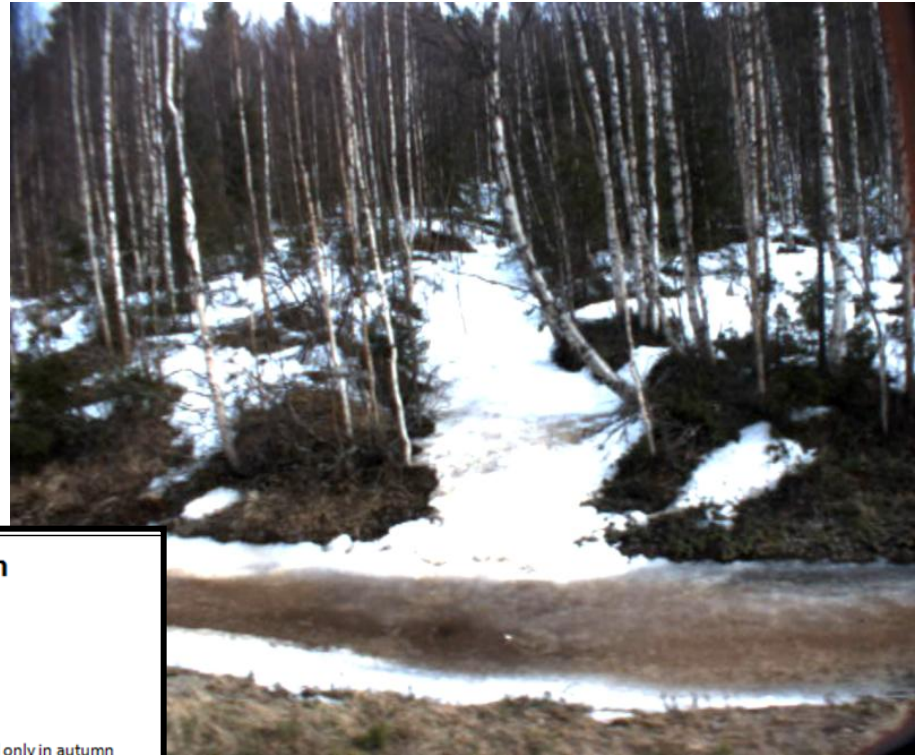
Road Doctor Cam Link for Outlet Ditches

Video camera
pointing 90°

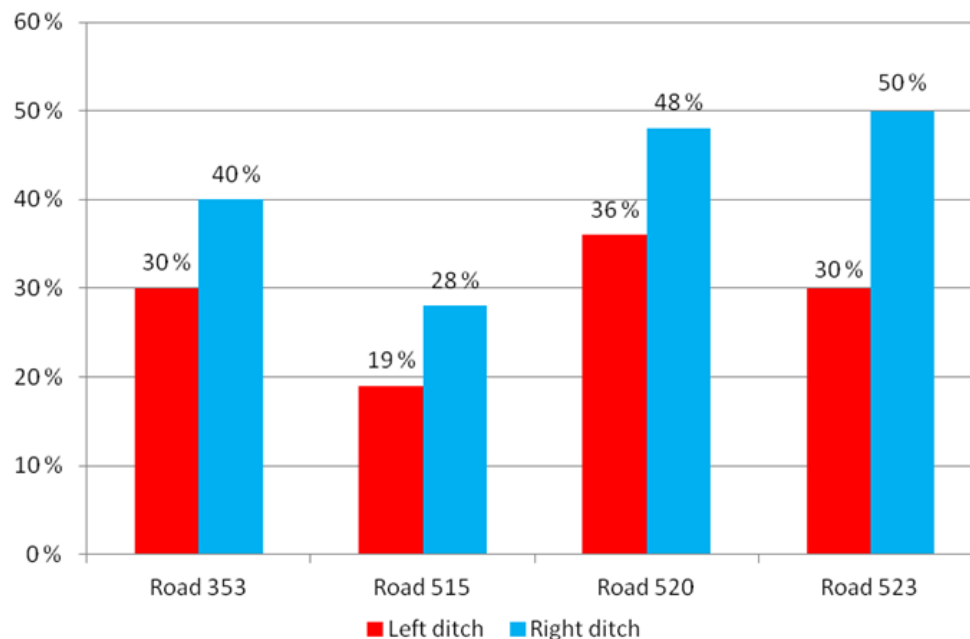
Proportion of ditches with acceptable depths
(ditch bottoms are 20cm lower than road structure)

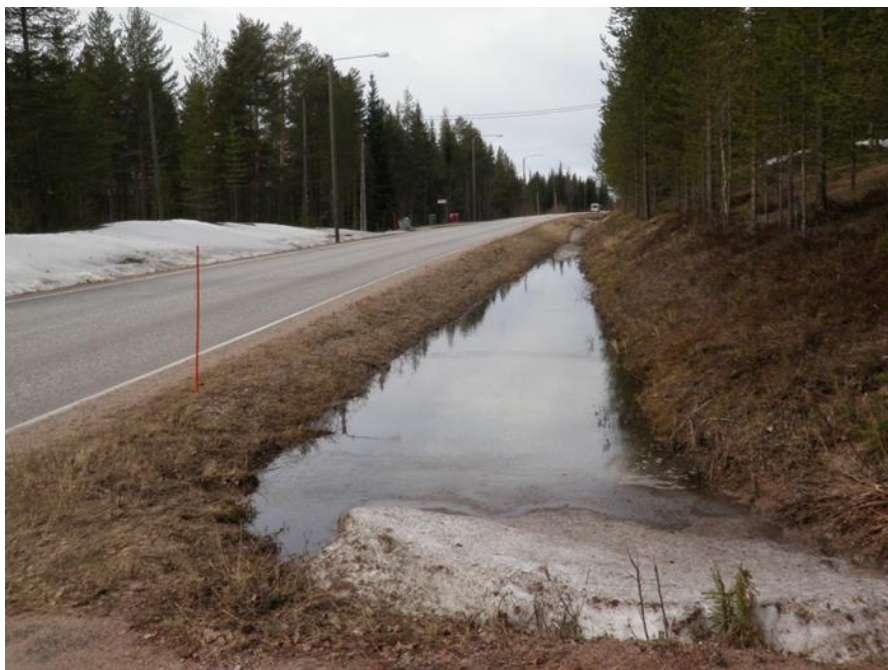
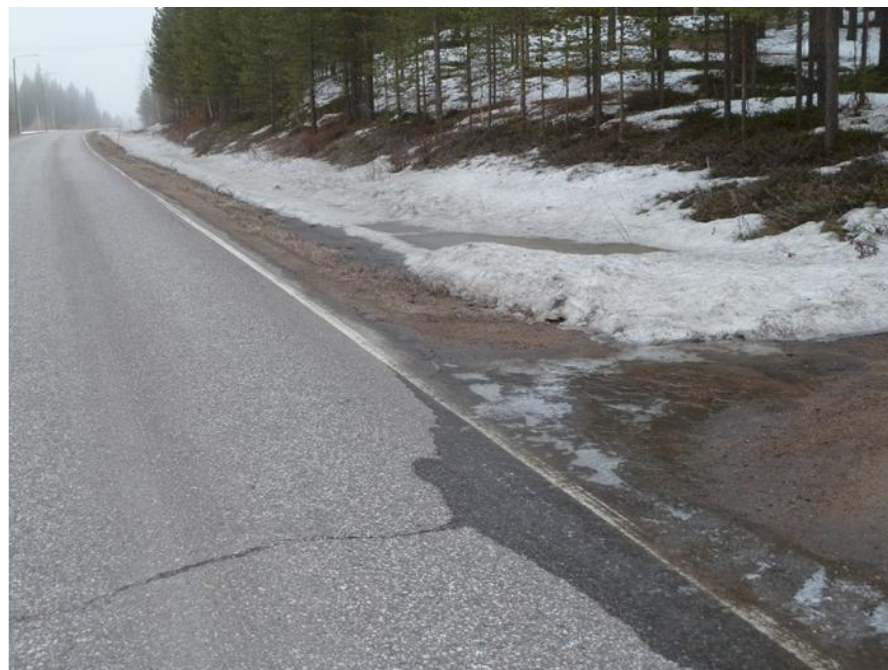
Rovaniemi follow Up: Rd 934 / 3-4

Special problem: Clogged Private Access Road Culverts

- Poor drainage is causing MAJOR problems in all ROADEX countries and better maintenance is even more important than earlier were evaluated
- New mobile laser scanner results really show the importance of good drainage maintenance
- In test road 934 > 50 % of the frost heave problem can be related to private road exit and their poorly working culverts
- Poor access road culverts cause also collapse of ditch slopes and further problems with roads

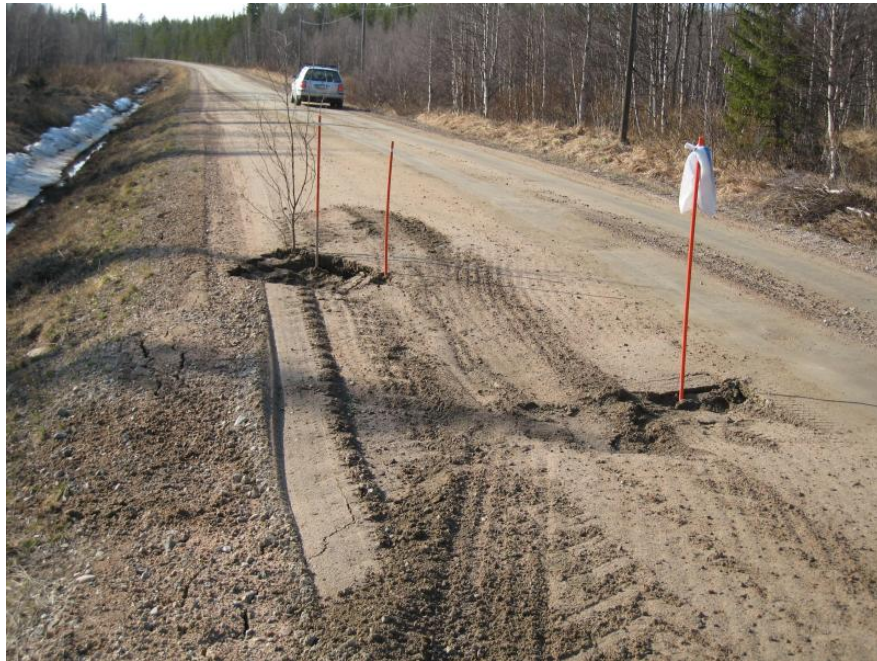
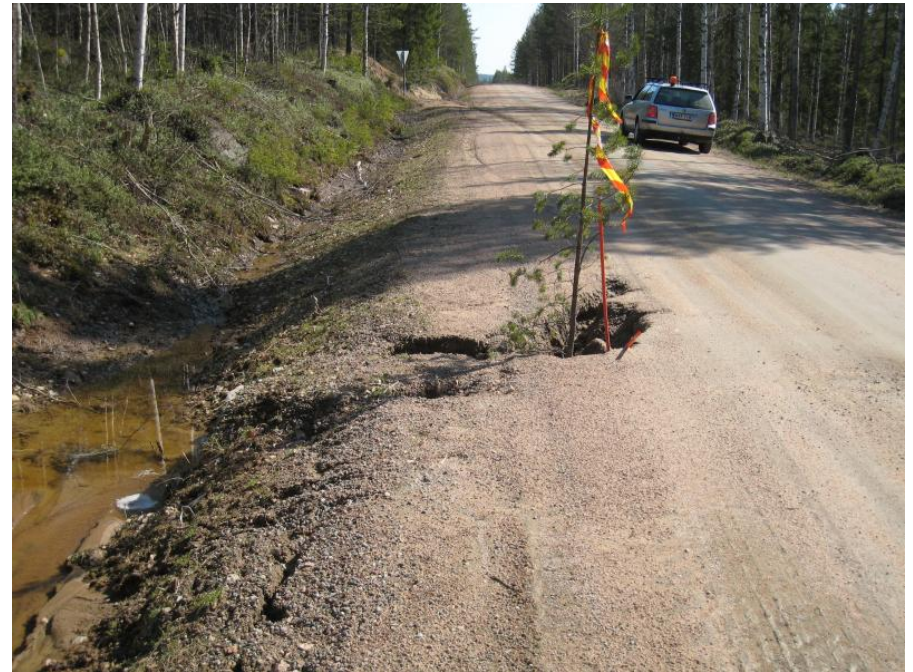
Formation of Ice Lenses Under Road at the End Point of Flooded Ditch

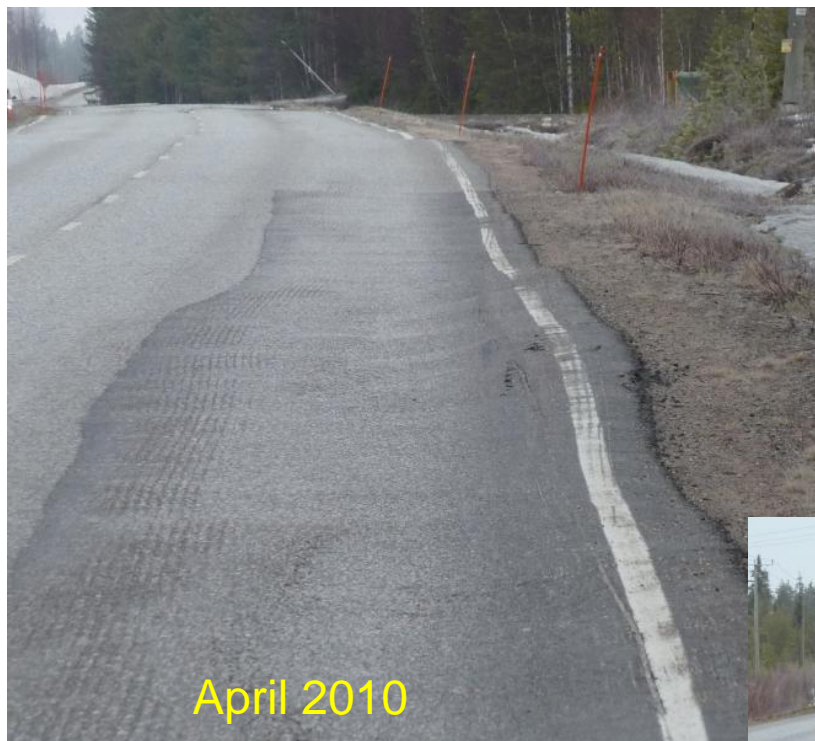
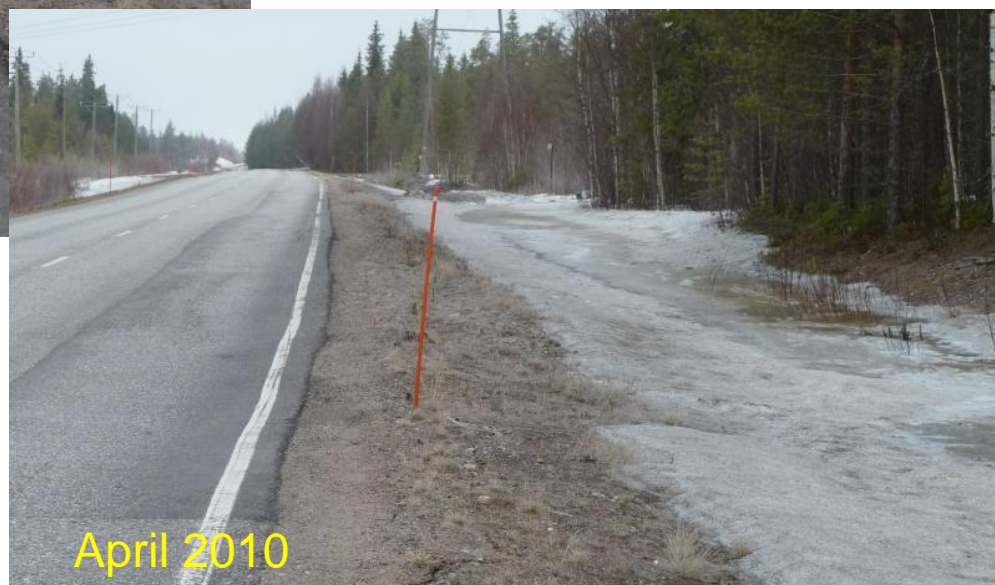
Special Drainage Problem – Sheet Ice

- Verges are causing problems in all ROADEx areas and should be always removed
- Even small ponding in ditches may cause problems
- Narrow (sharp) ditches cause problems
- Sheet Ice is causing major frost heave and deformation problems in road shoulders => traffic safety issue
- Visual drainage evaluation is not enough accurate and too subjective to enforce maintenance contractors for actions
