PERMANENT DEFORMATION

ROADEX II
NORTHERN PERIPHERY II

REPORT ON TASK 2.1

October 2004

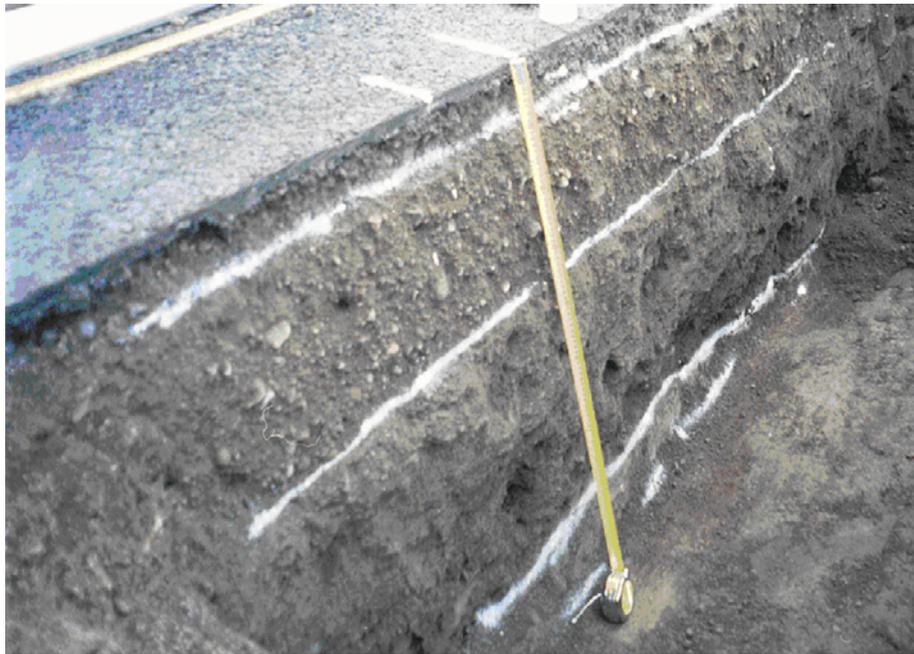
Figure 1. Cross sectional view of a thinly sealed pavement. (Layer boundaries picked out by spray paint) (photo: courtesy S Erlingsson)

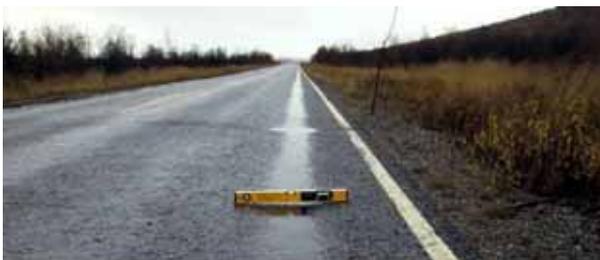
Figure 3. Water collecting in a wheel track of a thinly sealed pavement.

Ponding in a rut allows water into the pavement prematurely causing its loss of performance. Skid resistance due to aquaplaning and due to ice, when frozen, may result. Rutting may also be induced at subgrade level allowing water to pond there causing (hidden) deterioration of the subgrade.

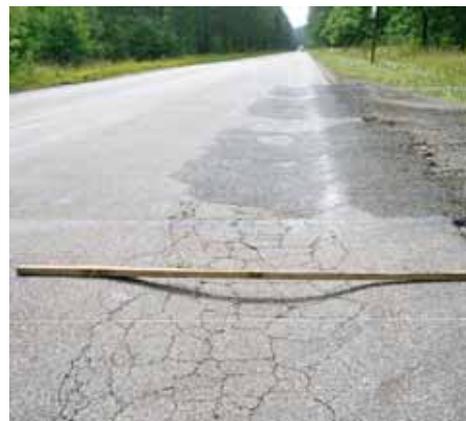
Figure 4. Rutting of a lower layers leads to distress in asphalt layers.

Furthermore, rutting of the aggregate and/or subgrade layers can lead to failure of the upper asphaltic layers (Figure 2.3). Less directly, rutting is usually not uniform along the length of the road so unevenness arises leading to user discomfort.

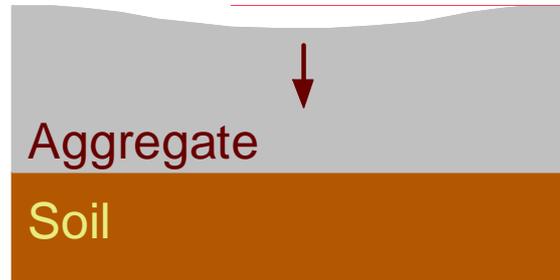
Figure 5. Mode 0 Rutting – compaction of granular layers alone.

Compaction of non-saturated materials in the pavements can be a contributor to rutting (Figure 5). Normally compaction prior to trafficking is considered sufficient to prevent further compaction under trafficking. Furthermore this mode is self-stabilising - i.e. compaction under trafficking hinders further compaction (Figure 6). It also causes the material to stiffen and hence to spread load better. Better load spreading leads to a reduced stress on the subgrade, thereby reducing the amount and risk of rutting at that level.

Rutting of this type is seen as a narrow depression relative to the original surface (Figure 5). The material affected is mostly near the wheel. Thus, for these reasons, a limited amount of rutting by this mode is beneficial. Good compaction minimises the amount of rutting observed.

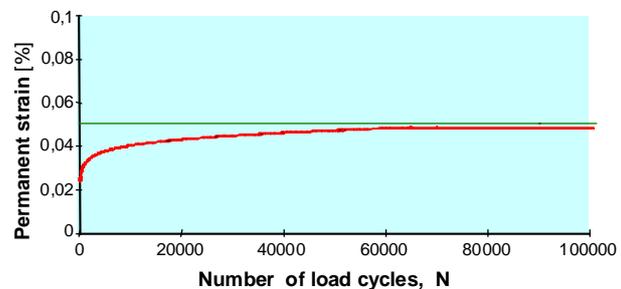
Figure 6. Permanent strain development for a crushed granodiorite.

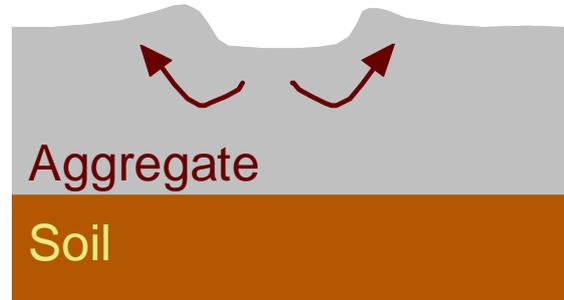
Figure 7. Mode 1 Rutting – Shear deformation within the granular layers of the pavement, near the surface.

In weaker granular materials, local shear close to the wheel may occur. This gives rise to dilative heave immediately adjacent to the wheel track (Figure 7) in which granular material has undergone large plastic shear strains and consequent dilation, leading to relatively loose material. This rutting is thus largely a consequence of inadequate granular material shear strength in the aggregate relatively close to the pavement surface.

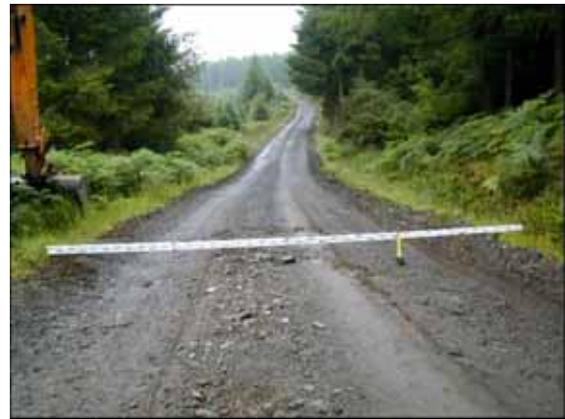
Figure 8. Scottish forest road exhibiting Mode 1 rutting. (photo: courtesy W Tyrrell)

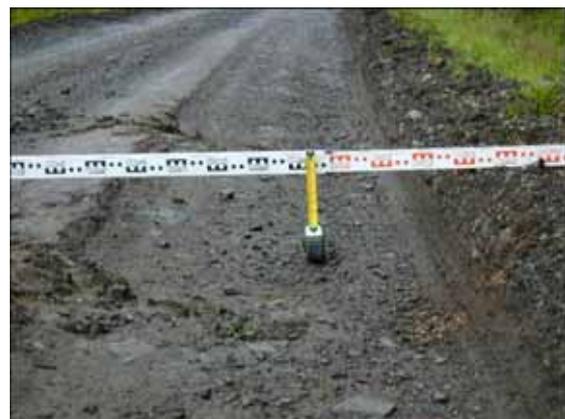
Figure 9. Close-up of rut in Scottish forest pavement. (photo: courtesy W Tyrrell)

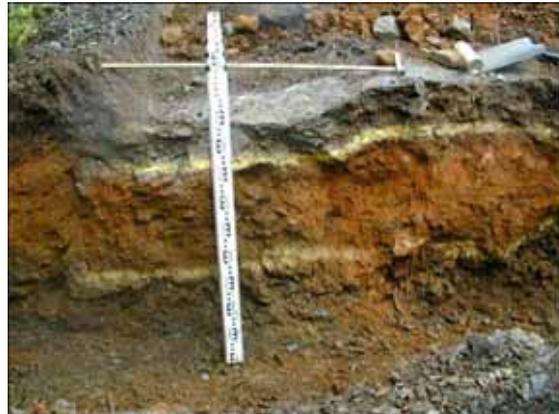
Figure 10. The pavement of Figures 2.8 & 2.9 seen in cross-section. (Layer boundaries picked out by spray-paint) (photo: courtesy W Tyrrell)

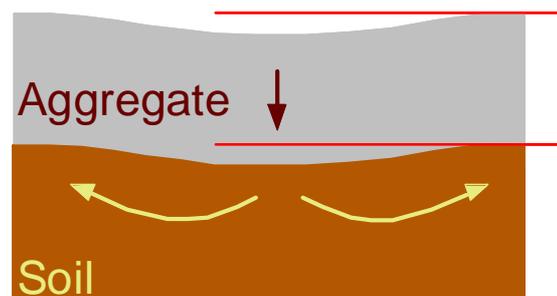
Figure 11. Mode 2 rutting – Shear deformation within the subgrade with the granular layer following the subgrade.

When aggregate quality is better, then the pavement as a whole may rut. Idealised, this can be viewed as the subgrade deforming with the granular layer(s) deflecting bodily on it (i.e. without any thinning) – see Figure 11. The surface deflection pattern is of a broad rut with slight heave remote from the wheel (as it is the displacement of the soil which causes this). An extreme example of this type of failure can be seen in Figure 12.

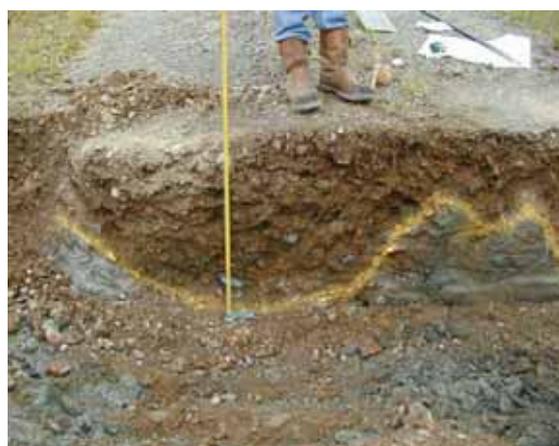
Figure 12. An advanced case of Mode 2 rutting seen in an exhumed pavement with a very weak subgrade. (photo: courtesy W Tyrrell)

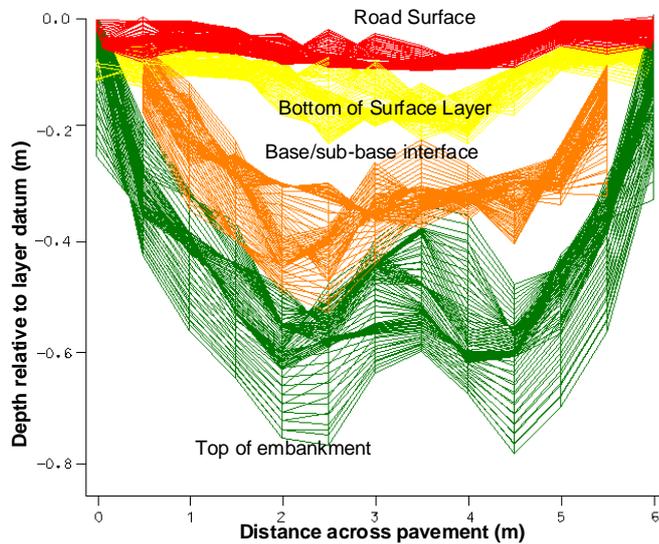
Figure 14. Mode 2 rutting at Kemijärvi, near Rovaniemi, Finland showing depth of interfaces as revealed by Ground Penetrating Radar.

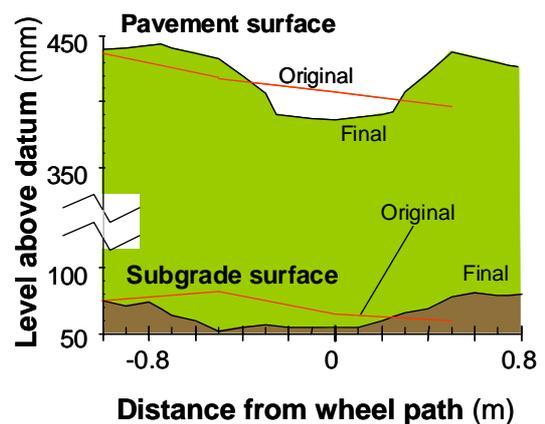
Figure 15. Rut observed on exhumation.

Particle damage (e.g. attrition or abrasion, perhaps by studded tyres) can be a contributor to the same surface manifestation as seen in Mode 0 rutting (Figure 15) though, of course, the mechanism is very different.

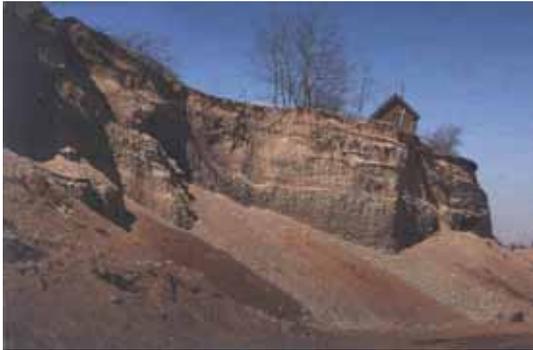
Figure 16. Glacial gravels being excavated from an esker deposit, Sweden.

The structural layers of the pavements addressed by this document are almost invariably formed of compacted, granular material. This will have been sourced either from alluvial or glacial sand and gravel deposits or from rock quarries (Figures 16 – 19) and then fully or partially crushed. In either event the long distances to established, commercial, aggregate production centres will often mean that there is pressure to source aggregate locally in order to reduce costs. In such circumstances the material used may be less than ideal.

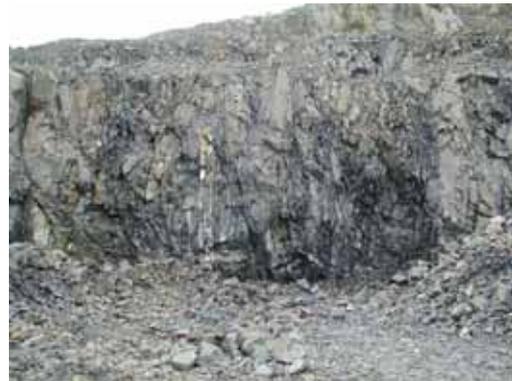
Figure 17. Metamorphic crushed rock quarry (greywacke-shale) at Balunton, Scotland. (photo: courtesy W Tyrrell)

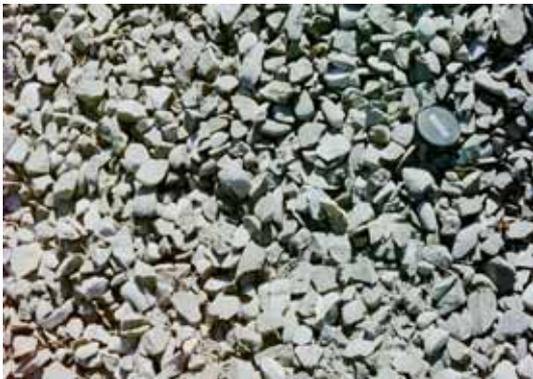
Figure 18. Alluvial gravel after partial crushing.

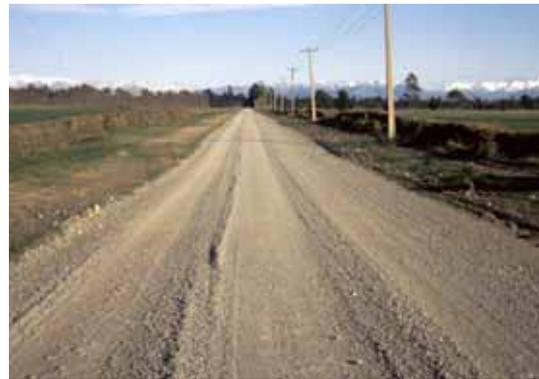
Figure 19. Partially crushed alluvial gravel in an unsealed pavement.

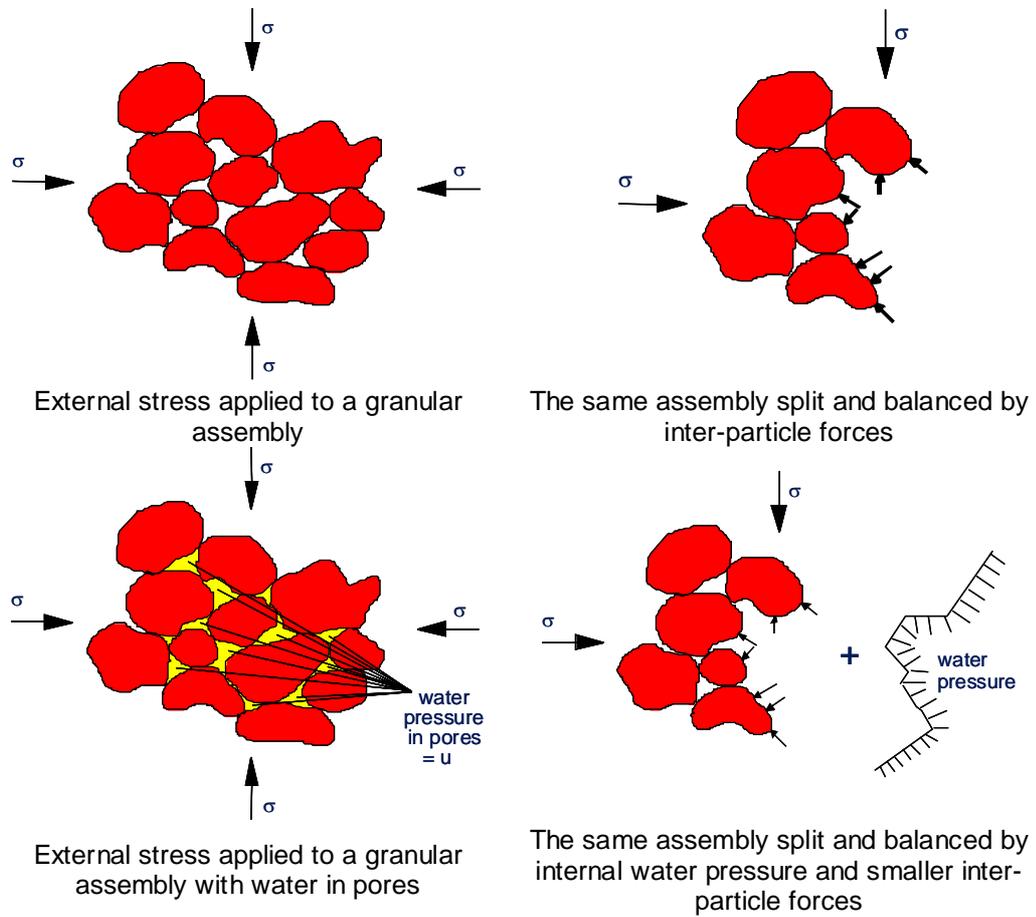
Figure 20. The importance of low pore water pressure to ensure good inter-particle stresses and, hence, good frictional characteristics.

Because aggregate is a geotechnical material it suffers the same limitations as other soils – in particular it is weakened by excess water in the voids between the stone particles. Under traffic loading the water becomes pressurised and this pressure in the pores between aggregate pieces opposes the stress, which is pushing the stones together (Figure 20). Thus the contact stresses between particles are not as large as they might be. In turn, this means that inter-particle friction is less than desirable meaning that the frictional strength and resistance to deformation is reduced from appropriate levels. In effect, the water in the pores can turn a good quality granular material into a poor one.

In both cases the problem is excess water causing frictional strength to decrease (Figure 20) and, hence, for rutting to occur more quickly and/or more severely. Figure 21 shows temperature, rainfall and internally available moisture in a pavement construction. The effect of freezing and the high moisture immediately after thawing is apparent. The effect of heavy rainstorms can also be seen in some temporary increases in pavement moisture. The higher fines content of the sub-base can also be seen to lead to higher moisture content throughout and a greater ‘reluctance’ to drain after high moisture content occurs.

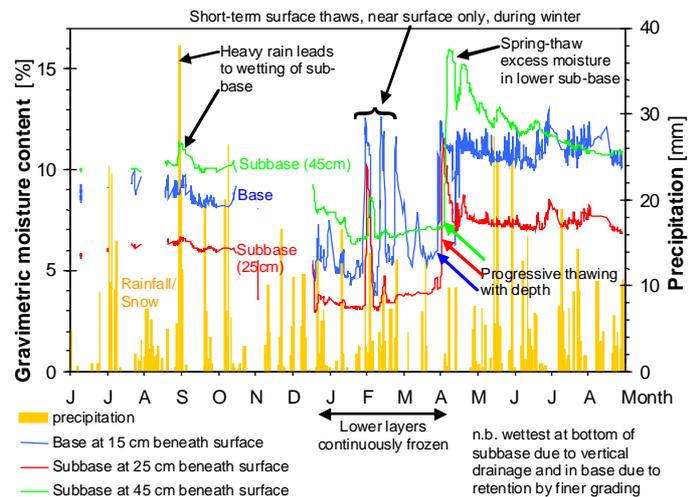
Figure 21. Environmental data for a pavement section over a period of 14 months showing free gravimetric moisture content, as indicated by TDR sensors, at three depths together with the precipitation. [COURAGE, 1999]

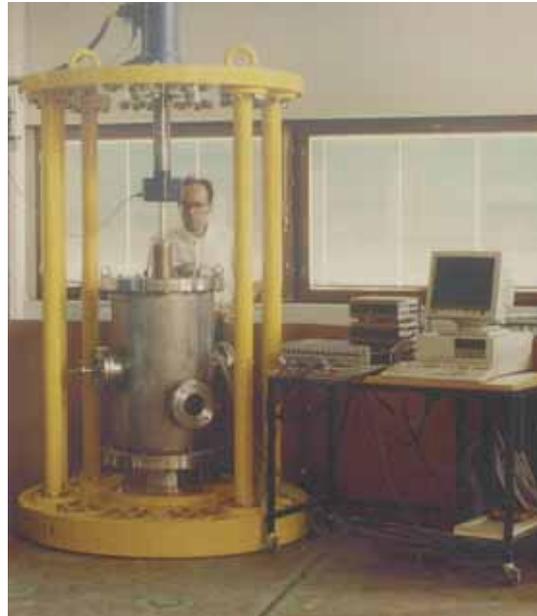
Figure 24. Repeated Load Triaxial Test Facility at Tampere University of Technology for 200 & 300 mm diameter specimens

- a) the repeated stressing of cylindrical specimens of compacted aggregate (prepared at a variety of conditions) in triaxial apparatuses (Figures 22 – 24),
- b) interpretation of the results of stage a) in a manner which could be used in an advanced Finite Element computer programme to compute the stresses in pavements constructed of the aggregates tested in stage a),
- c) deducing those parts of the pavement structure, and the amount of the pavement structure, which would deform plastically, thereby giving rise to rutting,
- d) relating the results from simple assessment methods to those from triaxial tests to determine material potential without resorting to advanced laboratory tests,
- e) drawing general conclusions and advice from the study.

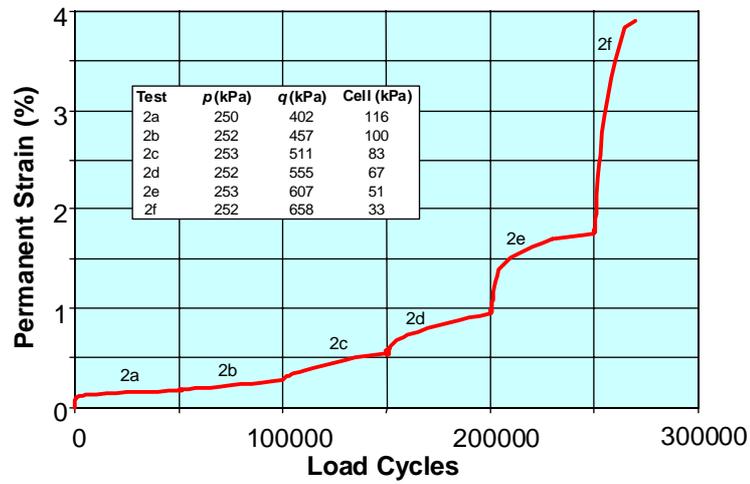
Figure 25. Cumulative plastic deformation (strain) under series of increasing axial load pulses and decreasing confining pressures, 5000 load cycles applied at each stress state

- d) Multistage tests in which a low stress pulse is applied, say, 1000 times. The axial repeated stress is then applied at an increased magnitude, on the same specimen, perhaps increasing the confining stress before doing so. This allows a picture of plastic deformation to be gained without resorting to lots of specimens, as would be necessary if plastic strain tests as listed under point iii, were used. The disadvantage is, of course, that the results under the later stages may be ‘distorted’ due to behaviour under earlier stressing. Figure 25 gives an example of this type of loading.

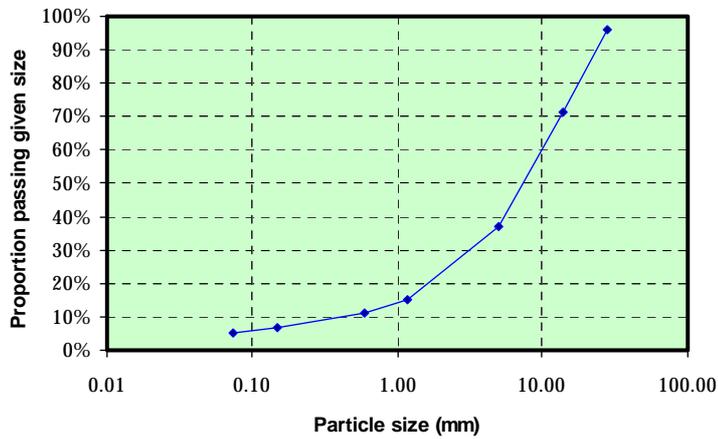
Figure 26. Grading of Scottish Quarriebraes material (without added fines).

- Compaction studies to determine the best conditions at which to perform the triaxial tests and, also, to allow the effects of inadequate compaction to be investigated.
- Grading analyses to assist in defining the particle sizes before and after contamination. The grading results for the two aggregates are shown in Figures 26 and 27.

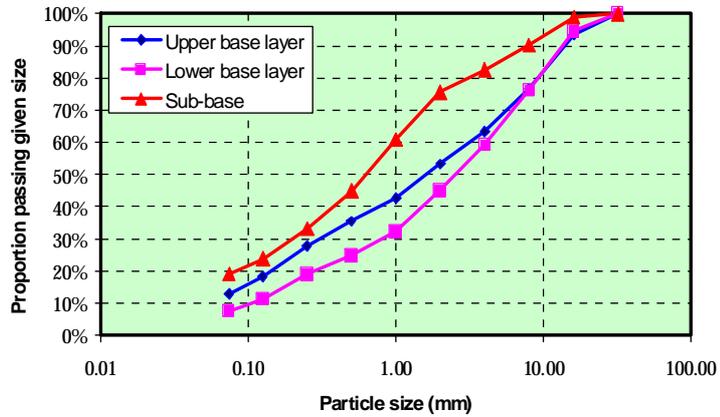
Figure 27. Grading of Finnish Koskenkylä material.

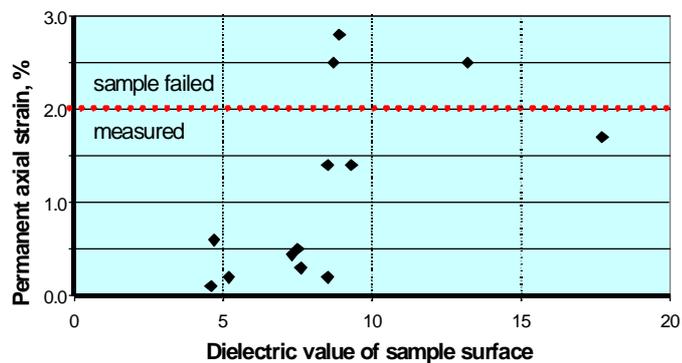
Figure 28. Permanent axial strains of specimens as a function of the dielectric value of the specimen's top surface. Values of permanent axial strain > 2% indicate early failure of the permanent deformation test.

Comparing Figures 31 and 28 it is tentatively suggested that a void ratio greater than 0.33 is required to guarantee that excess moisture won't be held by capillary forces in a granular material and that a void ratio of 0.24 or less is likely to be associated with excess plastic deformation. That is, rutting will be experienced too rapidly, in-situ, by typical granular base layers with such small pore space if water is made available to them (from rainfall, Spring thaw or malfunctioning drains).

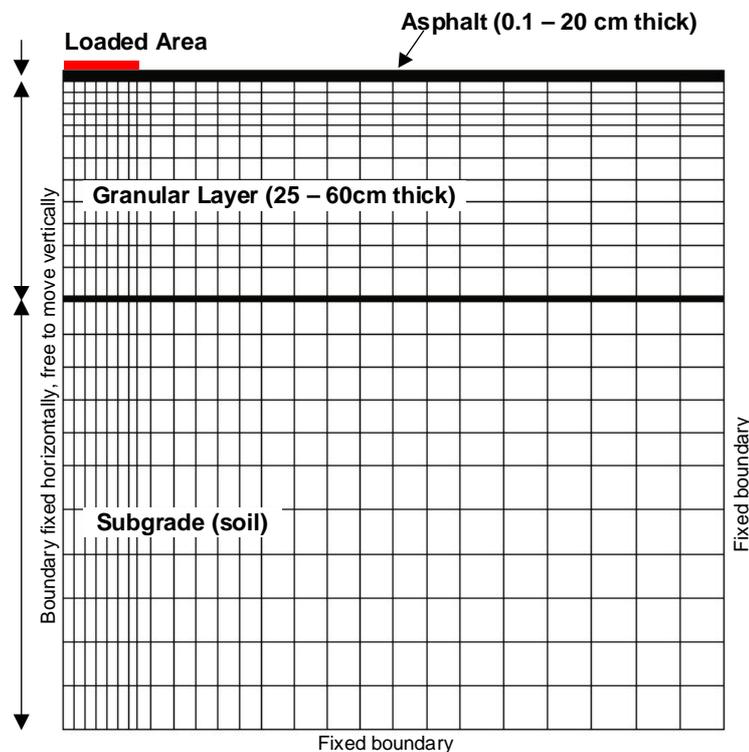
Figure 29. Typical finite element mesh used for the pavement analyses.

The asphalt and subgrade materials were allotted typical, constant stiffness properties. In the case of the asphalt this was a stiffness modulus of 1.5 GPa and a Poisson's ratio of 0.45, for the subgrade the values were 40MPa and 0.45 respectively. In the aggregate layer the model developed specifically at the Technical University of Dresden for modelling unbound granular materials, was implemented. Using this model FENLAP iterates until it find a complementary set of stresses and stiffnesses.

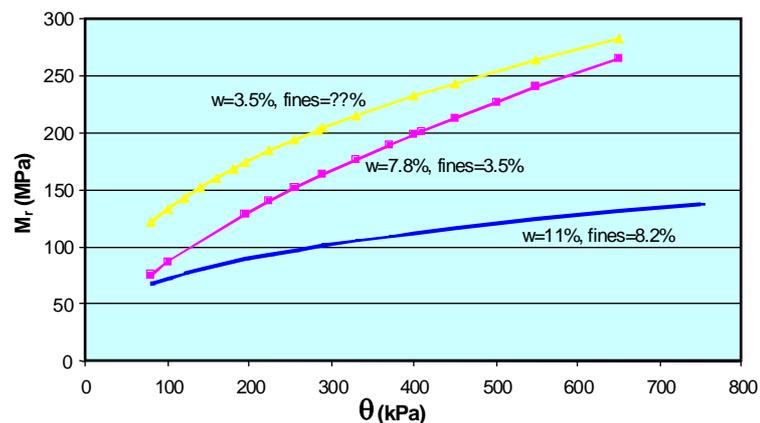
Figure 30. Modulus (M_r) related to stress level of testing, for a variety of test conditions (Quarriebraes aggregate). w = moisture content.

The triaxial testing showed a very clear change in mechanical behaviour with added fines and extra moisture. Figure 30 shows the reduced stiffness modulus, M_r , as a consequence of these two factors for some of the Quarriebraes aggregate. In the laboratory the moisture conditions are generally set by the tester – thus the results in this figure are largely the consequence of the water condition. As more water is put into the specimen the stiffness reduces. In practice this means that the aggregate layers of the pavement won't spread the load so well. This means that the stresses on the subgrade will be greater (this is discussed in more detail when the analytical work is described below).

The horizontal axis in Figure 30 shows θ where θ is the total stress (summed from the stresses acting in three directions at right angles to each other), i.e. $\theta = \sigma_1 + \sigma_2 + \sigma_3$. Two other stress parameters are used in this report. They are p (the mean normal stress) which is defined as $\theta/3$ (i.e. it is the average value of the three normal stresses applied), and q , the deviatoric stress (a measure of the shear stress applied). Simply stated, $q = \sigma_1 - \sigma_3$.

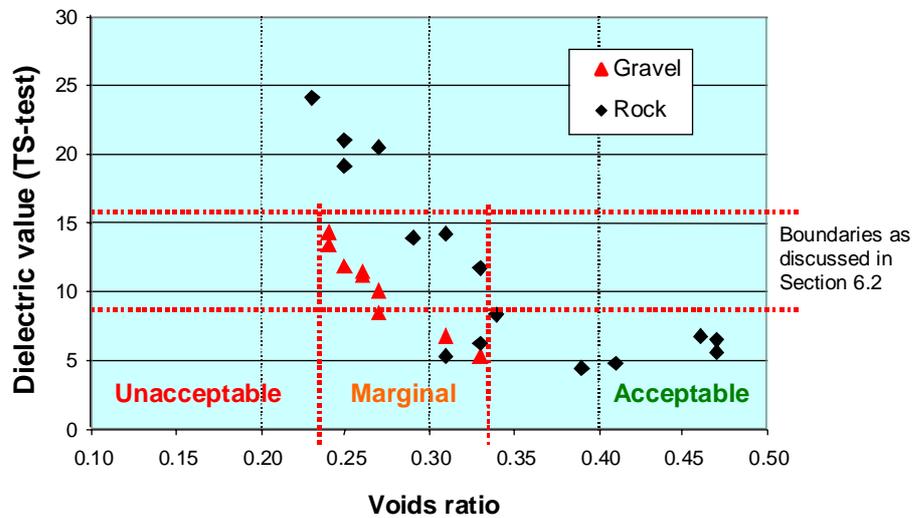
Figure 31. Dielectric values of the tested aggregates as a function of voids ratio.

However, the results of Figure 30 are representative of likely in-situ conditions as shown by Figure 31. Here specimens were compacted and brought to a rather dry condition. They were then stood in water for 1 week and allowed to absorb water to satisfy the suction demand caused by the soil's capillarity. Under this regime much higher water contents result in finer grained aggregates. In Figure 31 voids ratio is a measure of the volume of the pore space. This will be smallest when the pores between the large stones are most filled with fine particles. Thus the figure shows that, when there are less fines in a specimen, less free water will be held in the aggregate (and the dielectric value reduces). Hence the stiffness values (M_r) in Figure 31 should be towards the upper line for low-fines grading distributions and the lower line is, indeed, representative of high fines aggregates in equilibrium with supplies of water from the environment.

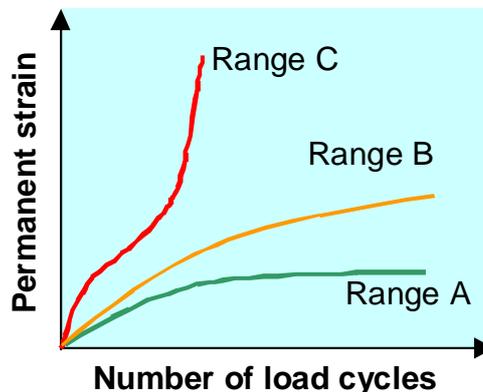
Figure 32. Indicative permanent strain behaviour.

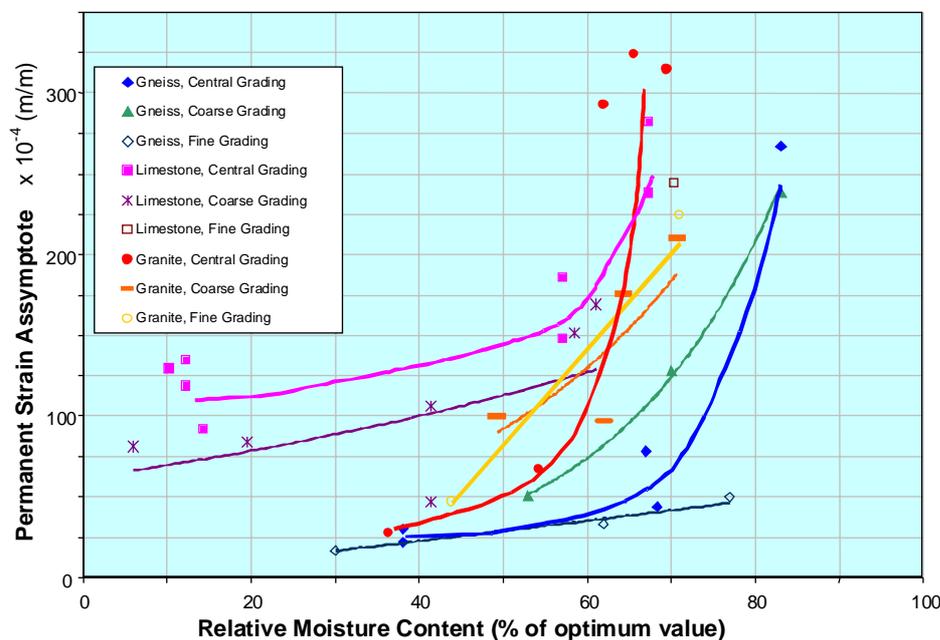
Figure 33. Permanent strain rate as a function of moisture content for 9 granular materials.

The amount of deformation to which Range A type behaviour finally stabilises is very dependent on the amount of water in the aggregate. Figure 33 shows the amount of deformation that will have occurred once stabilisation has been reached. The data are for several aggregates, with different fines contents, with changing water content (n.b. in this graph, to ease interpretation, Range A has been assumed even though some of the wetter specimens may be in Range B).

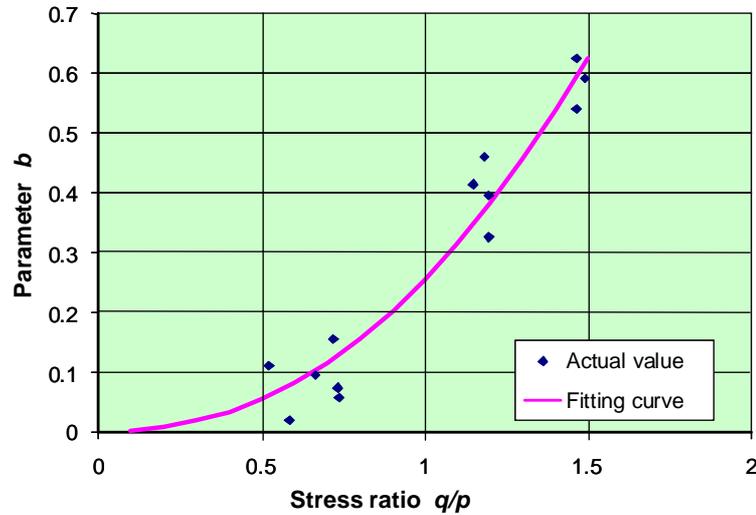
Figure 34. Values of permanent deformation equation (Eqn. 1) parameter b as a function of stress applied.

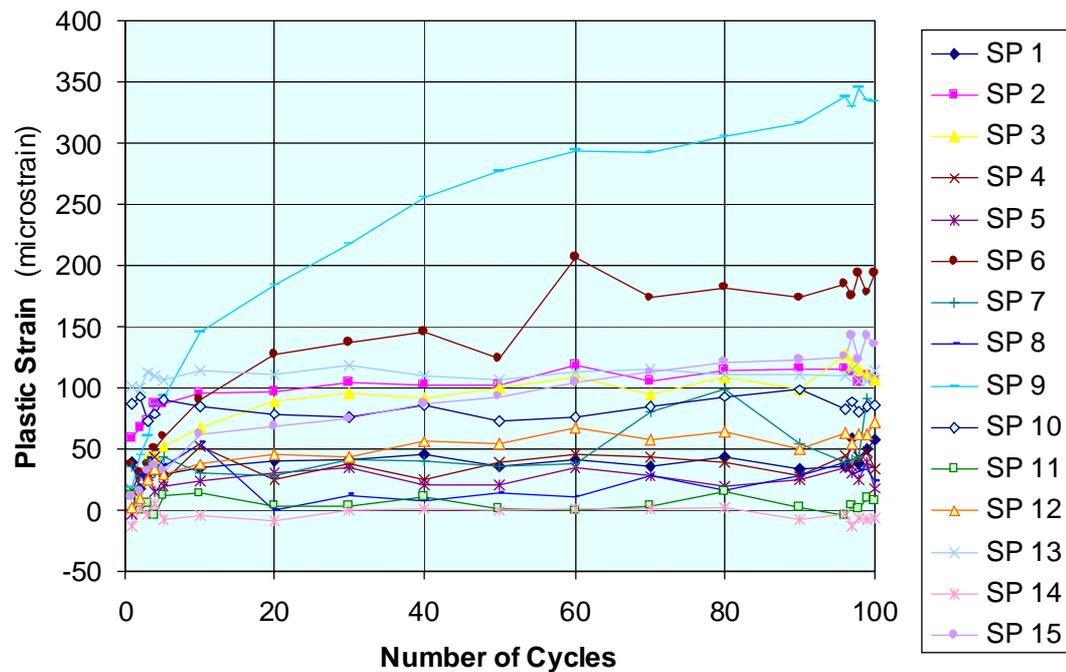
Figure 35. Development of Plastic Strain in a specimen of the Koskenkylä base aggregate in wet condition (Material Kb). 15 stress paths (SPs) have been applied, each of 100 pulses (to simulate trafficking). The stress paths are defined in Figure 37.

In Figures 35 and 36, first we may note the very large increase in strain from the wet specimen to the thawed specimen. To a large extent this is due to the increased moisture consequent upon freezing (see Table 1) and in part from de-densification due to the water pulled in upon freezing. It is obvious from these results that the cycle of freezing and thawing has significantly weakened the aggregate, leading to much higher rates of plastic strain.

Comparing Figures 35 and 36 readily reveals another feature. In Figure 36, once the initial settling of the specimen has been achieved (large plastic strains for Stress Paths 1 and 2) then it is clear that the stress paths which get closest to failure – Numbers 3, 6 and 9 – give rise to the highest amount of plastic strain, followed by Paths 5, 8 and 15, followed by 12. This sequence confirms that proximity to static failure is a key feature in the development of plastic strain and, thus, to the occurrence of rutting. Figure 35 also shows this stress-related plastic strain dependency, although the pattern is less obvious given the lower strain magnitudes.

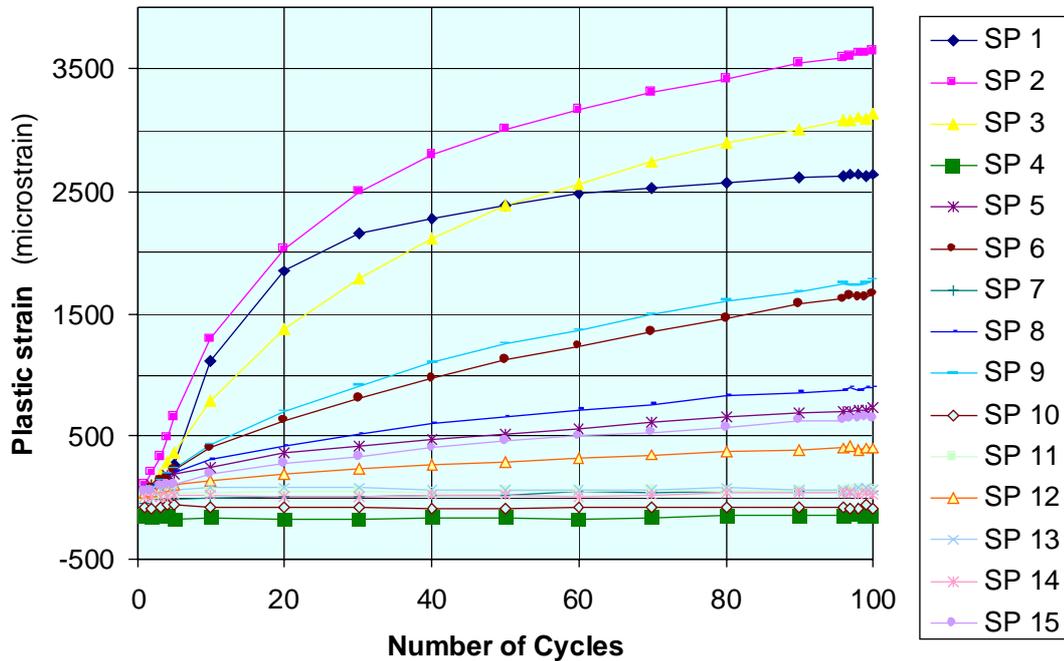
Figure 36. Development of Plastic Strain in a specimen of the Koskenkylä base aggregate after thawing (Material Kc). 15 stress paths (SPs) have been applied, each of 100 pulses (to simulate trafficking). The stress paths are defined in Figure 37.

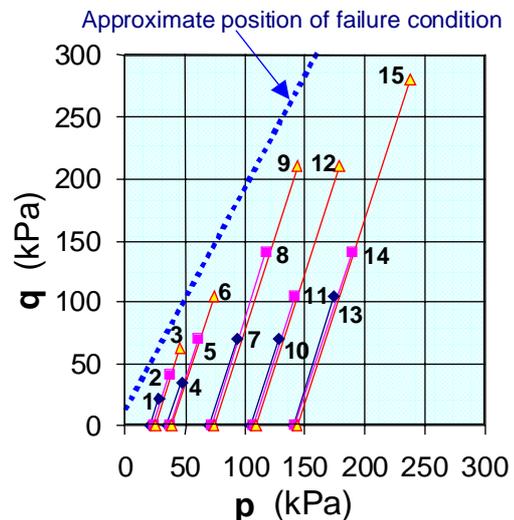
Figure 37. Stress paths used for data presented in Figs 8.6 and 8.7. The stresses q and p are, respectively the 'deviatoric' (i.e. shear) stress and the average stress ($=1/3^{\text{rd}}$ of $\theta = \sigma_1 + \sigma_2 + \sigma_3$).

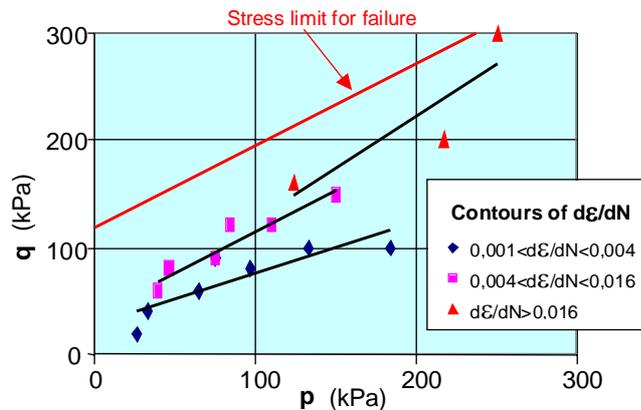
Figure 38. Plastic strain rate information obtained from test on Quarriebraes Qc material (saturated, high fines).

For the Quarriebraes material, similar results were obtained (although there were no freeze-thaw tests on this material). Figure 38 shows contours of plastic strain per cycle of loading together with the static failure envelope for the Qc material (Saturated, with high fines). Once again it can be readily seen that the plastic strain will be greater as the stress approaches the failure condition.

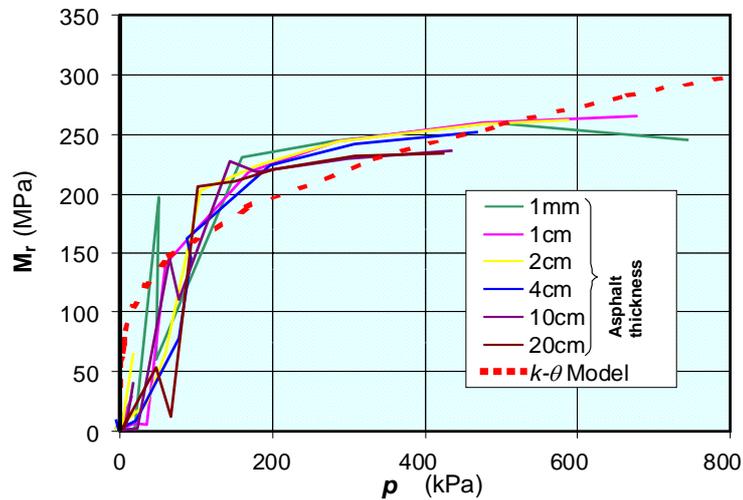
Figure 39. Non-linear modulus value (M_r) of the Quarriebraes Qa aggregate as a function of mean normal stress, p , in the analysed pavements (which used the Dresden model) and as defined by the “ k - θ ” model from laboratory tests.

Figure 39 illustrates the non-linearity of the modulus as found in the granular layers. It can be seen that, for the pavements represented by this plot (the thicknesses of asphalt are as shown, the aggregate is the Scottish Quarriebraes material with moderate fines in a ‘dry’ condition) that the stiffness values computed by the program fairly closely follow the k - θ relationship established from the laboratory repeated load triaxial testing. Small exceptions are at rather low mean stresses, p , where the stiffness tends to be a little lower than would be predicted by slavish use of the model and a little higher than would be expected at mid-range values of p . This difference can mostly be attributed to the different model implemented in the analysis.

It is interesting to note that the actual stresses experienced in the pavement can be quite a lot higher than those obtained from the laboratory testing (compare Figure 39 with Figure 30). It can also be seen in Figure 39 that only in the thinnest pavements are the highest values of p and, hence of modulus, M_r , discovered. This is to be expected as the thicker asphalts effectively spread the stresses from the wheel loading and, thus, the maximum stress on the top of the granular layer reduces as the asphalt thickens.

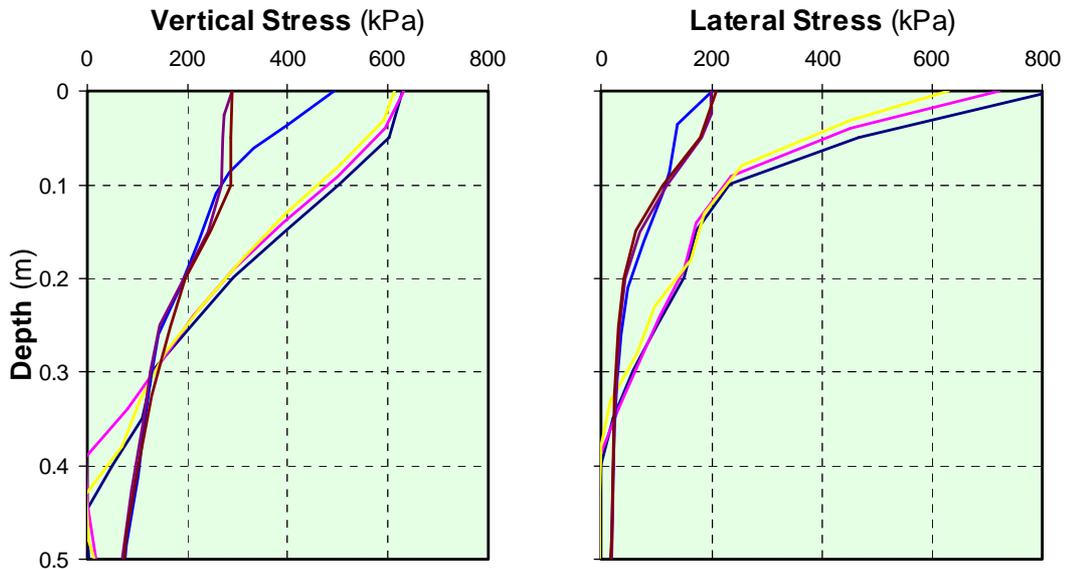
Figure 40. Variation of vertical and horizontal stress in the granular layer of pavements with various thicknesses of asphalt. Aggregate is Scottish Quarriebraes material in 'saturated', high fines condition (Qc).

Figure 40 shows the vertical and horizontal stresses in pavements containing the ‘saturated’ (moisture content is 11%) high fines, Quarriebraes aggregate base in their granular layers. The rapid diminution of both vertical stress and horizontal stress is evident. Note also how the increase of the asphalt above 4 cm thickness significantly reduces the vertical stress – because it is then that the asphalt begins to act as a beam in bending taking a far greater role in load spreading than it did when thinner. Whether this boundary in behaviour is exactly located at 4cm is, however, somewhat open to conjecture. Nevertheless, the principle is clear: Asphalt needs to be greater than a threshold thickness if it is going to achieve effective load spreading and significantly reduce stress on the lower aggregate base layers.

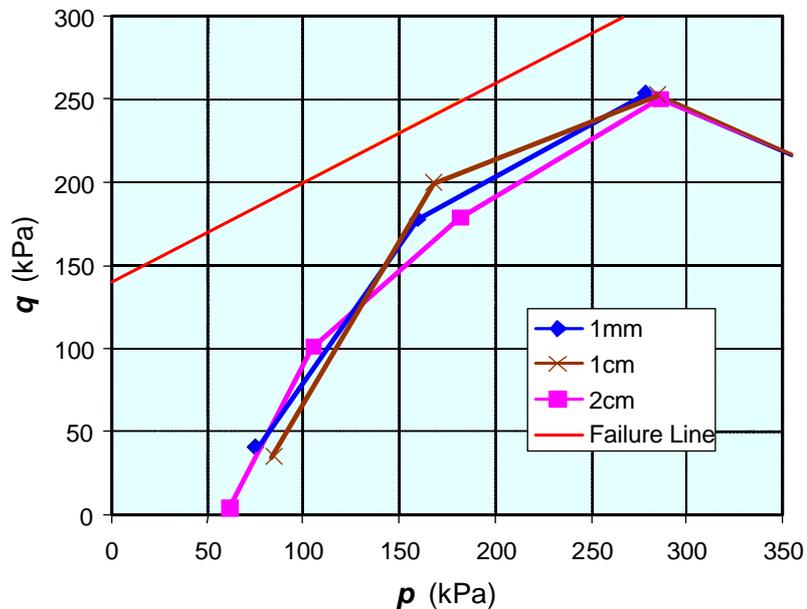
Figure 41. Stress condition at depths of 10, 12.5, 15, 20 and 25cm beneath the top of the asphalt. [Asphalt is 1mm, 1cm or 2cm thick as shown, so depth into aggregate varies with asphalt thickness. Stress at shallowest point on right, deepest point to right]. Data is for the Quarriebraes saturated high fines mix. (Compare with Figure 38).

Figure 41 presents the value of shear stress at a depth into the aggregate layer of around 1/3rd of the width of the loaded area (that would be approximately 10cm or greater beneath the pavement's surface), for the pavements with a 1mm, 1cm and 2cm thick asphalt covers. These depths have been chosen in line with the explanation given above in Section 2 (where Mode 1 rutting is described).

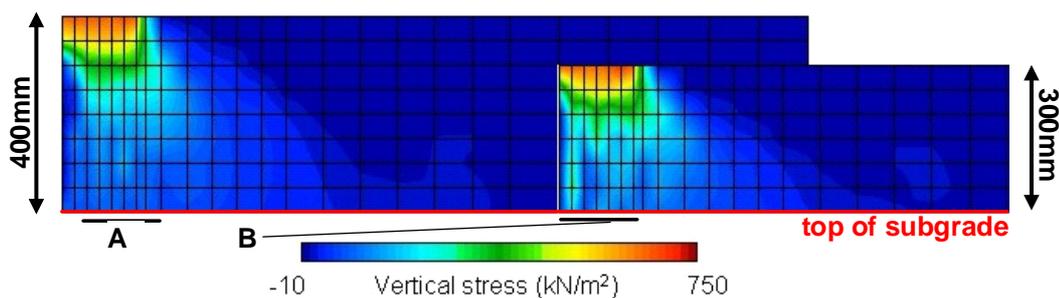
Figure 42. Vertical stress due to traffic (material self-weight stresses are excluded) in the aggregate layer. Note the lighter blue (higher stress) at B than at A. The right figure shows a 300mm thick aggregate pavement, the left figure shows a 400mm thick aggregate pavement. Both comprise Koskenkylä wet, Kb, aggregate. The bottom of the figure represents the top of the subgrade.

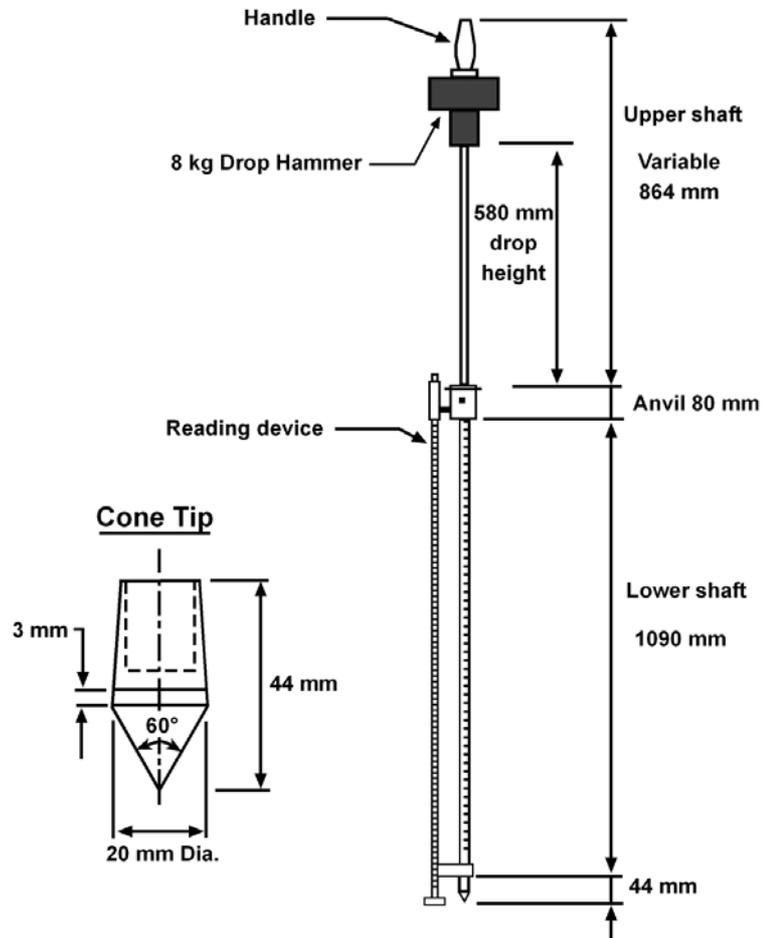
Figure 43. Dynamic Cone Penetrometer, DCP.

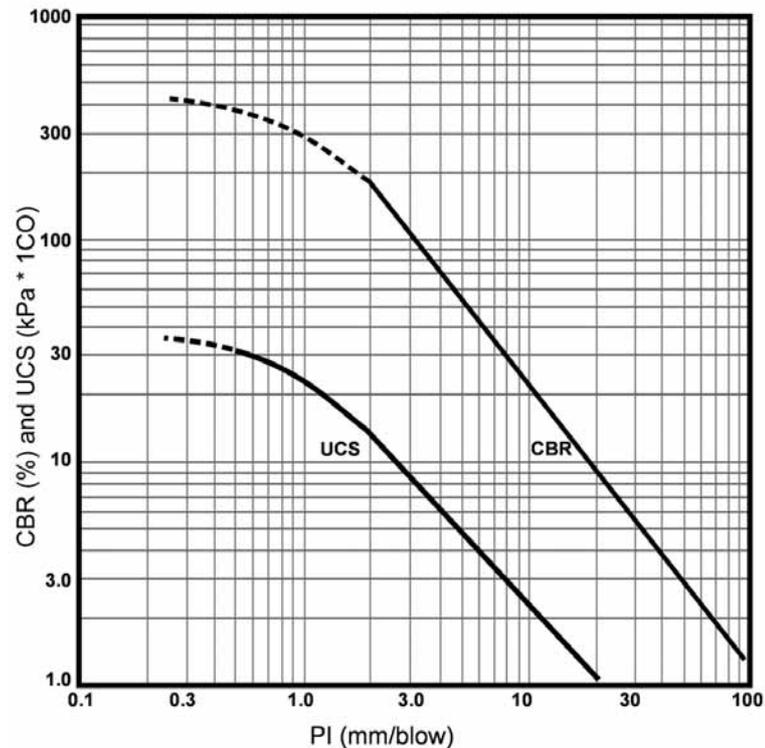
Figure 44. Converting from DCP penetration rate (PI) to CBR value or to Unconfined Compressive Strength.

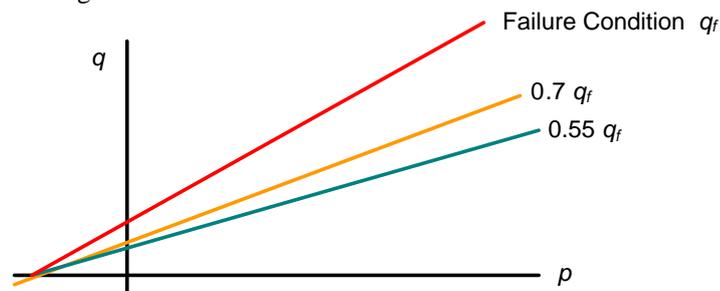
Figure 45. Sample design graph.

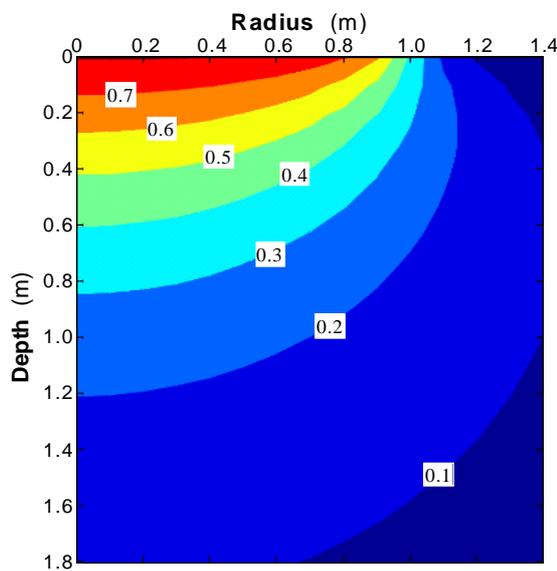
Figure A1 Non-dimensional values of p

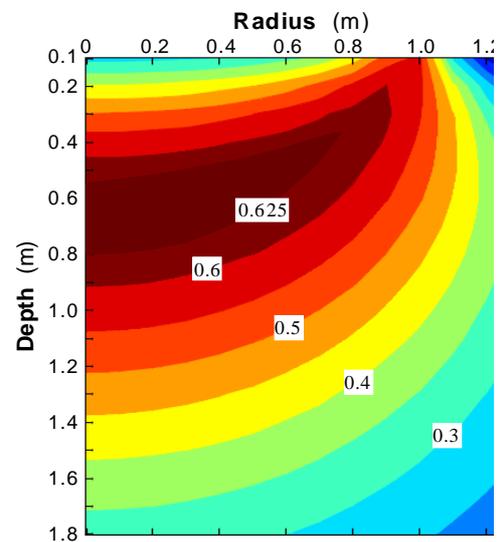
Figure A2 Non-dimensional values of q
