MANAGING RUTTING IN LOW VOLUME ROADS

Executive Summary

July 2006

Andrew Dawson
Nottingham Centre for Pavement Engineering

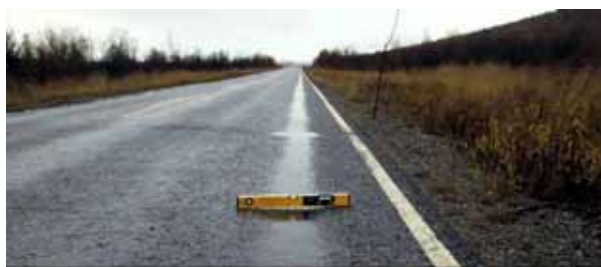
Figure 2.2. Water collecting in a wheel track of a thinly sealed pavement.

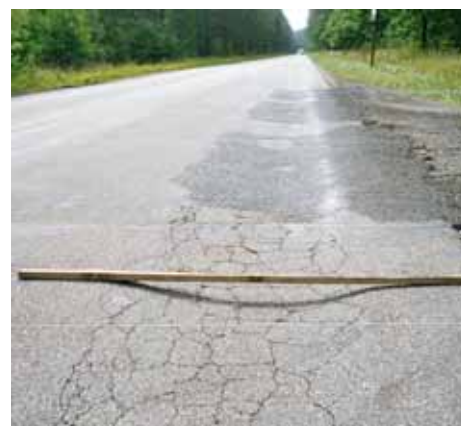
Figure 2.3. Rutting of a lower layers leads to distress in asphalt layers.

Furthermore, rutting of the aggregate and/or subgrade layers can lead to failure of the upper asphaltic layers (Figure 2.3). Less directly, rutting is usually not uniform along the length of the road so unevenness arises leading to user discomfort.

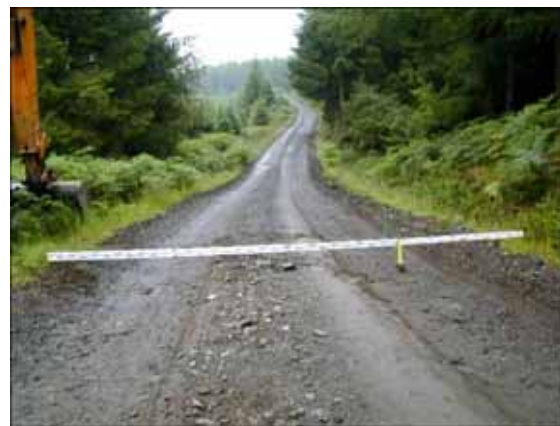
Figure 2.7. Scottish forest road exhibiting Mode 1 rutting. (photo: courtesy W Tyrrell)

Figures 2.7 and 2.8 show a Scottish pavement which exhibits this type of distress. Note the characteristic shoulder heave evident in the pictures. Internally such a pavement may look as in Figure 2.9. Here the local shear causing the ‘shoulder’ is clearly visible. There is no subgrade deformation evident (the yellow lines have been sprayed on to clarify the boundaries in

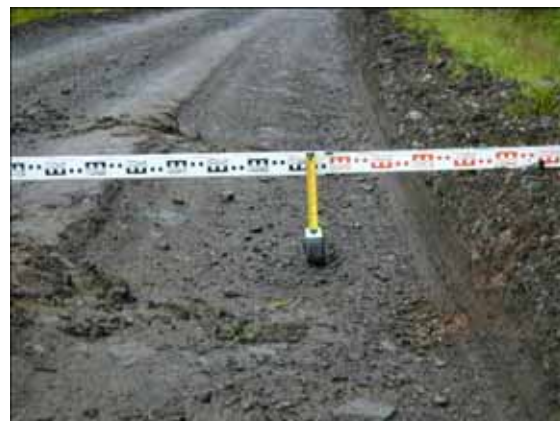
Figure 2.8. Close up of rut in Scottish forest pavement. (photo: courtesy W Tyrrell)

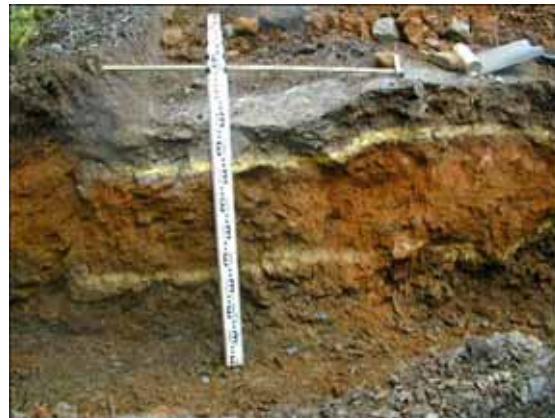
Figure 2.9. The pavement of Figures 2.7 & 2.8 seen in cross-section. (Layer boundaries picked out by spray-paint) (photo: courtesy W Tyrrell)

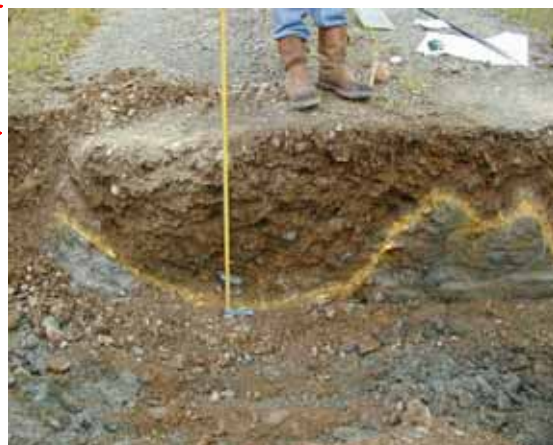
Figure 2.11. An advanced case of Mode 2 rutting seen in an exhumed pavement with a very weak subgrade. (photo: courtesy W Tyrrell)

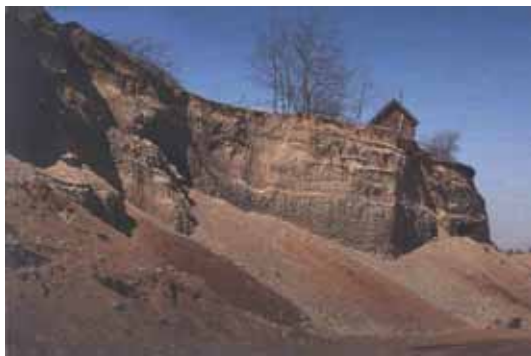
Figure 3.1. Glacial gravels being excavated from an esker deposit, Sweden.

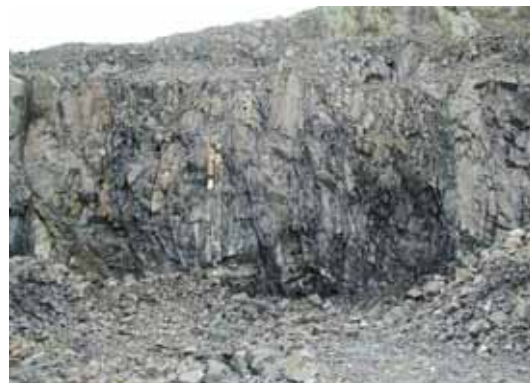
Figure 3.2. Metamorphic crushed rock quarry (greywacke-shale) at Balunton, Scotland. (photo: courtesy W Tyrrell).

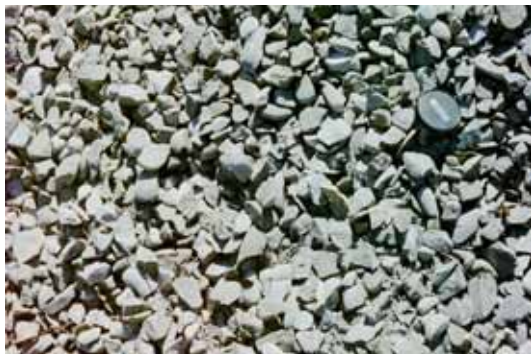
Figure 3.3. Alluvial gravel after partial crushing.

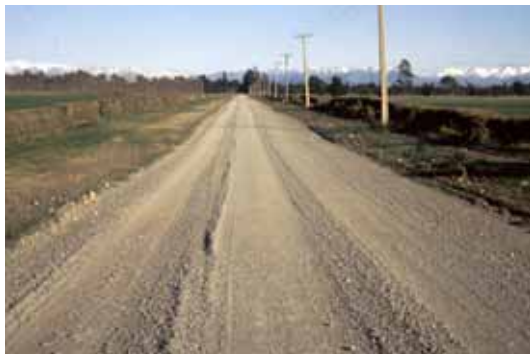
Figure 3.4. Partially crushed alluvial gravel in an unsealed pavement.

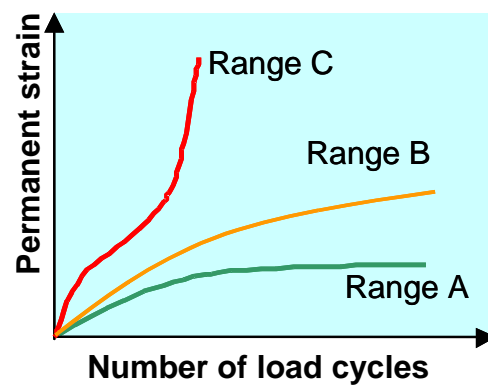
Figure 5.1. Indicative permanent strain behaviour

Under many cycles of repeated loading, as experienced by a pavement during trafficking, plastic deformation accumulates incrementally. Figure 5.1 shows the types of response seen. Range A behaviour is the desirable one because deformation (seen in the pavement as rutting) takes place initially but finally stops. The amount of deformation (rutting) to which Range A type behaviour finally stabilises is very dependent on the amount of water in the aggregate.

Analysis and experience of granular pavements shows that few, if any, aggregates can provide Range A behaviour directly under trafficking. Instead, Range B behaviour is likely for a well-behaved unsealed or thinly sealed pavement. Range A behaviour may be achieved under a thicker asphalt (e.g. > 80mm). The aim of the engineer with an unsealed or thinly sealed pavement should be, therefore, to obtain Range B type behaviour, not Range C which leads to rapid collapse of the pavement. Furthermore the engineer needs to keep the slope of the Range B line as shallow as possible, thereby prolonging the pavement's life.

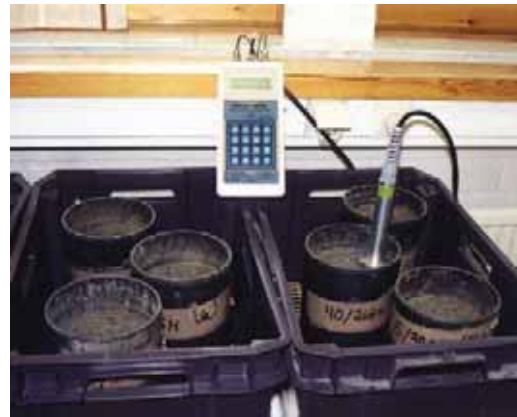
Figure 6.1 The Tube Suction Meter

The sensitivity to moisture should be determined using the Tube Suction Test (see Fig. 6.1) (although void ratio may be used as a first approximation to drainability). A specimen of aggregate is compacted, wetted and then allowed to drain. If the dielectric value from the Tube Suction Test is high after this action, then poor performance is to be expected. The extent of performance (good or bad) can be determined in the following manner.

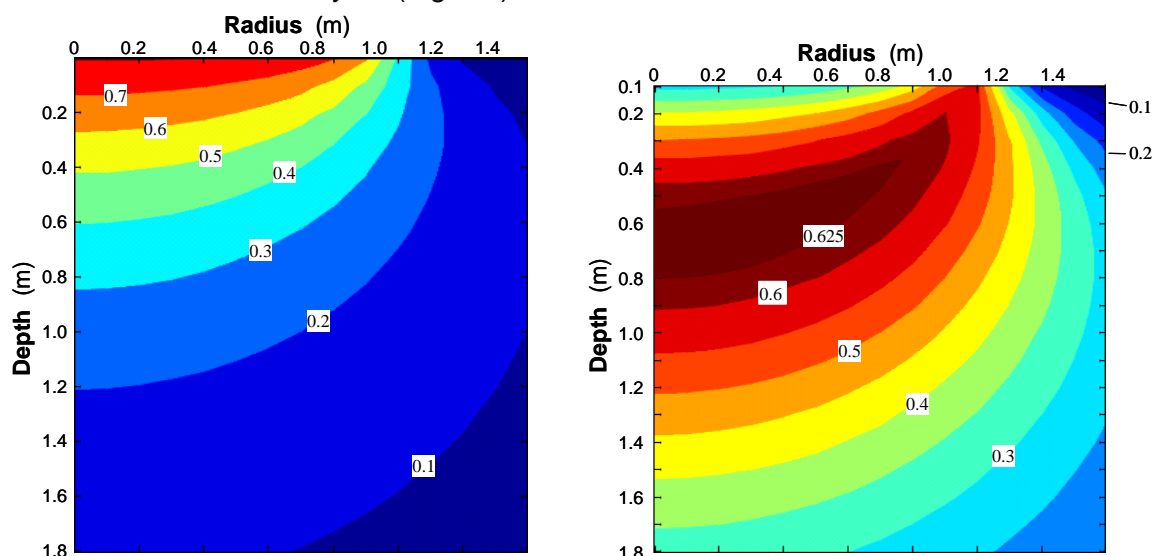
Figure 6.2. Stresses (expressed as a fraction of tyre pressure) beneath a loaded area 1m in radius.
Left = average stress. Right = deviatoric stress

To know what the stresses are in the aggregate layers of pavement, near the wheel, charts of stresses likely to be found in the pavement is provided to replace the Finite Element analysis (Fig 6.2). The use of theses charts is described in

detail in more detail in the parent report of which this document is an executive summary [Dawson & Kolisoja, 2005]. Boussinesq's stress analysis is the basis of the charts as that analysis doesn't require the modulus (stiffness) values of the aggregate to be known. This method doesn't work if there is an asphalt layer as Boussinesq's approach assumes that there is only one layer in the pavement, but it does approximate the unsealed pavement's stresses which is a more critical case.

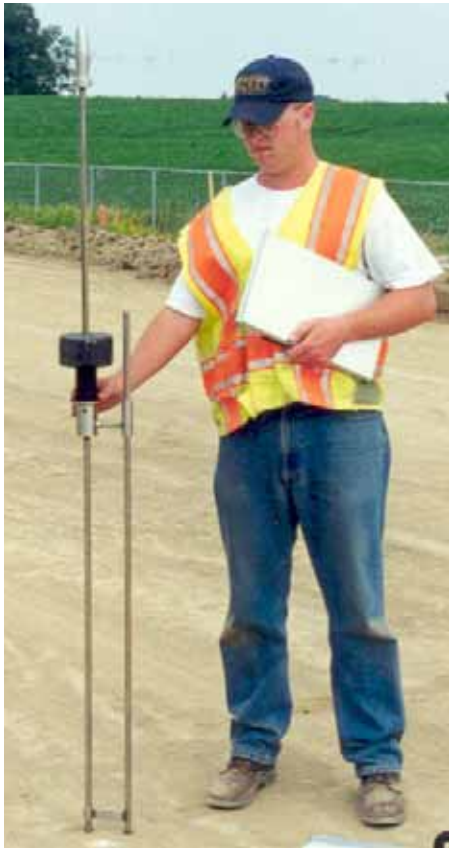
Figure 6.3 The Dynamic Cone Penetrometer (DCP)

To assess the strength of the aggregate the Dynamic Cone Penetrometer test (see Fig 6.3) is recommended as a simple, in-situ, method that gives a quick (although not very accurate) measure. The stress may then be compared to the available strength and aggregate adequacy for the pavement use can be determined.
