Timo Saarenketo, Annele Matintupa, Petri Varin, Pauli Kolisoja, Tomi Herronen,  
Anssi Hiekkahti

# SUMMARY OF PAJALA MINE ROAD IMPACT ANALYSIS – ROADEX IMPLEMENTATION

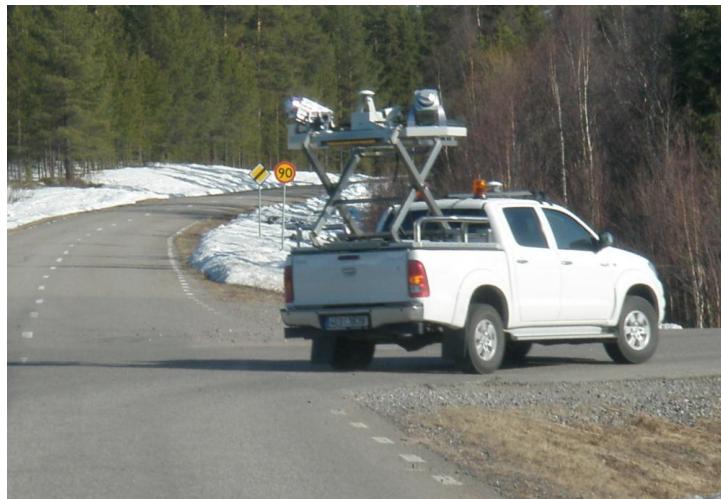
*Figure 2. GeoVap Quantum 3D mobile laser scanner vehicle on the Pajala road in April 2011.*

Mobile laser scanning using the Quantum 3D mobile laser scanner technique (Figure 2) by GeoVap Ltd from the Czech Republic was used for first time in the world to analyse continuous frost heave over the whole road section.

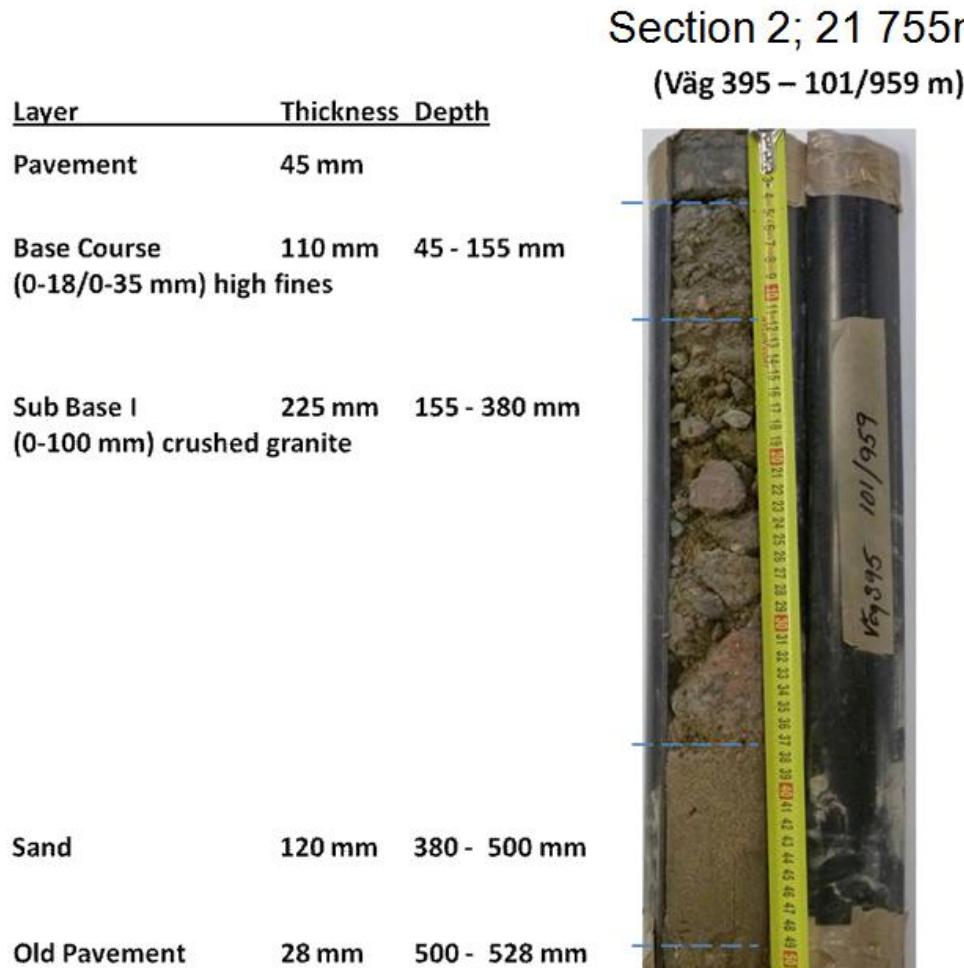
Figure 3: Example of drill core sample from road Section 2.

Twelve drill core samples and a tube suction test sample were taken from the full length of the surveyed road. The drill cores were used as references for the interpretation. Figure 3 shows an example of a drill core from road Section 2 at chainage 21,755m. Old pavement can be seen in the structure in the drill core at a depth of 500-528 mm.

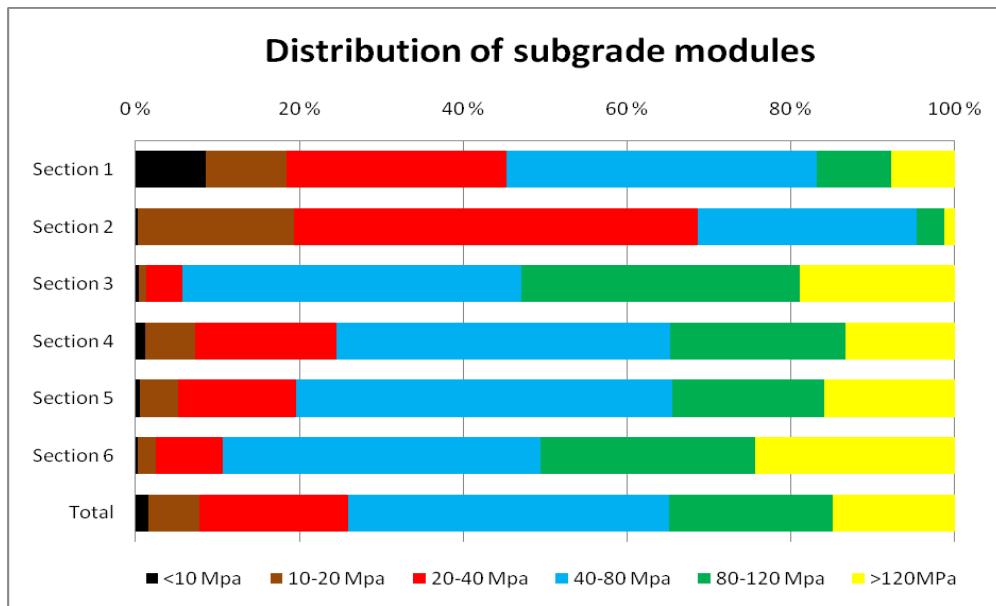
Figure 4. Distribution of subgrade moduli in each road section.

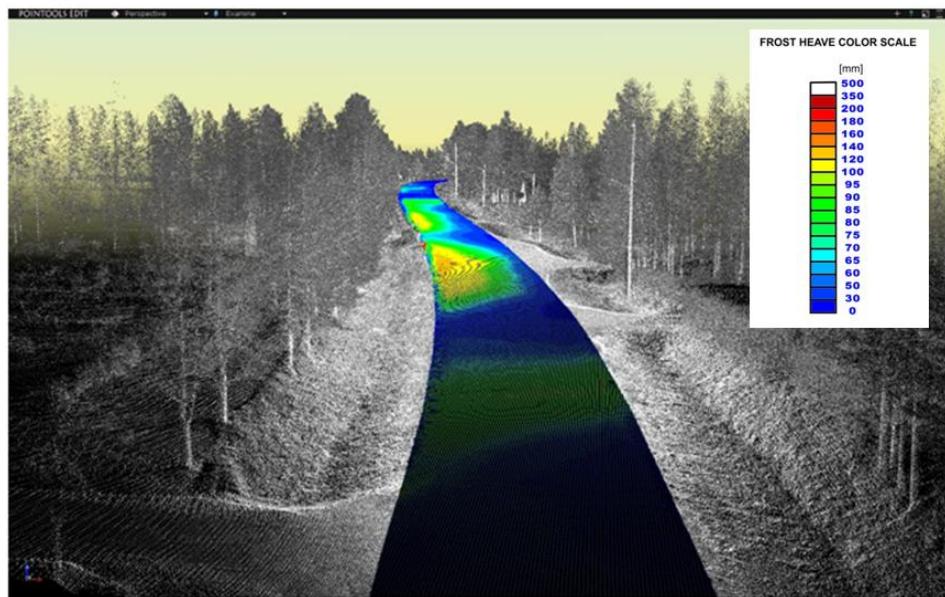
Figure 5. Example of a frost heave problem caused by a clogged, frozen or missing access road culvert. High frost heave values could be measured both sides of the private access road. The figure is based on the mobile laser scanner frost heave analysis data. Note the minor frost heave anomaly close to the nearest access road.

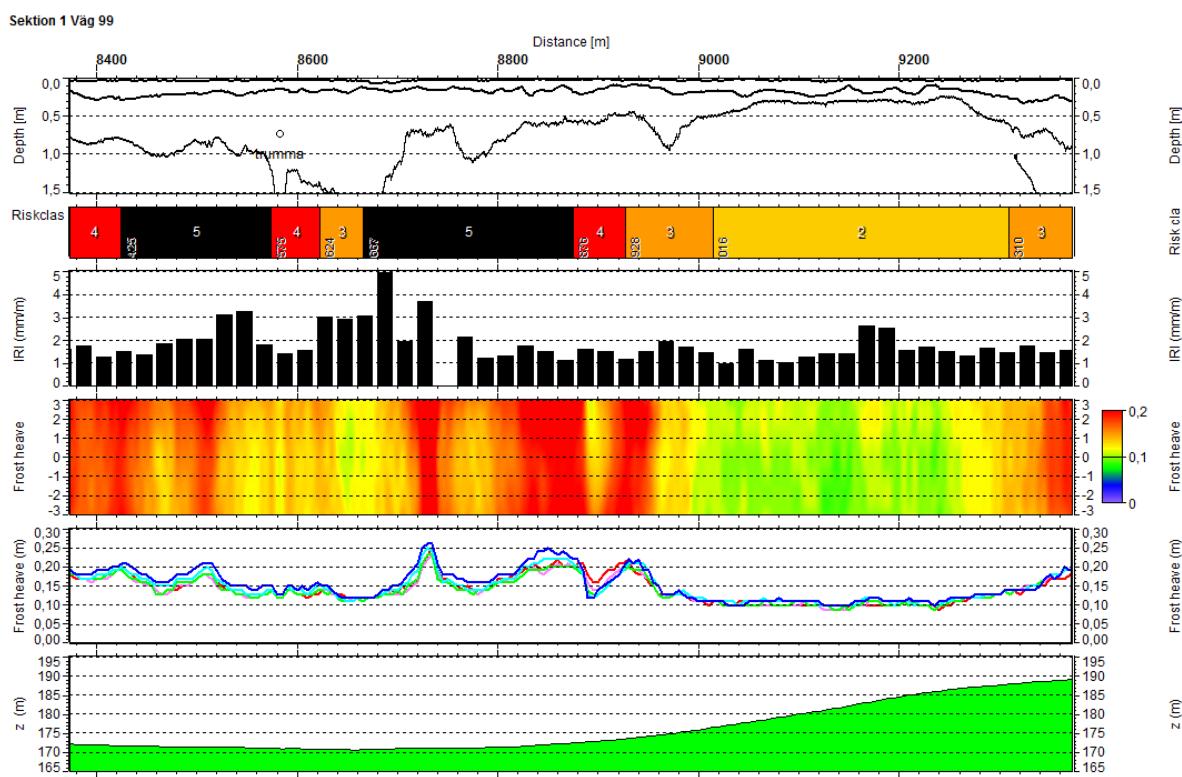
Figure 6: The upper frame gives the interpreted layer thicknesses, the second bar shows the risk classification and then IRI values. Below that the frost heaves are shown as a surface map and then as lines. The bottom frame describes the road profile.

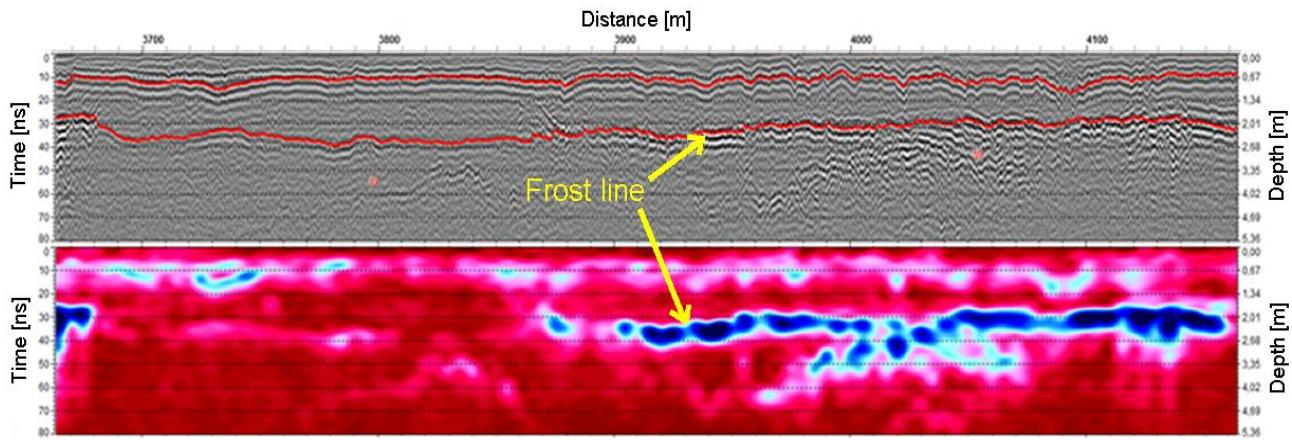
Figure 7: An example of moisture profile calculated from GPR data. The blue colour indicates areas with excess moisture and/or ice lenses in the structure.

According to the mobile laser scanner data the highest frost heave values were found in road Section 1 where the frost heave was generally more than 120 mm, and in some sections even more than 200 mm. In other the road sections the frost heave was less and the measured values varied from 40 mm to 120 mm. The smallest frost heave values were measured on the recently built road Section 6, where the majority was less than 40 mm. Small frost heave values were also measured close to river banks where the subgrade was sand. An example of a frost heave map is presented in Figure 5. Figure 6 shows an example of frost heave together with IRI values and a risk classification. In these sections one reason for the frost heaves was poor drainage. Figure 7 gives an example of a moisture profile calculated from GPR data. Road sections with excess moisture and/or ice lenses in the structure can be located from the moisture profile.

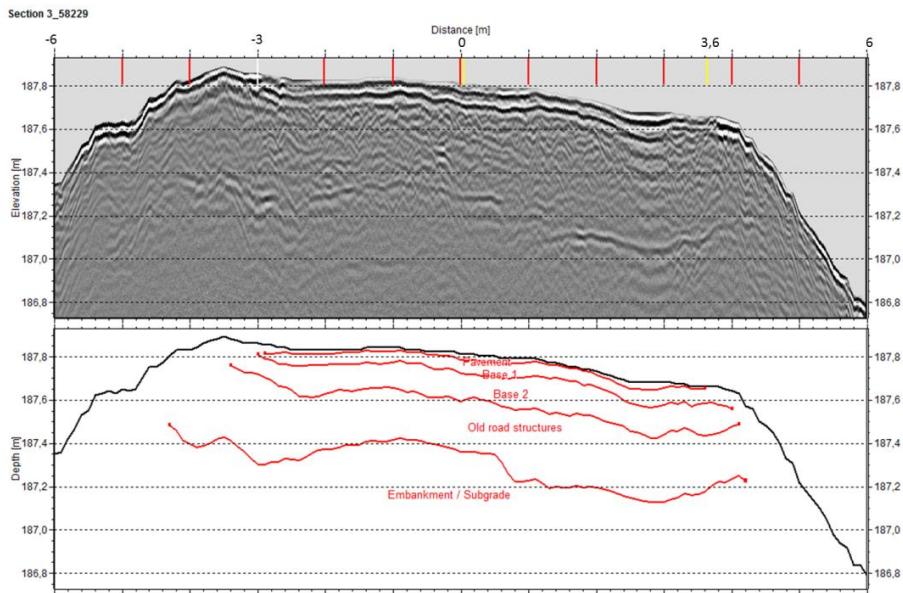
*Figure 8. Example of a cross section with severe Mode 2 rutting problems in the right lane in the inner curve, Section 3, 58+620 m.*

Road cross section analysis based on laser scanning and GPR data from the 1.5 GHz antenna showed that the road has both Mode 1 rutting (related to upper part of road structures) and Mode 2 rutting problems (related to weak subgrade). This analysis also showed that the road shoulders were very weak and that permanent deformation was taking place in the outer wheelpaths. Figure 8 presents an example of a cross section with Mode 2 rutting problems.

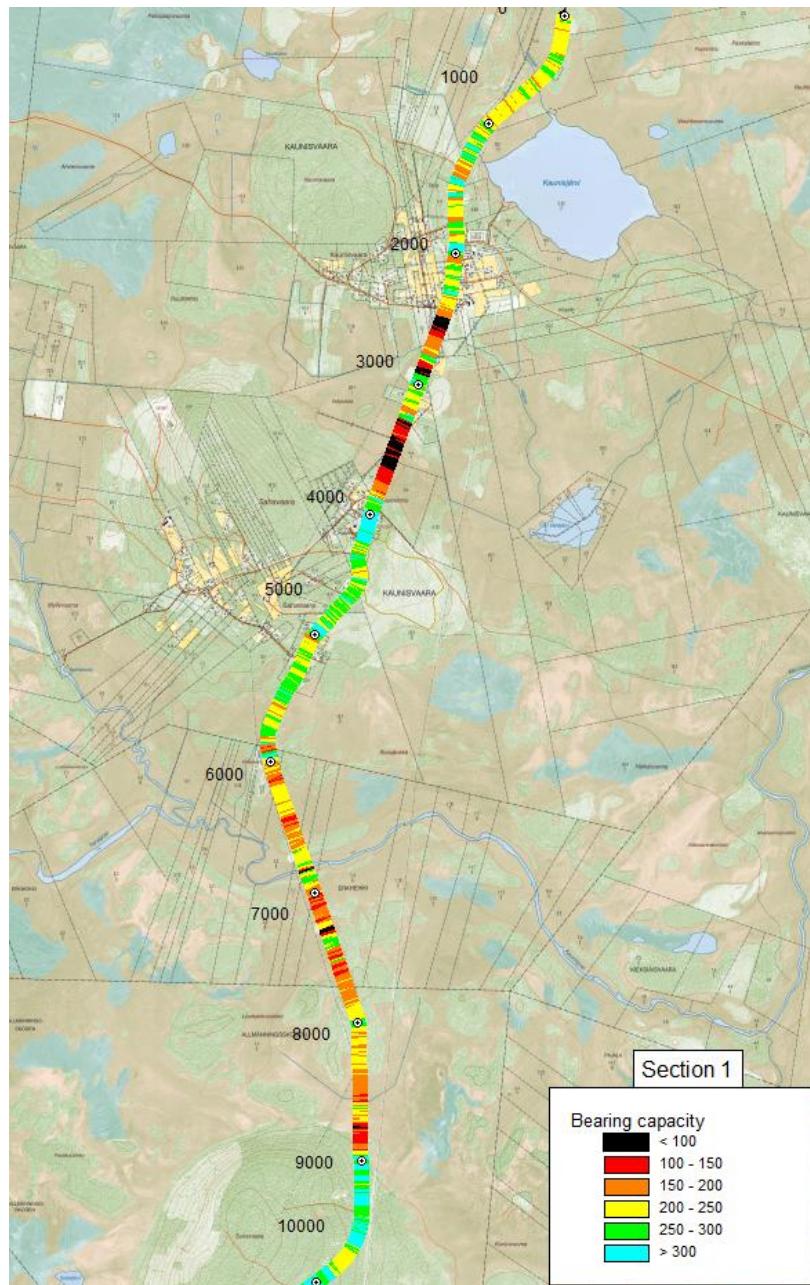
Figure 9. Bearing capacity on road Section 1, part 1.

The Odemark bearing capacity, calculated using the ROADEX Odemark method, varied substantially within and between the different road sections. The lowest bearing capacities were calculated on road Section 1 (Road 99) and the highest bearing capacities were from the new road Section 6 (Roads E10 and E45). Road Section 1 (Figure 9) had several weak sections and the weakest and longest sections were from 2,500m to 4,000m and from 11,500m to 13,000m. In road Section 6 the bearing capacity was mainly 300MPa or more. In other the road Sections 2-5 (Road 395) the bearing capacity varied between 150MPa and 300MPa. Here and there were some short weak (<150MPa) and good (>300MPa) sections.

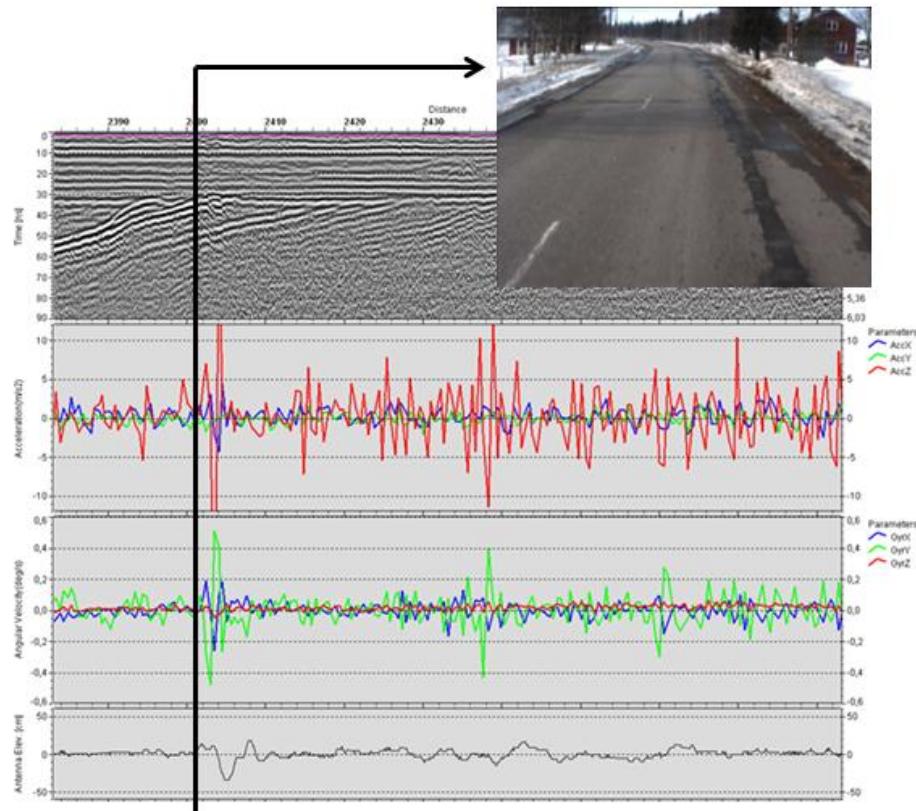
*Figure 10. The first window presents the GPR data from the ground coupled antenna, the second gives the acceleration in the x (blue), y (green) and z (red) directions, the third presents gyration speed in all directions. The bottom shows the antenna elevation from the air coupled antenna GPR measurements.*

Accelerometer surveys were performed in order to locate potential vibration problem sections. These were especially focused on those sections with a human settlement near the road as roughness in these locations would be the most critical. There were several villages/houses along the route that were very close to the road with major roughness. Figure 10 gives an example of such location.

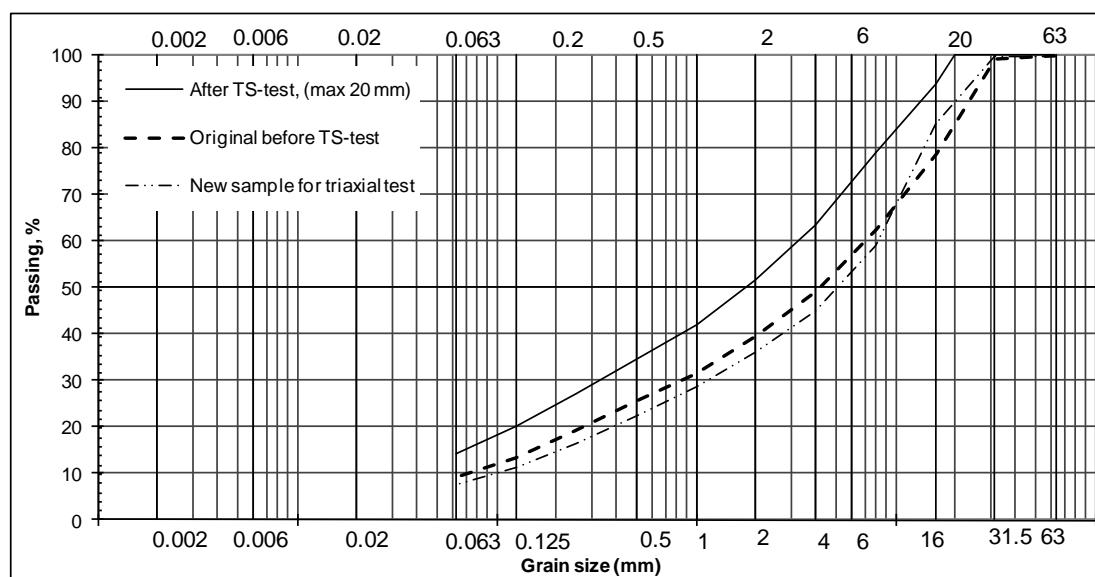
Figure 11. Grain size distribution of the base course aggregate from Road 395 101/959.

The permanent deformation response of the base course material was investigated using the large diameter repeated loading triaxial test facility available in the Laboratory of Earth and Foundation Structures at the Tampere University of Technology. The test material was taken from the unbound base course of Road 395 101/959 (Section 2 at 1,675 m). According to the Tube Suction tests the quality of the crushed gravel moraine aggregate having a fines content of 14.3 % and the maximum grain size of 20 mm was expected to be questionable. The original fines content of the aggregate was 9.2 % and the maximum grain size 32 mm as shown in Figure 11.

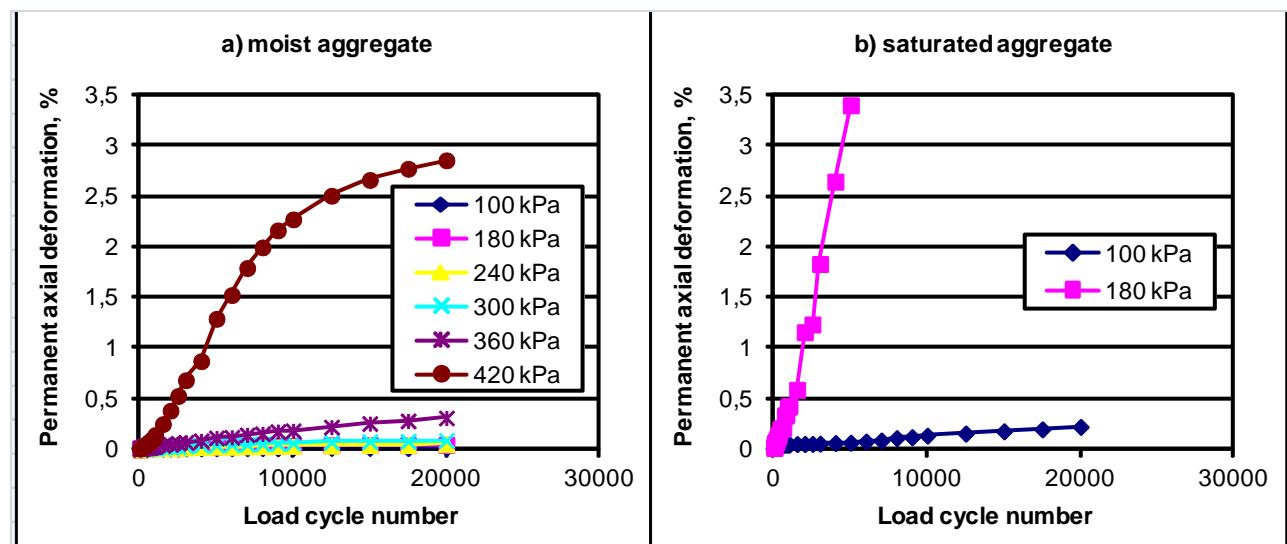
Figure 12. Accumulation of permanent axial deformation during the repeated loading triaxial test series: a) in moist base course aggregate and b) in base course aggregate saturated with water.

The test results summarized in Figure 12 clearly indicate the drastic effect of moisture content on the permanent deformation response of the tested base course aggregate. In a low moisture content, corresponding to a saturation ratio of about 44 %, the material could resist the accumulation of marked permanent deformations up to a repeated axial loading level of 360 kPa. When saturated the test specimen, having an estimated saturation ratio of about 90 %, started to collapse already in the early stage of the repeated axial loading pulse series of 180 kPa.

The physical reason for the big difference between the two test specimens is clearly in accumulation of excess pore water pressure and respective lowering of the effective stresses in

the saturated test material during the cyclic loading. Unfortunately the available test arrangements did not enable the continuous recording of the developing amount of excess pore water pressure in the middle of the test specimen. However, the manually recorded maximum value of excess pore water pressure in a tube connected to the lower end of the specimen No. 2 was observed to be of the order of 14 kPa at the end of loading. During the repeated axial loading series of 100 kPa the development of excess pore water pressure could not be observed.

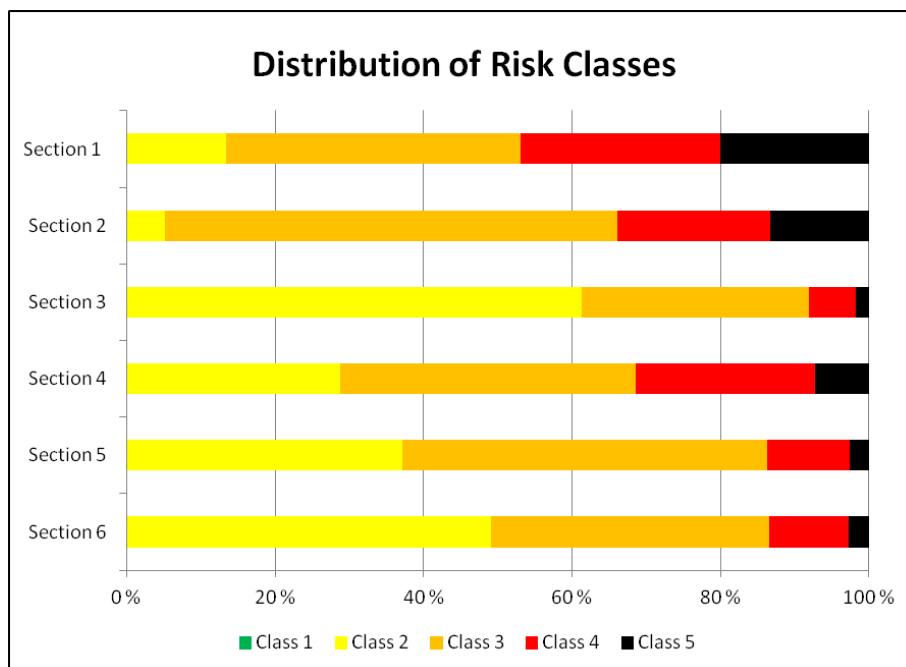
Figure 13. Distribution of risk classes in each road section.

The subgrade soil properties were given greater weight in this risk as the subgrade was considered to be the critical point in the road structure. The distribution of the calculated risk classes in each road section is shown in Figure 13.

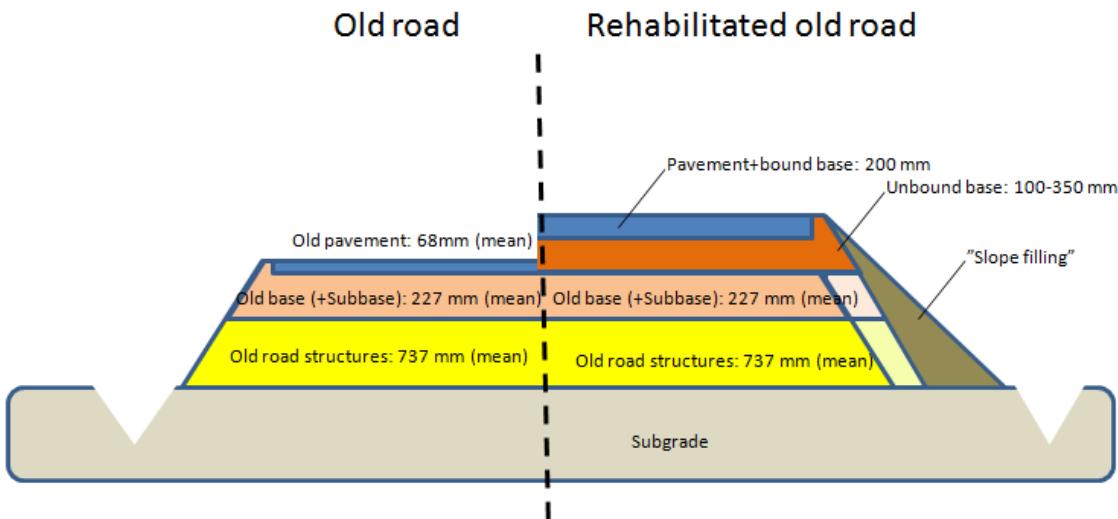
Figure 14. The principles of the basic structure used in strengthening.

Based on evaluations of numerous structural options, three main structural solutions were selected with practically all structural solutions containing 200mm of bound layers. The only exceptions were sections with a third lane, where the old road would be used mainly by empty trucks and would have only 100mm of bound layers. The most general solution was to add new layers (unbound base and bound layers) on the top after the old pavement had been removed and the old unbound base surface had been shaped (Figure 14).

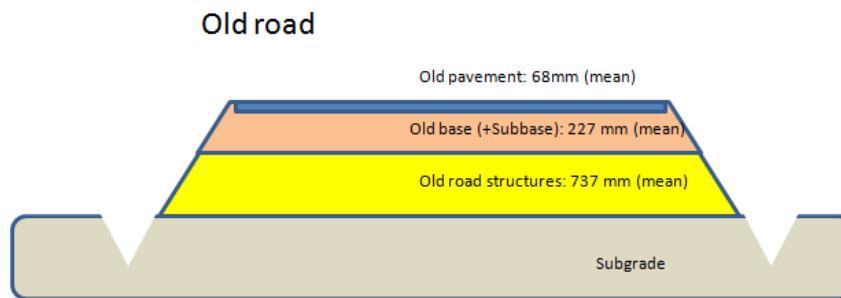
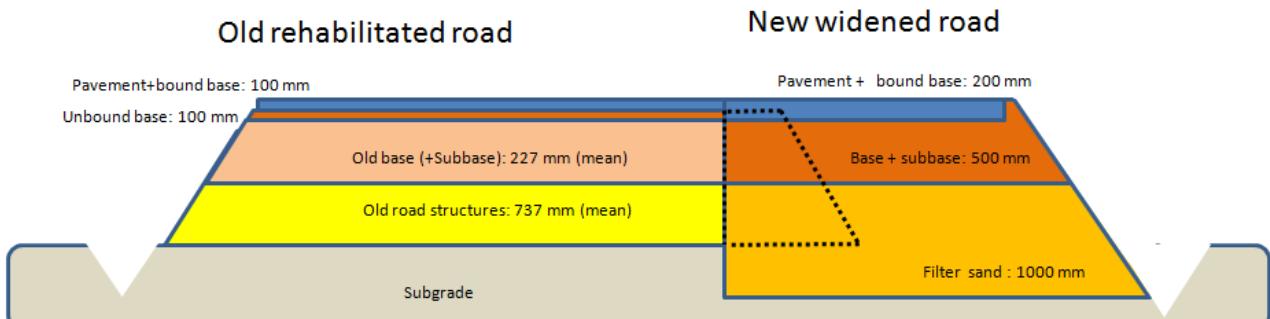
Figure 15. The principles of a third lane structure. If there is big difference in frost heave between the old road and new lane, then it is recommended that the third lane be separated from the old road in some way.

The strengthening of the old road over a weak subgrade proved to be difficult and that is why, in the weakest sections (mostly risk Class 5), it was recommended that a third lane should be built for the heavy trucks. In these sections savings can be achieved because the old road will not be so heavily strengthened: the structure will be 100mm bound layer and 100mm unbound layer (Figure 15). In the extremely weak sections (peat areas) with potential pumping problems it was recommended that steelnets should be used (Figure 16).

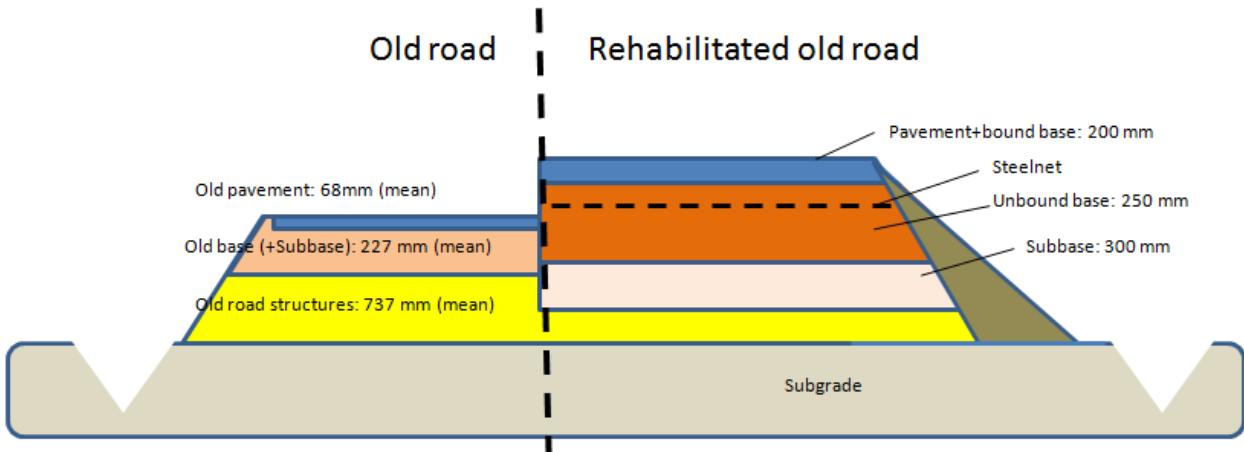
*Figure 16. Principles of the steelnet structure to be used in the weakest peat subgrade sections*

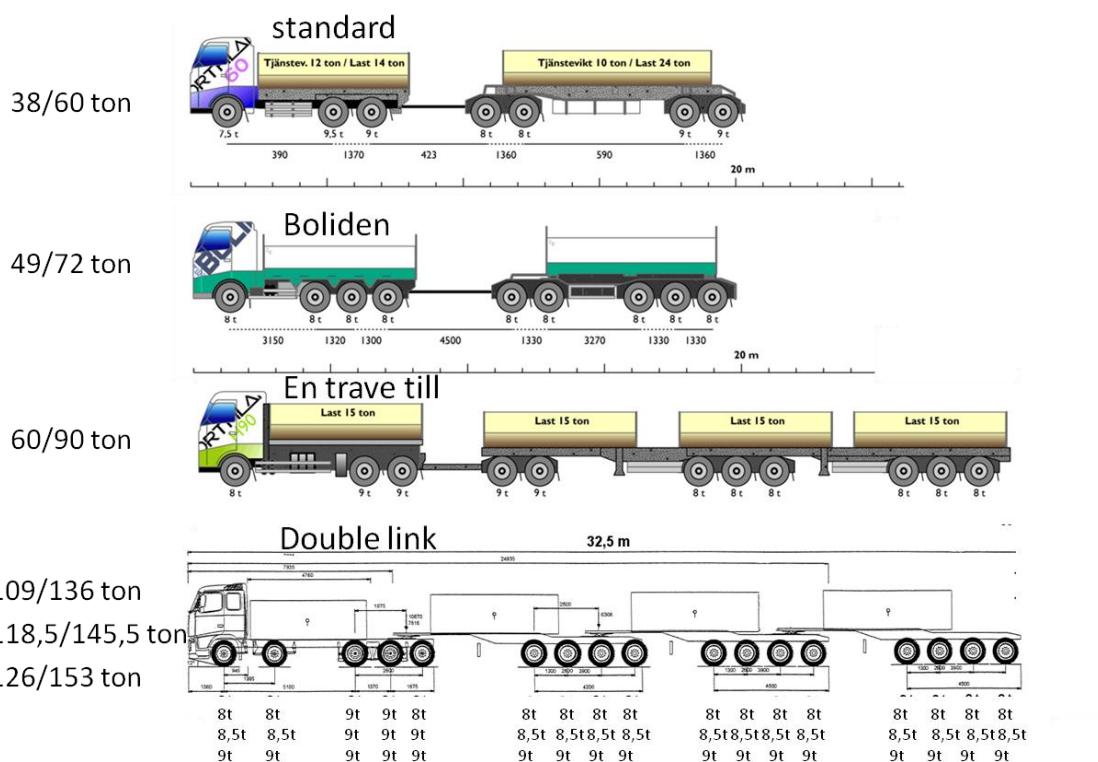
*Figure 17. Final truck options used in the evaluation. The difference between the double link options is only the axle weight.*

For the final evaluation the standard 60 tonnes truck option was naturally the first choice. The 72 tonnes (Boliden) and 90 tonnes (En trave till) options were also chosen, because they were more or less ready alternatives for the standard truck and had been used in Sweden previously. The 136 tonnes "Double link" truck option was chosen, because it was calculated to be best option according to the fourth power rule evaluation. The 145.5 tonnes and 153 tonnes "Double link" options were chosen in order to evaluate the effect of higher axle loads (8.5 tn and 9 tn) compared to the 136 tonnes option (8 tn). The truck options in the final analysis are described in Figure 17.

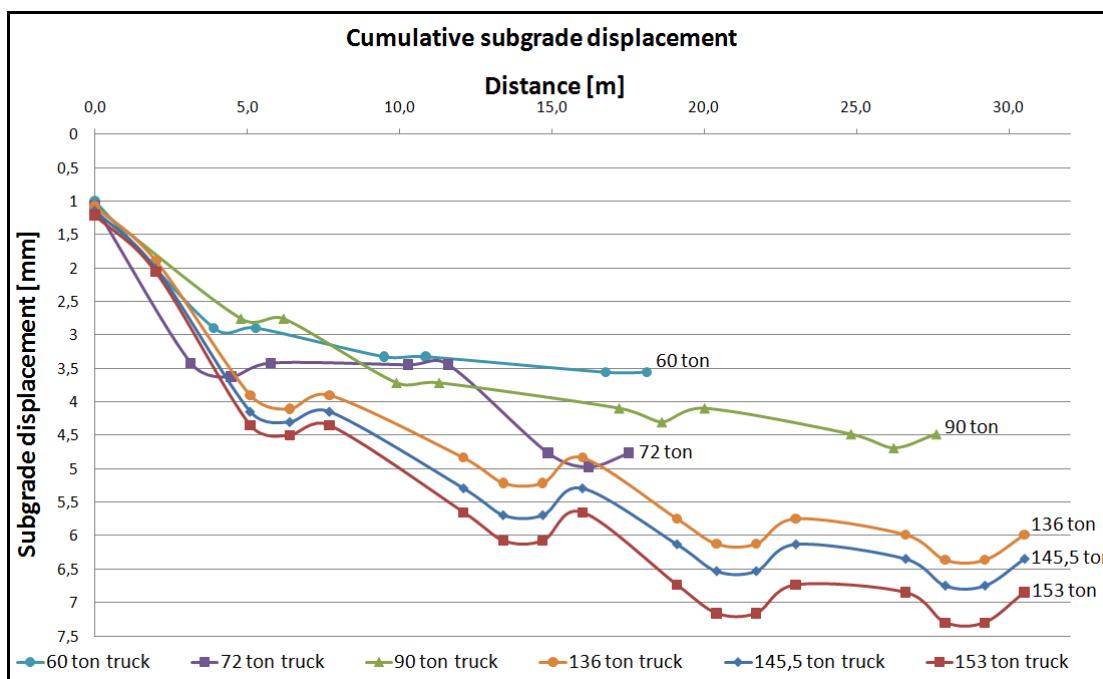
Figure 18. The cumulative displacement of a weak subgrade (modulus 10 MPa) calculated for each truck option. The horizontal axis gives the distance from the first axle of the truck. Zero is the first axle and the dots along the displacement curve represent the locations of the consecutive axles. The vertical axis displays the cumulative subgrade displacement calculated at one point.

Bigger differences could however be detected when cumulative subgrade displacement calculations were made for each of the truck options. On the basis of the cumulative subgrade displacement evaluation (Figure 18), the 60 tonnes option was again the best. The 72 and the 90 tonnes options were approximately on the same displacement level with each other with maximum cumulative displacement of 1.0 – 1.5 mm (approximately 30 - 40 %) greater than the 60 tonnes option. The "Double link" options were again the worst, with maximum cumulated displacements of between 6.5 mm and 7.5 mm, which were more than 2 times higher compared to a standard 60 tonnes truck. It should also be noted that the calculated cumulative subgrade displacement for the heaviest cases represented an optimistic / conservative estimate because the subgrade recovery in real life would not be as immediate as the BISAR® calculations show. This is for example due to development of excess pore water pressure and in real terms the cumulative effect could in unfavourable conditions be even stronger.
