Petri Varin, Bruce Wiljanen

RISK ASSESSMENT OF ROAD N59, NEWPORT TO MULRANNY, COUNTY MAYO, IRELAND

Demonstration project report

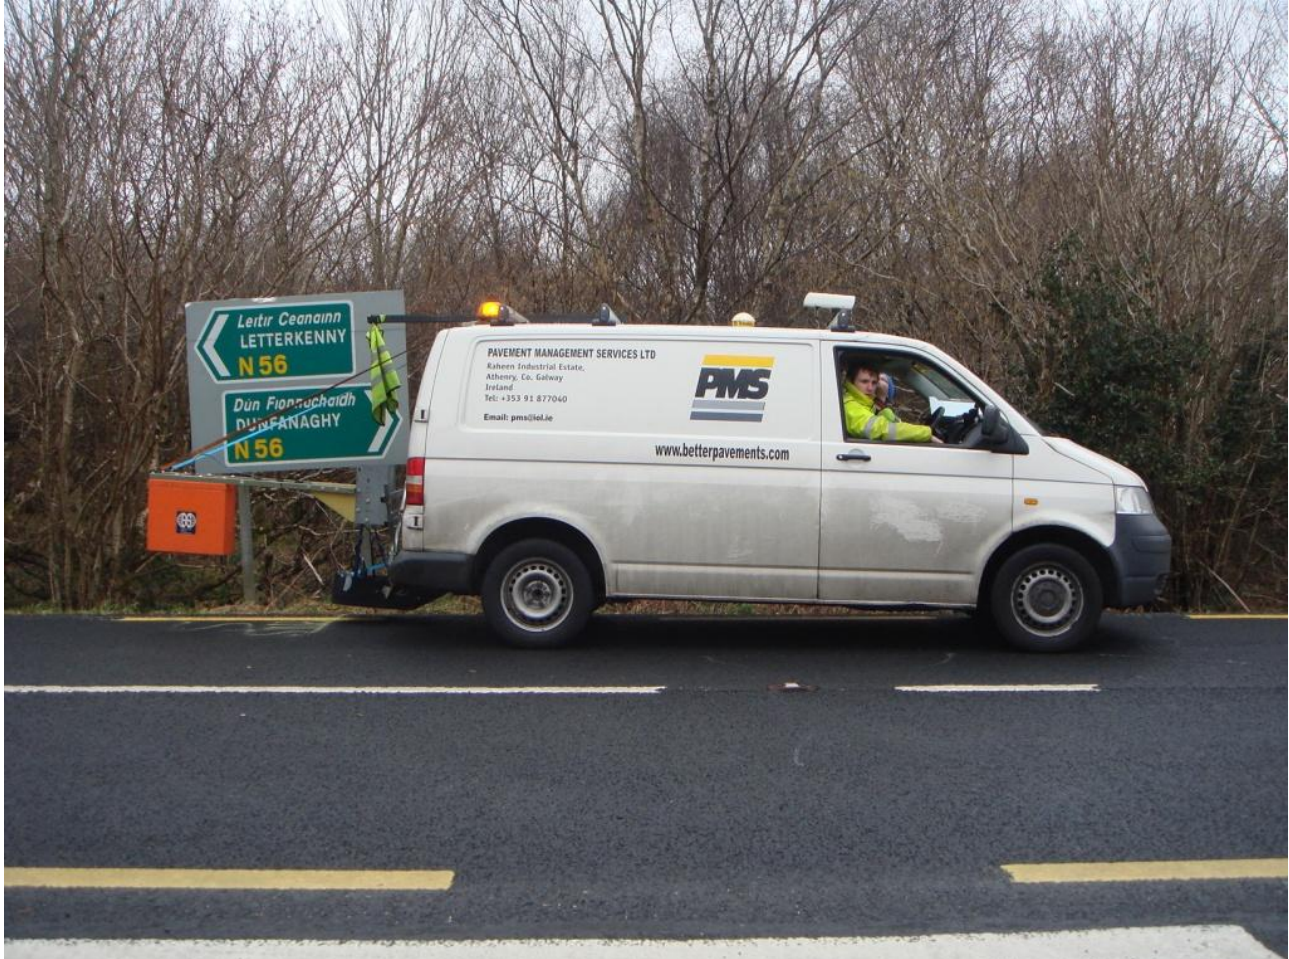
Figure 2.1 Measurement van with survey equipment

Ground penetrating radar (GPR) data was collected using a GSSI SIR-20 unit with two antennas, an air-coupled 1.0 GHz horn and a 400 MHz ground-coupled antenna (Figure 2.1). A digital video with GPS coordinates was also taken and 307 FWD points were tested, one every 50 metres in the westbound lane.

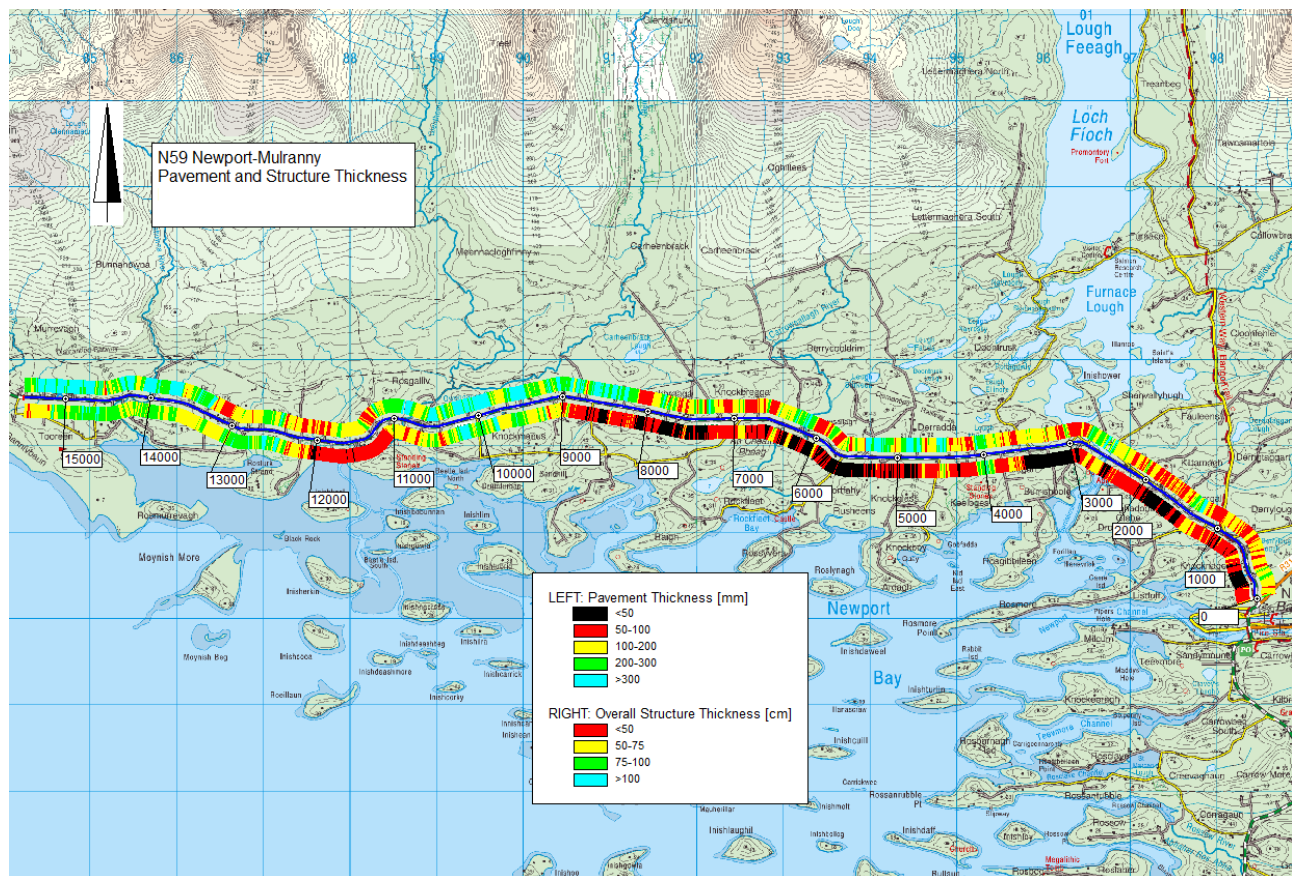
Figure 3.1 Pavement and structure depths on Road N59

The interpretation carried out mainly follows the two most important interfaces for this survey; the bottom of the bound layers and the interface between the road structure and the subgrade.

Generally the bound layers on road N59 are thin from 0 to 9200 m. From 9200 m to the end of the road section the bound layers are generally quite much thicker except between 11000 and 12000 m.

The overall thickness of the whole road structure varies mainly between 0.5-1.0 m. Also the overall thickness of the whole road structure is generally thinner from 0 to 8000 m and thicker from 8000 m to the end of the road section.

Figure 3.1 shows the depths of the road structures as a GIS map. Appendix 3 presents longitudinal profiles of the interpretations.

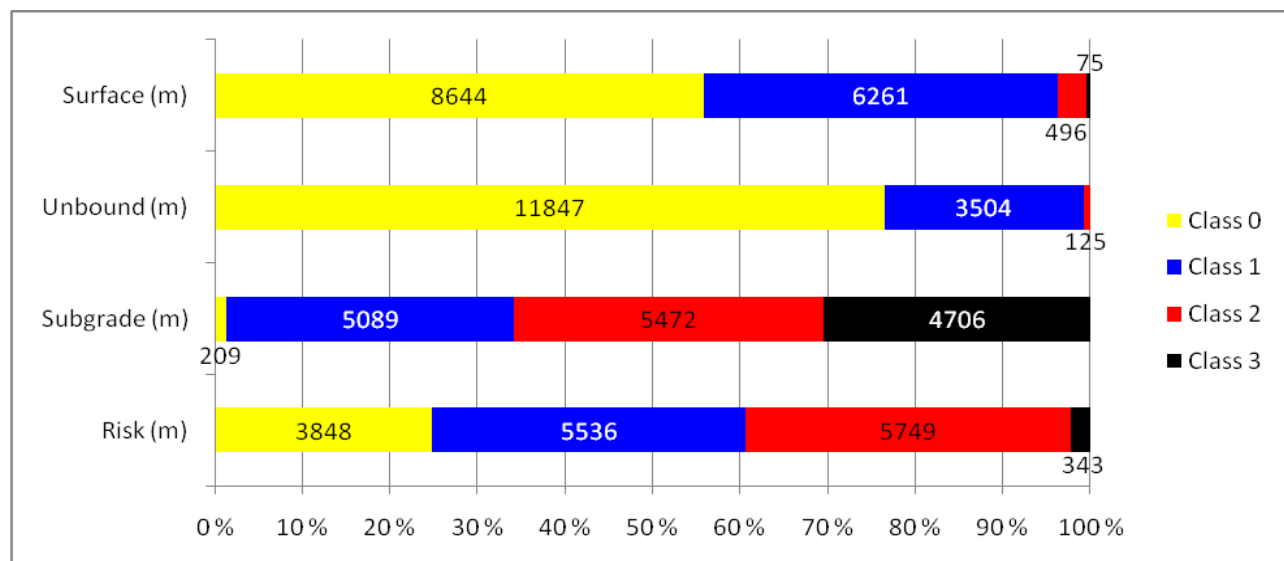
Figure 4.1 Statistical summary of the risk evaluation

A statistical summary of the risk evaluation is presented in Figure 4.1. These risk classes are also presented as coloured bars in the GIS map in Appendix 1 as well as in the profile printouts in Appendix 3.

A Class 2 and Class 3 failure risk was predicted for 6092 m of the road section (approximately 39 % of the total length). Approximately 61 % of the road (9384 m) had a reasonably well working structure with a rating of better than Class 2, i.e. failures only predicted after long continued heavy transportation.

From 0 to 9200 there is a weak soft subgrade combined with thin bound layers and slightly thinner overall structure thickness. The weakest subgrade section is located between 6500 and 9200 m.

From 9200 m to the end of the section the subgrade is generally stronger and the bound layers are thicker than on the first half of the section. The risks for failures on the subgrade level, and on the surface, are therefore much lower.

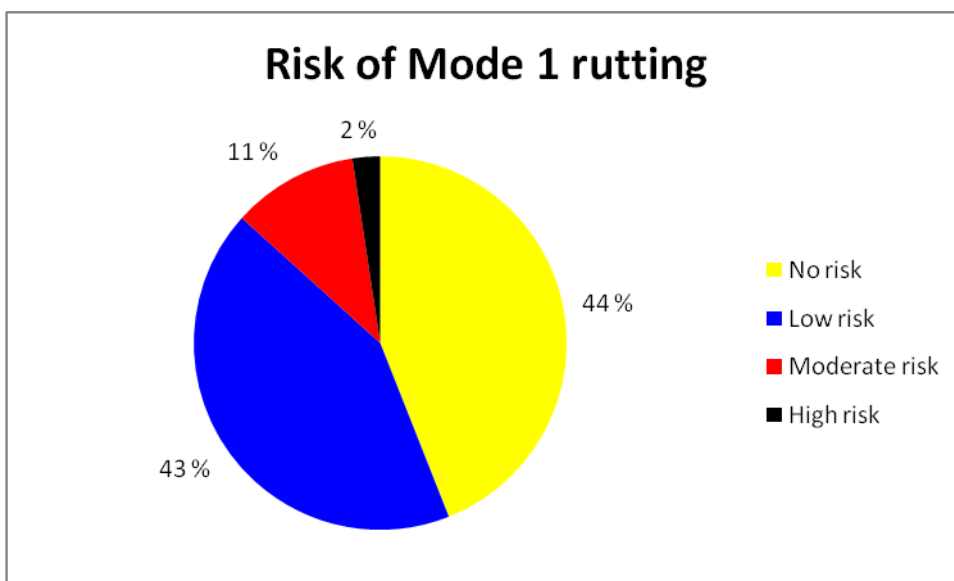
Figure 5.1 Statistical summary of the Mode 1 rutting risk evaluation

Mode 1 rutting is described as a problem of top layer weaknesses (ROADDEX III report, “Managing Rutting in Low Volume Roads” by Dawson & Kolisoja 2006). In this analysis the strain values calculated from the bottom of the bound layers are used as an indicator of risk for Mode 1 rutting. The statistics are presented in Figure 5.1 and a map of Mode 1 rutting risk in Figure 5.2.

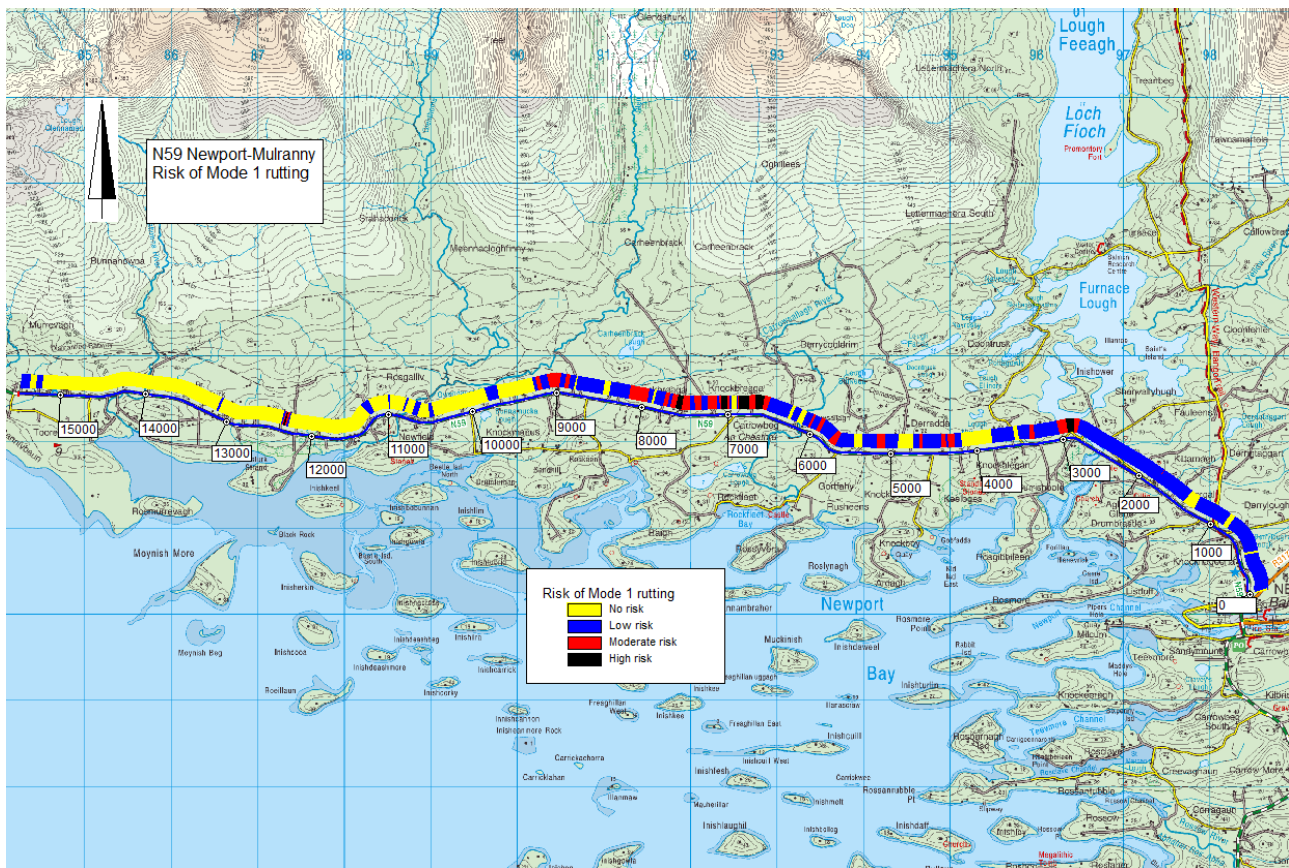
Figure 5.2 Mode 1 rutting risk shown as a map

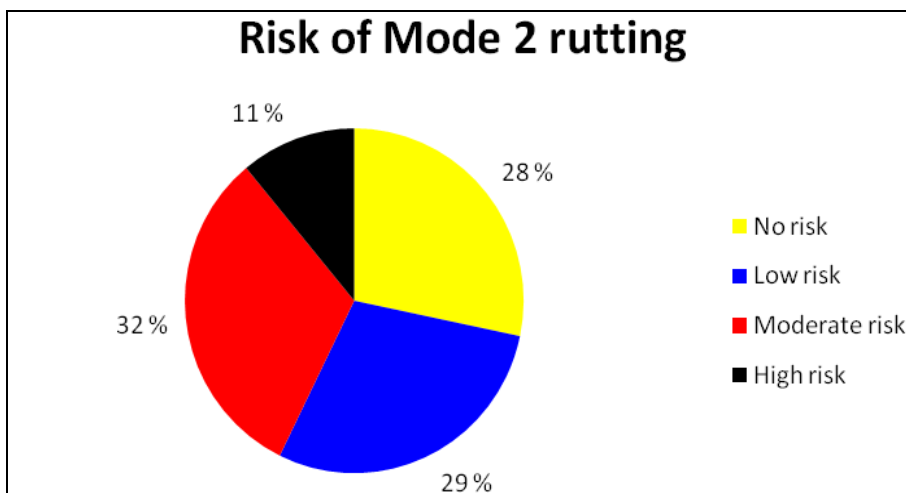
Figure 5.3 Statistical summary of the Mode 2 rutting risk evaluation

Mode 2 rutting is described as a problem of weak subgrade (ROADX III report, “Managing Rutting in Low Volume Roads” by Dawson & Kolisoja 2006). In this analysis a combination of subgrade moduli values and BCI calculated from FWD data are used to produce the results of risk for Mode 2 rutting. In Figure 5.3 a statistical summary is presented and in Figure 5.4 a GIS map of Mode 2 rutting risk.

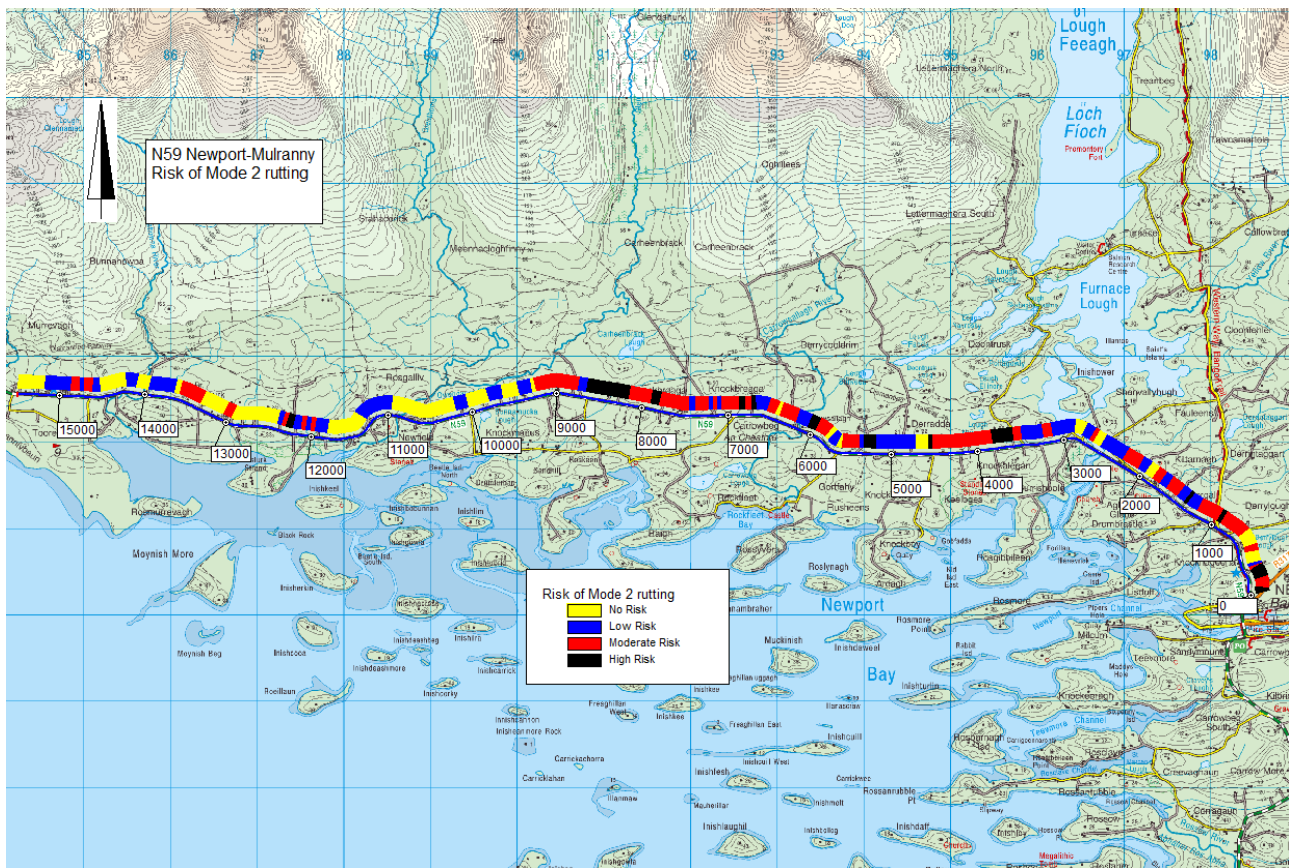
Figure 5.4 Mode 2 rutting risk shown as a map

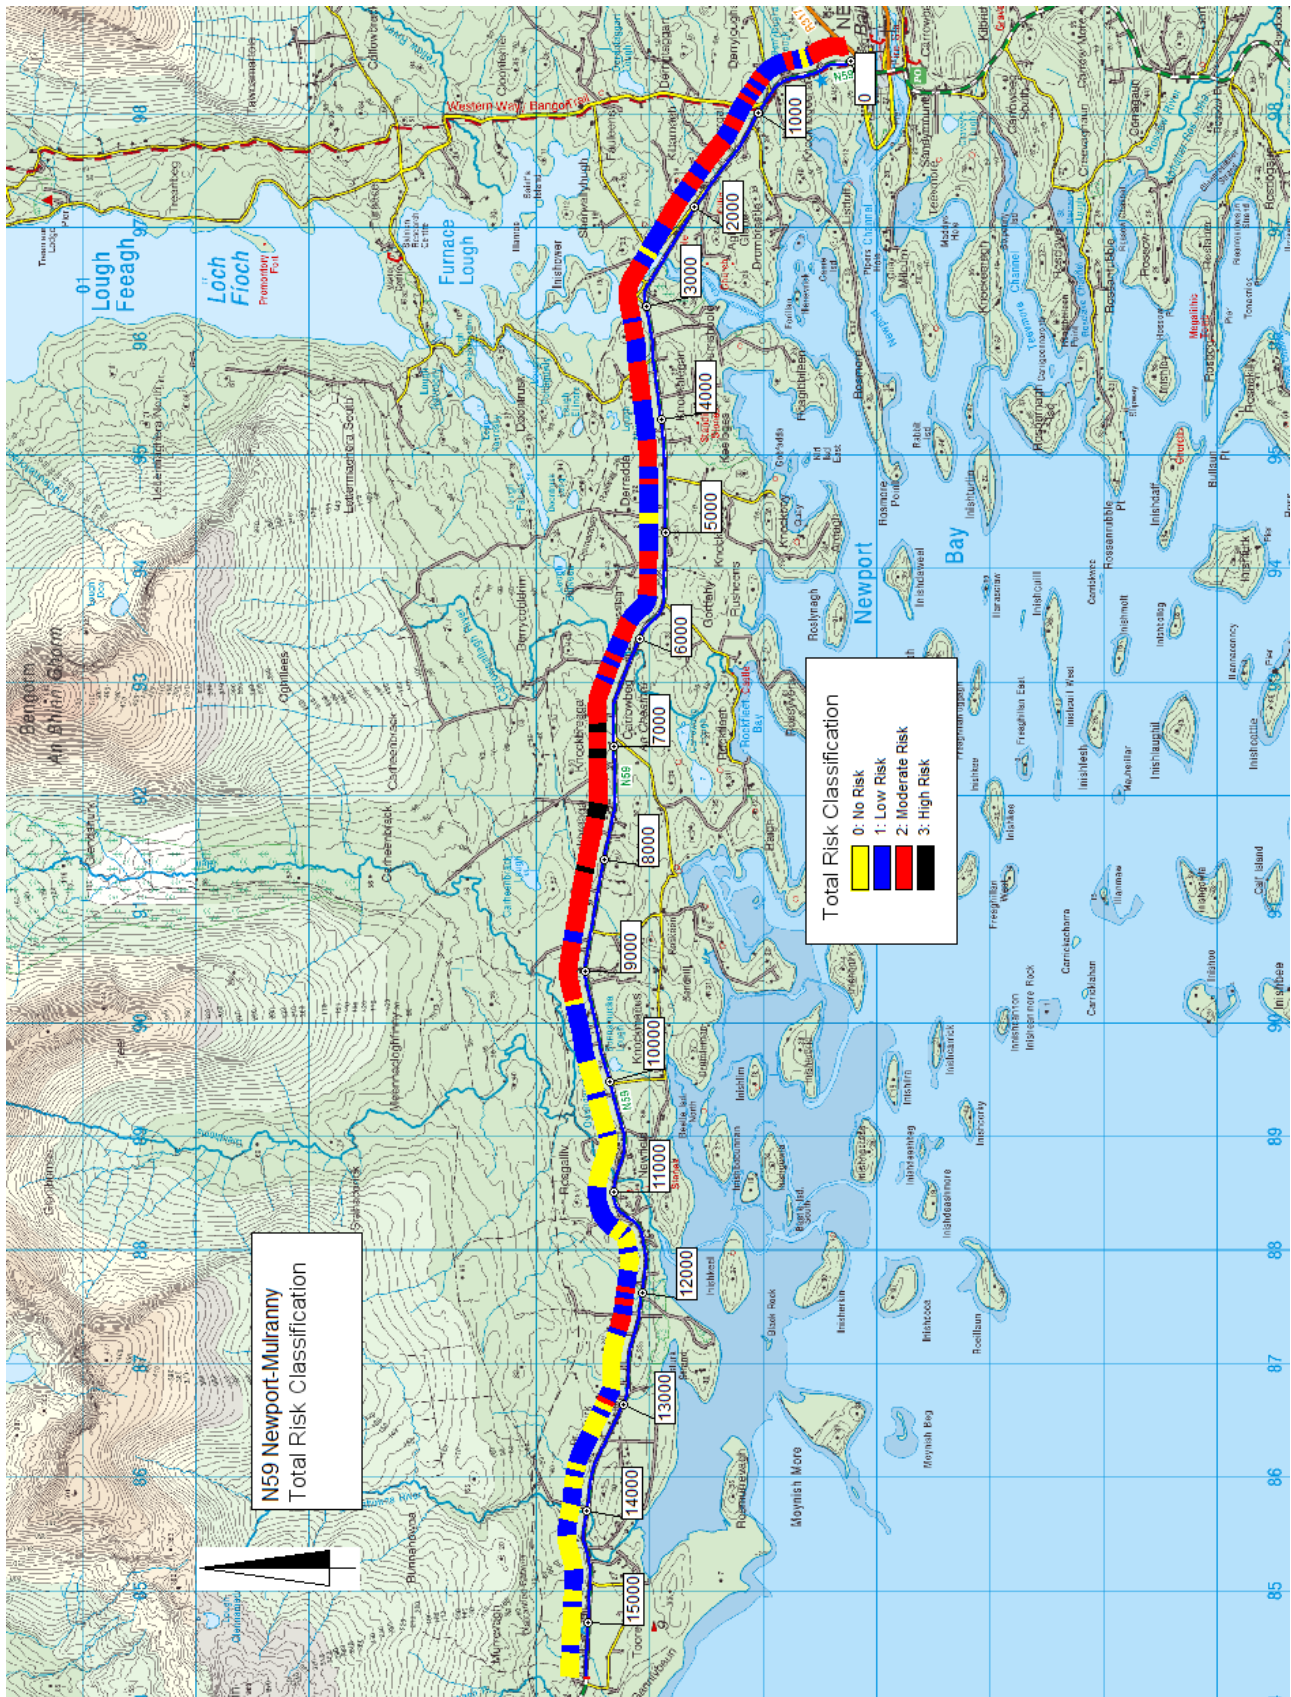
APPENDIX 1	Total risk classification shown as a map
APPENDIX 2	Initial bearing capacity shown as a map
APPENDIX 3	Longitudinal profiles

The back calculated layer moduli were then used in the calculation of the surface bearing capacity of the road structures. This surface bearing capacity mainly reflects subgrade related problems. In general it can be stated that road stiffness is extremely poor if bearing capacity is <100 MPa and if the value is >200 MPa there should not be an immediate risk of failures. This surface bearing capacity value can also be used to evaluate how much the road has to be strengthened in order to carry heavy trucks (see Table 6.1 and Appendixes 2 and 3).

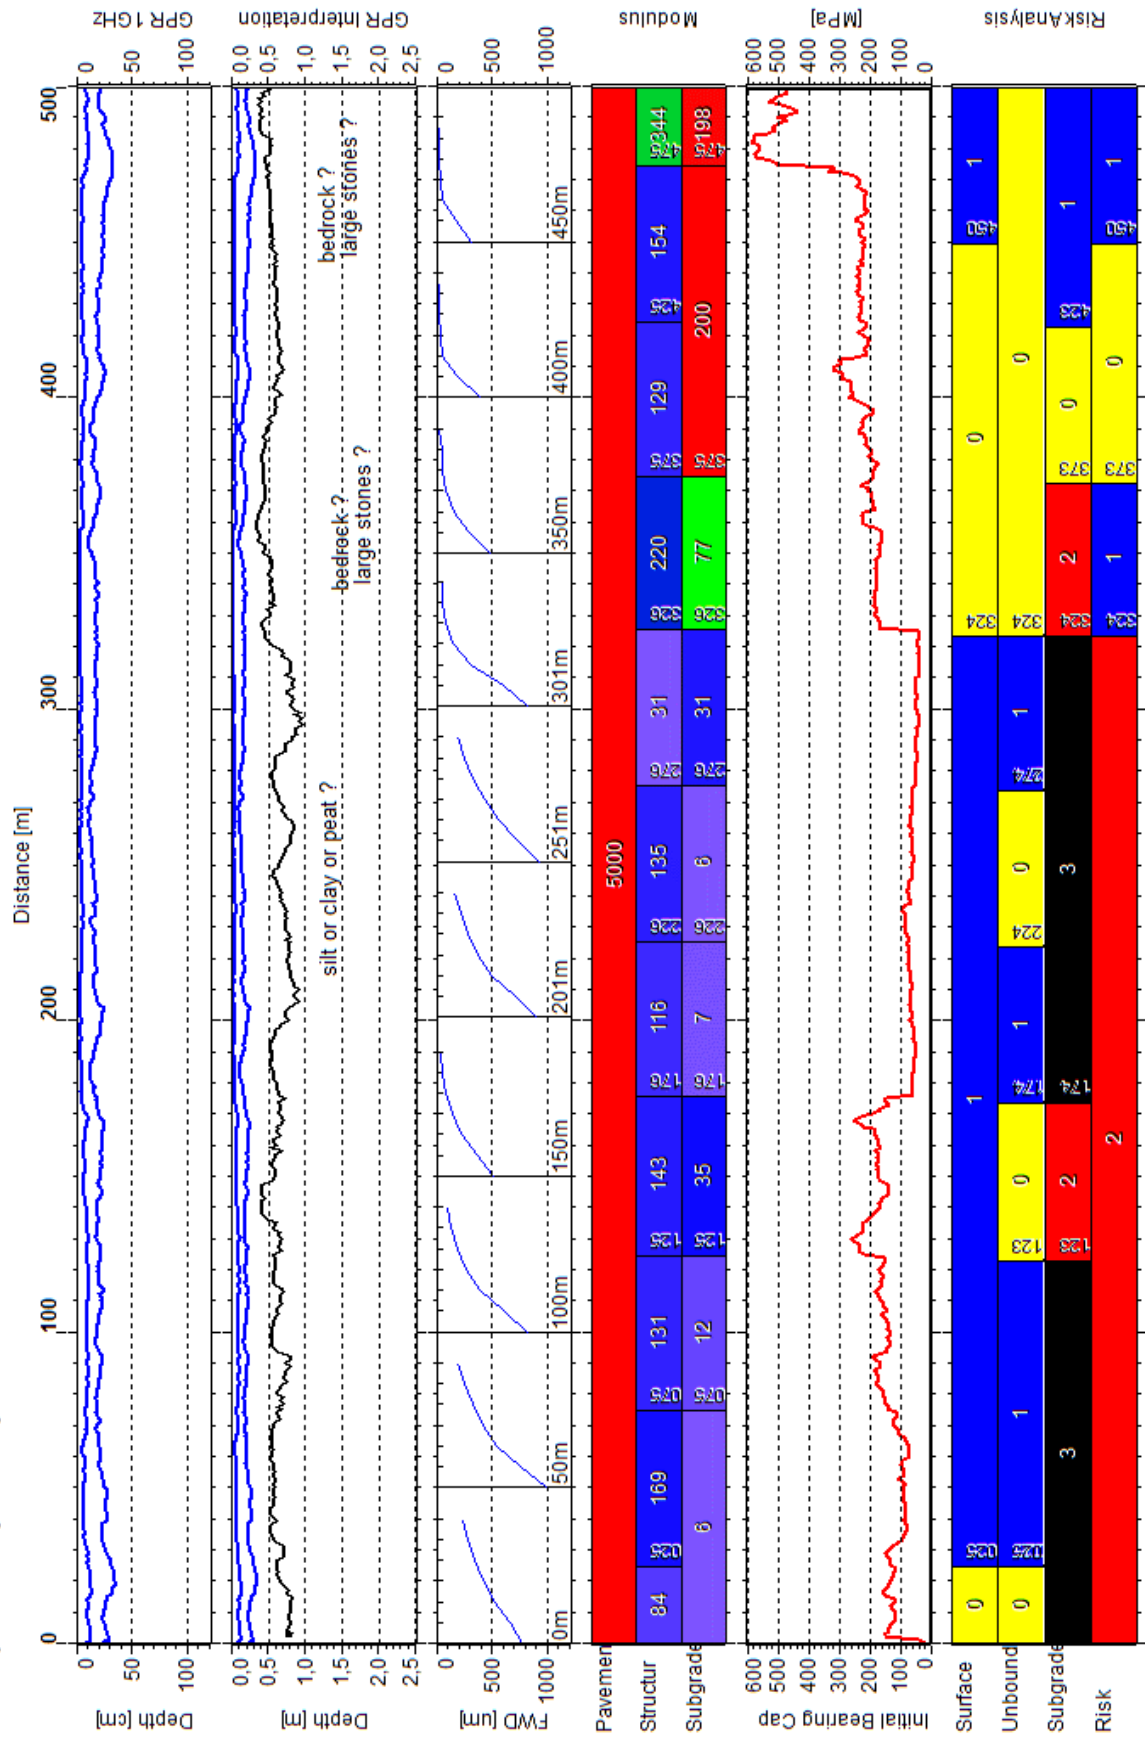
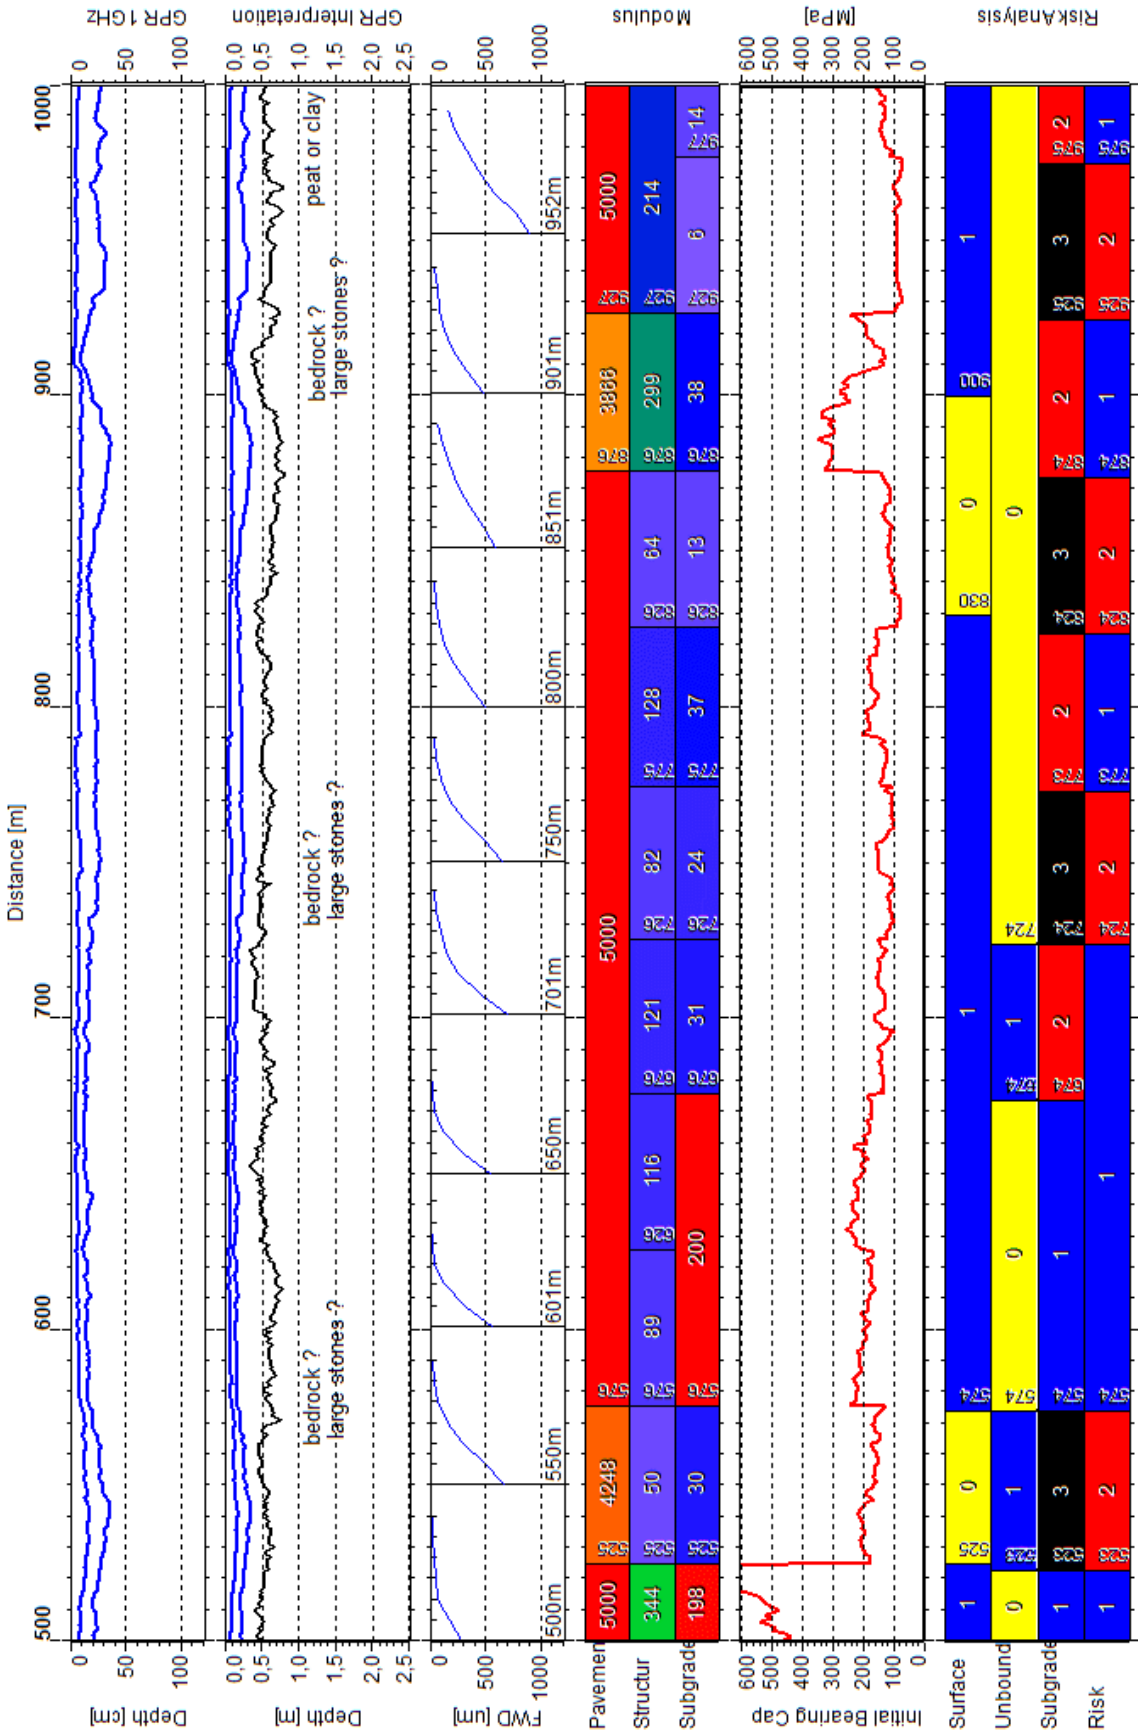
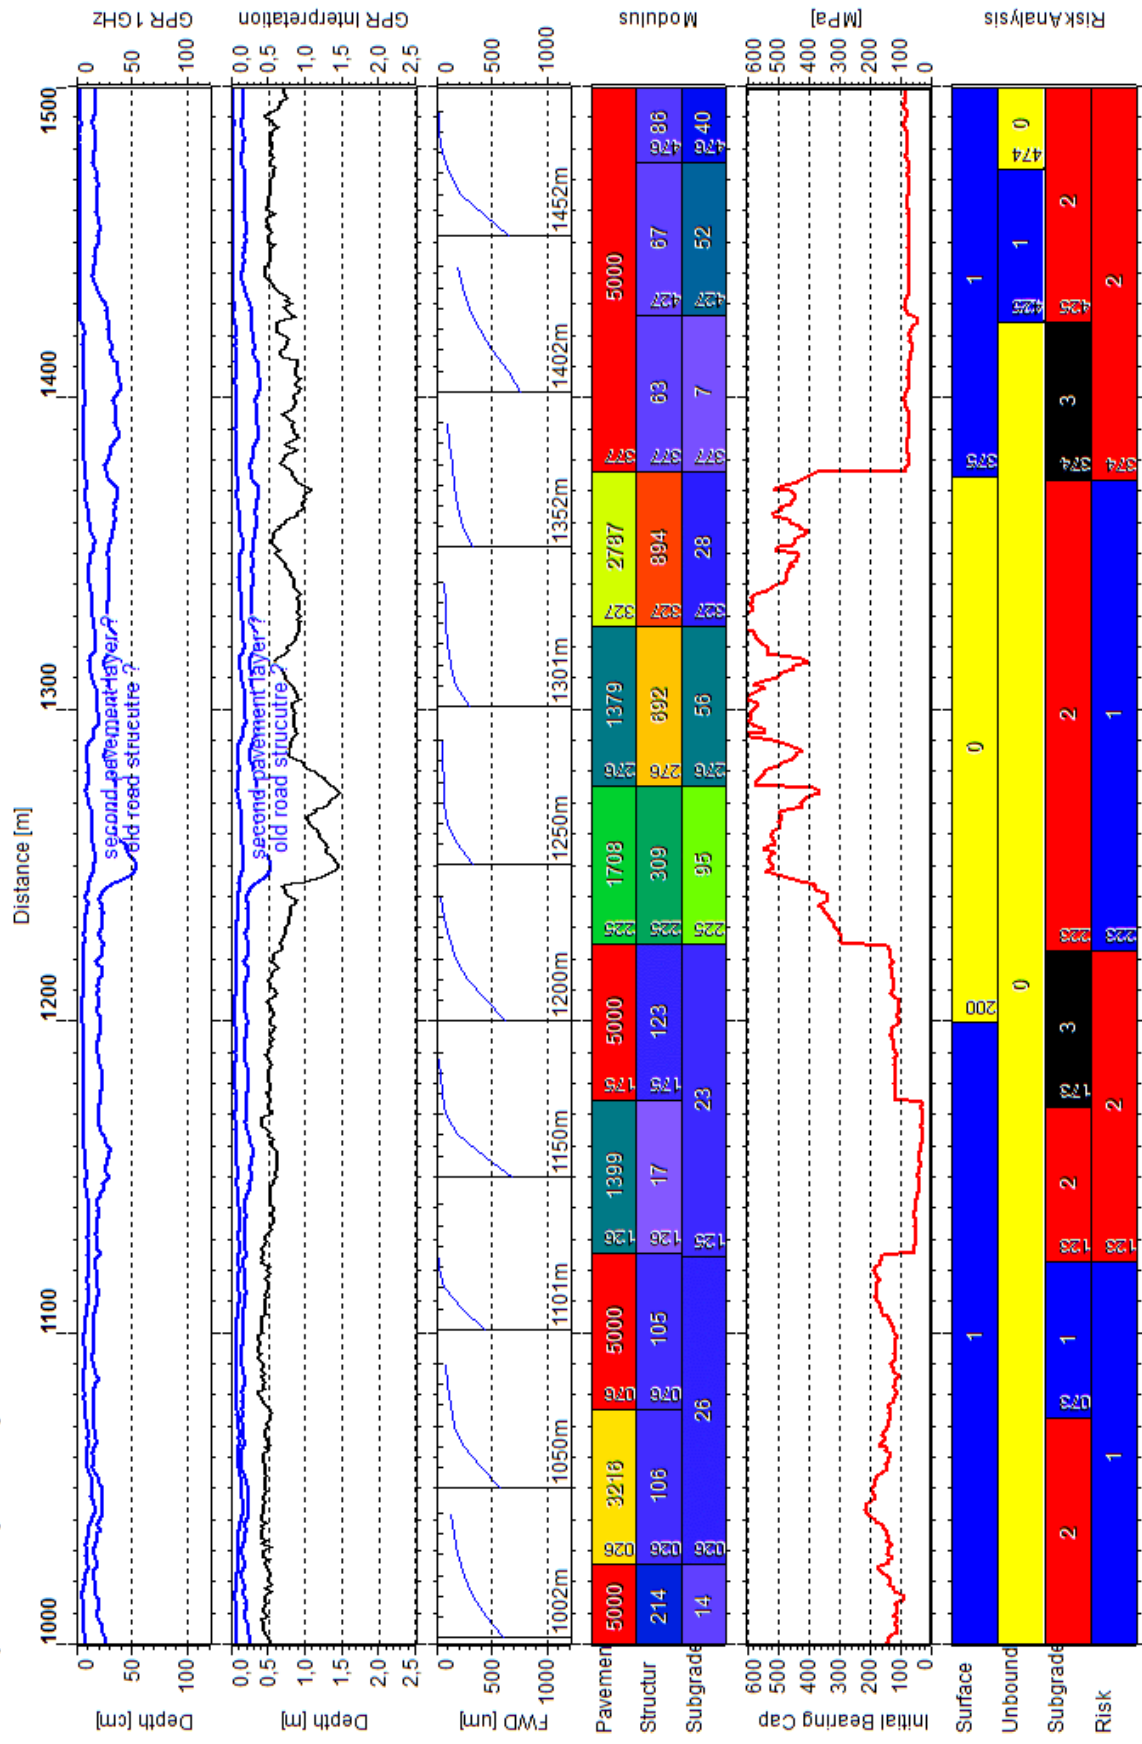
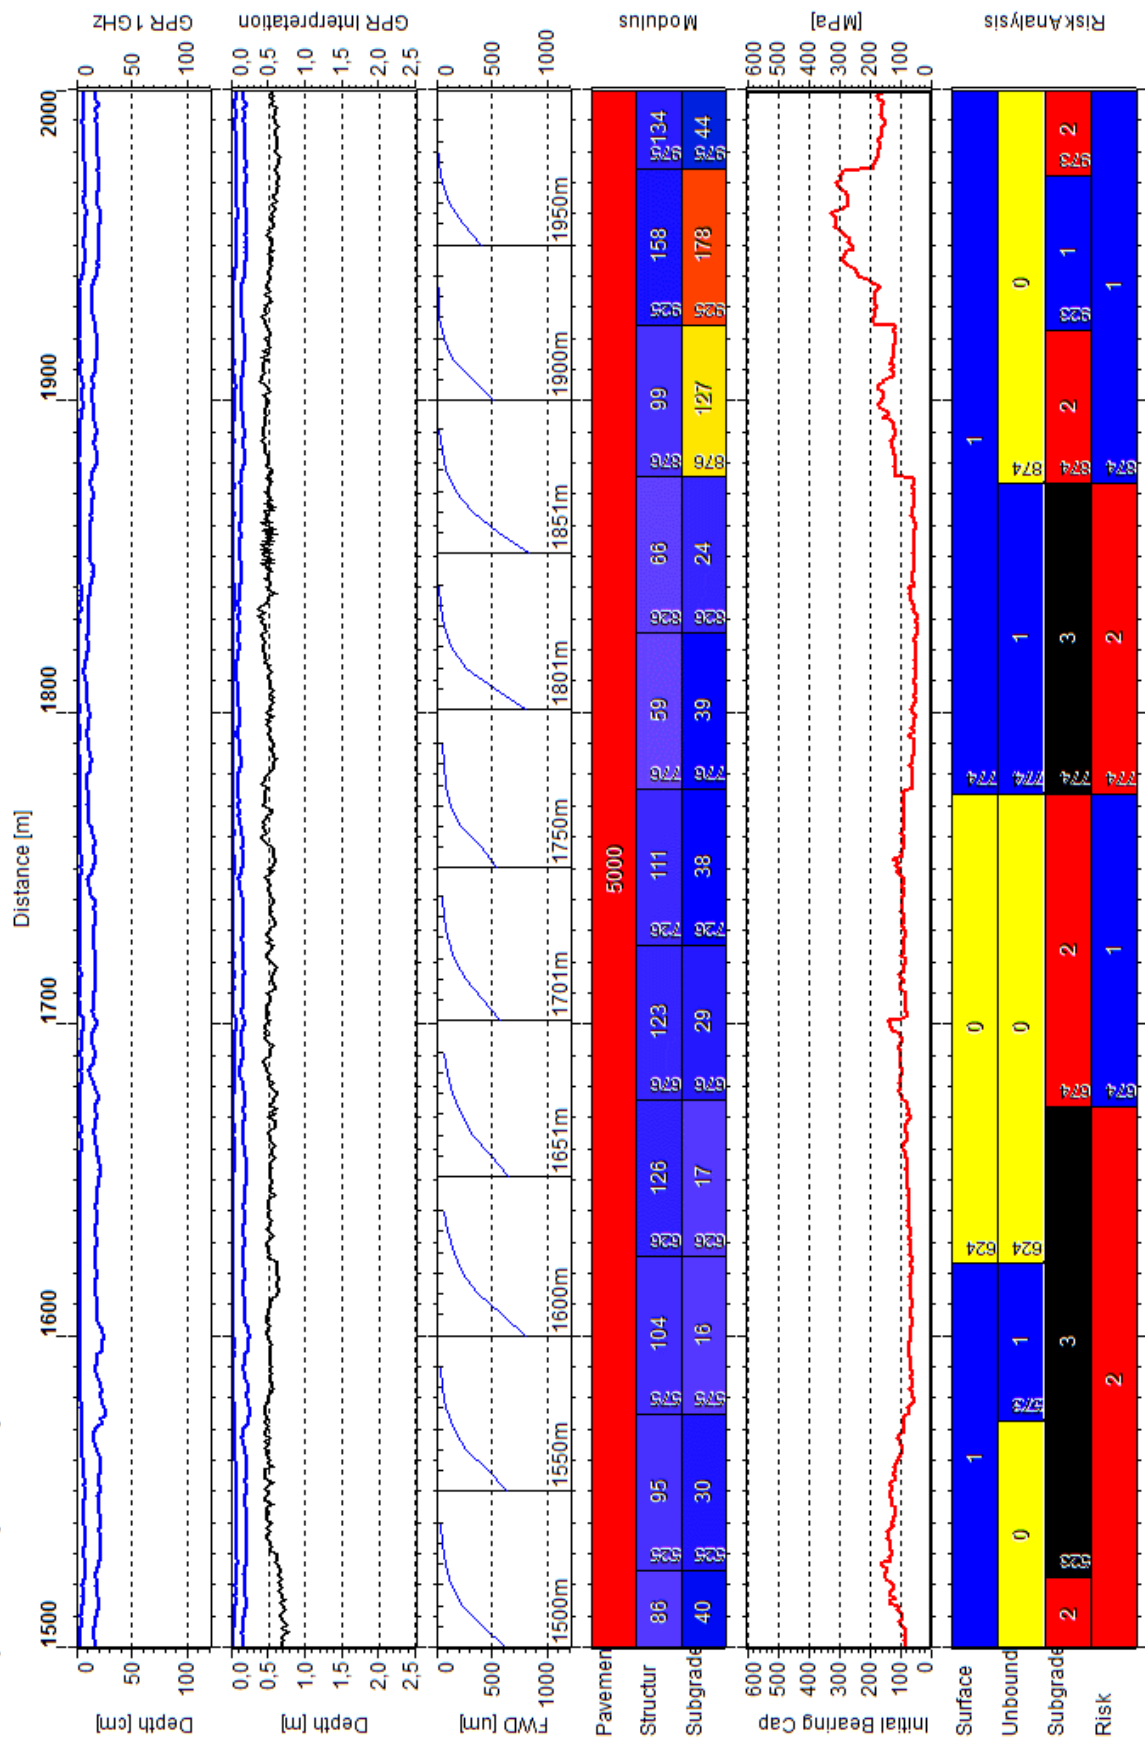
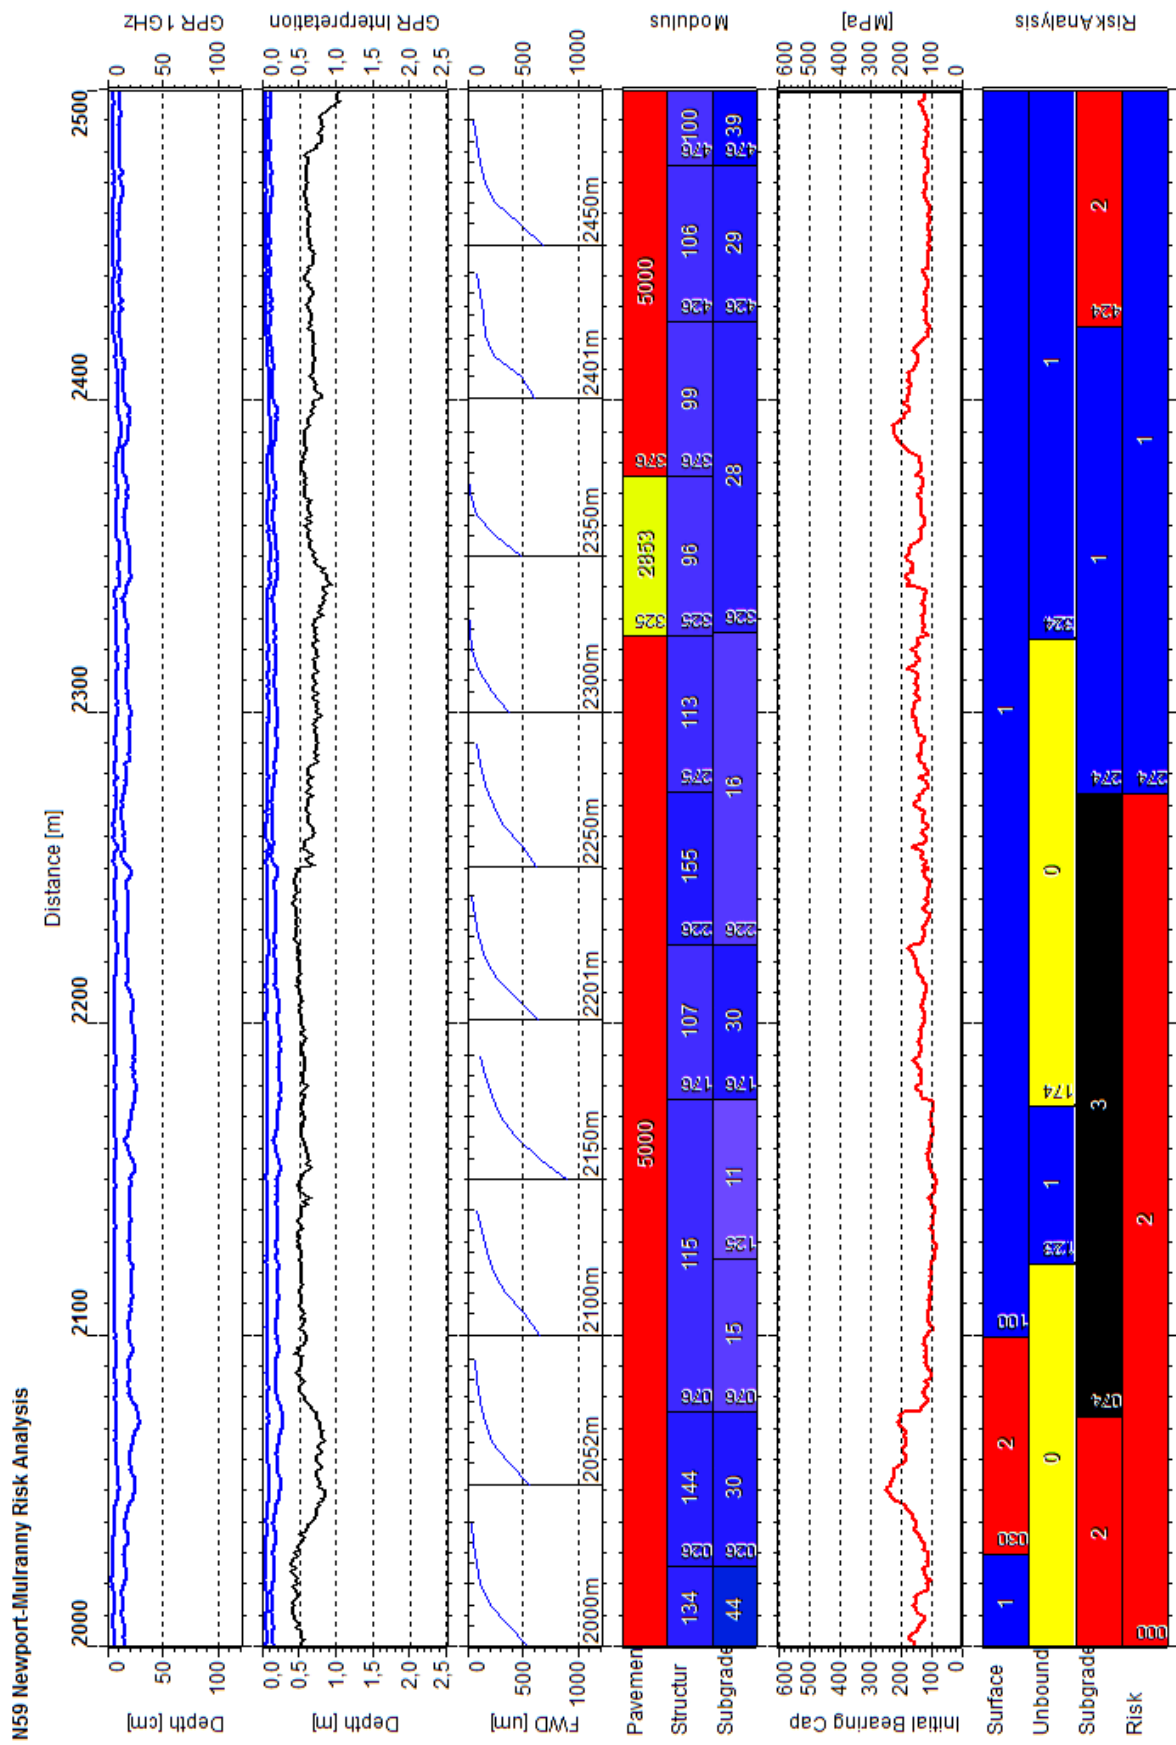
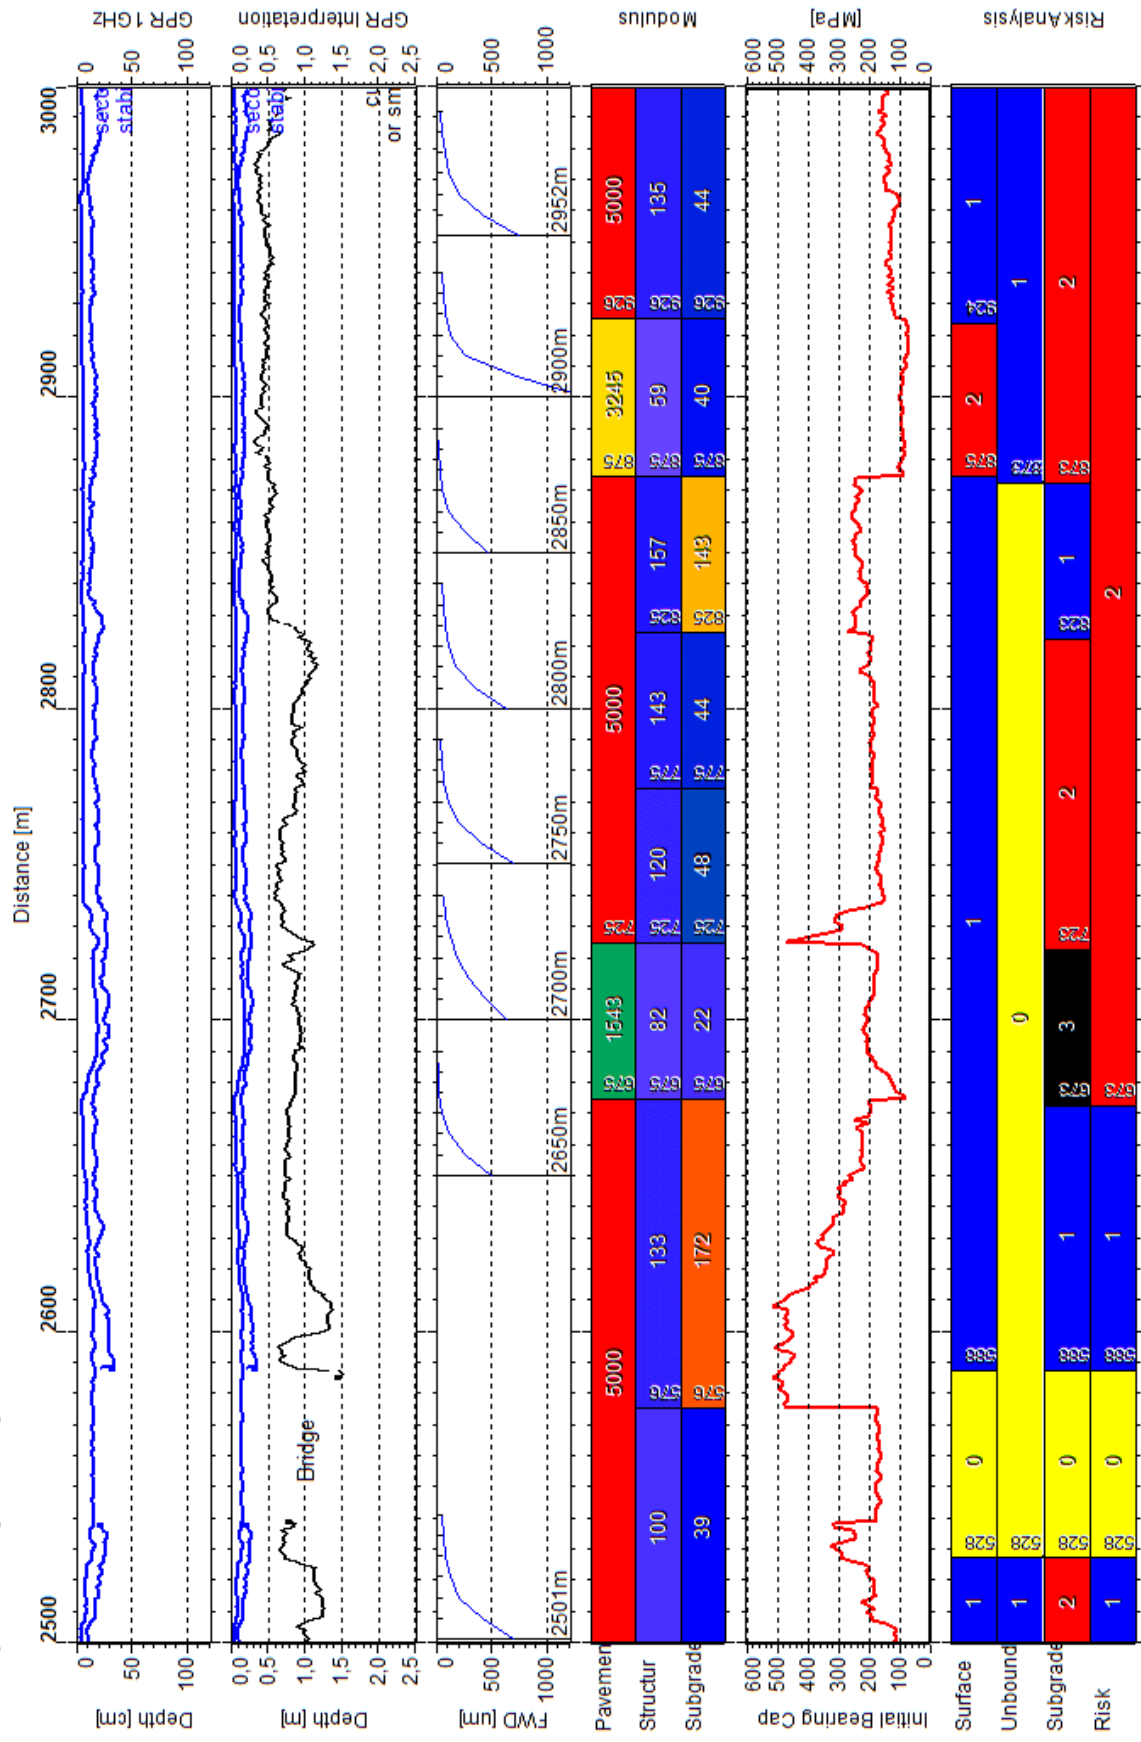
APPENDIX 3

N59 Newport-Mulranny Risk Analysis
