Petri Varin, Bruce Wiljanen

RISK ASSESSMENT OF ROAD N59, NEWPORT TO MULRANNY, COUNTY MAYO, IRELAND

Demonstration project report

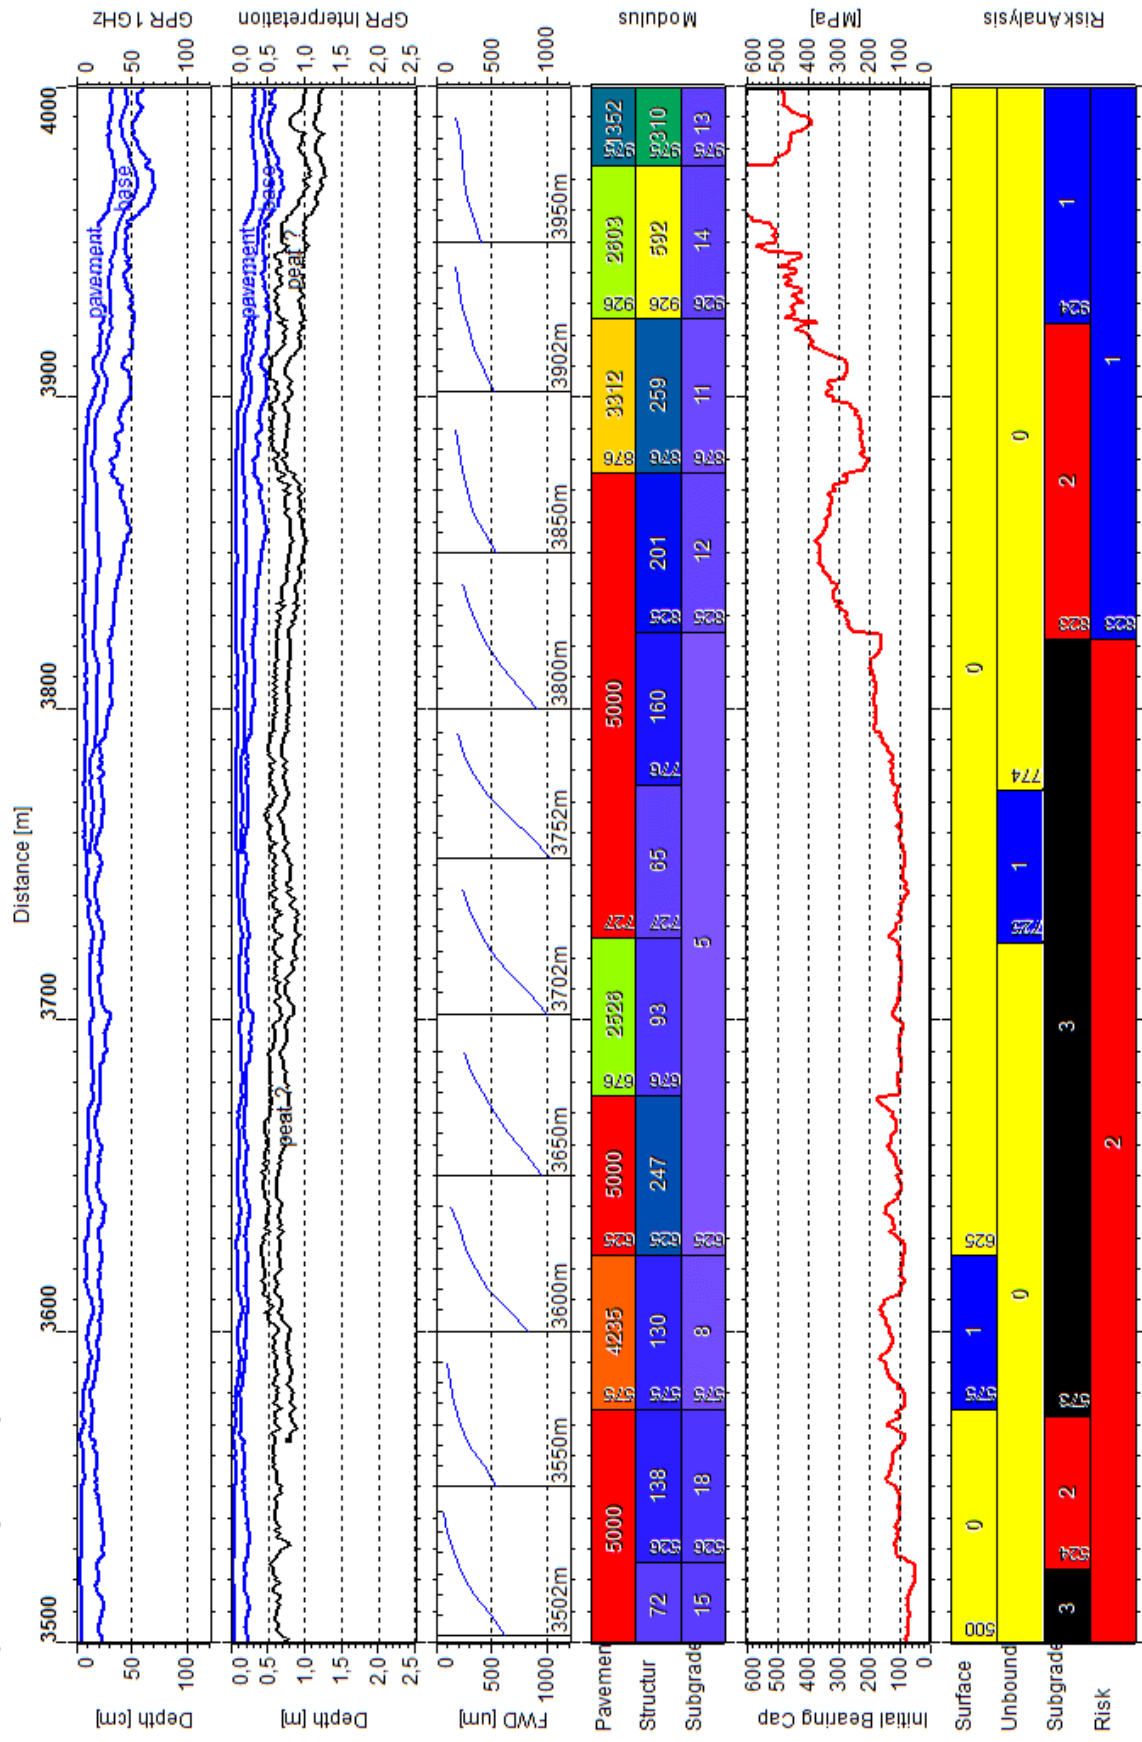
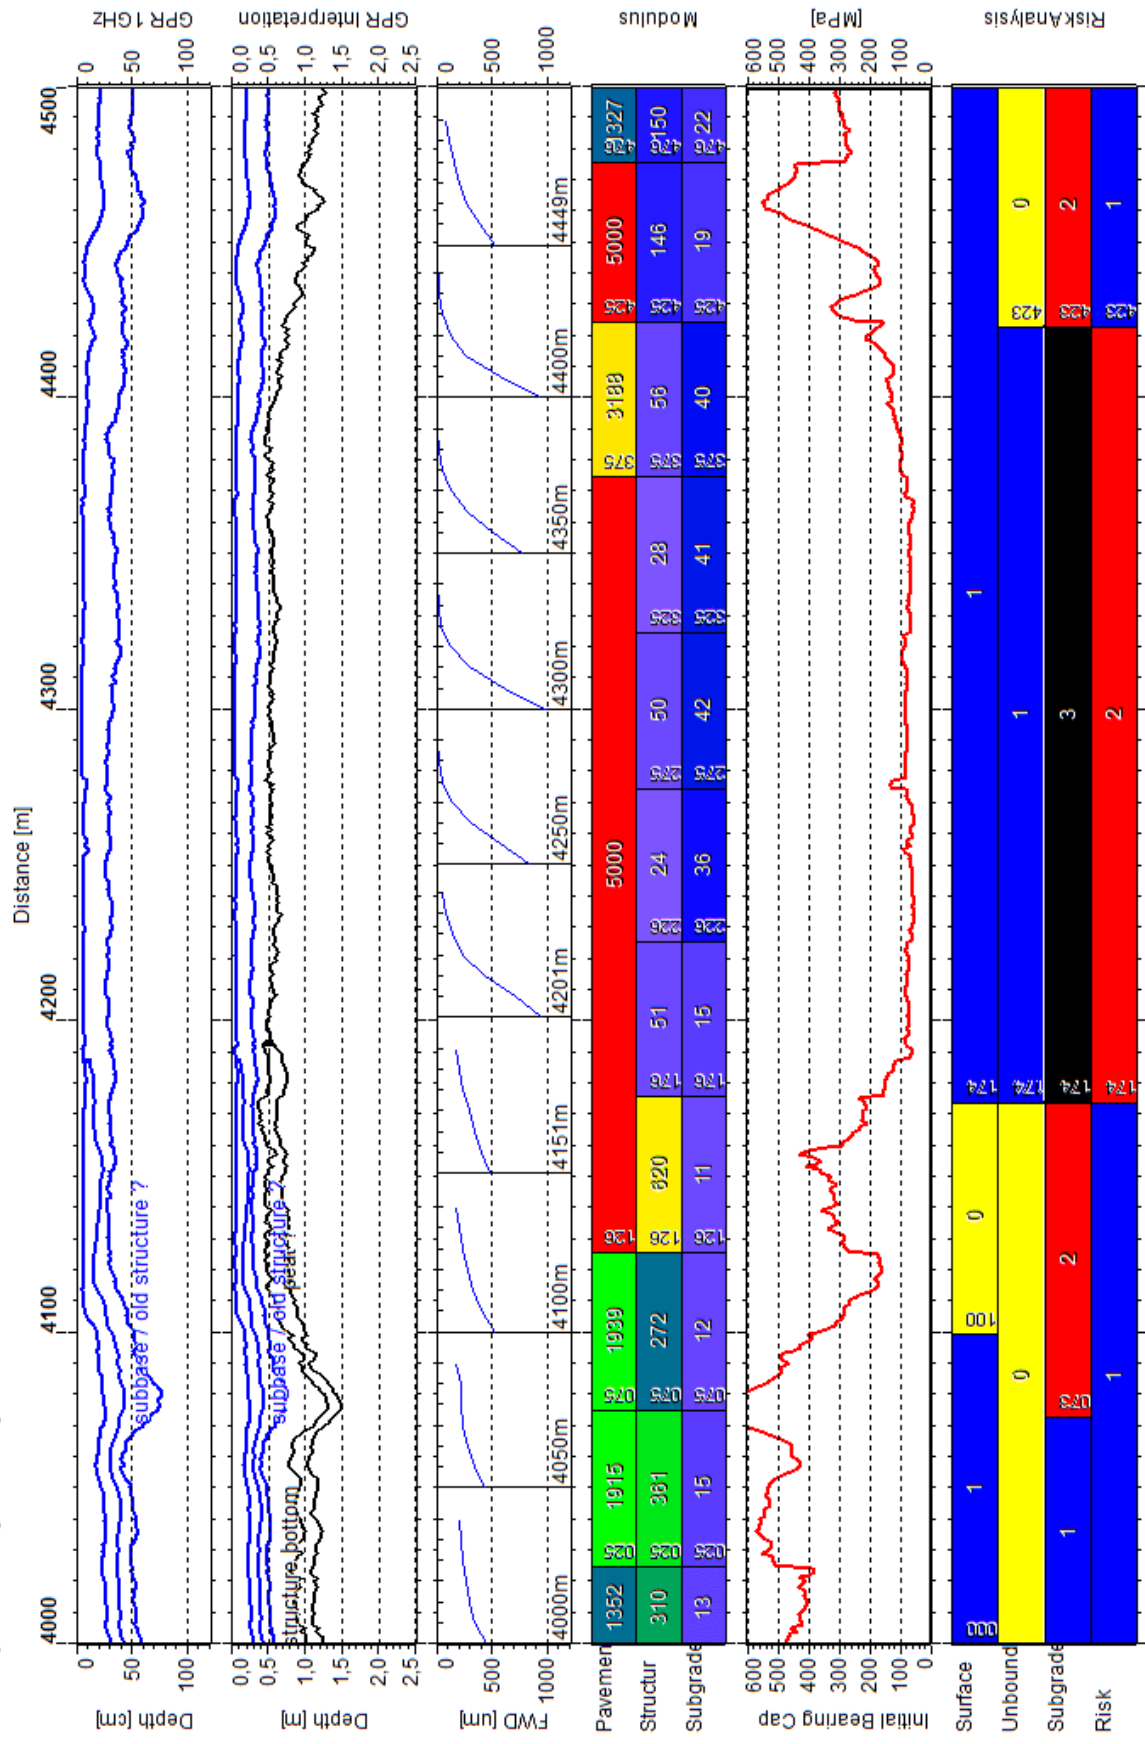
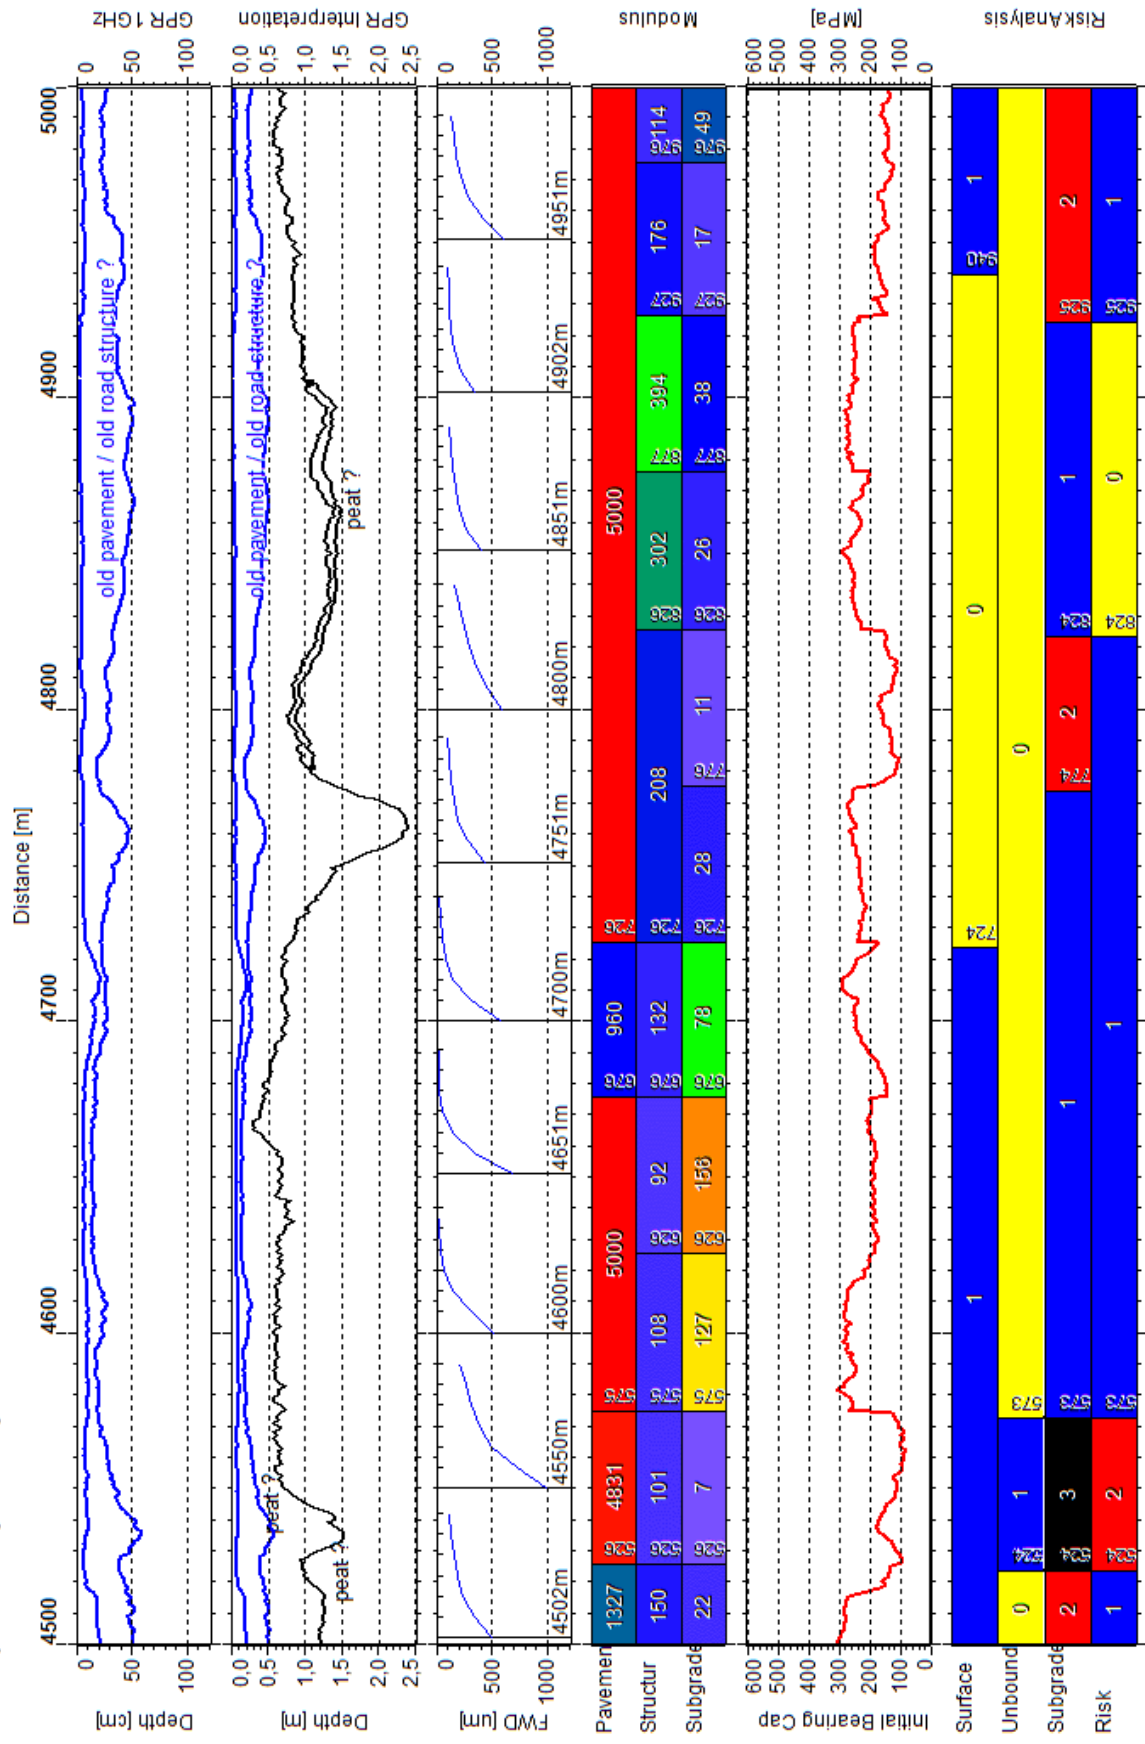
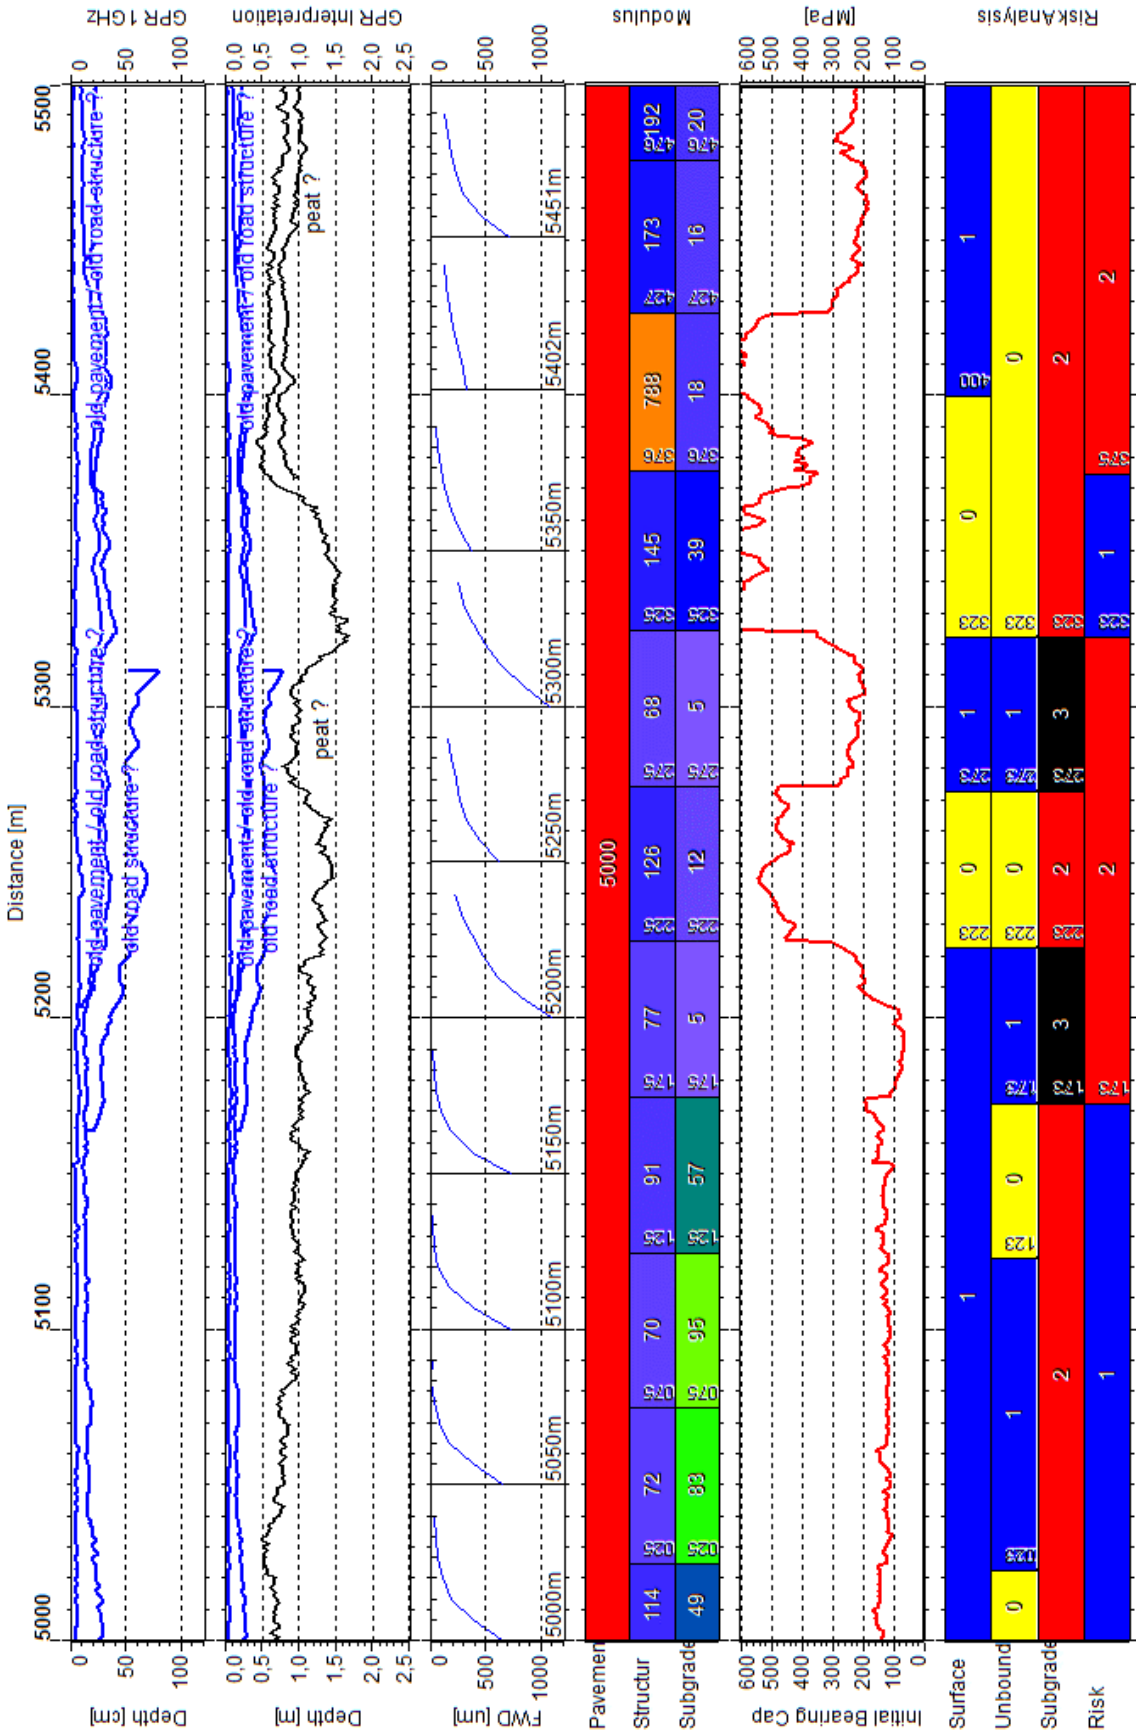
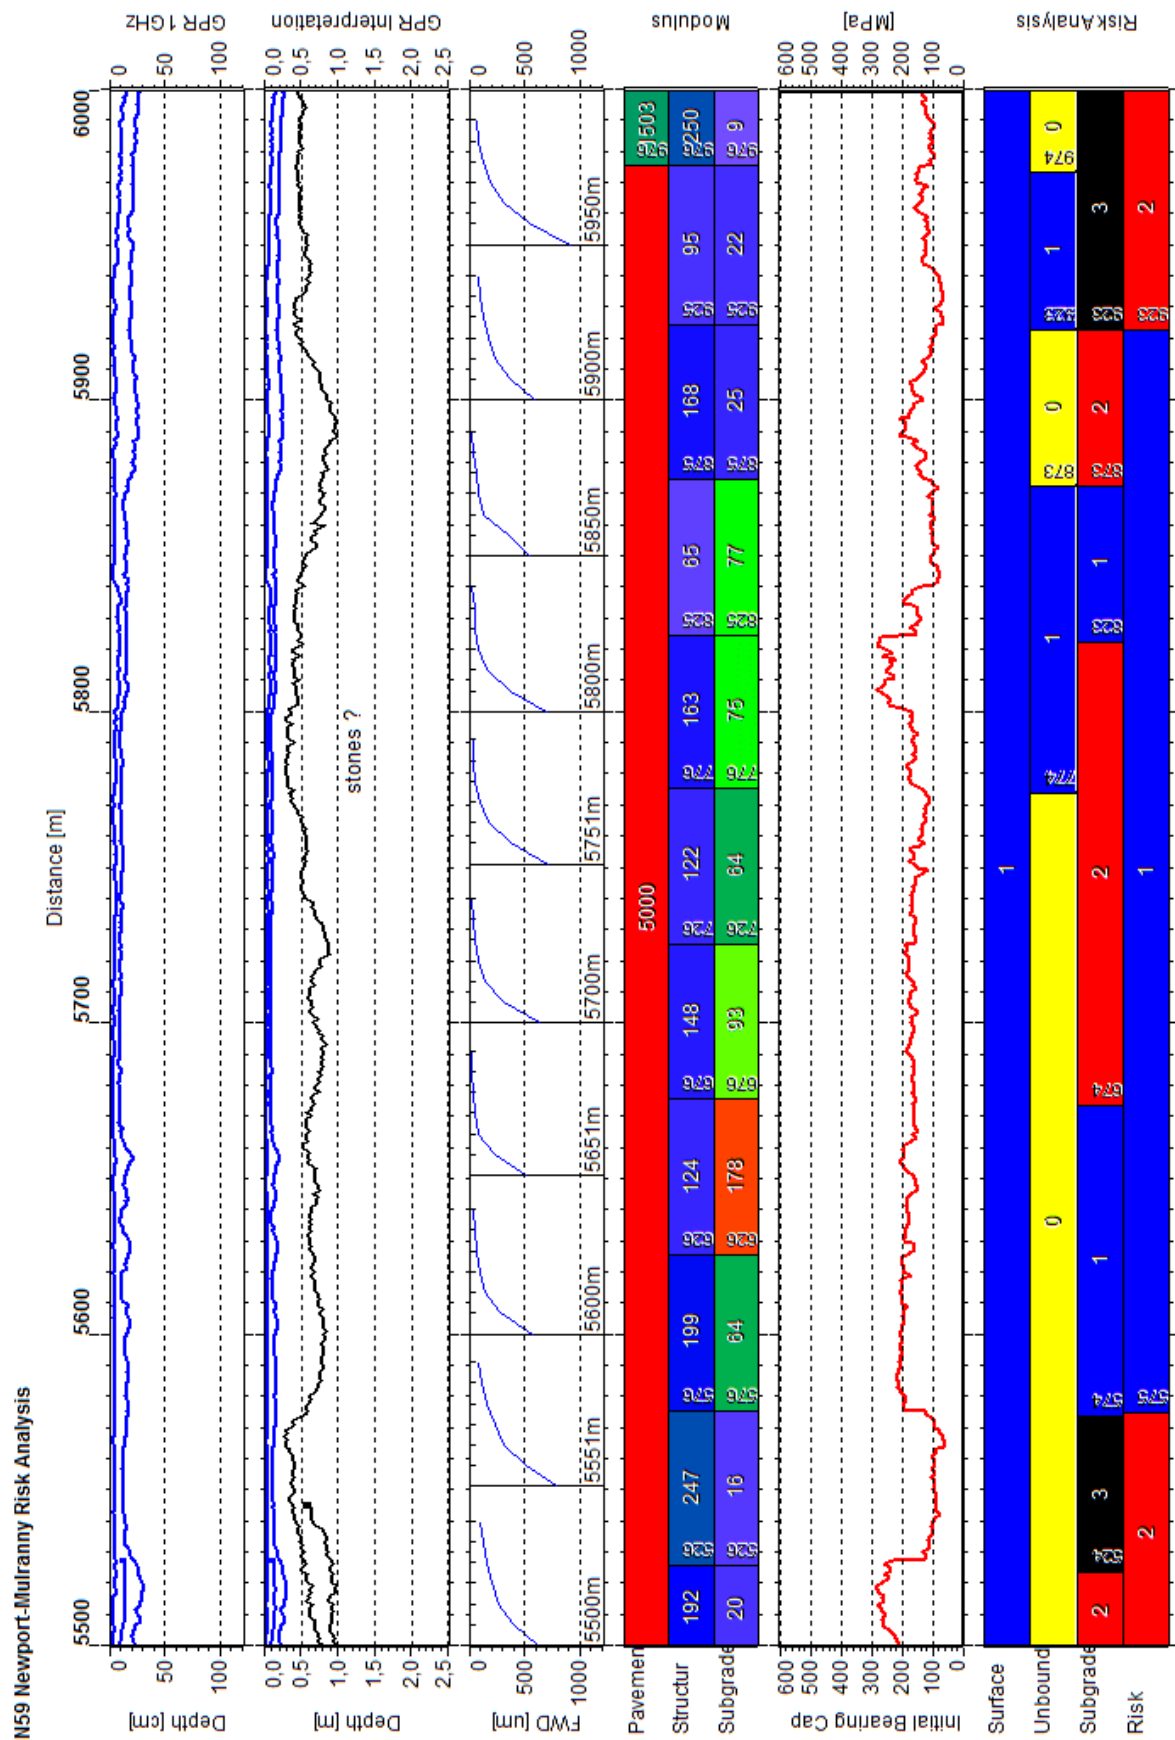
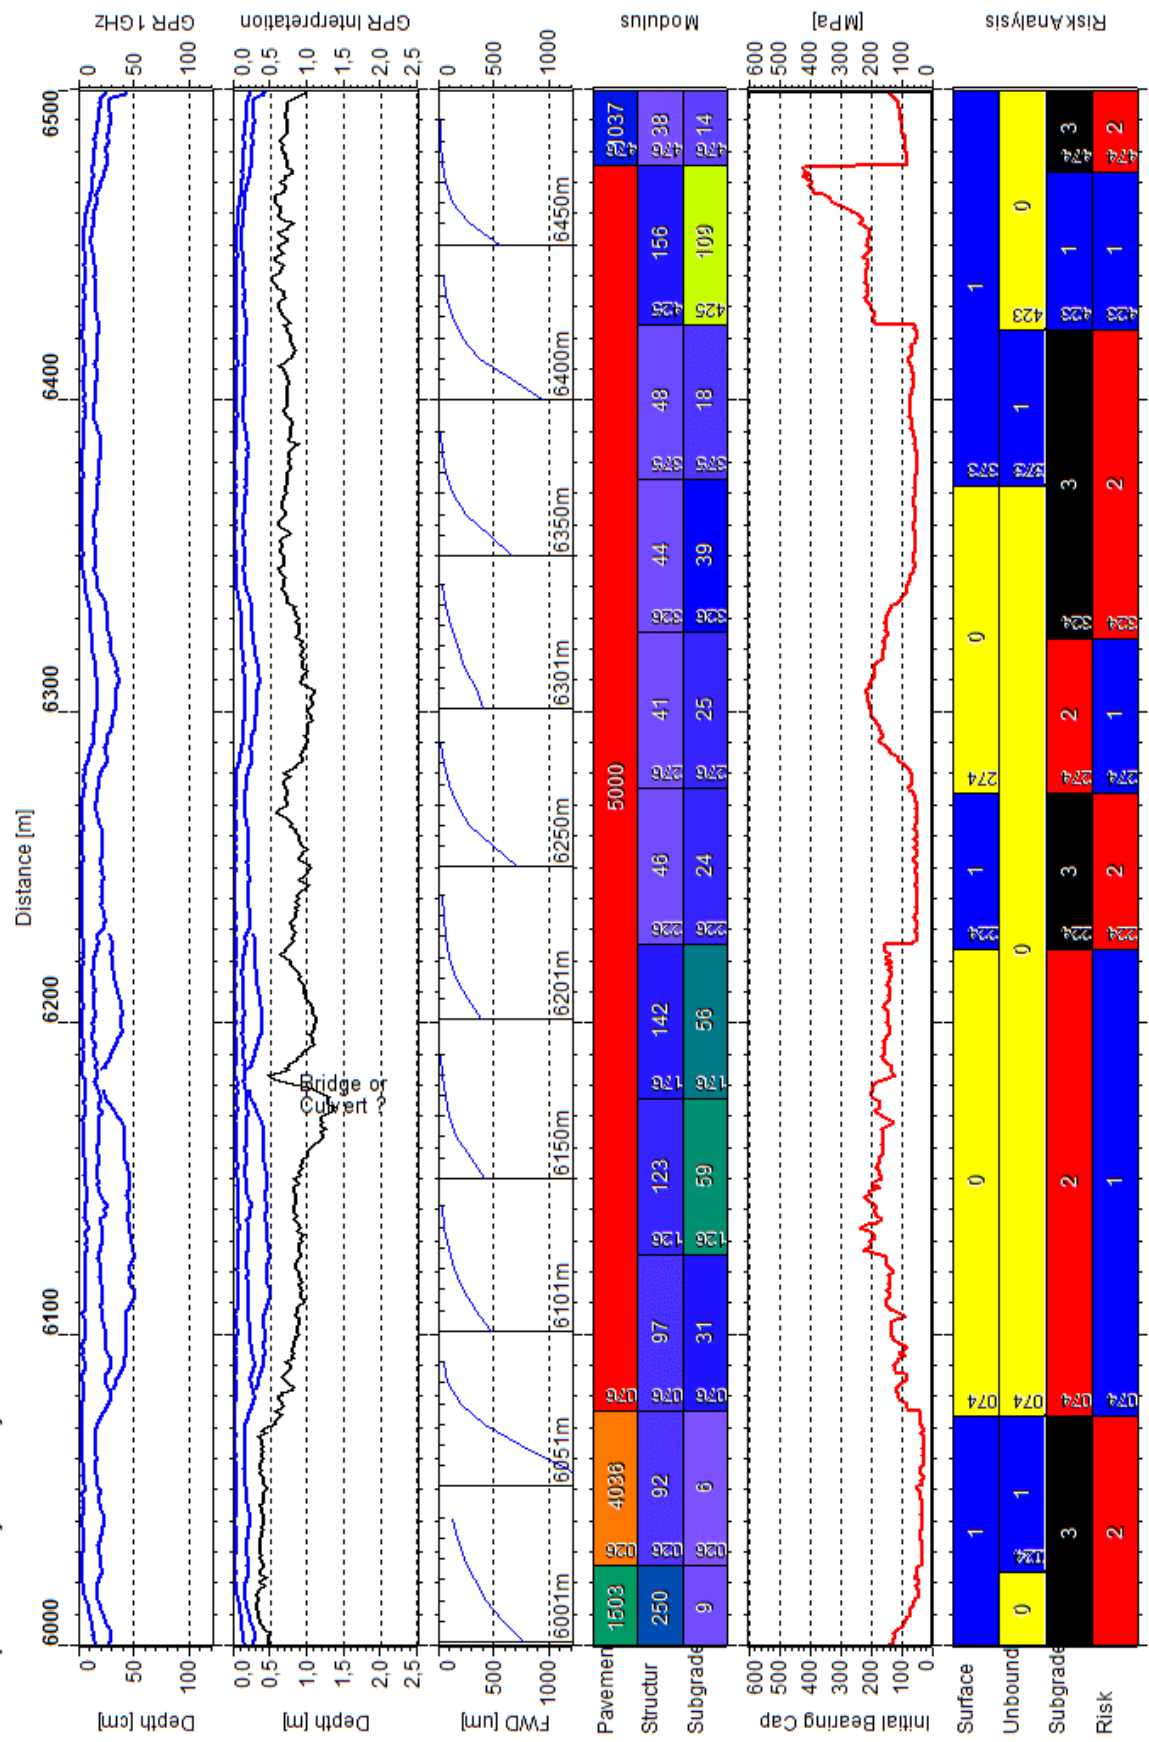
N59 Newport-Mulranny Risk Analysis

The risk evaluation was carried out through separate analysis of the condition of 1) the surface layers, including the performance of pavement and top part of the base (0-200 mm), 2) the unbound layers and 3) the subgrade. These analyses were based on the FWD data and GPR data.

A Class 2 and Class 3 failure risk was predicted for 6092 m of the road section (approximately 39 % of the total length). Approximately 61 % of the road (9384 m) had a reasonably well working structure with a rating of better than Class 2, i.e. failures only predicted after long continued heavy transportation.
