ROAD CONSTRUCTION IN GREENLAND – THE GREENLANDIC CASE

October 2007

ARCTIC TECHNOLOGY CENTRE

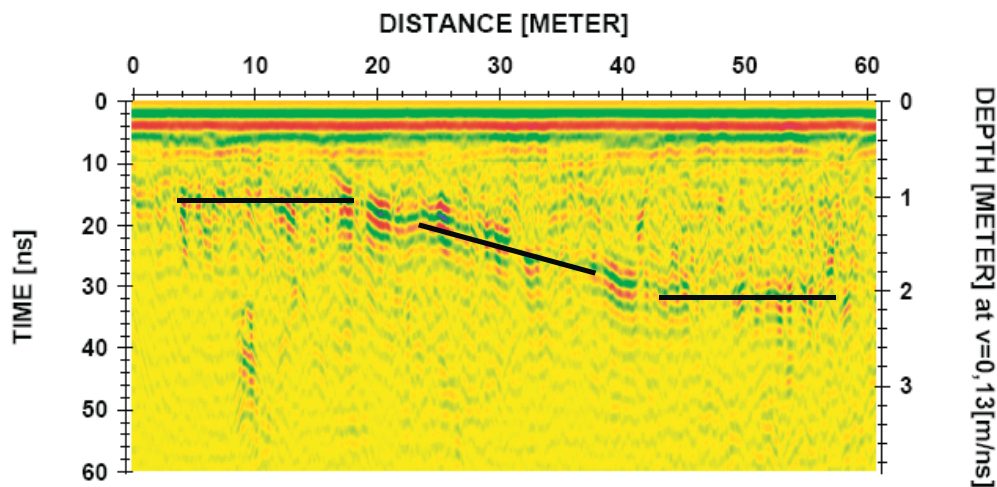
Figure 6. Radargram fra Sisimiut Airport. The black lines indicate the difference in depth to a reflector below the sunken area (to the right) and the adjacent area (left).

The present results does not allow us to determine the precise cause of the sinking, but it is evident that the sub-surface structure is different in this area.

Geophysical investigations in the area around Sisimiut Airport were carried out in August 2006. The main aim was to investigate the reason for sinking that has occurred in the northern part of the landing strip. The georadar study provided an overall impression of the sub-surface nature of the area. Figure 6 shows a radargram from one of the georadar profiles (the depth-scale is only approximate), which clearly shows the difference in depth to a reflector under the sunken region compared with the rest of the area.

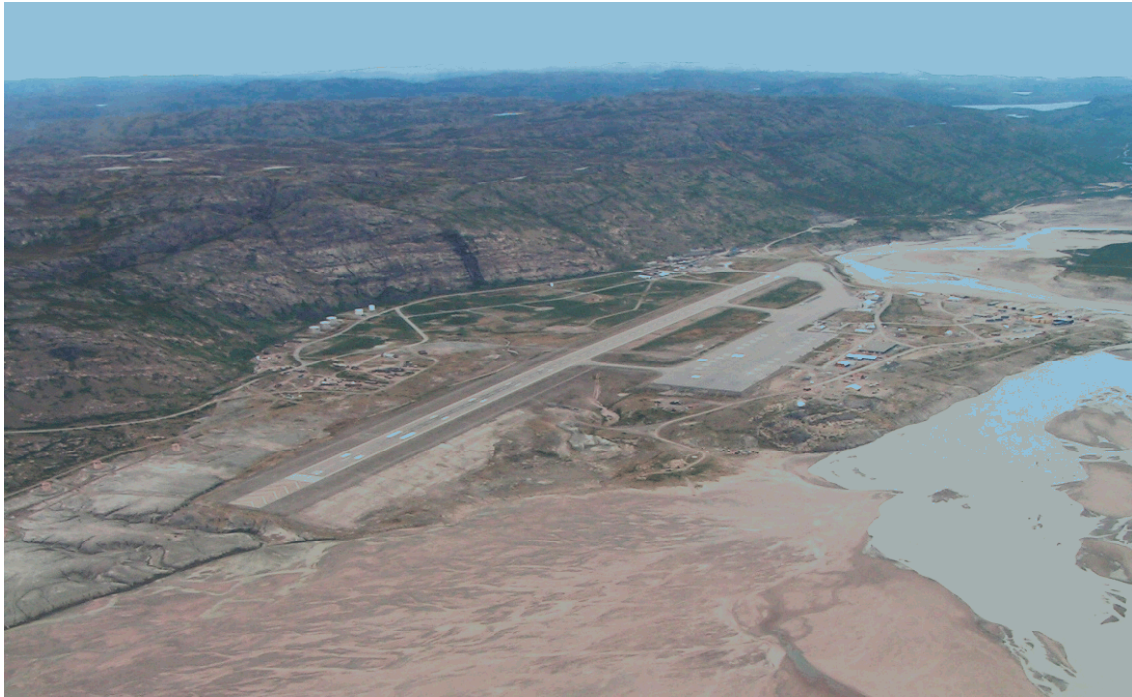
Figure 8. Kangerlussuaq Airport. Georadar investigations have been carried out in the southern apron to the right of the landing strip in this photograph.

In the autumn of 2000, three test areas on the apron were painted white to avoid sinking of the asphalt cover during thawing of the permafrost. One of the white-painted areas was used for georadar measurements to compare the annual behaviour of the frost level under normal black asphalt with that under a more reflective surface. The first measurements were taken in the summer of 2005 when a drill core to a depth of 15 meters and a small excavation down to the frost level were also carried out. The results from the drilling and excavation were used to determine the rate of propagation for the electromagnetic waves so that the true depth to the frost level could be determined in 2006 and 2007. The georadar measurements showed a clear relationship between the use of a reflective surface and a reduction in the annual variation in depth to the frost level. At the end of the summer (August) the difference in depth to the frost level is almost 20 ns, equivalent to a depth of almost 0.9 meters. This illustrates the thermal effect of a reflective surface compared with a normal black asphalt surface.

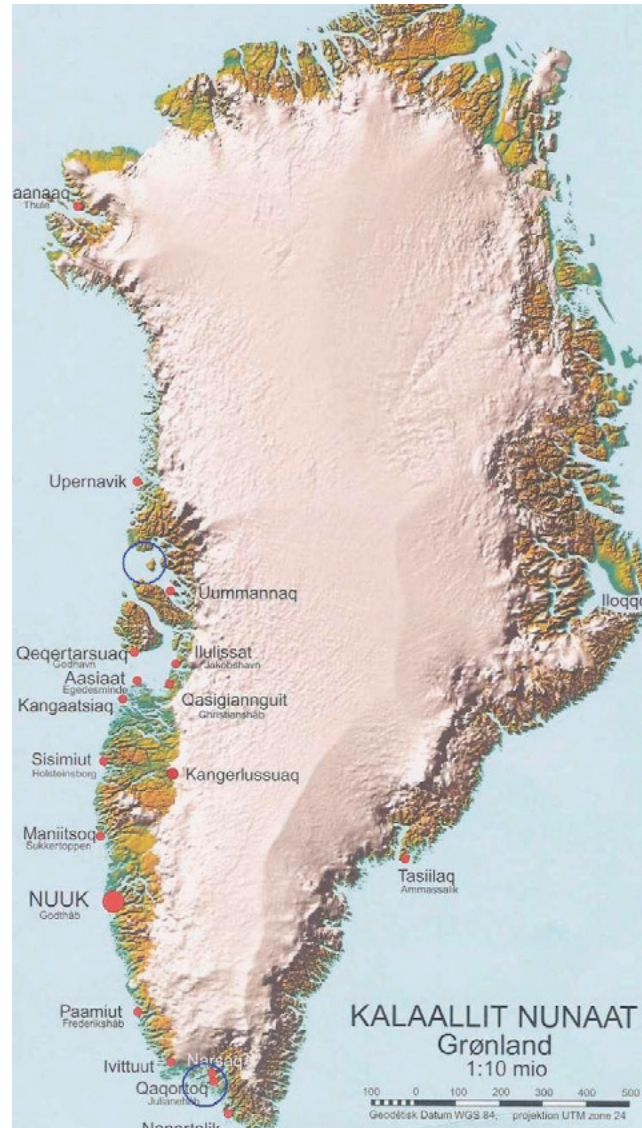
Figure 9. Locations (circled in blue) of areas near Narsaq in South Greenland and Illorsuit on the northern west coast where road studies have been carried out.

villages, there are, for example in the sheep-farming districts of South Greenland, gravel roads between the sheep farms and the nearest village. Several studies have been carried out of roads in South Greenland between grazing areas and villages, and also in the village of Illorsuit in North Greenland. Both areas are indicated in Figure 9.

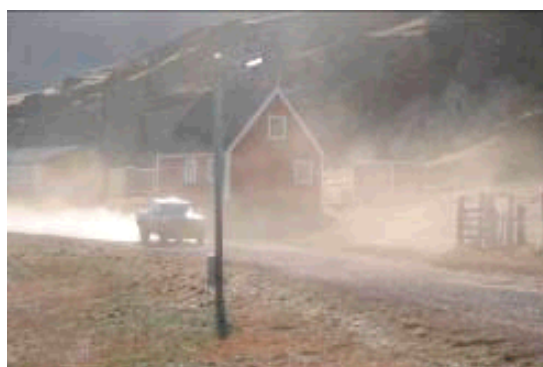
Figure 12. Loose gravel is widespread over the entire road surface. In dry weather this gives severe dust problems along most of the road which is detrimental for the population of Qassiarsuk. The road has a poor crossfall, and there are many potholes.

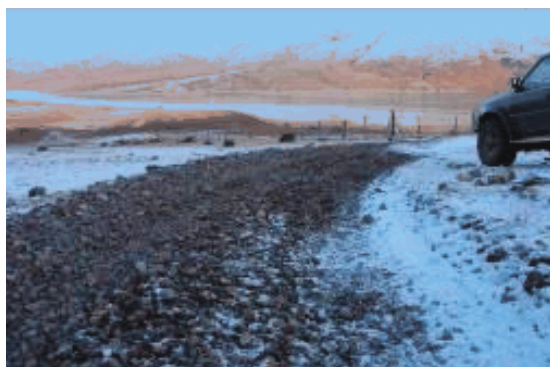
Figure 13. At bends in the road there are too many loose stones. This results in stones accumulating at the roadside and "excavation" of the road into a shallow ditch. The loose stones can also cause cars to skid dangerously.

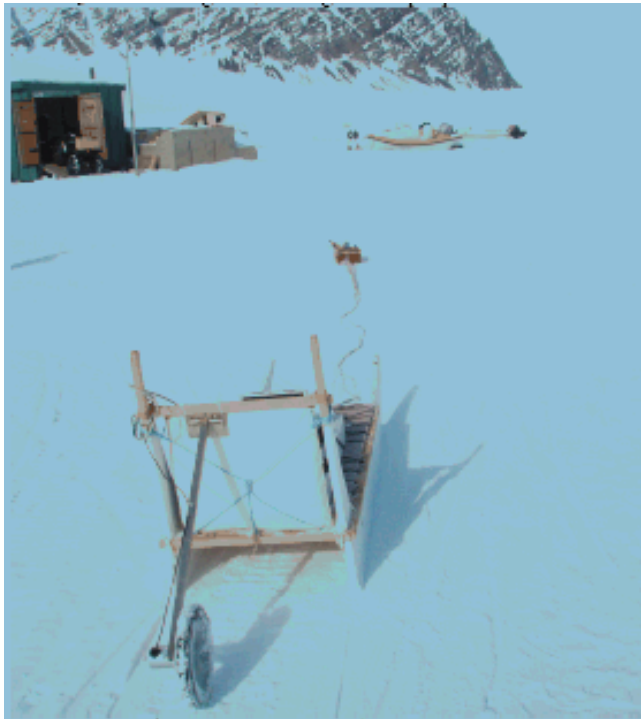
Figure 14. Instrument layout using a dog sledge. The georadar antenna is the red box in front of the sledge which pulls a measuring wheel.

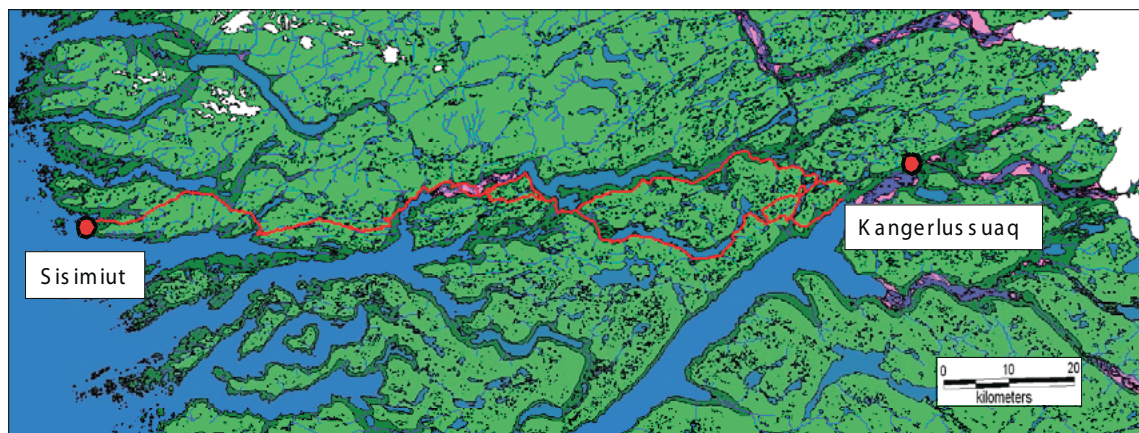
Figure 15. Map of the road route and surrounding area between Sisimiut and Kangerlussuaq. The map is based on the GEUS digital map on a scale of 1:100.000.

Figure 15 presents an overview of the area in which the road is planned. The map is based on a GEUS digital map on a scale of 1:100,000. The planned route is indicated by a red line on the map. In addition to this there are hiking maps on the same scale published by Scankort (3 map sheets: Sisimiut, Pingu og Kangerlussuaq), as well as maps on a scale of 1:250,000 published by Saga Maps. The entire stretch was photographed from the air by Scankort in 2003, who produced orthophotos and a digital contoured model, with a width of several kilometres, for the complete planned route for the road. A total of 386 pictures were taken. The flight altitude was such that a width of ~2300 meters was covered at a scale of 1:10,000. The flight path was selected

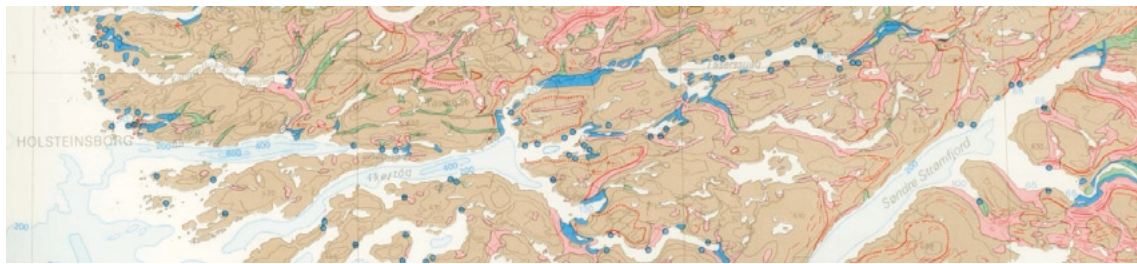
Figure 18. Part of the Greenland Geological Survey Quaternary geological map of West Greenland on a scale of 1:500.000. Brown areas are pre-Quaternary basement rocks which locally have a thin cover of sediments. Blue areas symbolise extensive marine deposits. Pink areas indicate extensive moraine deposits. Green areas consist largely of fluvial sediments. Significant moraine landscape features are indicated by red lines and the direction of ice flow is shown by red arrows (glacial striations) (GGU 1974).

The upper marine limit in the area is now located at between +120 and +140 m above present sea level at the western end of the area, decreasing to +40 m in the eastern part near Kangerlussuaq. This means that marine deposits occur in valleys and depressions in the area. These deposits may be overlain by fresh water sediments of fluvial or lacustrine origin (Figure 18).

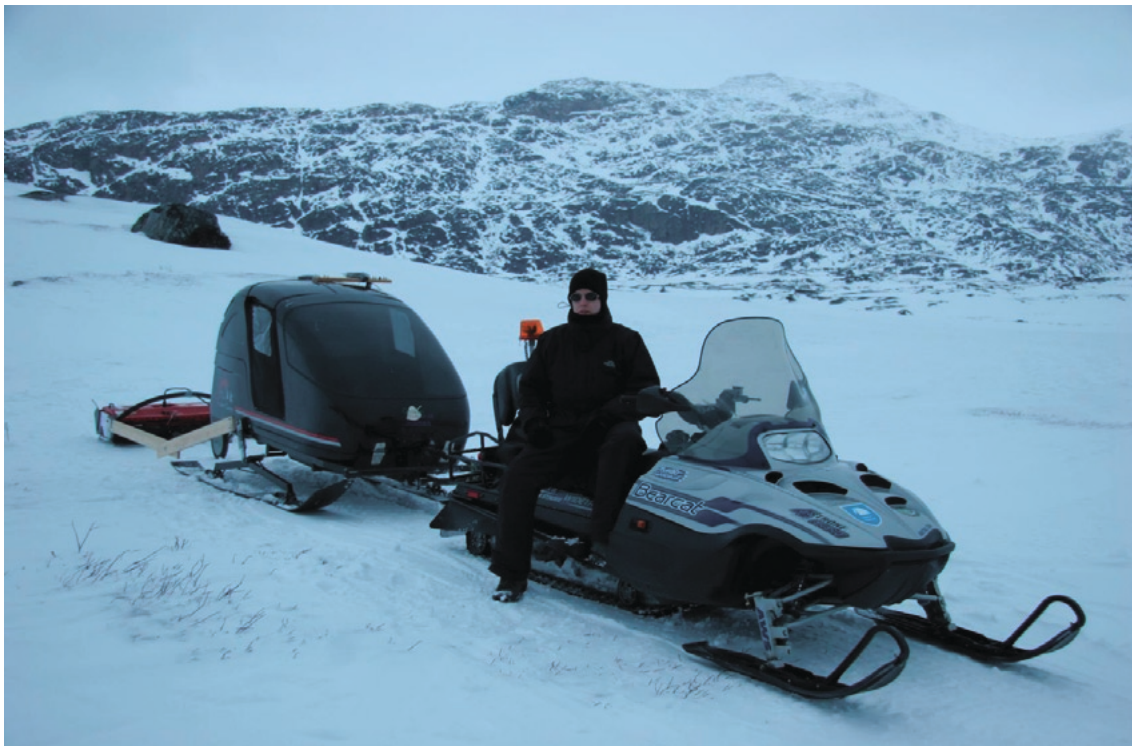
Figure 20. Making georadar measurements using a snow scooter

That part of the sub-surface that thaws during the summer period is called the active layer and it here that the characteristic permafrost phenomena develop. The thickness of the active layer varies systematically with the extent of the permafrost. If a road is built over a permafrost-affected area, the thermal balance will be changed and the depth to the frost line will decrease. In order to decrease frost-heave it is necessary to use frost-resistant material with low capillarity to construct dams in order to prevent addition of more water to the freezing zone. Another problem with road construction in permafrost areas is related to the thawing of already frozen soil when changes in the surface reflection of the sun's rays can result in thawing of the underlying soil. This can affect the strength properties of the soil and give rise to local sinking. Even the passage of cold water in the form of rain or melt-water can give rise to thawing of frozen subsoil so that effective drainage of the road construction must be achieved. All in all it is important to keep the soil frozen, at capillary-inhibiting material is used in the construction, and that there is effective drainage. The figures 19 and 20 show studies of permafrost in progress.

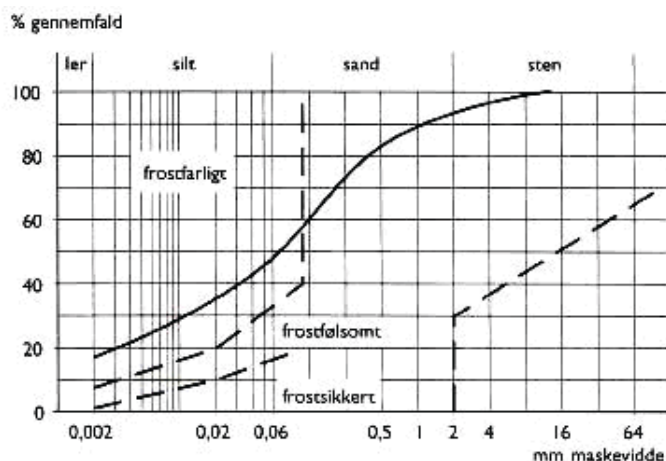
Figure 22. Schaible's criterion for frost-risk can be read off the sieving-curve. The figure is divided into three fields – one frost dangerous, one frost susceptible and one frost safe area.

The method used to assess the frost-risk of material compares its grain size distribution with Schaible's boundary curves (Figure 22). Frost-risk can generally be avoided if the grain size curves lie inside the frost-safe area in the figure.

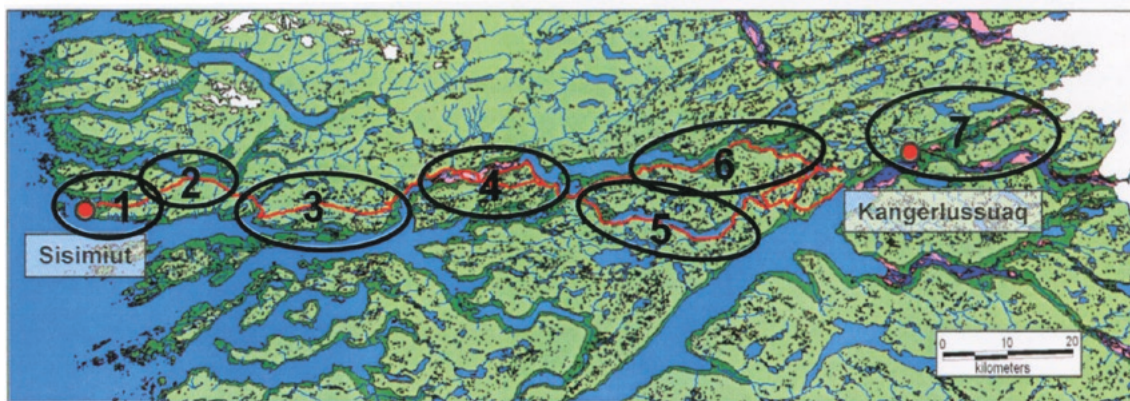
Figure 23. Location of the 7 areas along the length of the planned road from Sisimiut to Kangerlussuaq.

The ~170 km long stretch between Kangerlussuaq and Sisimiut has been divided into 7 areas starting from Sisimiut (Figure 23). The areas are as follows: 1: Sisimiut, 2: Første Fjorden, 3: Uttoqqaat, 4: Itinneq, 5: Amitsorssuaq, 6: Taserssuaq and 7: Kangerlussuaq. Over the last few years, students from The Technical University of Denmark and Aarhus University have collected geophysical data in the form of geoelectric profiles and probes together with seismic, georadar and measurements with the stangslingram, as well as drilling boreholes, photography and collecting soil samples along the entire stretch. The following is based on the reports produced by these students. A list of the relevant reports is presented in Appendix 4.

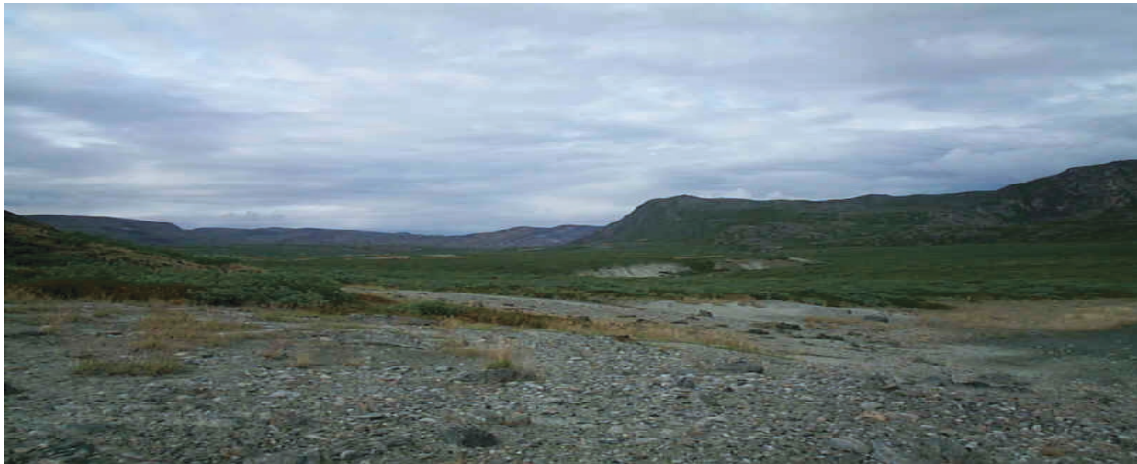
Figure 30. Type of location from where road-building material can be obtained.

The presence of frost-heaved stones in the area indicate the presence of ice wedges. In a low-lying area, permafrost has been found at a depth of ~0.4 m and inactive ice wedges, consisting of silt and fine-grained sand, together with pingo-like structures. The fine-grained material indicates that permafrost is widely developed which can be expected to give severe problems with regard to stability. Rock-fall material from the valley sides is quite widespread and could be used as road-building material, and there are no large variations in topography. Figure 30 shows the type of location from where road-building material can be obtained.

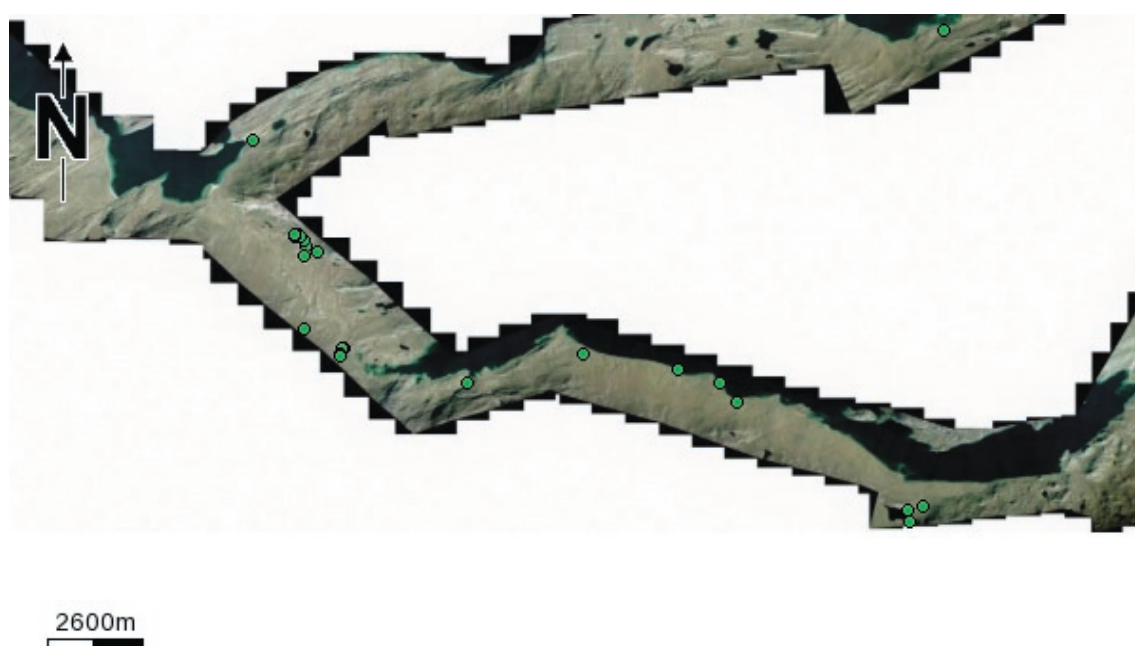
Figure 32. Aerial photograph showing soil sample localities in the Amitsorssuaq area. The southern shore of the Amitsorssuaq lake is visible in the photograph.

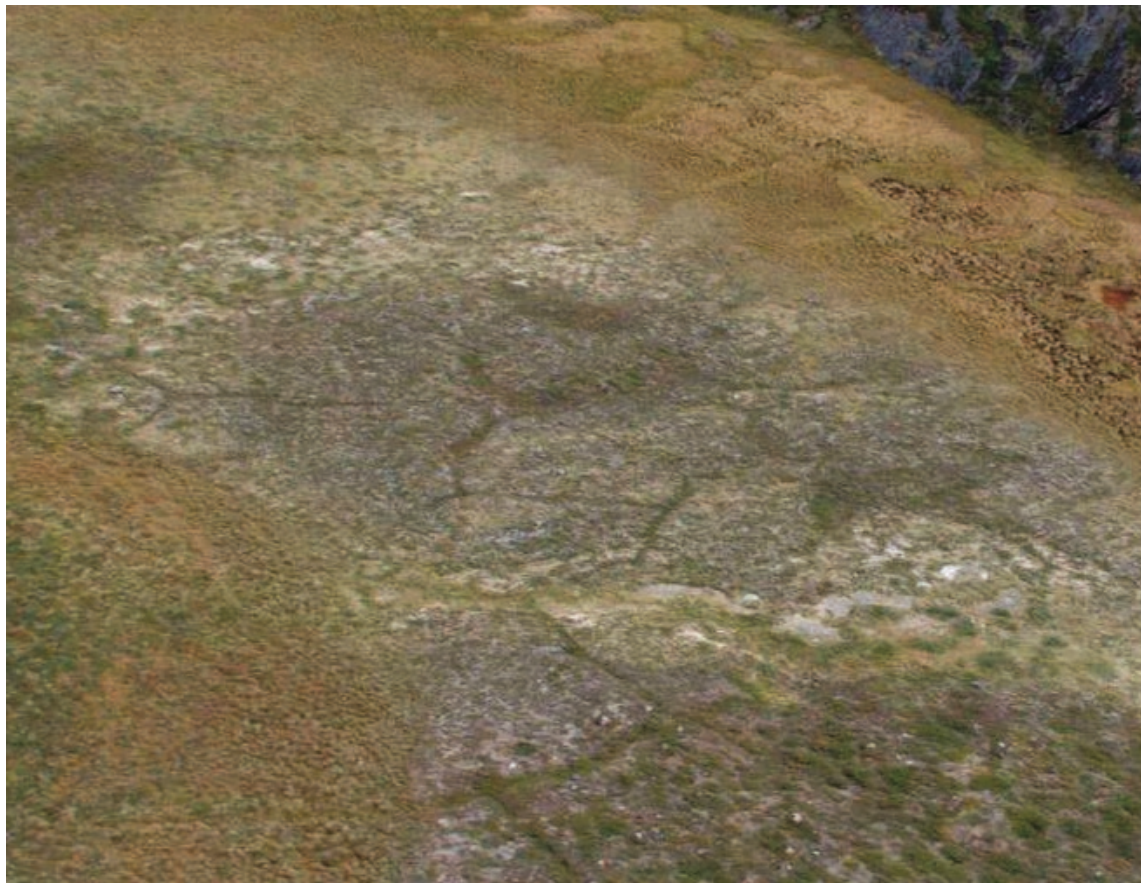
Figure 33. Aerial photograph of area with relict ice wedge polygons.

Taserssuaq: The geology in the area reflects a landscape which was formed by the interplay between glacial retreat and isostatic uplift. The area consists of a large, broad valley at ~100 m a.s.l., with basement rocks to the north and south. The area contains mainly silty and fine sandy marine deposits. The marine deposits are well preserved in the slopes down to lakes and waterways. The north-eastern slopes in particular have many locations with marine deposits that have been influenced by permafrost and considerable wind erosion. There are several terraces that represent earlier levels of the sea. There are also inactive ice wedge polygons, and at one locality permafrost was found at a depth of 0.8 m. The area with the polygons is on the valley floor and will often be in the shade because of the cliff to the south (Figure 33). A total of 16 sediment samples have been collected to cover the various types of deposit (Figure 34).

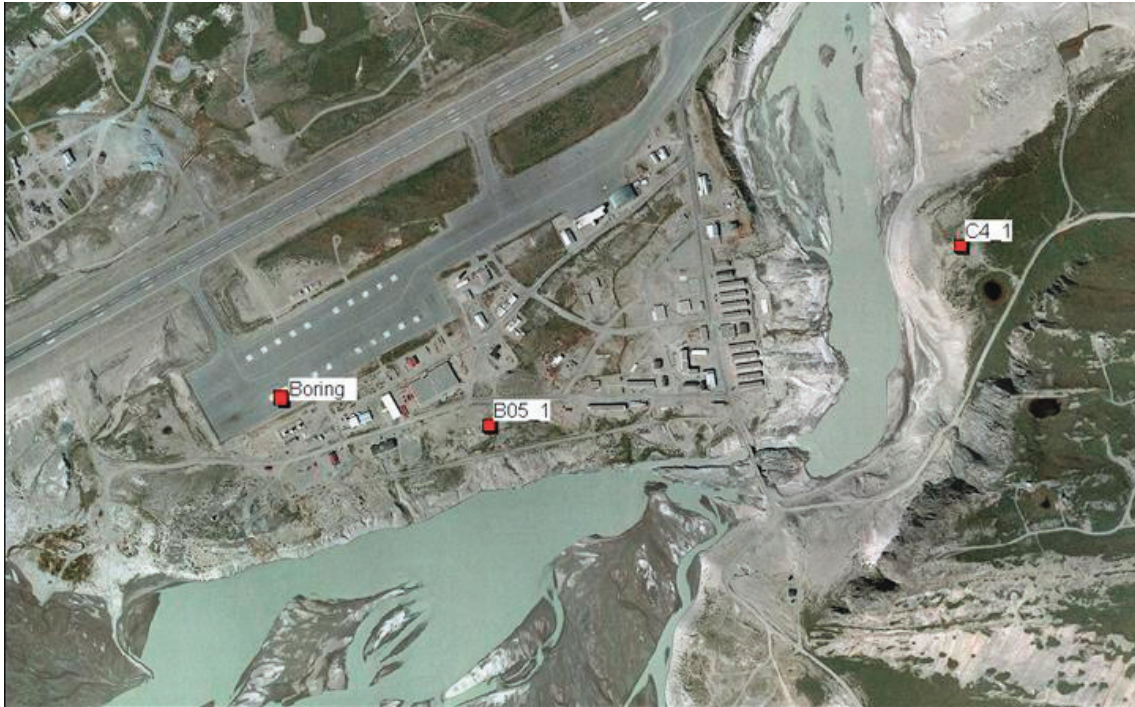
Figure 35. Location of boreholes C4_1 (Boring) and KAN 2005-01(B05_01) in Kangerlussuaq. The asphalt-coated airstrip is located to the left.

Two deep boreholes and one shallow manual hole were drilled in 2005 (Figure 35). Borehole 2005-01, near Watson river, contains ~4 m clay and silt deposits above a thick sequence of coarse sand of fluvial origin. The frost level in the borehole, which was drilled in July, was at 1.4 m and up to 4 cm-thick ice lenses were found in the

fine-grained deposits. Thermal probes that were installed have shown that the active layer has a thickness of 2.8 m (Ingeman-Nielsen et al., 2007). Boreholes at the airport (southern apron) showed that permafrost was present at a depth of 4 m in July 2005 beneath black asphalt (Jørgensen & Andreasen, 2007). The manual borehole (C4-1) revealed un-frozen sandy deposits down to a depth of 2 m. An electric probe in the same area indicated permafrost at a depth of ~2.8 m.

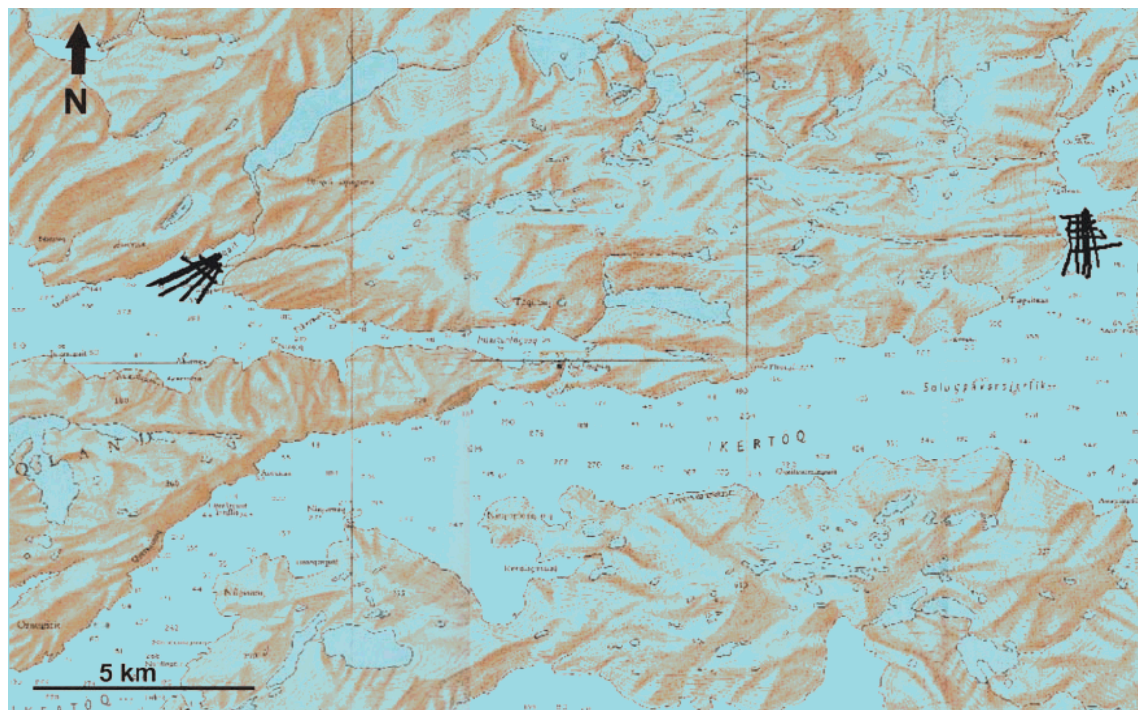
Figure 40. Location of the two areas where seismic studies were carried out in the summer of 2004. The two areas are located in Amerdloq near Uttoqqaat to the left and Ikertoq (Maligiaq) to the right.

Boomer seismic is a high resolution marine seismic method that uses a source with a high frequency. This frequency, which lies in the range 0.4-5 kHz, has a theoretical resolution of ~1 m, and the boomer can reach to a maximum depth of >100 m. A boomer consists of a capacitor that is charged by a transducer that consists of two flat, parallel plates. An electric current is formed between the plates and suddenly forces them apart by magnetic repulsion. This gives rise to an area between the plates with low pressure. The surrounding water flows towards the low-pressure area, forming an impulsive pressure wave. The fact that a boomer is transported on the water surface and can be handled from a small boat means that it is ideal for studies of small fjords and bays in Greenland (Reynolds, 1997). Figure 40 provides an overview of the areas in Amerdloq and Ikertoq.

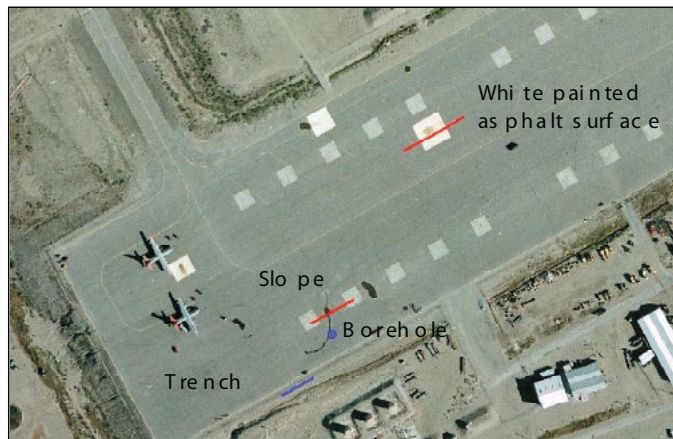
The earlier studies were carried out in the period from July 2005 to August 2006. A total of 5 profiles were studied during this period, all of which cross one of the white-painted areas on the apron (Figure 2). The white area is about 26.6 m wide and was established in the autumn of 2000.

Figure 2: The white-painted area is in the upper right part of the aerial photograph

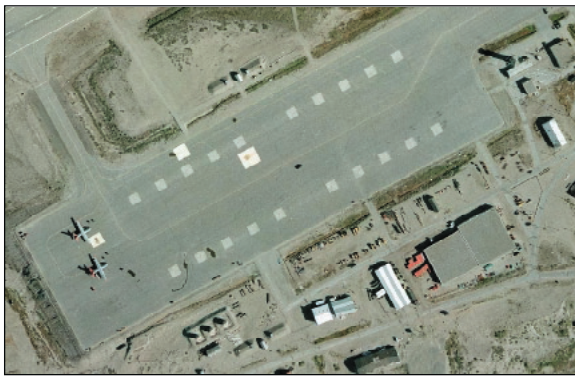
It would be most logical to locate the new fields beside the existing one (Location 1 in Figure 3). This location is preferable since the previous studies have shown a clear reflector between frozen and non-frozen subsurface materials.

The many different sizes of white-painted fields may, however, be a problem for the daily running of the airport. We have therefore made an alternative proposal in the already-restricted area at the southern end of the apron (Location 2 in Figure 3). If this location is selected it is important that the white-painted fields are not close to areas of the asphalt surface that have already sunk. It is also important that a clear frost-level reflector can be observed.

Figure 3: Location of new white-painted fields.

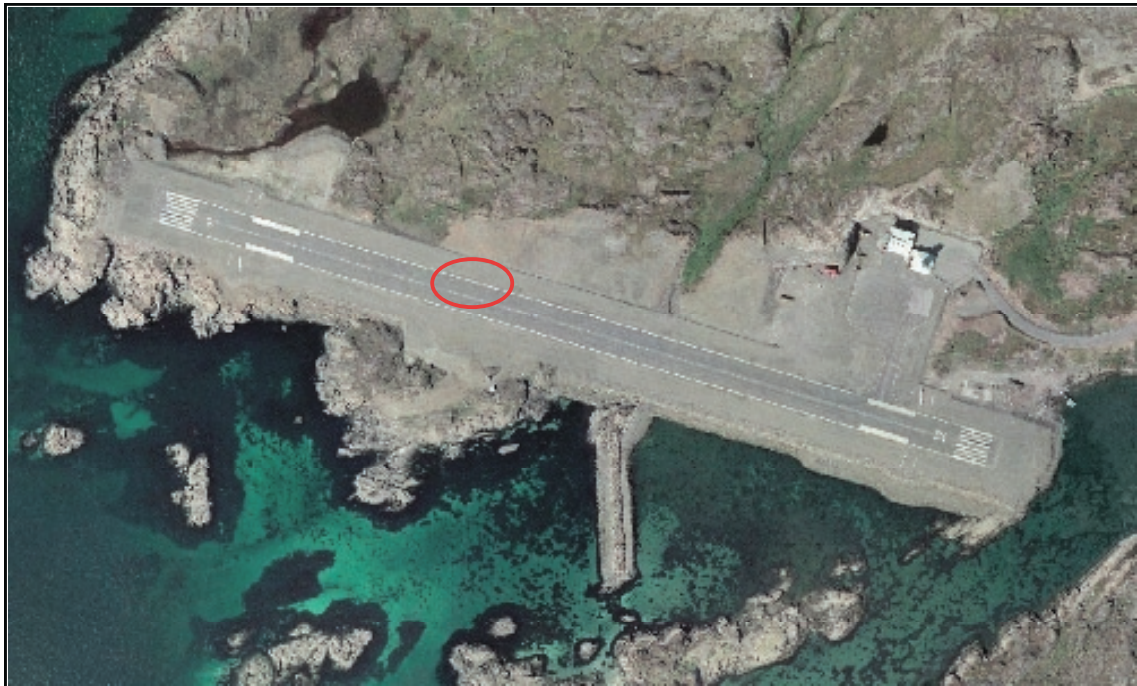
A geophysical investigation in the vicinity of a sunken area on the northern side of the landing strip at Sisimiut Airport was carried out on the 10th August 2006 in response to an enquiry by Rambøll A/S (Figure 1). The investigation was performed with georadar (GPR, Ground Penetrating Radar).

Figure 1: Orthophoto of Sisimiut Airport. The investigated area is circled in red.
