Annele Matintupa, Seppo Tuisku

SUMMARY OF DRAINAGE ANALYSIS IN SISIMIUT, GREENLAND

Demonstration Project Report

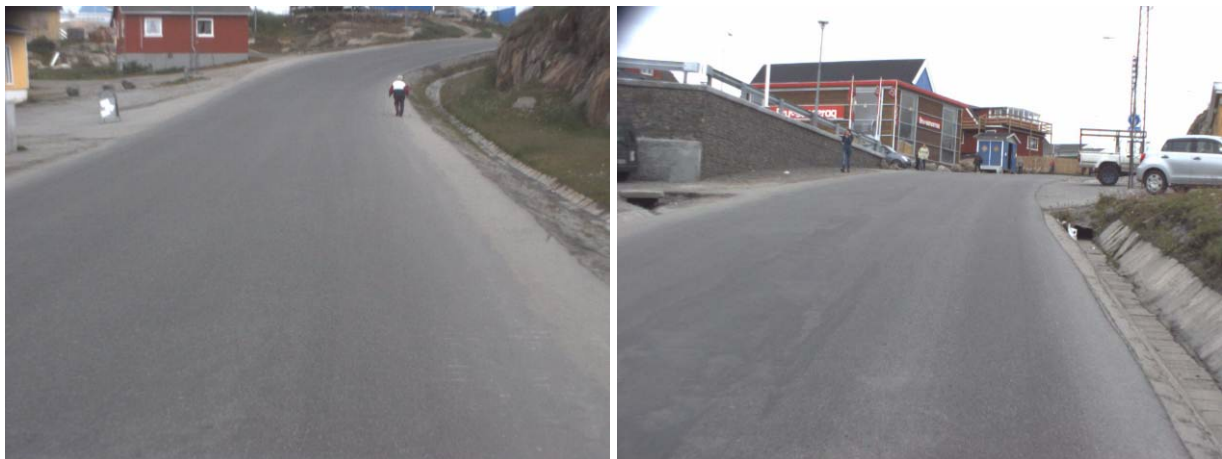
Drainage Class 1 means that the drainage condition is faultless. The cross-section of the road has preserved its form well and water flows unrestricted from the pavement to the ditch. Water has also a clear passage in the ditches.

Figures 22. Example photographs of drainage Class 1 in Sisimiut.

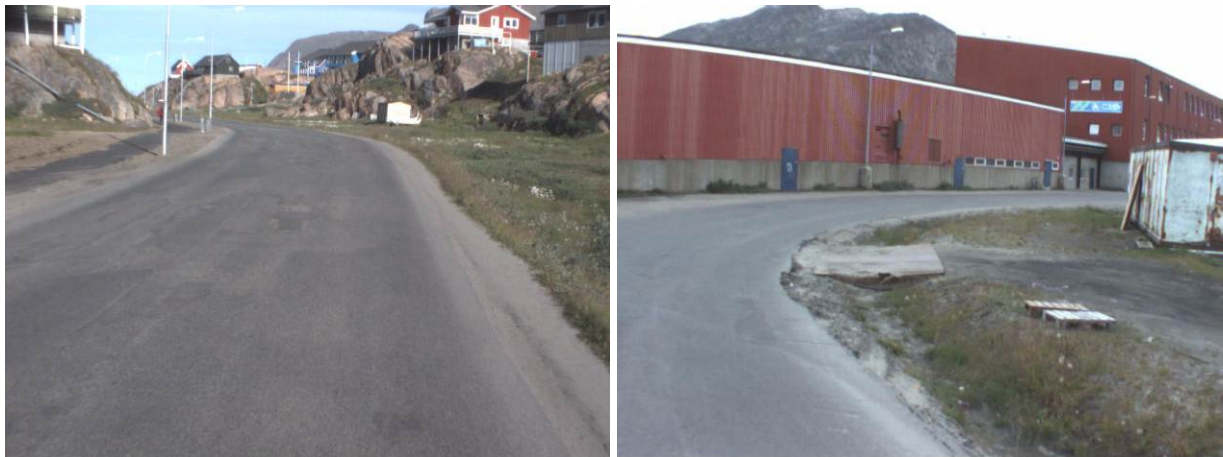
In drainage Class 2 there can be some visible changes to the road cross-section. The road shoulder has narrow verges or vegetation growth that is preventing the free flow of surface water from the road surface into the ditch. There is some vegetation in the ditch that restricts water flow

and creates damages. Some soil is sliding from the road side slope into the ditches and raising the bottom of the ditch.

Figures 23. Example photographs of drainage Class 2 in Sisimiut.

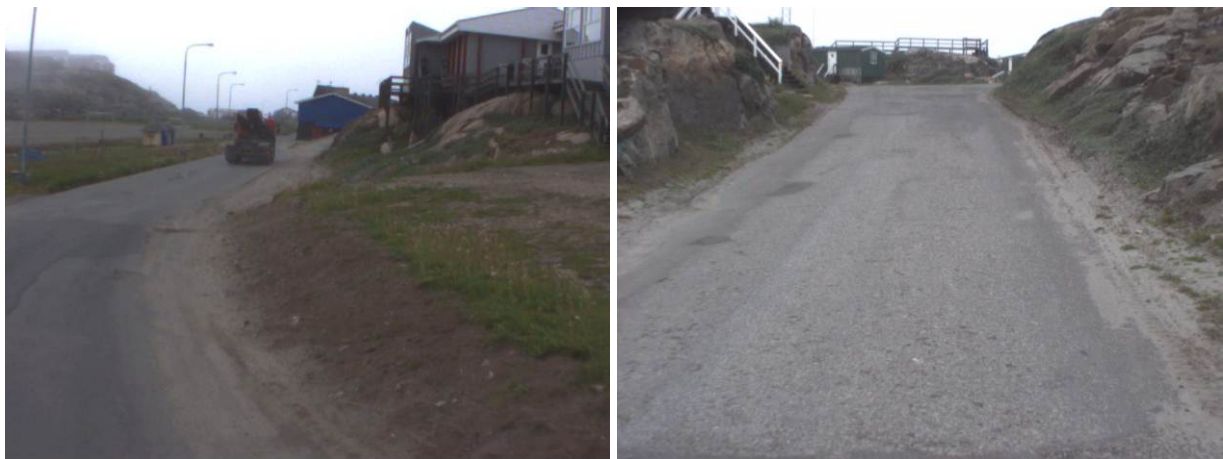
Drainage Class 3 covers those road sections with severe drainage problems. The road shoulder has a high verge and/or dense vegetation that are causing ponding on the traffic lane or on the shoulder. Vegetation is growing in the ditches and restraining the flow of water creating dams in the ditches. Unstable soil is flowing from ditch slopes into the bottoms of ditches and blocking the flow of water. Clogged culverts or outlet ditches is preventing the flow of water in the ditch. In the Sisimiut urban area many of the drainage Class 3 sections did not have a drainage system at all in some locations and clearly needed one. This was seen to be causing deformation and damages at the time of the surveys.

Figures 24. Example photographs of drainage Class 3 in Sisimiut.

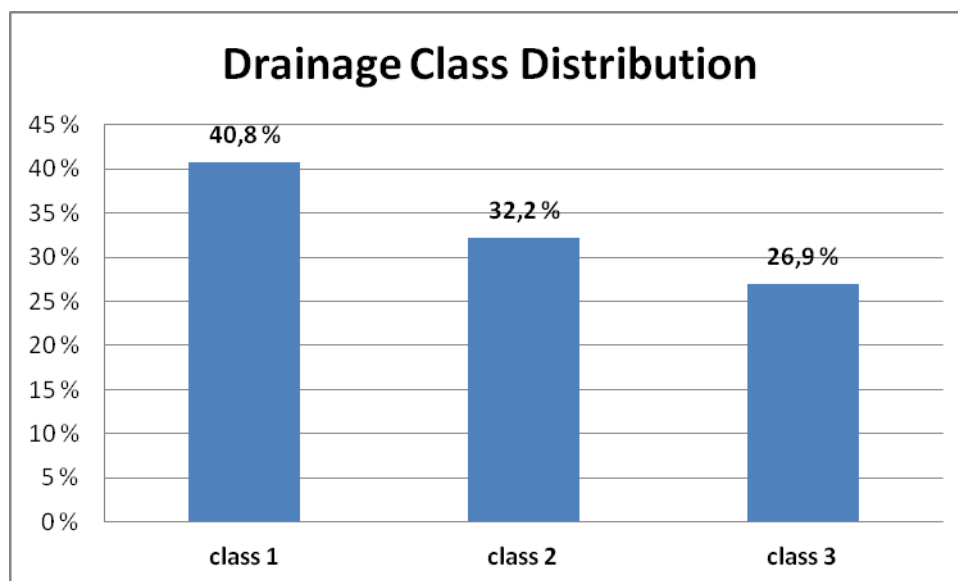
The drainage condition in Sisimiut was examined statistically, and in general the drainage was found to be in moderate condition. The distribution of the assessed drainage classes is summarised in Figure 25. The distribution of average drainage classes in each road section surveyed is presented in Figures 26-29. The gravel road section (Aqqaluartaap) has not been included in the summary as the map material available only covered part of the road.

Figure 25. Distribution of the drainage classes on the surveyed streets

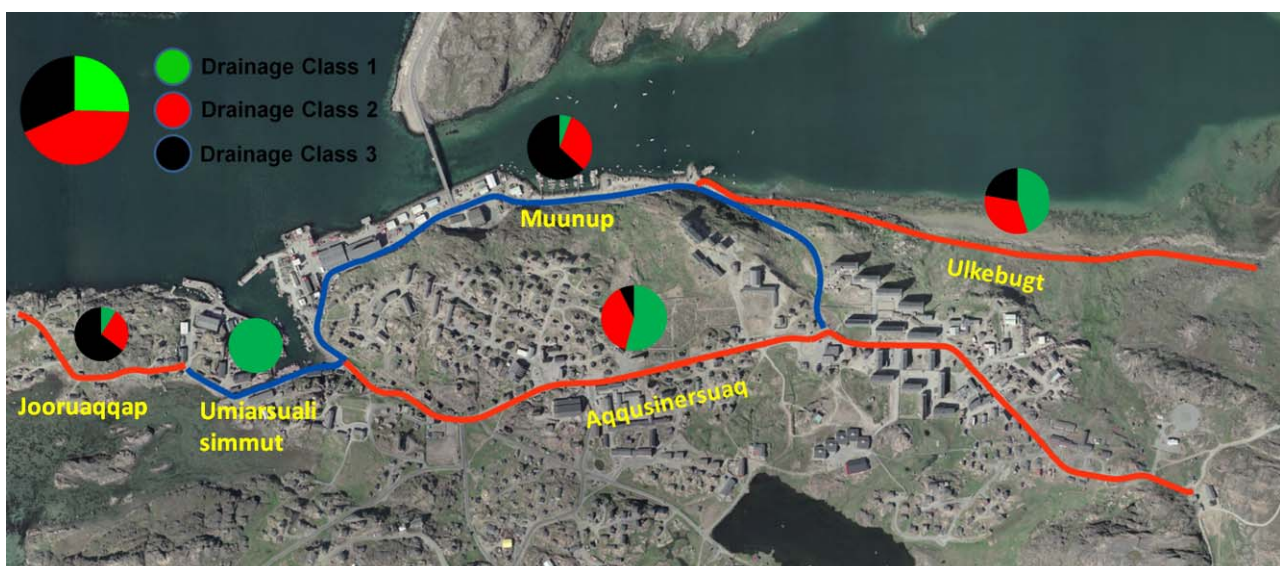
The drainage condition in the Sisimiut urban area was found to be variable. Umiarsualisimmut Street was in the best condition and was rated as drainage Class 1. Ulkebugt appears to be in poor condition statistically but this was mainly due to maintenance work being carried out at the time of the field survey. Saamualip, Eggaavimmut and Glahnip were the worst street sections for drainage condition statistically.

Figure 26. Distribution of average drainage classes in north-west part of the surveyed area.

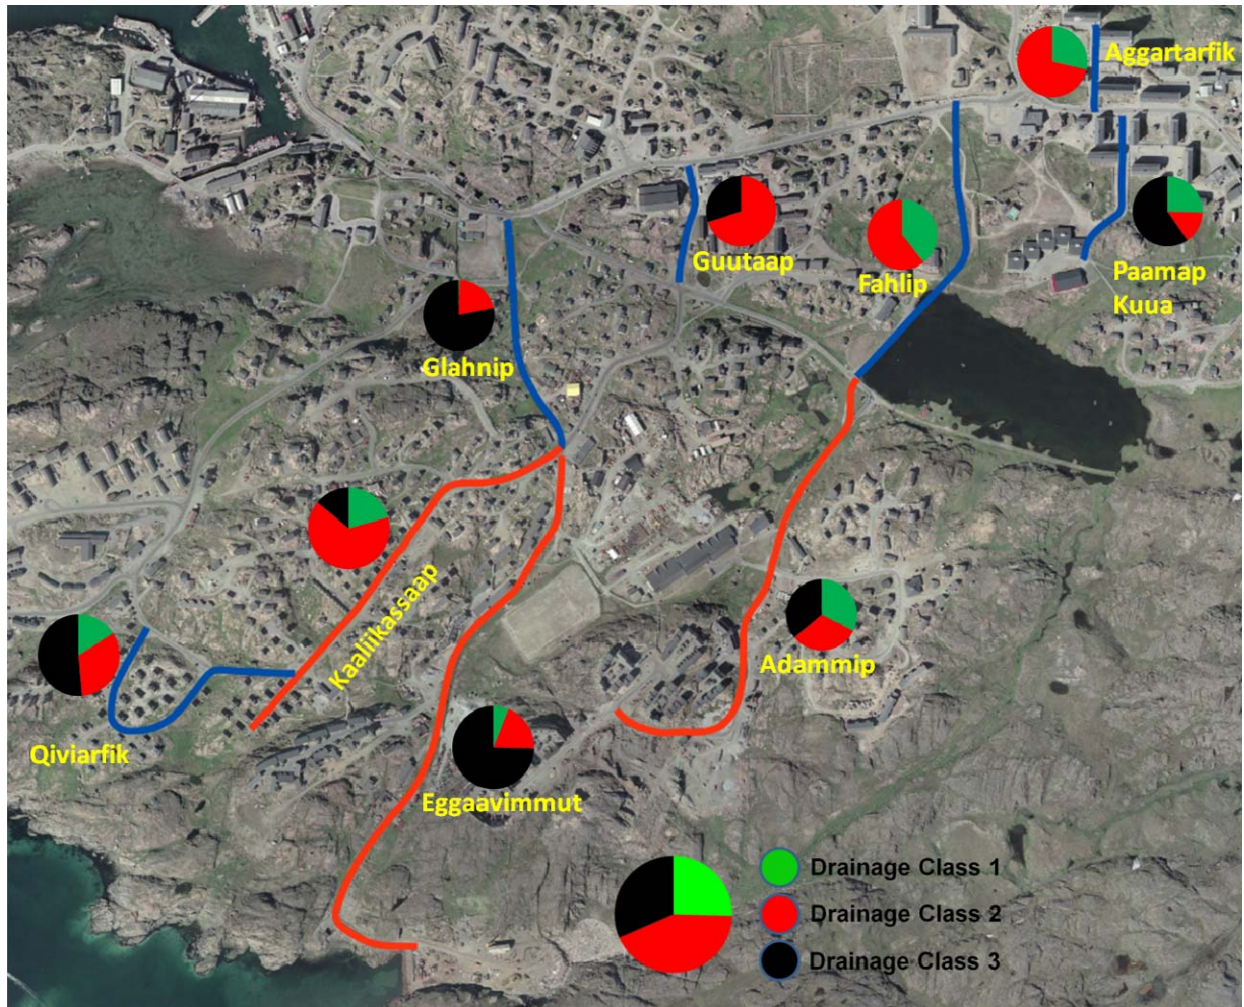
Figure 27. Distribution of average drainage classes in the south of the area.

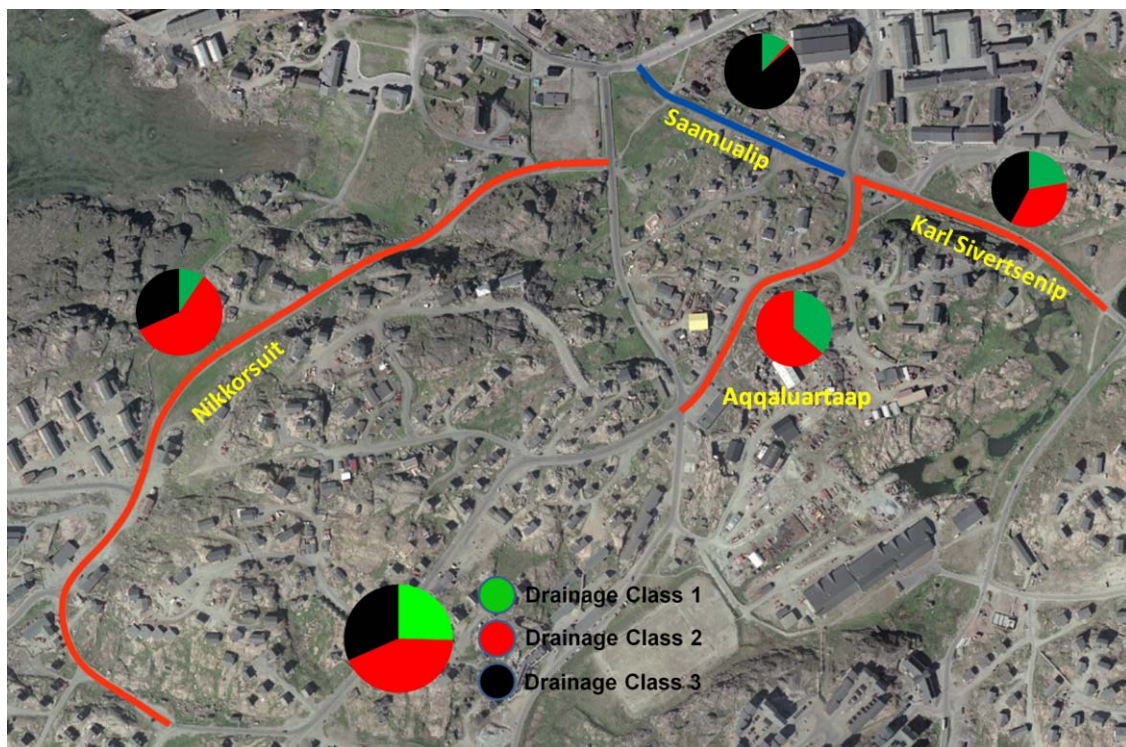
Figure 28. Distribution of average drainage classes in the north-east part of the area.

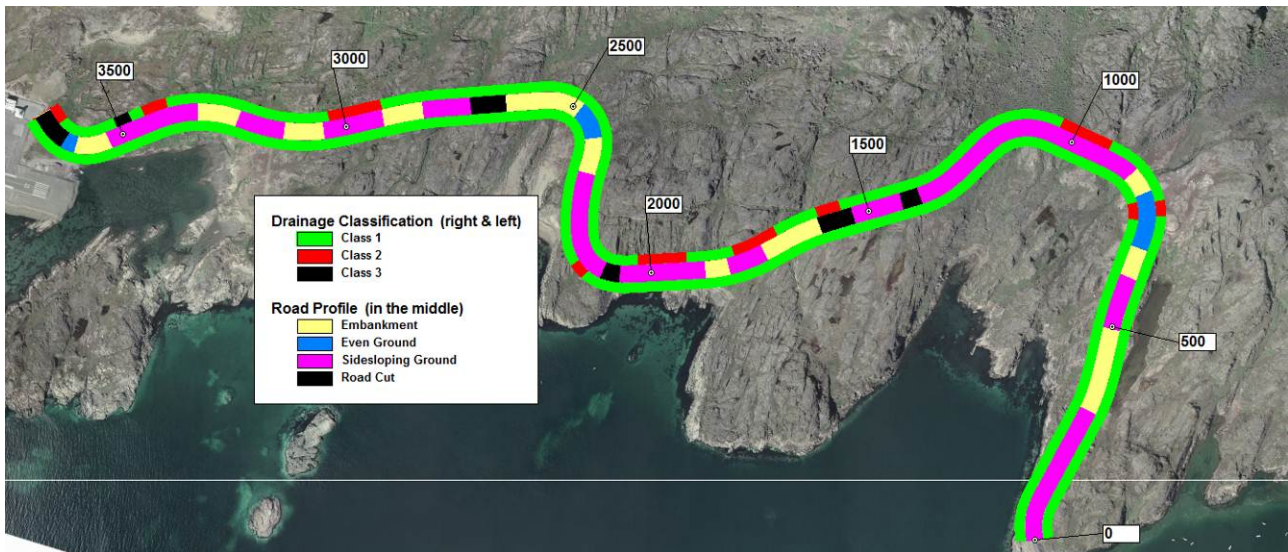
A GIS map showing the drainage classification of the Asummiunut road abstracted from Road Doctor™ is given in Figure 29. From this it can be seen that the Asummiunut drainage was in generally good condition. The road profile classification (in the middle) shows that most of the road had a side sloping road profile. Asummiunut was also longest road section surveyed.

Figure 29. Asummiunut drainage and road profile map. The middle coloured line indicates the road profile. The drainage classes of the roadside ditches are given on the outside.

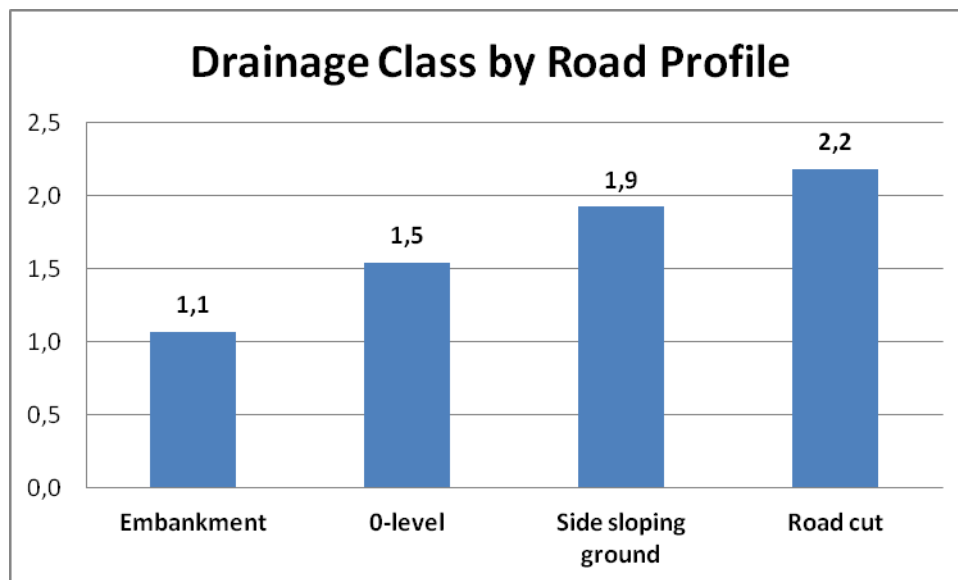
The variation of drainage class between the different road profiles is similar to the results of the earlier ROADDEX demonstration projects in the Nordic countries. Road cuts have on average the poorest drainage condition and embankment have the best drainage condition (Figure 31).

Figure 31. Average drainage classes by road profile.

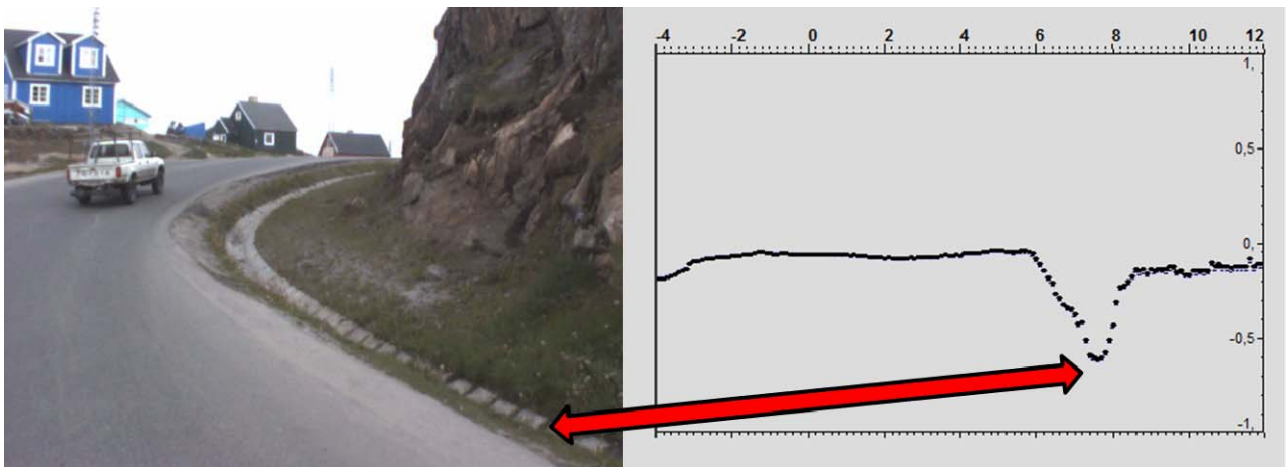
On Aqqaluartaap Street the road profile slopes mainly from right to left. The ditch on the right side is deep enough and the shape of the shoulder is good. The ditch is made of concrete (Figure 33).

Figure 33. Cross-section showing laser scanner data from Aqqaluartaap. The red arrow indicates the ditch which is in good condition and deep enough. The ditch bottom can also be clearly seen in the output from the laser scanner.

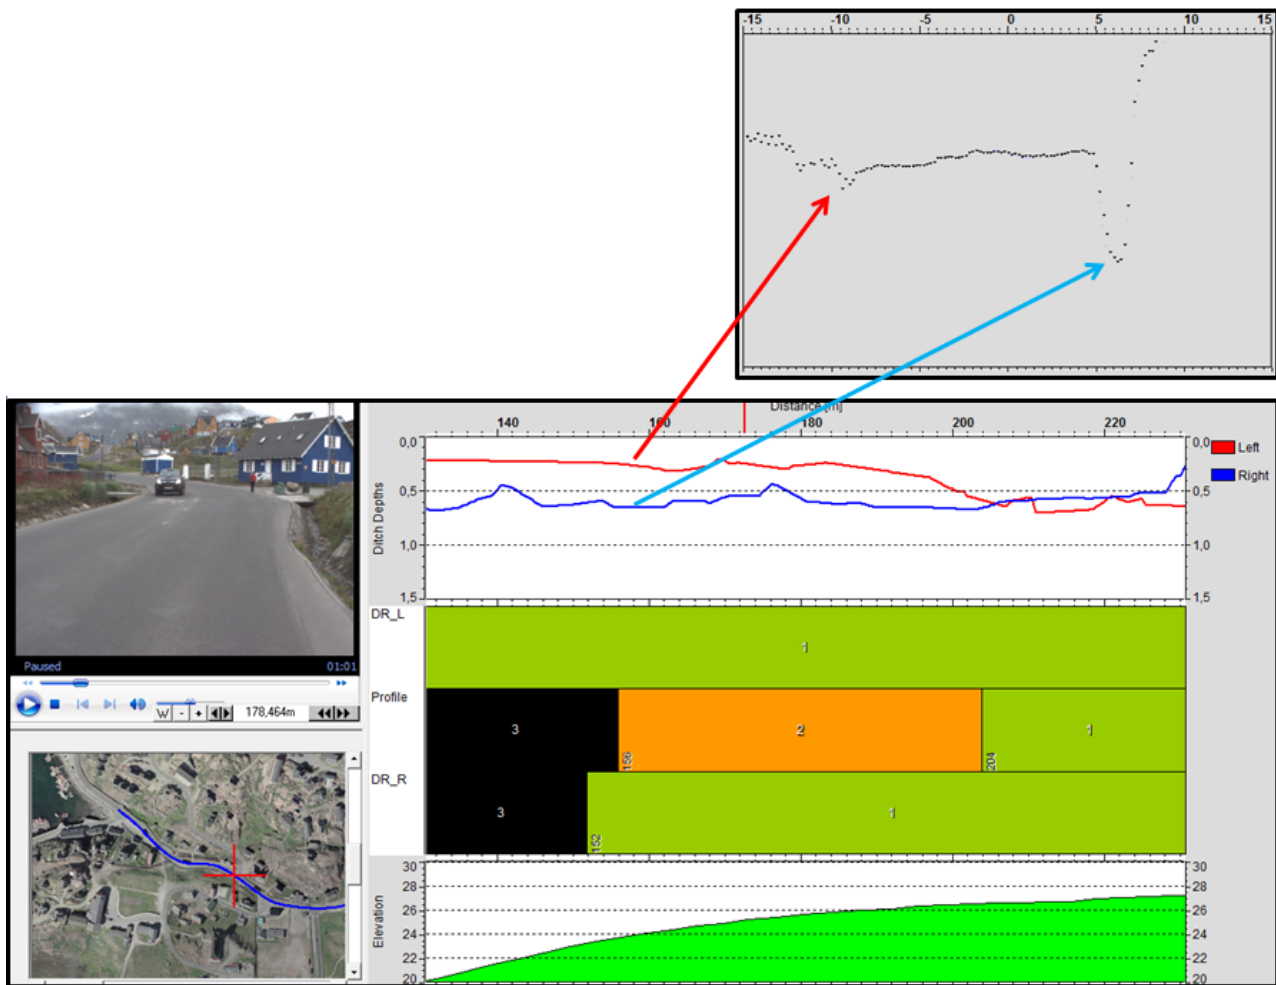
On the street sections where an open ditch was present, it was possible to calculate the depth of the ditch from the laser scanner data and present it in an analysis field to be compared with other road data. The red line in Figure 36 presents the depth of the left ditch and blue line presents the depth of the right ditch.

Figure 36. Ditch depth presented in Road Doctor™ analysis view. The example shown is from Akqusinersuaq. The top panel shows the ditch depths, the middle panel shows the drainage class and road profile, and the bottom panel gives an indication of the elevation of the road. A video and map is on the left side. All of the data on the screen can be reviewed integrated. The cross-section has been prepared from laser scanner data. The ditch bottoms are marked with arrows.

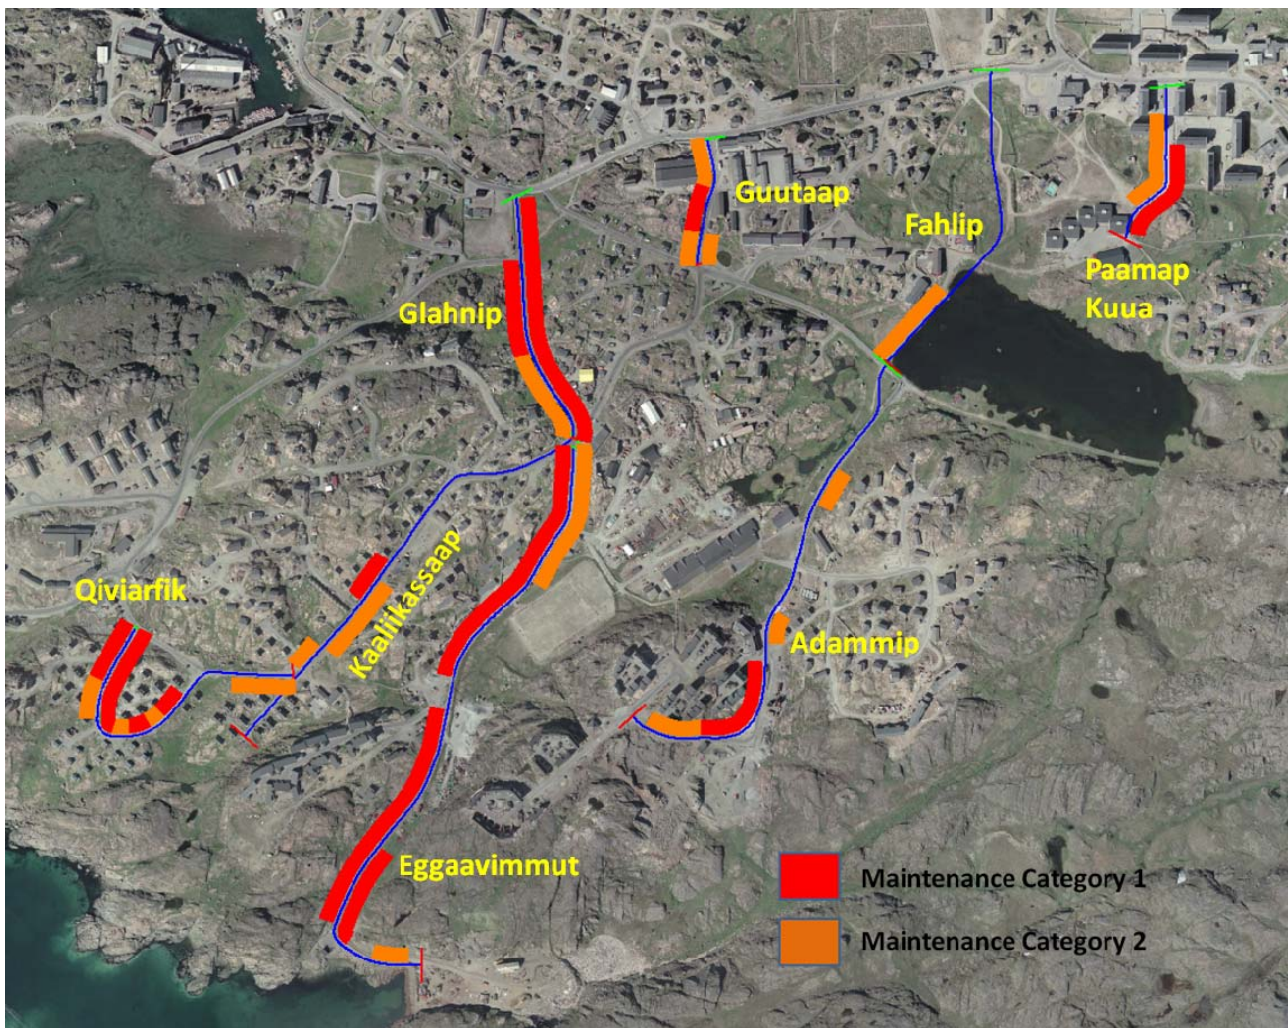
Figure 39. Sections for maintenance in the south part of the surveyed area.

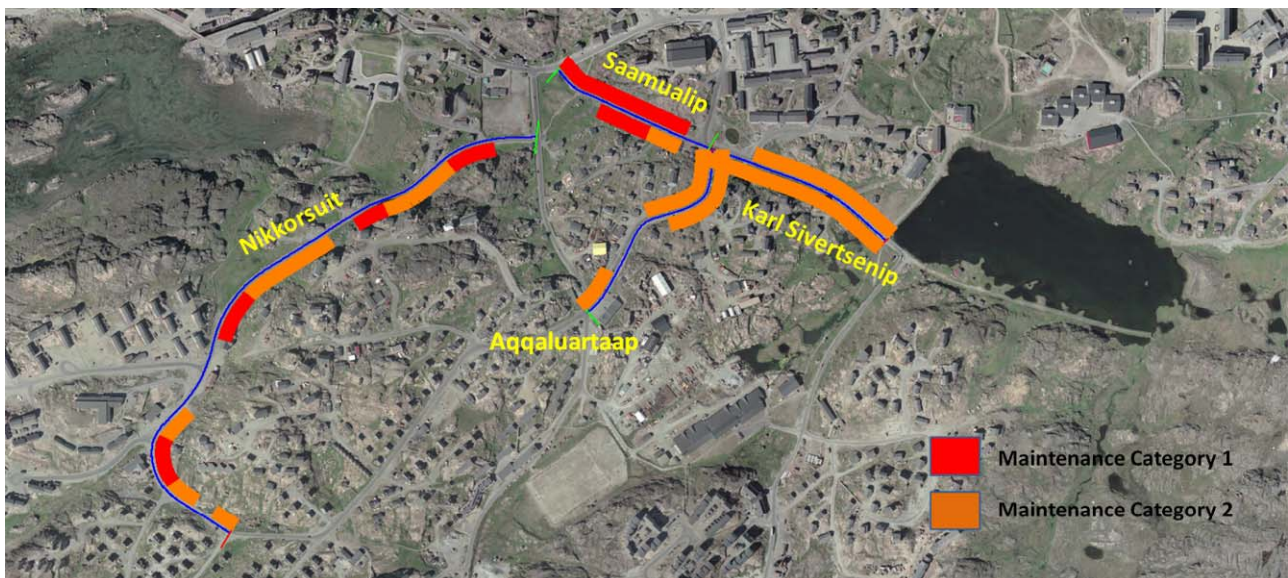
Figure 40. Sections for maintenance in north-east part of the surveyed area.
