Annele Matintupa, Seppo Tuisku

# **SUMMARY OF DRAINAGE ANALYSIS IN IRELAND, ROADS N56 AND N59**

**Demonstration Project Report**

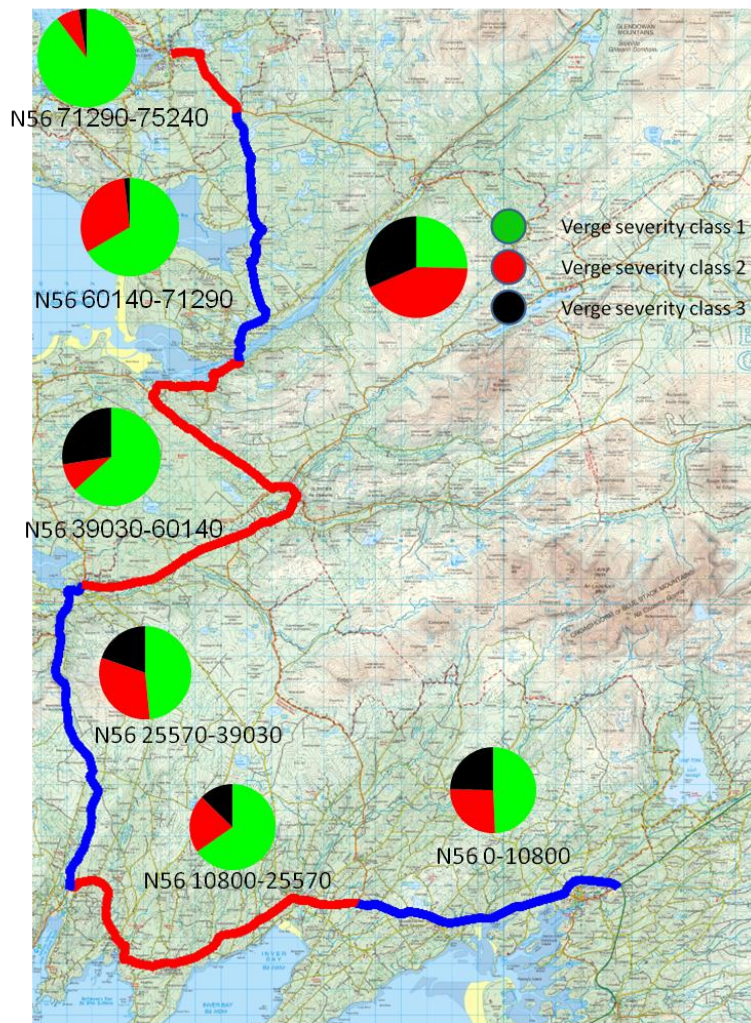
Verge classes follow the same trends as drainage classes in the first section of the N56. The road section with the fewest verges on the N56 is the section from the R252 intersection to Dungloe (71,290 – 75,240). The map of verge class along this road section is presented in Figure 20.

Figure 20: Verge class in the first part of road N56 from Donegal to Dungloe.

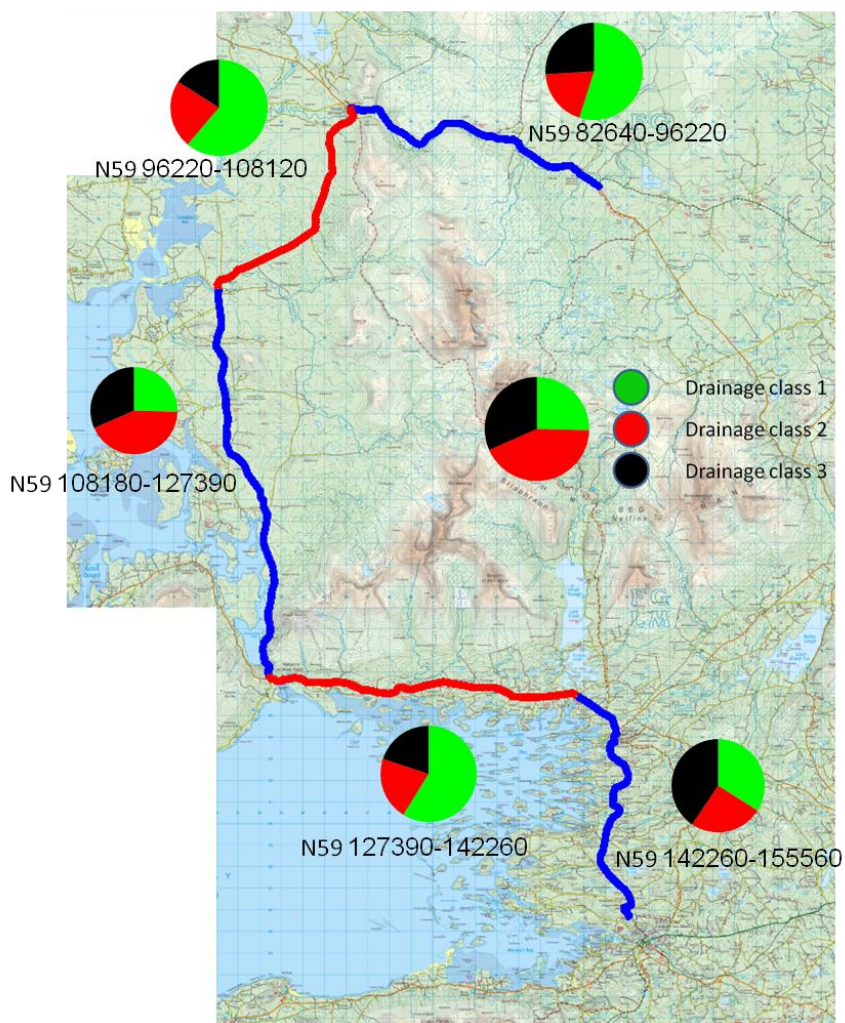
The second section of road N59 was from the R312 intersection to Westport. The drainage of this section is slightly worse than that of the first section. The worst section is from Achill Road R257 to Bridge (108,180 – 127,390m). A map showing the drainage statistics of this section is presented in Figure 23.

Figure 23: Drainage condition in the second part of road N59 from the R312 intersection to Westport.

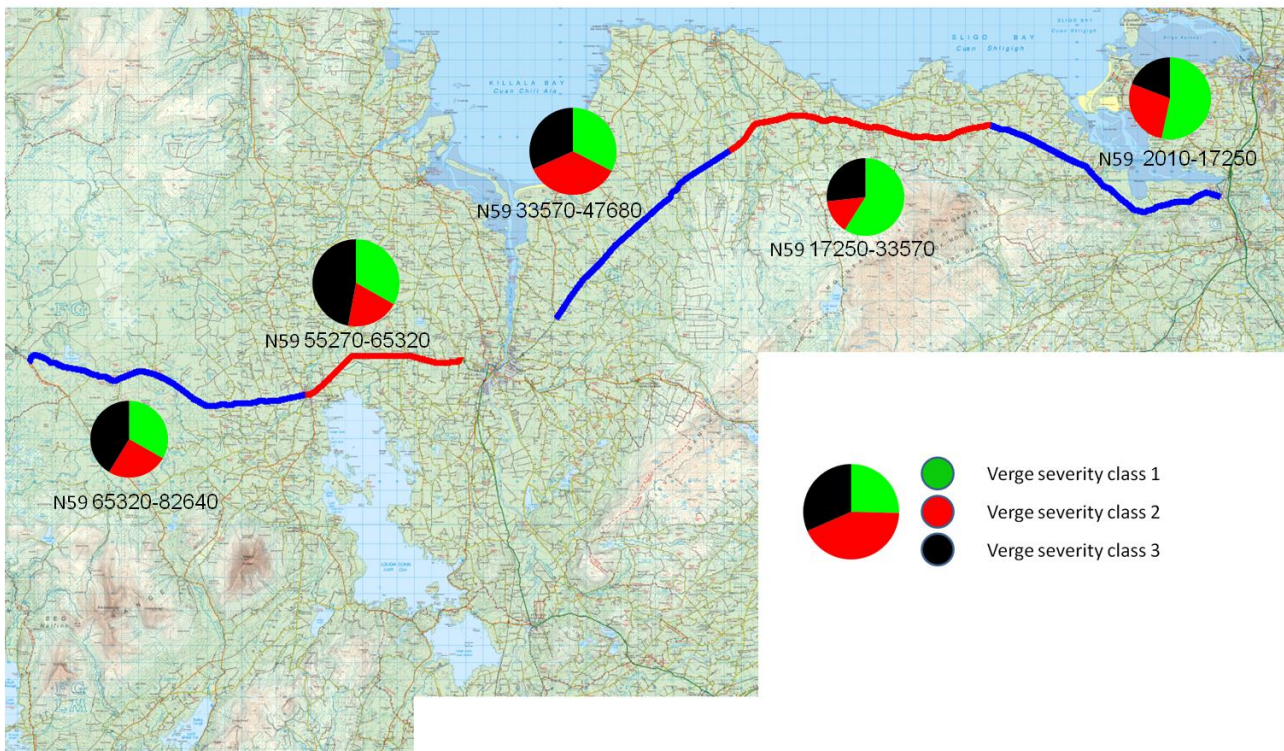
The class of verge varies significantly on the N59. The majority of the verges were rated as Class 1 on the following sections: from the Masreagh intersection to Owenberg (17,250 – 33,570), from the Burrishoole Bridge to Westport (142,260 – 155,560), from Erriff Bridge to the R336 (176,970 – 188,500) and from the bridge after Clifden to the R341 (224,090 – 237,870). The majority of the verges were rated as Class 3 on the section from Westport to Lischarney (157,700 – 165,510). Almost 80% of the verges are Class 3 in this section. Maps of verge class along the N59 are given in Figures 26 – 29.

Figure 26: Verge class in the first part of road N59 from Ballisodare to the R312b intersection.

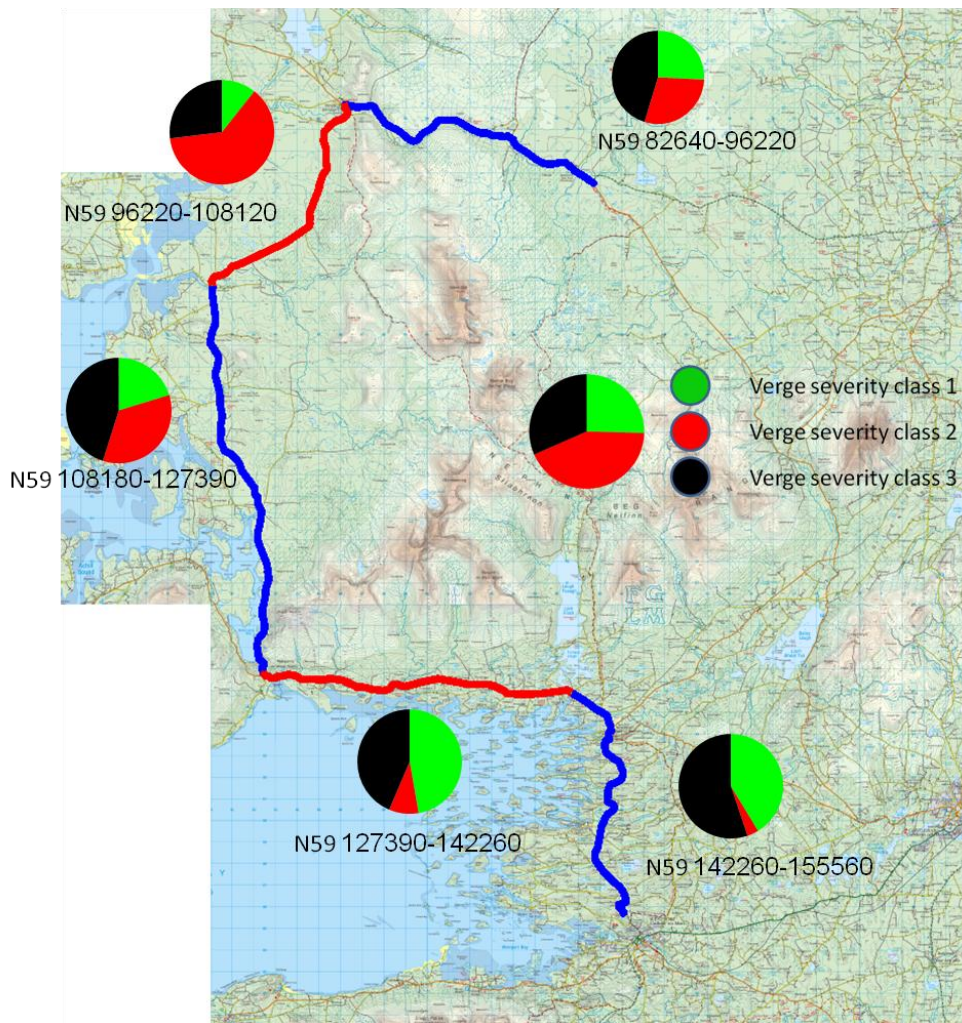
Figure 27: Verge class in the second part of road N59 from the R312 crossroads to Westport.

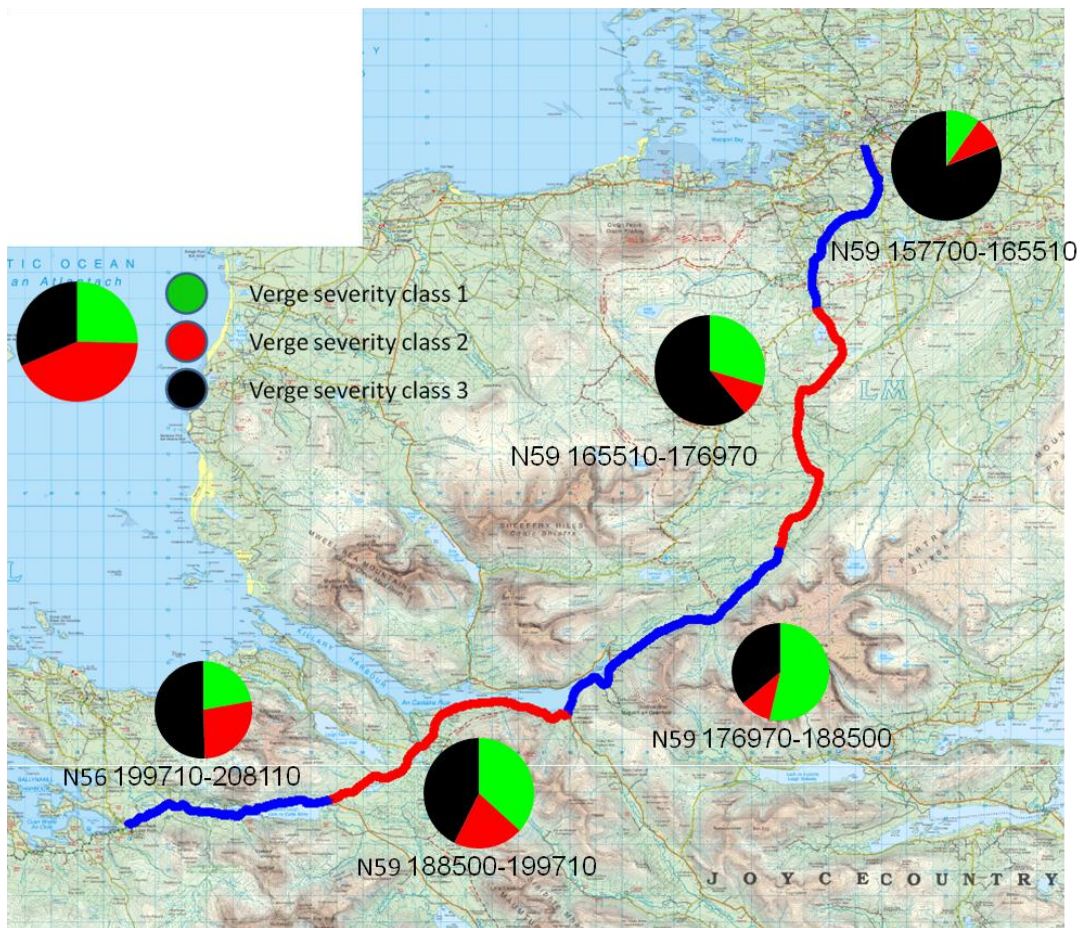
Figure 28: Verge class in the third part of road N59 from Westport to Letterfrack.

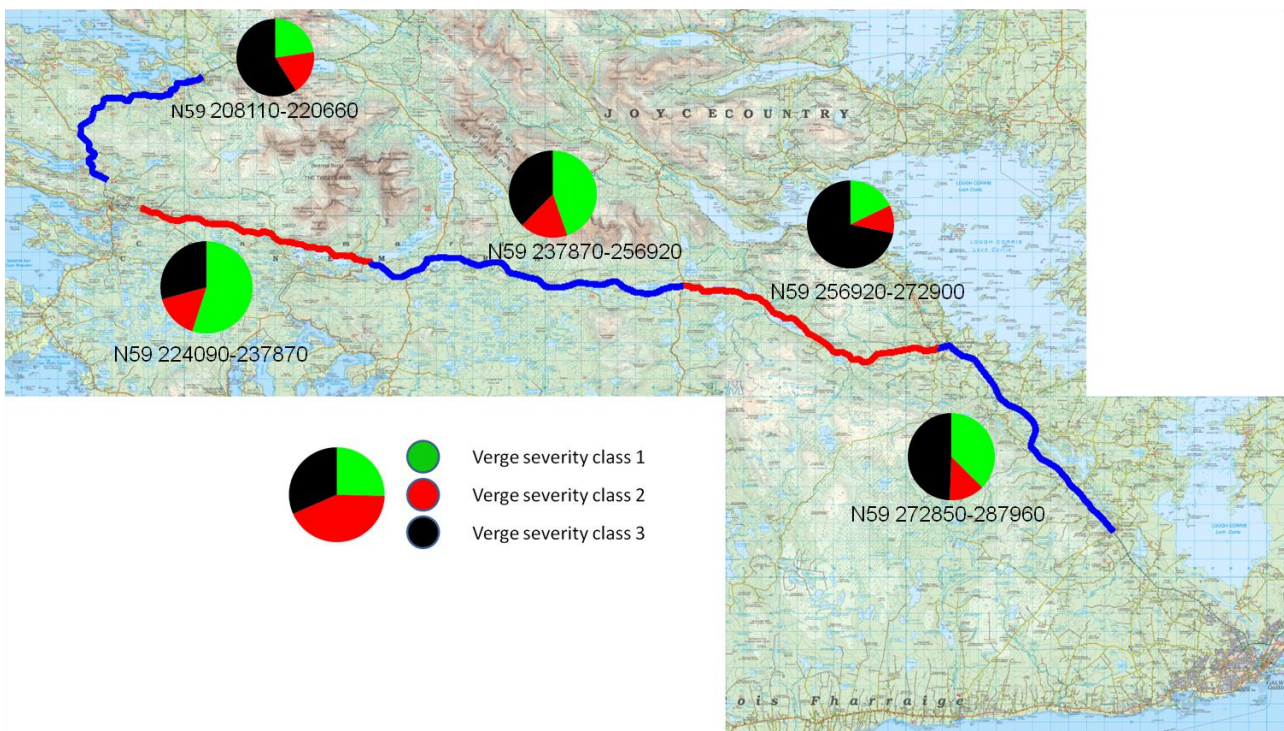
Figure 29: Verge class in the fourth part of road N59 from Letterfrack to Forest Hills.

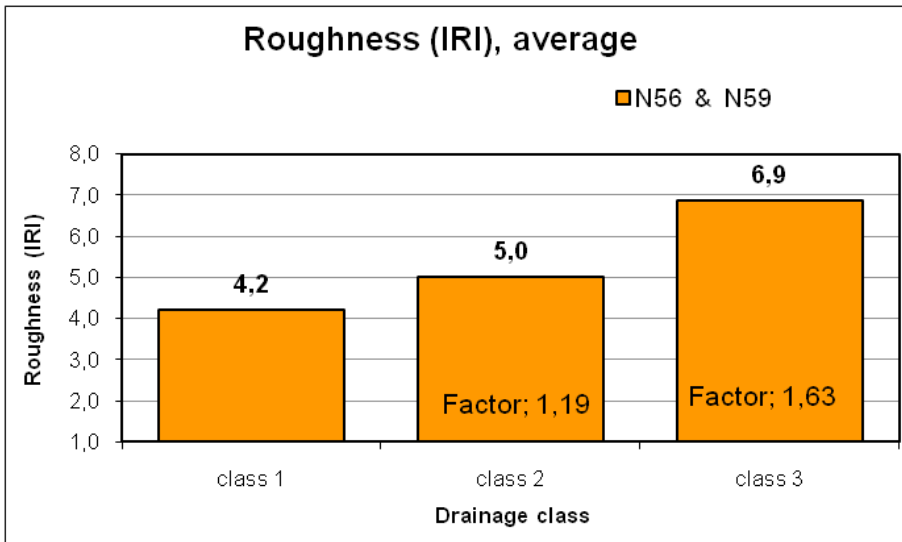
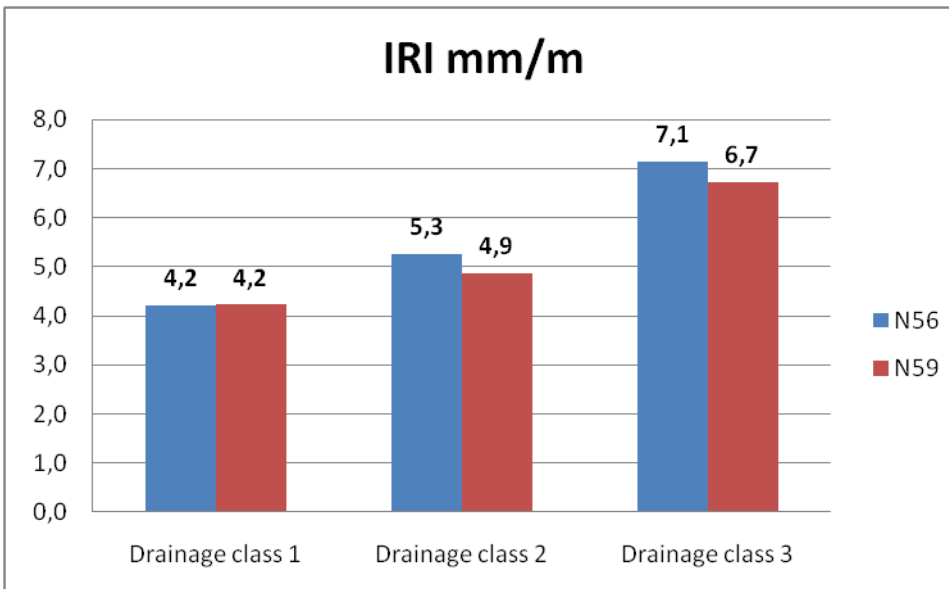
The average roughness (IRI) value for each drainage class on roads N56 and N59 is summarised in Figures 30 and 31. This clearly shows the impact of poor drainage on road roughness (IRI). In drainage Class 1 the average IRI was 4.2, i.e. an adequate level of comfort for driving. In drainage Class 3 the average IRI was 6.9, which equates to an uneven and uncomfortable road surface. Figure 31 also shows that the N56 is more sensitive to poor drainage.

Figure 30: The average roughness value for each drainage class in roads N56 and N59. The value on the top of the column presents the average IRI value for each drainage class. The factor inside the column shows how many times bigger the value is compared to the value for Class 1.

Figure 31: The mean roughness values for each drainage class in roads N56 and N59.

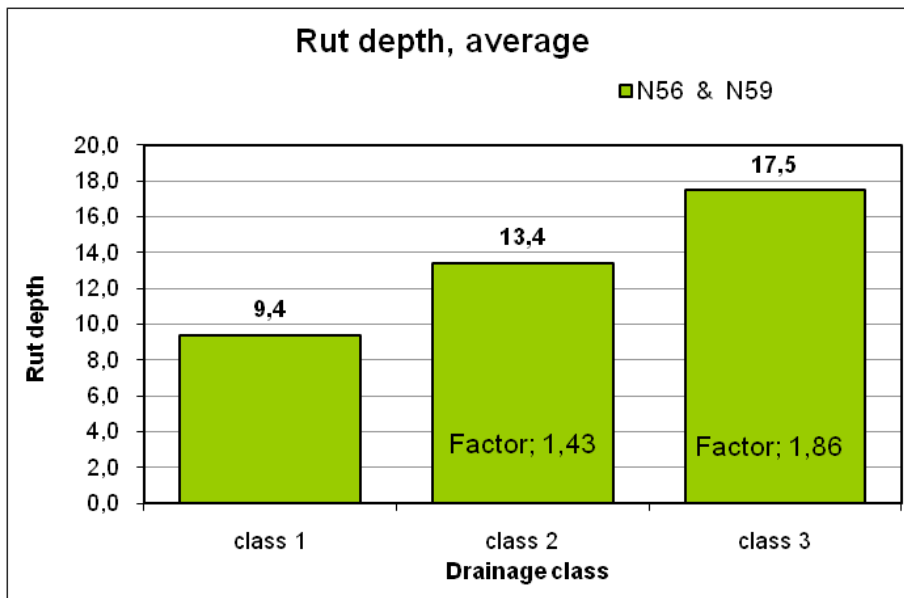
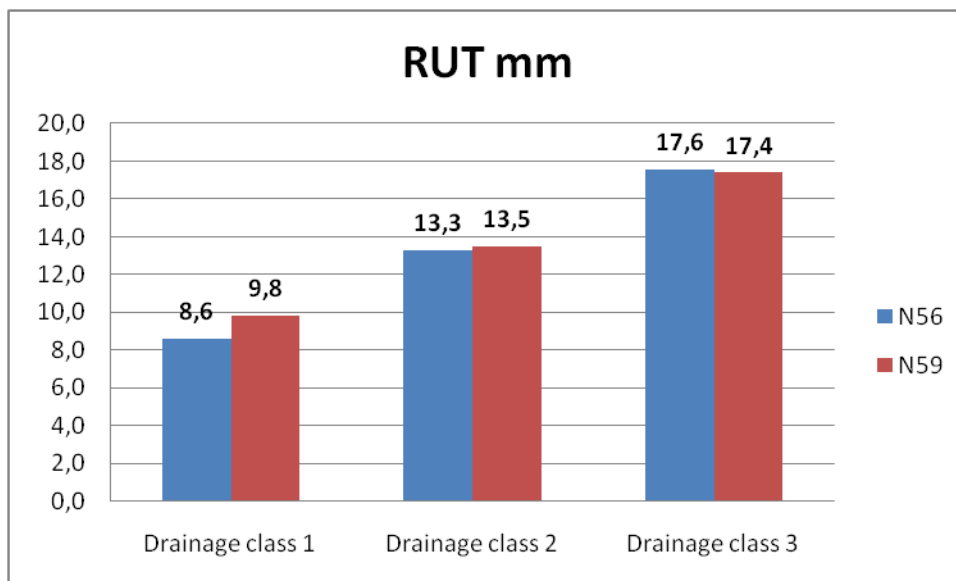
Figures 32 and 33 show that the impact of poor drainage on rutting is even higher when compared to roughness. The average rut depth in drainage Class 2 is 43 % higher than in Class 1, and in drainage Class 3 the rut depths are almost two times higher than in drainage Class 1.

Figure 32: The average rut depth value for each drainage class in roads N56 and N59. The value on the top of the column shows the average rut depth value on each drainage class. The factor shows inside the column shows how many times bigger the value is compared to the value for Class 1.

Figure 33: The mean rut depth values for each drainage class in roads N56 and N59.

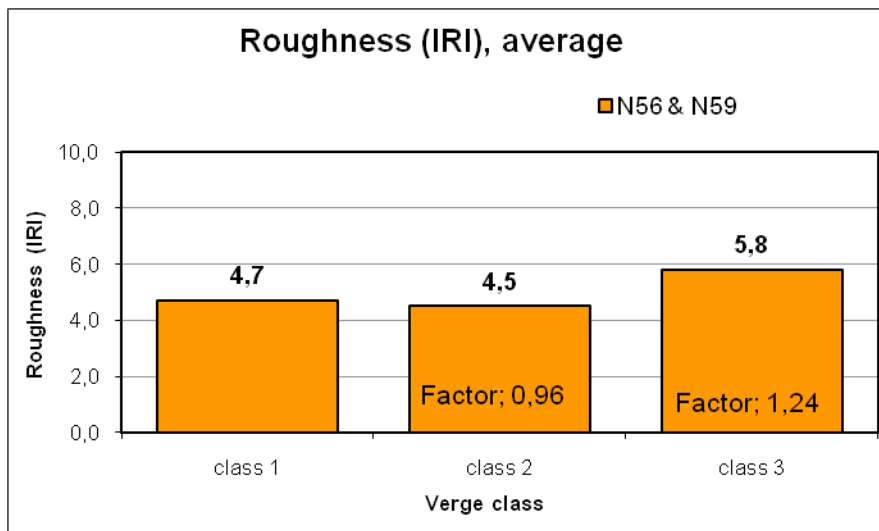
Verges also have an effect on roughness and rutting but not so great as average drainage class. Figure 34 shows that small verges with well maintained offlets do not affect roughness, but that IRI values are 1.24 times higher in verge Class 3 compared to verge Class 1 (no verges).

Figure 34: The average roughness value compared to verge class on roads N56 and N59. The value on the top of the column shows the average IRI value in each drainage class. The factor inside the column shows how many times bigger the value is compared to the value for Class 1.

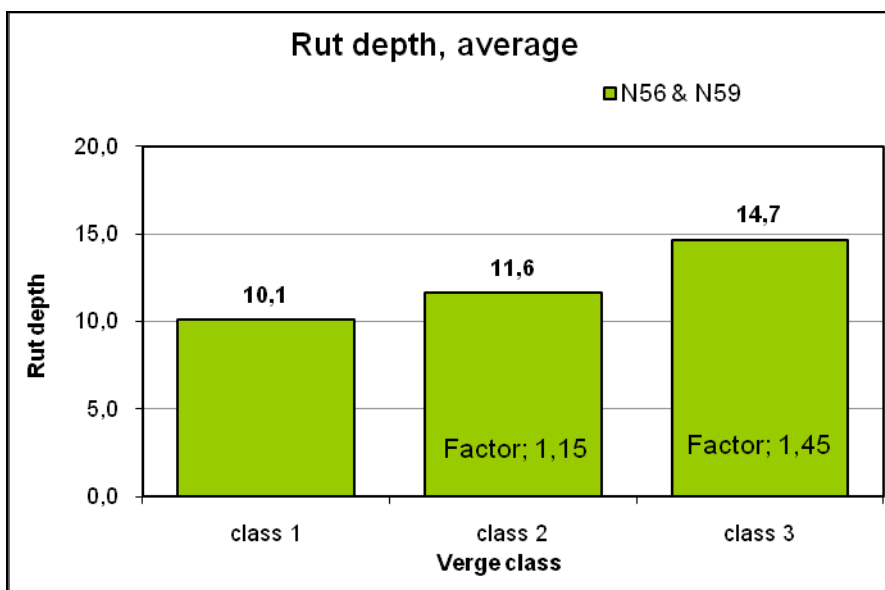
The correlation between average rut depths and verge class (Figure 35) is clearer than with roughness values. The average rut depth is 1.45 times greater in Class 3 compared to Class 1.

Figure 35: The average roughness value compared to verge class on roads N56 and N59. The value on the top of the column shows the average rut depth value for each drainage class. The factor inside the column shows how many times bigger the value is compared to the value for Class 1.

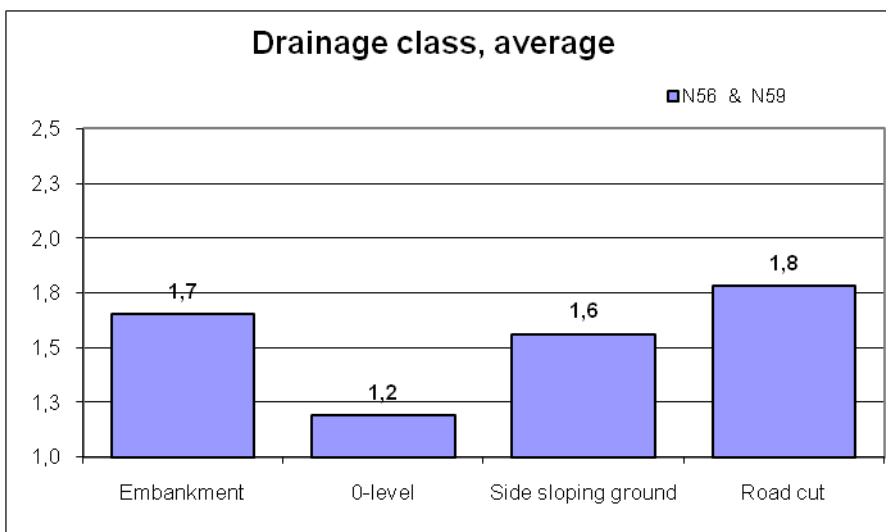
Figure 37 shows that the average drainage class was the best in road sections classified as “0-level” (i.e. the road was approximately at the level of the adjacent ground). The average drainage class in these sections was 1.2. The drainage was the worst condition in road cuts, but quite surprisingly the drainage condition in embankments was almost as bad.

Figure 37: The average drainage class for each type of road profile.

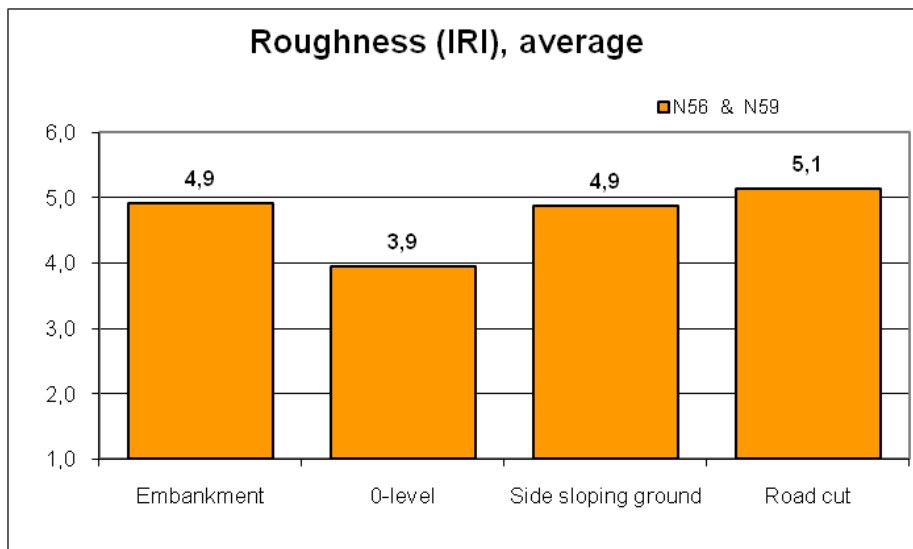
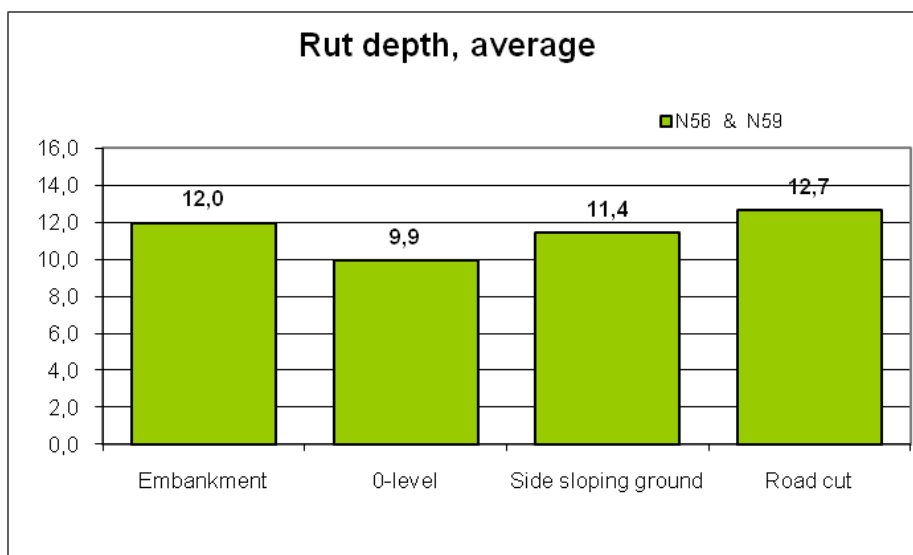
When roughness and rutting values were compared to road profile, the average values were about the same, except for 0-level where the values were slightly worse (Figures 38 and 39). The worst cases were always in road cuts.

Figure 38: The average IRI-value for each type of road profile.

Figure 39: The average rut depth for each type of road profile.

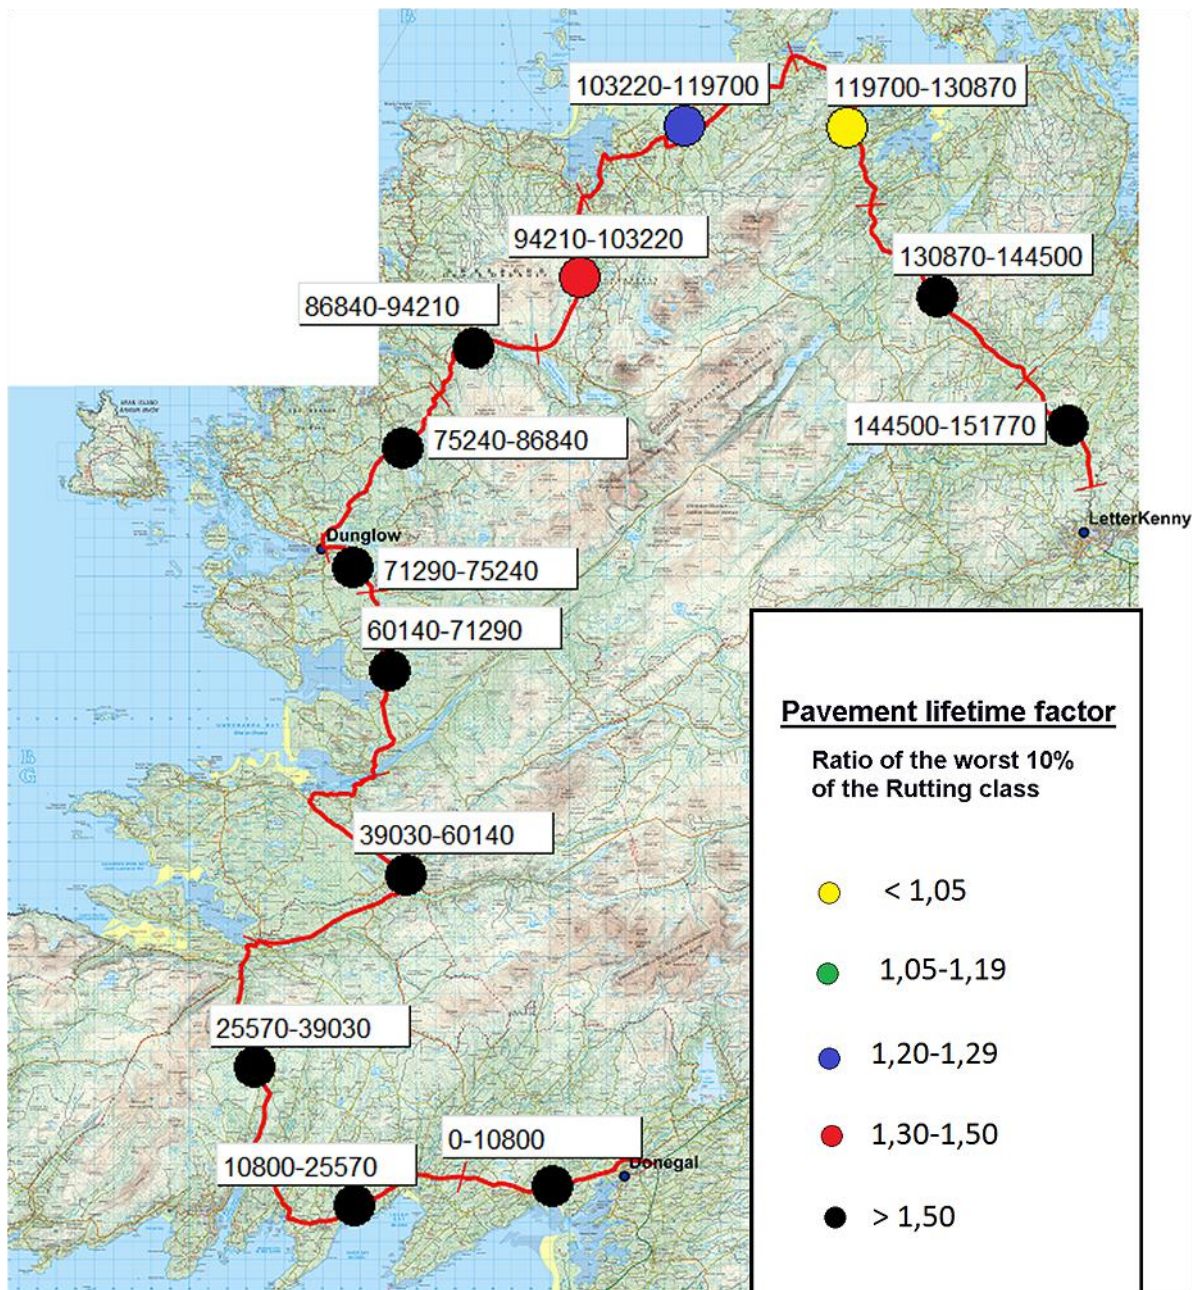
From Figure 40, the pavement lifetime factor (the ratio of the worst 10% rutting class) on road N56 is mostly >1.5, and so it is highly economic to improve the drainage on this road. Only on one section, from 119,700 to 130,870, was the pavement lifetime factor less than 1.05.

Figure 40: Pavement lifetime factor N56

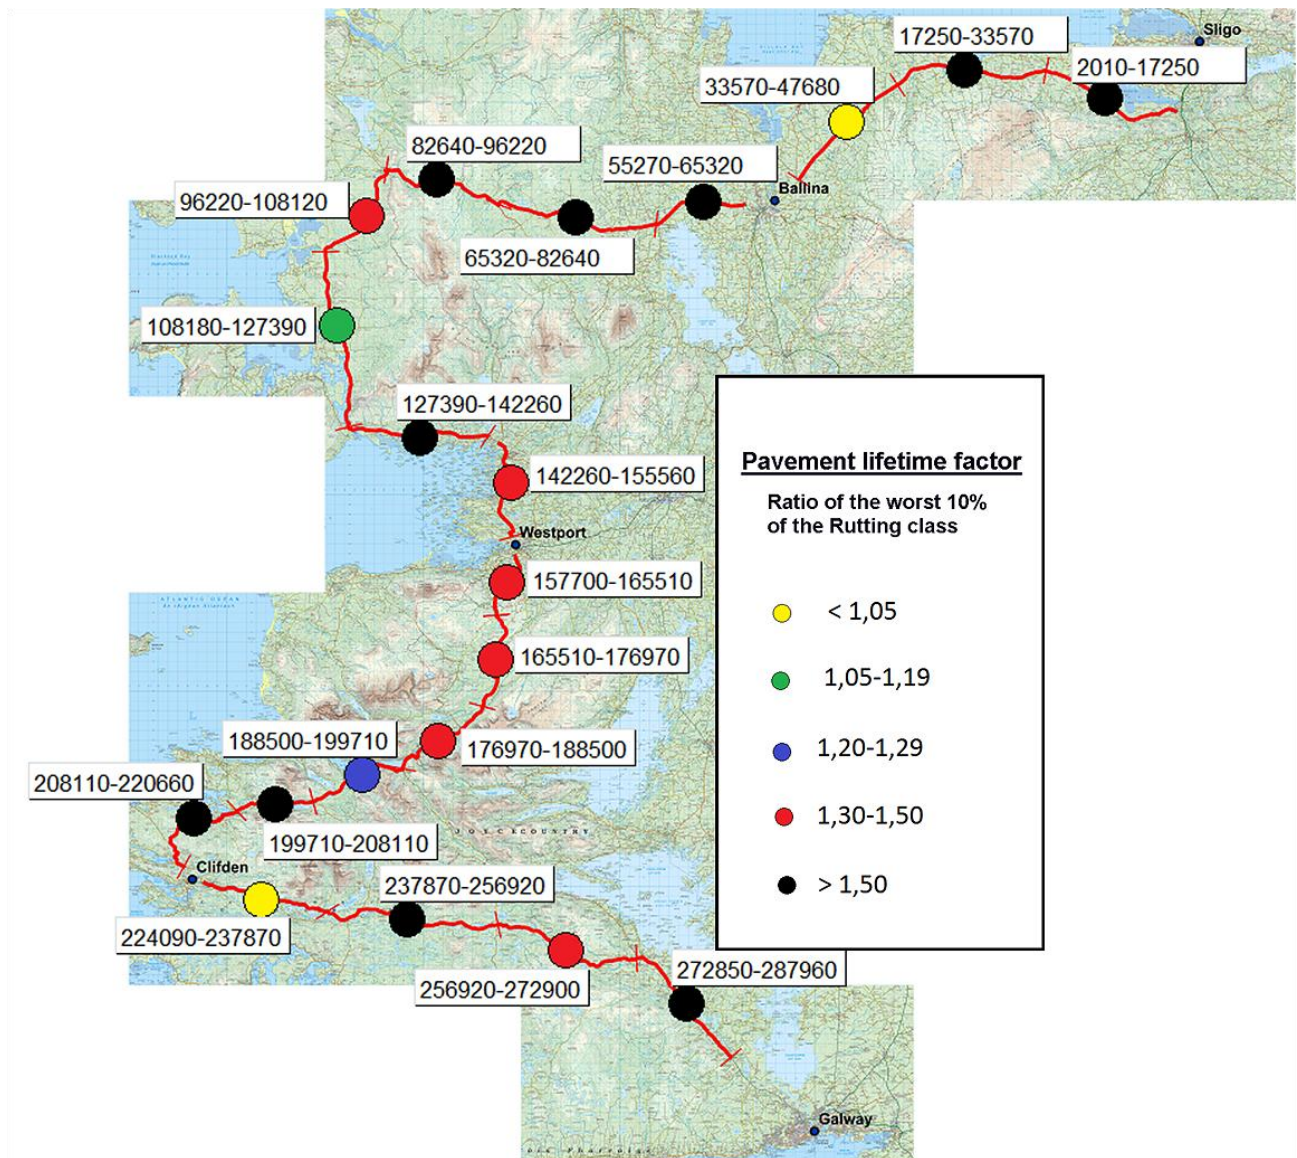
Road N59, on the other hand, has slightly better (but still not good) pavement lifetime factors, even though in general the drainage condition is worse than the N56. This indicates that the N59 has thicker road structures, or the amount of heavy traffic on the N59 is less than on the N56.

Figure 41: Pavement lifetime factor N59
