ROAD 16881 HUMALAMÄKI

Coarsening the base/sub-base course layers using only local stones

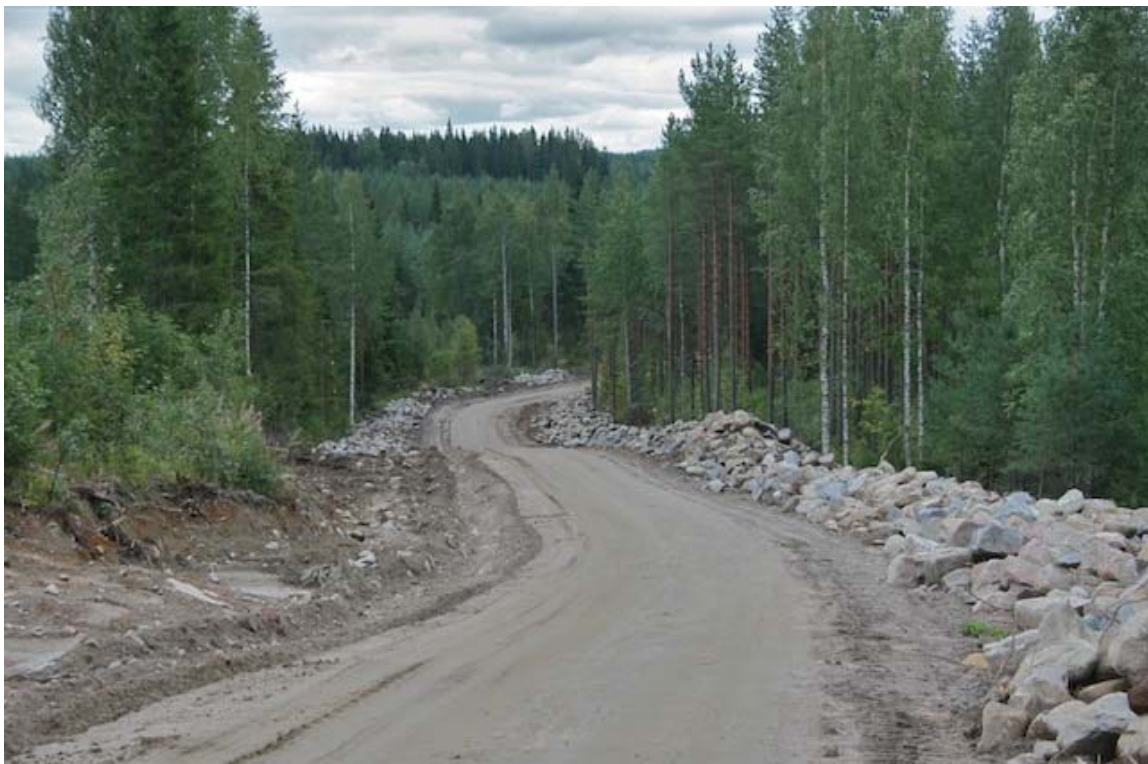
Figure 2.4 Rock materials removed from the road area

The landscape is generally hilly. The road passes through a variable landscape of hills, shady spruce forest and broad-leaved forests, as shown in figures 2.2 and 2.3. The terrain is mostly hard morainic soil and most of the hills are remnants of undulating bedrock. The range of topography results in the road having a range of features such as side sloping ground and bedrock hummocks. The terrain is also very rocky, a main reason why the road was chosen to be a test project for the rehabilitation method. Figure 2.4 shows an example of the amount of rock removed from the road area during the rehabilitation.

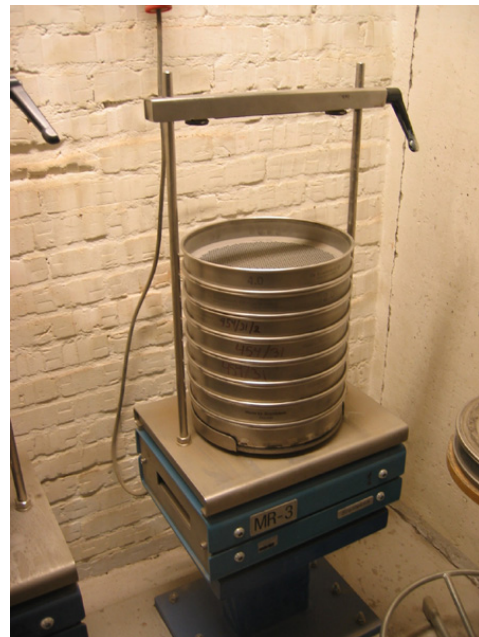
Figure 3.2 Grain size distribution is determined by sieving [2]

The grain size distribution is the most common laboratory test in estimating the properties of materials. The grain size distribution is determined by sieving. The test gives information on the amount of fines content and the particle size distribution curve. The amount of fines content and particle size distribution have an effect on the mechanical properties of the material and the results obtained can also give information for possible rehabilitation options during the design stage. [2]

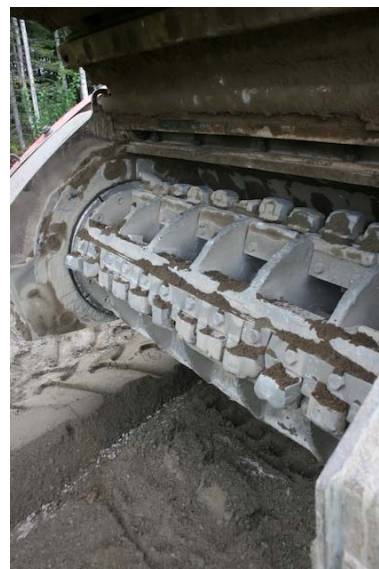
Figure 6.4 Crushing chamber

Stage three: The rock material produced in Stage two was spread on the road by road grader. Then the rock material was crushed and milled with a crusher mounted on the back of a tractor as shown in Figures 6.3 and 6.4. Rocks up to 300-350 mm rocks can be crushed quite easily [3]. Larger rocks can also be crushed but the operation takes more time and wears out the machine quicker [4]. The crusher used in this case was manufactured by Profiteam Holzer GES.m.b.H (PTH). The crusher was later modified by Tirkkonen. [3] This crusher mills and mixes stones down to a depth of 300 mm. The first mixing and crushing produces a material with maximum grain size of 55 - 65 mm [4]. The mixed material can be milled several times until the specified maximum grain size is achieved. Usually the specified maximum grain size is 32 - 55 mm. The crusher is stated to be able to work with any kind of material, regardless of the hardness of the stone.

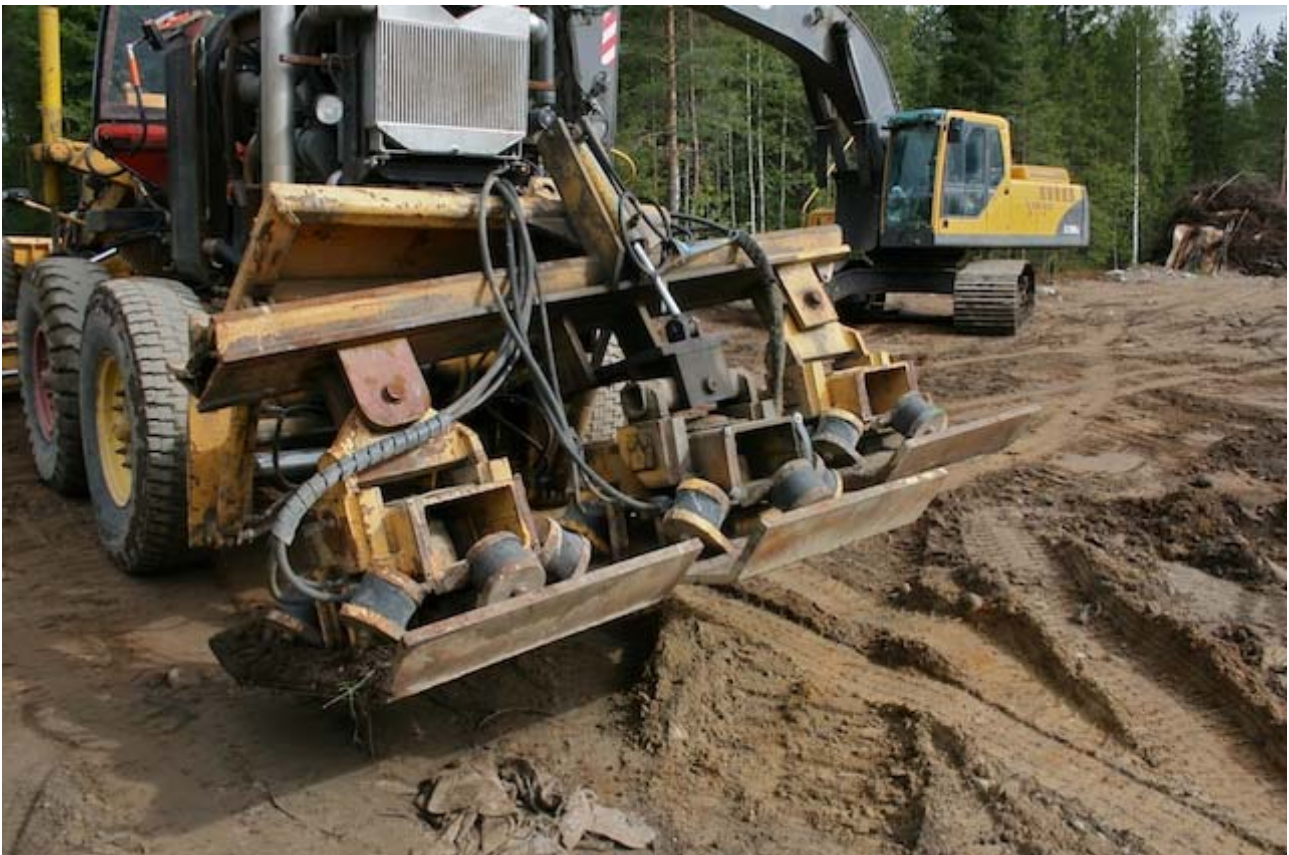
Figure 6.7 The grader and mounted compactor

Stage four: The road was shaped and finished to the required crossfalls with a grader and compactor as shown in Figures 6.6 and 6.7. The ditches were also finished with the excavator to ensure that the drainage worked and the road was kept dry.

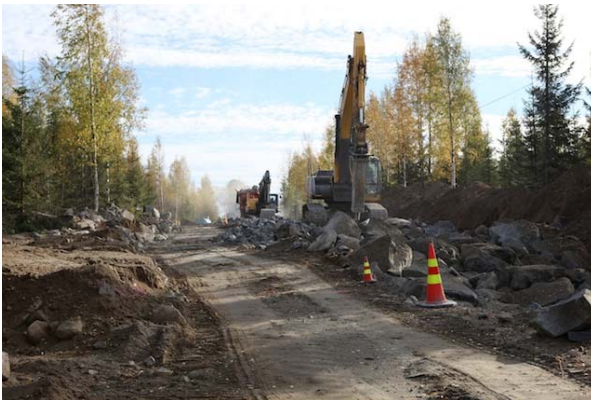
Figure 6.10 Blasted bedrock

Before the rehabilitation works started it was known that there were places where the bedrock was near the road surface and needed to be removed by quarrying. It was also decided to improve the forward visibility along the road by quarrying the steep hills. During these operations the bedrock present was found to be of such good quality that it was decided to quarry more material for the use of the ELY Centre of Central Finland. The facilities for the blasting and crushing were transported to the area and a storage area created for the crushed aggregate. These operations are shown in Figures 6.9 to 6.16.
