Ilkka Hyvönen, Nuutti Vuorimies, Pauli Kolisoja

ROAD 16583 EHIKKI-JUOKSLAHTI

Demonstration of a Possible Drainage Solution for an Eroding Sideslope and Ditch

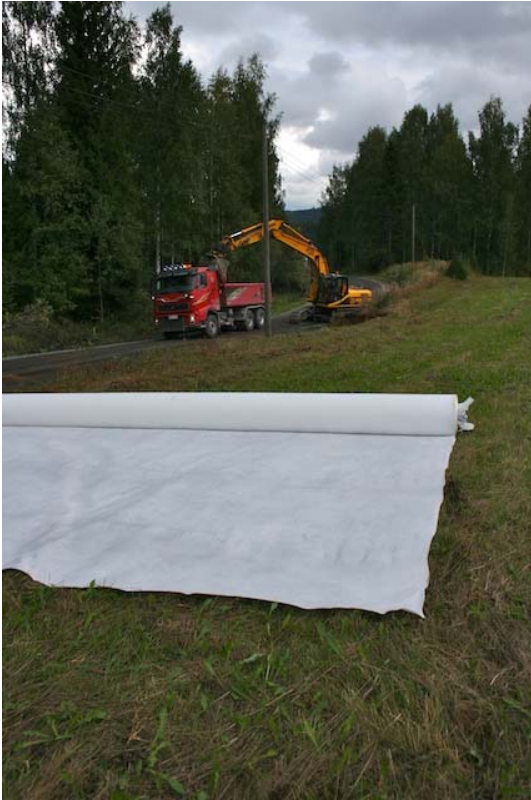
Figure 6.2 Cutting the geotextile

As the excavator cleared the ditch, the selected geotextile was laid on to the newly shaped ditch and slope. The geotextile was first rolled on the field and cut into smaller lengths to facilitate easier handling by one man, as shown in Figures 6.2, 6.3 and 6.4.

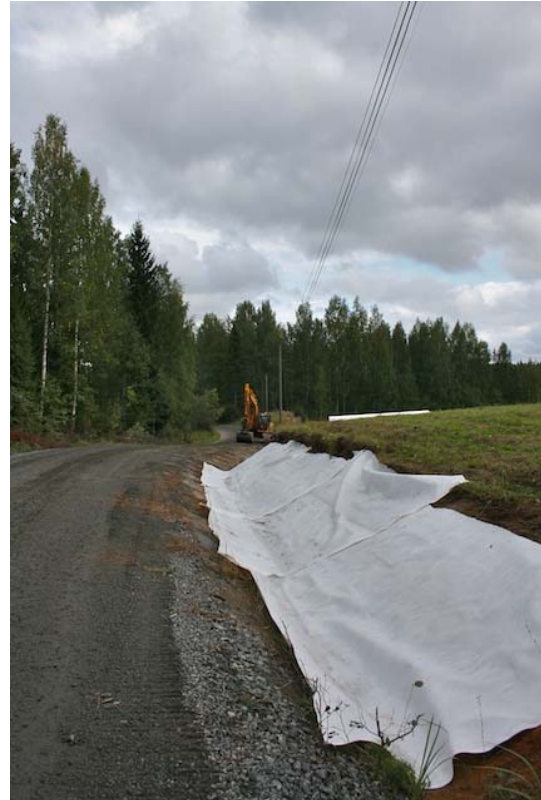
Figure 6.3 Installing the geotextile

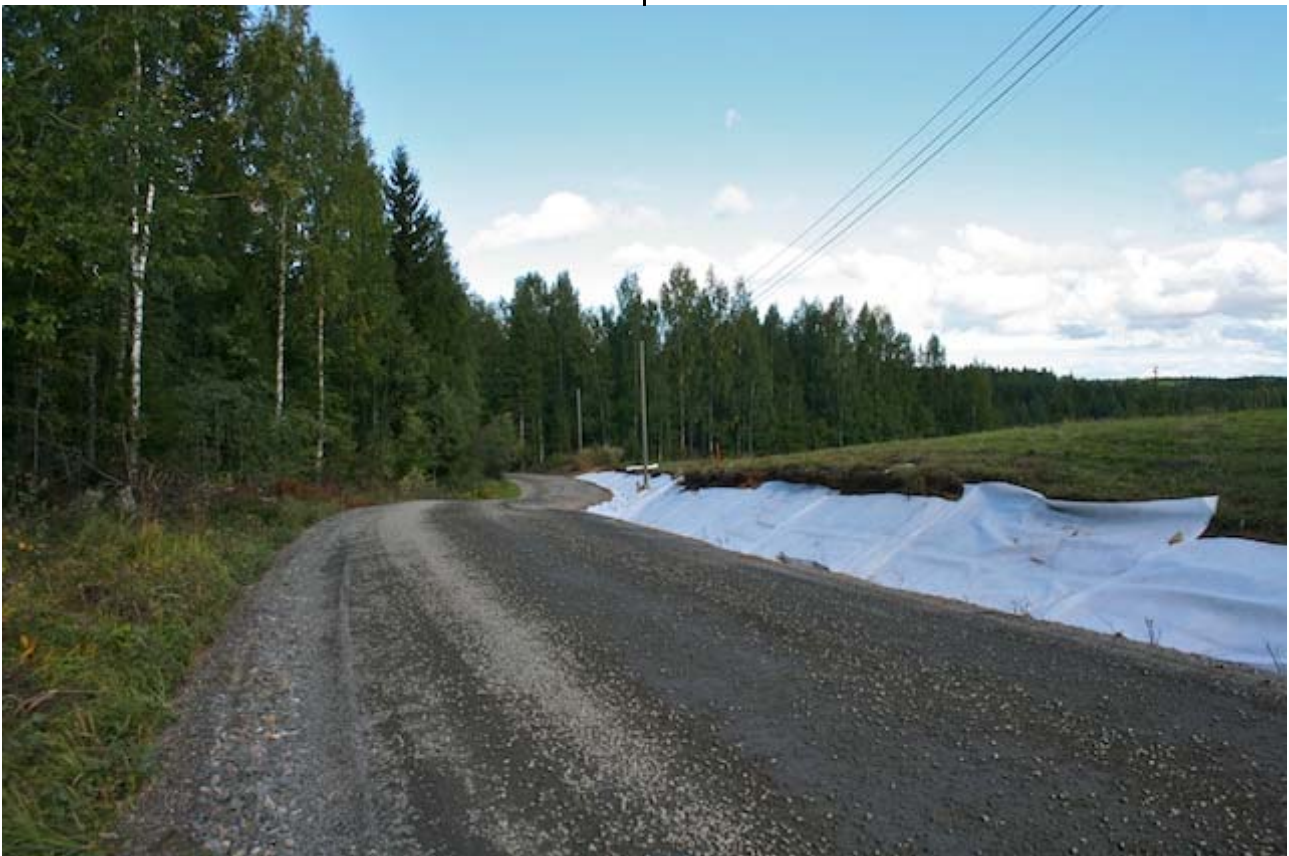
Figure 6.4 Installed geotextile

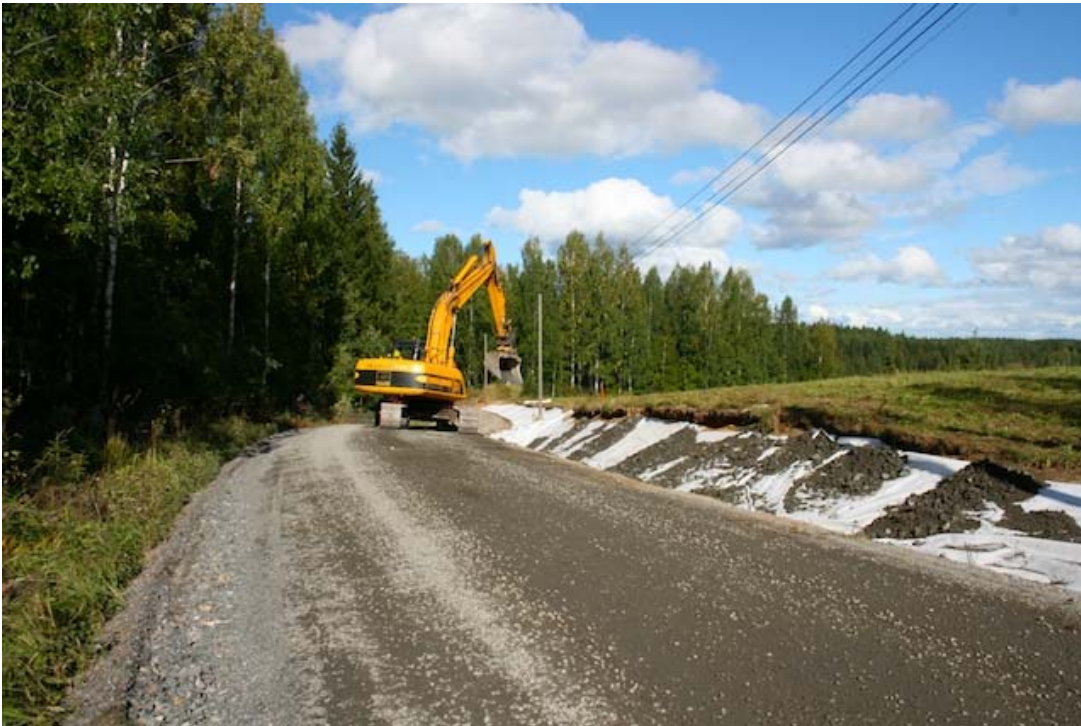
Figure 6.5 Adding some aggregate as a precautionary weight

At the end of the first day, the geotextile was installed and ready to receive the coarse graded material. A small amount of aggregate was laid on the geotextile to hold it down overnight as a precaution against wind damage, as shown in Figure 6.5.

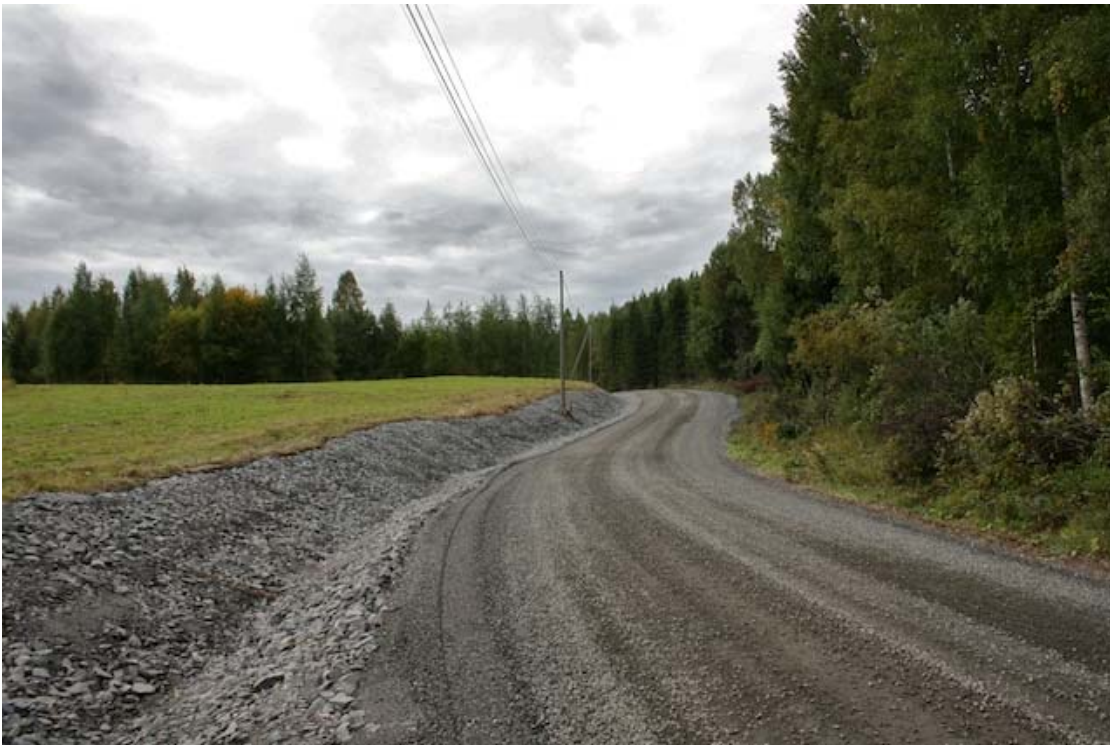
Figure 6.6 The finished installation (02.09.2010)

On the second day the installation was completed by laying the rest of the coarse graded aggregate on top of the slope and ditch sides. One earth-hauling truck was used for the operation and took the whole day. An excavator finished the work by shaping and compacting the aggregate with its dipper arm. The finished installation is shown in Figure 6.6.

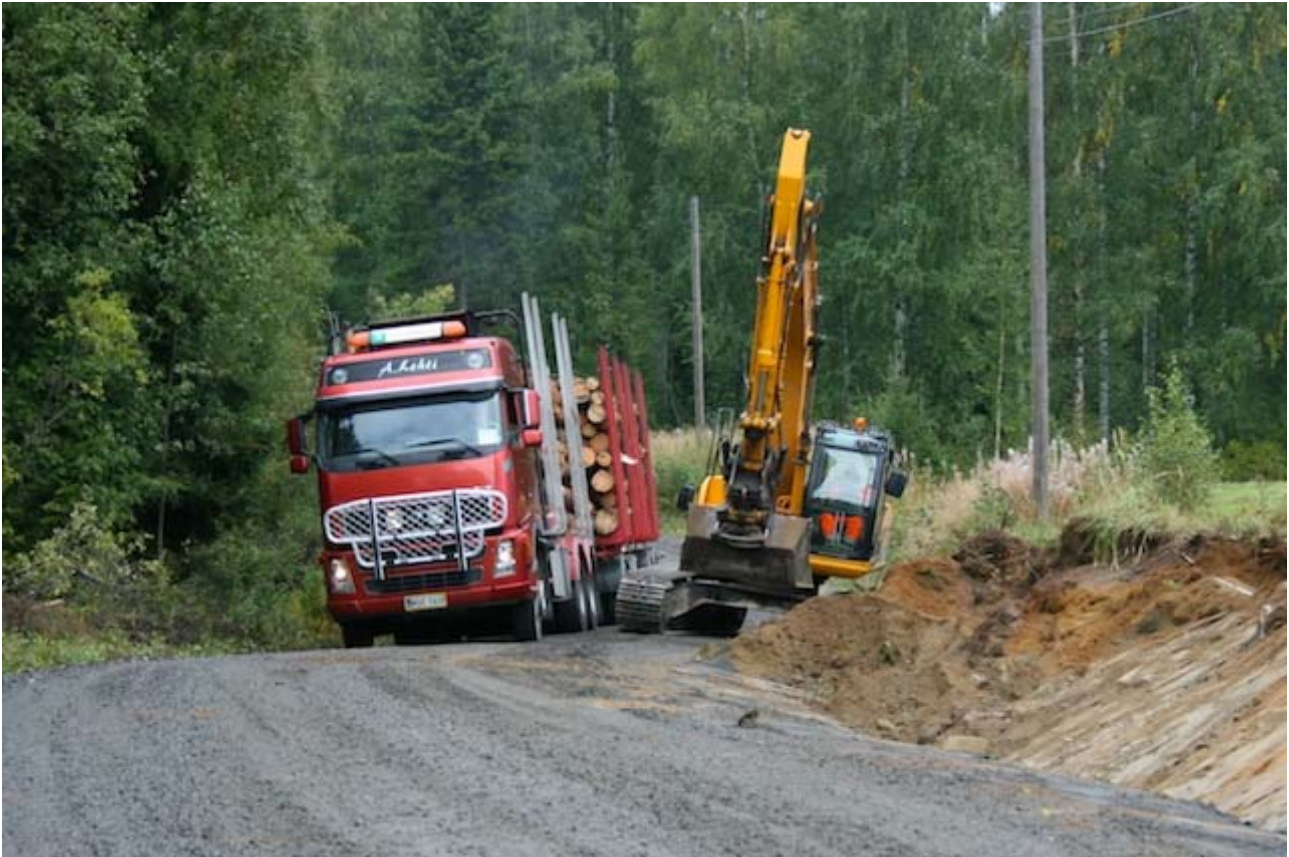
The works did not encounter any major problems on site. Nearby logging areas caused some minor traffic problems on the narrow road that required the excavator and earth-hauling truck to halt their work for a moment to let the logging trucks pass, as shown in Figure 6.7. Another minor issue was the presence of an overhead electric line close to the ditch. The excavator operator had to be careful not to damage the line with the boom. The electric line was immediately above the ditch from chainage 02/3360 to 02/3400 and the excavator had to work under this section of line.

Figure 6.7 *Passing logging truck*
