Ilkka Hyvönen, Nuutti Vuorimies, Pauli Kolisoja

# ROAD 16583 EHIKKI-JUOKSLAHTI

Demonstration of a Possible Drainage Solution for a Sloping and Rocky Terrain

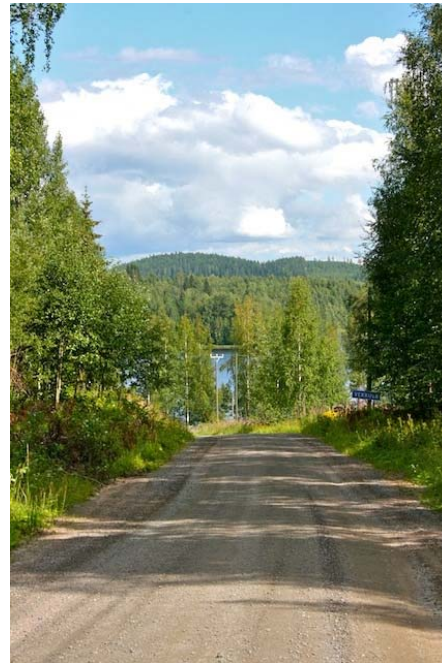
**Figure 2.2** Topography of the area

Road 16583 passes through a variable topography of hills, hummocks, lakes and peat-lands between hills, which creates challenging circumstances for the road. An example of this topography is shown in Figure 2.2. This range of topography results in the road, having a range of different features, such as side sloping ground and morainic hummocks. The terrain is mostly frost-susceptible morainic soil and in some places the bedrock is close to the surface.
