# ROAD 16583 EHIKKI-JUOKSLAHTI

Mode 2 Rutting Site on Peat

This report describes a ROADDEX demonstration exercise carried out on a low volume road section of Road 16583 from Ehikki to Juokslahti in Jämsä, Central Finland. The section was located on a peat subgrade and was reinforced with a geogrid. The road had been deforming and widening significantly over the section mainly due to clogged side ditches, a low outlet ditch, and settlement of the road structure into the peat subgrade. As it was very difficult in practice to improve the operation of the outlet ditch, it was decided to reduce the further development of permanent deformations on the road by the addition of a new base course layer reinforced with a geogrid. As a reference structure, half of the test section was built with the addition of a new base course layer underlain by a geotextile, which could be considered as a standard solution in this type of problem site.

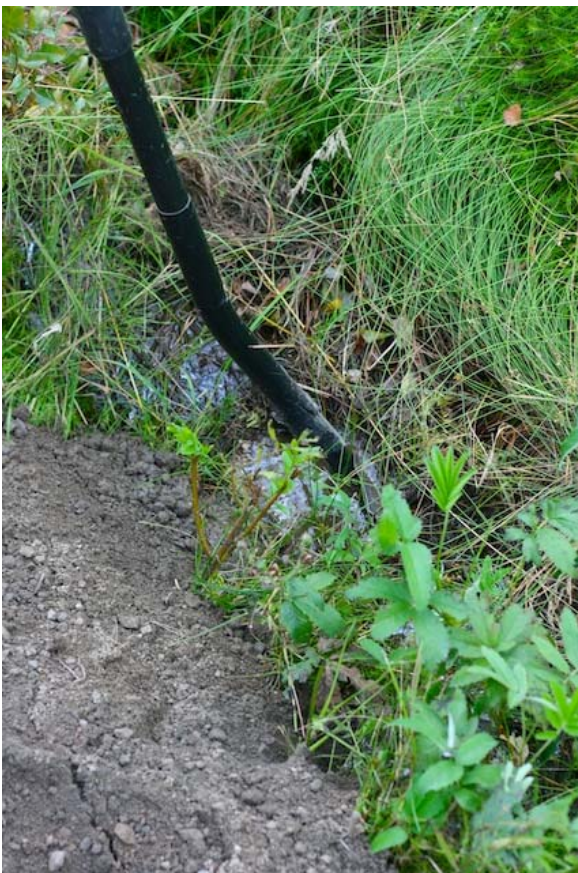
Normally site investigations are carried out only once for a road rehabilitation but in this site they were carried out twice. The first site investigation was carried out during the spring thaw process in April when road damages could be seen. The second visit, the 'official' site investigation, took place in the beginning of June 2010 when the road was in better shape and only severe damages remained. Inventory photos were taken during this investigation and the damaged sections of drainage systems were checked for location and condition.

**Figure 3.1** Checking the depth of the ditch

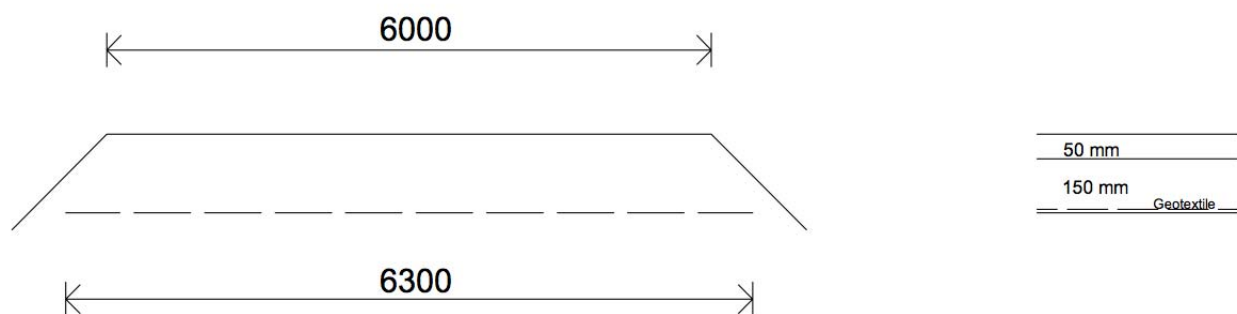
**Figure 5.1** The rehabilitation structure

The new structure in the reference section from chainage 02/100-200 comprises:

- 50mm wearing course
- 150mm crushed aggregate layer
- Geotextile
- Old road structure with wearing course removed

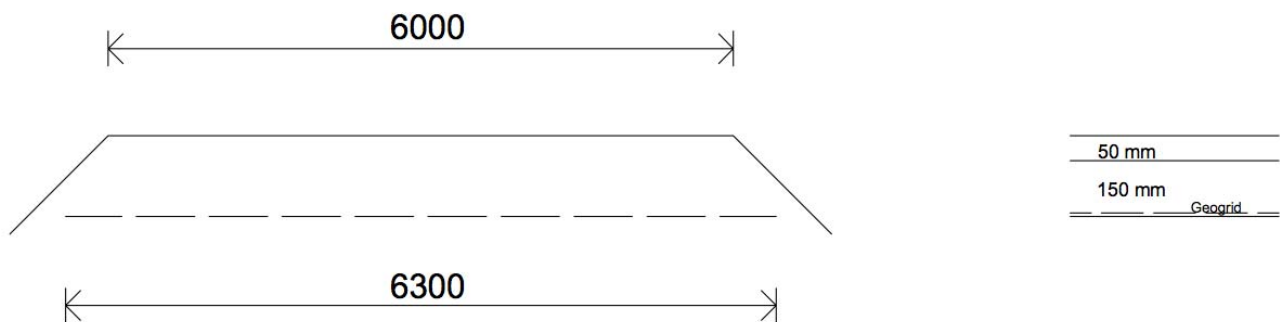
**Figure 5.3** Rehabilitation Structure

The new test structure in the geogrid section from chainage 02/200-266 comprises:

- 50 mm wearing course
- 150mm crushed aggregate layer
- Geogrid (Secugrid 40/40 Q1)
- Old road structure with wearing course removed

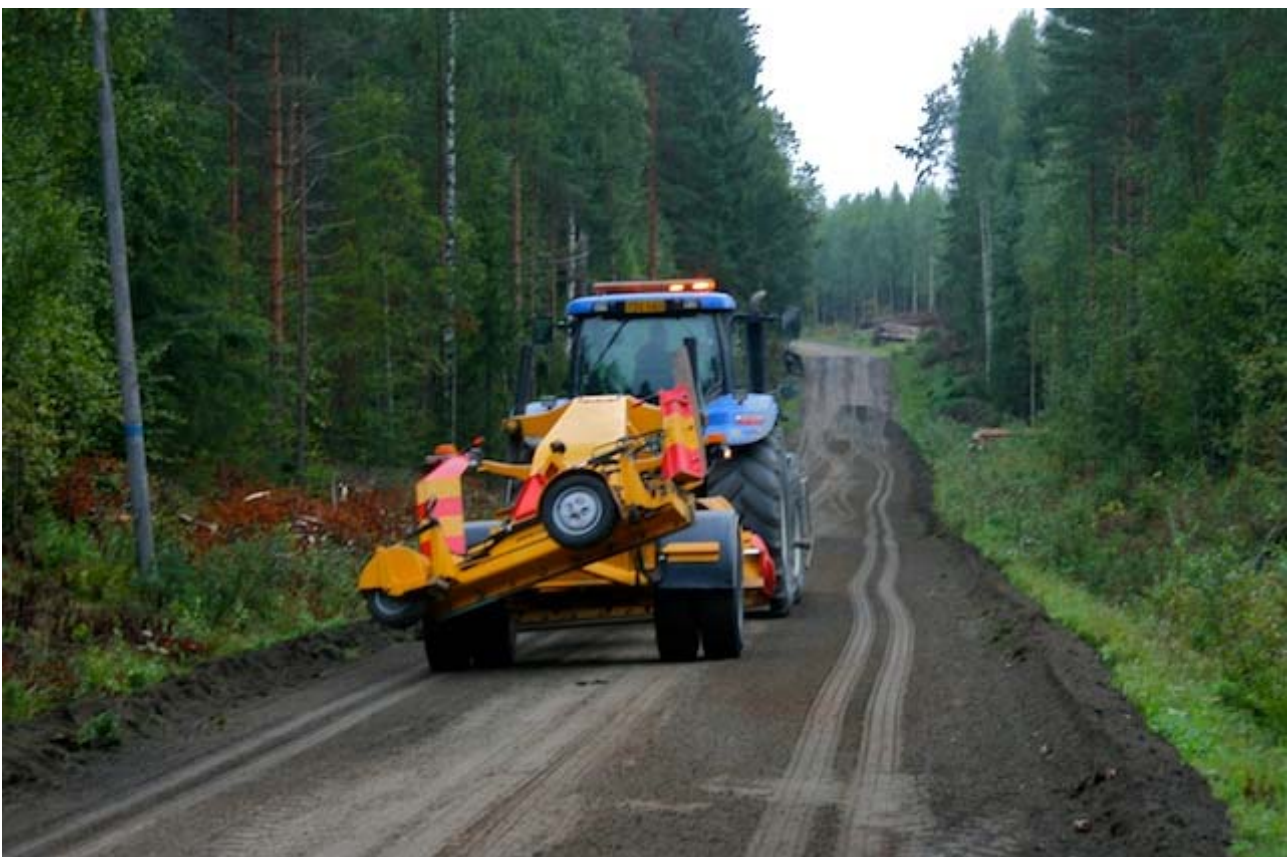
**Figure 6.1** Grader removing the old wearing course

Work started by removing the old wearing course from both sections. For this a 50 mm thick layer was planned to the sides of the road by a road grader, as shown in Figure 6.1. This old wearing course was used to support the soft edges of the road. The width for the new base layer was 5.8 metres.

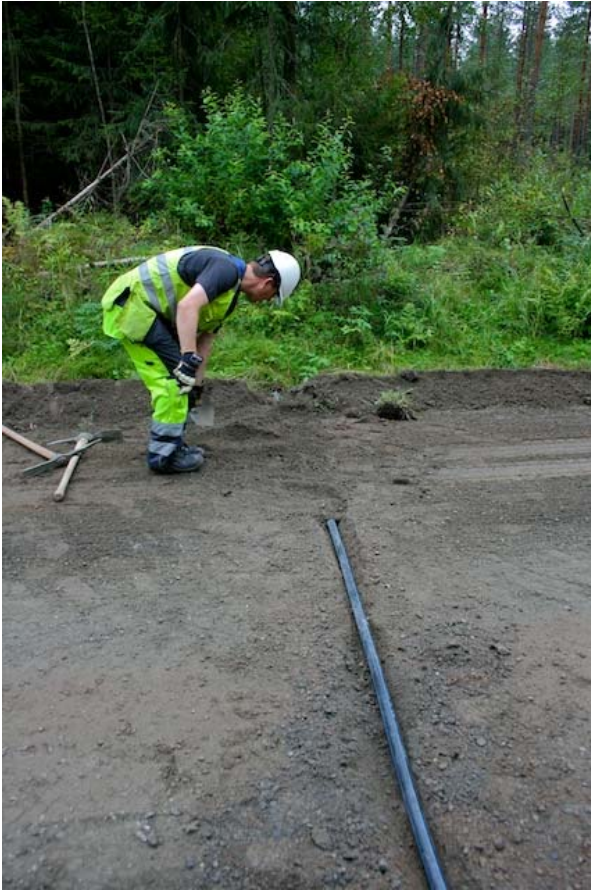
After the wearing course was removed, settlement pipes were installed in the surface of exposed road. 100 mm deep grooves were excavated for the pipes so that they would be protected from the passage of the construction trucks. The ends of the pipes were covered with duct tape to prevent rocks and sand entering and blocking them. The exact locations of the pipes were surveyed to help finding them afterwards if the ends became covered with road structure materials. The principle of the settlement pipe is explained in detail in Section 7.1.

**Figure 6.2** *Installing settlement pipe*

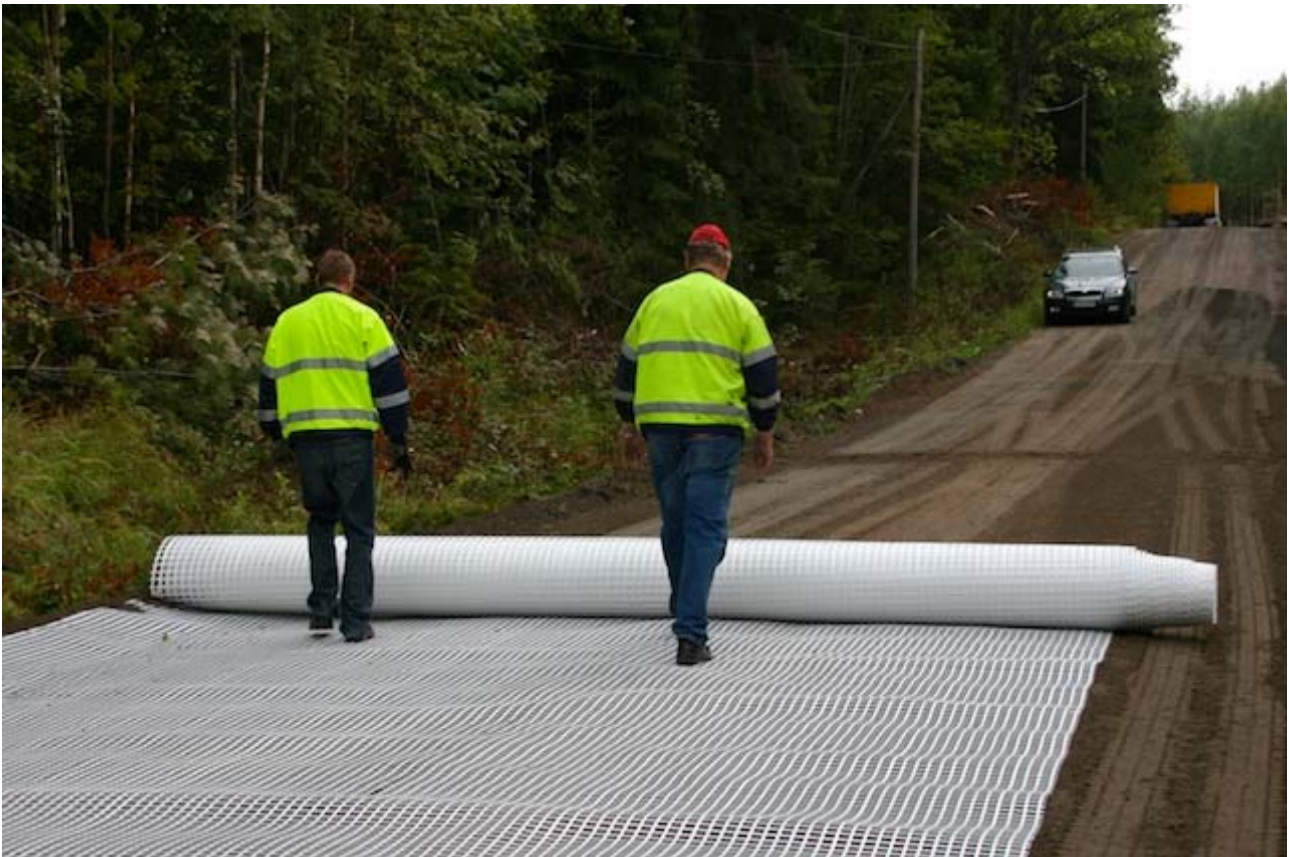
After the settlement pipes were placed in position, the geotextile and geogrid were installed above the settlement pipes in the reference and the test section respectively. The installation of the geotextile and geogrid was easy and a quick operation. Both materials were supplied in a roll and were easily rolled out over the road by two men, as shown in Figure 6.4. The width of the geogrid roll was 4.7 metres and an overlap arrangement was necessary to bring it up to the planned road width of 5.8. This was achieved by cutting the 100 meters long roll at 66 metres to obtain the extra material and overlapping the geogrid strip by 1.3 metres. Cutting was done with a simple knife and the splitting was carried out with a chainsaw. The cutting and splitting processes are shown in Figures 6.5 and 6.6. Cutting the geogrid and splitting the roll was not a problem in the test section as it was short but if a long section of road is to be rehabilitated with geogrid it is recommended that a full width geogrid should be used. The finished installation width for the geotextile was 5.25 metres, and 5.7 metres for the geogrid. The planned installation width for the geogrid was 6 metres, but only 5.7 metres of road was available after the grader removed the old wearing course. A lapped joint of one metre was provided at the junction of the reference section and test section.

**Figure 6.4** *Installing the Geogrid*

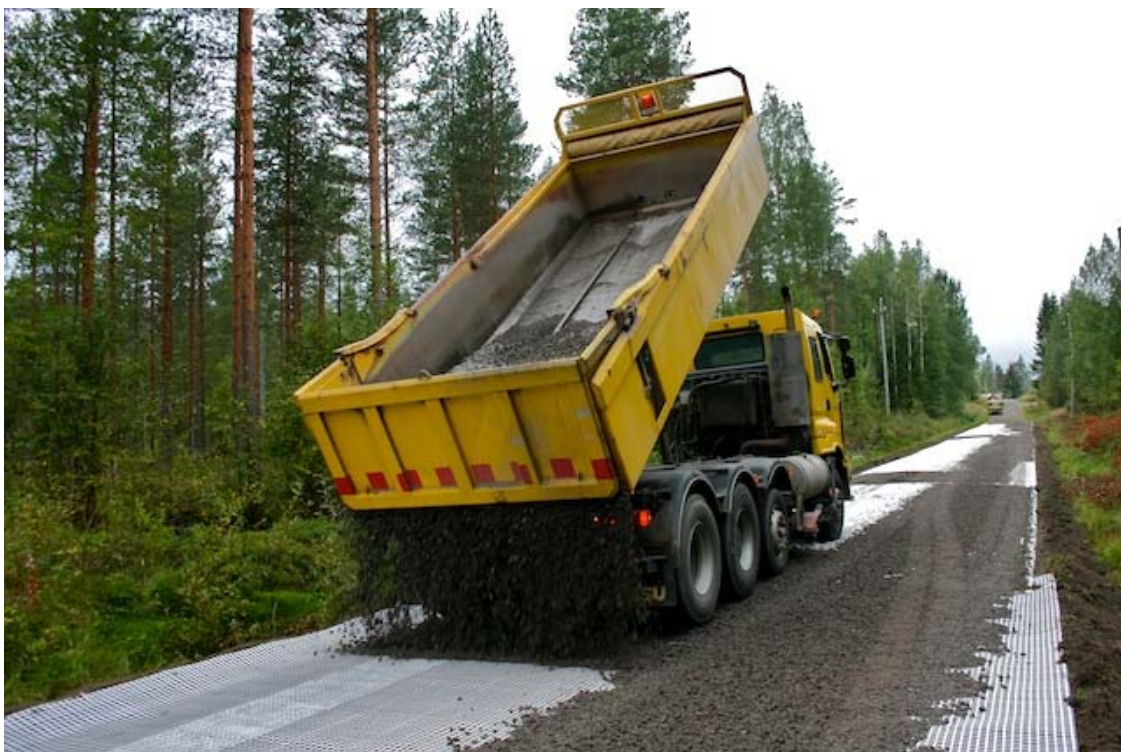
A 150 mm thick layer of crushed aggregate was laid on top of the geotextile and geogrid by a rear discharge truck. The total amount of crushed aggregate used was 200 tons for 166 metres of road. A 50 mm thick wearing course was then laid on to the aggregate layer in the same manner. The total amount of crushed aggregate used for the wearing course was 100 tons. After both structural layers had been laid, the road surface was shaped with an underbody blade on a truck. At the conclusion of the work the ditches on both sections were cleaned out. Over all, the whole rehabilitation work employed three men and two vehicles; an earth-hauling truck and a van, as shown in Figure 6.7. The installation of the geogrid could have been the same as the geotextile, if it had been supplied wide enough.

**Figure 6.8** *Applying the new base course*

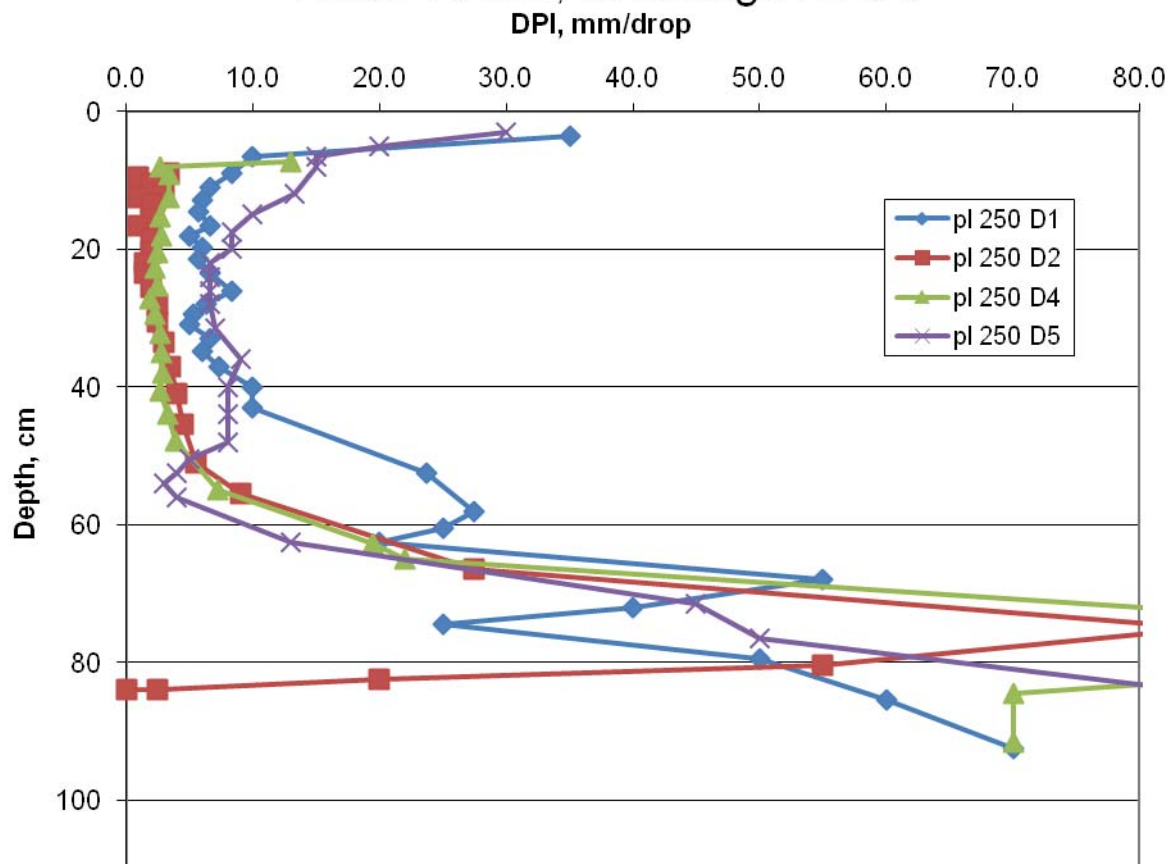
## Road 16583, Chainage 2/250

**Road 16583 Ehikki-Juoksolahti**

California Bearing Ratio (CBR)  
log CBR = 2,46 - 1,12\* log DPl

**Note!** The CBR values for the wearing course and base course  
represent dry season (summertime) conditions.
