ROAD 16589 SAALAHTI

Mode 2 Rutting Site on a Soft Subgrade

This report describes a ROADDEX demonstration exercise carried out on a low volume road section of Road 16589 Saalahti in Jämsä, Central Finland. A geogrid reinforcement was used in the demonstration to retard the development of permanent deformations of a gravel road section located on a silty subgrade. The demonstration section had been suffering from deformations primarily taking place in the subgrade material that had become very soft during the spring thaw of the seasonal frost. This had also resulted in severe widening of the road cross-section and almost total clogging of the side ditches. According to the GPR profiles the total thickness of the structural layers was much higher in the middle of the road than towards the edges of the road which was a clear indication of Mode 2 rutting.

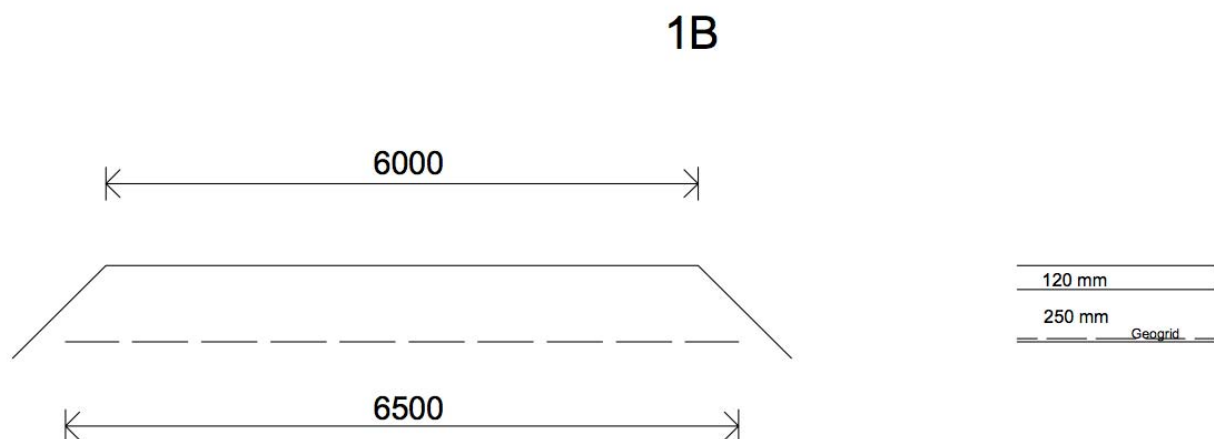
Figure 5.1 Rehabilitation Structure 1B

New structure 1B, chainage 01/1640-1760:

- 120 mm wearing course
- 250 mm crushed aggregate layer
- Geogrid Fornit 40/40
- Old road structure

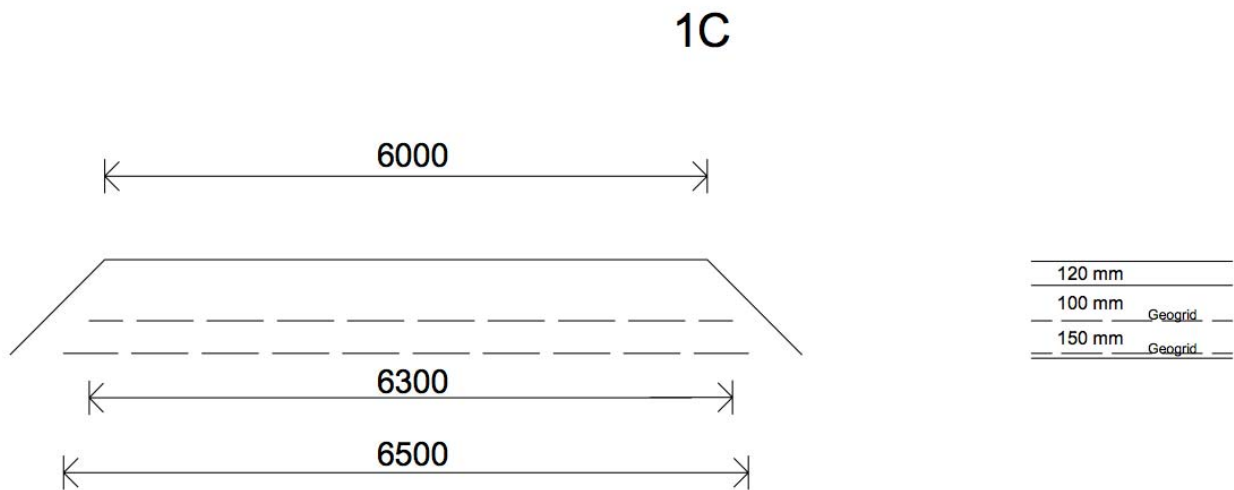
Figure 5.2 The Rehabilitation Structure 1C

New structure 1C, chainage 01/1760-1830:

- 120mm wearing course
- 100 mm crushed aggregate layer
- Geogrid Fornit 40/40
- 150 mm crushed aggregate layer
- Geogrid Fornit 40/40
- Old road structure

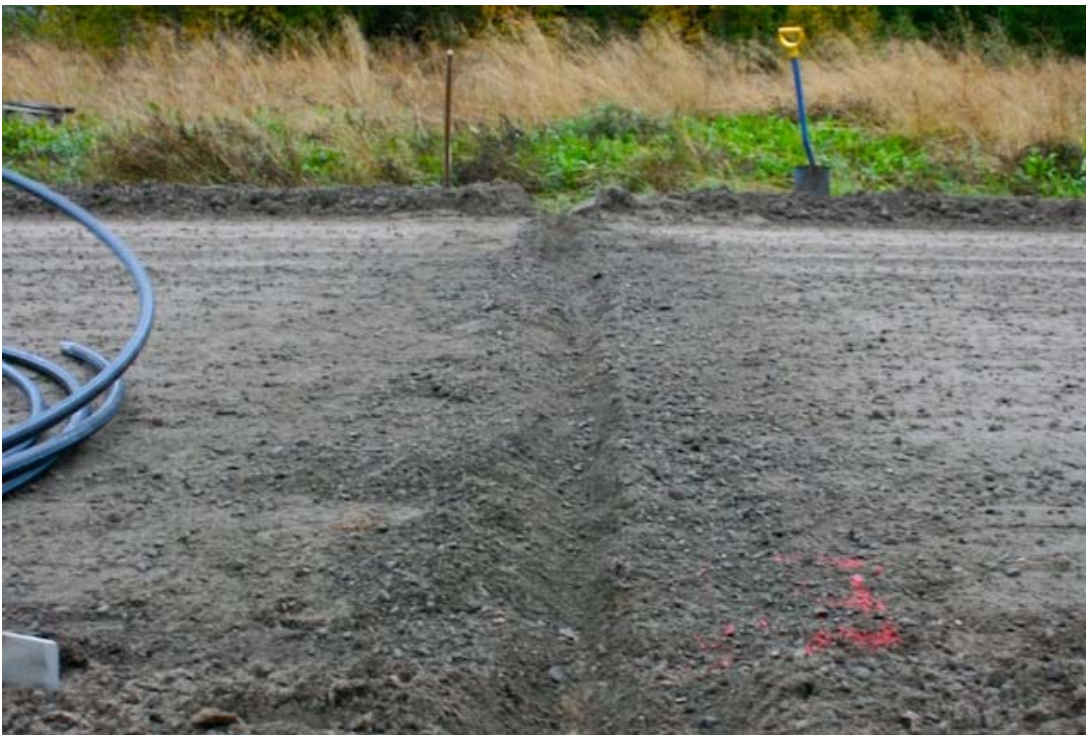
Work started by removing of the old wearing course. For this a 50 mm thick layer was planed to the sides of the road by a road grader. The width for the new base layer was 6.1 metres. When the wearing course was removed, settlement pipes were installed in the surface of the old base layer. Shallow trenches, approximately 100 mm deep ruts were excavated for the pipes so that they would be protected from the passage of the construction vehicles, as shown in Figure 6.1. The ends of the pipes were covered with duct tape to prevent the aggregate blocking them. The exact locations of the pipes were surveyed to help finding them afterwards if the ends of the pipes became covered with the road structure material. The principle of the settlement pipe is explained in detail in Section 7.1.

Figure 6.1 *Installing the Settlement pipes*

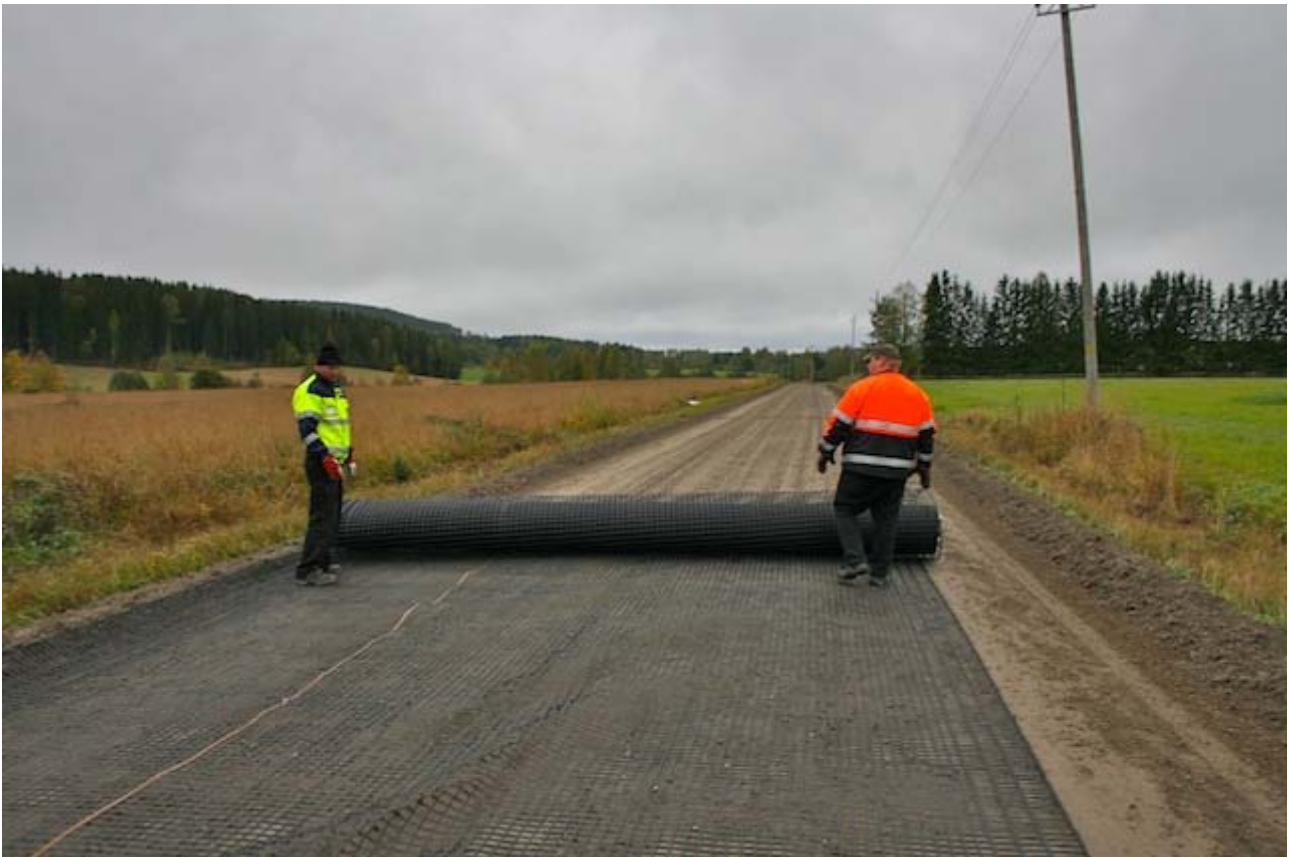
After the settlement pipes were placed in their position, the geogrid was installed above the old base layer and the settlement pipes. Installation of the geogrid was easy but the weight of the geogrid roll caused a slight problem which is described in Section 6.2. The installation was carried out by two men, as shown in Figure 6.2. The width of the geogrid was 5.2 metres, and an overlap arrangement was necessary to bring it up to the planned road width of 6.1 metres. For this the 200 metres long roll had to be cut into smaller pieces to get the wider coverage area. The cutting was done with an ordinary knife and the splitting with a chainsaw. The cutting and the splitting operations are shown in Figures 6.3 and 6.4.

Figure 6.2 *Installing the geogrid*

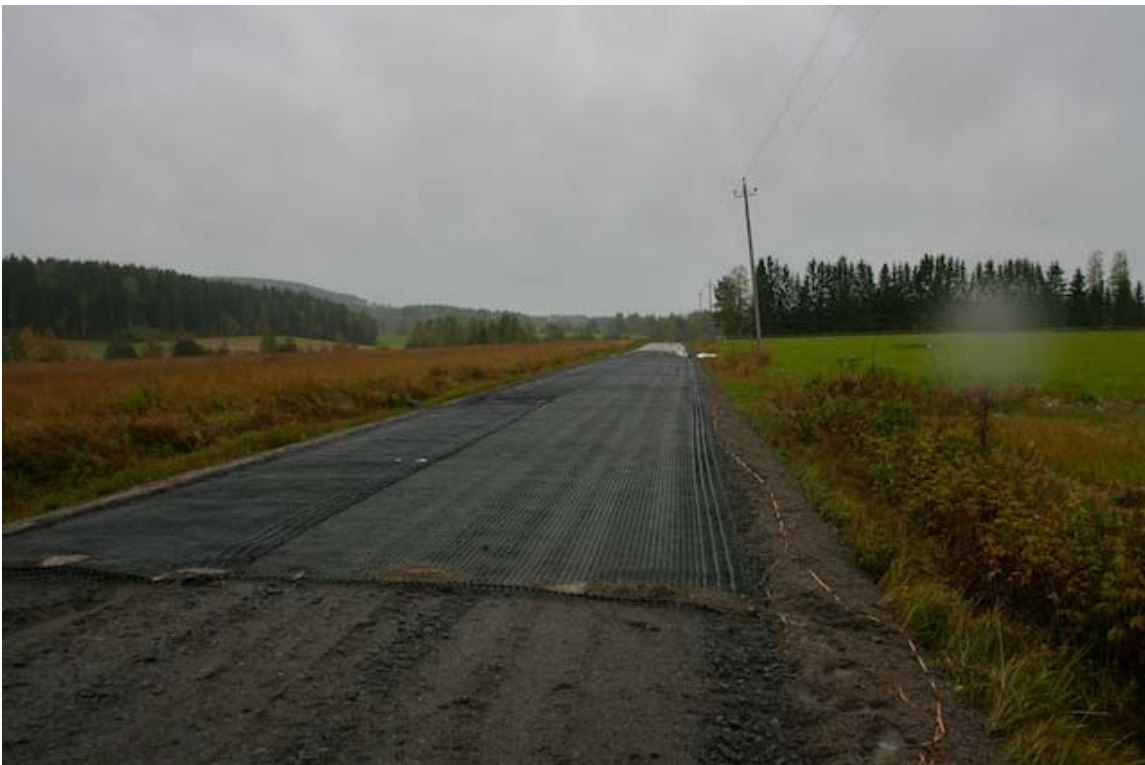
A 150 mm thick layer of base course aggregate layer was laid on top of the geogrid, the old base layer and settlement pipes, as shown in Figure 6.5. A further layer of geogrid was laid on top of this layer in test section 1C from the chainage 1760 to chainage 1830, as shown in Figure 6.6. Test section 1B was given an additional layer of 100 mm of crushed aggregate to bring its total thickness of base course up to 250 mm. Both sections were then completed with a 120 mm thick wearing course. Over all, the whole rehabilitation work employed four men and three vehicles; two earth-hauling trucks and a van.

Figure 6.6 *The second geogrid layer installed*

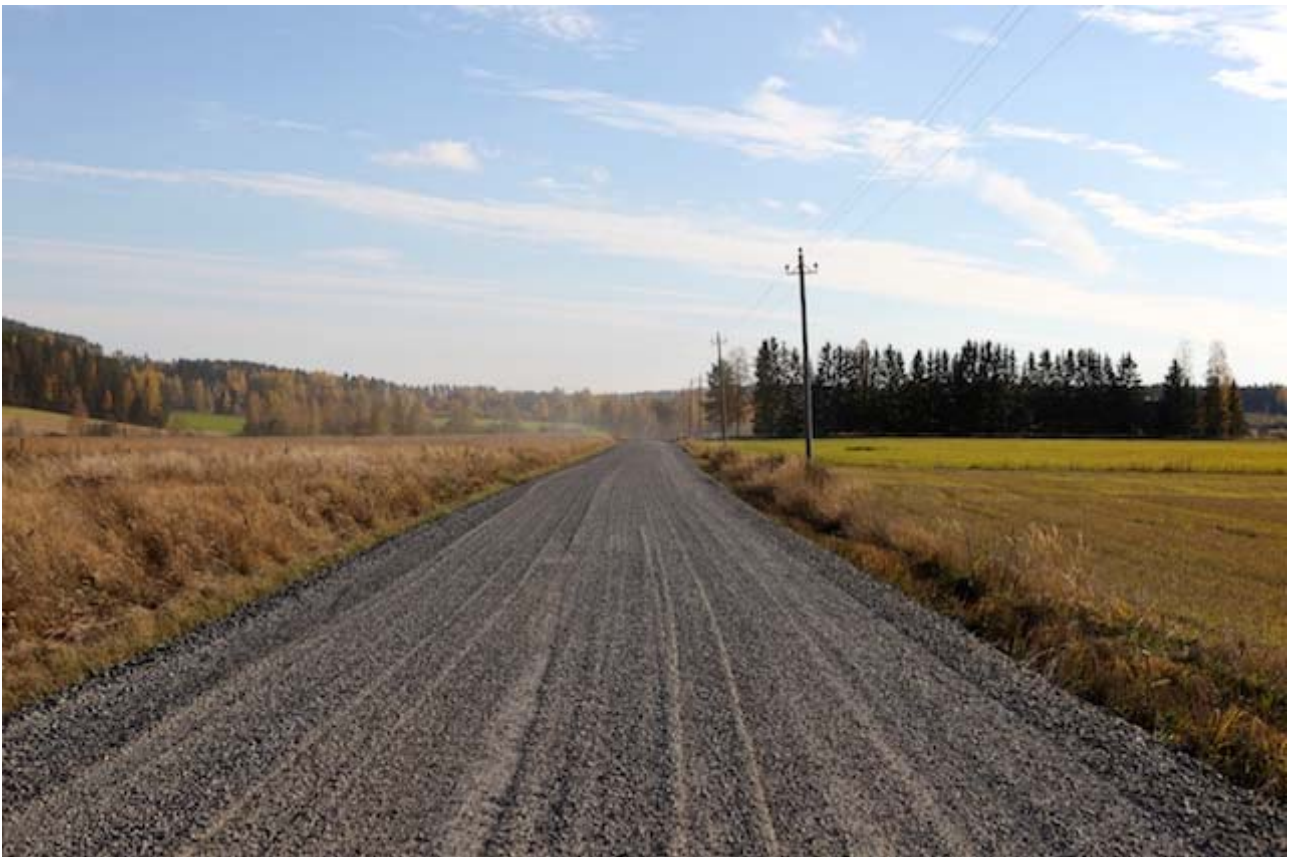
Figure 6.8 Improved test section after two weeks from construction. The side ditches have not yet been cleaned and shaped.

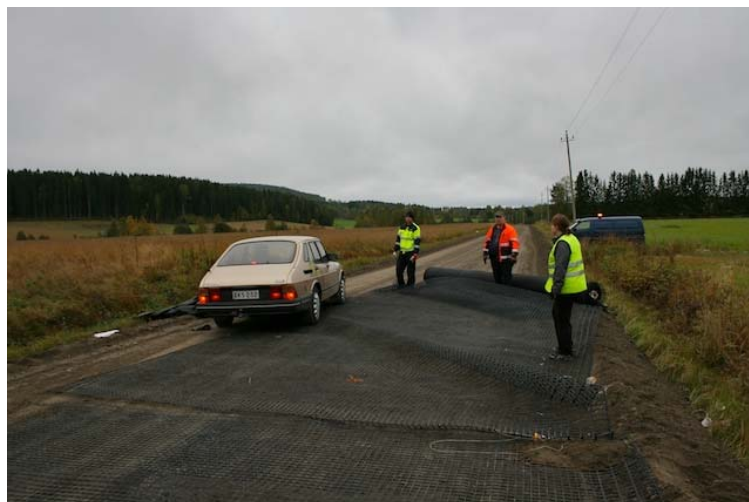
A further difficulty encountered on site was keeping the road open for vehicles. Even though the test sections were located on a low volume road delays in operations were caused by passing cars. The geogrid roll had to be moved to the side of the road so that the cars could pass, as shown in Figure 6.9.

Figure 6.9 *Passing car on Road 16589*
