ROADEX Drainage Demonstration Projects: N56 and N59, Ireland

Timo Saarenketo, PhD
Roadscanners, Finland

N56 & N59 IRELAND

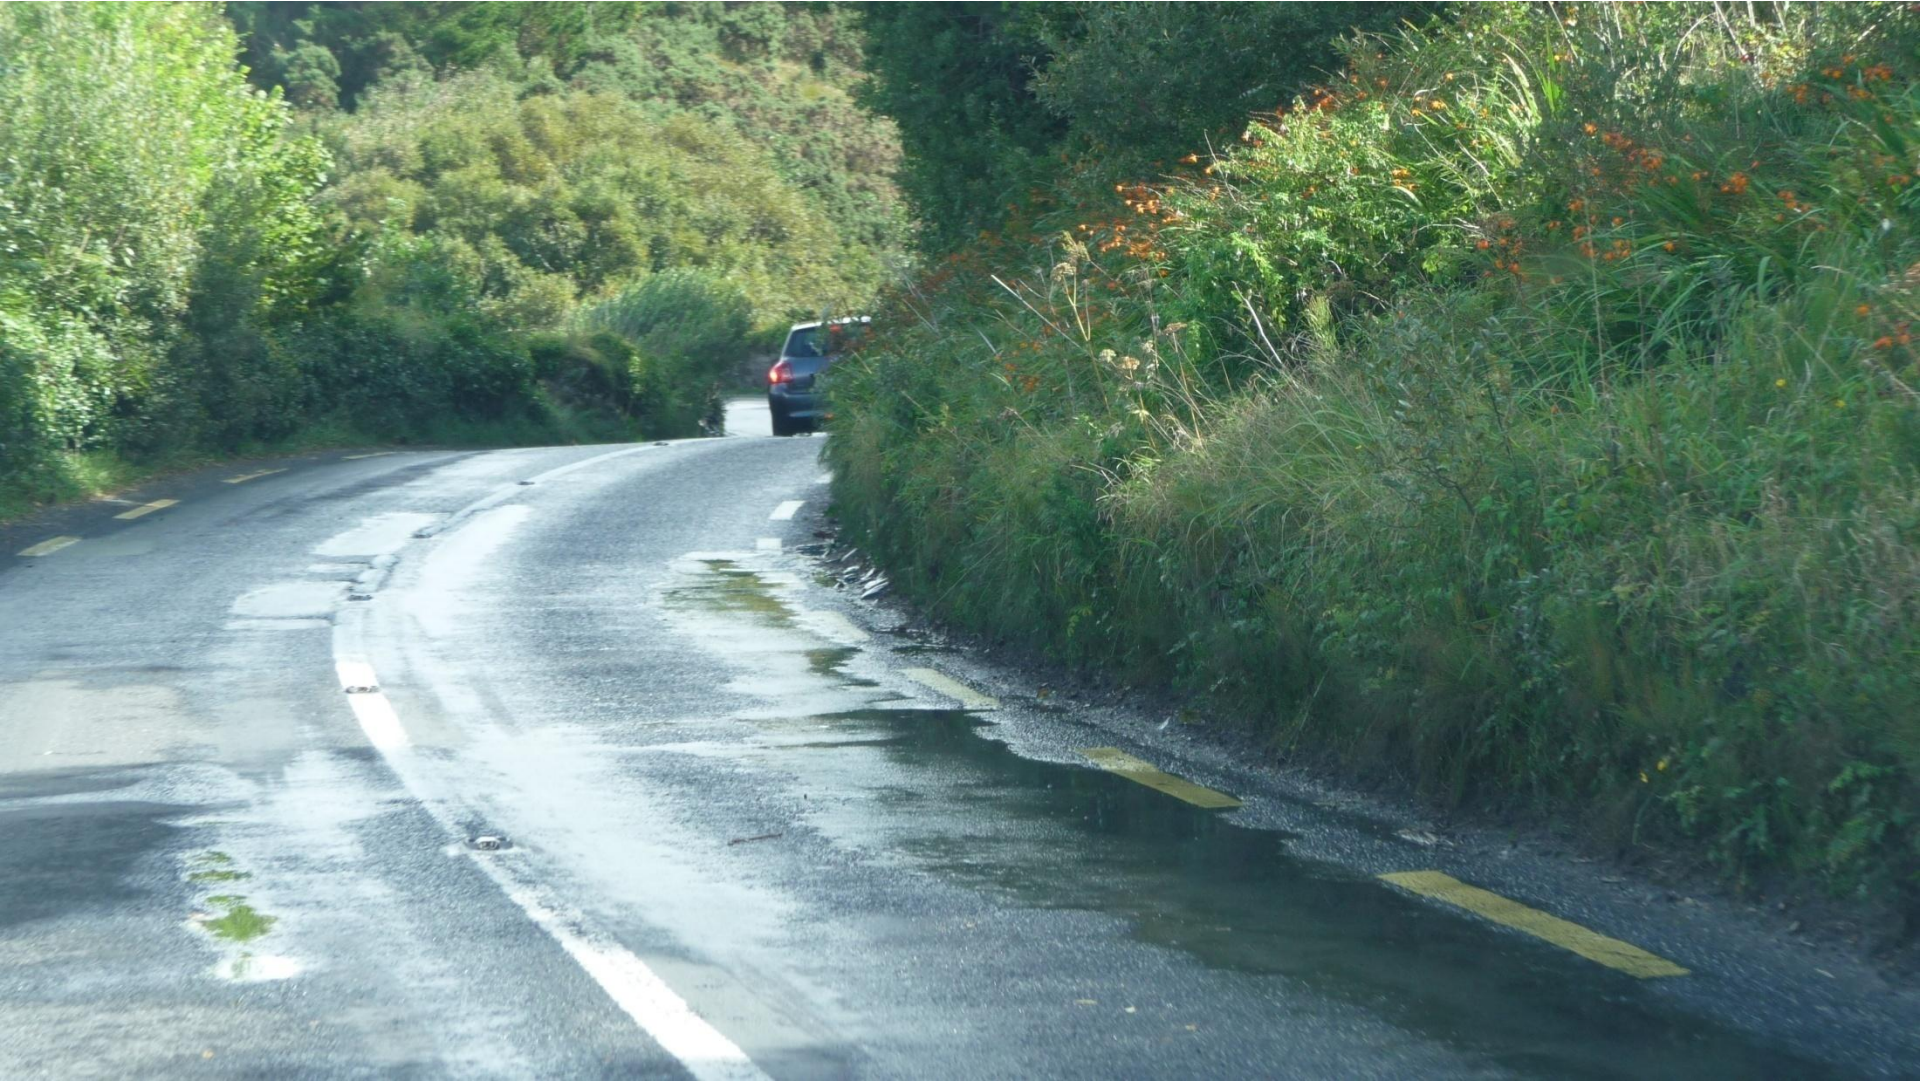
- A very special feature on the roads surveyed was the narrow road cutting
- In many cases there is a complete absence of ditches or any other drainage structure within these types of road cuts.
- This means that water generally flows along the road as there is no possibility for it to get off the road, and this causes erosion and deformation problems to the road

Problems in a road cutting

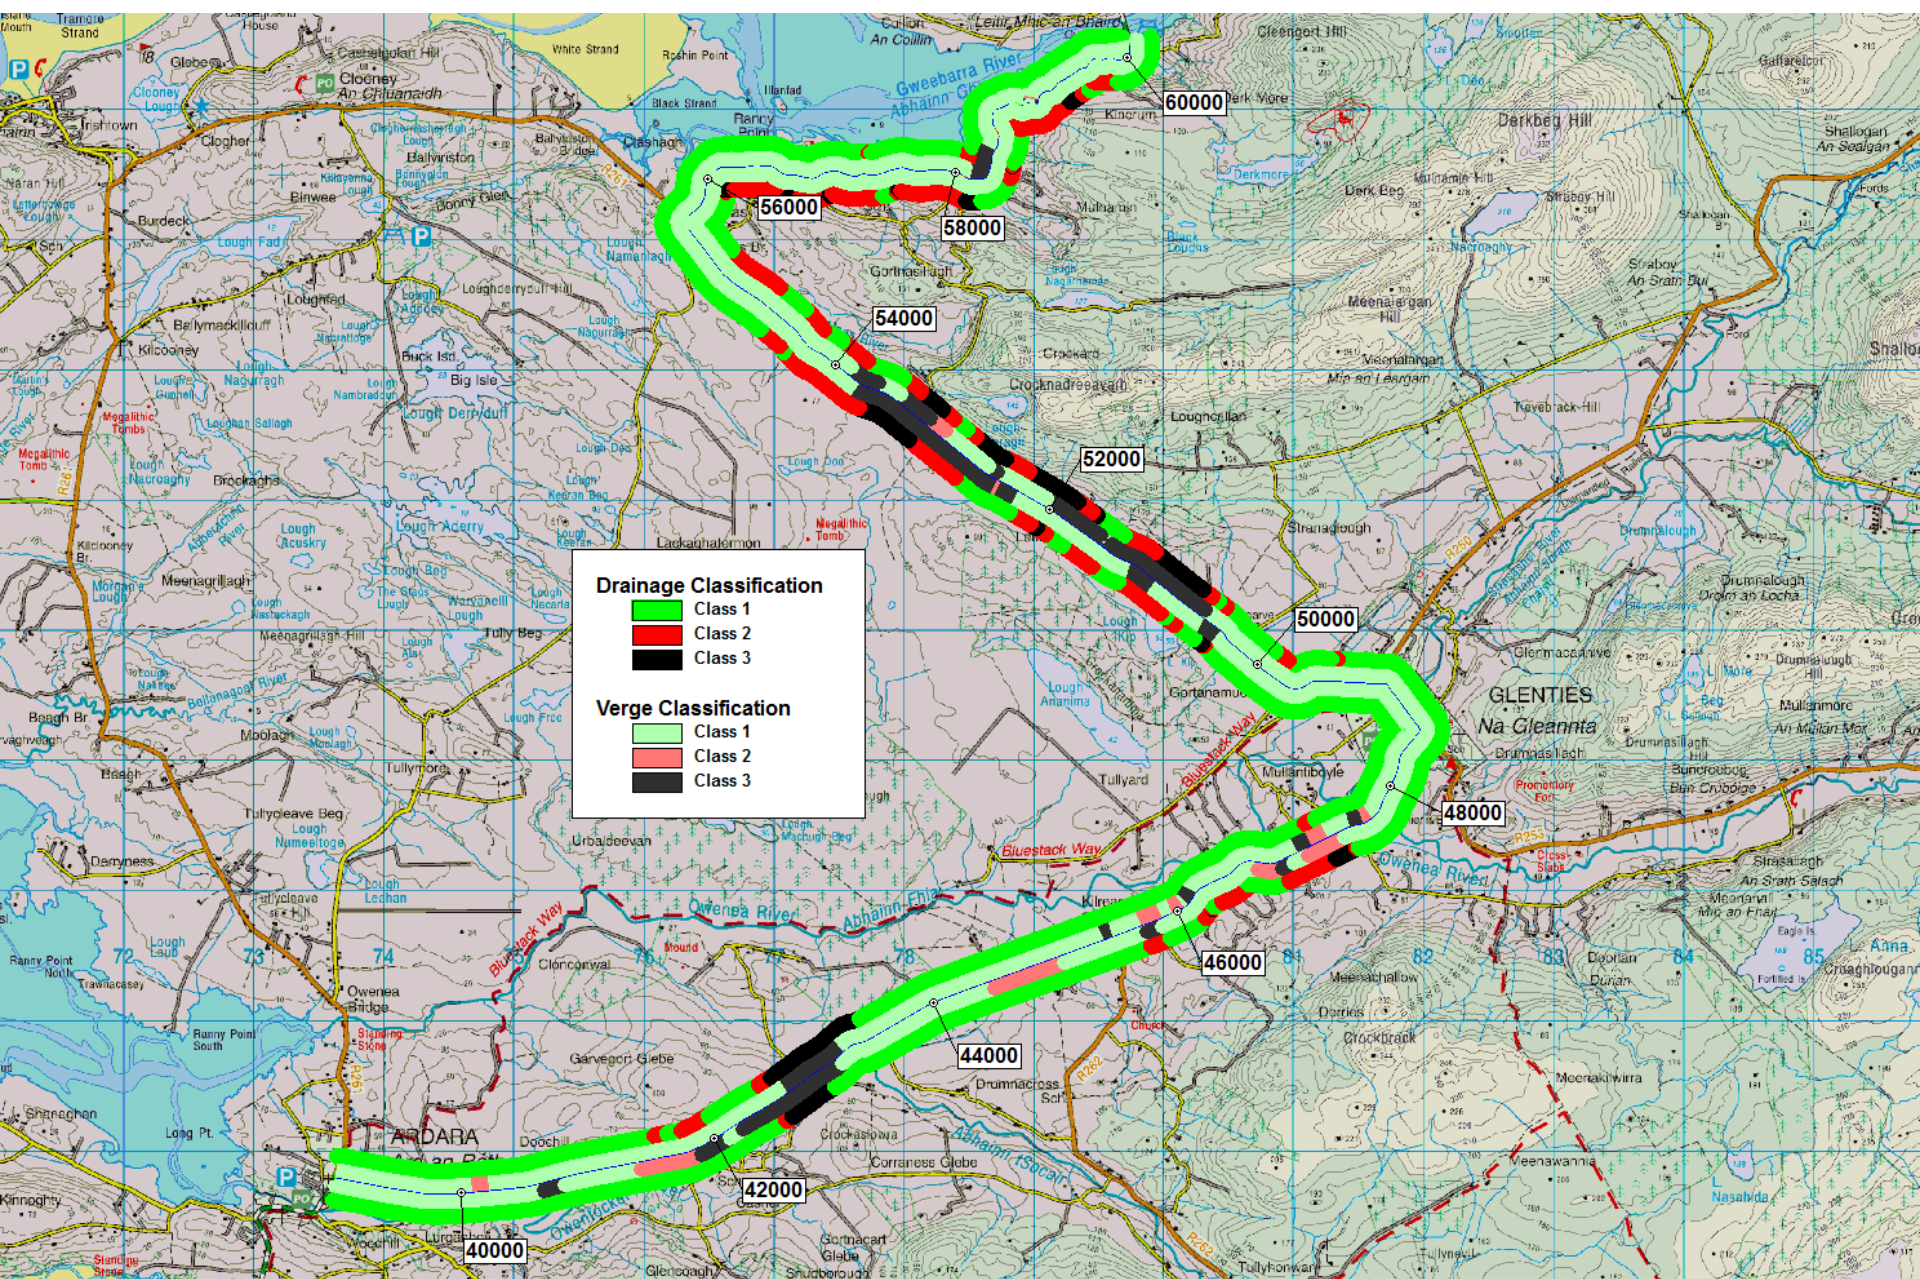
41900m the road profile is side sloping from left to right. Possibly there is a french drain but it's not working well enough. Higher IRI and Rutting values!

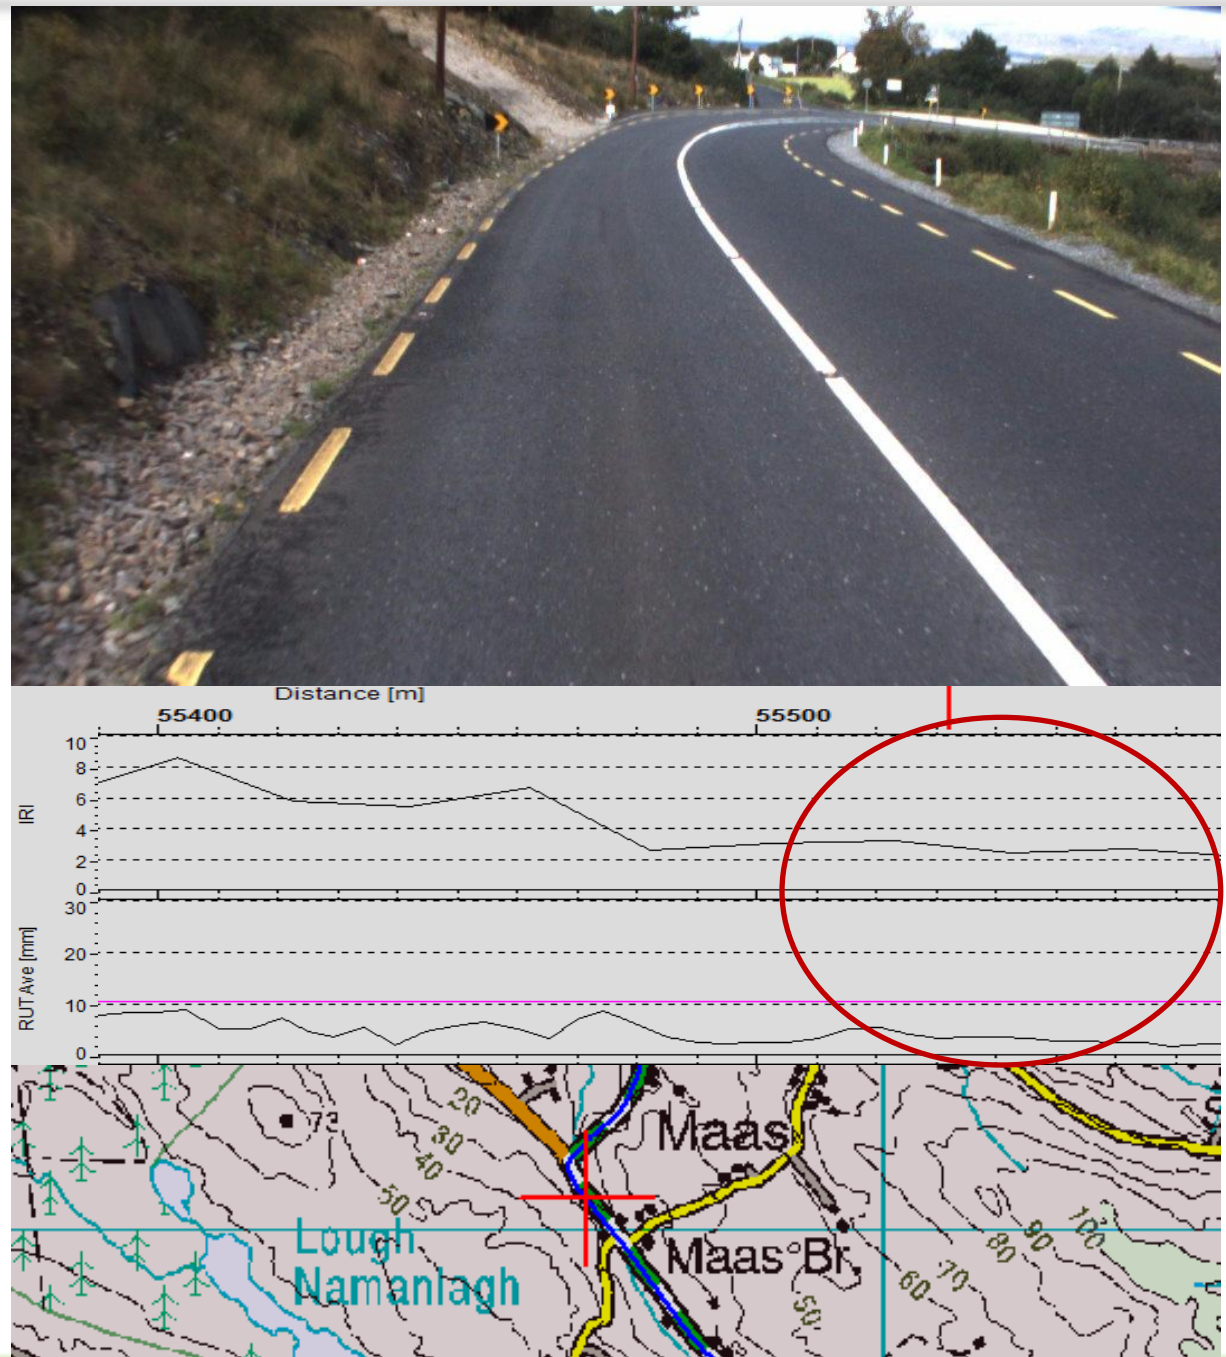
55200 new structure and there is a french drain on the left which seem to be working well. Low IRI and Rutting values on this part.

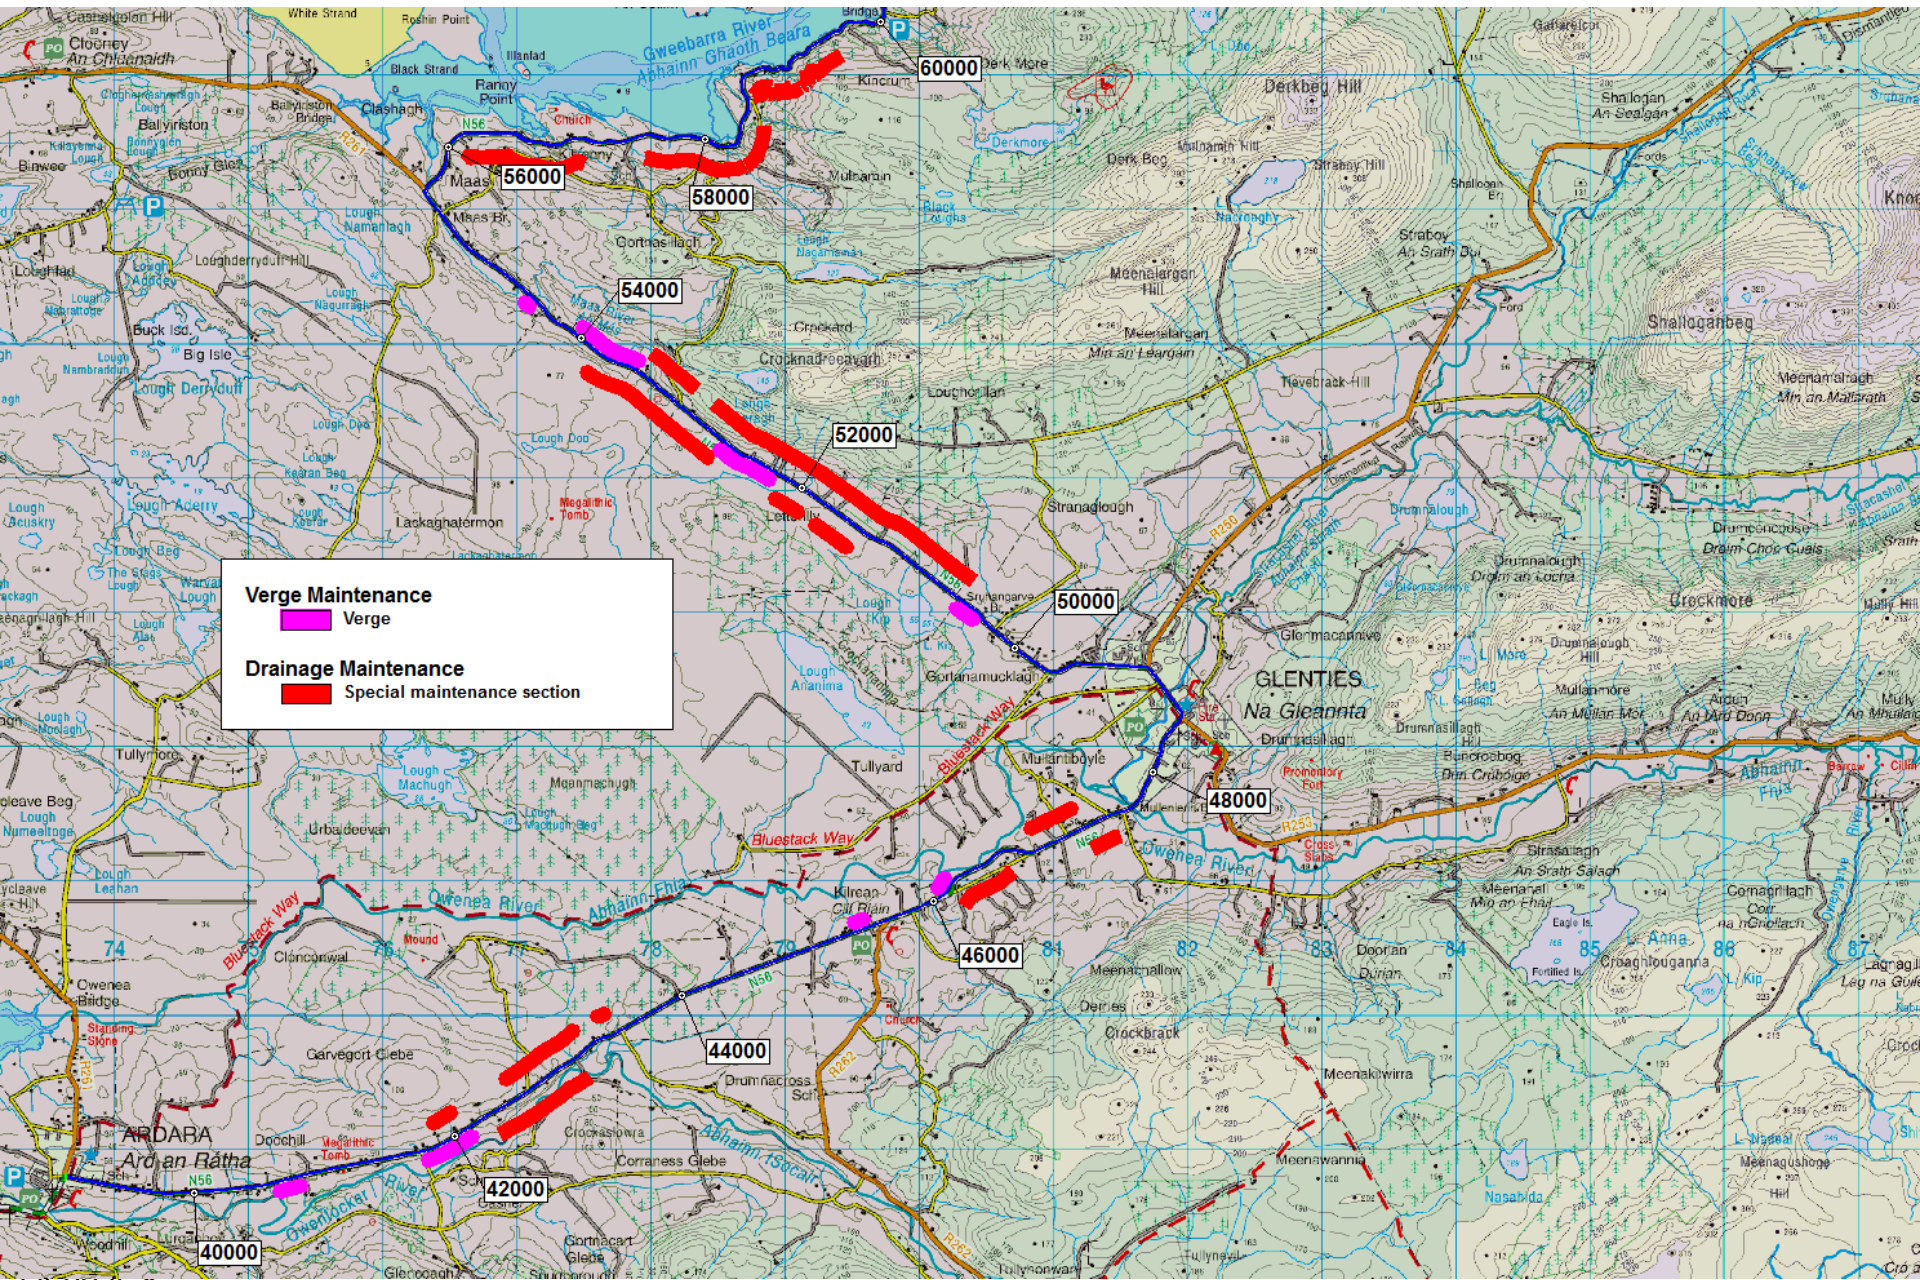
From 56000 to the end of the section the road is in quite steep side sloping ground. On the upper side there are drainage deficiencies in times. There is little room for a ditch which makes it hard to improve drainage.
