Petri Varin, Timo Saarenketo

ROAD WIDENING

Field survey report

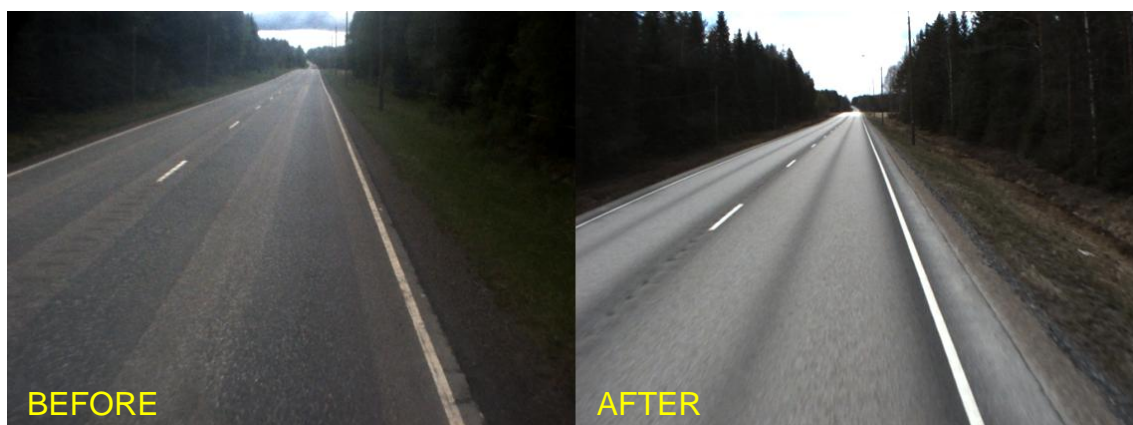
Figure 4.1_2. Widening on both sides of Hw 9 in Suonenjoki, Finland. After widening the traffic load is still on the old lanes and the widening is restricted to the shoulder and safety area only. See also the drainage improvement.

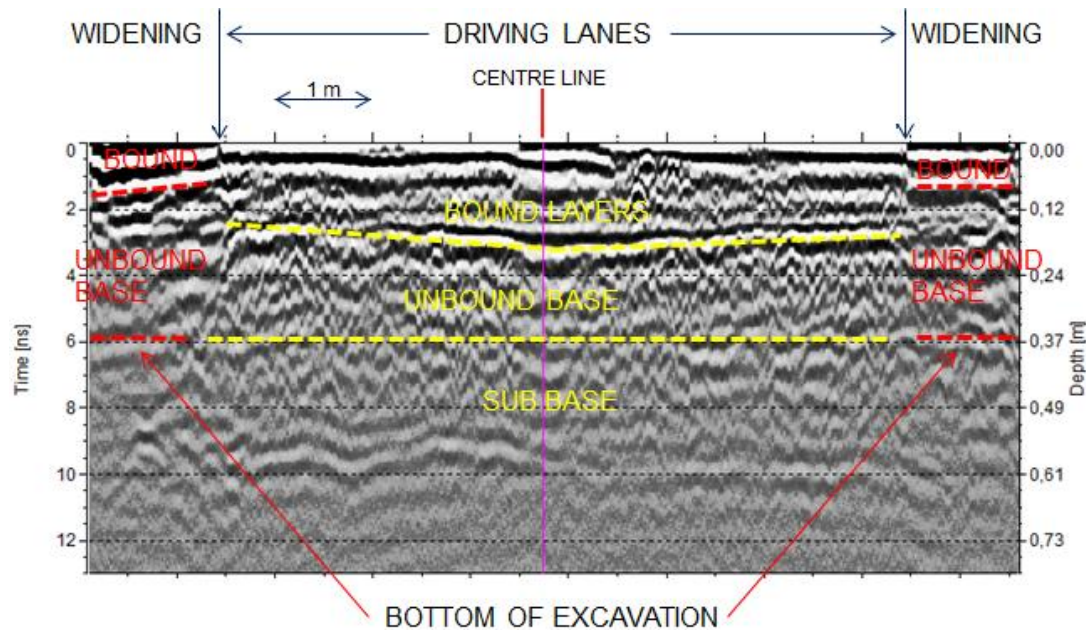
Figure 4.1_3 shows an example of a GPR cross section measured from the road. The bottom of the excavation before widening is on the same level as the bottom of the unbound base course on the old road. This is a good practice to achieve uniform behaviour. The Figure also shows that the overall thickness of the bound layers is somewhat thicker on the old driving lanes than on the new widened shoulders, but the traffic loading is also much less on the shoulders.

Figure 4.1_3. GPR (1.5 GHz) cross section of the widened structure on Hw 9

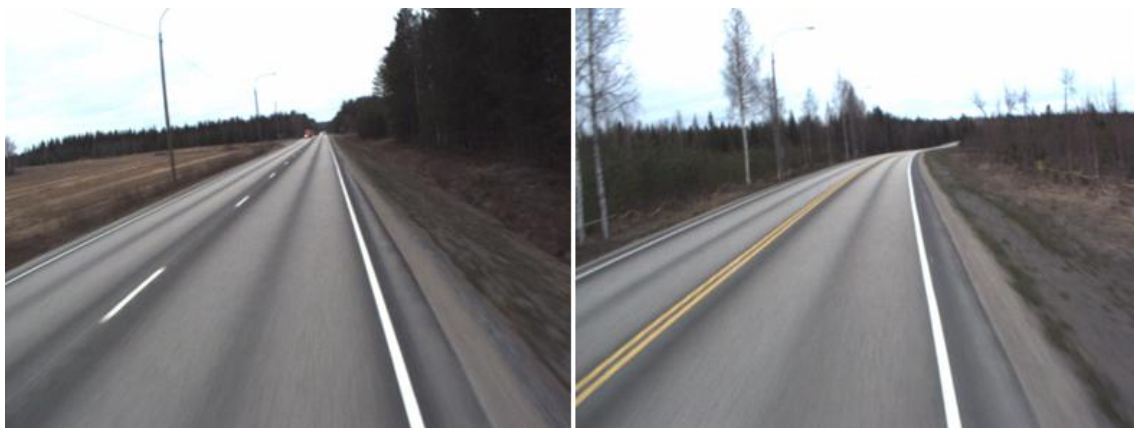
The monitoring results after the first frost season following widening showed no distress, such as cracks between the old road and the widening, or differential frost heave problems. The widening and the whole road were generally in a very good condition. Examples of the general condition in spring 2011 are presented in Figure 4.1_4. There were only some transverse cracks, longitudinal frost cracks in the middle of the road and opened pavement joints between driving lanes, but none of these were related to the widening. Examples of the damages in spring 2011 are presented in Figure 4.1_5.

Figure 4.1_4. Examples of the Hw 9 general condition in spring 2011, after first frost season

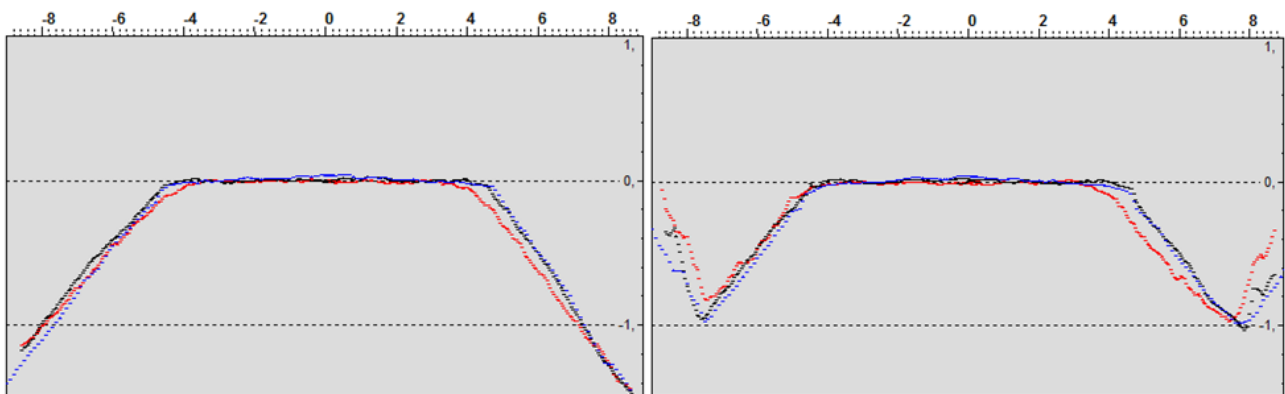
On the basis of the laser scanner measurements it can be concluded that the road section has maintained its shape very well, i.e. there are no major changes in the cross section profile when compared to the autumn 2010 measurements just after widening. Figure 4.1_6 gives two examples of laser scanner cross section profiles showing the situation in May 2010 (red colour, before widening), in October 2010 (black colour, after widening), and in May 2011 (blue colour, after the first frost season). From the figure it can be observed that the black and the blue cross section are almost exactly the same. The results also show that the repeatability of laser scanner measurements is good.

Figure 4.1_6. Examples of laser scanner cross sections in May 2010 (red, before widening), in October 2010 (black, after widening), and in May 2011 (blue, after the first frost season)

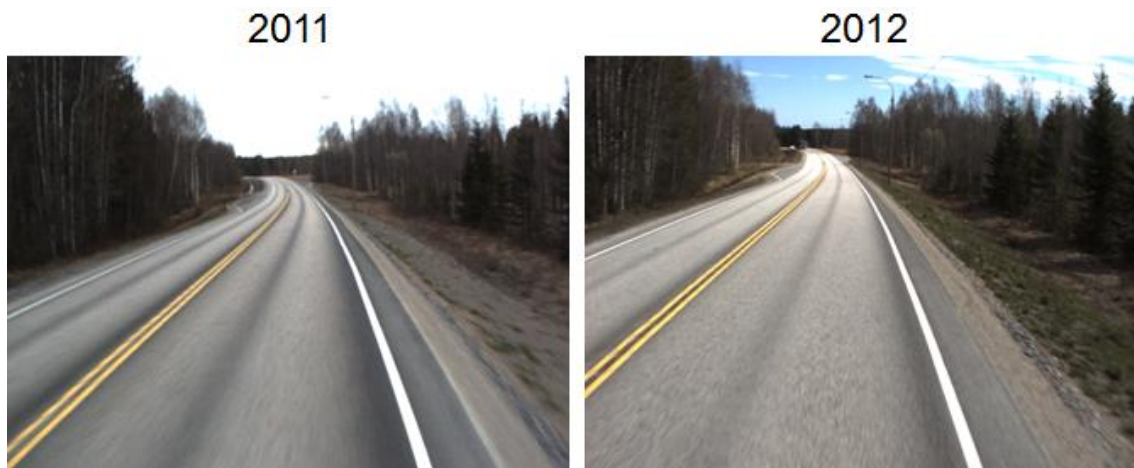
The results of the follow-up measurements with video and laser scanner in spring 2012 showed unchanged circumstances when compared to spring 2011 measurements. An example photograph from the same location in 2011 and 2012, representing the general condition of the road, is shown in Figure 4.1_7.

Figure 4.1_7. Comparison of the Hw 9 general condition in spring 2011 and spring 2012

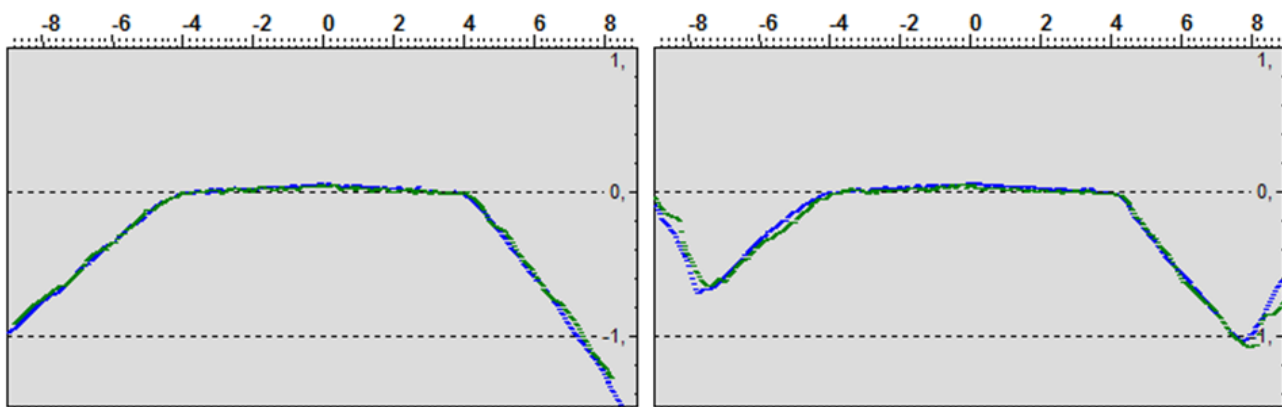
Figure 4.1_8 gives two examples of the laser scanner cross section profiles showing the comparison between the spring 2011 measurements and the spring 2012 follow-up measurements. The figures show that no changes in road's cross section shape have taken place.

Figure 4.1_8. Examples of laser scanner cross sections in May 2011 (blue, after the first frost season) and in May 2012 (green, after two frost seasons)

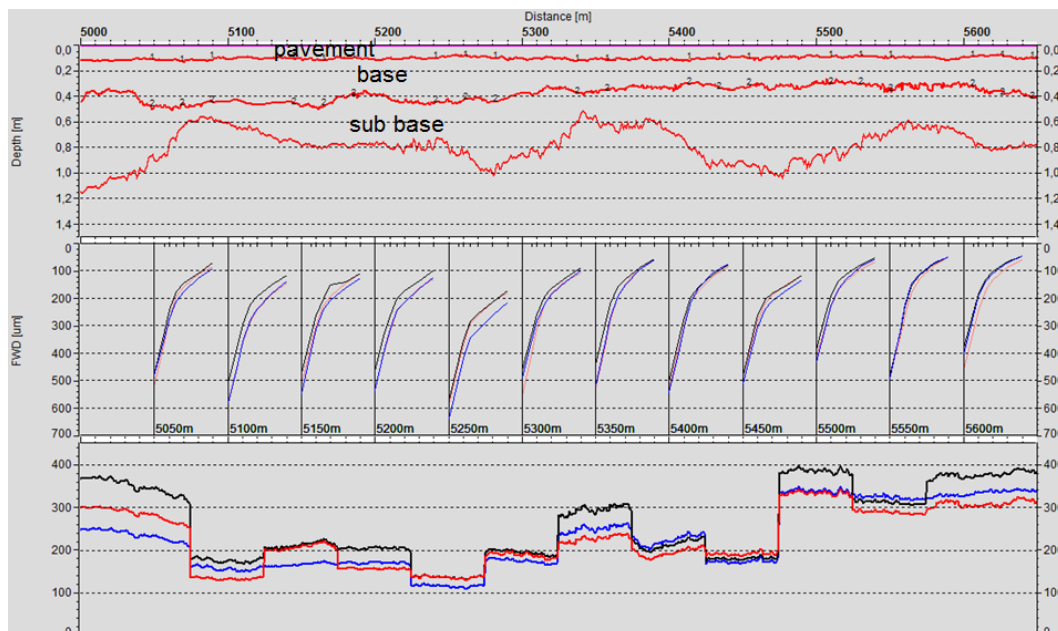
On this road a survey was also carried out to determine if the edges of the road were weaker than the centre i.e. if there were changes in the stiffnesses of the road structures. For this FWD tests were performed on selected sections. Three points were measured at each road chainage; on each edge, and one from the centre (between the wheel paths in the right lane). Figure 4.1_15 gives an example of data from these surveys. The top window records the interpreted structure thicknesses. The next window displays the FWD deflection bowls from the centre (between wheel paths) and both edges of the road. Finally, the bearing capacities calculated from each of the FWD data sets are presented in the last window. The black line is the bearing capacity on the centre of the road, the red line is the left edge and the blue line is the right edge. On Road 75 the edges of the road were not significantly weaker than the road centre. Only slightly higher bearing capacity values were obtained from the centre at certain locations. On the other hand the calculated bearing capacity values were surprisingly low for this road class and this explains the high amount of pavement distress.

Figure 4.1_15. Example data from Road 75 showing the interpreted structures, FWD deflections on the centre and both edges of the road, and the calculated bearing capacities.

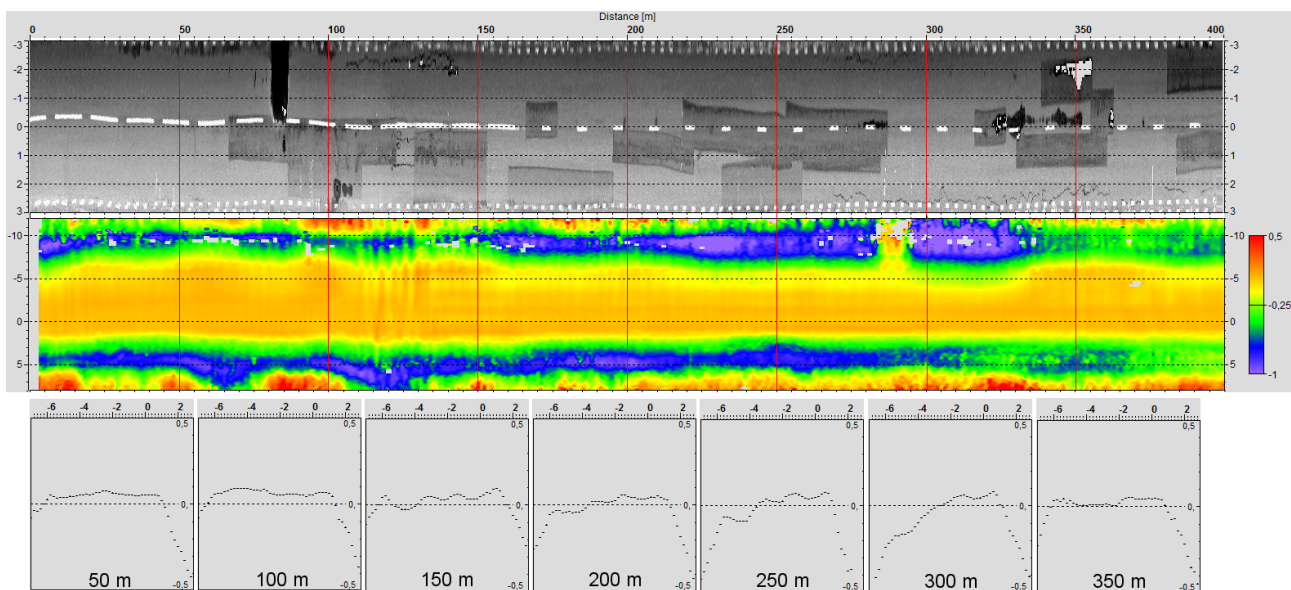
This road was a typical example of a road that had been widened and upgraded from an old gravel road. The structure could be also called a “light widening”, similar to Hw 9 in Finland, as the widening only comprised approximately 0.5 m wide and 0.5 m thick to both road shoulders. A general view of the condition of the road is shown in Figure 4.2_1. This road had been patched several times and the road width varied. Figure 4.2_2 shows the laser scanner survey data from the site. The first window shows the laser scanner emission map indicating multiple damages and patches across the road. The laser scanner height map is given in the second window. Seven laser scanner cross section profiles are displayed on the bottom. The red lines over the emission and height data show the locations of the cross section profiles. It can be observed from these laser scanner cross sections that the road has severe rutting problems and that the road is tilting to the left, especially on the section between 150 m and 340 m.

Figure 4.2_2. Laser scanner data from the Ohtanajärvi road.

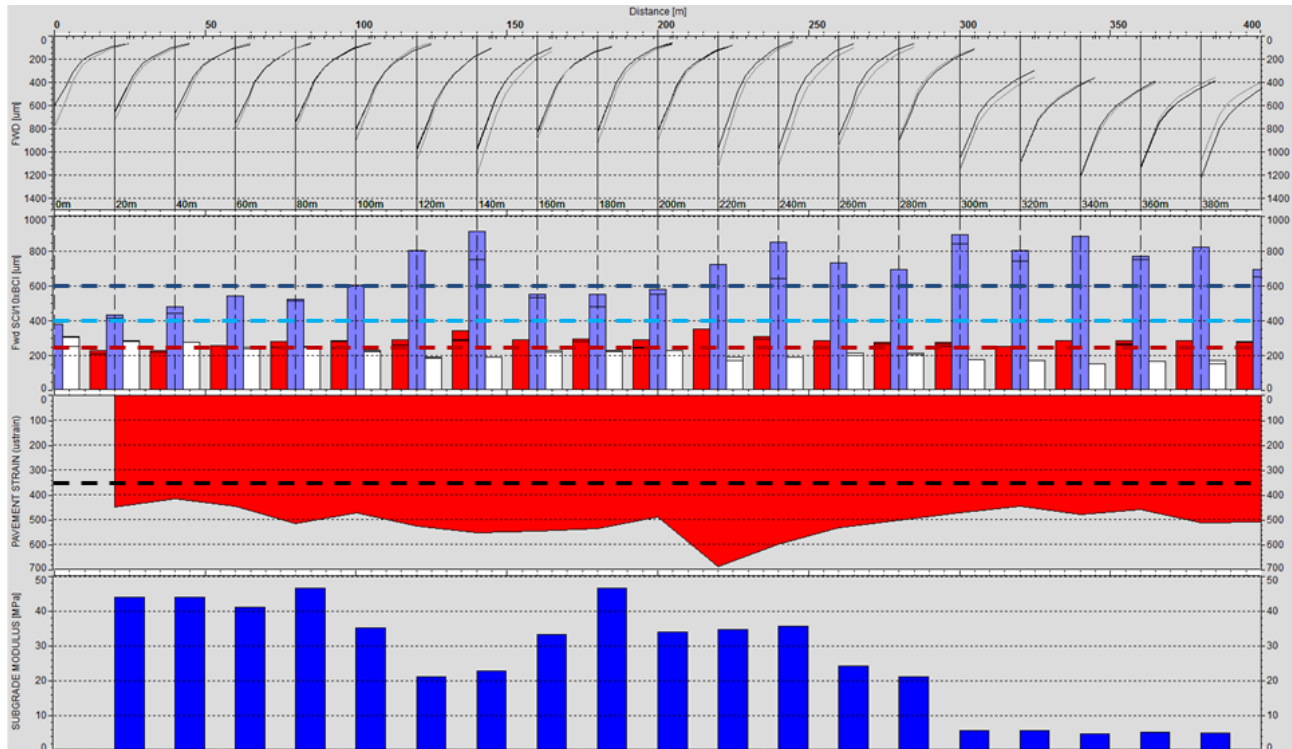
Figure 4.2_3. FWD analysis data from the Ohtanjärvi road

The FWD maximum deflections in the section are quite high, which tells that the subgrade soil is soft and that the road is weak. This can be seen also from the BCI values that are mainly around 60 – 80, which can be regarded as poor values. The road has very high risk for Mode 2 rutting. The high risk for Mode 2 rutting is verified with low subgrade moduli values, especially at the end of the test section. The SCI values and calculated pavement strain is high. This also indicates a risk for Mode 1 rutting.

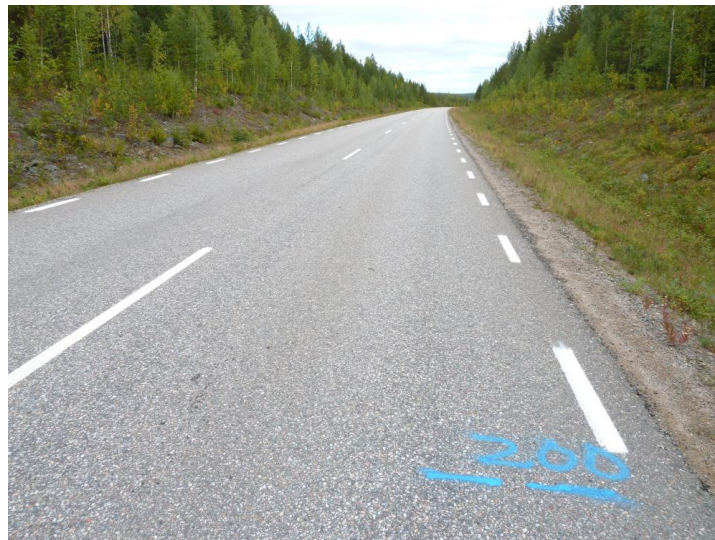
The Salmi test section offers an example of a road with a higher quality rehabilitation and widening. Generally this road had been performing very well, although there had been some reflection cracks. Figure 4.2_5 shows the general condition of the road and it is very good. In 2010 the road had a new overlay on the road and only very few distresses could be seen.

Figure 4.2_5. General condition of the Salmi road at chainage 200 m.

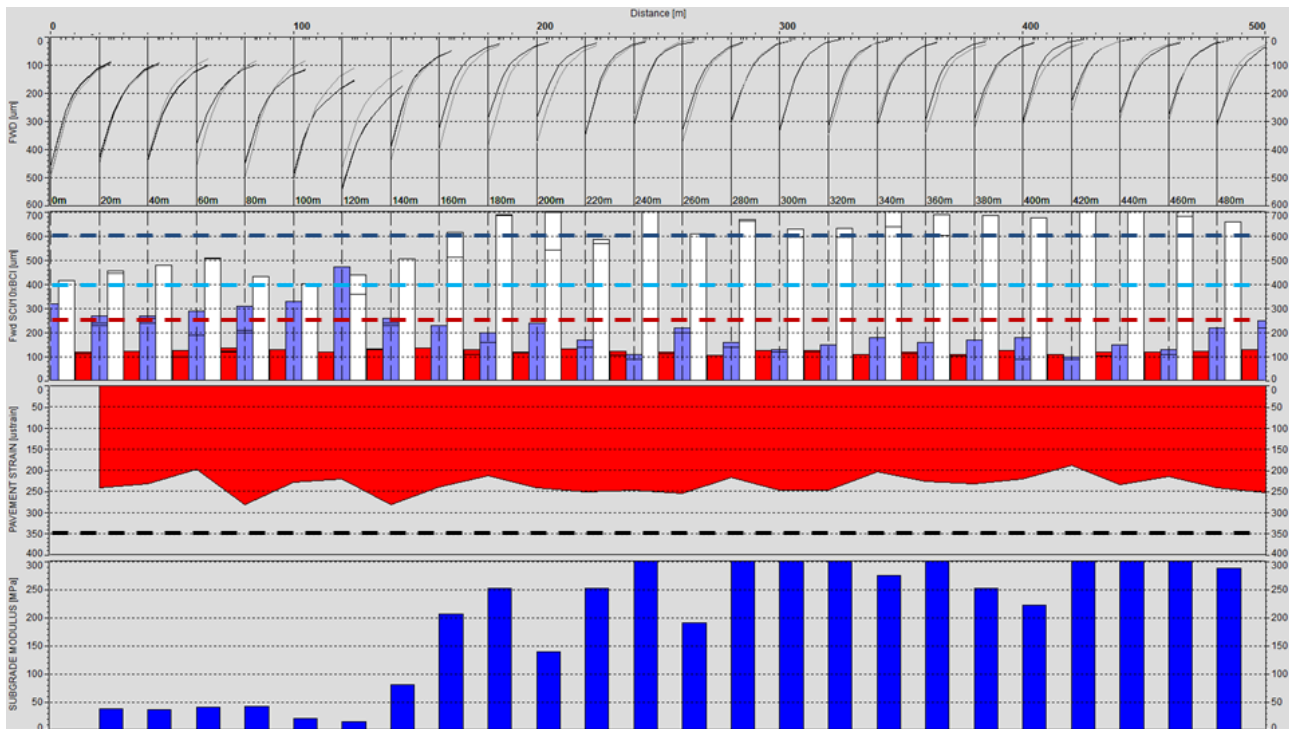
Figure 4.2_6 shows the falling weight deflectometer analysis data from the Salmi road. From the data it can be observed that the road structure is strong. The FWD maximum deflections are quite low and subgrade moduli values very high, except from the first 120 m where the subgrade is slightly weaker, but still not very soft. The BCI values are mainly around 20, which is a good value. Also the calculated pavement strain is at an acceptable level, so the road structure is performing very well.

Figure 4.2_6. FWD analysis data from the Salmi road. The top window presents the FWD deflection bowls. The second window shows the surface curvature index (SCI, red bars), the base curvature index (BCI, blue bars) and the E2 bearing capacity that is obtained from the FWD measurement (white bars). The red dashed line shows the limit for a weak SCI value. The light blue dashed line shows the limit for BCI value after which it can be regarded as questionable, and the dark blue dashed line shows the limit for a very weak BCI value. The third window presents the pavement strain value calculated from FWD measurements. The black dashed line shows the limit for poor strain value. The subgrade moduli are displayed in the last window with blue bars.

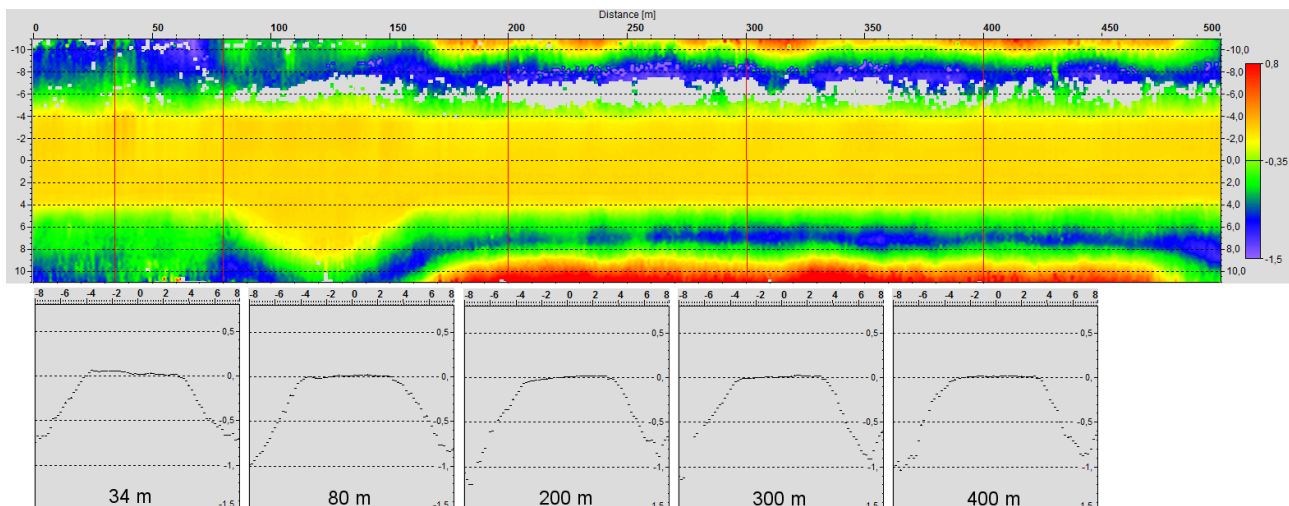
Figure 4.2_7. Laser scanner data from the Salmi road

From the laser scanner height map and the cross section profiles, presented in Figure 4.2_7, it can be noted that the road surface is generally very even and no rutting can be observed. The ditches are deep enough and drainage seems to be in good condition. The red lines over the data show the locations of the cross section profiles.

section and the crack in 2000. Figure 4.2_9 shows the same location in 2010 and the same reflection crack is still visible, even though the road had been paved since. The first laser scanner cross section profile in Figure 4.2.7 shows this location (34 m) and the observed unevenness. This type of sandwich structure must be avoided when designing a widening or any other kind of road rehabilitation. The old bituminous pavement layers must be removed, or crushed and homogenized, before construction.

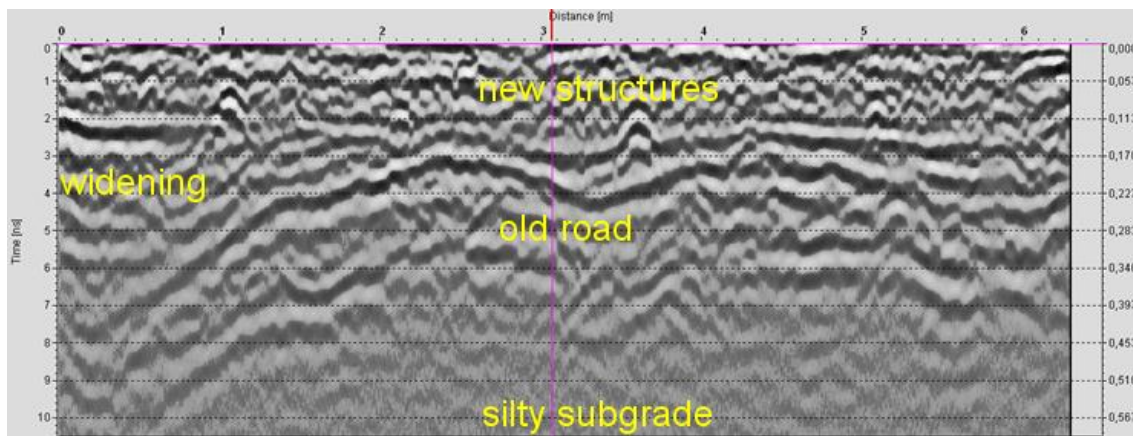
Figure 4.2_10. Karrbäck GPR cross section, 250m measured in 2000.

The Karrbäck road gives an example of a widened and upgraded road on very soft silty subgrade. The GPR cross section from the old data shown in Figure 4.2_10 shows that the road has been widened to left side before being upgraded. It can also be noted that the overall structure thickness is still relatively thin, 0.4 – 0.6 m.

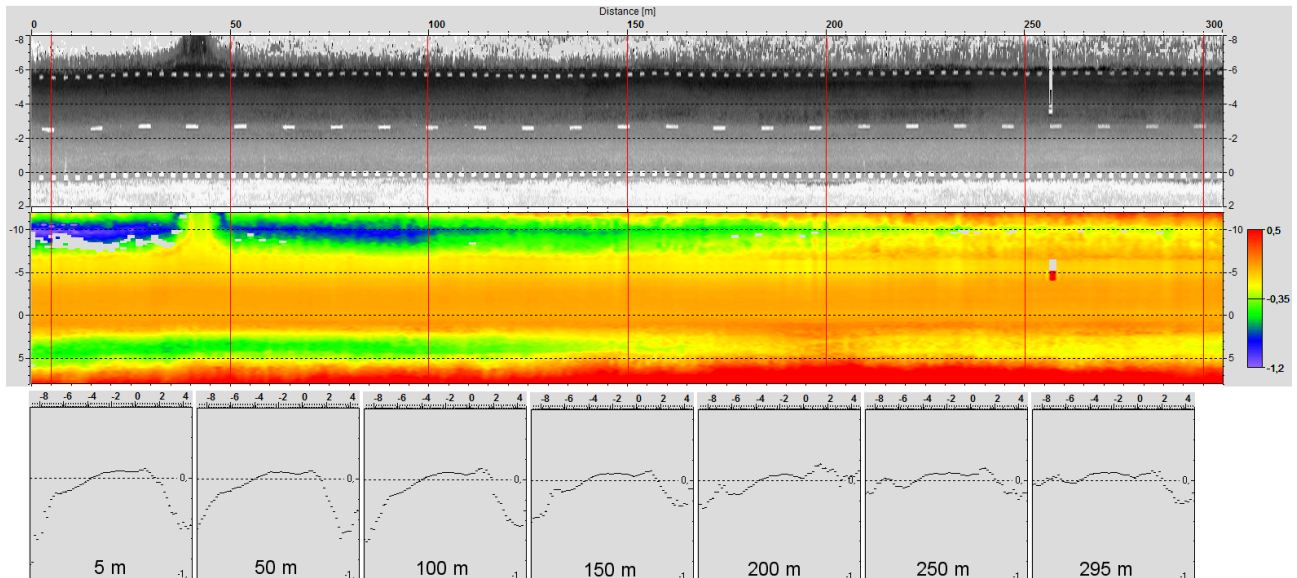
Figure 4.2_12. Laser scanner data from the Karrbäck road

Figure 4.2_12 shows the laser scanner survey data from the site. The first window shows the laser scanner emission map and it can be observed from the data that the pavement surface condition is quite good. From the laser scanner height map, presented on the second window, the shallow ditch depth can be clearly seen. The depth gets shallower towards the end of the test section. Seven laser scanner cross section profiles are displayed in the bottom window. The red lines over the emission and height data show the locations of the cross section profiles. It can be noted from the cross sections that the road is tilting to left, which is the widening side. Rutting has also taken place, especially on the widening side and on both road shoulders. The cross section series also displays very nicely the ditch depth getting shallower and shallower.

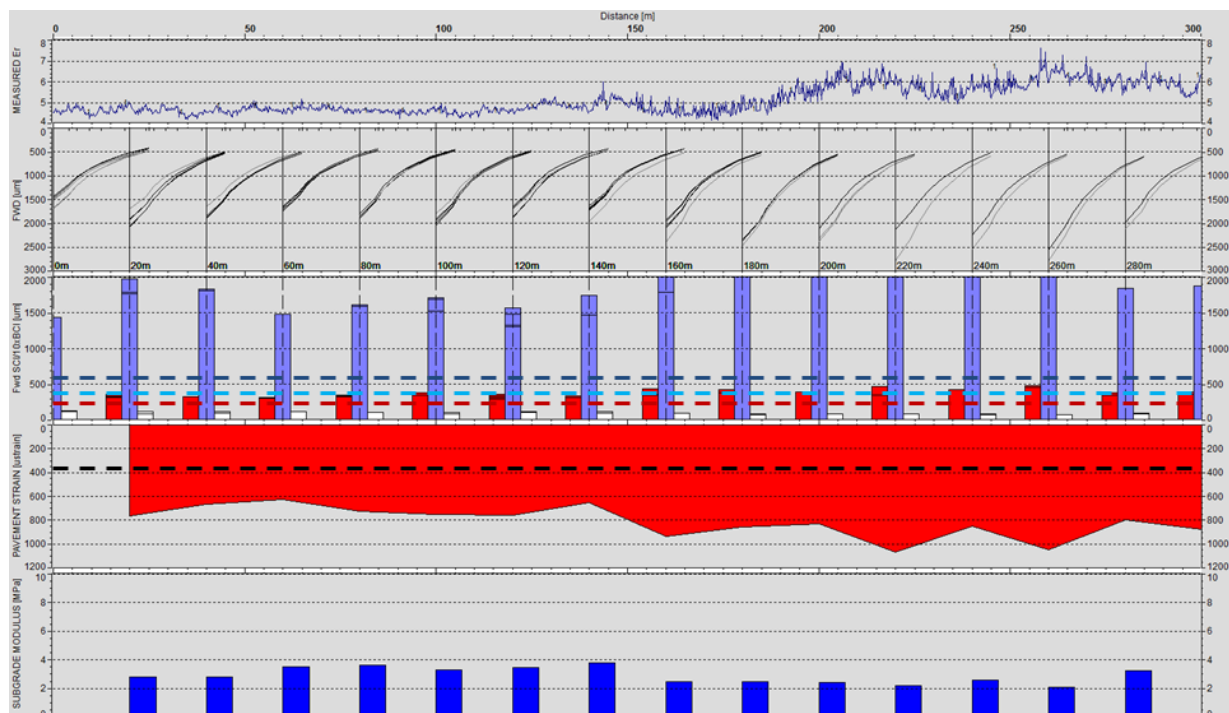
Figure 4.2_13. Pavement dielectric value and FWD analysis data from the Karrbäck road

Figure 4.2_13 also shows the FWD analysis data from the road. The second window presents the FWD deflection bowls. The third window shows the surface curvature index (SCI, red bars), the base curvature index (BCI, blue bars) and the E2 bearing capacity that is obtained from the FWD measurement (white bars). The red dashed line shows the limit for a weak SCI value. The light blue dashed line shows the limit for problematic BCI values, and the dark blue dashed line shows the limit for a very weak BCI value. The fourth window presents the pavement strain value calculated from FWD measurements. The black dashed line shows the limit for weak strain value. The subgrade moduli are displayed in the last window with blue bars.

The FWD maximum deflections are very high, which indicates that the subgrade soil is soft and that the road structures are extremely weak, worse than on many weak gravel roads. The soft subgrade is verified from the calculated subgrade moduli values that range from 2 to 4, which are extremely weak. All the base curvature index (BCI) values are approximately three to four times higher than the critical limits for Mode 2 rutting, so they can be regarded as extremely poor values. Also the calculated pavement strain and surface curvature index (SCI) values are very high, so there are problems also on the top part of the structure.

The road had been widened on the left side and there was some settlement and rutting taking place on that side, but the main problem with this road section was not related to the widening. The whole road was settling into the very soft silty subgrade. This phenomenon was made even worse by the fact that the ditches were filled, which caused the drainage to be ineffective. The data also showed that the road would fail badly in the near future and that the strengthening measures on the road had not been adequate enough.

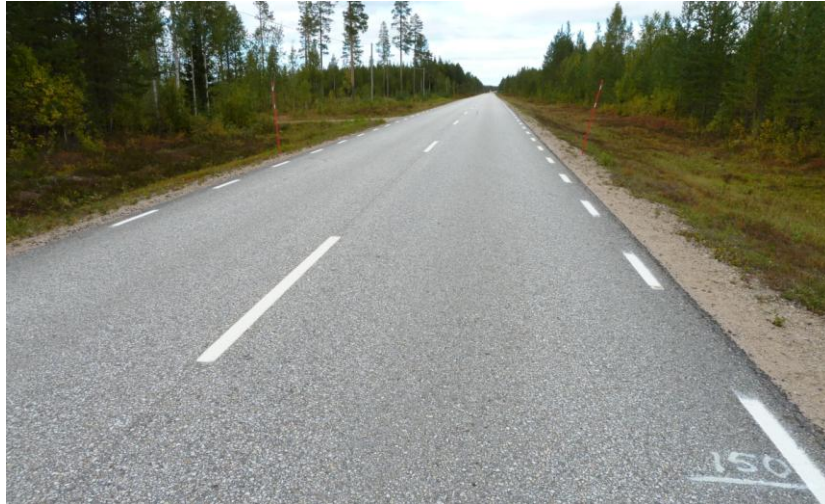
Figure 4.2_14. General condition of the Lapträsk road at chainage 150 m.

This test section gives an example of a road where steel reinforcement can be used to prevent longitudinal cracking. The road had been widened already earlier, but there were longitudinal cracking /frost cracking) and edge failures. After that steel nets had been installed. Figure 4.2_14 shows the road surface condition at the time of the survey in 2010 and it was very good.

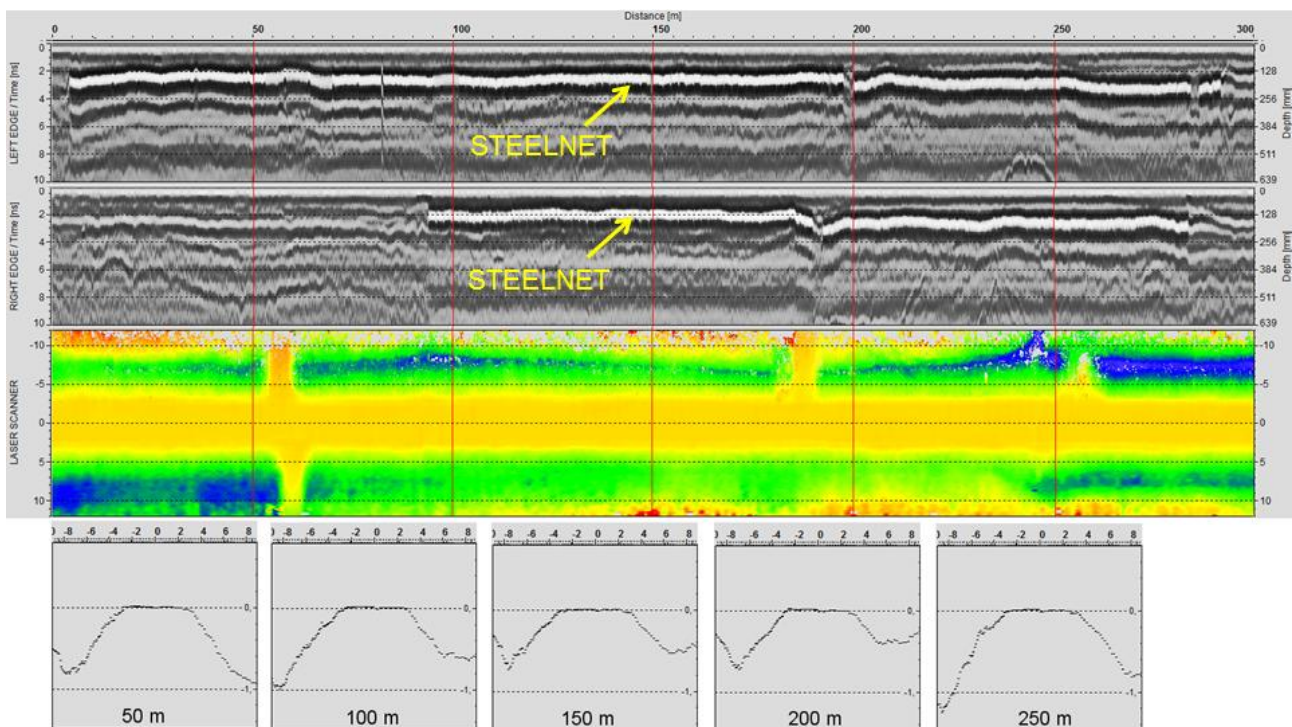
Figure 4.2_15. GPR and laser scanner data from the Lapträsk road

Figure 4.2_15 presents the GPR and laser scanner survey data from the site. The first window shows the longitudinal GPR profile from the left edge of the road and the second window shows the right edge. It can be observed that for the first 95 m there is reinforcement only on the left shoulder and after that the steel nets cover the whole cross section width of the road. This can be confirmed also from the GPR cross sections shown in Figure 4.2_16. The left cross section is from the beginning of the test section and the right cross section is from the chainage 200 m.

From the laser scanner height map and the cross section profiles, presented in Figure 4.2.15, it can be seen that the road surface is very even and no rutting can be observed. Drainage seems to be in relatively good condition also, except that the right ditch is too shallow from 100 m to 250 m. The outlet ditch on the right hand side is clogged which can be seen as poor subgrade moduli at chainage 200 m (figure 4.2_18). The red lines over the data show the locations of the cross section profiles.

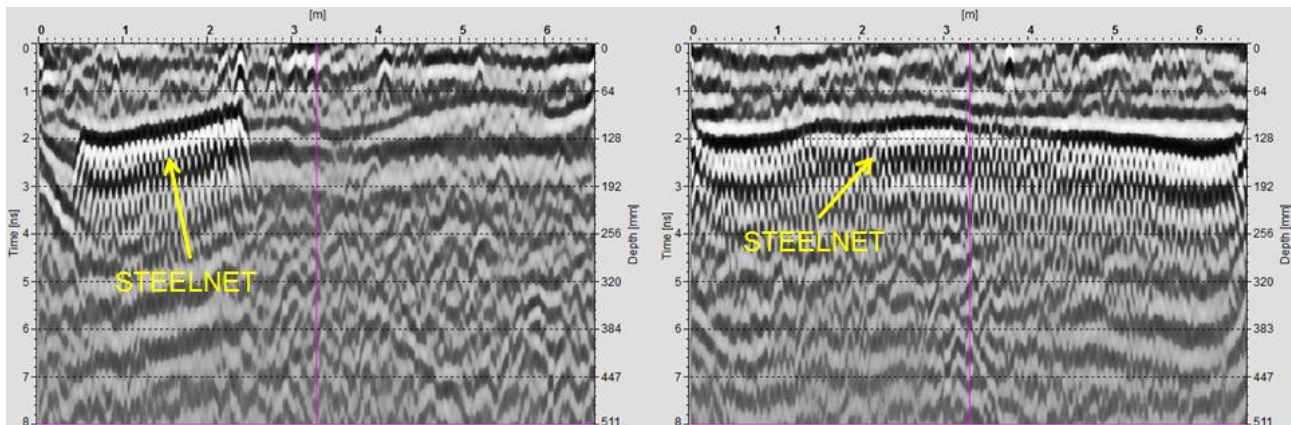
Figure 4.2_16. GPR cross sections showing that in the beginning of the test section the reinforcement is only on the left lane and after that the steel nets cover the whole cross section width of the road. The left cross section is from the beginning of the test section and the right cross section is from the 200 m pole. See also that the steel reinforcement does not reach to the pavement edge in the left cross section.

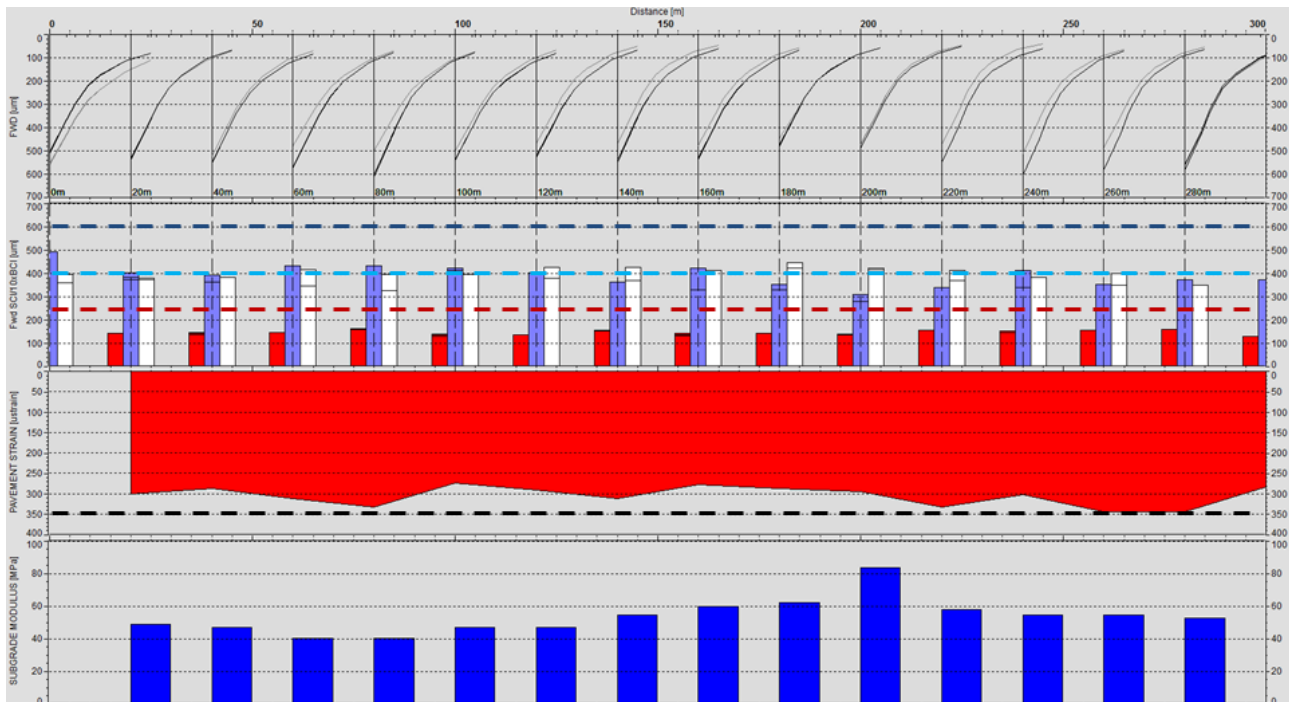
Figure 4.2_18 shows the FWD analysis data from the Lapträsk road. The SCI values are well below their critical limits and the pavement strain is also on acceptable level. The BCI values are just below limit value of 40 μm indicating that the reinforcement is strengthening the road over the

frost susceptible subgrade. Generally, the reinforced road structure is performing quite well, and there should not be any major problems in the near future especially if the drainage is improved.

Figure 4.2_18. FWD analysis data from the Lapträsk road. The top window presents FWD deflection bowls. The second window shows the surface curvature index (SCI, red bars), the base curvature index (BCI, blue bars) and the E2 bearing capacity that is calculated from the FWD measurement (white bars). The red dashed line shows the limit for a weak SCI value. The light blue dashed line shows the limit for problematic BCI values, and the dark blue dashed line shows the limit for really weak BCI values. The third window presents the pavement strain value calculated from FWD measurements. The black dashed line shows the limit for weak strain value. The subgrade moduli are displayed in the last window with blue bars.

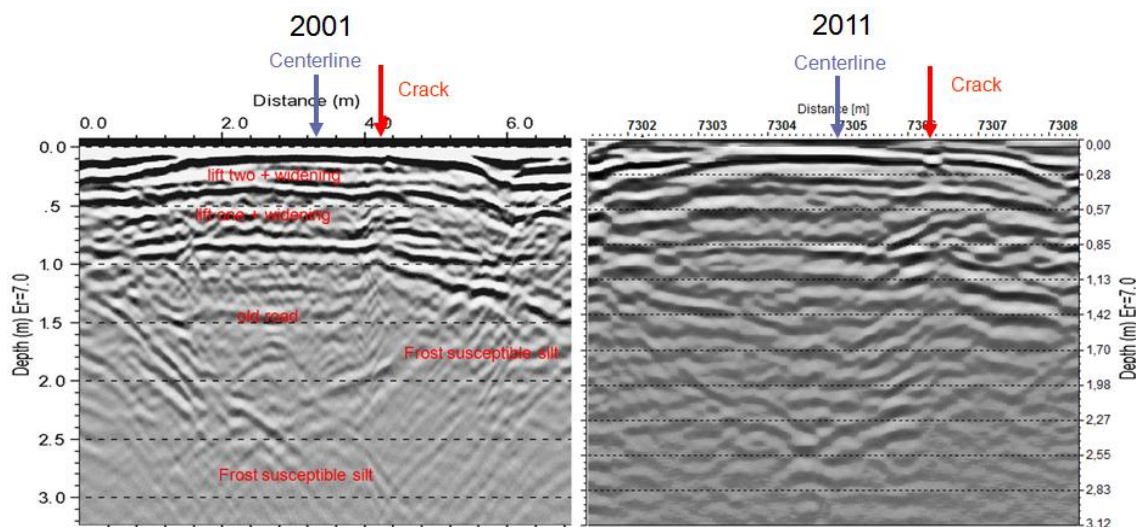
Figure 4.3_2. Engerud 400 MHz GPR cross section in 2001 and 2011

Figure 4.3_1 shows a photographs from the Engerud road taken in 2001 and in 2011. The same longitudinal crack can be seen in both photographs. The reason for the failure crack can be seen in the GPR cross sections presented in figure 4.3_2. The crack is located on the joint between the old road and the widening. The road structure thickness on the widening side is much thinner than on the old road side and the subgrade beneath is frost susceptible silt. As a consequence the frost behaviour is different and a reflection crack has formed due to traffic loading, settlement and frost action.

The glassfibre strengthening has not been able to prevent the reflection crack forming. It can be concluded that glassfibre is not an adequate strengthening method, if there are vertical shear forces taking place in the widening joint.

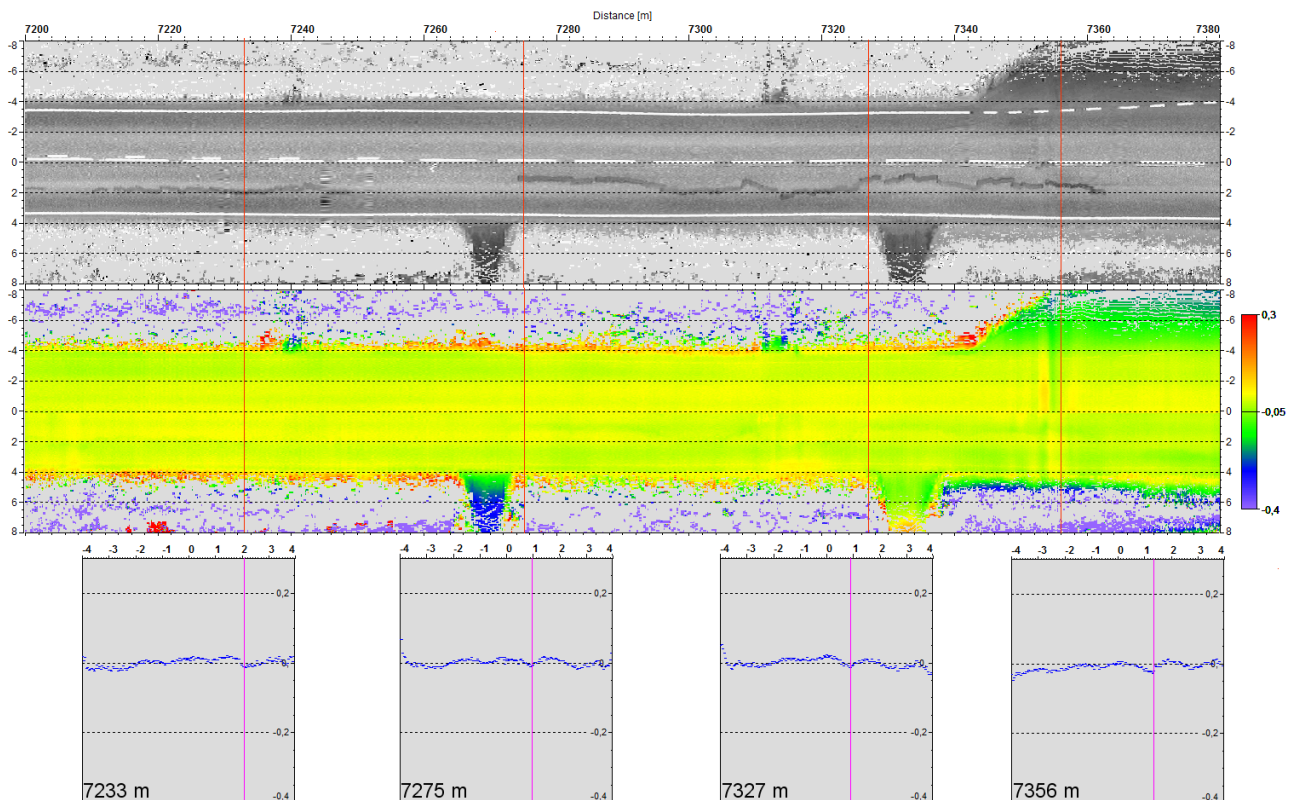
Figure 4.3_3. Laser scanner data from the Engerud road section

Laser scanner data from the Engerud road section is presented in figure 4.3_3. The first window shows the laser scanner emission map, height information is given in the second window, and four cross section profiles are displayed on the bottom. The red lines over the emission and height data show the locations of the cross section profiles. The pink line on each cross section shows the location of the reflection crack and data shows a clear groove indicating shear problems. Laser scanner cross section profiles indicate that the rut depth is higher on the widened side of the road. From the GPR cross sections it can also be seen that there are thicker pavement layers on both edges of the road, especially on the widening side. These facts indicate that some Mode 2 rutting has also been taking place in the road structure / subgrade interface.

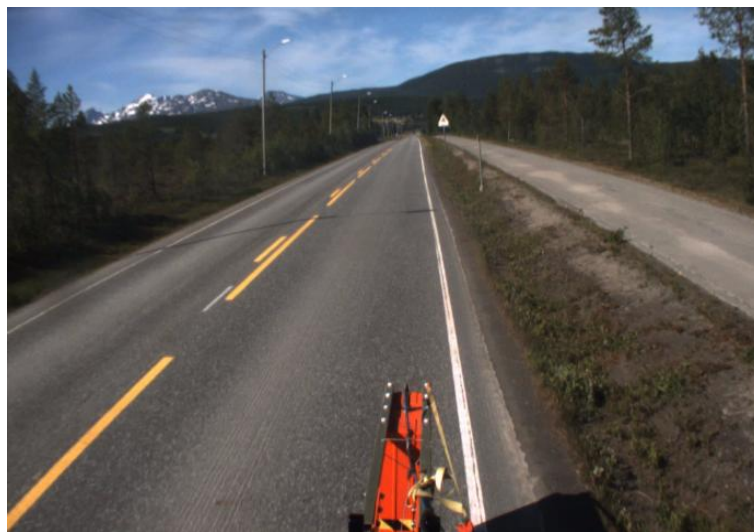
Figure 4.3_5. Road condition in 2011

settlement can be clearly observed, especially on the widening side on the left. But settlement can also be seen on the right edge of the road, which is a consequence of the construction of the bicycle path beside the road.

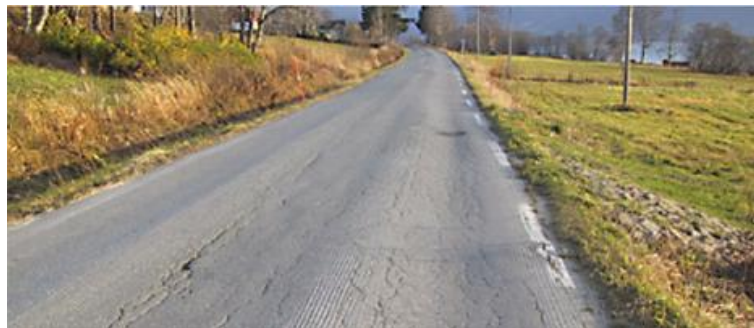
Figure 4.3_7. Road condition in 2001

The old road structure consists of low frost susceptible gravel. Before paving the road in 1986, 150 mm of crushed gravel was compacted on top of the old gravel road. The newest wearing course comprises soft bitumen asphalt. The subgrade is mainly low frost susceptible gravel and moraine. The road condition was very bad in 2001, especially on the old road side (right), while the widened side (left) was slightly better (Figure 4.3_7.). The photograph in Figure 4.3_8 from 2011 shows that the road had been repaved since 2001, and that a reflection crack had formed between the old and widened area. In 2011 the drainage condition was much worse than 2001.

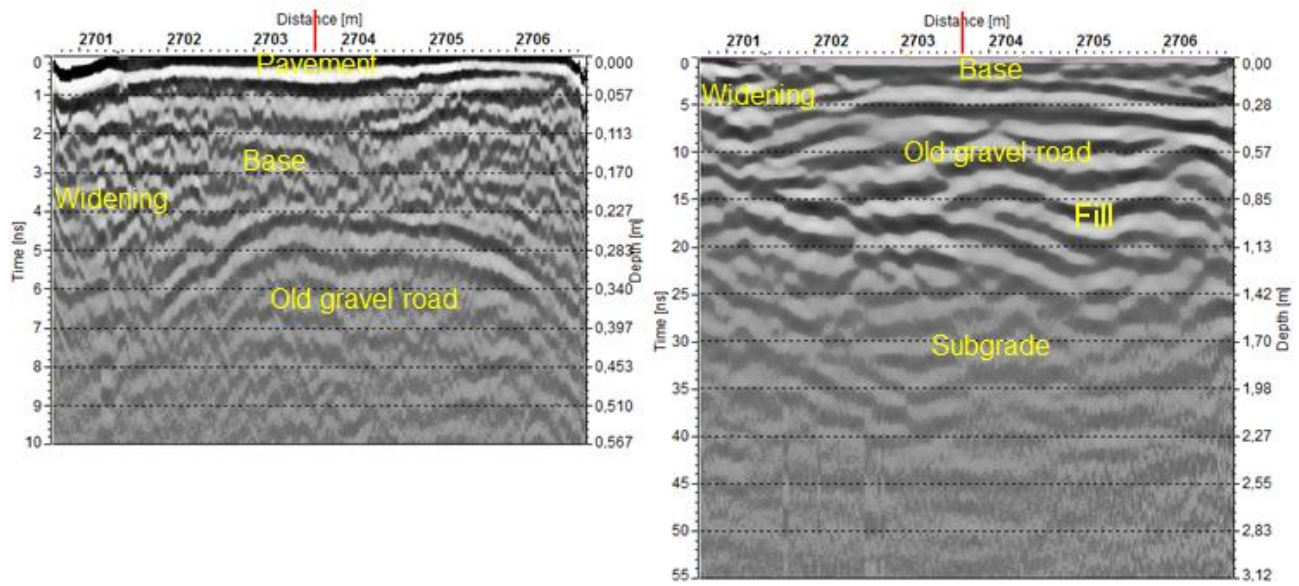
Figure 4.3_9. GPR cross sections (left: 1.5 GHz, right: 400 MHz) from Tennes road

Examples of GPR cross sections are given in figure 4.3_9. The left cross section is from the 1.5 GHz antenna showing the top part of the structure. The right cross section shows the 400 MHz antenna data which reaches deeper. On the cross sections the old gravel road can be seen clearly beneath the new base course. The road has been widened to the left, which is the uphill side, as the road is located on side sloping ground. On the 400 MHz cross section a wedge shaped embankment fill can be seen beneath the old road. On the structure - subgrade interface, Mode 2 rutting can be observed in the 400 MHz cross section.

The 1.5 Ghz cross section (left in Figure 4.3_9.) also shows shoulder deformation problems on the widened left side of the road that can be related to the drainage problems on the upper side of the road.

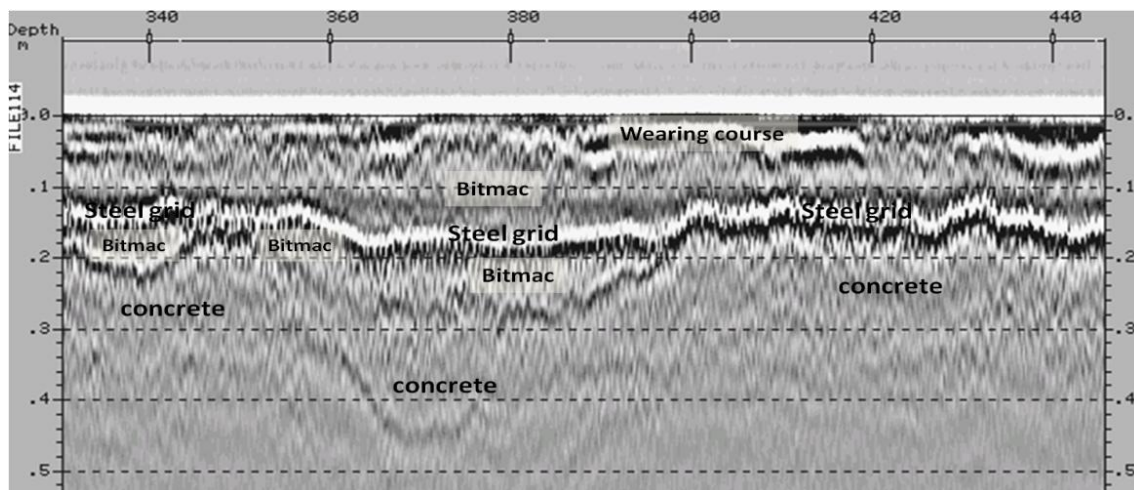
Figures 4.4.1_5 and 4.4.1_6 show how the road construction was carried out in practice. Figure 4.4.1_7. presents the 1.5 GHz GPR survey data after the construction was finished. This shows that the steel grid was partly installed on the top of the concrete slab and partly over the bituminous base course (bitmac). Figure 4.4.1_8. shows photographs taken from Killimster Moss in 2000 after the construction, and three years later in 2003.

Figure 4.4.1.7. 1.5GHz GPR longitudinal profile measured over the strengthened structure. This GPR data shows that the bitmac was used to lift the grade line in the lowest spots before steel grid was installed but mainly the steel grid was installed on the top of concrete (starting from 400 m.)

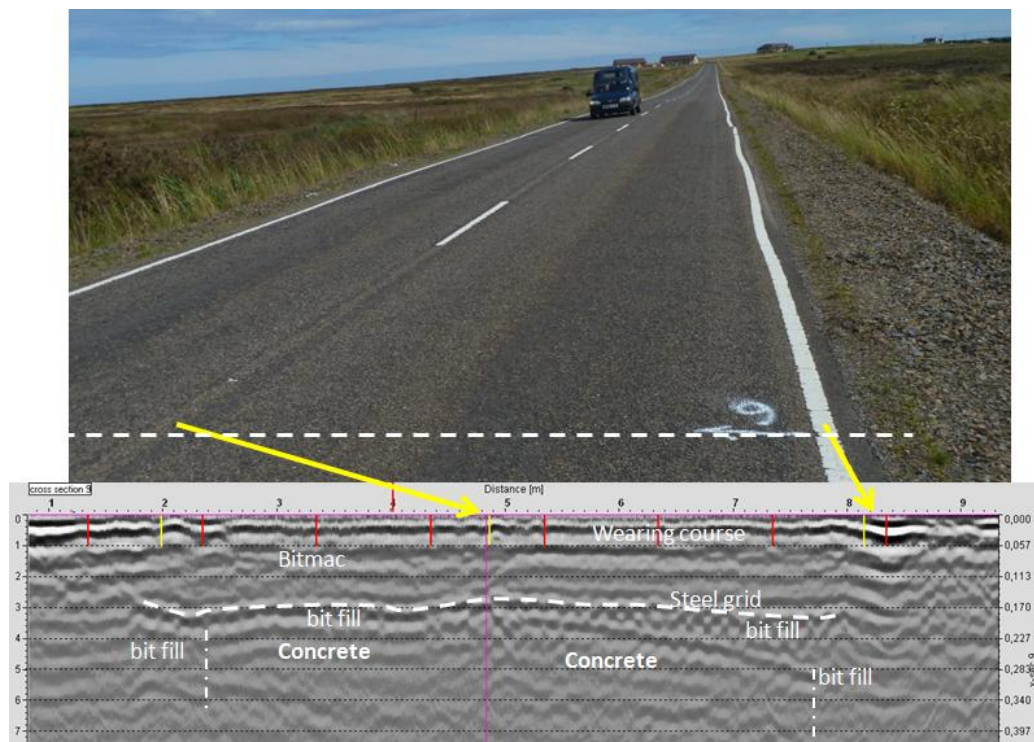
Figures 4.4.1_11 and 4.4.1_12 present cross sections from the 1.5 Ghz GPR survey: “Cross Section 2” was measured at a problem section and “Cross Section 9” at a section where no damage could be seen. A main difference, that could explain why damage appear where it does, is that on the problem sections the steel grid has been installed directly on top of the concrete slab and in this case hardly any bonding has happened between the slab and the bituminous layers. The longitudinal cracks in the road centre were reflecting the lateral movements of the concrete slabs due to traffic loading.

Figure 4.4.1_12. 1.5 Ghz GPR cross section from a well performing road section with no damages. There is 40 – 100 mm of bituminous material between the steel grid and concrete slab. The slab on the right hand side (left lane) has started to tilt. Yellow arrows show the location of road centre and right edge in GPR data
