Petri Varin, Timo Saarenketo

ROAD WIDENING

Field survey report

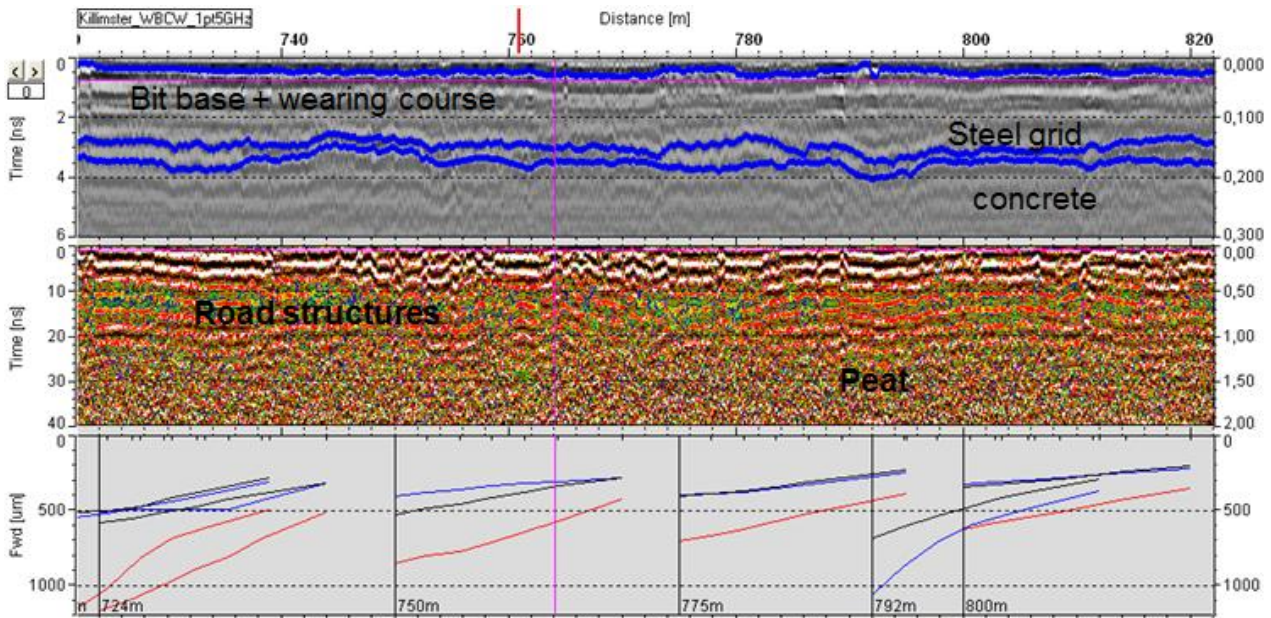
Figure 4.4.1_13 gives an example of longitudinal GPR profiles with FWD deflection bowls from a short section and Figure 4.4.1_14 gives GPR interpretations and FWD deflection bowls from the full road section surveyed. This data confirms that the structure has been performing better on those sections where there are bituminous layers beneath the steel reinforcement. The FWD data

Figure 4.4.1_13. 1.5 GHz GPR data (top field) showing the thickness of the wearing course and bituminous base, steel grid and concrete surface level. The middle field presents 400 Mhz GPR data showing the road structures and underlying peat. The lowest field presents the FWD deflection data. The black FWD deflection bowls are taken from the road centre (concrete), the blue bowls are from the right shoulder and the red deflection bowls from the right shoulder.

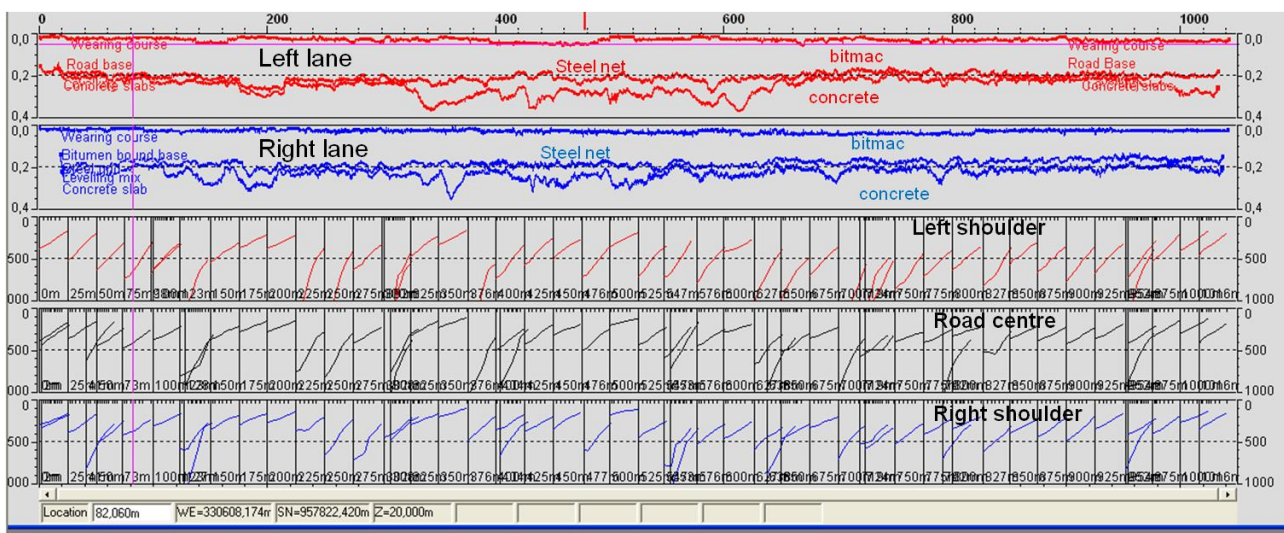
also shows that the biggest problems with load distribution are in the areas where the structure thickness is changing. The total deflections are much higher in the left shoulder that is mainly used by the heavy traffic. Figure 441_14 also verifies that the steel grid should have been installed deeper in the structures, ie at depth of 250 mm as ROADEX recommends. This can be seen in the road section at chainage 200 m where steel grids are at depth of 250 mm and the deflections are “perfect”, confirming the benefit of the high tensile strength of a steel grid when it is optimally used. Installing steel grids deeper was discussed during the design phase but could not be done because of the higher cost of the work, and lack of available funding.

Figure 4.4.1_14. GPR data thickness interpretation (red: left lane, blue right lane) and FWD deflection bowls (red: left shoulder, black: road centre, blue: right shoulder) from Killimster Moss. See “perfect” deflection bowl shapes around 200 m in all survey lines where the steel grid has been installed deeper.

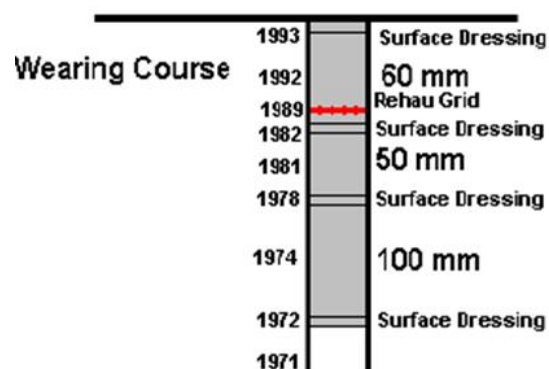
A test section from road B874 was measured in the first ROADEX project in 2000 in order to test how well a geogrid had been performing on a marginally widened weak low volume road resting on peat. The road was originally built in the mid 19th century and Rehau geogrid was installed during a road widening in 1992. According to the Council road data base this single lane road had been given seven layers of surface dressing and thin overlays since the early 1970's. The road was then slightly widened and Rehau grid laid with a 60 mm of bituminous overlay with one more layer of surface dressing given the following year (Figure 4.4.2_1). The ROADEX survey in year 2000 showed that the road shoulders were still settling (Figure 4.4.2_2)

Figure 4.4.2_1 Paving history of the Sibster road from 1970's to the first ROADEX survey in 2000.

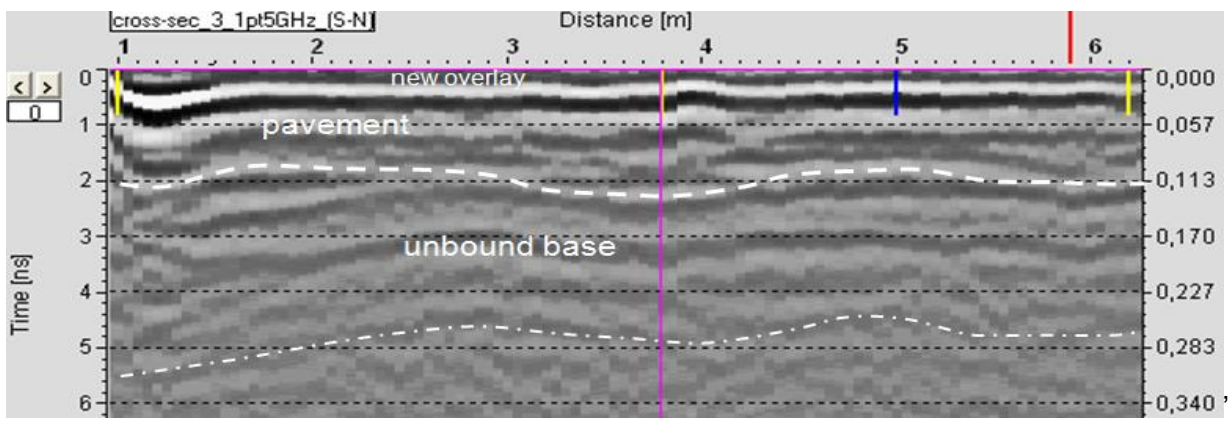
Figure 4.4.3_2 presents a typical GPR cross section measured in Rogart in 2011. It shows that the road has had an overlay of approximately 30 mm thick on the top of old pavement in the last ten years. The cross section also shows that the thickness of the overlay is slightly thicker in the left edge of the pavement indicating that the compaction of the widening might not have been sufficient enough and that there has been small amount of Mode 0 rutting in the widened area due to compaction. This phenomenon could be seen in all the surveyed cross sections. The Rogart test section has drainage deficiencies in the left side of the road as the GPR data shows strong reflections indicating high moisture content in the pavement.

Figure 4.4.3_2. Example of a 1.5 GHz GPR cross section on the Rogart test section in 2011.
