Anne Peltoniemi-Taivalkoski, Timo Saarenketo

# **DRAINAGE MAINTENANCE FOLLOW UP – EXPERIENCES FROM THE ROVANIEMI AND KITILÄ PROJECTS, FINLAND**

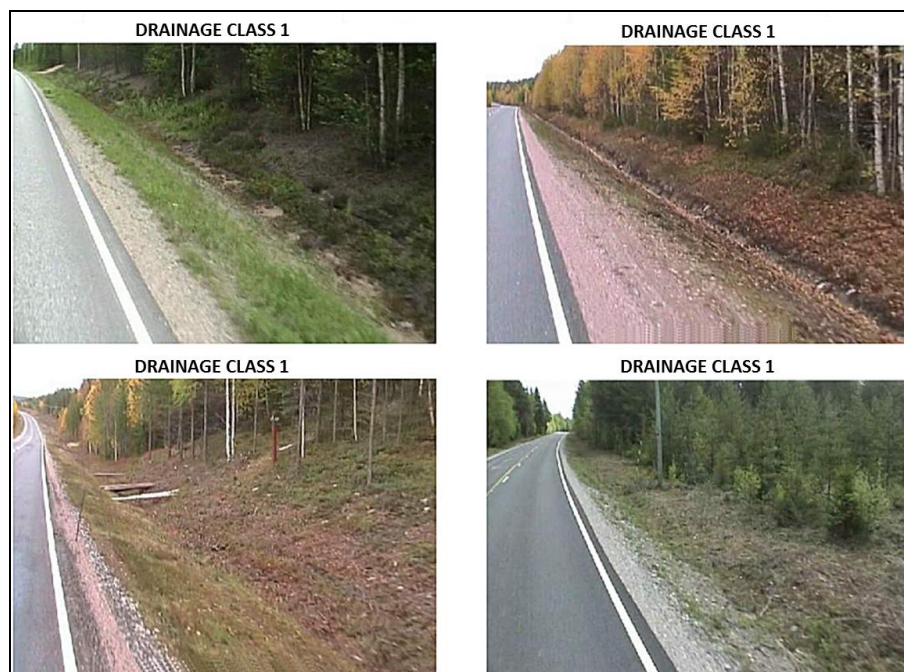
Drainage conditions were classified into three different classes according to the ROADDEX proposal (Saarenketo 2007): good (Class 1), adequate (Class 2) and poor (Class 3). In Class 1, the drainage is defined as faultless and water has a clear passage in the ditches (Figure 3.1). In Class 2, the vegetation prevents water flow from the pavement to the ditch and it also creates dams in the ditches. The soil slipping from the road slopes raises the bottom of the ditch (Figure 3.2). In Class 3, the road shoulders may have high verges or the dense vegetation can cause ponding on the road. Vegetation and unstable soil restrains water flow in ditches (Figure 3.3). All the problem cases lead to the development of deformation and damages in the road profile.

Figure 3.1. Examples of ditches with drainage Class 1.

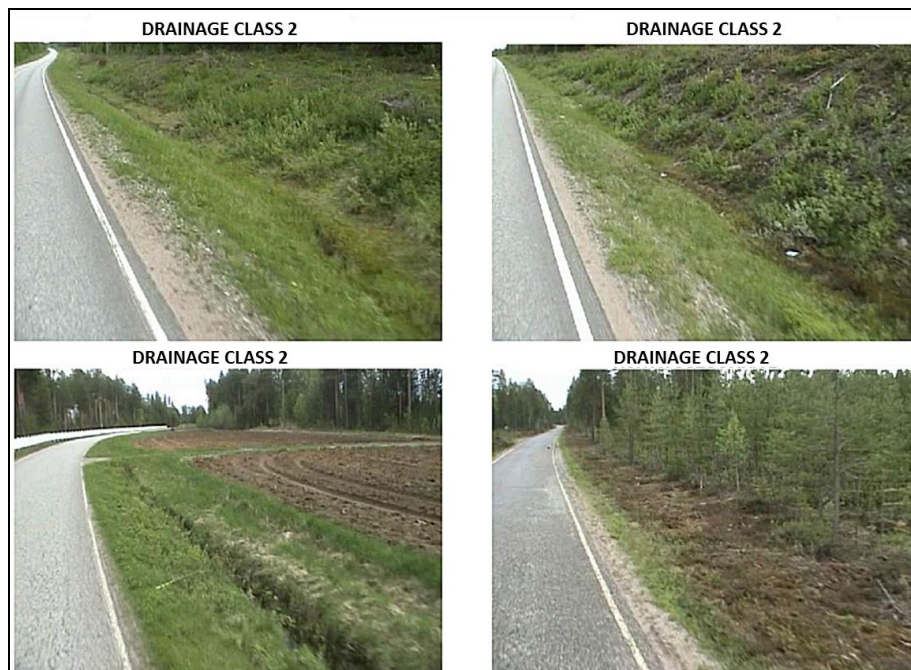
Figure 3.2. Examples of ditches with drainage Class 2.

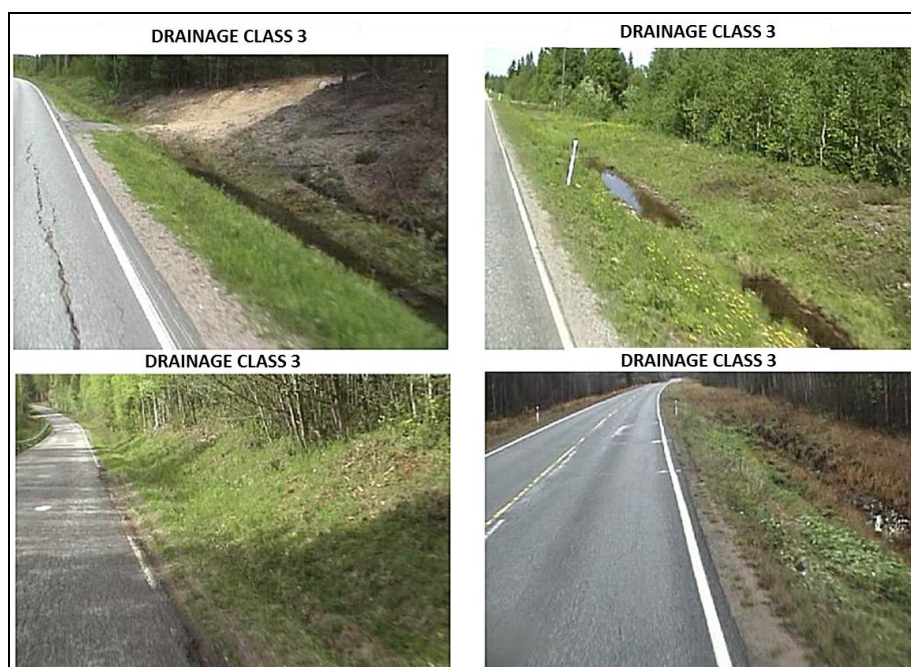
Figure 3.3. Examples of ditches with drainage Class 3.

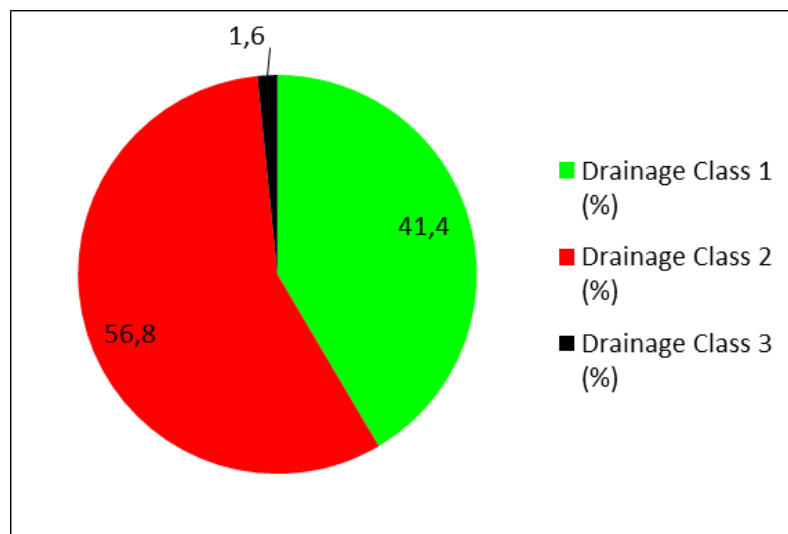
Figure 432\_1 shows the drainage analysis results of the condition of the special drainage maintenance class sections in Rovaniemi maintenance contract area. The Figure shows that in the Rovaniemi maintenance area the special drainage maintenance class sections were mainly (56.8 %) in adequate condition (Class 2) in 2011 and the relative proportion of the ditches that were in good condition (Class 1) was 41 %. Poor condition ditches (Class 3) were observed on less than 2 % of the roads surveyed, which was only about 150 m in length. When individual roads were compared, the biggest share of the drainage Class 3 could be found on road section 222 of road 78, where the percentage of poor condition was 7.2 %. The best condition was road 934, from section 3 on, where 61.5 % of the follow up sections were classified to be in good condition. Outlet ditches in the special drainage maintenance class sections were for the most part in good condition. In some single cases vegetation growing in the outlet ditches was slowing down the flow of water and making them flood.

*Figure 432\_1. Distribution of the drainage classes in the special drainage maintenance class sections in the Rovaniemi maintenance area in 2011.*

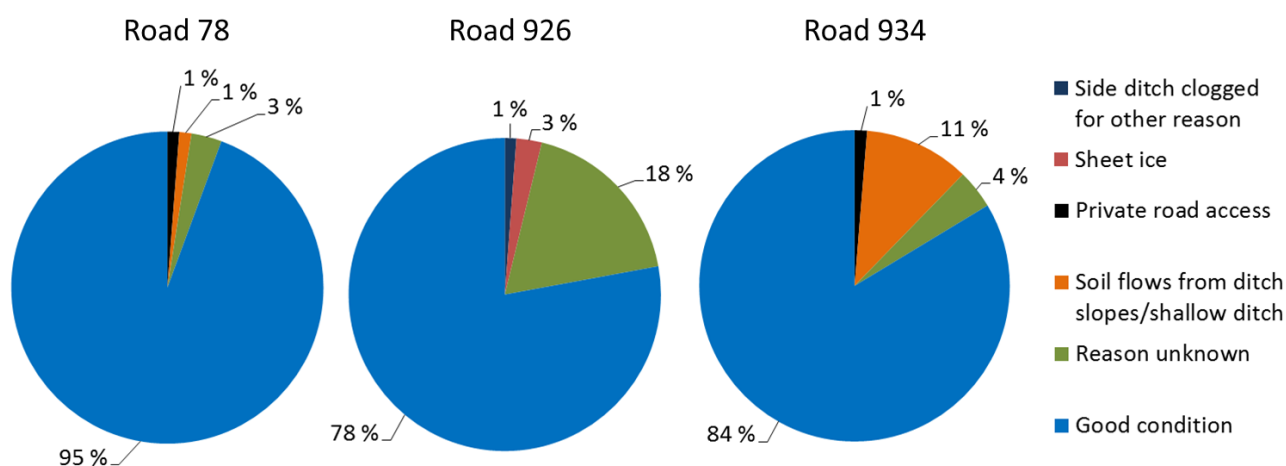
When comparing the rutting and roughness values to the condition of the side ditches, the results showed that 84 – 95 % of the special drainage maintenance class sections were in good condition in the Rovaniemi maintenance contract area (Figure 432\_2). That means that neither rutting nor roughness values had risen. Most of the special drainage maintenance class sections on road 78 were on the left side of the road and 95 % of the total length of the special drainage maintenance class sections was in good condition. On the road 926 over three quarters of the special drainage maintenance class sections were in good condition. Three of four special drainage maintenance class sections were on the left ditch on section 17 of road 926. On road 934 almost all the ditches were repaired during 2010-2011 and over 80 % of the special drainage maintenance class sections were in good condition.

Figure 432\_2. Reasons for the higher rutting or roughness values on roads 78, 926 and 934 in the special drainage maintenance class sections in Rovaniemi.

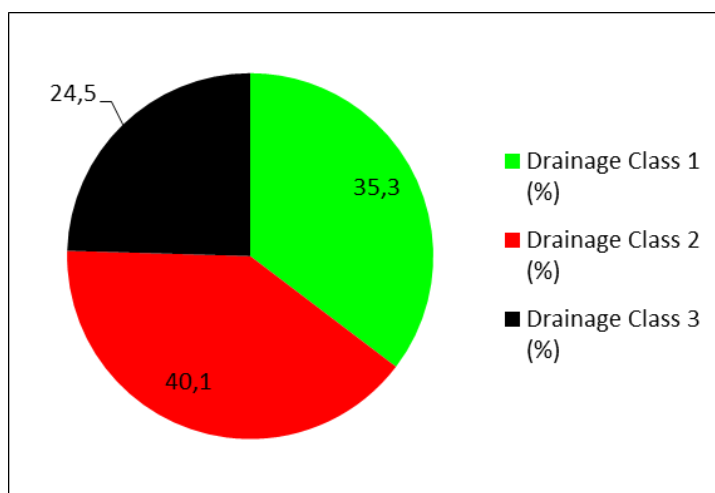
The terrain in the Kittilä maintenance area varies from dry and sandy soils to very wet peat bog areas. Figure 433\_1 presents a statistical summary of the drainage analyses of the special drainage maintenance sections in the Kittilä maintenance contract area. The proportion of good drainage Class 1 was only 1/3, and only on highway 21 were there sections where the drainage was entirely in good condition.

The main reason for the poorer results than in the Rovaniemi area can be found on road 80, sections 11 and 12, where the amount of drainage Class 2 and 3 was high as the sections were located in peat areas. Another problem road was road 93, where there were difficulties in repairing the ditches because of permafrost and because of the high amount of flat peat bog areas.

*Figure 433\_1. Distribution of drainage classes in special drainage maintenance class sections in Kittilä maintenance area in 2011.*

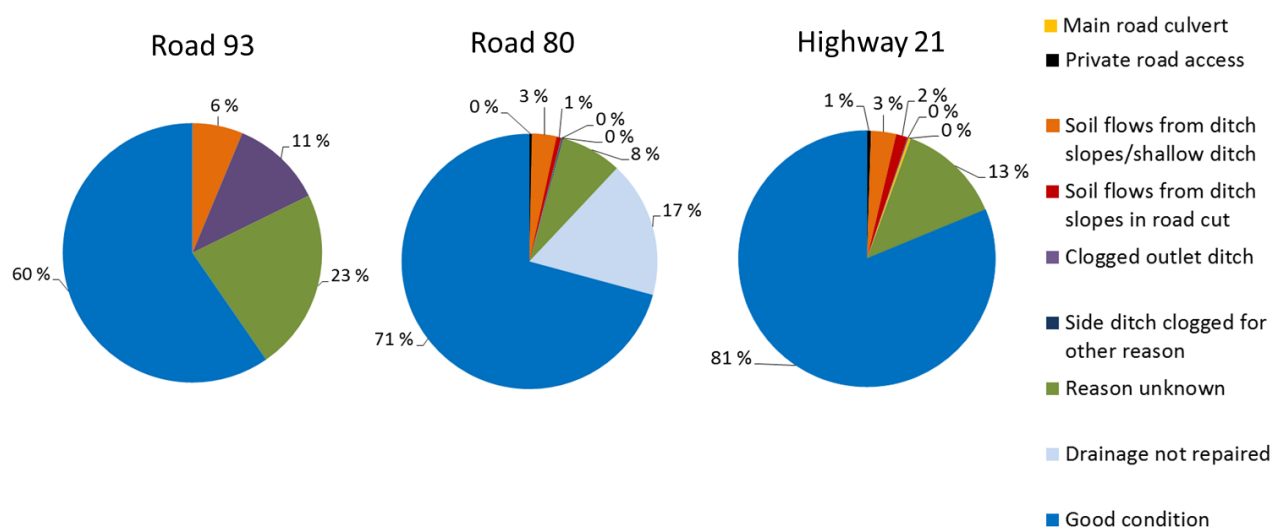
When the anomalous roughness and rutting values were compared with the condition of the side ditches, the results showed that on highway 21 over 80 % of the follow up sections were in good condition, but this reduced to about 70 % on road 80, and just 60 % on road 93 were in good condition. The statistical analysis and problem diagnostics from the Kittilä maintenance area special sections are shown in Figure 433\_2.

Figure 433\_2. Reasons for the anomalous rutting or roughness values on roads 93 and 82 and highway 21 in the special drainage maintenance class sections in 2011, in Kittilä.

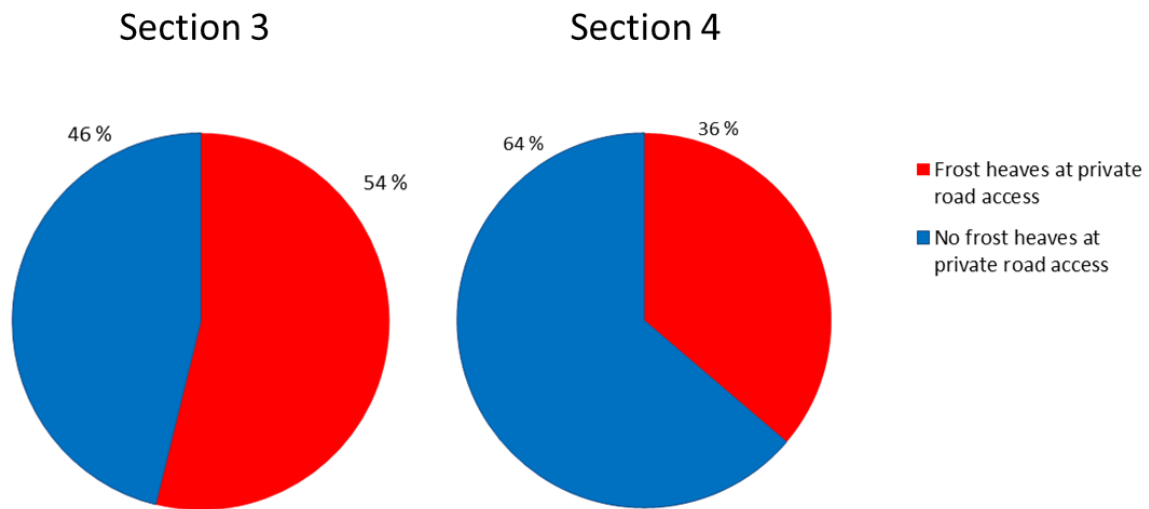
Point cloud frost heave videos made it easy to detect the places where frost heaves occurred and immediately it was noticed that frost heave locations were regularly situated close to private road accesses. The number of such accesses giving rise to frost heave problems was really high. Statistics showed that frost heaves were found at around 54 % of private road accesses on section 3 (Figure 442\_1). On section 4 the proportion was slightly smaller at 36 % but this section was located mainly on sandy ground. The data shows that clogged private road access culverts block the water flow downstream and this causes ponding in the ditches. Frost heaves are created over a short period in spring when the snow starts to melt. At that time the road structures are still

frozen, and when water is permitted to infiltrate into the cold road structures this causes differential frost heaves.

Figure 442\_1. Amount of frost heaves associated with private road accesses on road 934, sections 3 and 4.

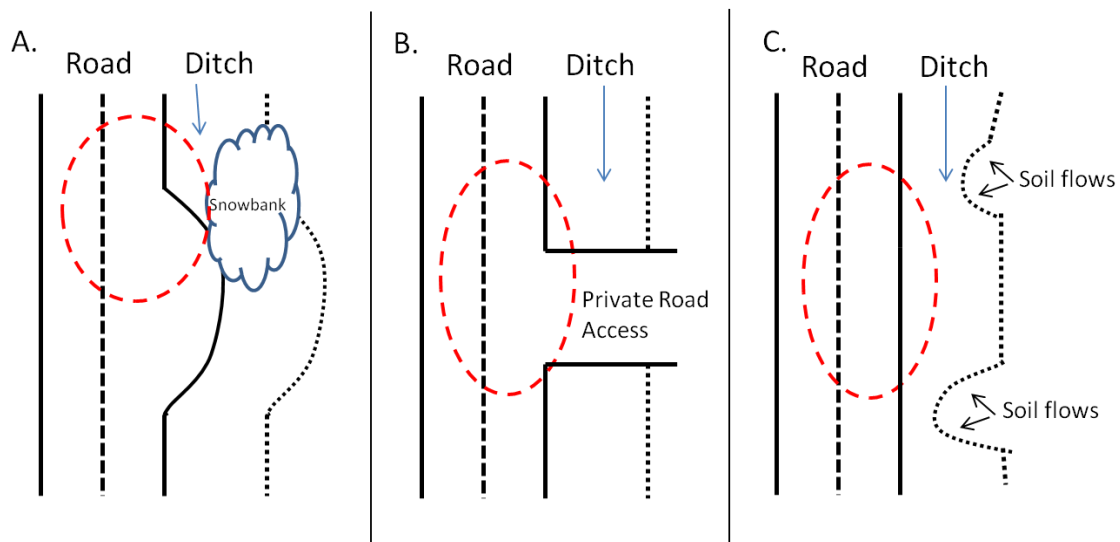
Based on this study, three main drainage problem types causing road damages could be found (Figure 5\_1). The first type involves bus stops and rest areas where during winter the cleared snow from the road, bus stops and rest areas, is stored off the road and above the ditches (Figure 5\_1A). In spring, when the snow begins to melt, these snowbanks prevent the water flow in the ditch causing the water level to rise. This enables water to infiltrate into the cold road structure and this causes frost heaves and high rutting and roughness values to the road. The second type concerns clogged or missing private road access culverts (Figure 5\_1B). These slow down the water flow or stop it totally. When the water level rises enough it infiltrates into the road and causes road damages as described above. Additionally the high water level resulting from a clogged culvert also causes the ditch slopes to become saturated with water and the soil on the ditch slopes to flow into the ditch. This raises the bottom level of the ditch, or blocks it altogether (Figure 5\_1C). Soil flows also restrict the water flow in ditches.

*Figure 5\_1. Three common problems causing damages to roads. Water flow is marked with a blue arrow and the area that is most likely going to be damaged is circled with a red, dashed line.*

*A: Snowbank behind bus stop or rest area preventing the water flow. B: Clogged or missing private road access culvert. This hinders the water flow and causes problems to road at private road access. C: Soil flows from ditch slopes preventing water flow.*

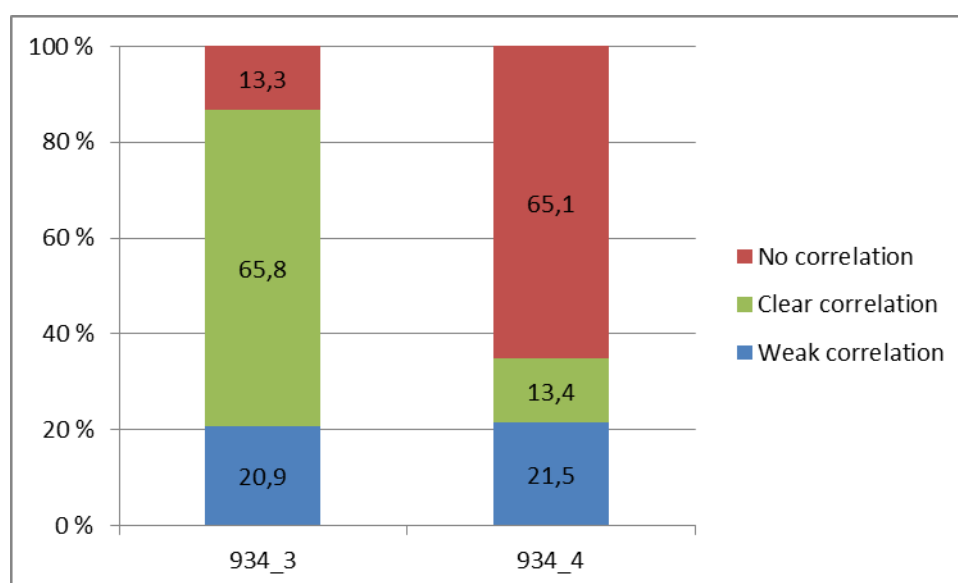
The correlation between anomalous rutting and roughness values and frost heaves were compared on road 934 section 3 and 4. In this comparison all the rutting and roughness values higher than average were marked and then checked if there were clear, weak or no frost heaves at each point. The comparison was made over the full section lengths. The results differed in the two sections (Figure 5\_2). On section 3 over 65 % of the anomalous rutting and roughness values had a clear correlation with adjacent frost heaves, whereas on section 4, 65% of the rutting or roughness values did not correlate with frost heaves at all. In these sections the reason for the visible rutting was poor road materials and the rutting Mode was mainly Mode 1. The results that frost heaves are not the only reason for the growth of rutting and roughness values. Other circumstances, such as road structure quality and the amount of heavy traffic, can have an impact on rutting and roughness too.

Figure 5.2. Correlation between frost heaves and anomalous rutting and roughness on road 934, sections 3 and 4.

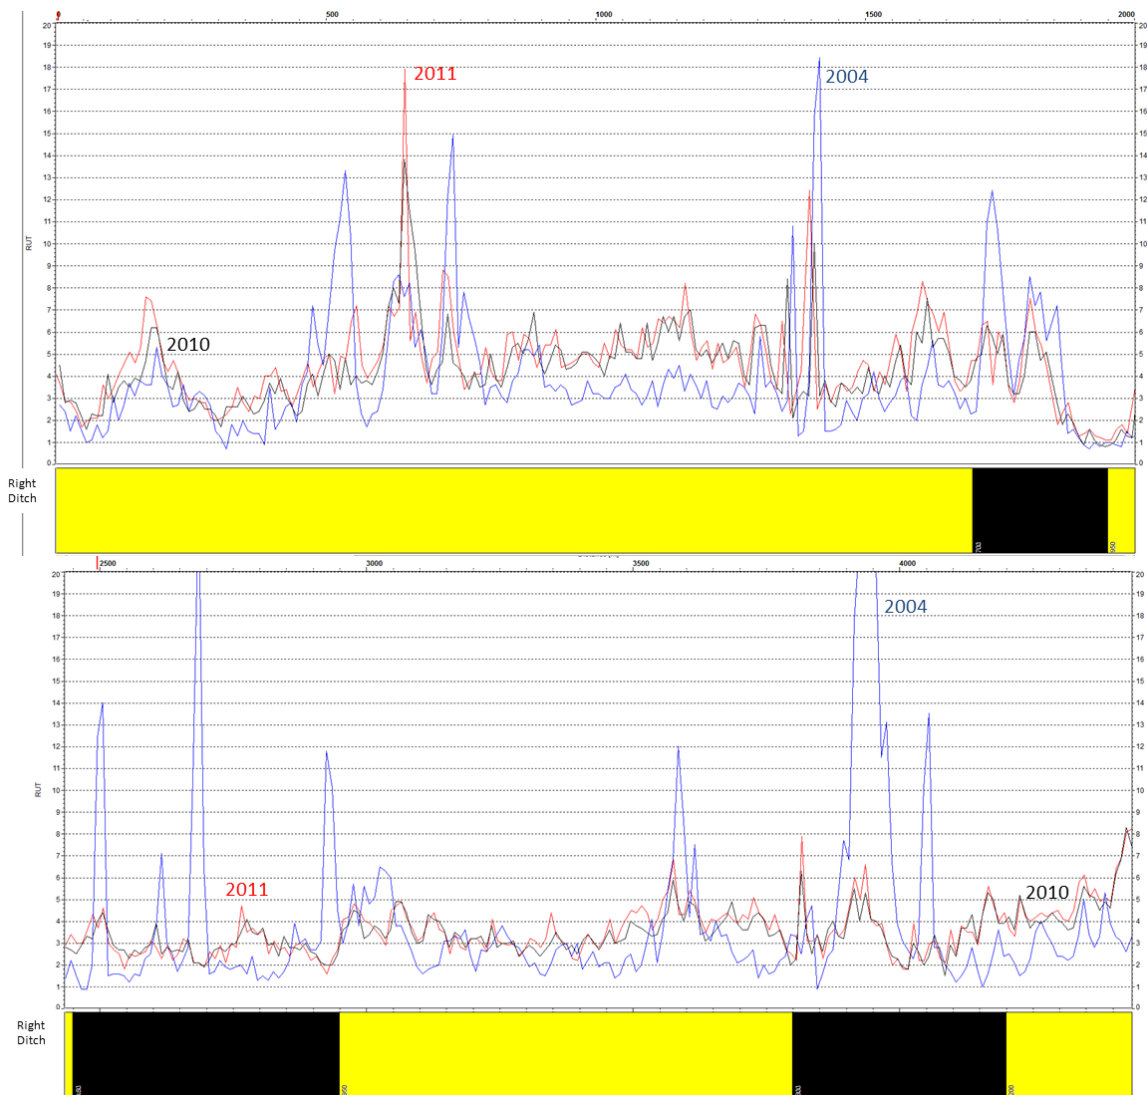
In summary it can be stated that the drainage analysis method developed in the ROADDEX project, has been proven to give reliable results in the Rovaniemi and Kittilä maintenance areas. Most of the selected sections for follow up monitoring were located at the most critical sections from a pavement life time perspective. Figure 5\_3 shows an example from road 934 on how improving the drainage has ensured that the rutting values have been retained at a low level. The results from 2004 are the rutting values measured before the drainage was improved, and the pavement repaired. When the rutting values from 2010 and 2011 are compared to those of 2004, it can be seen that outside the special drainage management class sections the 2010/11 values are higher at some points than before the drainage and pavement was repaired. This clearly shows that the improvement of the drainage has had a good influence on the condition of the road, and where the improvement was not carried out the values have tended to grow.

Figure 5\_3. Example from road 934 showing how the improved drainage has helped the rutting values stay at a low level in the special drainage maintenance class sections. These sections are marked with black in the second and fourth frames. The first frame shows rutting values between 0 – 2000 m and the third frame the rutting values between 2450 – 4400 m.

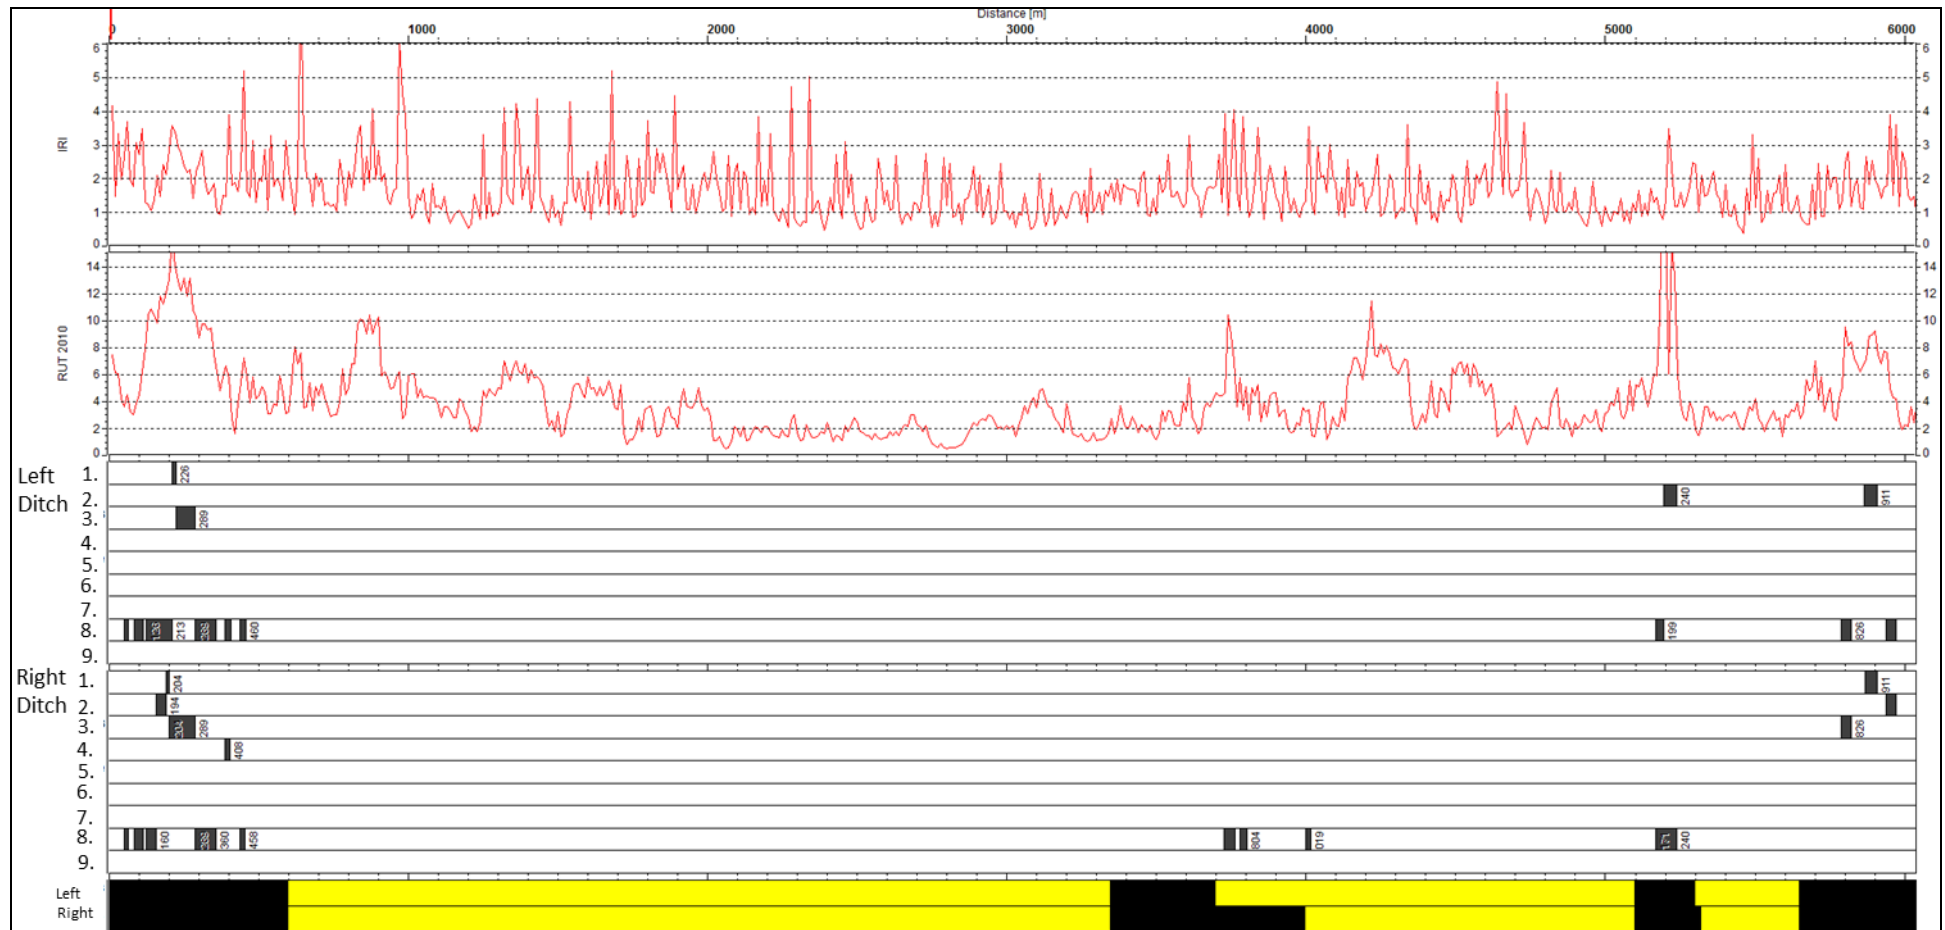
Appendix 1. Comparing the anomalous roughness (first frame) and rutting values (second graph) to the problems observed in the drainage video. The problems in each ditch are marked separately. The categories the problems were divided into are: 1. private road access, 2. soil flows from ditch slopes or shallow ditch, 3. soil flows from ditch slopes in road cut, 4. clogged outlet ditch, 5. side ditch clogged for other reason, 6. sheet ice, 7. main road culvert, 8. reason unknown and 9. drainage not repaired. The lowest graph shows the special follow up sections on both ditches. This example is from highway 21, section 205.
