SUMMARY OF DRAINAGE ANALYSIS IN REGION NORD, NORWAY

Demonstration Project Report

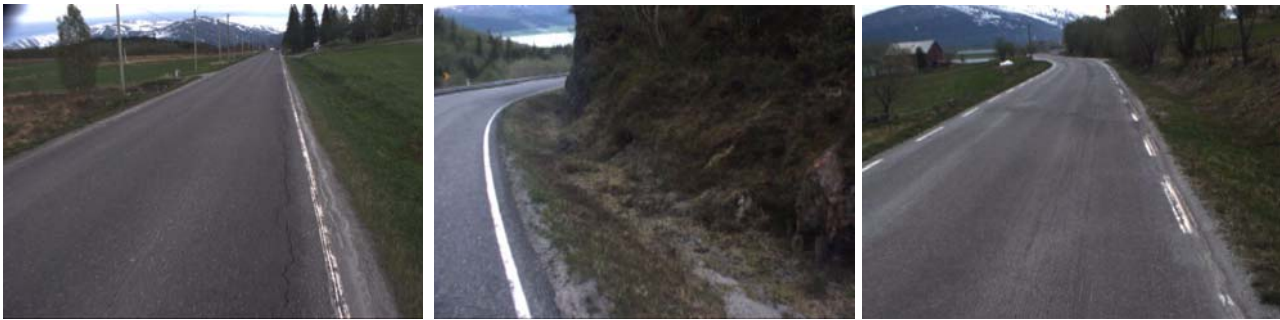
In drainage Class 2 there can be some visible changes to the road cross-section. The road shoulder has narrow verges or vegetation growth that is preventing the free flow of surface water from the road surface into the ditch. There is some vegetation in the ditch that restricts water flow and creates damages. Some soil is sliding from the road side slope into the ditches and raising the bottom of the ditch. This hinders water flow and raises the ground water level. Examples of drainage Class 2 are presented in Figure 7.

Figure 7: Examples of road sections with drainage Class 2 in Region Nord in Norway.

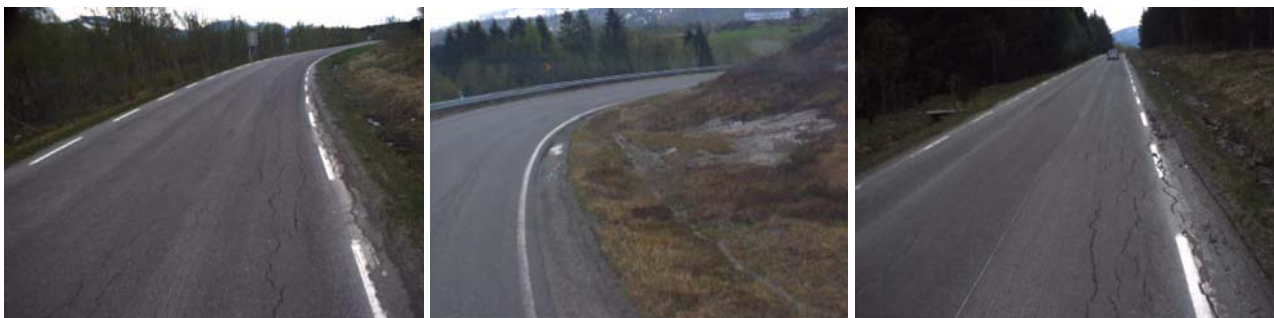
Drainage Class 3 covers those road sections with severe drainage problems. The road shoulder has a high verge and/or dense vegetation that are causing water ponding on the traffic lane or on the shoulder. Vegetation is growing in the ditches and preventing the water flow and creating dams in the ditches. Soil is flowing from ditch slopes into the bottoms of ditches and blocking the flow of water. Clogged culverts or outlet ditches are preventing the water flow in the ditch. All of these situations lead to the development of deformation and damage in the road cross-section. Examples of drainage Class 3 are presented in Figure 8.

Figure 8: Examples of road sections with drainage Class 3 in Region Nord in Norway.

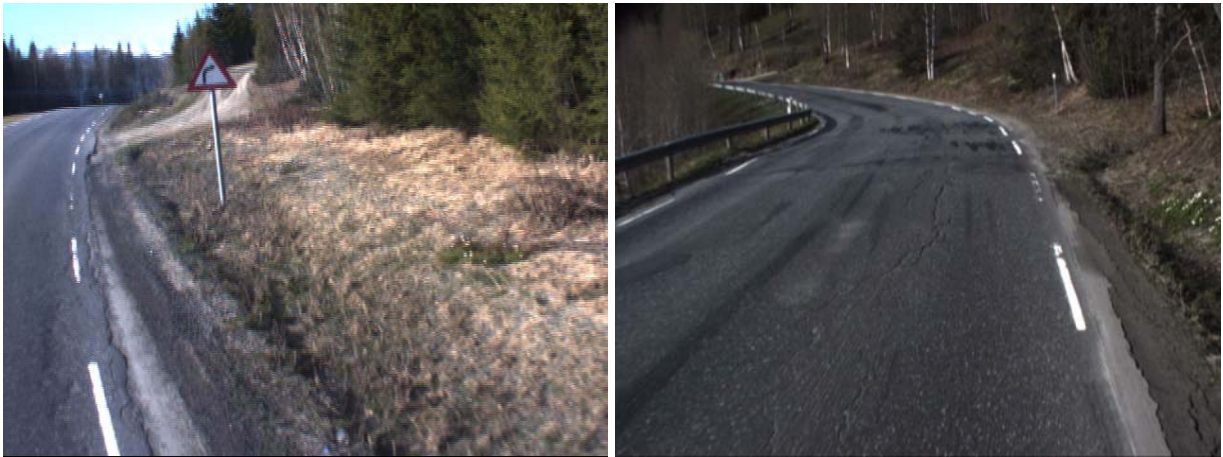
Figure 14: Drainage problems in a steep side sloping road profile, chainage left: 4530m, right: 4960m

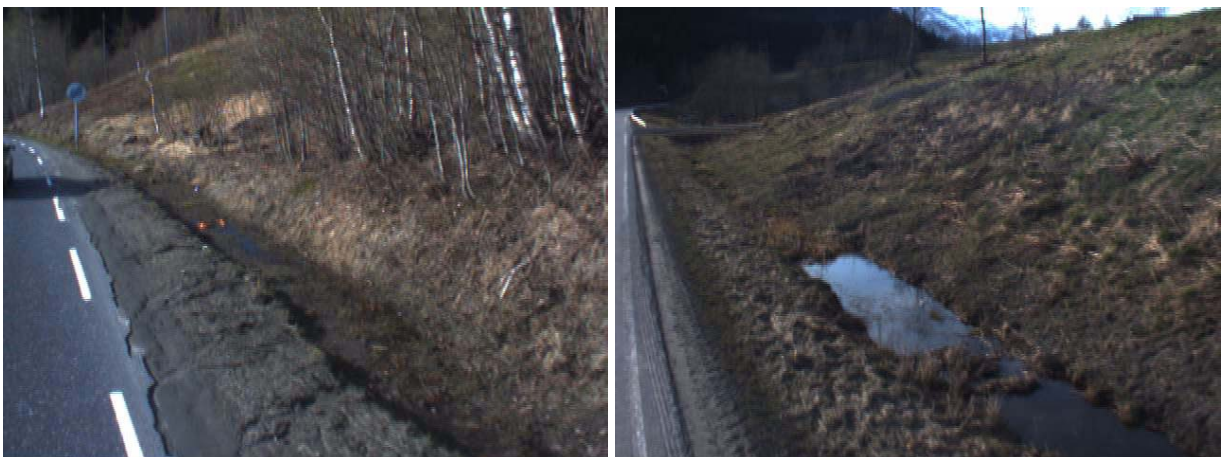
Figure 16: Water standing on the upper side of the slope, chainage left: 7370m, right: 34610m

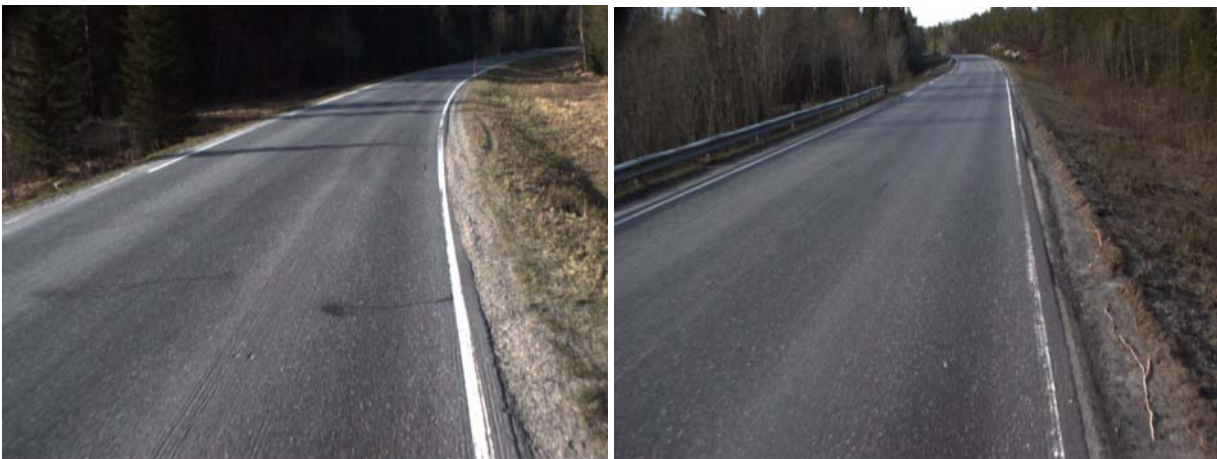
Figure 21: Verge is blocking the water, chainage left: 15270m, right: 16200m

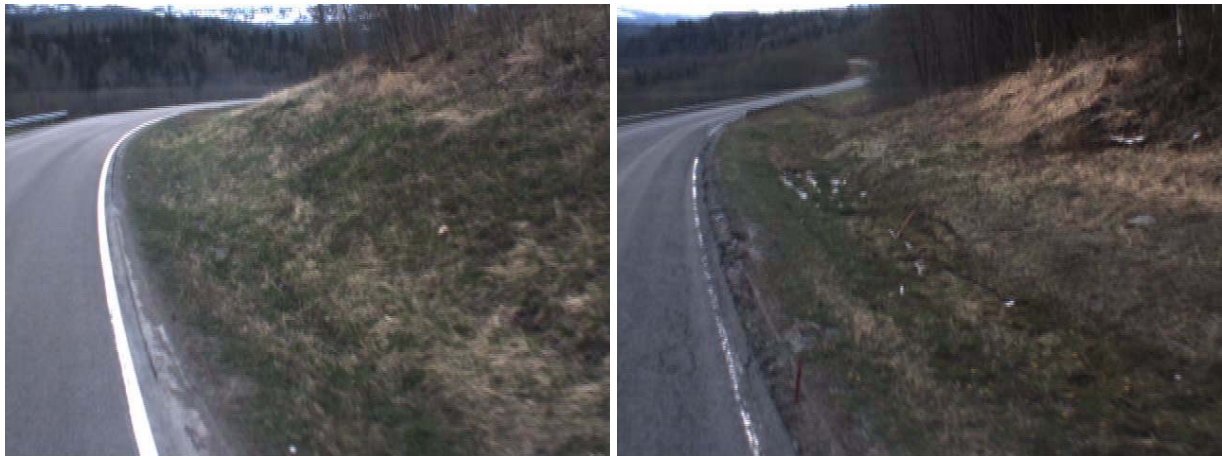
Due to the instability of the soil, some ditch walls had collapsed into the ditch (Figure 24). If the ditches are going to be cleaned here, this soil might need some kind of protection against erosion.

*Figure 24: Problems with instability of the soil, also a verge problem
chainage left: 1370m, right 2470m*

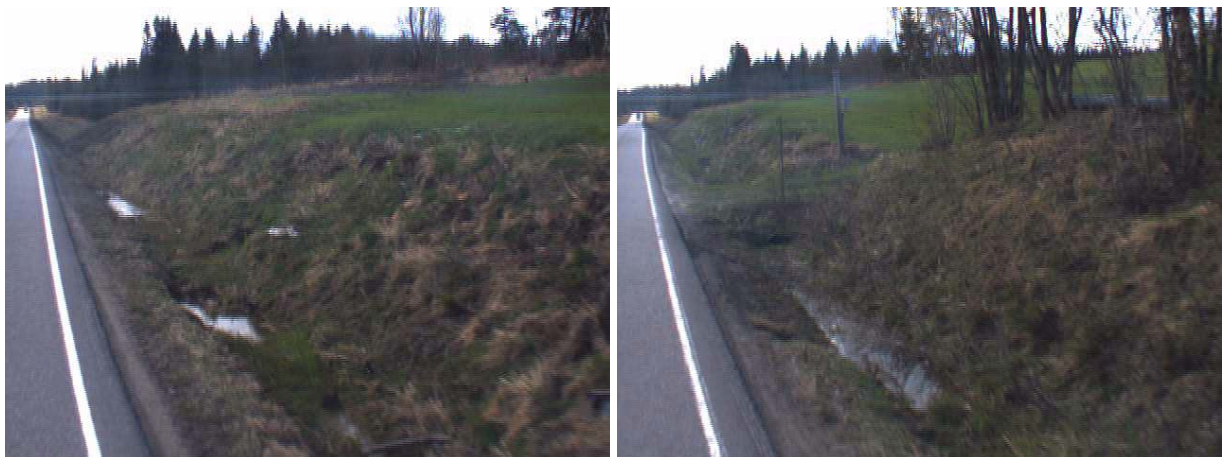
From chainage 6000m to 7000m on the left side the drainage system clearly needed improvement (Figures 25). The road profile varied inside the section but mostly it was side sloping from left to right.

Figure 25: Left: Standing water in the ditch at chainage 6750m, Right: Partly blocked culvert in a private access road junction at 6800m

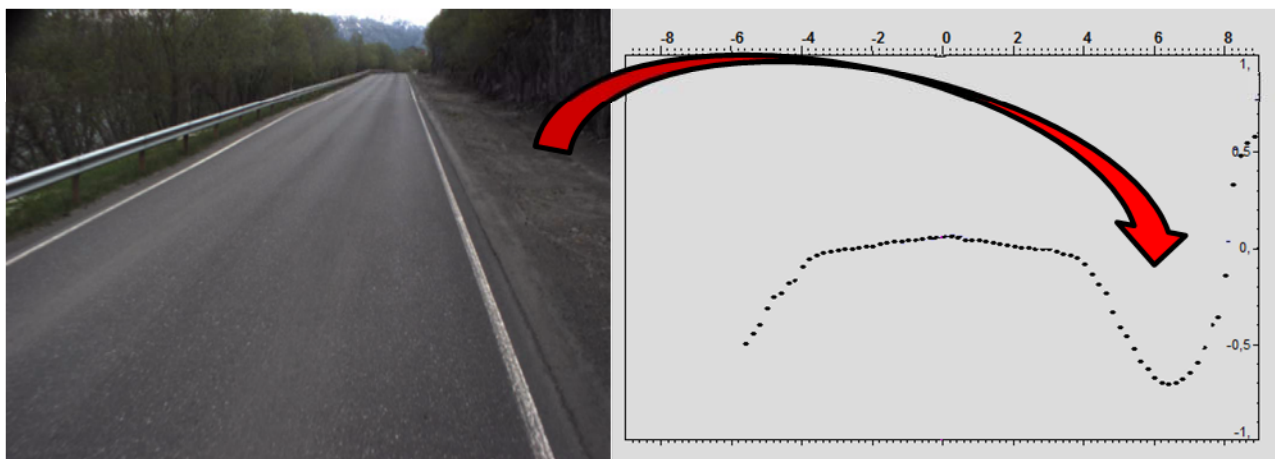
Figure 41: Upgraded drainage system (chainage 18600m)

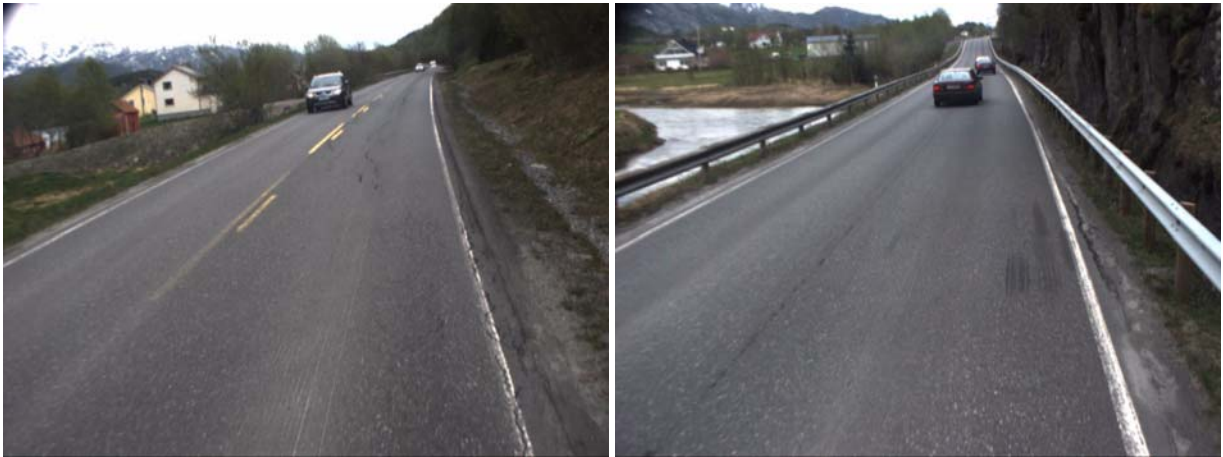
There were however a couple of lengths that still needed drainage improvement. This was especially the case at the end of the section where vegetation growth was reducing the efficiency of the deep ditches. (Figures 42 and 43). High verges were also a problem in some sections (Figure 44).

Figure 42: Left: Shallow ditch in side sloping road profile at chainage 19280m. Right: No room for a ditch between the cutting and guardrail at 21690m

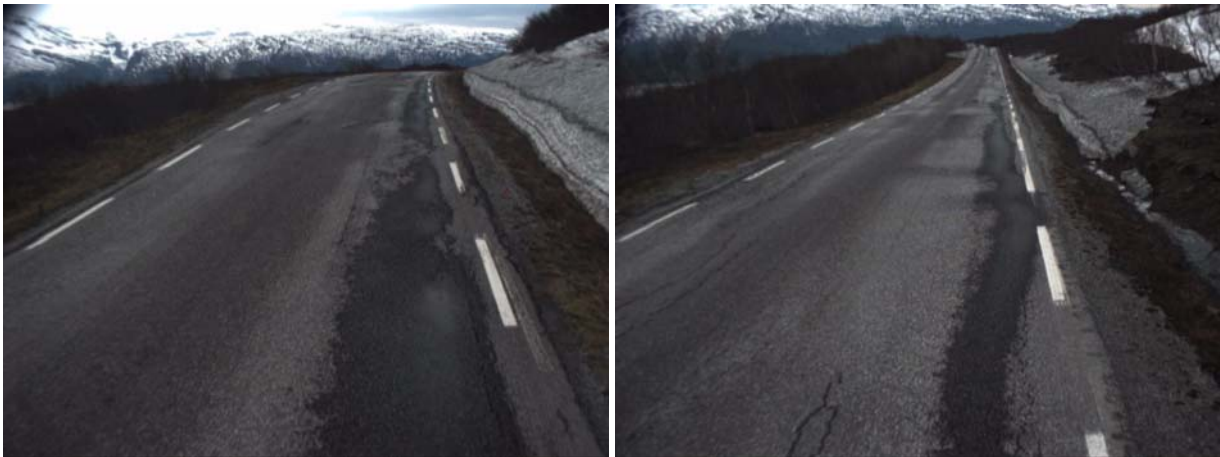
From chainage 19000m to 21500m, where the road was at its highest elevation, some snow still remained at the time of the field survey. In some sections snow partly covered the ditch bottom which made it difficult to evaluate the drainage condition (Figure 50).

Figure 50: Snow in the ditches, left: chainage 20320m, right: 20710m.

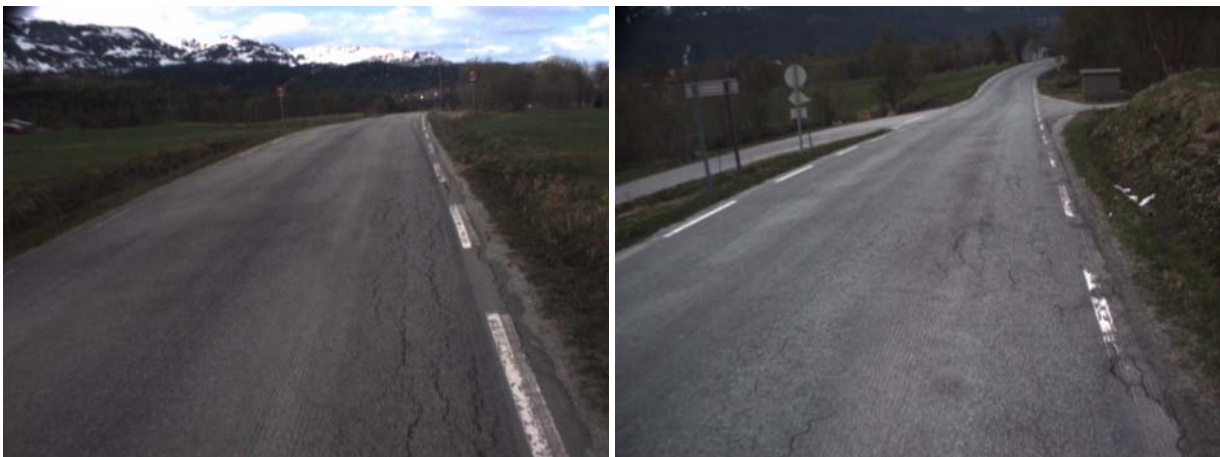
In the last part of the surveyed chainage there were several sections with shallow ditches. Examples of these are shown in Figure 51.

Figure 51: Shallow ditches, chainage left: 27870m, right: 28300m

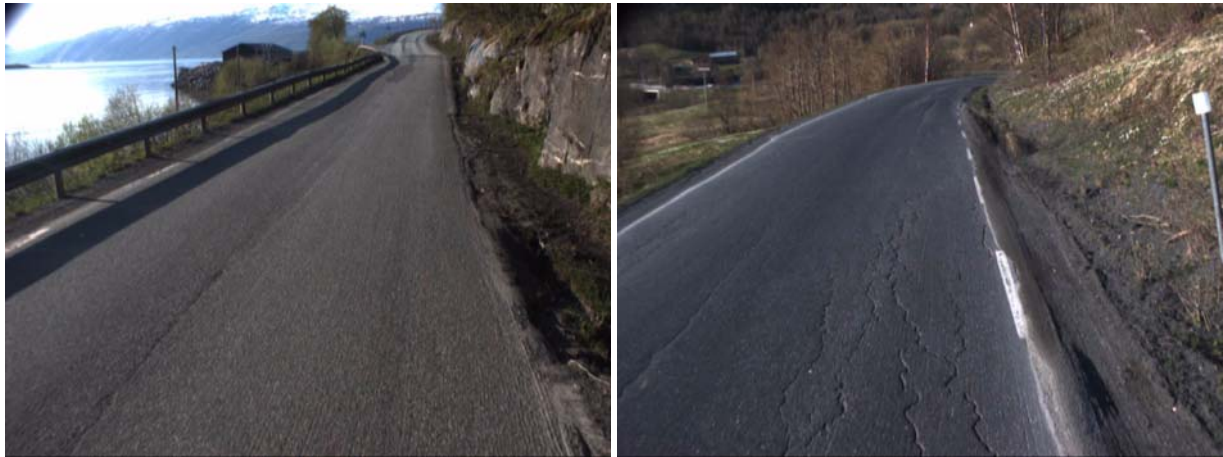
Figure 54: No room for a decent ditch, chainage left: 2690m, right: 11500m.

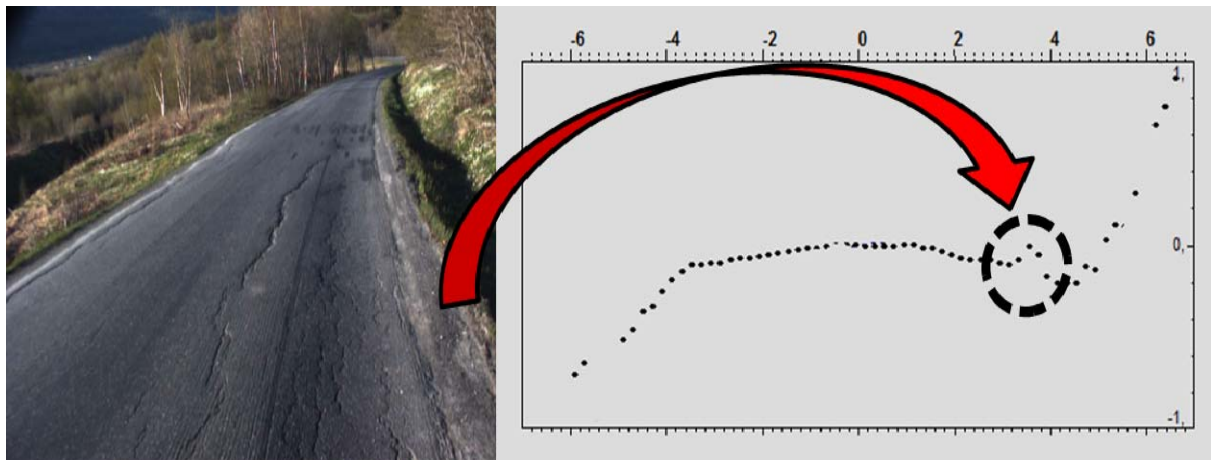
Figure 55: Unstable material has partly filled the ditch and a high verge is blocking water flow (chainage 9840m). Laser scanner data shows also deformation on the right lane.

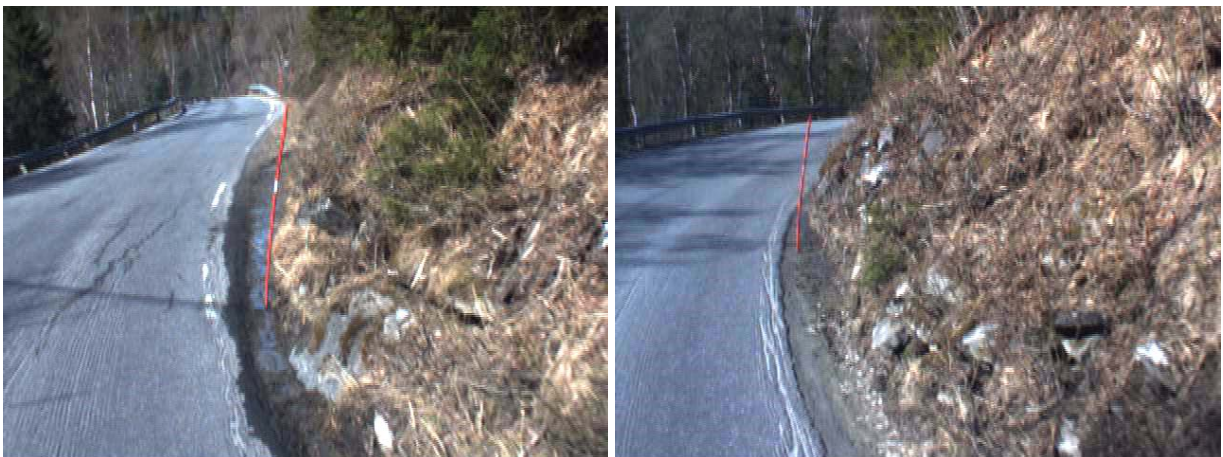
Figure 58: Steep side slope, not enough room for open ditch, chainage left: 6165m right: 6190m.

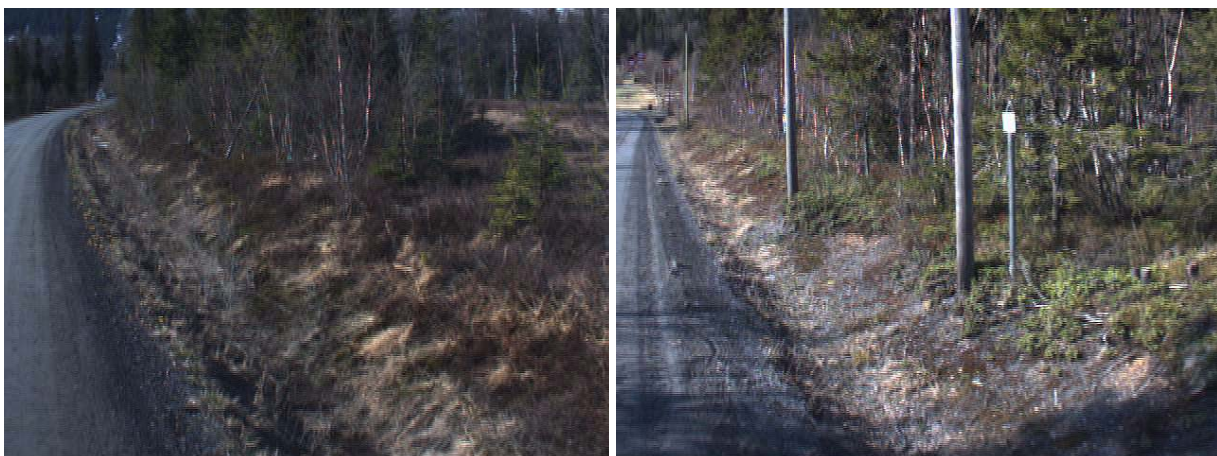
At the beginning of the road there was a section where the road profile was “even ground” and the drainage was not working efficiently due to the ditch being too shallow and vegetation blocking the water flow (Figures 66).

Figure 66: Shallow ditches at chainage 150m and 1000m.

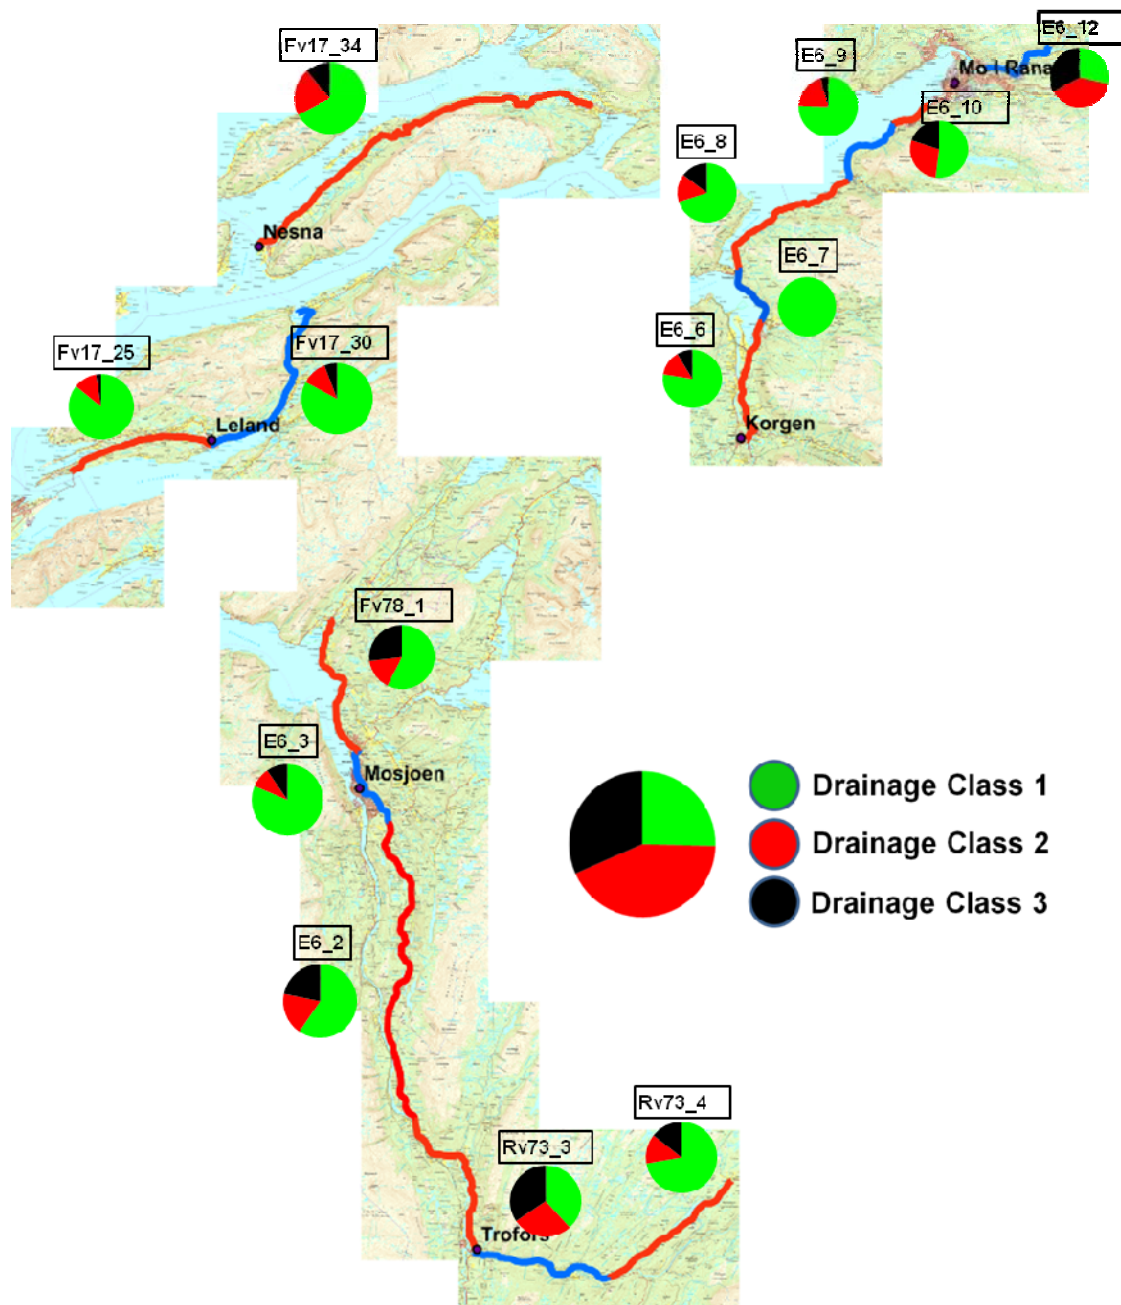
The drainage classification of each road section surveyed was examined statistically. The worst sections for drainage classification in average were the E6 section 12 and the Rv73 section 3. However both of the roads Fv17 and E6 had several sections which were in quite good drainage condition. The distribution of average drainage classes in each surveyed section is shown in Figure 74.

Figure 74: Distribution of average drainage classes in the surveyed paved roads.

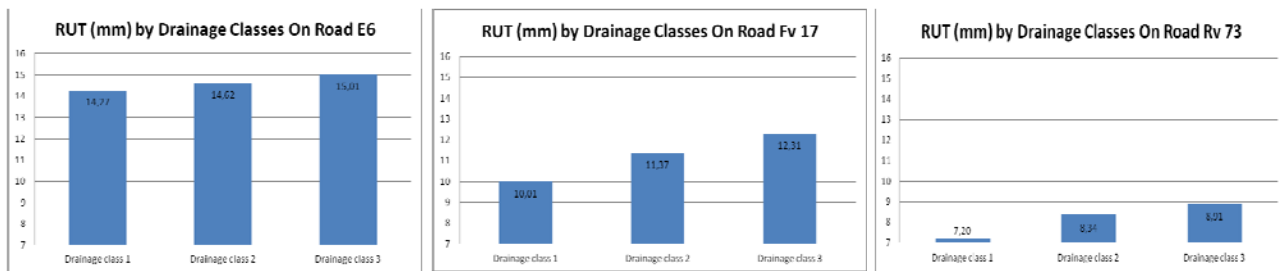
The deepest rutting values classified according to drainage class were on road E6, and the lowest were on road Rv73. On each road the rutting depth increased when the drainage condition was poorer (Figure 77).

Figure 77: Mean average rut depth values classified by drainage classes on the surveyed roads.

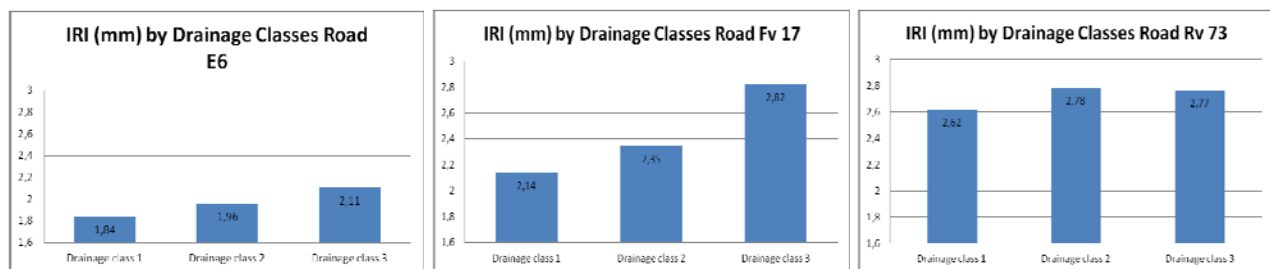
Figure 78 presents the mean average IRI values by each drainage class. The highest roughness values were on road Rv 73 and the lowest values were on road E6. The IRI values followed the same pattern as the rutting values and increased when the drainage was classified poorest (i.e. drainage Classes 2 & 3). The average roughness ratios are summarised in Table 3.

Figure 78: The mean average IRI values classified by drainage classes in surveyed roads.

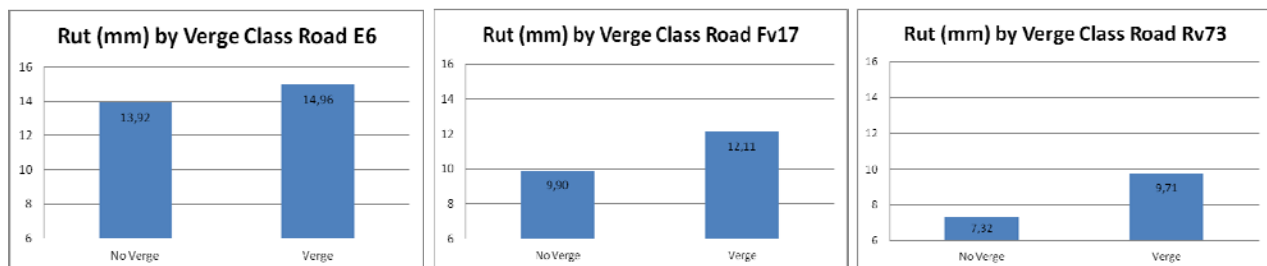
The deepest ruts, classified according to verge class, were on road E6 and the lowest on road Rv73 (Figure 79). The trend follows the same circumstances as drainage class.

Figure 79: Mean rutting values classified by verge classes in surveyed roads.

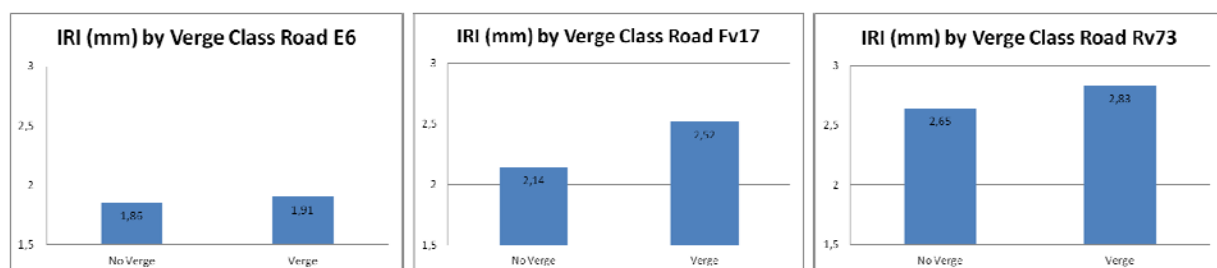
In contrast to rut depths the highest roughness values classified by verge were on road Rv 73 and the lowest values on road E6 (Figure 80).

Figure 80: Mean roughness values classified by verge classes in surveyed roads.

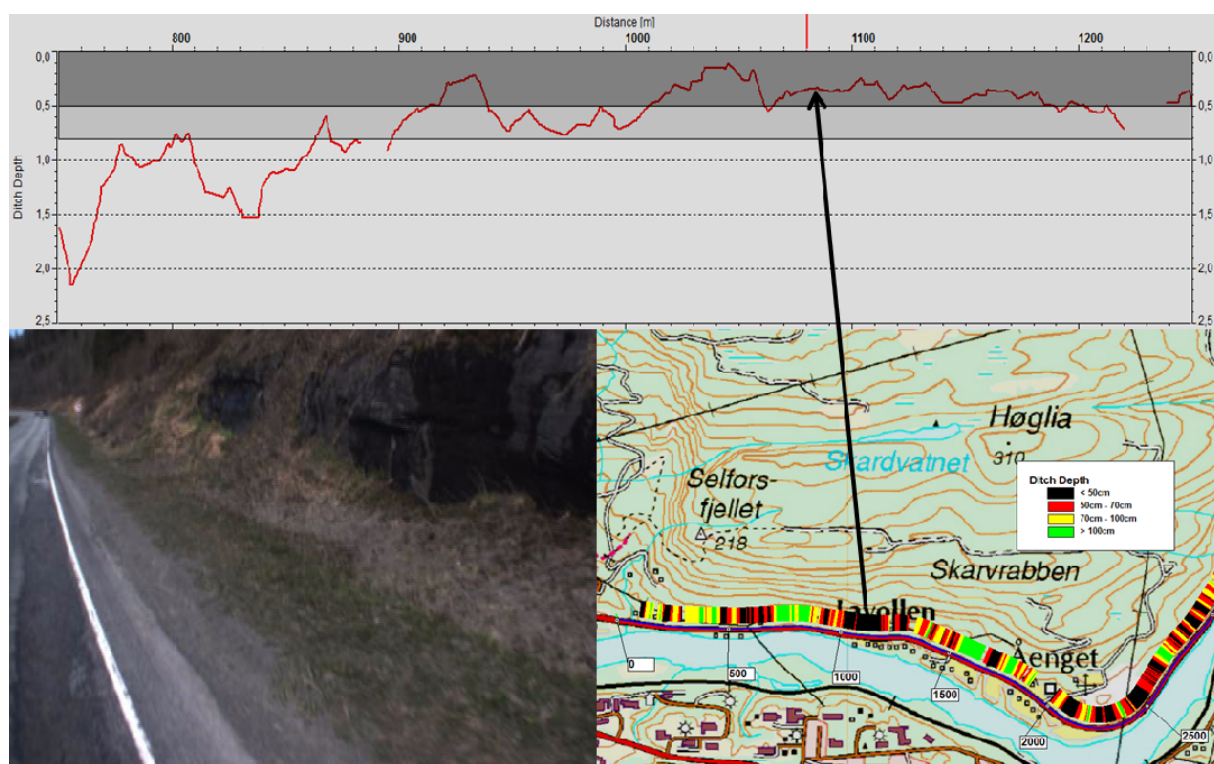
According to the Nordic countries recommendations ditch depths should be 20-30cm lower than the bottom of the road structure. Figure 81 shows an example from road E6 section 12, chainage 900m - 1200m. This shows a shallow ditch in the ditch depth analysis field (top panel) and the ditch depth map (right). Chainage 1080m is marked with the black arrow both in the map and in the ditch depth analysis field. The same chainage is also shown in the still photograph from the survey video.

Figure 81: Ditch depth in the analysis field and in the map view, road E6 section 12, chainage 900m - 1200m.

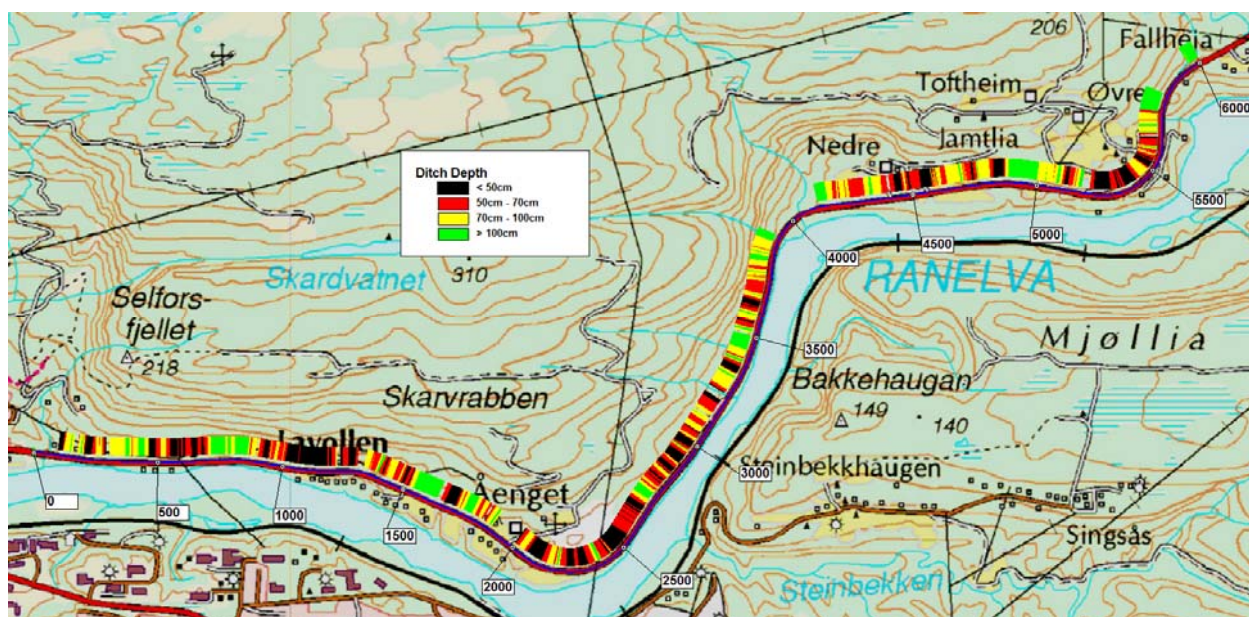
Figure 82: GIS ditch depth map of section 12 on road E6.

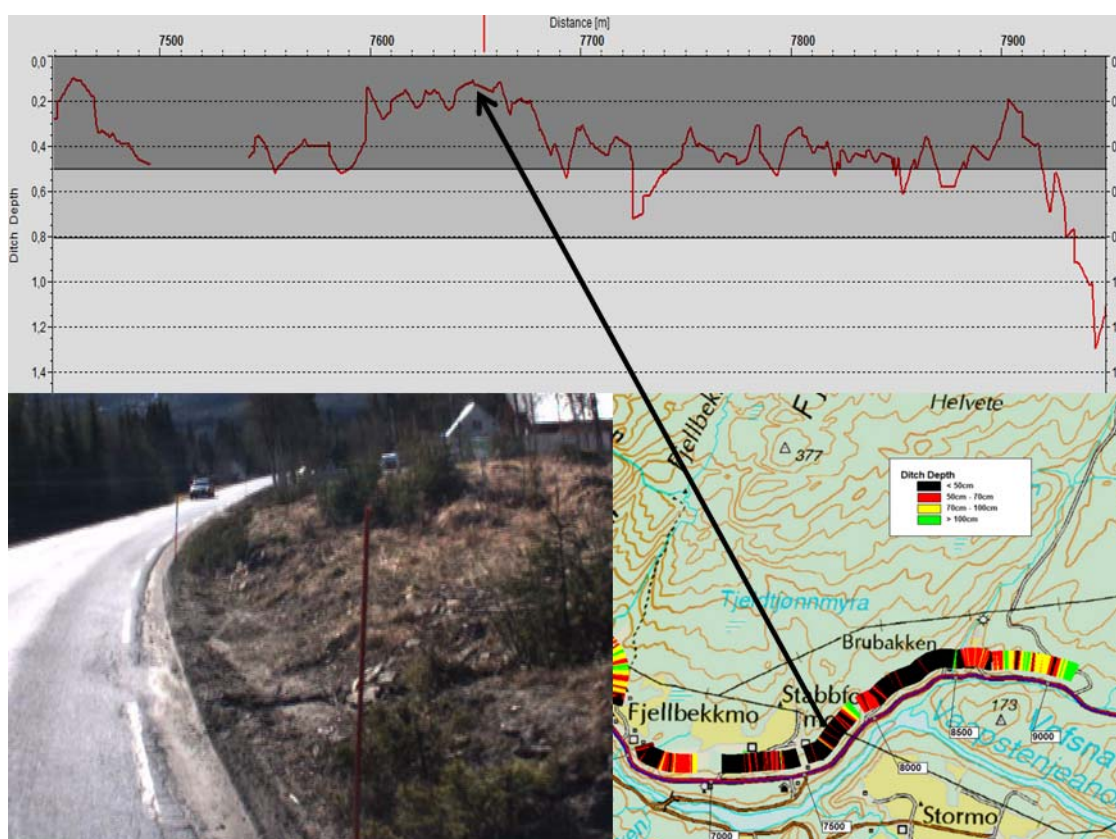
Section 3 of road Rv 73 had problems with the depth of the ditch on the upper side of the side slope, and especially in the chainage from 7000m to 8500m. (Figure 83). The GIS map of the section in Figure 83 shows the ditch depth along the section, and in the analysis field there is a detailed view from 7400m to 7900m. The black arrow indicates chainage 7650m in both views.

Figure 83: Ditch depth in the map view and analysis field, Section 3, road Rv 73, chainage 7000m – 8500m.

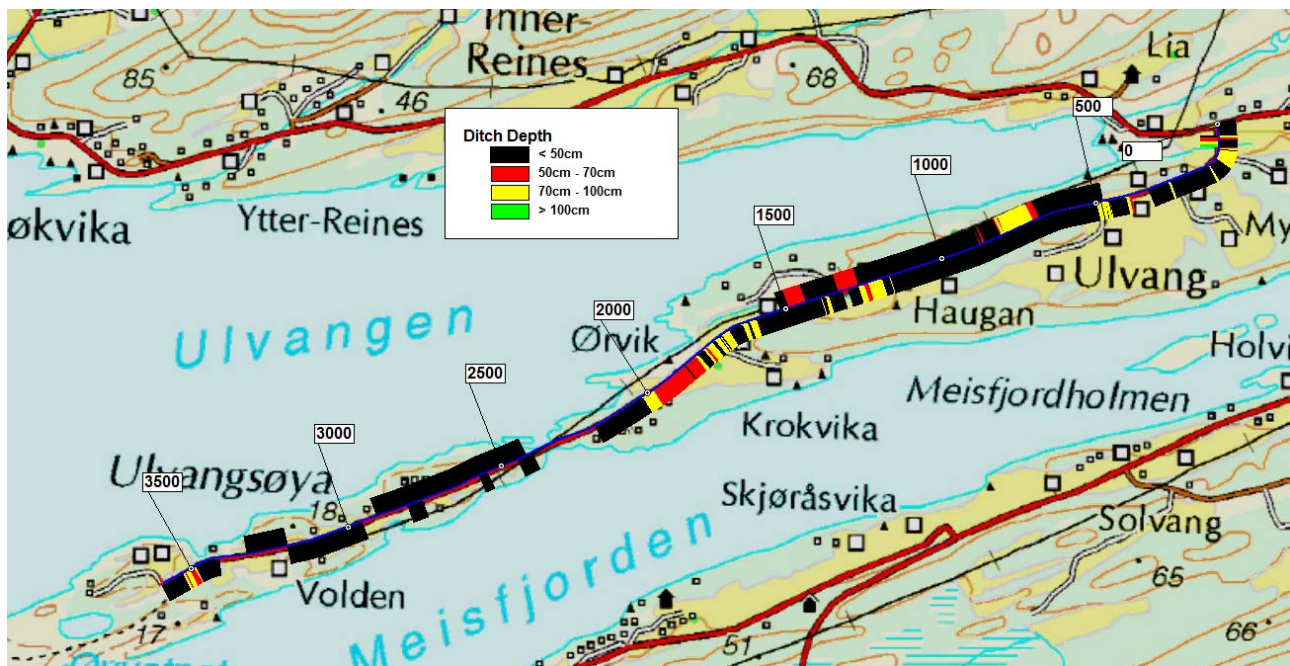
Figure 84: GIS ditch depth map of road Fv 213.

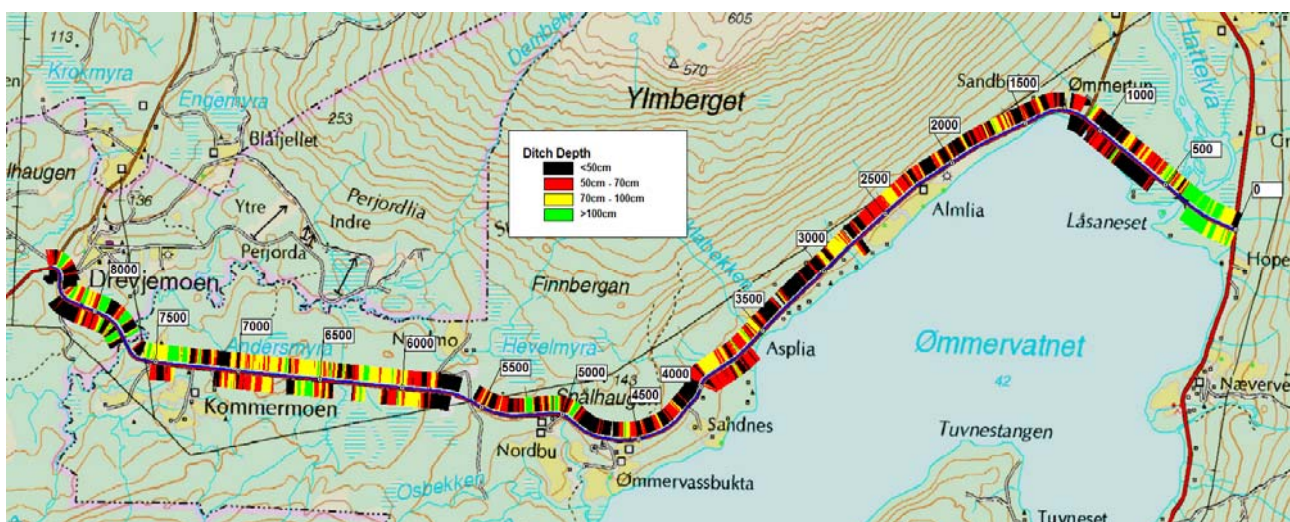
Figure 85: GIS ditch depth map of road Fv 254.

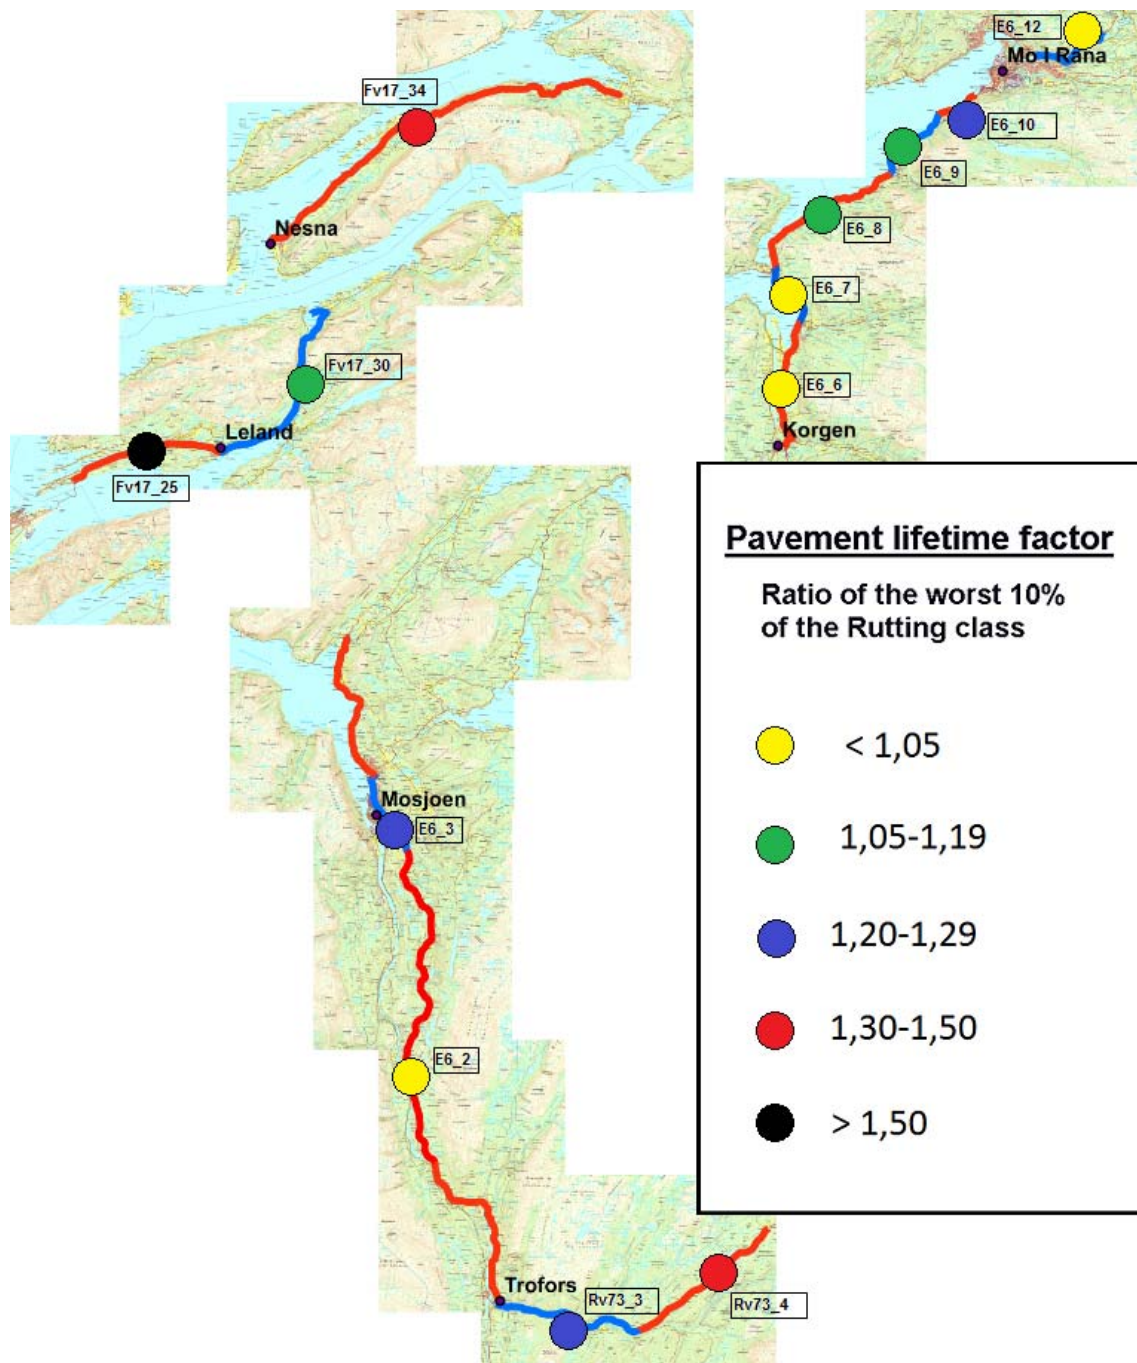
Figure 86 shows the results of pavement lifetime factor calculations (the ratio of the worst 10% rutting class) for the roads surveyed in the Region Nord. These factors varied from a value <1.05 for some sections of the road E6, to a value >1.5 for the section 25 on Fv17 road. Overall the Fv17 and Rv73 on average appear to have worse lifetime factors, even when the drainage is on average (especially on Fv17) better than road E6. Road Fv78 was left out of the analysis because of the quality of the old profilometer data. As mentioned earlier, the averaging of the profilometer data to 20 metres could skew the results of the pavement life time calculations.

Figure 86: Pavement lifetime factor for the roads surveyed in the Region Nord, Norway.

Drainage improvement will be the most economical on those sections which have a lifetime factor greater than 1.5. For example on surveyed sections in Region Nord in Norway, the improvement would be the most economical on section 25 of the road Fv17.

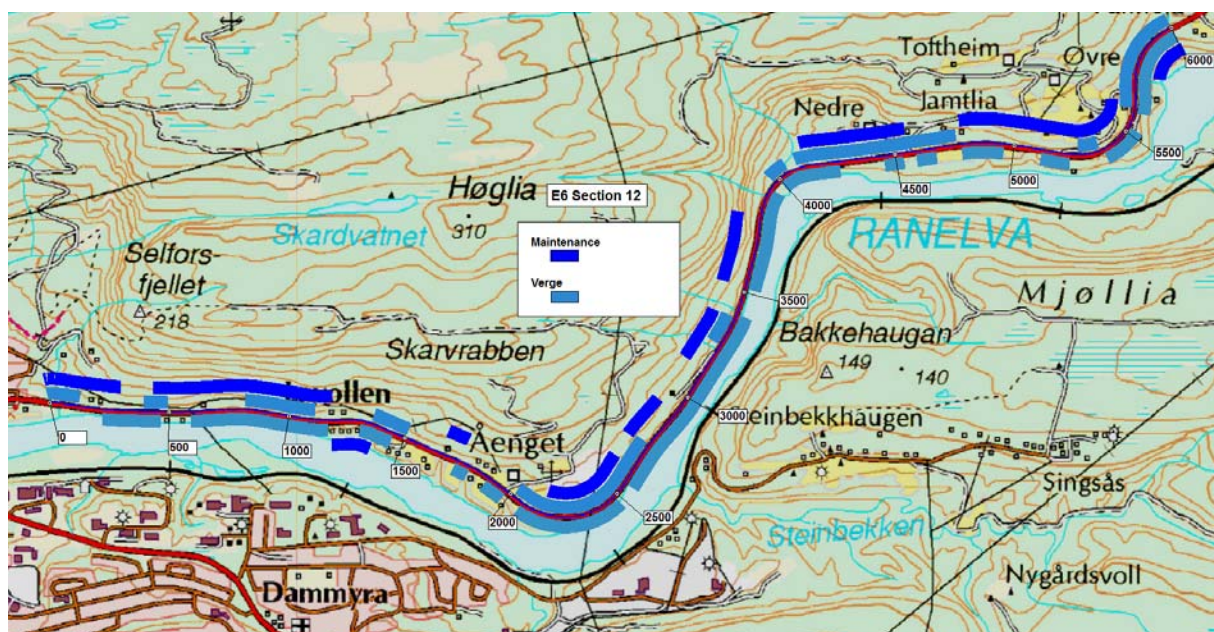
As part of the drainage demonstration project in the Region Nord proposals were made to improve the drainage in section 12 of road E6. The aim was to give an example of how to identify problematic sections. In the GIS map in Figure 87 the darker blue lines represent the sections which need drainage maintenance in the ditches, and the lighter blue lines represent the sections which have problems with the verge.

Figure 87: Road E6 section 12 drainage maintenance map.

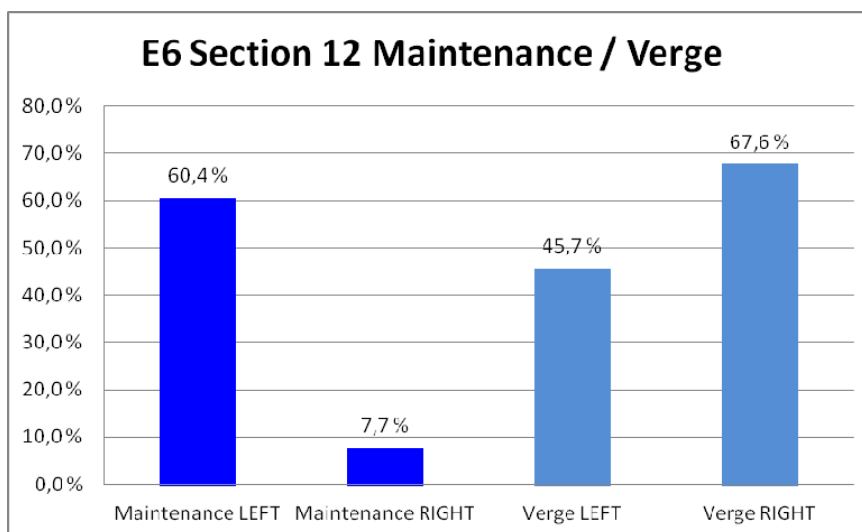
In nearly all of section 12 the road profile was in side sloping ground (94.6%) and mostly the drainage problems were on upper side of the slope. On the left side of the road approximately 60% of the chainage needed maintenance attention, whereas only 8% needed it on the right side.

Figure 88: Percentage of maintenance action and the presence of verge on road E6 section 12.
