VEHICLE AND HUMAN VIBRATION DUE TO ROAD CONDITION

A Report from Studies on Low Volume Roads in the EU Northern Periphery of:

- Demonstrations of Truck Ride Measurements in ROADEX Partner Areas
- Effectiveness on Isolation of Ride Vibration by a Tyre Pressure Control System
- Impact from Road Maintenance Standard on Truck Drivers Working Environment

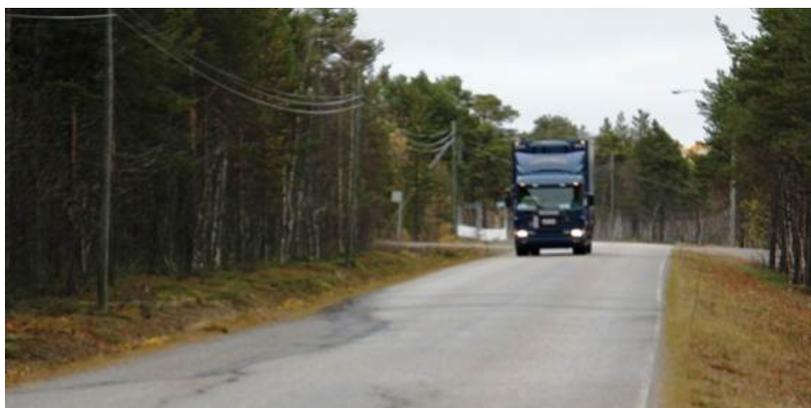
Figure 13 Exterior of test truck approaching the pavement edge damage seen in Figure 14

There are of course also non-manmade root causes to road features that excite high spinal compression stress. One example is pavement edge slump, where the lack of a robust pavement shoulder has led to deformation of the pavement edge as seen in Figure 13. This kind of road damage can result in intensive ride vibration as shown in the 1 minute graph at the bottom of Figure 14.

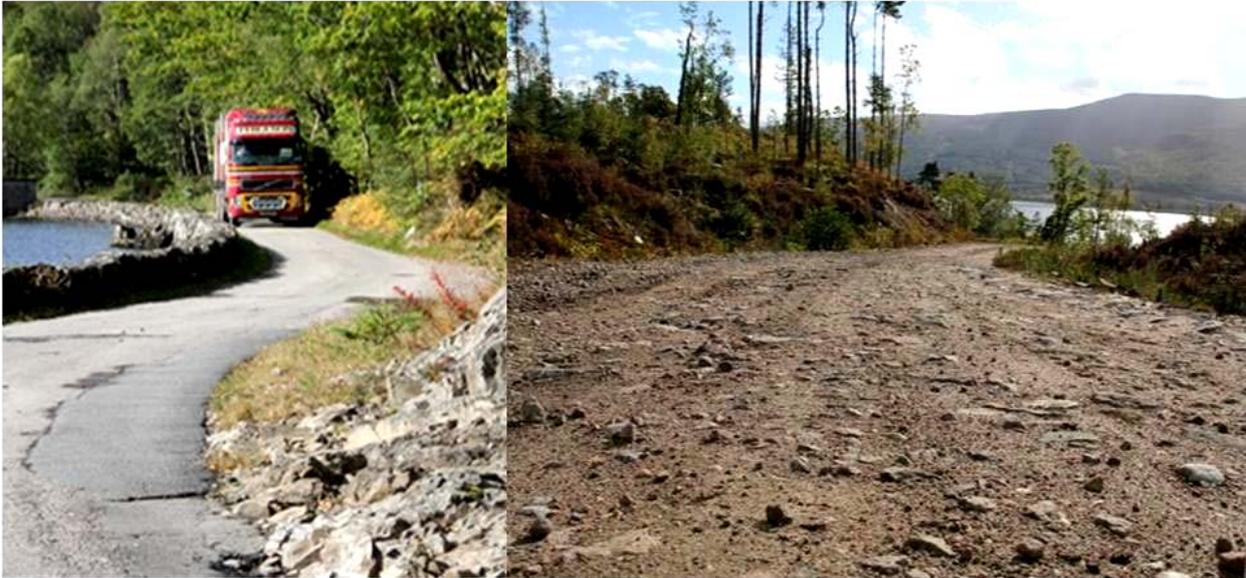
The road to Loch Arkaig was very narrow and the timber storage was on a stony and very rough dirt road, see Figure 30.

Figure 30 Photos from the Loch Arkaig route

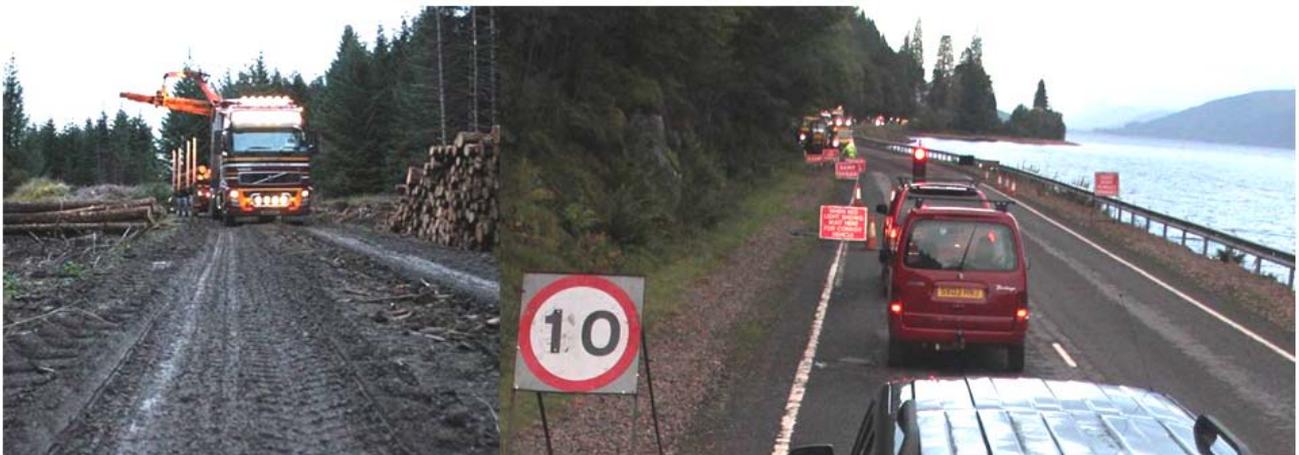
The timber storage area at South Laggan was on a muddy and thus very soft dirt road. There was a road work zone on the A82 public road on the route back to the BSW sawmill in Corpach, see Figure 31. The test truck had to wait in line, as traffic was directed to pass by the zone where asphalt was being milled off. This caused a bias in the measured ride vibration exposure, reducing repeatability between round trips.

Figure 31 Photographs from the South Laggan route

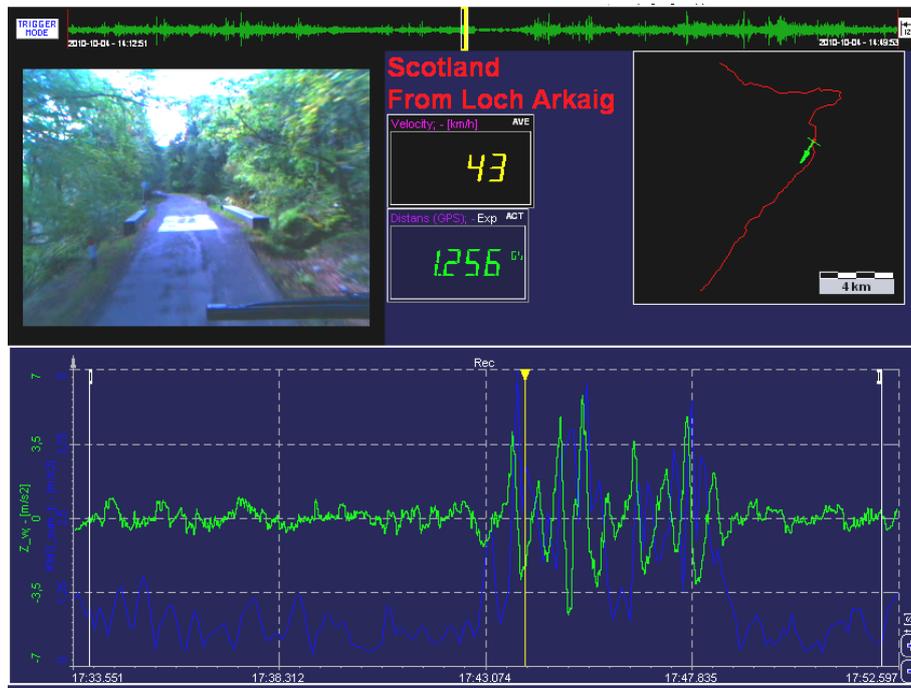
Figure 35 The truck felt severe bumps also when Southbound on B8005

The second example of an “unhealthy” bump is an arch-shaped bridge, also on Road B8005, as shown in Figure 34 and Figure 35. Travelling northbound at 56 km/h, the truck almost went airborne, when it was accelerated vertically with 0.9 G. Take-off occurs at 1 G (10 m/s^2). When the truck went southbound at the lower speed of 43 km/h, the driver incurred a maximum vertical vibration of 5.7 m/s^2 , as seen in the 40 second long graph. Note that the intensive vibration started tens of metres before the bridge itself, when riding southbound. This indicates that the causes of the truck ride problem included settlements in the backfill behind the bridge abutment.

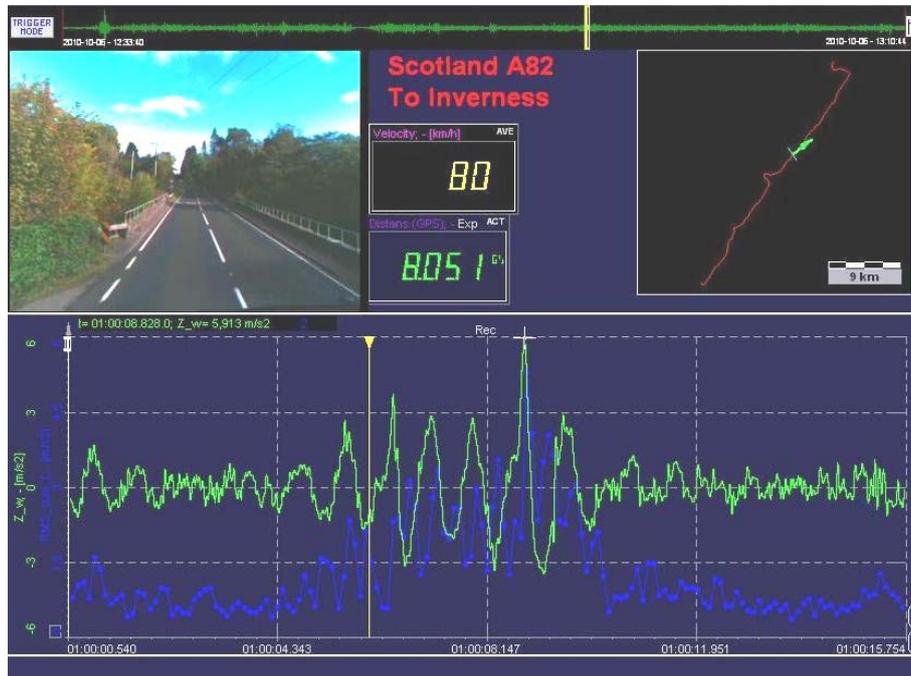
Figure 36 The truck incurred severe bumps on a bridge on the A82 bound for Inverness

The problem with bumpy rides at bridges was present also on national road A82, as seen in Figure 36. The frequency-weighted vertical acceleration of the driver seat peaked at 5.9 m/s^2 ; almost 0.6 G. This can be compared to the 0.7 G (unweighted) vertical acceleration being used in many countries as design target value for traffic calming speed bumps on urban low speed streets.

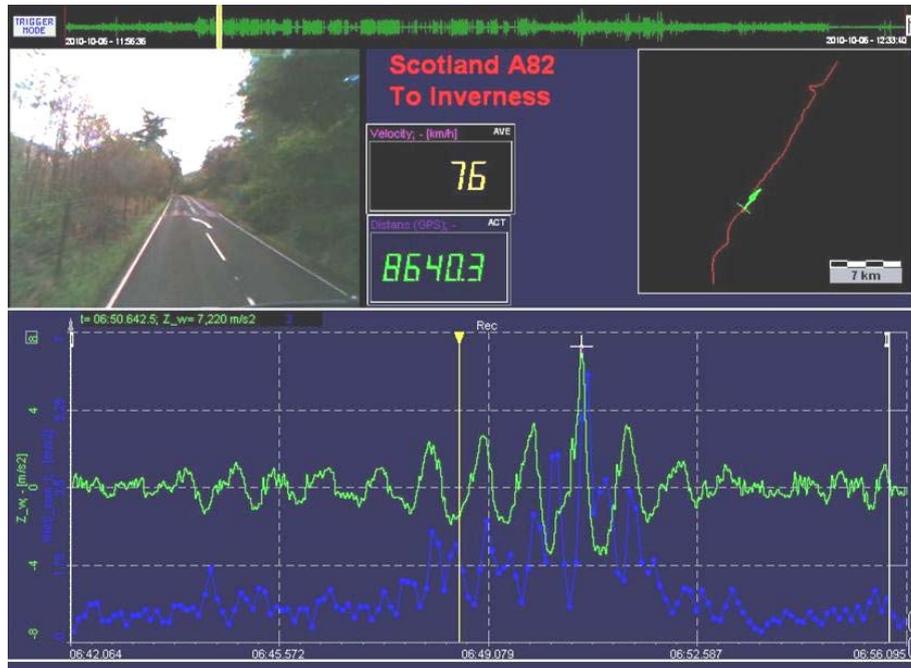
Figure 39 The truck suspension shows resonance at low frequencies / long wave unevenness

As reported in the ROADEX III case study on Road 331 in Sweden, truck suspension systems can magnify bounce, pitch and roll vibration at frequencies in a range between 0.7 and 3 Hz due to resonance. At highway speeds around 80 km/h (50 mph), these frequencies are excited by unevenness with wavelengths in a range of about 7 - 31 m. An example of truck resonance on an uneven section of highway A82 from Ft William to Inverness is shown in Figure 39.

This kind of long wave unevenness is difficult to repair with a traditional asphalt overlay, since the paver tends to “roller-coast” in undulations of more than some 10 m long. Good practice in repair of such unevenness is careful filling of the hollows, and preferably also gentle milling of the ridges, before resurfacing. The procedure should preferably be done after laser-scanning the undulations, computer aided design of the undulation repair, and computer aided control of the milling works. Extensive experience from Sweden shows that the final paving layer should preferably not be laid with computer aid due to the complexity of controlling the paving plants floating screed. The final paved wearing course layer should be laid on the prepared surface with correct slopes, preferably created with a milling machine controlled with computer aid.

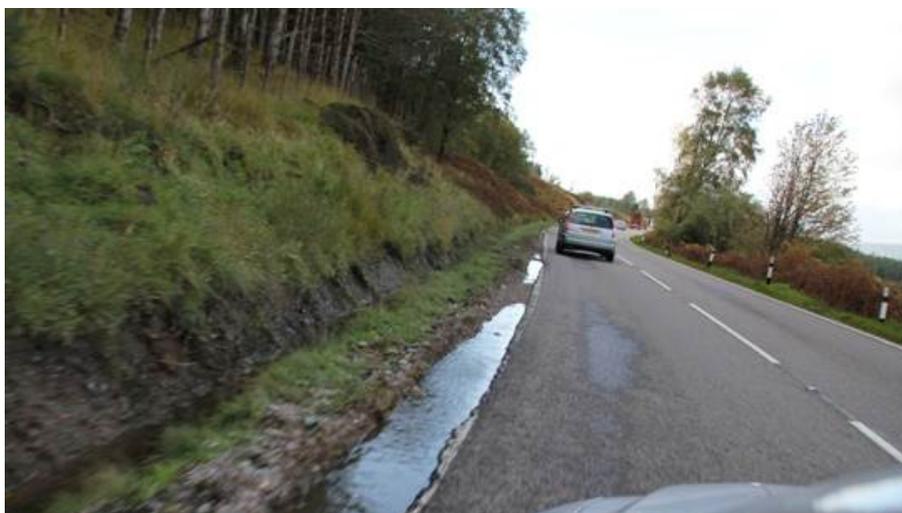
The test truck and trailer were modern vehicles with fairly high capacity and thus large dimensions and weight. These types of wide long vehicles can be incompatible with narrow lanes and sharp curves, as seen in evidence in the form of the deformed grass verge in Figure 42. The lack of horizontal clearance at many sections of the test roads is visible also in Figure 43 and Figure 44.

Figure 42 Water pooling in deformed shoulder at the exit of a sharp inner-curve on narrow A82

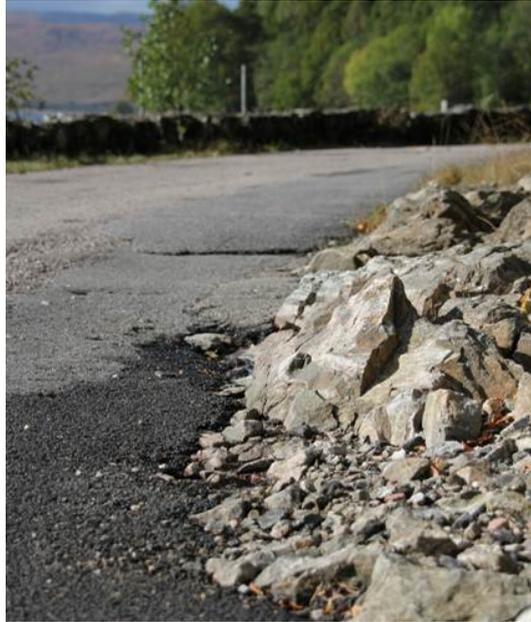
Figure 43 Hazardous rock edges at the pavement edge on Road B8005 at Loch Arkaig

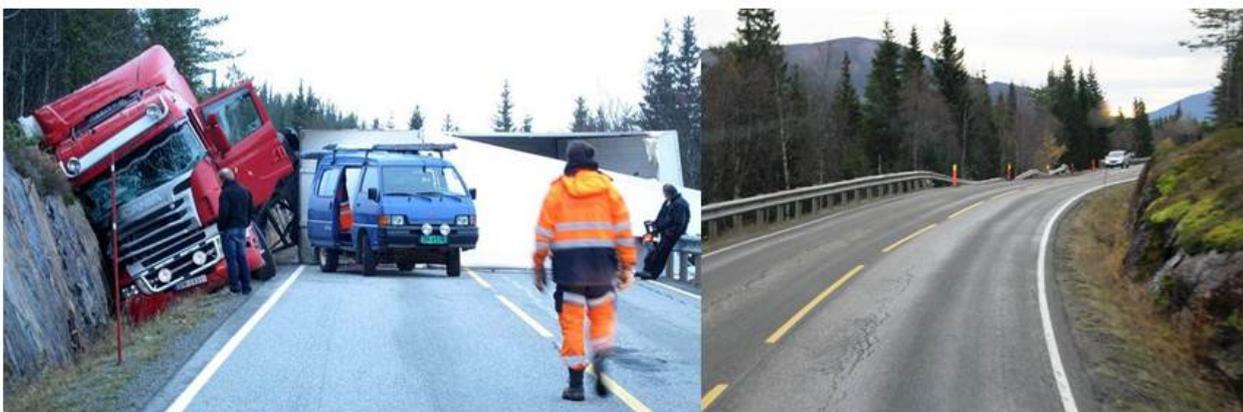
Originally, the ROADEX demonstration project in Norway was scheduled for a trip on the E6 Bodø – Tromsø road, with a fish-truck from Transportsentralen Lillestrøm (TSL) on Saturday 15 October 2011. However, on the cold night between 13 and 14 October, the truck from TSL was destroyed in a rollover-crash near Svartåstjønna, located between Smalåsen/Smeelehaesie and Namsskogan. The crashed truck is shown in the left photograph (by Anne Brekkvassmo) of Figure 45. The crash site is showed in the right photograph, taken by J Granlund while riding the replacement test truck. Fortunately the truck driver survived the crash with minor injuries.

Figure 45 The original test truck crashed between Smalåsen and Namsskogan

The truck crash in October 2011 seen in Figure 45 took place at an S-curve some 600 m north of the island Storholma, at about the same latitude as the small Svartåstjønn Lake. This curve has been the scene of several other crashes in the past. However, the crash in October 2011 is not registered in the database. The truck driver was a Swede working in Norway. He survived the crash with minor injuries, while the truck had severe damages. This S-curve has several risk factors. One of these is the poorly synchronized transition between the inner and outercurves, as seen in the graph in Figure 66. “Fragments” of superelevation from the innercurve continue into the outercurve, with a cross slope of -0.1 % at curvature 1.4 (radius 731 m). At another section of the innercurve, the cross slope is adversely banked into +0.8 % superelevation. With such road geometry, vehicles tend to be “pushed” into the oncoming traffic. To correct this, the cross slope at the entrance of the outercurve, at about RDB-distance 6130 m, should be lowered by reconstruction down to some -3 %. This is illustrated by red arrows in the graph. “Safe combinations” of cross slope and curvature form a rather large zone, briefly illustrated by the blue transparent field marked in the figure. Data in this blue area are proper combinations, as they result in a modest need for side friction between tyre and road. The equation between side friction demand and the factors horizontal curvature, cross slope and speed is derived and discussed thoroughly in the ROADEX III report by Granlund (2008).

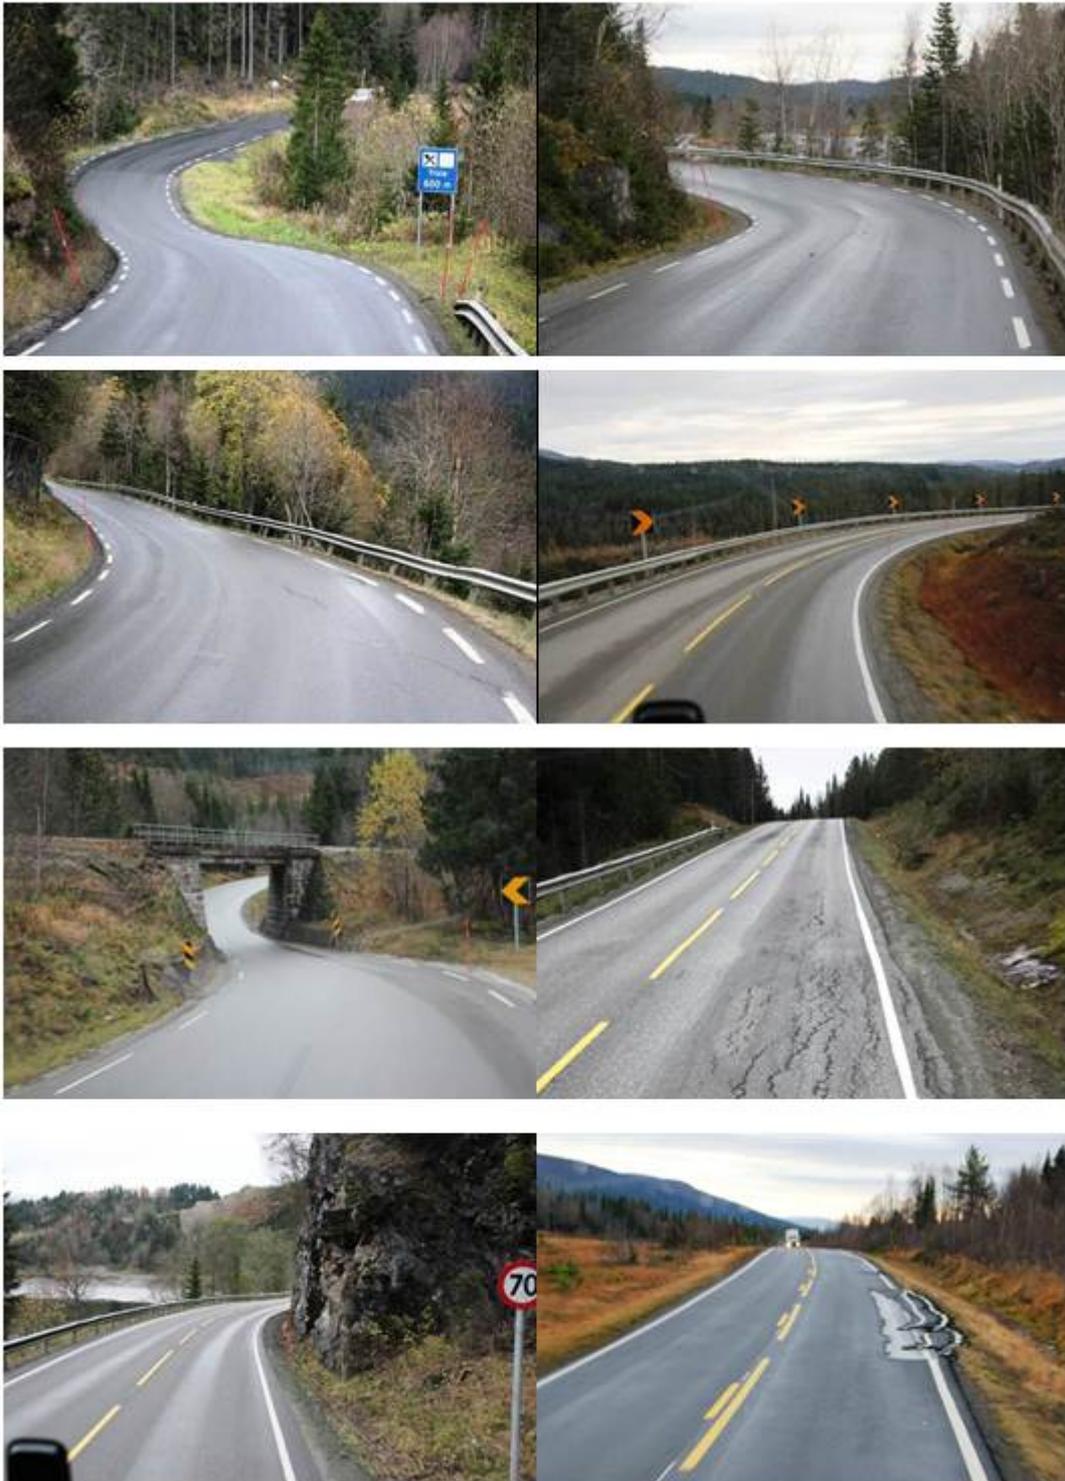
Figure 50 Photographs from E6 Fauske - Trondheim

The E6 in northern Norway can be a very demanding road, as seen in Figure 50. In winter time, many Norwegian professional drivers prefer, if possible, to use the 100 km longer route on the European Highway E45 through Sweden instead.

As seen in the bottom right photograph, a newly resurfaced section was also in a hazardous condition. The wearing course had delaminated from the old surface, obviously when a heavy vehicle had braked hard. It is of no use to have good brakes on heavy trucks if pavement layers aren't glued with enough amount of tack-coat to each other, sufficient to withstand the brake forces.

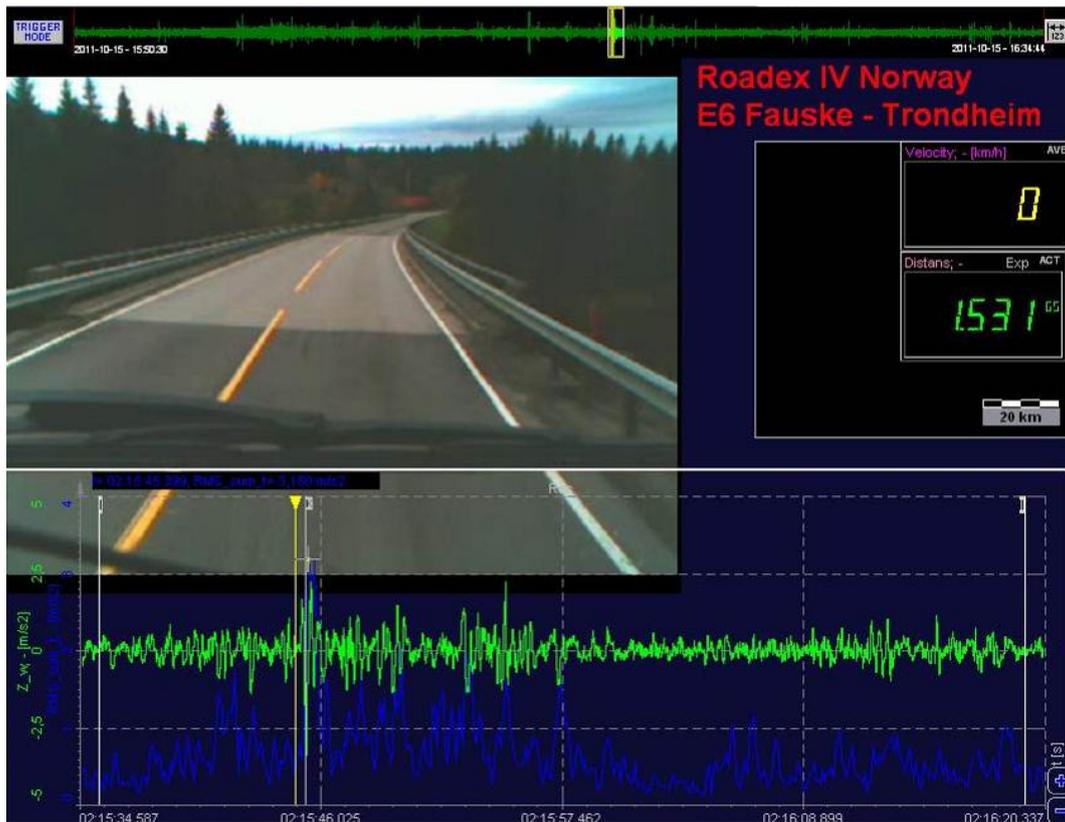
Figure 52 Unhealthy truck ride at a another bridge on E6

Just as in the ROADDEX demonstration projects in Finland, Sweden and Scotland, the test on the E6 in Norway showed that road/bridge joints can be extreme “hot-spots” when it comes to poor truck ride quality. The problem is preventable however, as properly maintained pavements do not give a ride problem. At the problem sites, the cause is typically settlements in backfills behind the bridge abutment, or an improper road profile over the steel beam transversal joint. The latter is often in the form of “steps” between the asphalt and the bridge joint, or the asphalt surface being below the joint beam, instead of properly being some 3 - 8 mm above the joint.

Two typical examples with an unhealthy truck ride over rough road/bridge joints on the E6 are shown in Figure 51 and Figure 52.

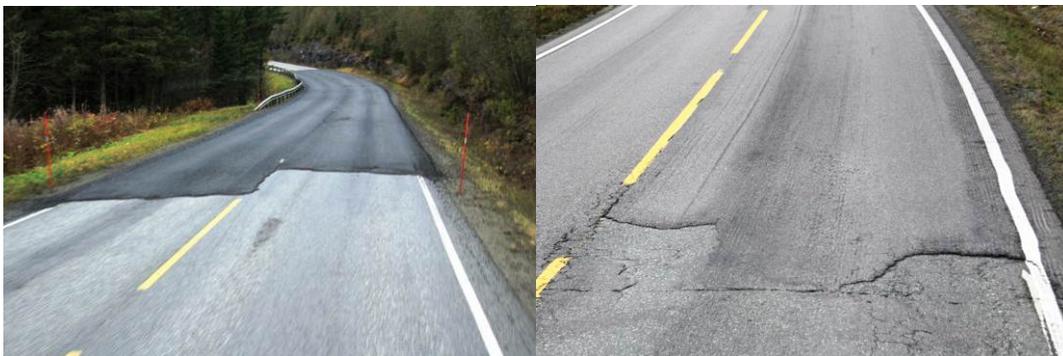
Figure 53 Improper transversal joints at new and old asphalt patch repairs on E6

A frequent bumpy problem, common to Norwegian Nordland/Trøndelag and other ROADEX Partner areas, happens at transversal joints at the starts and ends of overlays and patch repairs. Two examples of bad transversal joints are shown in Figure 53. The left photograph is of a fresh made joint, while the right photograph is of a several years old and well-worn joint. These two rough joints resulted in unhealthy mechanical shock in the truck driver seat, as can be seen in Figure 54 and Figure 55. Another example of a bad new joint is given in Figure 56. While “joint shocks” are typically lower than shocks at “natural” potholes and bumps, the joint shocks are more or less man-made. Thus the joint shocks may be perceived by road users as more “unnecessary” and frustrating, while they are obviously easy to prevent by improving the practice for asphalt repair works on highways.

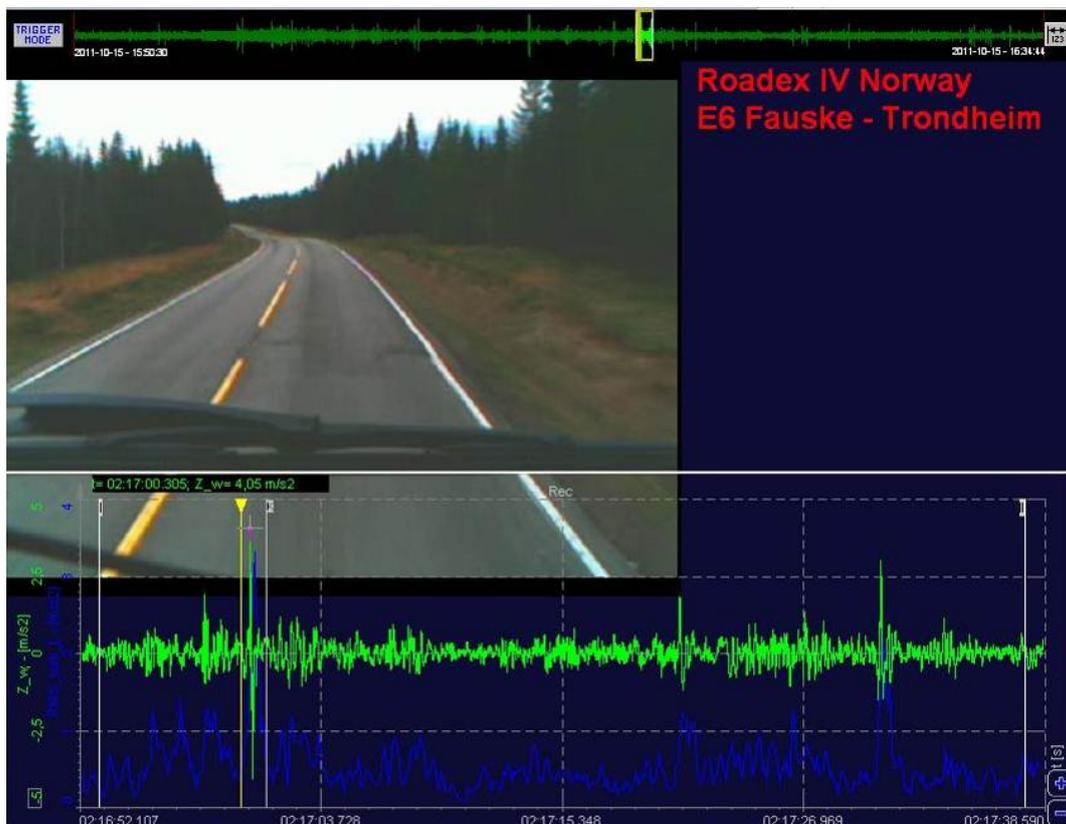
Figure 55 Mechanical shocks in the truck driver's seat at the old bad asphalt-joint

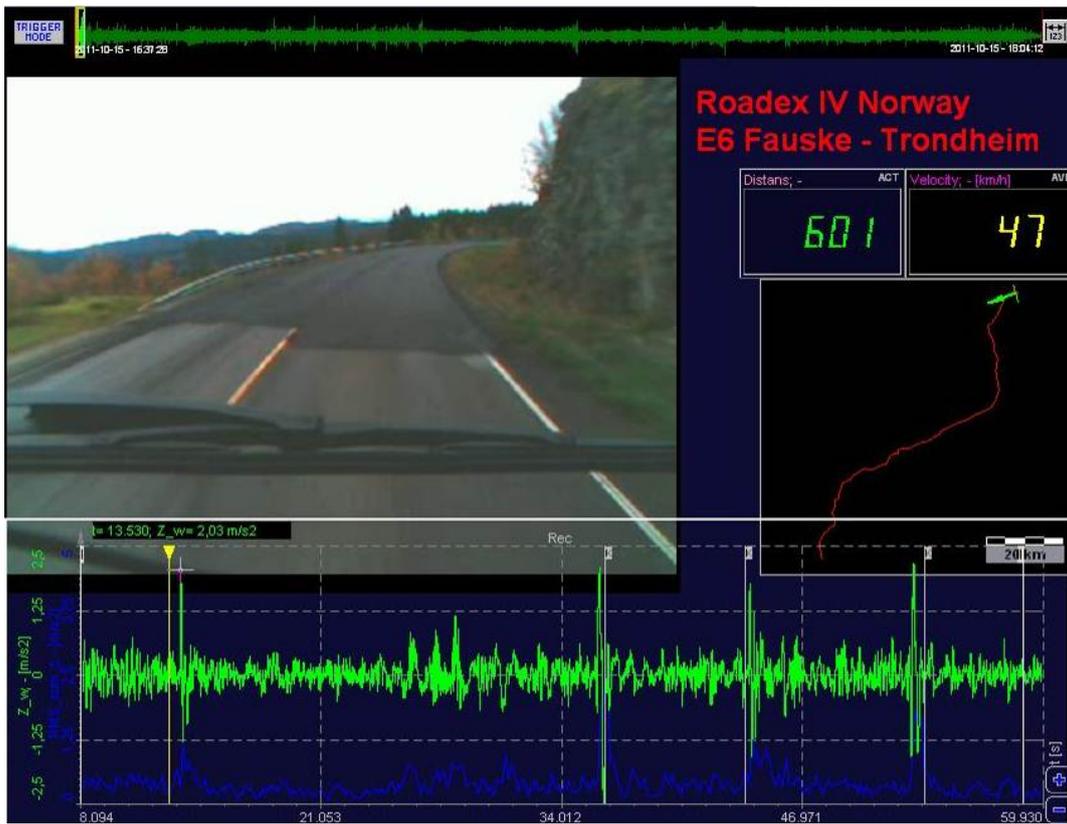
Figure 56 Mechanical shocks in the truck driver's seat at another bad asphalt-joint

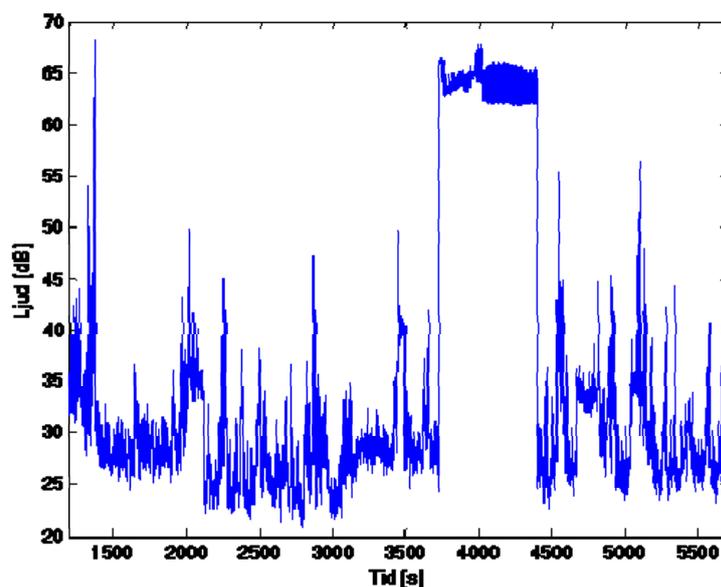
Figure 60 Interior cab noise 65 dB from thermo-cooler disturbed the sleep at time 3700 – 4400 sec

Excessive working time is a major cause of stress, depression and illness, and the purpose of the driving and rest time regulation is to protect professional driver's health and safety. It is assumed that during rest hours, a professional driver will get a good rest of at least 11 hours in any 24 hours. However, during the sleep rest between the long measurements in the demonstrations on the E6 in Norway, the sleep in the truck cab was periodically seriously disturbed by noise from the diesel-powered freight thermo-aggregate (the refrigeration unit at the front of the trailer). The in-cab noise was measured at some 25 – 35 dB, with some transients up to 50 dB from cars stopping and starting at a nearby gas station as seen the noise records in Figure 59 and Figure 60. However, as the thermo-aggregate started up every 1½ hour, the noise rose to a sleep-stopping level of 63 - 67 dB! Conventional thermo-coolers typically operate at 74 – 78 dB outdoor noise, but the rear wall of the truck cab does provide some noise isolation. When wakened several times during the stipulated sleep hours, the driver does not get proper rest and may become a drowsy and hazardous driver. A fairly simple solution would be to install electric power outlets at truck rest areas, to permit thermo-trailers aggregates to be operated on electricity (quiet mode) instead of on diesel fuel (noisy mode) during the sleep hours. Providing infrastructure in format of power outlets is indeed a road safety related service that could be provided by public authorities, rather than organized by truck operators. The cost for the electricity should of course be paid by the hauliers who use the facility, and who in turn will make corresponding savings on reduced diesel fuel consumption by the thermo-cooler during the driver rest hours.

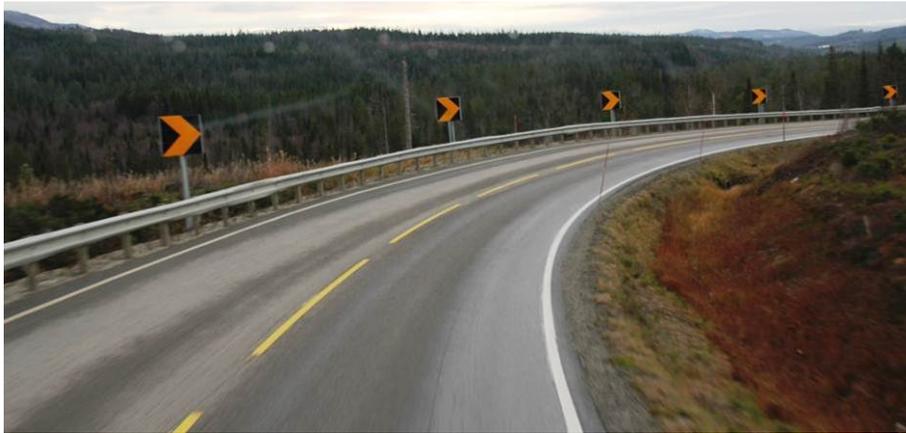
At a short S-curve some 3 km south of Smalåsen, there have been three fatal crashes within 44 m, as well as other fatal, and non-fatal crashes within the full length of the curve. Several of the crashes in this curve involve heavy goods vehicles on long haulage. The curve has recently had the safety upgraded, with new crash barriers and curve warning signs, as seen in Figure 64. However, some parts of the recently resurfaced southbound inner-curve are adversely cambered. At 14/720 km on the Road Data Base, the data from 25th August 2011 shows road geometry where vehicles tend to be “pushed into the oncoming traffic”. Several of the crashes in the curve, including two fatal, were head-on crashes. Road geometry data show that these sections need to be corrected as per the long red arrows in the graph in Figure 65. There are also some sections both in the innercurve and in the adjacent outercurve that need to be lifted up at the road edge in southbound direction. This will strongly reduce the need for side friction, and hereby also reducing the risk for crashes.

Figure 64 The extremely hazardous curve 3 km south of Smalåsen

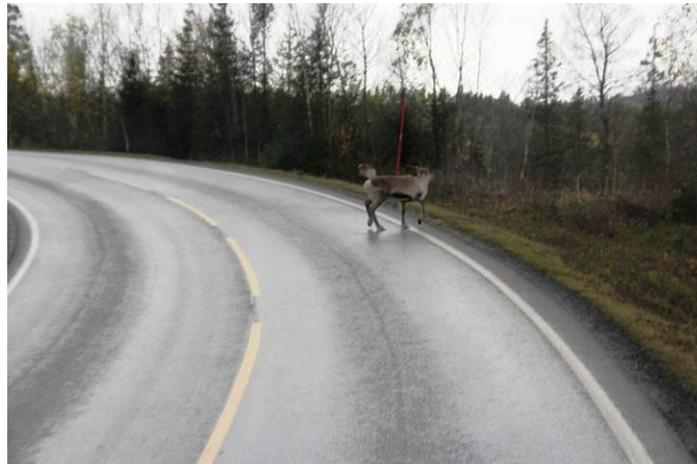
Wild animals, such as the reindeer, as seen in Figure 70, are a common crash risk on the curvy, narrow and often ice-slippery roads in Northern Norway. Roadside fencing may be an effective measure against these types of large wild animals on the roads.

Figure 70 Wild reindeers and other animals bring crash risk

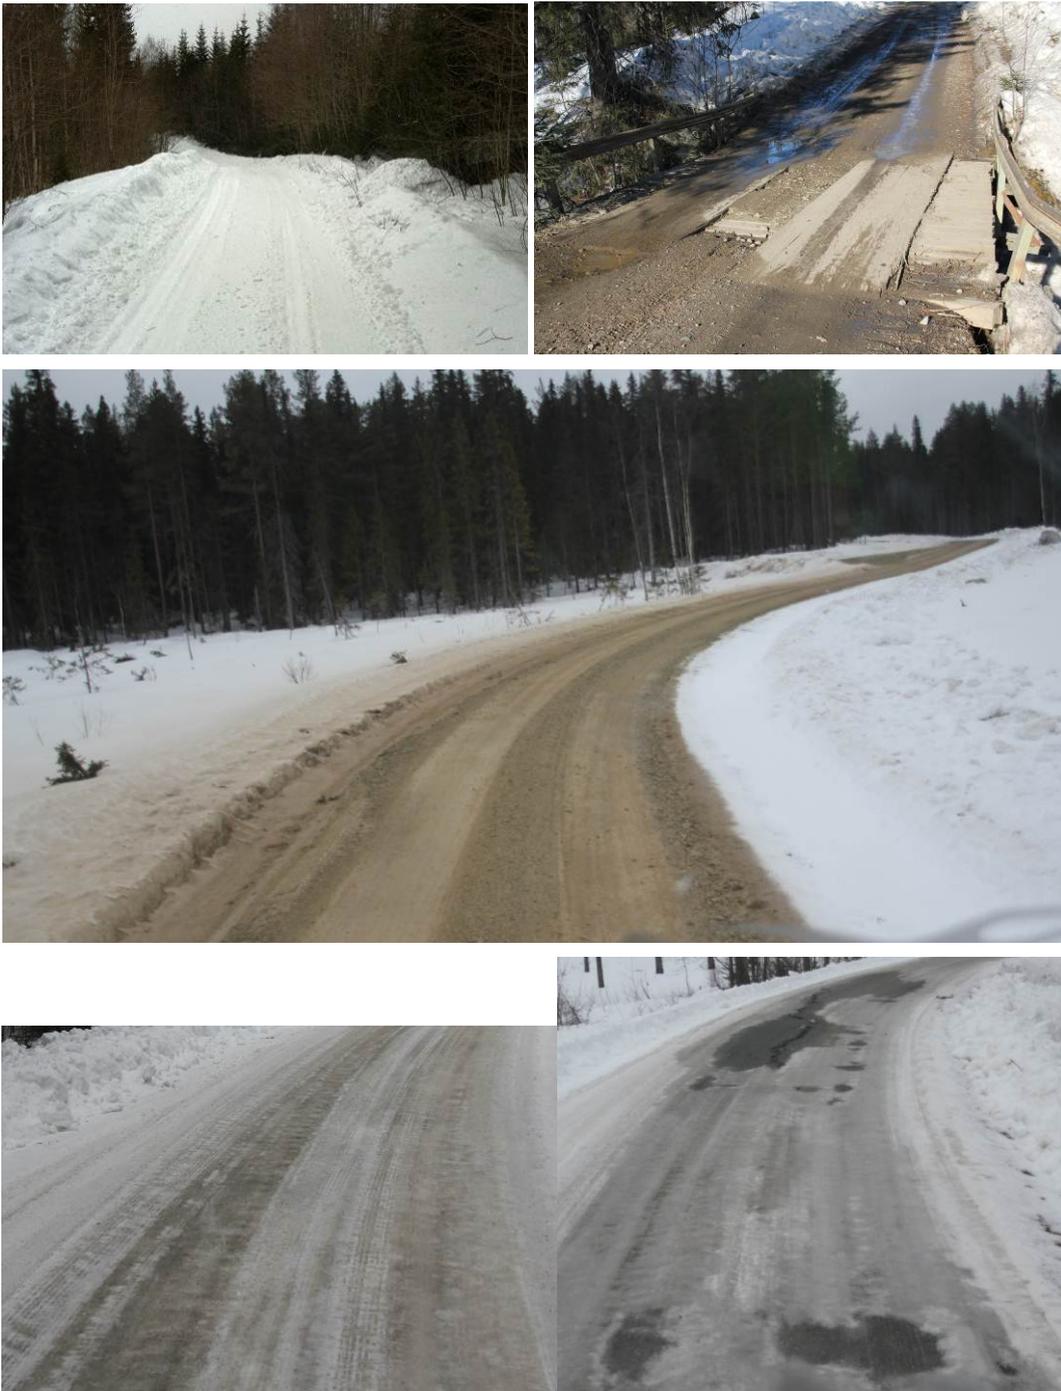
The condition of Swedish forest roads varies greatly. Thick snow, as seen in the upper left photograph in Figure 77, can in winter smear out potholes and other roughness on dirt-roads. Private bridges are often simple and in poor condition. Before the commencement of any larger haulage operations, the forest roads are normally reinforced and graded, as seen on the middle photograph. In fact, private forest roads are often in better condition during timber logging operations than public local roads are. The two bottom photographs in Figure 77 are from public local roads in Edsele. The left photograph shows corrugated thick ice, while the right shows a combination of corrugated thick ice with high steps up/down to the bare asphalt, with its severe deformations and wide frost-related cracks. As the truck tyre hits such a step, a mechanical shock is created and sent up through the truck and into the driver's seat. The corrugations in the thick ice on the poorly maintained public road caused terrible noise in the truck cab as well as to the exterior environment.

Figure 77 Late winter on forest roads and local public roads in the Ramsele / Edsele areas

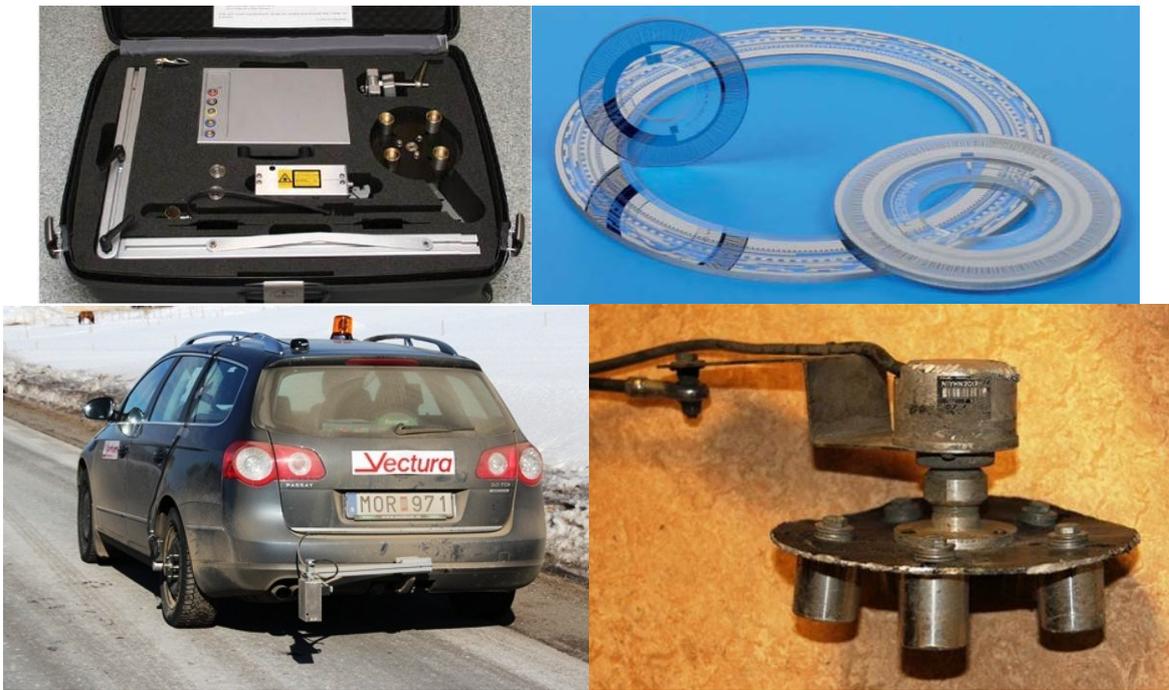
During the 17th March 2011, some 600 km of frost-damaged rough roads had been measured by the time the truck was unloaded in Rundvik. Before the trip back to Ramsele via Road 1035, the mounting of the LaserProf System was inspected without any remarks. From Rundvik the truck and the profiling car drove on the E4 to Överhörnäs and Road 348 to Bredbyn without problem. On Road 1035 from Bredbyn there were several long-wave bumps/hollows with extreme amplitude at sections that had been reconstructed just a few months before. At one of these bumps, the powerful magnets could not keep the odometer in position, and it bounced off the car and was destroyed, see lower right photograph in Figure 84.

Figure 84 The portable LaserProf System and the odometer after being “killed” at a bump

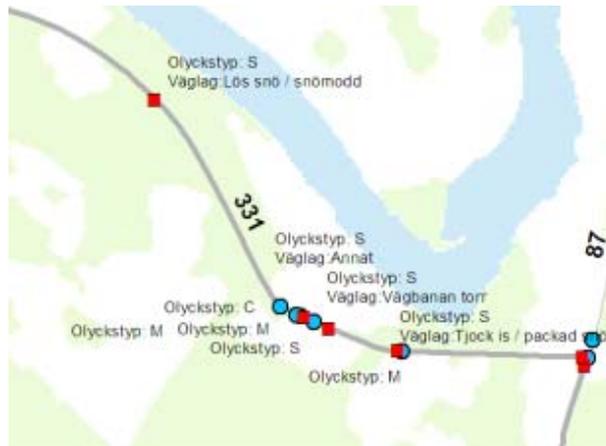
The ROADEX III report by Granlund (2008) included a discussion of the improperly banked Roos curve. As seen in Figure 90, crashes have clustered there, showing that the curve is multiple times more hazardous than the average for the road. This curve was unchanged at the time of the demonstration survey in 2011. A photograph of the swaying test truck of 2011 is shown in Figure 91. As can be seen, the inner wheels almost have a lift-off due to severe weight transfer in the hazardous outercurve.

Figure 90 Crashes have clustered at the improperly banked Roos curve
