ROADEX III
NORTHERN PERIPHERY

Health Issues Raised by Poorly Maintained Road Networks

March 2008

Johan Granlund
Swedish Road Administration Consulting Services

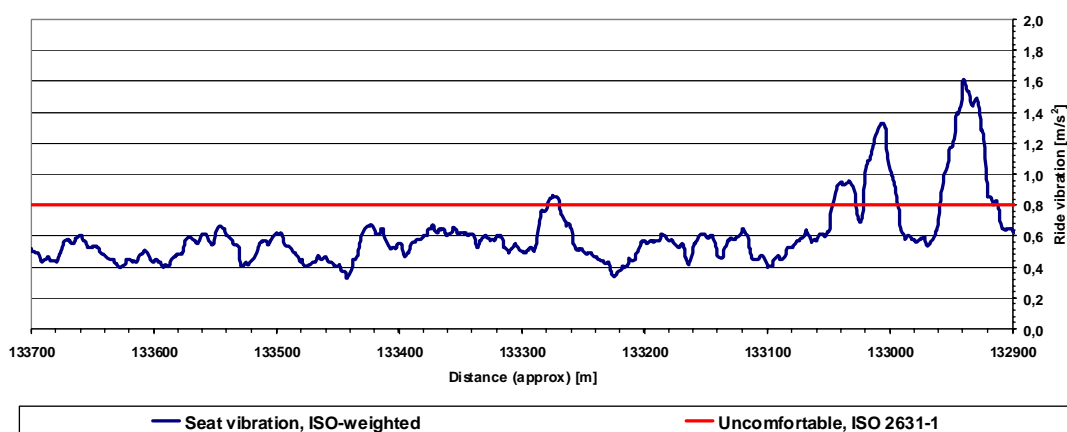
When driving at normal highway speed over this new culvert, the driver was exposed to “very uncomfortable” transient vibration, as seen in Figure 42.

Figure 42 Very uncomfortable truck seat vibration when driving over the new culvert in Gammelmo

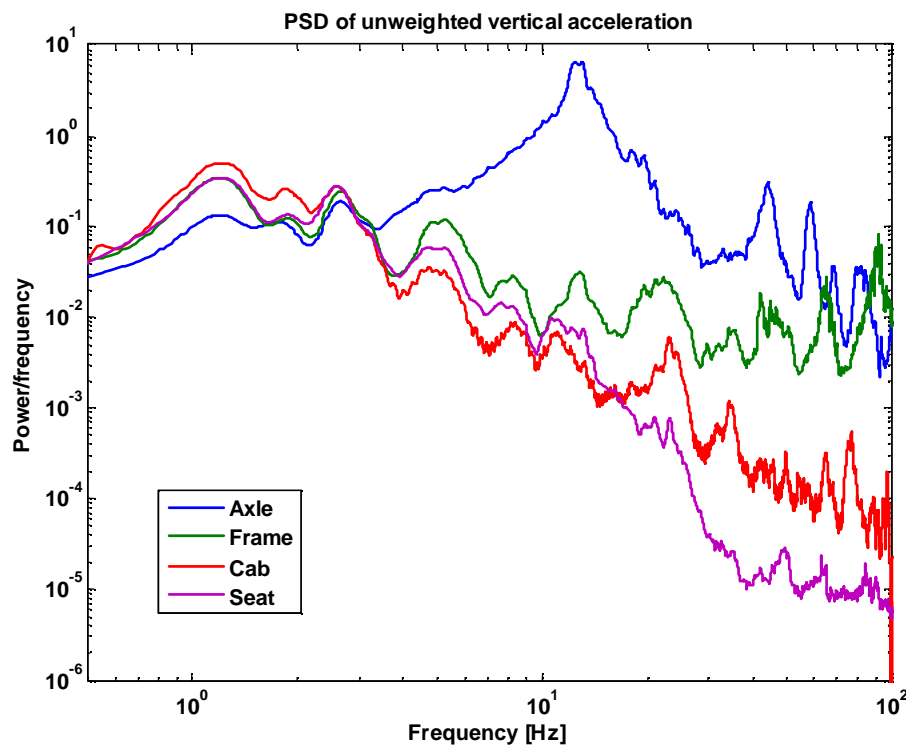
Figure 48 Power Spectral Density of vertical acceleration in the trucks suspension systems

The blue trace at the top of Figure 48 shows the vibration recorded at the wheel axle. There is a wide vibration maximum at about 11 Hz, and high clear resonance peaks at about 45 Hz, 60 Hz and wide maximums below 2.7 Hz. The lack of a clear peak at the 11 Hz maximum may be due to superposition of several peaks. One such peak is the wheel axle parallel hop resonance; another is the wheel axle tramp (roll) resonance. The 45 Hz peak may be related to the tyre's 1st eccentric modal resonance. As the wheel is close to the vibration source (the road), Formula 1 can be accurately used to relate the 11 Hz frequency with maximum intensity to road roughness with wavelengths of 2 m. The other peaks relate to 0.37 m, 0.5 m and 8 m. The intensity at the 45 Hz vibration peak is equal, or below, the intensities from 6.5 to 20 Hz. This bandwidth corresponds to a road roughness ranging from 1.1 to 3.3 m. This waveband, 1.1 to 3.3 m, is obviously perceived by the truck wheel axle as the worst roughness in the road section.

The red trace, third from the top in Figure 48, shows the vibration in the truck cab¹⁵. Just as in the frame, the maximum is at 1.2 Hz, and is related to road profile waves with some 18 m length. At frequencies above 4 Hz, the cab vibration is much lower than the frame vibration. Below some 2.7 Hz, the cab suspension system amplifies the frame vibration. Similar to the frame, the truck cab perceived the waveband from 7 to 31 m as the worst unevenness in the road section.

The vibration intensity of a truck wheel axle can be very high, from 0.7 to 3 Hz in Figure 48. At 78 km/h, these frequencies correspond to road roughness with waves ranging from 7 to 31 m. The peak vibration in the frame, cab and seat occurs at 1.2 Hz, which corresponds to road profile waves of approximately 18 m lengths.

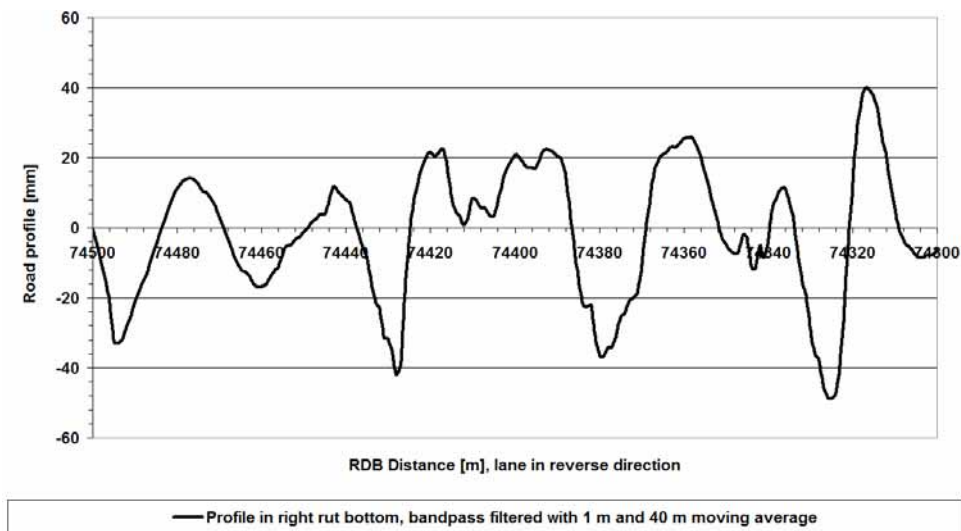
These truck responses show a ride problem that is related to long wave unevenness in the road. This finding is confirmed when analyzing the same road profiles scanned by the laser/inertial Profilograph. A typical road profile example from the 17 km section is given in Figure 50. It records up to 60 mm deep hollows in wavelengths of over 30 metres.

Figure 50 *Rd 331 Viksmon - Viksjö: Unevenness with high amplitudes at up to over 30 m long waves*

The SRA Central Region plans to carry out a traditional asphalt overlay for this road section in 2008. However, its steep 7 - 31 m waves are obviously too long to be efficiently repaired by a simple asphalt overlay. These waves are so long that the paving equipment will simply ride along them, only raising the unevenness by the thickness of the new asphalt mat. To produce a good solution, the road machines must be effectively controlled and forced to make the necessary changes to the unevenness, as the present defects are much longer than the machines themselves. It can be claimed that these waves can be repaired by subjective spot fillings before paving the mat. However, this ad-hoc method is unable to make the alterations necessary without using an excessive amount of costly asphalt. A proper and cost-effective repair of this road requires an accurate measurement of the road 3D-geometry, and a careful (computer aided) rehabilitation design at each 5 m section. The benefits in terms of the reduced low frequency ride vibration of this type of road repair method are presented in detail by Granlund & Lindström (2004) [13]. Another alternative is a more costly "total pavement reconstruction". Unless one of these two methods is used, much of the low frequency vibration is likely to remain for heavy vehicles after the road repair has been carried out.

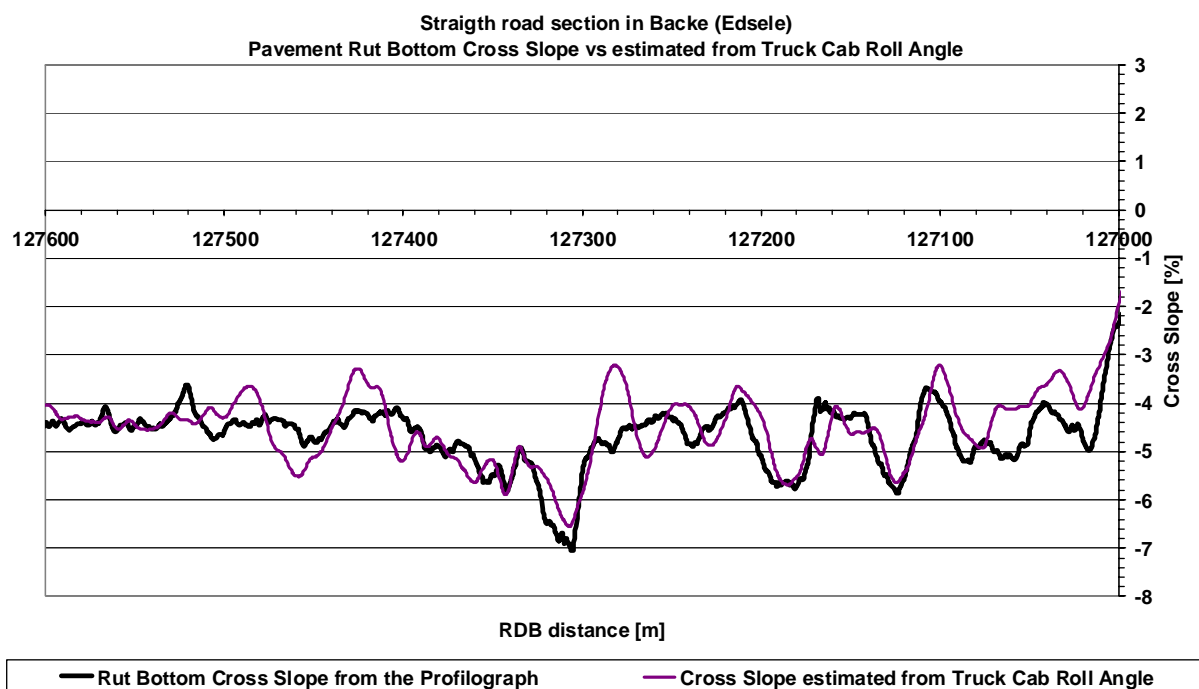
Figure 52 *Good fit between pavement Cross Slope and Truck Cab Roll Angle*

The cross slope (CS) magnitude is remarkable at the Hazardous Site at Backe (Edsele). The section has values ranging between -4 % and -7 %, see Figure 52, despite the design value for straight roads being -2.5 %. The maximum value allowed for CS when designing extremely sharp curves in Sweden is +/-5.5 %. Obviously this straight section has too much CS. Excessive CS contributes to a poor work environment for professional drivers as they have to sit in an awkward side sloping position to counteract the adverse CS, causing the spine to be twisted, while also being exposed to high ride vibration.

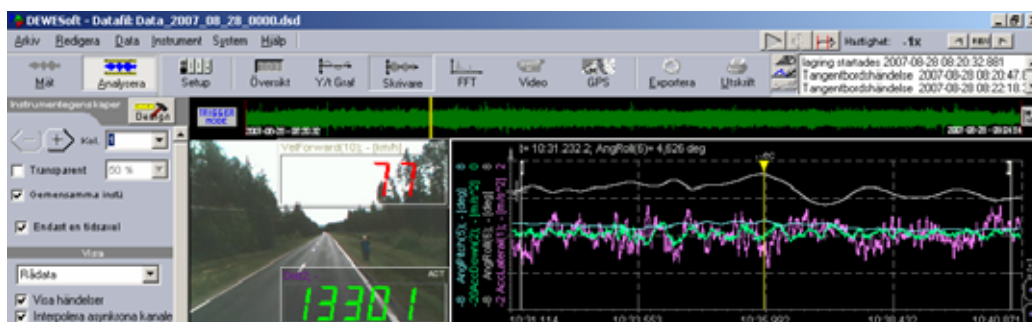
A cut screen-print from the onboard Dewetron system is given in Figure 54. The recordings were captured synchronized with photographs taken from the roadside as in Figure 53 above. The forward facing video in Figure 54 actually shows the exterior photographer standing beside the road. The white undulating top trace shows the variance of the truck cab roll angle, recorded by the OxTS RT 3050 unit. The peak rate of the change in roll angle at the Hazardous Site at Backe (Edsele) was over 3 °/s. In the case of the test vehicle, a roll angle of 1 ° corresponds to a 35 mm vertical displacement between the left and right tyres.

Figure 54 *HS Backe (Edsele): ROW video and some of the recorded truck ride data*

Section 127/325 km was rated as “*very uncomfortable*” and “*hazardous*” by the truck drivers. The vector of roll and pitch rates peaked at 4.48 %/s. This touches the threshold used in New Zealand, as presented in section “3.3.2.2 *Roll vibration is excited by undesired variance of Rut Bottom Cross Slope*”. The section’s RBCSV peaked at 0.47 %.

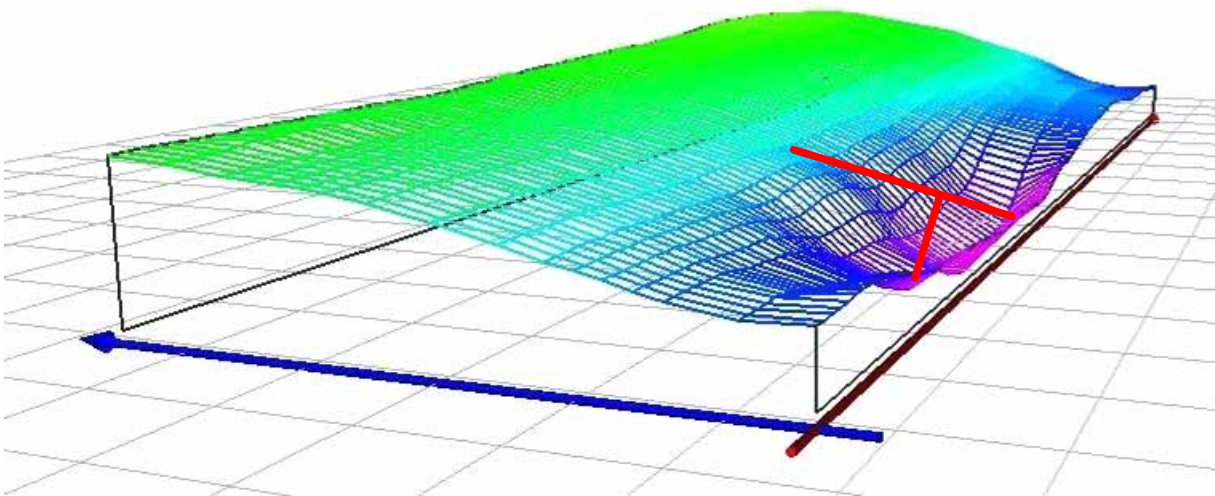
The HS Åkerö pavement edge damage is seen on photo in Figure 55. Take note of the exploded truck tyre to the right! Traditional optical photographs do not reflect unevenness very well. A better way of visualizing unevenness is to use a 3D laser scan. This highlights all of the unevenness features. A Profilograph scan of the HS Åkerö damage can be seen in Figure 56. The deformation at this site was found to be 69 mm deep.

Figure 56 *Profilograph 3D plot of the HS Åkerö 69 mm deep edge deformation*

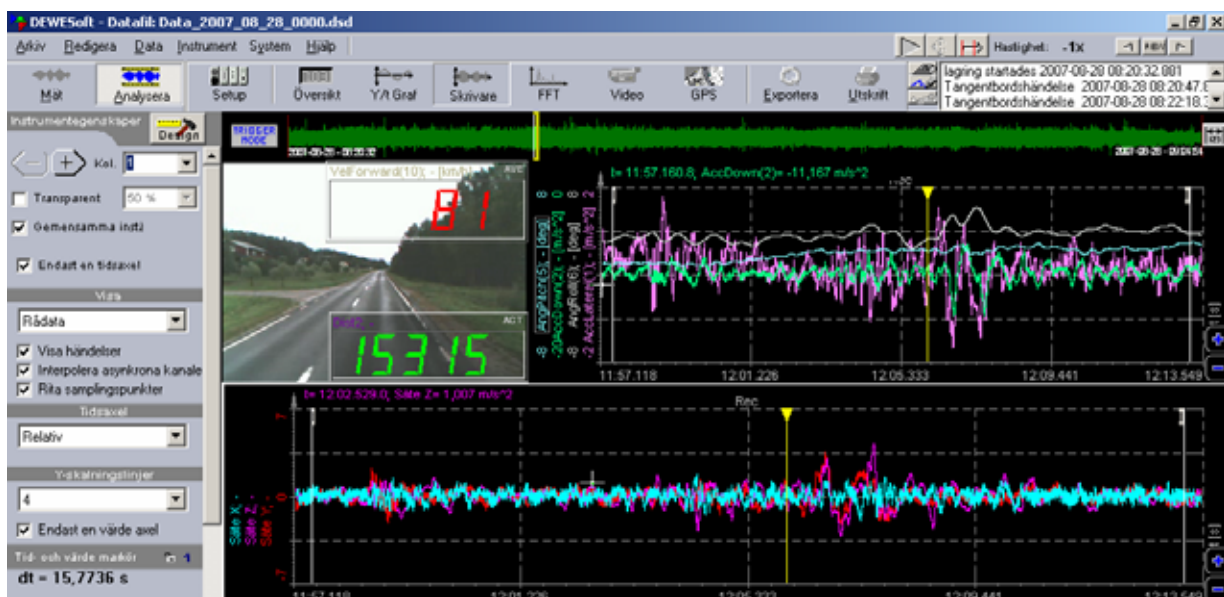
Figure 57 *HS Åkerö: ROW video and some of the recorded truck ride data*

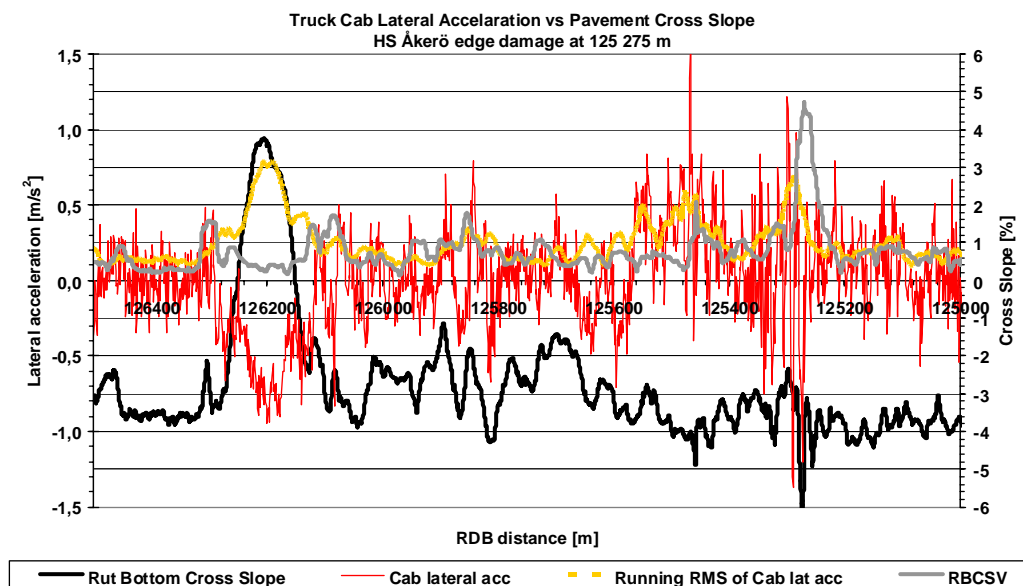
Lateral acceleration is commonly recognized as a key parameter for vehicle driving stability, and thus for traffic safety. This is especially relevant on slippery surfaces, where the lateral friction forces are small. When a vehicle changes its roll angle quickly, the roll motion is accompanied by a lateral acceleration. An example from HS Åkerö is given in Figure 67. This shows a left hand curve (curvature -1.6) at distance 126/200 km, reflected by the change of sign in cross slope as it becomes superelevation through the curve. The graph for “Running Root-Mean-Square of Truck Cab Lateral Acceleration” shows a semi-static level of 0.78 m/s^2 through the curve. This can be compared to the value of 0.66 m/s^2 for lateral RMS acceleration recorded on the section of straight road with severe edge damage at HS Åkerö, section 125/275 km. In this latter section, the peak lateral acceleration was -1.37 m/s^2 , whilst the peak lateral acceleration in the curve at 126/200 km was only -0.94 m/s^2 .

The HS Åkerö example clearly shows that severely deformed pavement edges are a serious safety hazard, as they may result in lateral acceleration forces comparable to the lateral forces experienced when travelling a horizontal curve.

The grey trace in Figure 67 shows that the pavement RBCSV parameter was registering approximately 0.1 % through the curve, where the cab lateral acceleration was fairly constant with low vibration. However as intended, the parameter quickly gives a clear alarm of 1.18 % (being over 6 times larger than the 0.1 to 0.2 % noise level) when it enters the HS Åkerö section of pavement edge damage. This example also shows that the RBCSV parameter does not give “false alarm” due to normal superelevation transitions at left hand curves, where the truck cab roll angle smoothly tilts from side to side.

Figure 67 Edge damages may excite as much lateral acceleration as a horizontal curve do

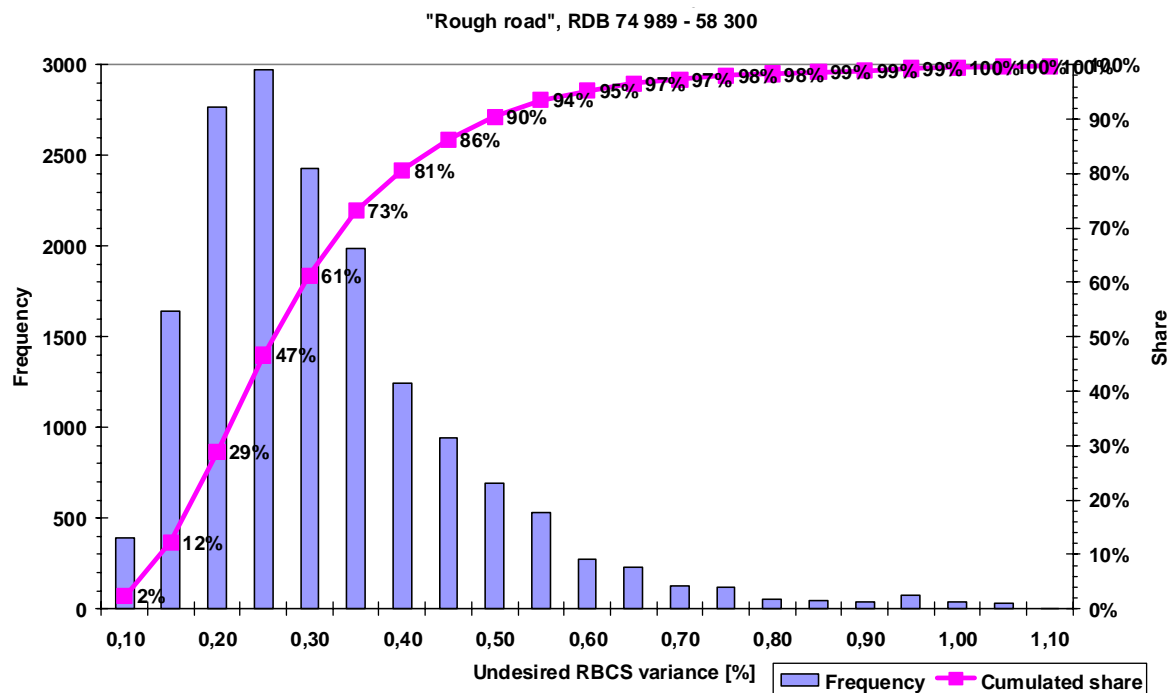
The 17 km from the junction with Hw 87 in Viksmon, and down southeast to Östergräninge, is a rough section with severe pavement edge deformations, resulting in intense lateral vibration in the truck cab. An unusually large number of traffic accidents have taken place on this section, including the HS Björknäset, as seen on the black spot map in Figure 28. The distribution of Rut Bottom Cross Slope Variance (RBCSV) values on this section is shown in Figure 69.

Figure 69 RBCSV distribution at the rough road section S Viksmon – Östergraninge

On the rough road, 0.30 % RBCSV is exceeded on 39/100 of the length, as seen in Figure 69. Again, 0.30 % RBCSV is exceeded on 3/100 of the length of the old road Östergraninge - Viksjö, which include some Hazardous Sites. This shows that 0.30 % RBCSV can be a good draft limit value.

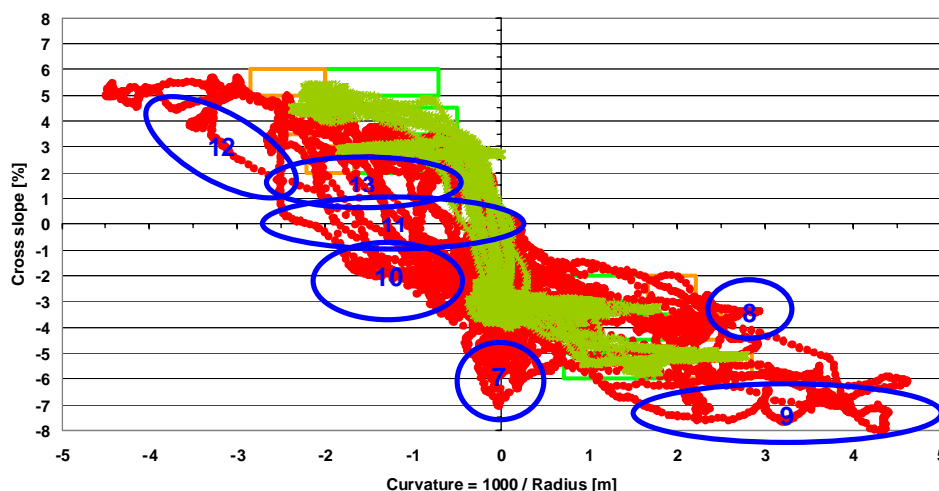
Figure 73 Comparison of data from *old Rd 331* and *new Hw 90*

Data from 12.3 kilometres of the old Beaver Road 331 (Ramsele - Edsele) are compared with data from new Hw 90 in Figure 73. In this plot, several uncomfortable and hazardous families of road alignment data can be identified. Note that the Curvature axis has been widened, to make it possible to plot data from the sharp curves on Rd 331.

Straight sections with excessive Cross Slope (CS) are marked “7” in Figure 73. These sections include CS greater than the permissible banked sharp curve allowed in Sweden. These cause an uncomfortable ride. They are also a health risk, since they force the driver's spine into an awkward twisted position making it much more susceptible to Whole-Body Vibration. These sections are also hazardous when overtaking another vehicle, as the large difference in CS between the two lanes causes large lateral vibrations if the overtaking is done with a quick lateral manoeuvre. On the section Nordankäl - Backe, a straight section had CS down to - 8.5 % (not shown here).

Wide right hand curves with too little negative CS are marked “8” in Figure 73. These curves contribute to skid accidents as they do not generate sufficient lateral support to reach a dynamic balance when cornering in slippery conditions.

Left hand curves where the banking is tilted to the wrong side are marked “10”. These are of course extremely hazardous, as it is difficult to avoid skidding in slippery conditions. For heavy vehicles, the risk for rollover accidents is obvious.

Sections with close to 0 (zero) % CS are marked “11”. With few exceptions, these are entrances or exits of left hand curves. Unless these sections happen to be in a longitudinal grade, they will also have a Drainage Gradient close to zero. This will cause water to pond, and the road will often develop local (surprising) ice spots in cold weather. These bring unacceptably high skid risk, so these sections should be checked for Drainage Gradient. This type of analysis is done in the next section of this report.

Left hand curves with too little CS are marked “12”. These curves contribute to skid accidents, as they do not generate enough lateral support to reach a dynamic balance when cornering in slippery conditions. It is noticeable that almost none of the left hand curves have excessive positive CS.

The family marked “13” can be described as “poorly synchronized CS transitions”. This family includes sections where CS transitions take place at a curve radius sharper than - 3200 m (Curvature -0.3). In practice, these are sections where the curve has started, but the superelevation is applied later in the curve. Or even worse; in curves where positive superelevation suddenly becomes negative CS before the curve is finished. This kind of road feature can come as a dangerous surprise to road users, unfamiliar with local hazards. The data families “10” to “12” may also include poorly synchronized transitions.

Figure 73 also includes families of unacceptably sharp left and right curves on Rd 331. When these curves are evaluated against the acceptable risk level stated by the SRA Road Design Manual [15], many are even too sharp at the lower reference speeds of 70 and 50 km/h. As per the Tylösand declaration (see section “7.2 The Tylösand Declaration”), SRA must as soon as possible make sure that all of these curves gets warning signs, and should start planning for straighten them out.

It is interesting to see that Figure 73 is non-symmetric. It shows that hazards are more common in left hand curves, than in right hand curves.

A method to quantify the problems with incorrect banking at the road network level could be developed. Such a method could be drafted from an analysis of plots such as Figure 73.

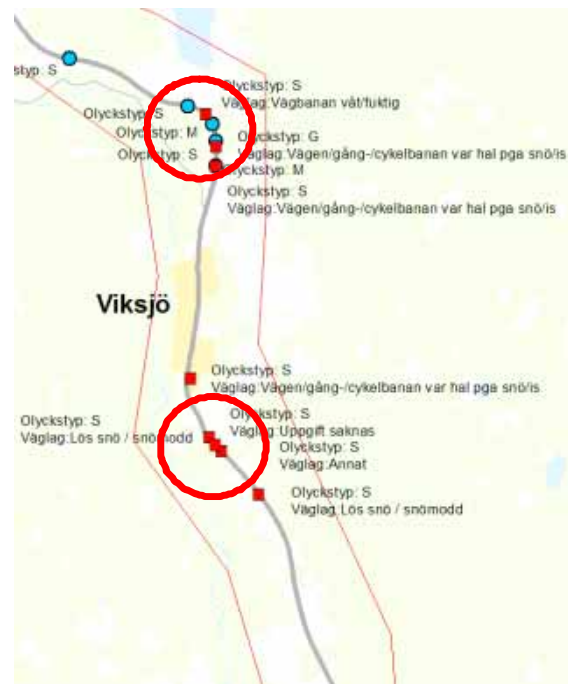
Figure 75 Hospital record plot from HS N Viksjö and HS S Viksjö [Hans Johansson, SRA]

There are two Hazardous Sites (HS) at Viksjö; one just north of the village and the other just south of Viksjö, as seen in the hospital record plot in Figure 75.

The HS south of Viksjö shows three fatal heavy truck accidents at exactly the same location. In the flat village of Viksjö the speed limit is 50 km/h. At the south exit, the limit is raised to 70 km/h. The road makes a short and sharp left hand curve, as it begins a long and steep downhill grade. Then it makes a wide right hand curve, followed by a short but very sharp left hand curve. This third curve also ends the grade, and the road goes over a bridge at the bottom of the valley. In the grade, truck drivers have lost control of their vehicles. At the exit of the third curve, each of the trucks have missed the bridge and made a large hole in the - obviously undersized - crash barrier. All of these lethal rides ended with a 20 m long and 12 m deep jump into the rift.

The northern HS at Viksjö shows an unusually high number of accidents leading to hospital care, as seen in Figure 75. The curve is sharp and induces high lateral cornering forces; the curvature reaches -5.12 (radius tighter than 200 m). Despite this fact, the maximum allowed superelevation of 5.5 % has not been utilized, as the curve only has about 4 % in the northbound direction. Furthermore, it has a warping Rut Bottom Cross Slope Variance of 0.54 %, which is significantly above the above proposed "warping limit" of 0.30 % RBCSV. In addition to these features, at the southern entrance of the curve, the Drainage Gradient is below the 0.5 % minimum limit value on a long section as shown in Figure 80.

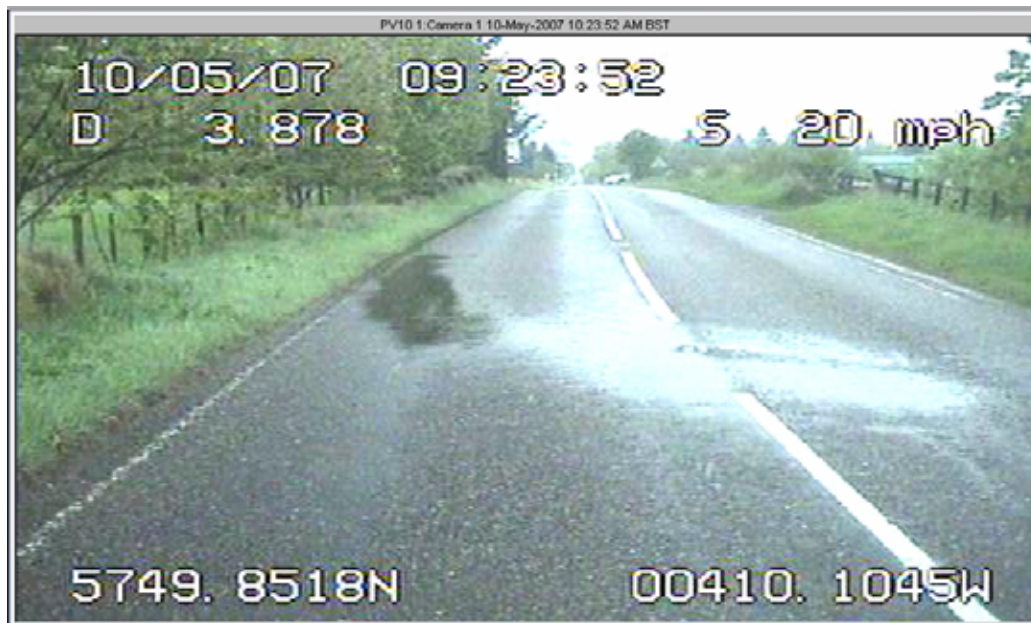
Figure 78 *Water ponding at a CS transition section [Photo from the UK road network survey]*

Where the “Drainage Gradient” of a non-permeable road surface is lower than 0.5 %, water will not run off and water pools can be formed in wet weather. Water ponding, such as seen in Figure 78, increase the skid accident risk.

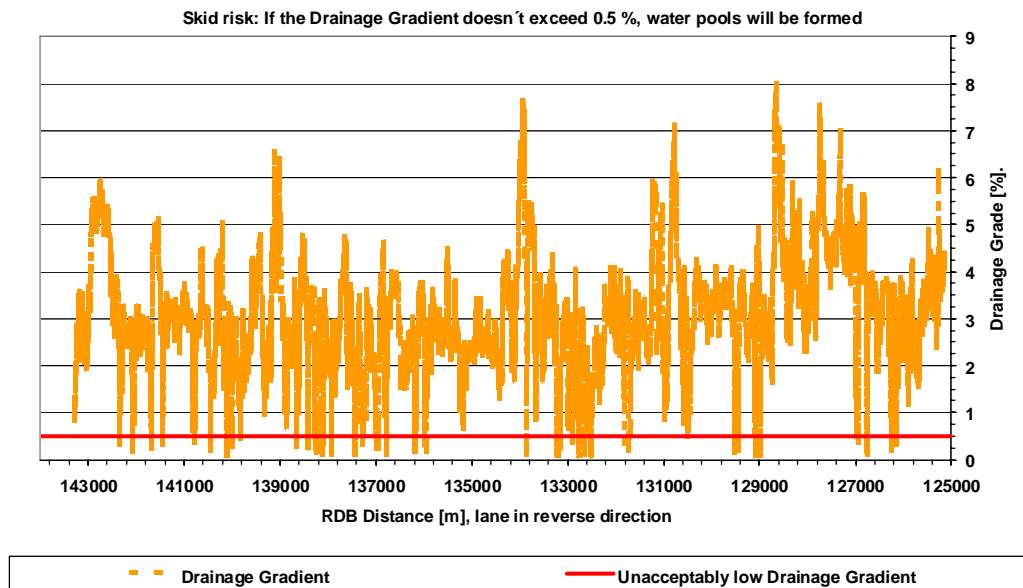
Figure 85 Many sections between Ramsele and Åkerö show unacceptably low Drainage Gradient

South of Ramsele, there is a 18.5 km long road section that, despite low traffic volume, shows an increased accident number, as seen in Figure 28. This section has a lot of skid risk areas with insufficient Drainage Gradients, as seen in Figure 81.

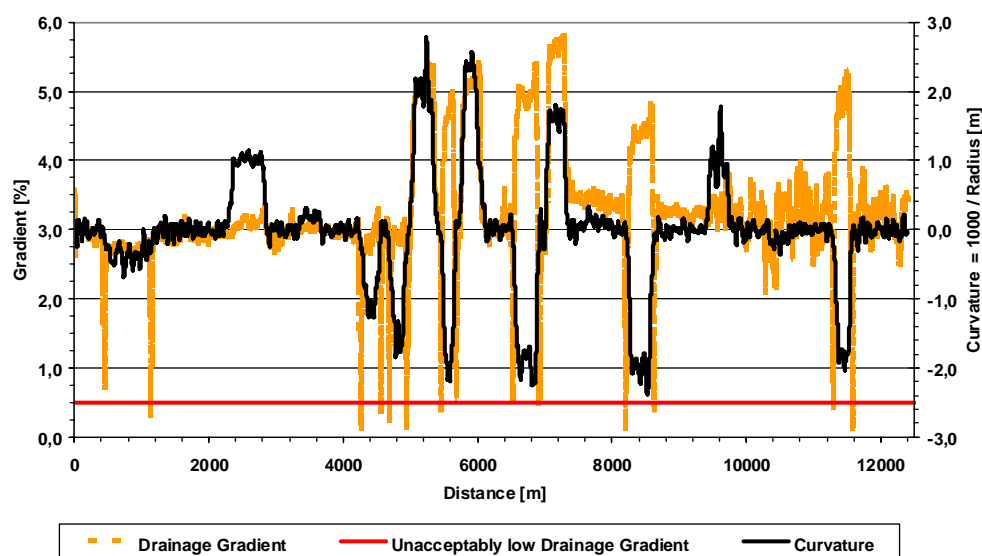
Figure 86 *The new section on Hw 90 has unacceptable skid risk at left hand curves*

For reference purposes, Drainage Gradient (DG) was calculated for a 12.3 km new section on Hw 90 north of Sollefteå. This section had been reconstructed totally, after the study by Ahlin et al (2000) [3]. However, the resulting DG plot was surprising and gave some very valuable knowledge. As seen in Figure 86, the new road section has 12 skid risk areas; one per km. The black Curvature trace clearly shows that all skid risk areas are located at the entrances or exits of left hand curves (having negative curvature). No skid risk areas can be seen at right hand curves or on straight sections. Tests on data from highways and expressways in various parts of Sweden demonstrate that this new knowledge on skid risk hot spots has a generic application.

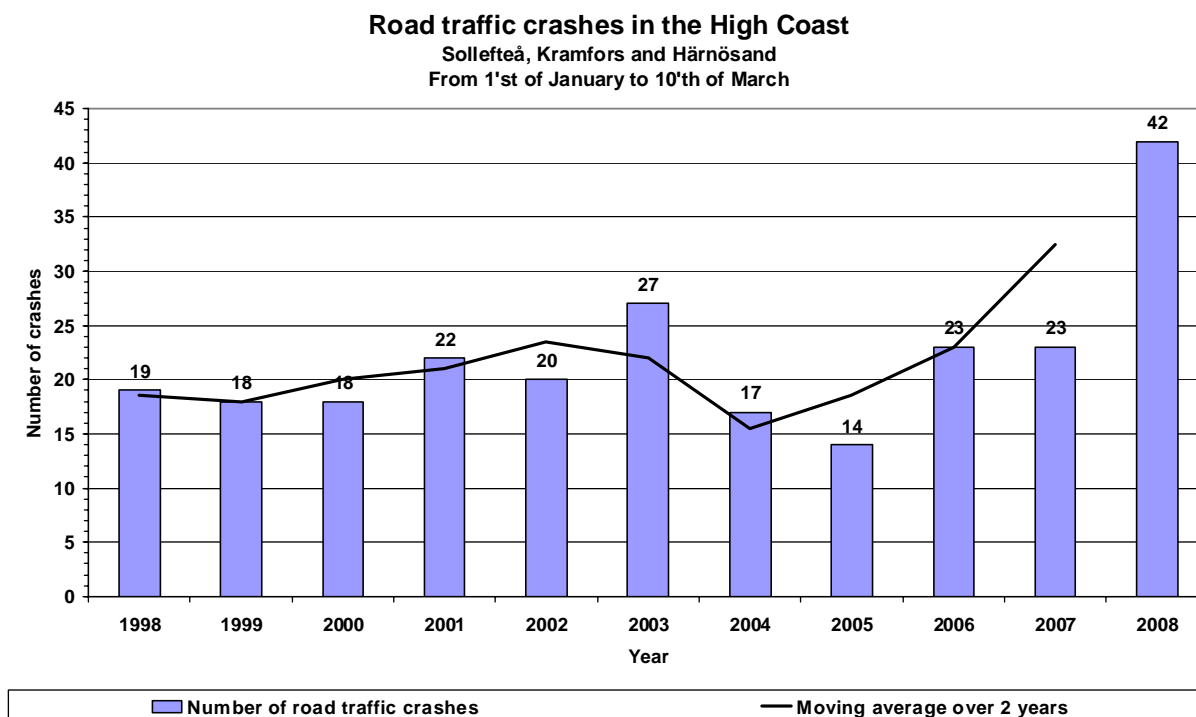
Figure 90 *A strong trend of increased road traffic crashes*

A relevant example is the strong increase in road crashes in the High Coast Ådalen (Sollefteå, Kramfors and Härnösand) in SRA Central Region, as seen in Figure 90. In the period from 1 January to 10 March, the number of crashes has increased from 18 to 23 during the 10 year period 1998 - 2007. Given the mean value of 23 in the past ten years and considering the natural variance of this statistic (the standard deviation over the past ten years was 3.7 crashes), there was over 95 % probability of less than 31 crashes in 2008. However, the 2008 outcome was 42 crashes. This is an increase by 109 %, as compared to the ten years before. The Rescue Leader had reported poorly maintained roads as a causal factor behind more than

50 % of the crashes in 2008, while 25 % also involved deep ice ruts. The High Coast Rescue Department also see a clear relation to the extreme and unsteady climate. Most crashes were single car accidents. Most of these took place on straight road sections in daytime, and many of the crashed cars were driven by women. [Personal communication with Peter Carlstedt, Head of High Coast Rescue Department] [73].

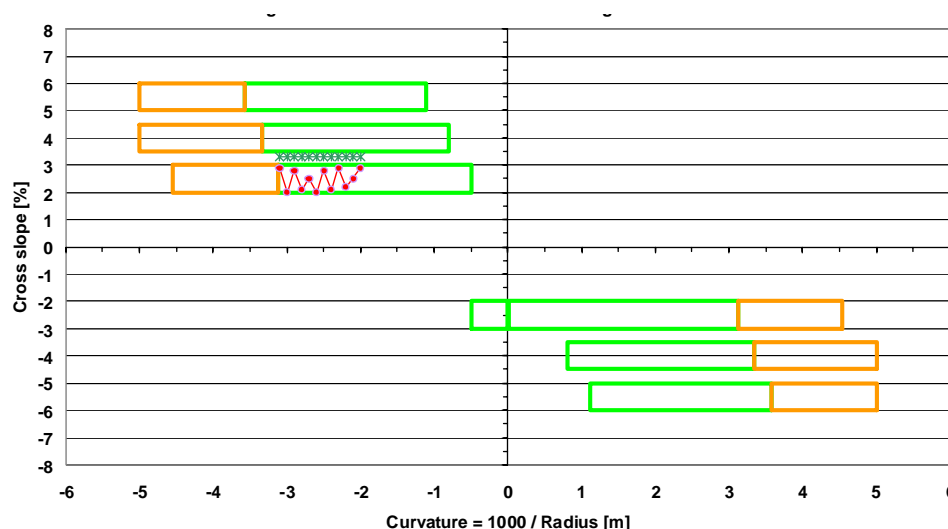
Figure 91 What is worse on an old road: CS outside tolerance boxes, or high RBCS variance?

The red dots in Figure 91 are inside the tolerance box for the design of new 70 km/h roads, whereas the green stars are outside the box. The green stars however represent a road section offering a safer and more comfortable ride, than a section represented by the red dots.

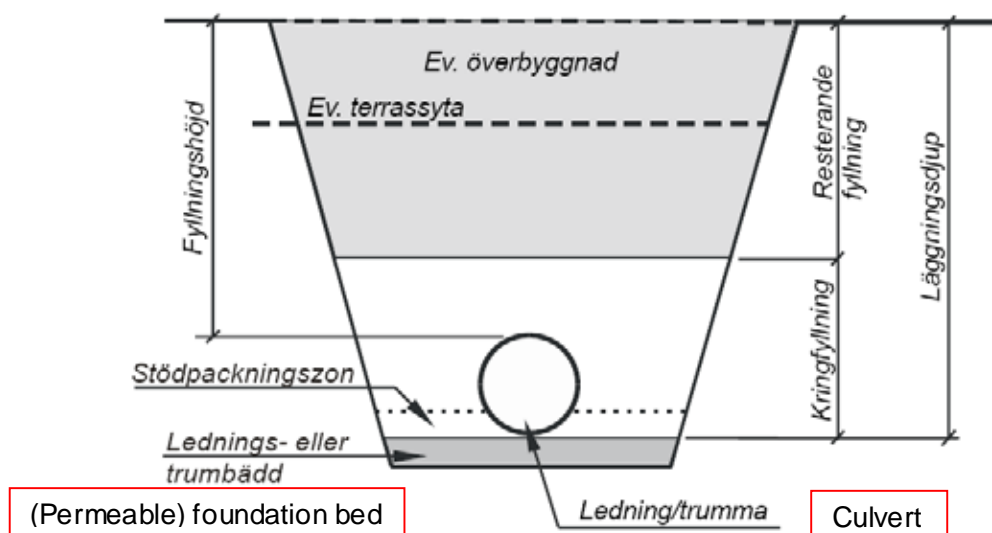
Figure 92 Section of a culvert on its permeable foundation bed [40]

Culverts manufactured with Portland Cement Concrete (PCC) are usually manufactured for a design life of up to 100 years. It is therefore surprising that so many apparently sound concrete culverts need to be reconstructed within only 5 - 20 years after their installation. As seen on Rd 331, a common failure mode is a full collapse, caused by water piping in the soil below the culvert. This shows a need for a revision of the culvert design code. Can water really be expected to flow within a culvert, when the culvert itself is founded on a permeable gravel bed at the bottom of the culvert ditch in low-permeable soil (so water can pipe its way beneath the culvert), as seen in Figure 92. Should not the foundation need to be made low-permeable? These are questions that culvert experts should consider.
