Annele Matintupa, Seppo Tuisku

SUMMARY OF DRAINAGE ANALYSIS IN IRELAND, ROADS N56 AND N59

Demonstration Project Report

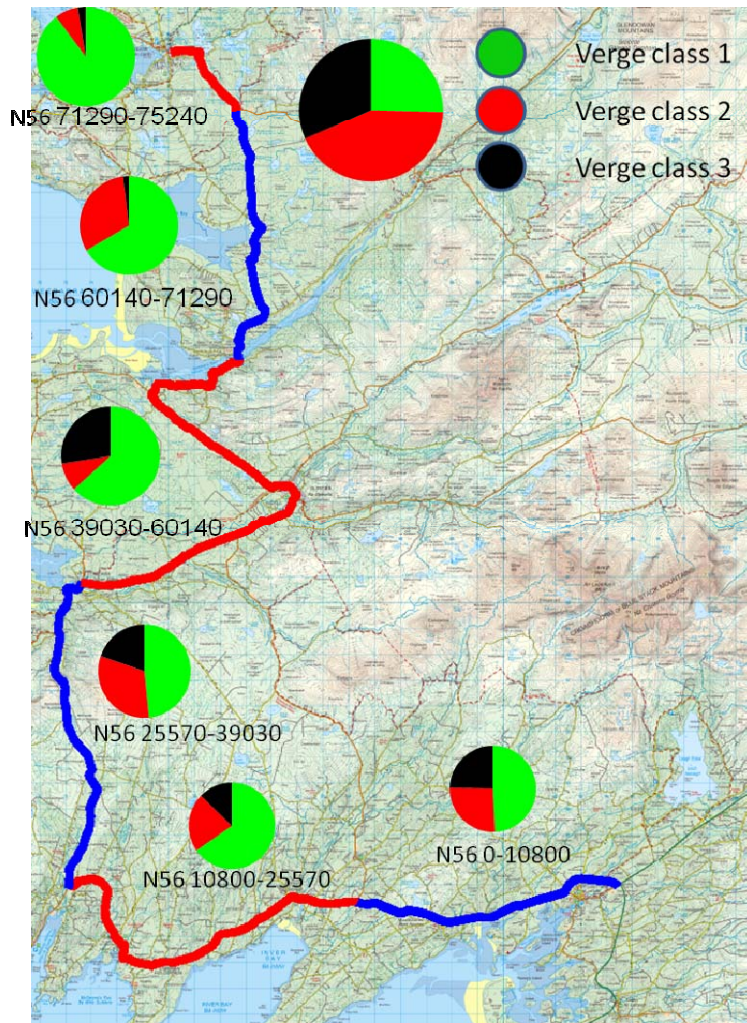
Figure 20: Verge class in the first part of road N56 from Donegal to Dungloe.

Verge classes follow the same trends as drainage classes in the first section of the N56. The road section with the fewest verges on the N56 is the section from the R252 intersection to Dungloe (71,290 – 75,240). The map of verge class along this road section is presented in Figure 20.

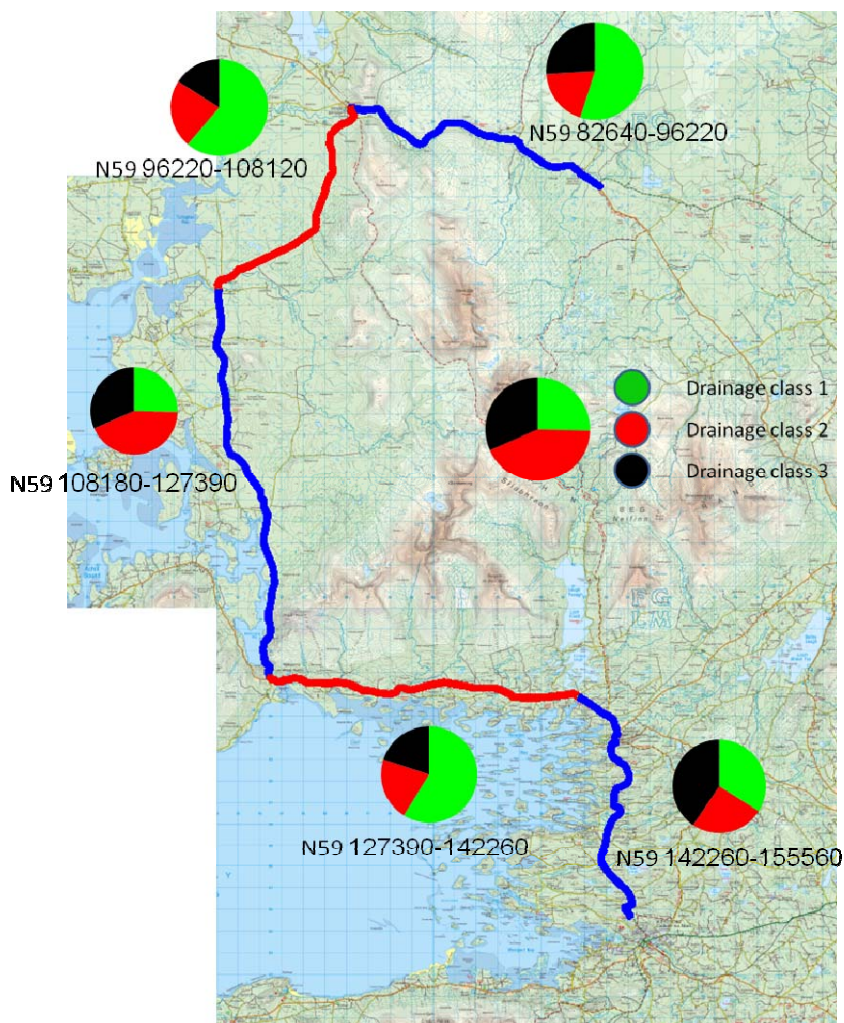
Figure 23: Drainage condition in the second part of road N59 from the R312 intersection to Westport.

The second section of road N59 was from the R312 intersection to Westport. The drainage of this section is slightly worse than that of the first section. The worst section is from Achill Road R257 to Bridge (108,180 – 127,390m). A map showing the drainage statistics of this section is presented in Figure 23.

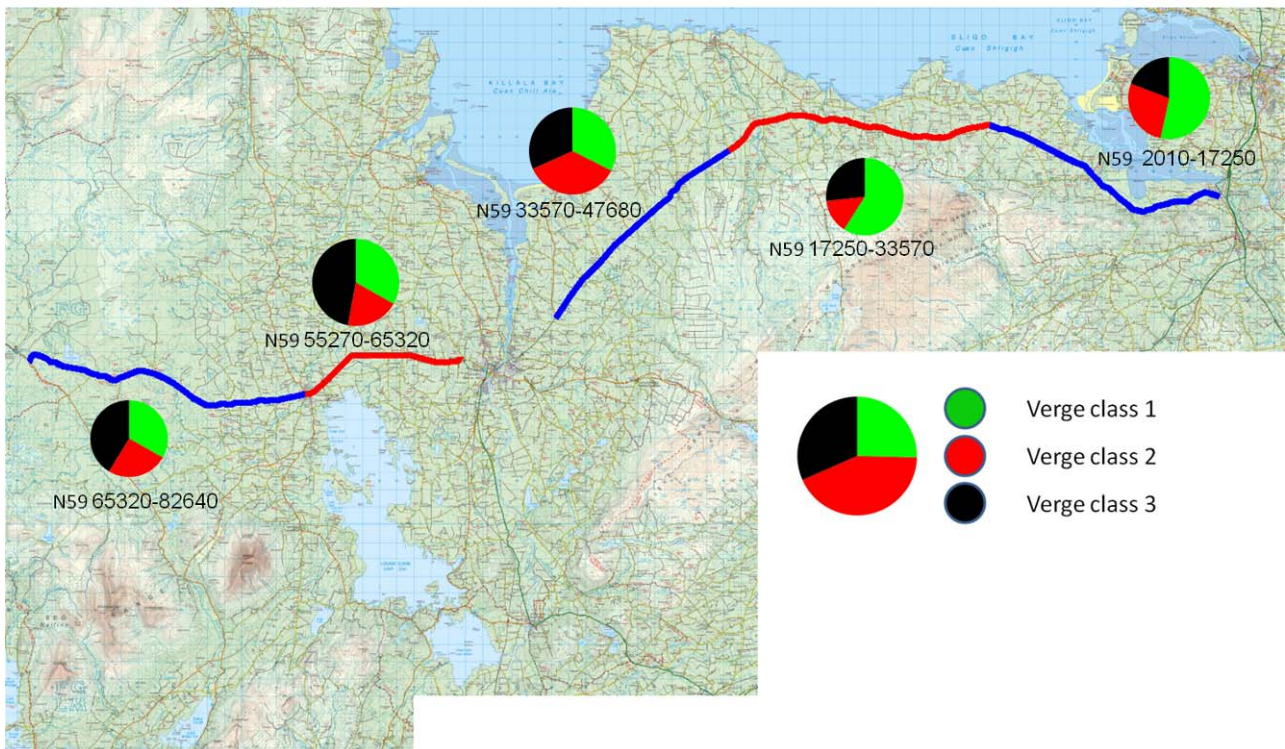
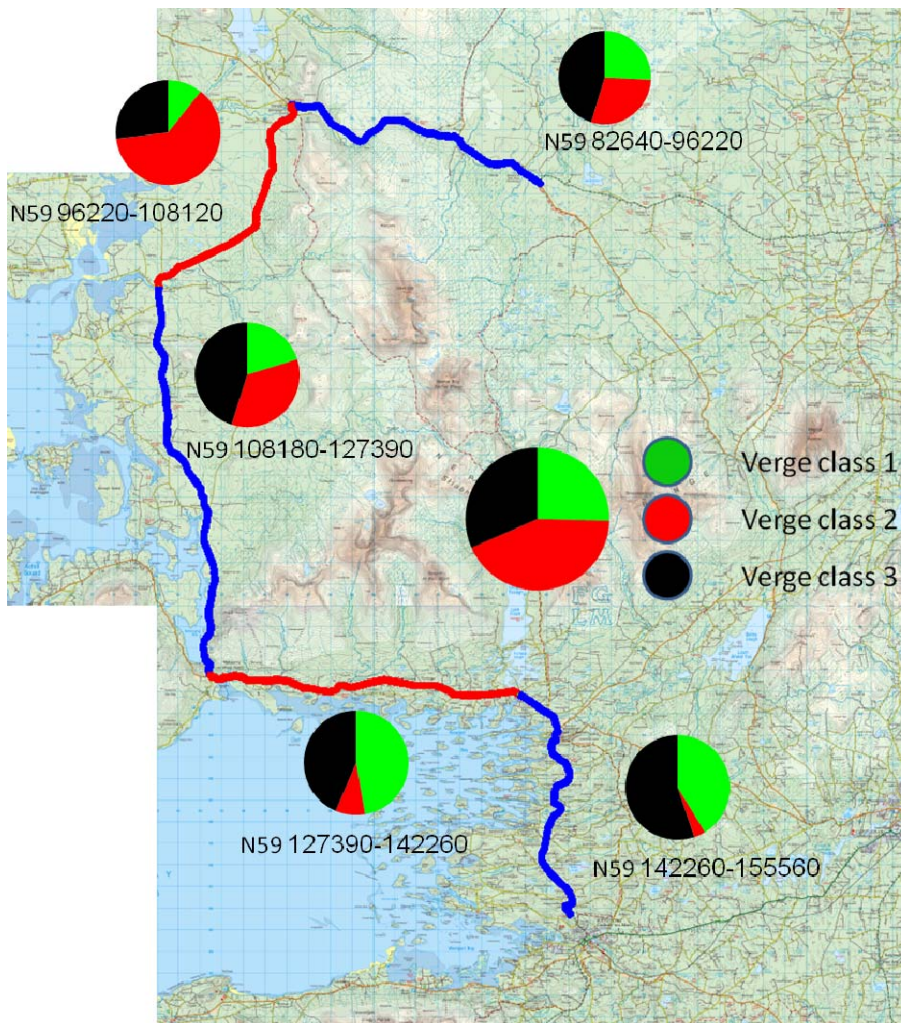
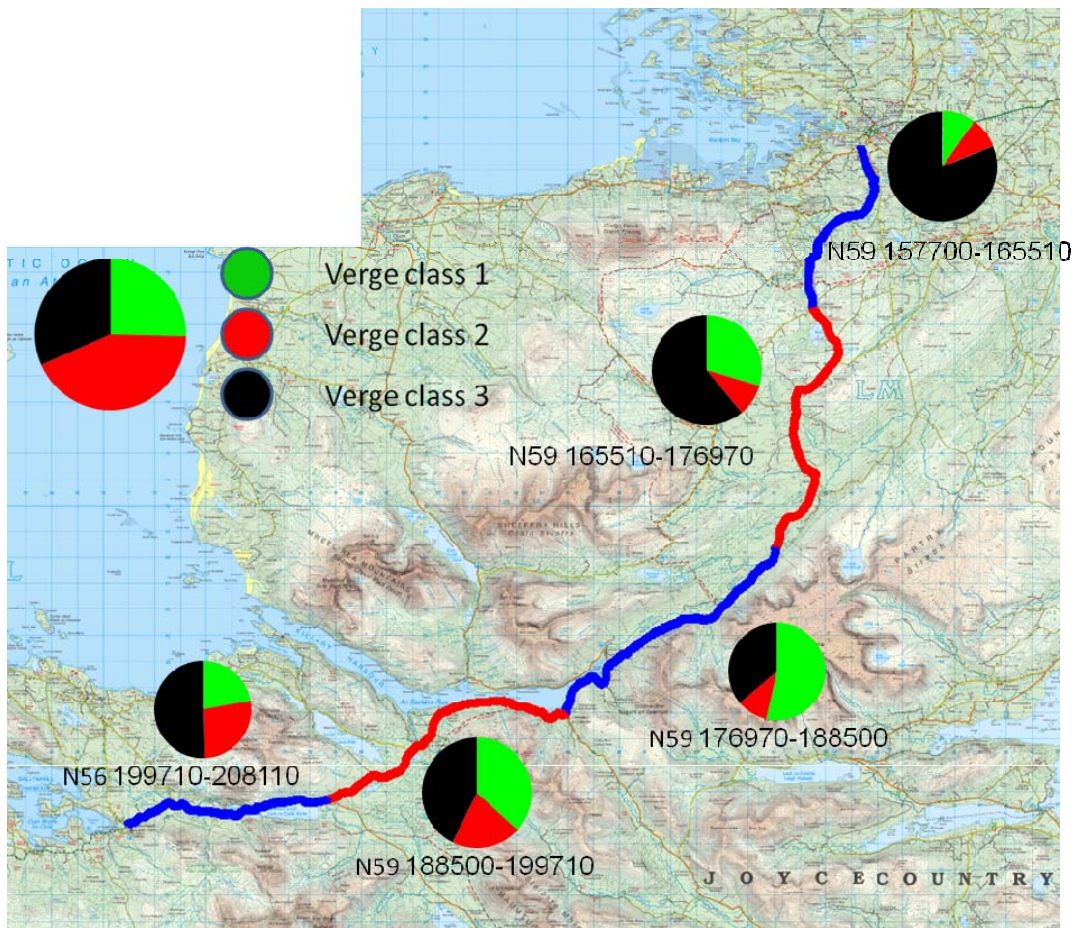
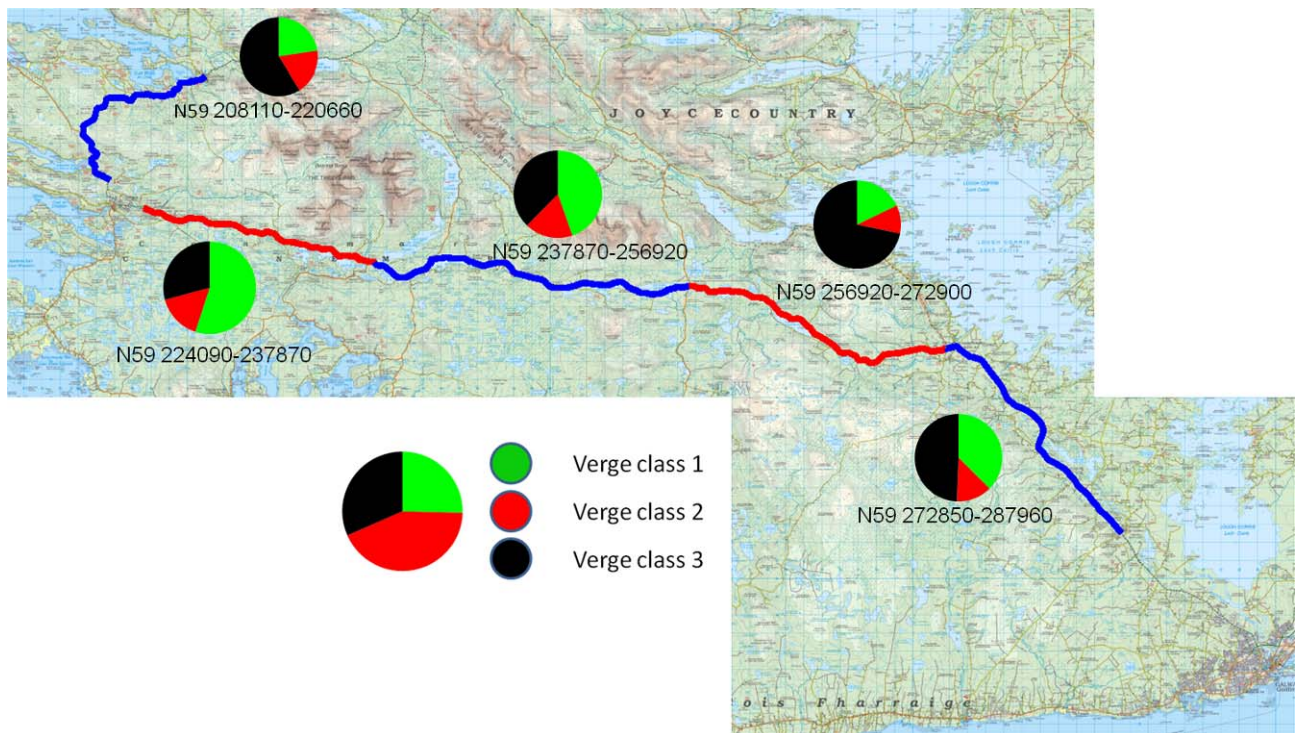
The class of verge varies significantly on the N59. The majority of the verges were rated as Class 1 on the following sections: from the Masreagh intersection to Owenberg (17,250 – 33,570), from the Burrishoole Bridge to Westport (142,260 – 155,560), from Erriff Bridge to the R336 (176,970 – 188,500) and from the bridge after Clifden to the R341 (224,090 – 237,870). The majority of the verges were rated as Class 3 on the section from Westport to Lischarney (157,700 – 165,510). Almost 80% of the verges are Class 3 in this section. Maps of verge class along the N59 are given in Figures 26 – 29.

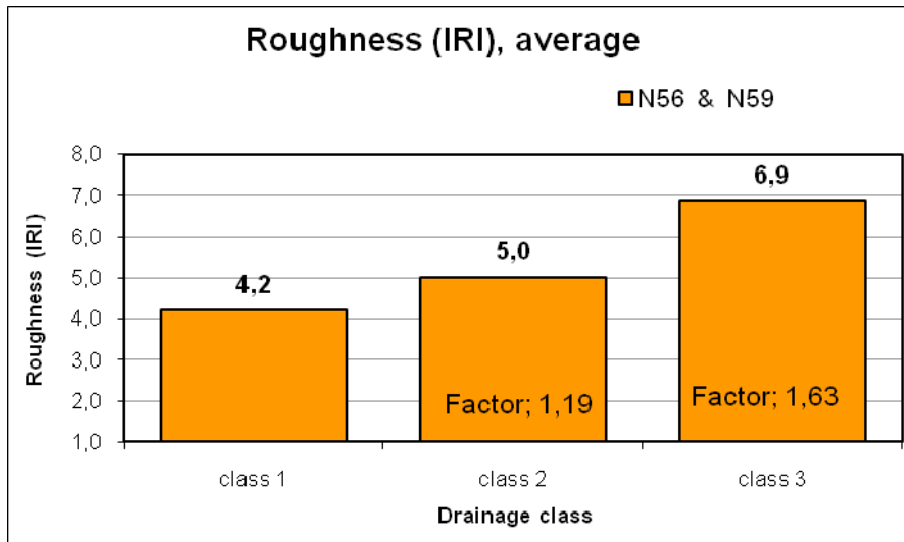
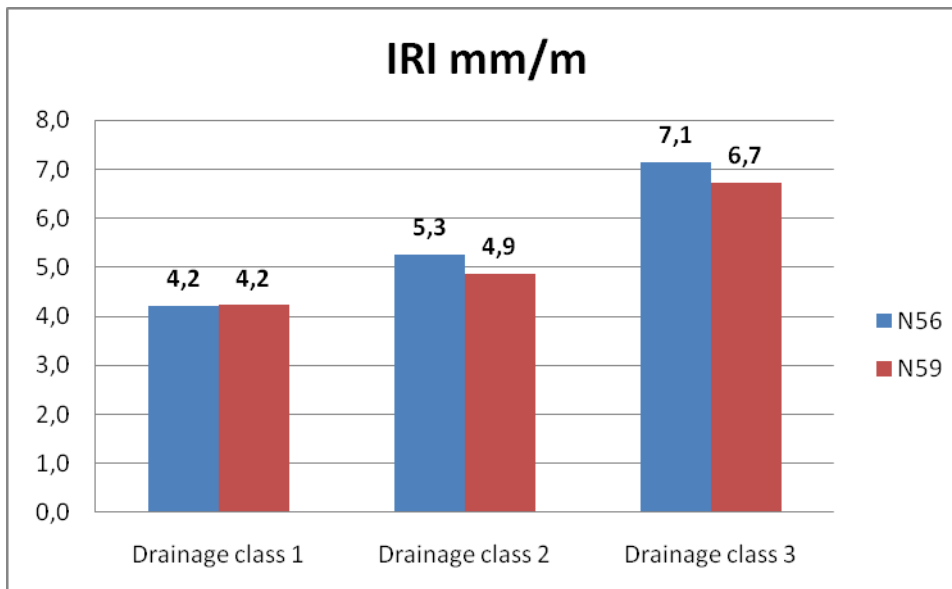
Figure 30: The average roughness value for each drainage class in roads N56 and N59. The value on the top of the column presents the average IRI value for each drainage class. The factor inside the column shows how many times bigger the value is compared to the value for Class 1.

The average roughness (IRI) value for each drainage class on roads N56 and N59 is summarised in Figures 30 and 31. This clearly shows the impact of poor drainage on road roughness (IRI). In drainage Class 1 the average IRI was 4.2, i.e. an adequate level of comfort for driving. In drainage Class 3 the average IRI was 6.9, which equates to an uneven and uncomfortable road surface. Figure 31 also shows that the N56 is more sensitive to poor drainage.

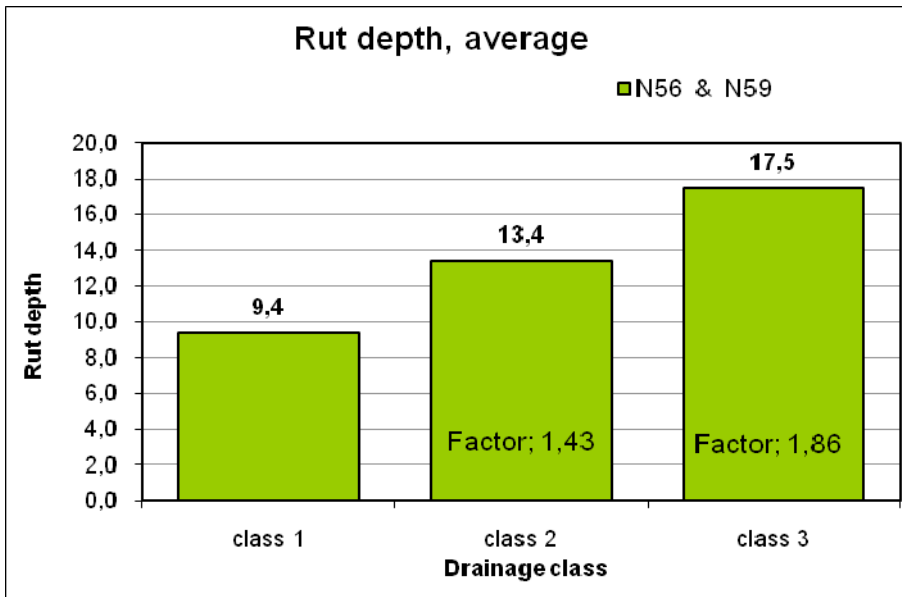
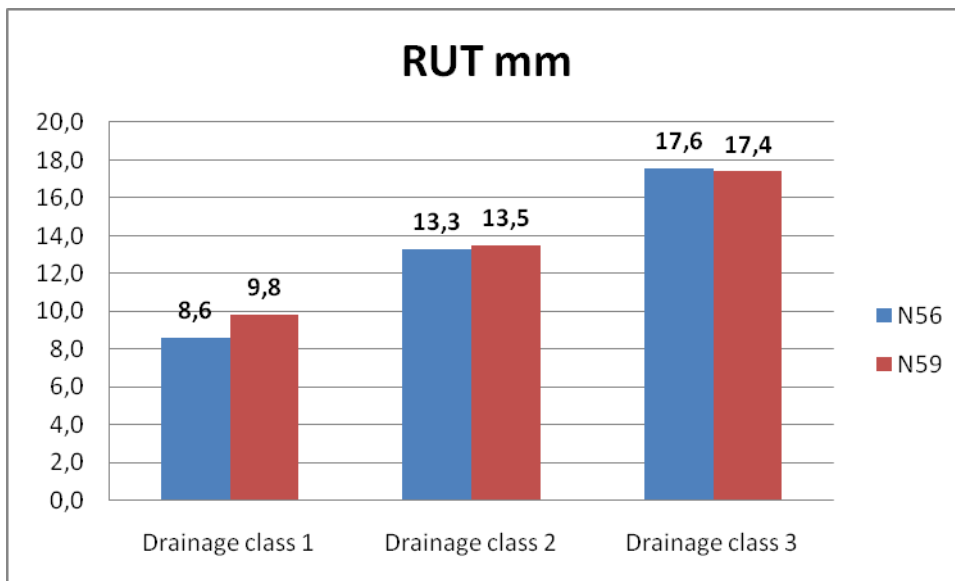
Figure 32: The average rut depth value for each drainage class in roads N56 and N59. The value on the top of the column shows the average rut depth value on each drainage class. The factor shows inside the column shows how many times bigger the value is compared to the value for Class 1.

Figures 32 and 33 show that the impact of poor drainage on rutting is even higher when compared to roughness. The average rut depth in drainage Class 2 is 43 % higher than in Class 1, and in drainage Class 3 the rut depths are almost two times higher than in drainage Class 1.

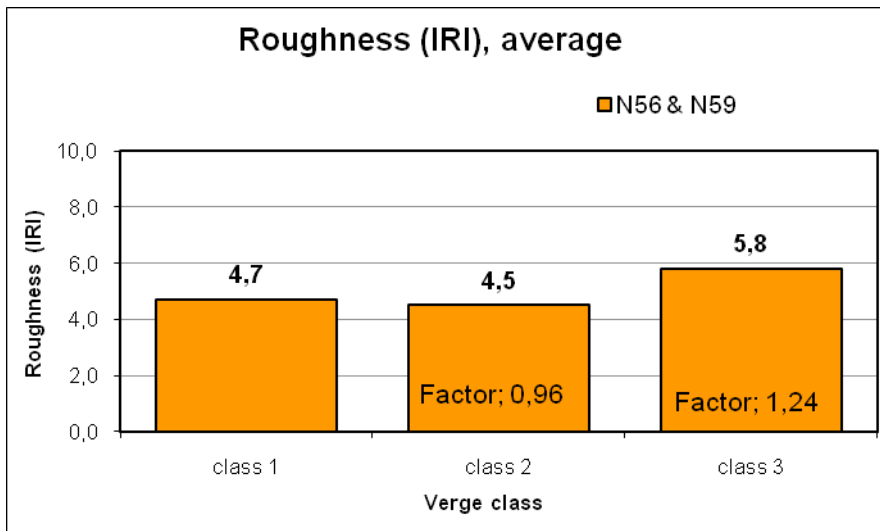
Figure 34: The average roughness value compared to verge class on roads N56 and N59. The value on the top of the column shows the average IRI value in each drainage class. The factor inside the column shows how many times bigger the value is compared to the value for Class 1.

Verges also have an effect on roughness and rutting but not so great as average drainage class. Figure 34 shows that small verges with well maintained offlets do not affect roughness, but that IRI values are 1.24 times higher in verge Class 3 compared to verge Class 1 (no verges).

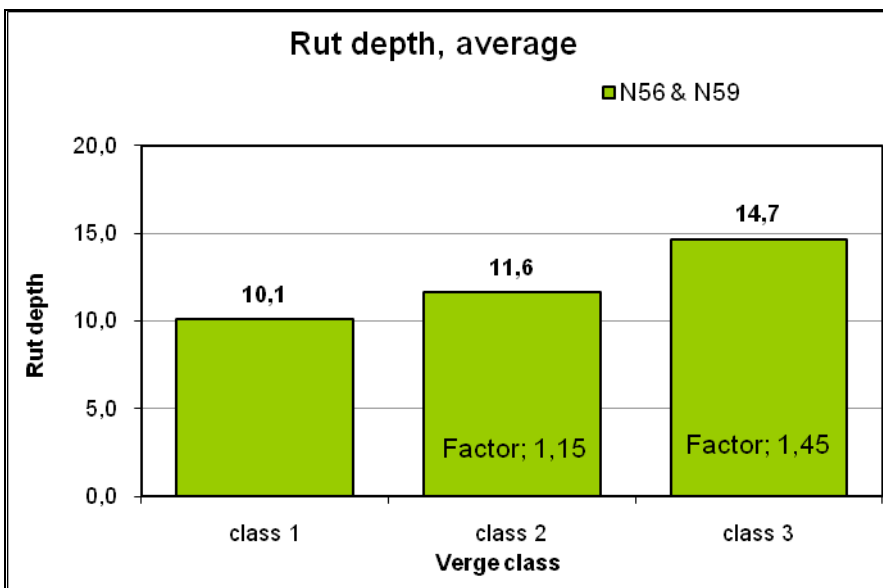
Figure 35: The average roughness value compared to verge class on roads N56 and N59. The value on the top of the column shows the average rut depth value for each drainage class. The factor inside the column shows how many times bigger the value is compared to the value for Class 1.

The correlation between average rut depths and verge class (Figure 35) is clearer than with roughness values. The average rut depth is 1.45 times greater in Class 3 compared to Class 1.

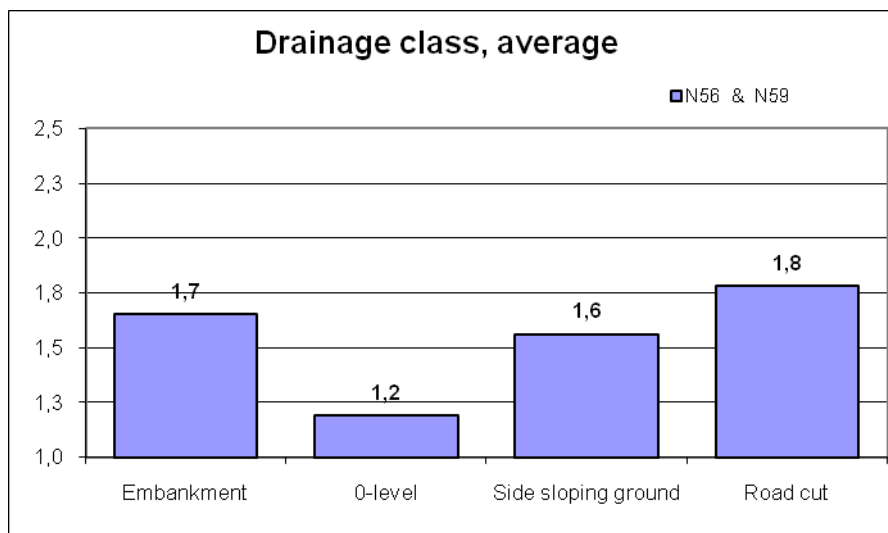
Figure 37: The average drainage class for each type of road profile.

Figure 37 shows that the average drainage class was the best in road sections classified as “0-level” (i.e. the road was approximately at the level of the adjacent ground). The average drainage class in these sections was 1.2. The drainage was the worst condition in road cuts, but quite surprisingly the drainage condition in embankments was almost as bad.

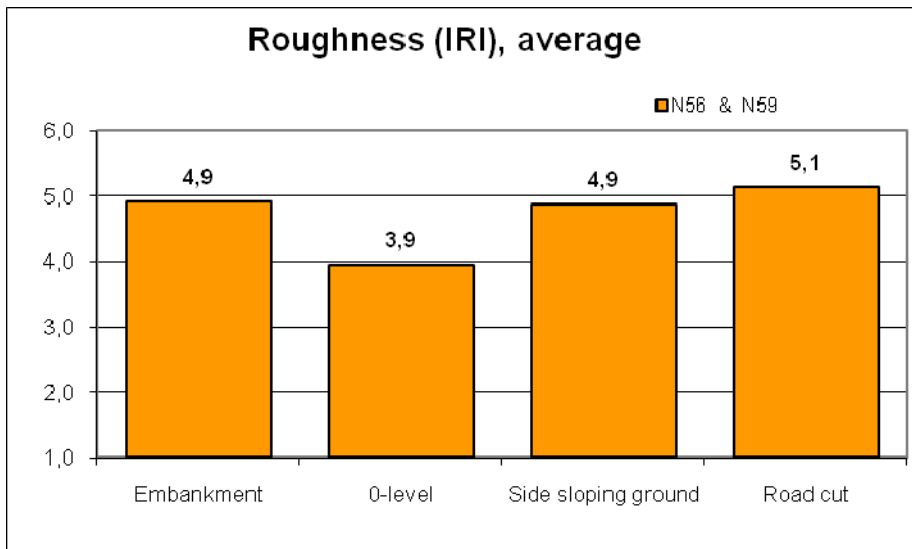
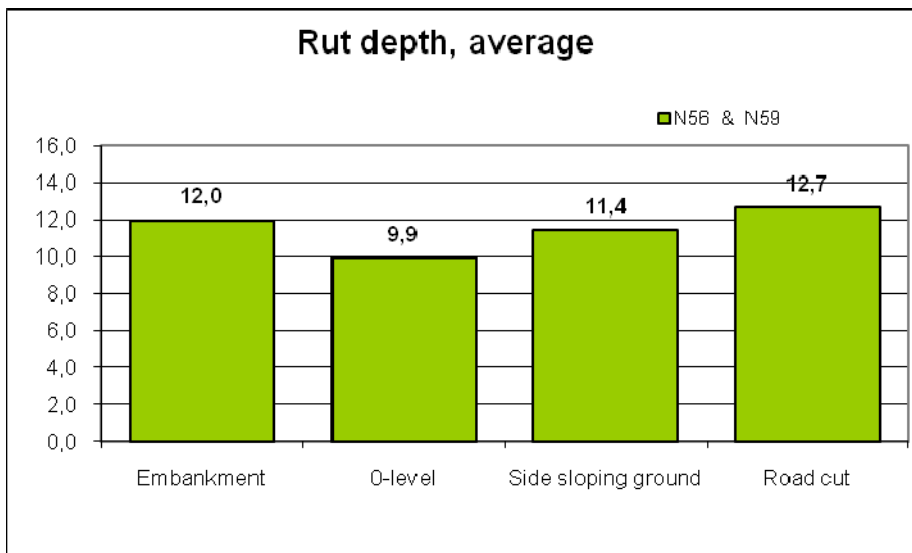
Figure 38: The average IRI-value for each type of road profile.

When roughness and rutting values were compared to road profile, the average values were about the same, except for 0-level where the values were slightly worse (Figures 38 and 39). The worst cases were always in road cuts.

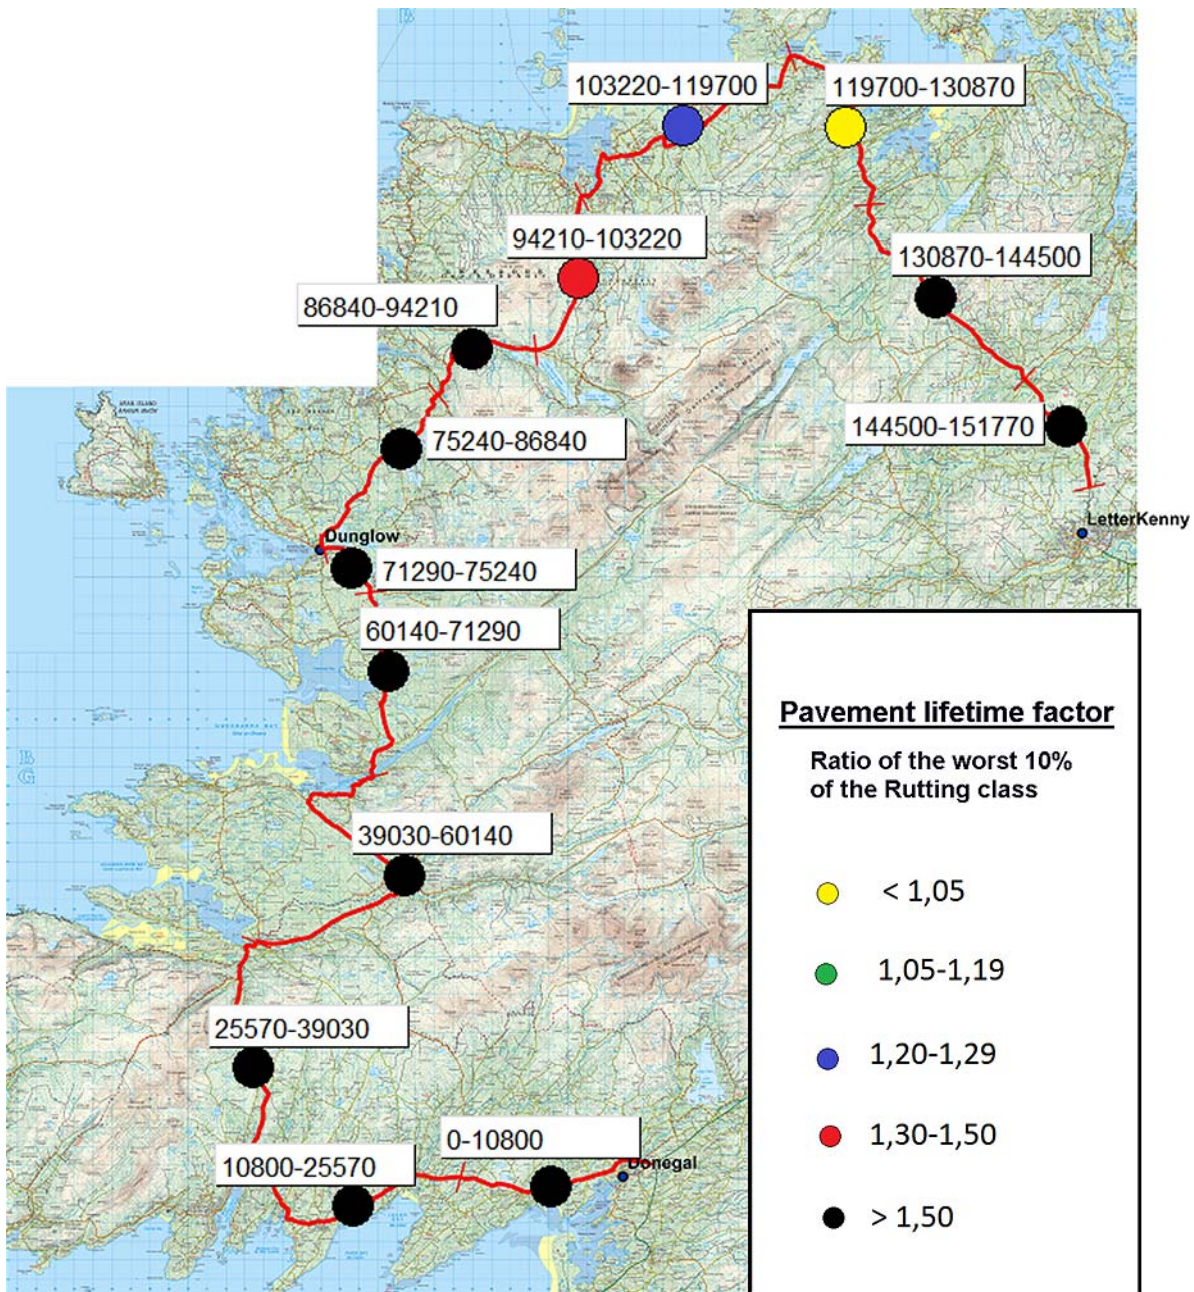
Figure 40: Pavement lifetime factor N56

From Figure 40, the pavement lifetime factor (the ratio of the worst 10% rutting class) on road N56 is mostly >1.5 , and so it is highly economic to improve the drainage on this road. Only on one section, from 119,700 to 130,870, was the pavement lifetime factor less than 1.05.

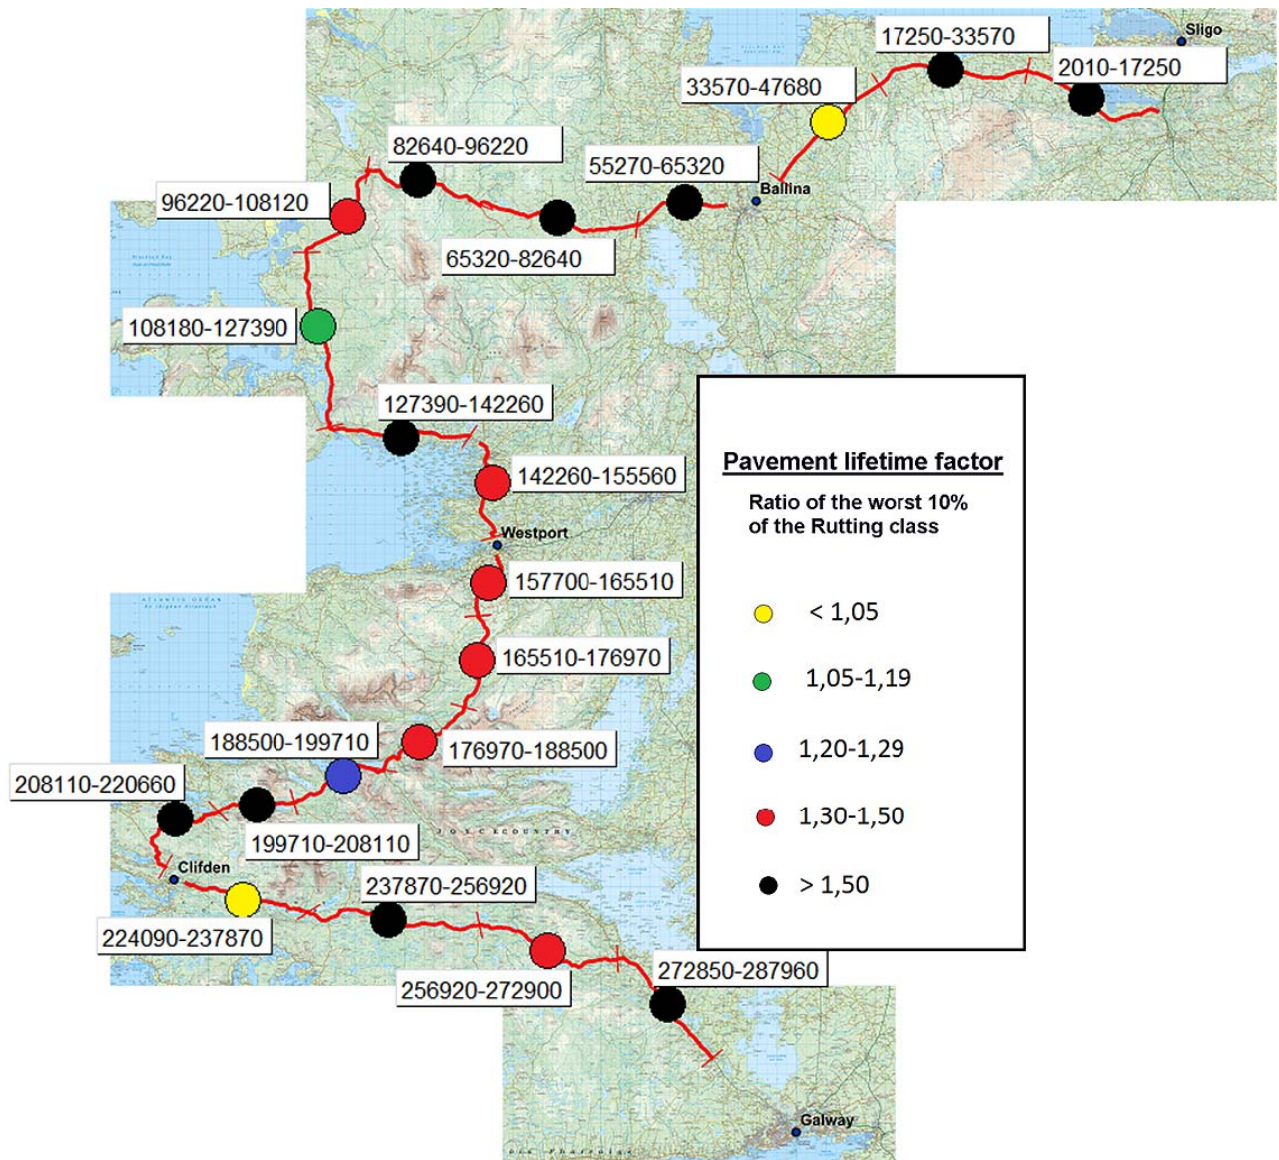
Figure 41: Pavement lifetime factor N59

Road N59, on the other hand, has slightly better (but still not good) pavement lifetime factors, even though in general the drainage condition is worse than the N56. This indicates that the N59 has thicker road structures, or the amount of heavy traffic on the N59 is less than on the N56.
