Annele Matintupa, Seppo Tuisku

SUMMARY OF DRAINAGE ANALYSIS IN THE SCOTTISH HIGHLANDS

Demonstration Project Report

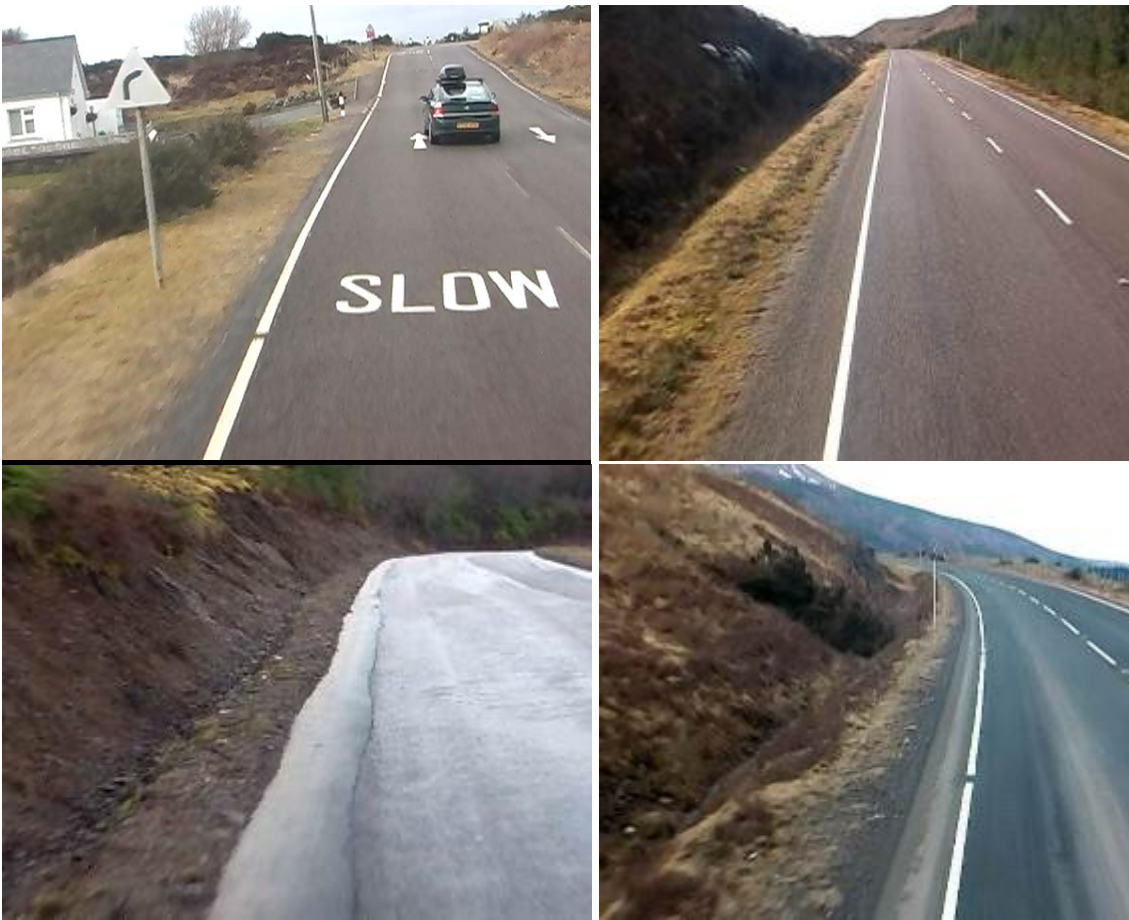
Drainage Class 1 means that the drainage condition is faultless. The cross-section of the road has preserved its form well and water flows unrestricted from the pavement to the ditch. Water has also a clear passage in the ditches. Where a verge is present it has enough offlets to let the water flow to the ditch.

Figures 33: Examples of road sections with drainage Class 1 in Highland

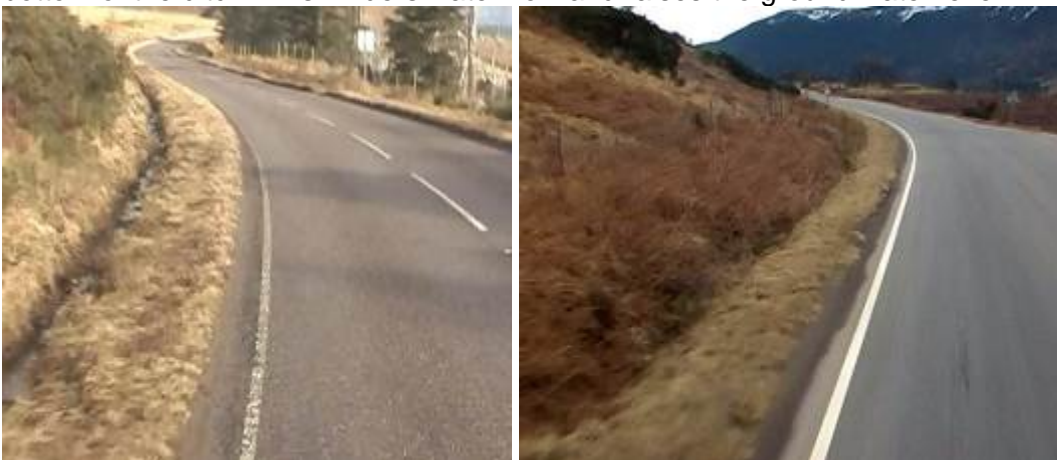
In drainage Class 2 there can be some visible changes to the road cross-section. The road shoulder has narrow verges or vegetation growth that is preventing the free flow of surface water from the road surface into the ditch. There is some vegetation in the ditch that restricts water flow and creates damages. Some soil is sliding from the road side slope into the ditches and raising the bottom of the ditch. This hinders water flow and raises the ground water level.

Figures 34: Examples of road sections with drainage Class 2 in Highland

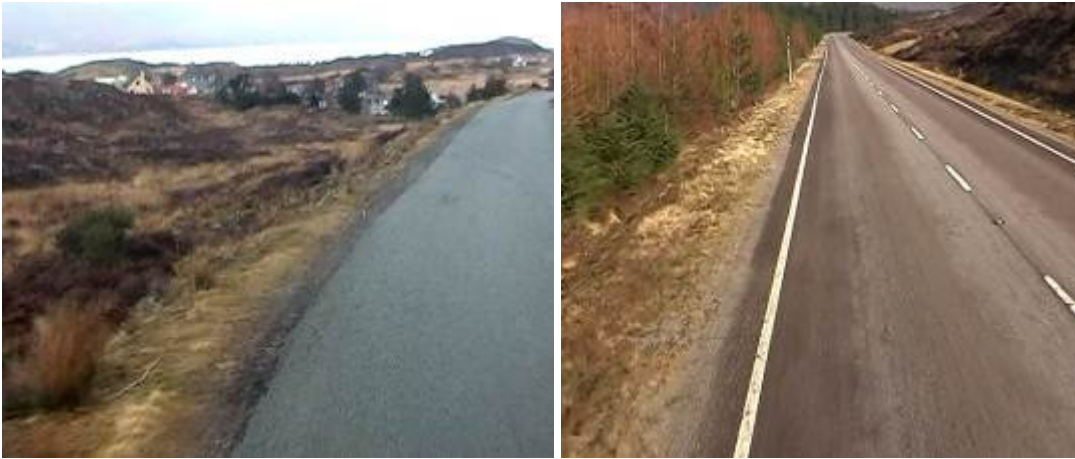
Class 1 verges cover those road sections where there is no verge and water can flow freely from road surface. Figure 33 presents two examples of verge Class 1 road sections.

Figure 36: Two examples of verge Class 1, i.e. road sections without verges.

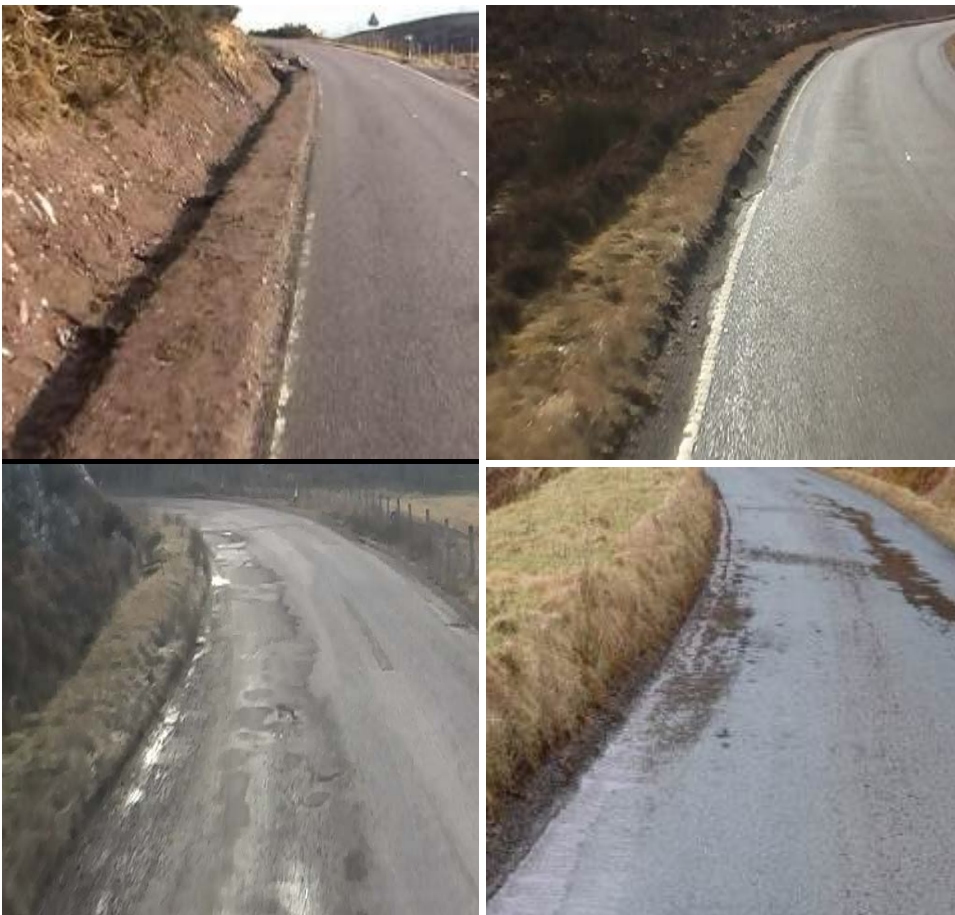
Class 2 verges cover all road sections with verges. The height of verges can vary from low verges, which only have a minor effect, to high ones which clearly prevent surface water flowing away from road surface. The spacing and type of offlets vary. In some sections the offlets can be totally blocked which then leave the water running in the edge of the pavement. In sections where drainage maintenance has been carried out the offlets are usually well open and water can flow freely from the road surface.

Figure 37: Examples of verge Class 2, roads with a verge. The effect of verges on the workings of the road drainage system varies a lot in different circumstances.

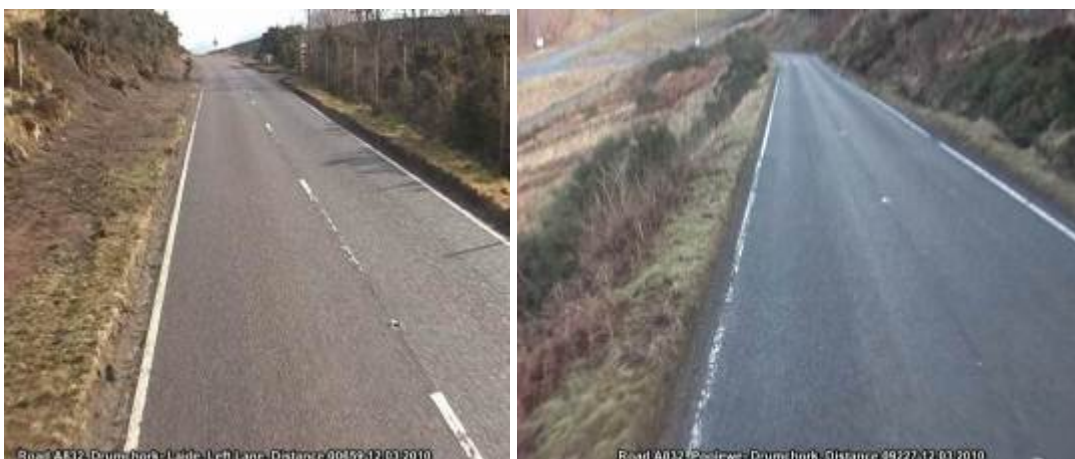
Figures 52: Left: Class 0= No visual damages, Right: Class 1= Minor damages
