Annele Matintupa, Seppo Tuisku

SUMMARY OF DRAINAGE ANALYSIS IN THE UMEÅ AREA, SWEDEN

- SEASONAL TESTS**

- TOOLS FOR OUTLET DITCH INVENTORY**

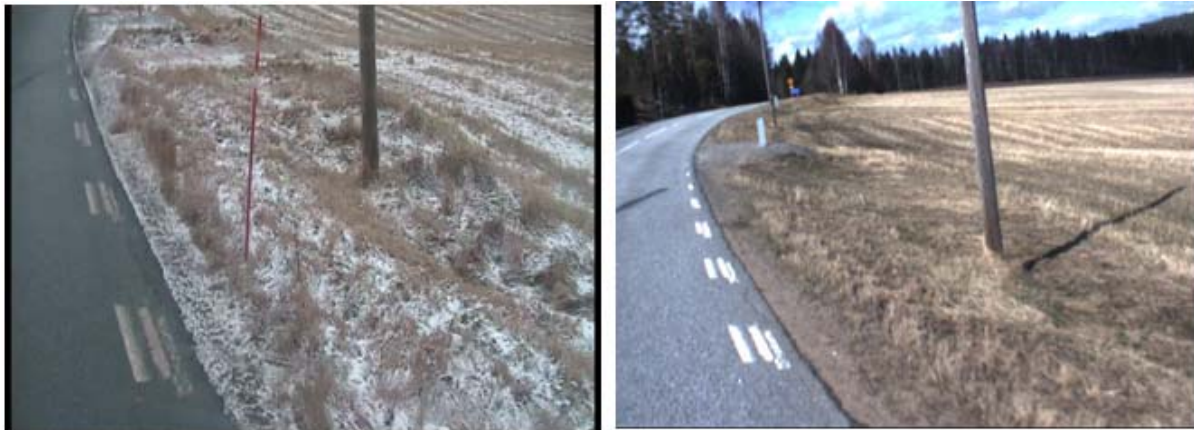
Figure 3. Example of autumn (left) and spring (right) data from Road 353, chainage 10600m.

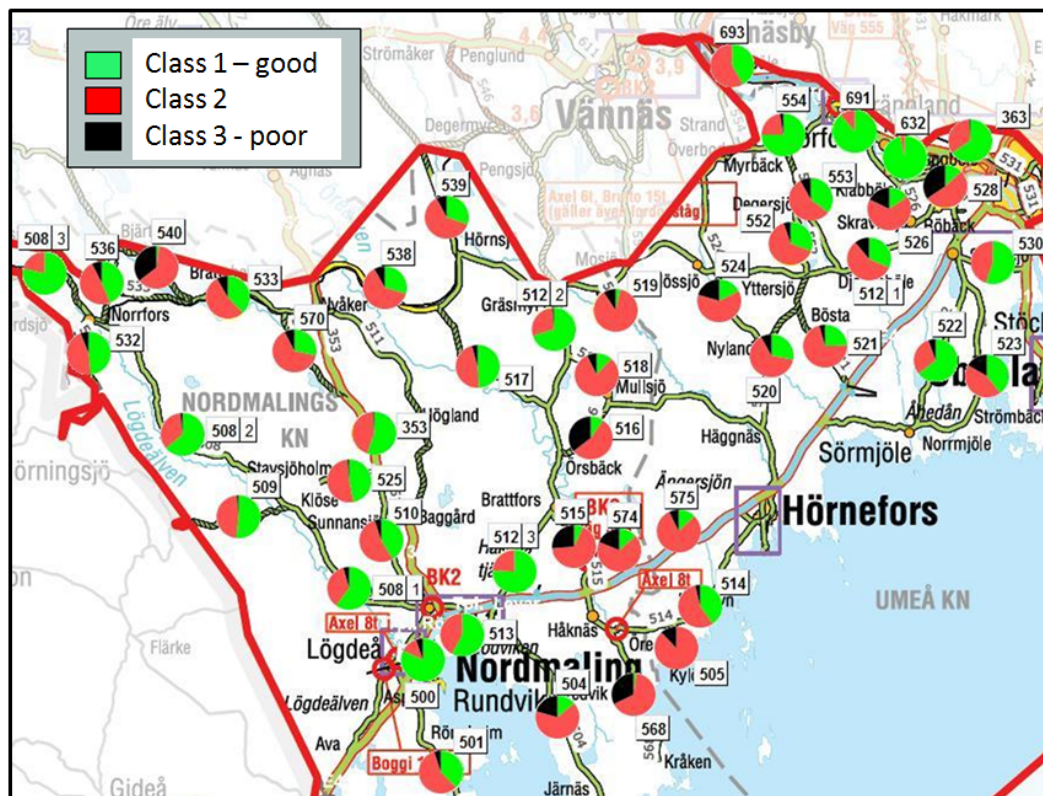
The results of the drainage statistical analysis are presented in Figure 16. The drainage of Road 540 in the North-East seemed to be in the poorest condition (mainly Class 2 and 3) and roads in the North-West area (363, 632 and 691) were in the best condition (mainly Class 1). These roads were located mainly on sandy subgrades.

Figure 16. The distribution of drainage classes on the roads surveyed.

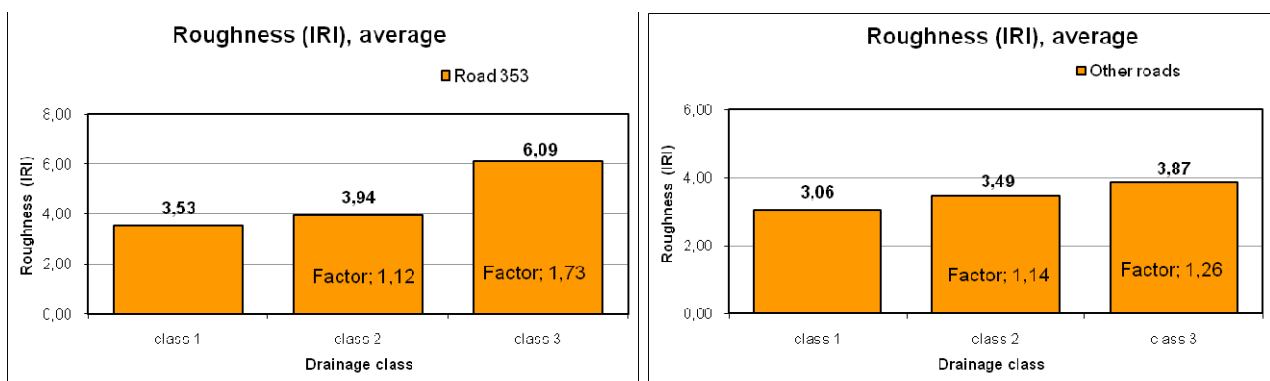
The effect of drainage was compared to roughness and rutting values. A statistical analysis was carried out for those roads that had rutting and roughness information from past years. These statistical calculations were divided into two groups. Road 353 was treated as a separate road because it was clearly a busier road than the others, while roads 500, 501, 504, 505, 508, 510, 511, 512, 513, 514, 517, 518, 520, 522, 523, 524, 525, 528, 538 and 552 were considered as an average. In the statistics the average of these roads is called “Other roads”. The average roughness values compared to the drainage classes is presented in Figure 52_1. According to these graphs, the roughness value correlates quite well with the drainage class. The poorer the drainage class, the higher the average of IRI-value.

Figure 17. The average roughness value compared to the drainage class of Road 353 (left) and of the other surveyed roads (right). The value on the top of the column shows the average IRI-value

in each drainage class. The factor shows how many times bigger the value is compared to the value of Class 1.

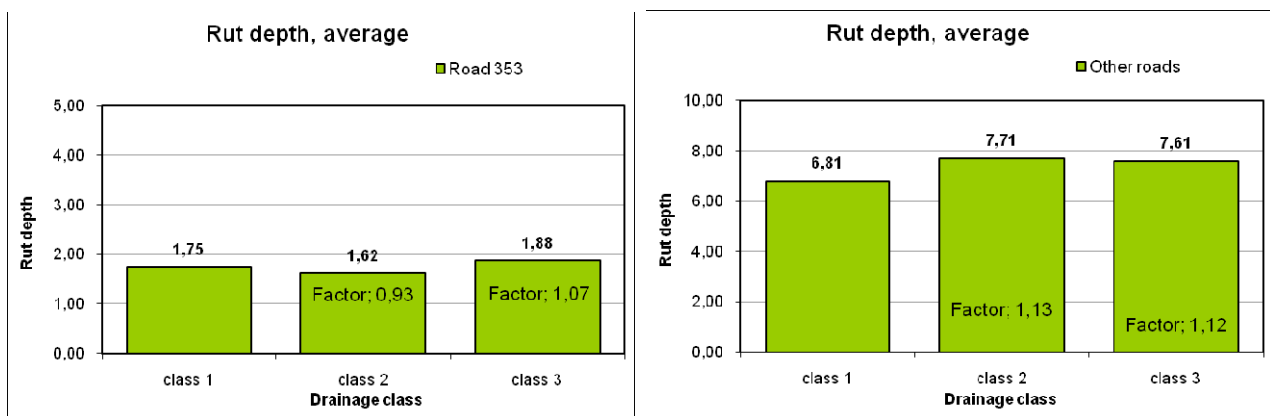
Average rut depths for each drainage classes are presented in Figure 18. These rut depths do not correlate so well with the drainage classes as did the roughness values. The average of rut depth seemed to be at the same level in all three drainage classes. A reason for this could be explained by the fact that a great part of the roads were located in side sloping ground and the rutting and roughness values were measured on the embankment side, not the road cut side. Similar results were found in the ROADDEX drainage analysis carried out on roads in the Western Isles, Scotland. Another reason for the relatively poor correlation was that some of the roads had been recently repaved.

Figure 18. The average rut depth value compared to drainage class of Road 353 (left) and of the other roads surveyed (right). The value on the top of the column shows the average rut depth value in each drainage class. The factor shows how many times bigger the value is compared to the value of Class 1.

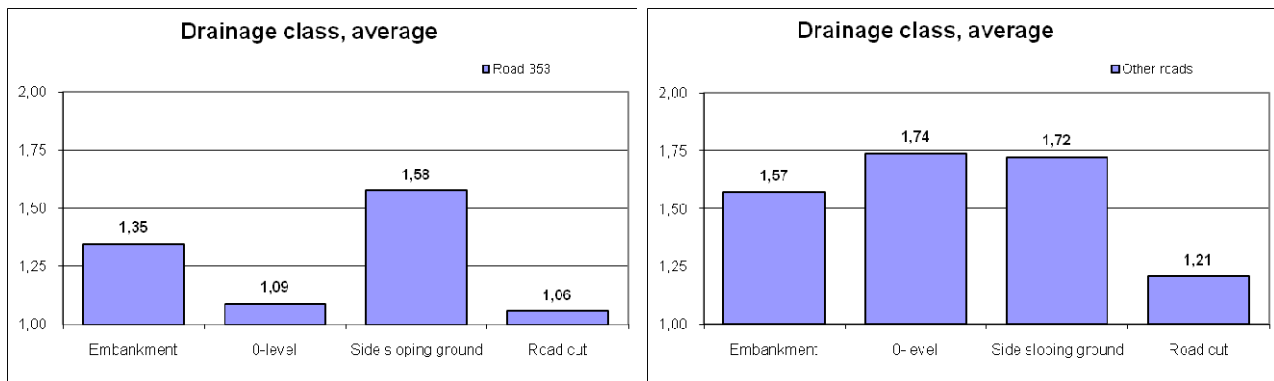
Drainage classes, rut depths and roughness values were also compared with the road profile (Figure 19). On Road 353 the drainage seemed to be in the best condition in sections which were on 0-level (the average drainage class was 1.09), and surprisingly in road cuts (1.03). The drainage condition was in the worst condition, according to the statistics, on the side sloping ground. On the other roads surveyed the best drainage values were in the road cuts, and the worst values on the 0-level and side sloping ground.

Figure 19. The average drainage classes from each road profile, Road 353 (left) and the other roads surveyed (right).

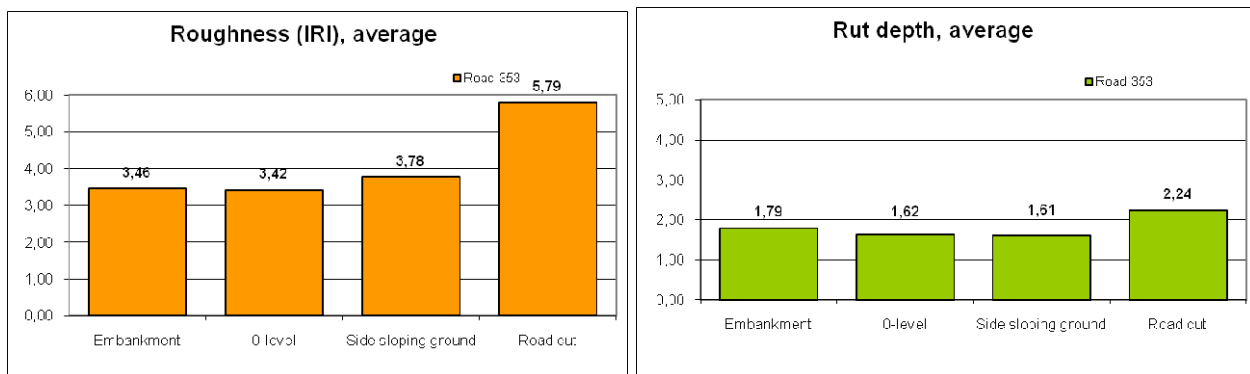
On Road 353, the poorest drainage condition was identified in sections on side sloping ground and the best drainage condition, again quite surprisingly, was on the road cut sections. On the other hand Figure 20 shows that the highest average roughness and rutting values were measured in road cuts, which tells that visual drainage evaluation might not always give reliable results on such sections and new techniques, such as GPR and laser scanners, could have a use in future surveys for drainage analysis.

Figure 20. The average IRI-value and average rut depth from each road profile, Road 353.

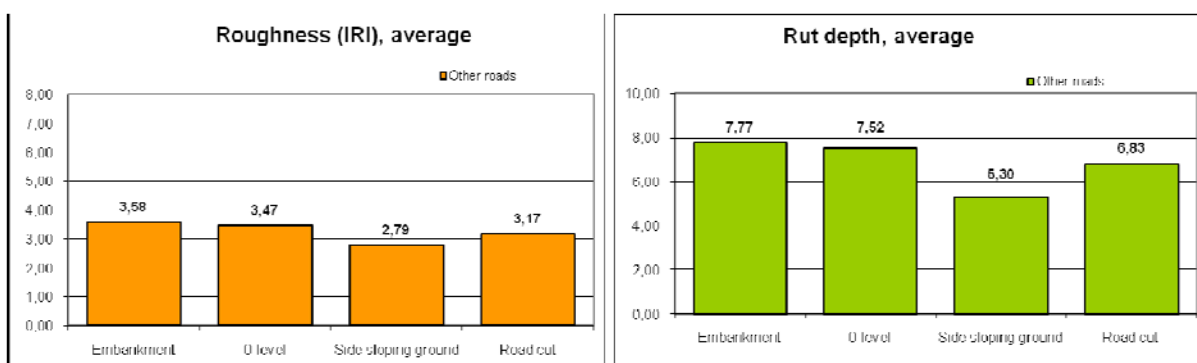
On the other roads surveyed, the average rut depths and roughness values were approximately on the same level (Figure 21). The IRI value was, on average, at the same level on all road profiles. The lowest (2.79) IRI value was on the side sloping ground, the highest IRI value was on embankments (3.58). The rut depth was lowest on the side sloping ground (5.30) which supports the argument that the rut depths were measured on the “wrong side” of the road.

Figure 21. Average IRI-value and average rut depth from each road profile for the other roads.

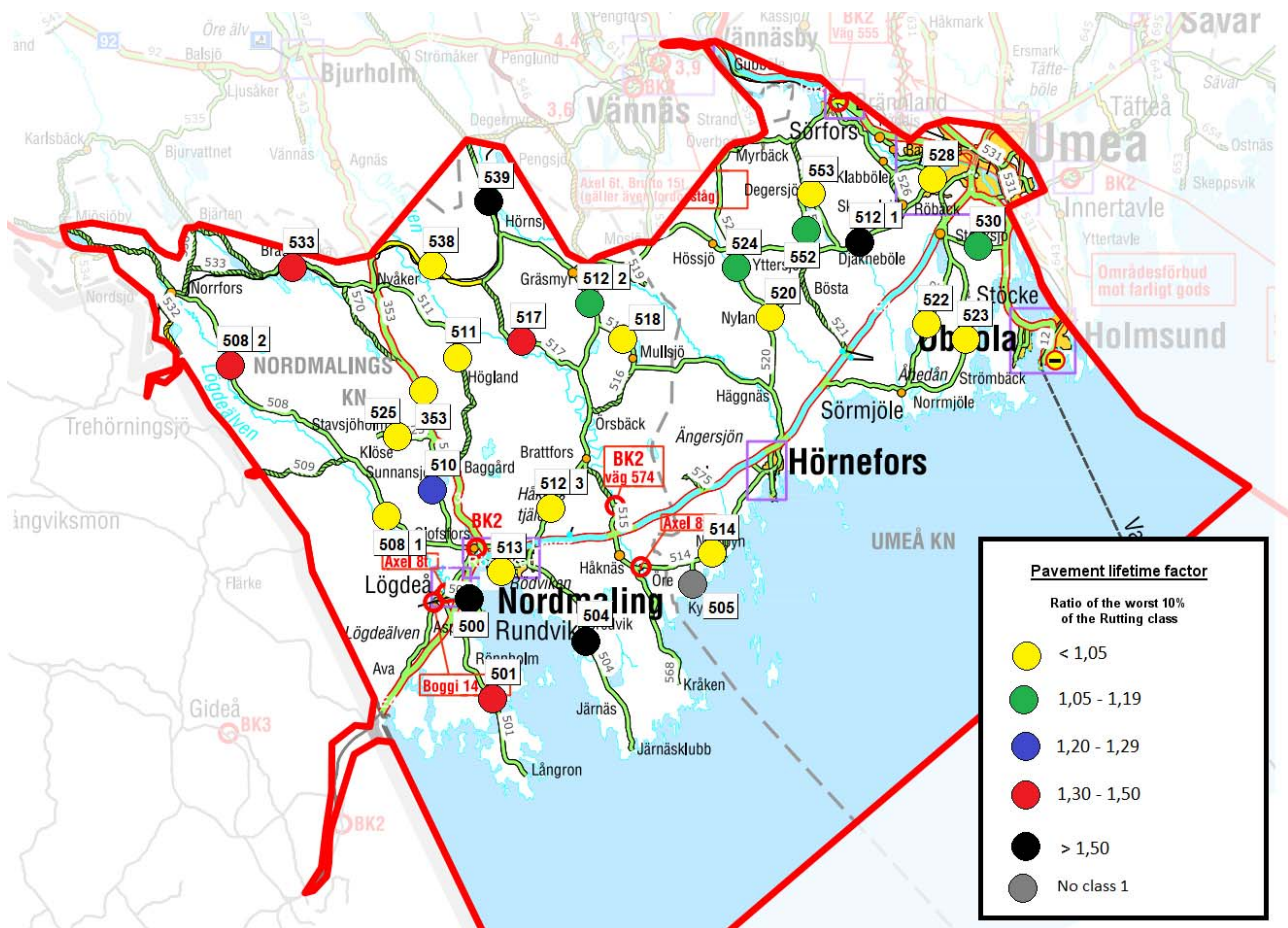
A map of the calculated lifetime factors on the surveyed roads of the Umeå Södra area is given in Figure 22. A great part of pavement lifetime factors were less than 1.05 but there were some roads where the life time factor was higher than 1.5 and in these road drainage improvement could be very economical. The reason for the low life time factors is most likely the previously mentioned fact that profilometer surveys were carried out on the embankment side of the road. On the other hand in most of the roads with low life time factor the drainage was in good condition. The only roads that had relatively poor drainage and low life time factor were roads 518, 520 and 553.

Figure 22. Pavement lifetime factors in the Umeå Södra area.

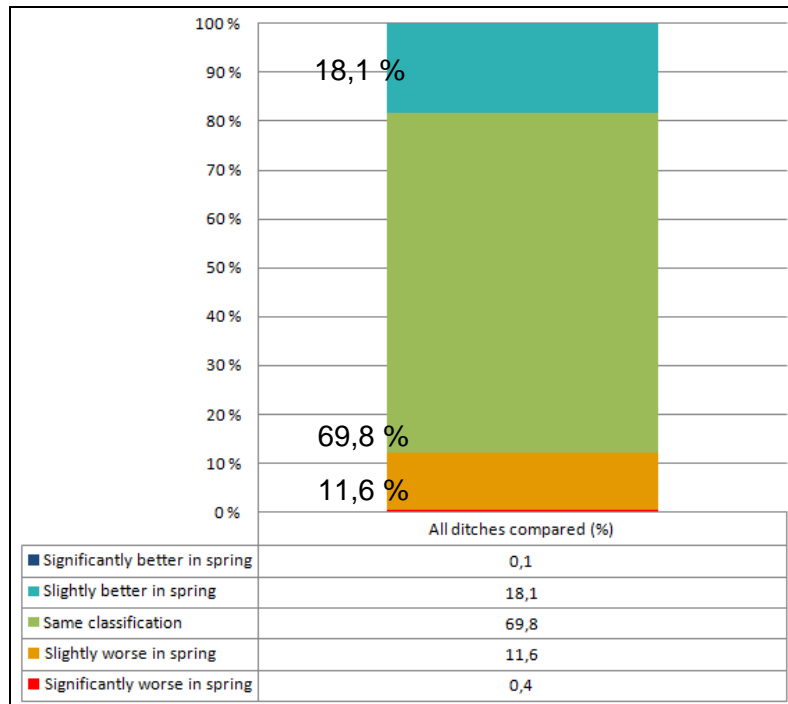
According to the results of these seasonal tests the majority (69.8%) of the drainage were classified into the same class both times, and only a small proportion of the drainage classes were significantly different (Figure 23). Only 0.1% of ditches were classified to be significantly better in spring and 0.% significantly worse in spring.

Figure 23. The distribution of comparison classes.

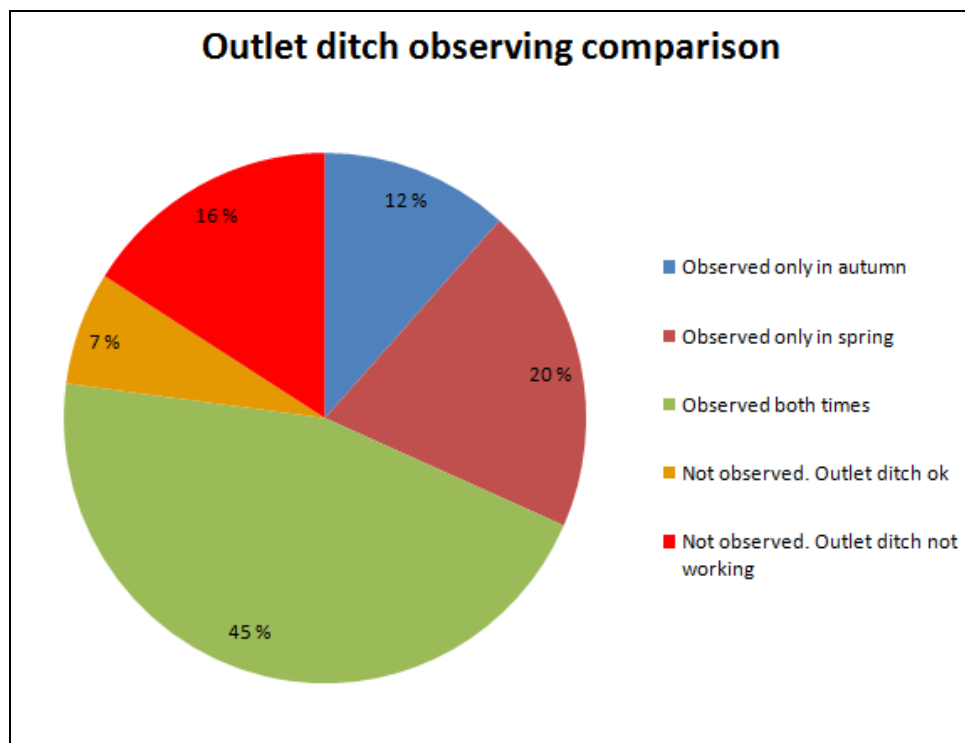
outlet ditches and their condition. This was then compared with the autumn and spring analysis results. These comparisons showed that only about half (45%) of the outlet ditches had been observed both times, and that one in four (23%) of the outlet ditches had not been observed at all. The majority of these unobserved outlet ditches were not working and were critical to drainage performance. The statistics of the outlet ditch observations are summarised in Figure 25.

Figure 25. Statistical summary of the outlet ditch comparison.

The results of these comparisons clearly show that a third video camera can make the outlet ditch inventory more reliable. It is not easy to observe outlet ditches from a moving car, and even if it is observed the assessment of its condition can still be unreliable.

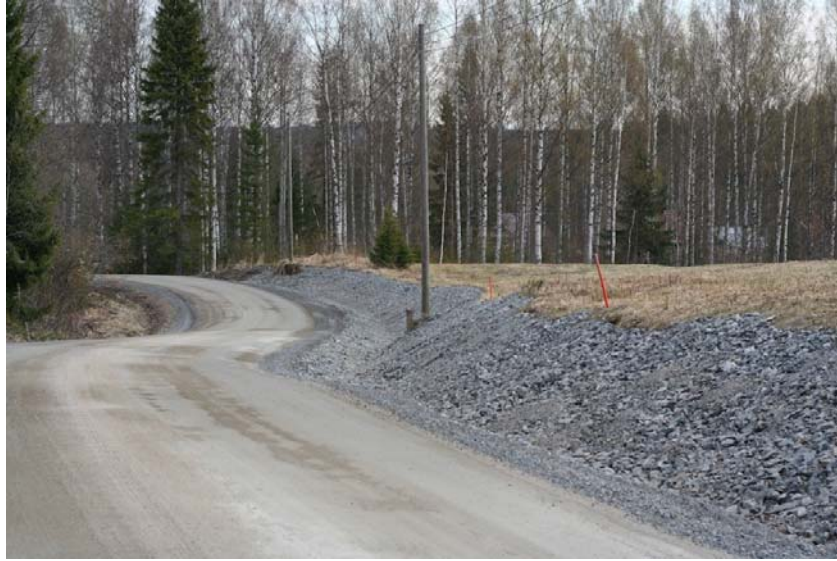
Figure 26. The example of supported slopes adjacent to a ditch. Photograph from the ROADEx test site, Jämsä, Finland.

The ROADEX project has proposed new structural solutions to strengthen slopes that are sensitive to erosion. Slopes can be supported by rocks or ballast to prevent soil flowing to the bottom of the ditch. Figure 26 shows an example of a typical structure. The photograph was taken at the ROADEX test site in Jämsä, Finland.
